Report on Visit to North Eastern October 2009

By Oliver Hawes (Geotechnical Engineer)

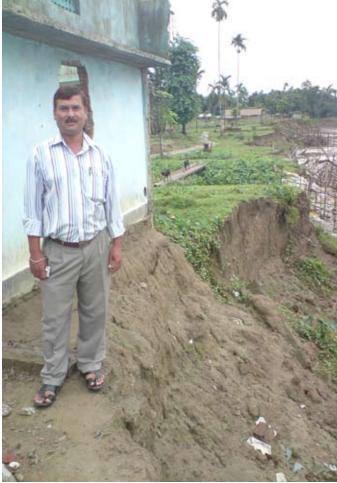
Tipling, Assam, October 2009 - A high priority area for the District Commisioner because homes are having to be abandoned. In the picture a representative of the Water Resources Department"

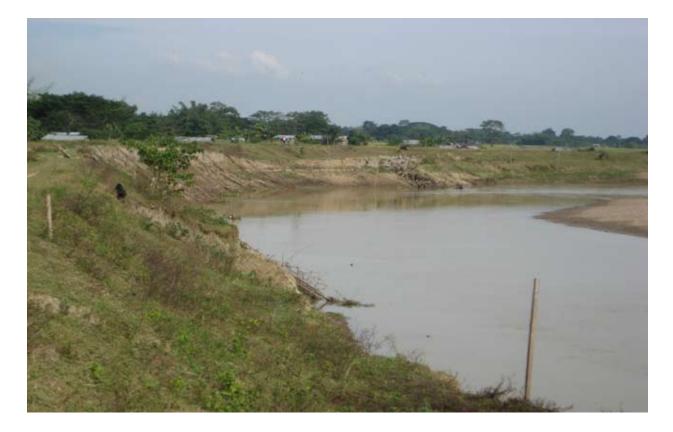
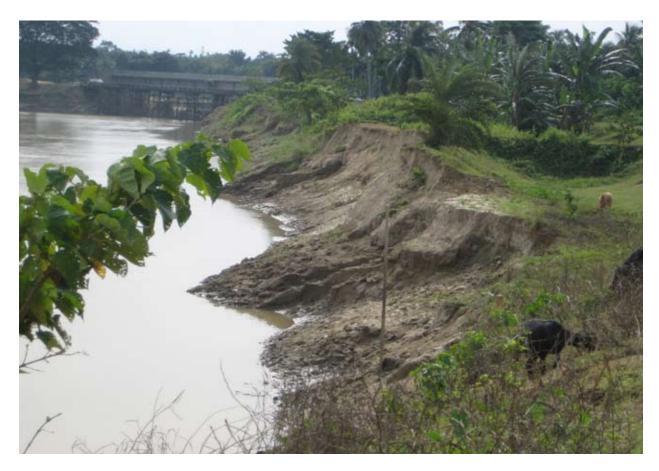
Above and below: Typical problems of river bank erosion

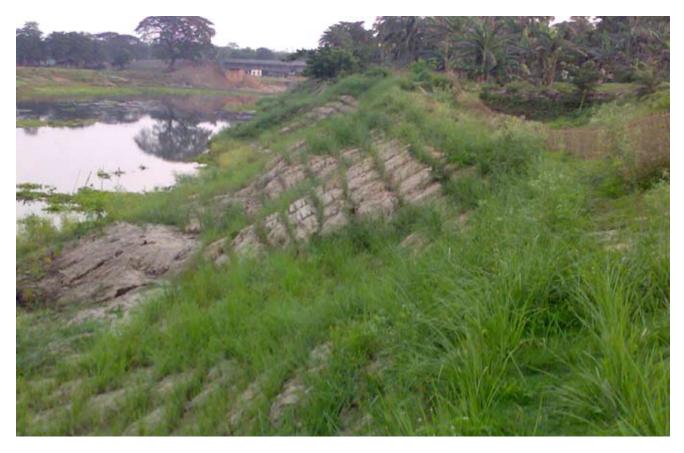
Repaired and stabilized with Vetitiver hedgerows (vertical and horizontal). Vetiver after first season's grouth and before trimming, Telehi, Assam, October 2009

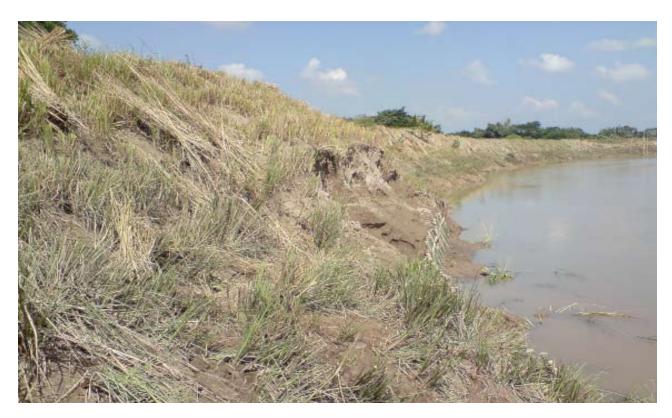
Slumping caused by undercutting of bank below low water level. Telehi, 28 October 2009, after the flood water had gone down and the vetiver was trimmed

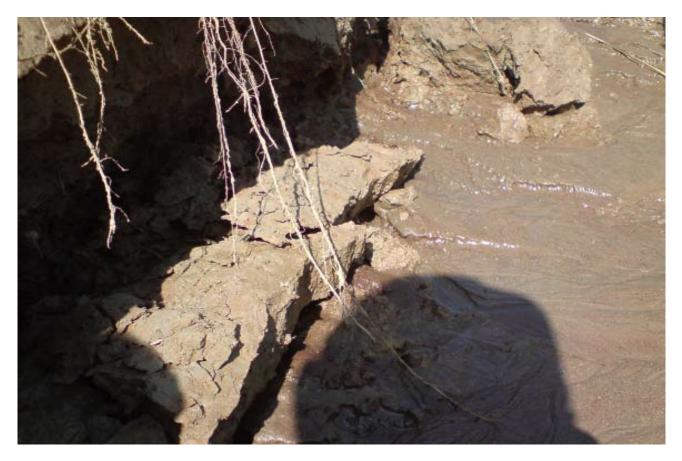
On 22 October we had report that a small section had slipped (5x5m). I've prepared a separate paper on these sites.

Telehi, Assam, October 2009, a steep section of the bank that failed, note water seepage at the base of the slope from adjoining ground and length of Vetiver roots recovered from the failed area

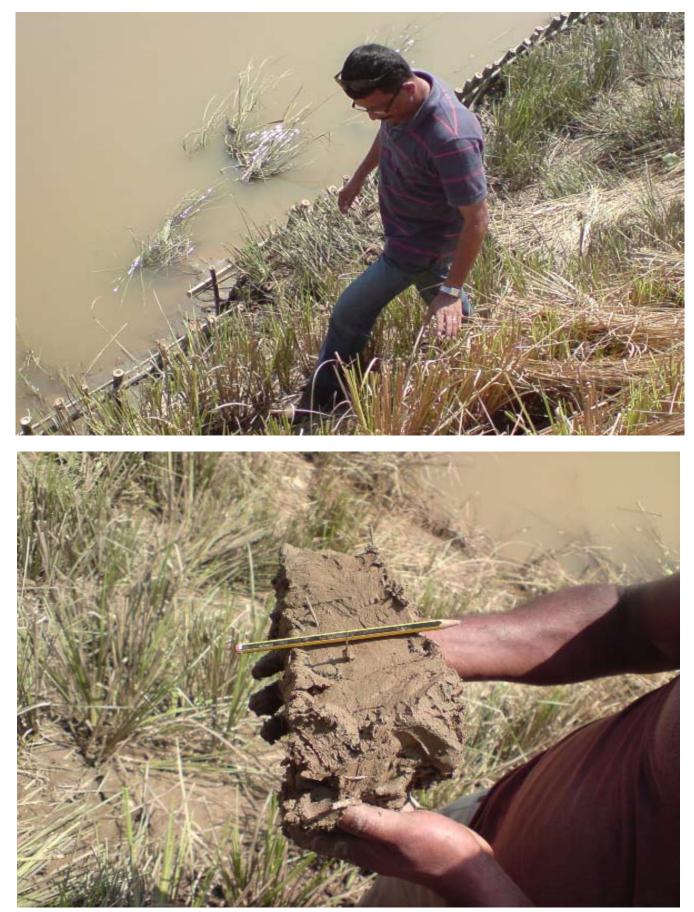
100 to 150mm of clay sediment was deposited within the river bank planted with vetiver during the monsson season 2009, Telehi, Assam, October 2009

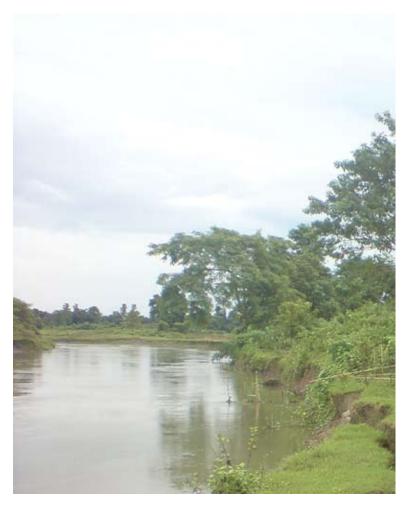
In addition to the erosion caused by the flow of water, the river banks tend to slump when the water level in the river starts to recede after the floods. This is because the soils are relatively impermeable so that the pore pressures remain high; this causes the effective stress on the shear surfaces to be low, resulting in a low shear strength. The failures often show themselves as initial tension cracks at generally less than 1m but up to about 2m behind the slope crest.

Tension cracking develops as the the river goes down - Dirak, Assam, October 2009

4. Where space allows 2 rows of vetiver planted behind the crest of the slope may be beneficial in some areas to assist the reduction of pore pressure as the river level goes down.
