RAVINE STABILISATION IN KIKWIT CITY IN OCTOBER 2005

This is the head of a 100 m long ravine; it is 15 m deep and covers 20,000 square meters. This required 120,000 slips and is seen just after the initial planting was done, 12 km of hedges were planted and all the work was completed in 18 day for \$US 7, 000. There are over 180 ravines like this in Kikwit, which has a million people.

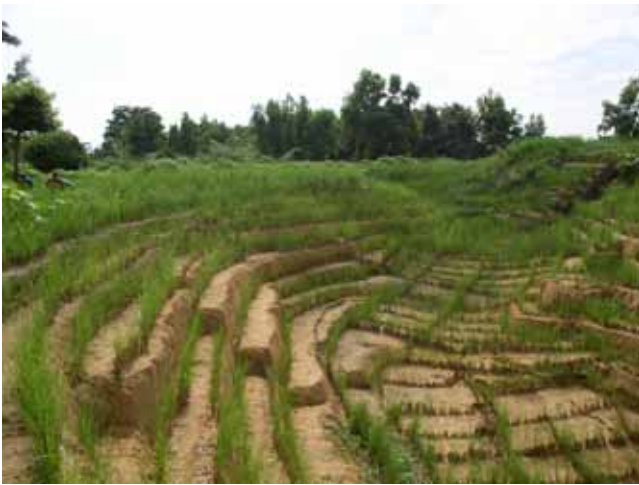
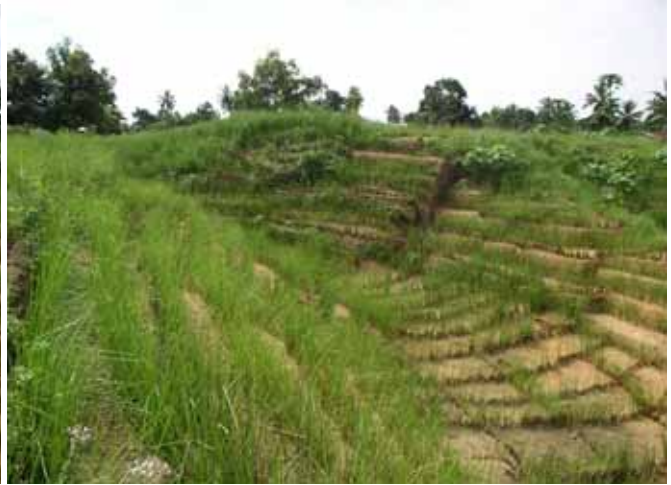
Left side of ravine two months after planting

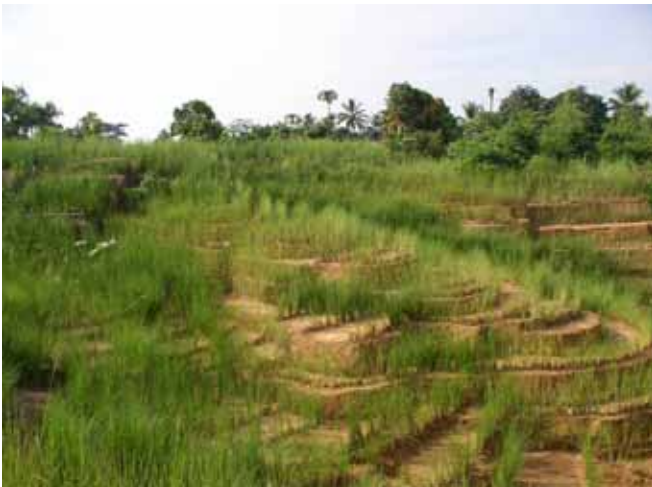
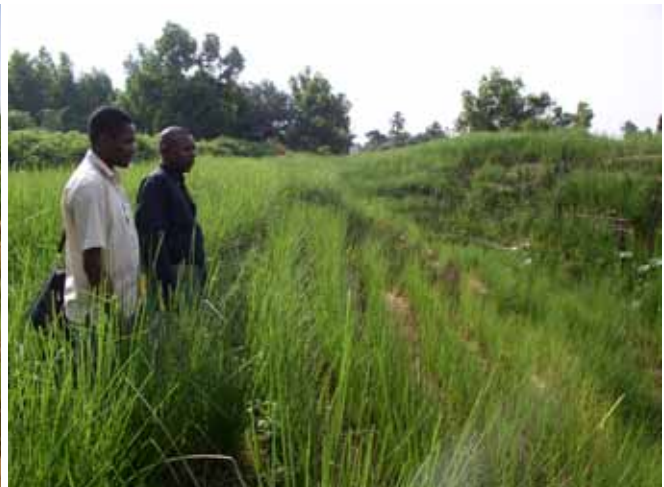
The same area four months later

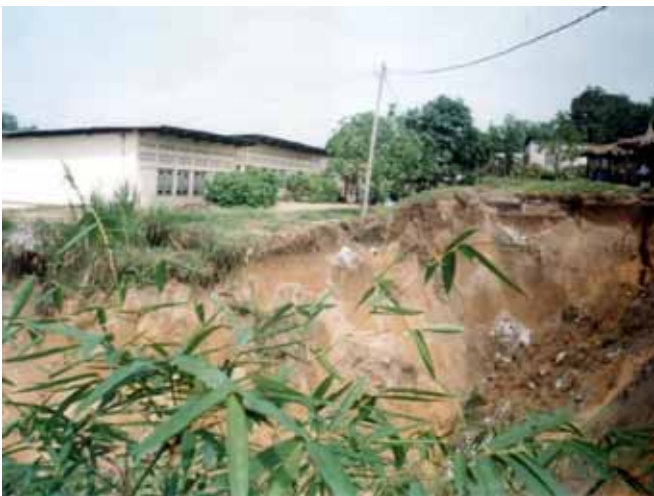
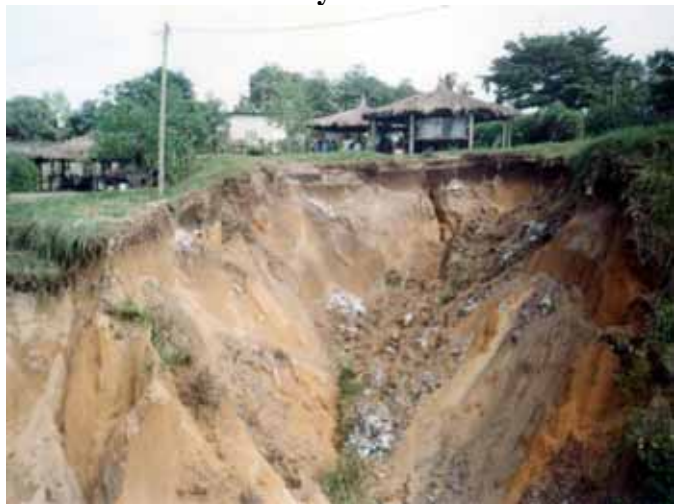
Erosion threatens a public school and its community halls

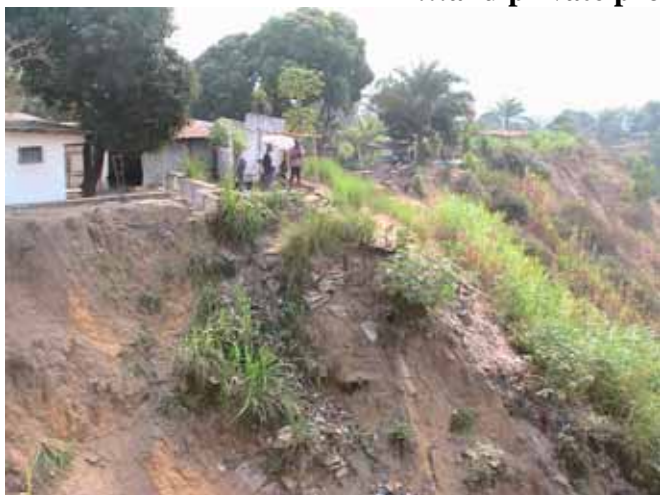
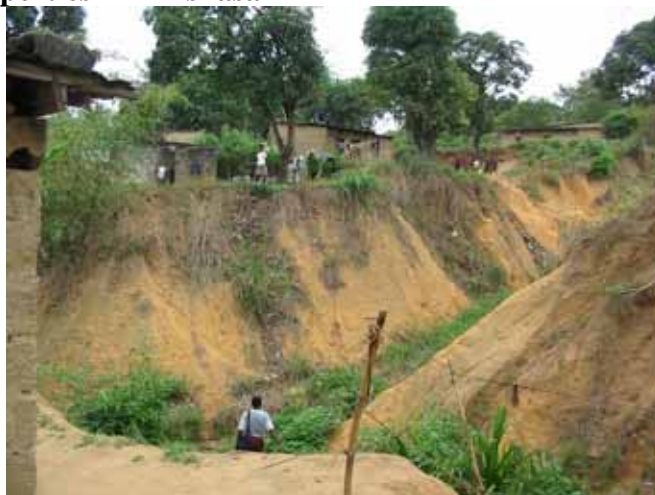
...and private properties in Kinshasa

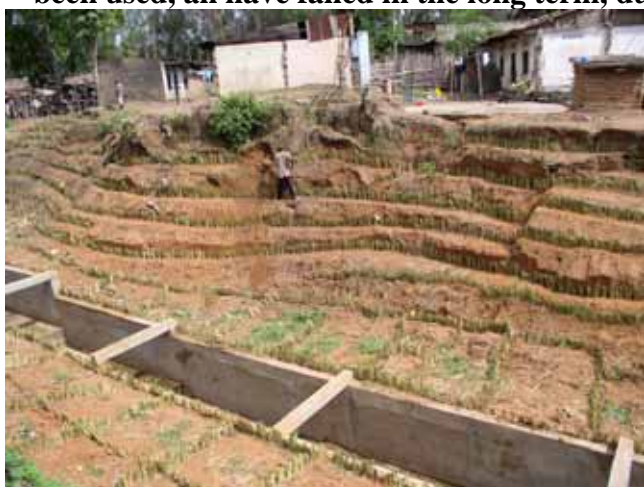
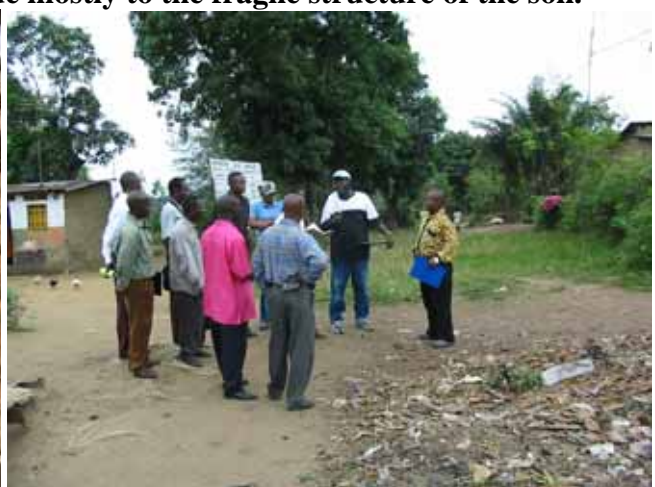
Property is threatened and communities are looking for methods of stopping this massive erosion around Kikwit City. Although many methods, ranging from hard to soft structures, have been used, all have failed in the long term, due mostly to the fragile structure of the soil.

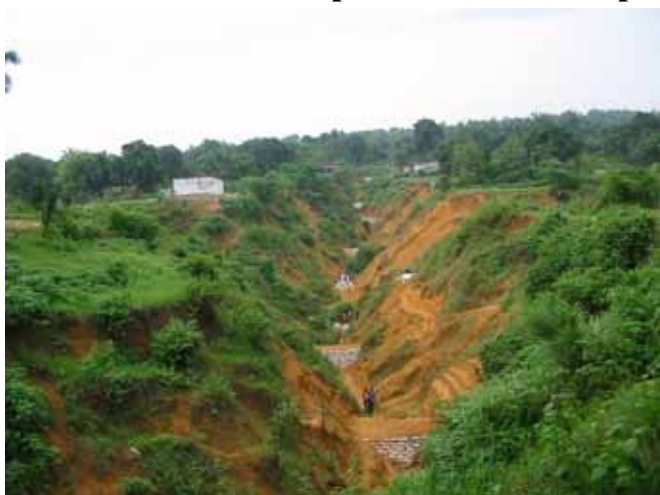
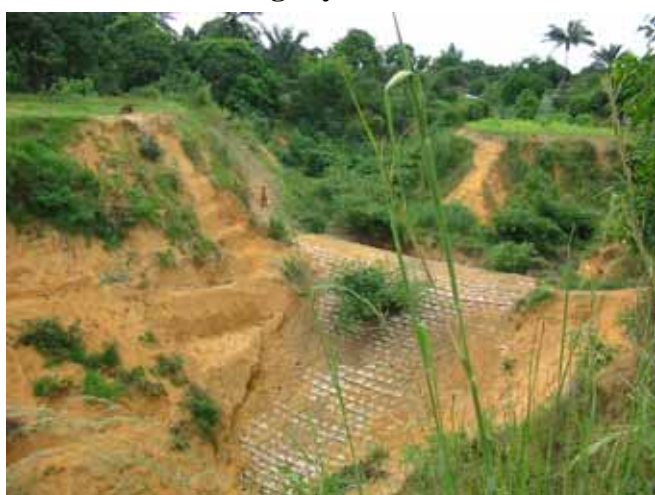
An elaborate series of check dams, built with sand bags, to stabilize this large gully, but they are ineffective as the steep side walls will collapse after rains and the gully continues to erode

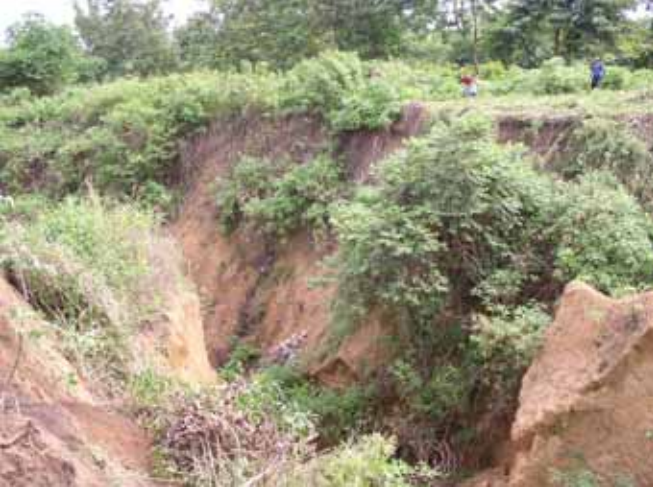
ITPKA Ravine before re-profiling

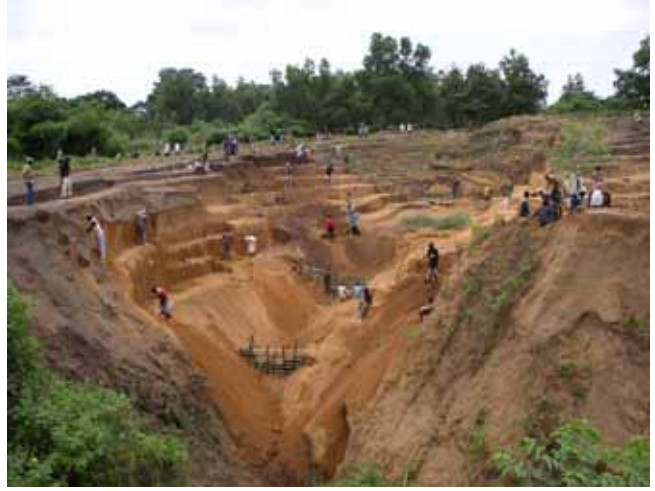
Re-profiling the ITPKA ravine slopes

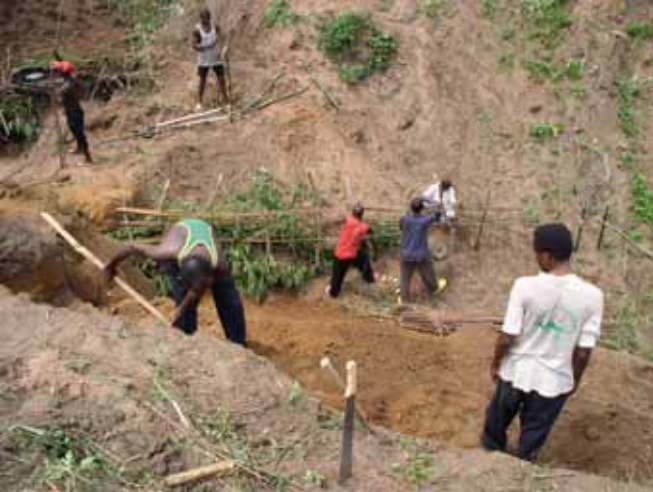
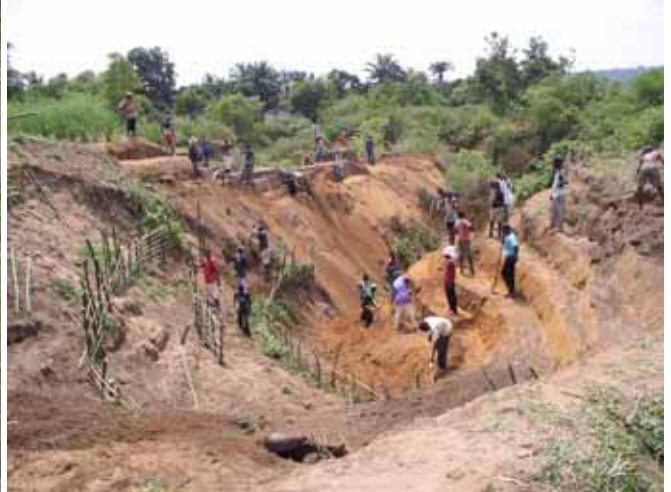
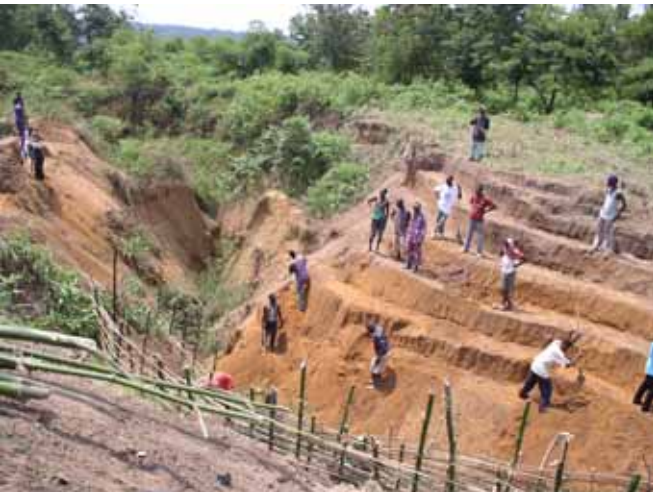
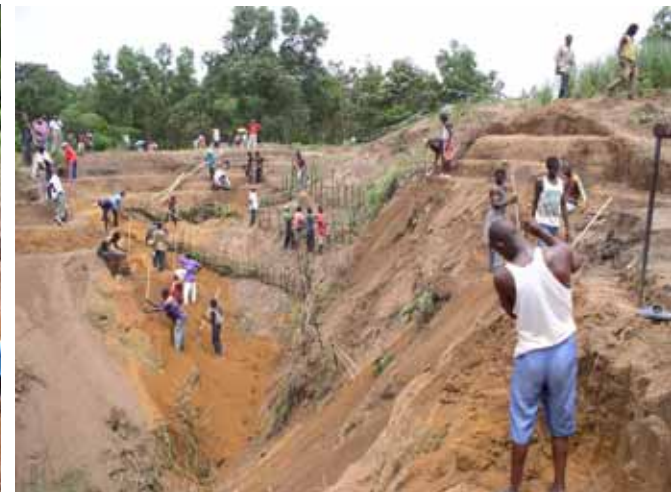
Retaining barriers built with tree branches providing temporary support for bench terraces on very steep and highly fragile soils

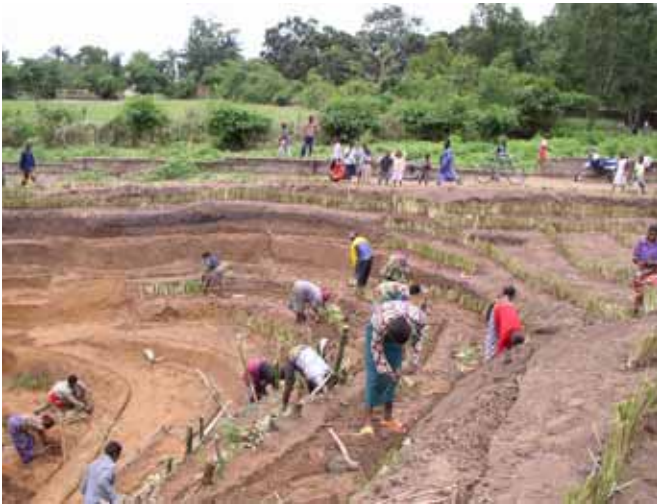
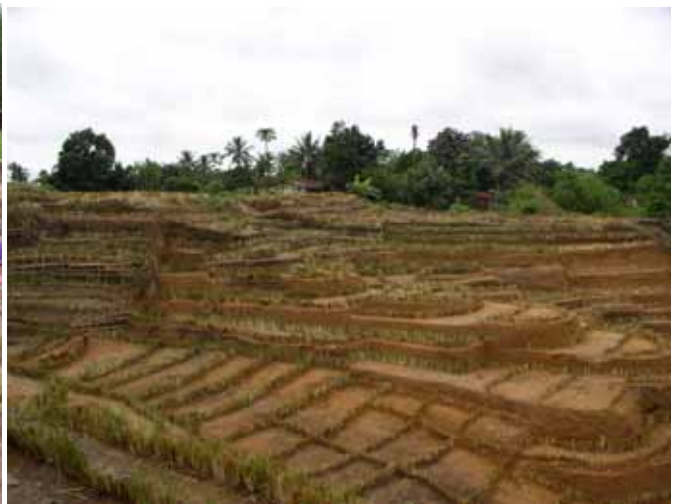
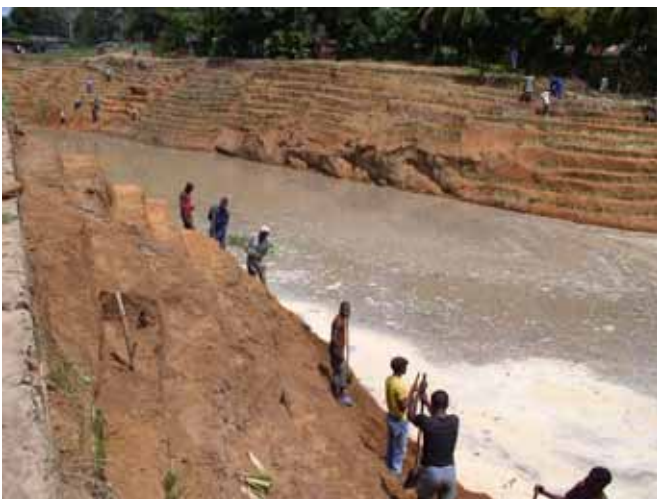
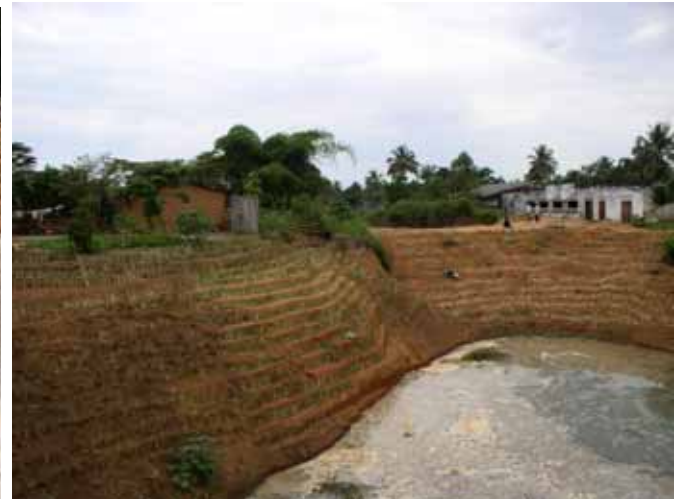
Planting vetiver hedges on contour lines on the terraces

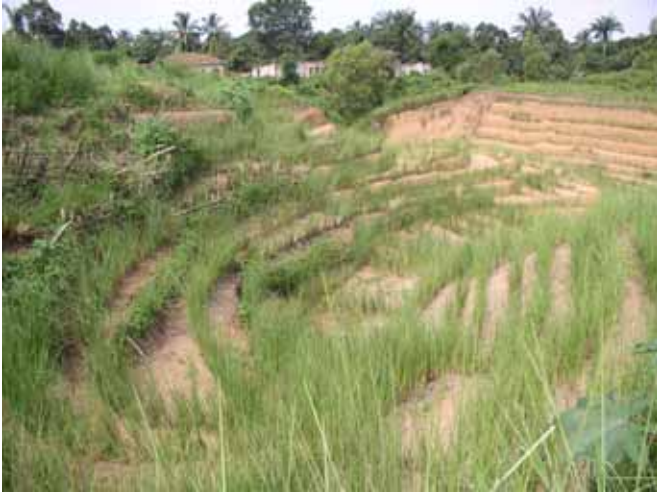
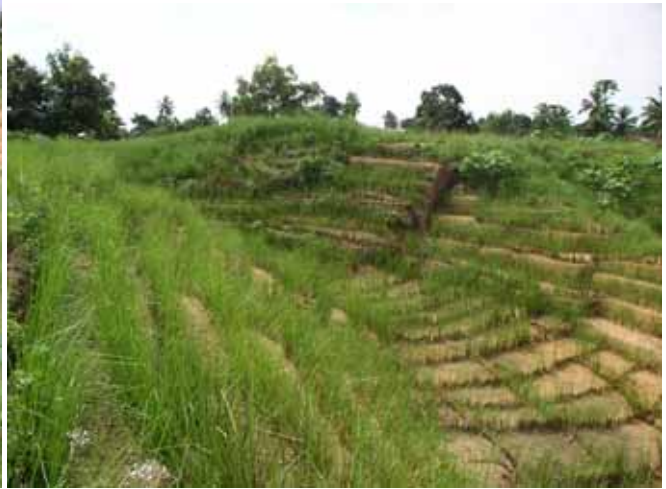
Vetiver growth 60 days after planting

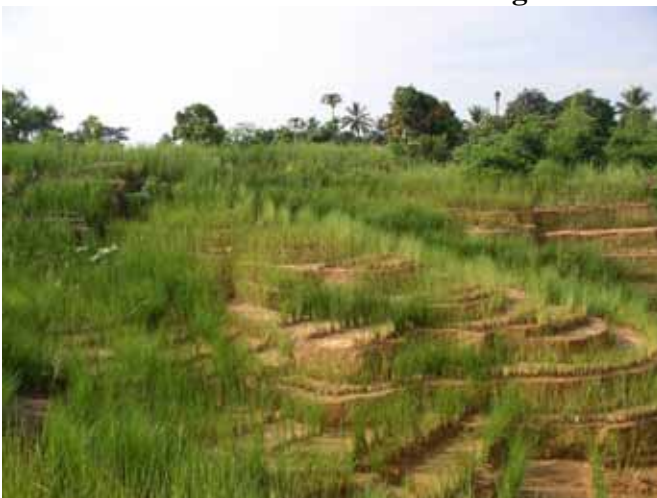
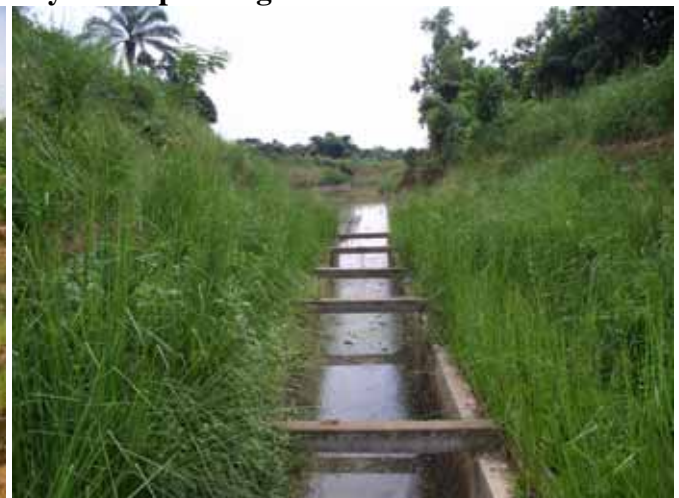
Vetiver growth 120 days after planting

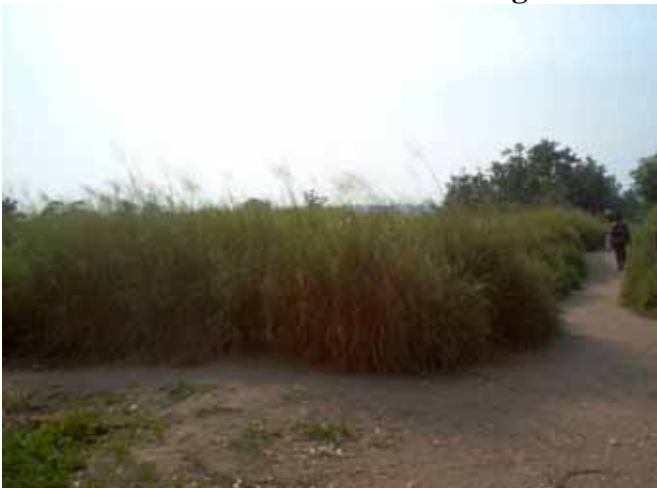
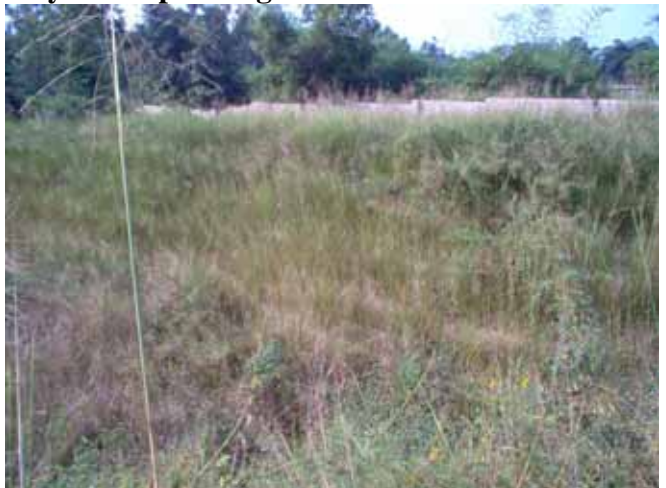
Vetiver growth 240 days after planting
