Vetiver System for Stream Bank Stabilisation

**(With special references to the river and canal bank stabilisation
in Australia and Vietnam)**

Paul Truong

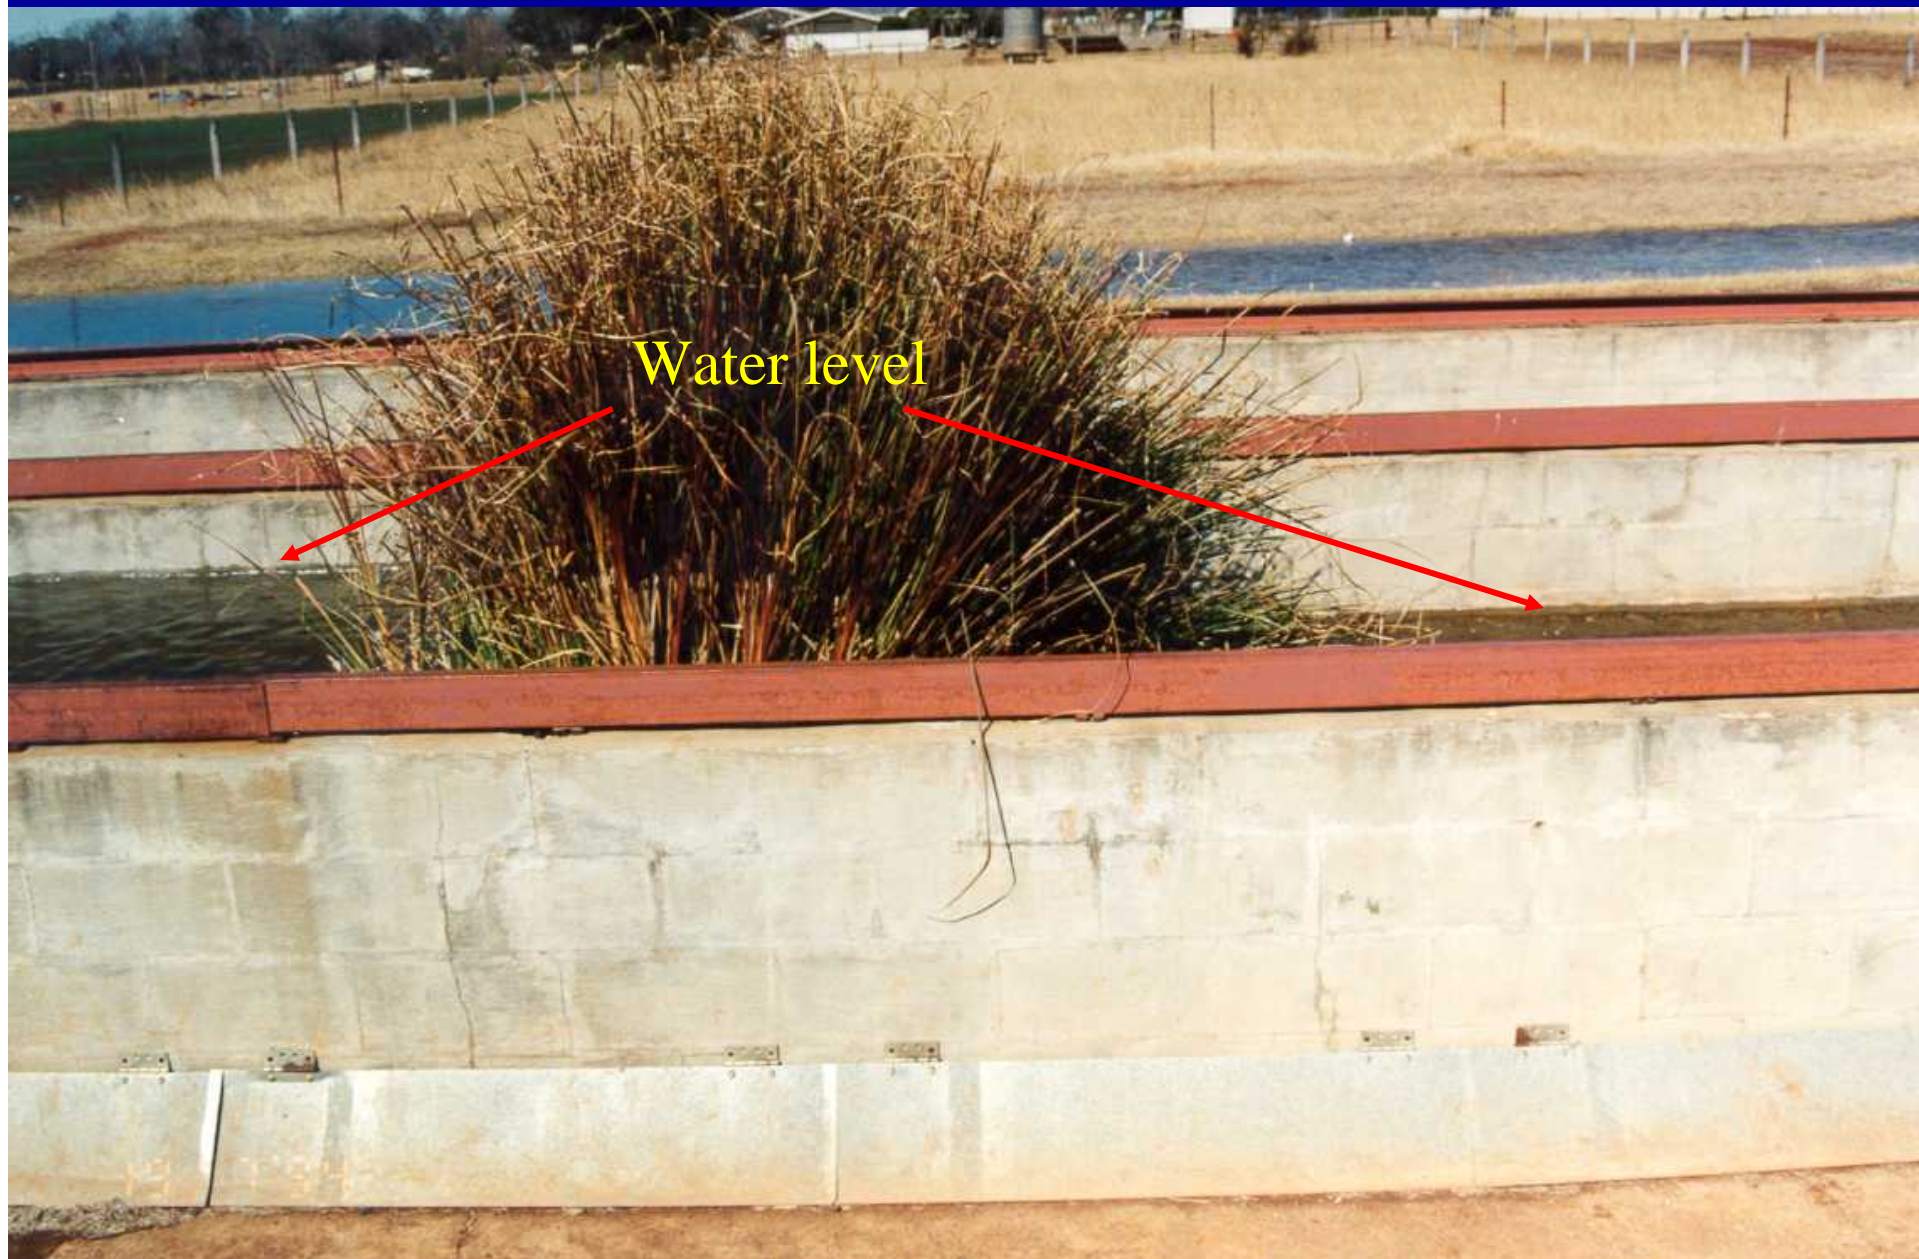
In flume test a mature hedge can bank up water to 600mm depth

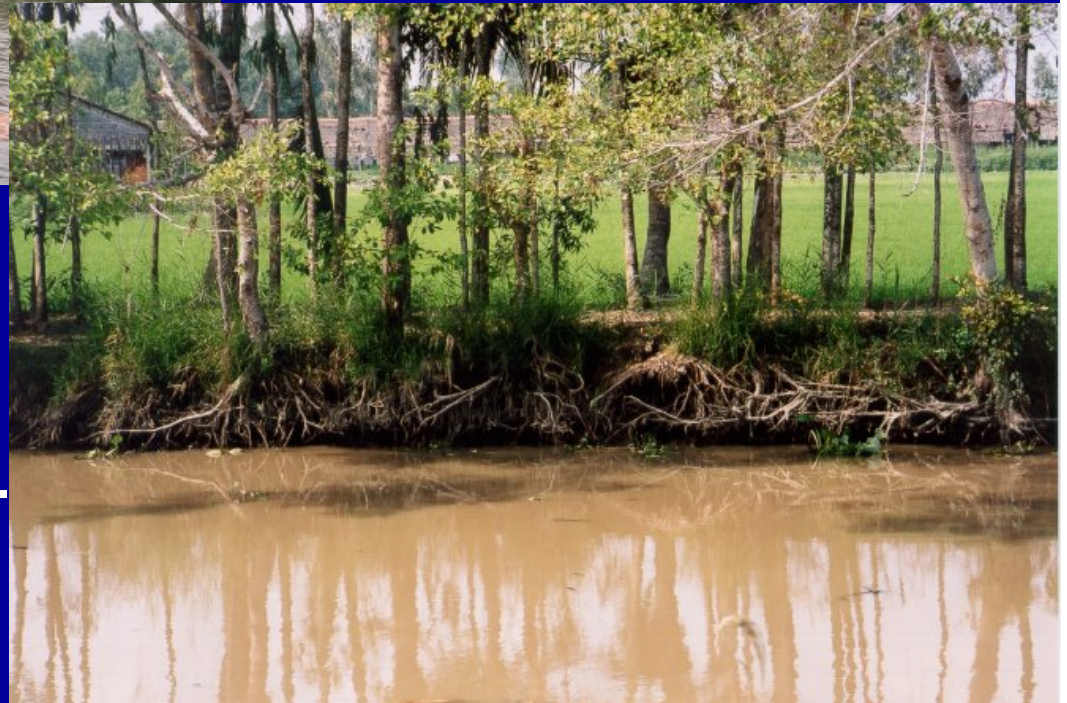
Soft structure:

Using the water hyacinth barrier.
But Erosion continues behind it

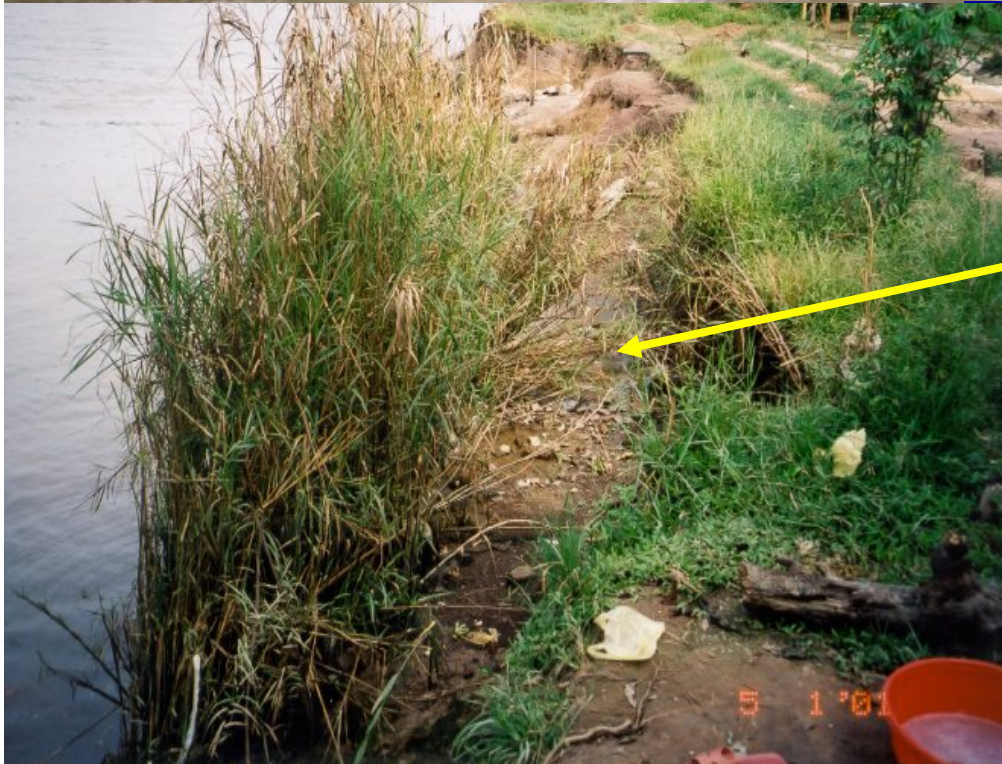
From the front it looks like this bank is well protected. But erosion continues as waves from unprotected section upstream got behind it.

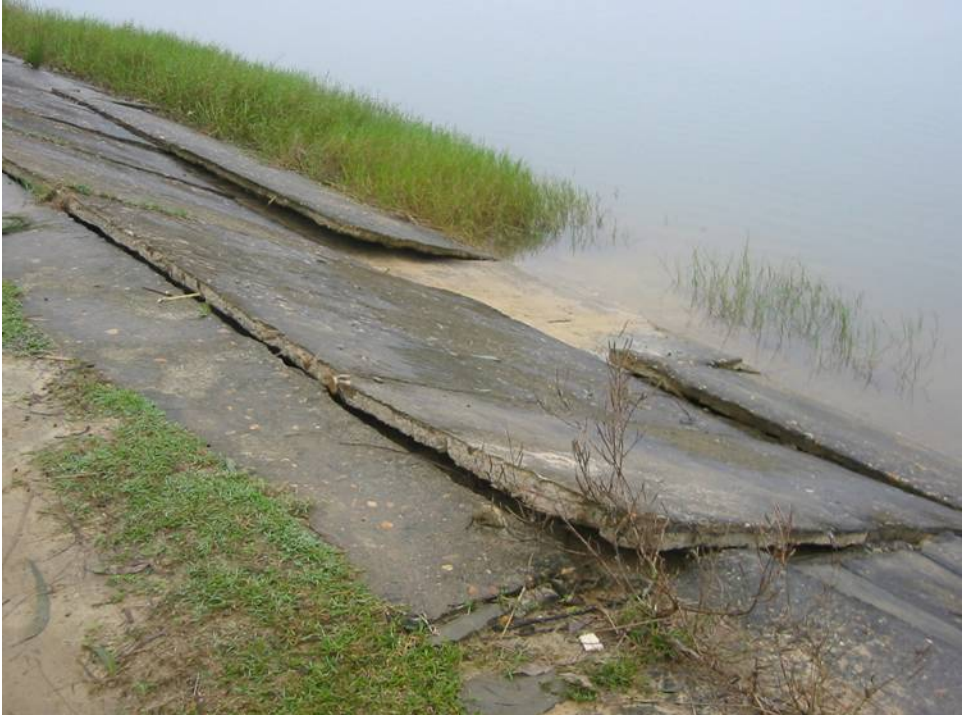
Hard structure:

Concrete plate cover on river dike

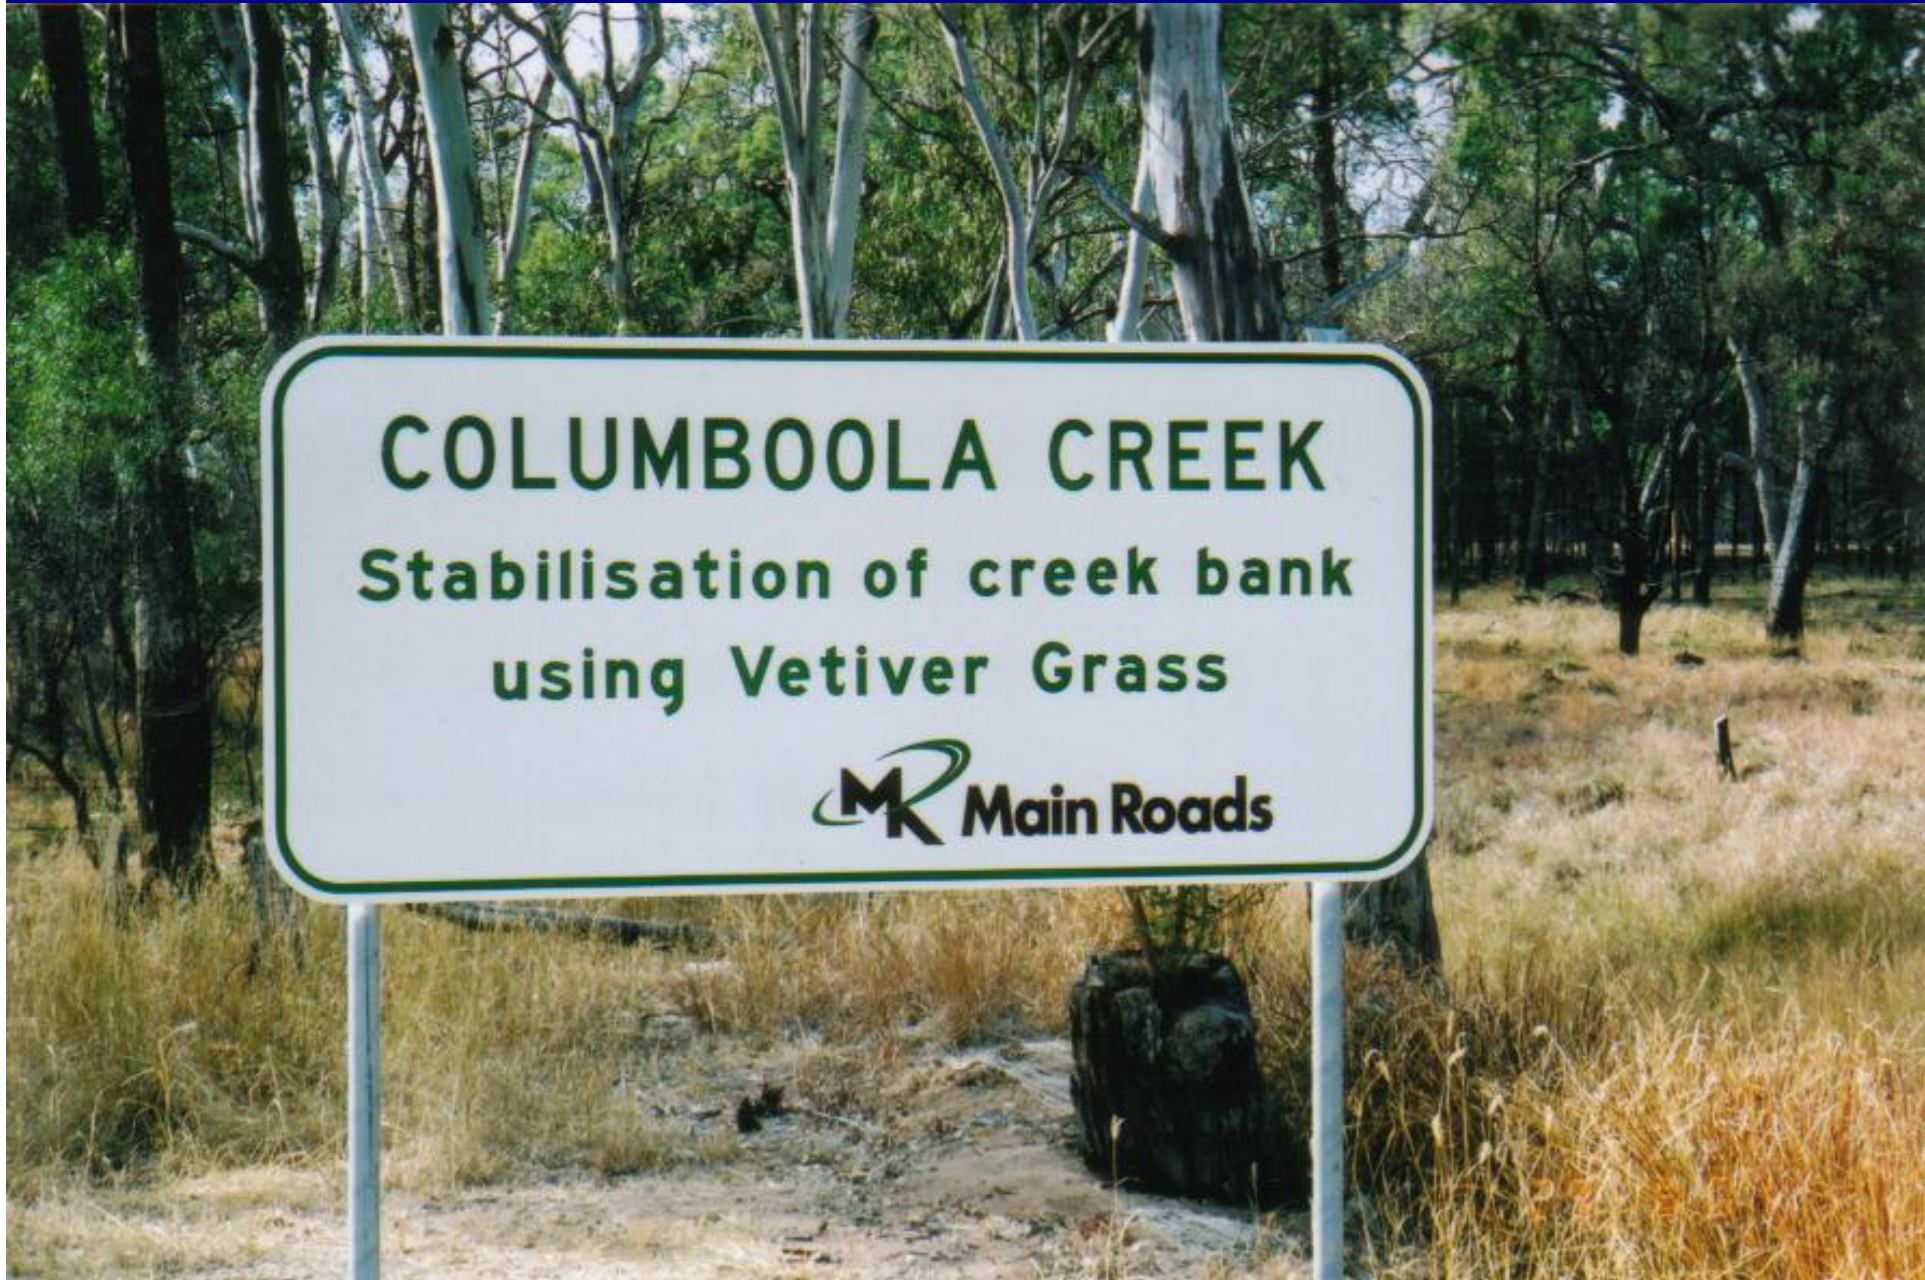
Severe erosion on the abutment of the Coolumboola Creek

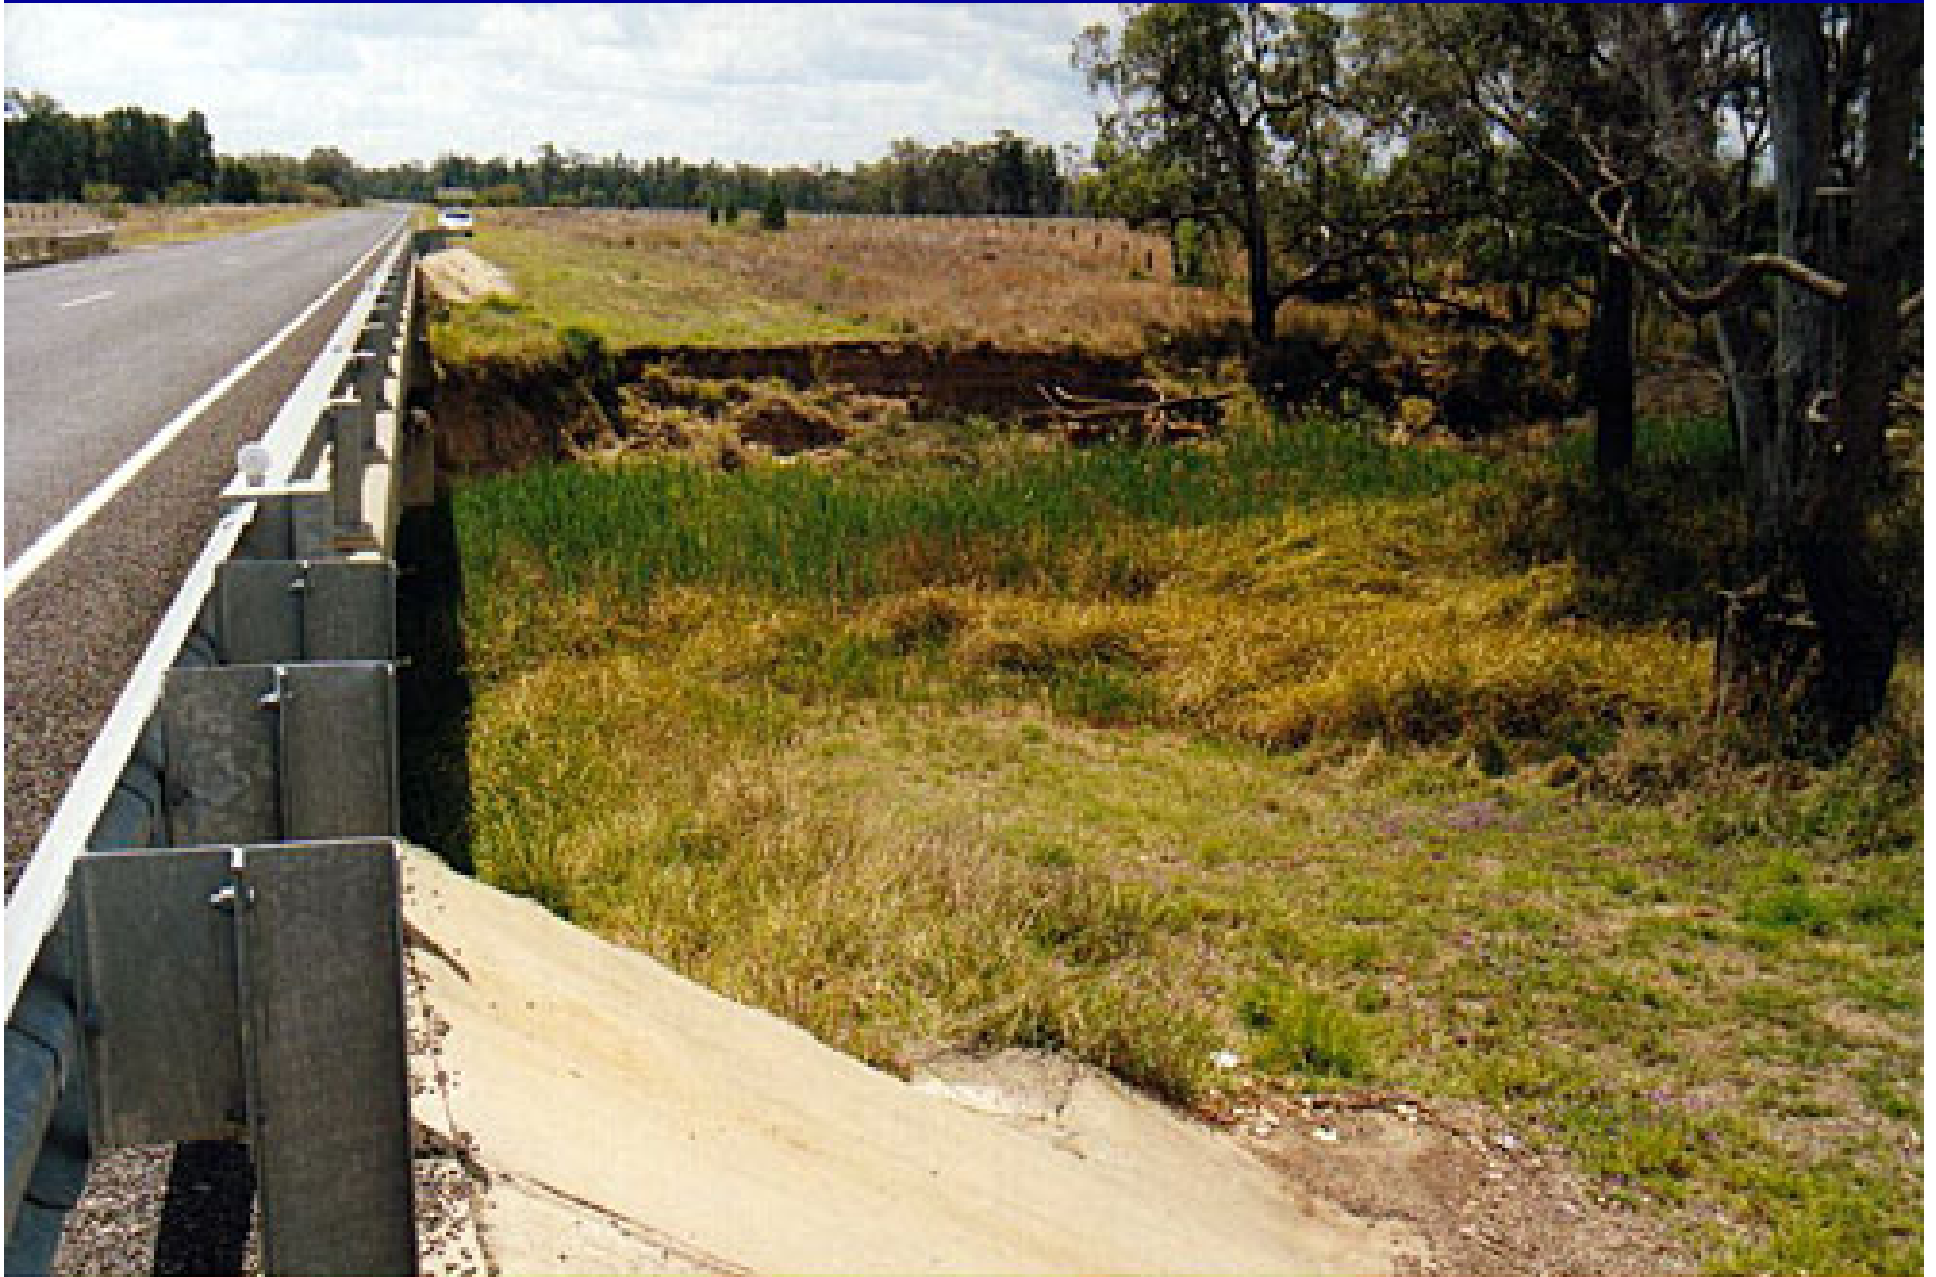
Severe erosion on the abutment of the Coolumboola Creek

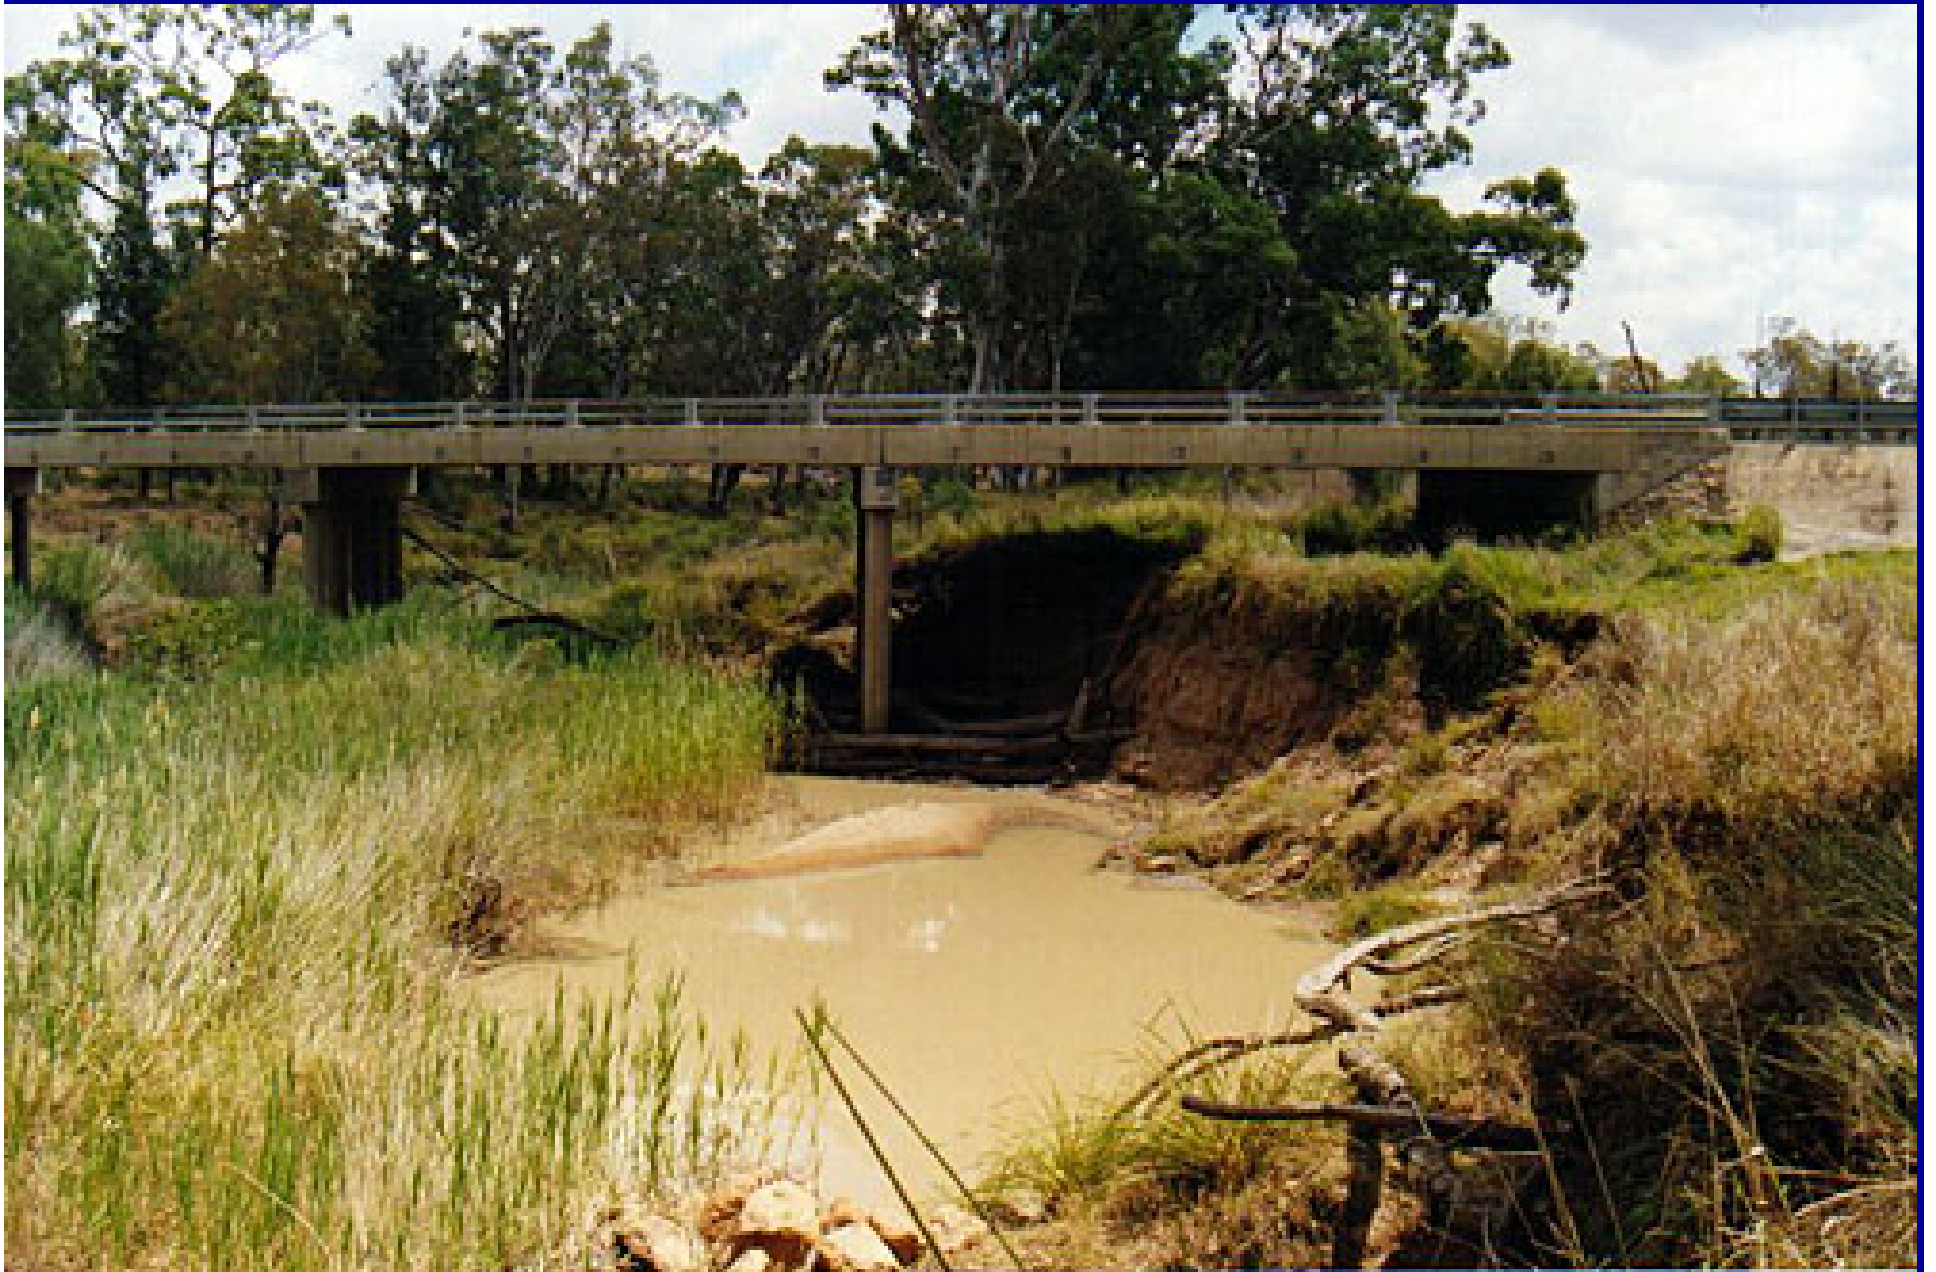
Vetiver planted after reparation

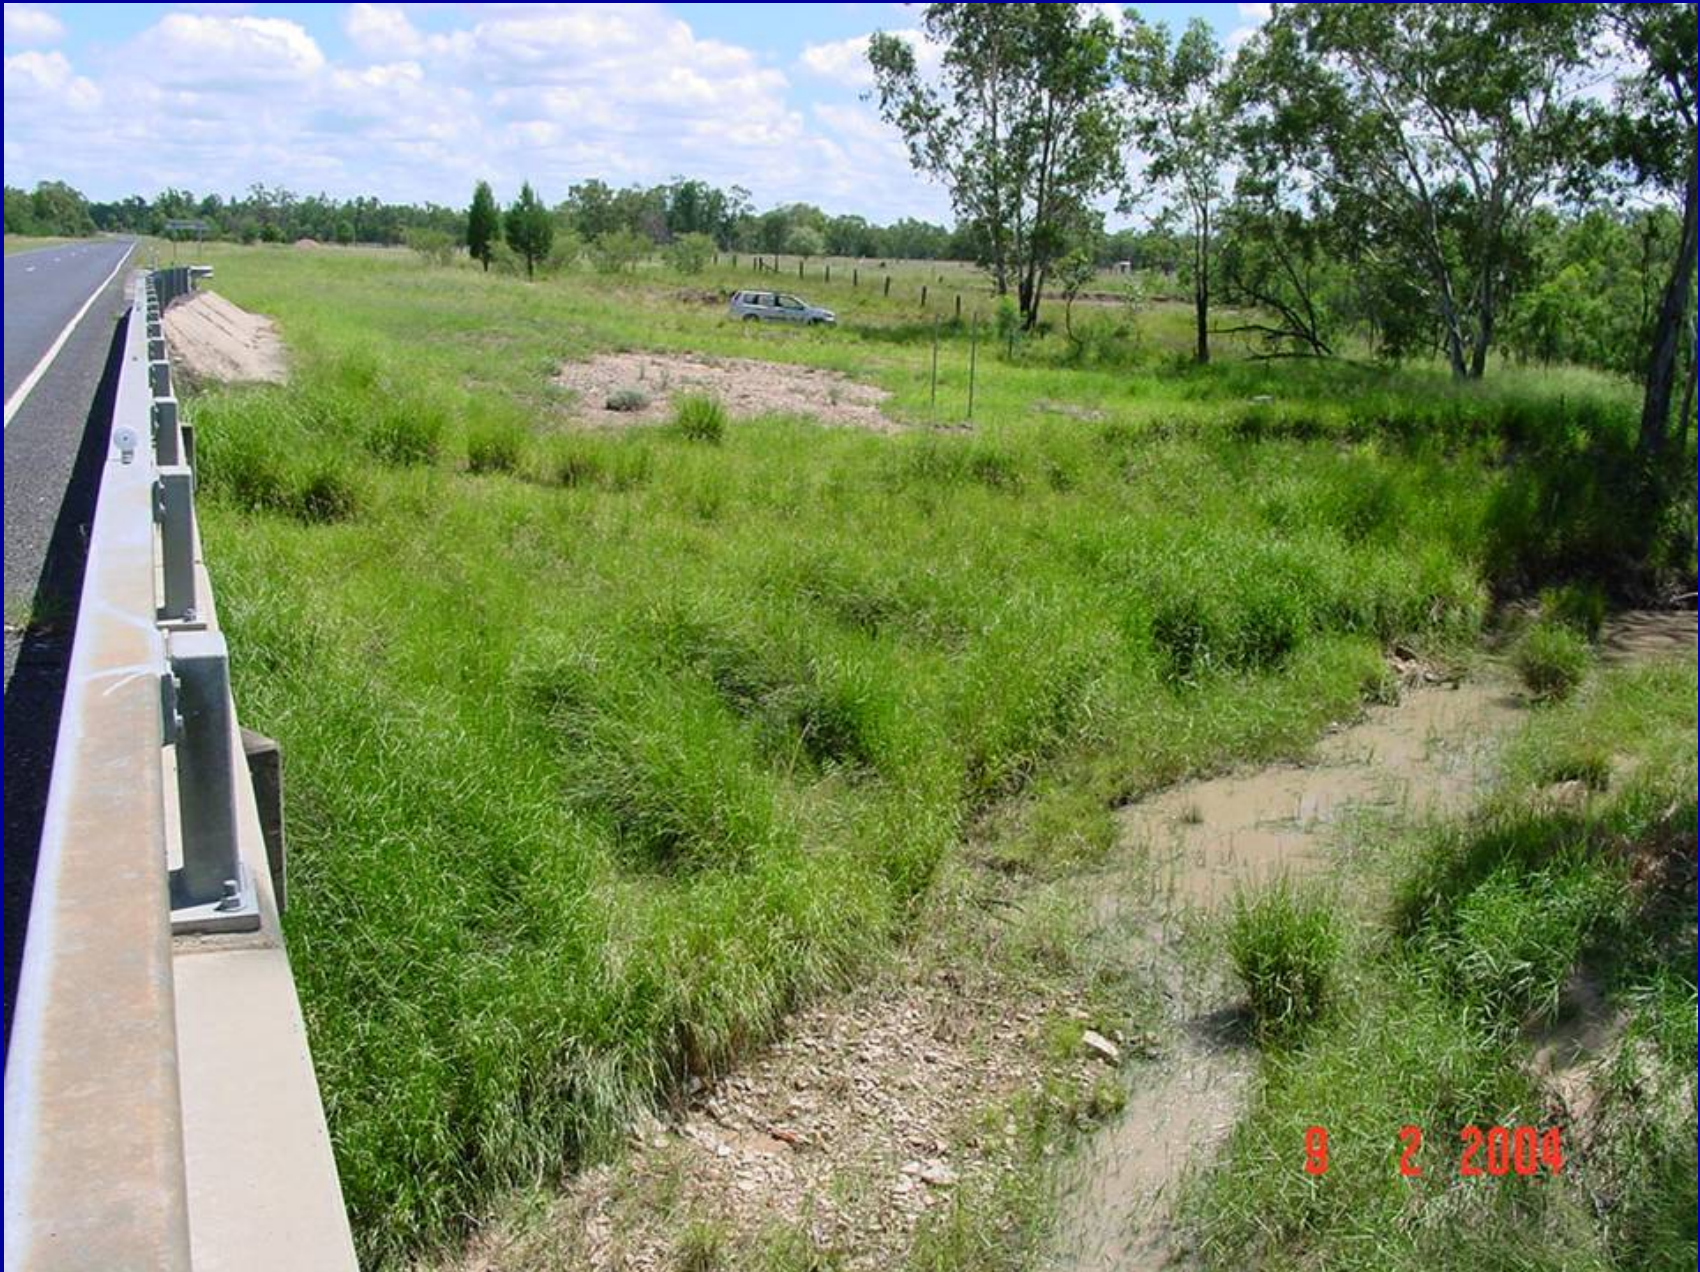
Five years after planting and after several flash floods

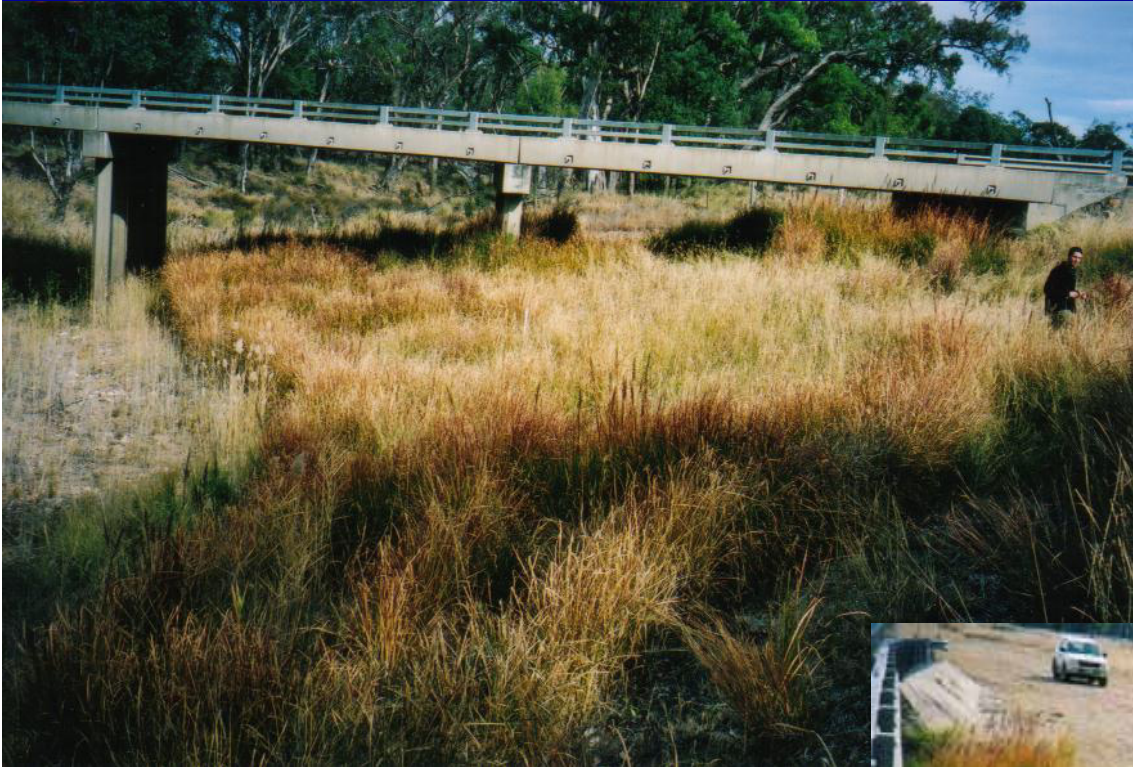
**Yellow leaves due to
winter frost**

**Note the bare area
between rows. No other
plants have survived**

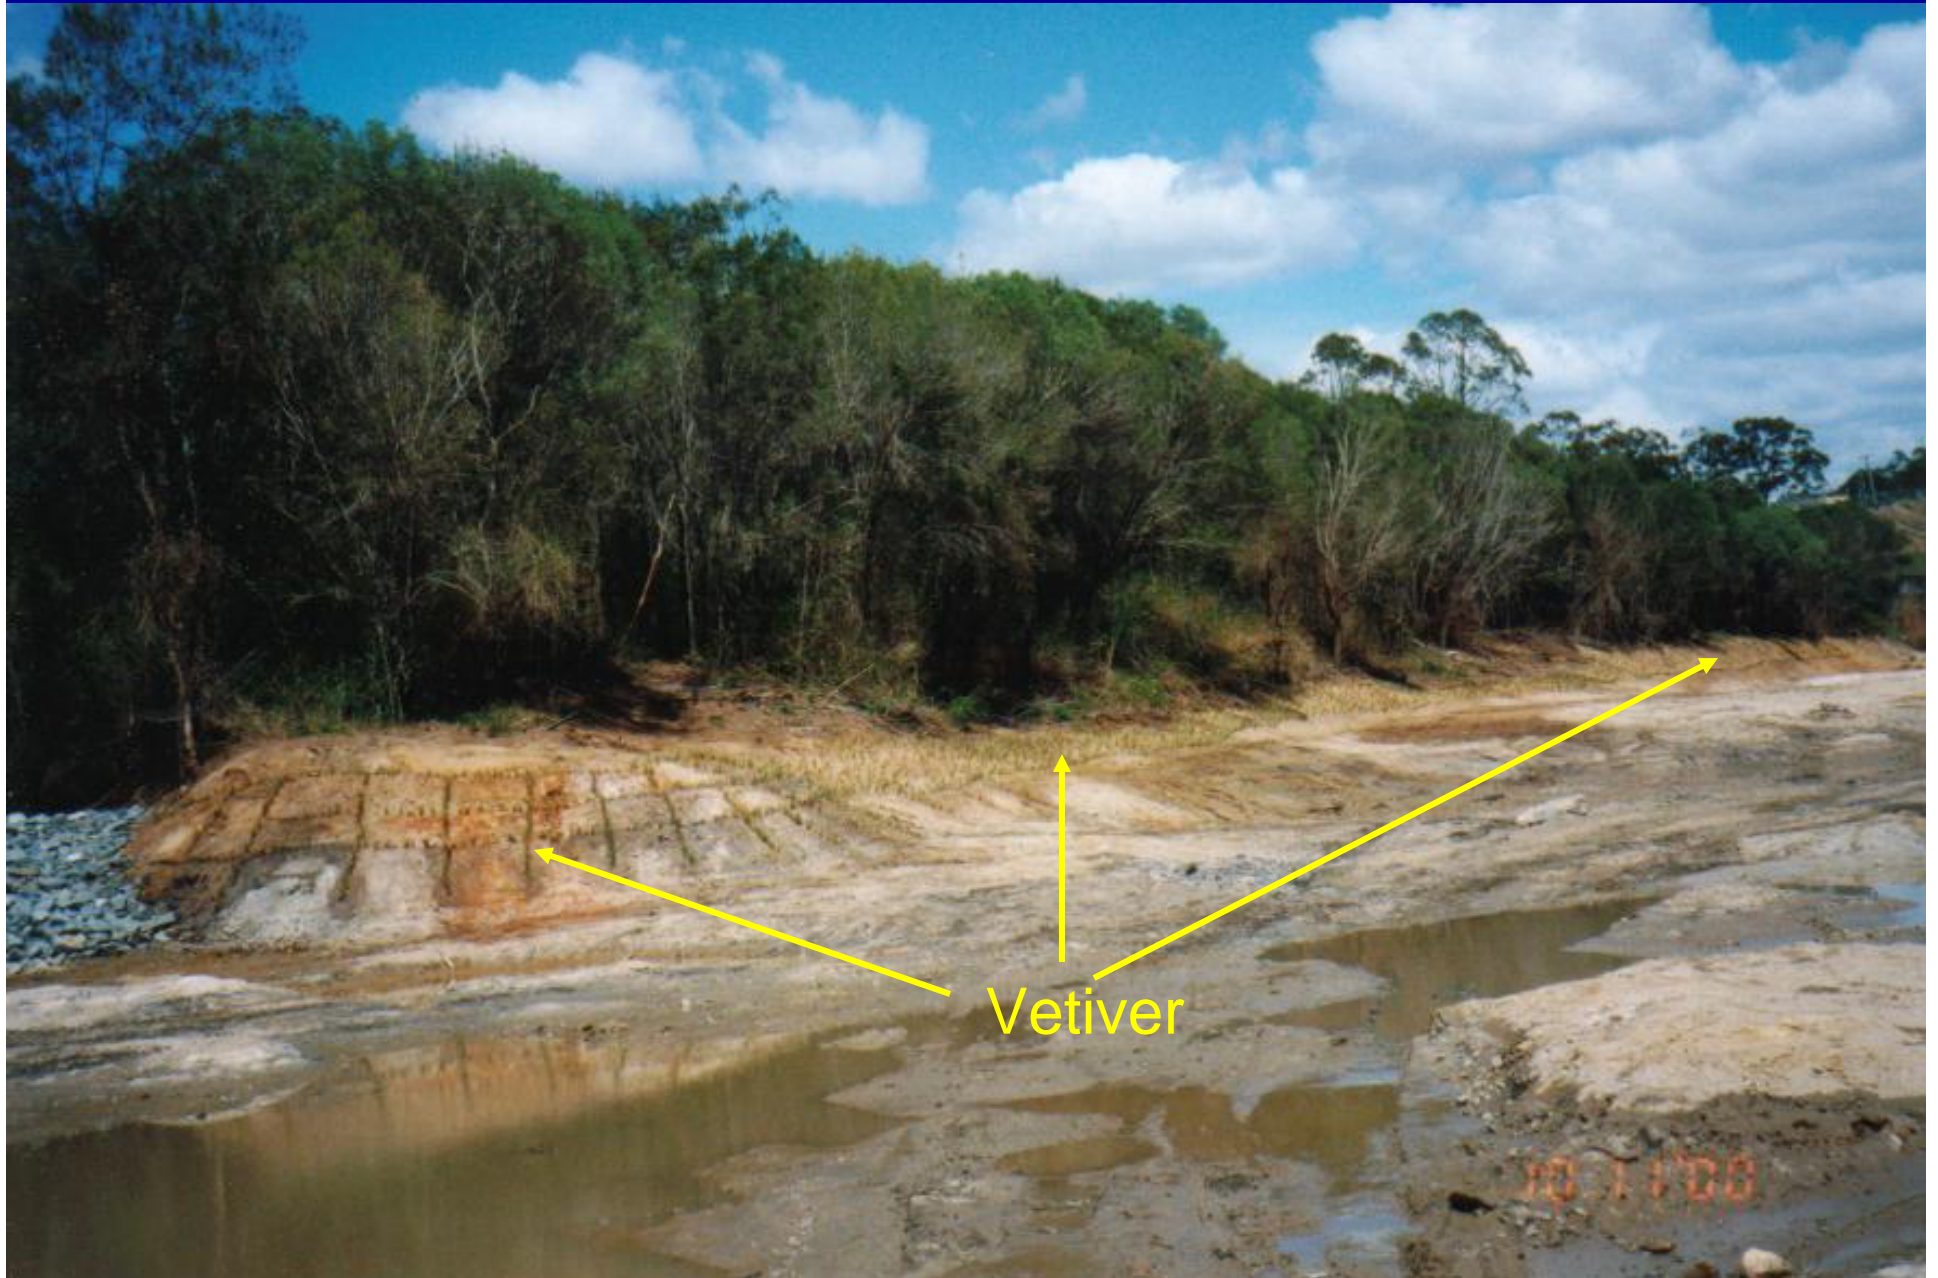
Stabilisation of creek bank of a Dam spillway

One year after planting
The water is brackish

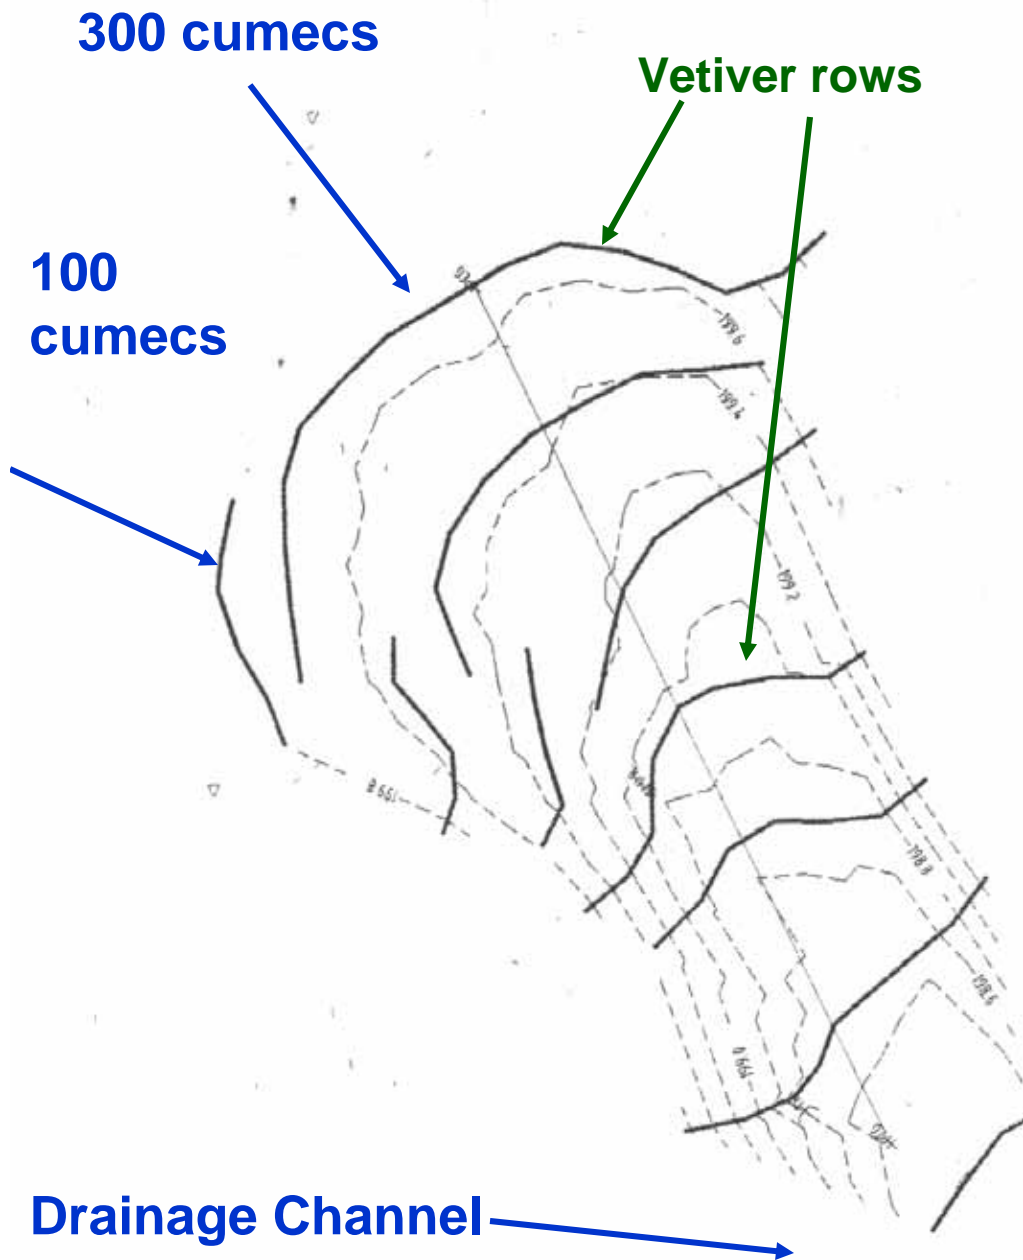
Flood erosion control in drainage channel

Vetiver hedges were established to spread water out and also to divert water to the drain

Looking sideways towards the channel opening

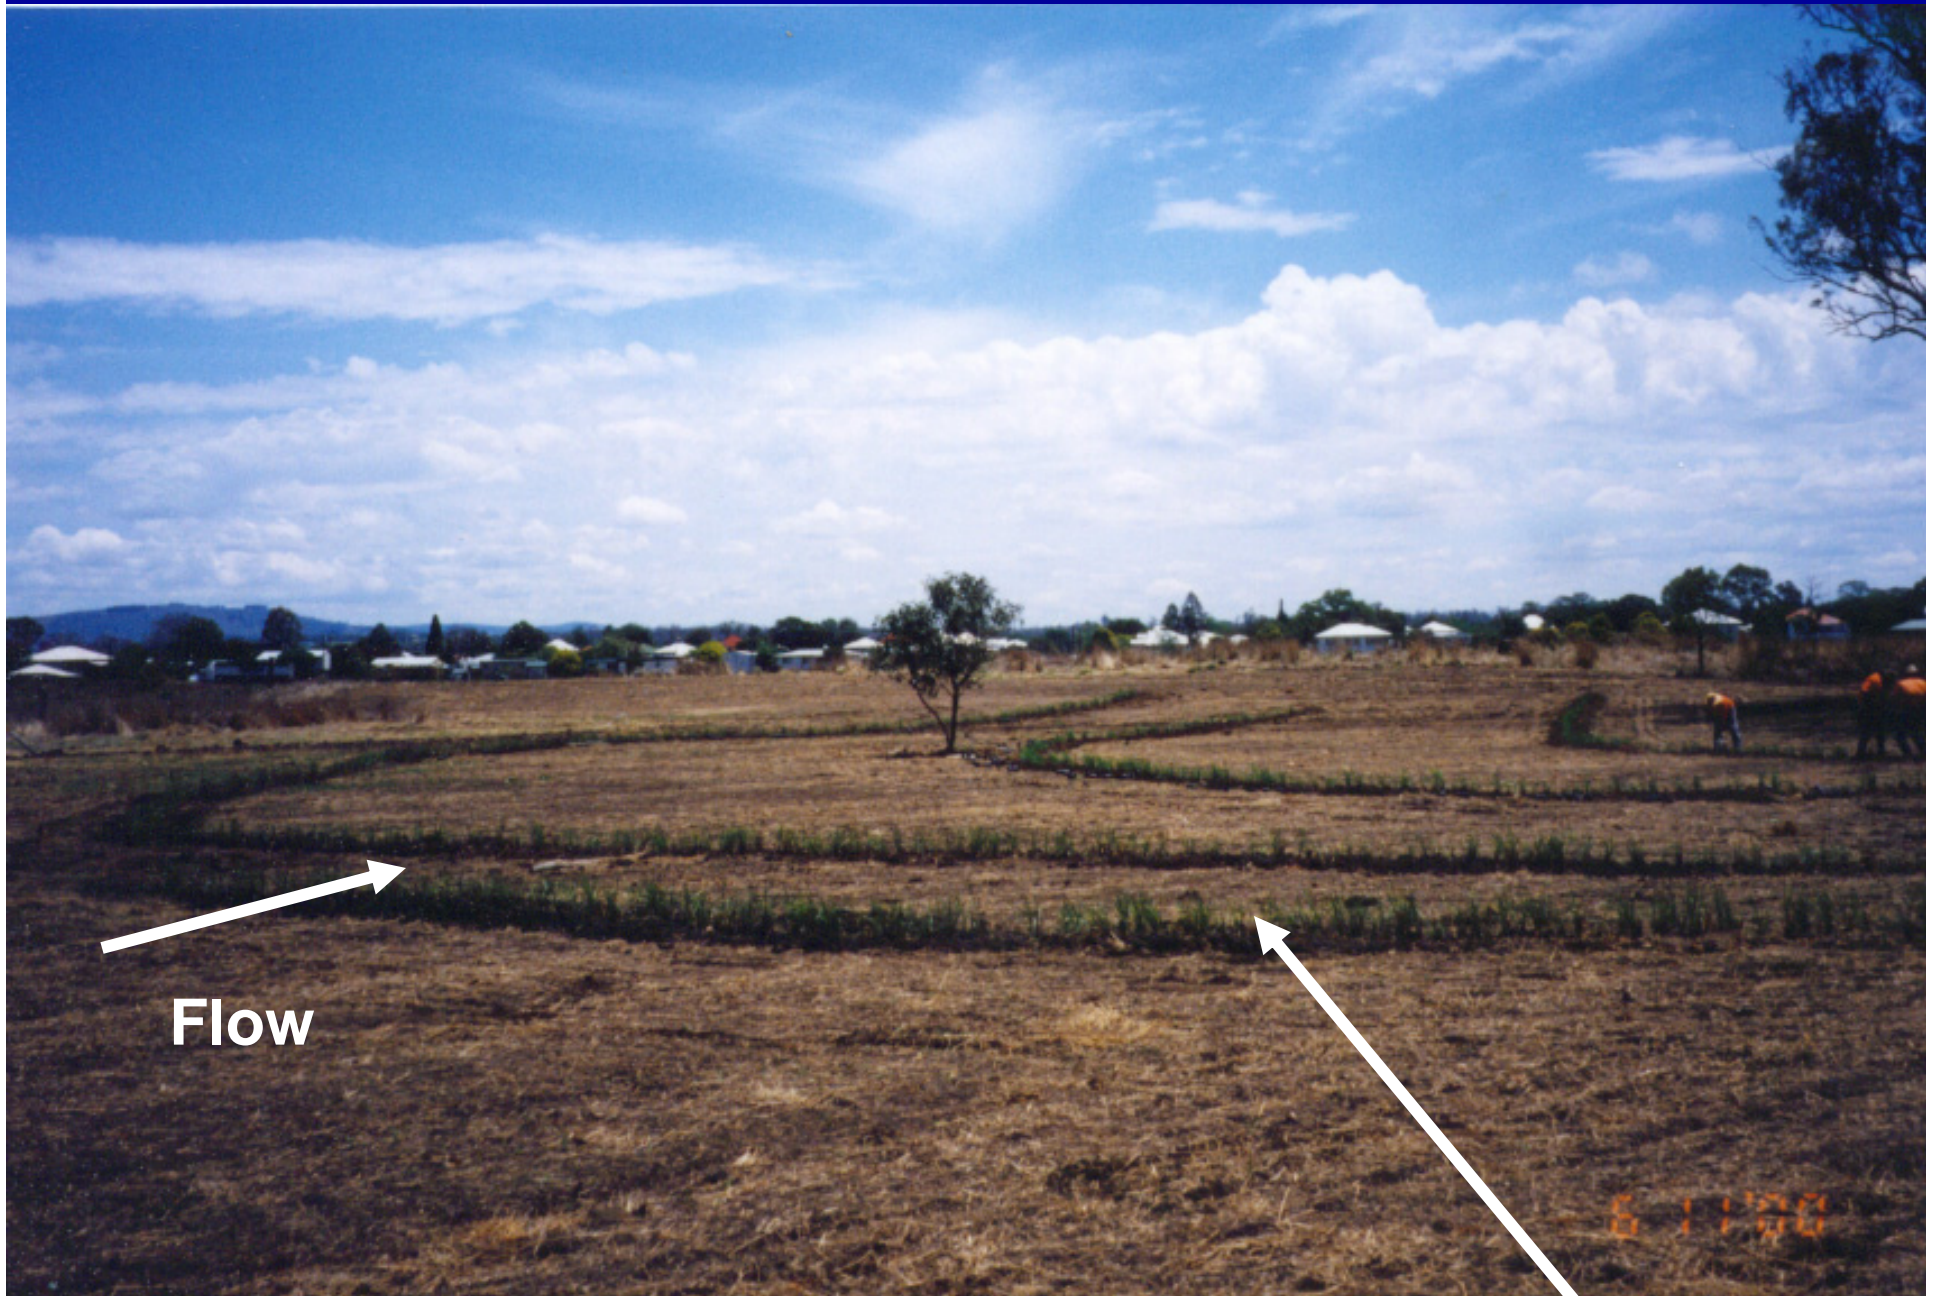
A big storm hit the area 3 months after planting and the whole site was flooded (Upper section)
