Vetiver System for Stream Bank Stabilisation

**(With special references to the river and canal bank stabilisation
in Australia and Vietnam)**

Paul Truong

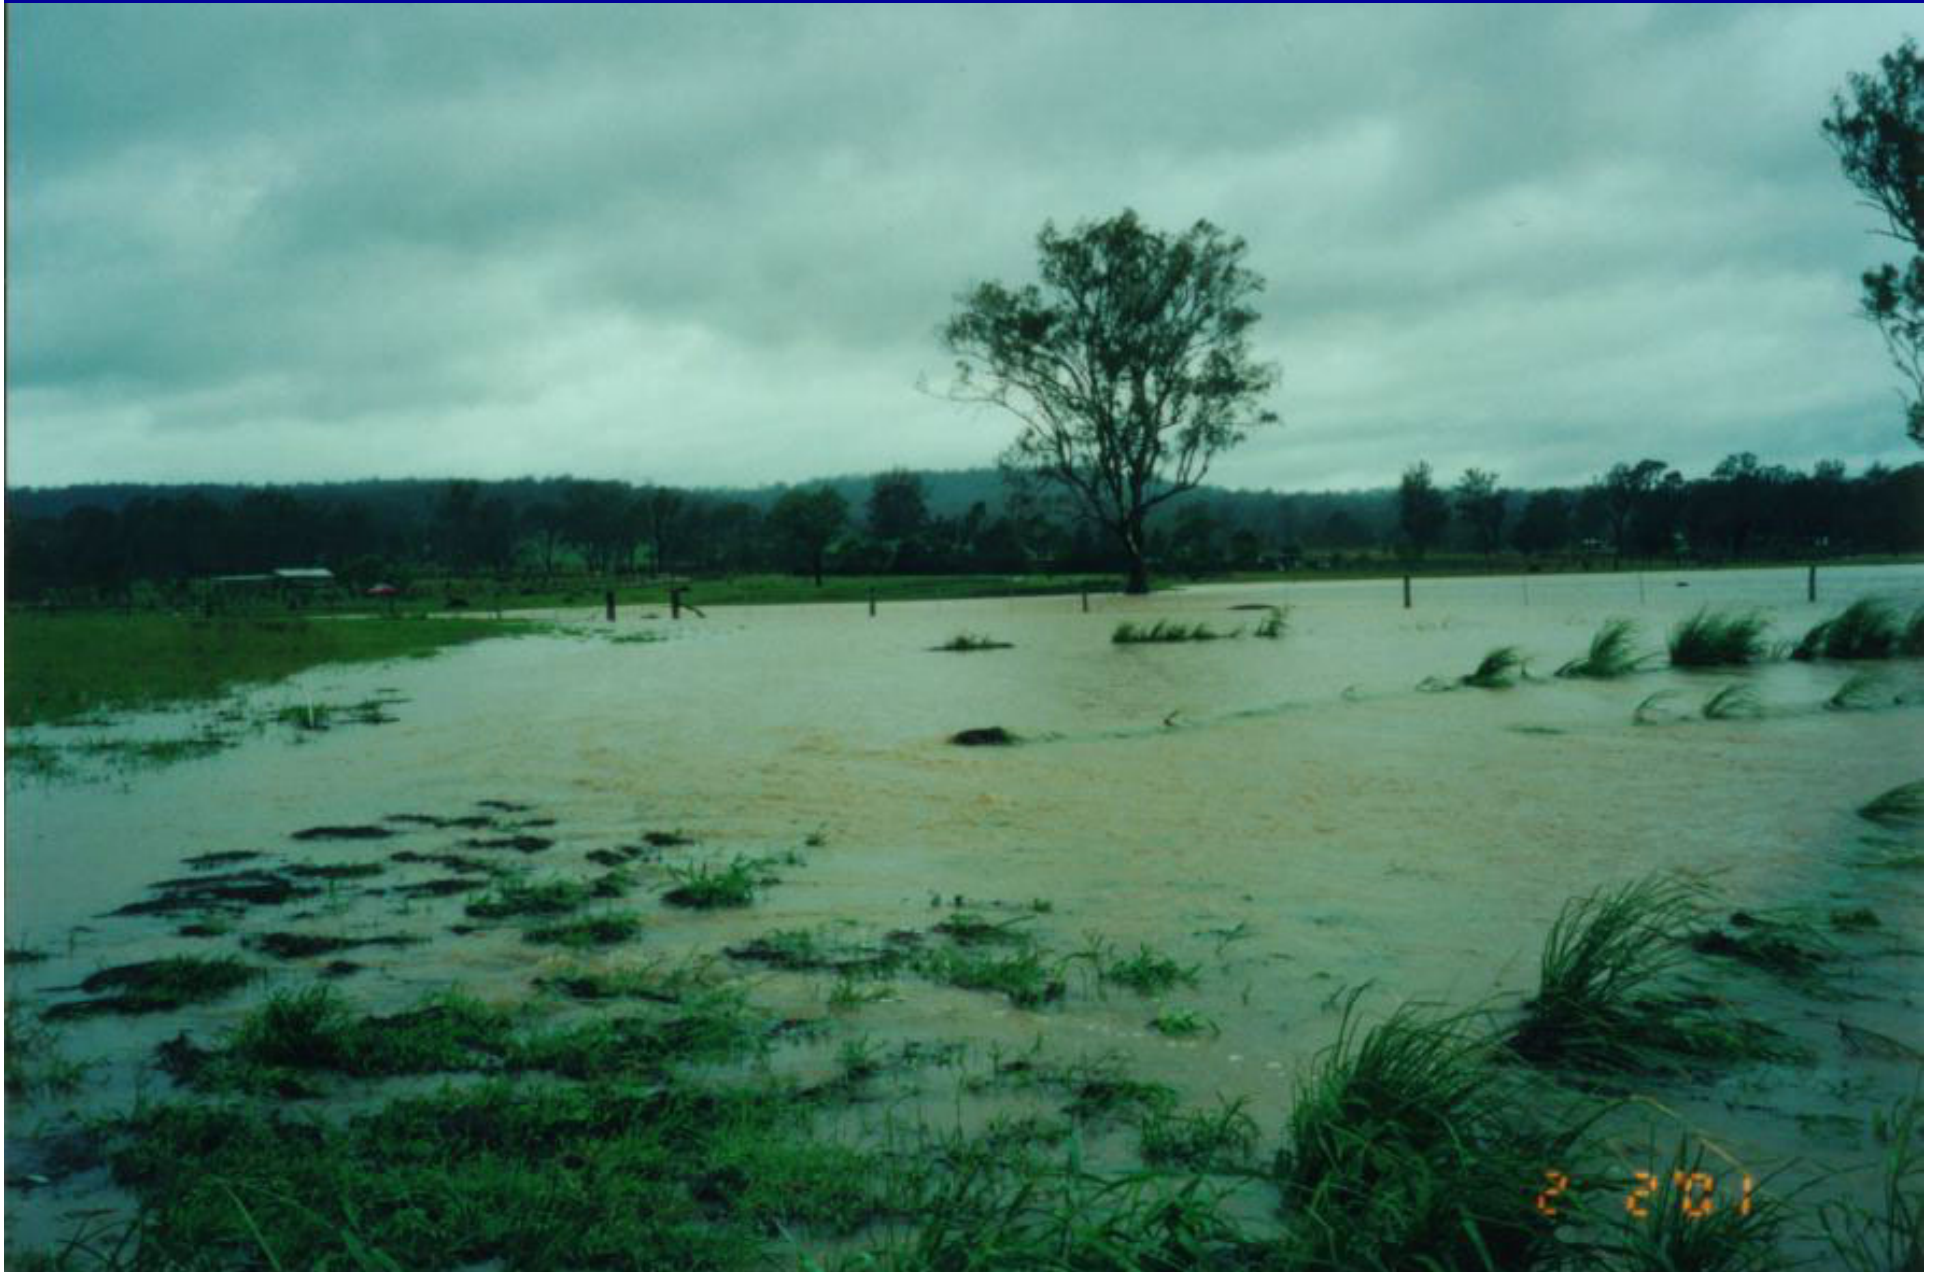
Very fast flow flattened and inundated most of the hedges. The velocity was estimated up to 5m/sec in some areas

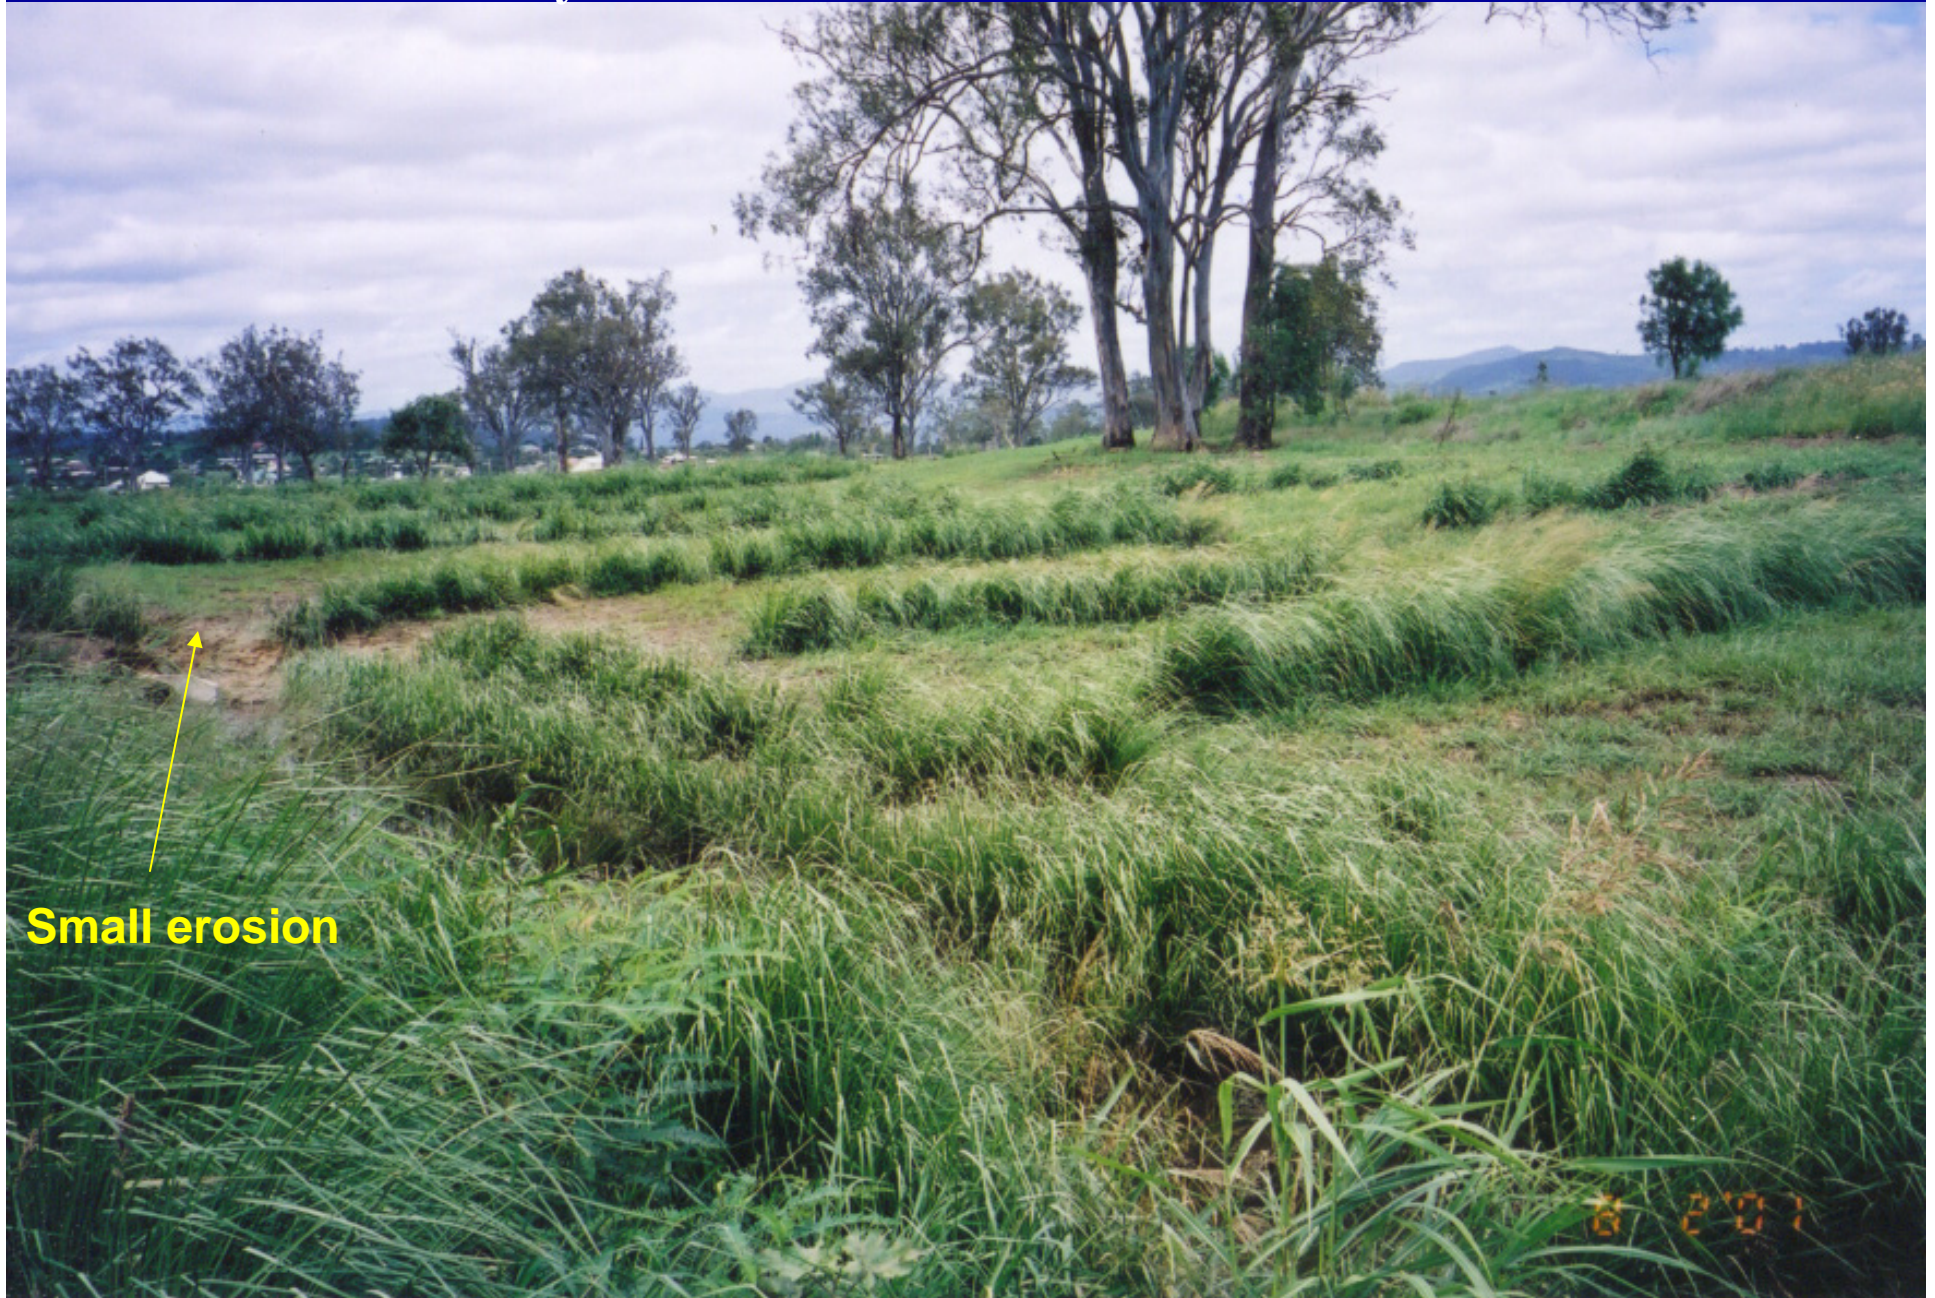
Small erosion

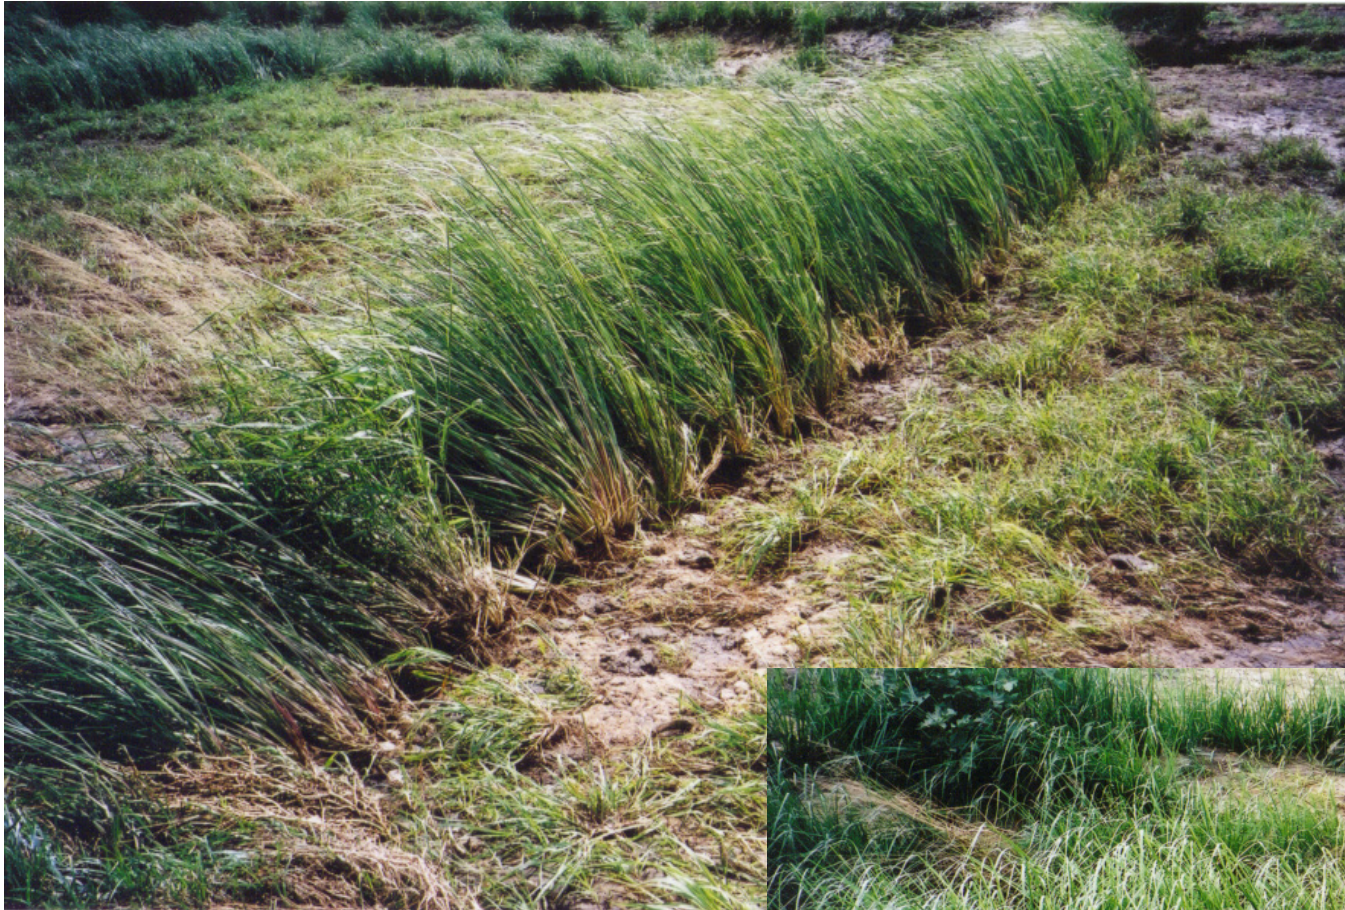
**Strong flow
exposed part of the
crowns but failed
to dislodge the
plants**

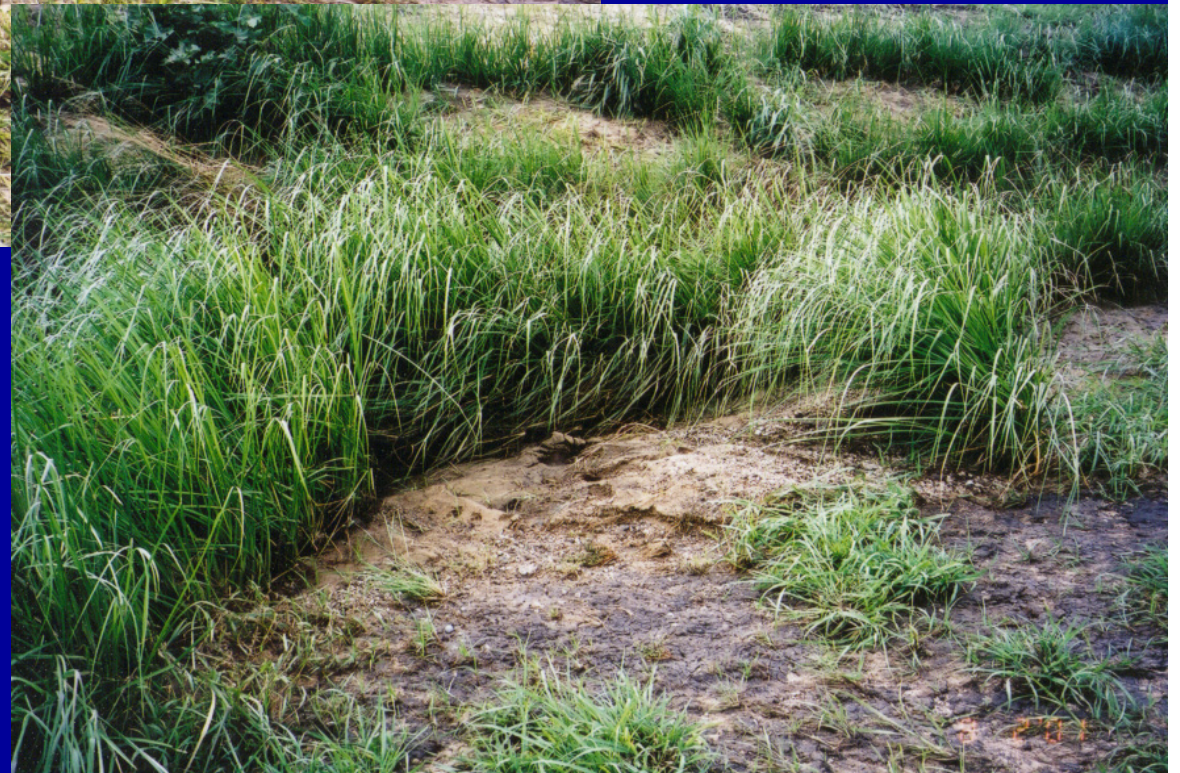
Trapping sediment

General view of channel seven weeks after flooding

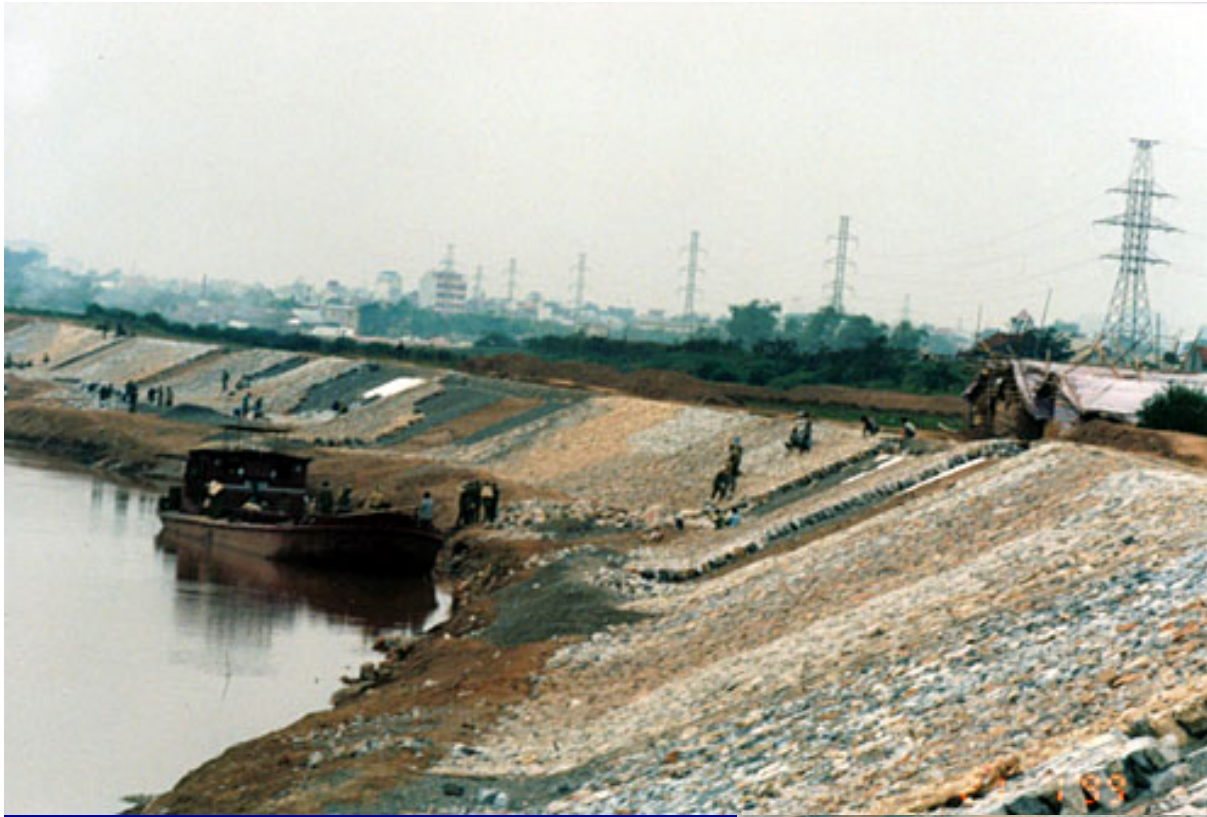
Gabions and rock baskets are being used to repair recent flood damages which threatened the levee bank of the Red River

A very elaborate and costly engineering structure, these rocks came from far away quarries

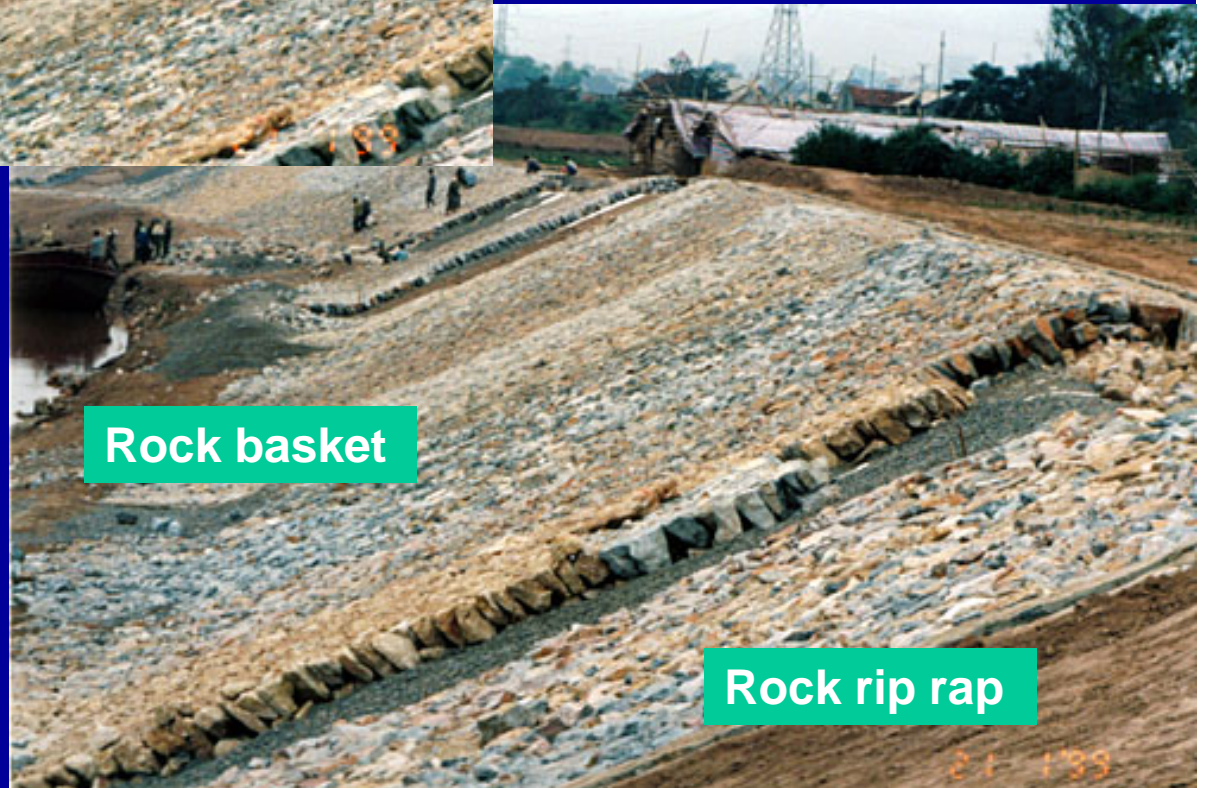
Rock basket

Rock rip rap

But this method provided no protection as this bank had been previously covered by similar rock baskets. Remnants of the old rocks which collapsed in the last flood, were still visible in the river.

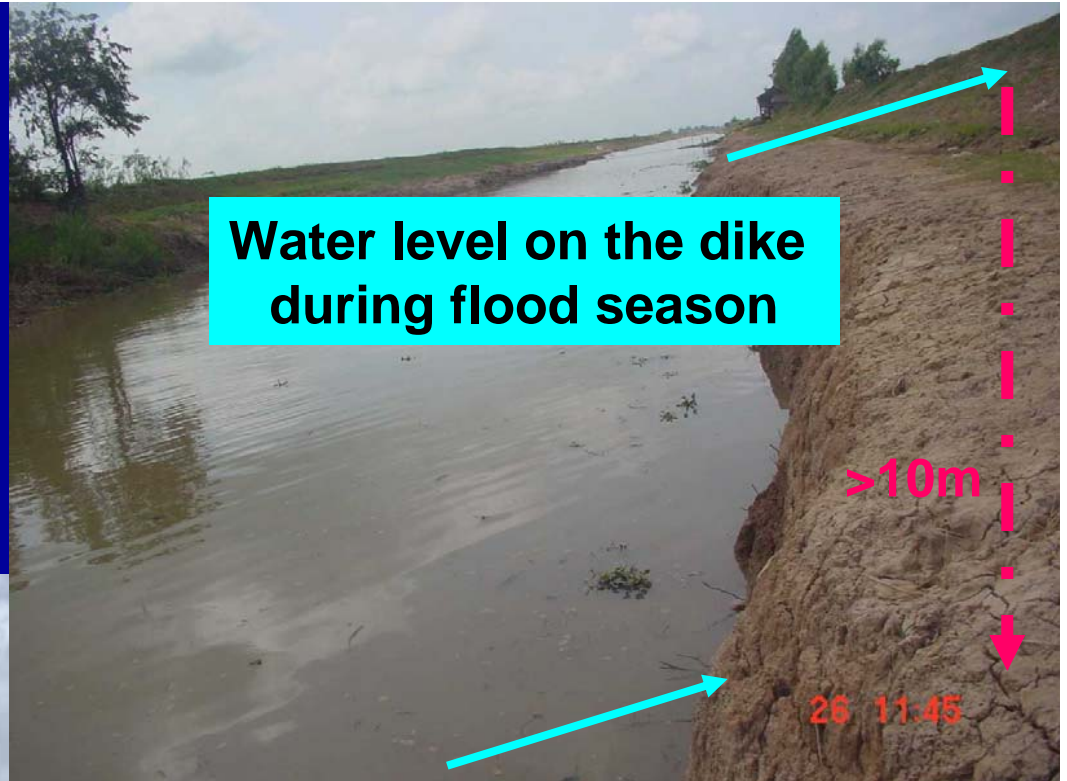
Water level on the dike
during flood season

Level during dry season

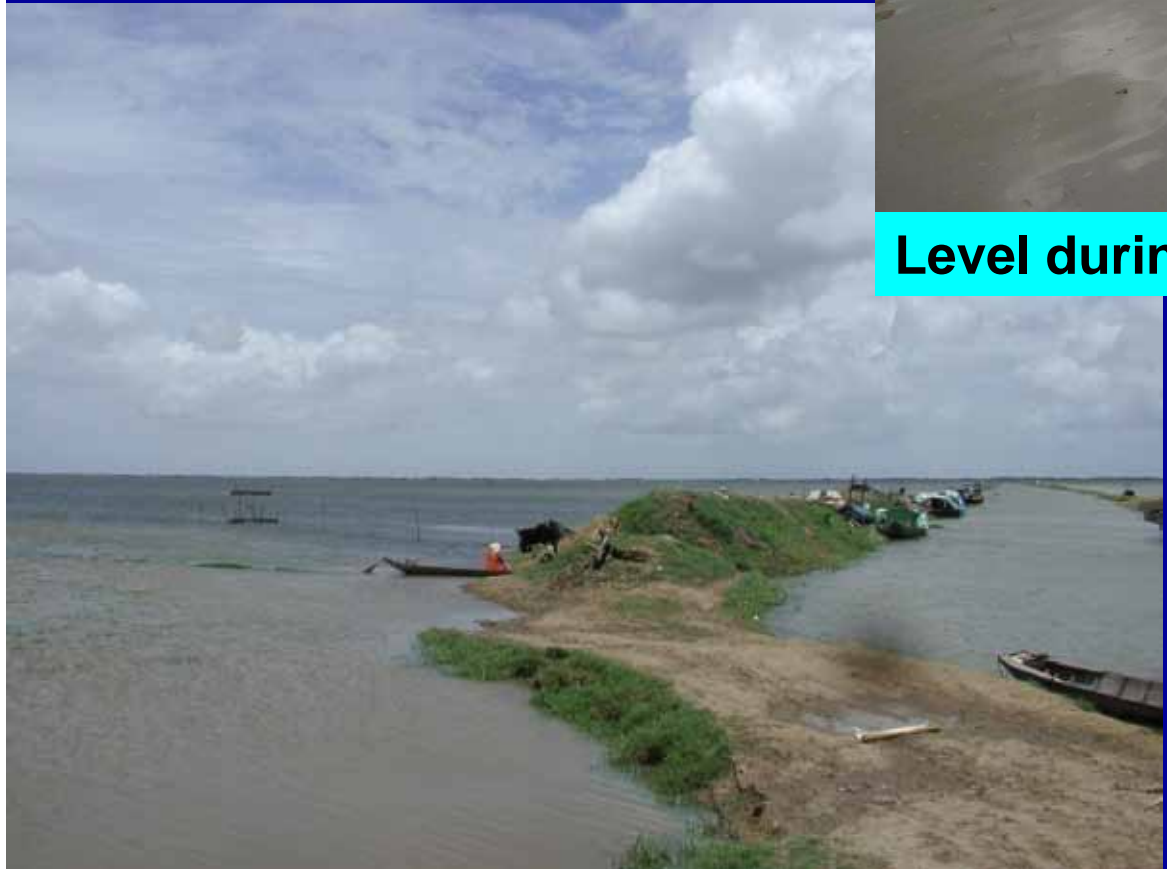
A precious piece of land 5m wide is kept intact due to Vetiver

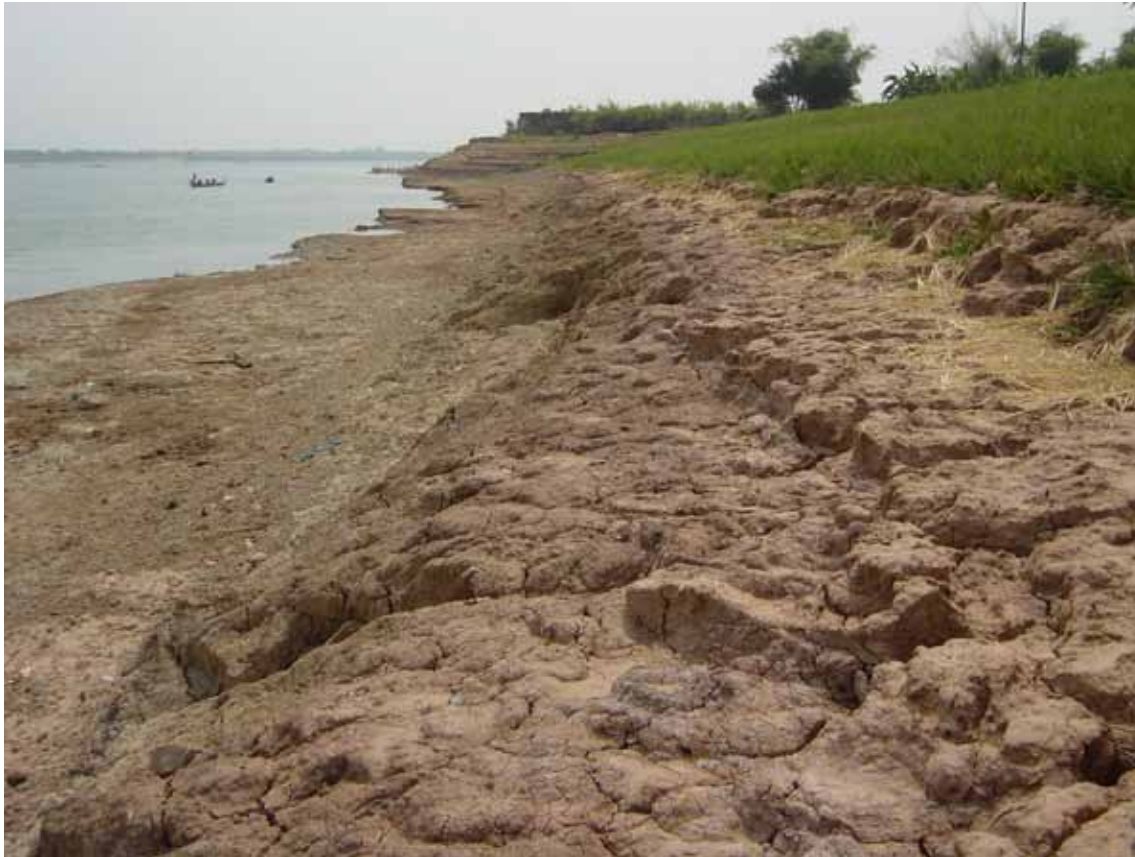
Cambodia
**Erosion on the bank
of the Mekong river**

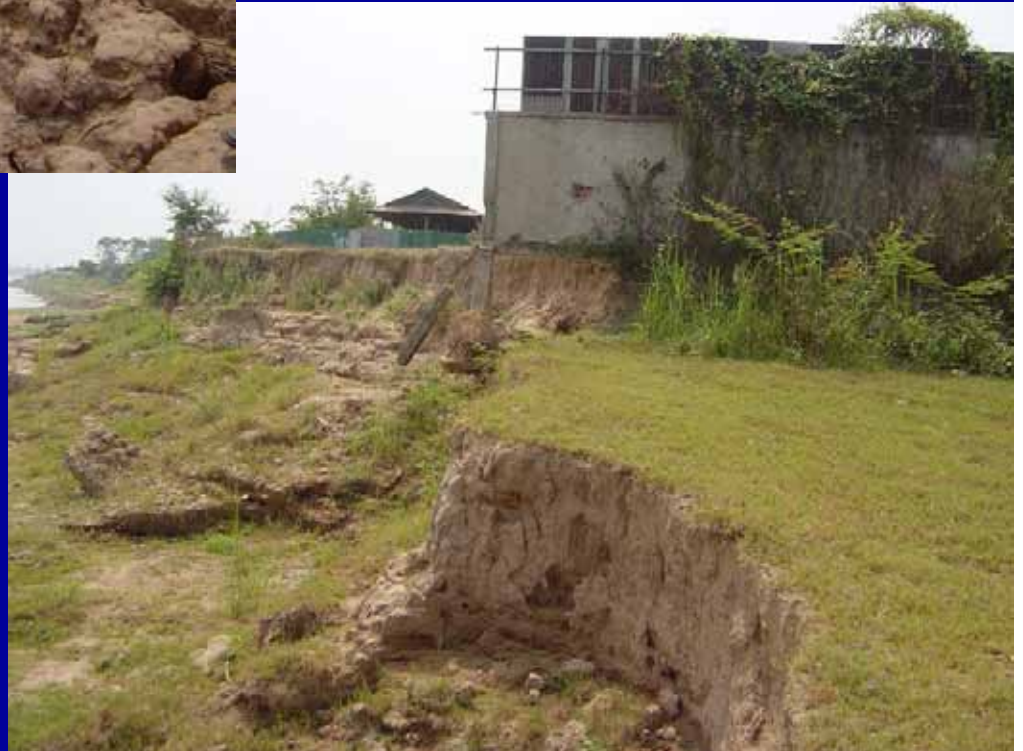
Cambodia Vetiver planting following earth shaping

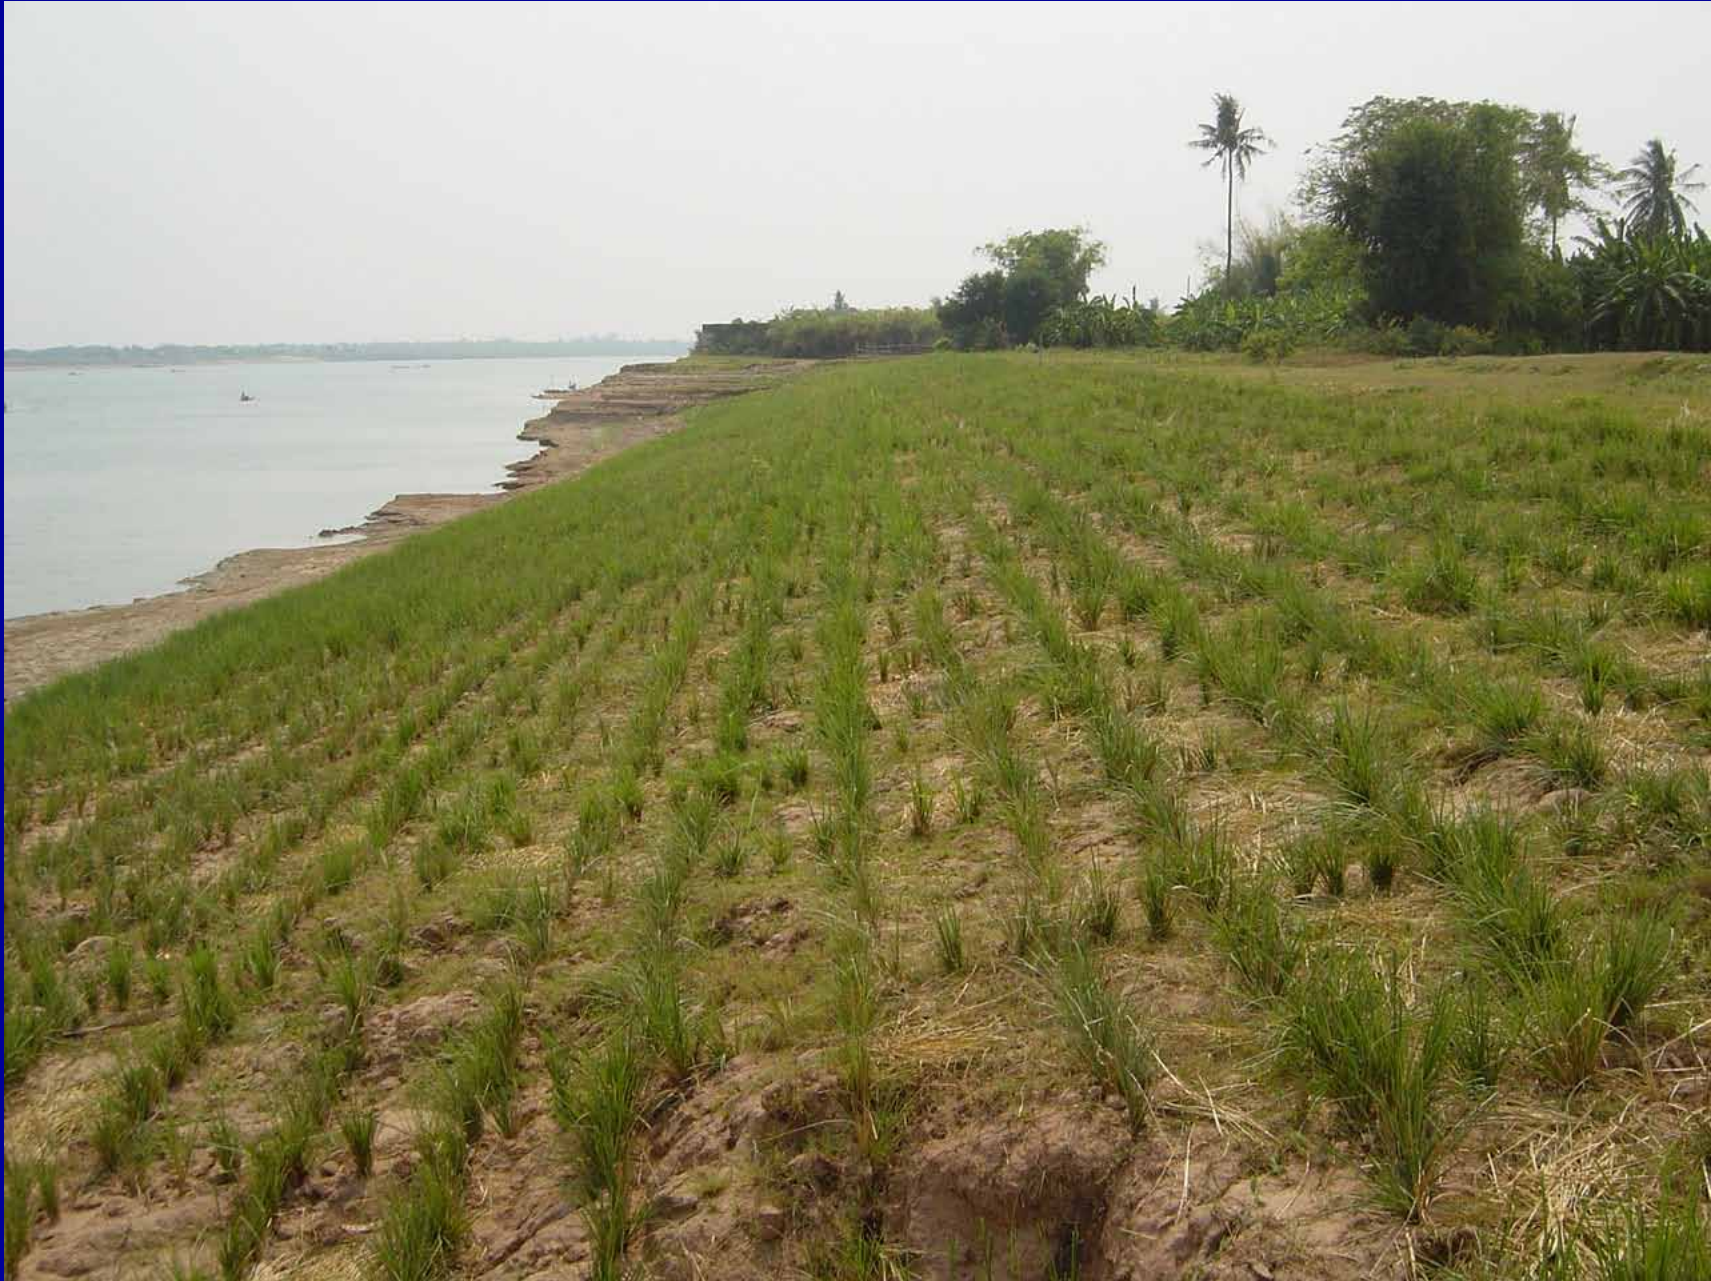
Cambodia Eight month after planting

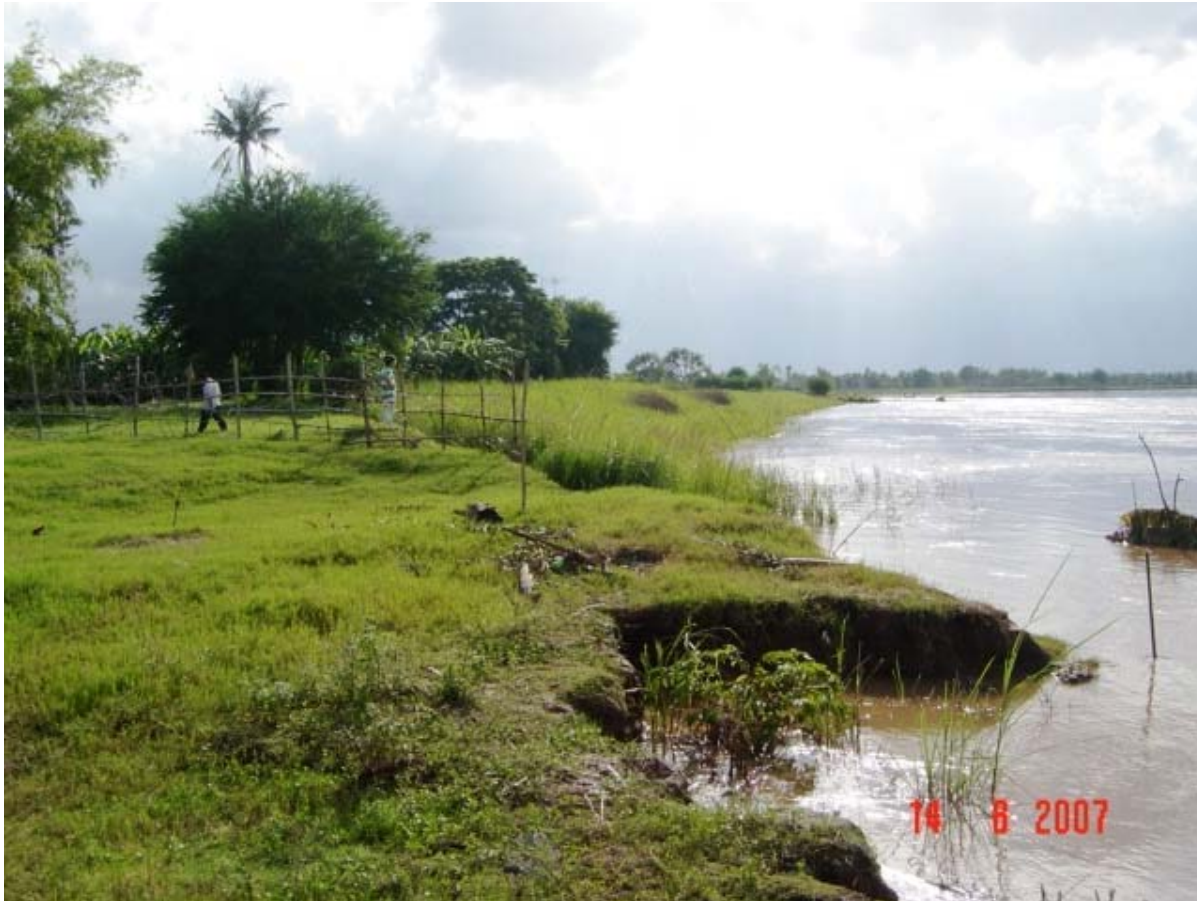
Cambodia
Annual flooding with
depth level between
15-20m

Flood level

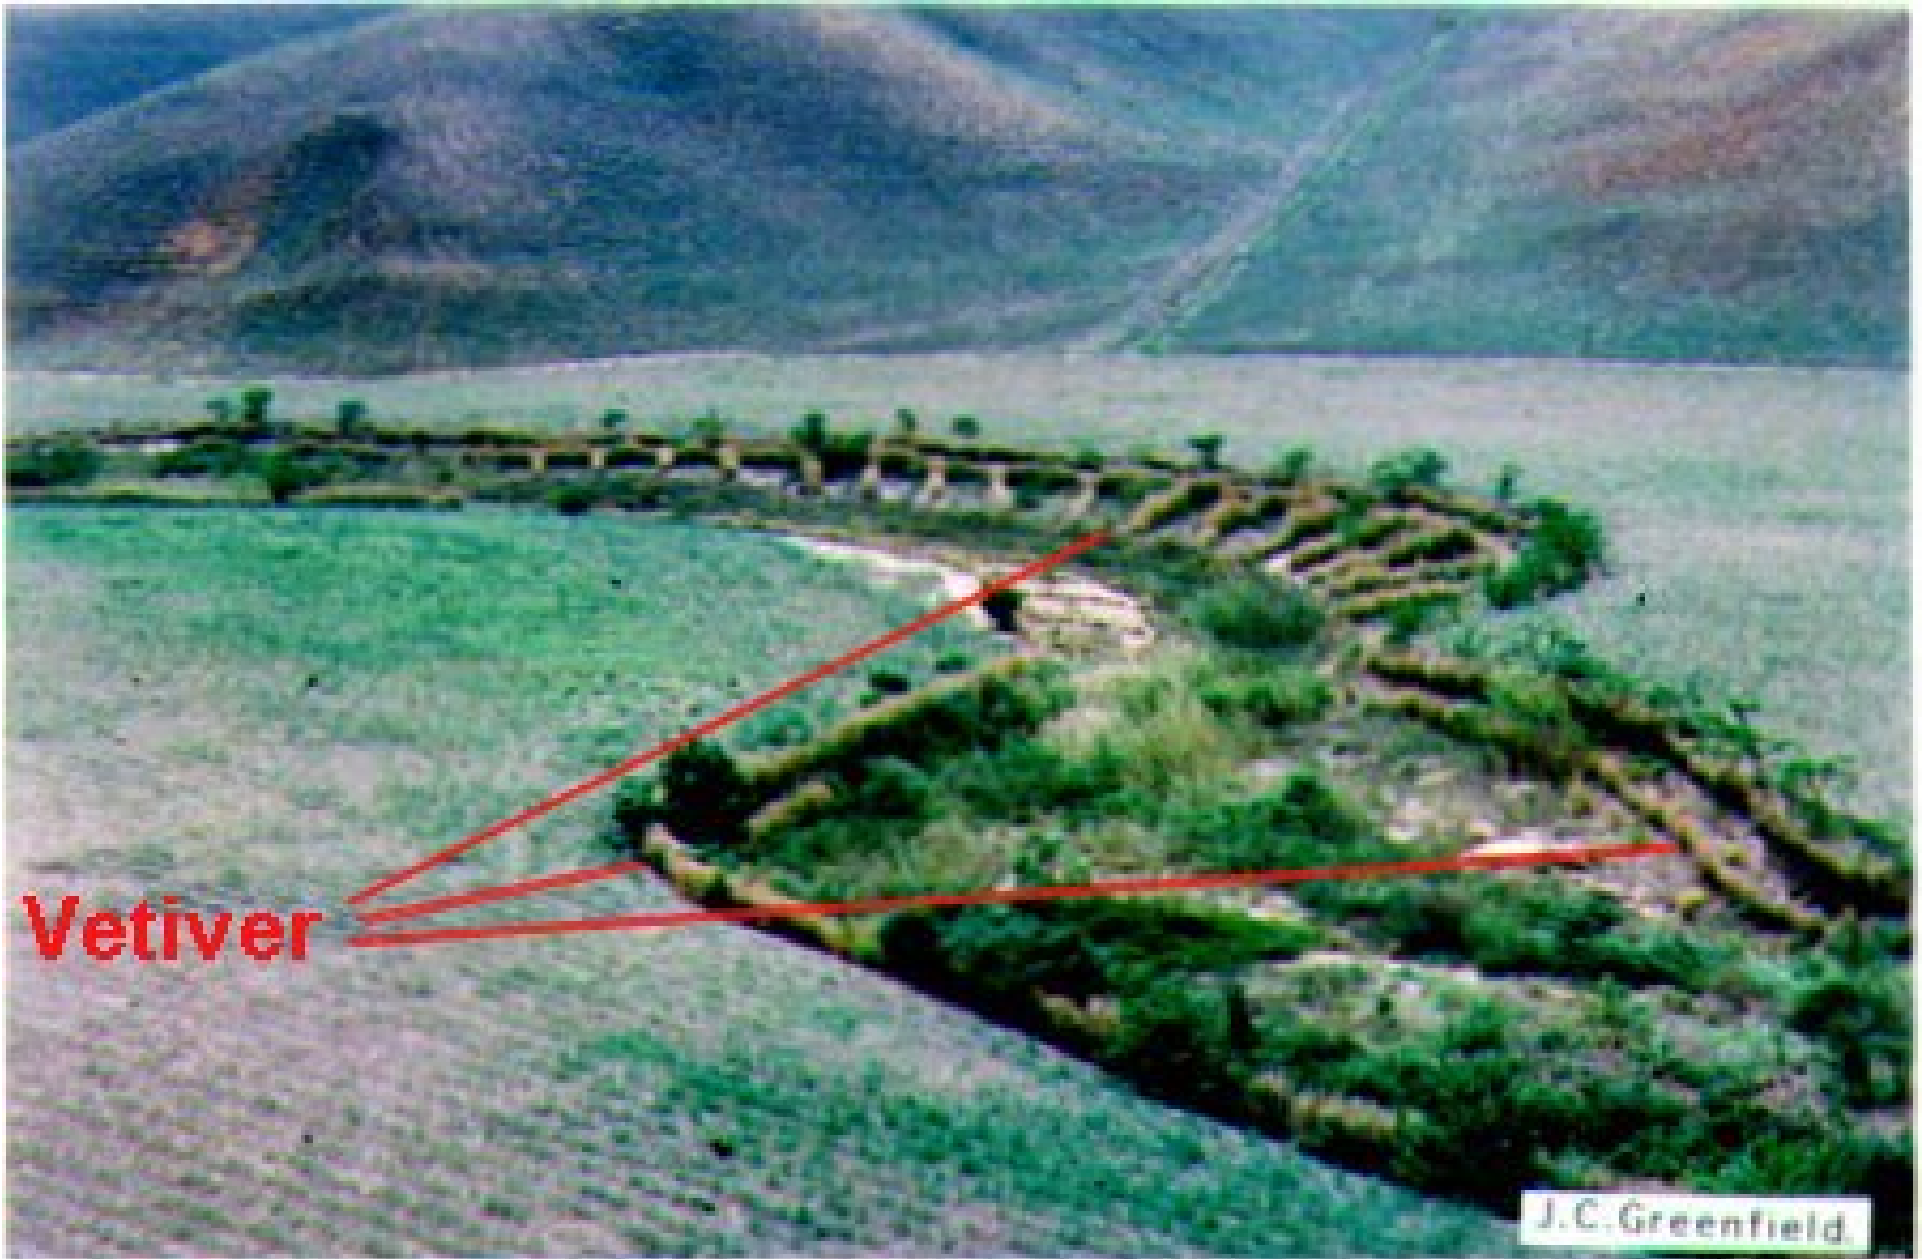
***South Africa:* A very well layout provided complete protection against erosion**

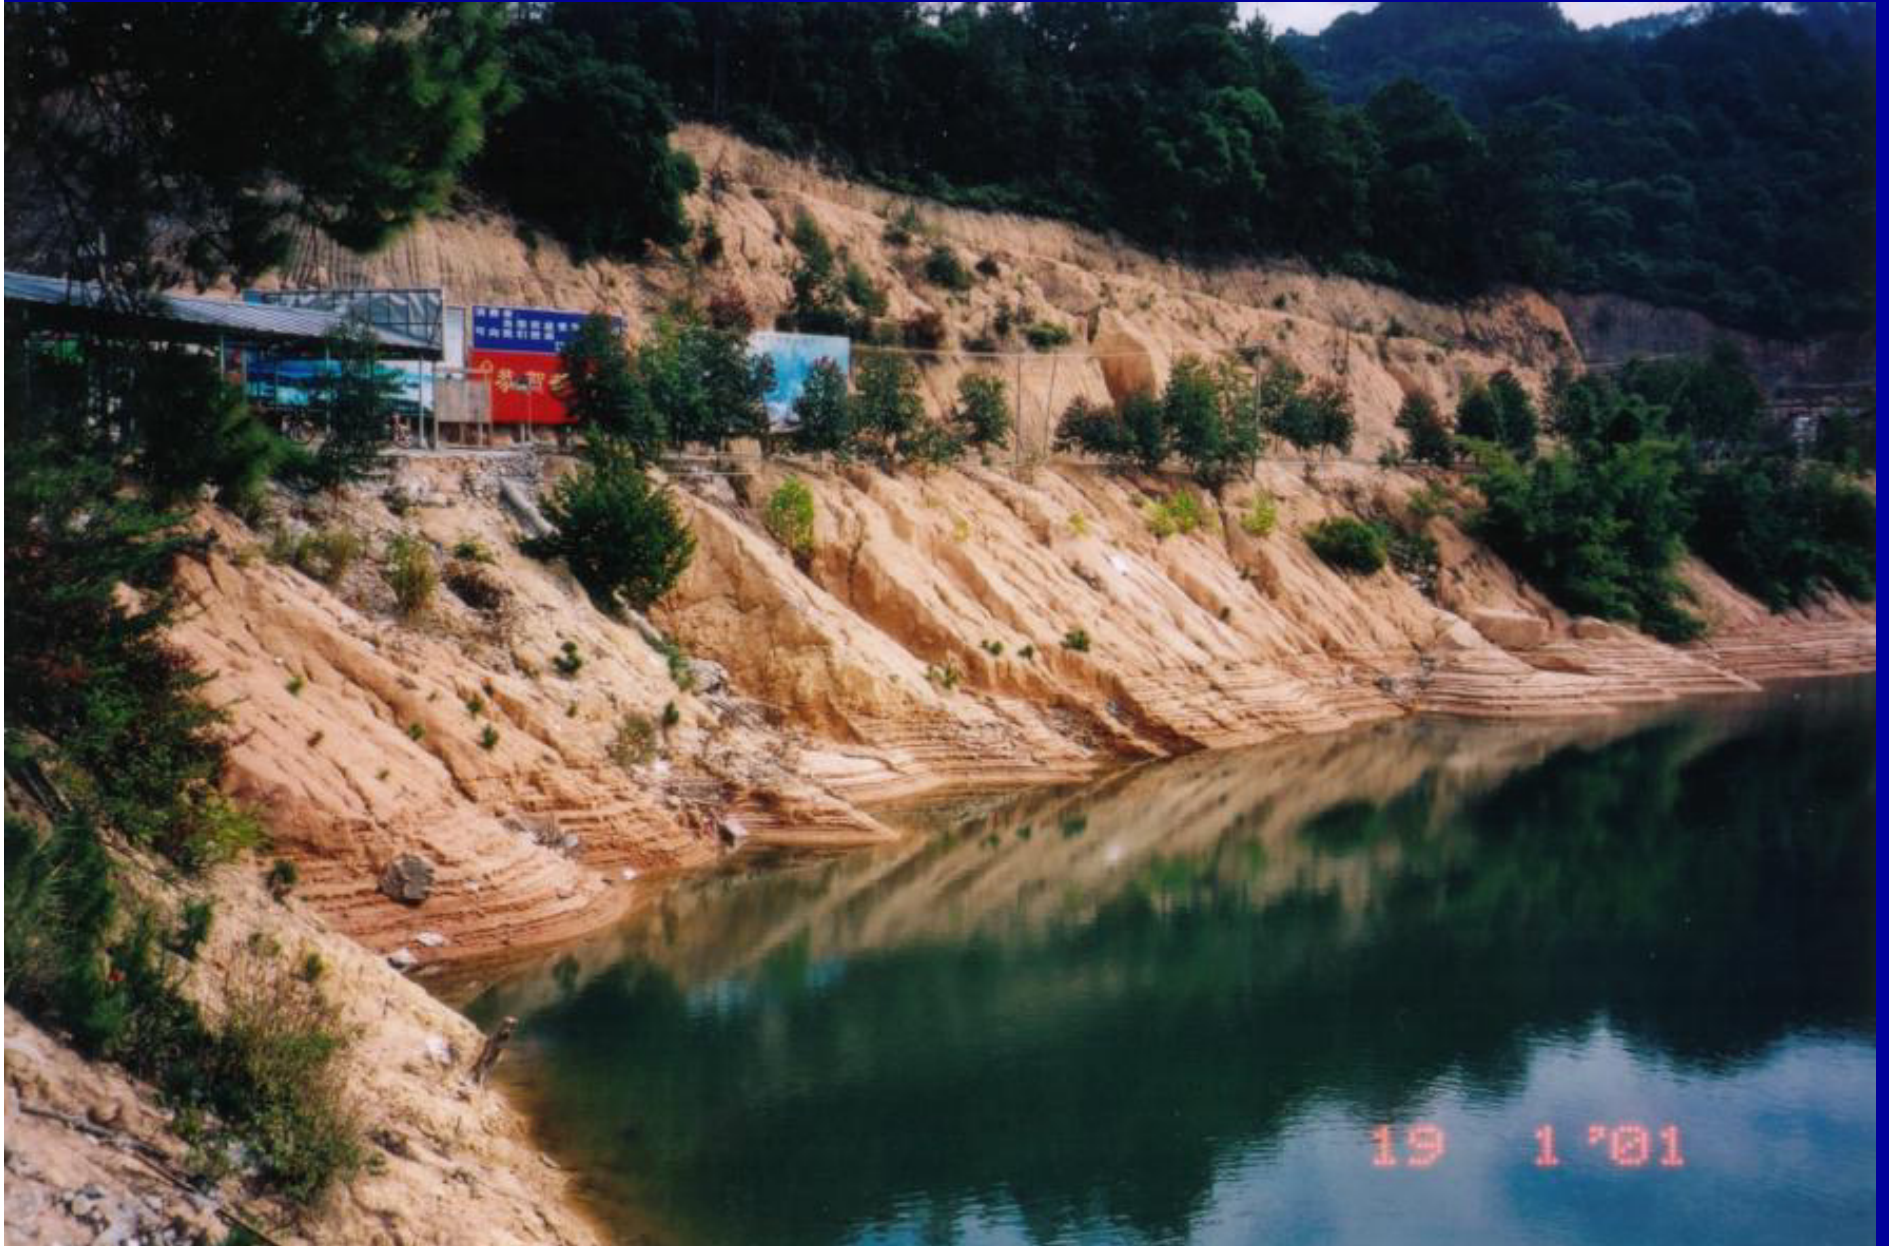
China: Highly erodible and badly eroded of the often flooded shore line of Lake Evergreen in Guangdong
