Vetiver System for Stream Bank Stabilisation

**(With special references to the river and canal bank stabilisation
in Australia and Vietnam)**

Paul Truong

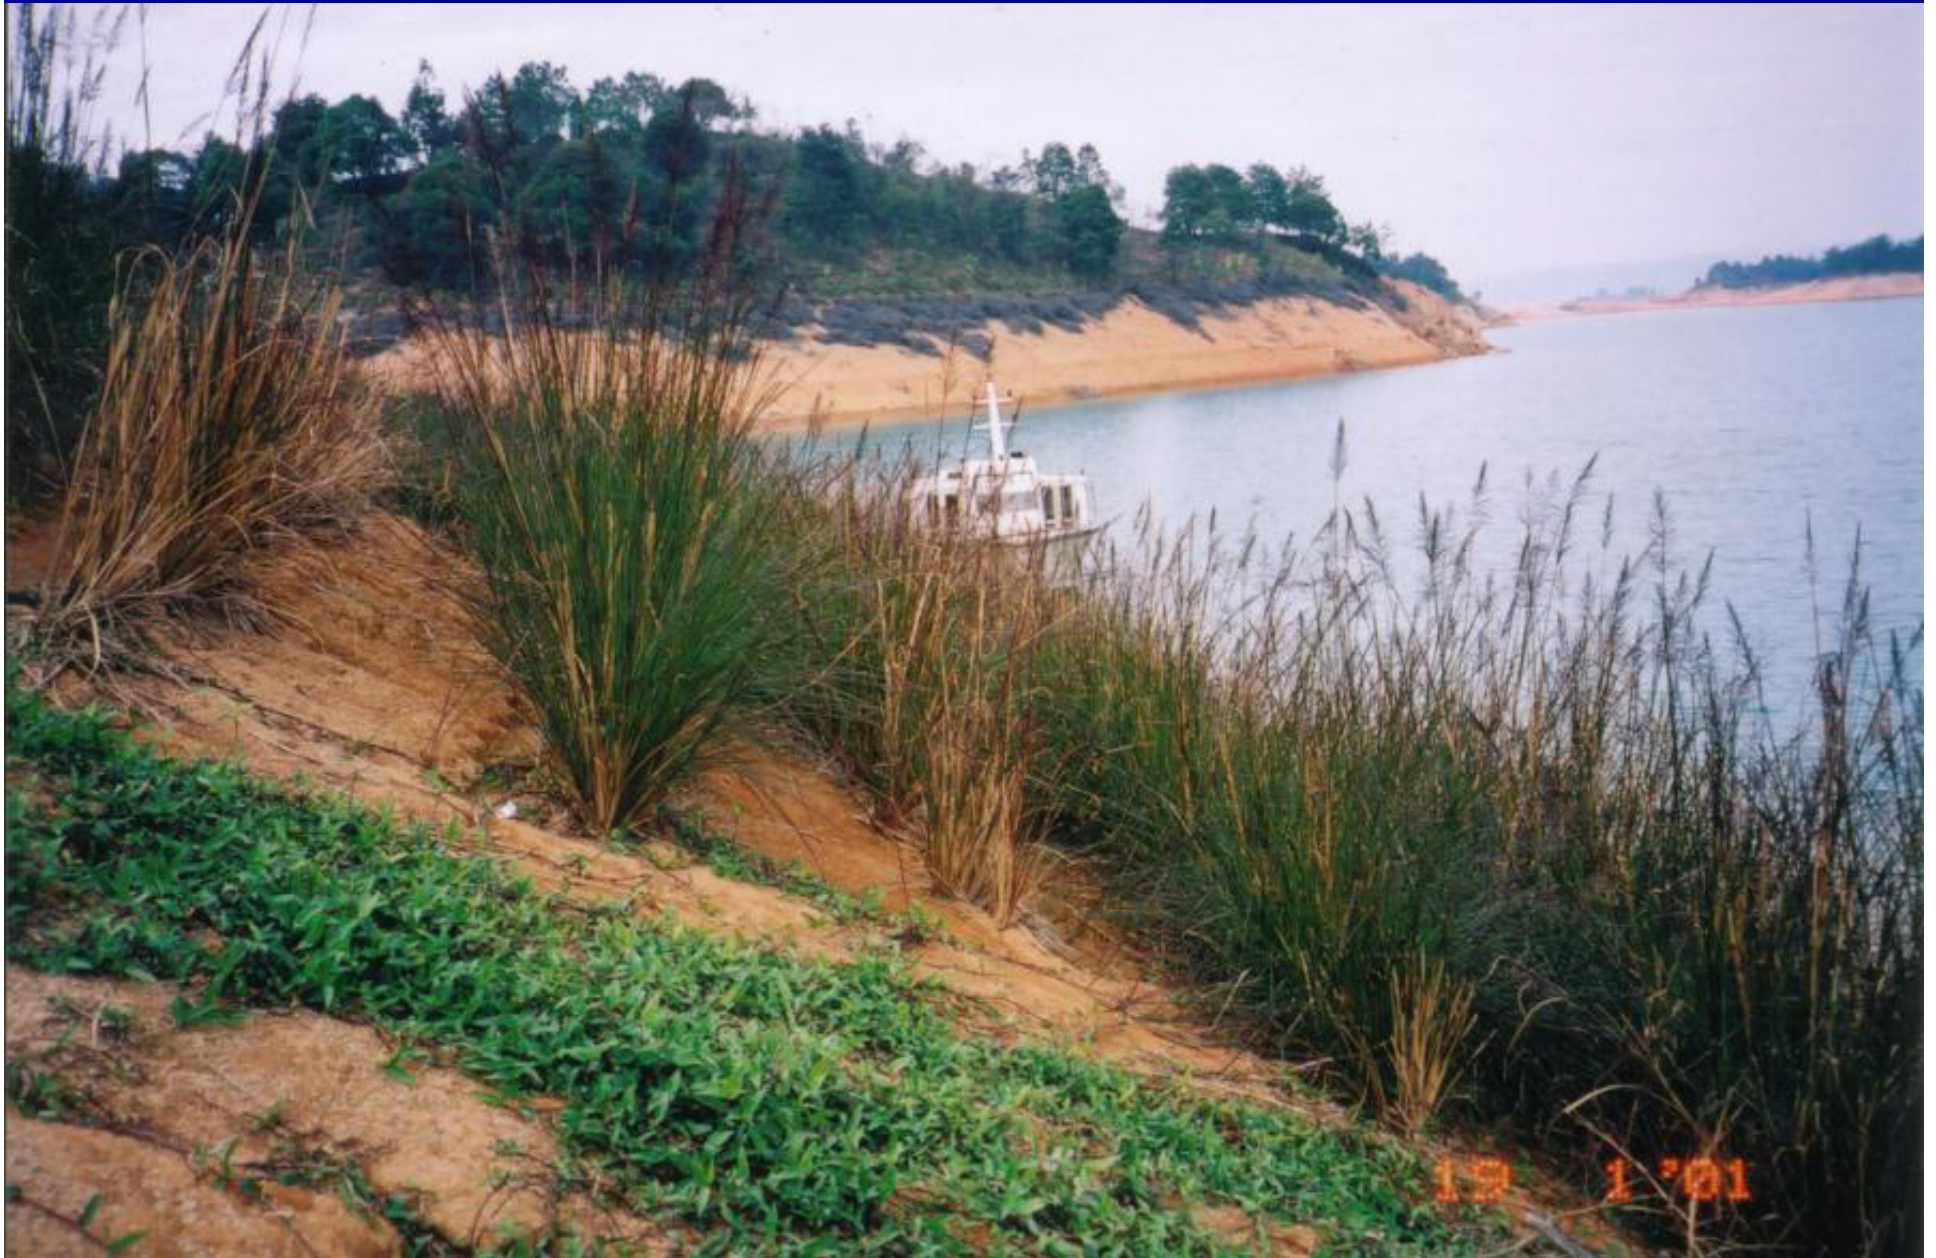
This section of the bank has been successfully stabilised by vetiver grass in a trial

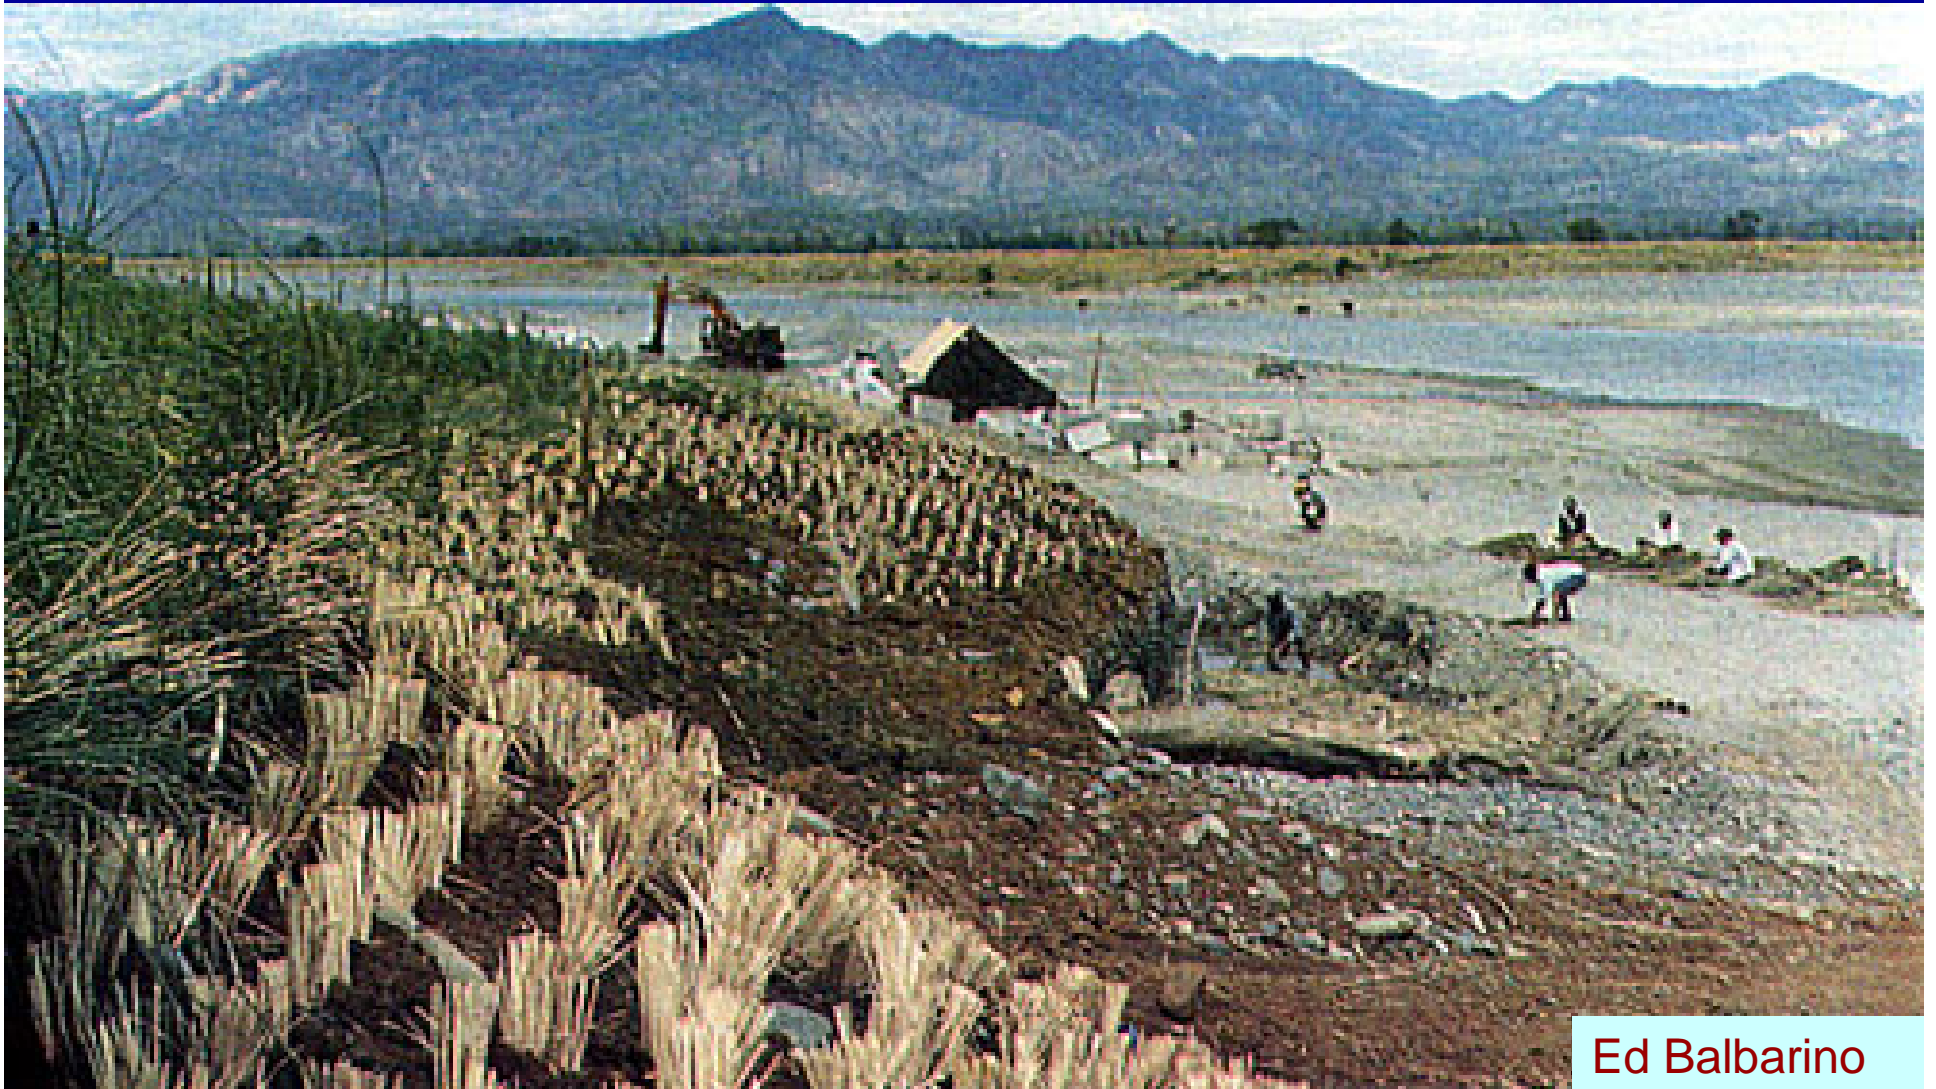
Philippines: Vetiver was planted to protect the bank of Abra River against flood erosion

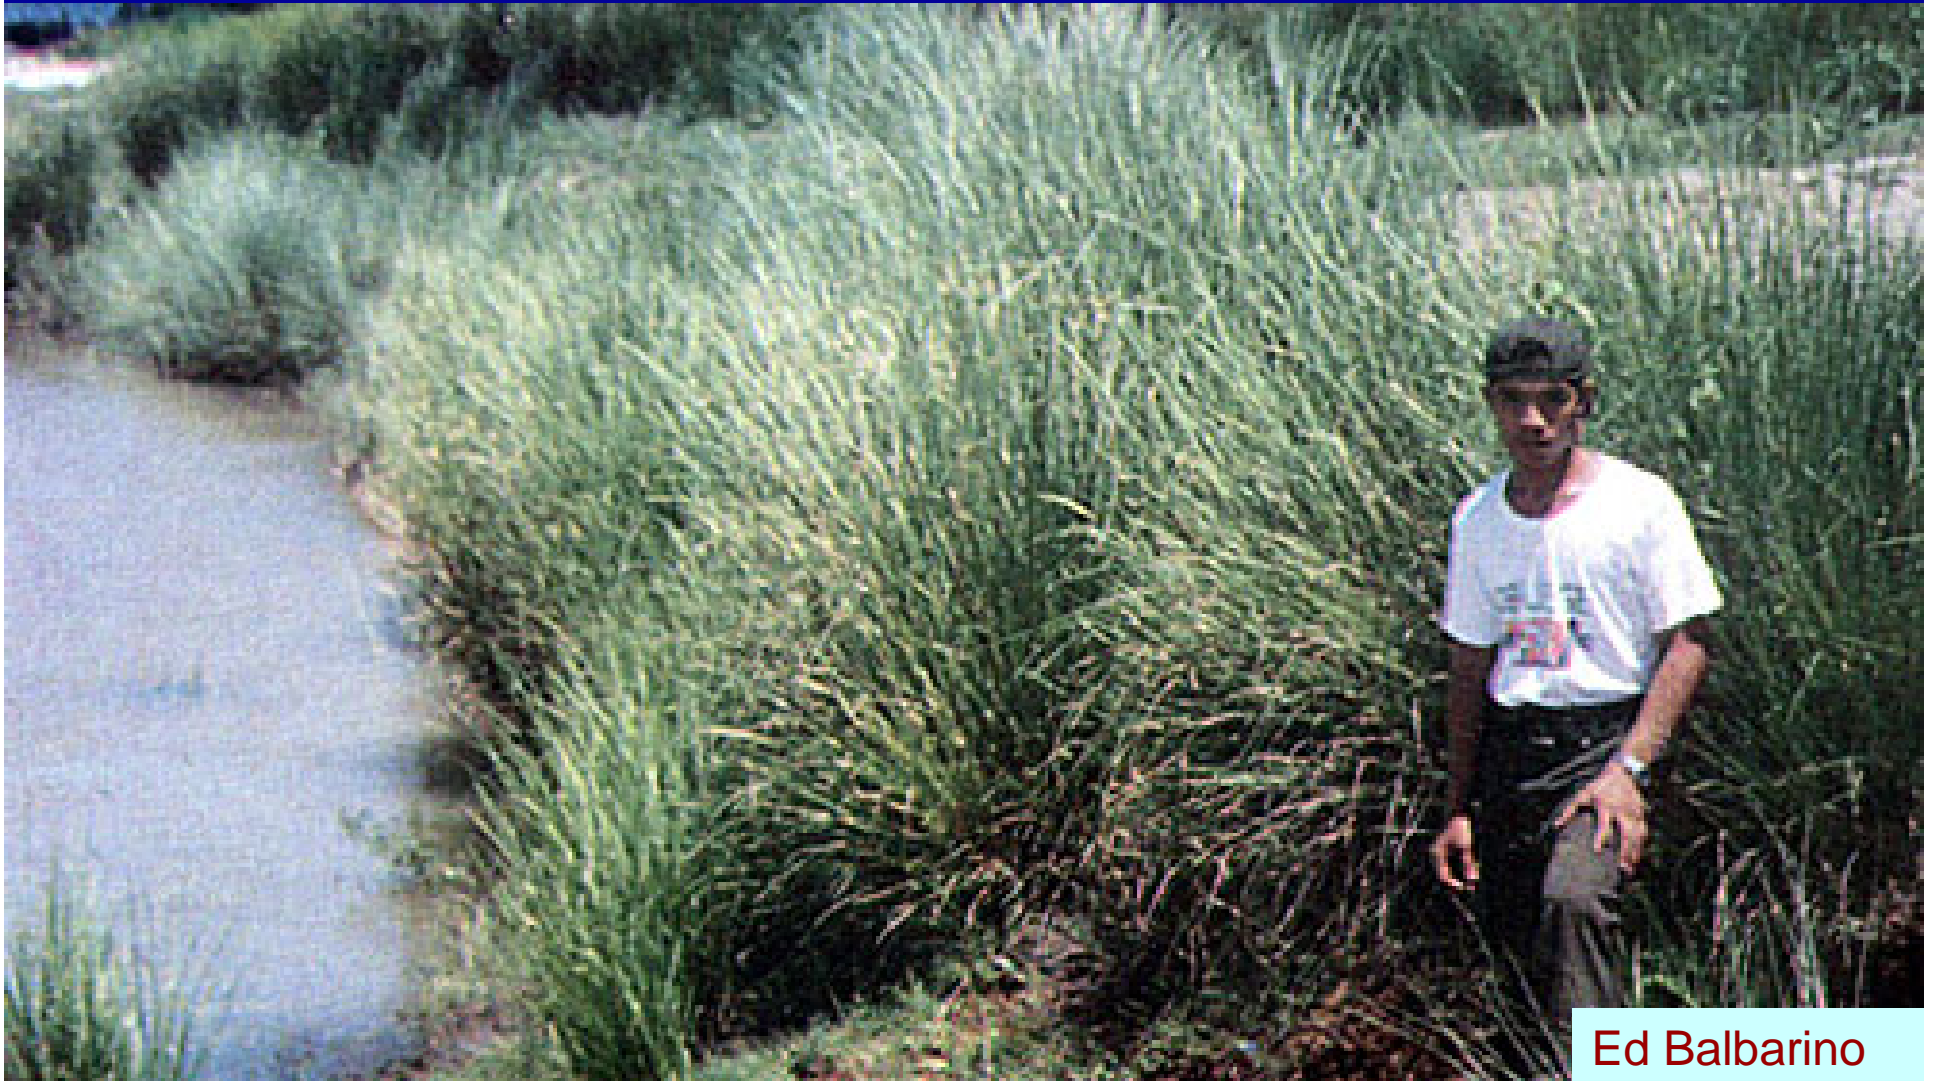
One year after planting, the bank was successfully stabilised
