VETIVER GRASS FOR SUSTAINABLE AGRICULTURE ON ADVERSE SOILS AND CLIMATE IN SOUTH VIET NAM

Le Van Du¹ and P. Truong²

1 Nong Lam University, HCMC, VietNam.

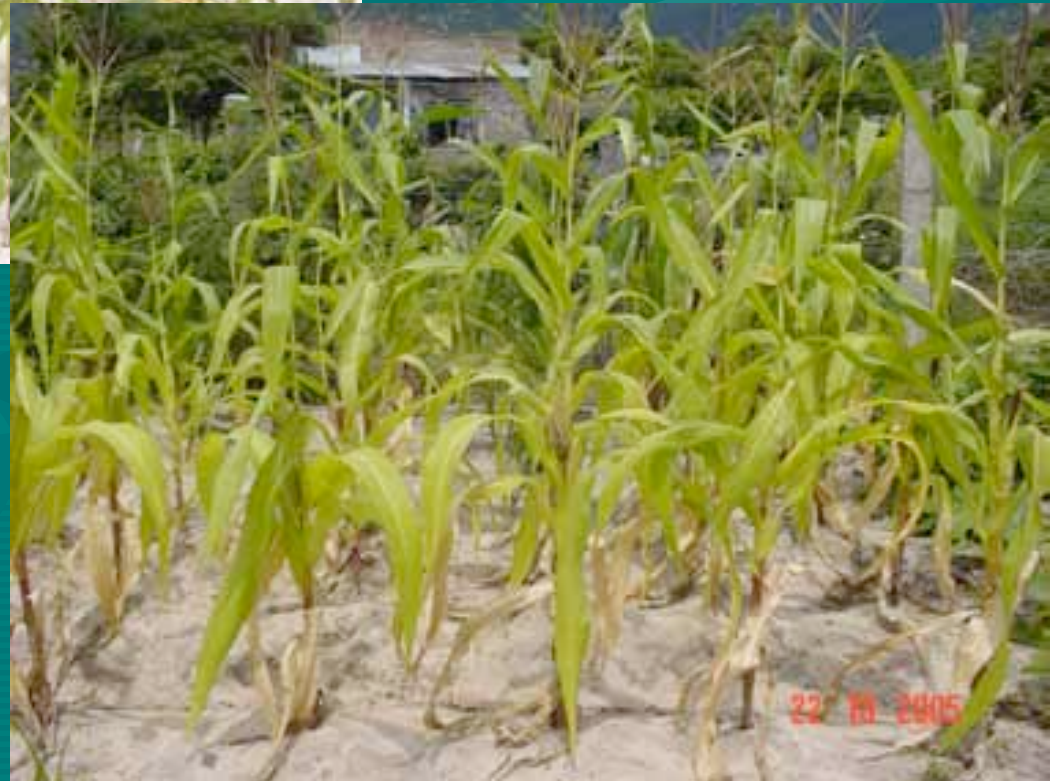
BUT VETIVER GREW EXTREMELY WELL UNDER THE SAME CONDITONS 75 DAY OLD CROP

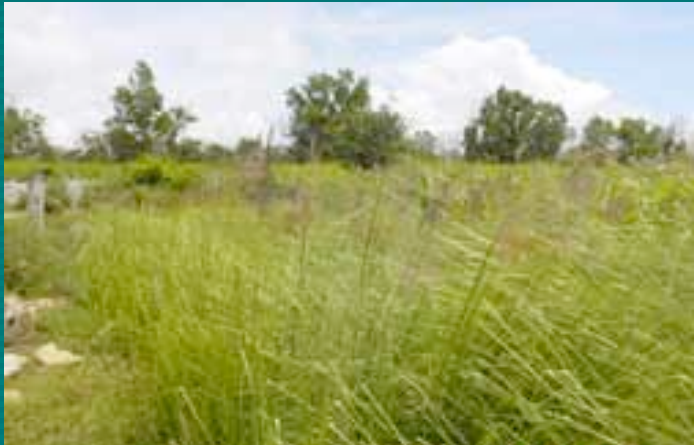
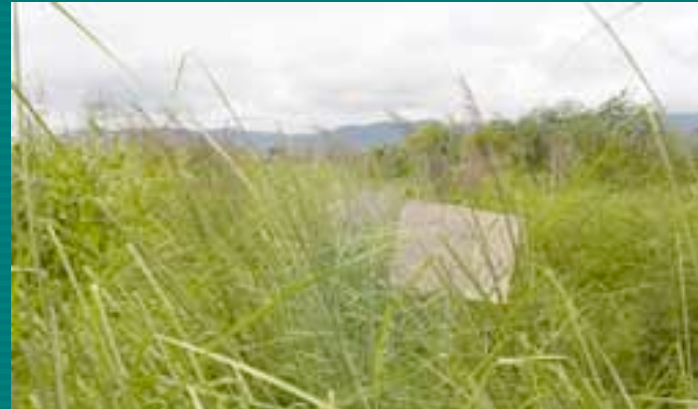
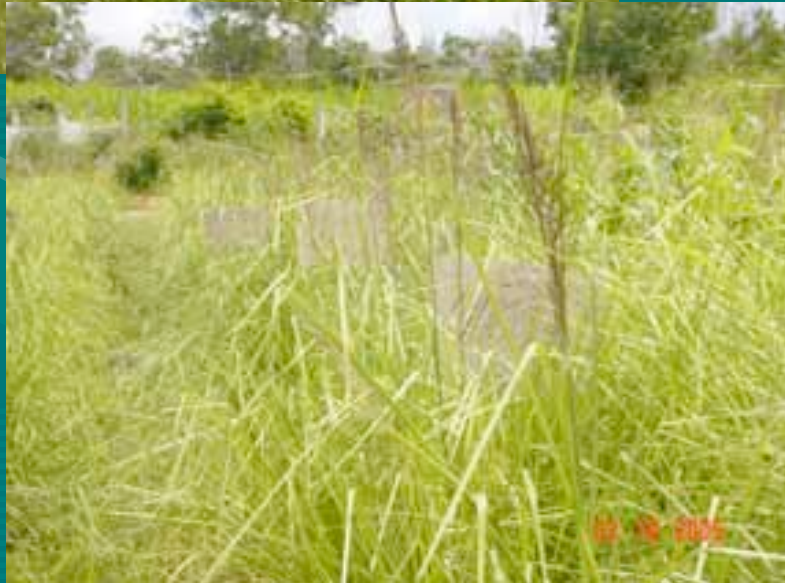
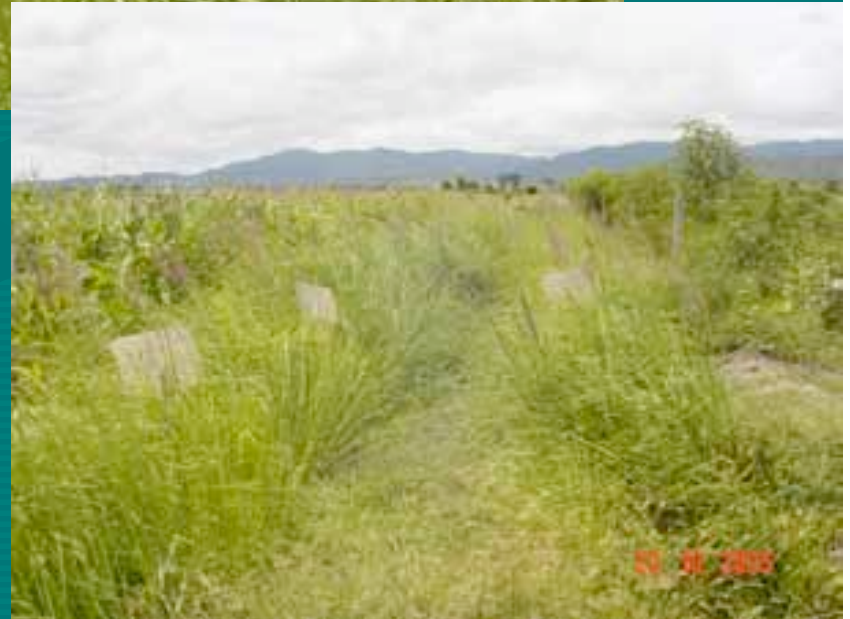
**75 DAY OLD CROP PRODUCED 25T/HA OF
FRESH LEAVES
(800g FRESH LEAVES/ CLUMP) ON THIS SOIL
WITHOUT RAIN OR IRRIGATION**

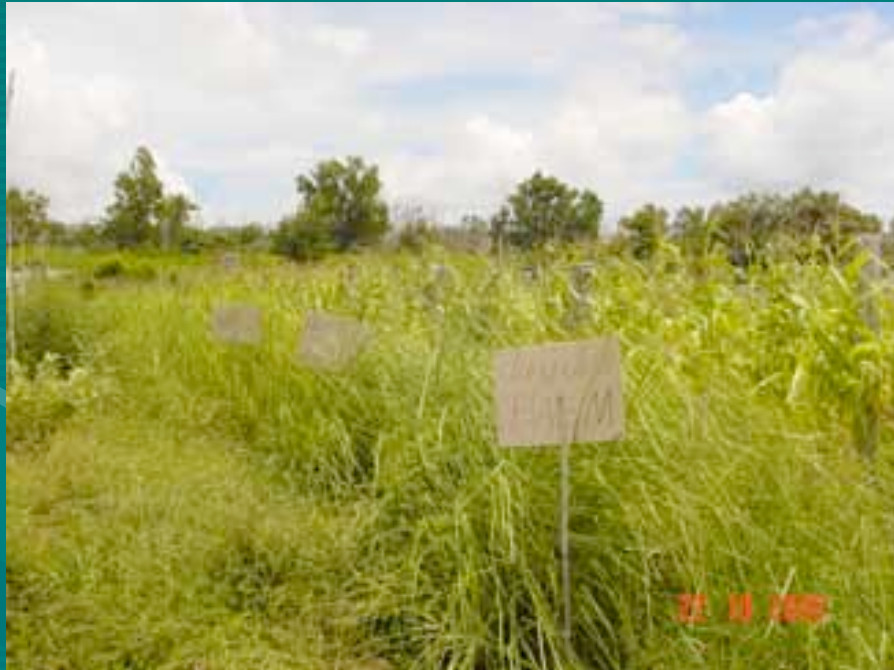
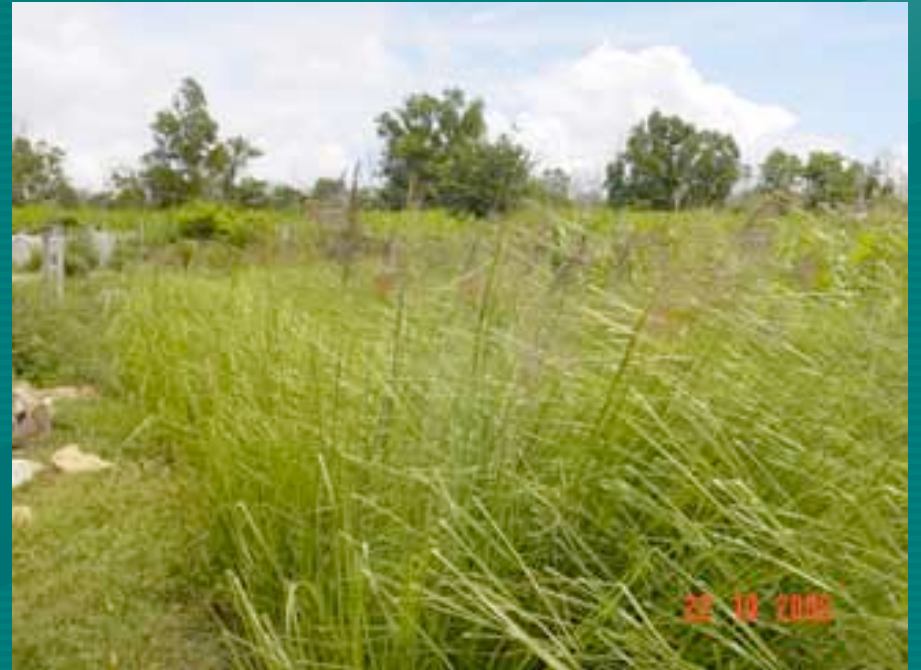
**AFTER 3 MONTHS VETIVER ROOTS REACHED 700MM,
PENETRATING THROUGH THE COMPACTED LAYER.
REACHING THE UNDERGROUND WATER TABLE**

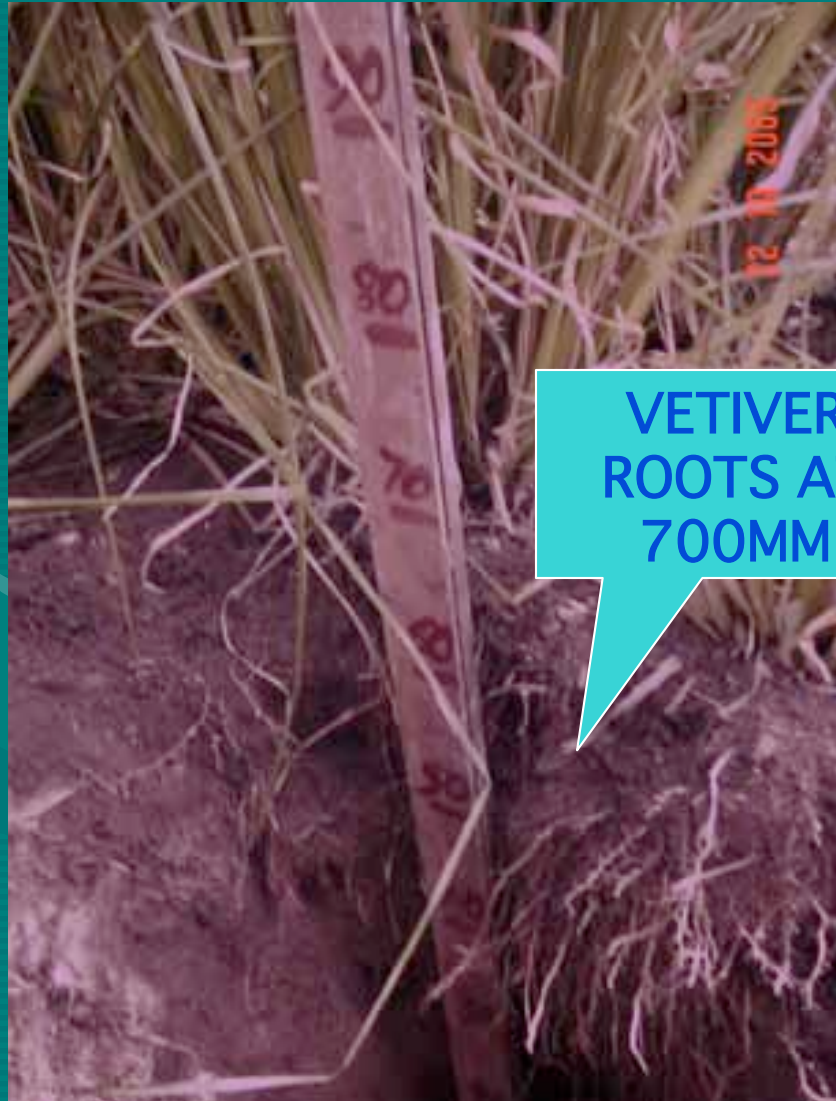
**VETIVER
ROOTS AT
700MM**

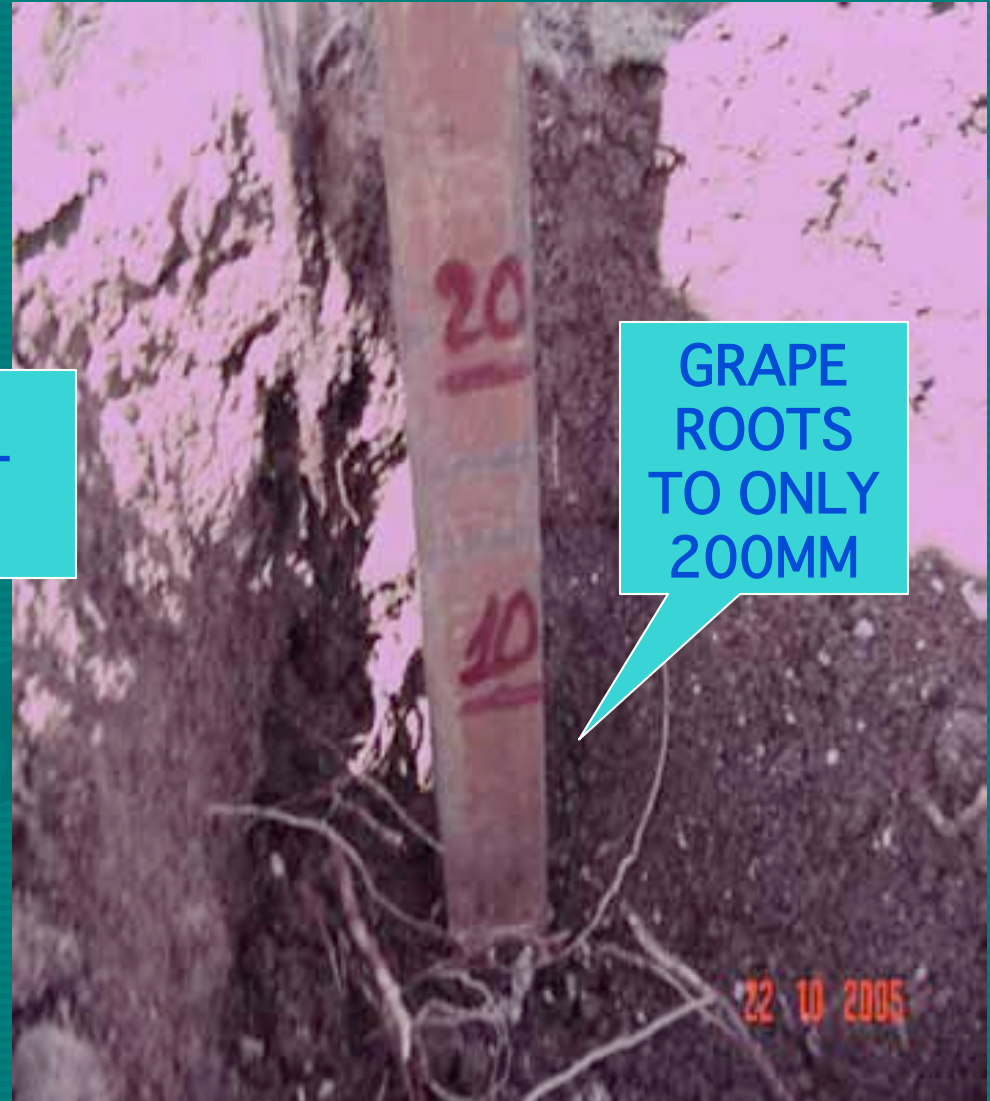
**GRAPE
ROOTS
TO ONLY
200MM**

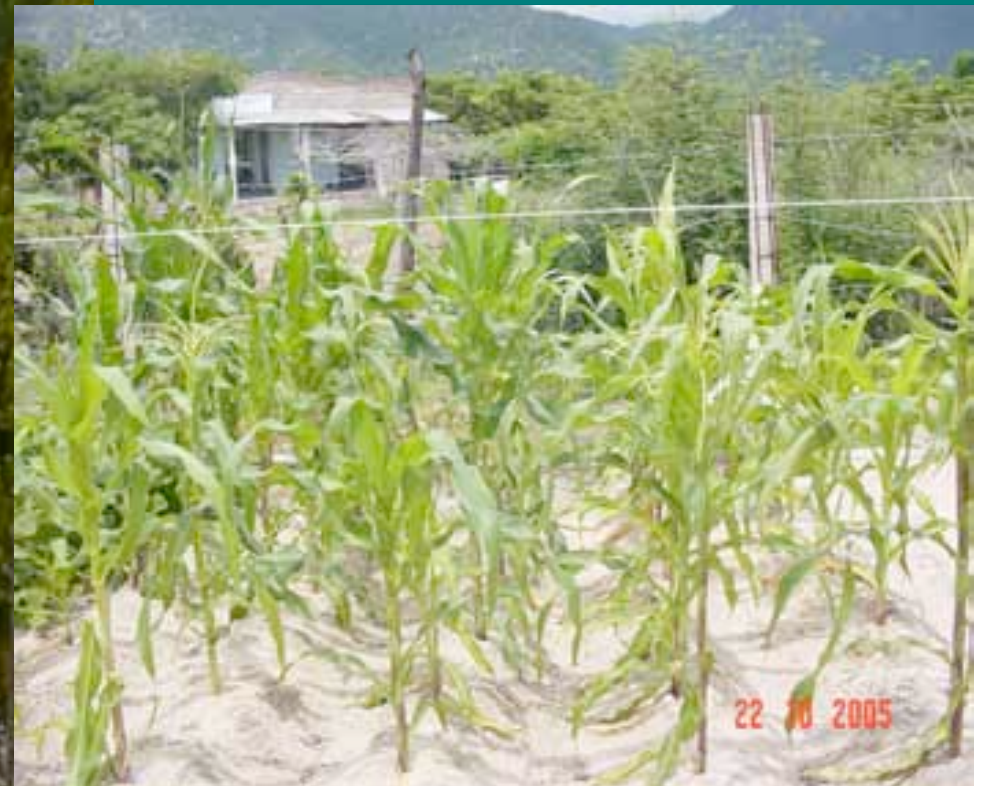
When the green vetiver shoot and leaf was composted and used for corn and grape crops, yields improved markedly

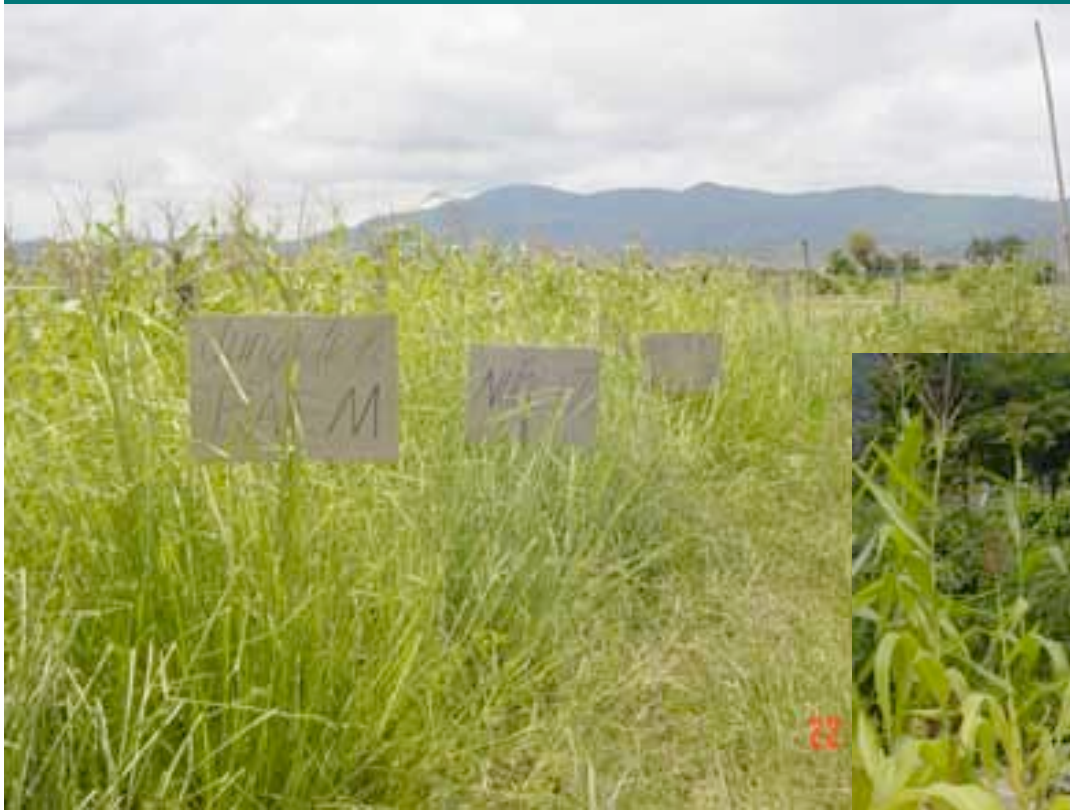
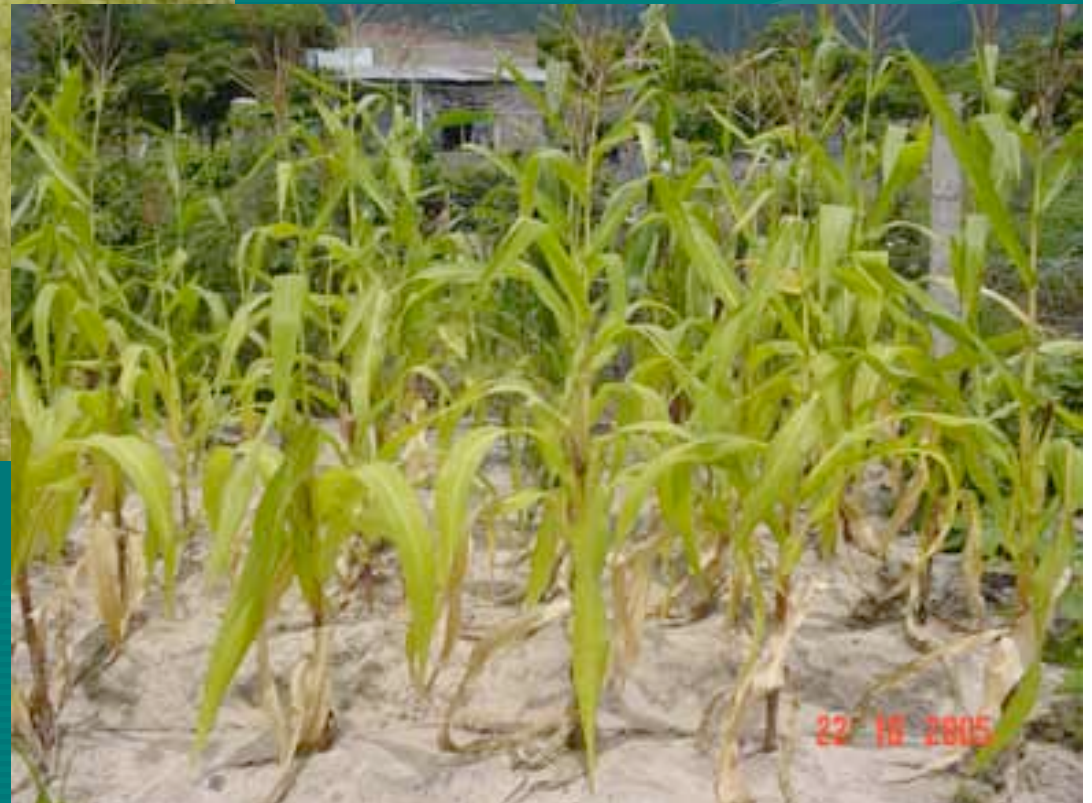
Contrast between Vetiver and corn crops 2 months after planting

The reasons why there was so much discrepancy in growth between Vetiver and corn

- Once the penetrating and massive Vetiver roots pierced through the compacted gypsum layer it would tap into the underground water supply
- In contrast the corn plant can not do this because:
 - its poorer root system.
 - Even if its root could reach the underground water supply, corn cannot tolerate the high pH and saline water.
- Resulting in very poor growth in the corn crop

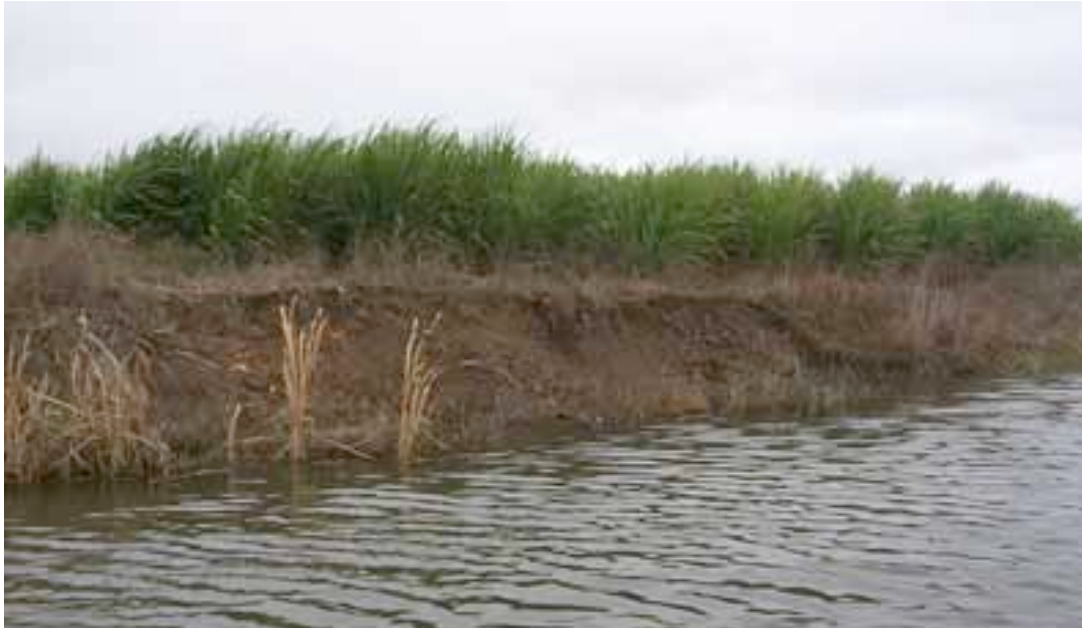
Highly erodible canal and dike banks, and road batter

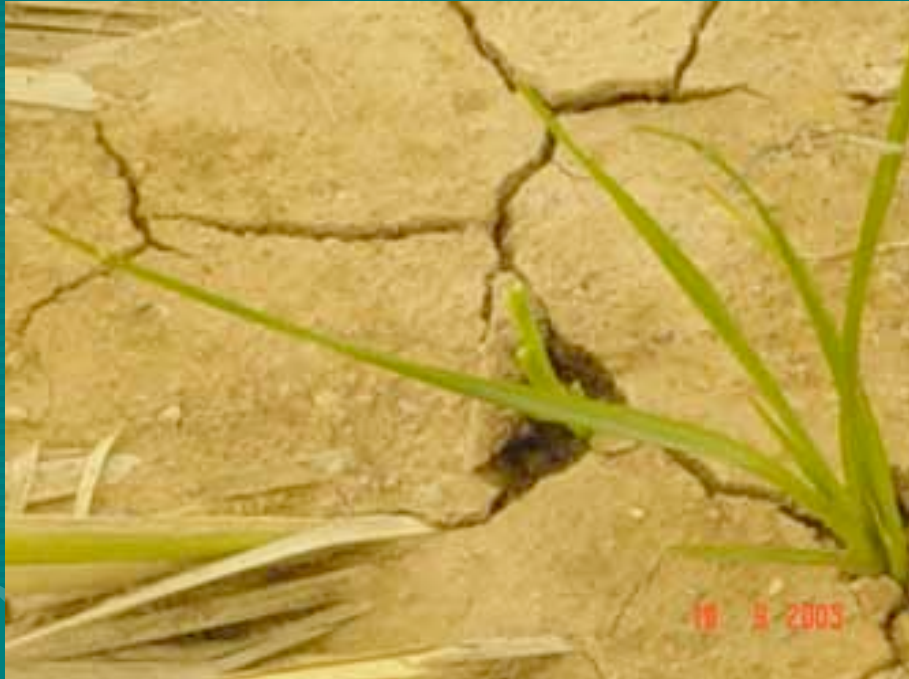
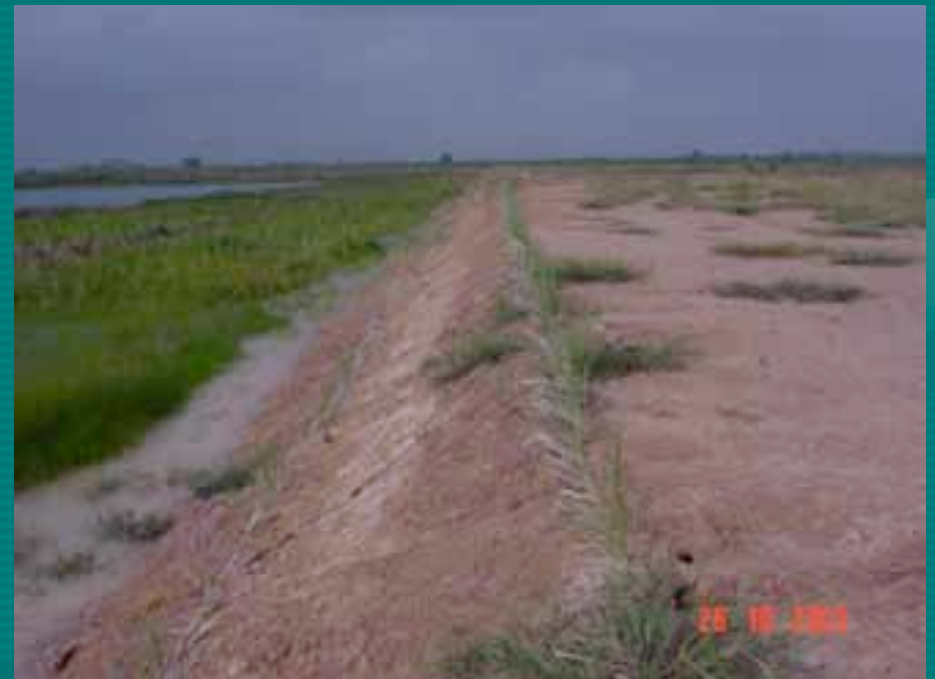
One month after planting

- **Vetiver can be established and grew well on these extreme acid sulfate soils**

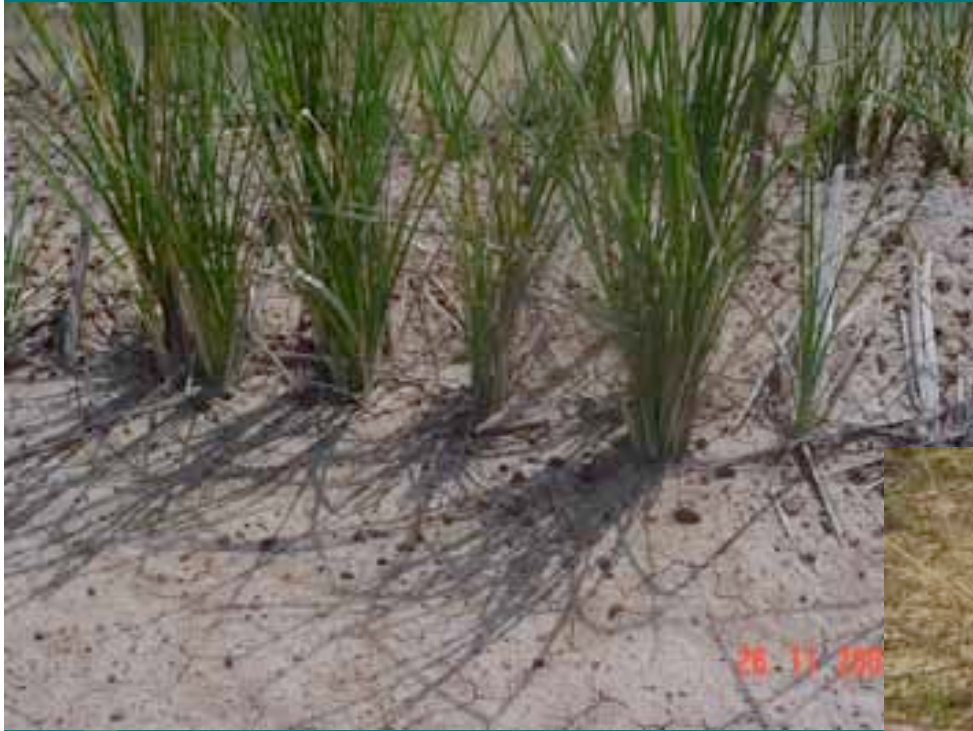
Six months after planting

Erosion was reduced to 1/3-1/5 of the level before vetiver planting

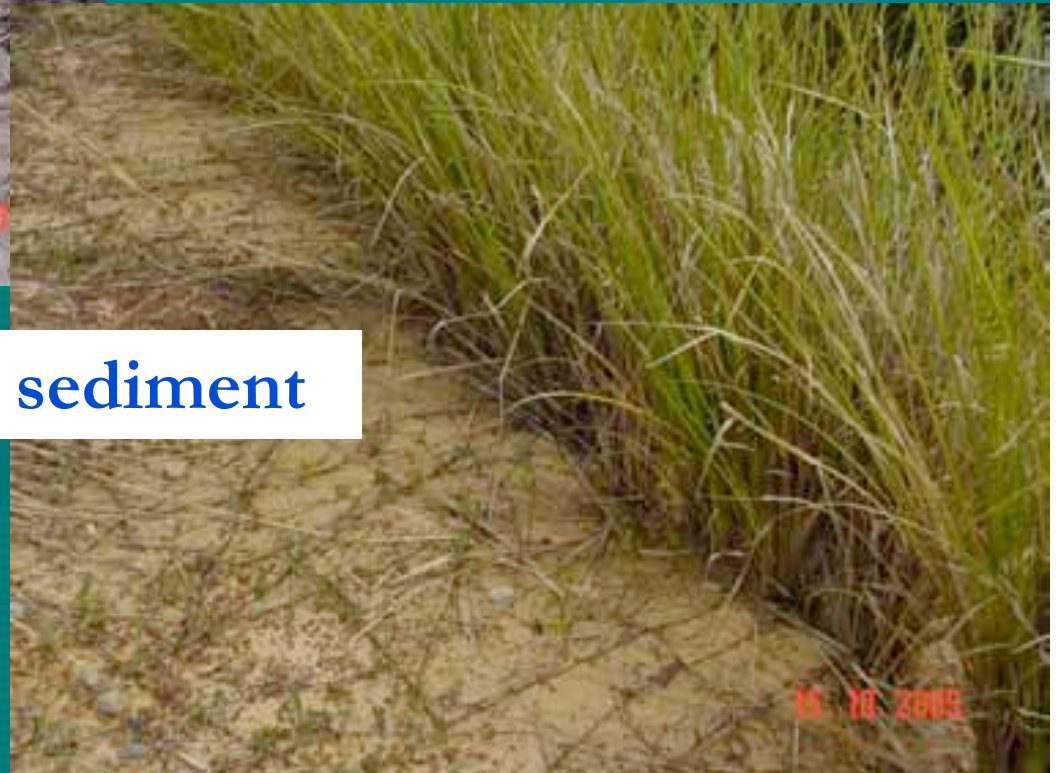
Trapped sediment

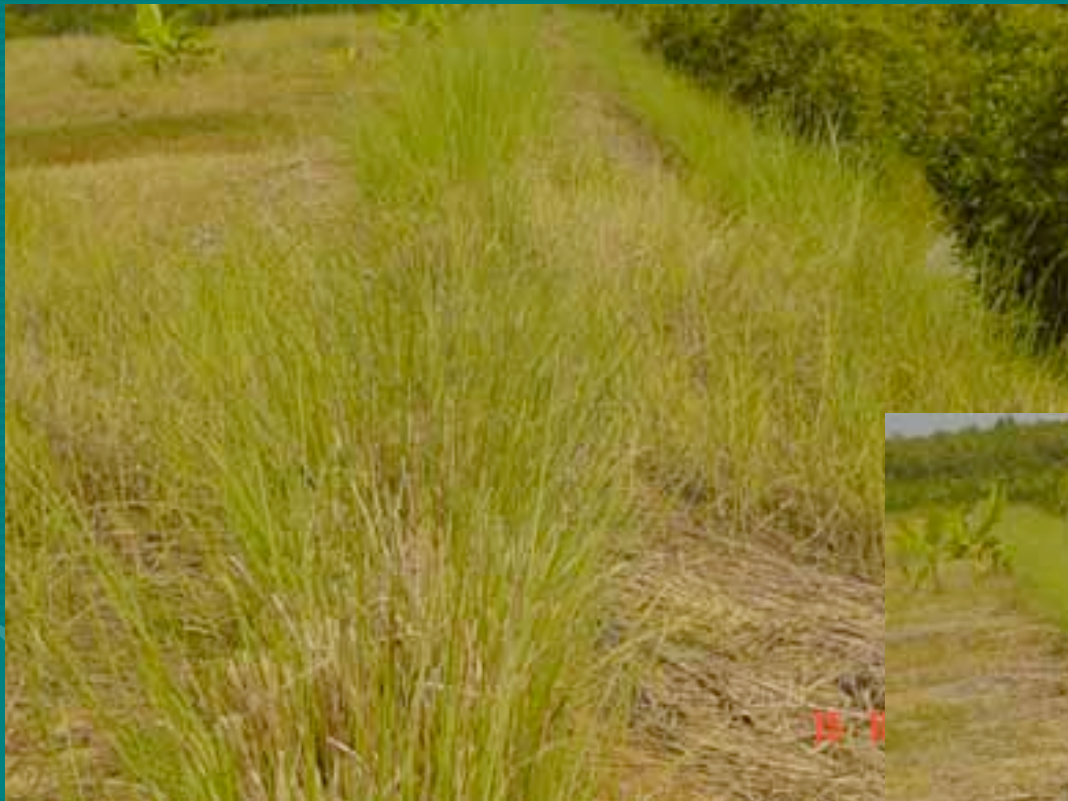
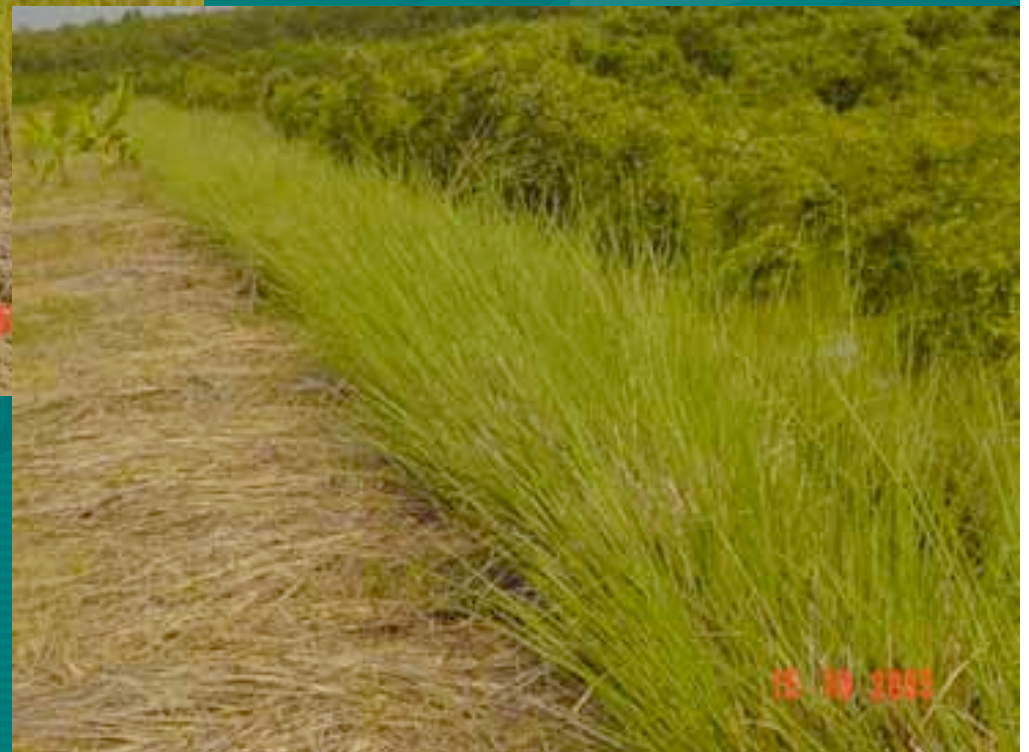
15 months after planting

- No more erosion and return of local native vegetation between vetiver rows

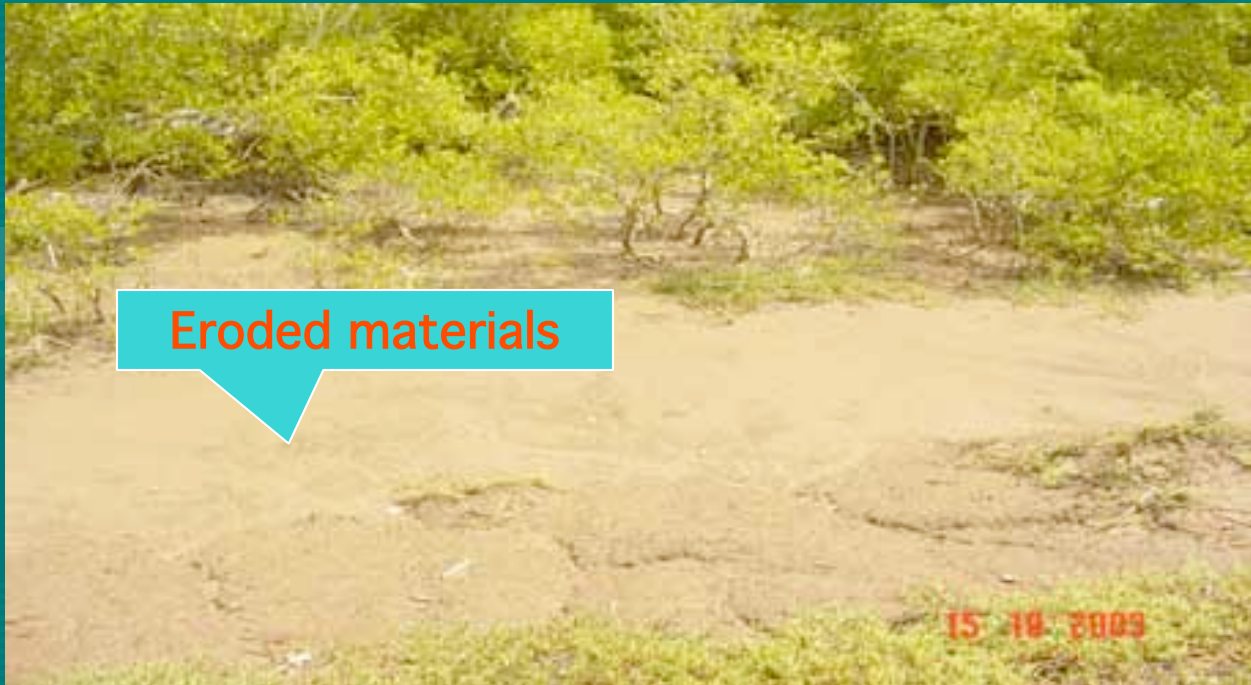
Eroded materials

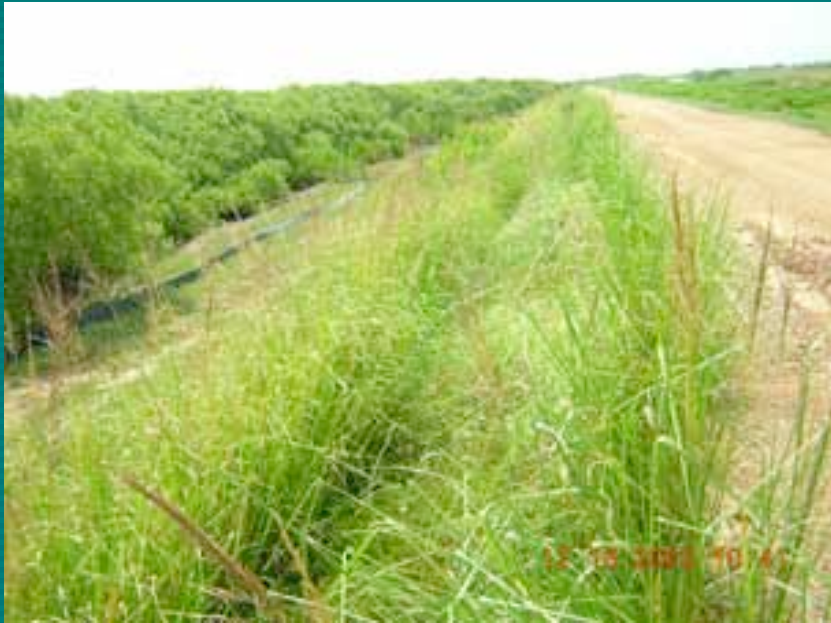
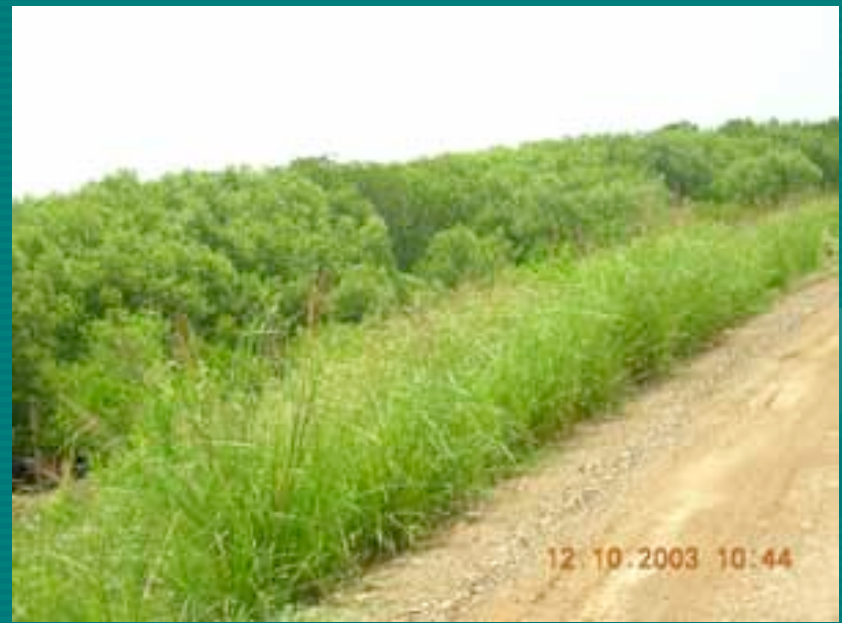
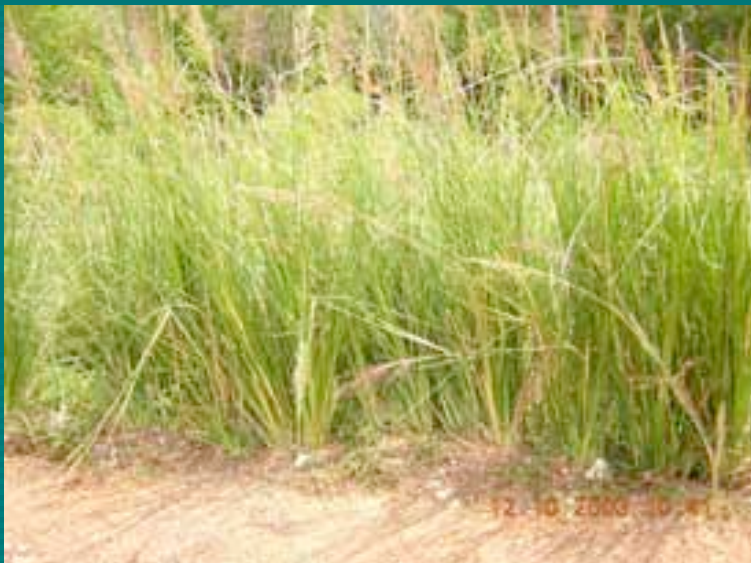
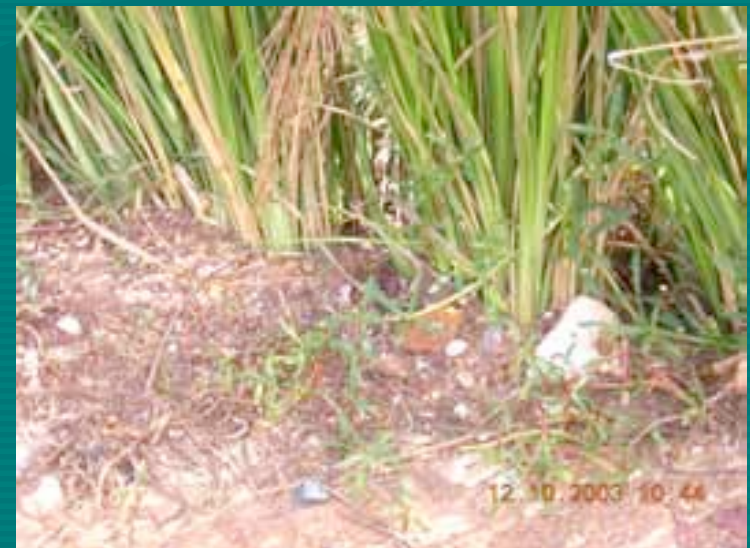
12 months after planting

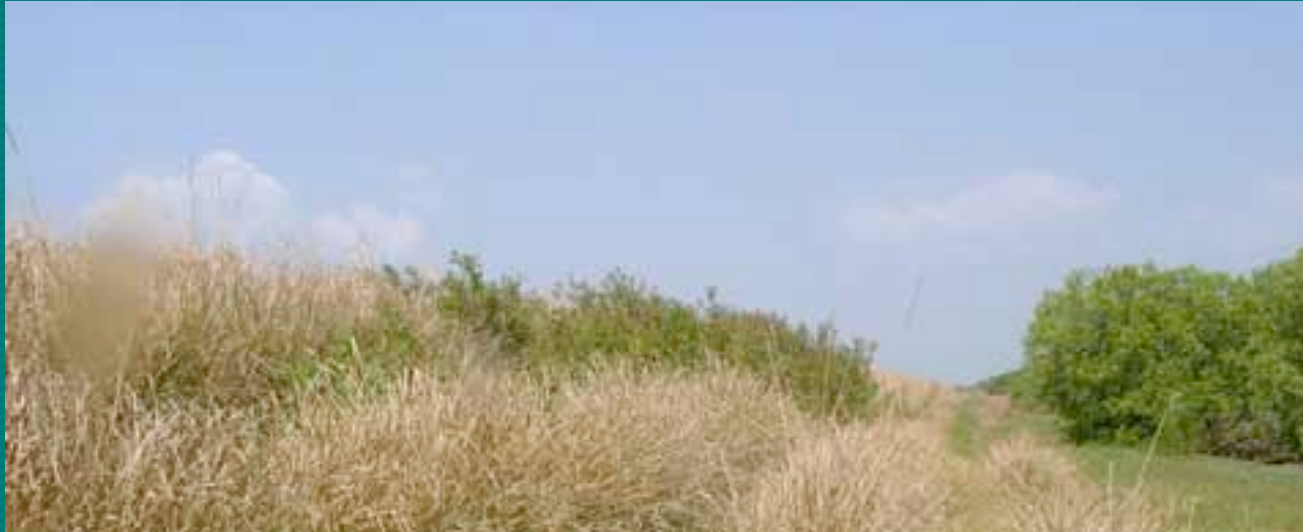
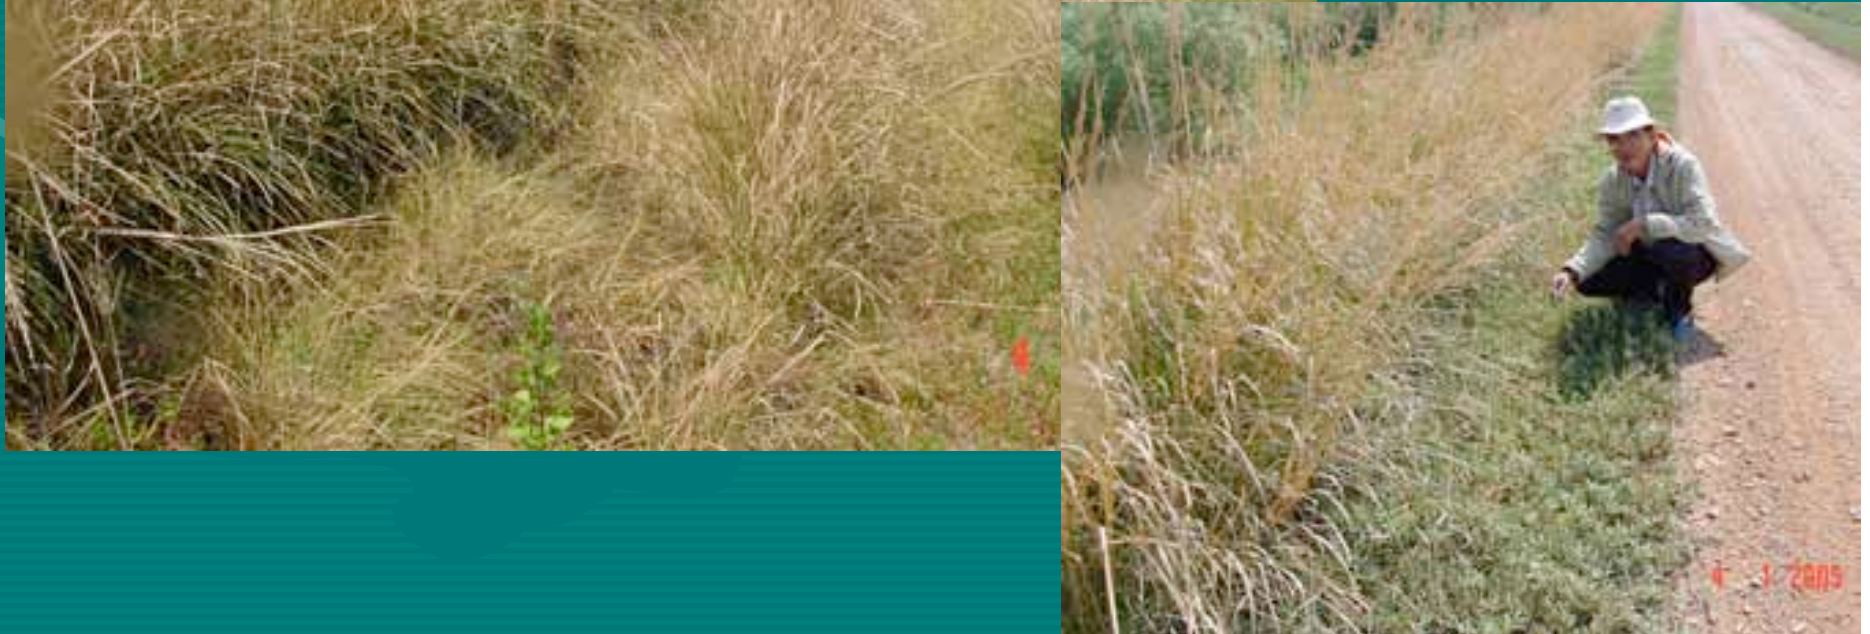
Three years after planting

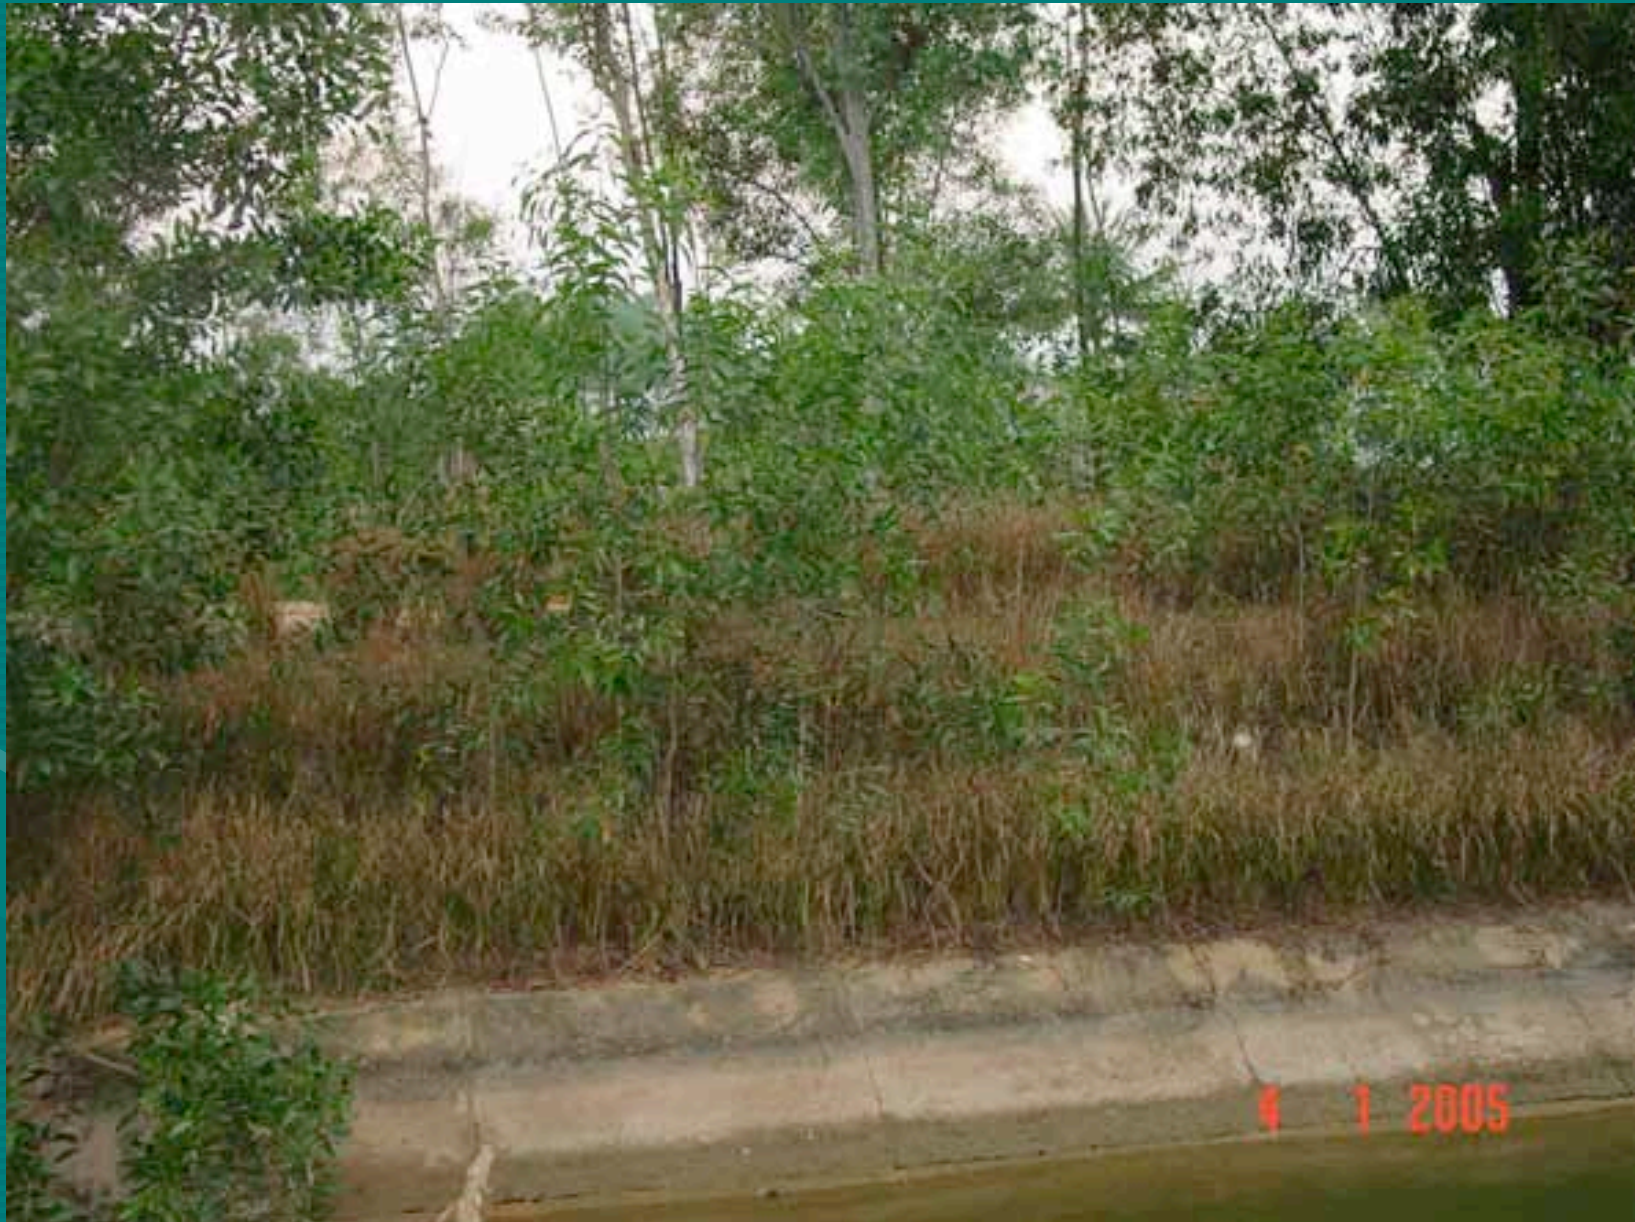
One year after planting, no more erosion on the channel banks and the trees returned

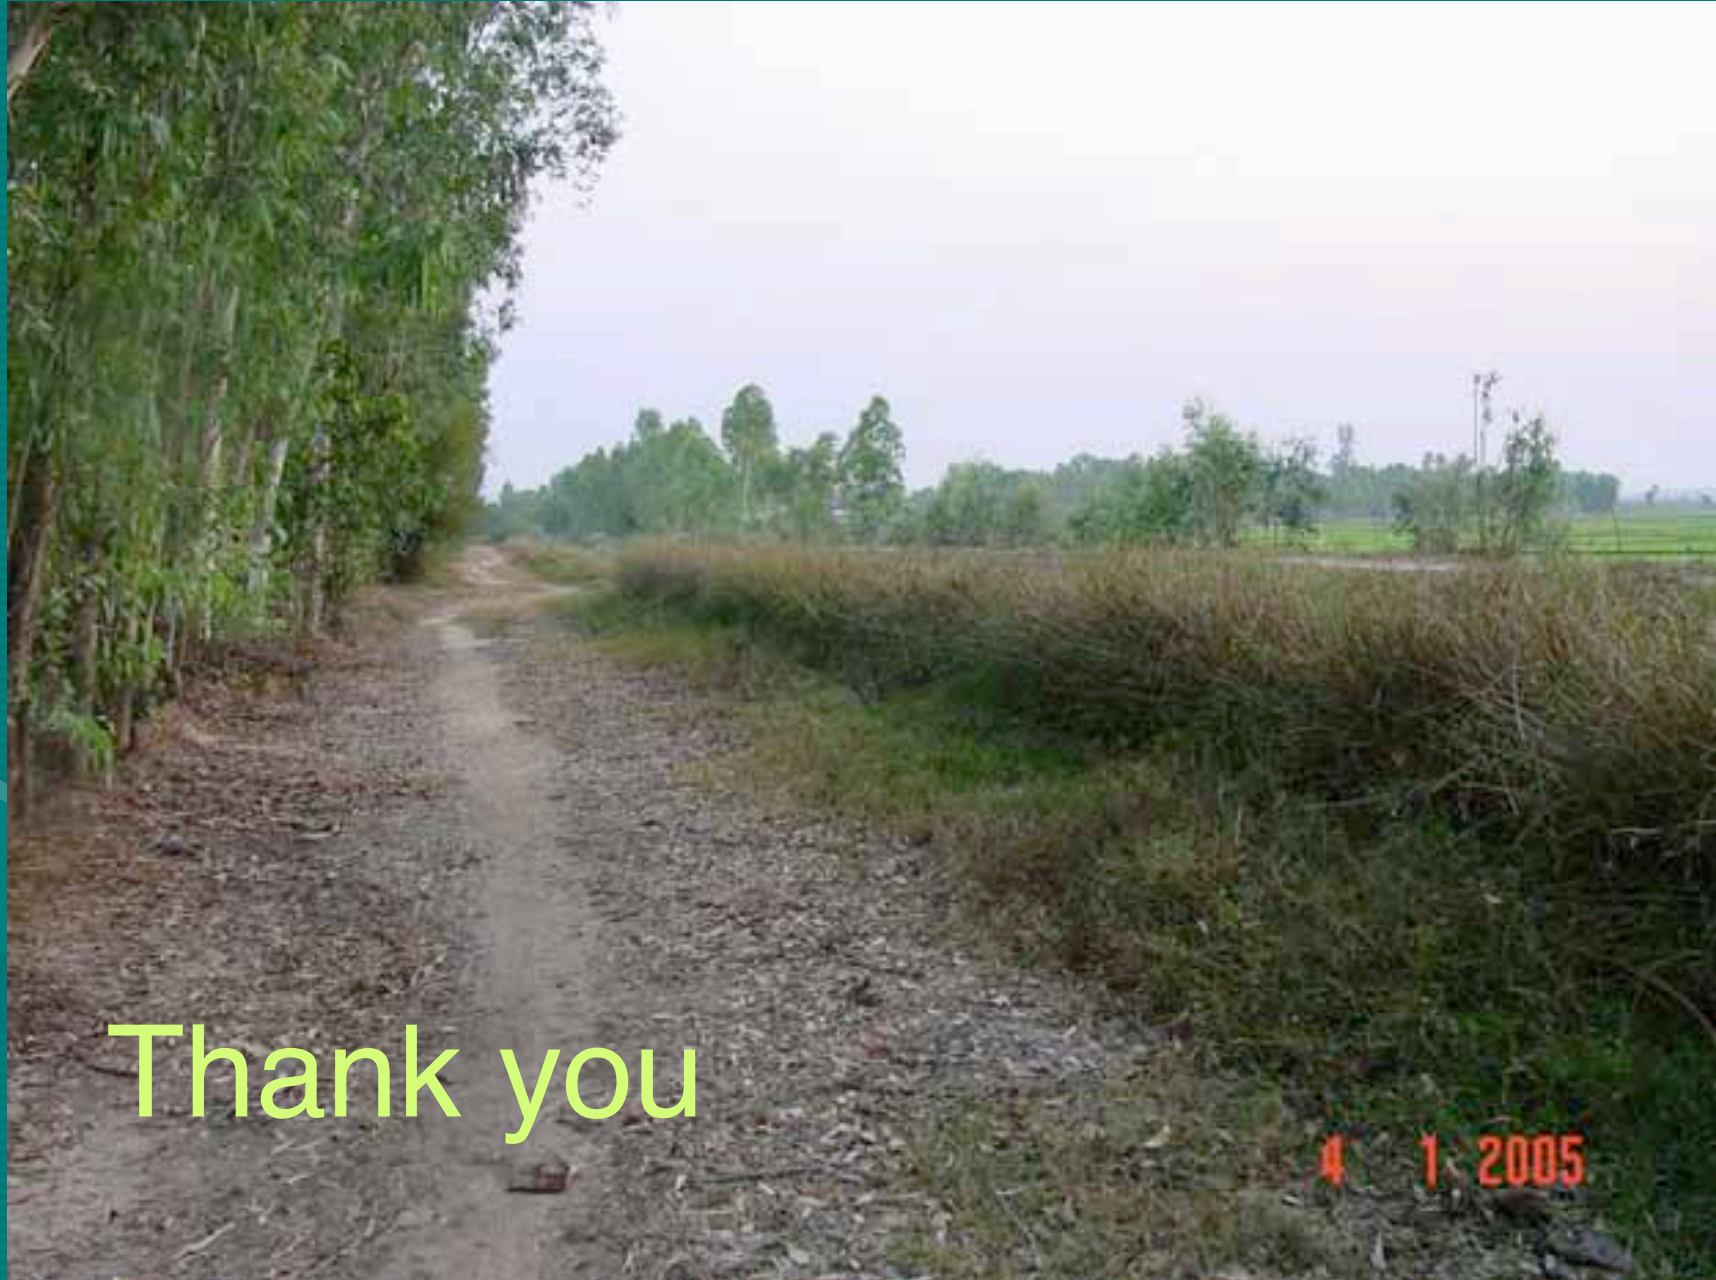
One year after planting, the road stabilised
