Natural Disaster Prevention and Mitigation through Vetiver System

Dr. Uthai Charanasri
Mae Fah Luang Foundation
Doi Tung Development Project ,
Mae Fah Luang , Chiang Rai Thailand

Prevention of landslides by planting vetiver hedgerows on highways , dykes , and railroads slopes

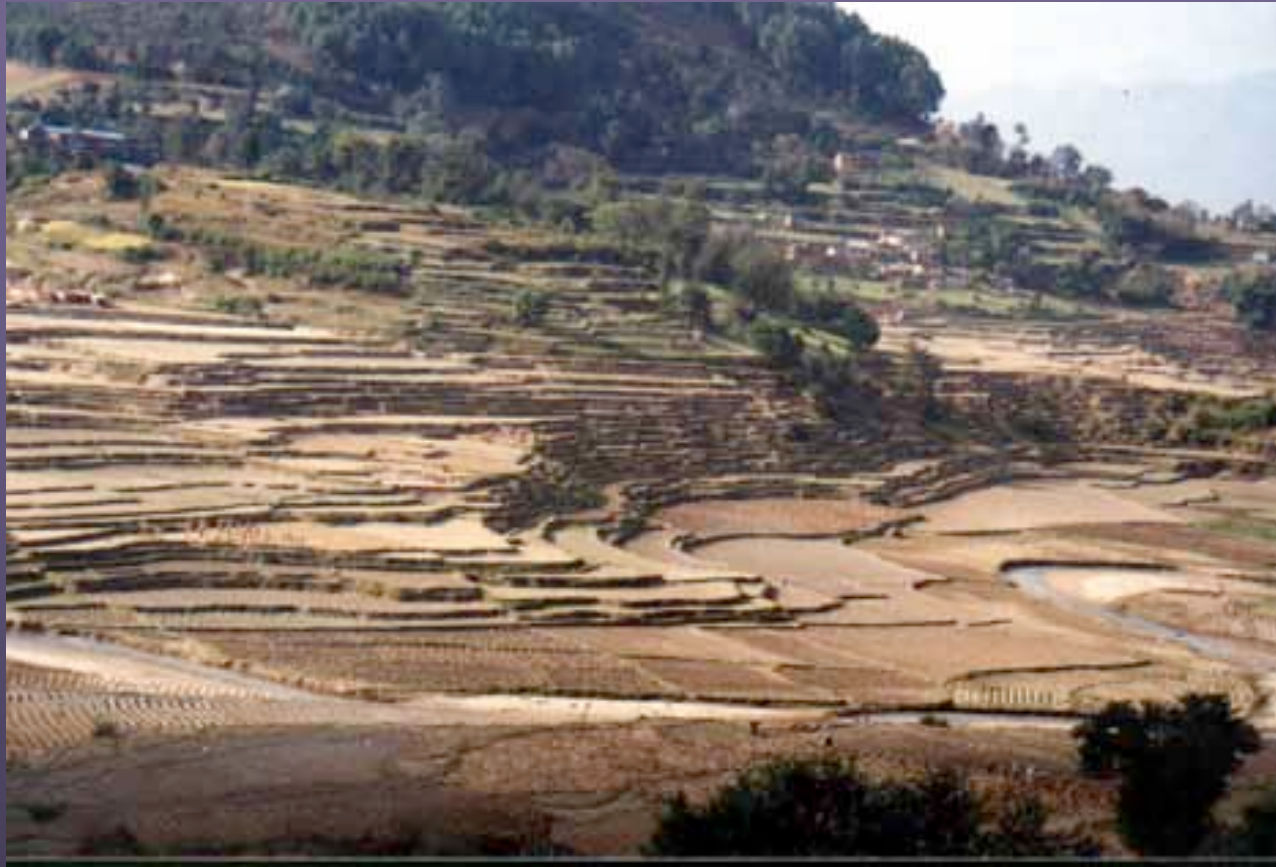
Figure 1: Erosion control in highland agriculture system in Nepal : Rice paddy field and terracing

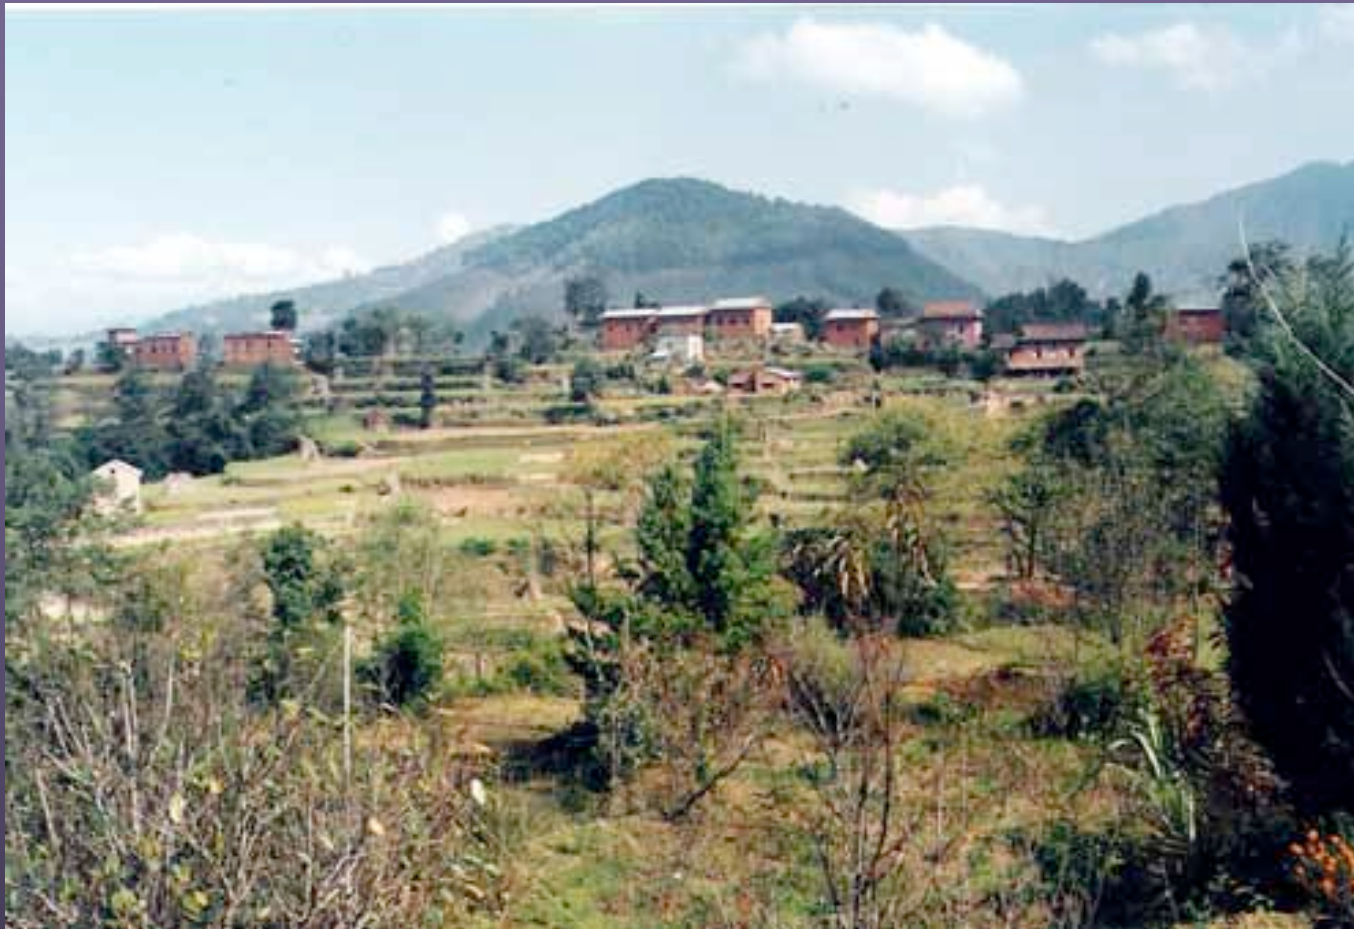
Figure 2: A good example Living quarter always on the high ground in Nepal , a country with long experiences on erosion control.

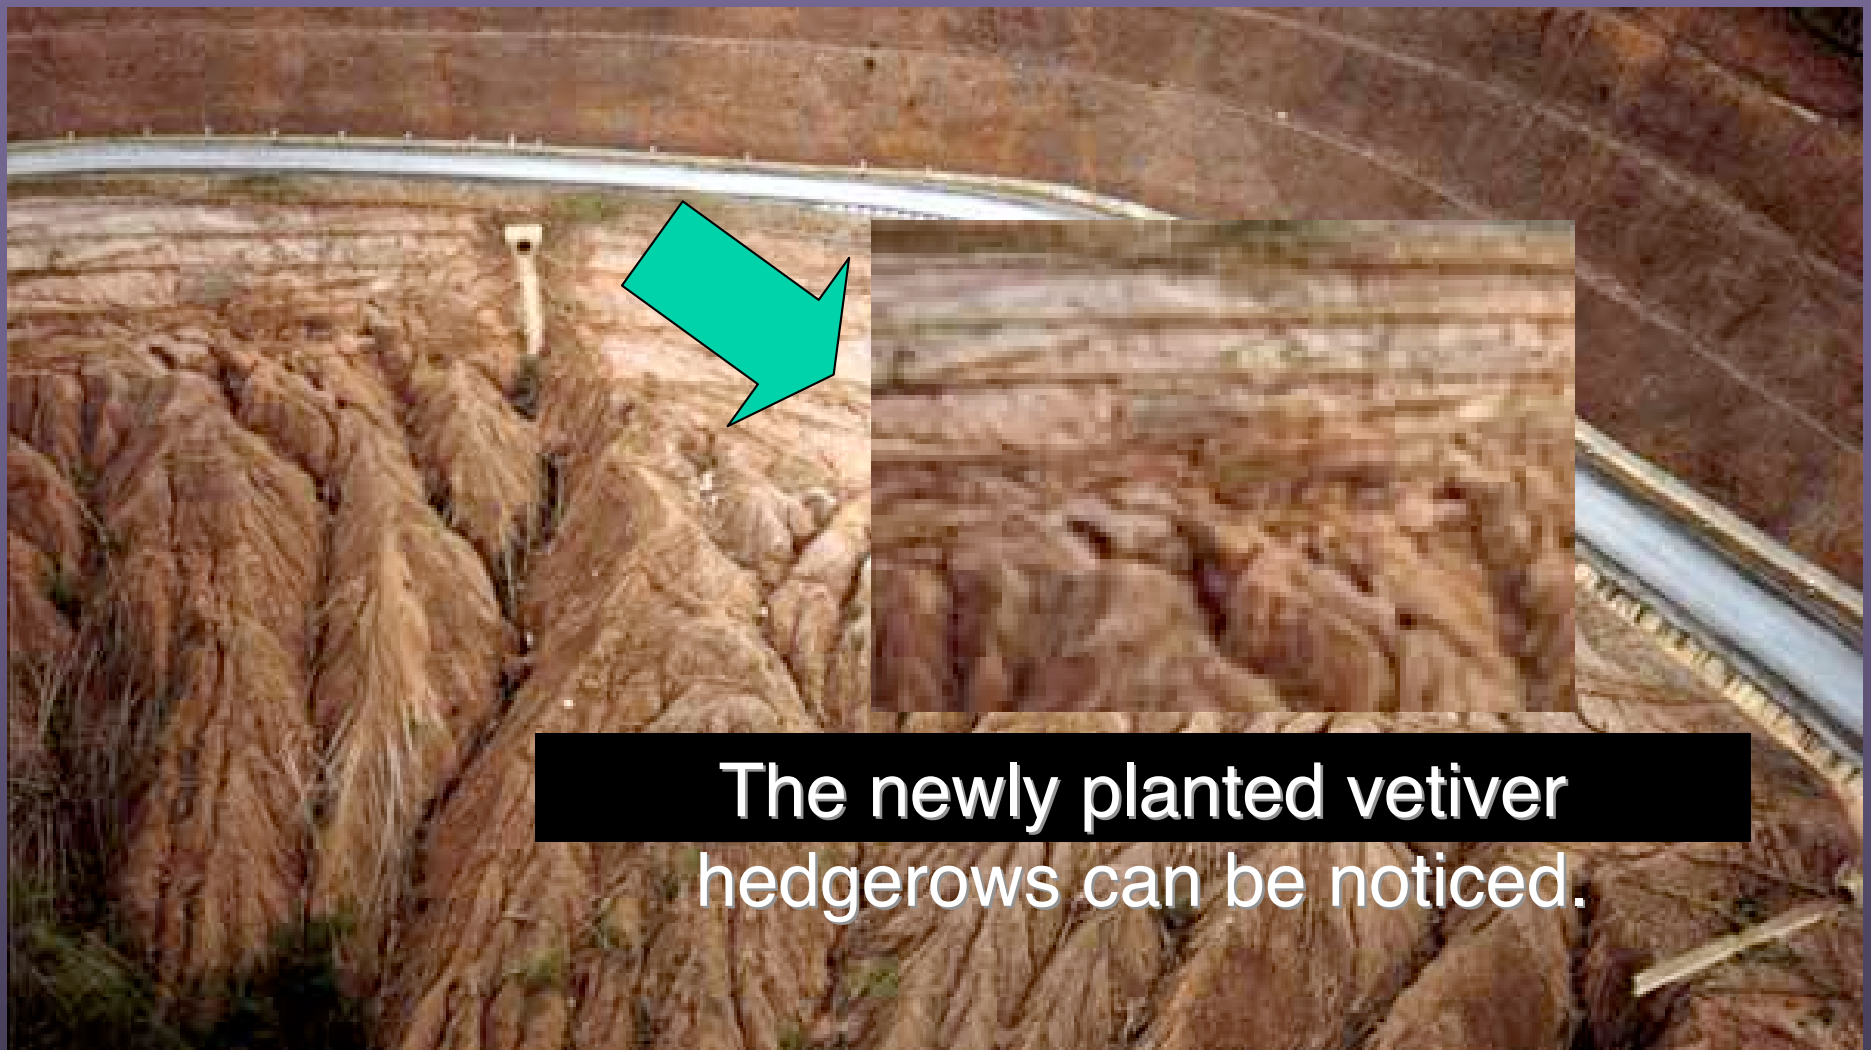
Figure 3 : Gullies form on the sideslopes of a new road after 1 rainy season exposure without hydroseeding and vetiver planting.

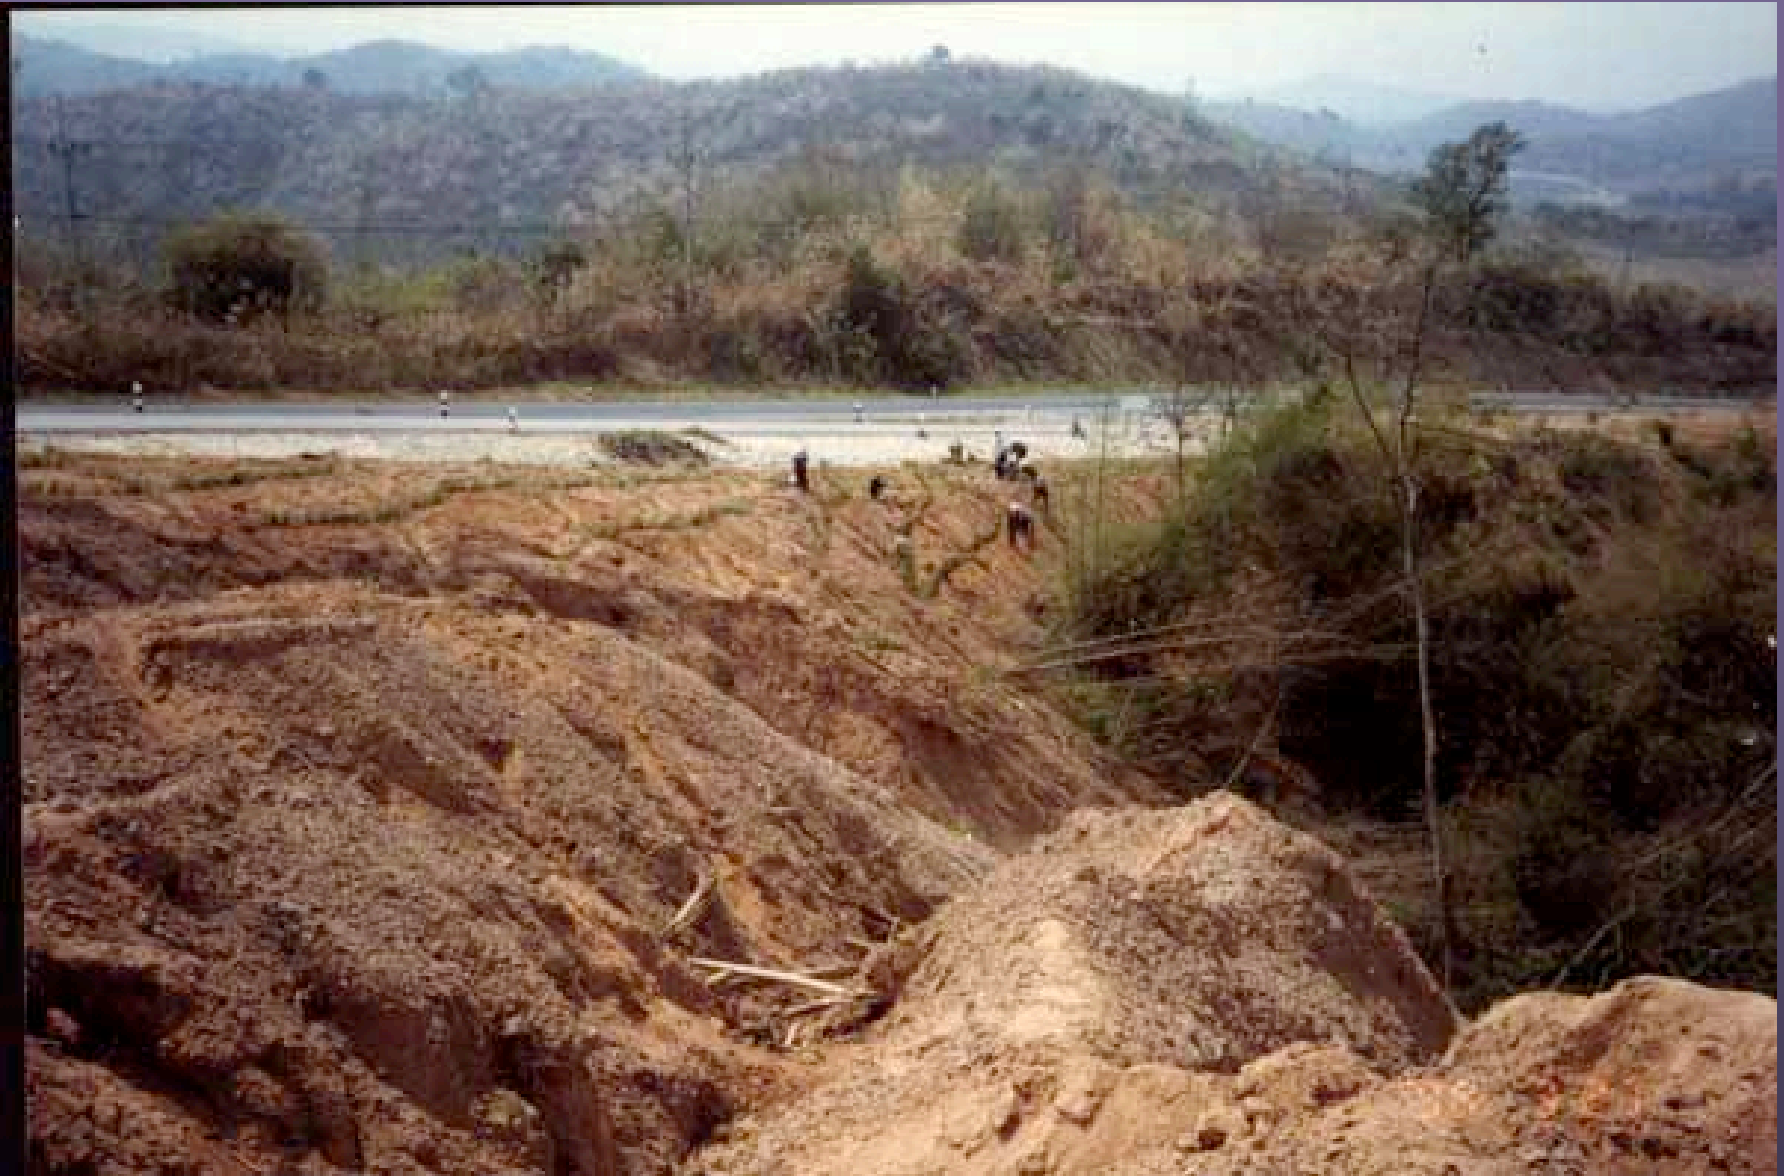
Figure 4 : Planting vetiver hedgerows to stabilize gullies on the road sideslopes.

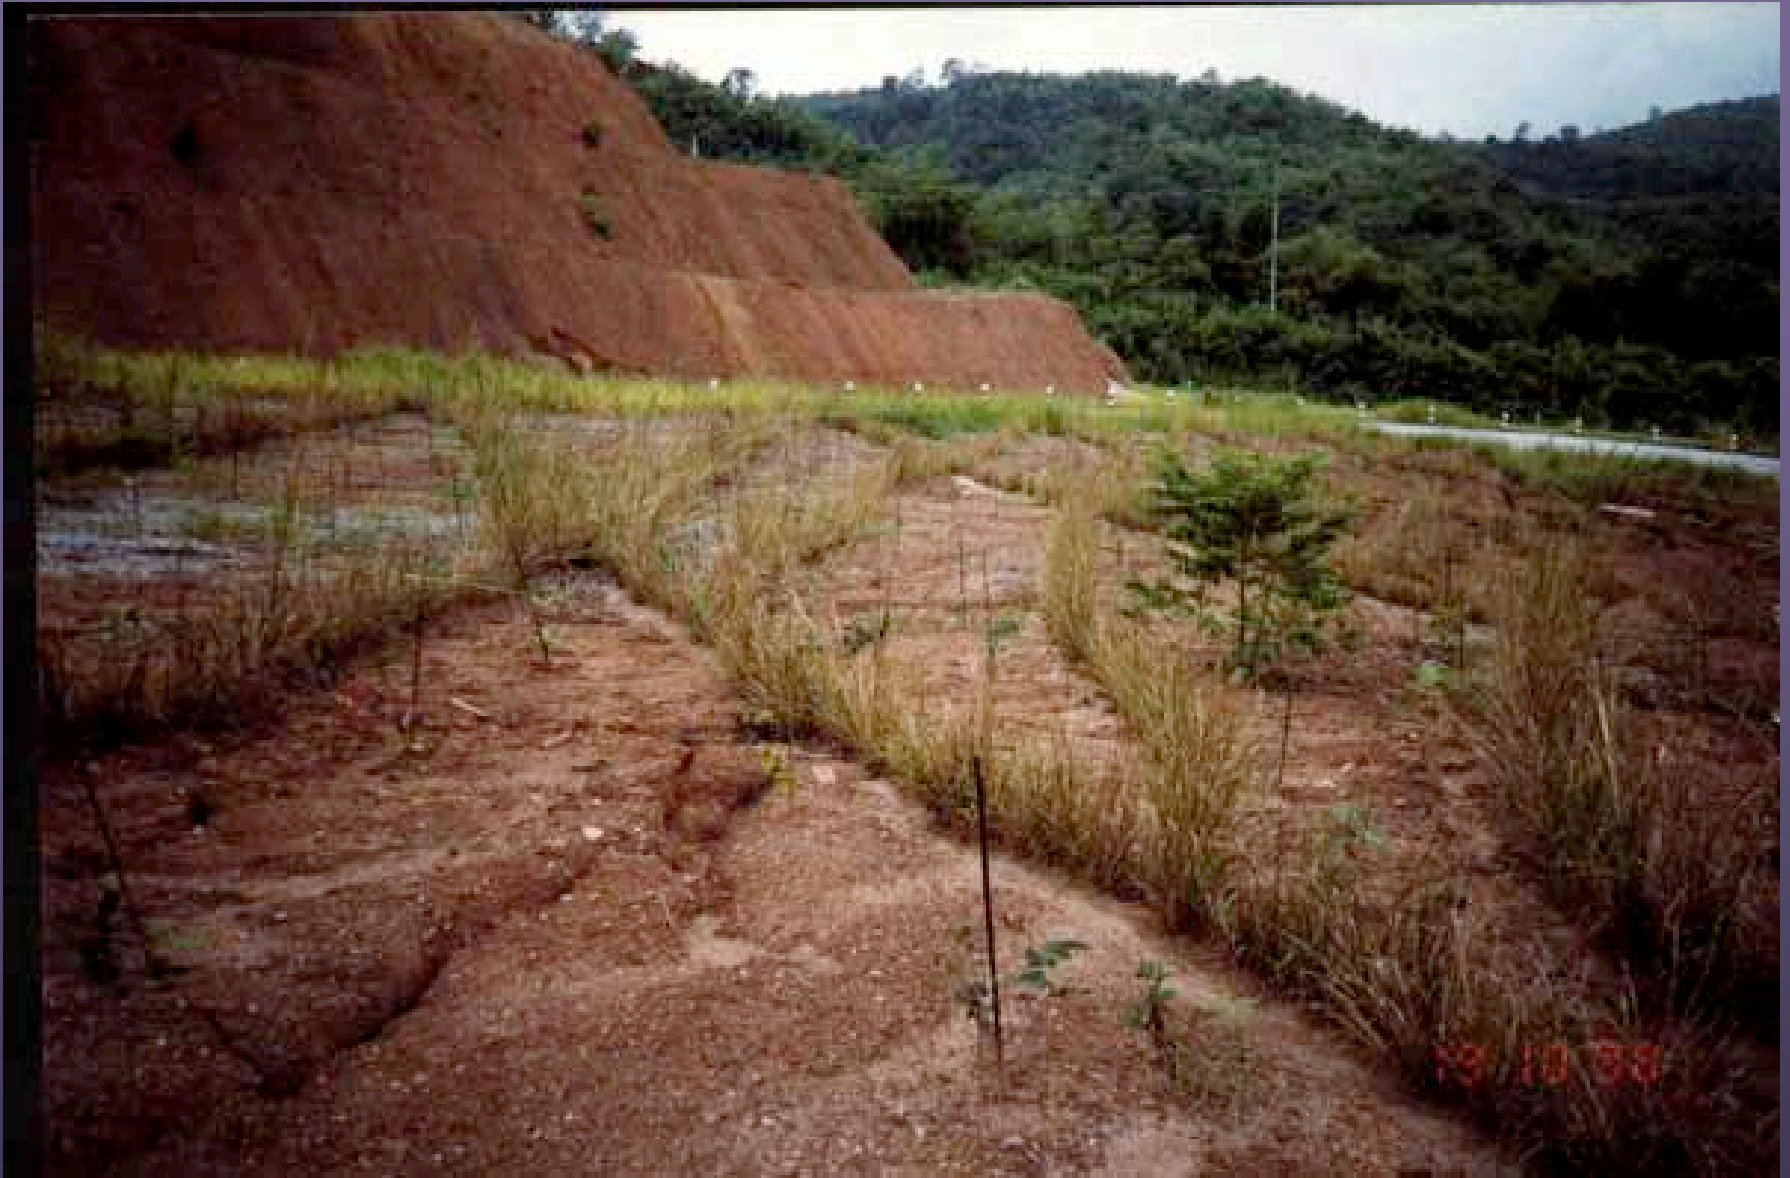
Figure 5. Well-established vetiver hedgerows network 6 month old to protect the ridges above the gullies and to diffuse run-off water.

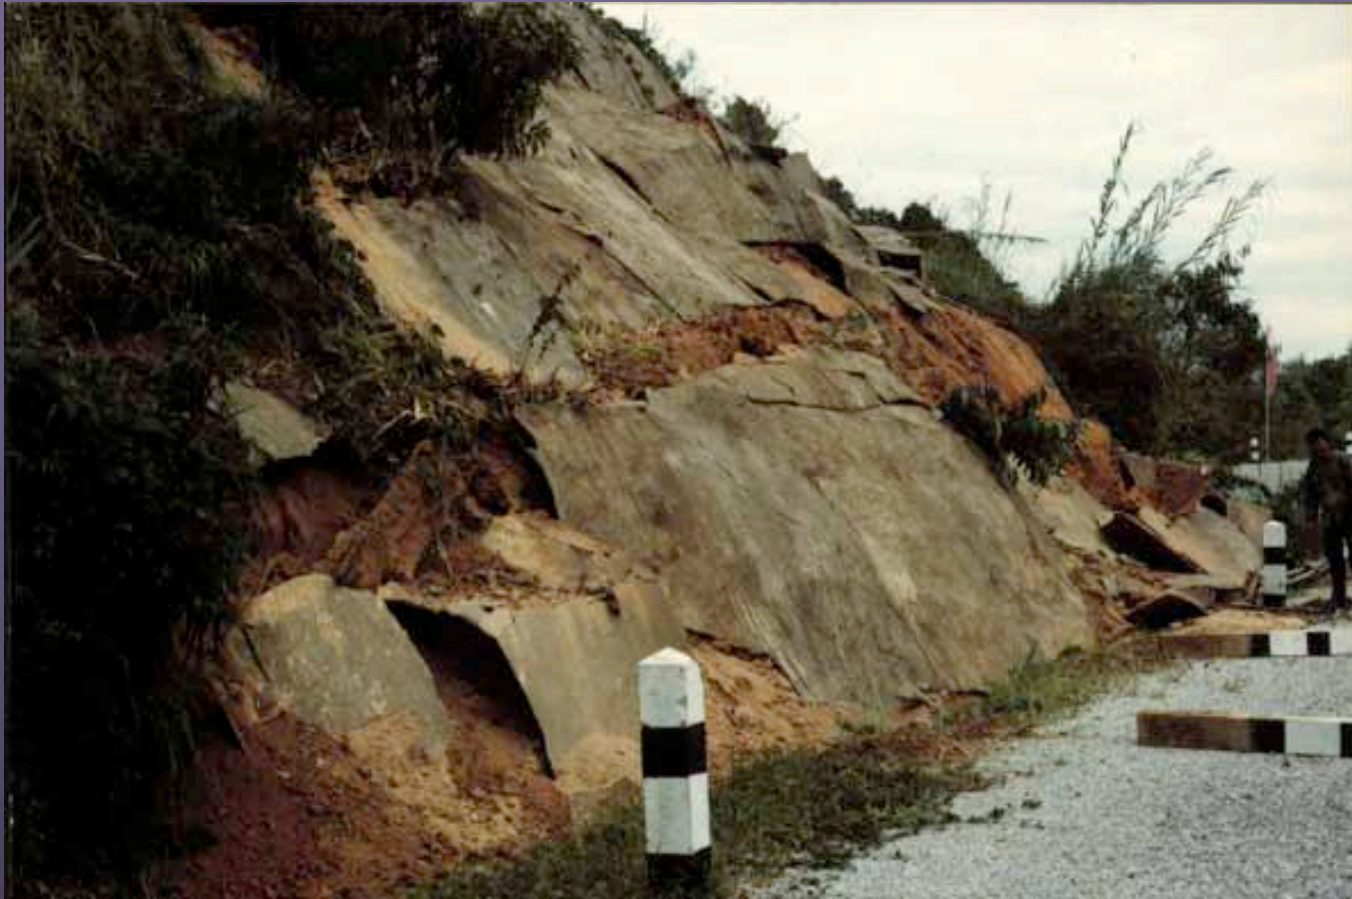
Figure 6: Ineffective stabilization of the road backslope utilizing cement-sprayed metal netting against landslide

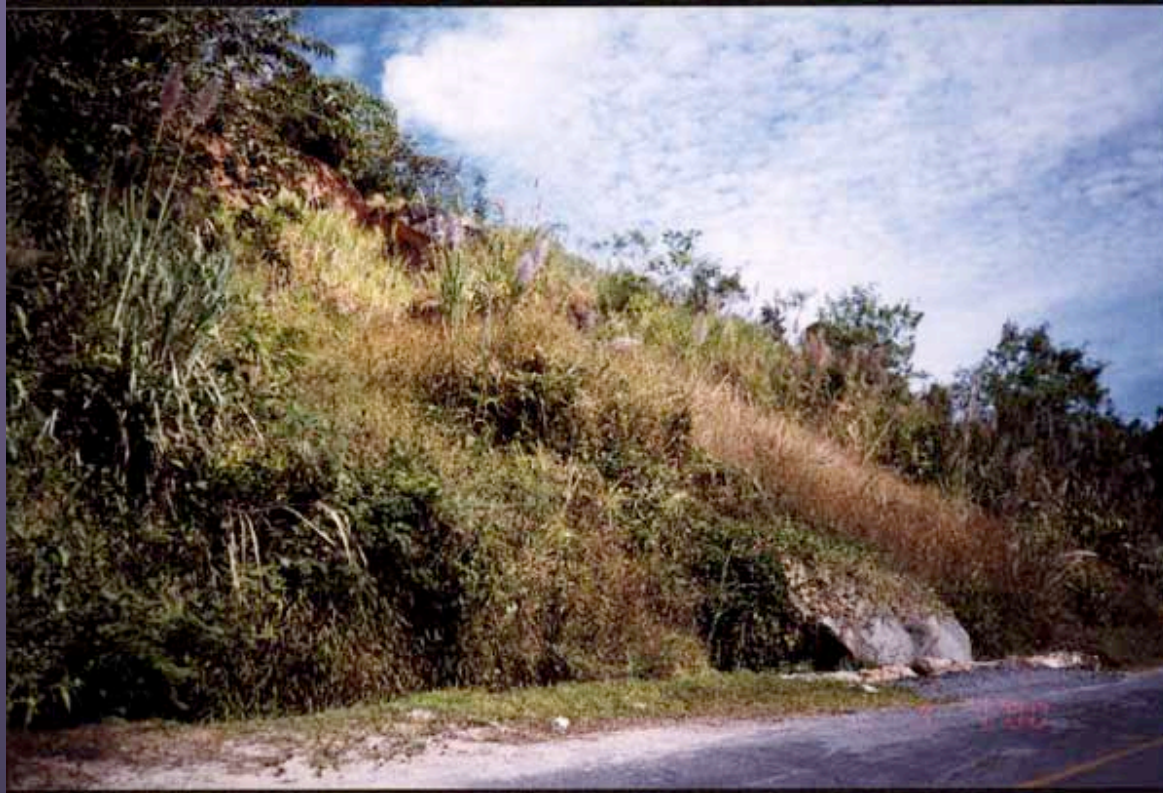
Figure 7 : The same gully as in figure 6 four years after planting vetiver hedgerows.

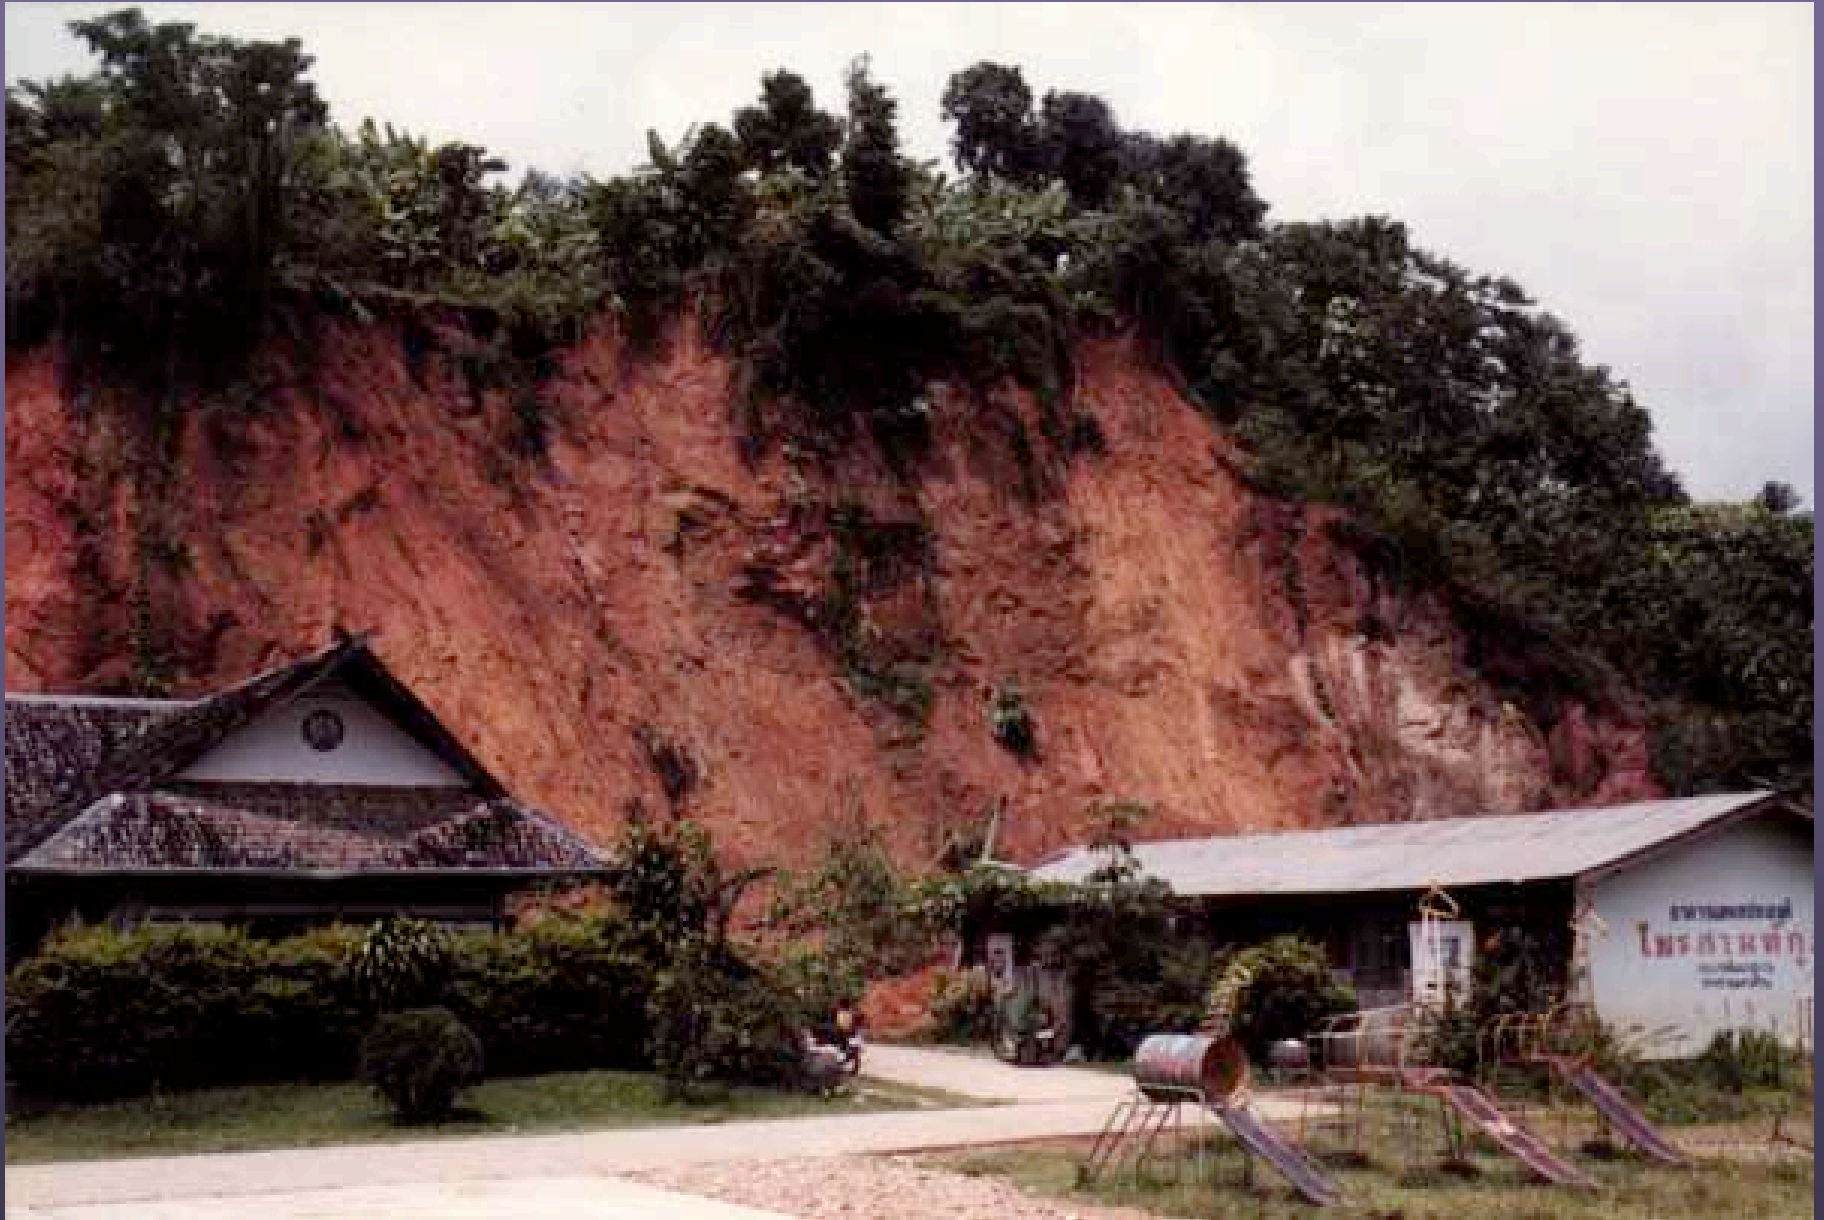
Figure 8. Landslide causing damages to the nursery and daycare center at Hauy Nam Kun village.

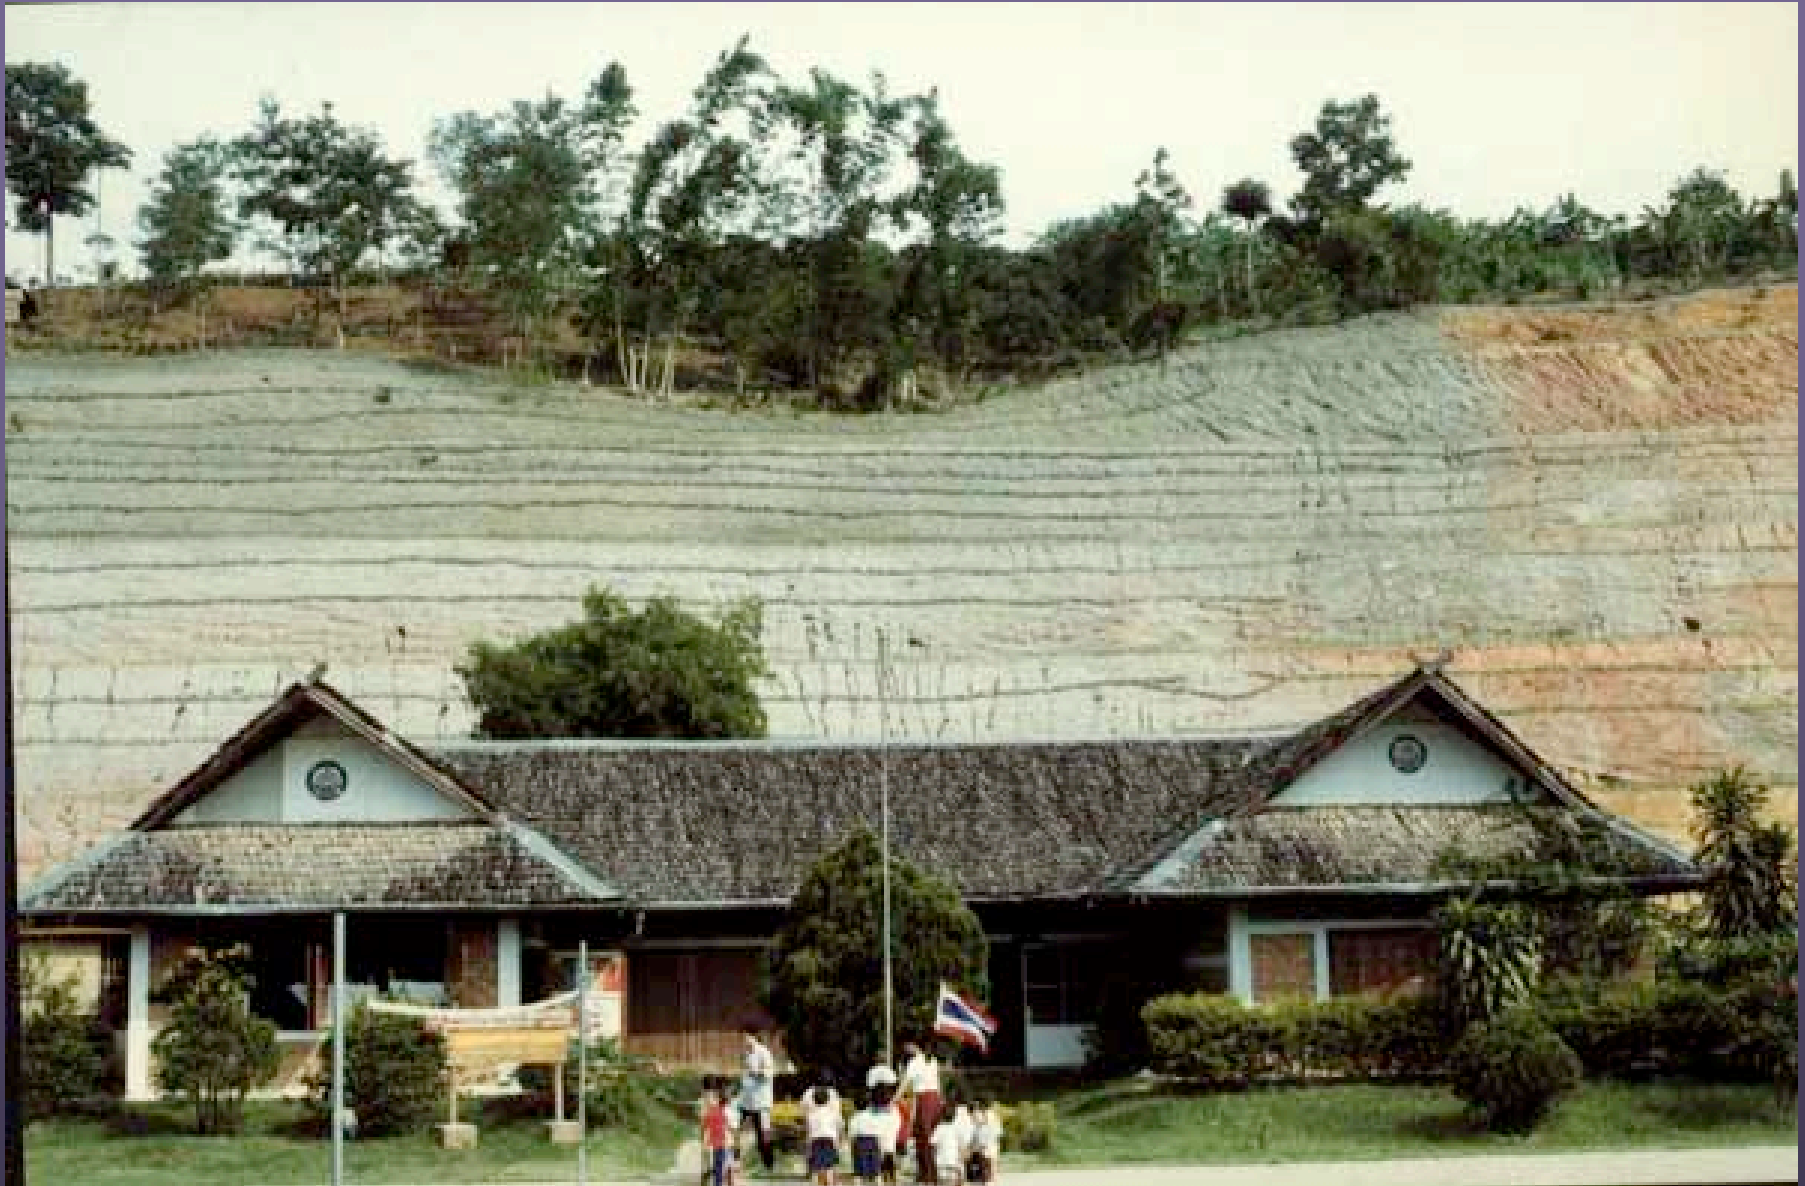
Figure 9: The same site as in figure 8 after making the terraces, planting vetiver hedgerows and hydroseeding of bermuda grass on the backslope.

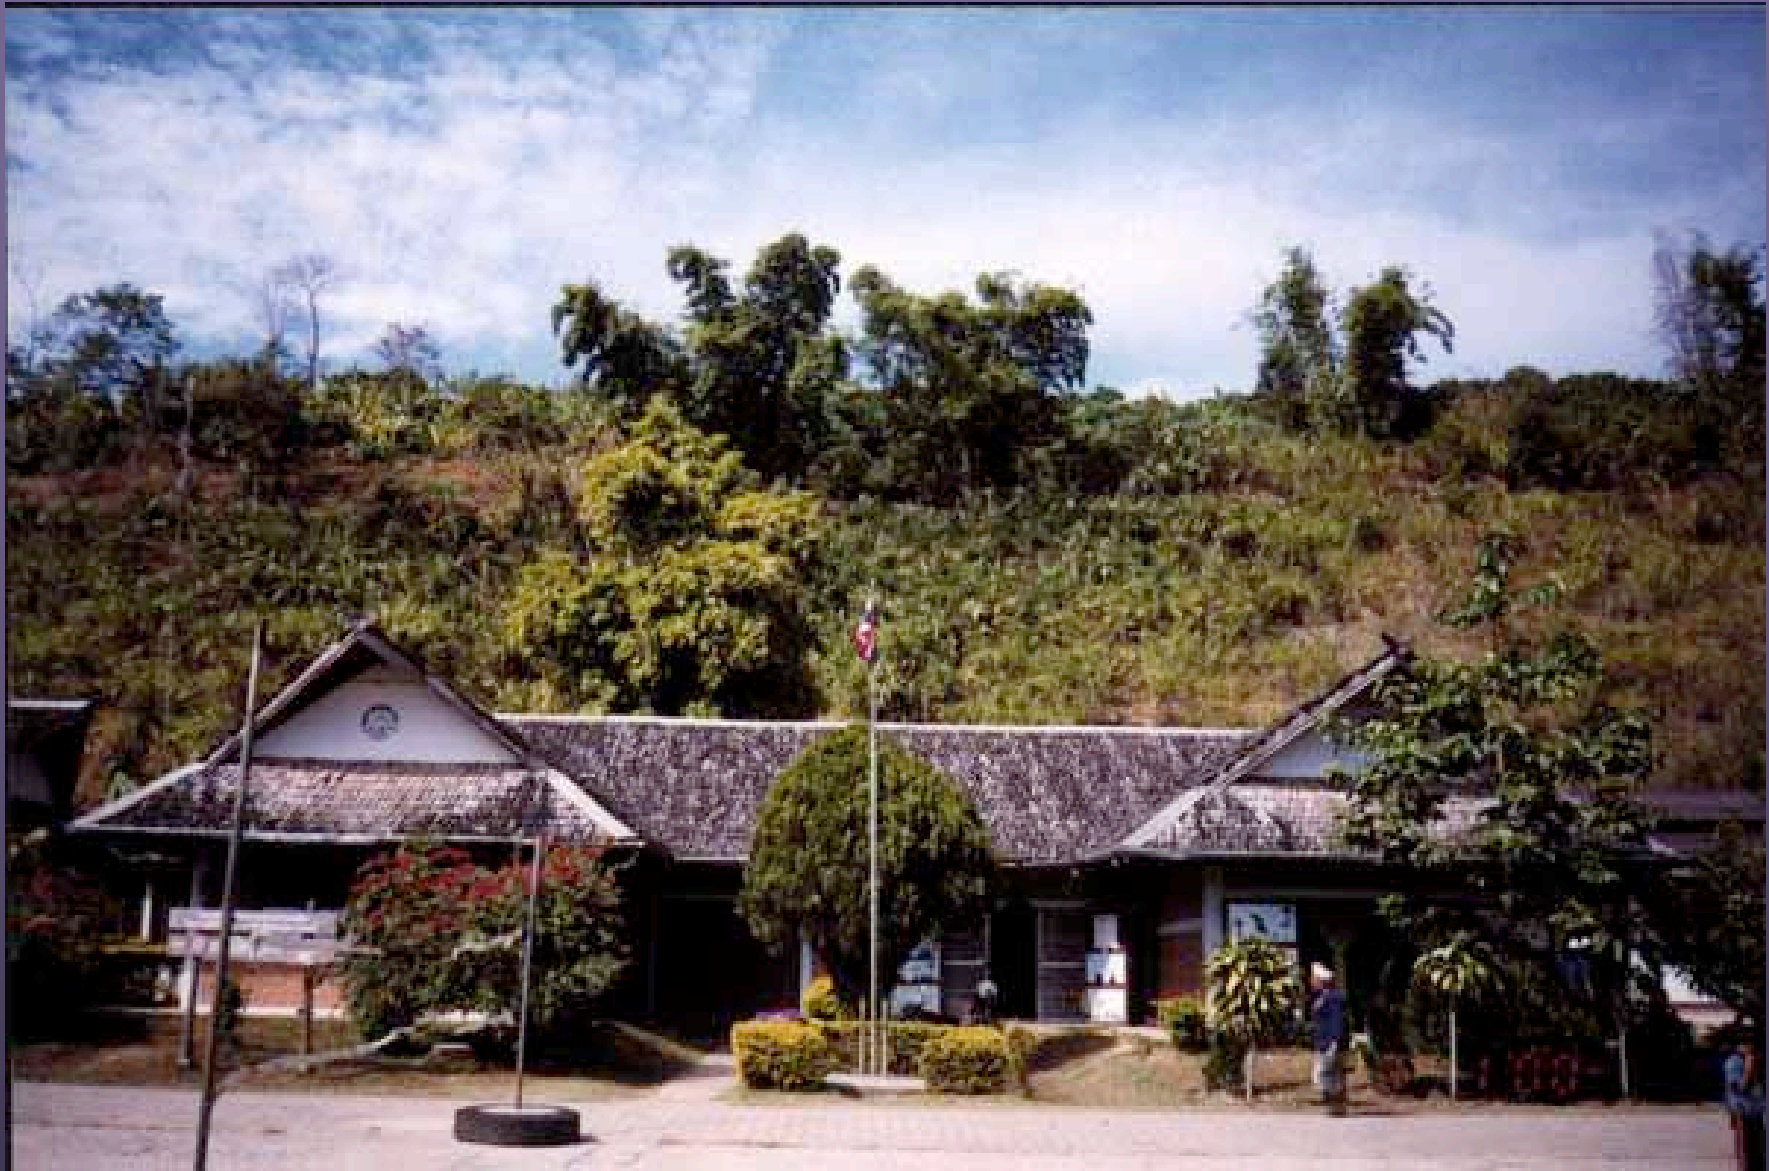
Figure 10: The same site as in figure 8 & 9 four years after planting vetiver hedgerows.

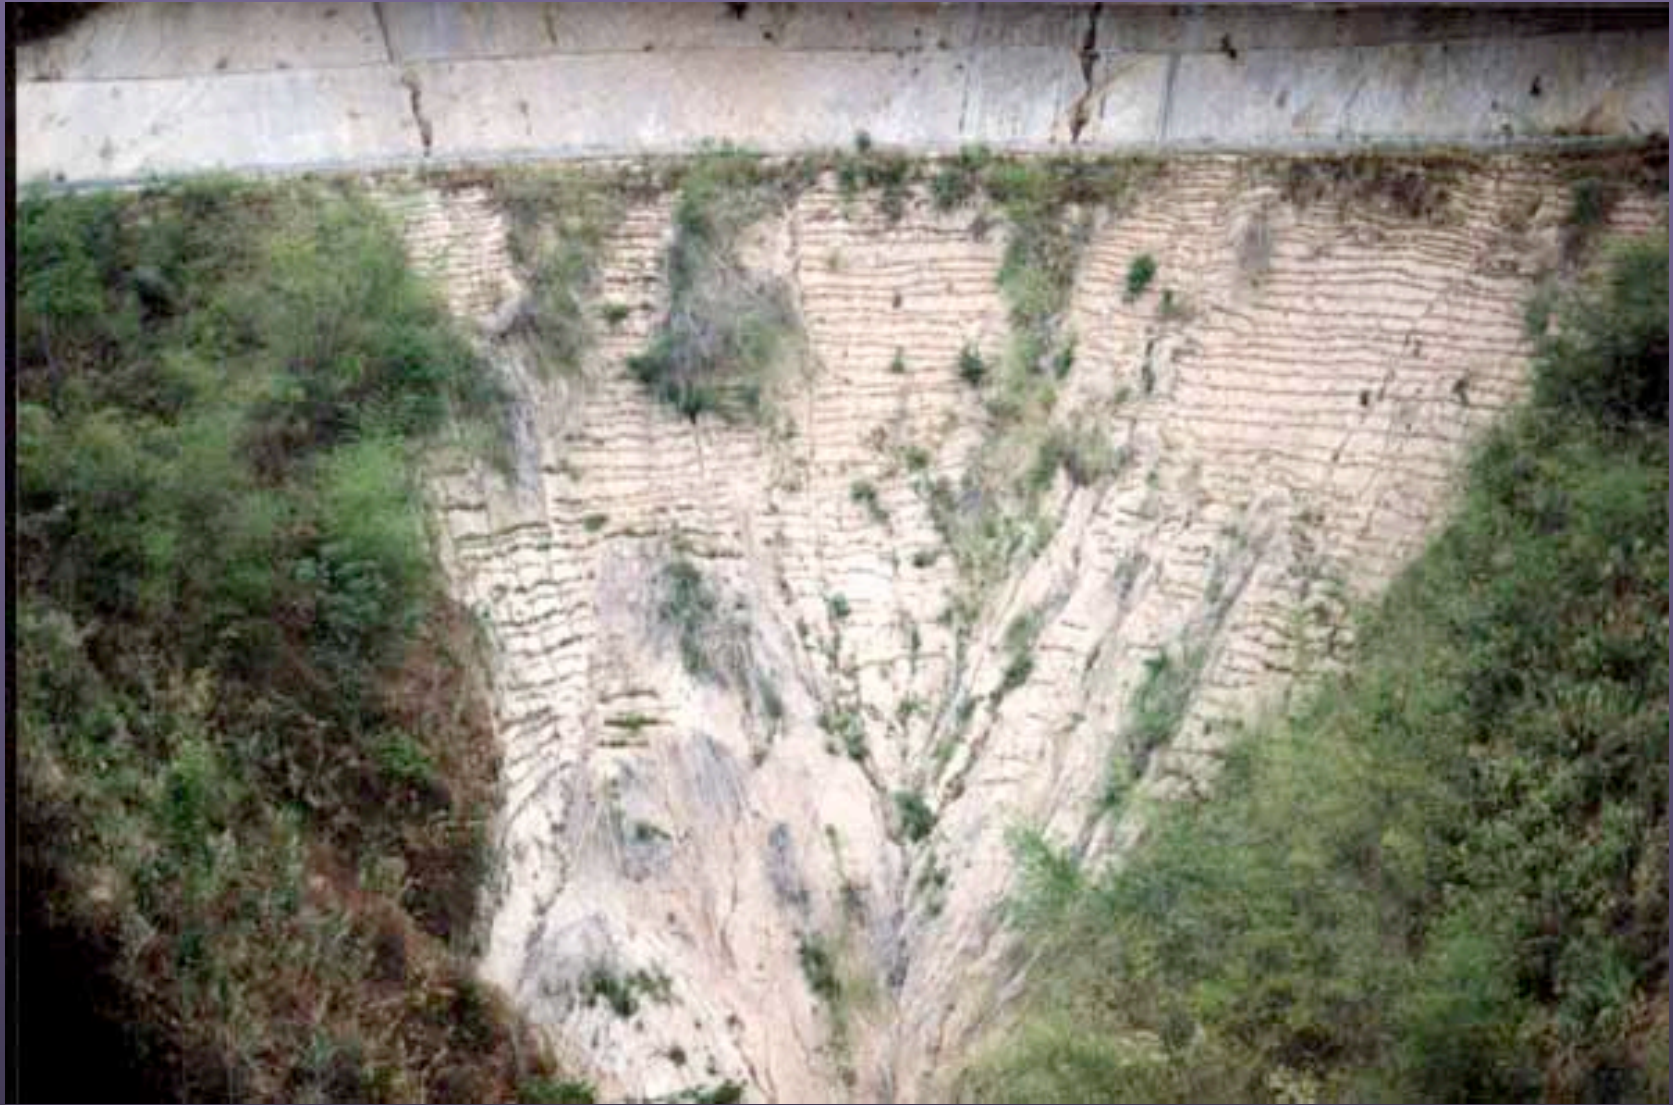
Figure 11: Aerial view of a bare lower slope with new planting of vetiver hedgerows on a new road.

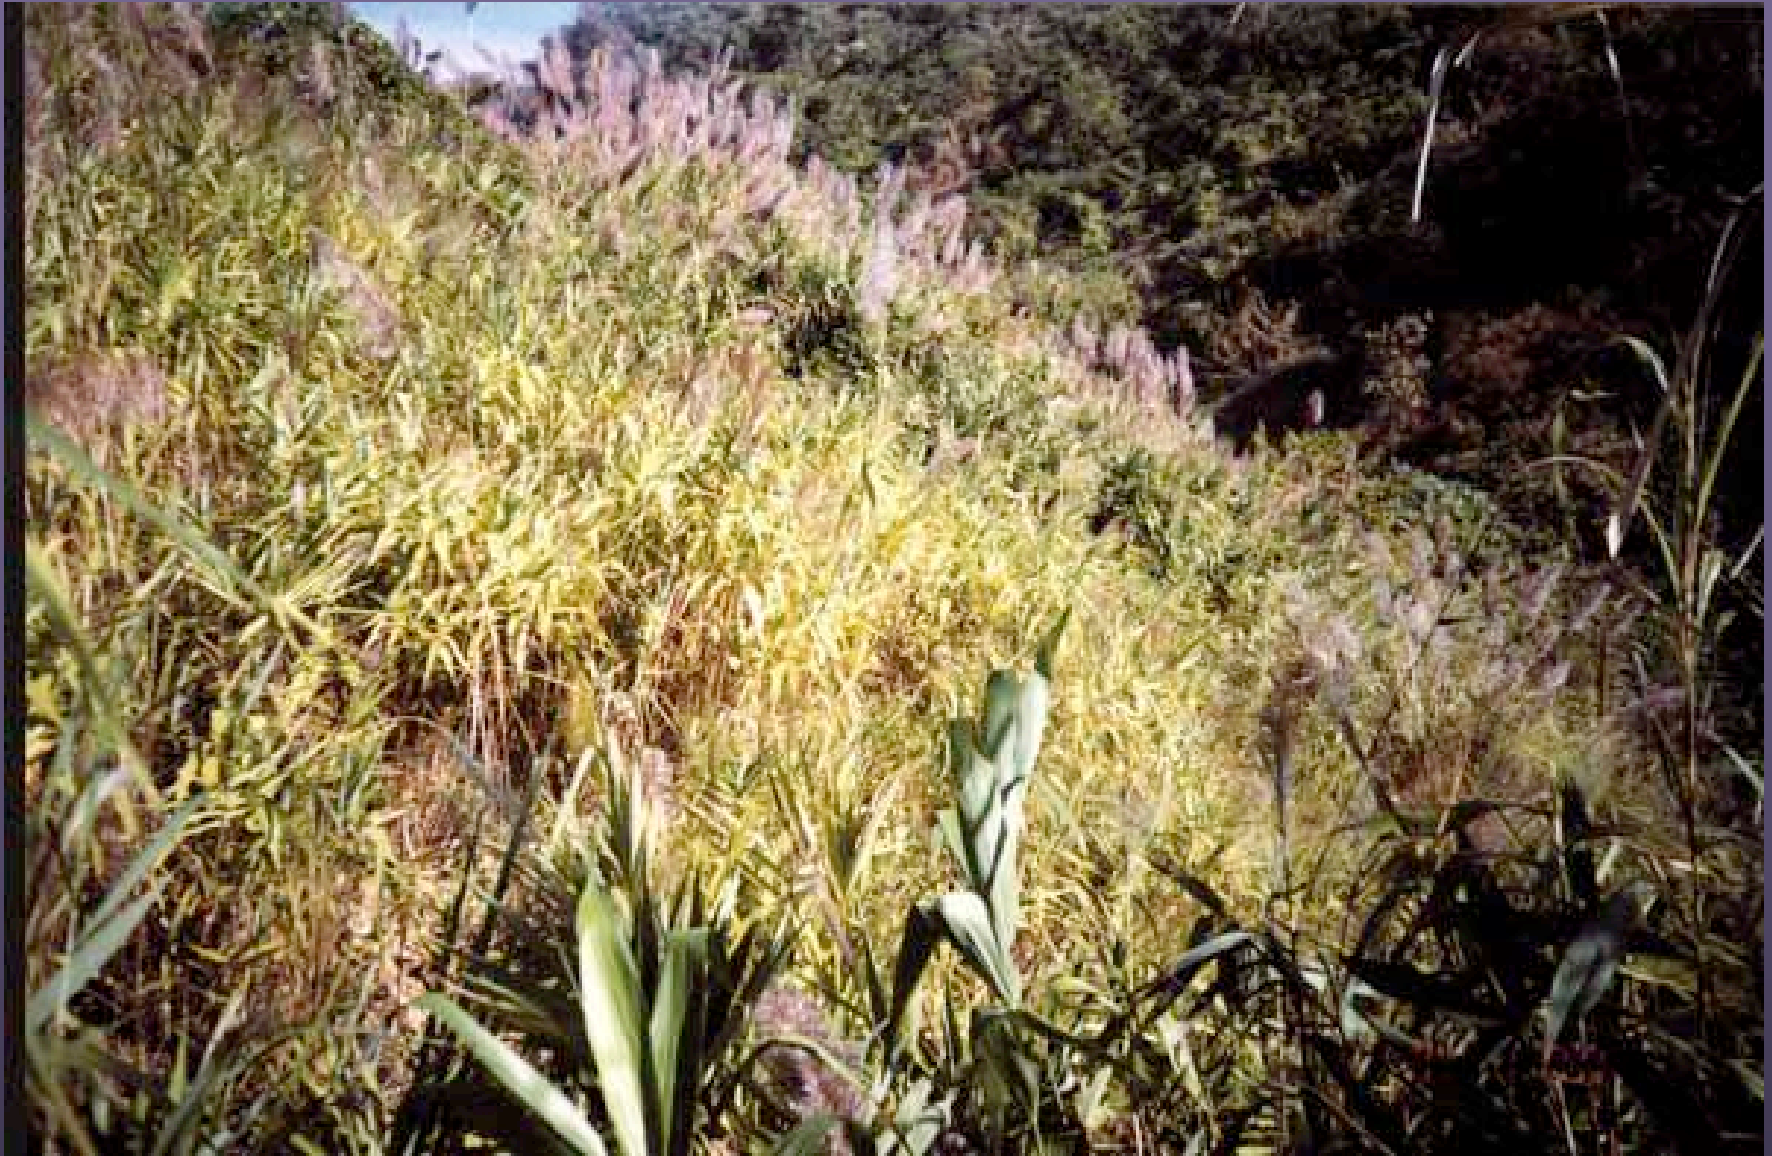
Figure 12: Sideslope of new road four years after vetiver hedgerows planting with native plant species taking over vetiver grass completely.

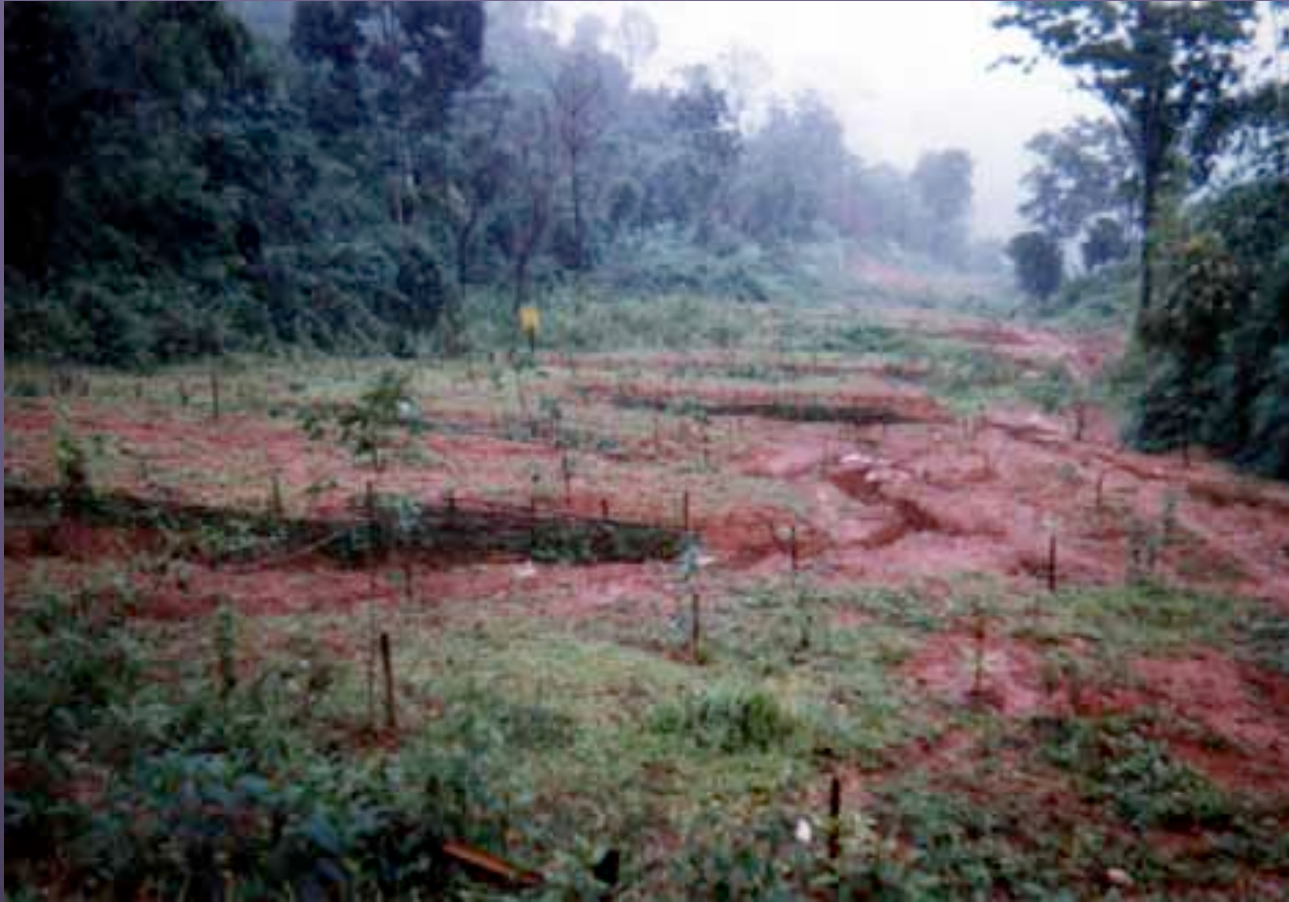
Figure 13: Erosion on gas pipeline construction ground after completion of construction work in Kanchanaburi Thailand (PPT. :Photo)
