Natural Disaster Prevention and Mitigation through Vetiver System

Dr. Uthai Charanasri
Mae Fah Luang Foundation
Doi Tung Development Project ,
Mae Fah Luang , Chiang Rai Thailand

Prevention of landslides by planting vetiver hedgerows on highways , dykes , and railroads slopes

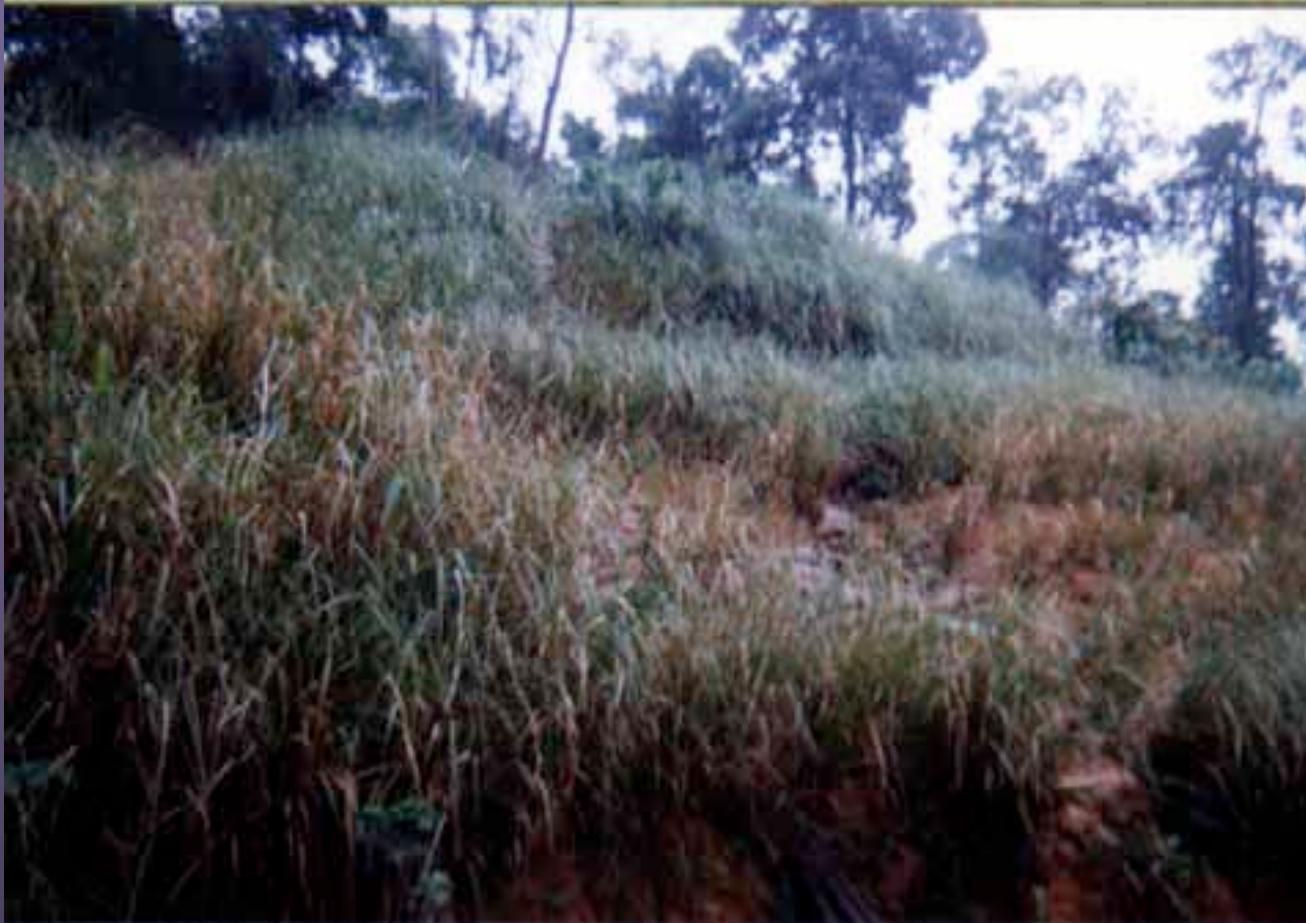
Figure 14 : Control of soil erosion with vetiver technology on gas pipeline right of way in Kanchanaburi Thailand (PPT. :Photo)

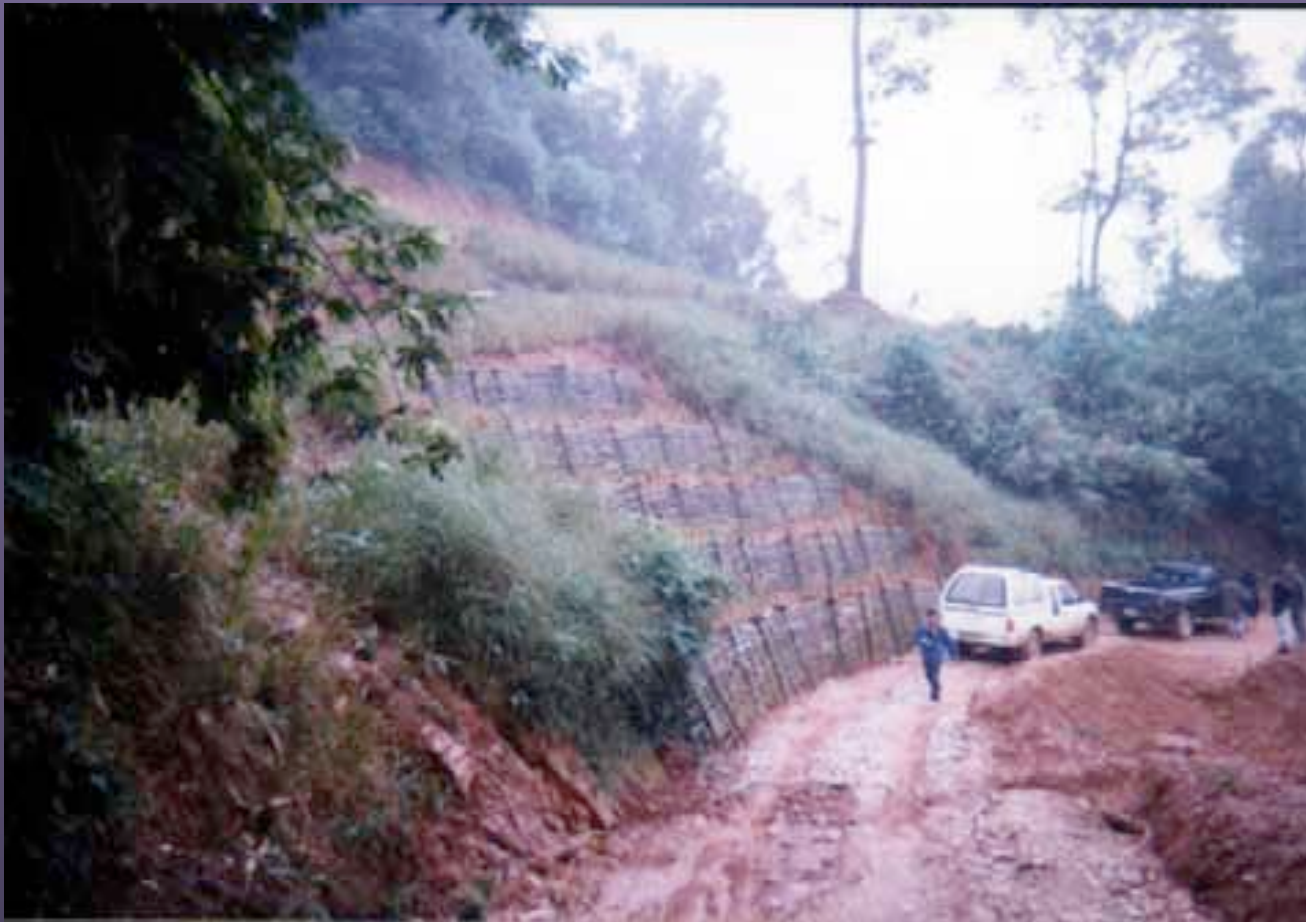
Figure 15: Control of soil erosion with vetiver technology on cut slope above the gas pipeline right of way in Kanchanaburi Thailand(PPT. :Photo)

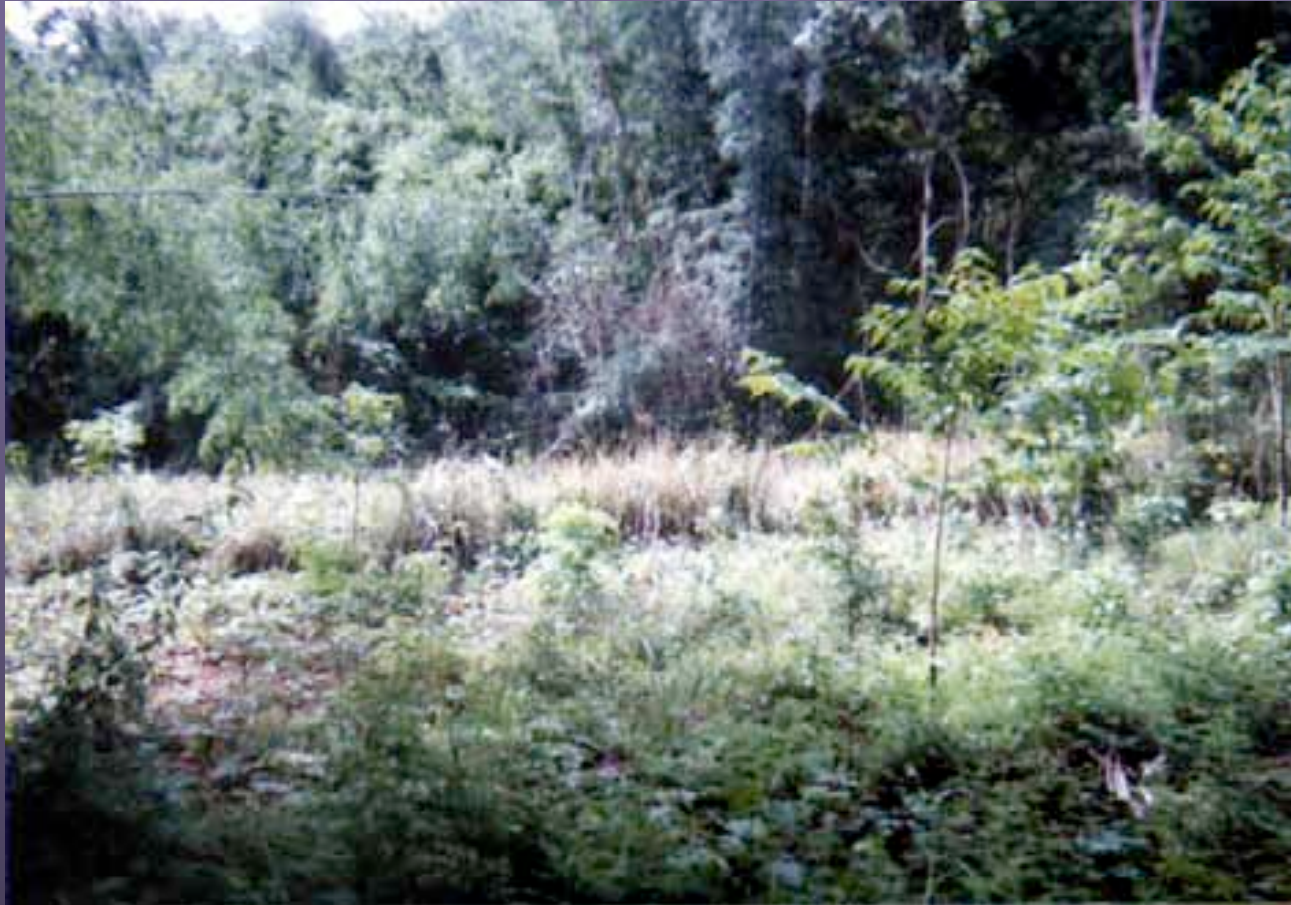
Figure 16: Vetiver technology and reforestation on the gas pipeline right of way in Kanchanaburi Thailand (PPT. :Photo)

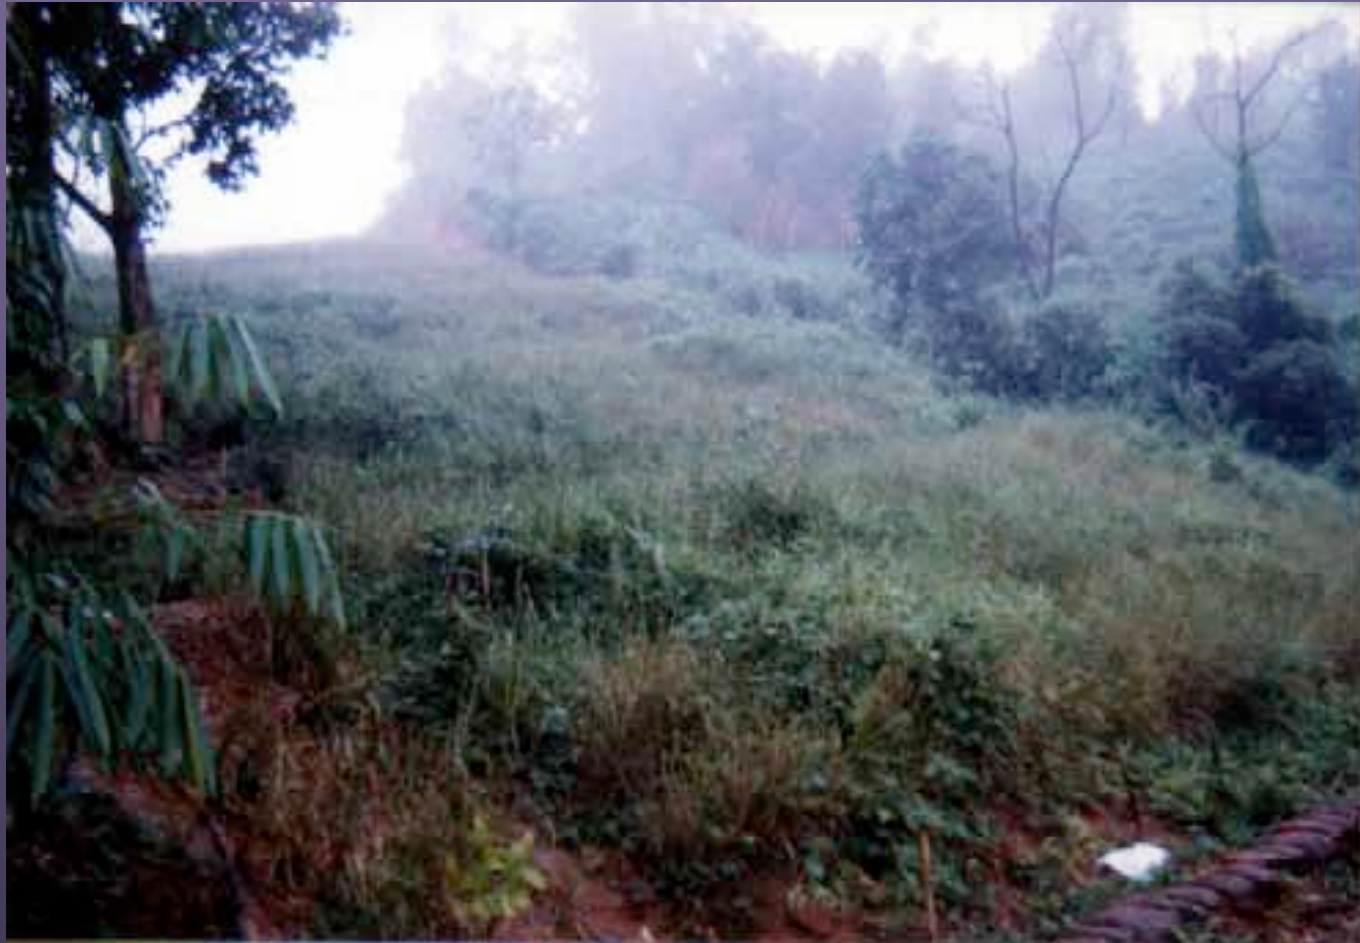
Figure 17: Vetiver technology and reforestation on the gas pipeline right of way in Kanchanaburi Thailand (PPT. :Photo)

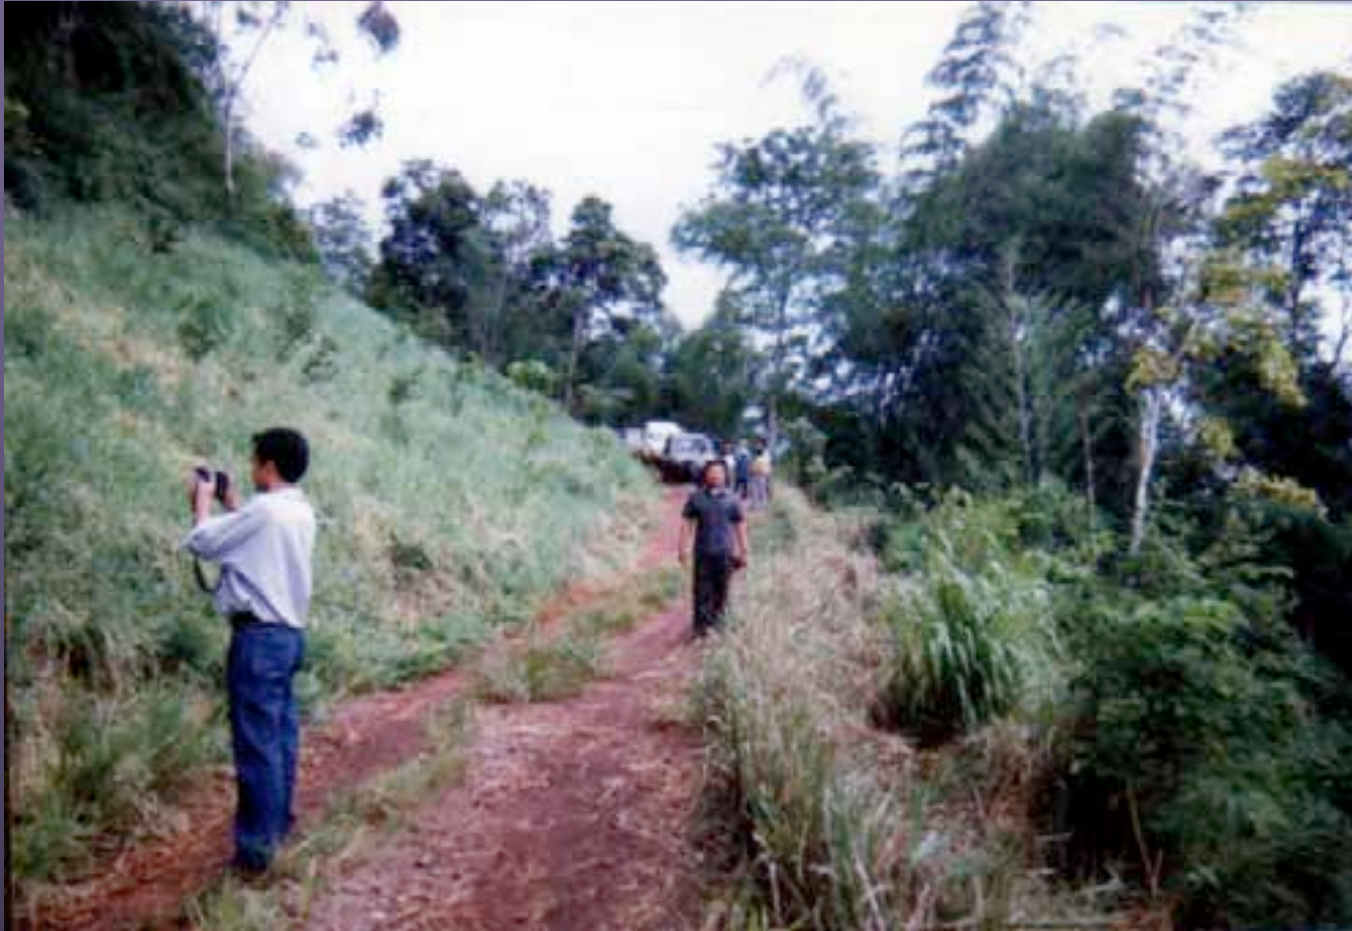
Figure 18: Vetiver hedgerows well established on side slope below the gas pipeline right of way in Kanchanaburi Thailand (PPT. :Photo)

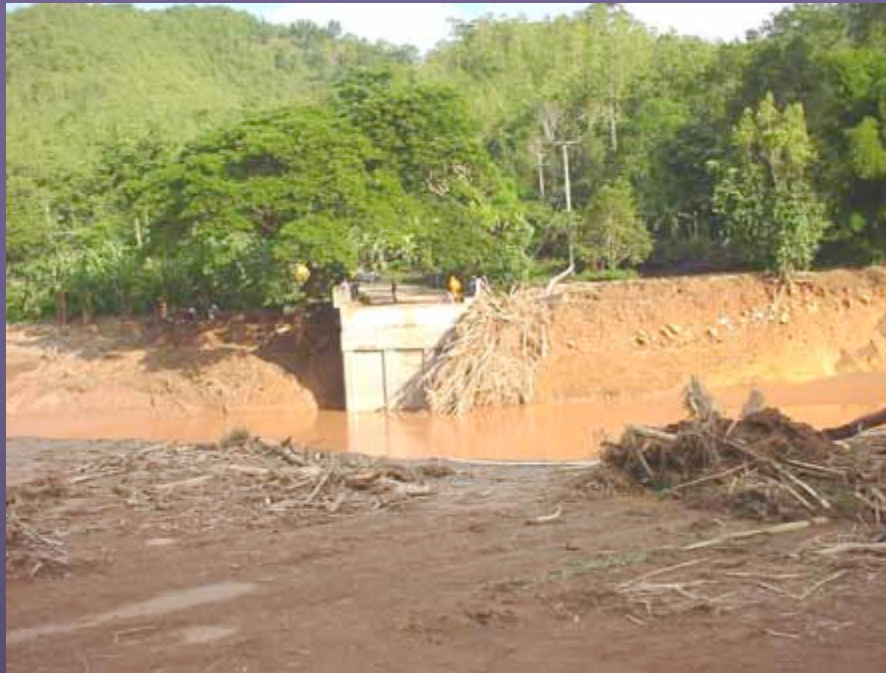
Figure 19: A washed away bridge caused by strong water current after over 300 m.m. rainfall in 24 hours on mountainous area of Uttaradit province : Northern Thailand May 22 , 2006

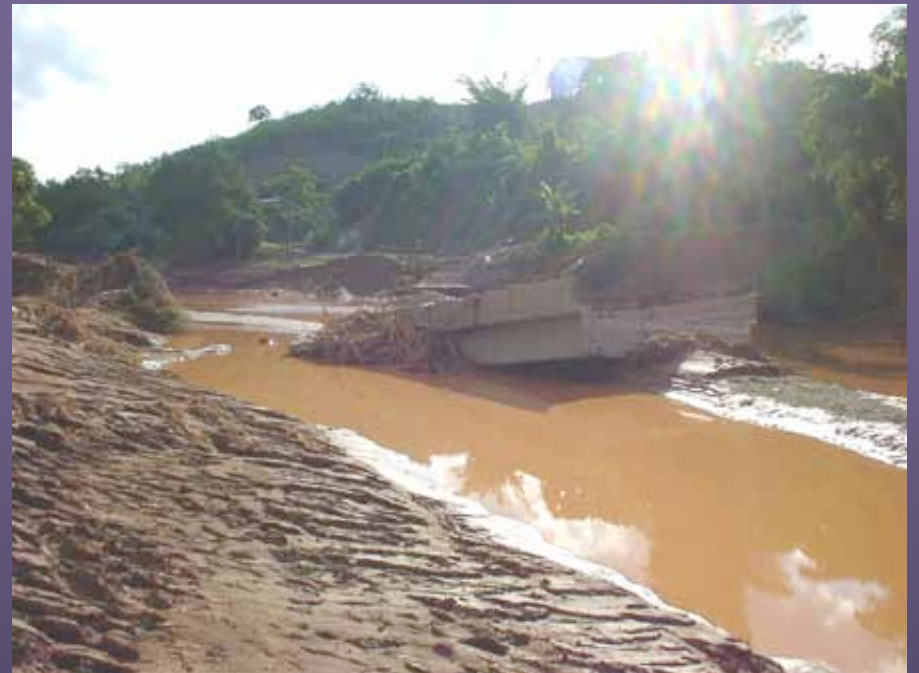
Figure 20: Mud and debris deposit on riverbanks brought by flash flood and inundation of a river after over

**300 m.m. rainfall in 24 hours on mountainous area of Sukhothai Province : Northern Thailand
May 22 , 2006**

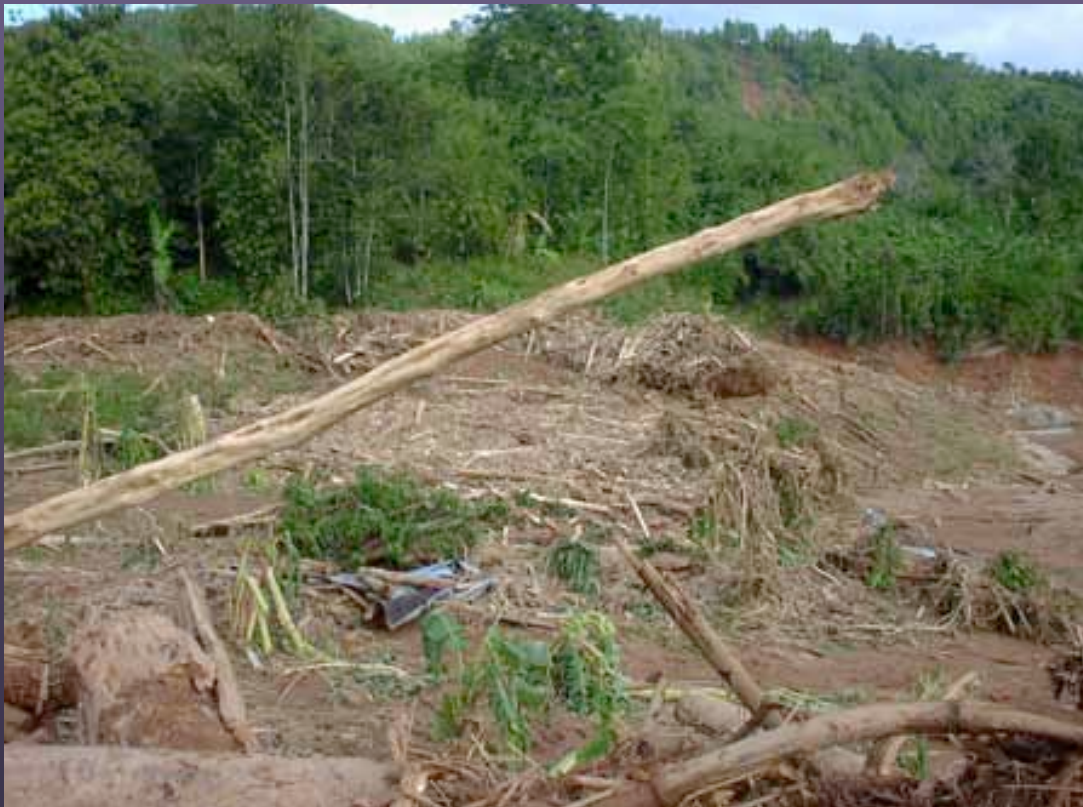
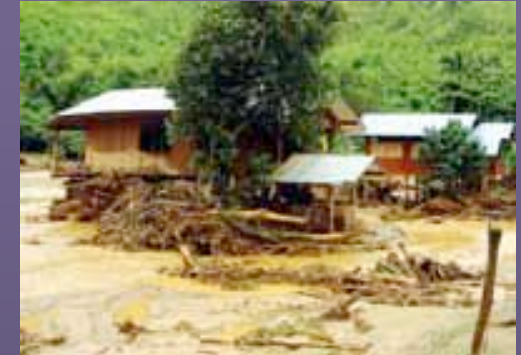
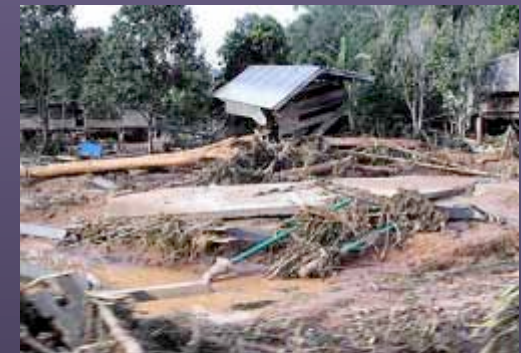
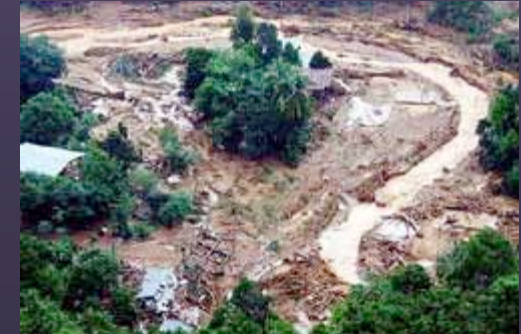
**Figure 21: Landslide cause by strong water current after over 300 m.m. rainfall in 24 hours on mountainous area of lower part of Northern Thailand
May 22 , 2006**

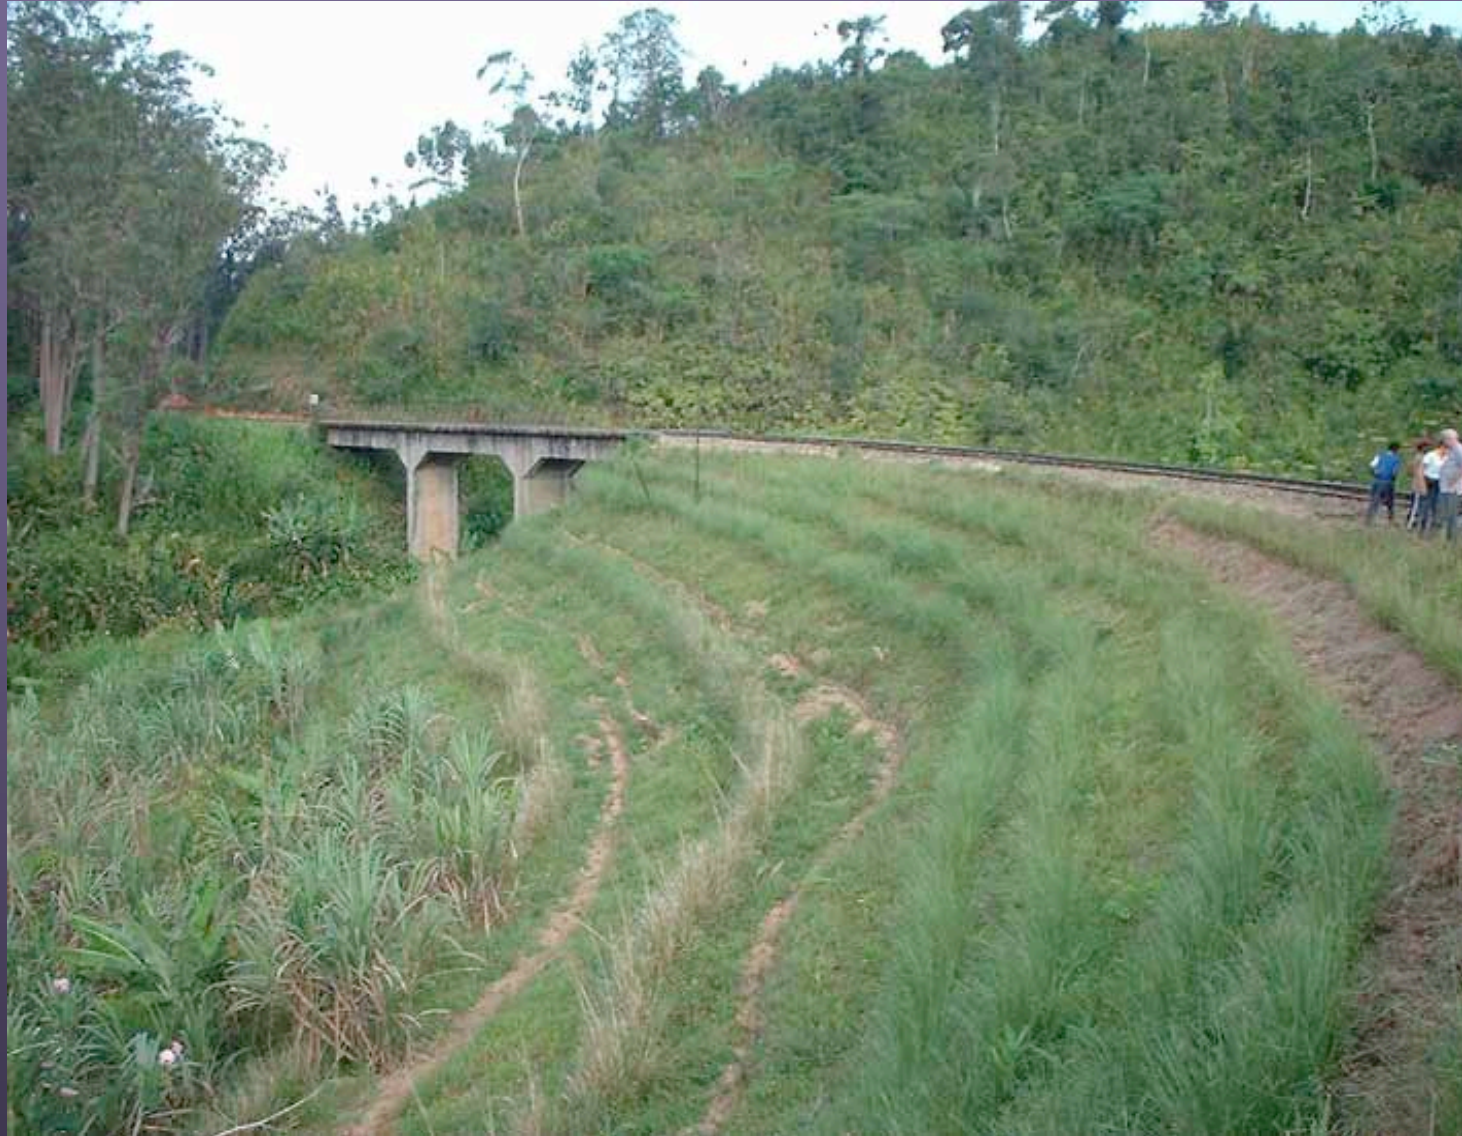
Figure 22: Restoration of railway in Madagascar after cyclone damage (Hengchaovanich and Freudenberger : Photo)

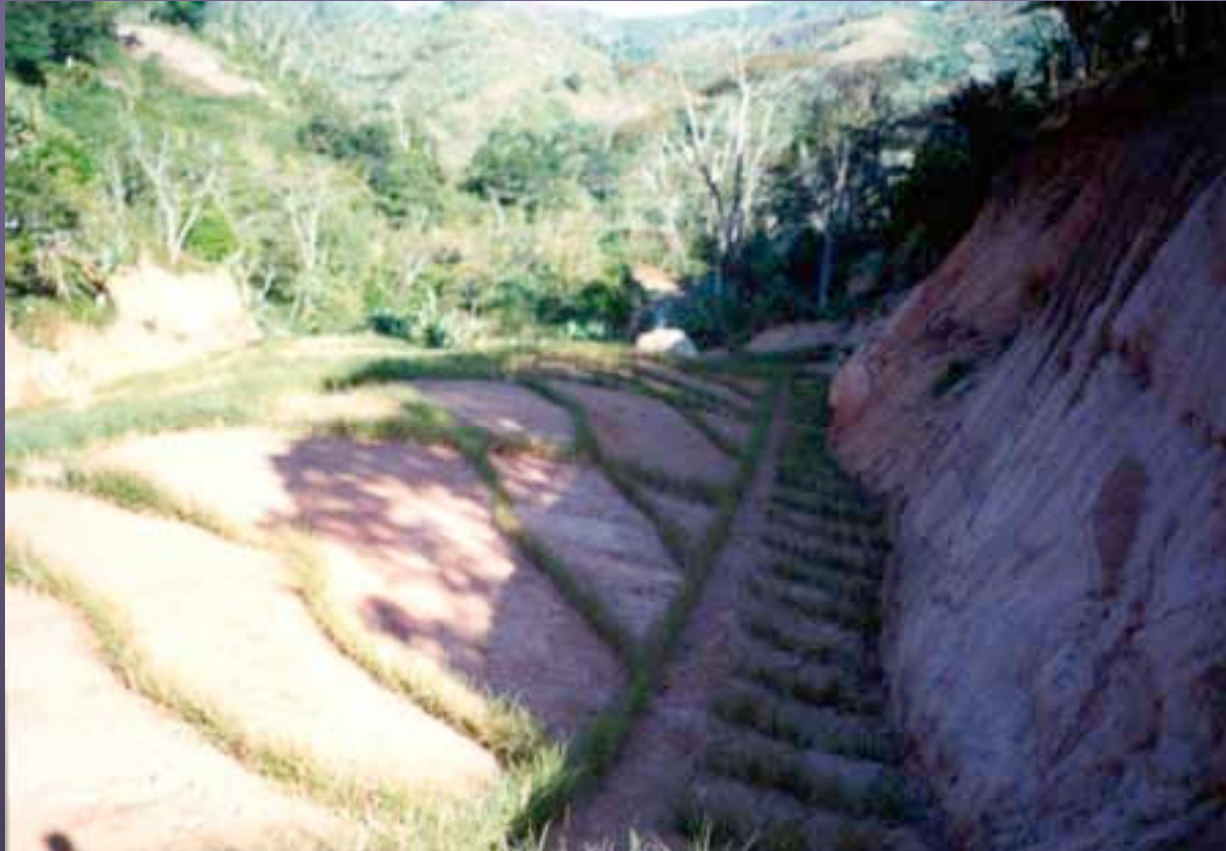
**Figure 23: Repair ground above railway tunnel in Madagascar after cyclone damage
(Hengchaovanich and Freudenberger : Photo)**

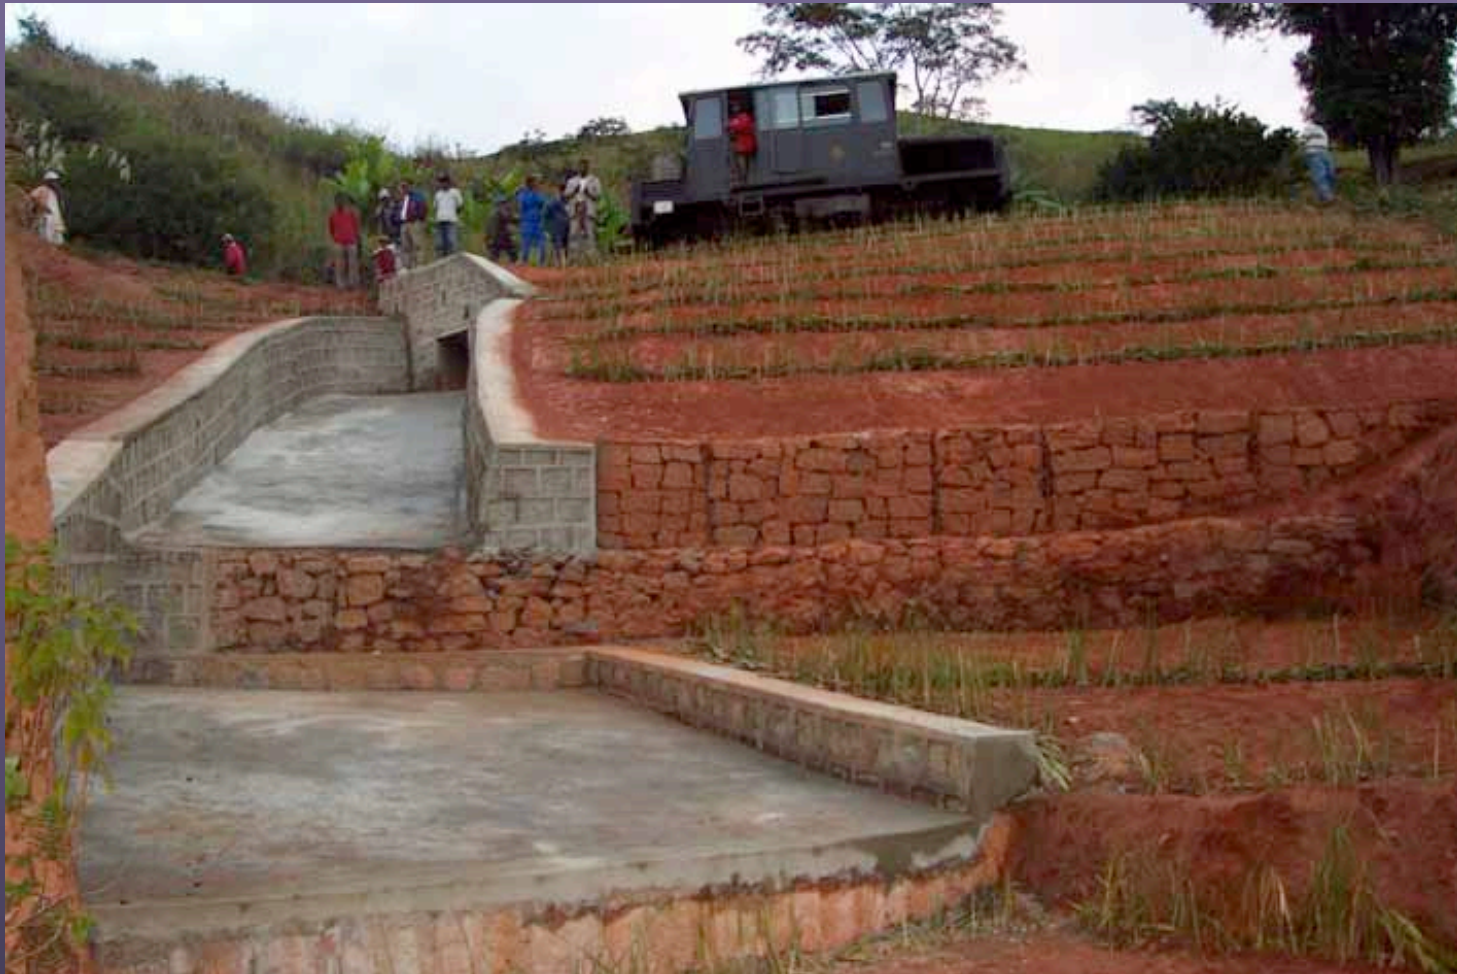
Figure 24: A restored cement drainage and vetiver hedgerows on the ground above railway Madagascar after cyclone damage (Hengchaovanich and Freudenberg : Photo)

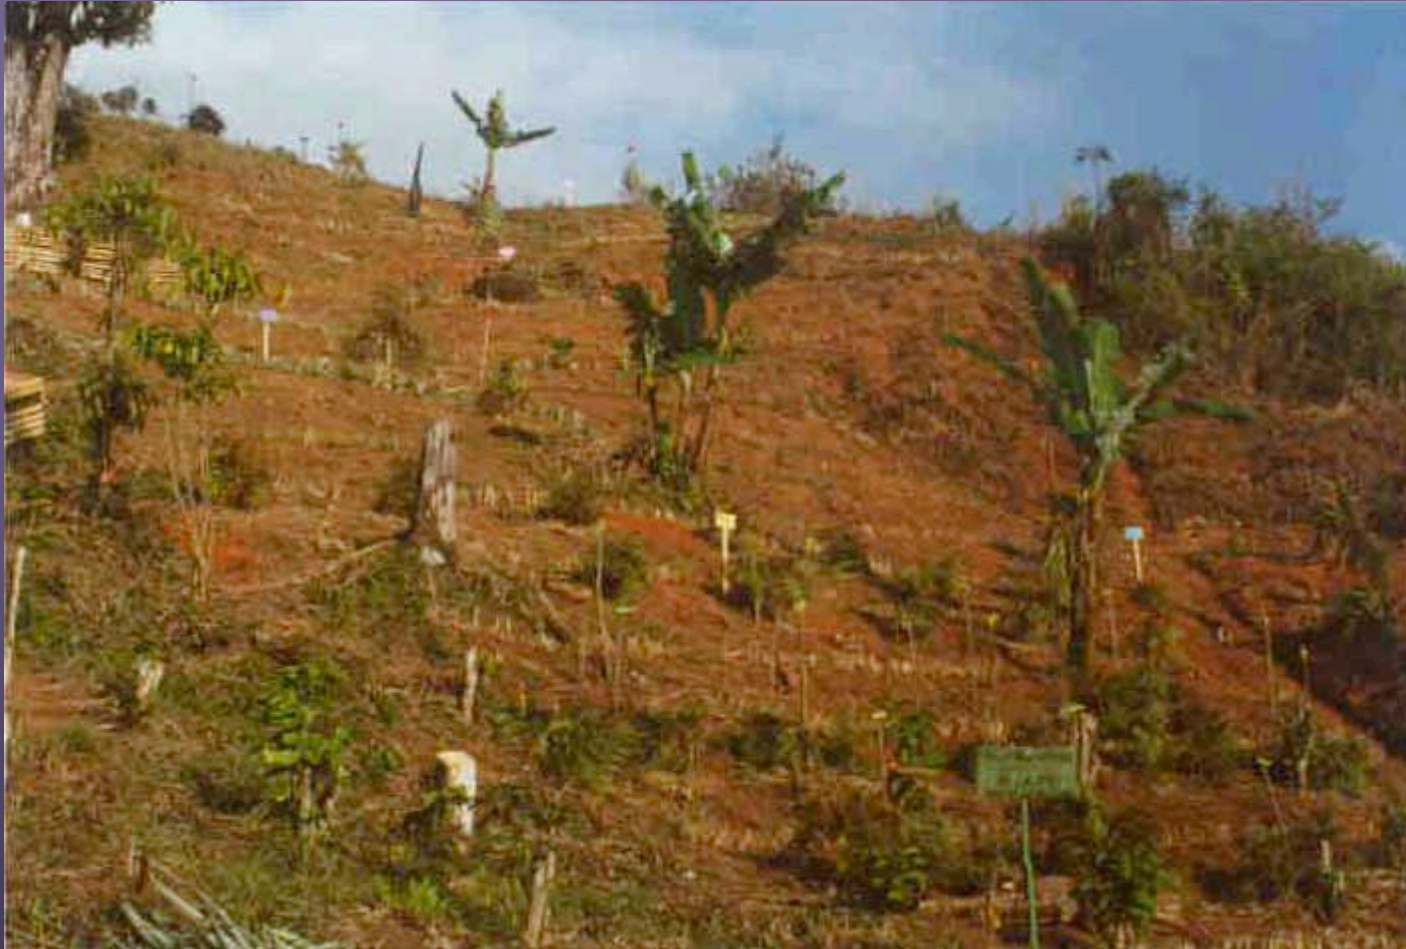
Figure 25: Vetiver technology in agriculture system on railway right of way (Hengchaovanich and Freudenberger : Photo)
