VETIVER INITIATIVES IN PAPUA AND WEST PAPUA, INDONESIA

Abstract

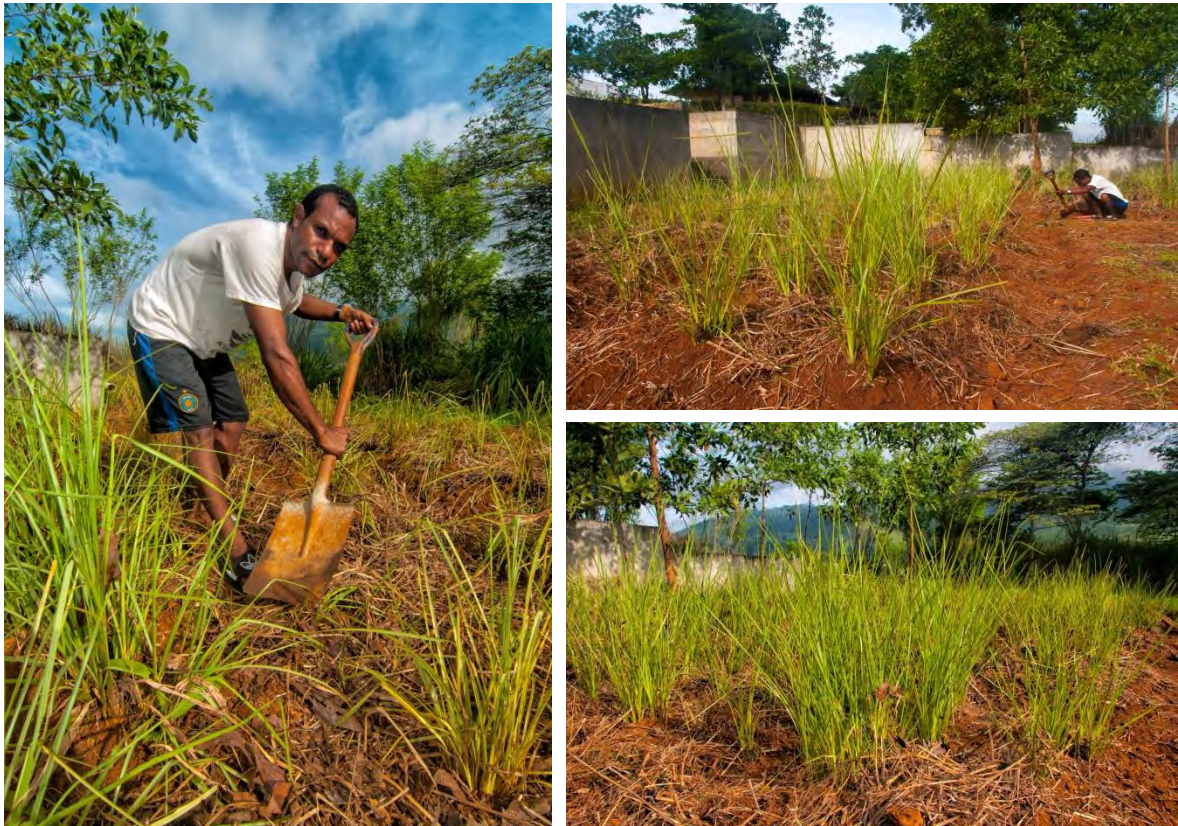
Figure 1. Setting up the first nursery and training local people to work in it, 2008.

DSP created vetiver nurseries (Figure 1.) to propagate slips obtained from Bali from Norm van't Hoff and David Booth and this provided the plants for a number of projects focusing on Vetiver use or having Vetiver as an important component.

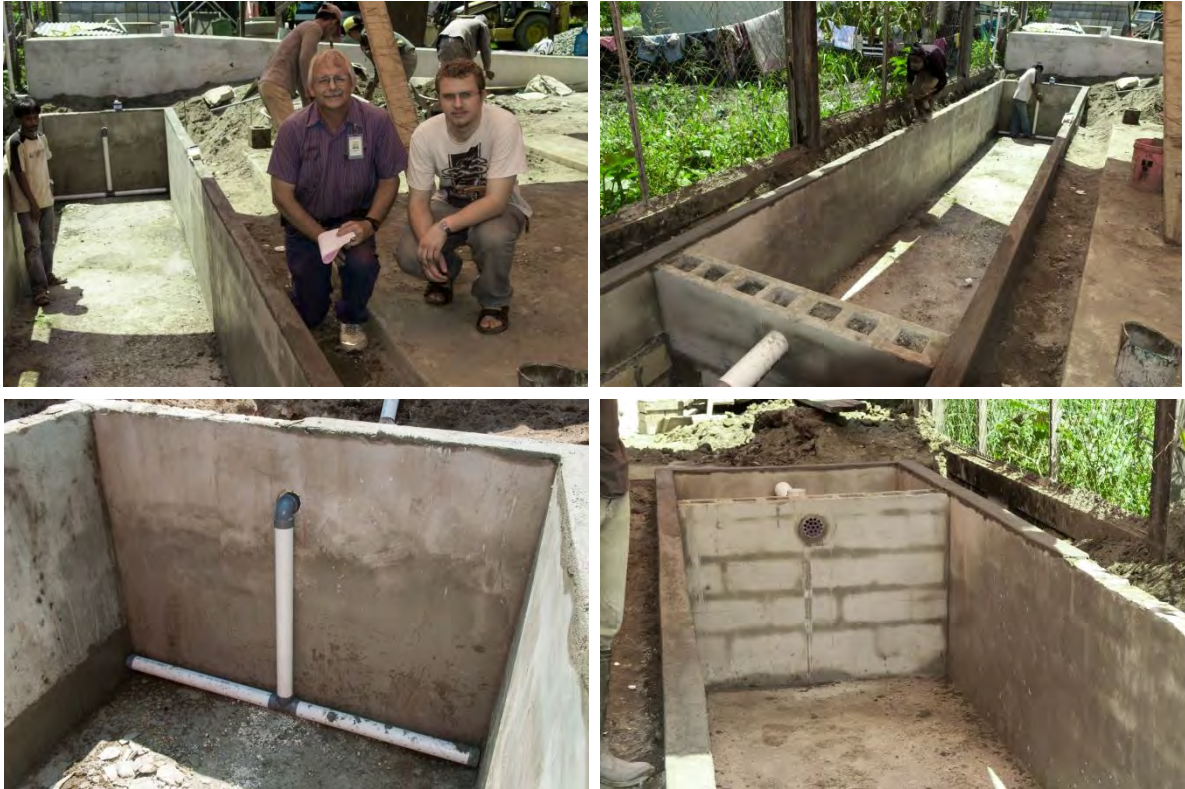
Figure 2. YAJASI's HSSF Wetland in construction. Top left: YAJASI technicians responsible for implementing the design. Top right: The wetland. Bottom left: Design of the intake system. Bottom right: Looking towards the outflow system and vertical leach chamber. Note the underlying brick construction can be clearly seen in this photo.

The wetland needed to effectively treat between 1,500 and 2,000 liters of sewage and grey water per day. The septic tanks system is of twin compartment design and effluent is actively pumped out of this into the bottom of the input end of the CW. Active pumping is necessary because insufficient gravity flow of effluent is produced without it, the site being quite flat. The CW (Figure2) has the following dimensions length 8 m., width 1.5 m., and depth 1 m., with substrate filling to 85 cm. The vertical leach field for treated effluent is 1.5 x 1.5 m. and several meters deep.

Most of the construction work was overseen by the local Indonesian contractor and though completed successfully some problems emerged. The CW component was constructed using inexpensive and poor quality limestone-concrete blocks plastered over with a thick cement layer (the normal method in Indonesia), rather than with poured, reinforced concrete, as was recommended. These limestone blocks (Indonesian batu tela) are highly porous and crumble easily, and should not be used for applications which need to be waterproof. Consequently, the CW would not hold water and several attempts were made to seal it using more cement plaster. These ultimately proved unsuccessful and so the whole inside surface of the CW was coated with a layer of tar, and this appears to have been mostly successful. Later, a problem with the pumping regime emerged—the wetland was being overwhelmed by pumping pulses too long, and this was adjusted.

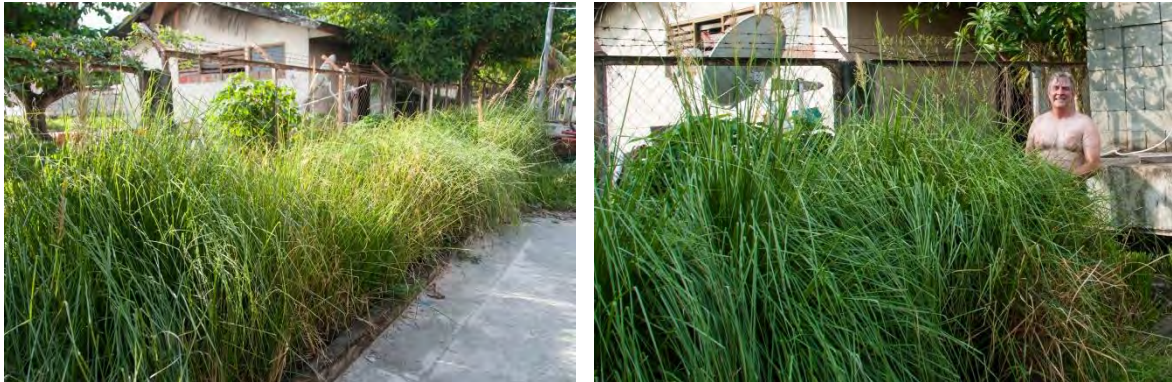
Figure 3. Vetiver is growing well in the wetland. Maintenance consists of trimming the grass every three to four months.

By the beginning of 2012 the surviving plants were well established and had been trimmed at least twice. Visual tests showed cloudy water smelling of raw sewage at the intake end and clear, odorless water throughout the output end but no empirical tests were done. By the time I arrived back to Papua in October 2012 the CW was looking lush and overgrown, and visual checks showed the same results as described above. In December I commenced maintenance on the system, consisting of trimming the grass to just over 300 mm⁴,

uprooting the larger clumps, dividing them, and replanting slips at 200 mm spacing or less throughout the system.

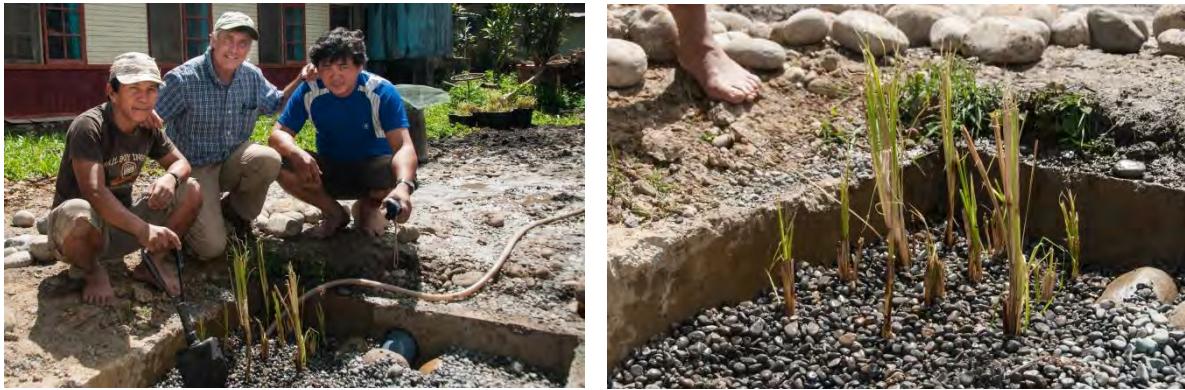
Figure 4. Small HSSF Wetland in Wamena at end of construction.

DSP planned the wetland system and trained local construction workers in constructing it and planting it with Vetiver. Dimensions were 4 m. long, 1 m. wide, and 80 cm depth. Media for this wetland consisted of small pea-sized gravel over a base of medium-sized river rocks. Planting and maintaining Vetiver in this media is much easier than in that of the YAJASI wetland.

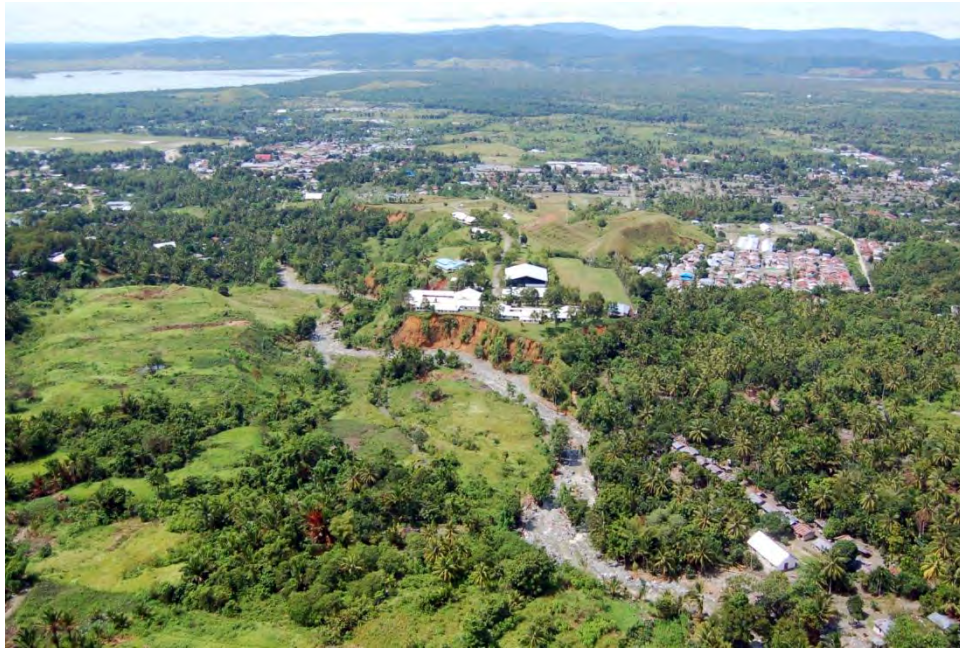
Figure 5. Hillcrest International School (middle) looking to the south towards Lake Sentani, March 2007. Photo: Tim Harold.

DSP was contacted by Hillcrest International School (HIS). HIS is an international K through 12 school in Papua, Indonesia, founded and run by a number of non-denominational Christian organizations and NGOs, with legal framework provided by an Indonesian private foundation. The High School part of HIS was built at the top of a very steep soil cliff, with a river, prone to torrential flooding at times, flowing from the north near the bottom, around to the east. The river is part of the greater Sentani Watershed and drains a significant area of the Cyclops ranges to the north. There is evidence that at times the river flowed several hundred meters to the east and bypassed the cliff, however now it flows alongside the bottom of the cliff and is primarily responsible for the erosion that created the cliff.

In early 2007 a violent rainfall in the upper catchment induced a torrential and unusually violent flood, modifying the river's course, back to one of its historical channels (squatter gardening alongside the river just upstream from the HIS property was almost certainly a large factor in this also). As a result of the flood the new course came straight to the western edge of the bottom of the HIS cliff and ran along the bottom to the east, scouring what little was at the bottom, before resuming its former channel to the east. This presented a direct and immediate erosion threat to the buildings and land at the top of the cliff, exacerbating the prior existing threat of the cliff to school structures.

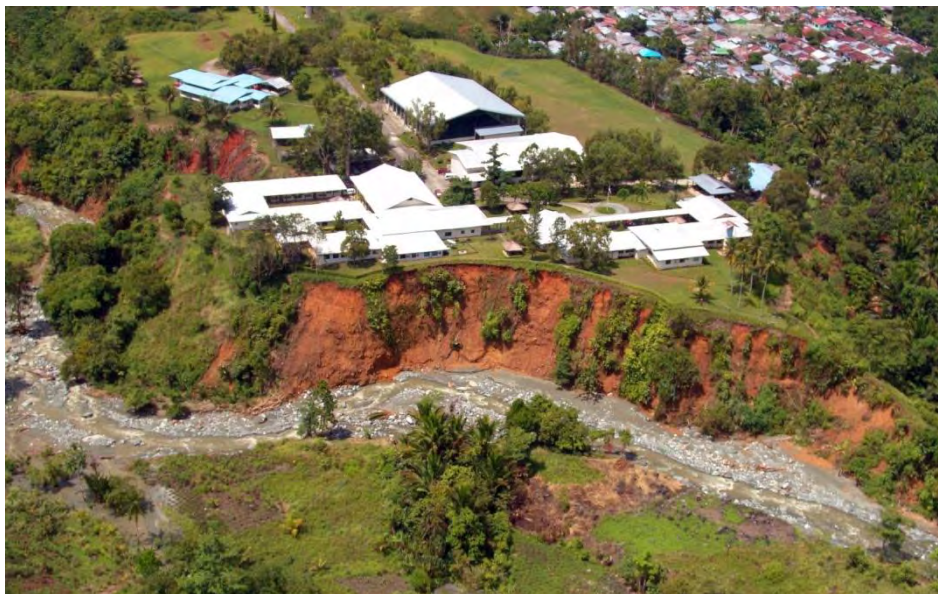
Figure 6. Detail of the primary slip area showing the river eroding the base of the cliff, March 2007. Photo: Tim Harold.

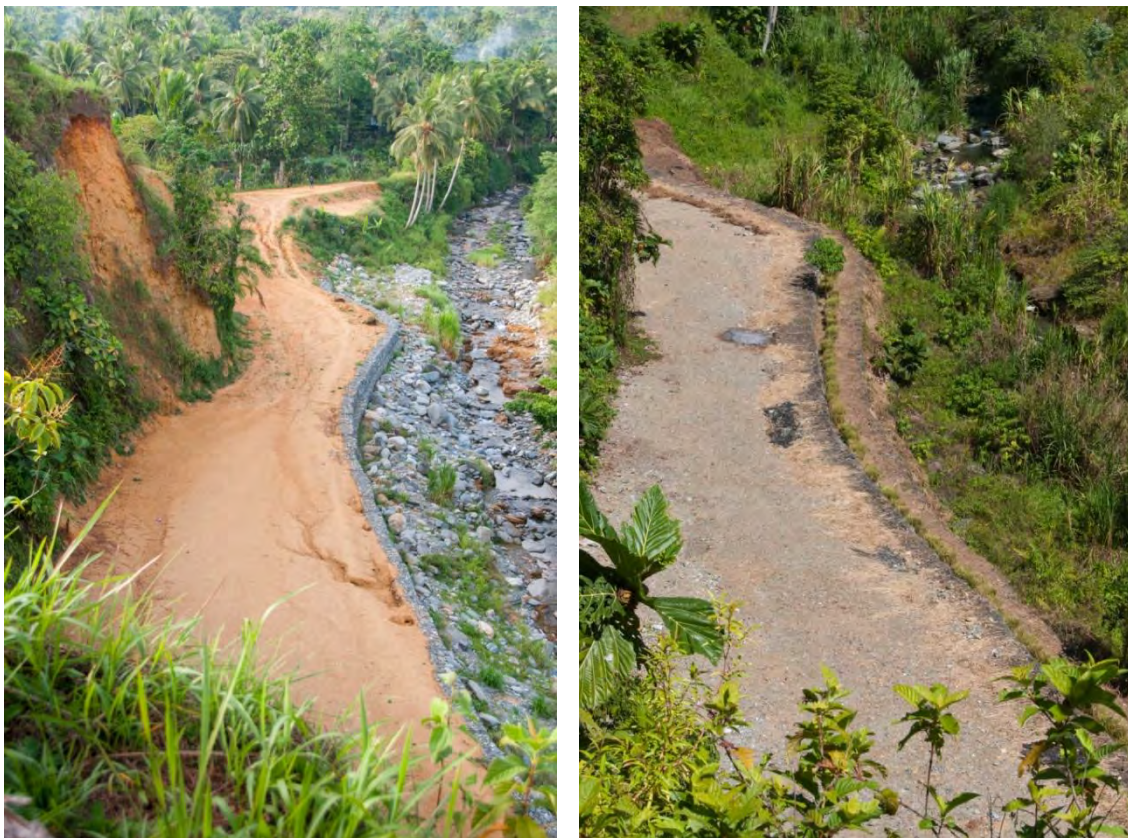
Figure 7. (Left) Following first gabion installation and before planting with vetiver, October 2009 and (right) following planting and trimming, December 2012.

The first planting of vetiver grass occurred behind the one previously constructed gabion which ran the length of the cliff and consisted of one row of slips. Then HIS' head maintenance man put in a second row of gabions. The work was done manually by men contracted from the local village to pull rock out of the adjacent river and fill the rock cages. Due to access restrictions (lack of a road) and the fact that no heavy machinery was available due to large municipal projects at the time, back-filling was left uncompleted, despite plans to the contrary (Mueller, pers. com.).

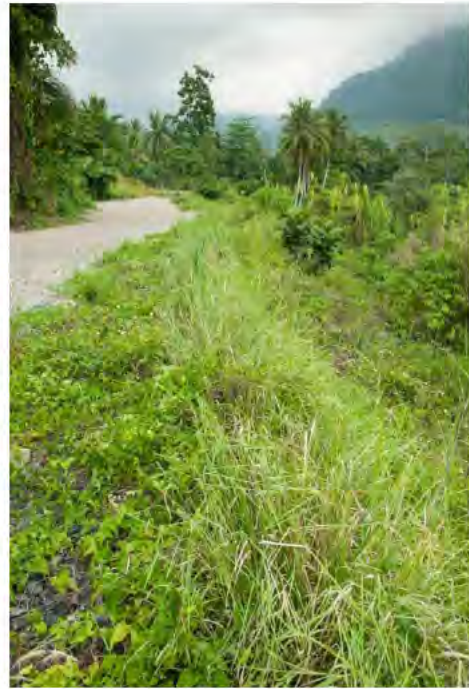
Figure 8. Most of the vetiver grass grew well despite being threatened by weeds, December 2012.

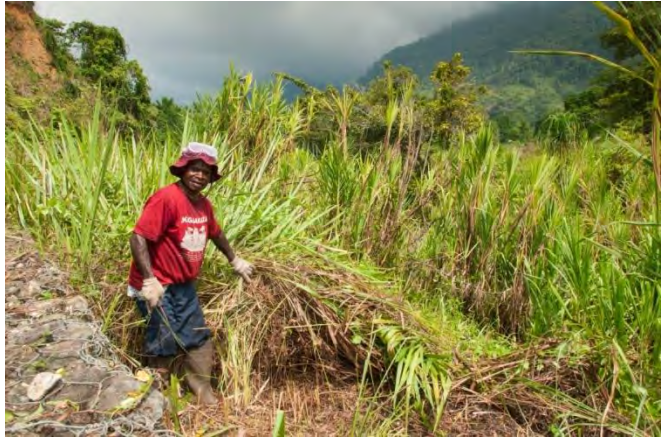
Figure 9. Intensive weeding plus trimming of vetiver, December 2012.

I returned to Papua in October 2012 and checked on the status of the project. The vetiver was thoroughly overgrown with invasive non-native shrubs and the native pioneer *Imperata cylindrica* grass. In early December I directed the HIS maintenance manager to provide two local men for weeding (he had arrived since the project was implemented and had little knowledge of it, but he did have some valuable previous experience with vetiver grass in erosion control situations on Saipan). They uprooted weedy vines and *Imperata*

where possible and slashed other shrubs and herbs, clearing everything out from among the vetiver.

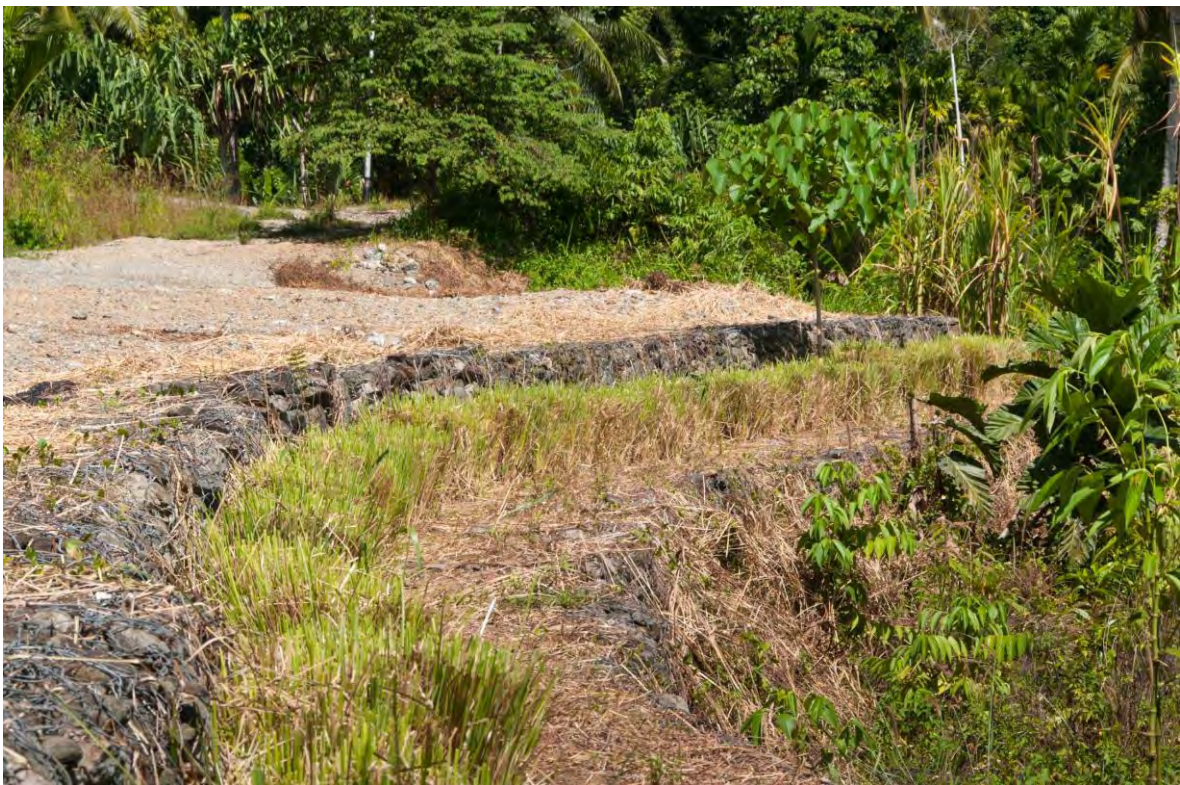
Figure 10. After weeding and trimming, December 2012.

When this was done it became clear that there were large gaps in many parts of the rows, possibly from mortality of newly planted slips, but more likely from plants being shaded out by invasives and *Imperata*. The staggered pattern of two rows was not evident, though in some places the hedge is rather thick. Despite this, the buildup of sediment and soil behind the gabions and the vetiver grass is quite impressive, though probably due mostly at this stage to the gabions. I have made some recommendations (below) to repair the existing vetiver hedge and to add a hedge along the top of the higher gabion prior to the next phase of the project, which will add another gabion (or two?) along with corresponding vetiver grass hedges.

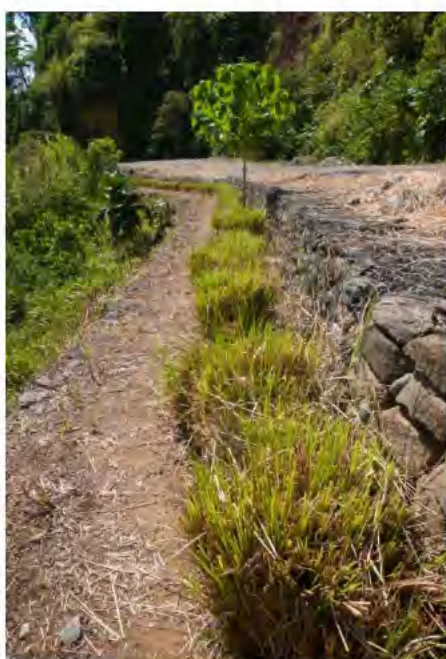
Figure 11. After intensive weeding and trimming.

In order to complete this Phase One of the project it is imperative that the vetiver hedge be upgraded to original specifications. This should consist of planting an additional, estimated, 1500 vetiver slips in gaps and along the top rear of the highest gabion. Slips or plants in polybags should be planted at a spacing of 200 mm and irrigated until well established.

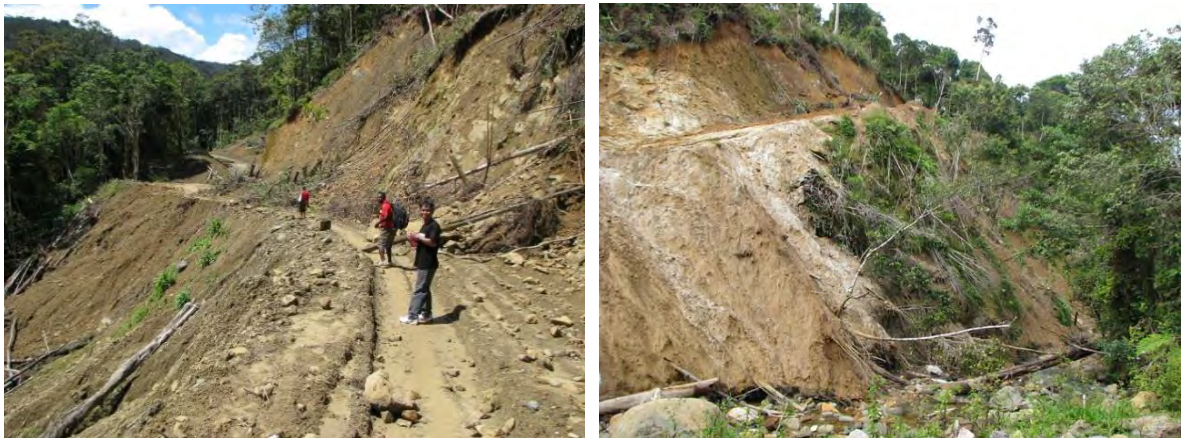
Figure 12. Left: Surveying the road. Right: A typical landslide.

The first step the program took was to perform a rapid survey the road system in July of 2011. As a result of that survey, it was readily apparent to all stakeholders that the road system was experiencing erosion and landslides on a massive scale along the entirety of its length, and any effort to address it would require complete buy-in from the affected communities and eventually the local government as a sponsor if the program would have any hope of moving forward. It was also clear that the vast majority of the road batters consisted of slopes exceeding 45°—something the Vetiver System Technical manual

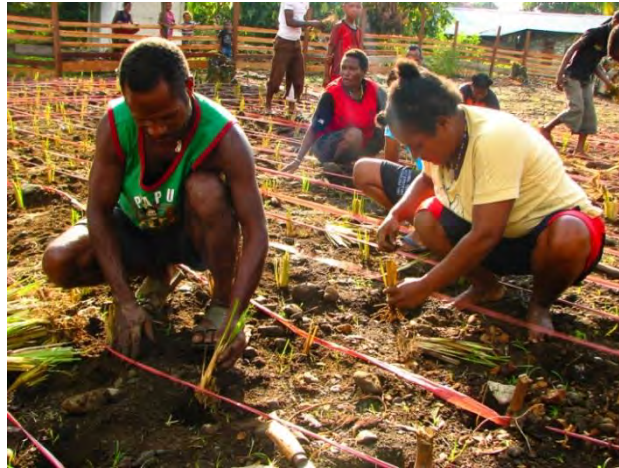
Figure 12. GPKAI community members plant the initial nursery.

The second step the program took was to purchase a small amount of high-quality Vetiver plant stock with which a nursery could be established. Due to the sheer scale and number of sites along the road that required stabilization and no access to funding which would enable the purchase of sufficient plant stock to stabilize those areas, it was decided that the most appropriate solution was to establish Vetiver nurseries to propagate sufficient amounts of the plants. The GPKAI leaders petitioned their constituency for enough funds to be able to purchase 1,000 high-quality Vetiver slips from The *East Bali Poverty Project*⁷, which were graciously provided at discounted pricing to the community, in order to begin the initial nursery. This initial nursery was located in the Manokwari regency of West Papua in the lowlands, where the rich alluvial soil and warm temperatures allowed the Vetiver slips to grow quickly.

After eleven (11) months, with trimming every four (4) months to promote tillering, the plants had matured to the point that they could be vegetatively propagated. At this point, the GPKAI leaders invited various members of the GPKAI constituency to an introductory meeting where VS was formally introduced to community members and YMP3 offered a hands-on training workshop for anyone who was interested helping the pilot program.

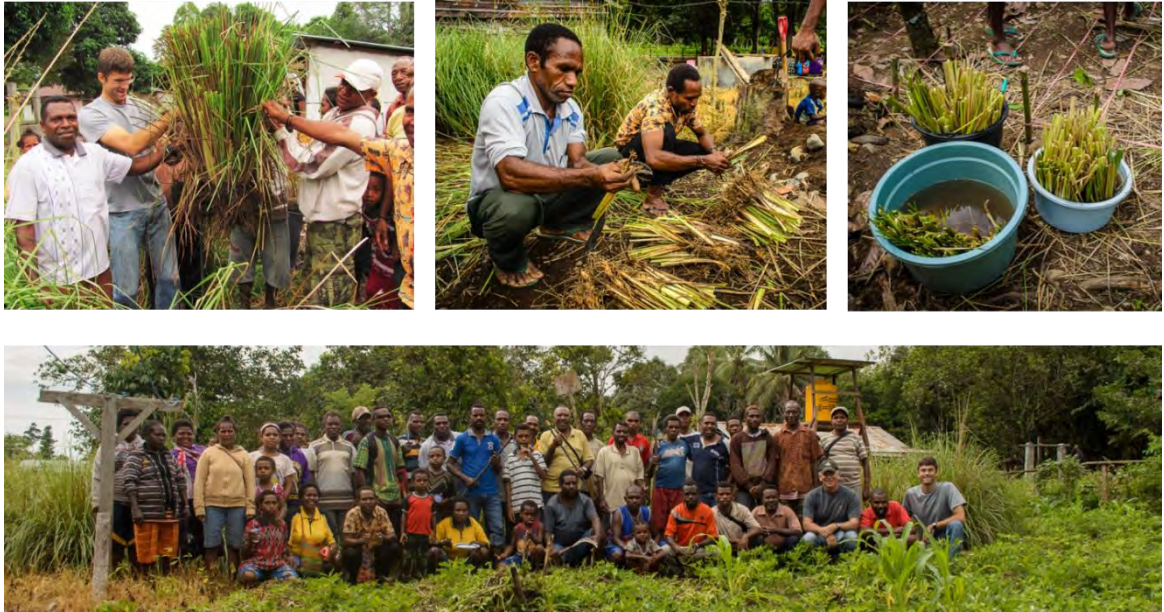
Figure 13. The Vetiver Propagation Training.

Over the next several years as plants matured and were ready to be propagated, the program has continued to expand its modest nursery to the point that there are currently 3 established nurseries varying in capacity from several thousand mature plants to tens of thousands of mature plants. All this was accomplished without funding from external sources, but rather, was a community effort with many individuals throughout the Meyah GPKAI constituency volunteering their time to help.

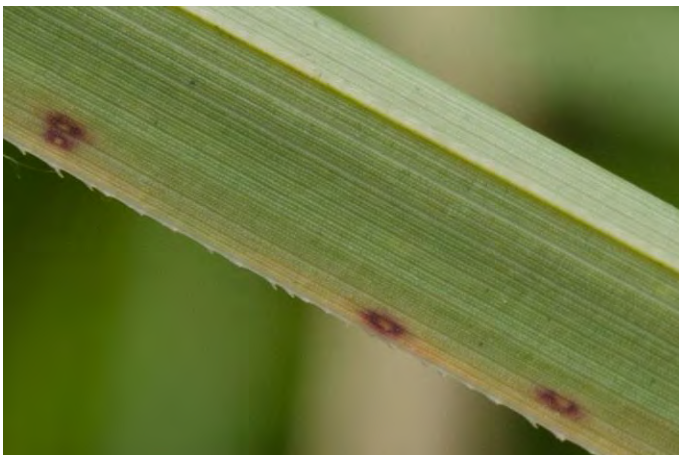
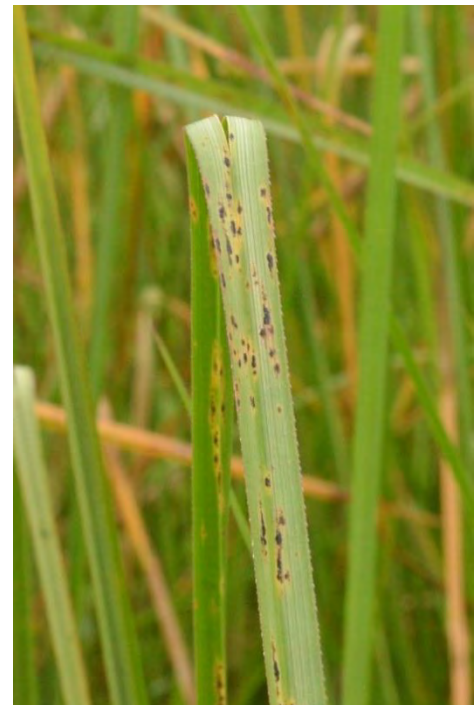
Figure 14. The Vetiver leaf blight/rust.

In parallel with the development of the production nurseries owned and operated by the GPKAI program, another smaller experimental nursery was developed by YMP3's CD branch at a separate location within the capital city of Manokwari, West Papua. Plant stock for this experimental nursery was purchased at an earlier date from the same source as the other nurseries. After ten (10) months of growth, it was readily apparent that some type of leaf blight or rust disease was affecting Vetiver, causing significant numbers of the leaves to die off. A literature review on Vetiver diseases, yielded the research of Dr. P.K. Yoon of Malaysia Yoon in 1991⁸, where the leaf blight or rust caused by the fungi *Curvularia sp.* looked identical to that which was affecting our experimental nursery. We subsequently followed Yoon's remedy of trimming the plants to 40cm. New stem growth appeared to be disease free, however after 4 months of healthy growth the leaf blight returned. The experimental nursery plants were then trimmed to 40cm, dug-up as whole clumps, and transplanted to a new location within the same city. Again after 4 months of growth the disease returned.

It is interesting to note that while the same type of leaf blight is also present within the GPKAI production nurseries, the damage is not even remotely close to the kind of damage we were witnessing with the experimental nursery in Manokwari, which is less than 20km away.

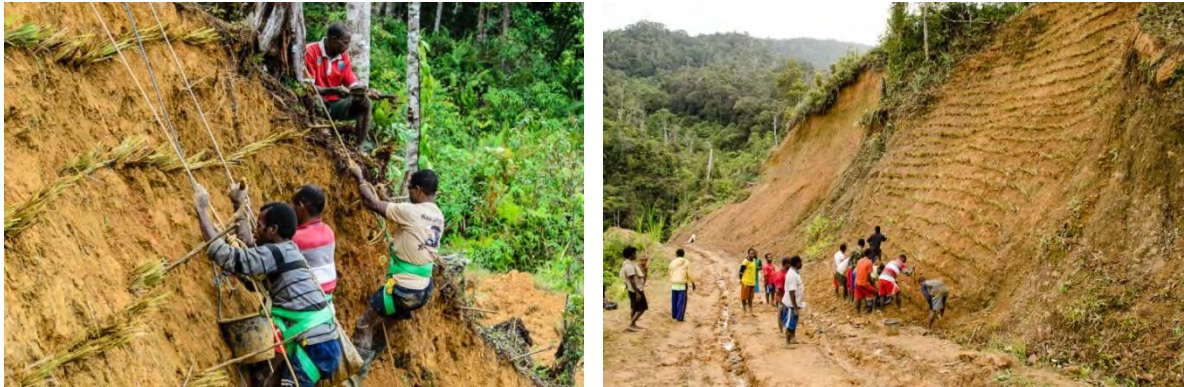
Figure 15. Left: Using rappelling equipment to plant. The slope varied from 60° to almost 90° in some sections. Right: Nearly finished planting.

try...indeed it was clear that if VS was to be successful, it would have to be able to succeed on these extreme slopes. The first trial site was identified near the village of Testega because the stakeholders felt it represented one of the more challenging slopes to stabilize while logistically it would be simple to access and plant (close to a large village). In similar fashion to the nursery propagation activities, the stabilization planting was accomplished without funding from external sources, but rather, was a community effort with many individuals throughout the Meyah GPKAI constituency volunteering their time to help.

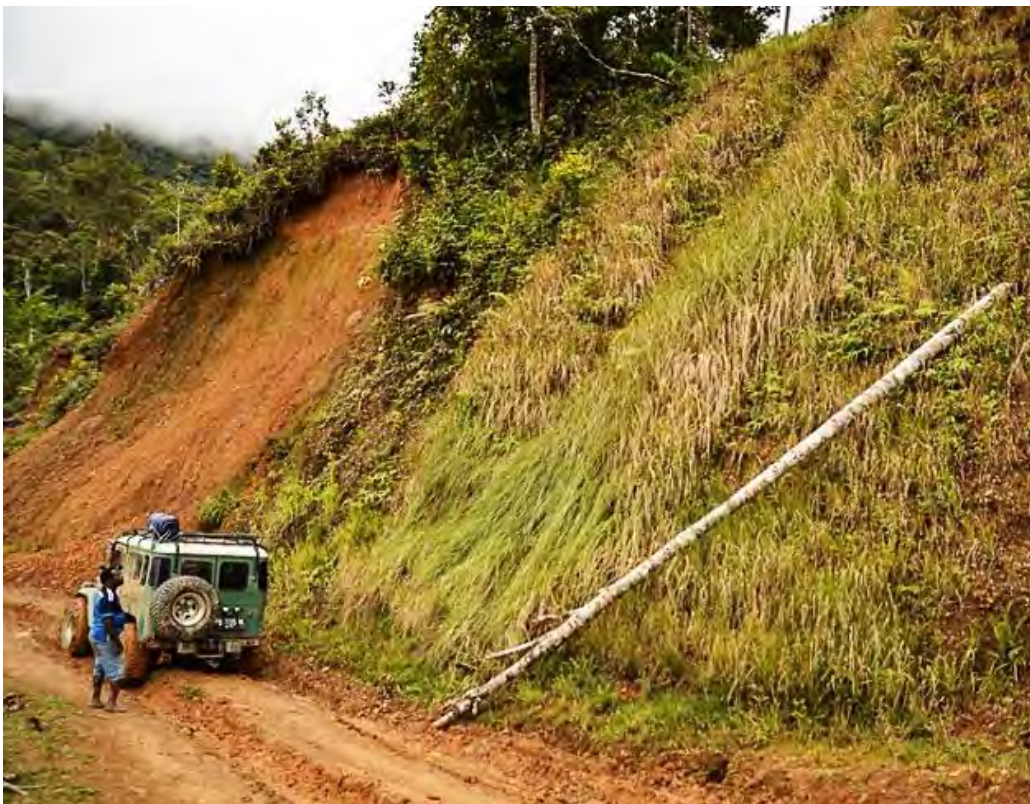
Figure 16. Success! Twelve (12) months after planting, the control on the left portion of the slope continues to experience erosion while on the right-hand side the Vetiver is protecting the slope.
