# VETIVER SYSTEM FOR EROSION CONTROL OF LEVEE BANKS AND SEA DIKES IN LOW LYING FLOOD PRONE AREAS

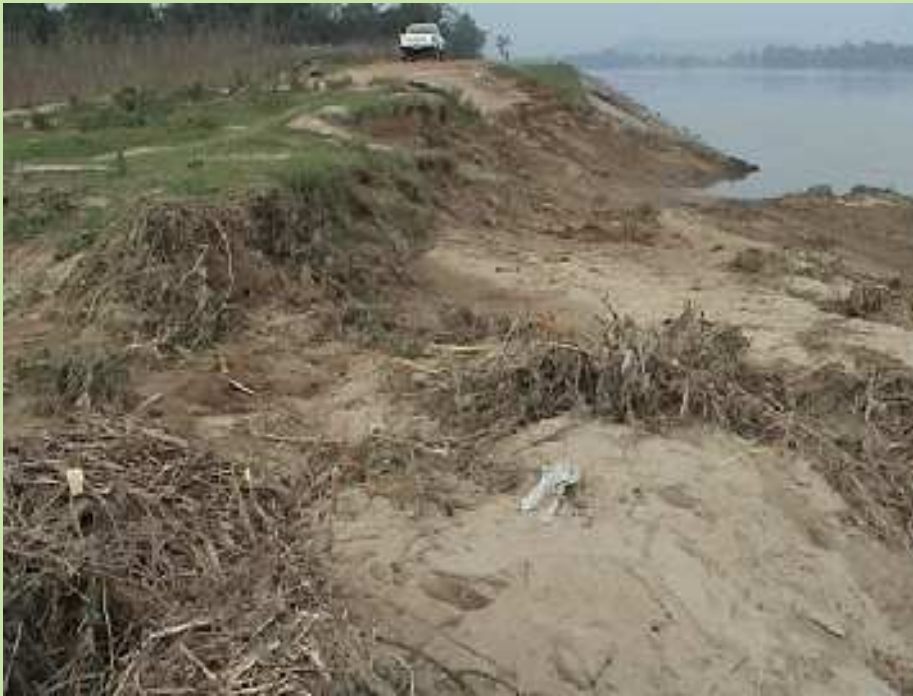
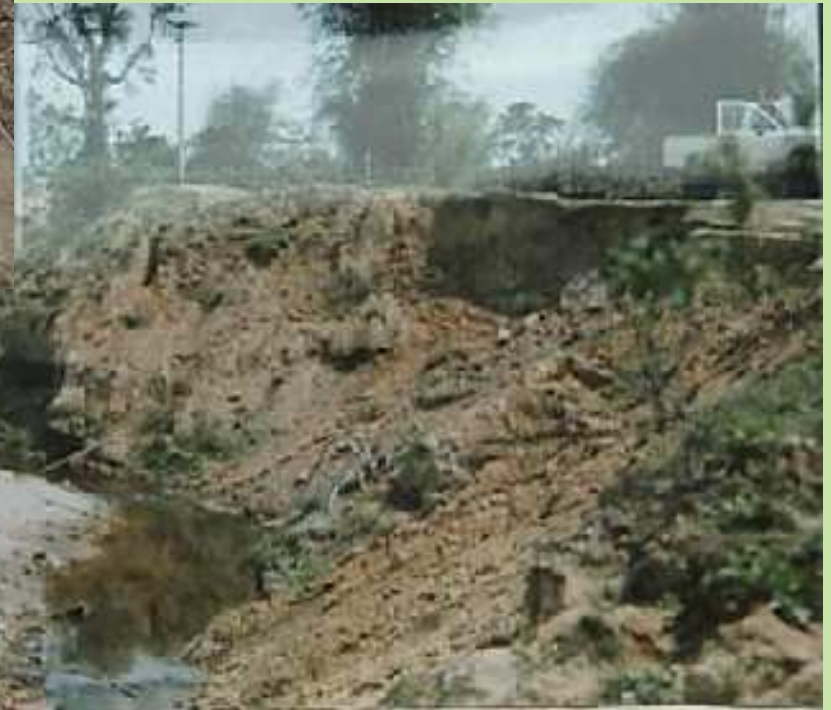
# Flash flood caused enormous damage to infrastructure such as levee banks in the central coastal provinces of Vietnam

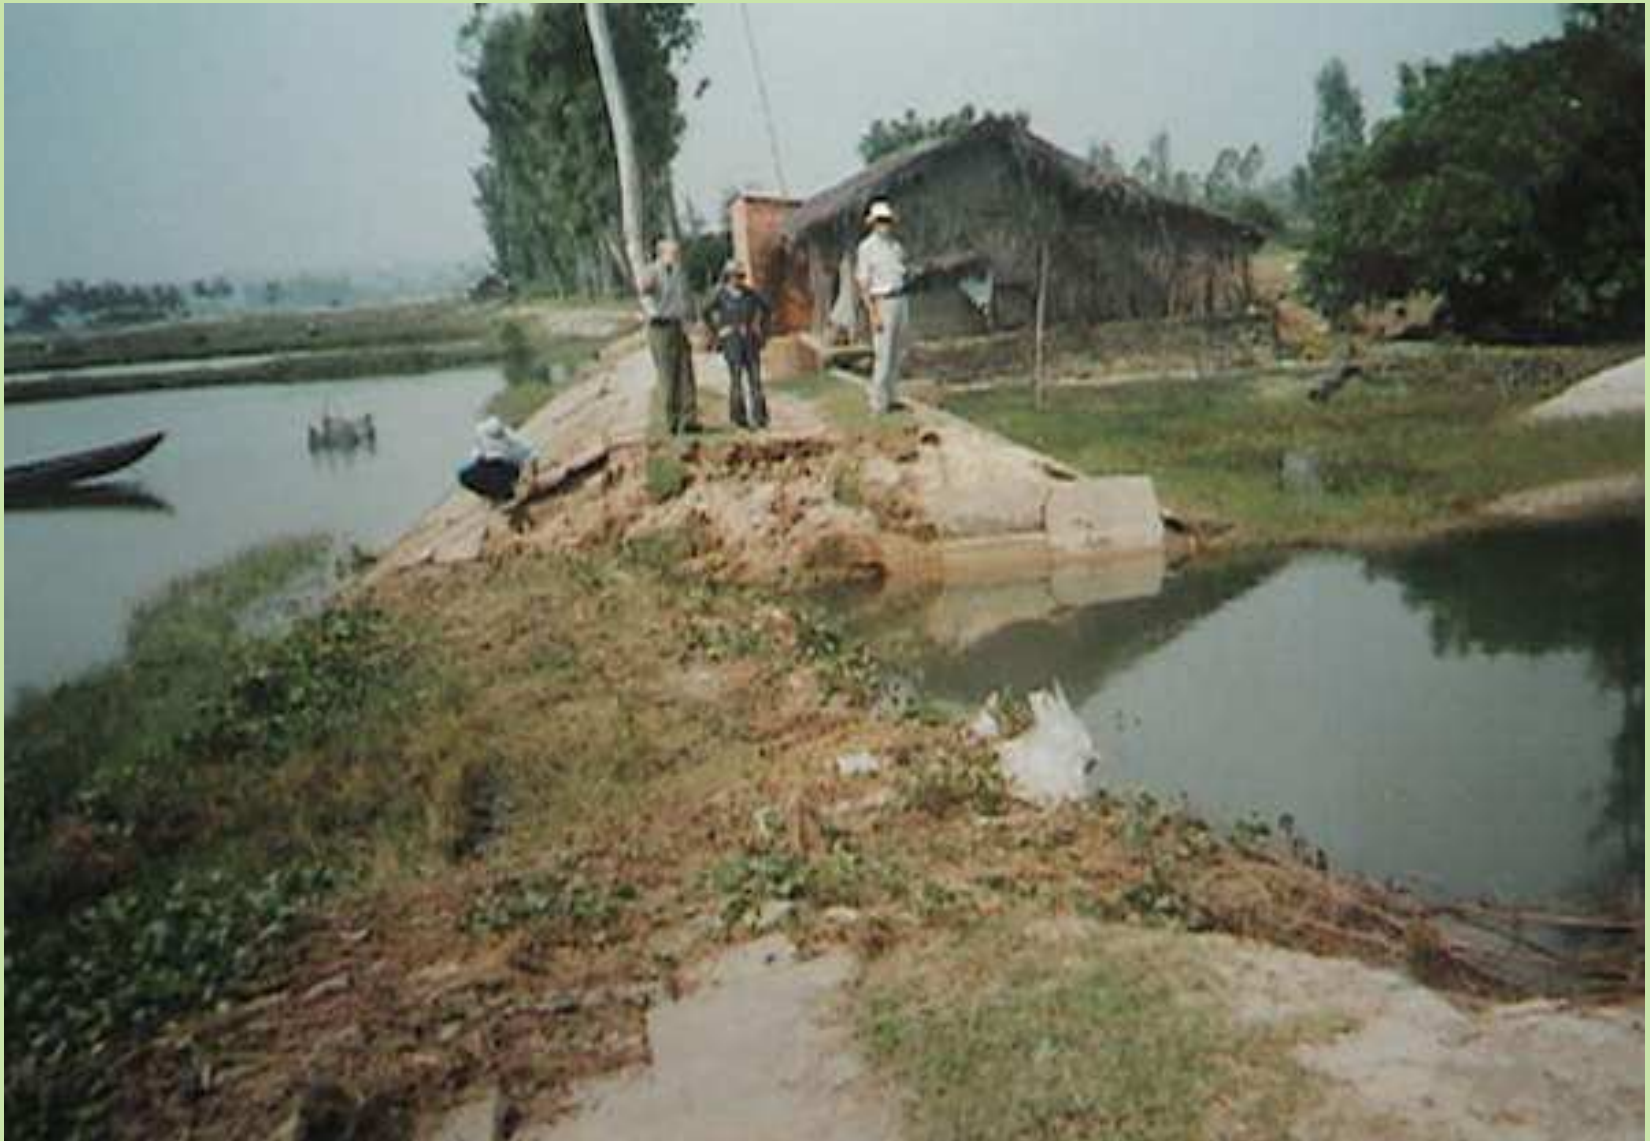
## Severe damage to rural roads

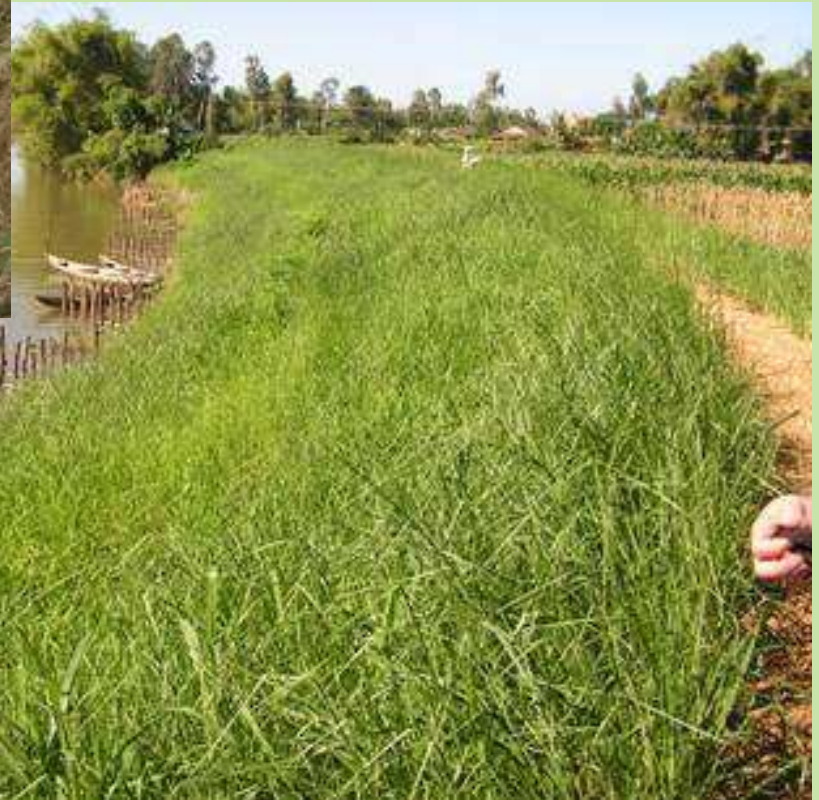
# Vetiver stabilisation of river bank before and after vetiver protection

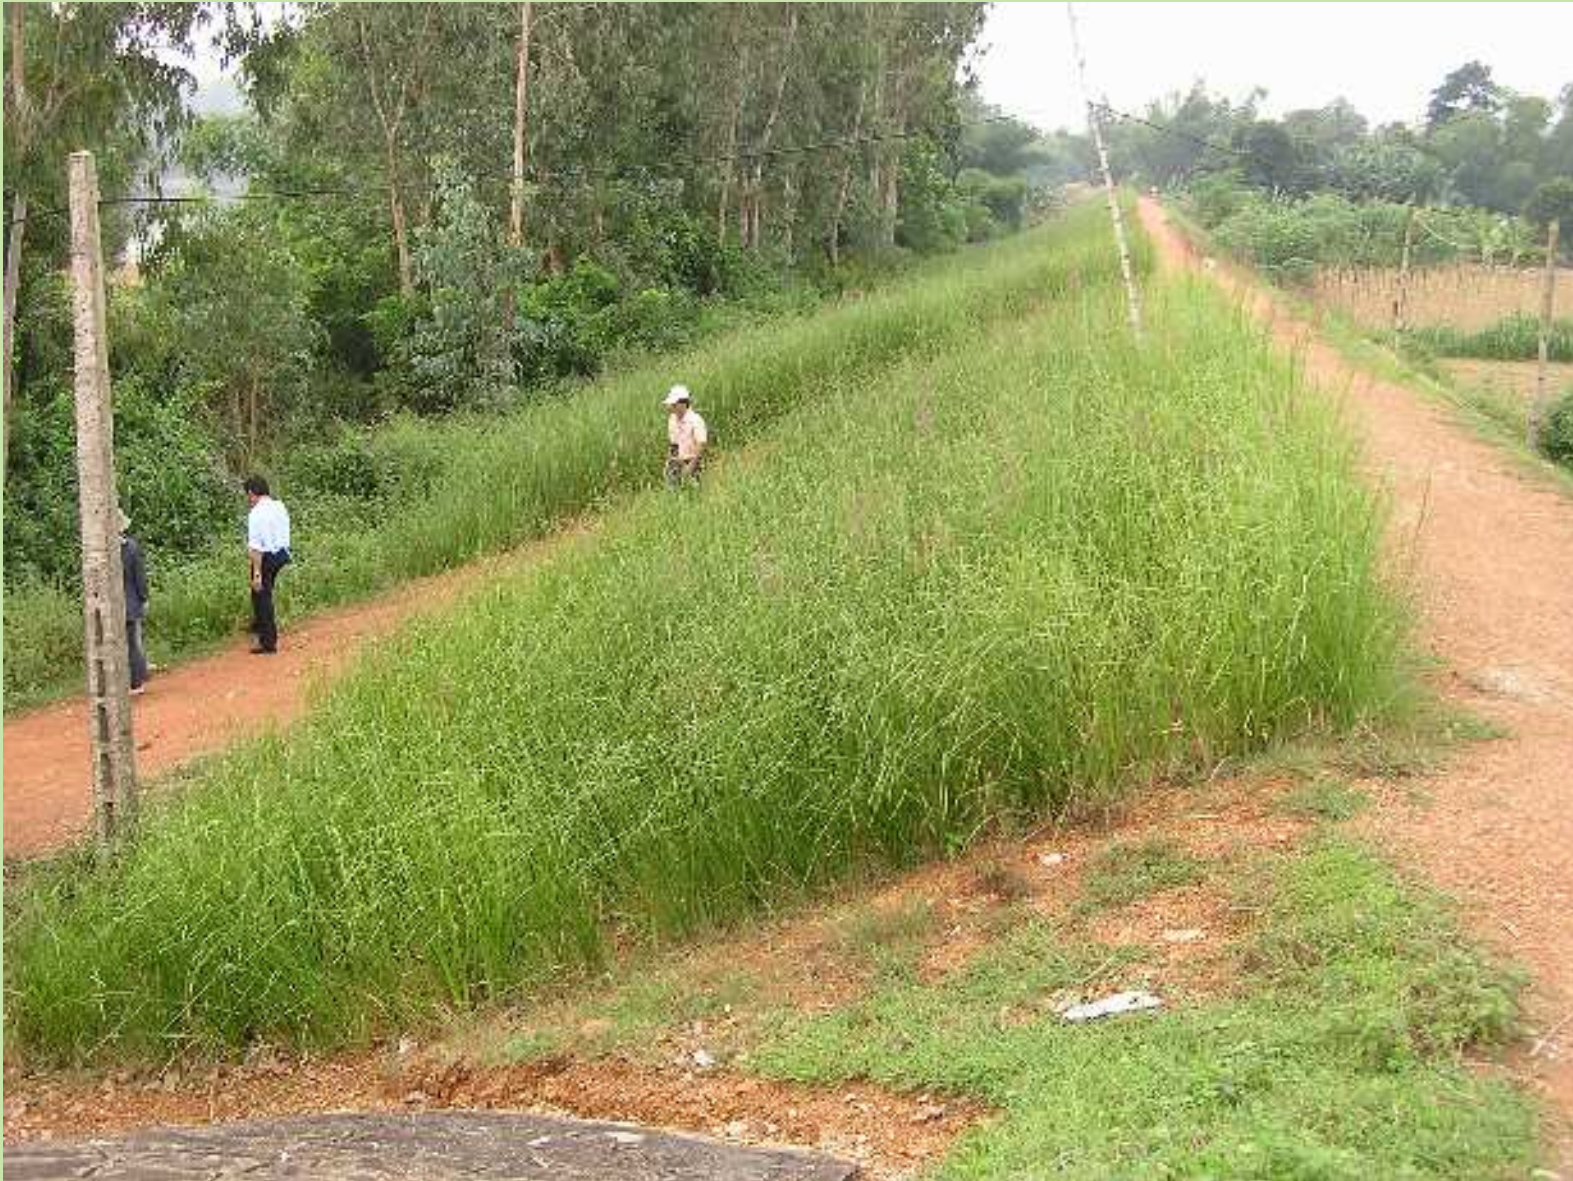
# Vetiver stabilisation of a large levee bank

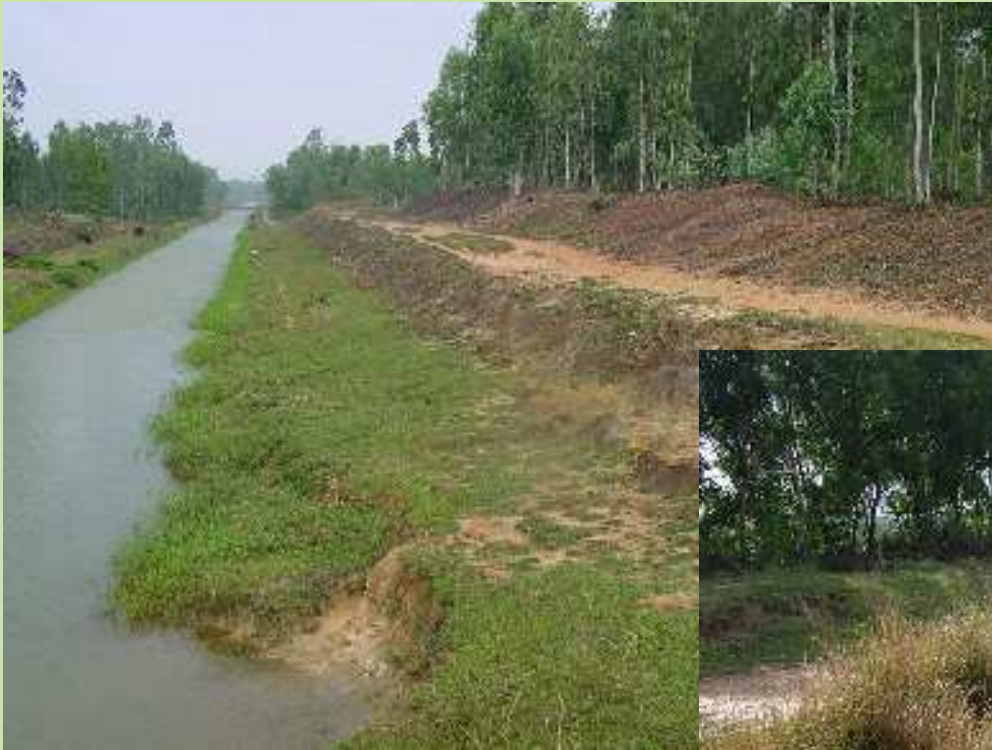
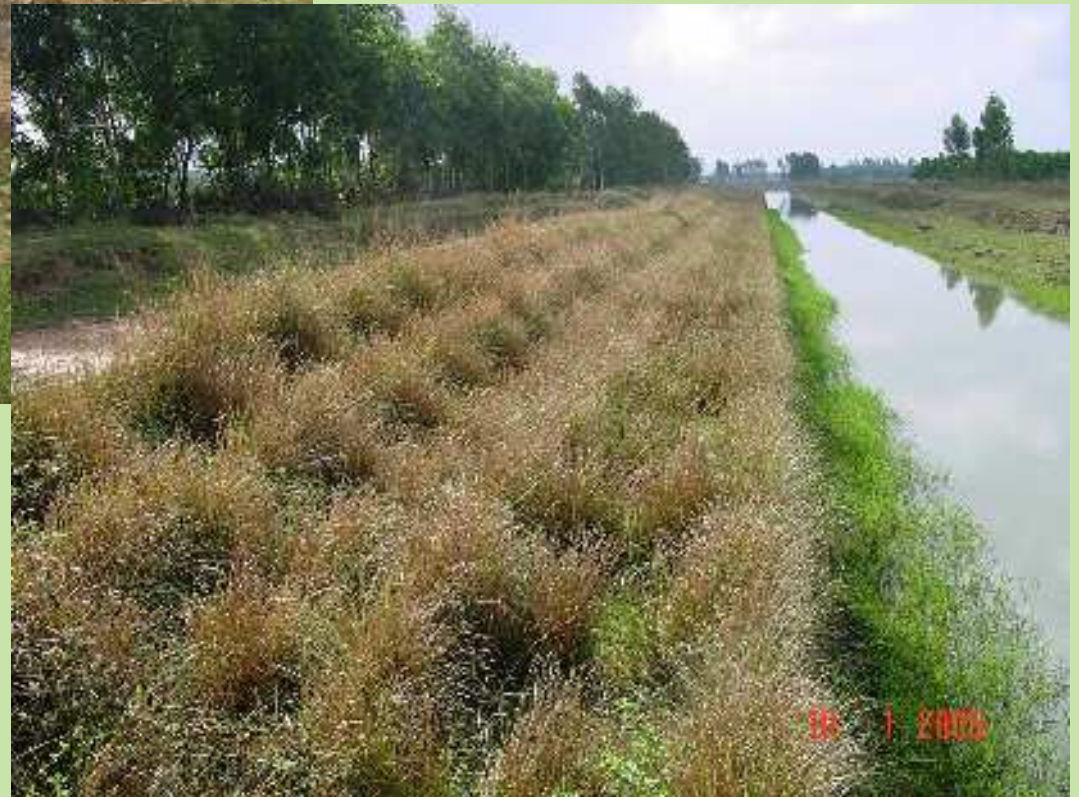
# Vetiver stabilisation of drainage channel bank before and after

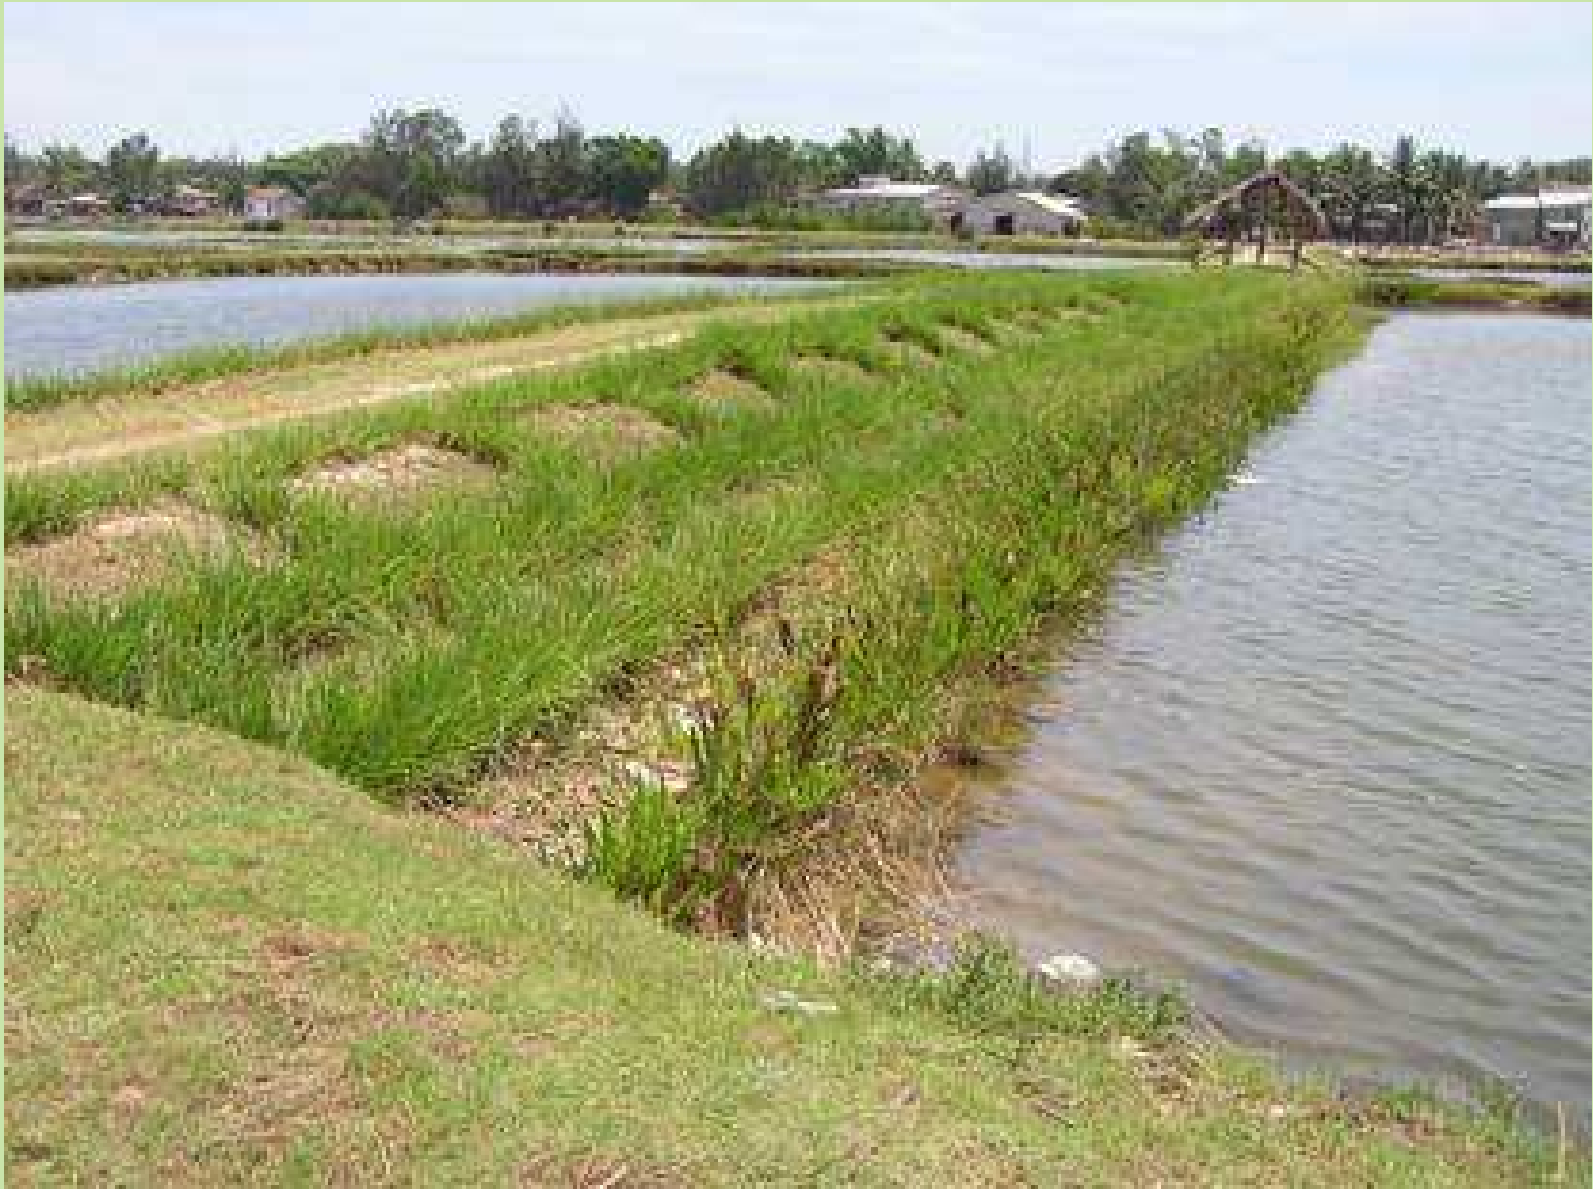
# Stabilisation of aquaculture infrastructure

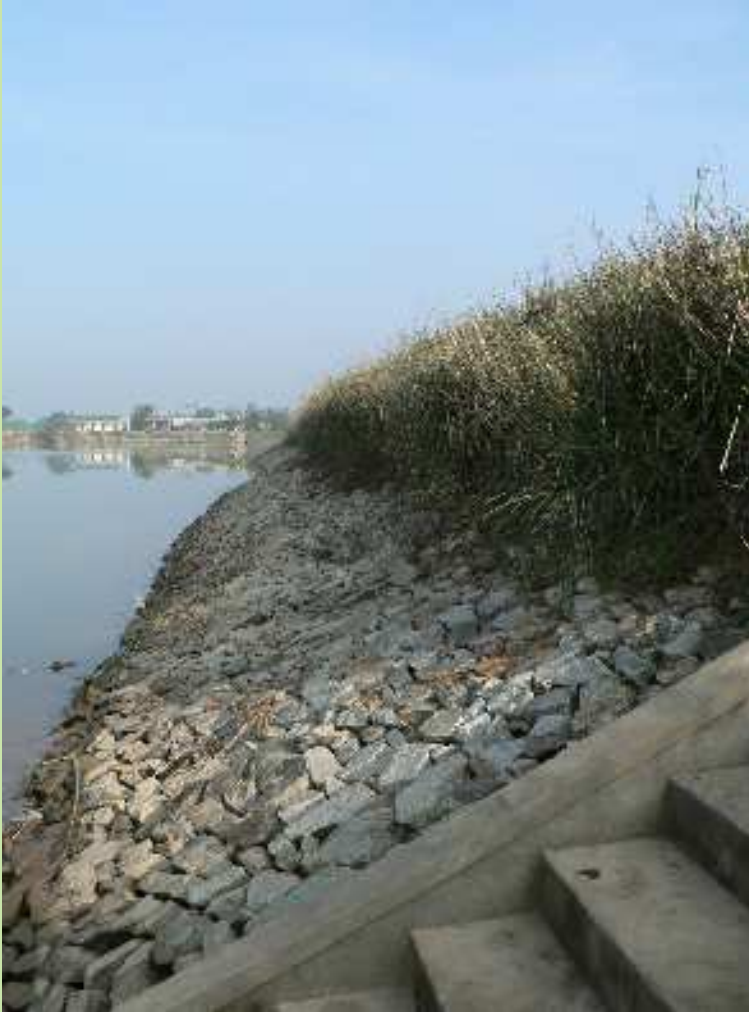
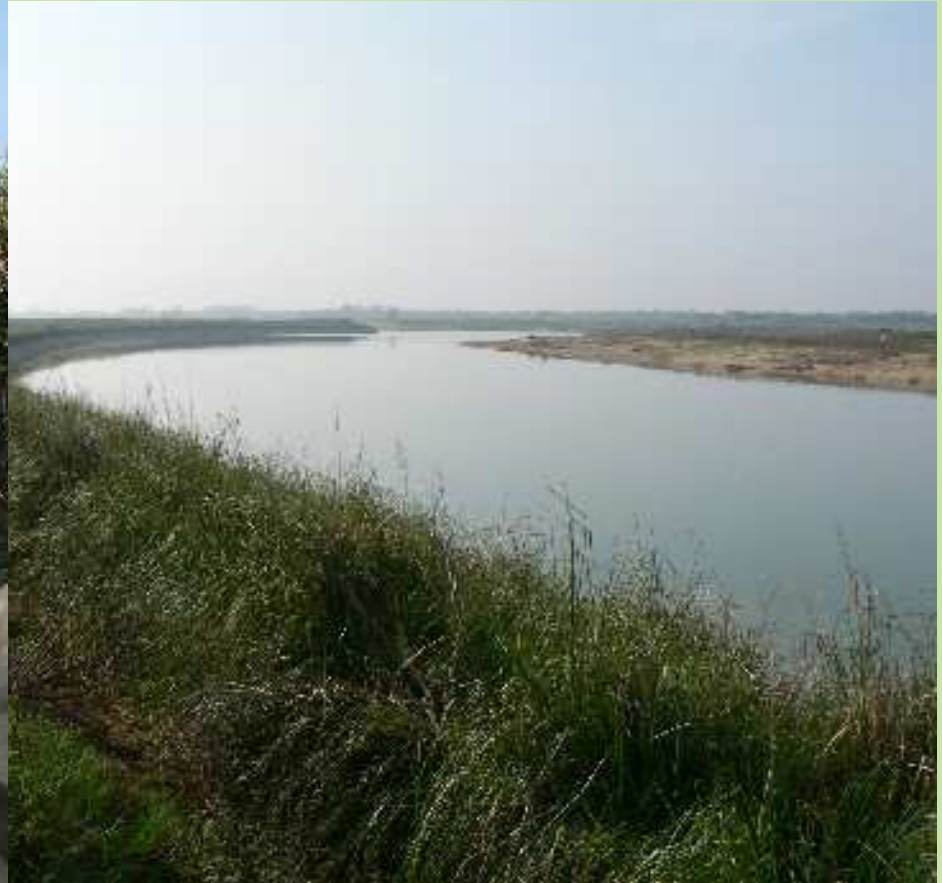
# Re-enforcing and protecting hard structure of a river bank in Vietnam

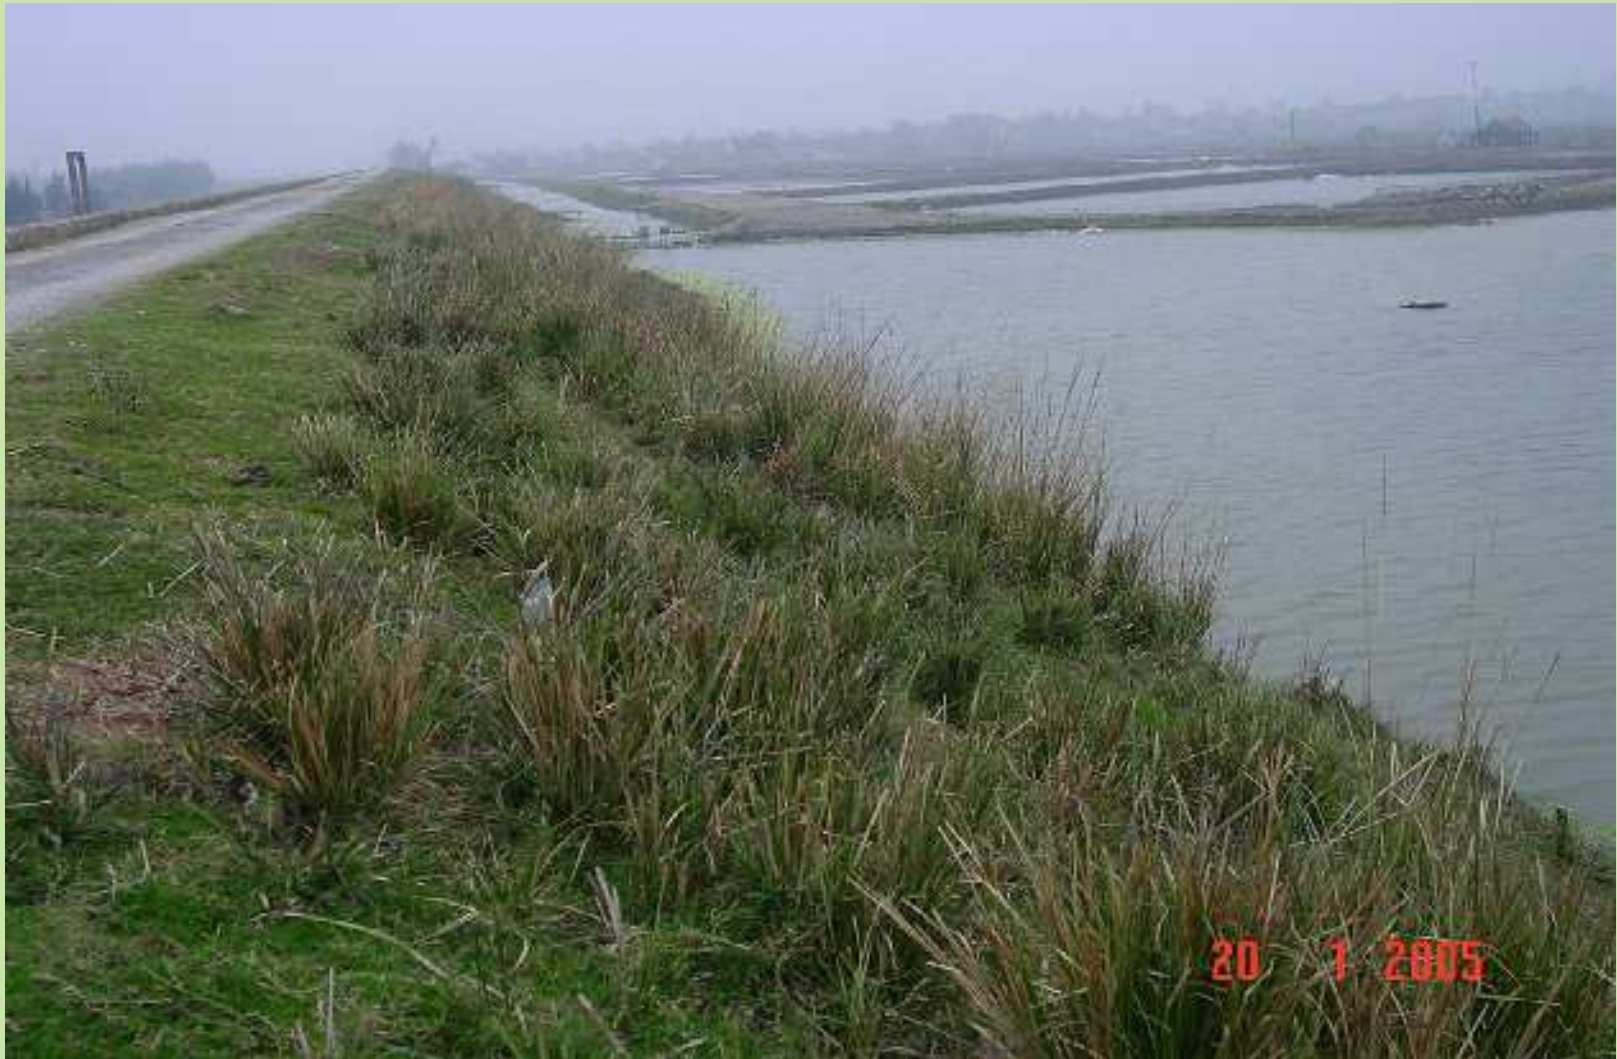
# Stabilisation of the inner wall of a sea dike in Nam Dinh province, Vietnam

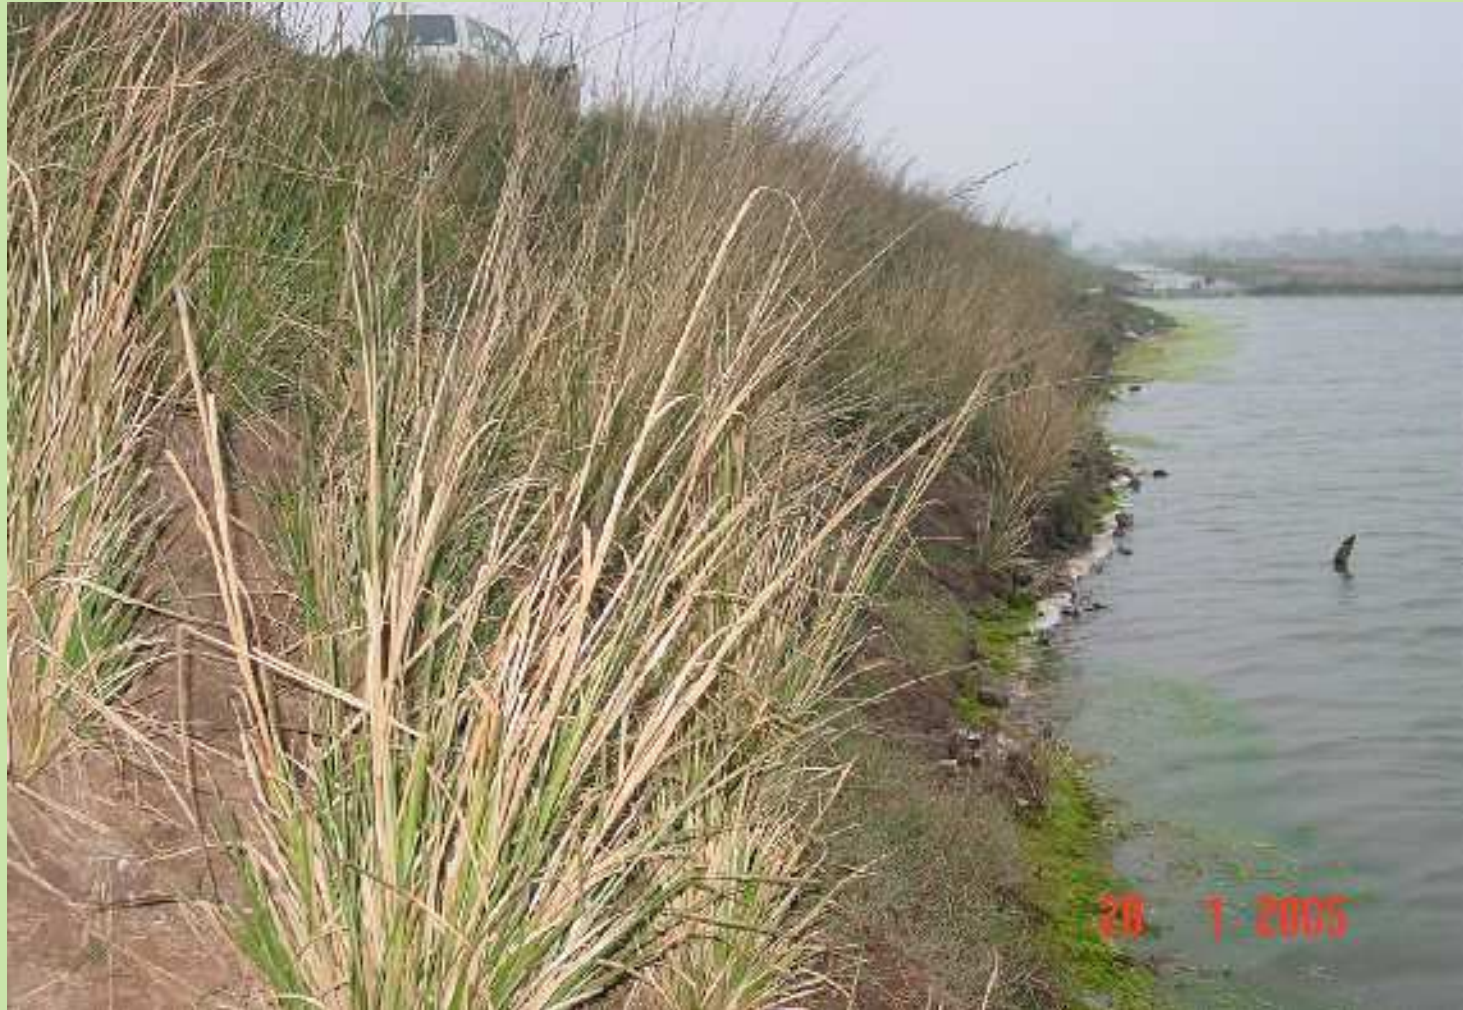
**When this dike was over topped by a recent typhoon, the unprotected part of the dike was washed away, while the vetiver planted section remained intact.**

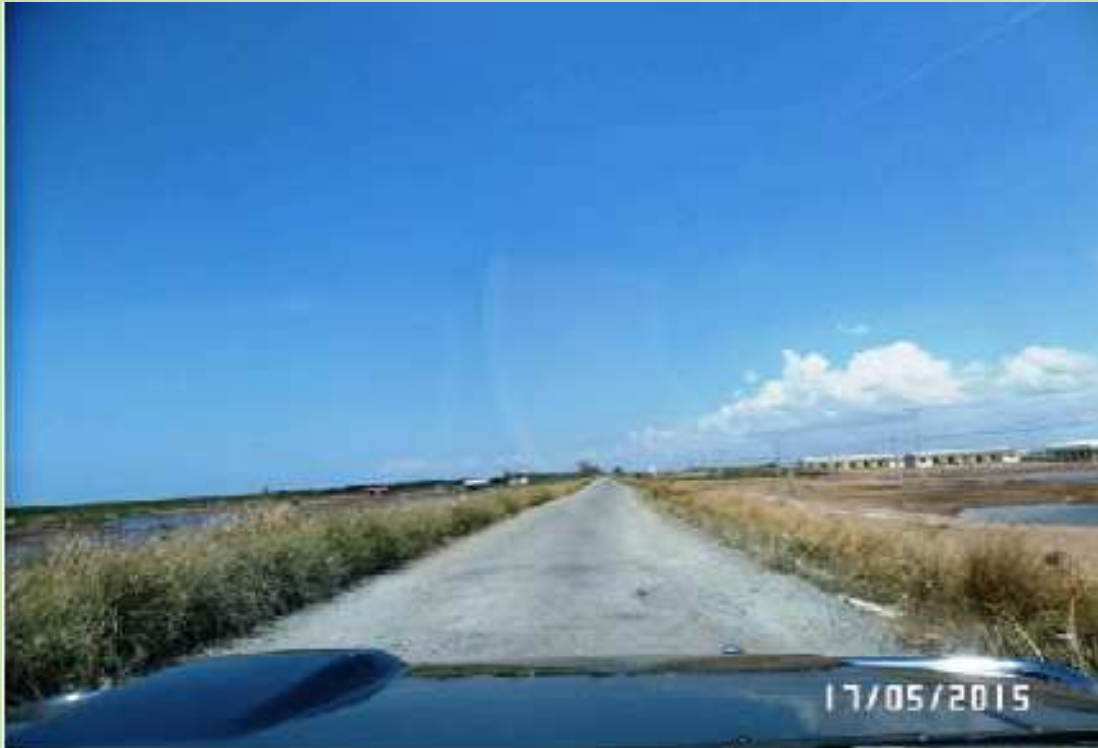
**Vietnam, Mekong Delta –  
eight year old vetiver  
stabilizing dike road**

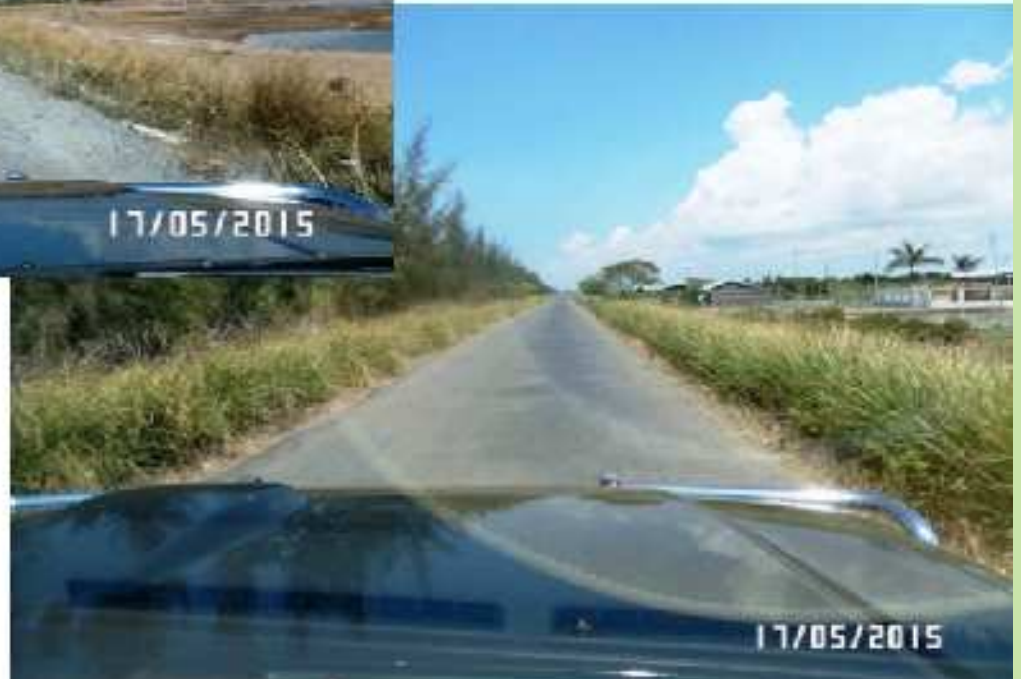
**Note: no erosion evident  
on road shoulder. Much  
lower road maintenance  
costs.**

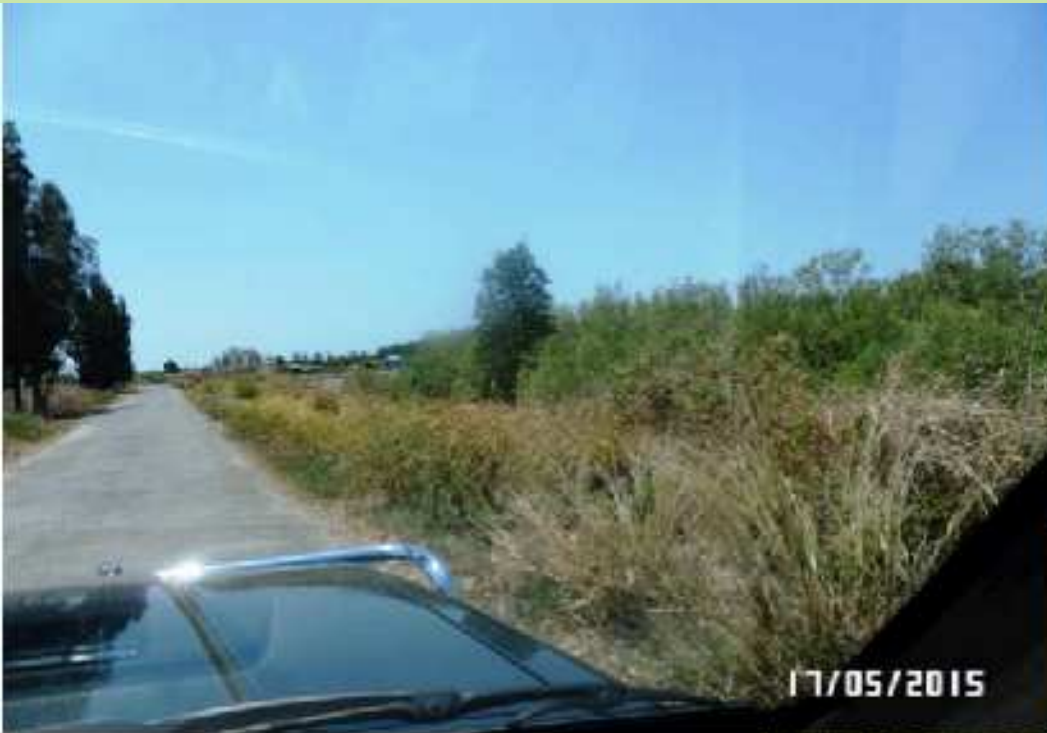
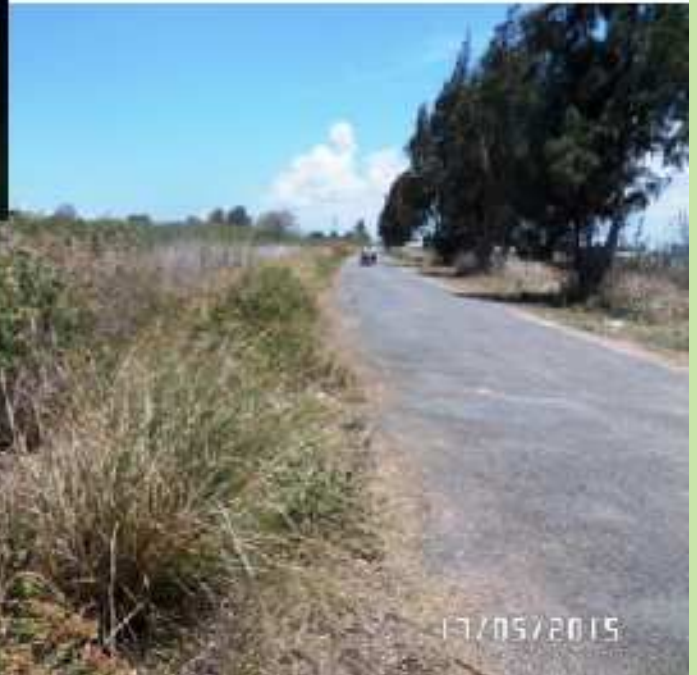
**Excellent vetiver growth on both  
inside and outside  
batter on this  
Mekong Delta dike**

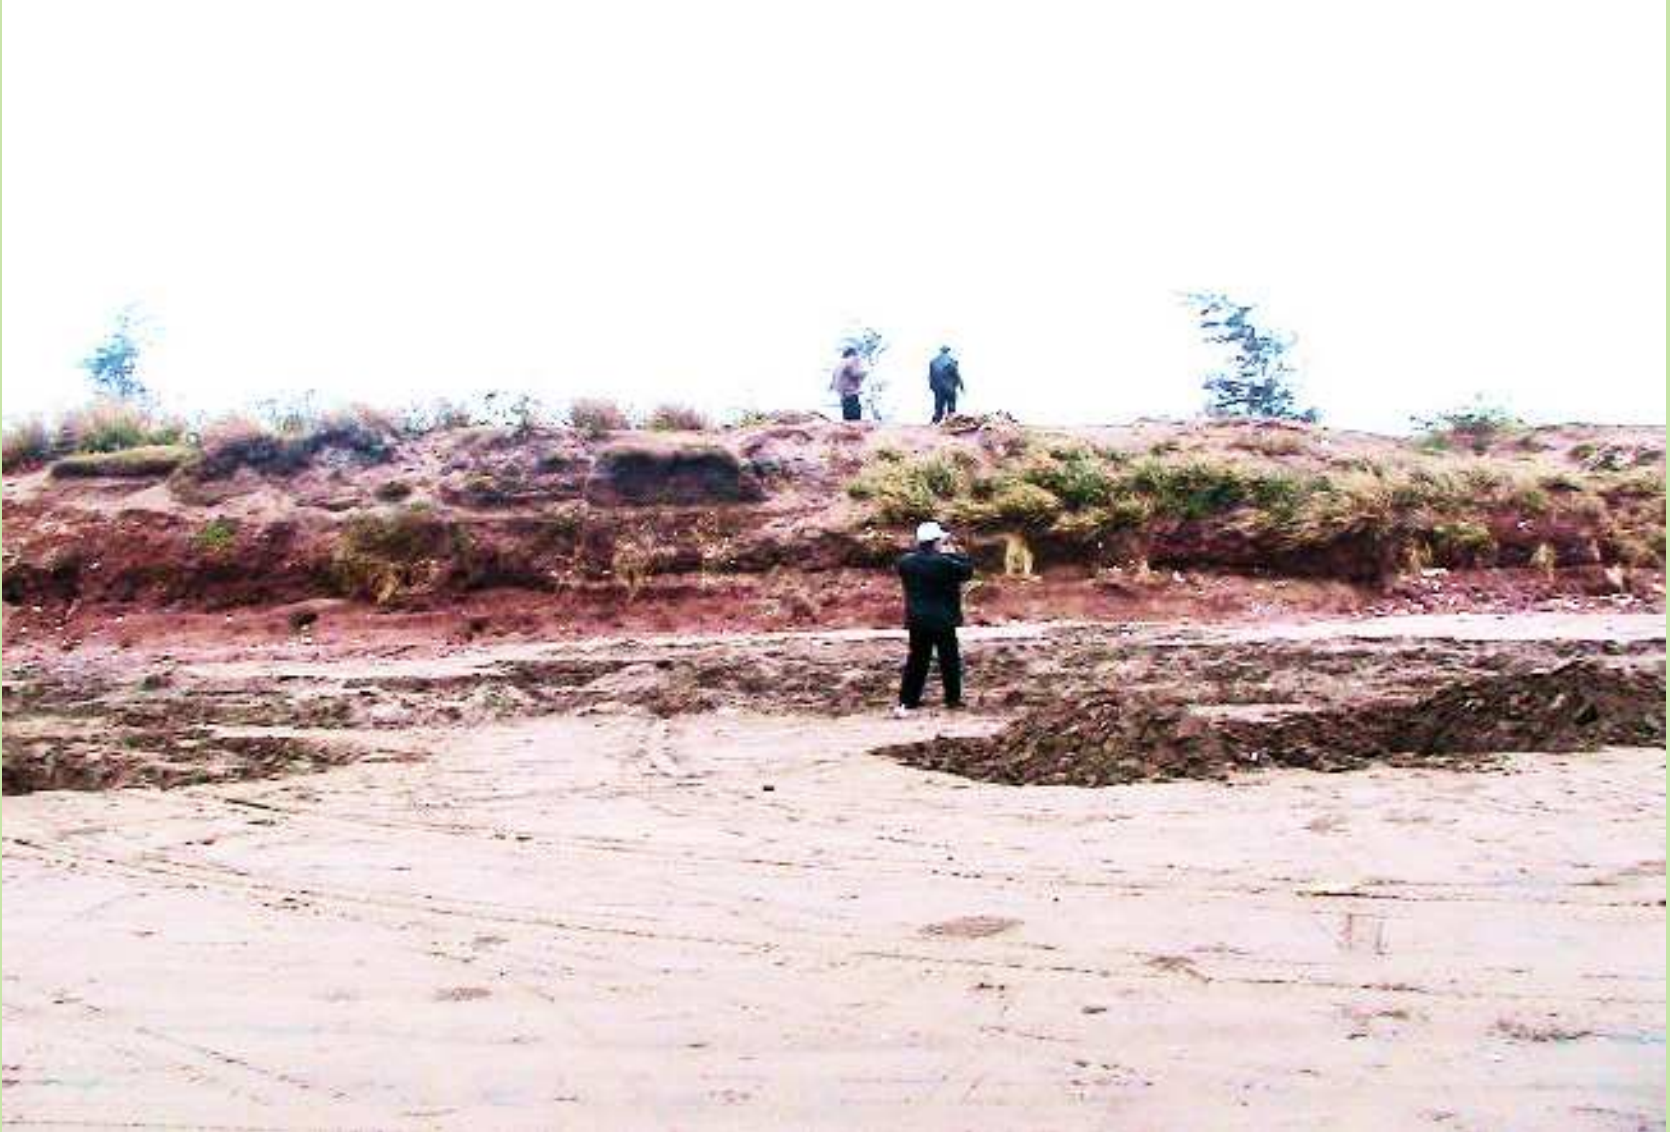
**The sea-facing wall of this dike was badly damaged (left) while the right side, planted with vetiver remained fairly stable**
