Case Study - Vetiver Grass on steep batter slopes at Gove

Summary

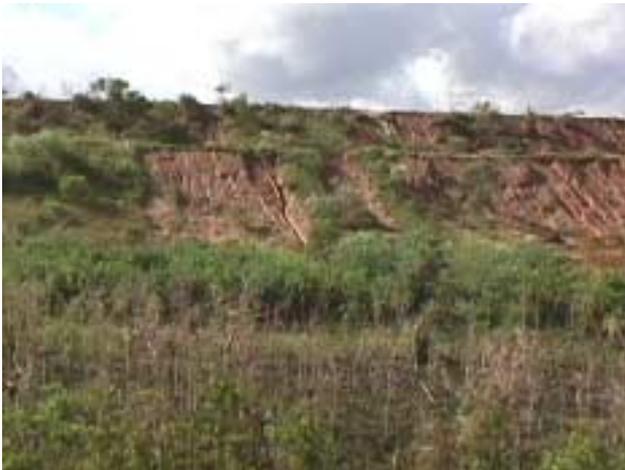
The Residue Disposal Area (RDA) of the Gove Mine experienced an extreme rainfall event on 21 and 22 April 1999. Monitoring at the RDA indicated that maximum rain in a 24 hour period was 294 mm, with a total of 306 mm falling in 48 hours. Large areas of outer batter slopes of a water retention dam designated as Pond 5 were affected by slipping of the surface soil layer and associated gulying.

It appears that most of the erosion initially started on the upper tier, causing the table drain on the middle berm road to block and overflow down the lower tier. This resulted in further soil slips and associated gulying. In all, about 5 ha of batter slopes were affected by erosion and required remedial works.

Plate 1: View of upper and lower batter slip areas

To stabilise steep slopes such as those at Pond 5 against landslips, it is necessary to both minimise the discontinuity between the topsoil and underlying clay and to increase the shear strength of the topsoil layer. Vetiver grass is ideal for this purpose due to its deep rooting nature.

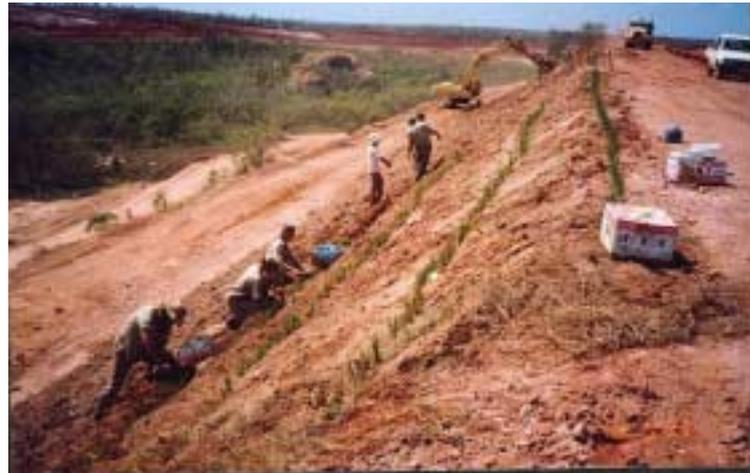
Plate 2: *Initial planting operations.*

The vetiver planting program included sourcing vetiver, developing and operating a temporary on-site nursery for handling vetiver slips, planting of vetiver, watering, weeding, and (where necessary) replacement of plants. The work was carried out by staff from the local company YBE, with supervision from Landloch field staff.

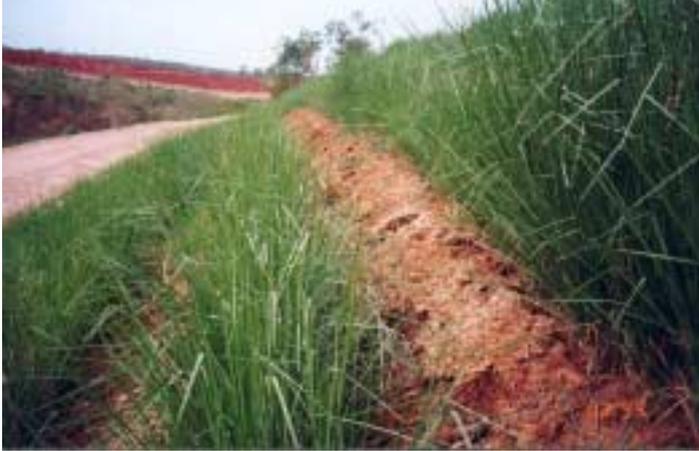
By late November, the earlier vetiver plantings were 1.3 metres high, with vetiver plantings that were weeded reaching heights of approximately 2 metres late in the wet season. By June the vetiver roots had extended about 1.0 m into the soil profile.

Plate 3: *Vetiver approximately 1.3 metres high. (Area planted on September 9-12, photograph taken 12 weeks later).*

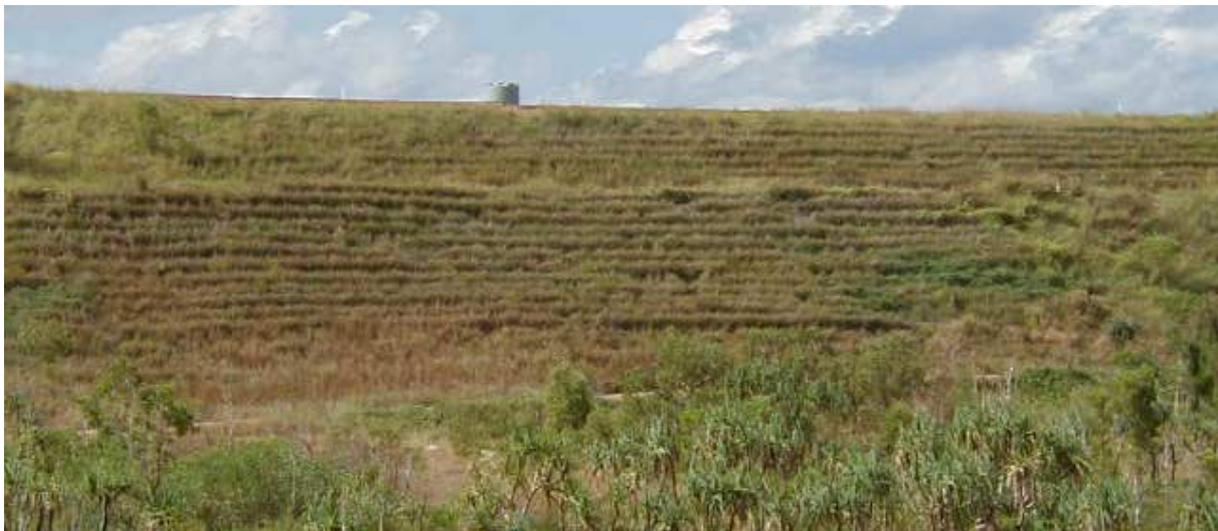
Plate 4: *Vetiver on Pond 5 batter slope, photograph taken in July 2001*
