**Vetiver System for Erosion and Sediment Control,
and Stabilisation of Steep Slopes**
**(With special references to the Ho Chi Minh Highway,
Vietnam)**

Paul Truong

**Director, The Vetiver Network International,
Veticon Consulting, Brisbane, Australia.**

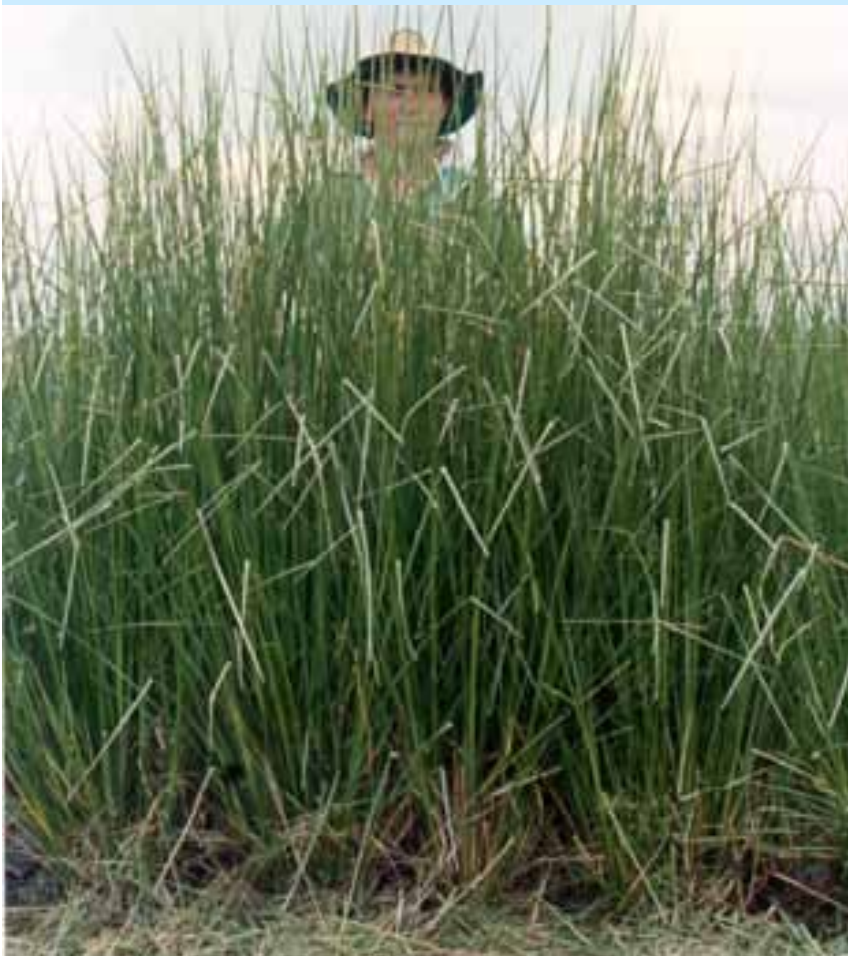
Tall Erect and stiff stems, forming a thick hedge when planted in row

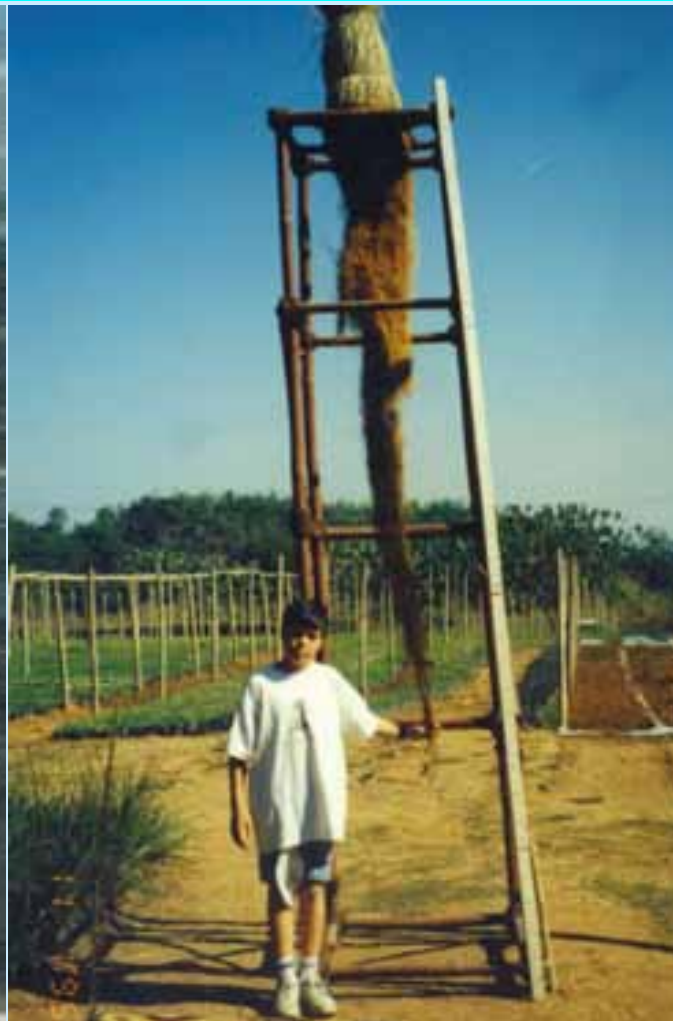
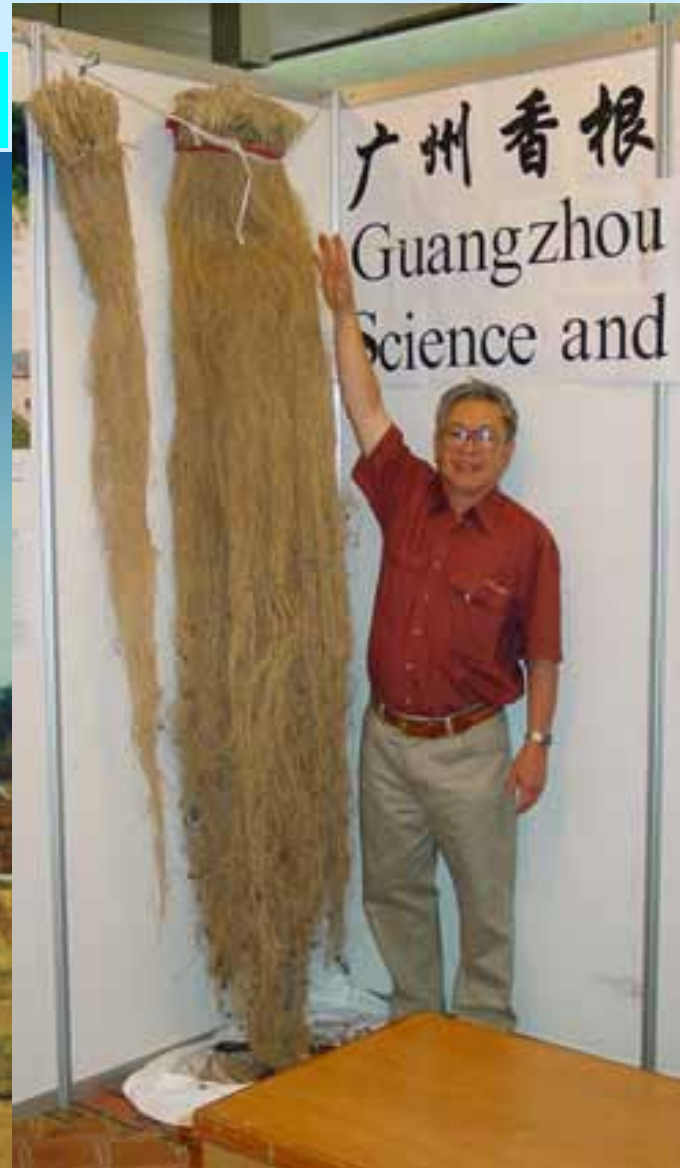
Deep, extensive and penetrating root system

One year old: 3.3m deep

- **Although classified as a grass, for land stabilization purposes, Vetiver plants behave more like fast growing trees or shrubs. Per unit area Vetiver roots are stronger than tree roots.**
- **Extremely deep and massive finely structured root system, capable of reaching down to 2 to 3m in the first year. Many experiments show Vetiver grass can reach 3.6m in the first 12 months on fill slope**
- **This extensive and thick root system binds the soil and at the same time makes it very difficult to be dislodged and extremely tolerant to drought.**
- **Vetiver roots can penetrate compacted soil profile such as hardpan and blocky clay pan common in tropical soils, providing a good anchor for fill and topsoil.**

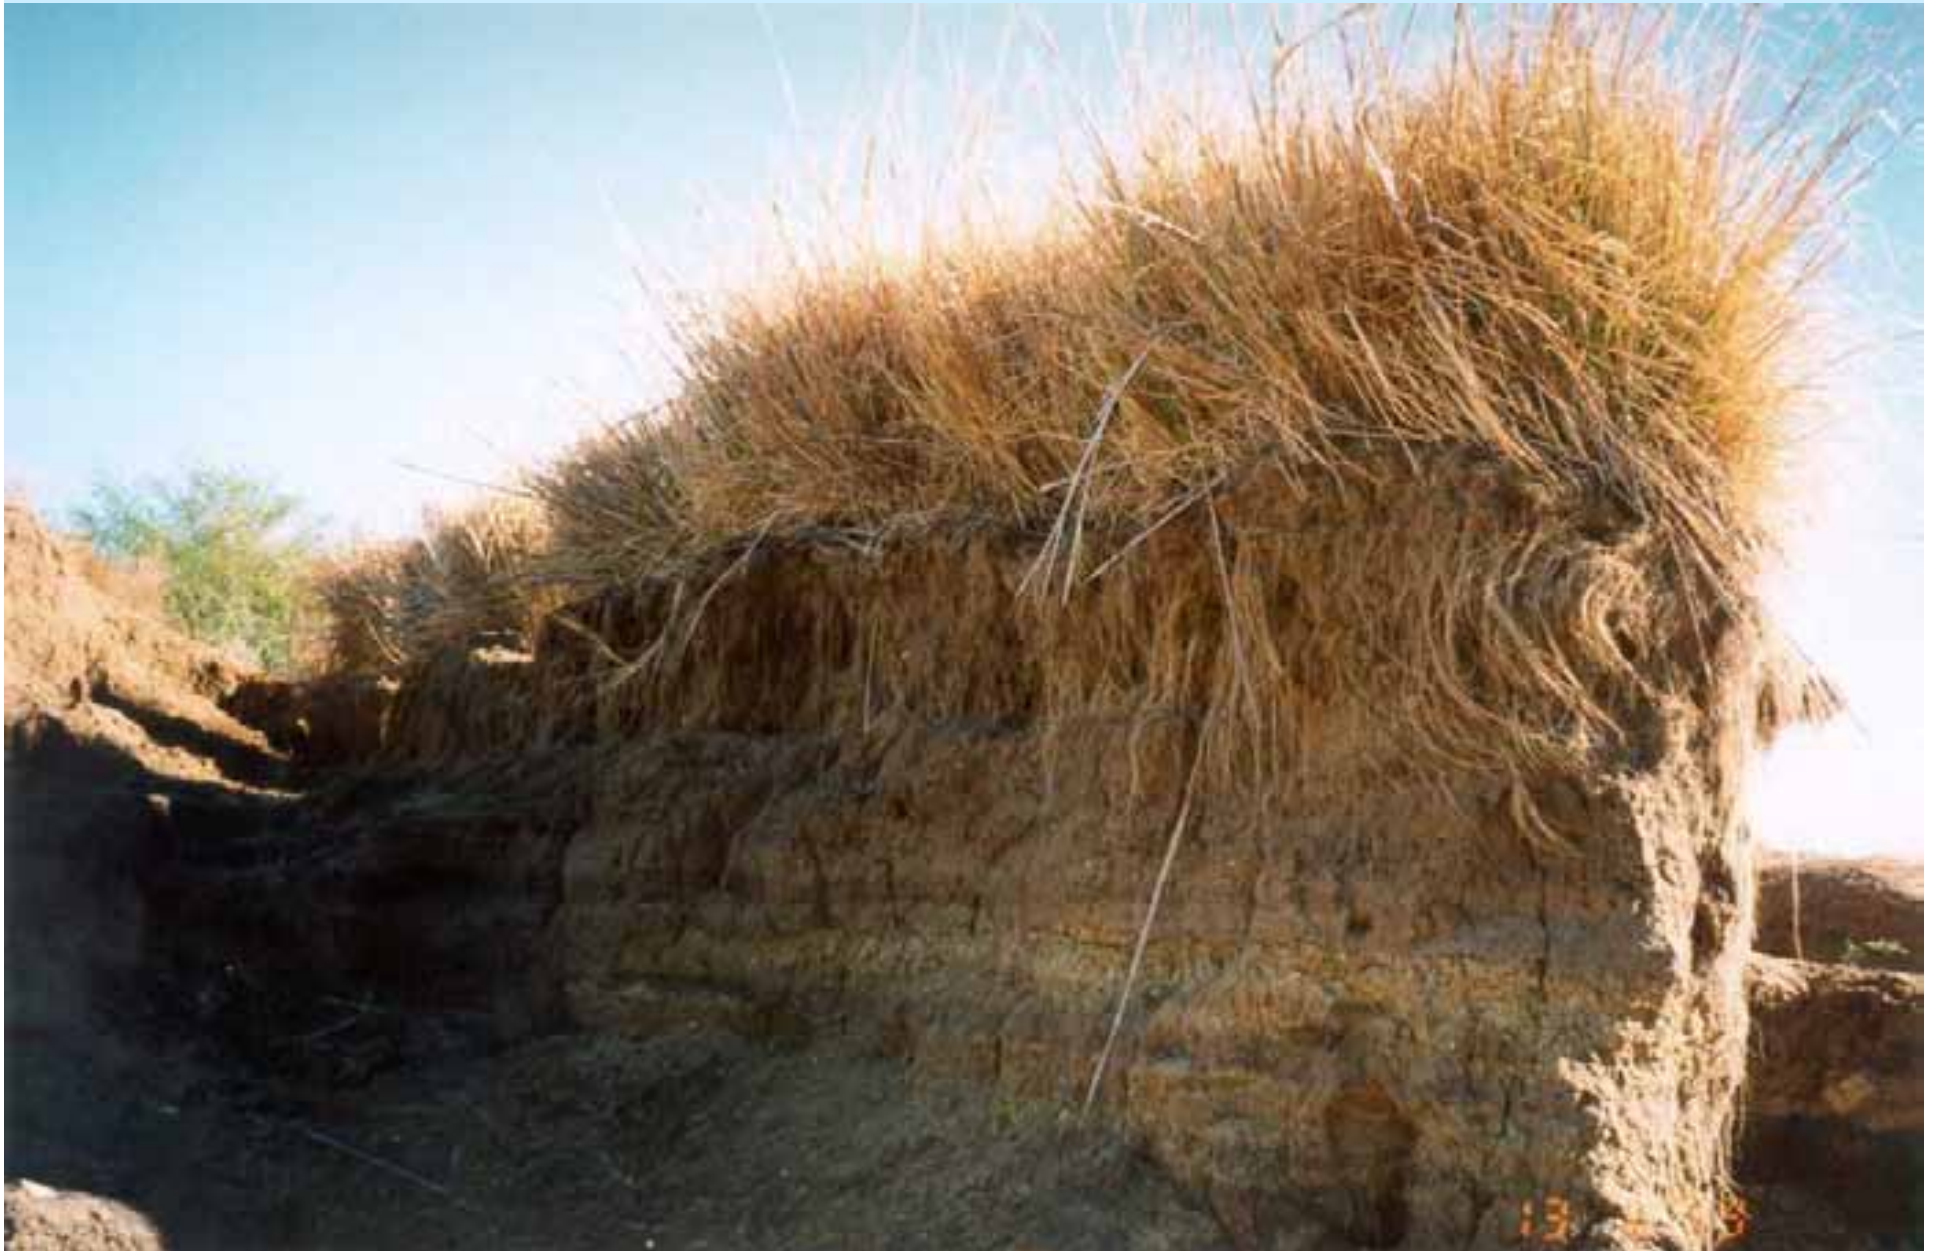
Strong root reinforcement holding up this wall of soil against water erosion

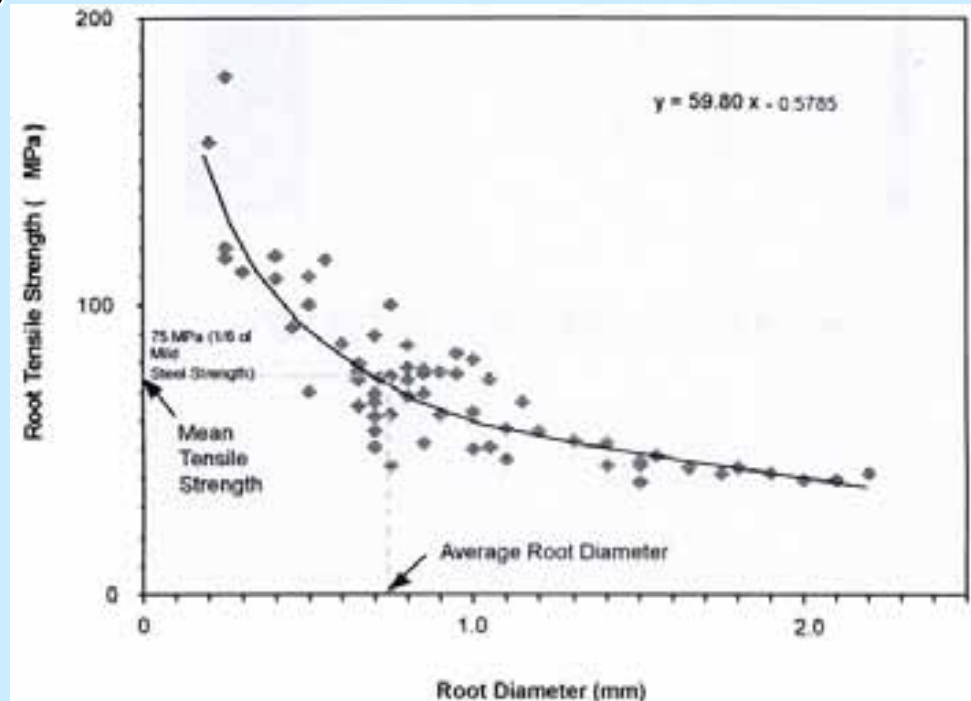
Tensile strength of vetiver roots

- Tensile strength increases with reduction in root diameter, i.e. stronger fine roots provide higher resistance than larger roots.
 - Tensile strength of vetiver roots varies between 40-180 MPa for the range of root diameter between 0.2-2.2 mm.
- Mean design tensile strength is 75 MPa (appr. 1/6 of mild steel) at 0.7-0.8 mm root diameter - the most common size of vetiver roots.
 - This indicates vetiver roots are as strong as, even stronger than many hardwood species (Hengchaovanich and Nilaweera, 1996).

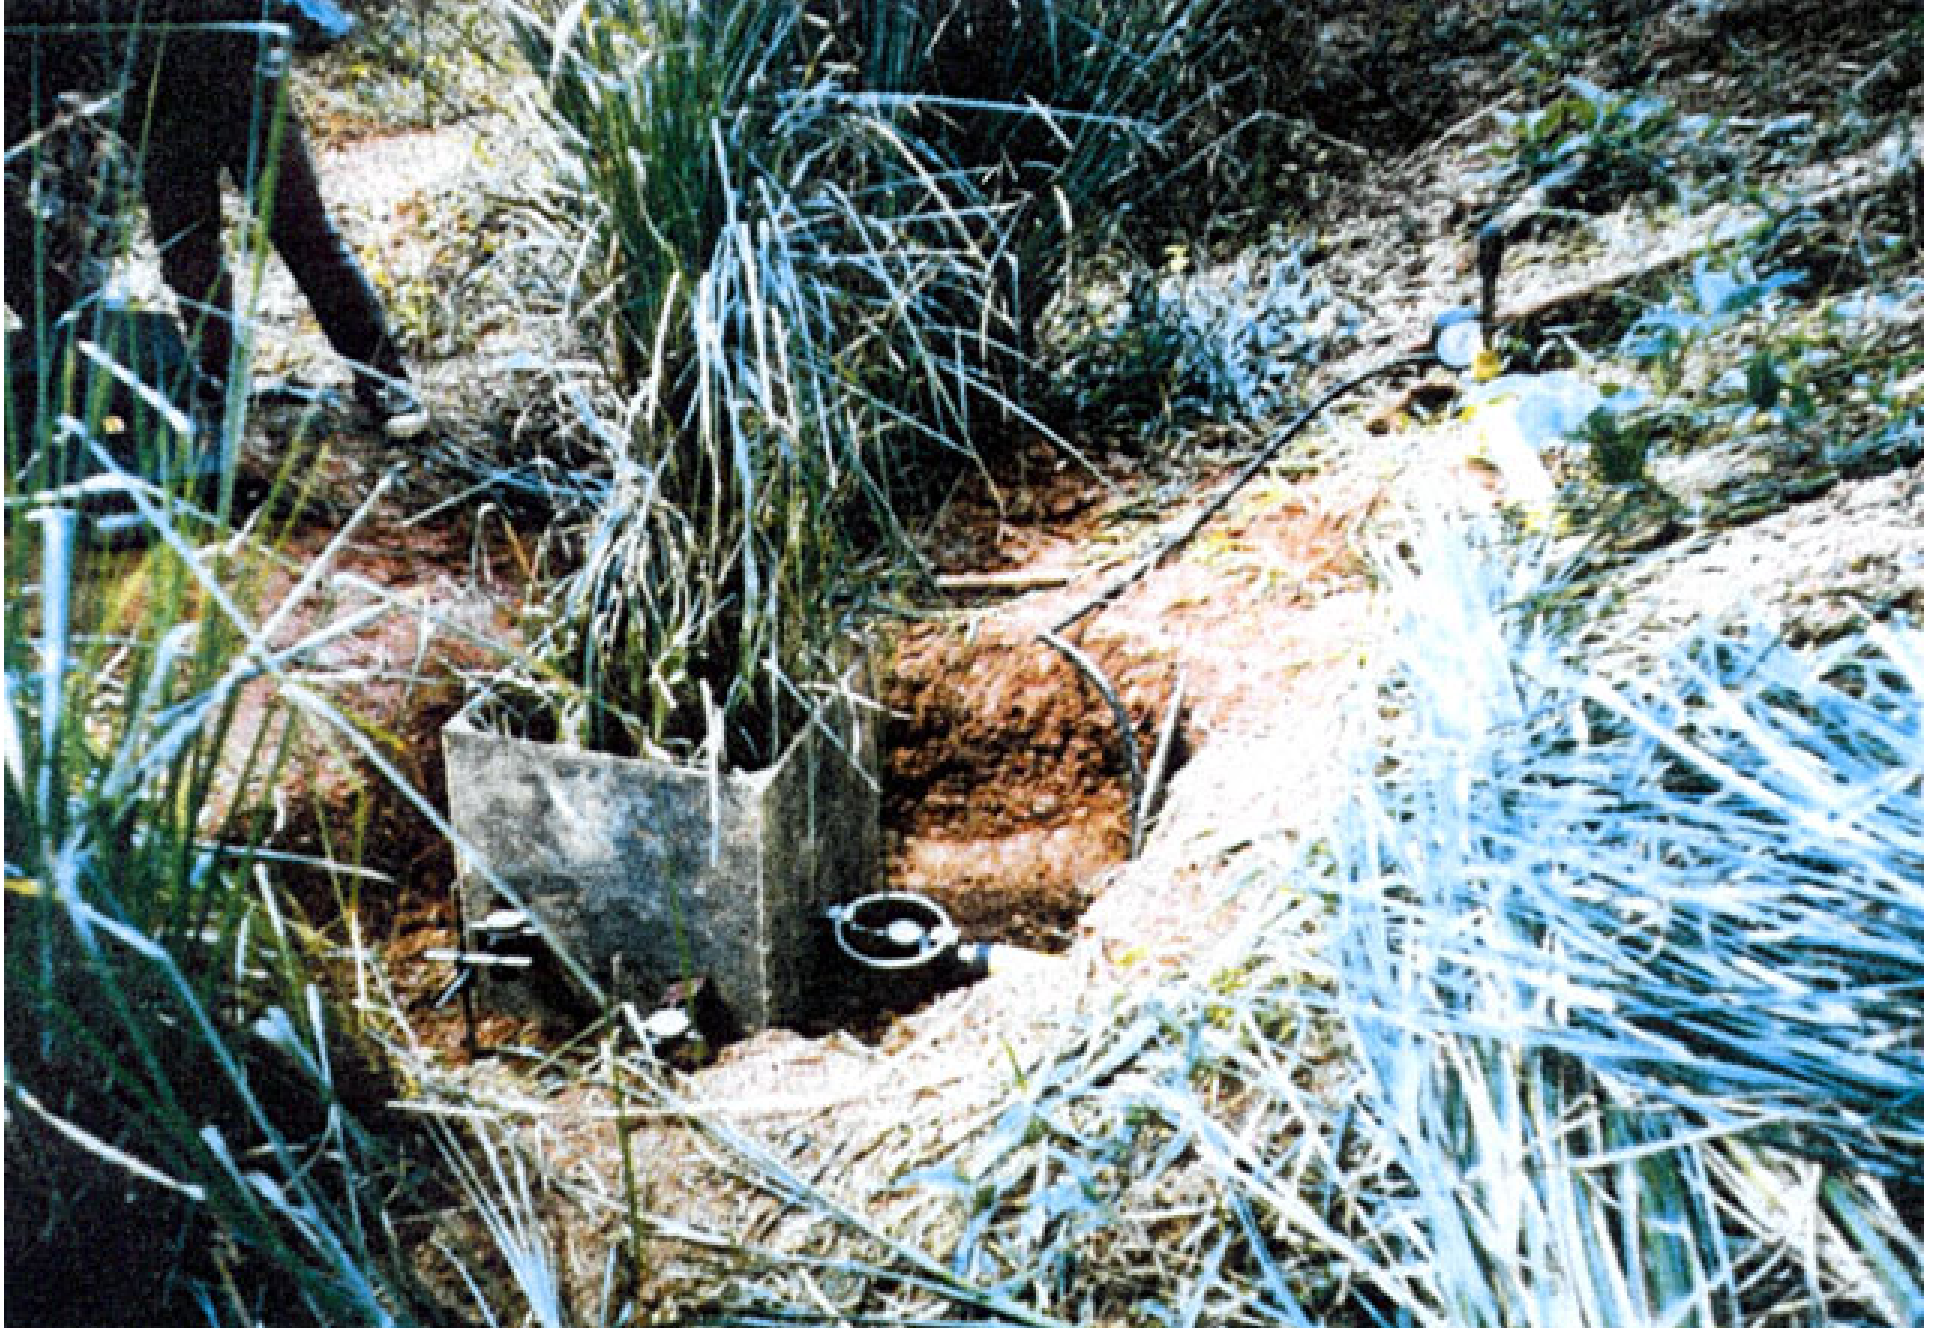
Shear test of vetiver roots

- Soil block shear test also showed that root penetration of a two year old Vetiver hedge with 15 cm plant spacing can increase the shear strength of soil in adjacent 50 cm wide strip by 90% at 0.25 m depth. The increase was 39% at 0.50 m depth and gradually reduced to 12.5% at 1.0 m depth.

- Moreover, because of dense and massive root system it offers better shear strength increase per unit fiber concentration (6-10 kPa/kg of root per cubic meter of soil) compared to 3.2-3.7 kPa/kg for tree roots (Hengchaovanich and Nilaweera, 1996).

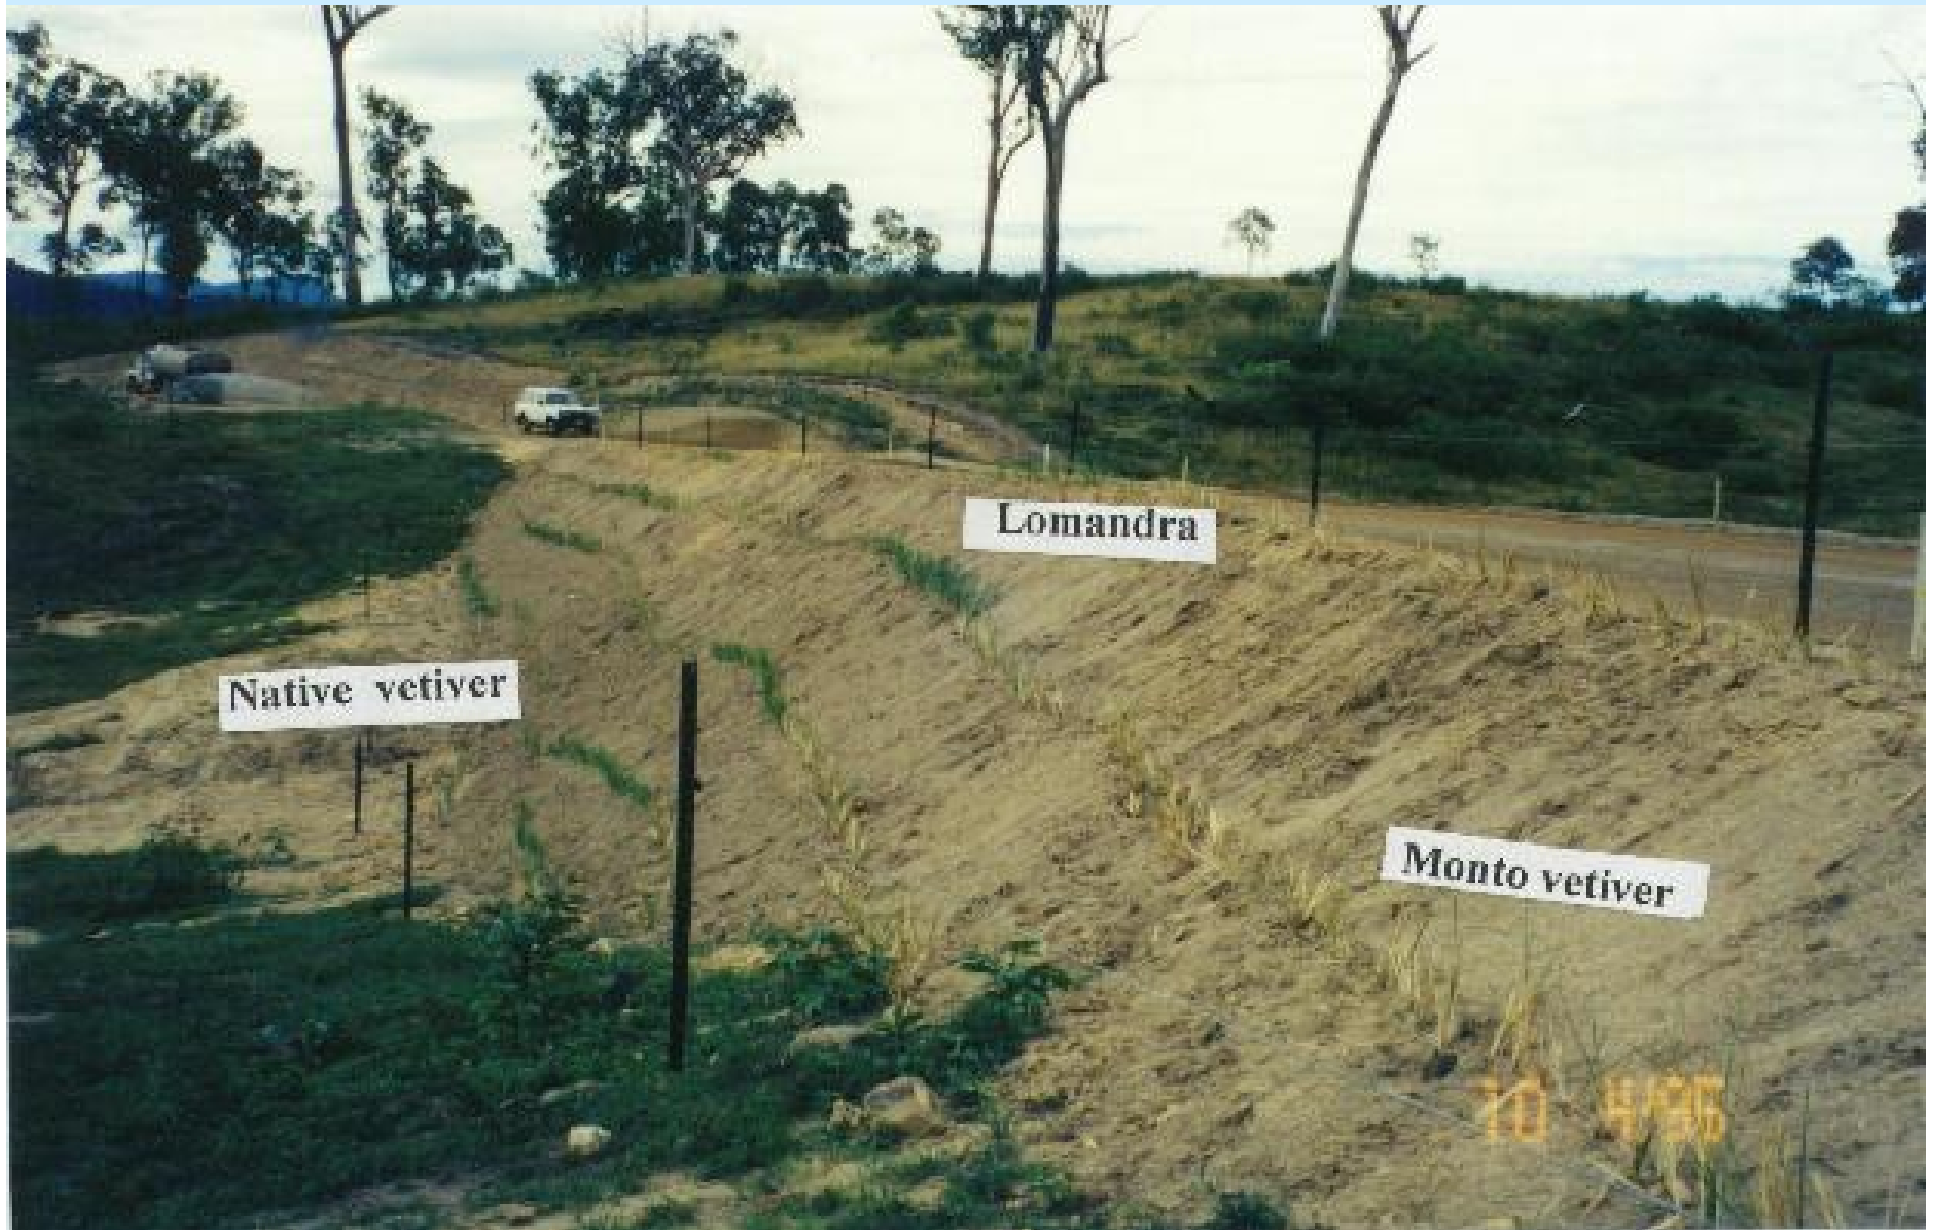
Australian trial on a fill batter

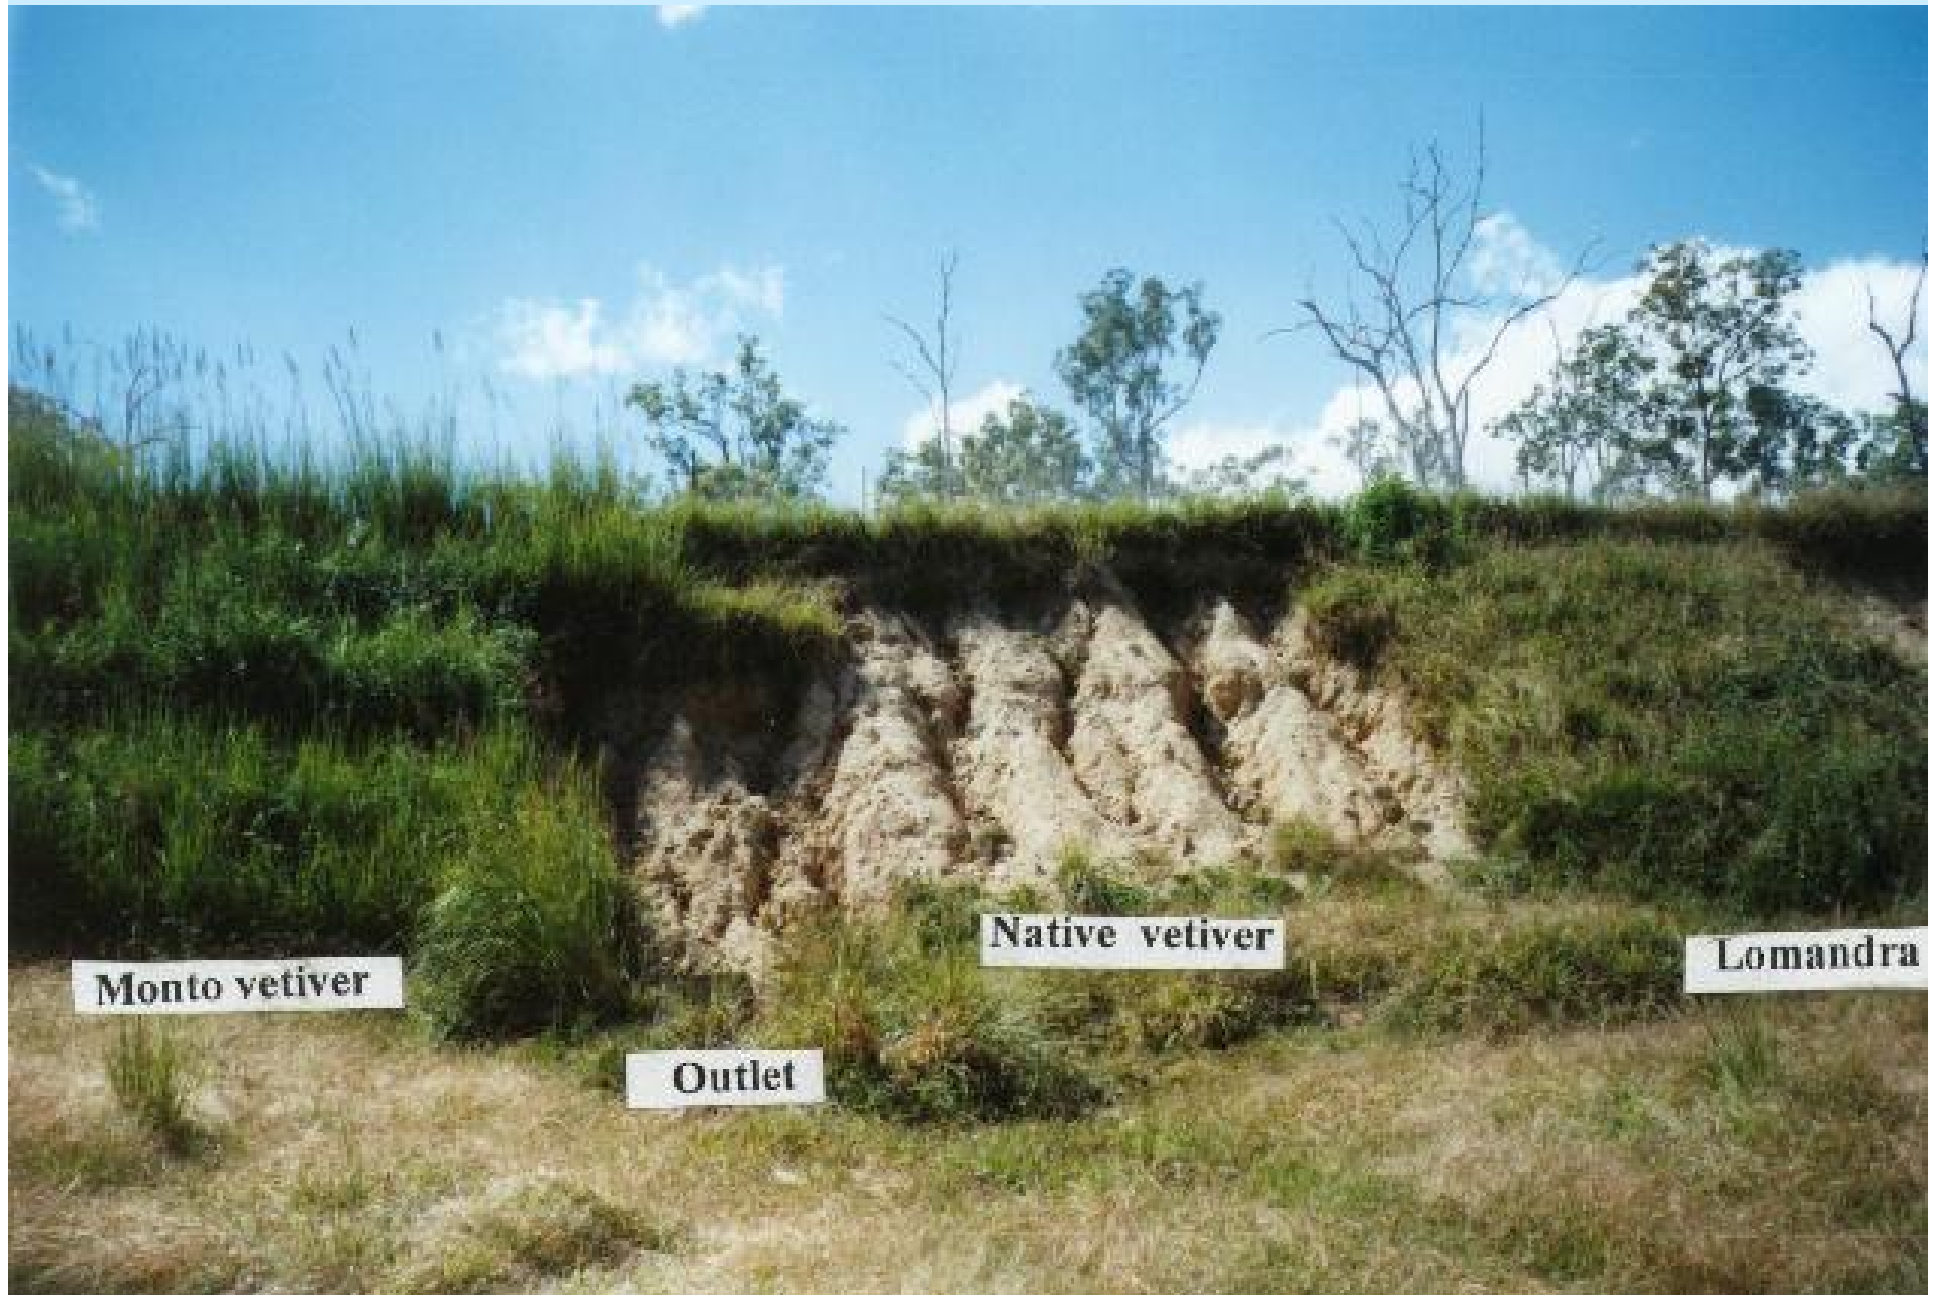
After 400mm of rain in 10 days

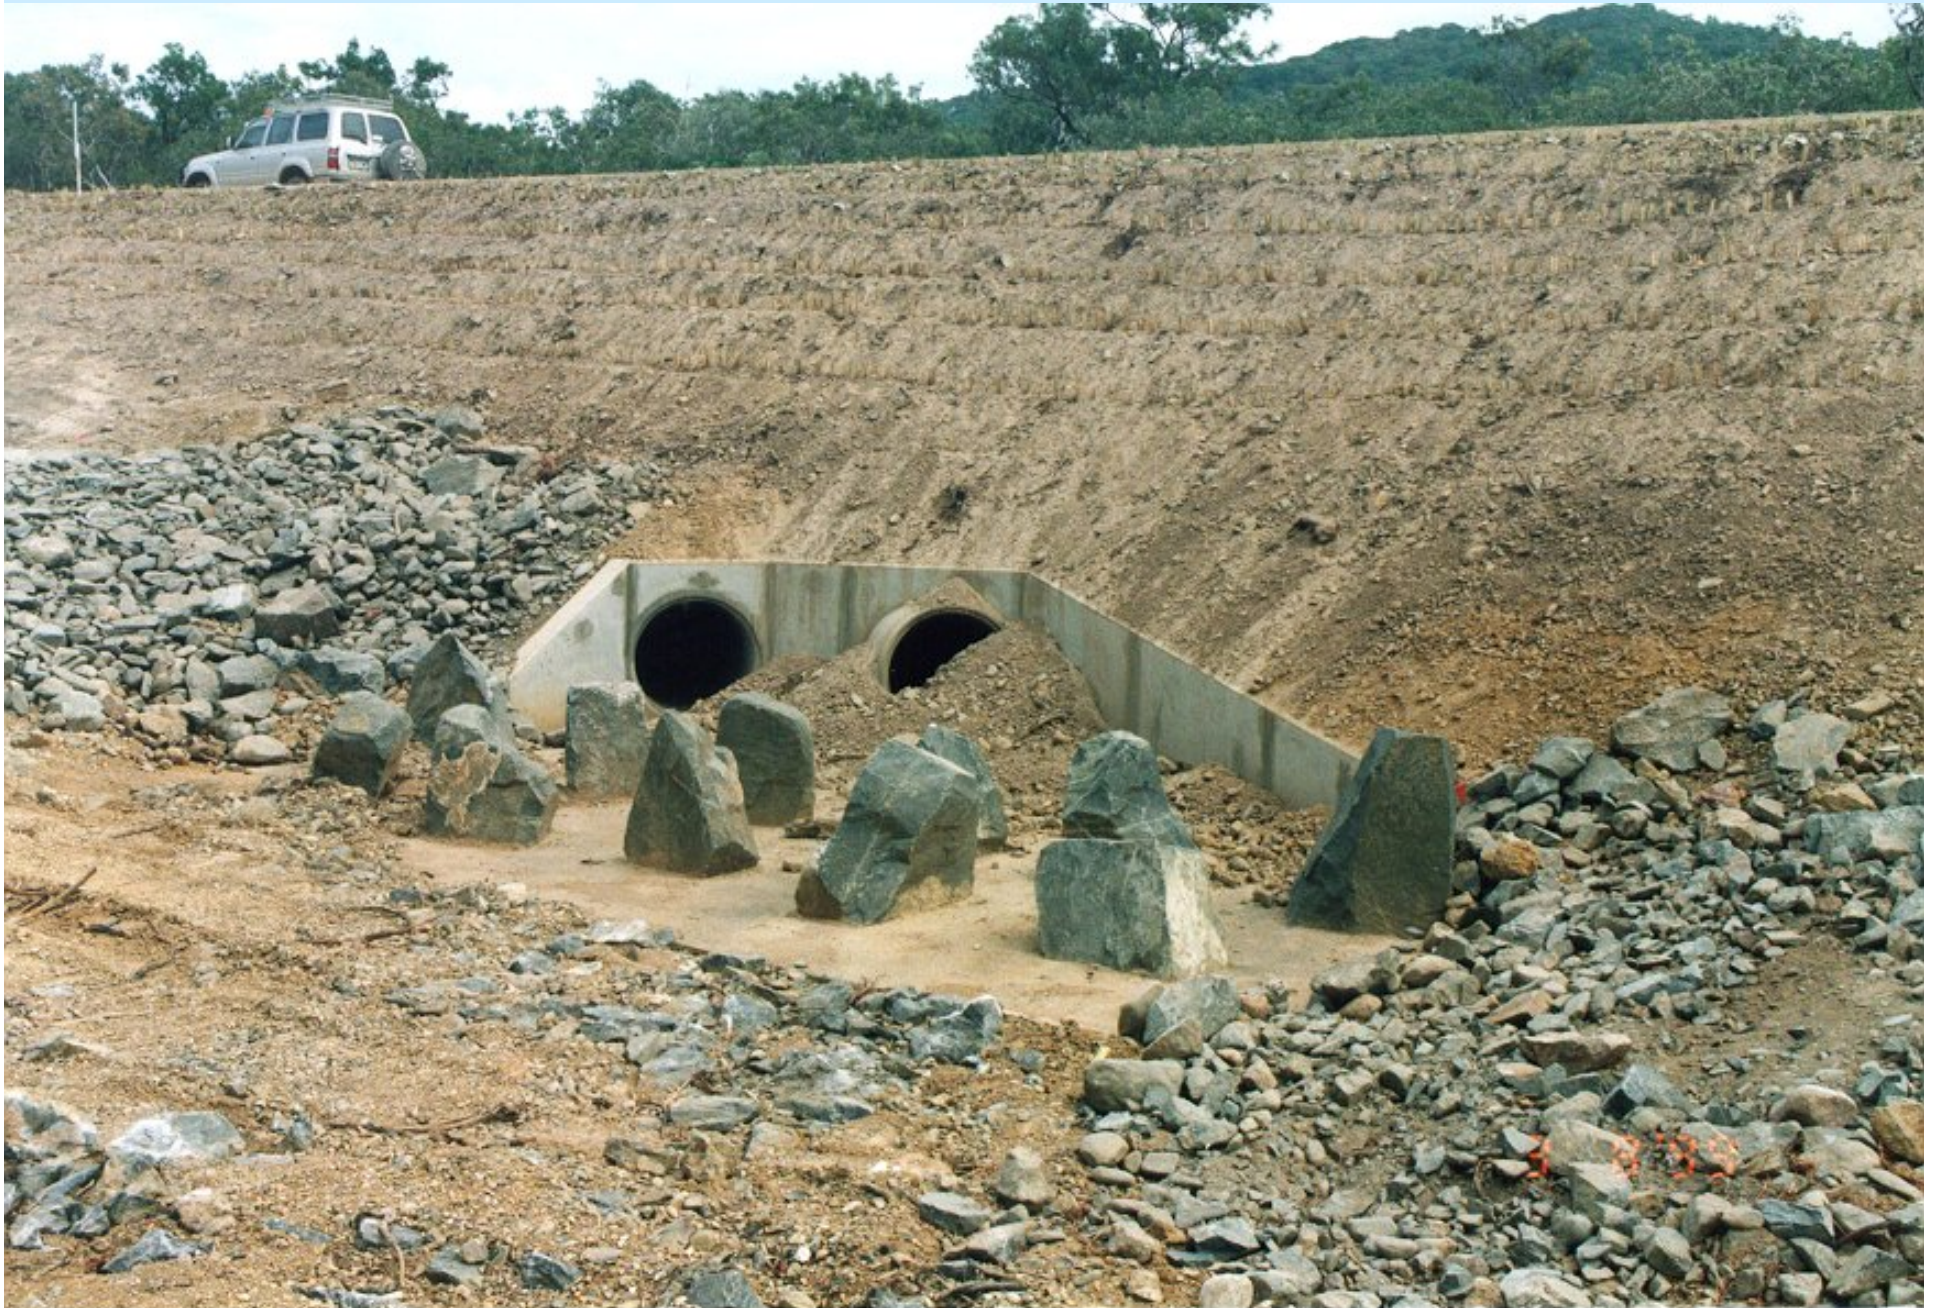
Steep batter protected by vetiver hedges

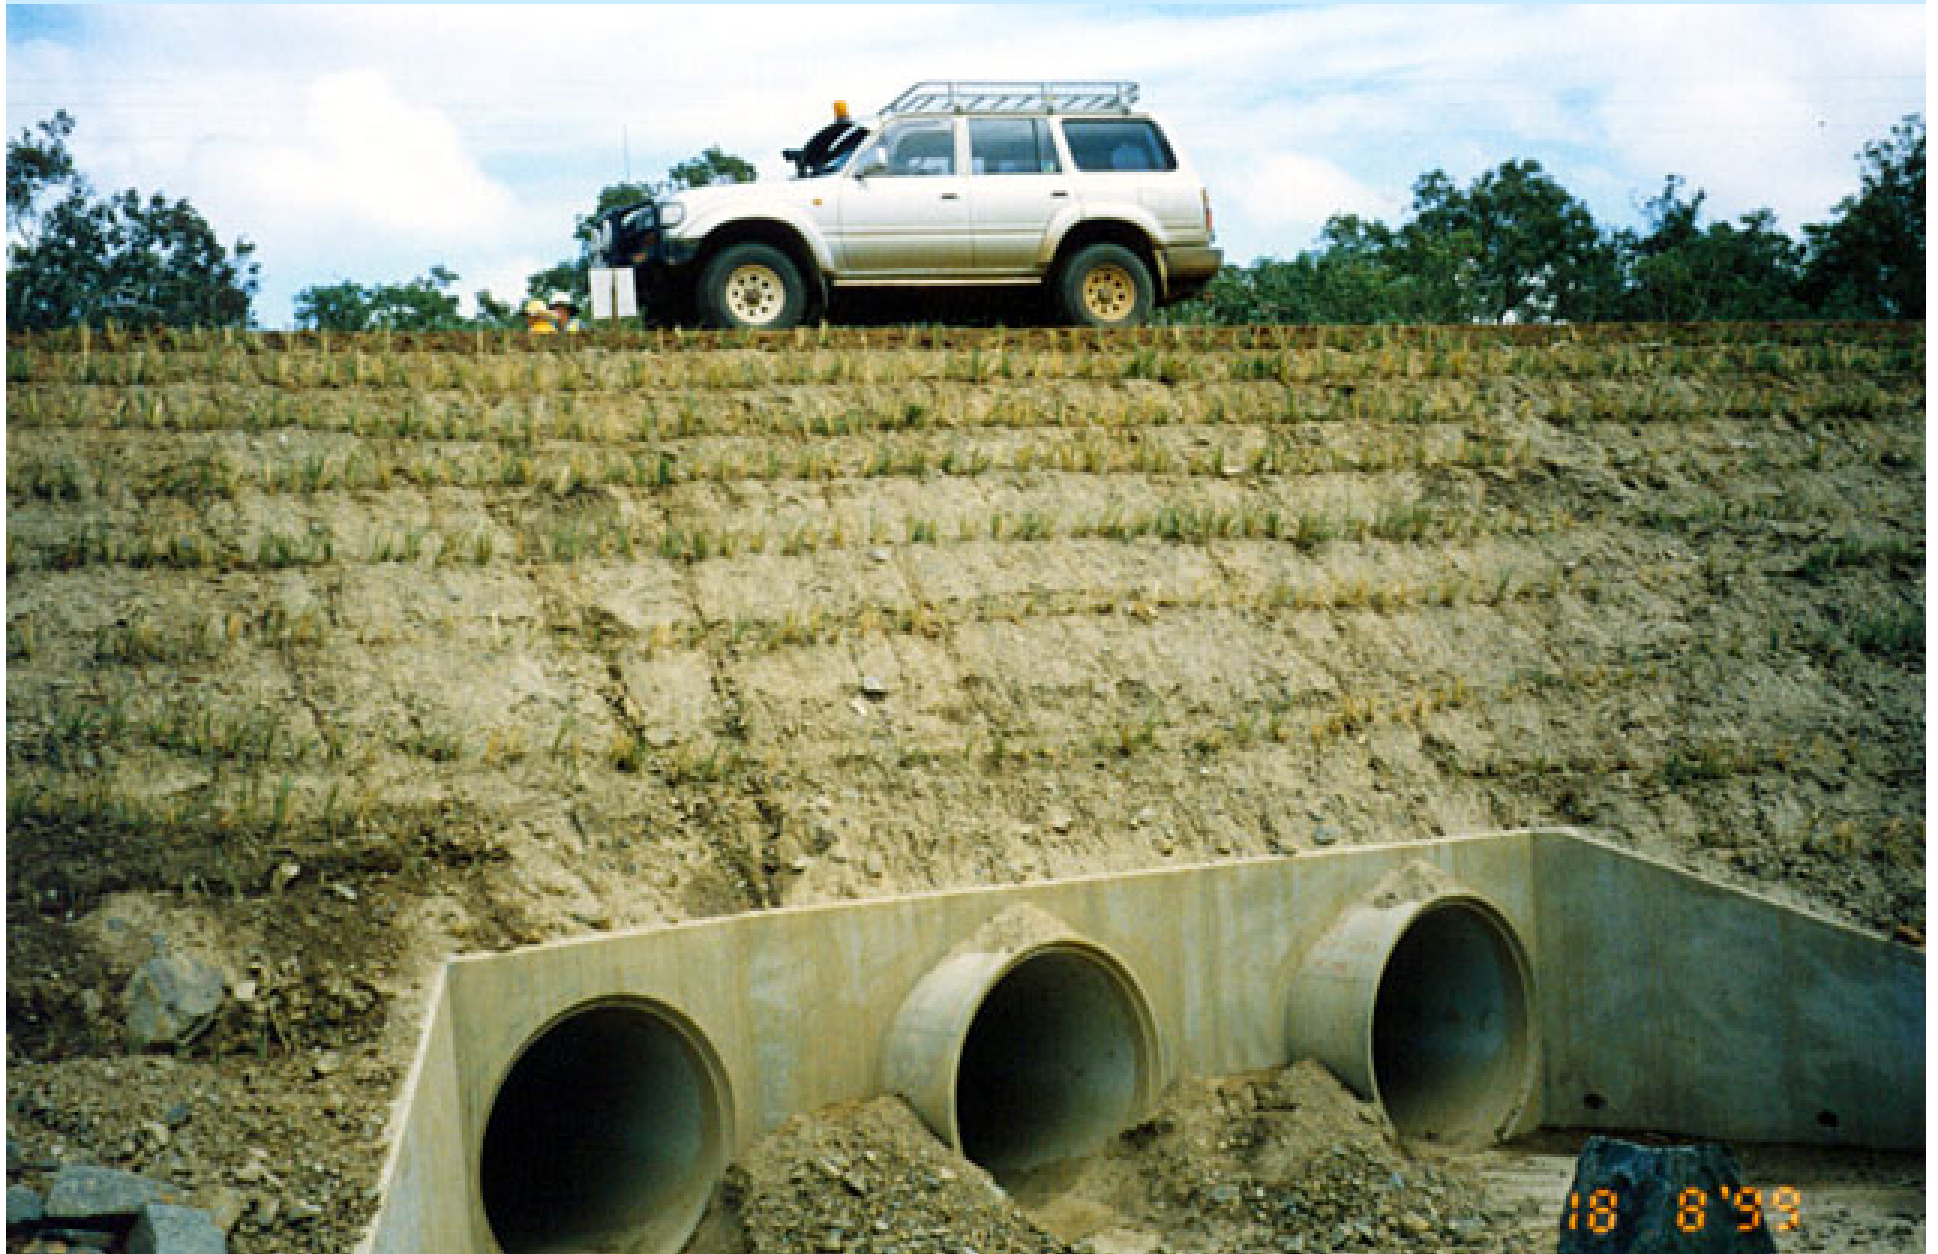
Close up view of steep batter protected by vetiver hedges

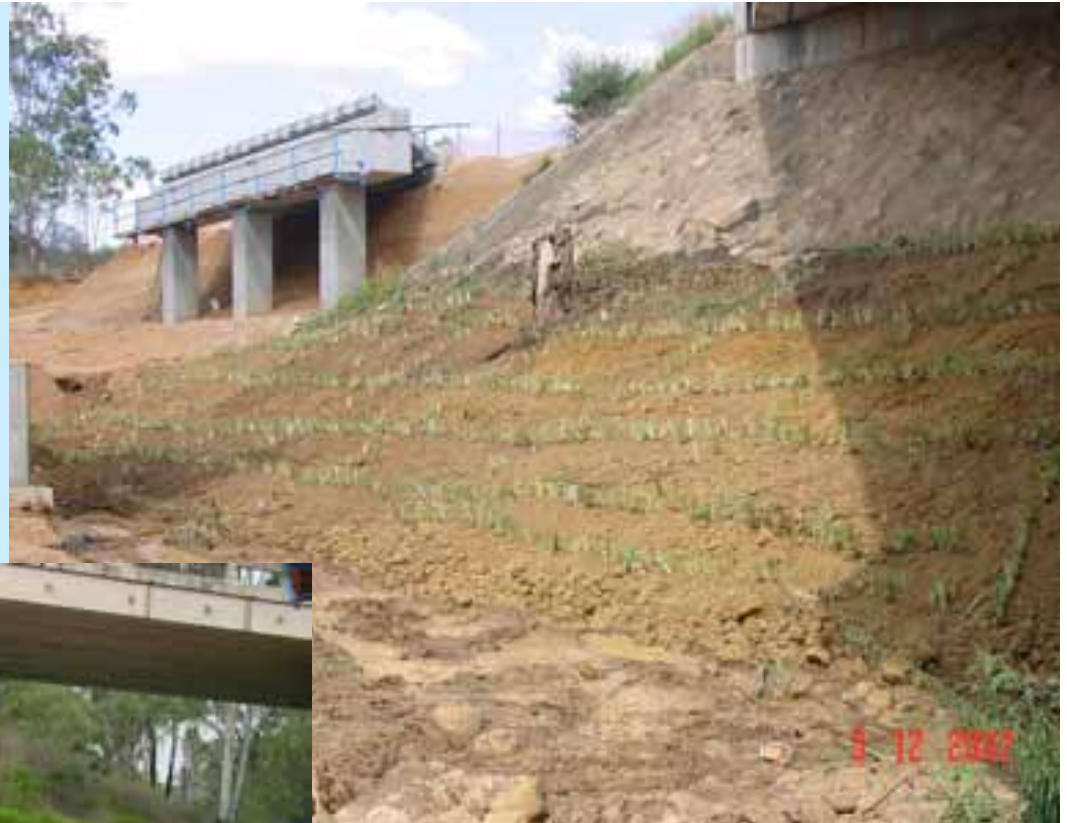
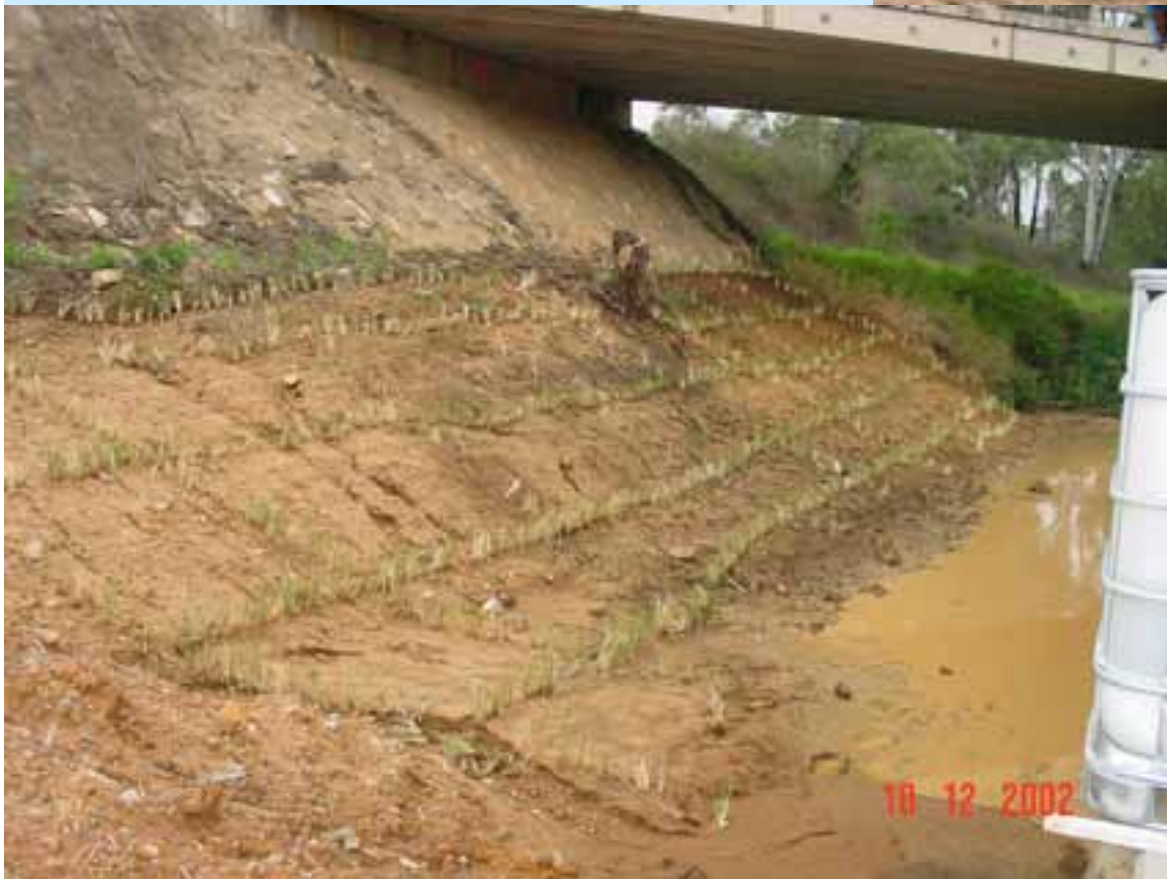
Bridge abutment stabilisation

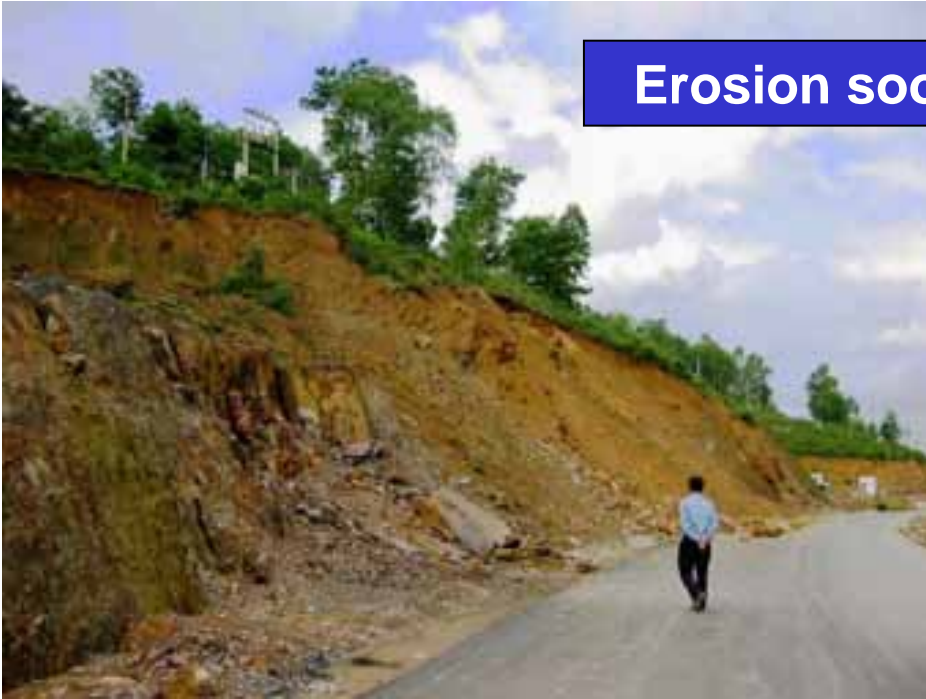
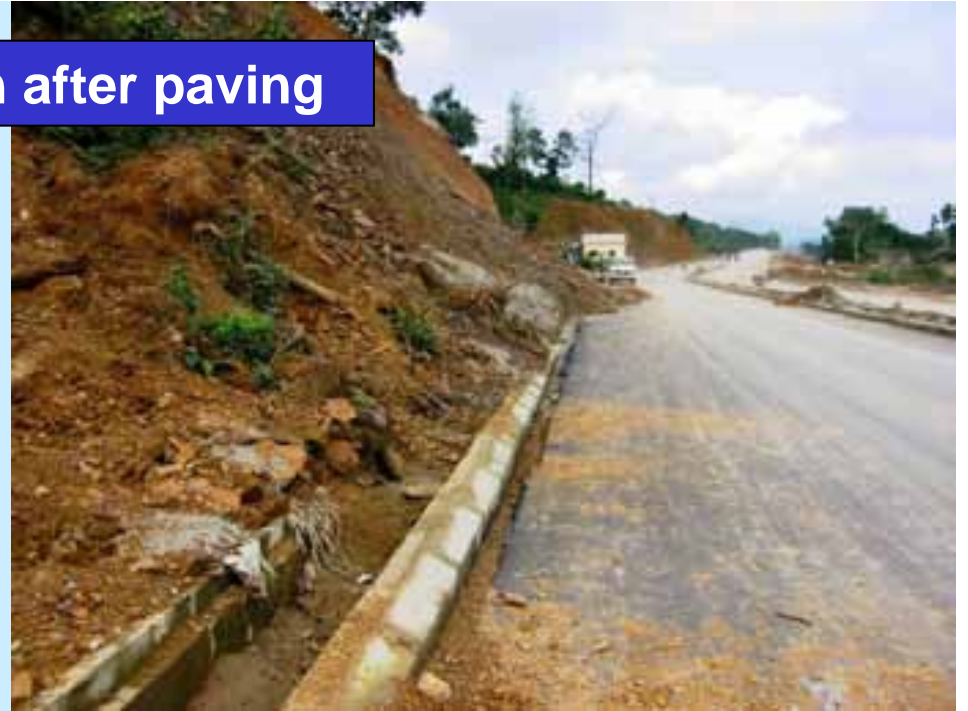
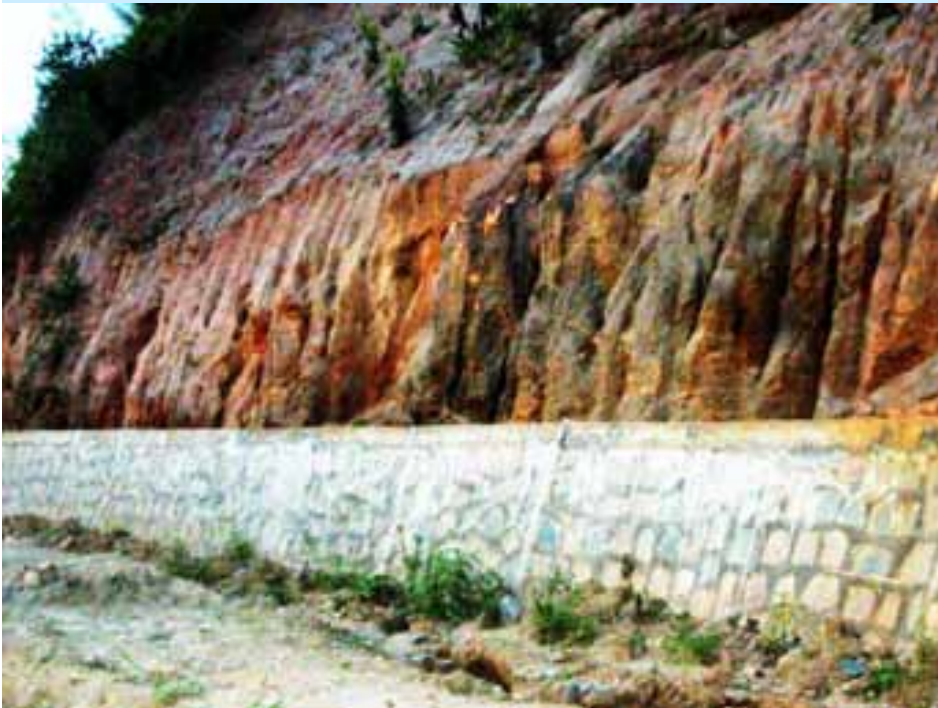
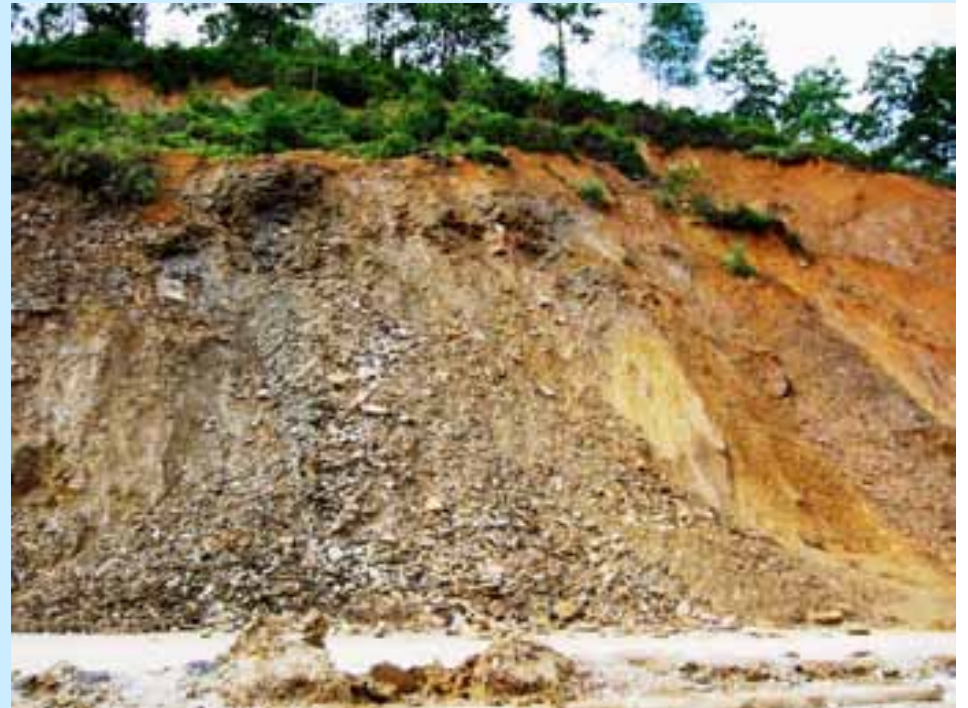
Erosion soon after paving
