**Vetiver System for Erosion and Sediment Control,
and Stabilisation of Steep Slopes**
**(With special references to the Ho Chi Minh Highway,
Vietnam)**

Paul Truong

**Director, The Vetiver Network International,
Veticon Consulting, Brisbane, Australia.**

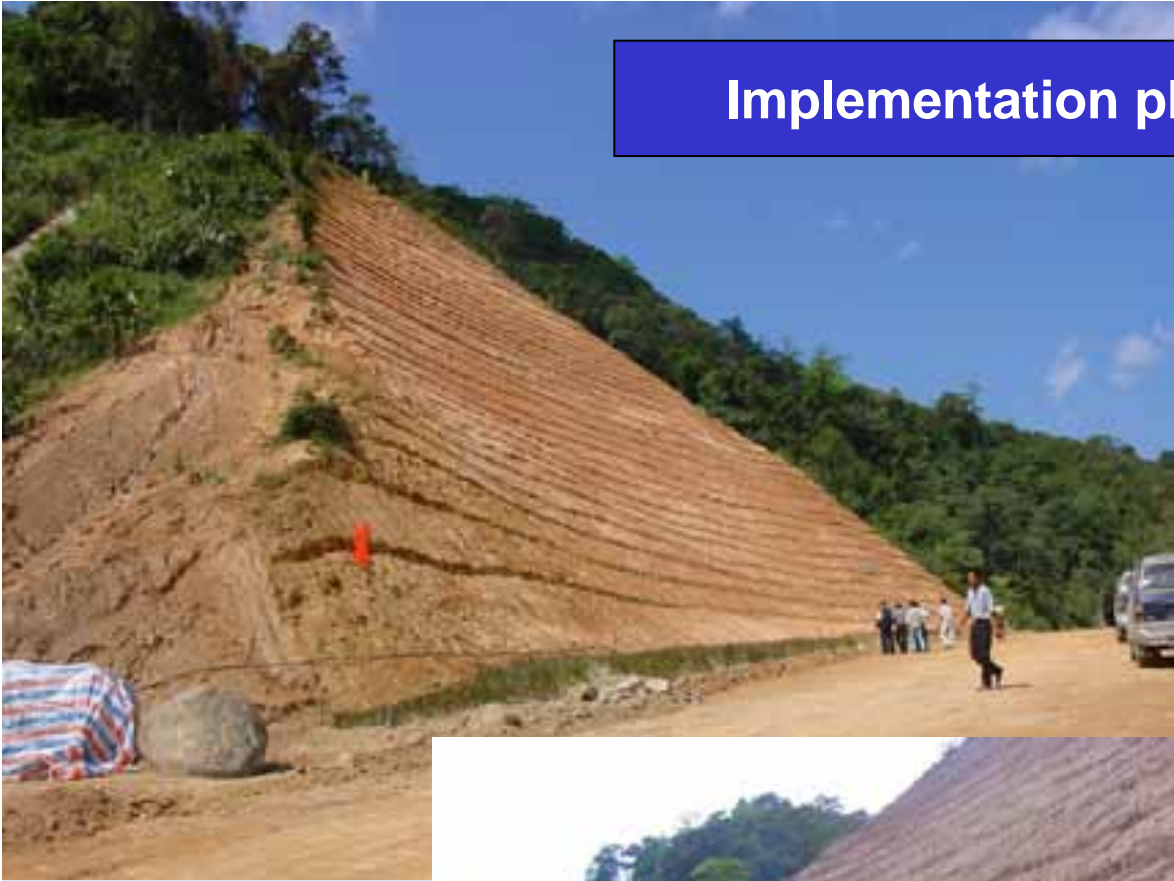
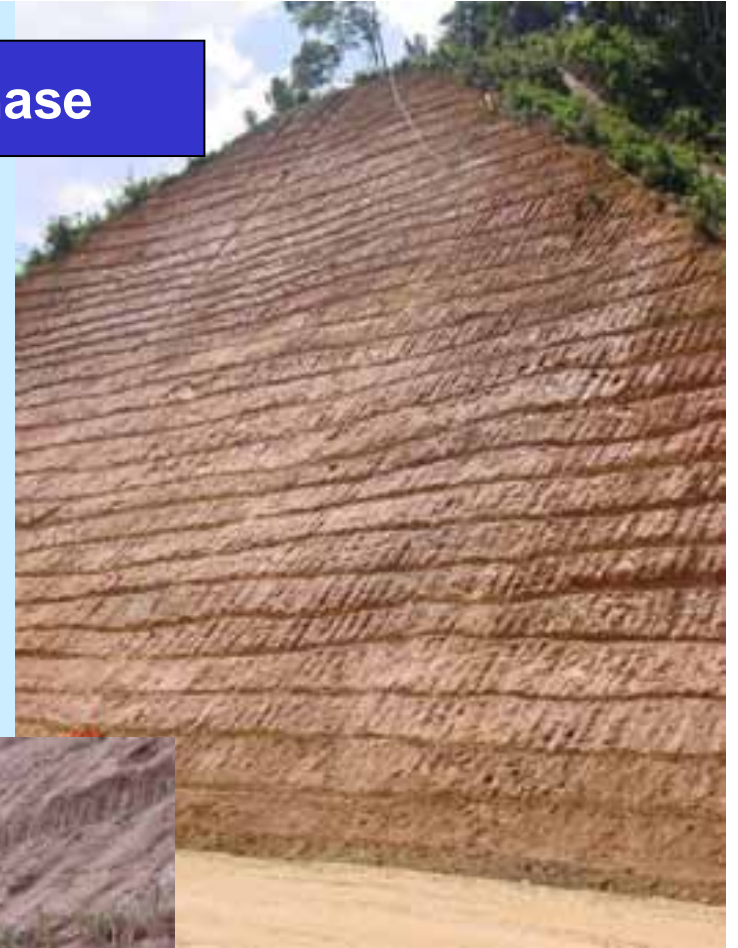
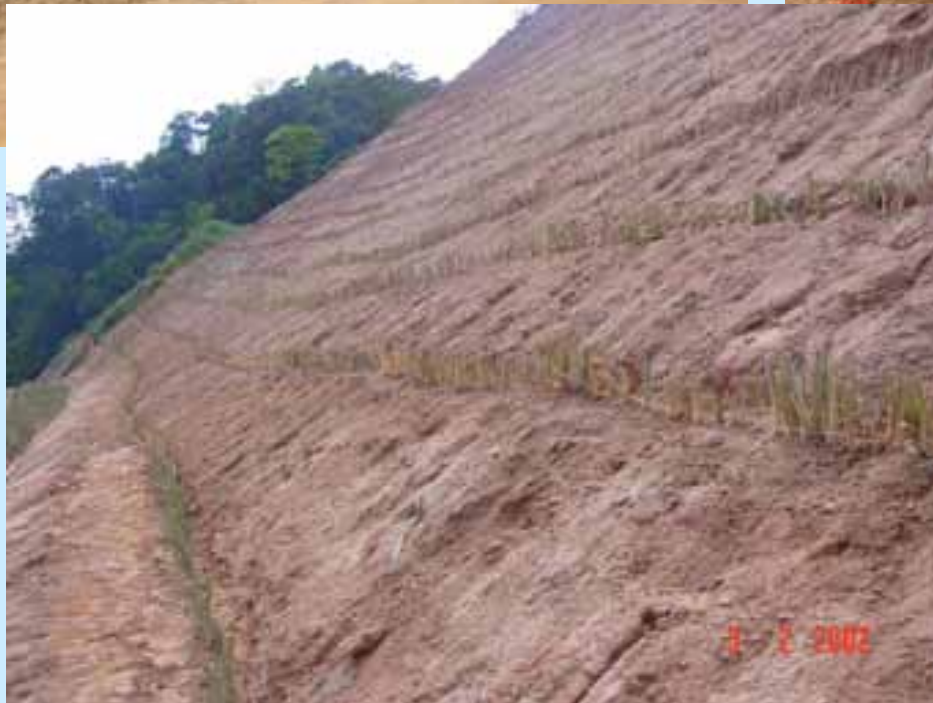
Implementation phase

**On a 1.5H:1V
gradient, 55m
high cut slope**
