VETIVER SYSTEM FOR ENVIRONMENTAL PROTECTION OF OPEN CUT BAUXITE MINING AT “LOS PIJIGUAOS” –VENEZUELA.

Keywords: Bauxite, phyto-technology, bioengineering, slope stabilization, erosion control, gullies

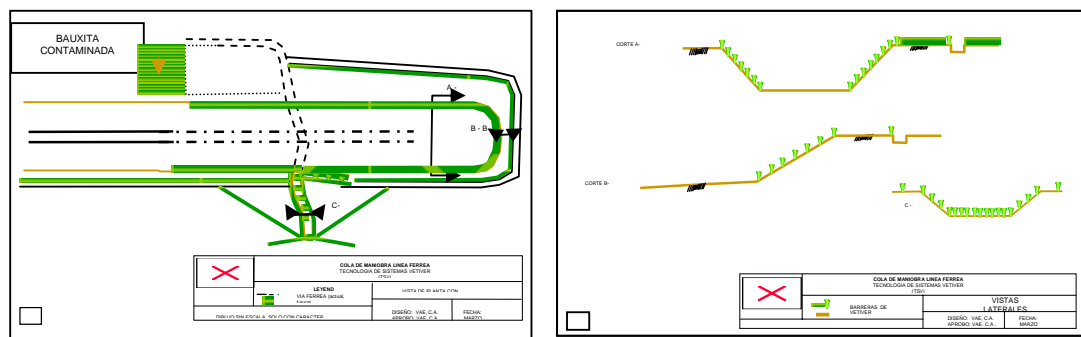
Fig 1: Design drawings

After doing an evaluation from the sites to recover, soil samples are taken for its analysis; there are observed factors like: ways of water presence in the area of the zone to treat, stability of the soil, slopes of the land and which will be the use of the barrier; with all this information is determined the Vertical Interval (VI) to apply, which generally is located between 0.80 m and 1.00 m. Subsequently proceeds to design the barriers (fig. 1)

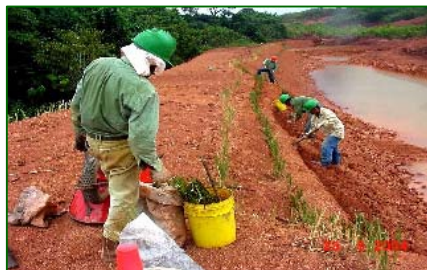
photo 1

With the sowed of vetiver plants (photo 1) the phenomenon of erosion in the slopes has been controlled; achieving besides to reinforce the structure of the dike, thanks to the net of roots which moor the ground. The barriers formed by their leaves offer an additional over elevation, due to they behave like a porous wall (photo 2) that allows the lagoon to release water through its crest, when rains of great dimensions fall; simultaneously they captures the sediments suspended in the waters that pass through them.

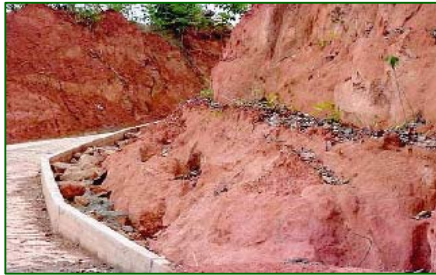
photo 3

One of the problems that commonly appears in engineering is the erosion of the transition areas between the concrete and the ground; very particularly in the zones by which the rainwater drains (photo 3). The VS was applied in curbstones of a hard pending road of 1.200 m that leads to “the adduction”. Although the road was in its first year, in some sites the curbstone presented deep furrows; even though as prevention a poor concrete mantle had been applied, the action of waters continued eroding and the damage in the referred zone persisted before the planting.

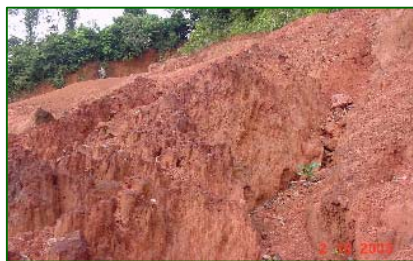
photo 5

During the previous evaluation in April 2.003 (summer), the road to the adduction was recently constructed so the conformation of the slope was homogenous. In October 2.003, when the planting began (final of rains) furrows of important size had formed in the three slopes and began to appear some gullies (photo 5). The land was manually conformed. It was necessary to work moored, like in rappel (photo 6). Subsequent to planting, the growth of the plants was relatively fast.

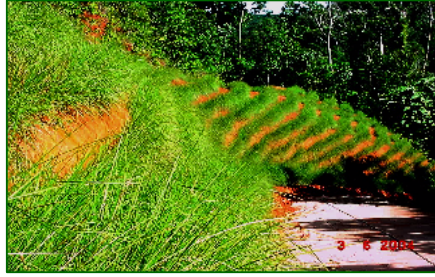
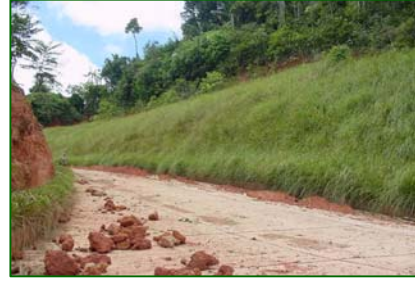
The slope is stable and the barriers are strongly developed (photos 7 and 8). Additionally the presence of pioneering vegetal species for the recovery of the original forest has been observed in it.

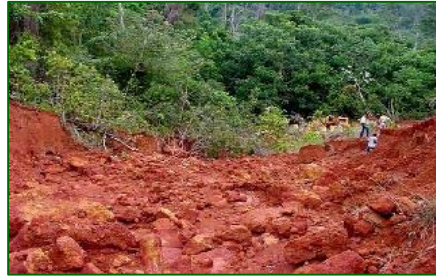
photo 9

This was a gully of 95 meters in length, (photo 9) formed by vertical walls with unevennesses up to -5,00 m, that reached up to 15,90 m wide. It had been repaired in diverse occasions but also continue failing; later a torrent flood of concrete was constructed to lead waters, nevertheless, the visual contamination and the risk that which waters looked for their previous course continued.

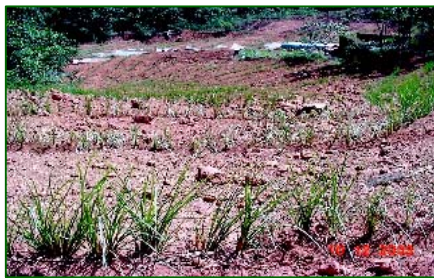
photo 10

For the application of the VS a machine conformation of the land was made, previous to the planting of vetiver (photo 10). Seed was made at the end of the cycle of rains and it limited the formation of the barriers in its totality. Although irrigation workings were not made, and the summer in the region is strong; the plants of vetiver stayed in a latency state until the rains restart, five months later. In the 2.004 took place a reseed in some failed points; in that occasion all the plants grew vigorous (foto 11).

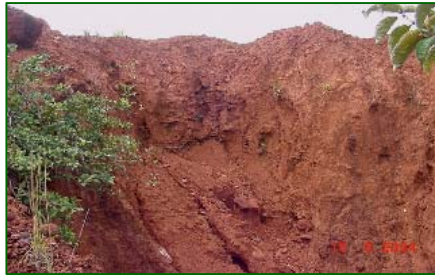
photo 12

- One of 15 mts of depth with an inclination of 80° (photo 12). Formed by the rupture of the dock of a sedimentation lagoon that was constructed near a depression, according to previously used criteria today discarded. It was required to seed by points, that is to say, it was not possible to open ditches due to the instability of the land (photo 13). During the phase of establishment of the plants three focused slidings happened, caused by the rains. These were reseeds in each occasion. At the moment the recovery is total.

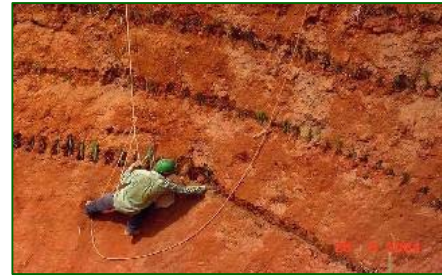
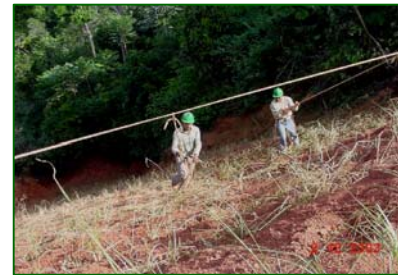
In the execution of both cases, the workers moor themselves using technical similar to rappel (photos 13 and 15).

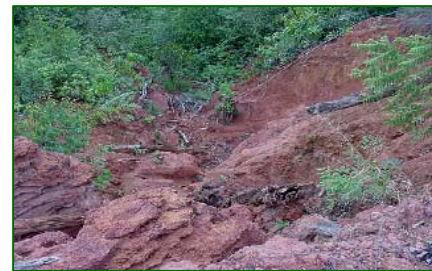
photo 14

- The other had a depression of approximately 40 m of depth and an inclination of 60° (photo 14). Of a similar origin to the previous one, it was modified by the action of works made in the lagoon that produced it. The overturning of the material formed a very unstable slope caused by filling without compacting; to it was added the filtration of the lagoon through the inferior part of the slope; all these elements were conjugated so a sliding happened after to have seeded. The works of repair were undertaken the following year. Today it is stable and also there is presence of other pioneering vegetal species.

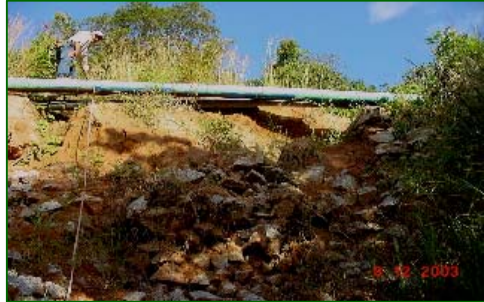
photo 16

At km 4 of the road that leads to the mine happened a sliding that considerably deteriorated a stone wall that was in the area, leaving in addition without support a pipe section that leads potable water to the residential camping (photo 16). The security's department of Bauxilum declared an emergency in front of the possible rupture of this pipe which represented a double risk:

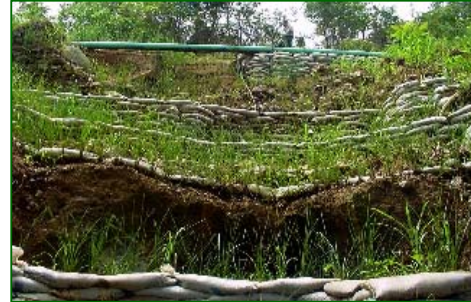
photo 17

Two options were considered to solve this situation; the first was to construct a tightened screen. The other however, was to build terraces with the accustomed soil-cement walls and to anchor them with barriers of vetiver. Last one was adopted and the project required only of a month for its execution (photo 17). The other proposed design was rejected as engineering solution by slow and expensive.

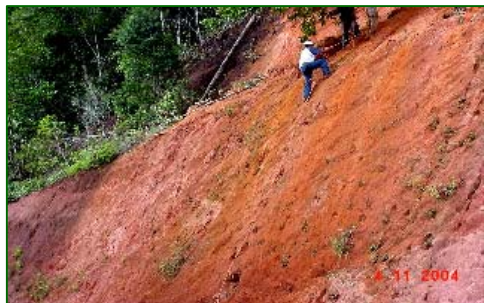
photo 18

In km 10 from the route to the mine two slidings took place in slopes of cut with a high of 15 m and 25 m respectively, and an inclination of 75° (photo 18). The slopes are located in the East face of the mountain; across (at the West) a leafy vegetation exists; this situation restricts the incidence of light in the zone to few hours of the day.

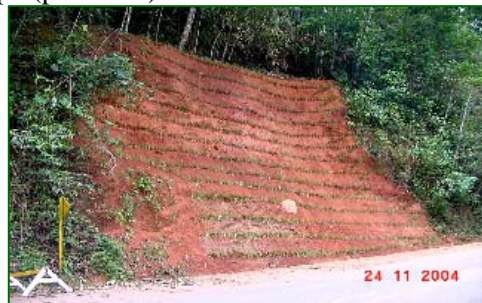
photo 19

The growth and development of the plants were very poor due to the little incidence of solar light, to the point that at the date, two years later, the presence of them is hardly noticed. Nevertheless the slope stays stable; perhaps by the absence of the waters that were turned aside to another slope (photo 19).

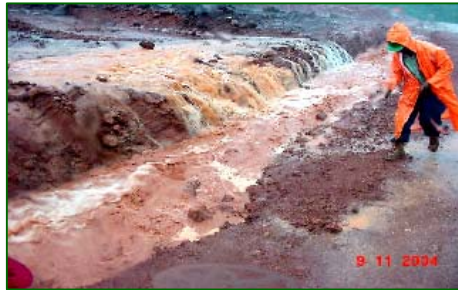
photo 20

Due to the strong currents that moves through those drainages (photo 20), sometimes is required to install provisional barriers with sand bags, rocks or wood, previous to the vetiver planting to avoid that the plants be dragged before they root in the ground. In other cases we have worked with barriers preformed in the nursery anchoring them with the use of steel treenails and mooring them strongly.

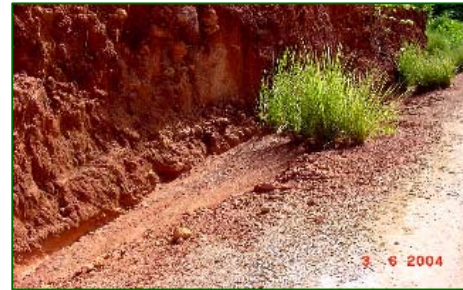
photo 21

The establishment of barriers of vetiver as sediment filter not only has fulfilled that intention but also the process of erosion when filling up has reverted and to form terraces in the located areas above waters (photo 21).

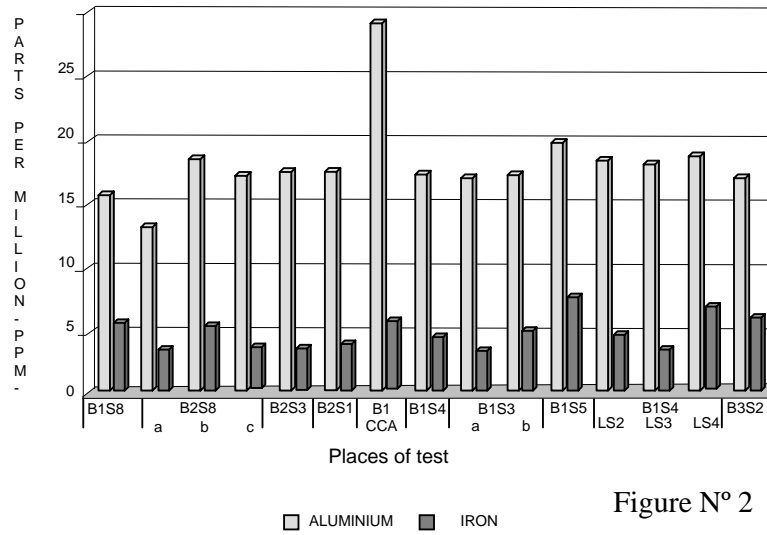
Figure N° 2

The table N° 1 gathers the values obtained in the samples of ground; whereas in the figure N° 2 the graphical comparison of these results settles down.

PRESENT IRON AND ALUMINUM IN THE GROUND

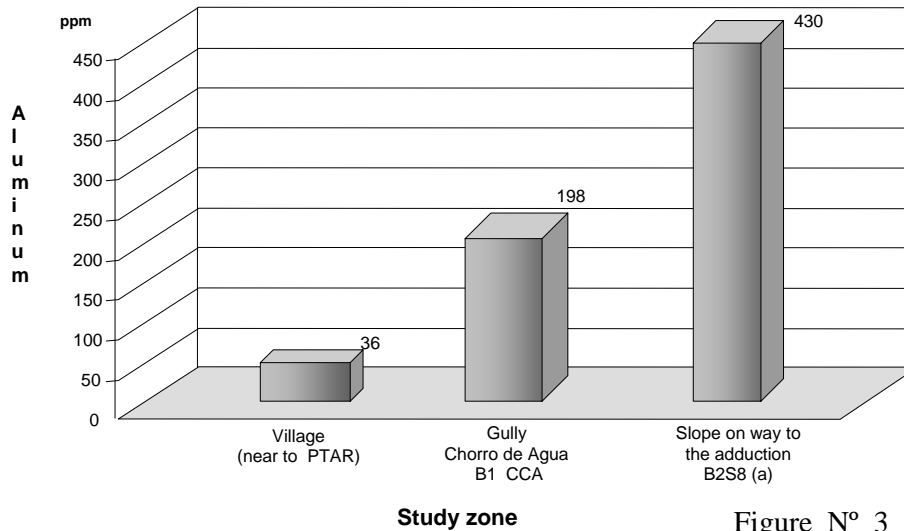
Figure N° 3

On the other hand, the table N° 2 shows the aluminum levels contained in the leaves of the sampled plants, which are compared graphically in figure N° 3.

ALUMINUM ABSORPTION IN VETIVER PLANTS (LEAVES)

- From the samples obtained to determine the aluminum content present in the plant, were obtained the biggest results (values) in the plants established in the slope of the route to the adduction of the mine (B2S8a), presenting 430 ppm of accumulated aluminum 34 months after the planting. Next, appear values of 198 ppm in the plants established in the gully of the stream “Chorro de Agua” (water spurt) (B1 CCA), with a time of planting of 26 months. Both groups of plants established in the areas in recovery process.
The lowest values of 36 ppm correspond with the species established in the proximities of Served Waters Treatment Plant (PTAR by its acronym in Spanish) that is located in the Populated Center; and therefore they are not associated neither to the process of operation of the bauxite mineral, nor to grounds derived from this type of mineral.

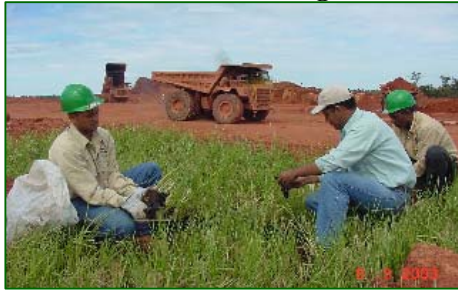
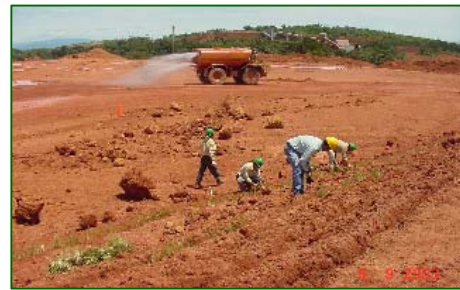
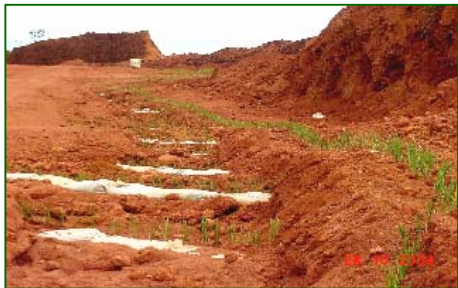
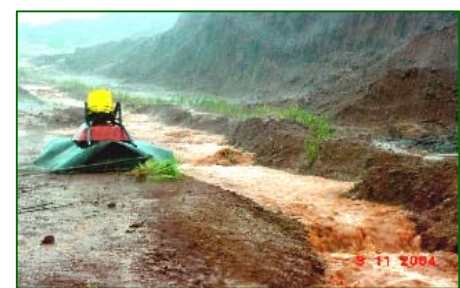
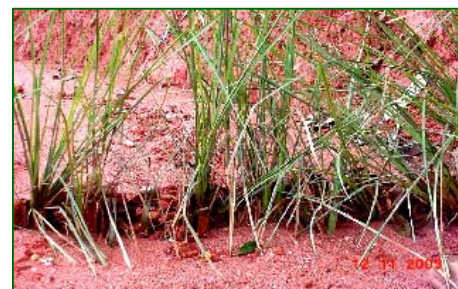
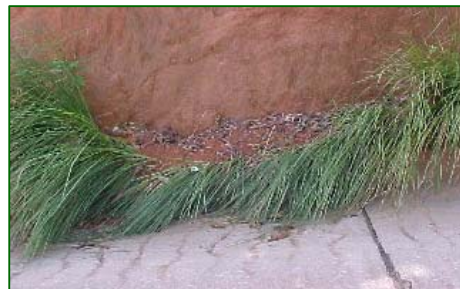
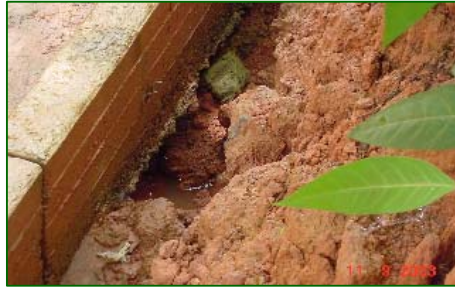
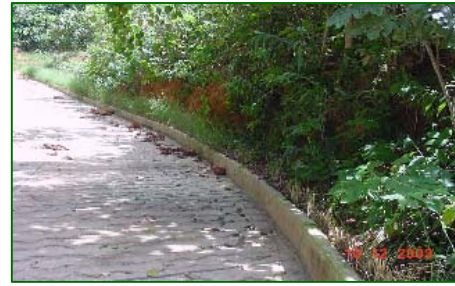
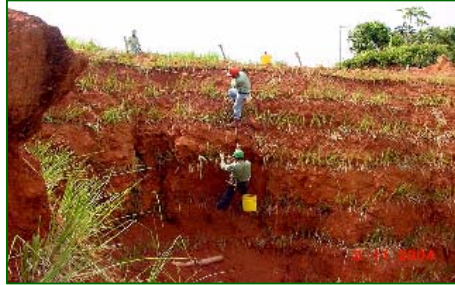
Preparation and planting of vetiver in a lagoon border, near to the deposit patio of bauxite (photos 24 and 25). Barriers provisionally installed, while vetiver consolidates (photo 26). Rain fell 2 weeks after seeding in the roadside ditch (photo 27). Sediments retained by barriers in formation (photo 28) and established (photo 29). Erosion in curbstones before the planting (photo 30). Effect of the shade in the growth of the plants (foto31). Repairing damages caused by the rain in one gully during the establishment phase (photo 32). Our human equipment (photo 33)
