COMMUNITY MOBILIZATION FOR THE CONTROL OF RAVINE EROSION WITH VETIVER TECHNOLOGY IN THE CONGO

A. Ndong¹ and P. Truong²

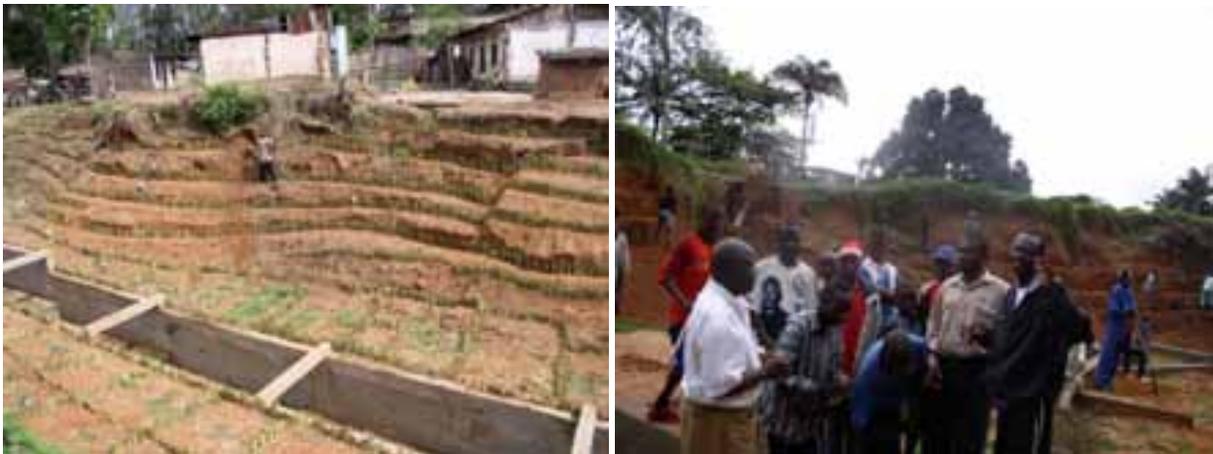
Photo 1: Property threatened and community concerns and participation

The erosion problem in the town of Kikwit mostly affects the local population who are the first victims. To realize the objectives of this project, notably to show the local population new anti-erosion techniques with the *Vetiver Zizanioides*, it was necessary to first mobilize the local community in order to implicate them directly in this endeavor (Photo 1)

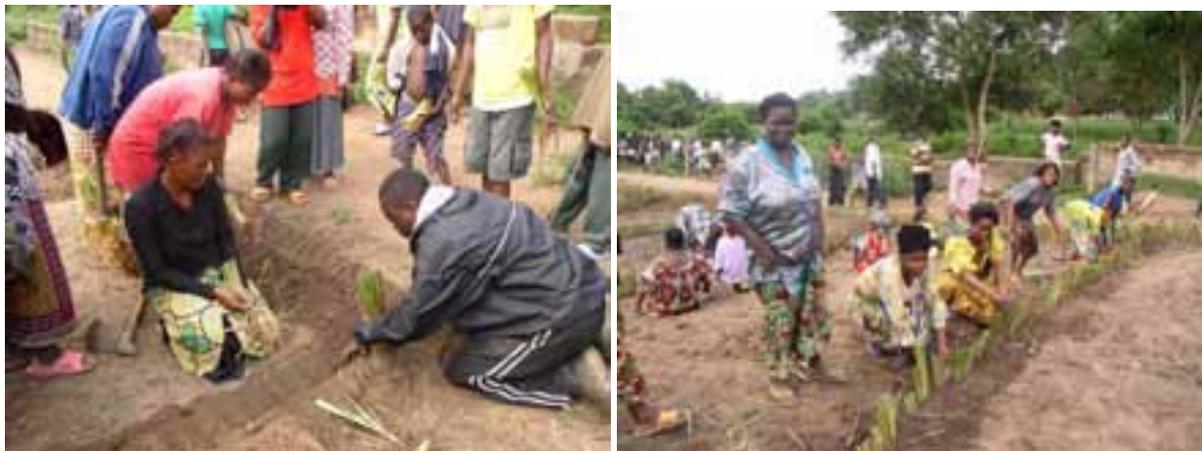
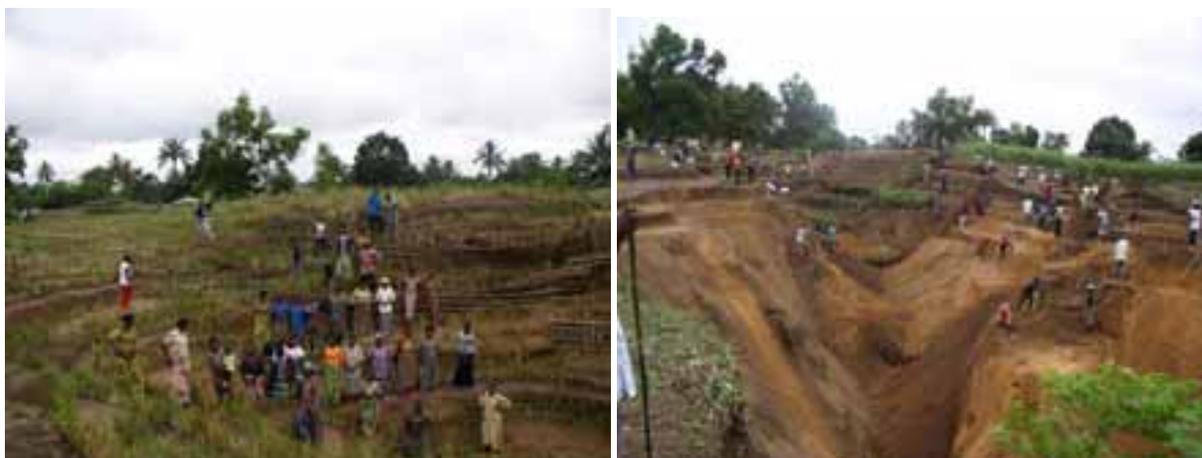
Photo 2: Community support and participation through demonstration

months, from October 2004 until September 2005. Implicating the local community in multiplying vetiver had a double advantage; not only did it allowed the population to amass vegetative materials for their individual needs, it also offered them a new source of income through the sale of the vetiver shoots (Photo 2).

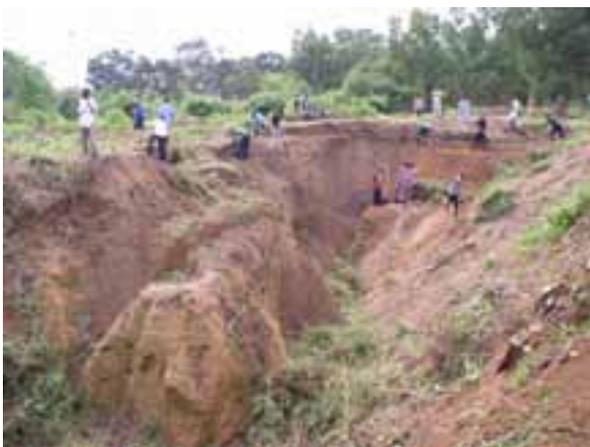
Photo 3: Ravine ITPKA before re-profiling

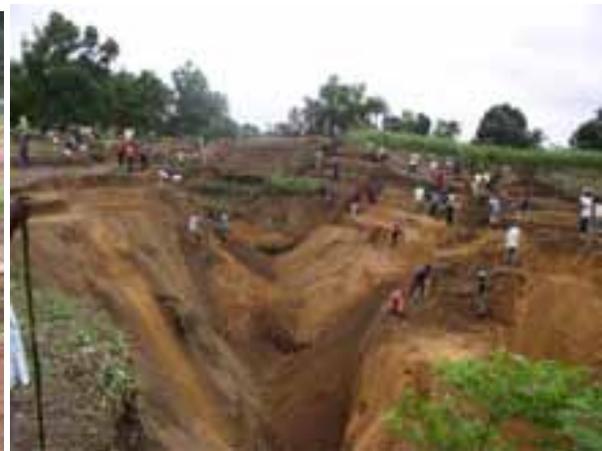
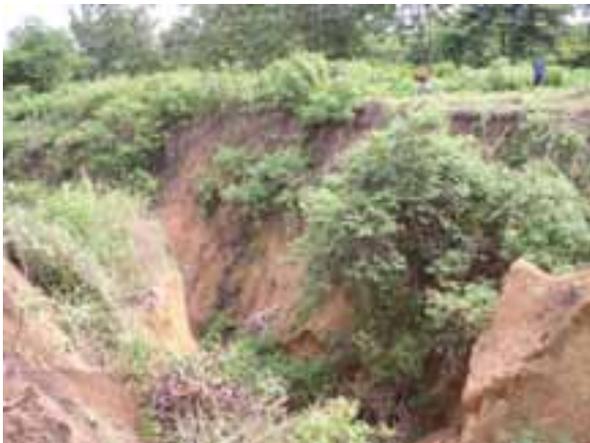
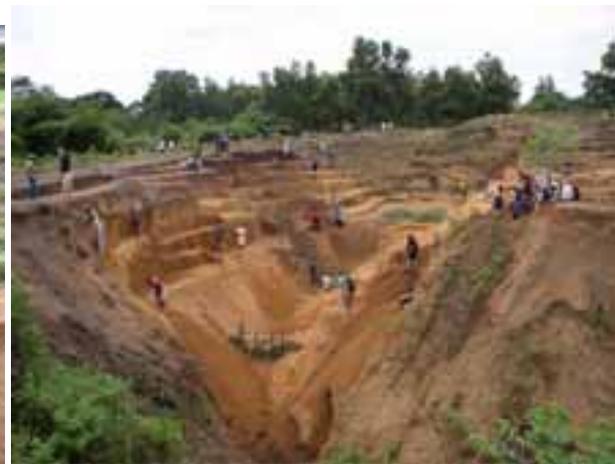
Re-profiling the slopes of ravine ITPKA

The slopes of a ravine are generally steep, very sharp and steeper than 45°. Under these conditions, the slopes are not stable and are often subject to landslides and collapse until reaching an equilibrium profile. It is therefore difficult and nearly impossible to plant a hedge of vetiver along contour lines in this case. Thus we established successive terracing along the slope to facilitate the planting and to create a more stable slope profile to prevent further collapses or landslides (Fig.1 and Photo 3).

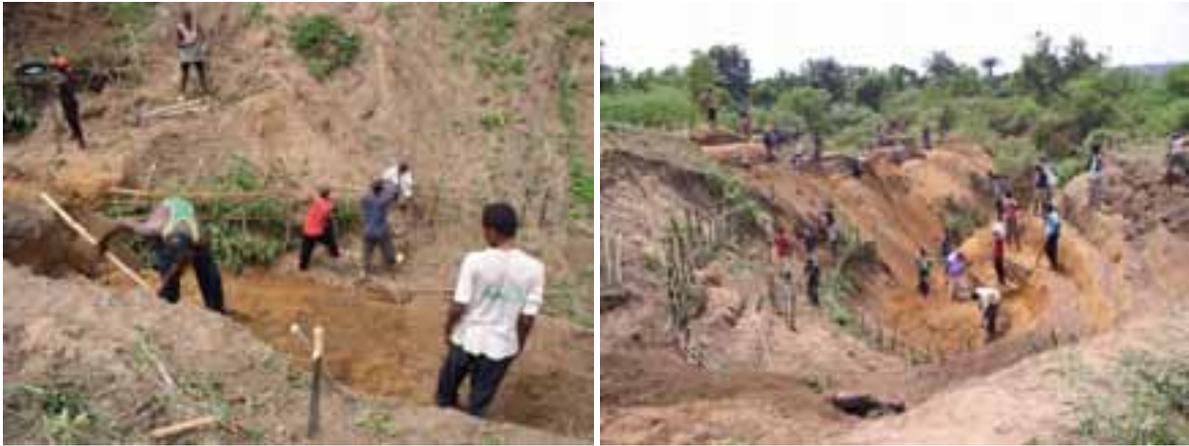
Photo 4: Retaining barriers built with tree branches

These terraces have variable height and width depending on soil texture. Cuts are easy to make on loam and sandy loam soils. Nevertheless, creating terraces on sandy soil is more difficult due to the fragility of the composition. Under these conditions, we place tree branches secured by sinking posts in places to secure particles of the fragile soil. Terraces of this type were generally 50 to 100 cm in width and height (Photo 4).

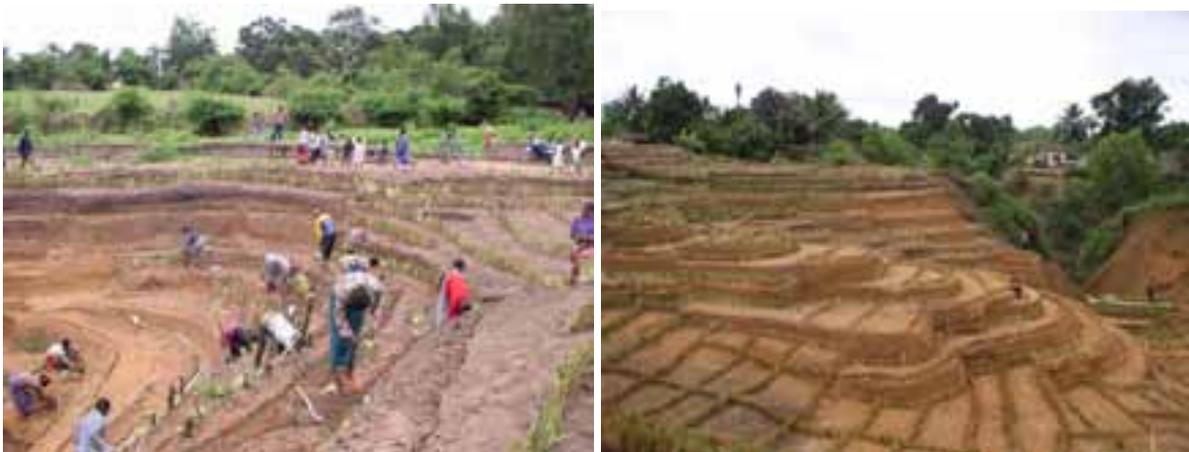
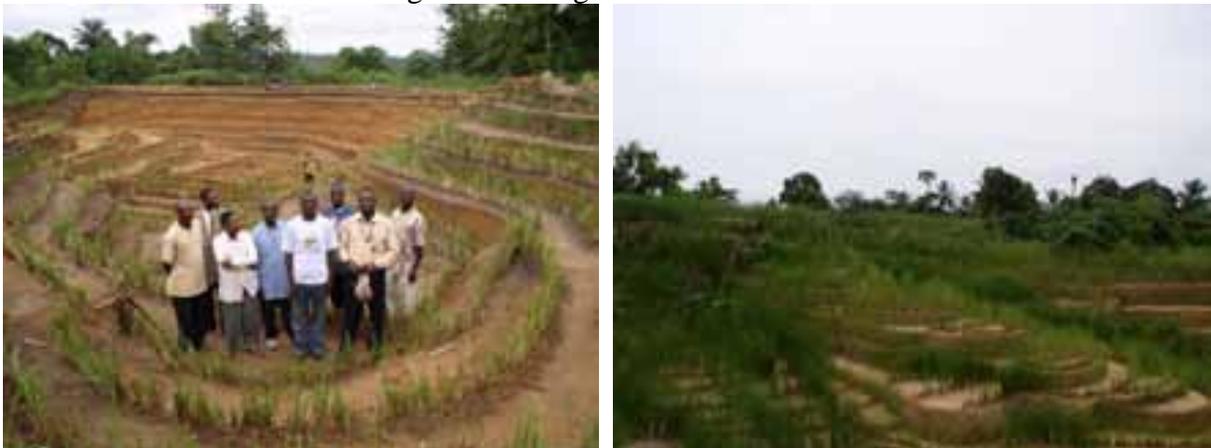
Photo 5: Planting vetiver hedges on contour lines on the terraces

The successive vetiver hedges were planted on terraces contour lines established during the re-profiling of the ravines. The distance between two hedgerows were set between 50-100cm and the splits (composed of three tillers) were planted 10 cm apart in order to quickly form a dense hedge (usually after a few months) (Photo 5).

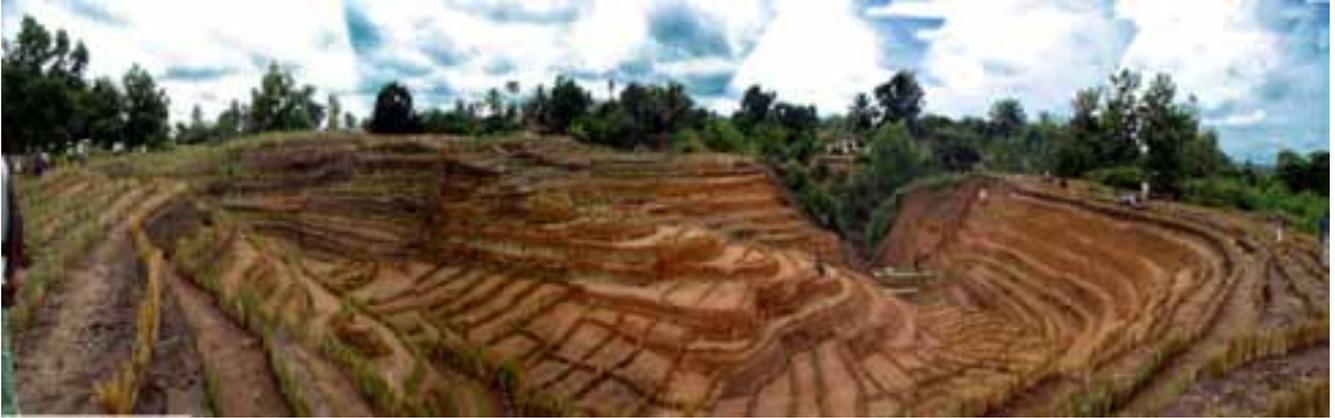
Photo 6: Panoramic view of the ITPK Ravine, showing Vetiver hedges along contour lines

The above table shows that re-profiling the ravine to plant vetiver permitted changing the slopes into terraces that could follow the contour lines. Vetiver was planted in successive hedgerows as illustrated in Photo 6.

At this stage, the vetiver plants could not yet develop because they needed a few days to adapt to their new environment. Therefore, one could not observe the forming of the dense hedgerows as they relate or depend on the level of development of the plants. On the other hand, the extension of the ravine heads and landslides had been stopped by the time the picture was taken, not because of the Vetiver, but mostly because of the re-profiling which gave the slopes a profile of equilibrium. The water retention basins also stopped the progress of the heads as they limited the water run-off on the ravine before the vetiver hedges had reached an optimum development height capable of stabilizing the site.

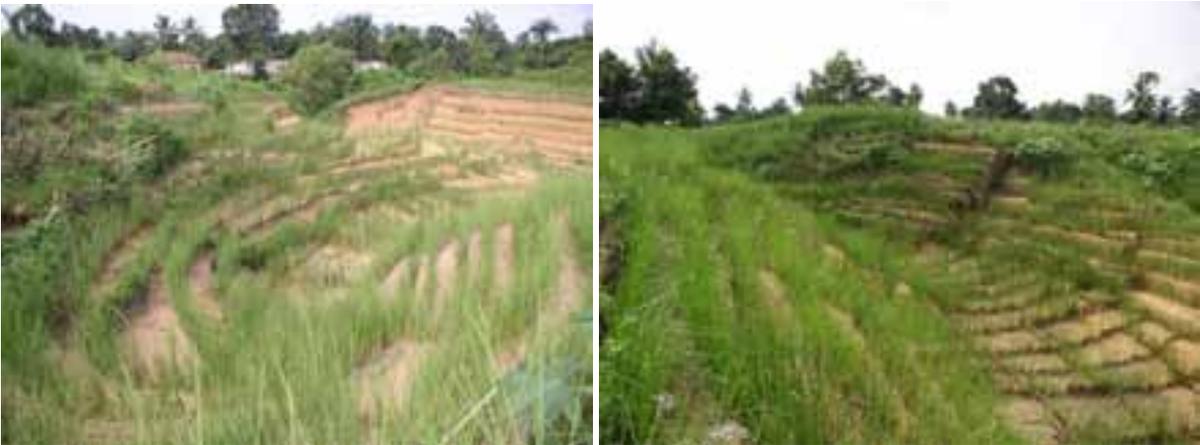
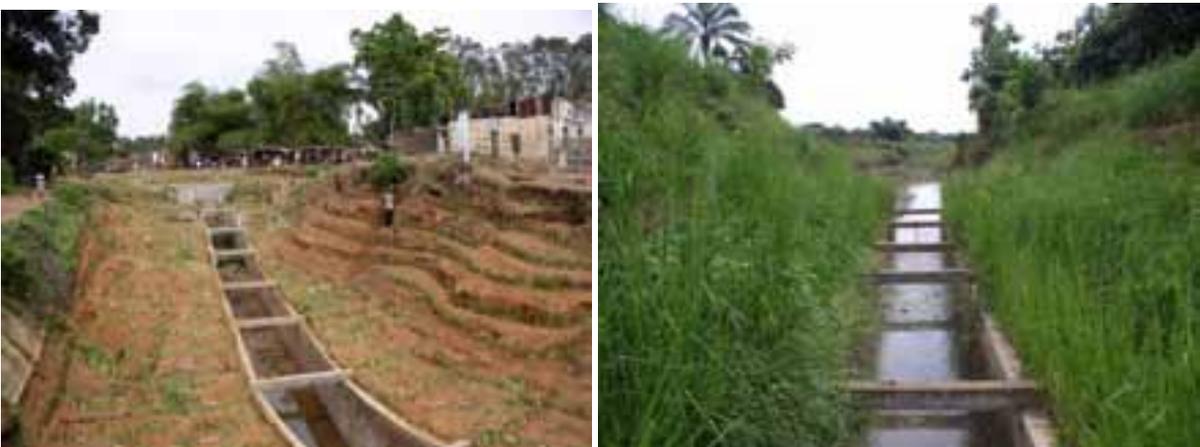
However, 60 days after planting (photos 6 and 7), these plants had reached their average growth level, leaves started to reach normal heights and the new tillers had grown from the base. Consequently, hedges density was also average, that is, one could still see space and distinguish between the plants in the hedgerow (Photo 7).

Photo 7: Vetiver growth at 60 days

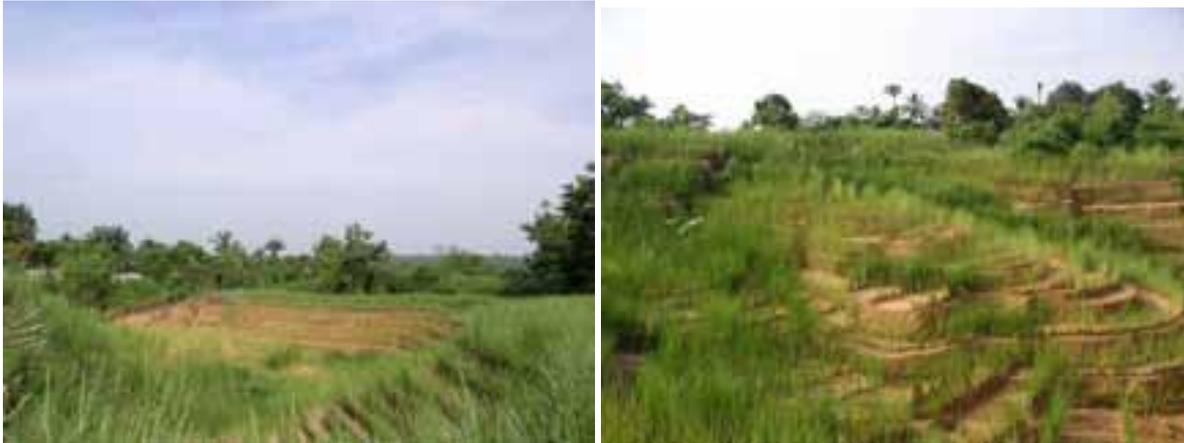
After 120 days, one could see that the vetiver plants started to reach a good level of growth by observing the height of its leaves and the growth of new and more tillers. Growth was reaching a point where plants in the hedgerows began close in on each other permitted the hedge to become more dense as compared to 60 days. No further landslides were observed. The photos show the site at 120 days (Photo 8).

Photo 8: Vetiver growth at 120 days

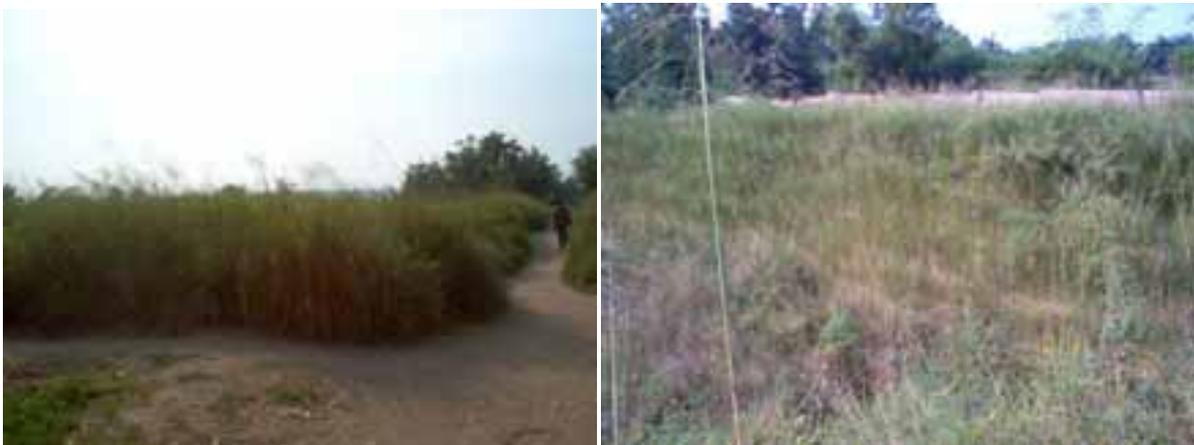
At 240 days after the start of the demonstration plot, plants had reached their maximum height at approximately 1.5 to 2m providing healthy and dense hedgerows resulting from new tillers bunched close to each other. This eliminated spacing between plants in the hedgerows. Vetiver hedge development on the site transformed the landscape into a form of savanna, allowing the growth of other new and indigenous grasses. The three heads of the ITPK ravine and its slopes have totally stabilized by the dense savanna of vetiver as shows on the above photos.

Photo 9: Vetiver growth at 240 days
