REDUCING THE FOOTPRINT & INCREASING THE HANDPRINT Through Positive Interventions with The Vetiver System

Presentation at ICV-5, Oct 28-30, 2011

Applications of VS used at Anandpur Sahib

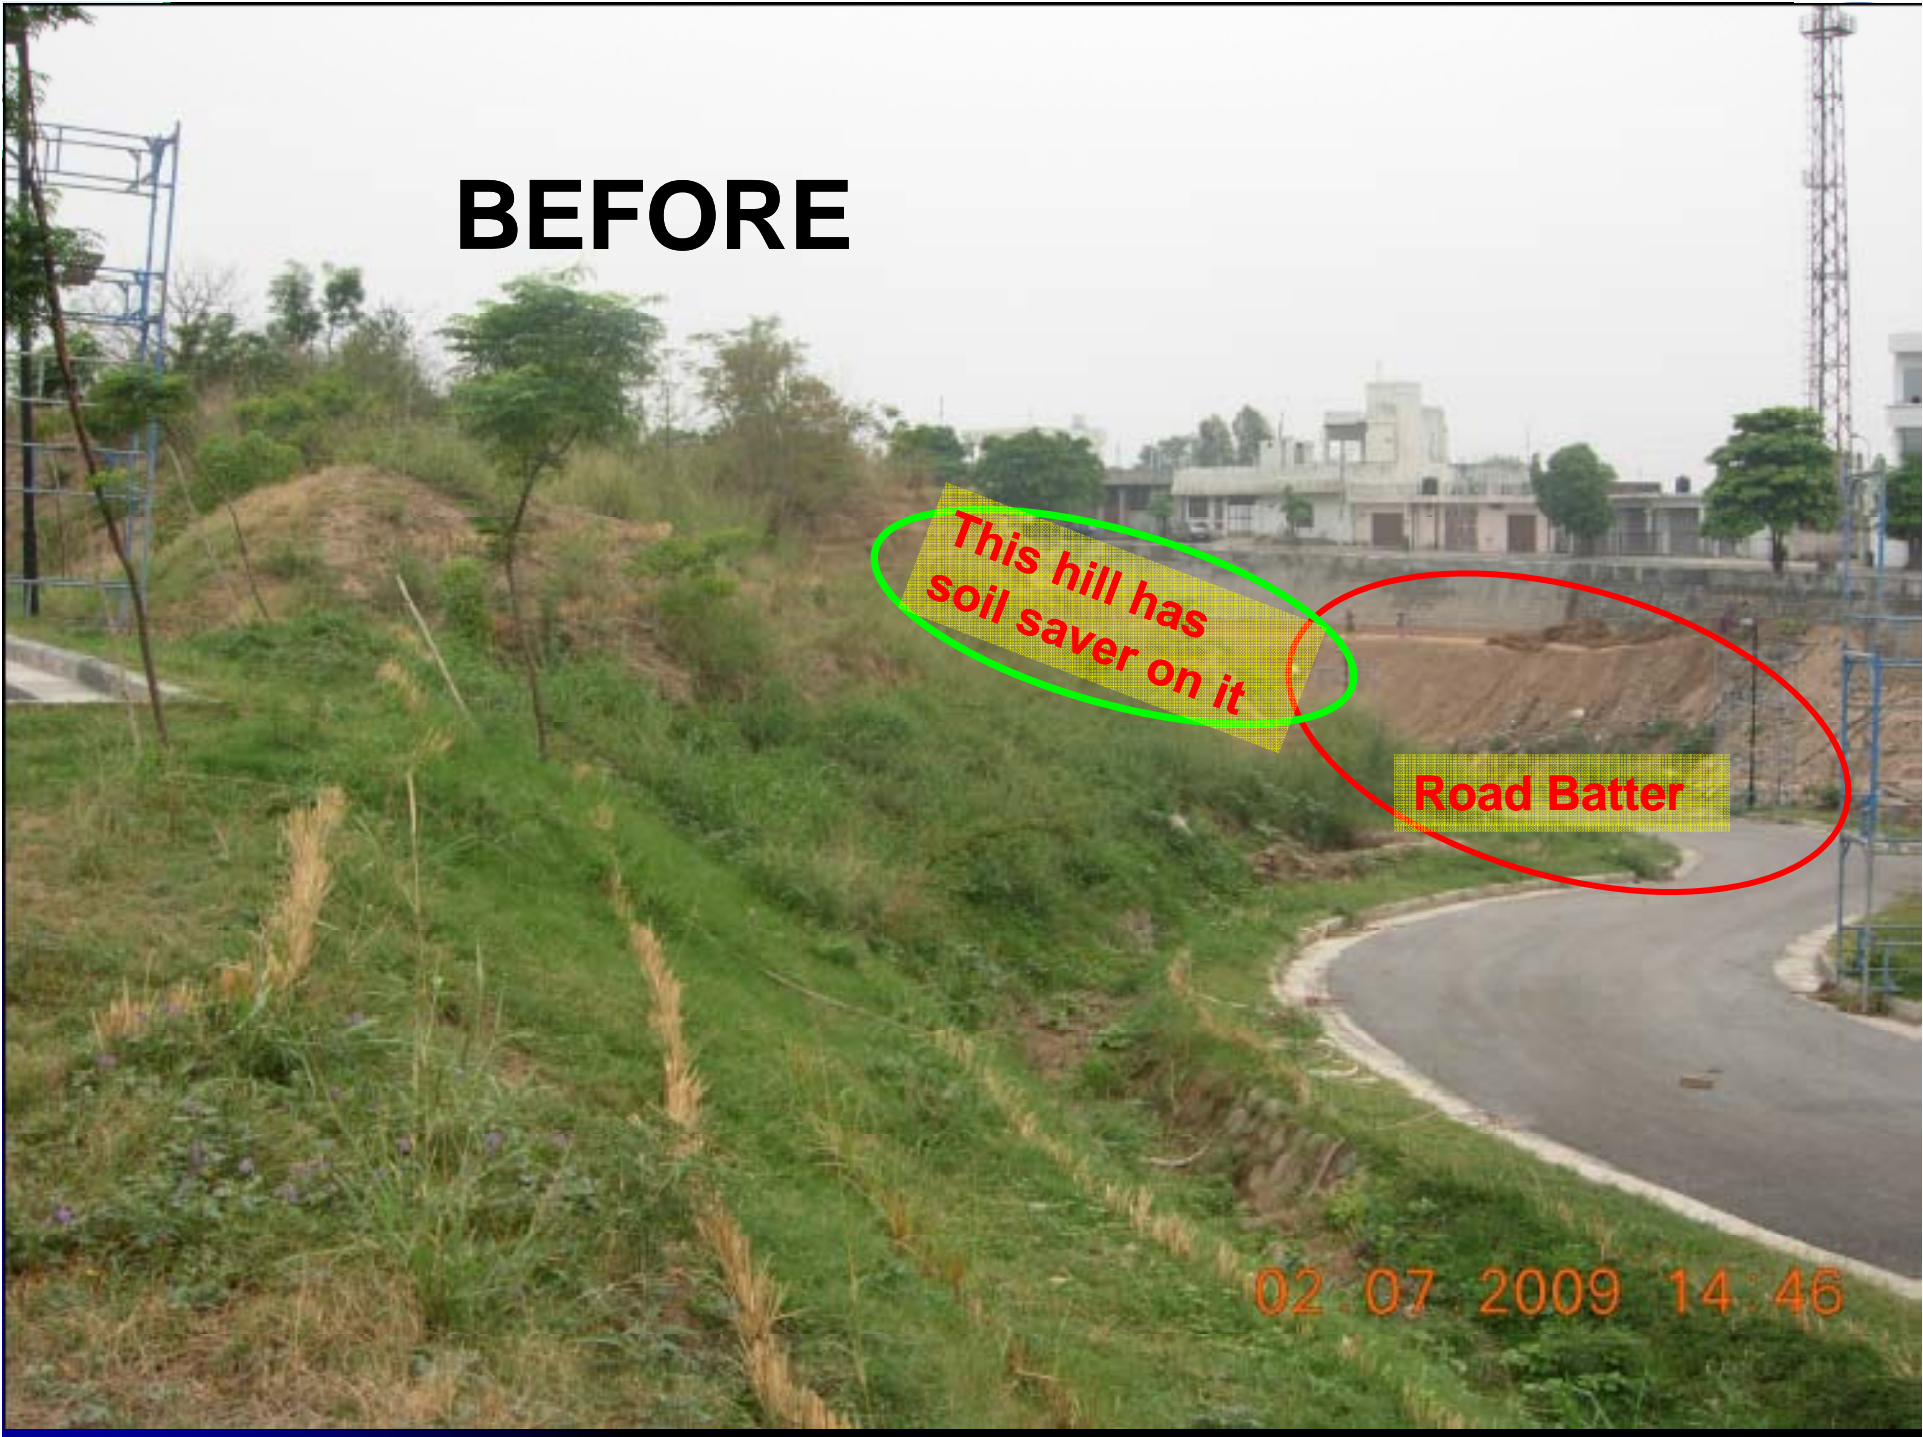
BEFORE

This hill has
soil saver on it

Road Batter

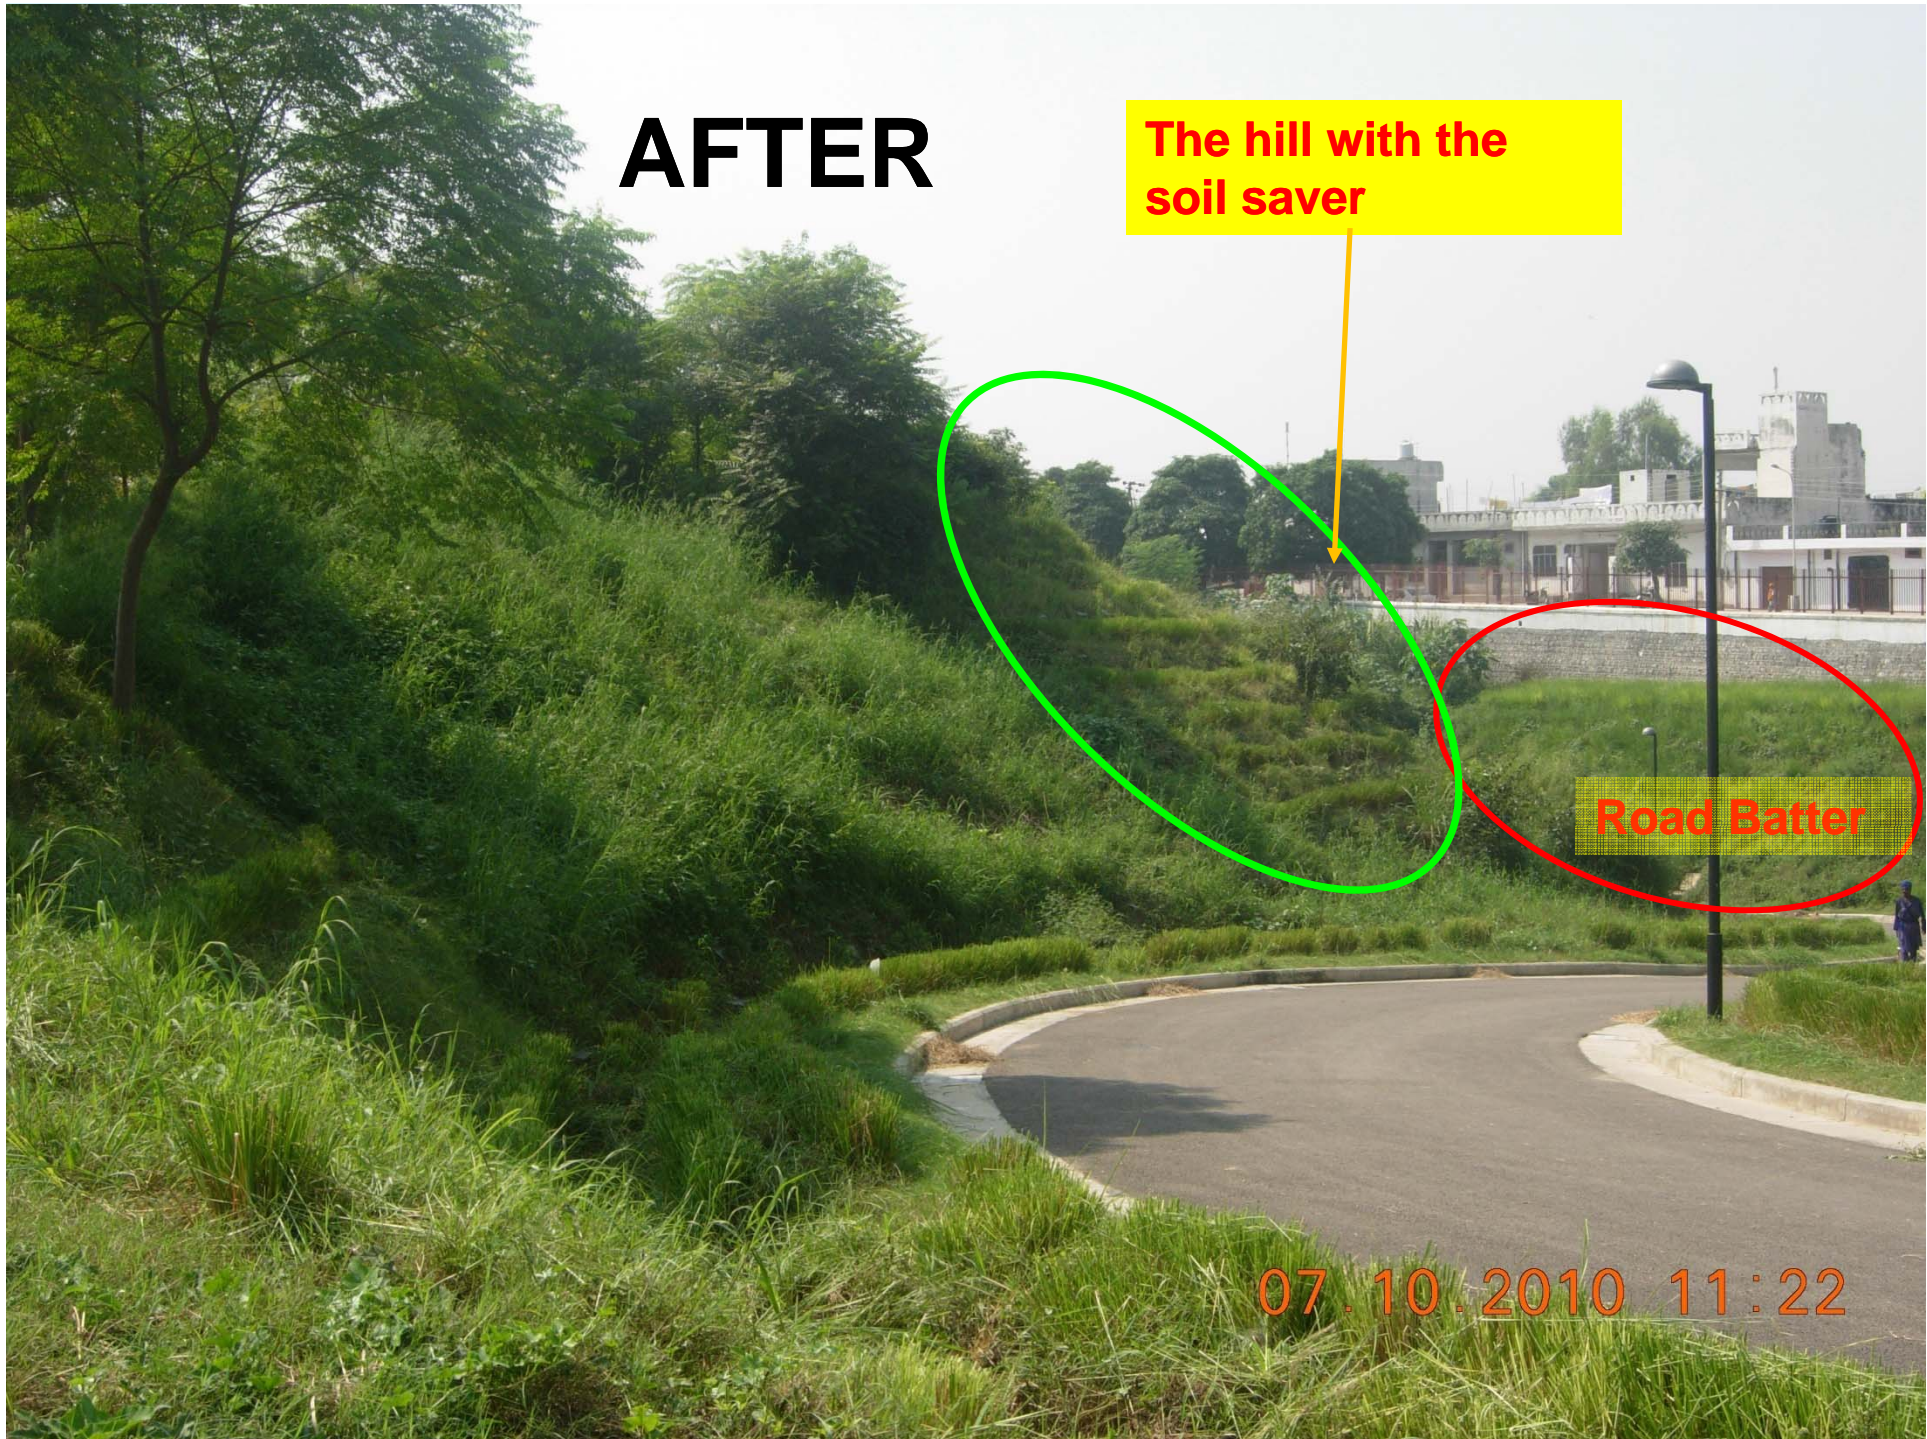
AFTER

The hill with the soil saver

Road Batter

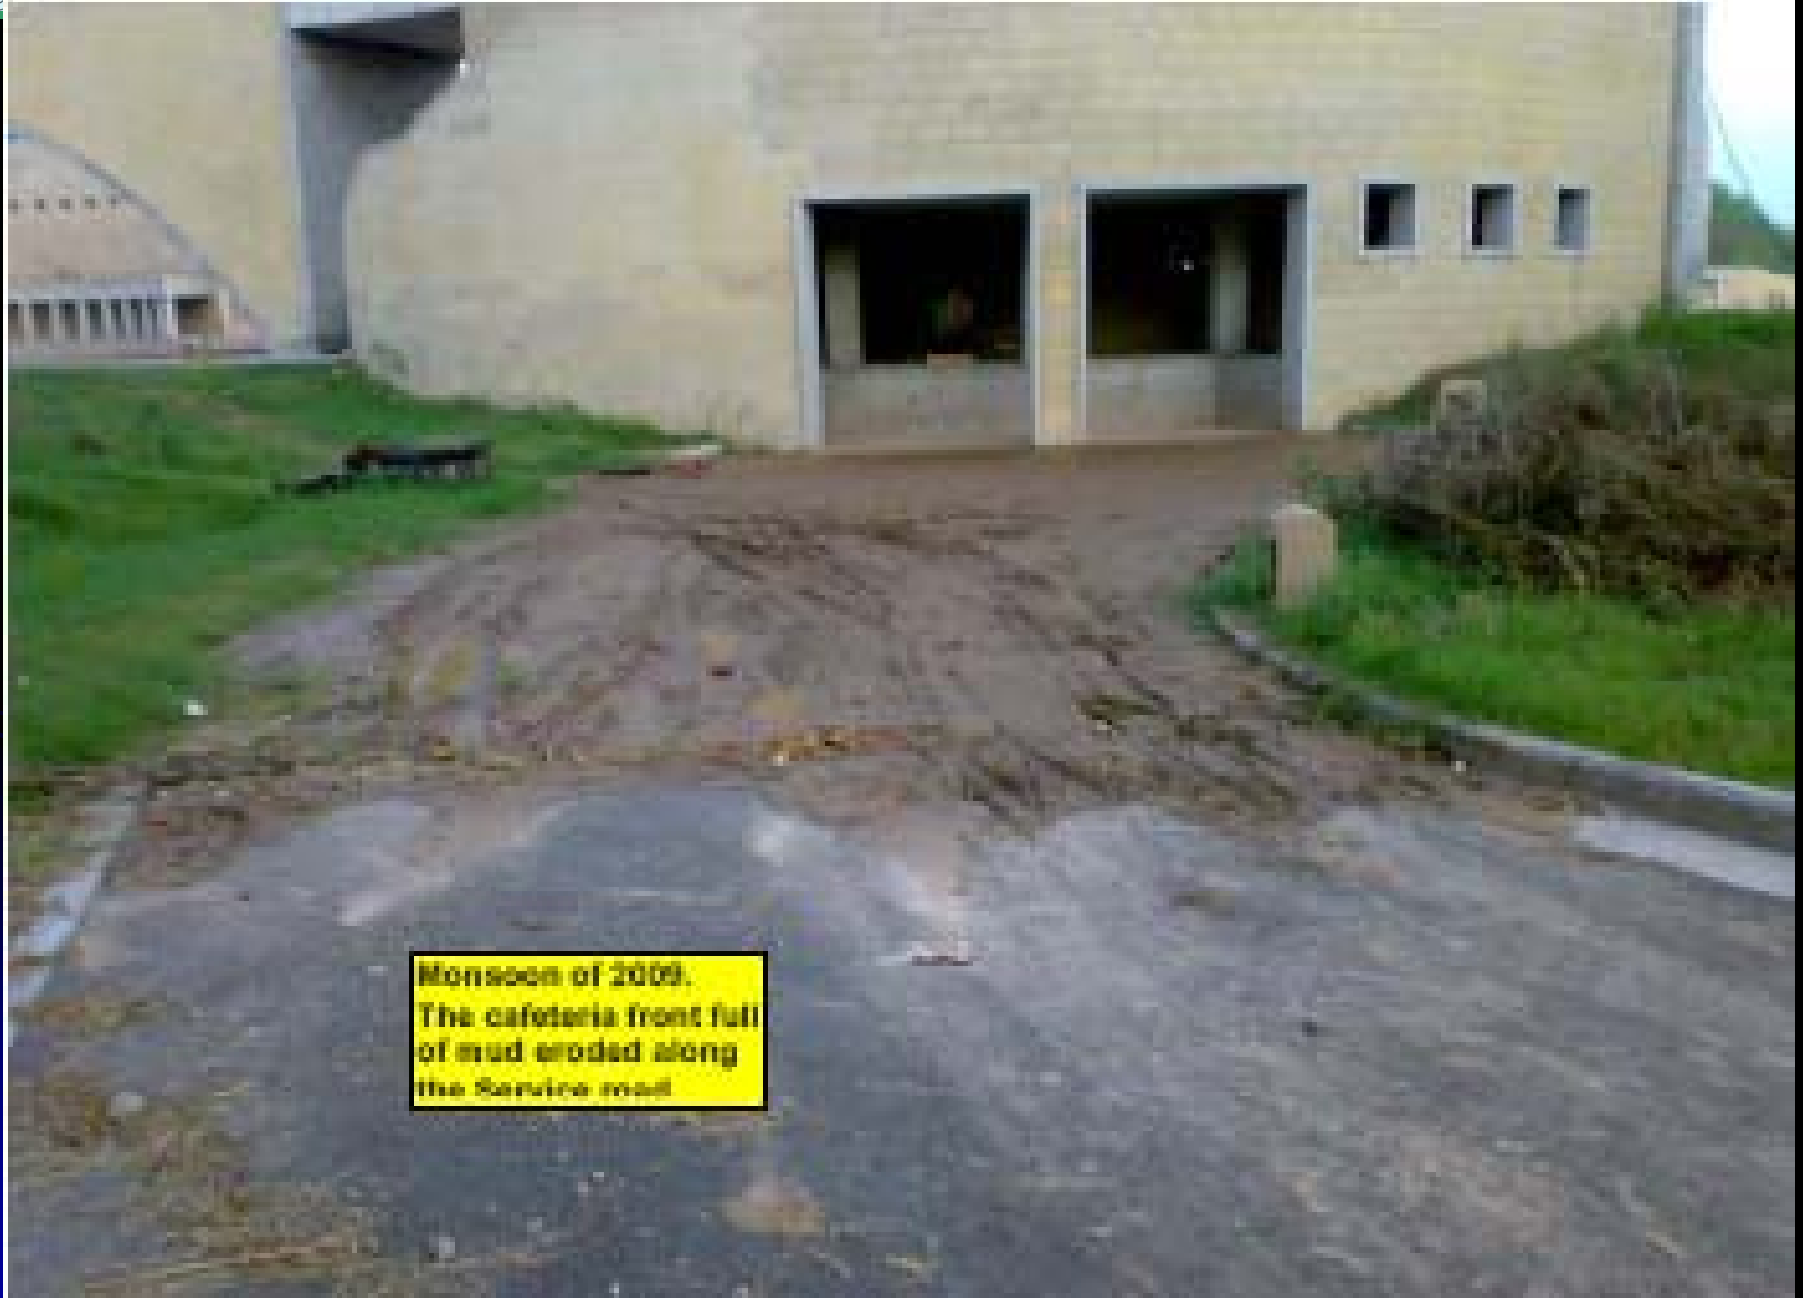
Monsoon of 2009.
The cafeteria front full
of mud eroded along
the Service road

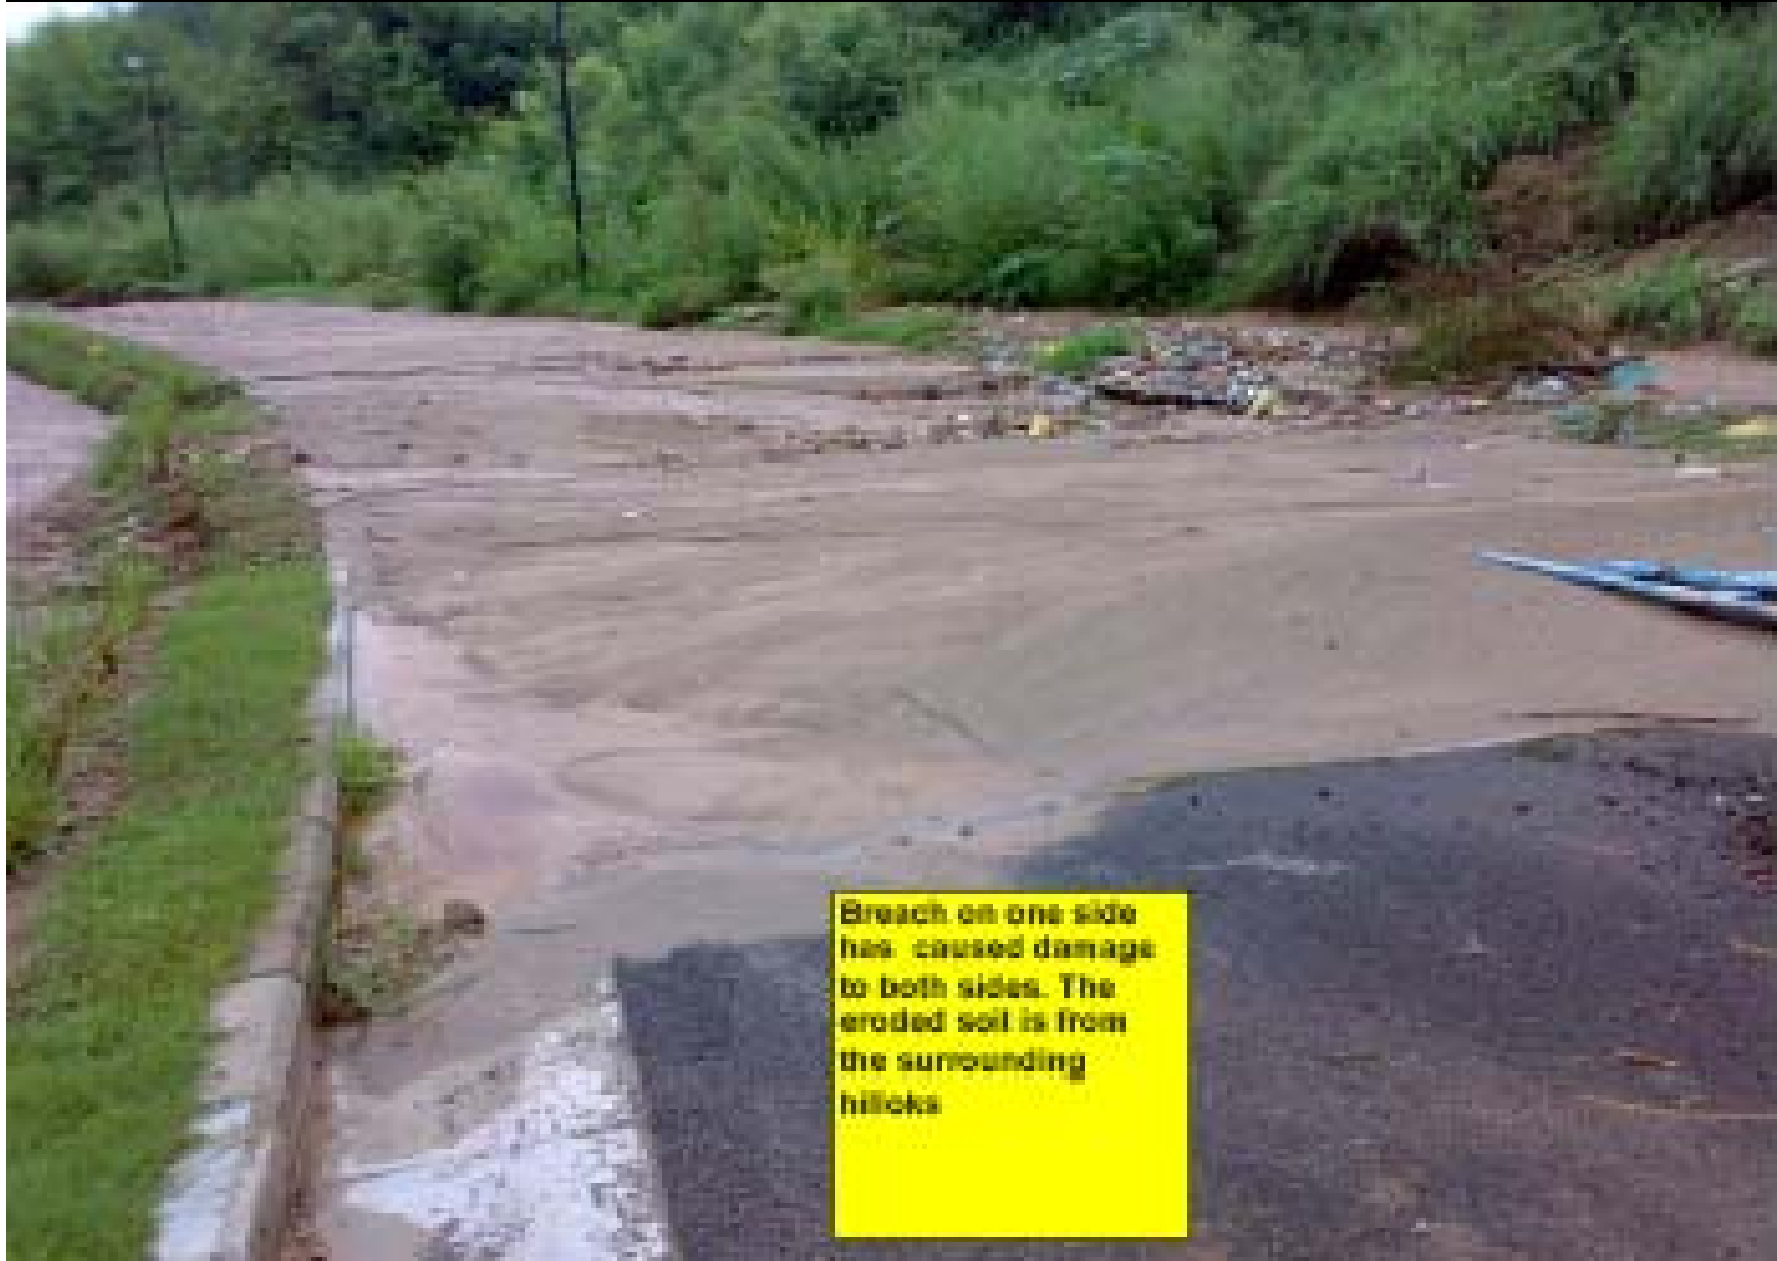
**Breach on one side
has caused damage
to both sides. The
eroded soil is from
the surrounding
hillocks**

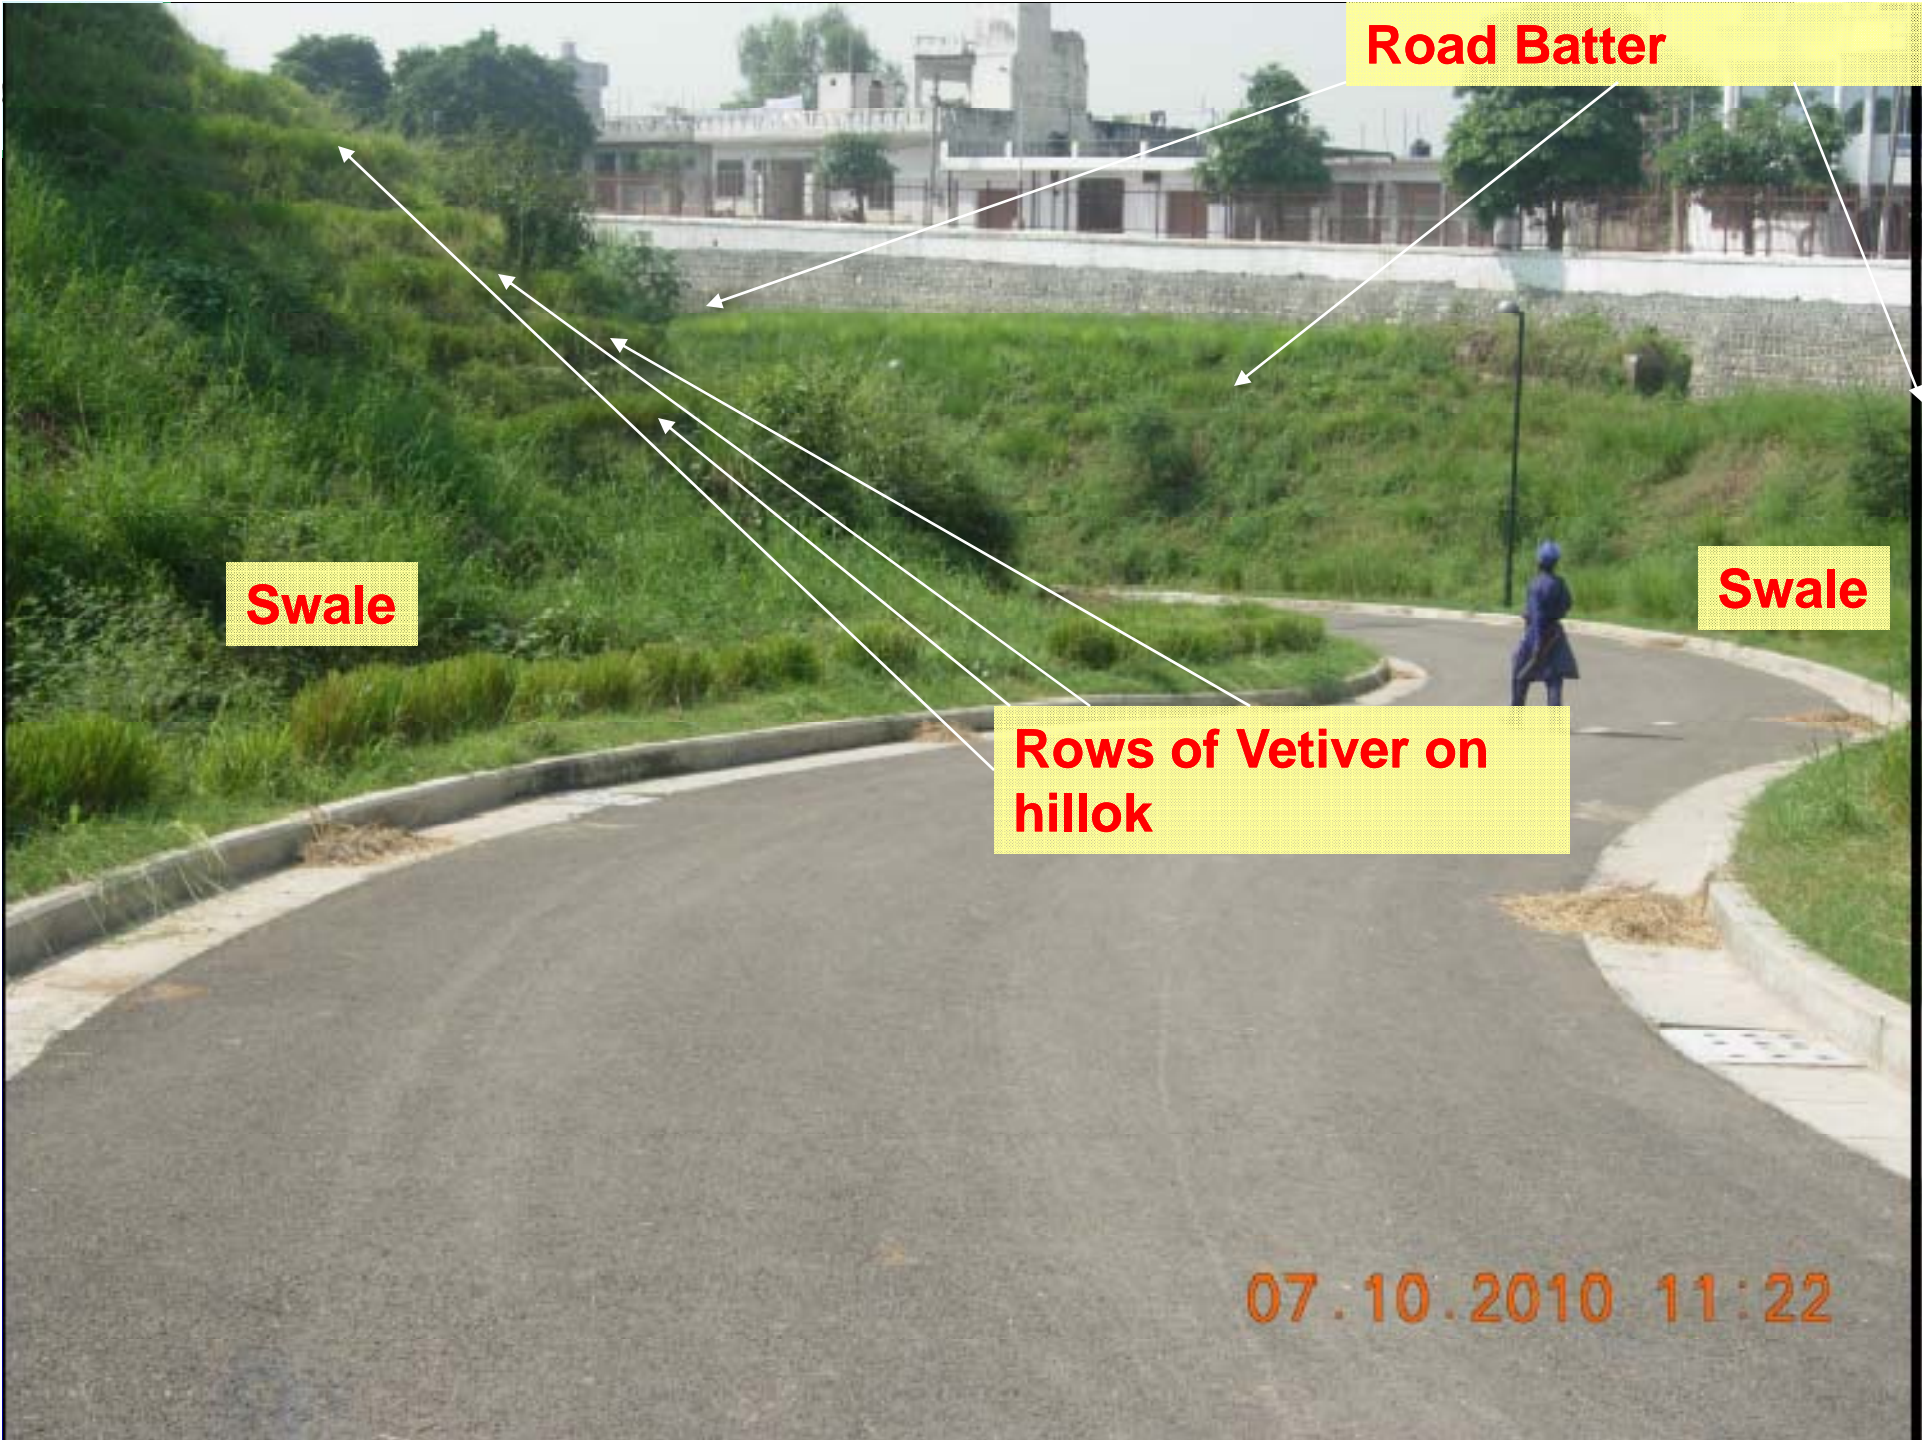
Road Batter

Swale

**Rows of Vetiver on
hillock**

**Vetiver Stopping
Erosion from Hillock
and cutting down
Velocity of flow in
swale**

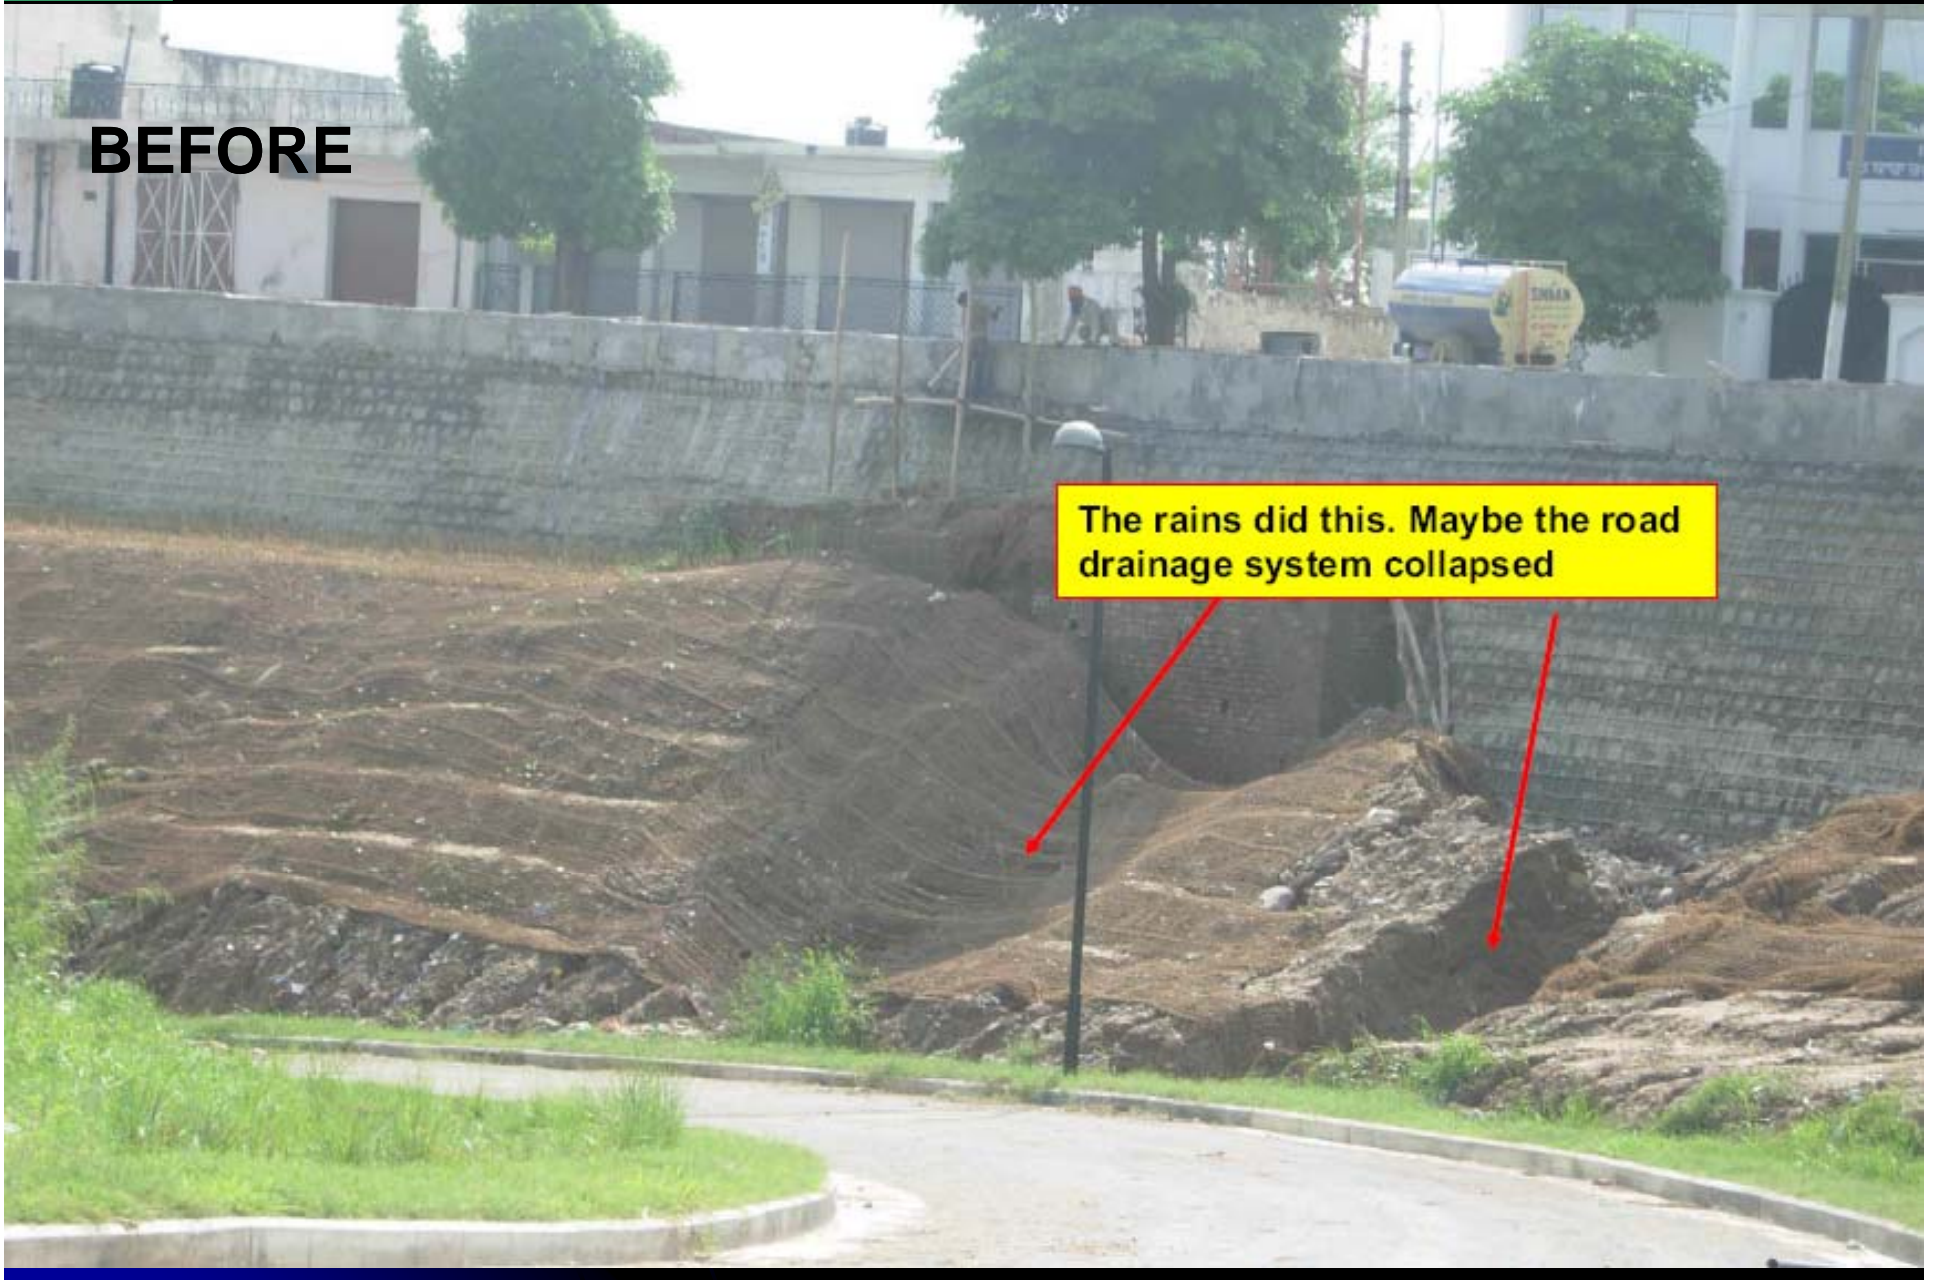
The rains did this. Maybe the road drainage system collapsed

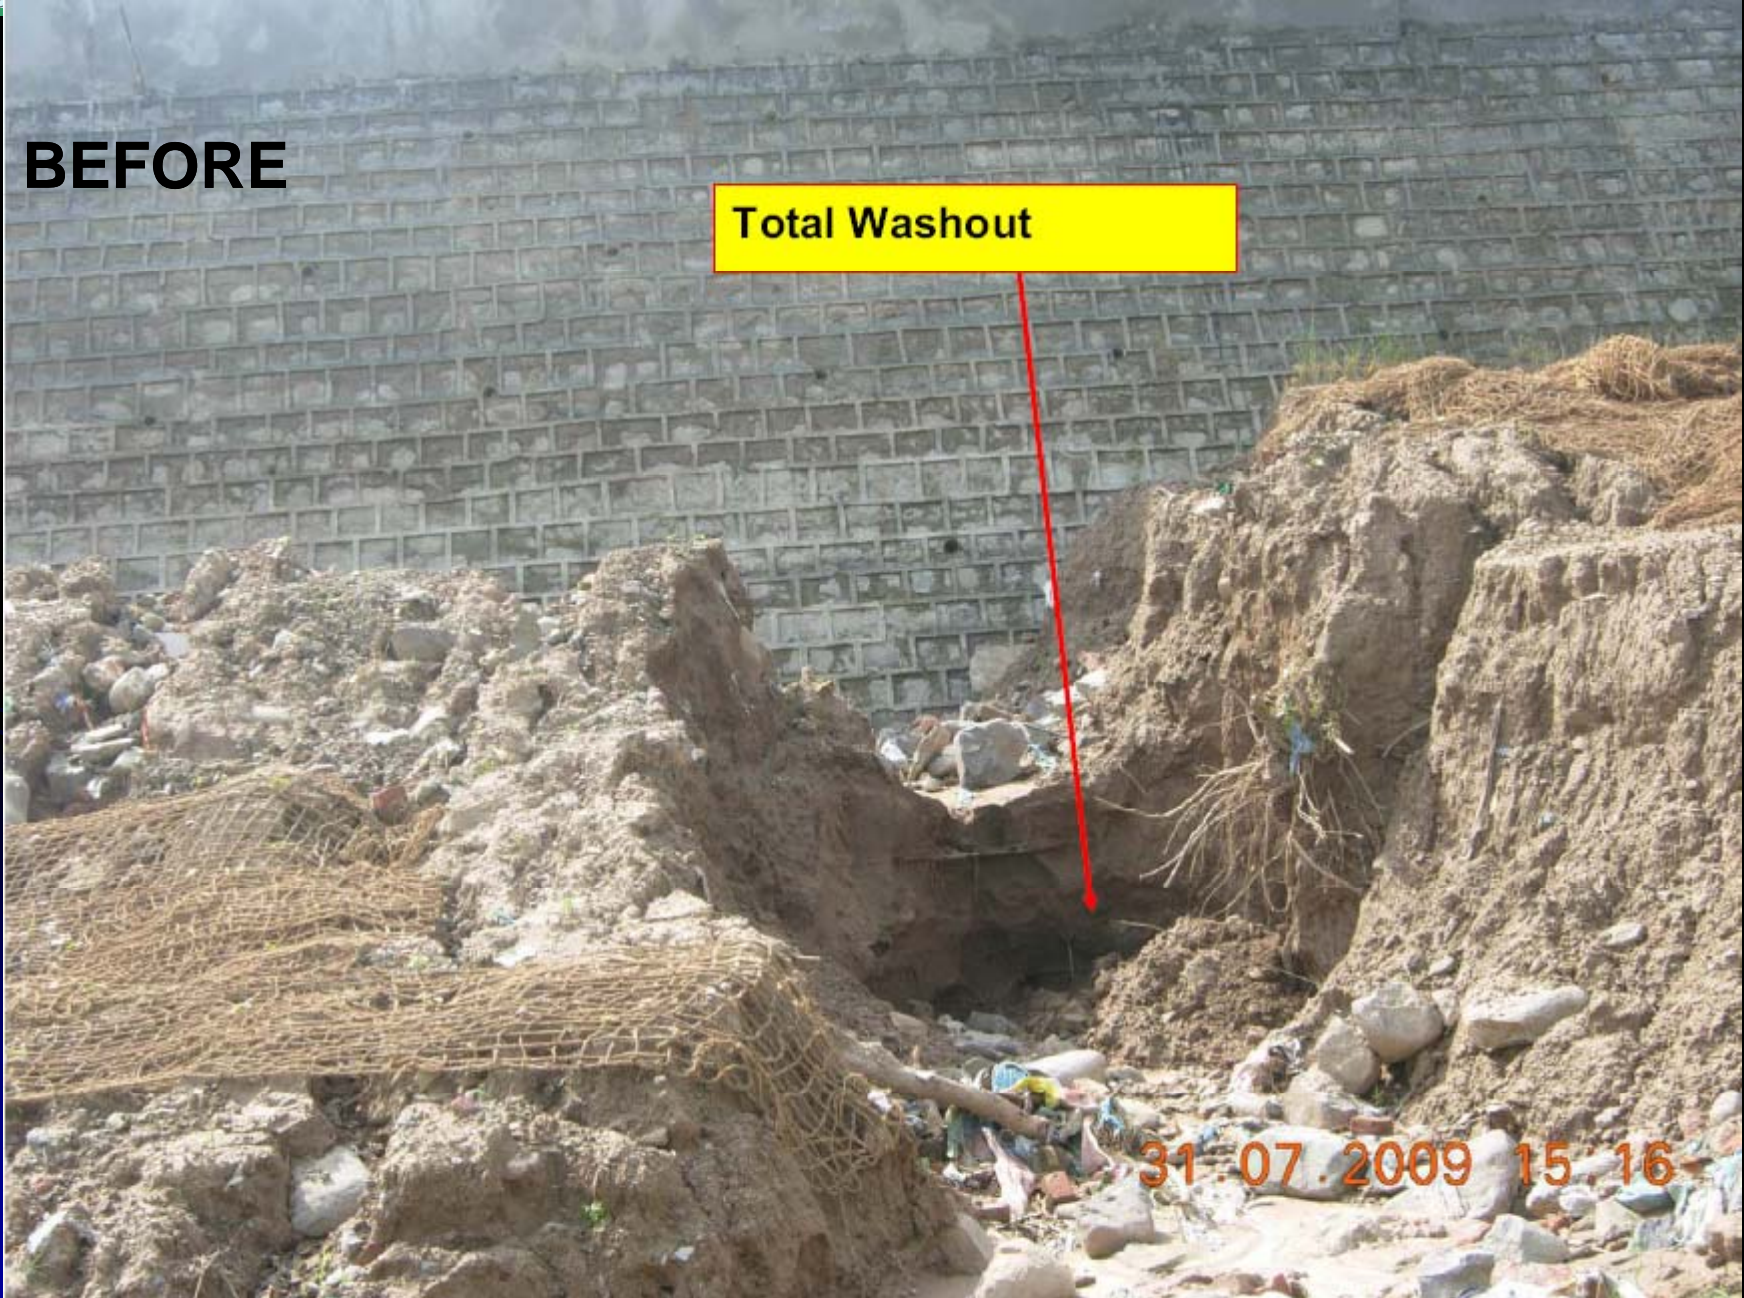
Total Washout

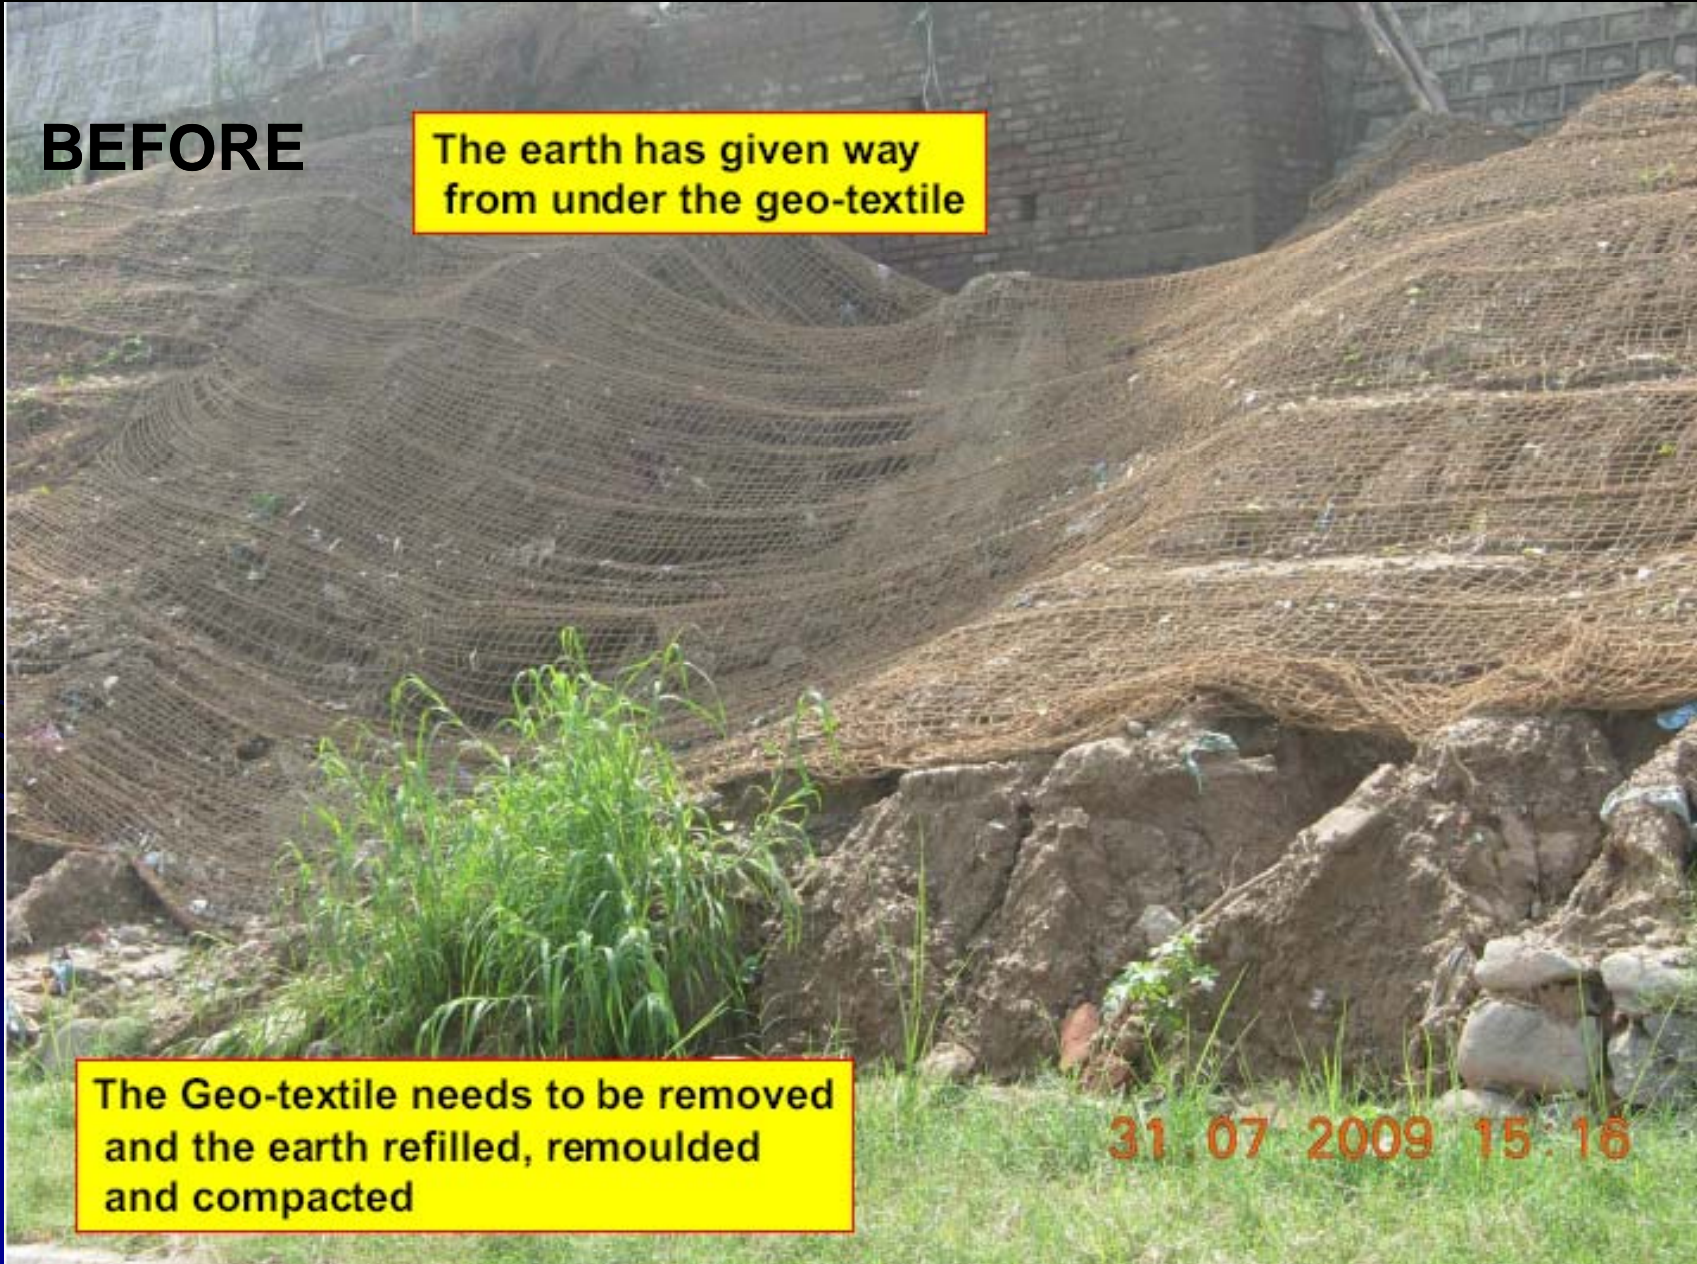
The earth has given way
from under the geo-textile

The Vetiver that we grew
on top has survived

The Geo-textile needs to be removed
and the earth refilled, remoulded
and compacted

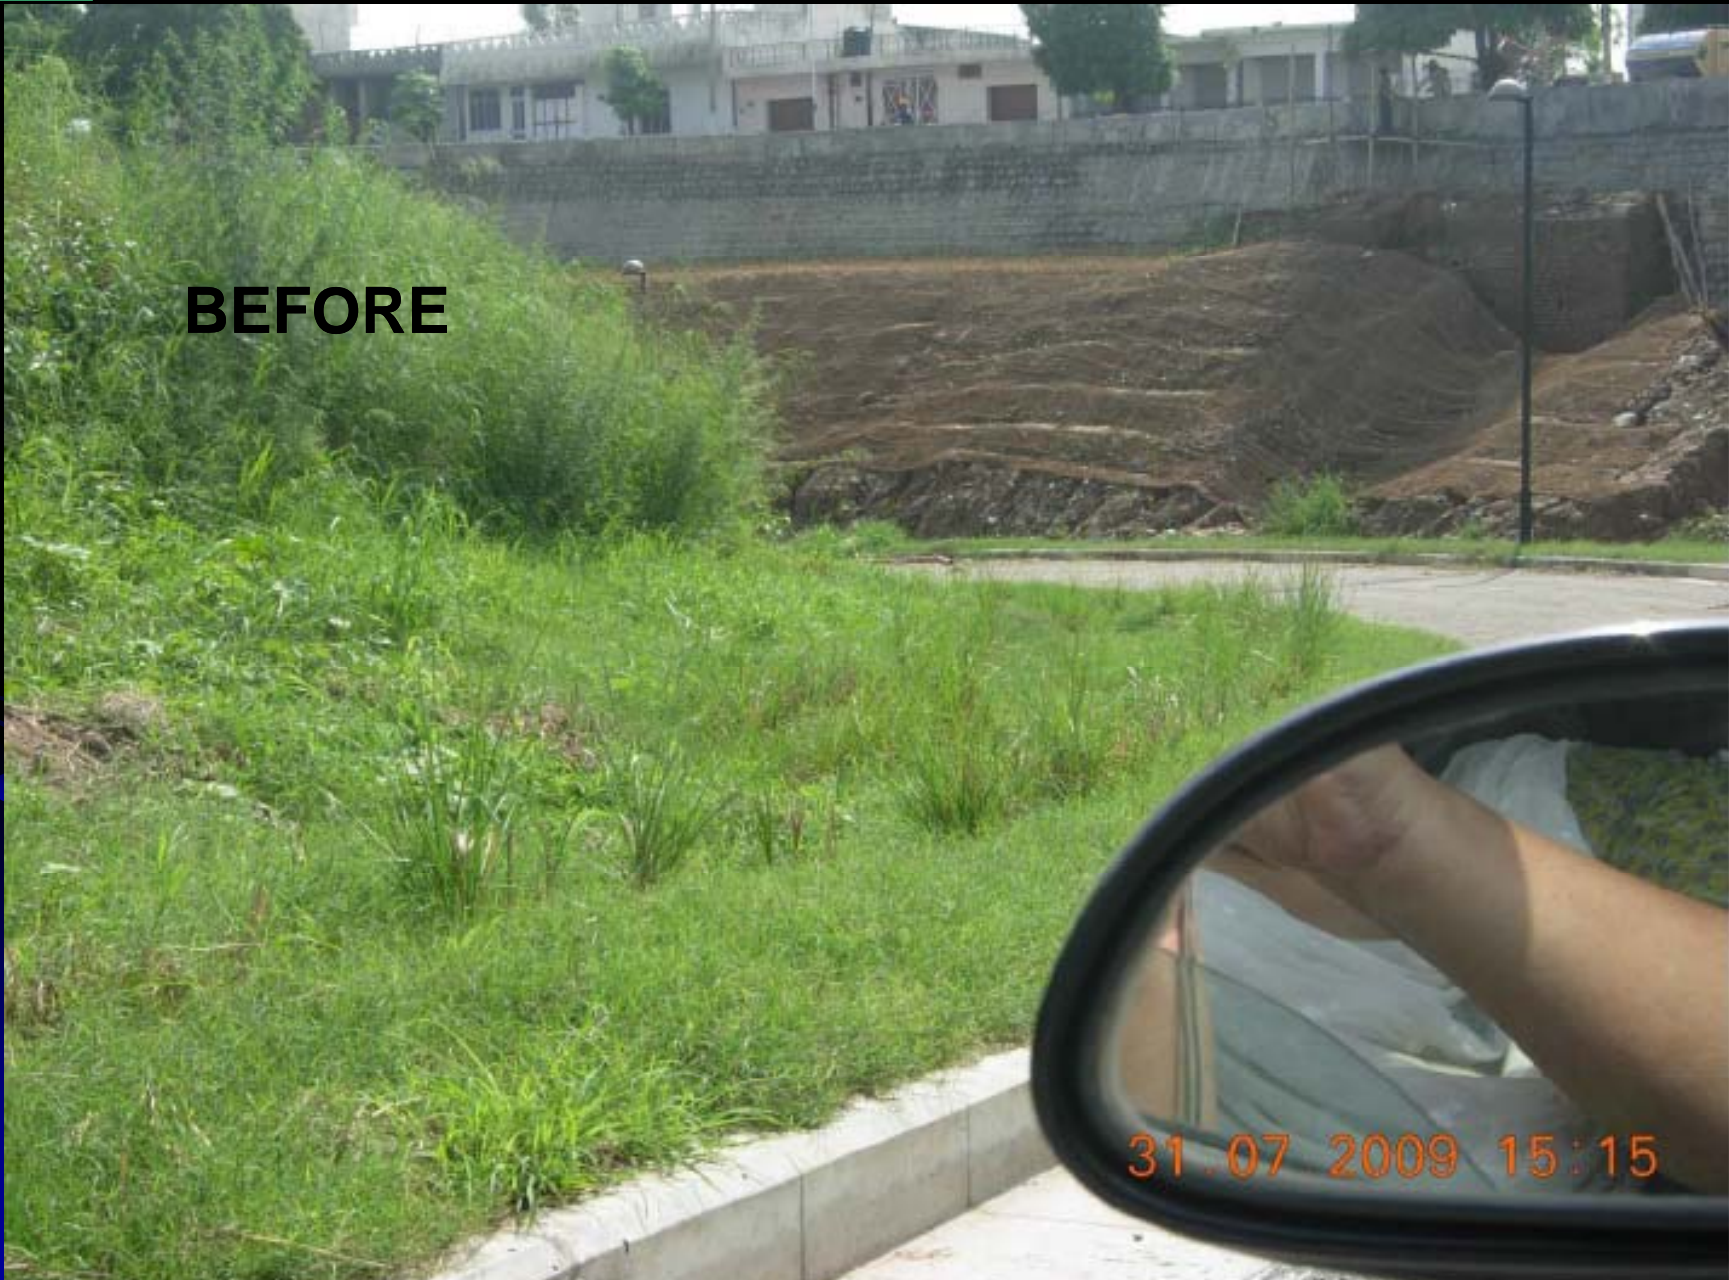
Vetiver has stabilized the entire slope
