REDUCING THE FOOTPRINT & INCREASING THE HANDPRINT Through Positive Interventions with The Vetiver System

Presentation at ICV-5, Oct 28-30, 2011

Applications of VS used at Anandpur Sahib

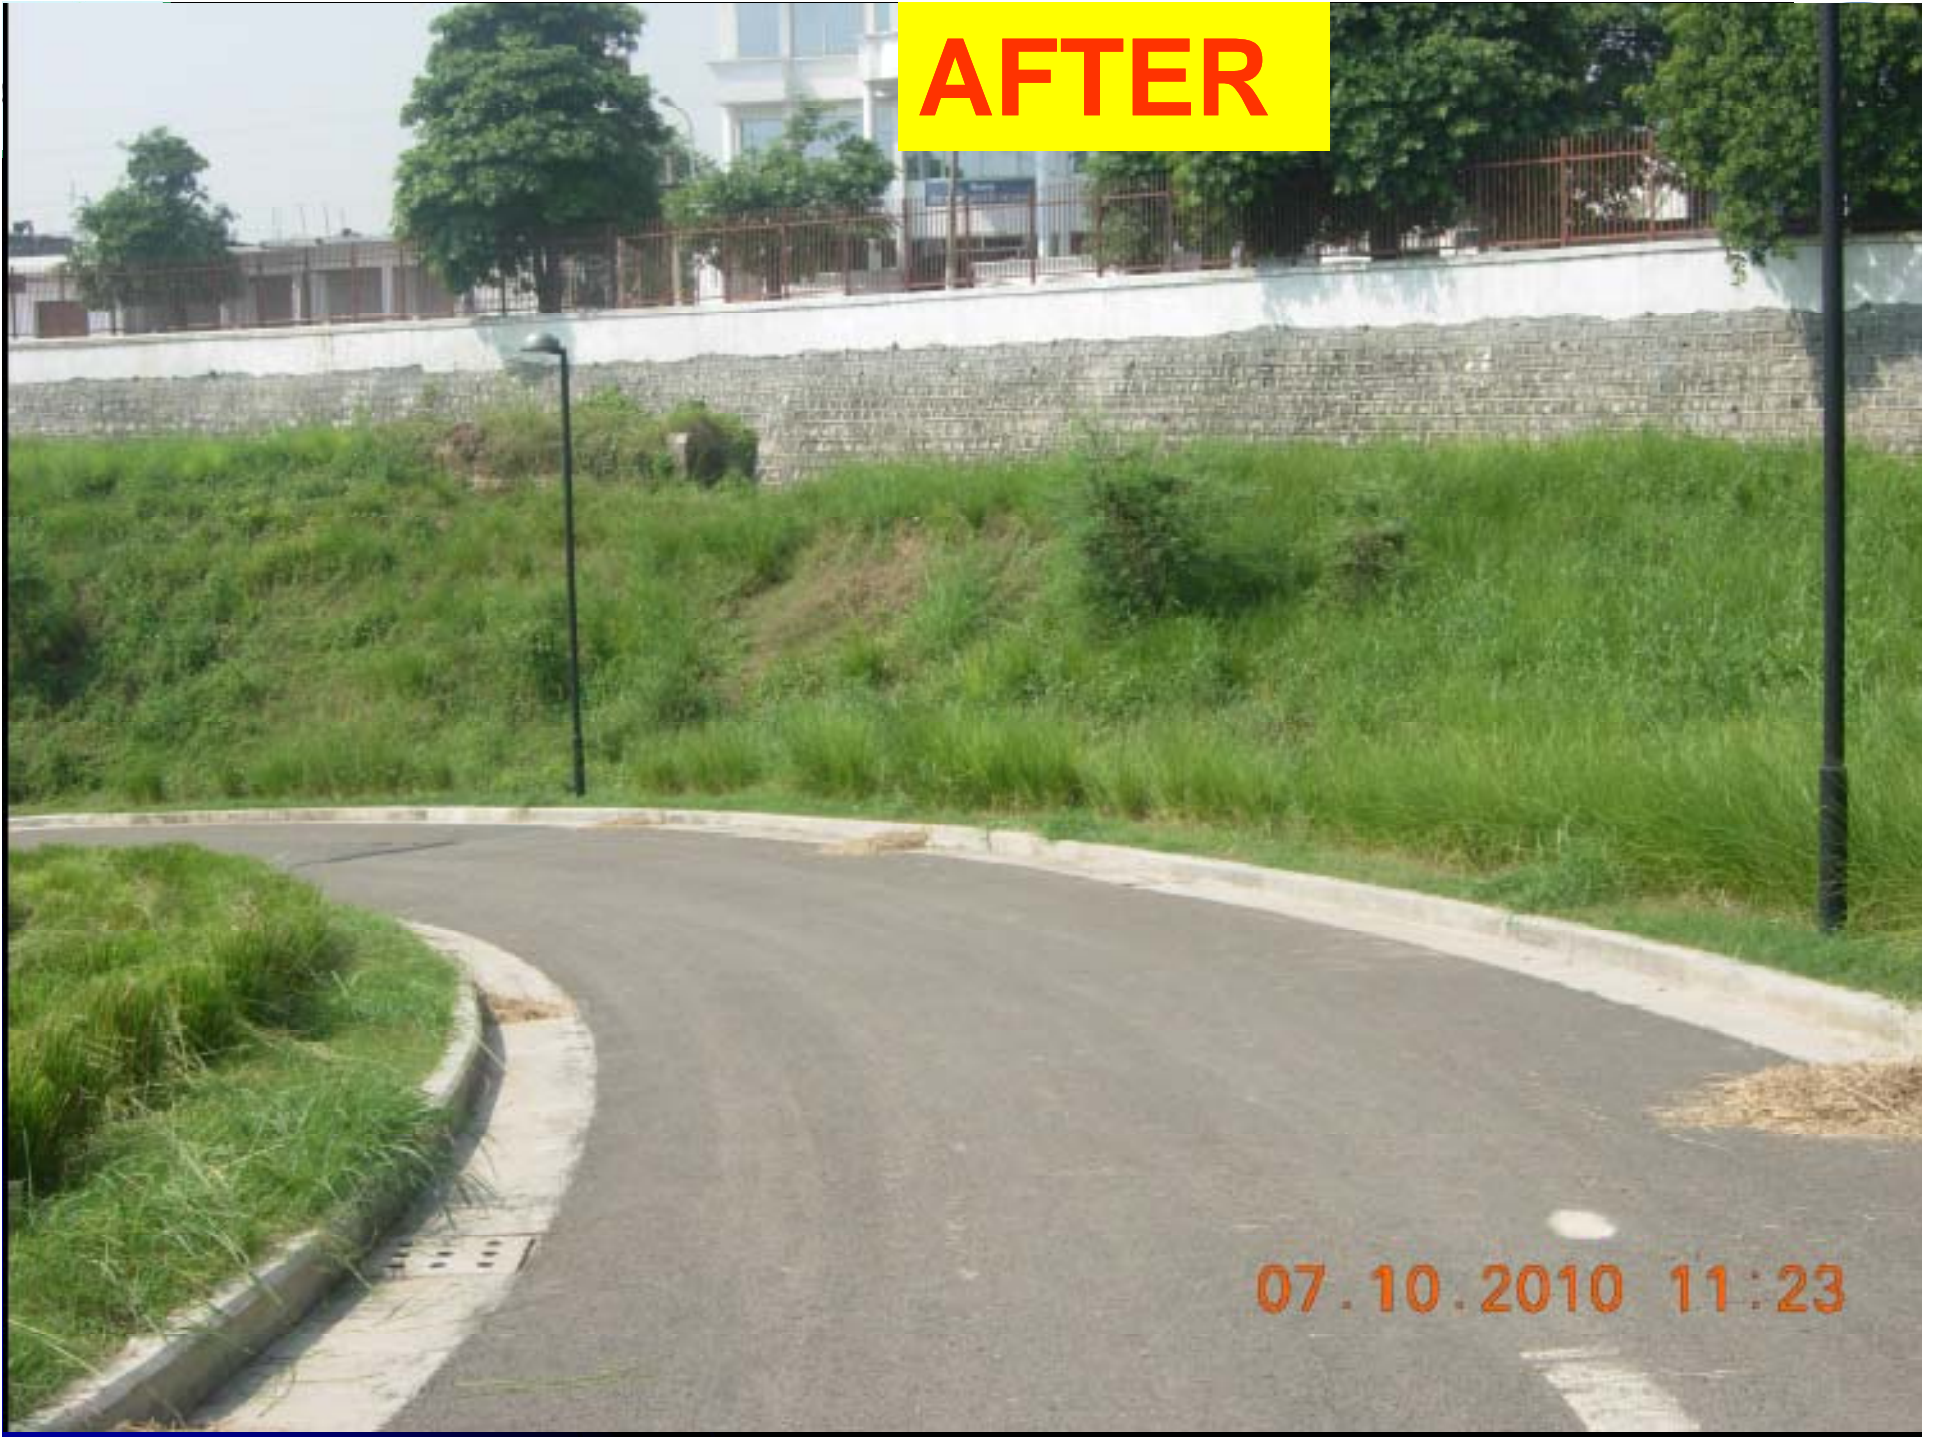
**Not a single breach along
the entire length despite
heaviest rains in recent
times**

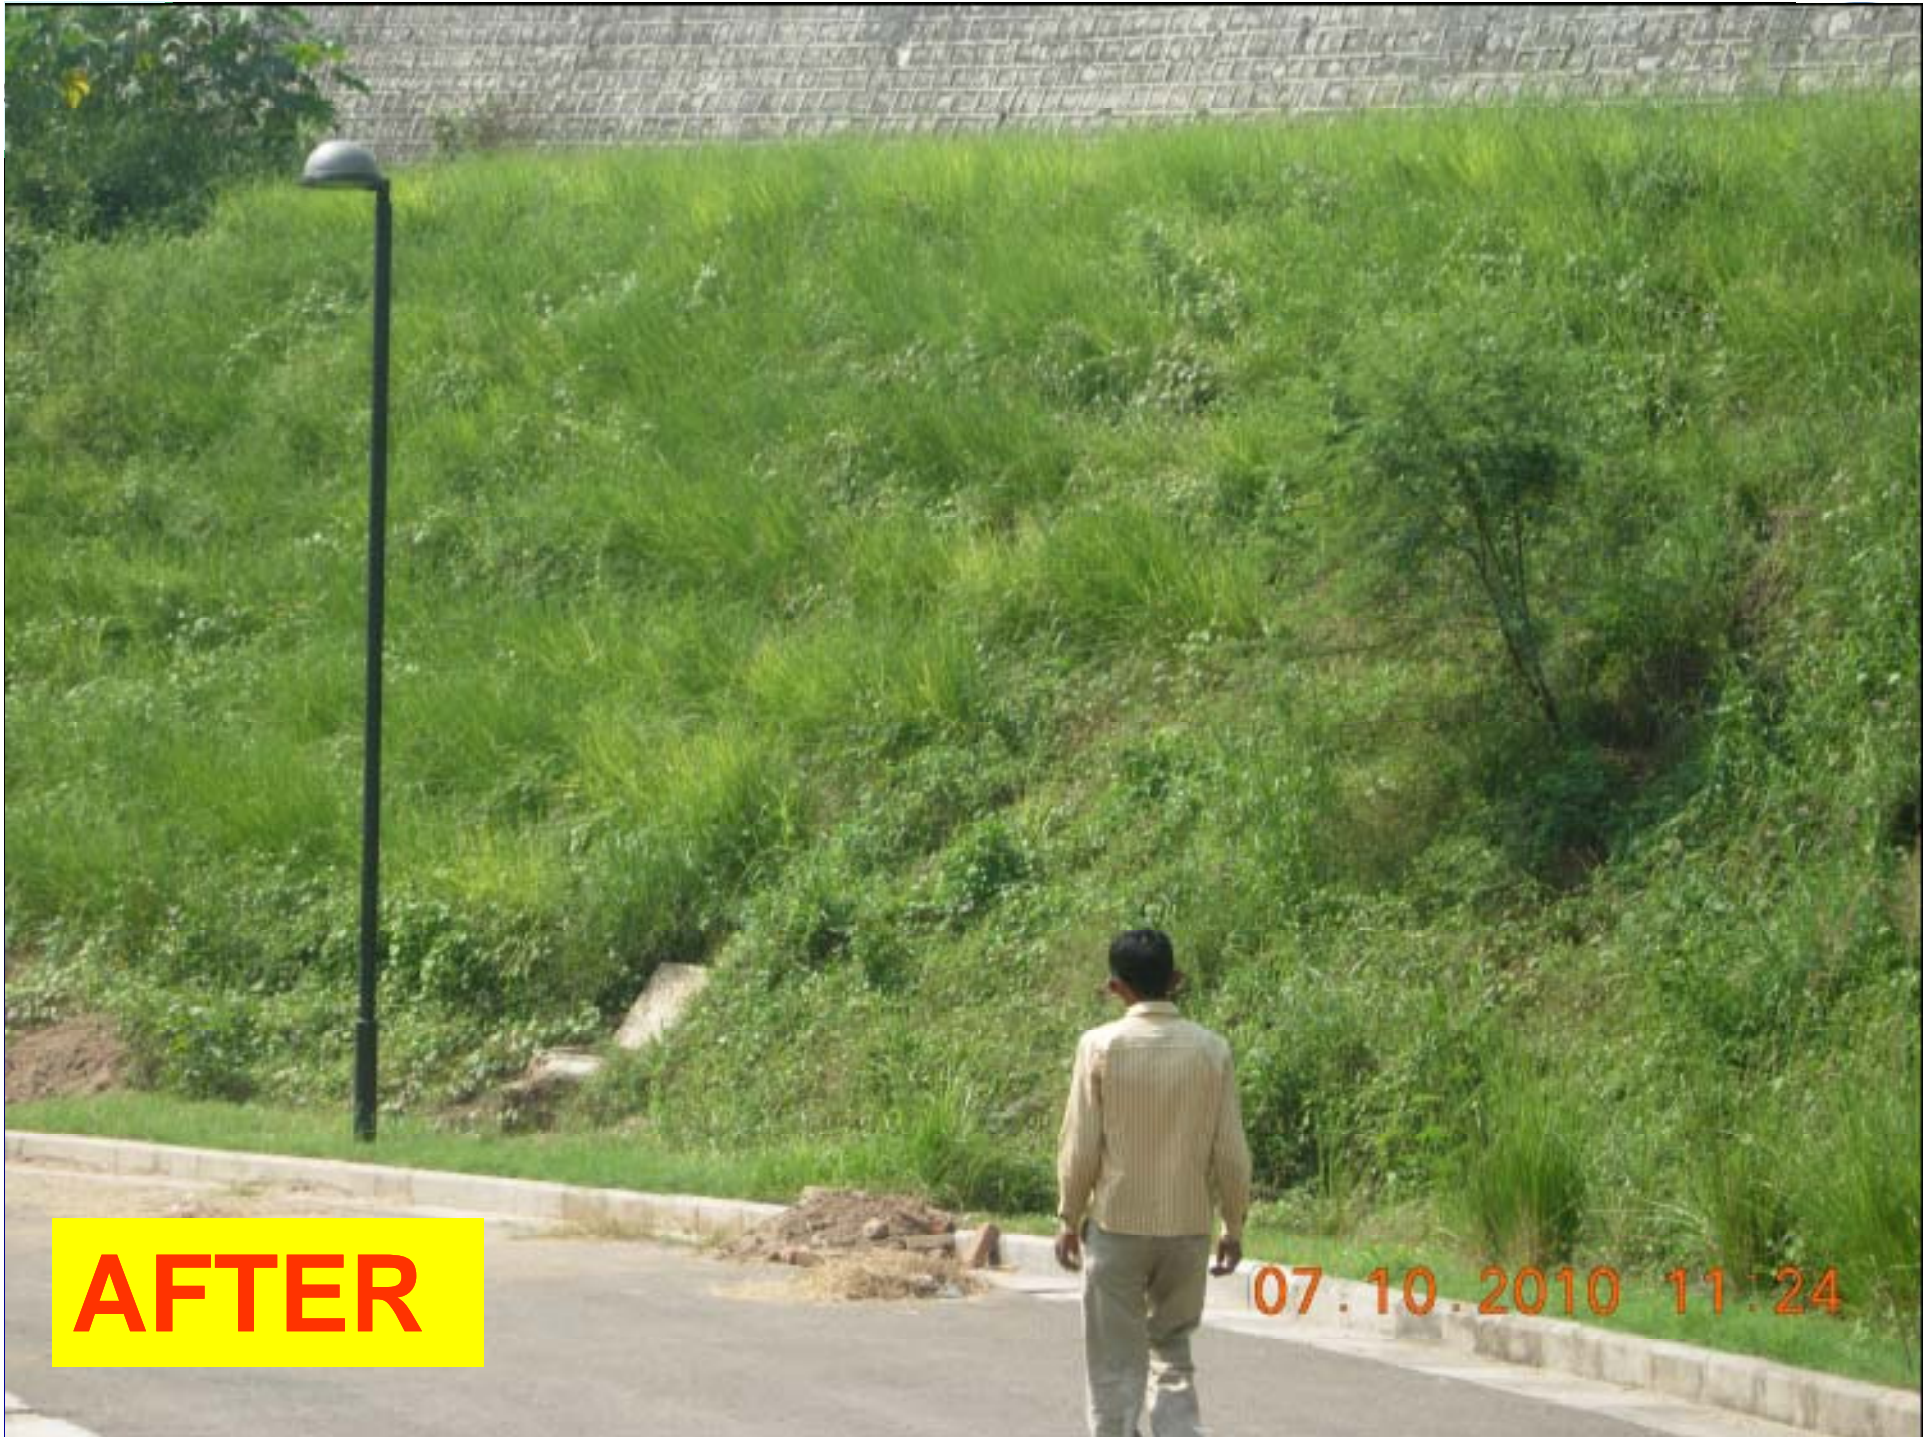
**This Slope is Over
60 degrees steep**

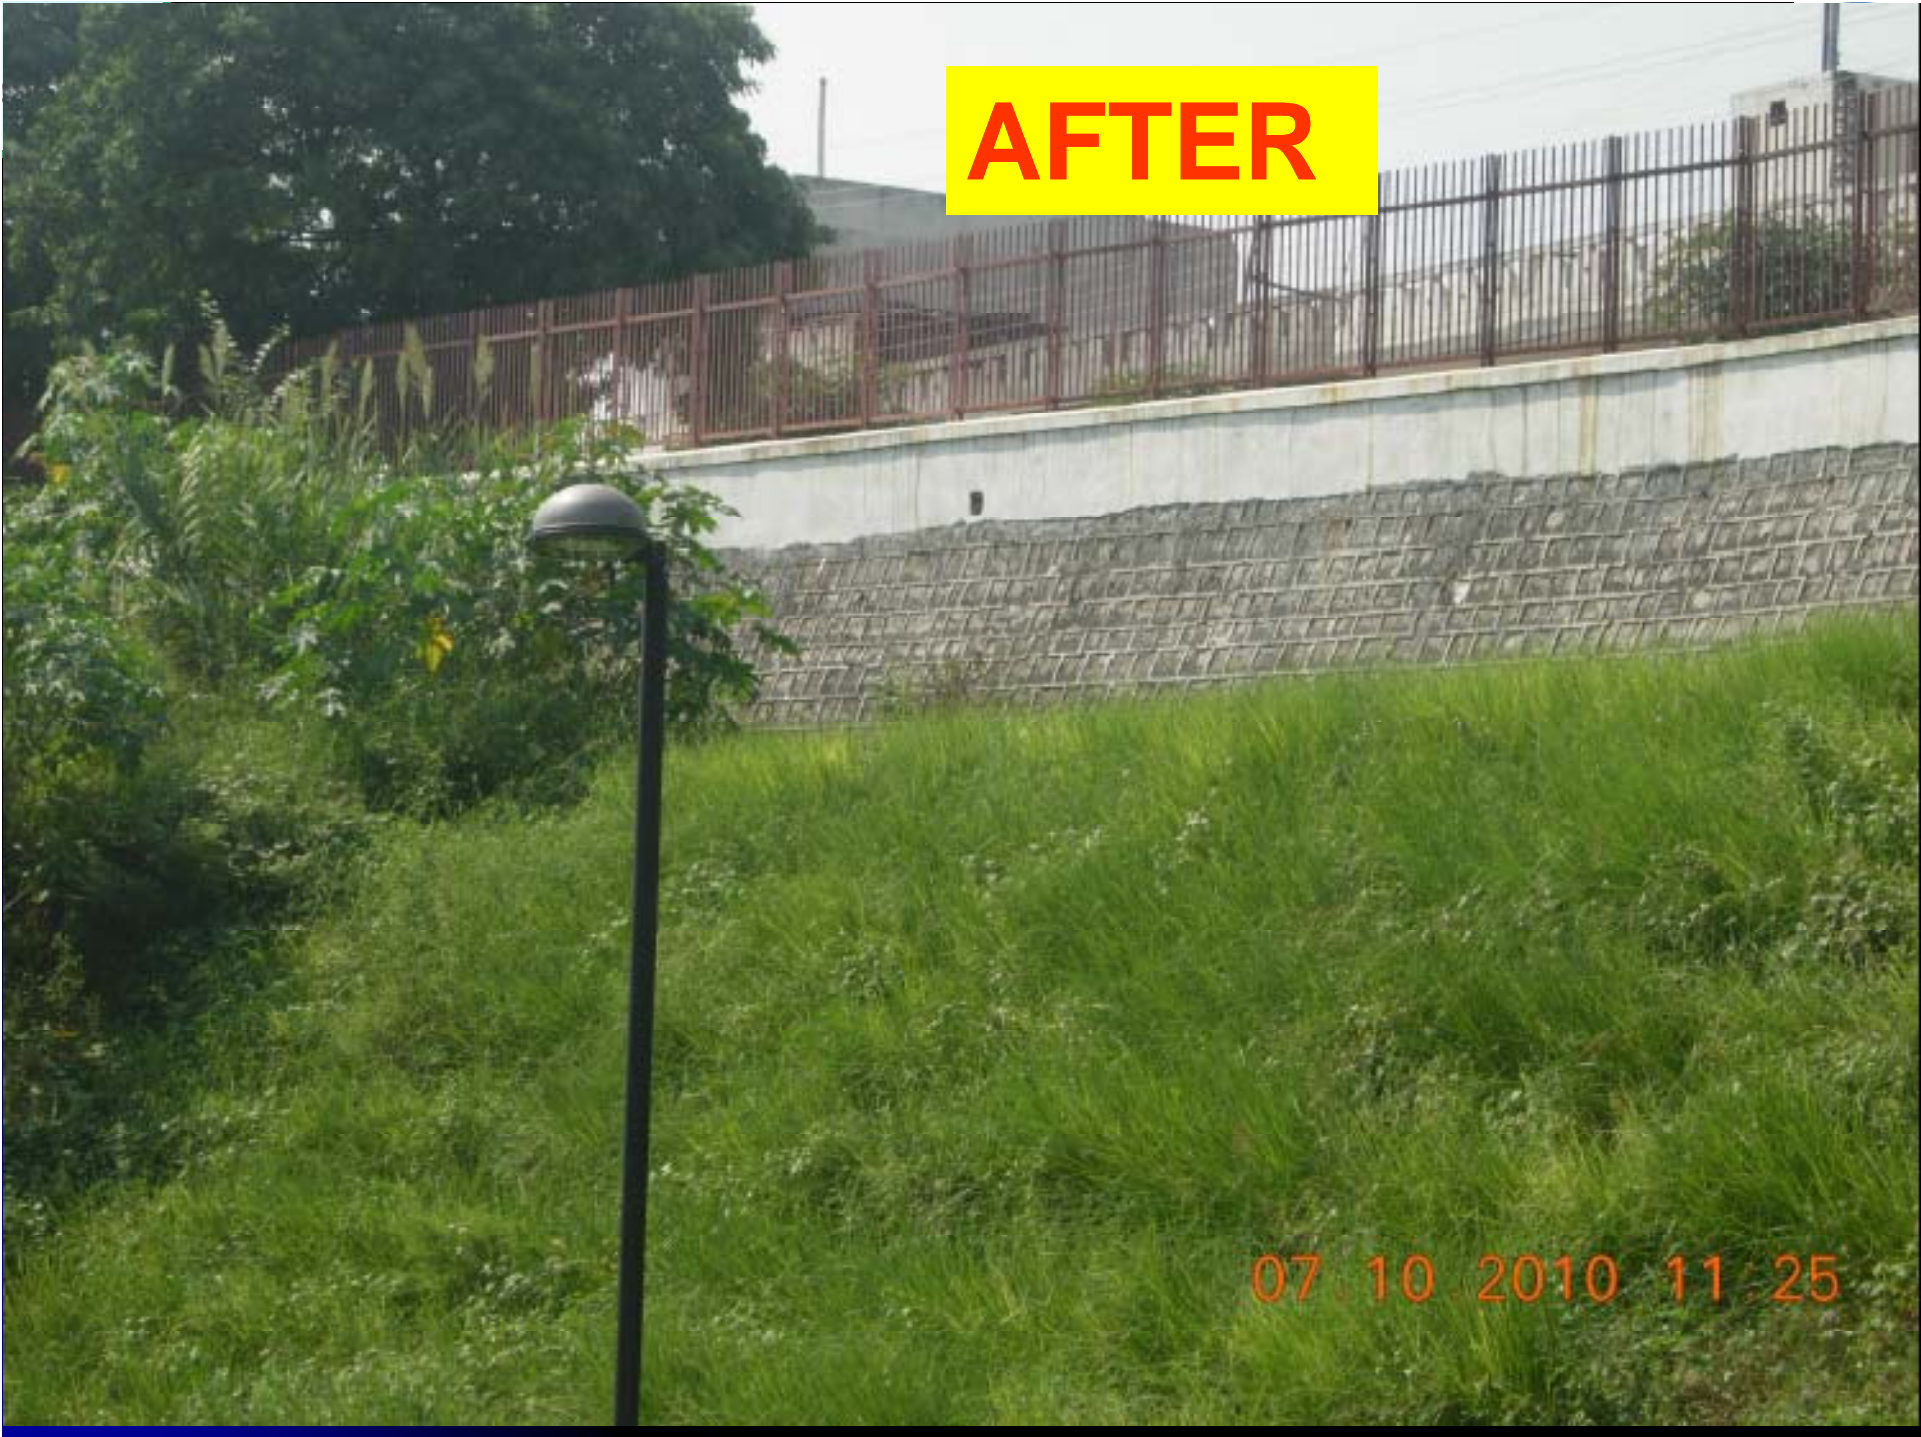
Vetiver has retained moisture within the slope enabling other vegetation to grow.

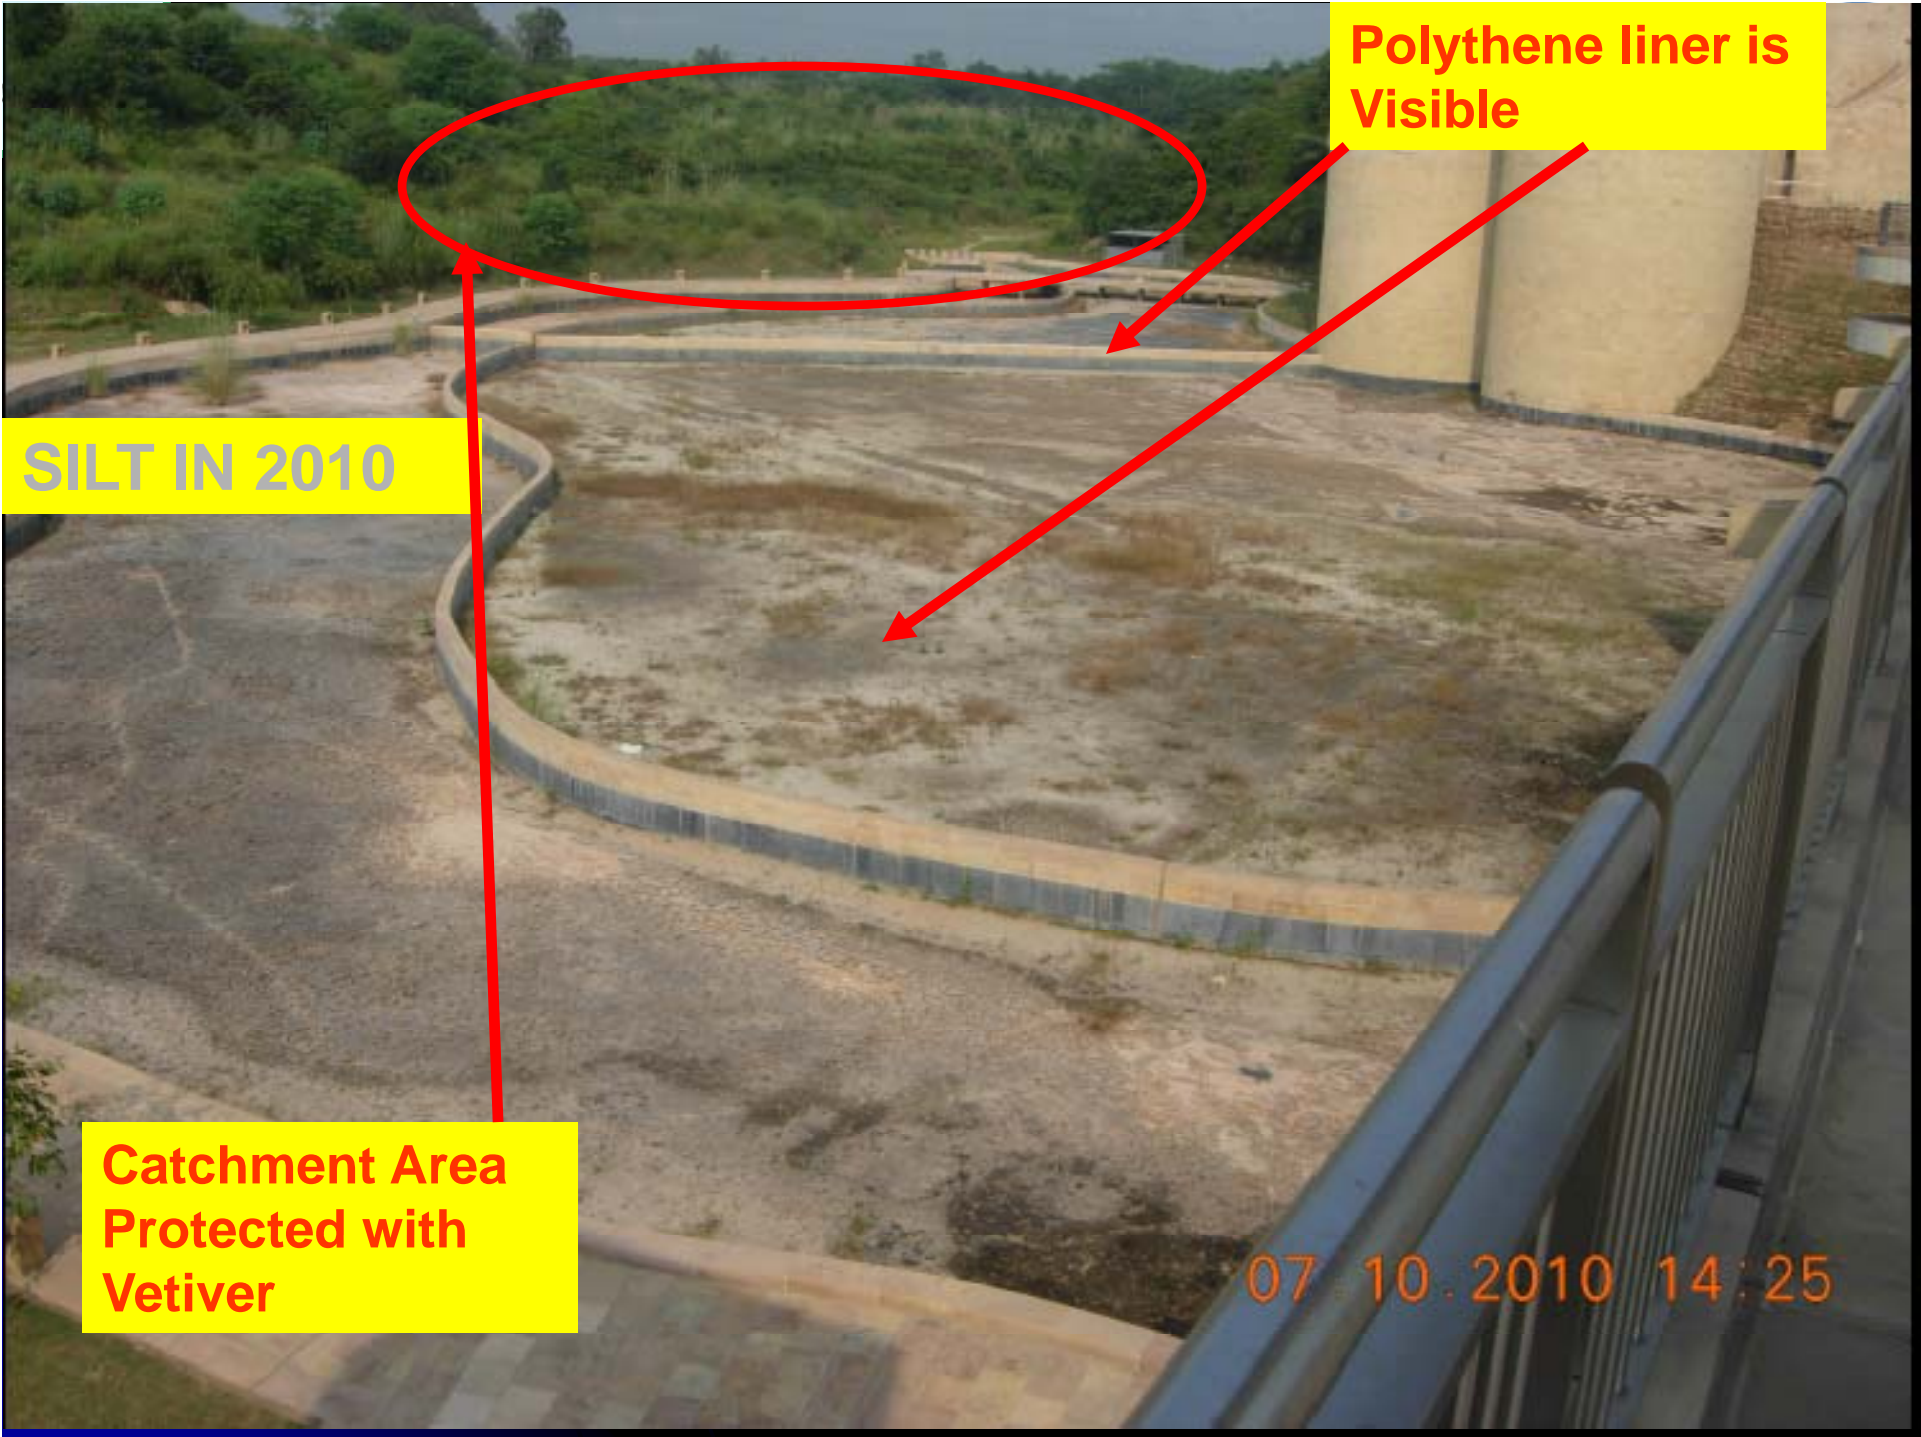
SILT IN OCT 2009

Polythene liner is Visible

SILT IN 2010

Catchment Area Protected with Vetiver

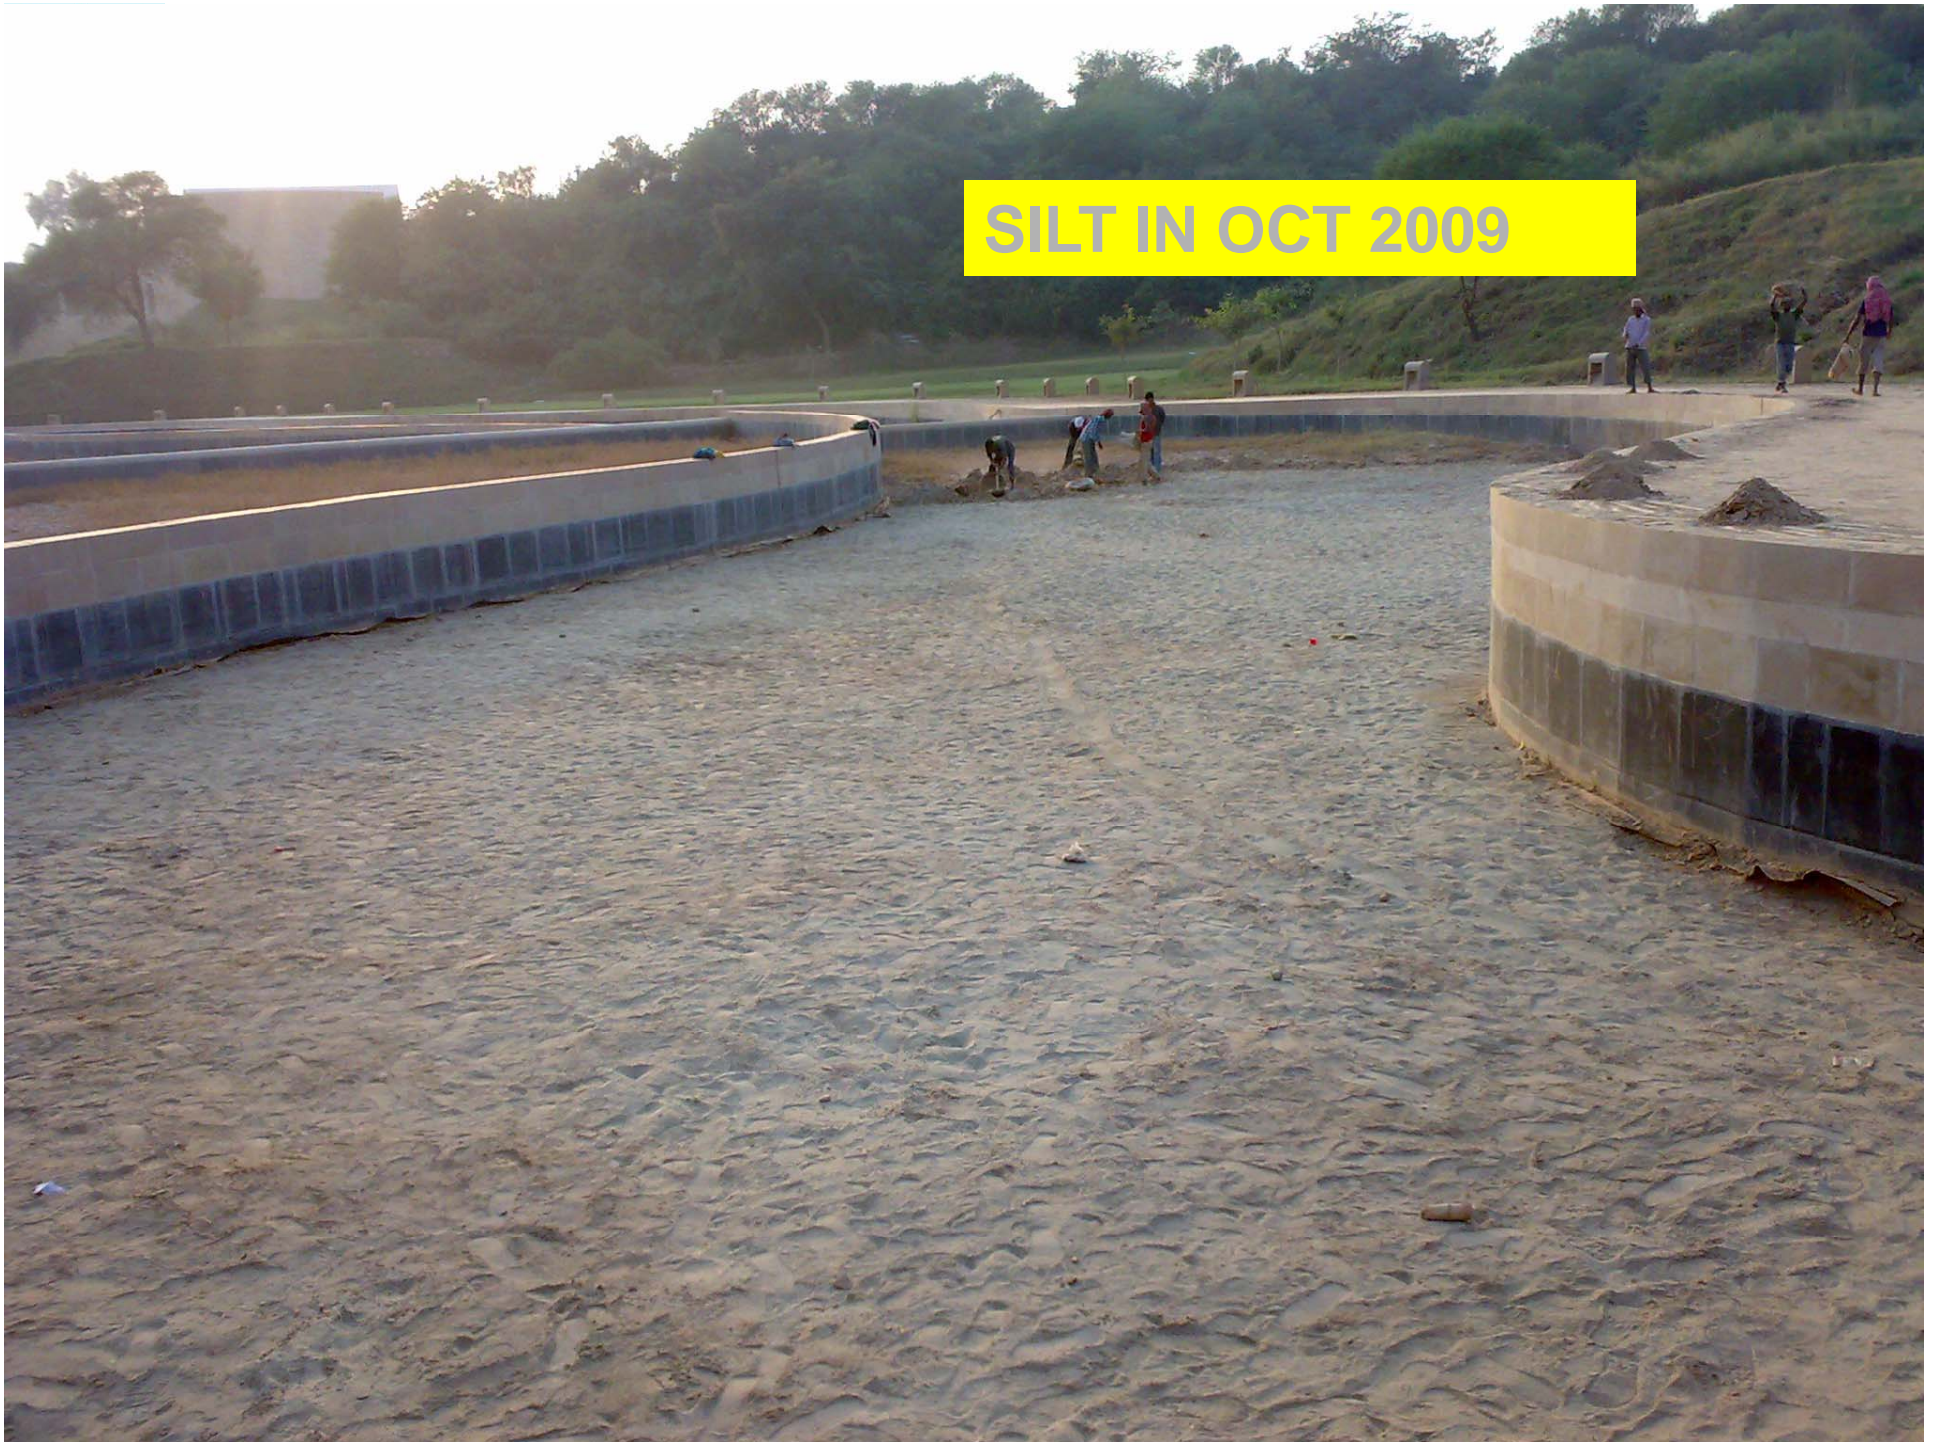
SILT IN OCT 2009

SILT IN 2010

First Cell:
Zero Silt

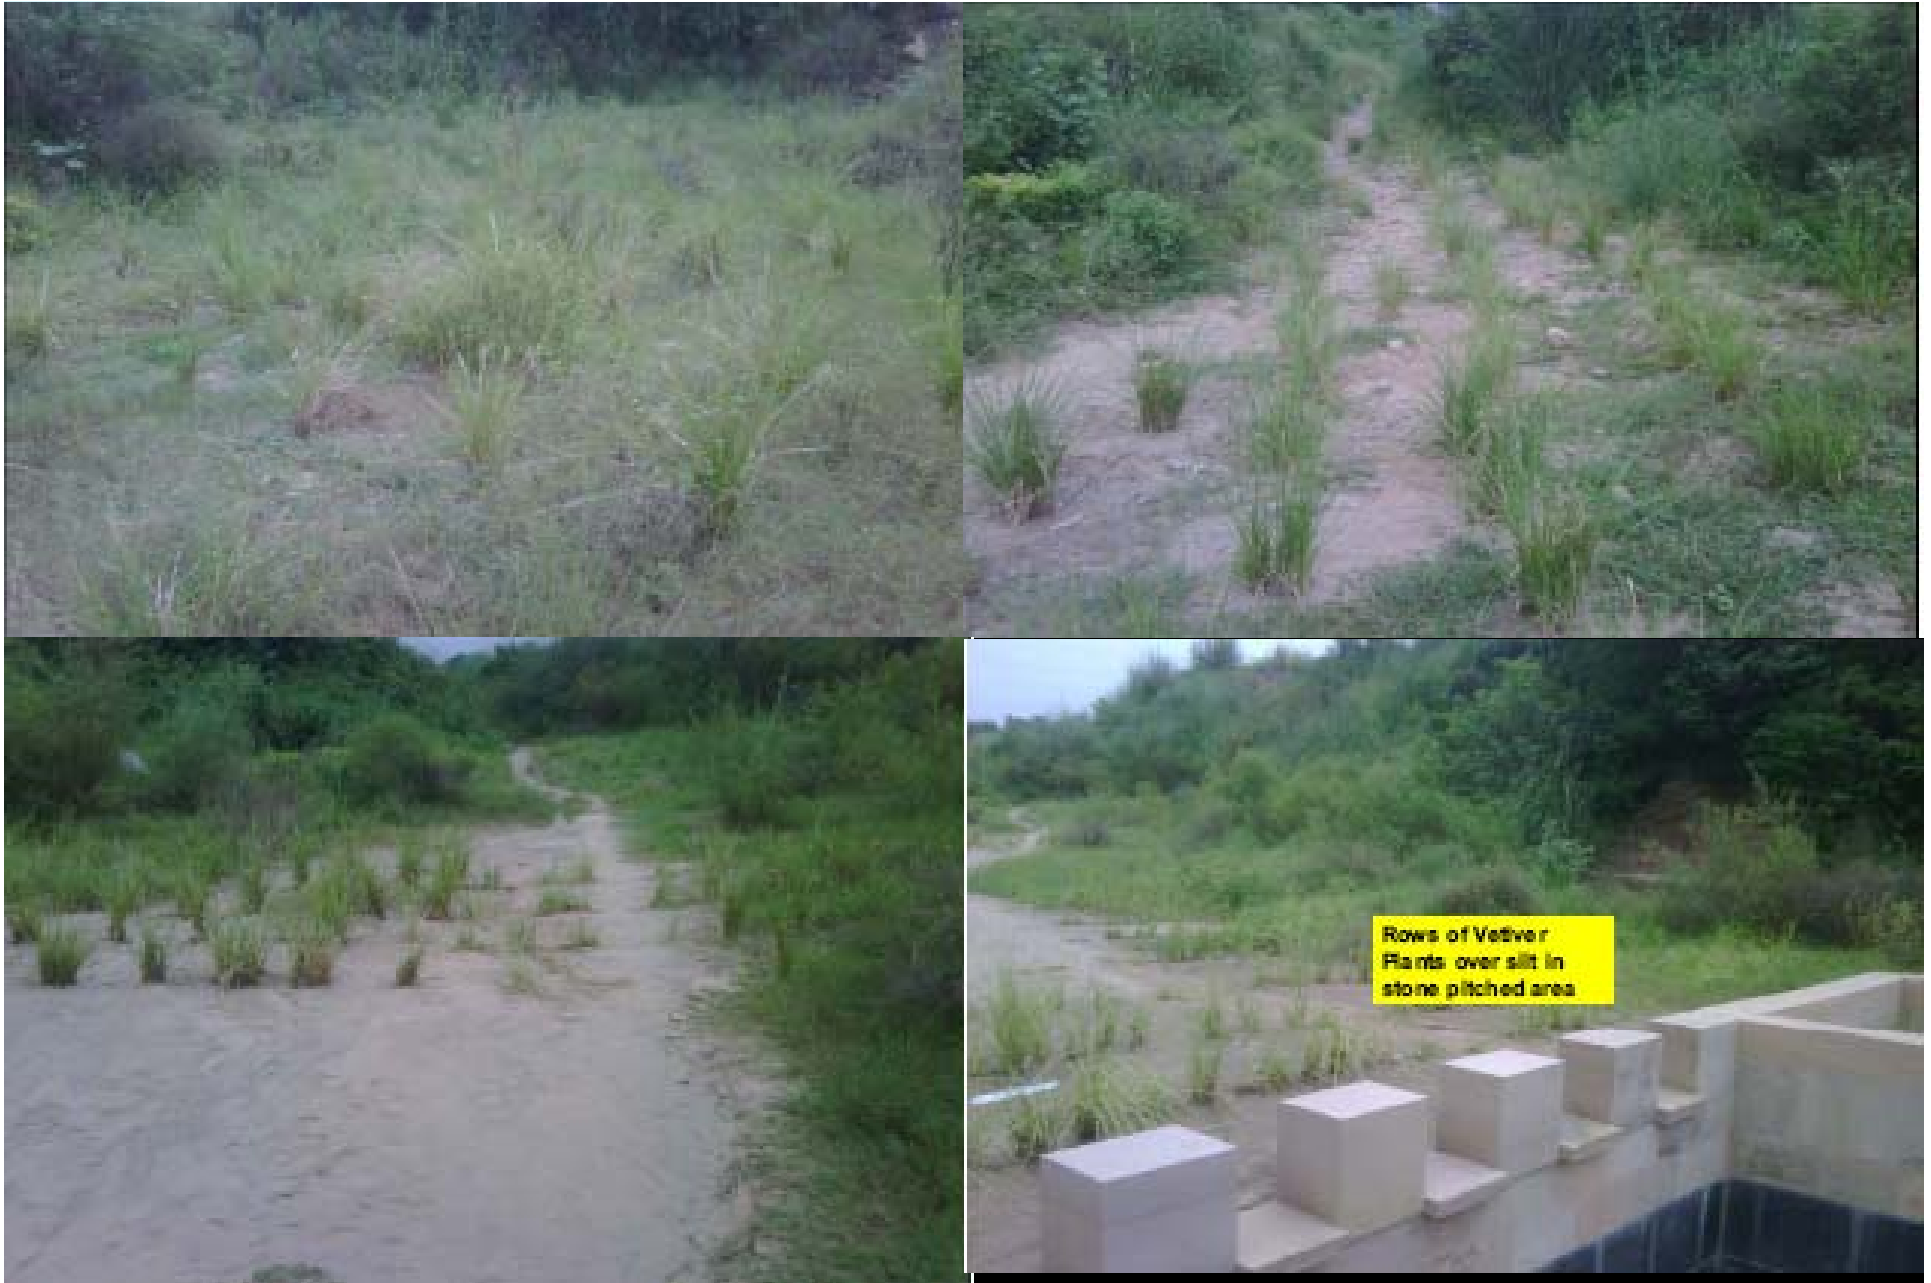
Our Intervention: Clumps of Vetiver strategically Planted in the rain to Prevent Silt Carried by the same rain to the Water Body.

The Silt was reduced by 99% at the end of the same monsoon as planting

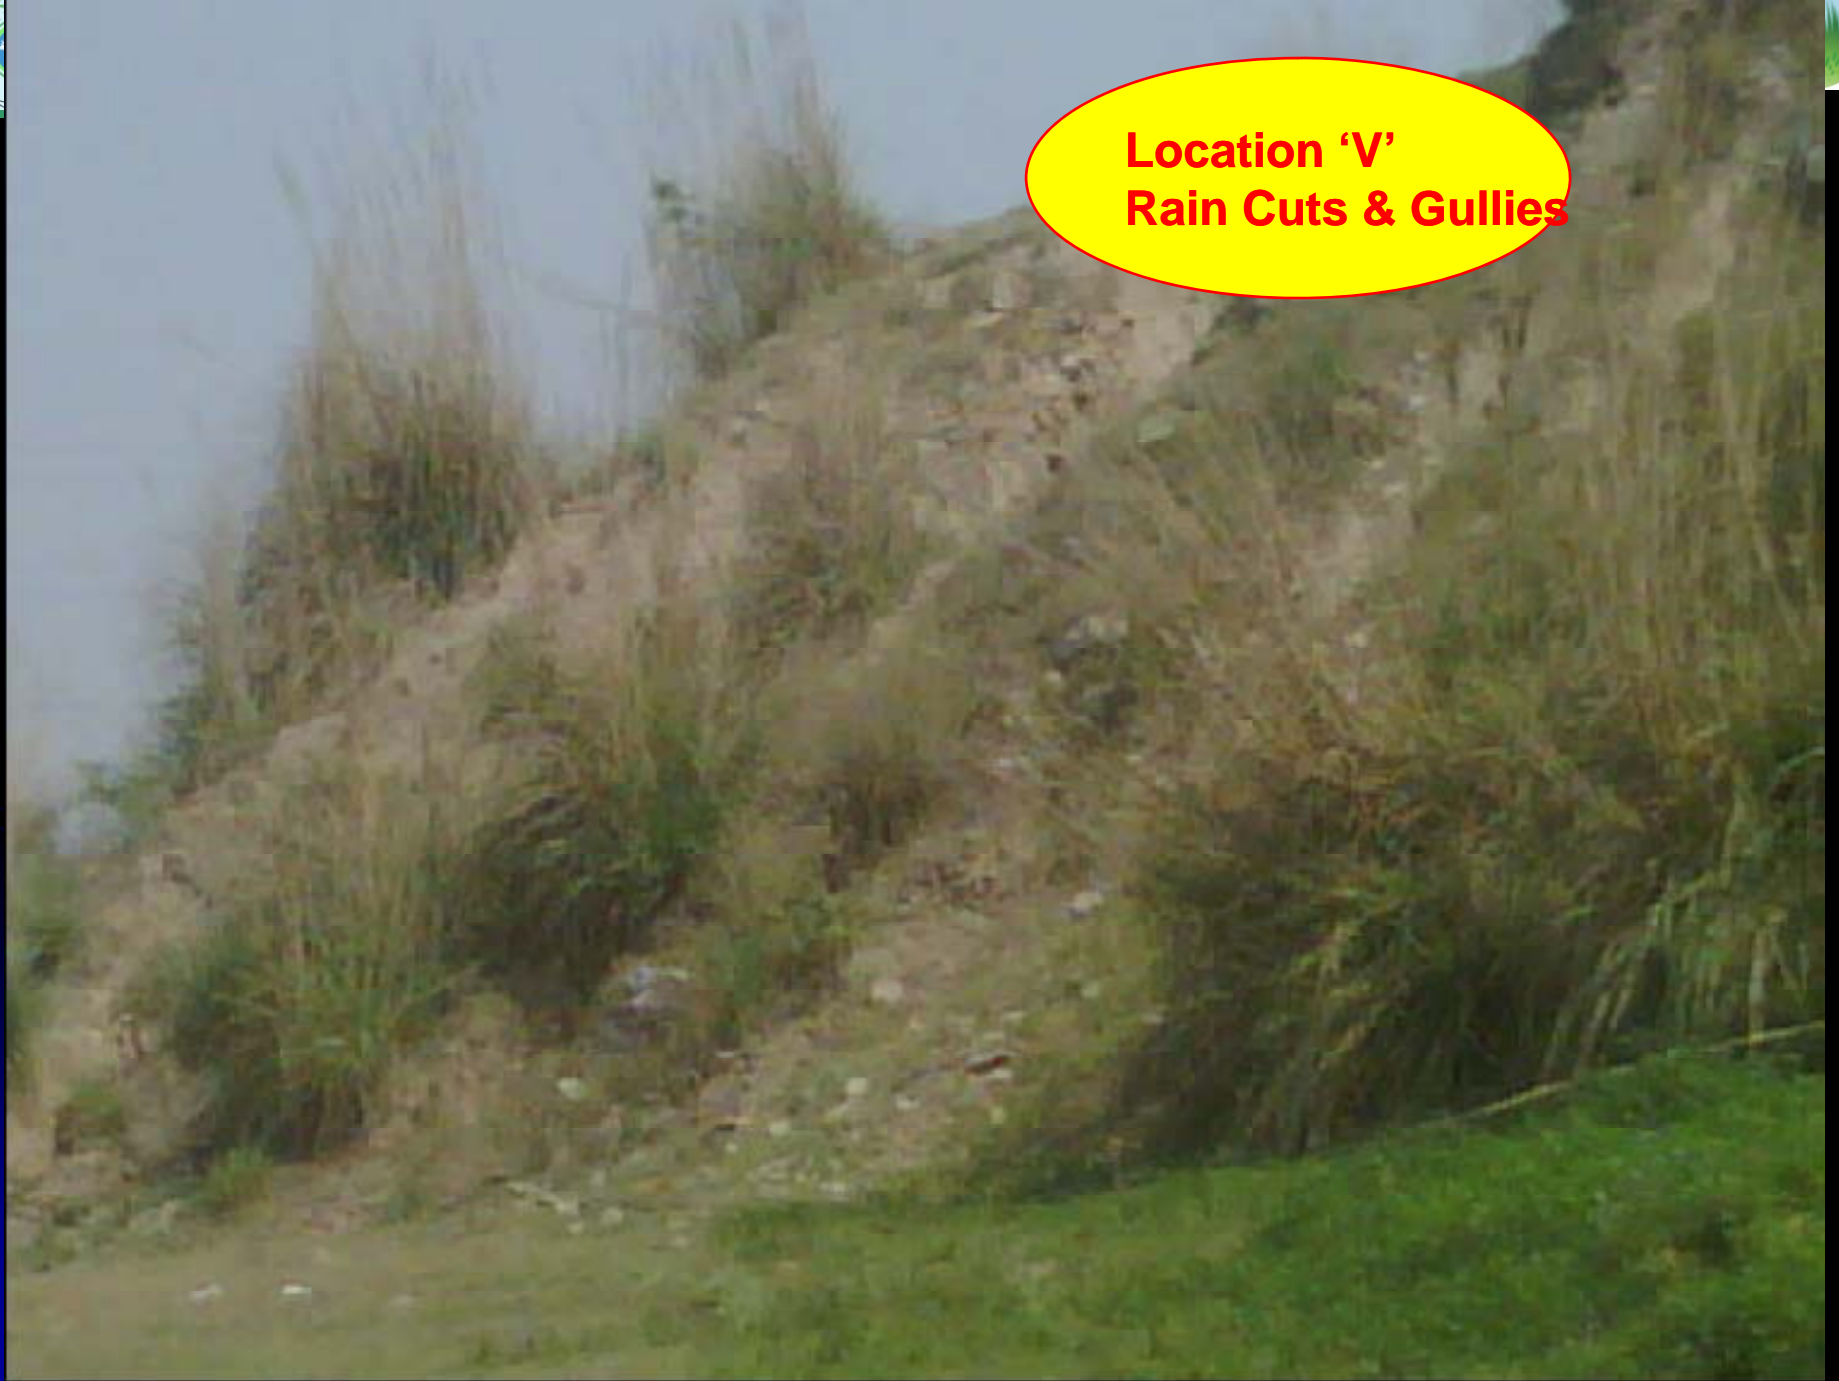
**Location 'V'
(Behind Drop off)**

**Location 'V'
Rain Cuts & Gullies**

The dangerous Rain Cuts and
Gullies Behind Drop off and
some other Gullies in the
Catchment area of the water
Body, need the same
treatment

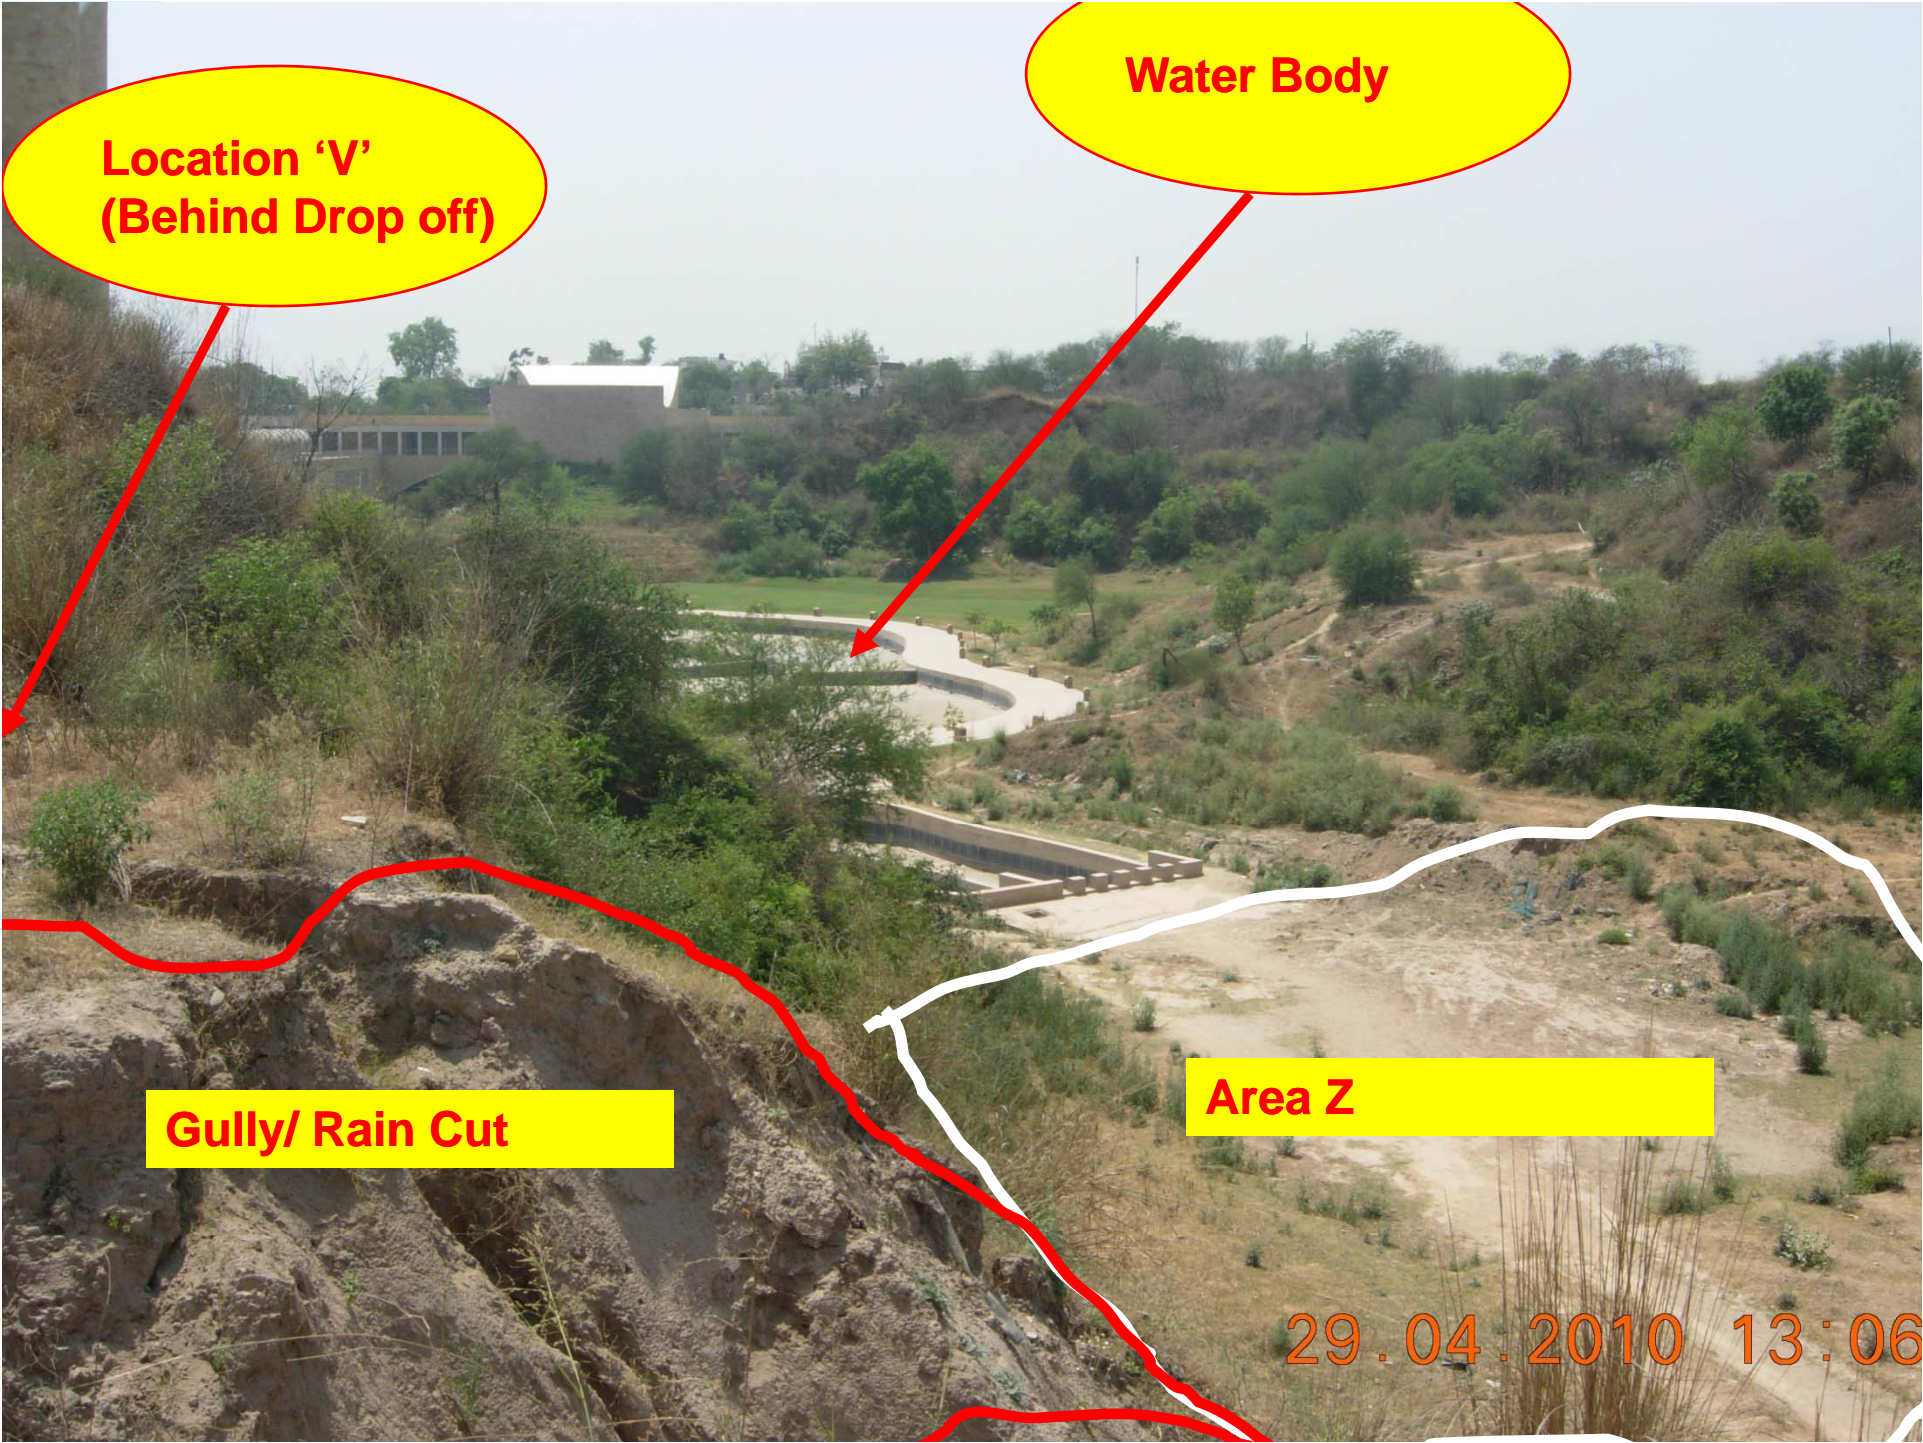
**Location 'V'
(Behind Drop off)**

Water Body

Gully/ Rain Cut

Area Z
