REDUCING THE FOOTPRINT & INCREASING THE HANDPRINT Through Positive Interventions with The Vetiver System

Presentation at ICV-5, Oct 28-30, 2011

Applications of VS used at Anandpur Sahib

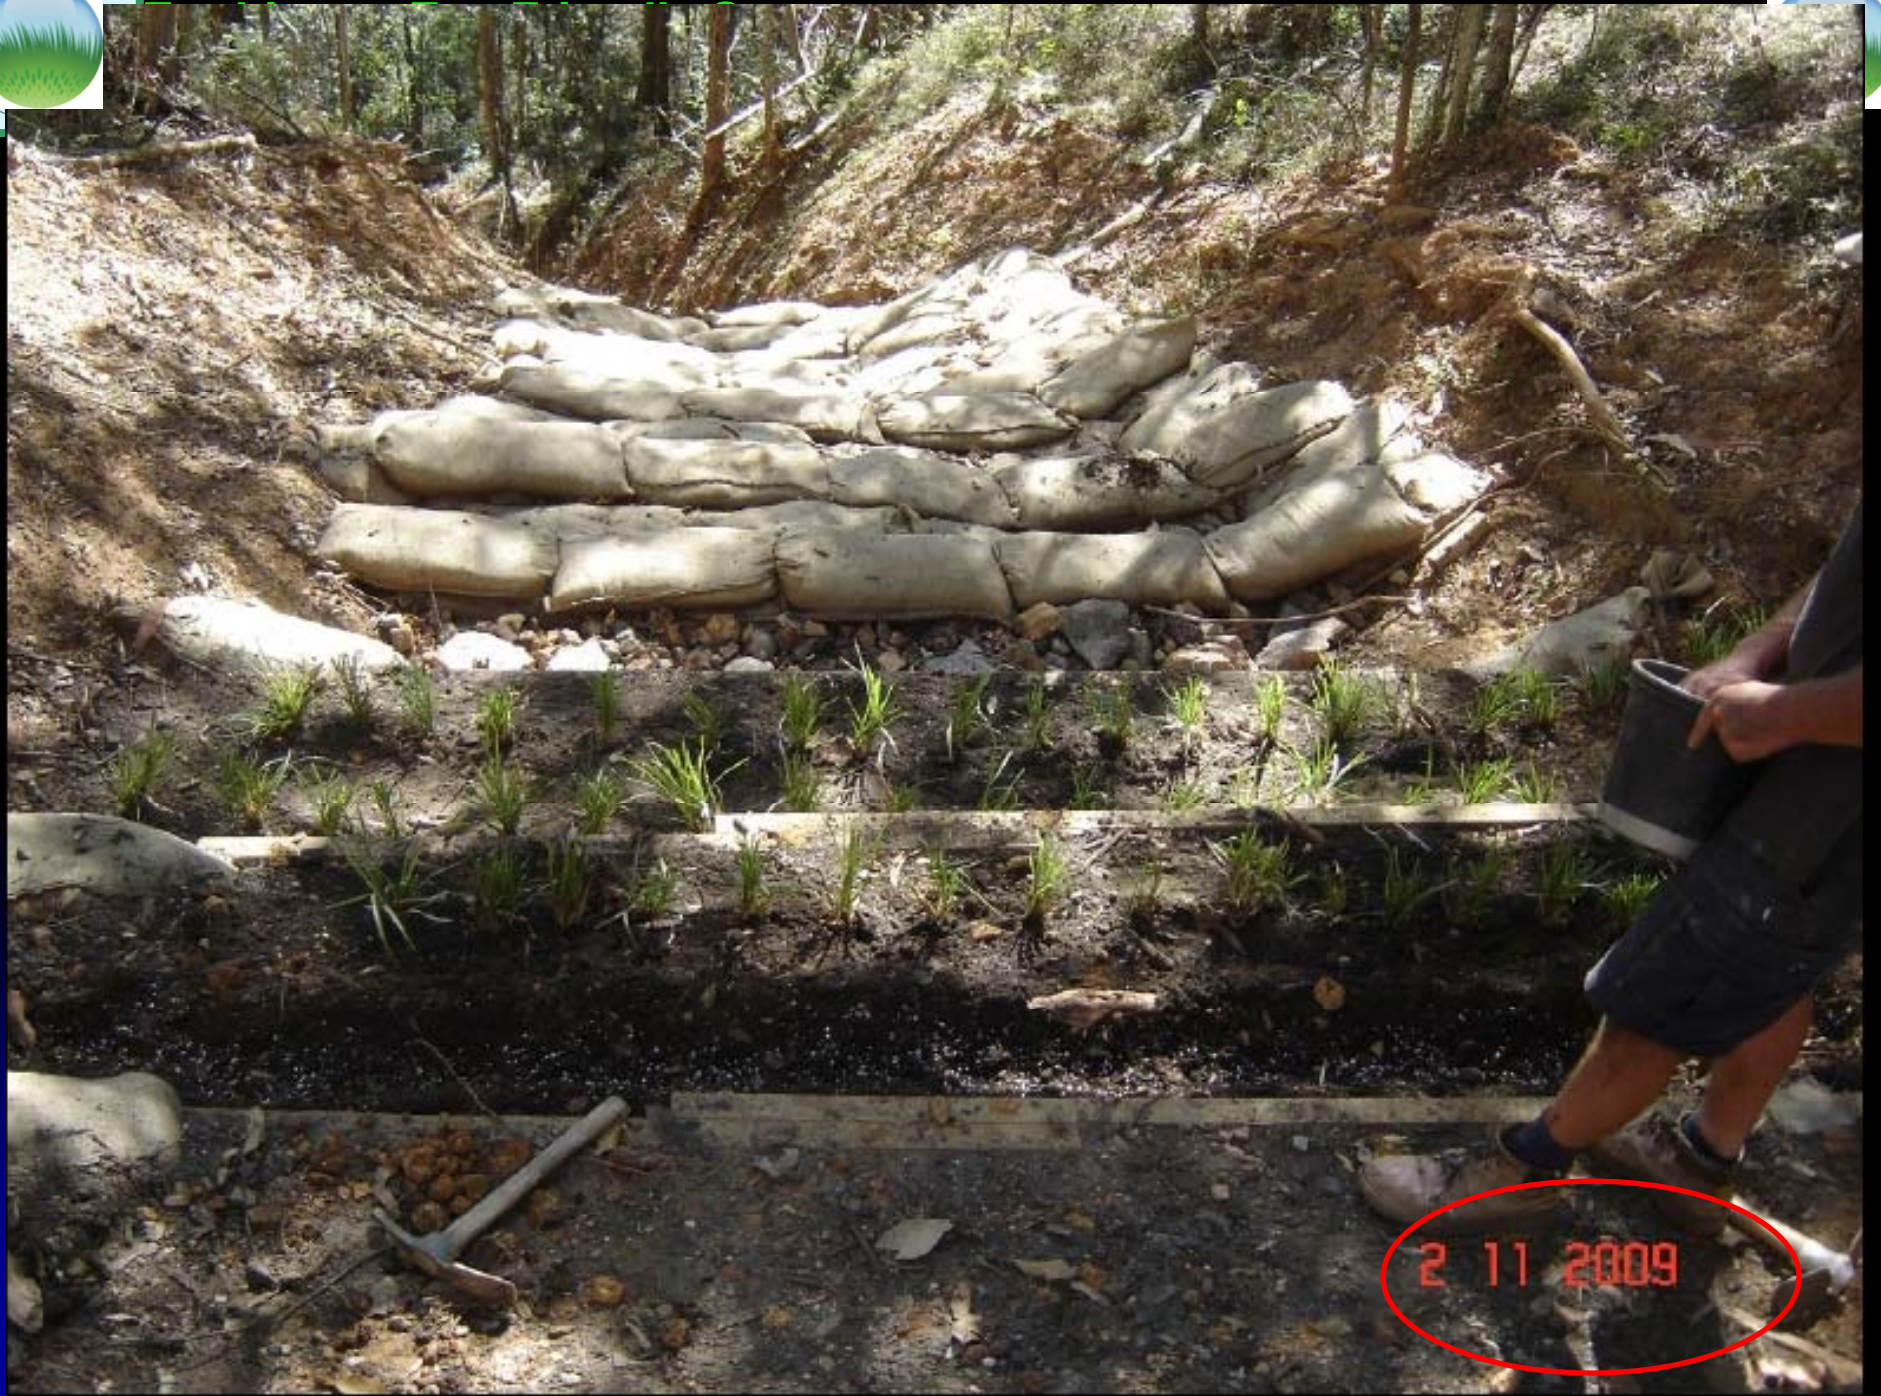
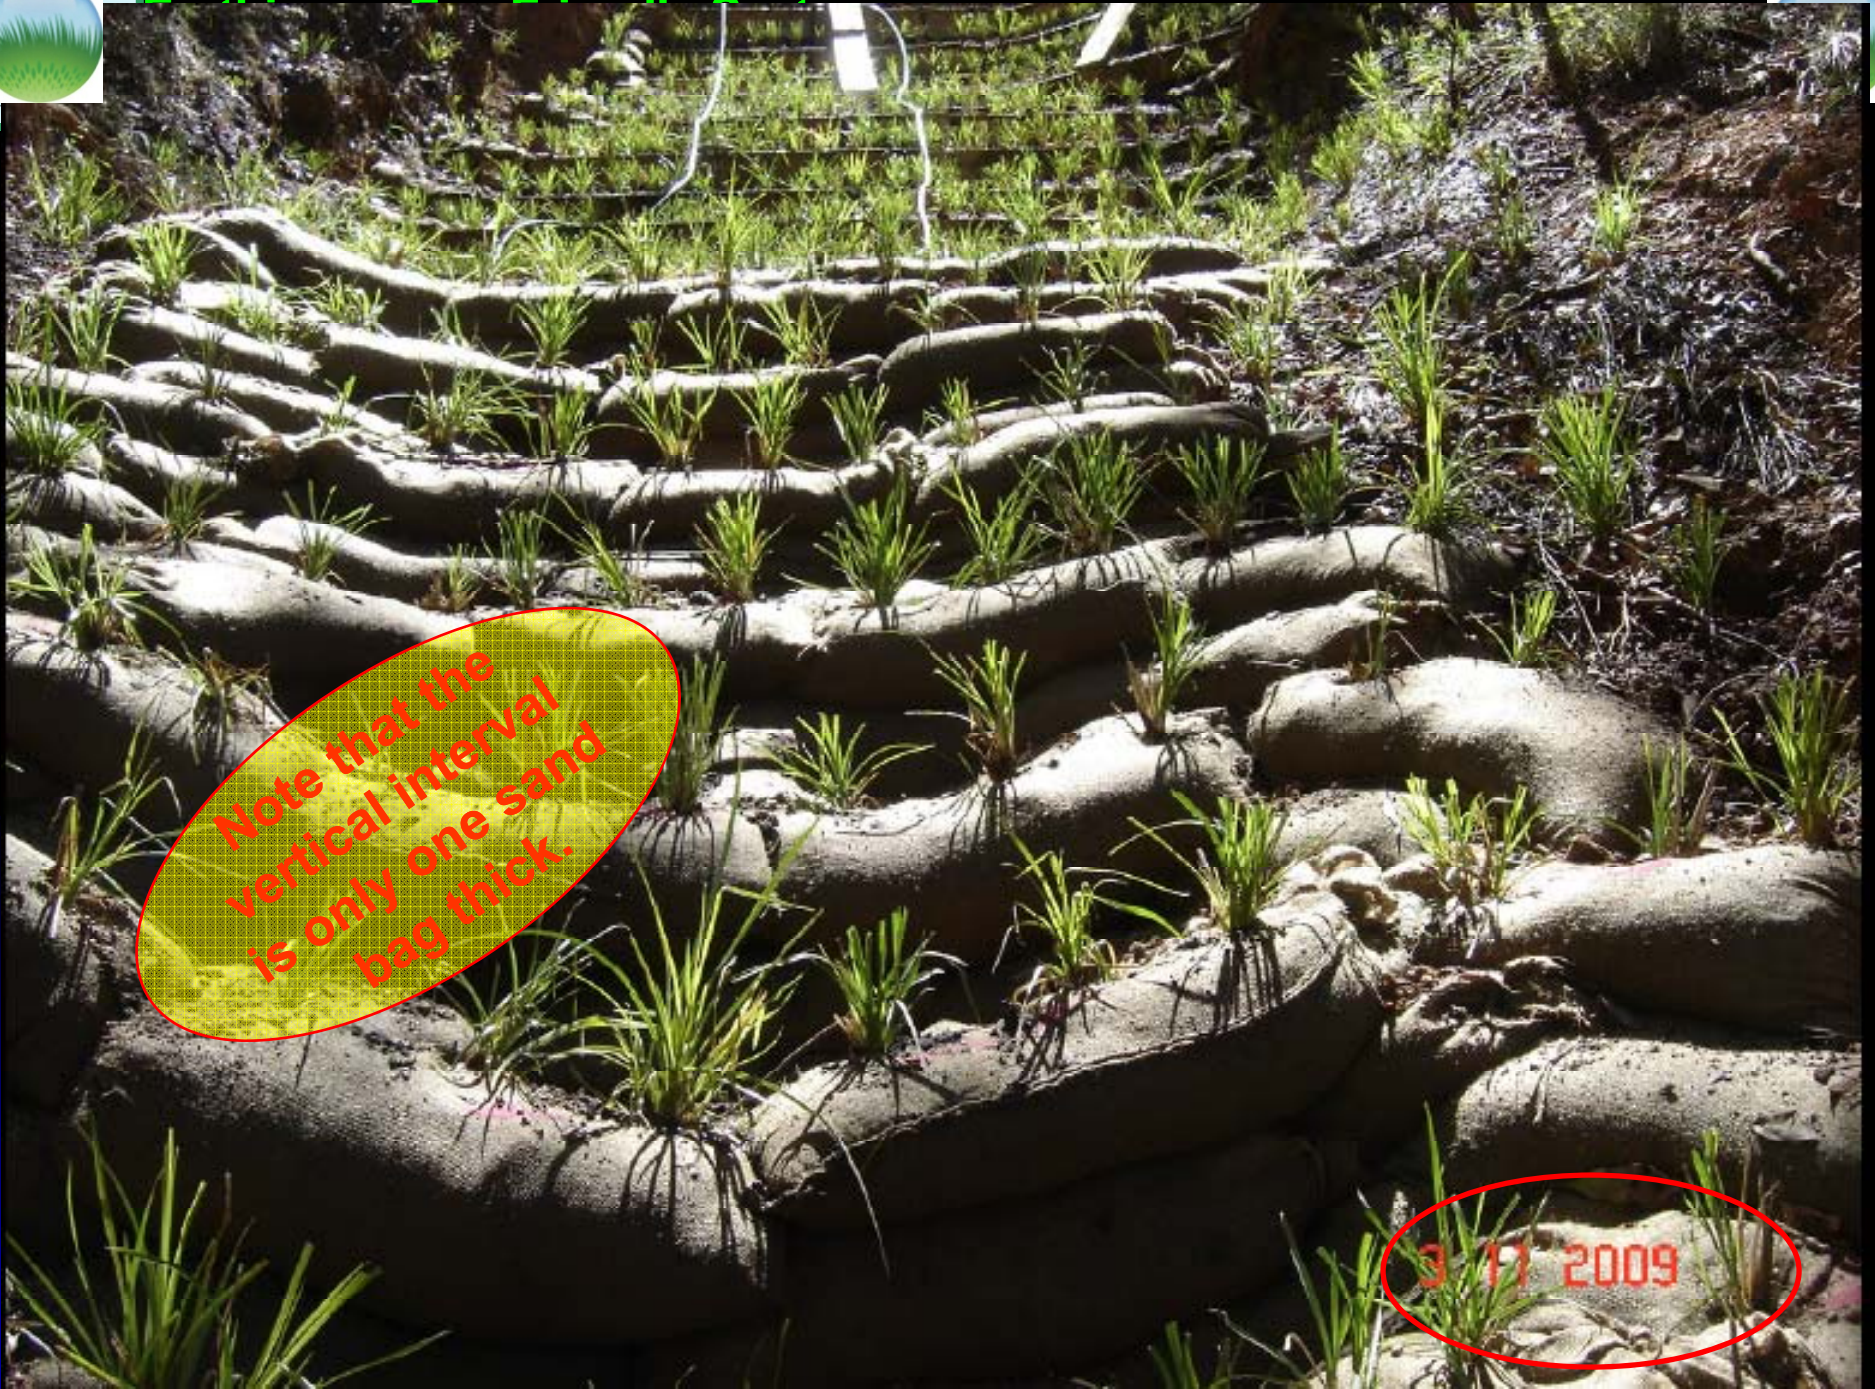
Gully Control by Dr. Paul Truong, Australia

- The Gully was reshaped and bags were placed the same has **has been done here**
- The bags were filled with 1/3 to 1/2 of soil+ N&P fertilizers for fast growth
- and 1/2 sand to make it heavy to sit firm on the surface.

Note that the vertical interval is only one sand bag thick.

In just Two months!

**Fertilizer and
soil has made
the difference**

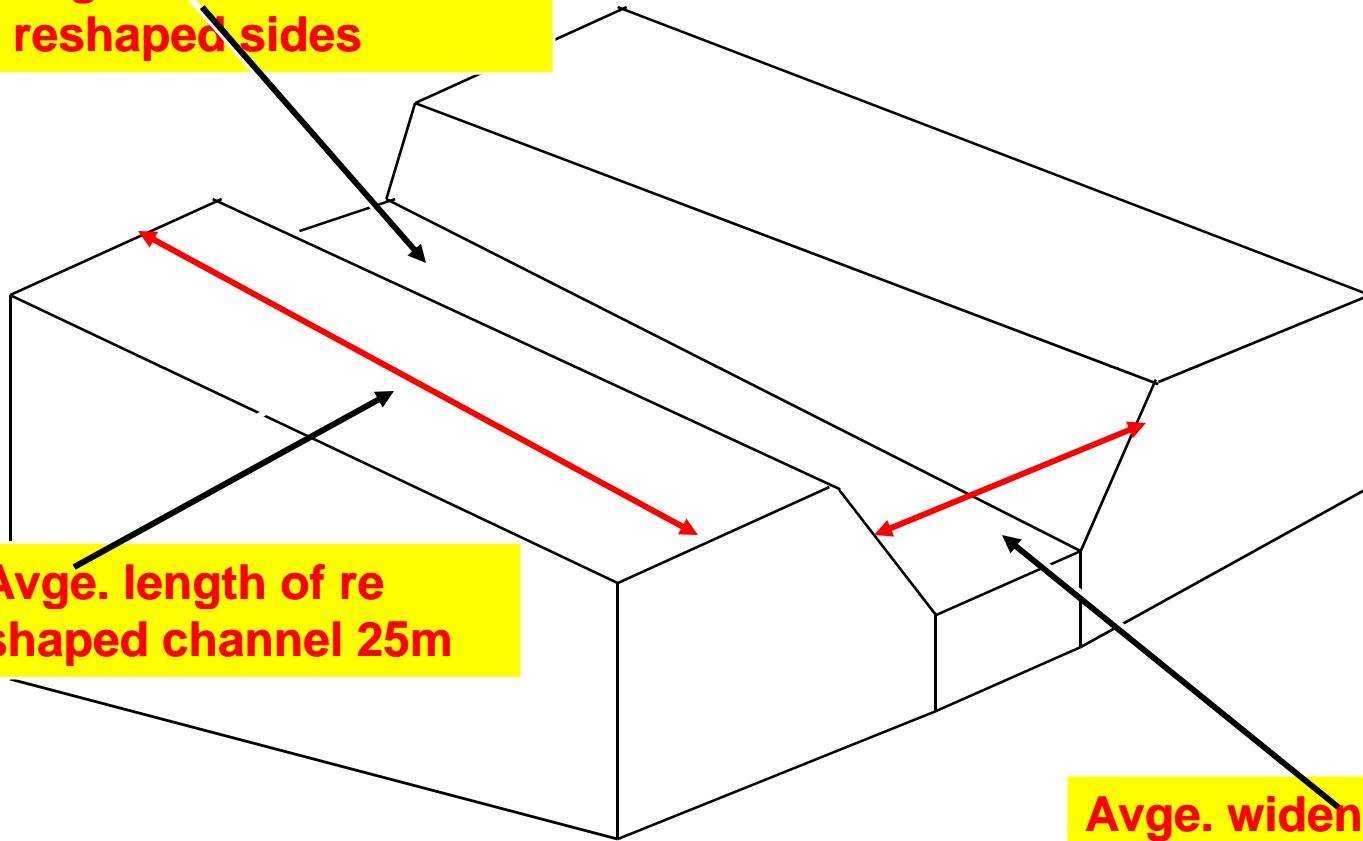
1 or 2 layers of Soil bags + soil from reshaped sides

Avge. length of re shaped channel 25m

Avge. widened width of re shaped channel 10m

Average 5 rows running across reshaped slopes.

Total rows per raincut (average) = $5+5=10$

Total length of rows/raincut = $10 \times 25 = 250\text{m}$

Total length/ raincut in addition to the rows running across hill = $250+50= 300\text{mtrs}$

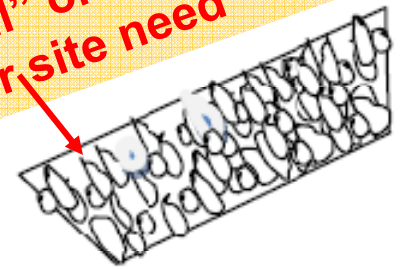
Trapezoidal "porous wall" one or two as per site need

Vetiver rows running across hill, already accounted for

Assume 5 additional rows at the bottom of the canal, total length = $5 \times 10 = 50\text{m/ raincut}$

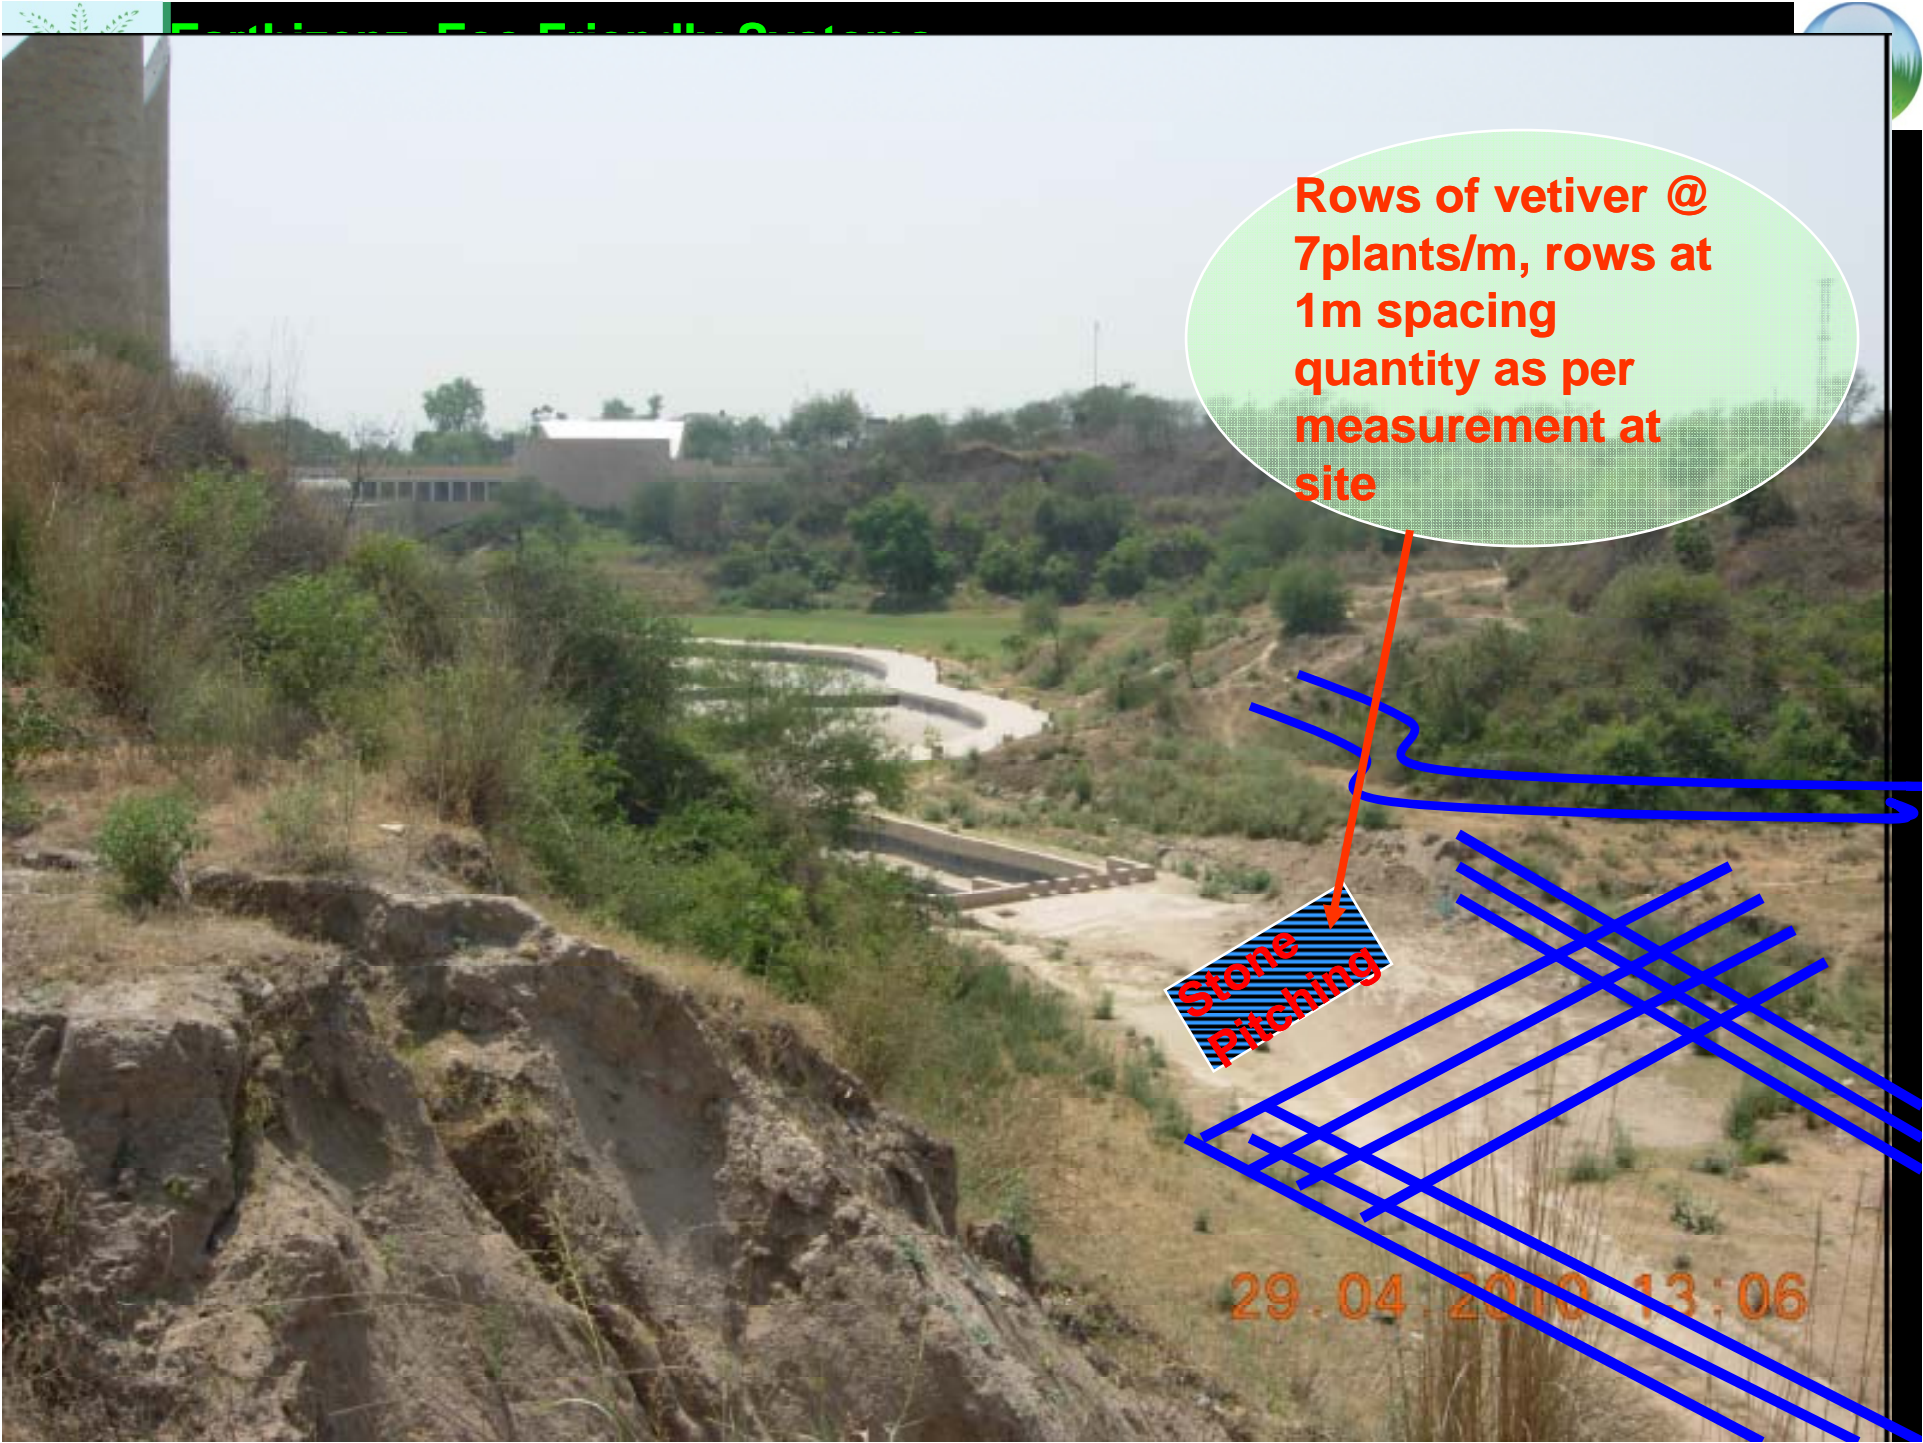
**Rows of vetiver @
7plants/m, rows at
1m spacing
quantity as per
measurement at
site**

**Stone
pitching**

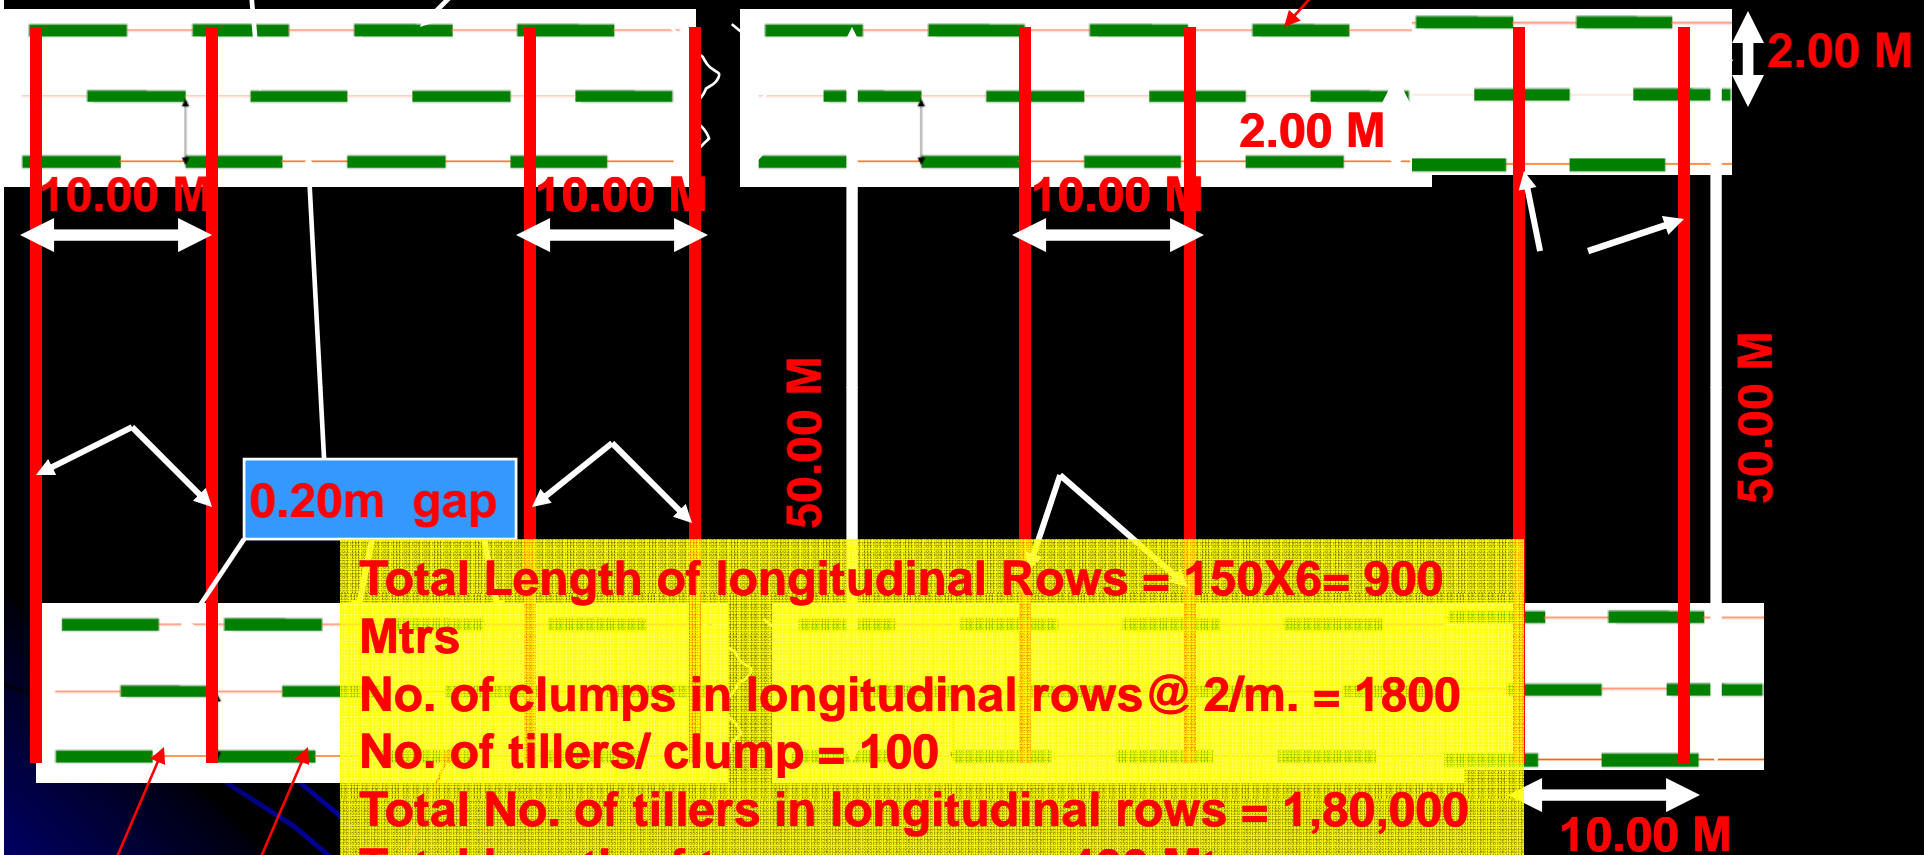
Total Length of longitudinal Rows = $150 \times 6 = 900$ Mtrs

No. of clumps in longitudinal rows @ 2/m. = 1800

No. of tillers/ clump = 100

Total No. of tillers in longitudinal rows = 1,80,000

Total length of transverse rows = 400 Mtrs

No. of clumps @ 3/m in transverse rows = 1200

Total tillers @ 100/clump = 1,20,000

Total tillers in basin area = 3,00,000
