# Vetiver Solution – A Total Success in Landslide Stabilization at Itaipava, Petropolis, Rio de Janeiro, Brazil

João Henrique Eboli\*, Paulo R. Rogério\*\* and Paul Truong\*\*\*

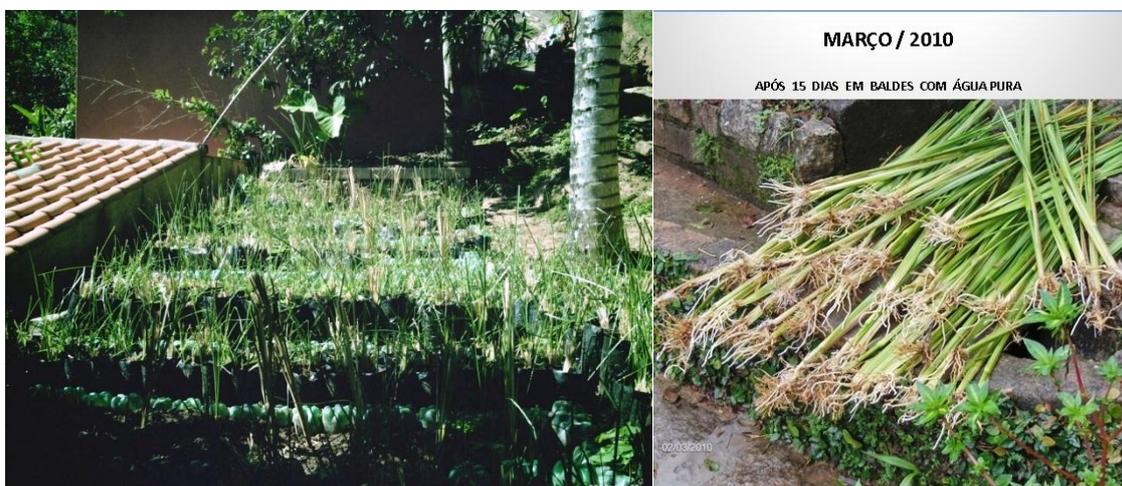
**Fig 4. Vetiver nursery and healthy vetiver slips ready for planting out**

Vetiver slips were raised in nursery first when young and when vigorously growing roots emerged the slips were ready for planting out (Fig.4).

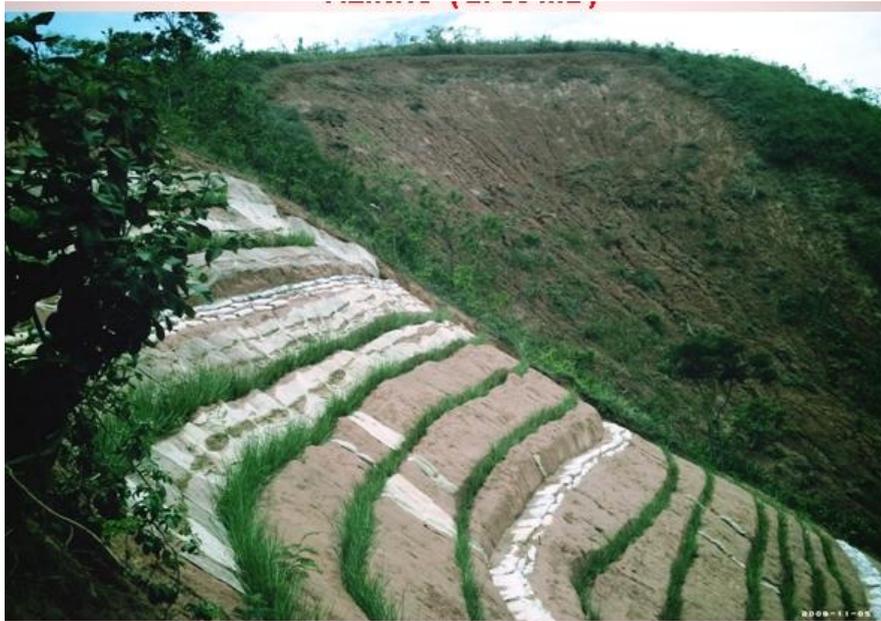
**Fig 5. Contour rows planted at VI between 1 and 1.5m**

The Vetiver slips were planted at 10 plants/m (4 inches) and Vetical Interval (VI) varied between 1.0 and 1.5 meters. The Vetiver was planted in July/2008 and completed by December/2008 (Fig. 5).

The land between the Vetiver hedgerows was totally covered with mulch (straw and sawdust: 0,5 kg/m<sup>2</sup>) and jute bags to improve the soil roughness between the contour lines.

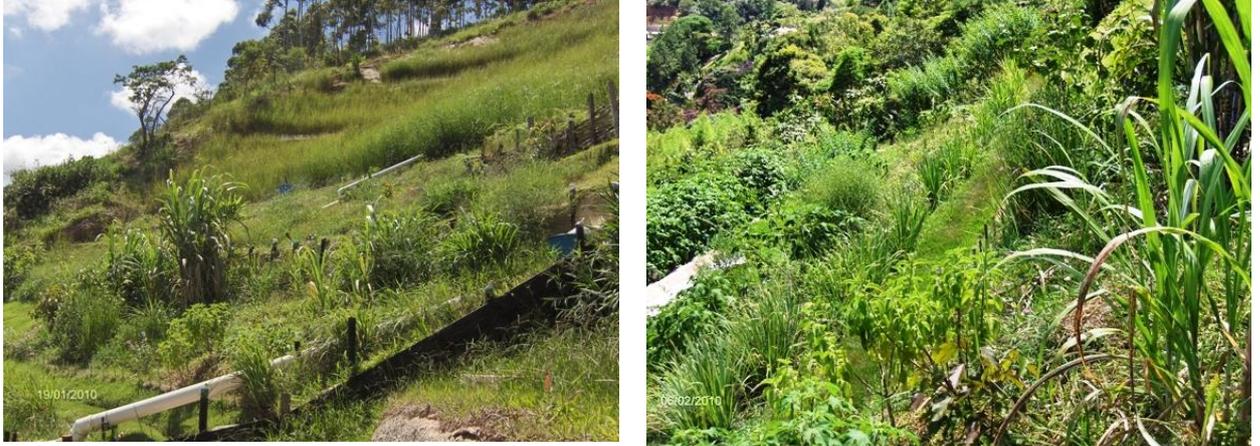
**Fig 7. Shrub and fruit tress planted in inter spaces on lower slope**

On the lower part of the slope, in addition to the Vetiver planted as a “live nail”, some leguminous plants, shrubs, fruit trees, grass, were planted. Today 95% of the area is fully covered with vegetation (Fig.7).

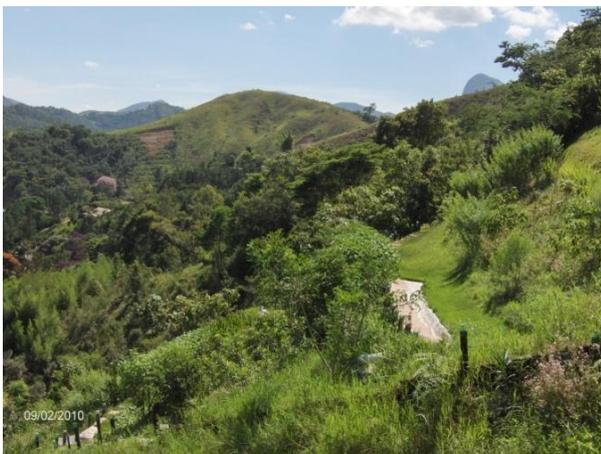
**Fig.8: Lower part of the slope**

After three years since the landslide, although suffering strong winds and heavy rains, the hill slope remained fully intact with the help of the Vetiver, which is now fully grown and mature, and firmly holding the soil ( Figs.8 and 9 ).

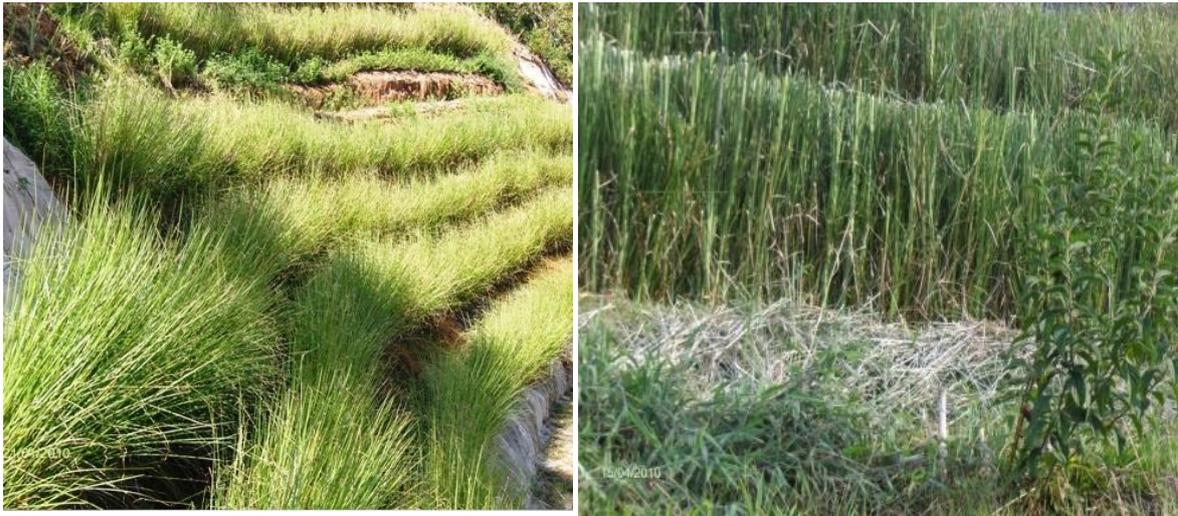
**Fig.10: “Soil Nails” and the green wall**

It should be noted that in December 2010 the monthly precipitation has reached 350 mm (concentrated in the last few days of the month) and during the week before January 11, 2011 the precipitation was 60 mm, and the slope remained intact thanks to the “Soil Nails” and “Green wall” (Fig.10). In December 2010, 2 years after planting, root depth measured at three points along the slope were 2m-2.5m deep into the soil mass, but most impressively is the fantastic root network between the plants.

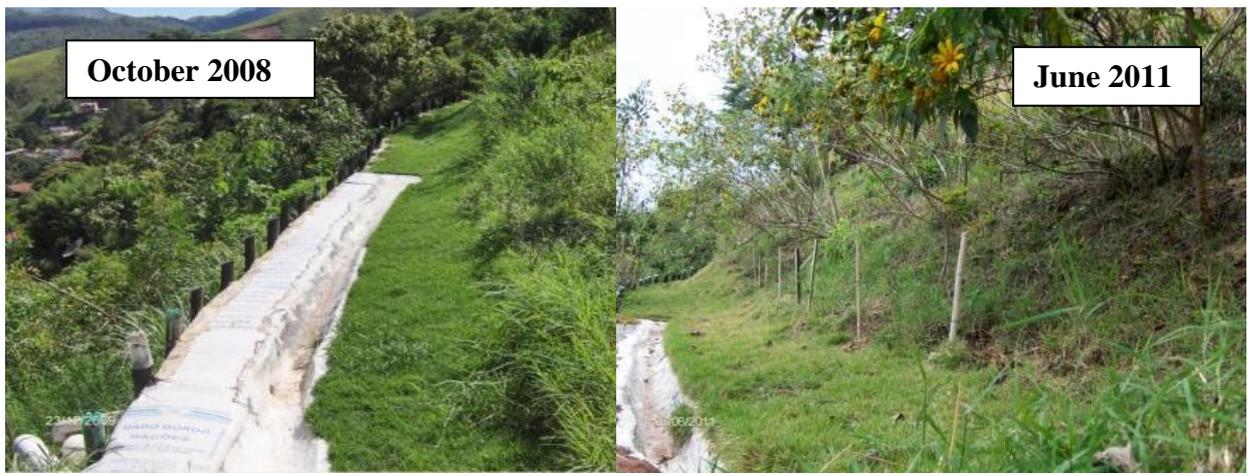
**Fig.11: Before and after**

Figs.11 shows the before and after scene of a properly installed wall incorporated with vetiver planting.

Also Vetiver can be placed in the voids of the wall. When planting Vetiver, more “natural soil nail” will hold the wall into the soil mass, exerting great adherence. There are instances where the Vetiver solution can be used as a stand alone technology or can be combined with others. Each case must be separately evaluated and defined during project design. In the present application, to reduce the gradient on the lower part of the slope, four retaining walls of 1m high each reinforced with soil/cement were built.

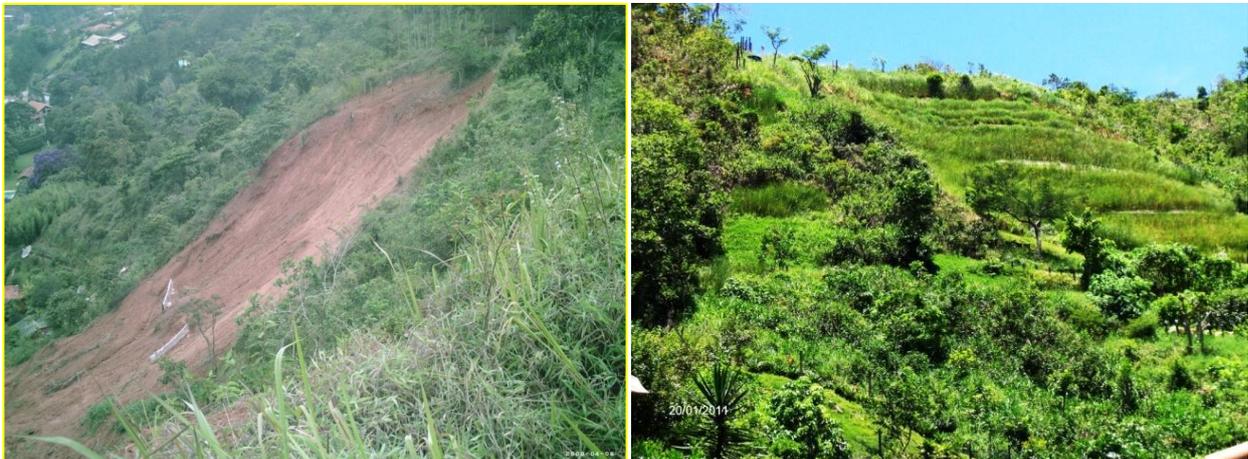
- So far the slope has maintained its integrity demonstrating and proving in the real world that the plant *Vetiveria zizanioides* can rehabilitate and maintain slopes affected by landslides. This is due to properties of having strong and lengthy roots, equivalent to an engineer's soil nail.
- The VS will fail when not properly applied or not well maintained. The Vetiver when installed and following the correct technical guidelines is a guaranteed success.
- Perhaps the only real defect of the Vetiver solution is: *Too cheap to be true, too cheap to believe when compared to heavy stone structures.*
- Here is the final living proof

April 2008

January 2011
