The Fifth International Conference on Vetiver (ICV-5)

Application of Vetiver System for Erosion Control in Brazil

Eng. Paula Leão Rodrigues Periera, Project Manager DEFLOR Bioengineering and Dr. Paul Truong, Technical Director TVNI

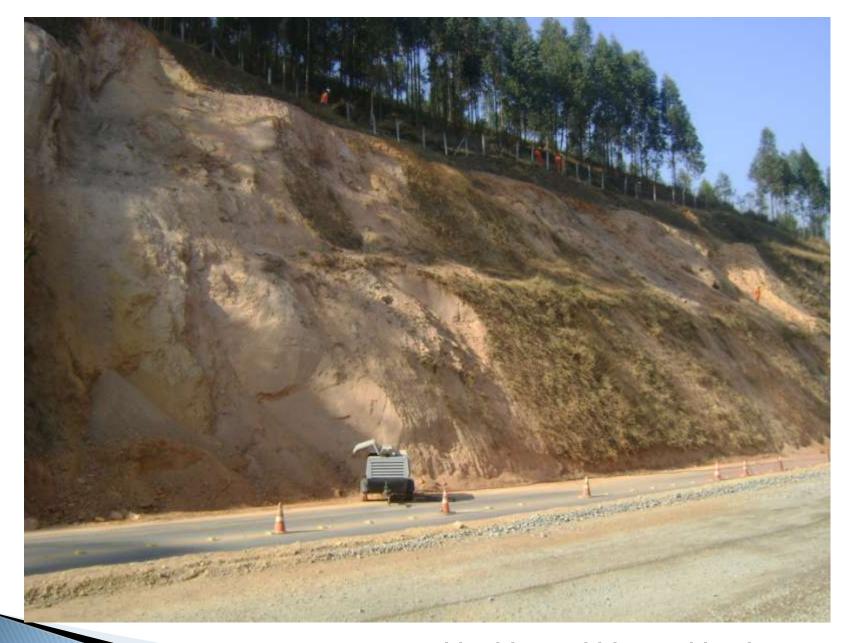
A typical highly erodible site like this are common

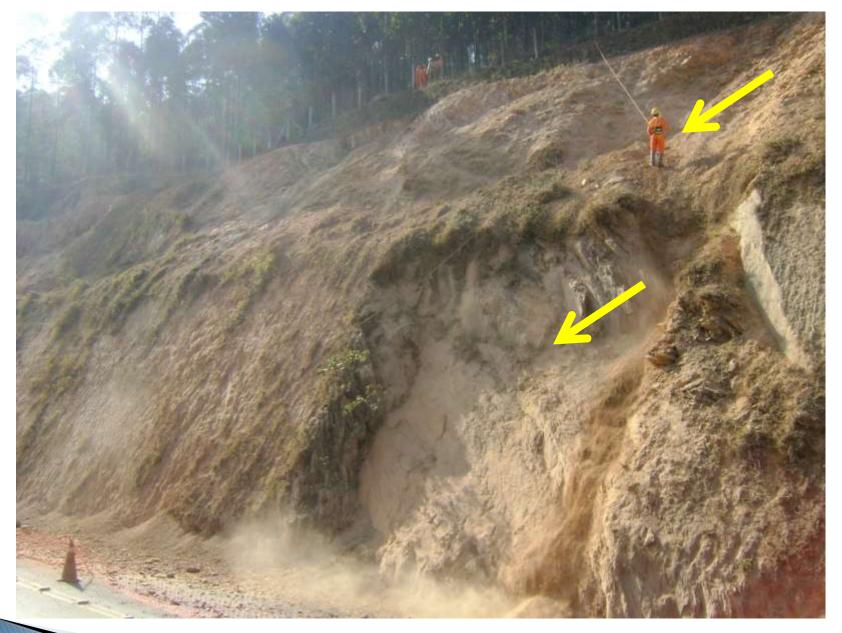
Note the large scale of the erosion on this highly erodible slope

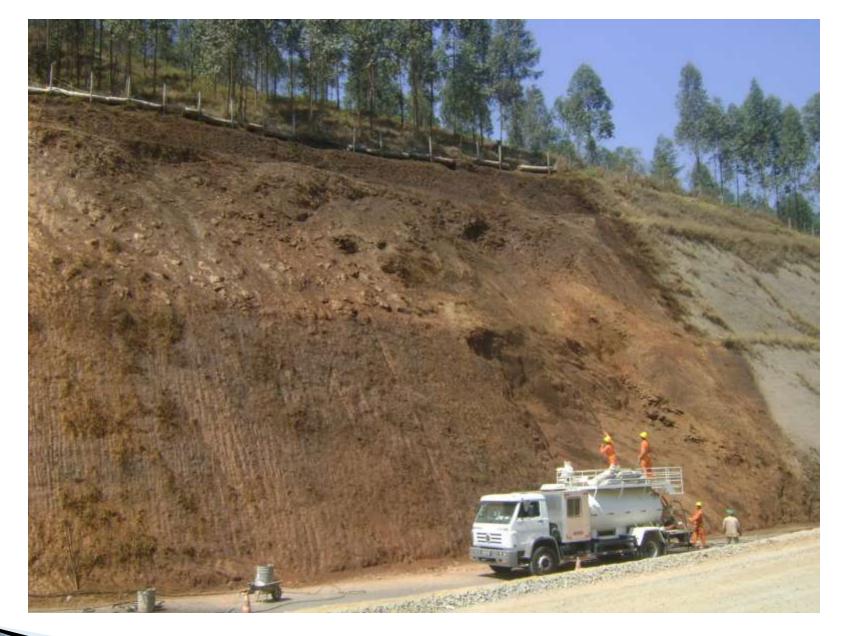
Hydroseeding after minimal surface reparation

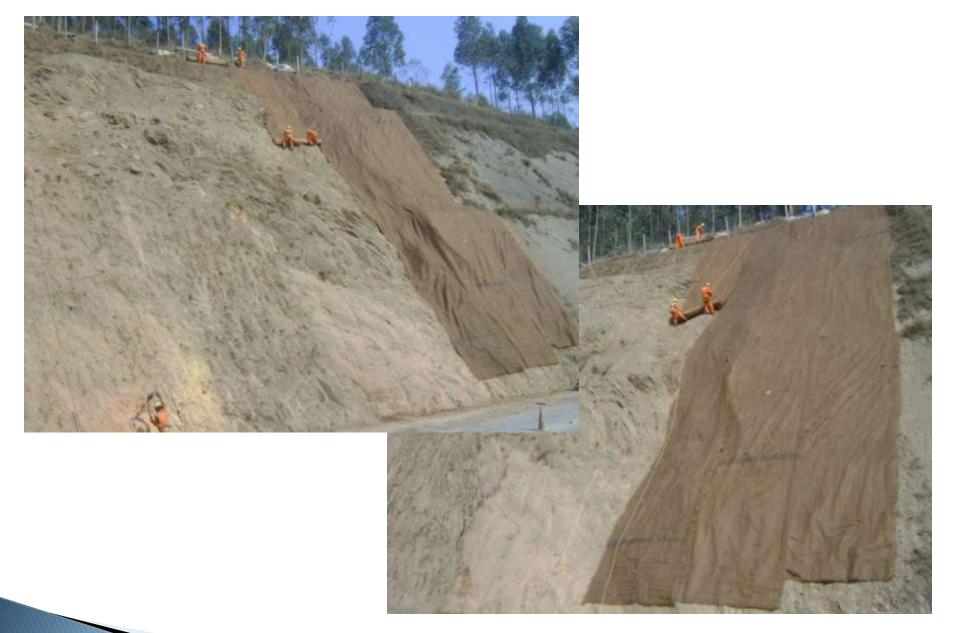
Coconut blanket laying

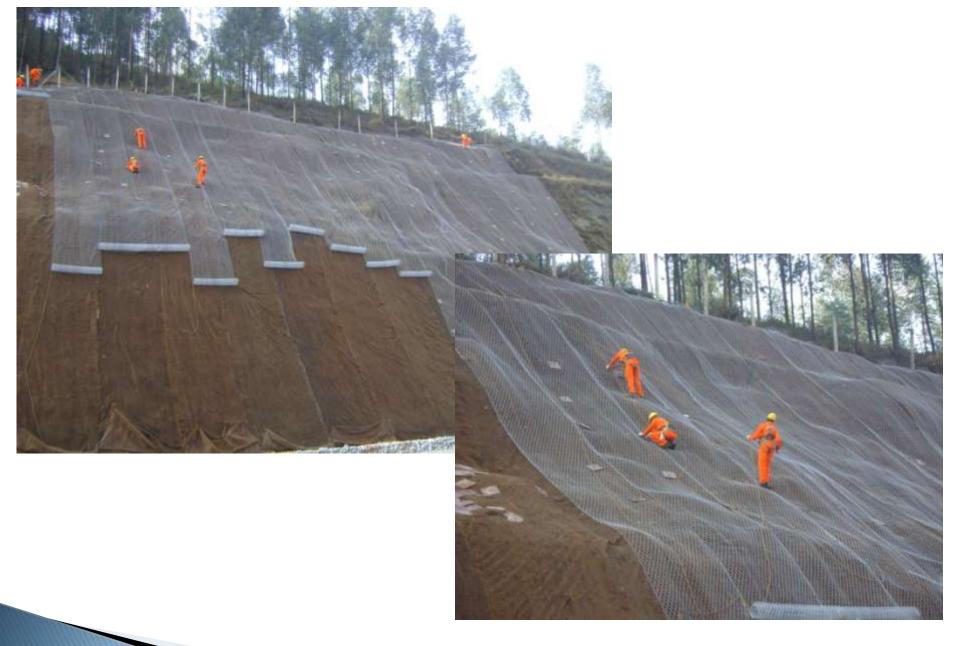
Wire mesh laying for extra structural protection

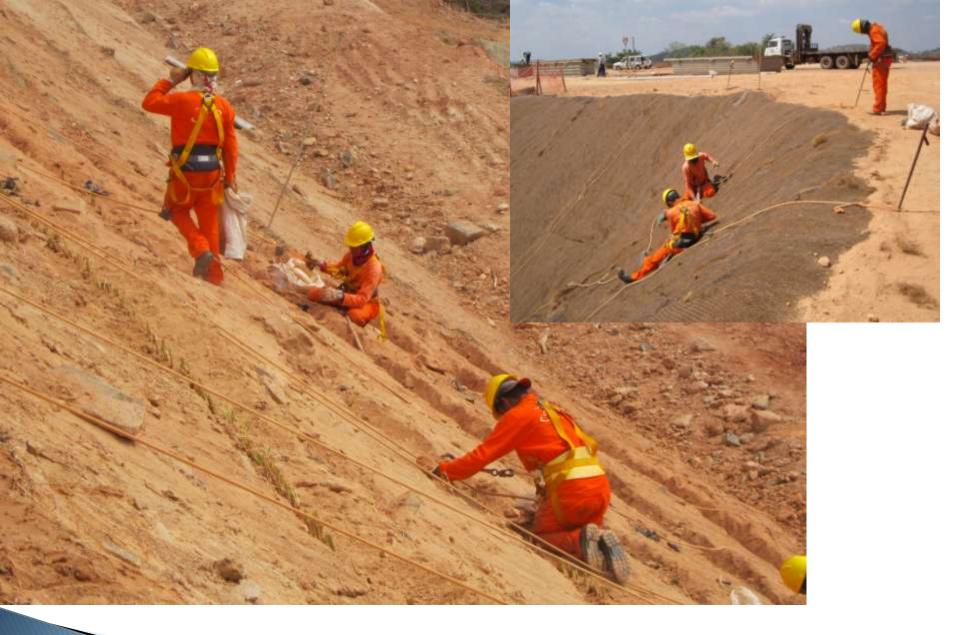
Planting on very steep slope requires security rope

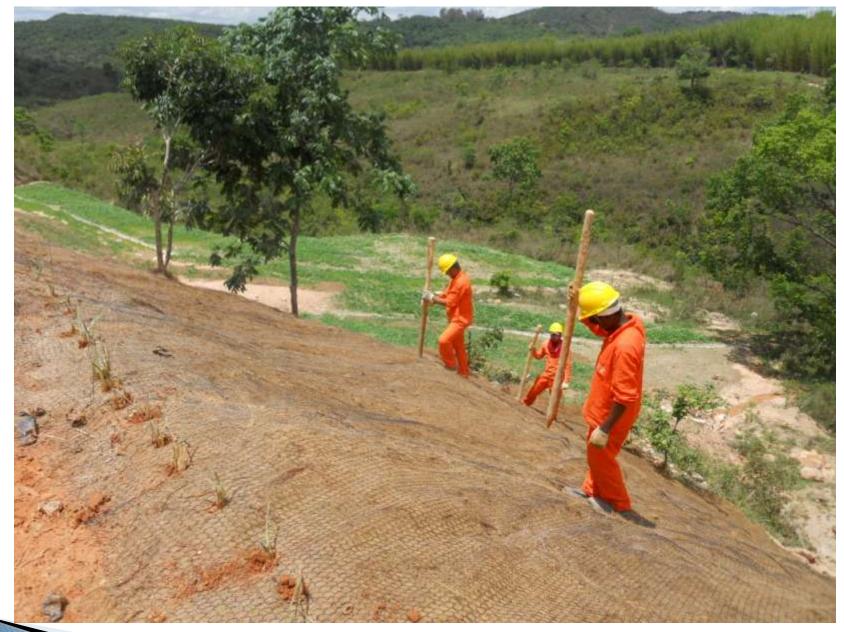
Using sharp poles to pierce coconut blanket for planting

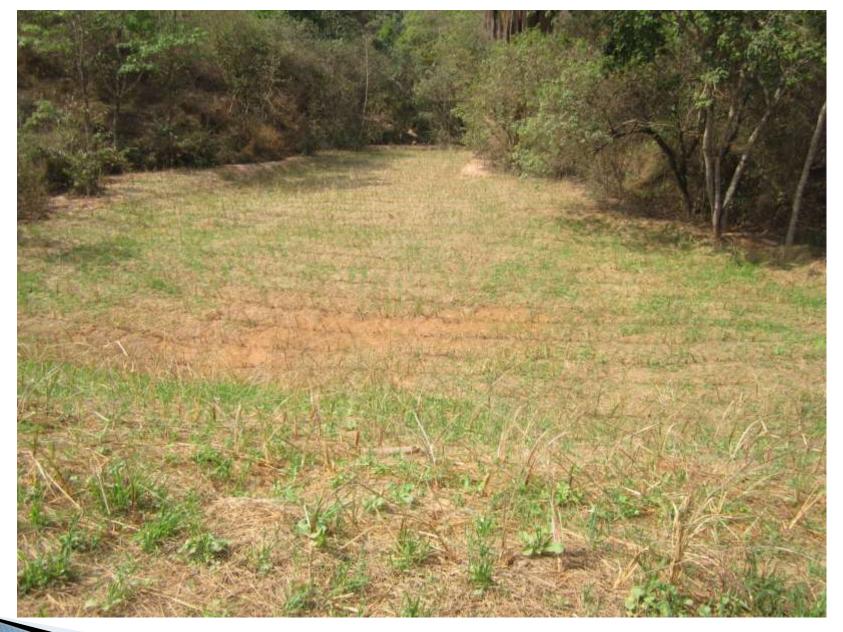
Grass straw blanket

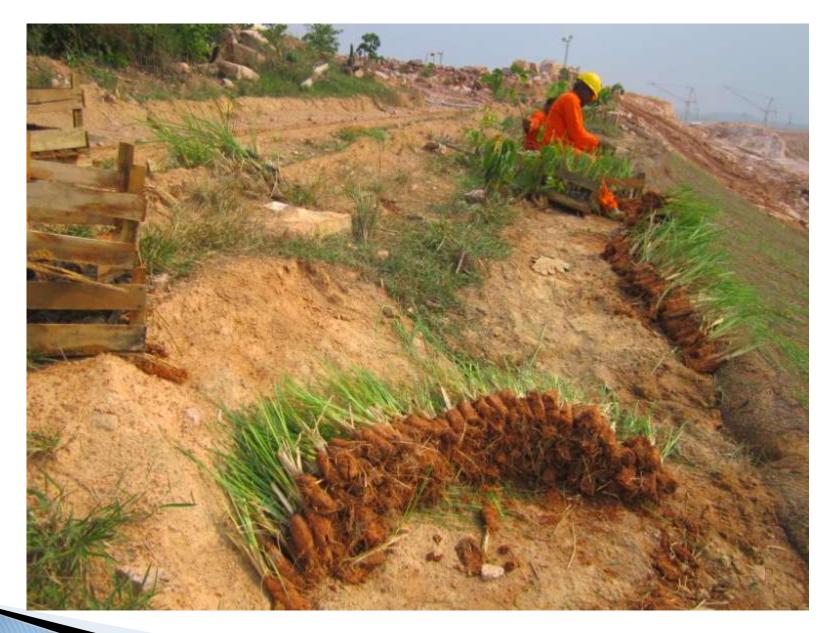
Vetiver plants ready for planting

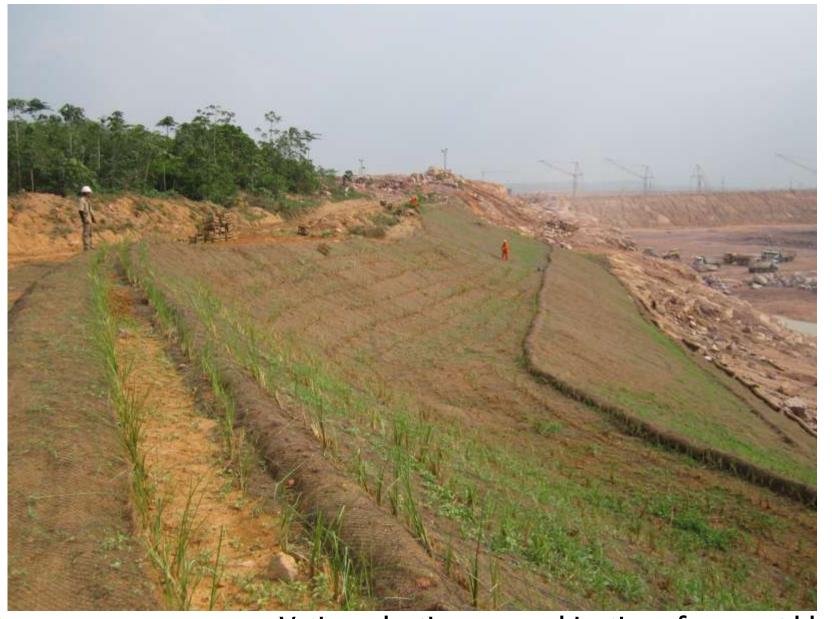
Vetiver planting on combination of coconut blanket and Bermalonga, (a Deflor product made from straw and coconut fiber) on highly erodible sites

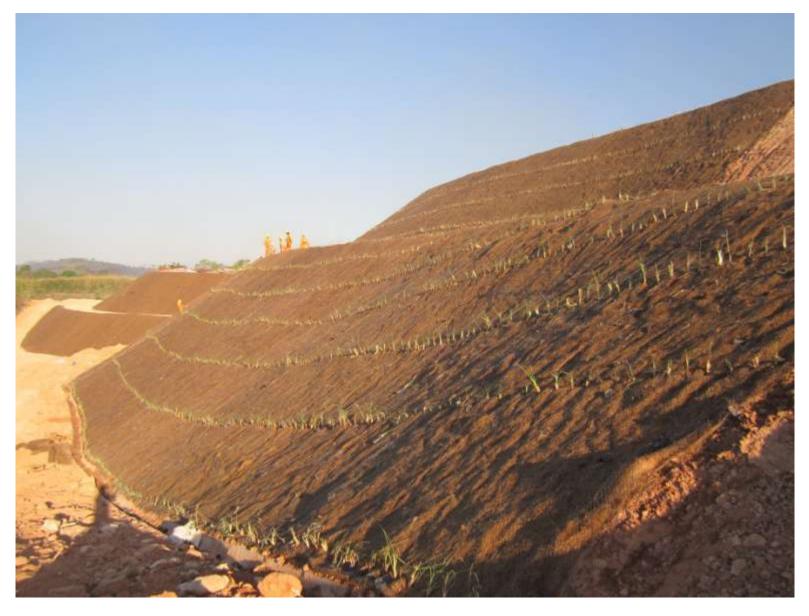
Vetiver planting on contour line on slope protected with coconut blanket

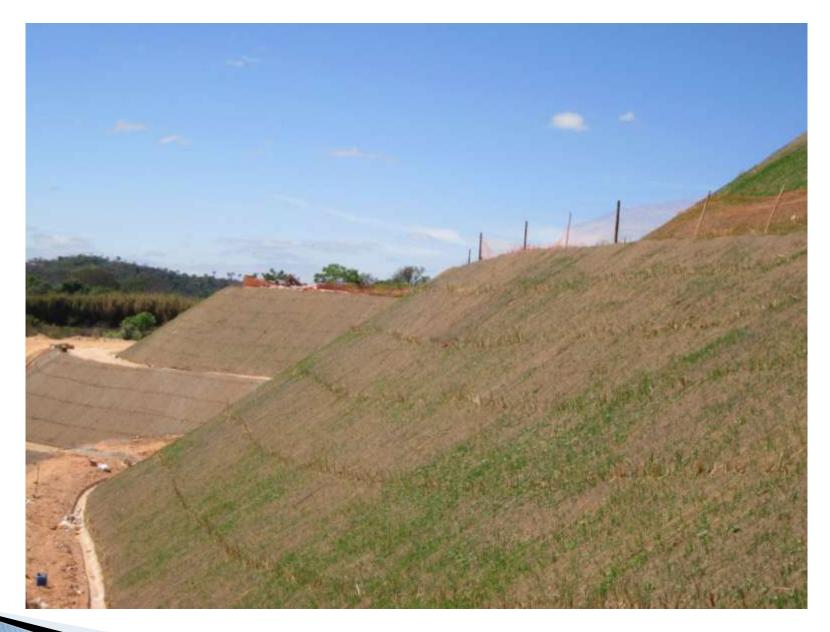
Two weeks after planting

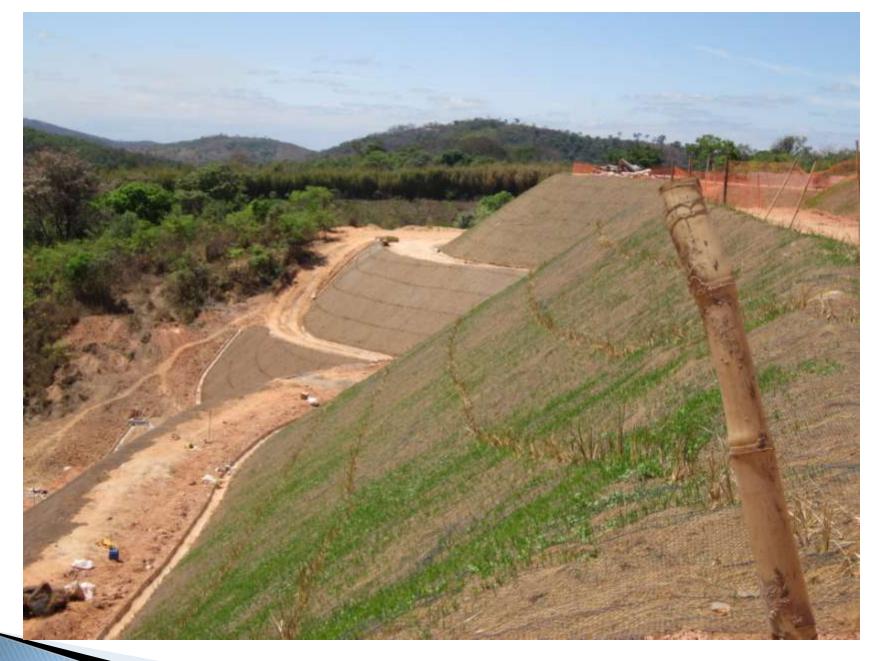
Three weeks after planting

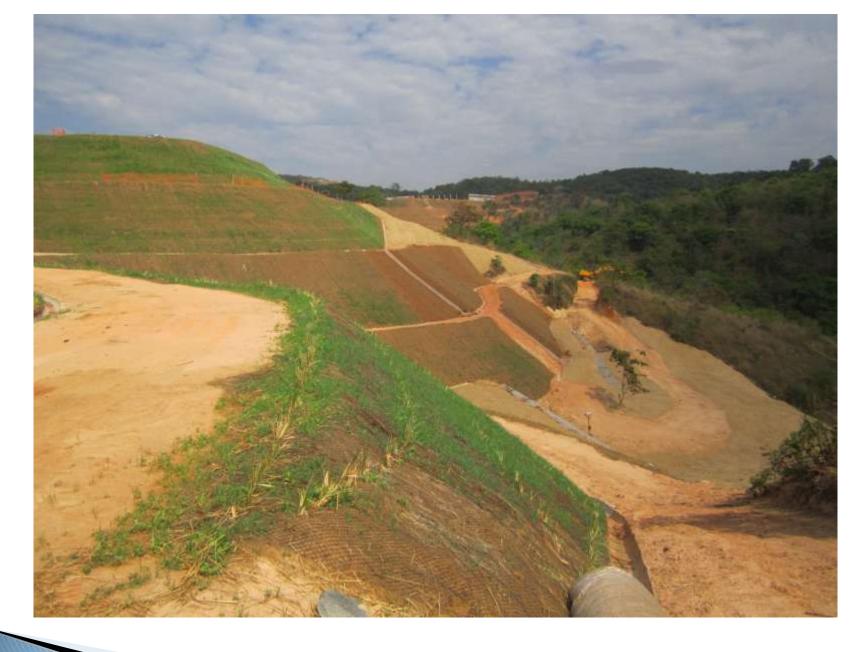
A highly complex set of cut and fill slopes

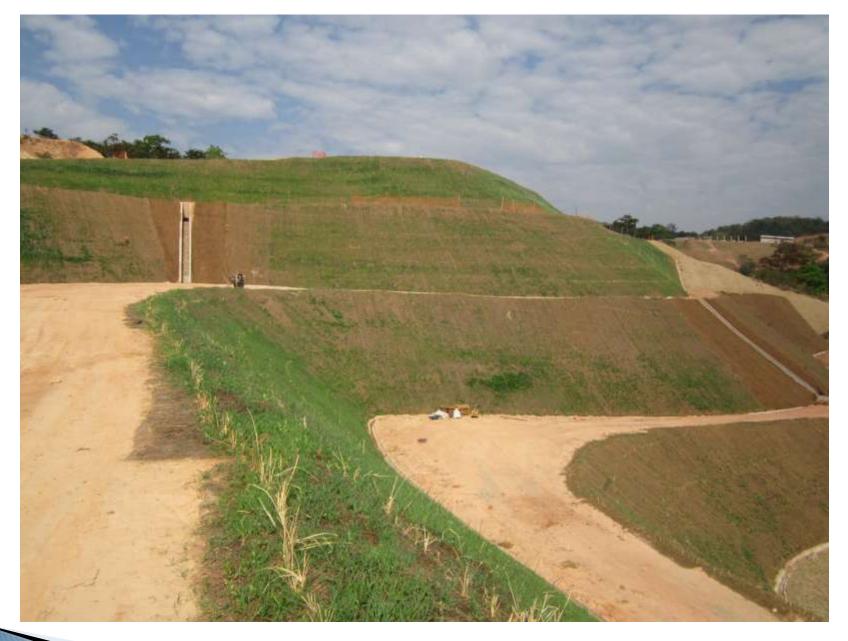
Two weeks after planting

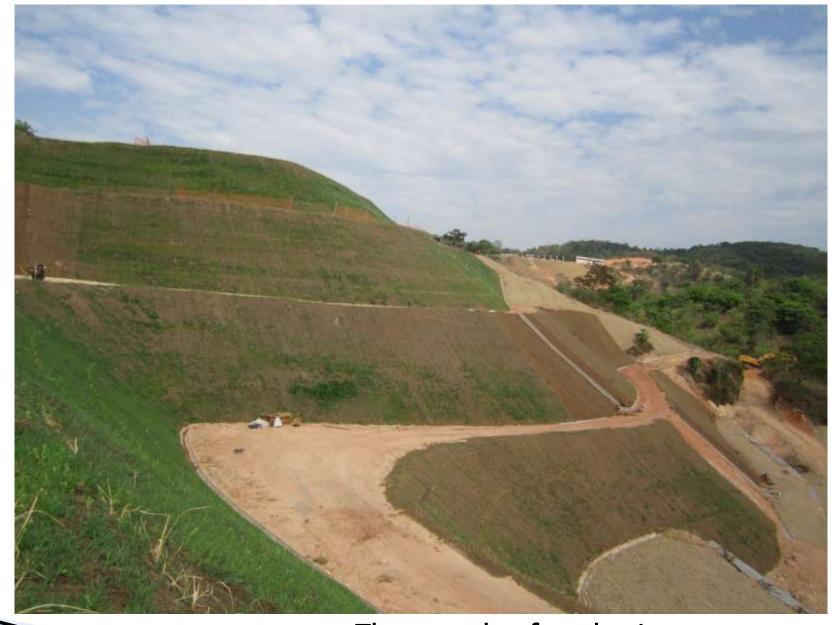
Three weeks after planting

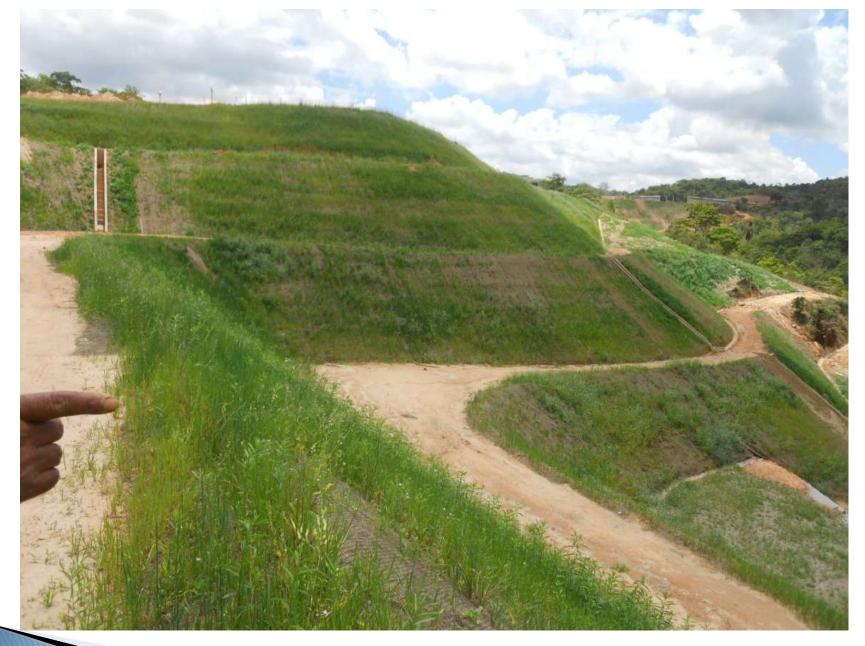
Four weeks after planting

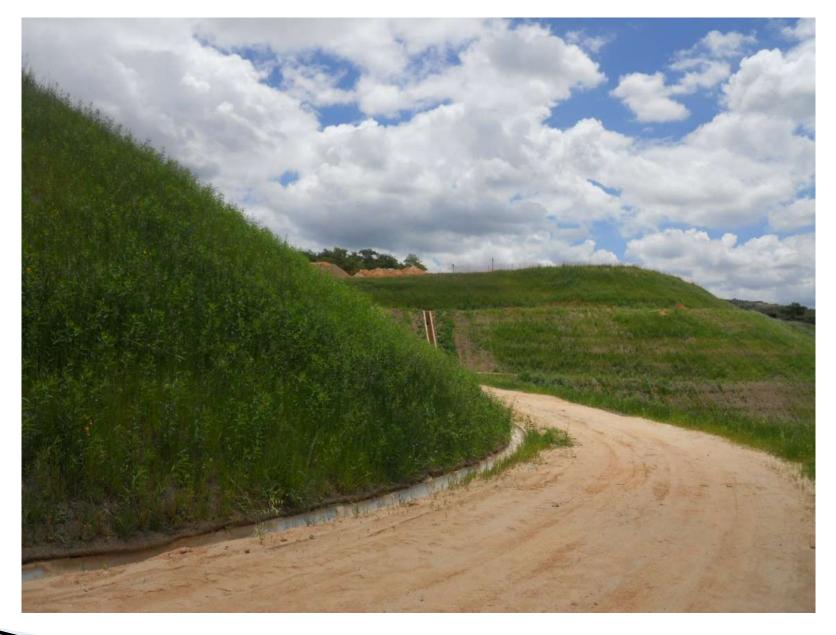
Five weeks after planting

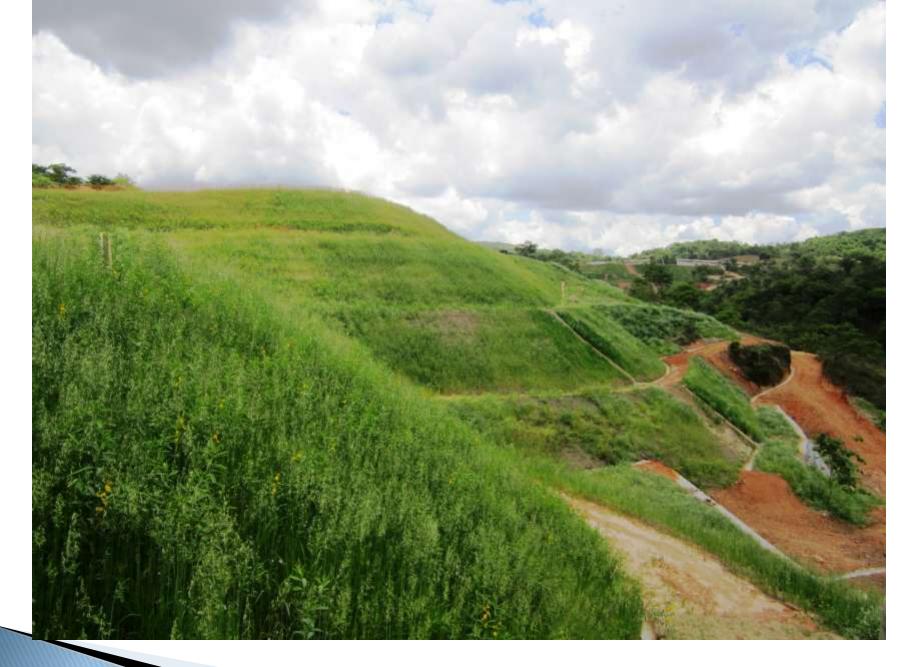
Two months after planting

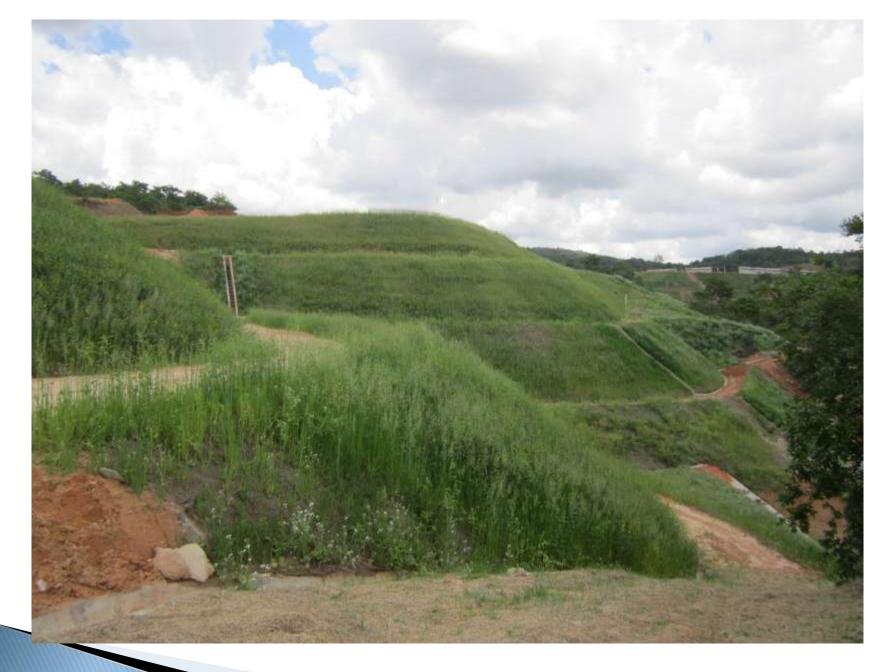
Two months after planting

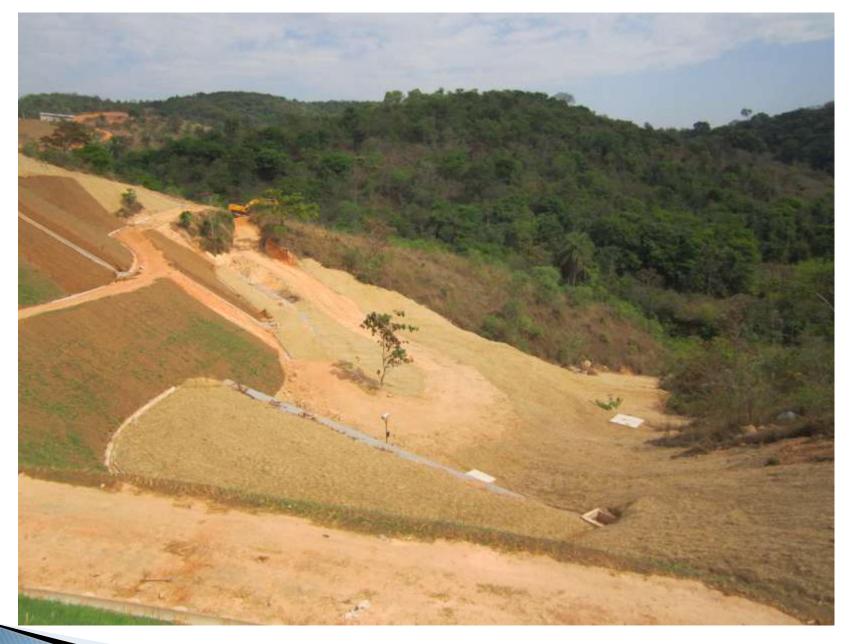
Another examples of very complex set of cut and fill slopes

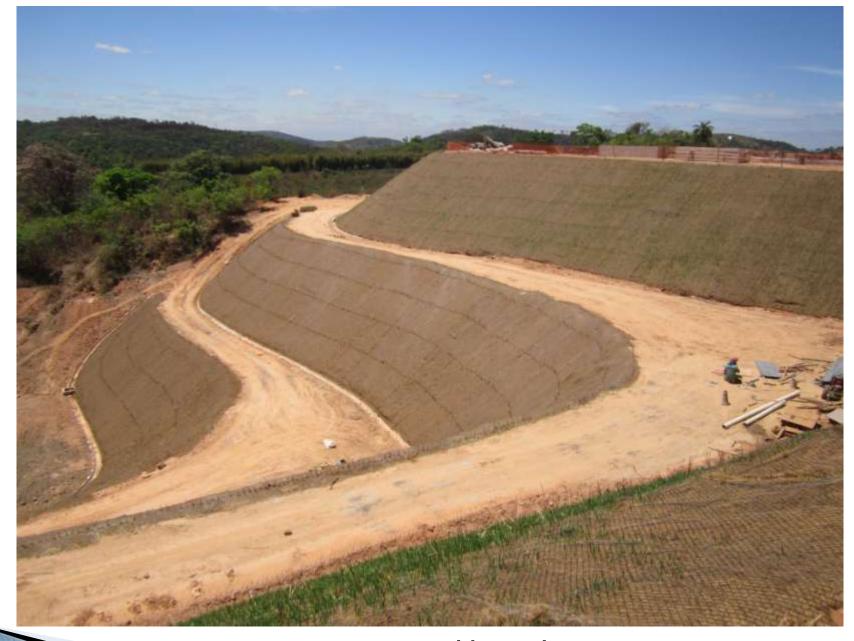
A very steep and long slope requiring extensive terracing

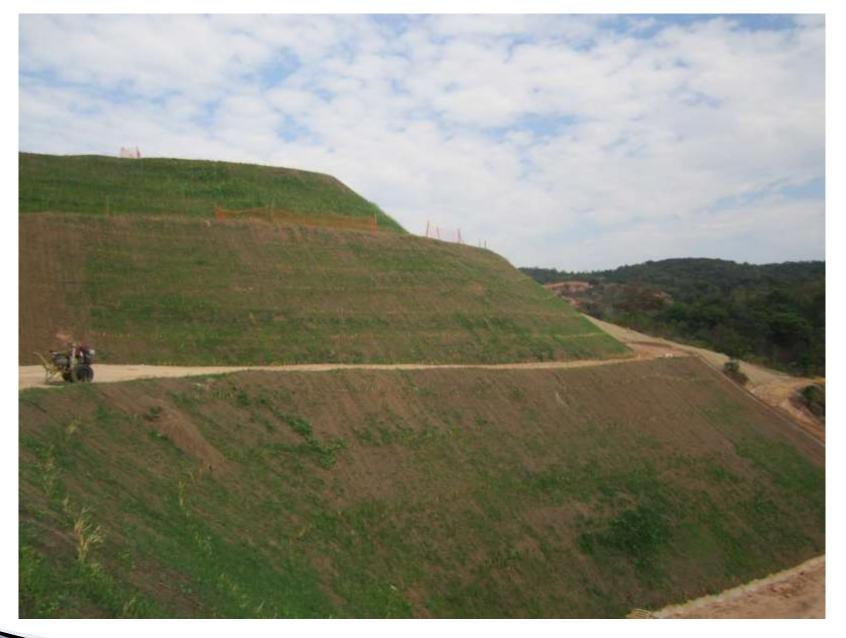
Two weeks after planting

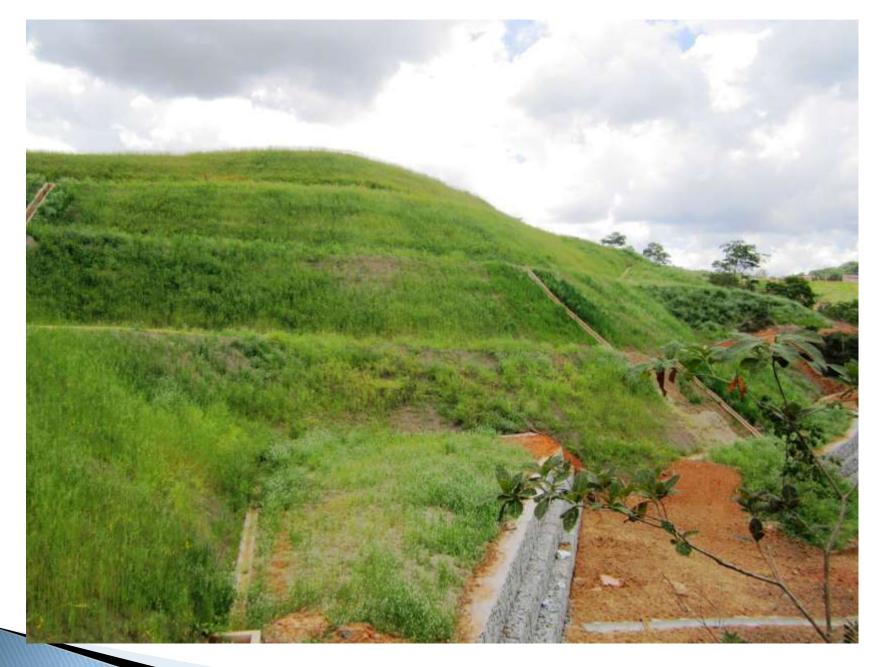
Two months after planting

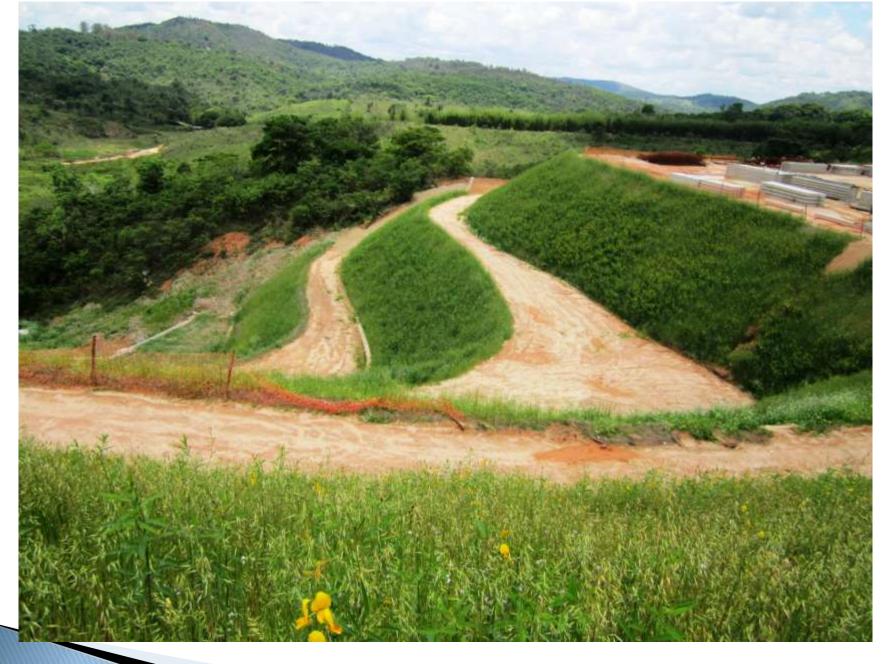
Two months after planting

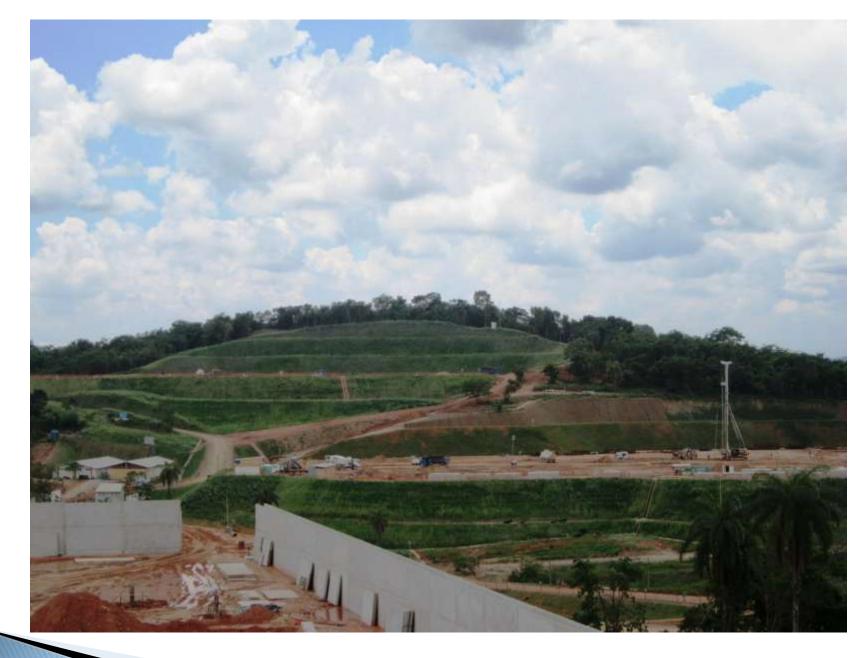
A well protected industrial estate

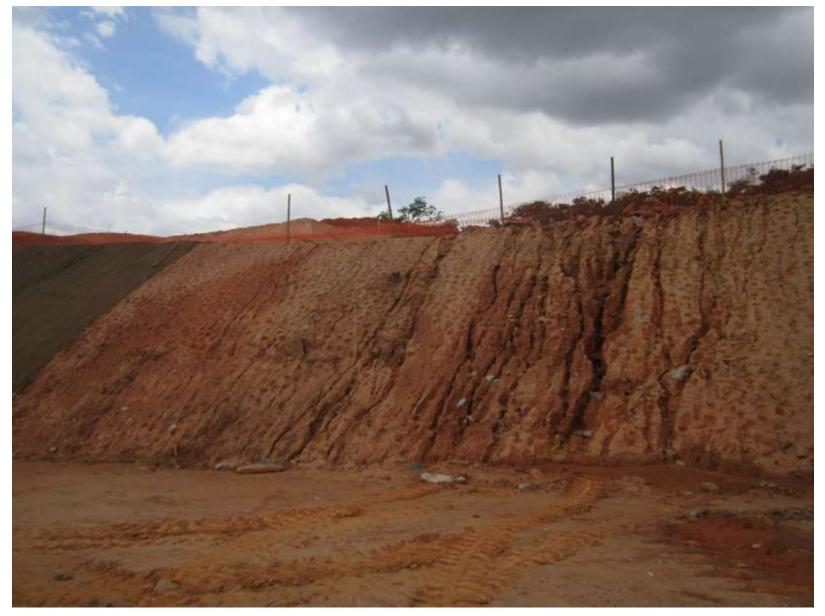
Typical erosion without blanket and/or Vetiver Grass

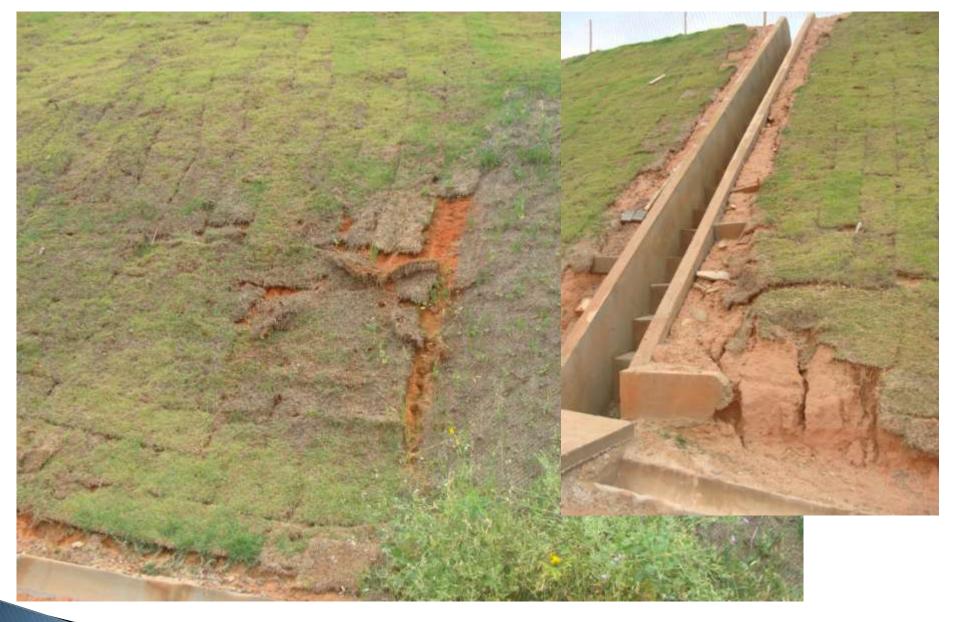
Ineffectiveness of grass turf on steep slope, poor soil, short roots and dry conditions (no growth)
