The Fifth International Conference on Vetiver (ICV-5) “Vetiver and Climate Change”, Lucknow, India, 28-30 October 2011

Vetiver System for Natural Disaster Mitigation in Vietnam: Some Lessons Learned After a Decade of Application

Tran Tan Van* and Paul Truong**

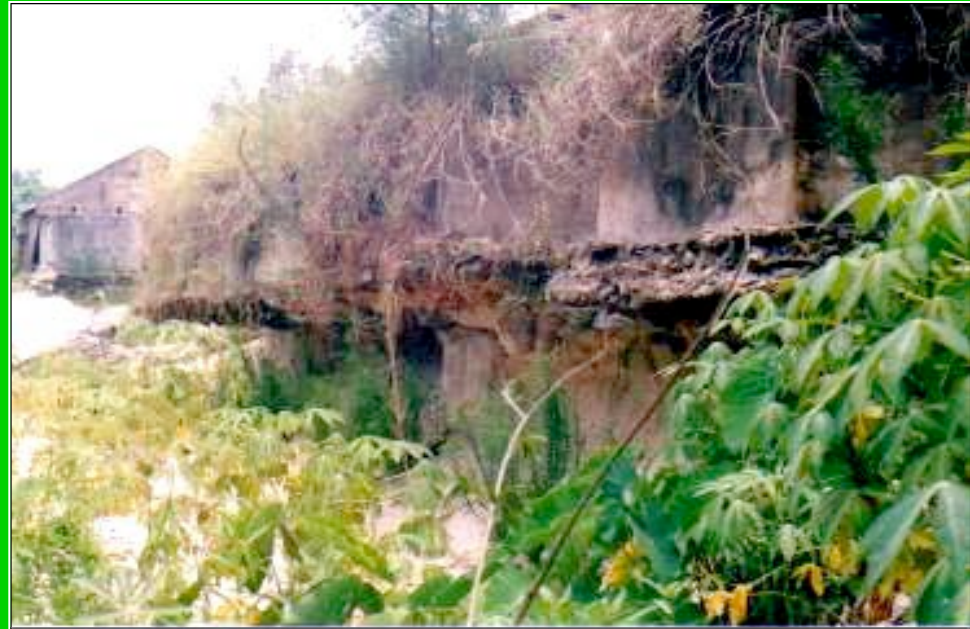
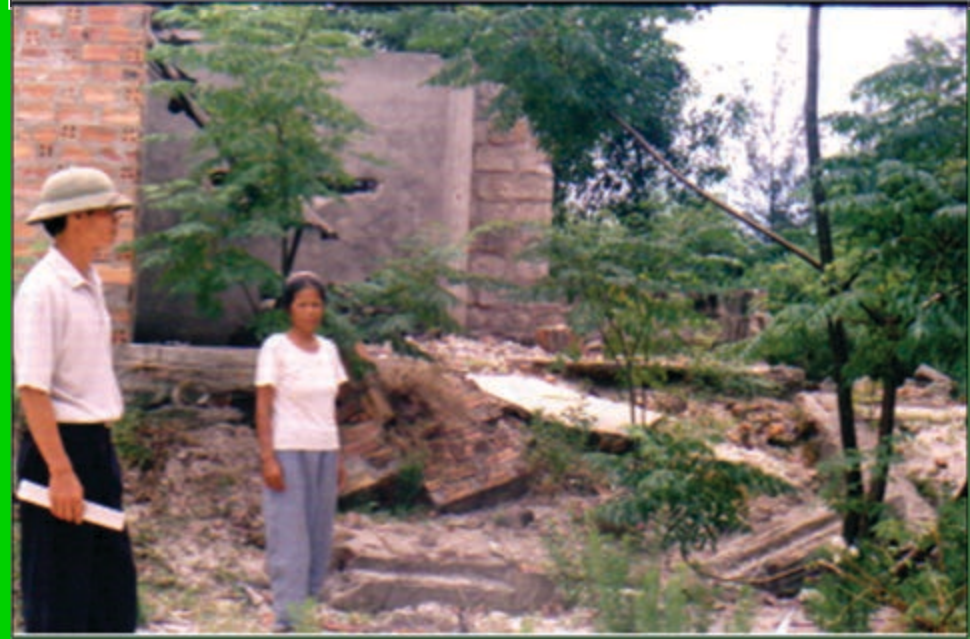
Sand dunes in Central Vietnam - the problem

- A vast area of more than 70,000 ha along the coastline of Central Vietnam, having severe climatic and soil conditions
- The sand dunes migrate westward to invade the inner, narrow coastal plain under the action of wind and water
- The government tries for years to mitigate this hazard by implementing forestation programs using such varieties as Casuarinas, wild pineapple, eucalyptus, acacia etc. without positive result

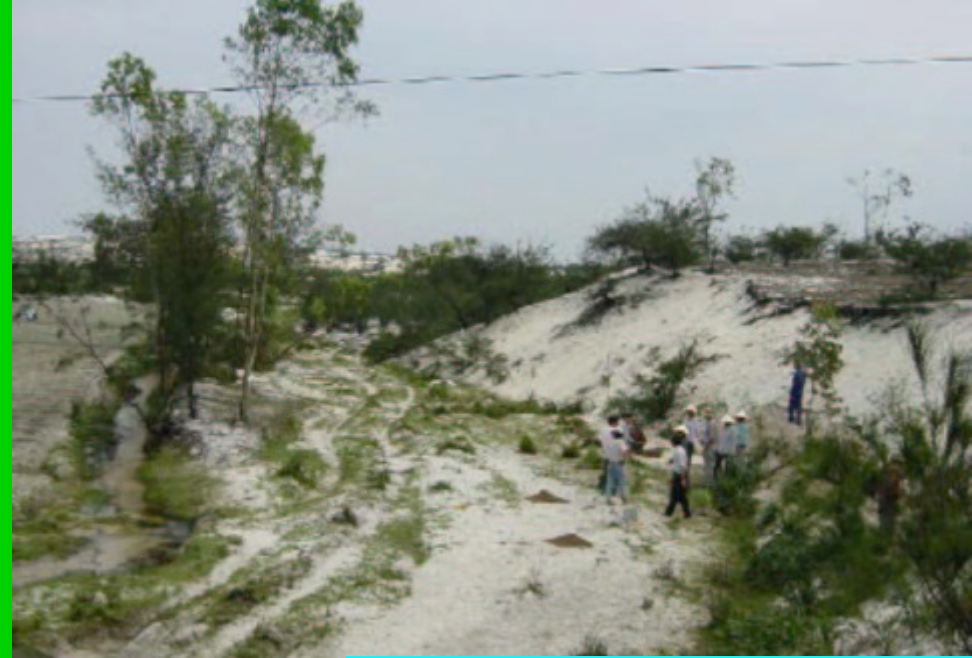
- The trial was carried out in February 2002 with Dutch Embassy financial support
- VS was planted in 3 rows along the contour lines on the slope of the sand dune, starting from the edge of the stream
- VS was subject to different soil treatments:
 - In polybags
 - Bare root
 - With green manure
 - With good soil
 - W/o anything

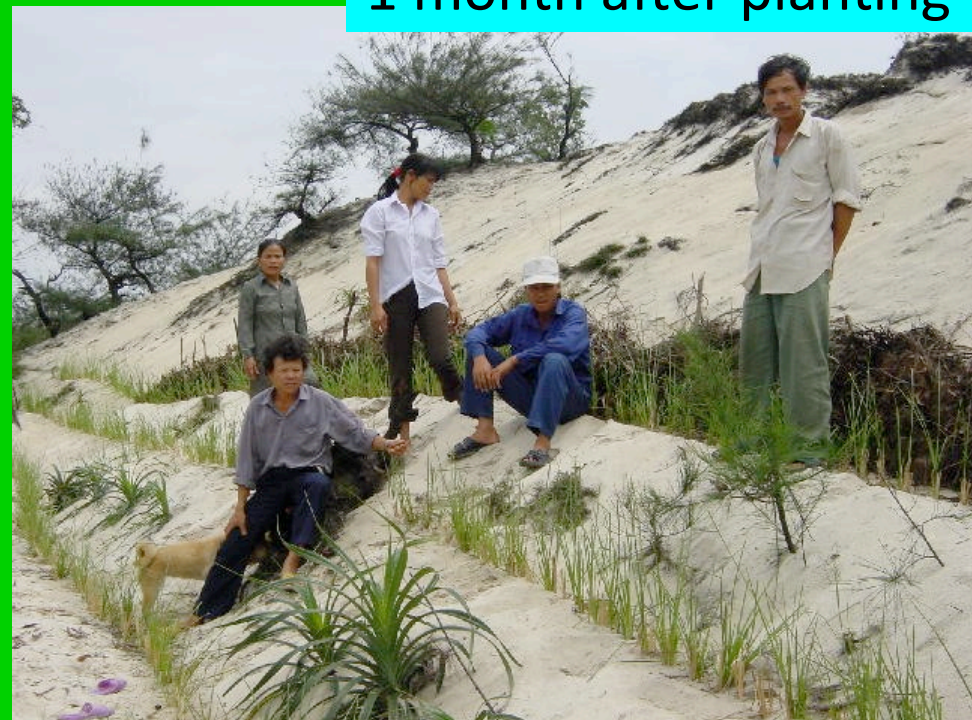
1 month after planting

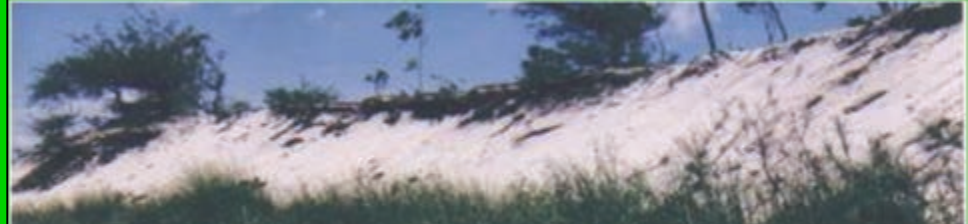
hs after

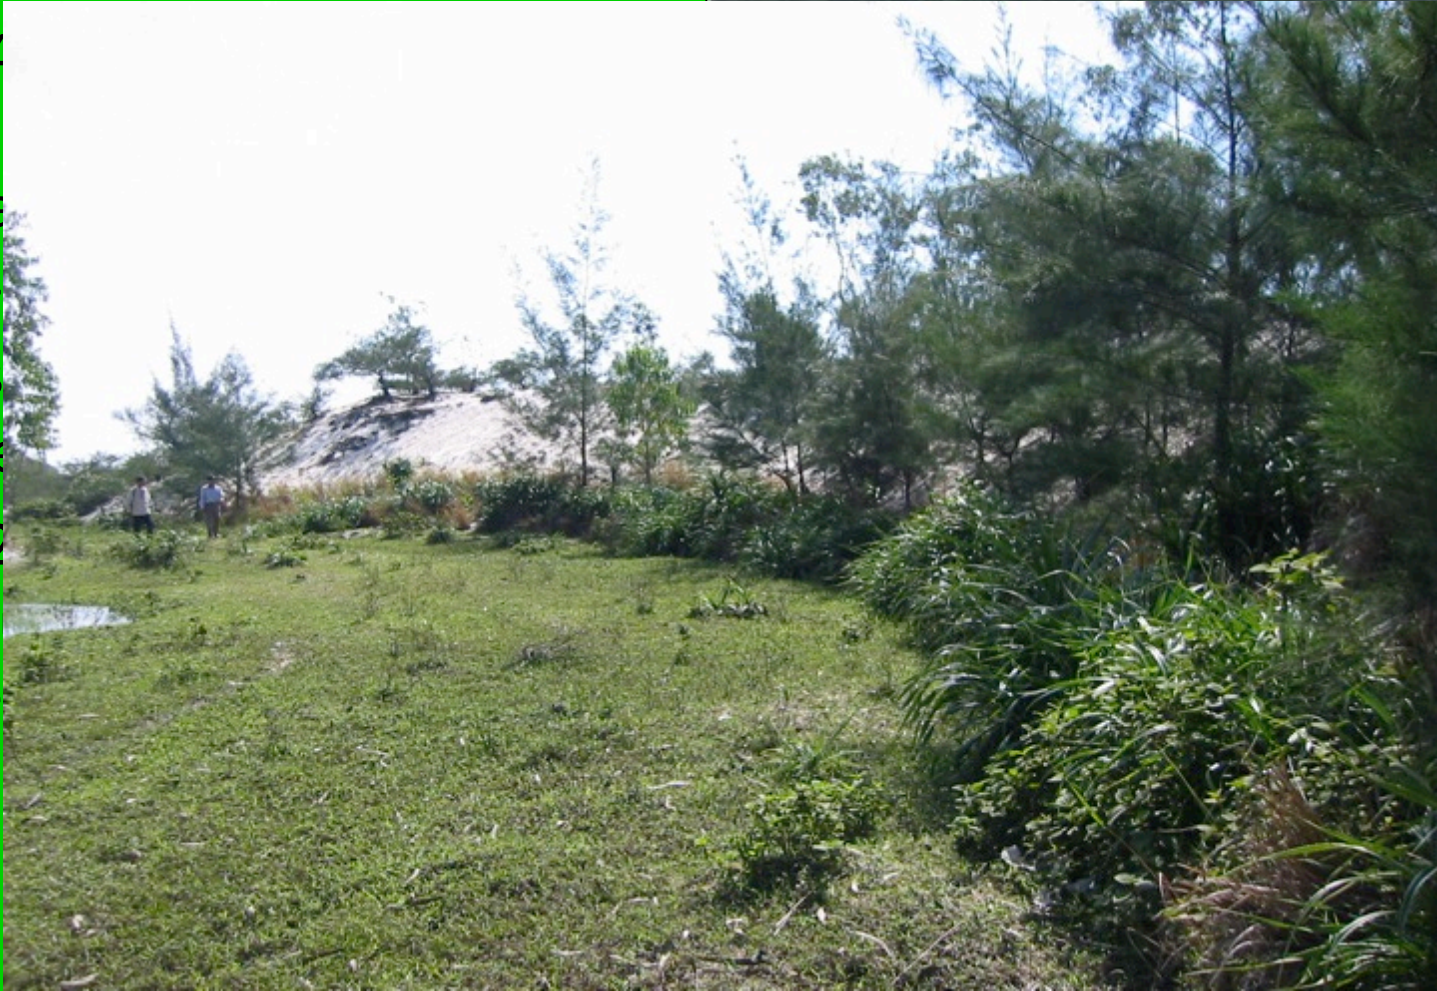
2 years after planting

- By trying several planting options it can be concluded VS can establish on poor sand dunes as long as its root can penetrate deeply enough into the sand to get water
- Even though still young, the grass could survive both the harsh winter ($<10^{\circ}\text{C}$) and the hot summer ($>40-45^{\circ}\text{C}$)
- Under the latter condition, it is necessary to supply the grass with enough water, especially when the grass is still young (sometimes the farmers had to water the grass twice a day)
- Placing dry mulching on-top and along the rows was very useful: first to help prevent the grass from being buried by hot sliding sand; and second to help distribute the supplied water evenly and gradually).

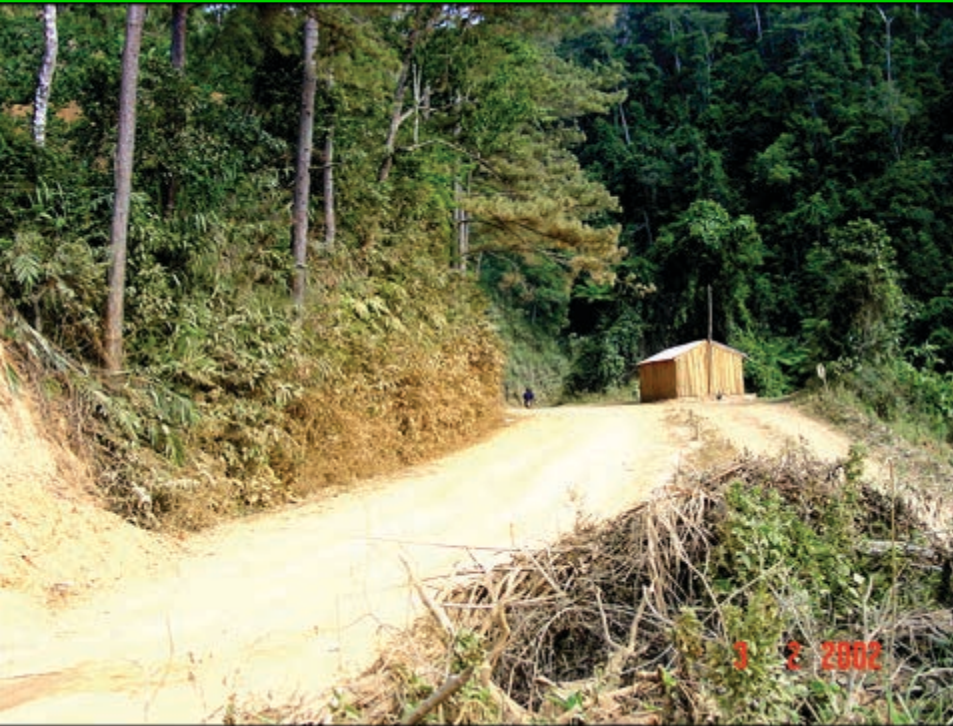
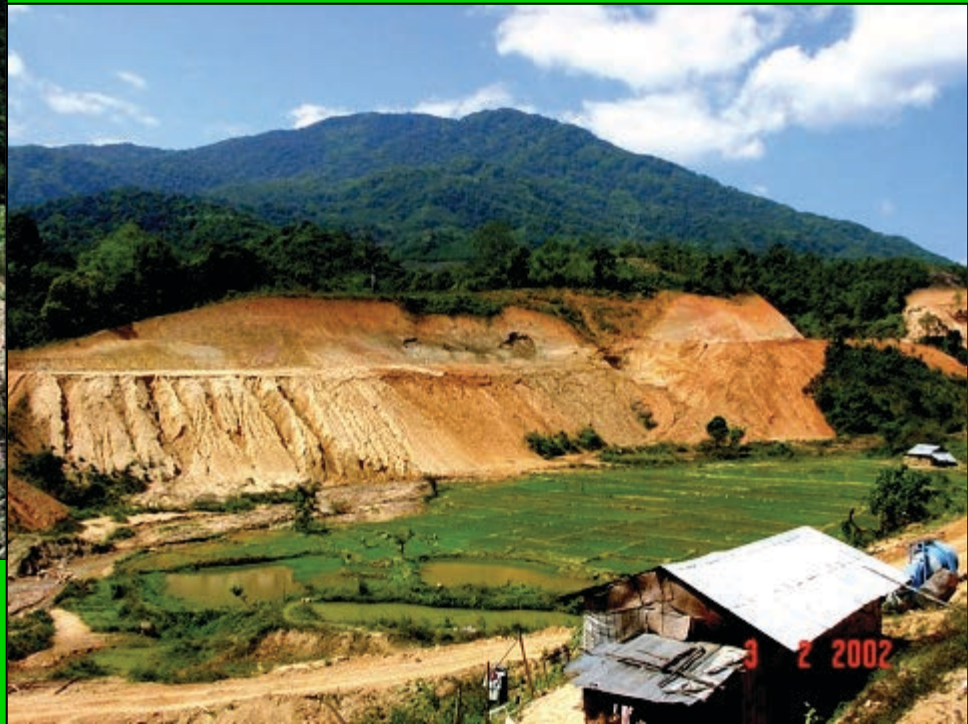
At many locations the road alignment never existed before and had to go through rugged

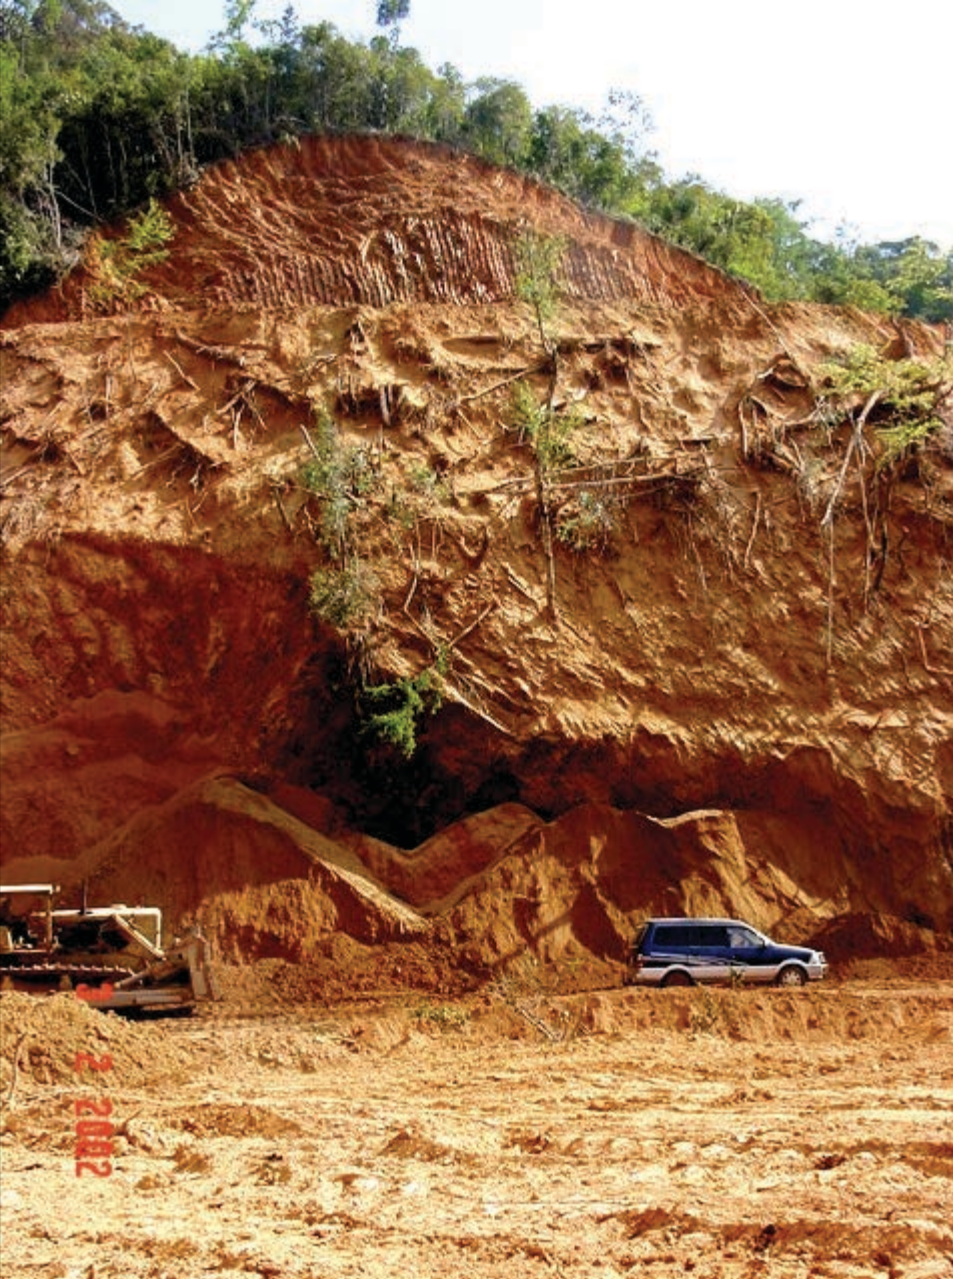
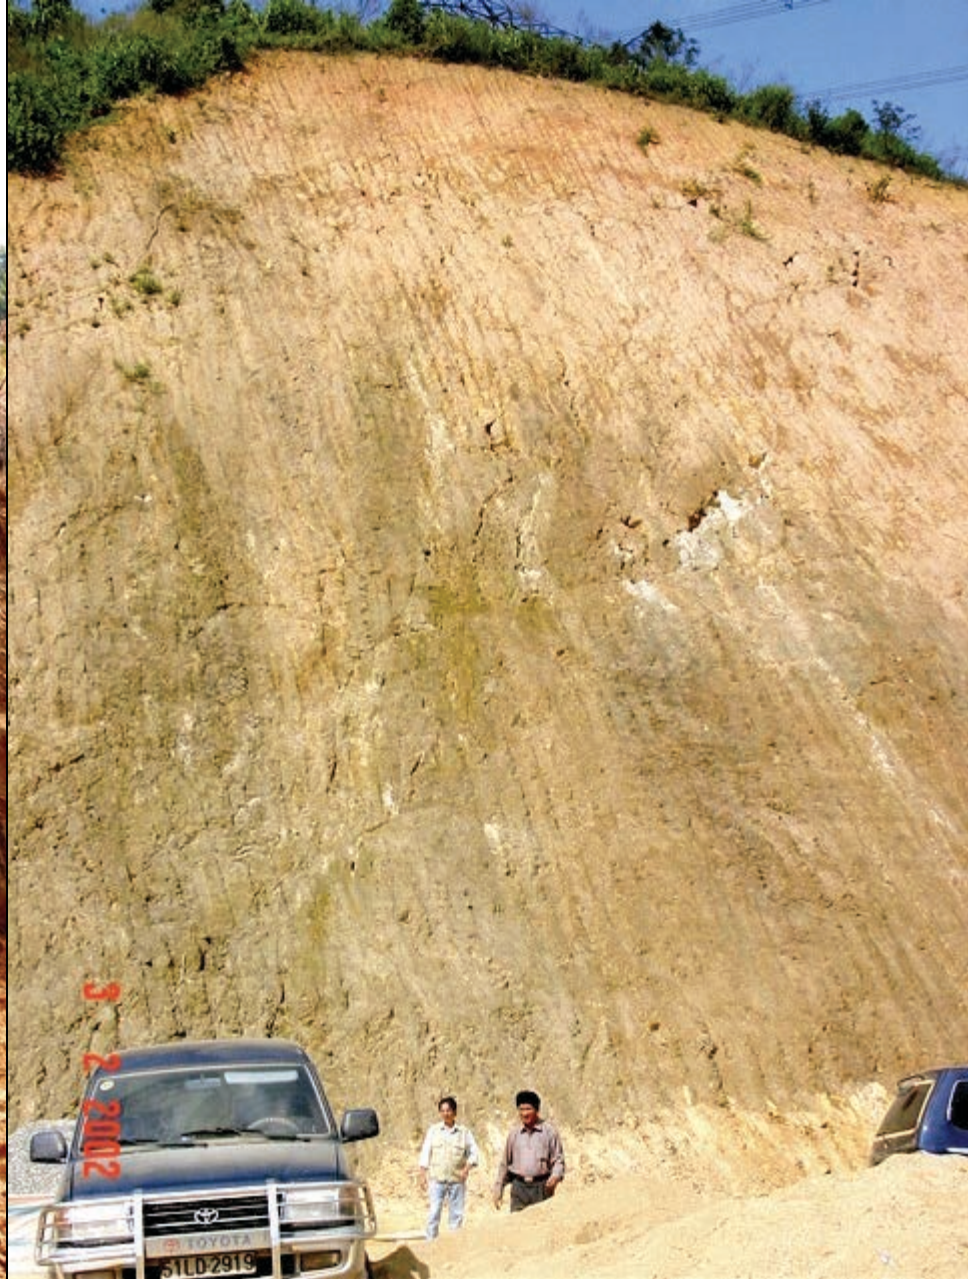
Many cut slopes designed and constructed not to the standard, tens of m in height, very steep, often $>60-75^\circ$ with rare benches etc.

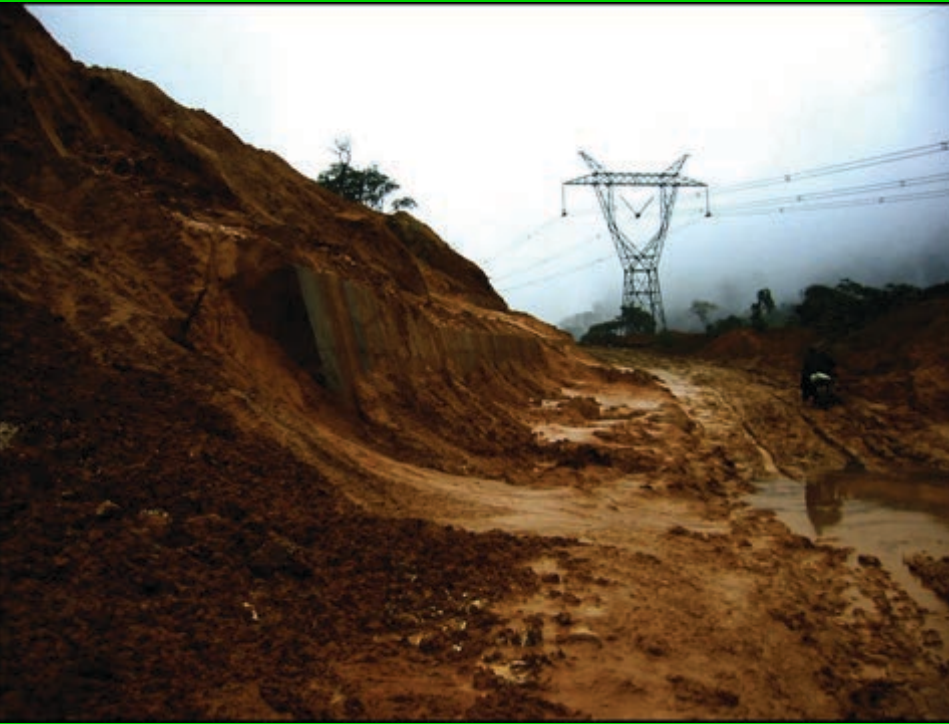
Ready to slide down during the rainy season

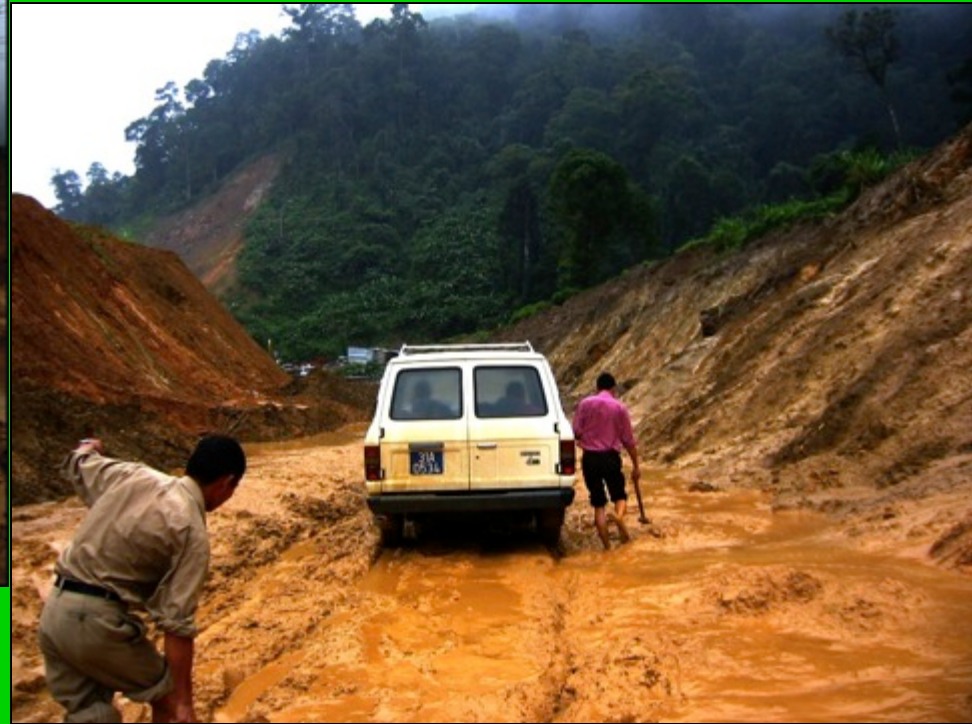
Under time pressure, at many locations the primary aim was to get the road operate first, leaving behind many other aspects e.g. safety of cut slopes, waste disposal, environmental impacts, nature conservation etc.

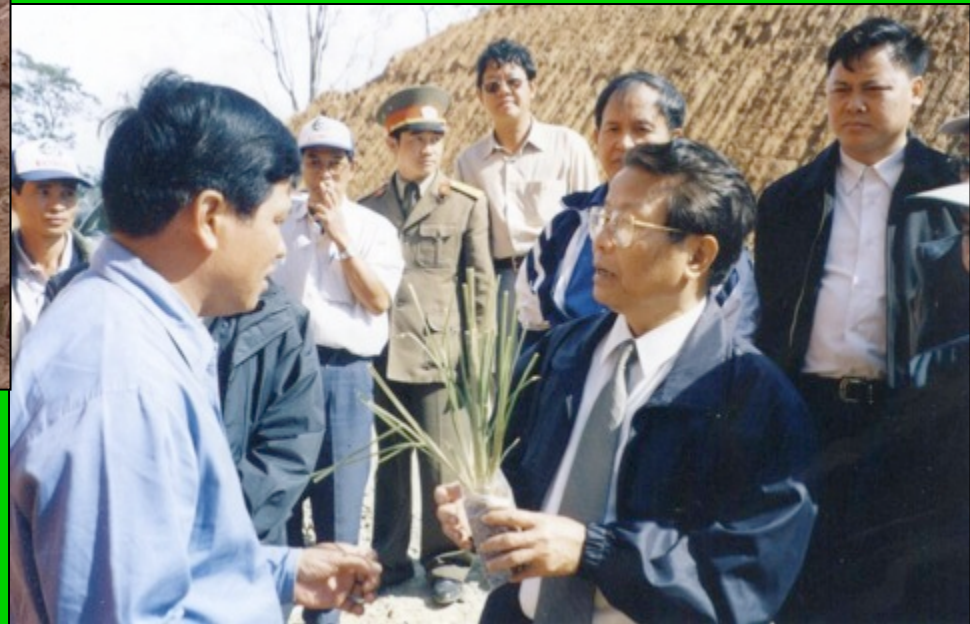
In early 2002, Pham Hong Duc Phuoc (Ho Chi Minh City Agro-Forestry University) and Thien Sinh Co. tried for the first time the use of VS for a cut slope on the newly constructed HCMHW

In 2003, the Ministry of Transport allowed the wide use of VS for slope stabilization.

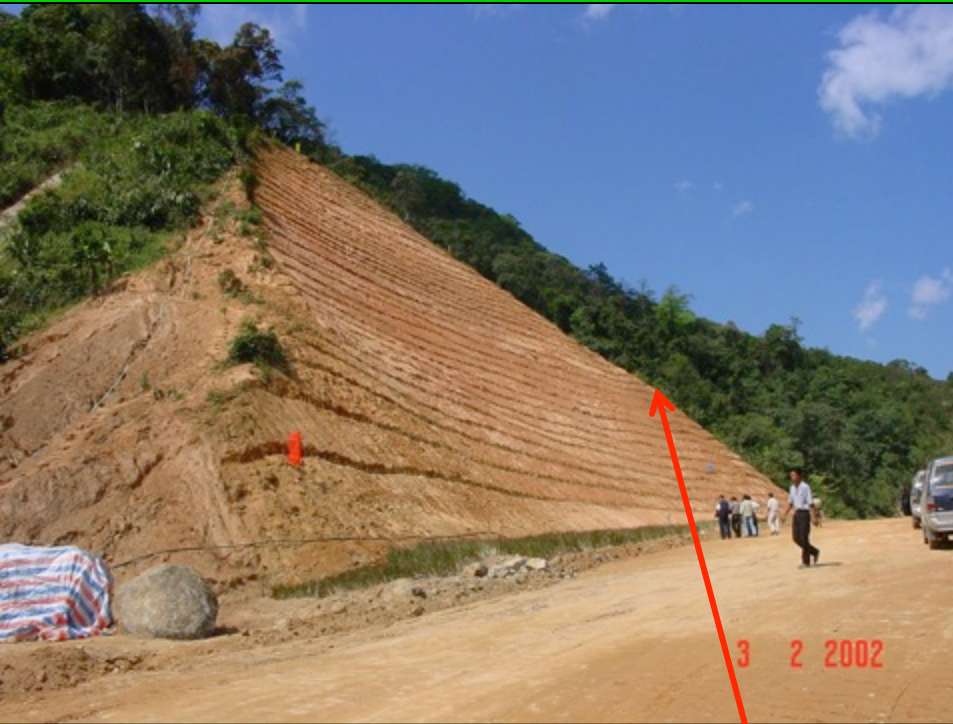
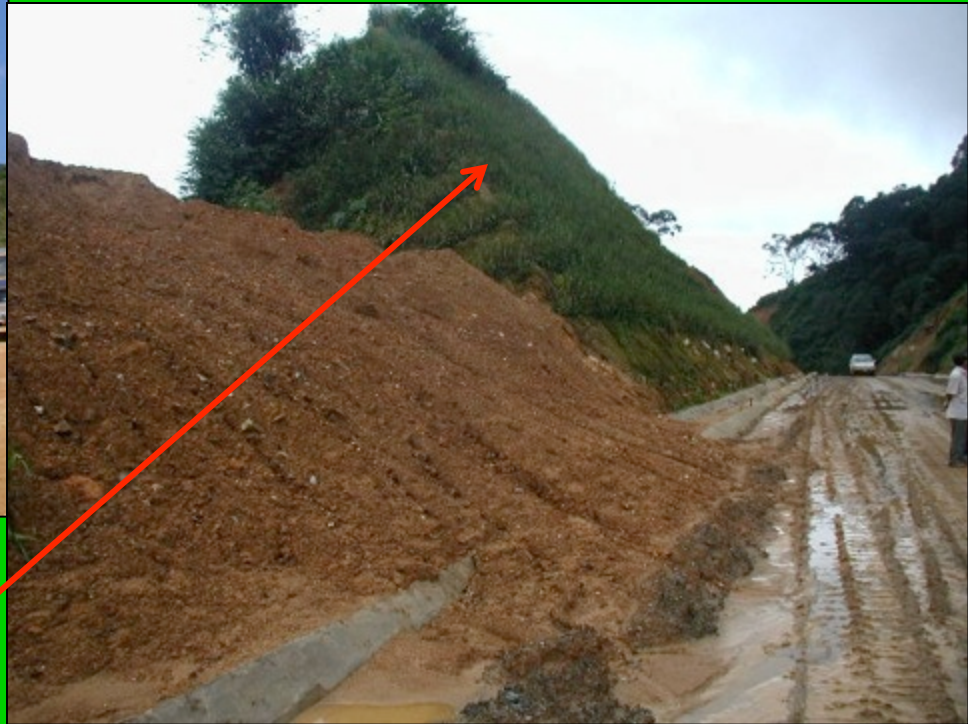
Trial site at planting and one year later

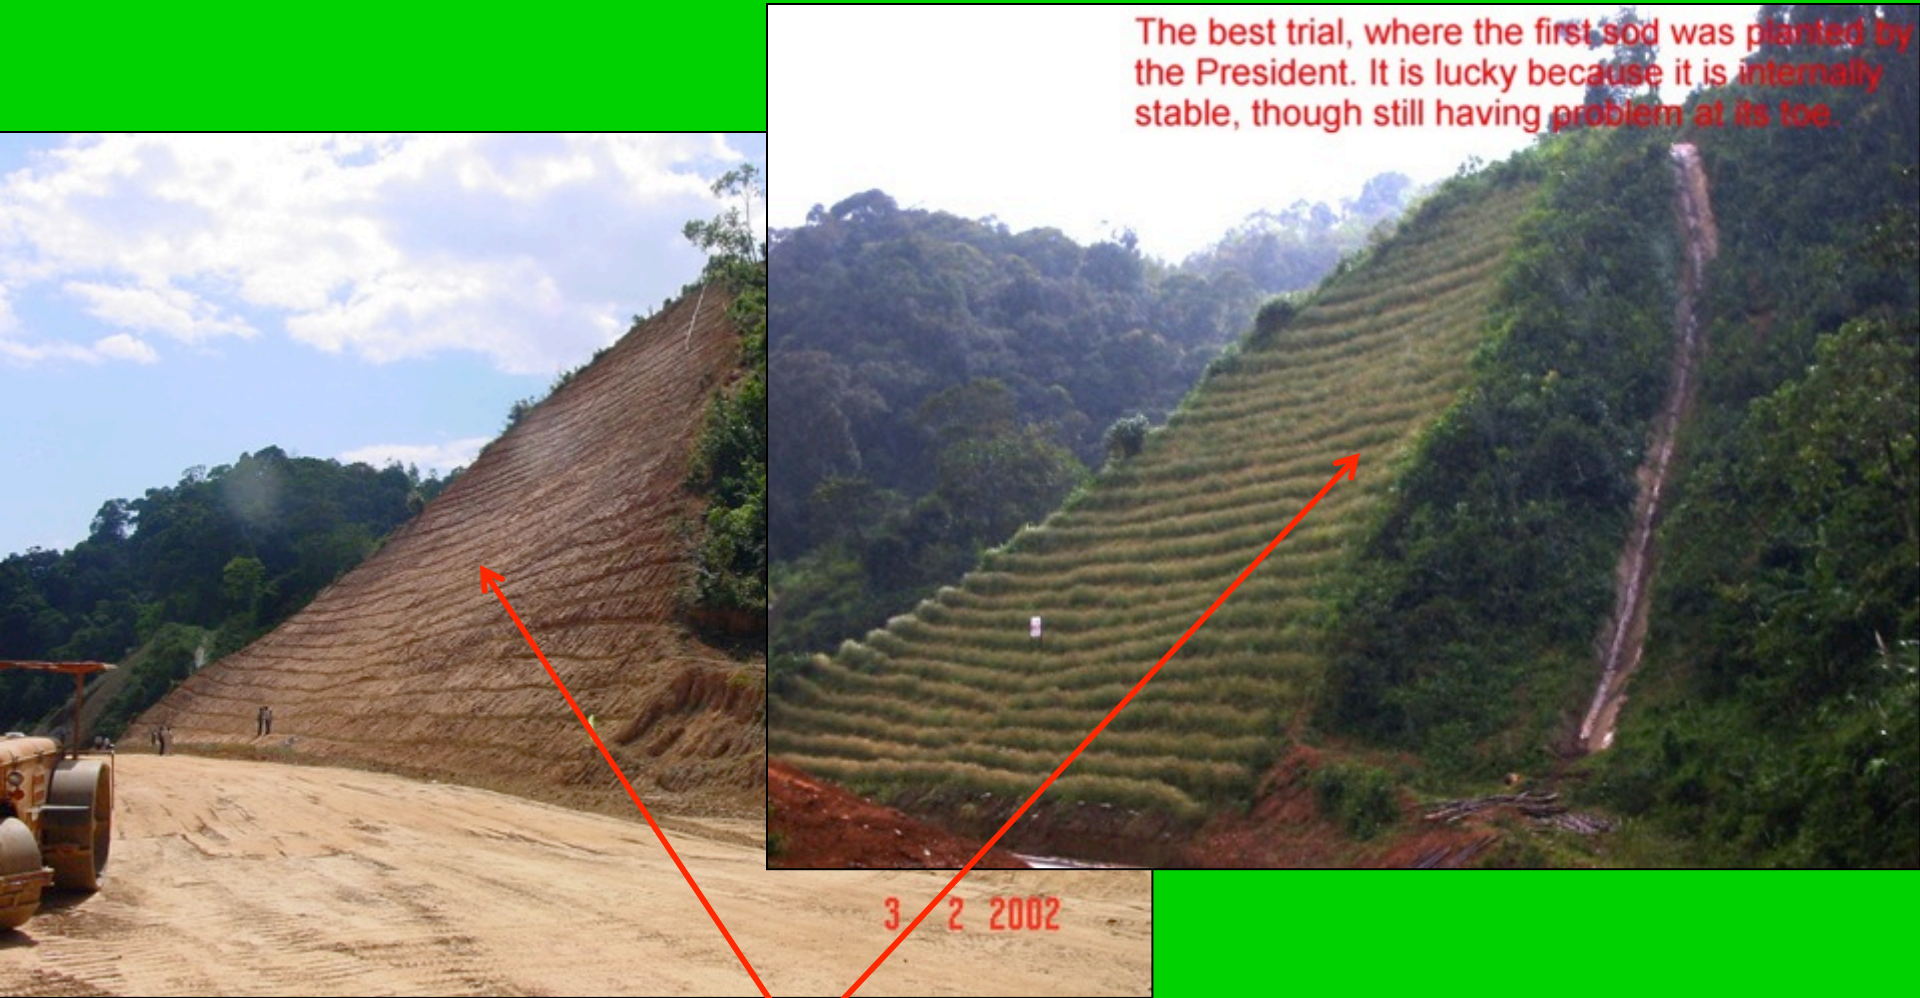
Trial site at planting and one year later

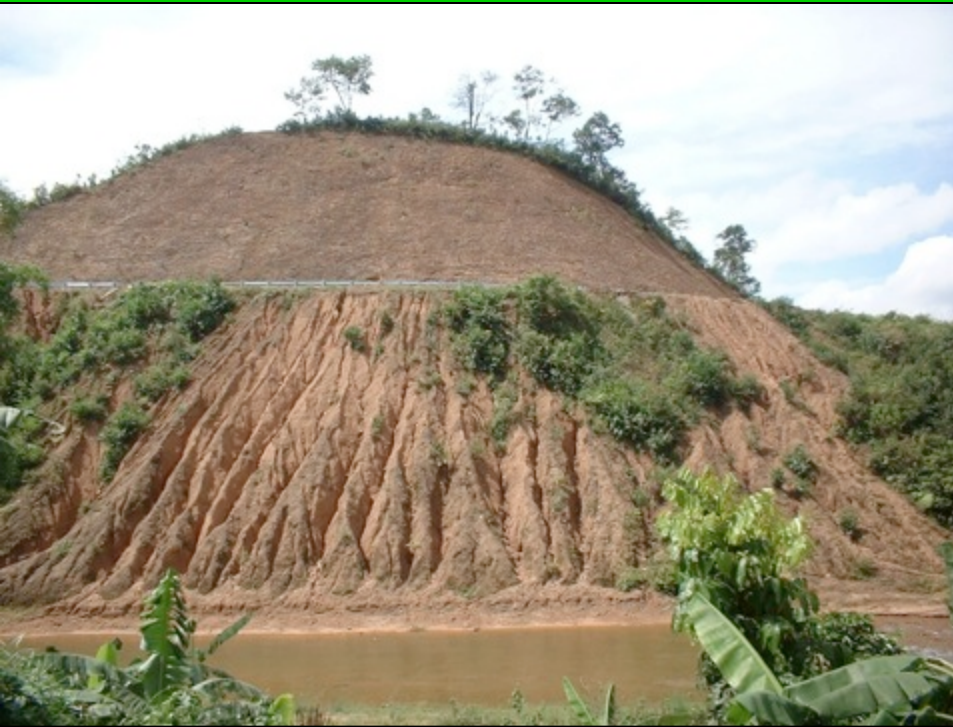
The use of Vetiver helps increase the environmental friendliness of the road

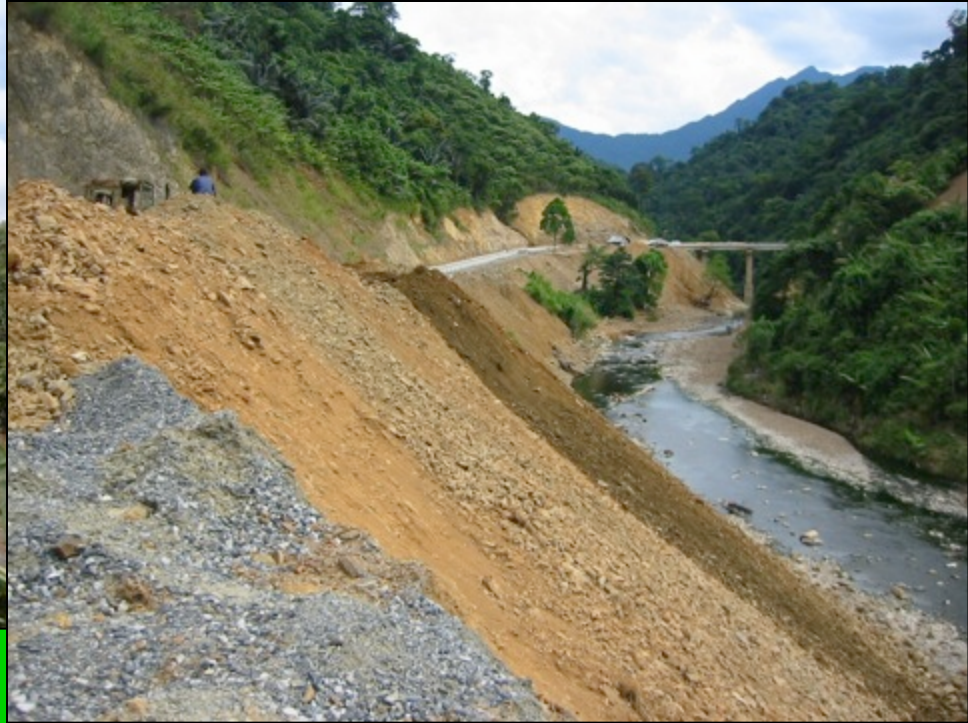
Applied primarily for slope surface protection it greatly reduces surface erosion, which otherwise causes downstream hazards

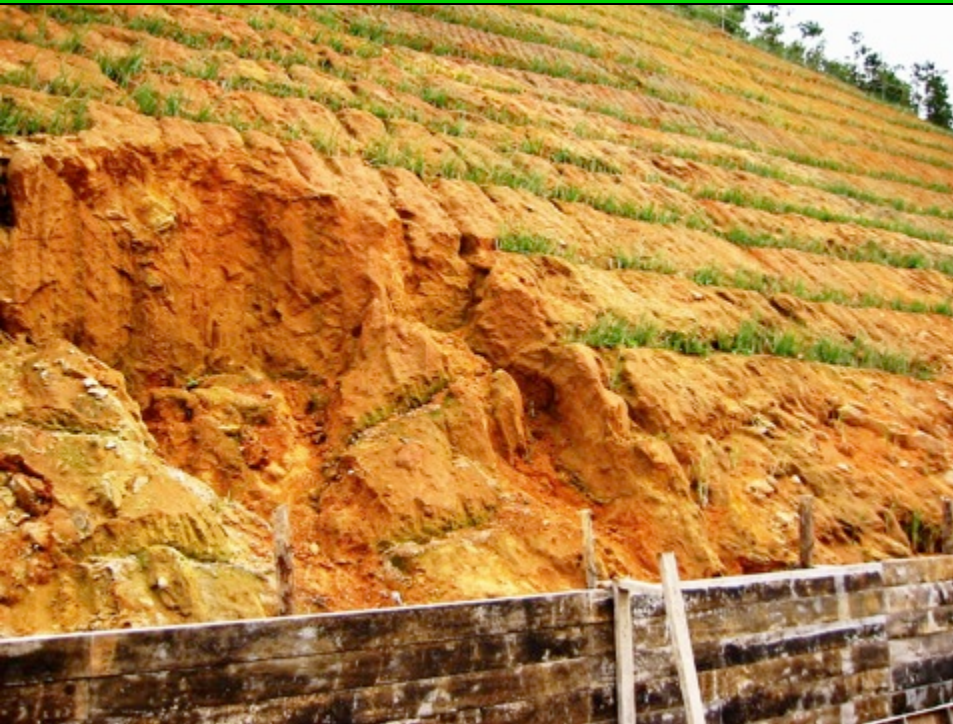
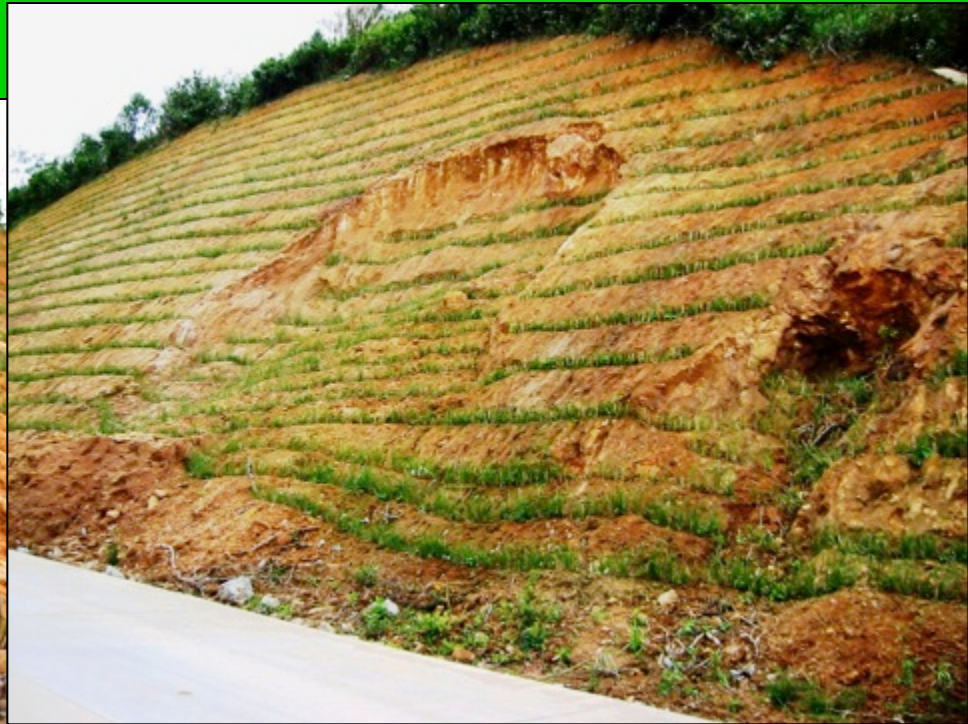
The slopes should first be internally stable as the VS is not immediately effective (slopes can fail before roots have established)

Timing is very important as stabilization may take place earliest 3-4 months after planting

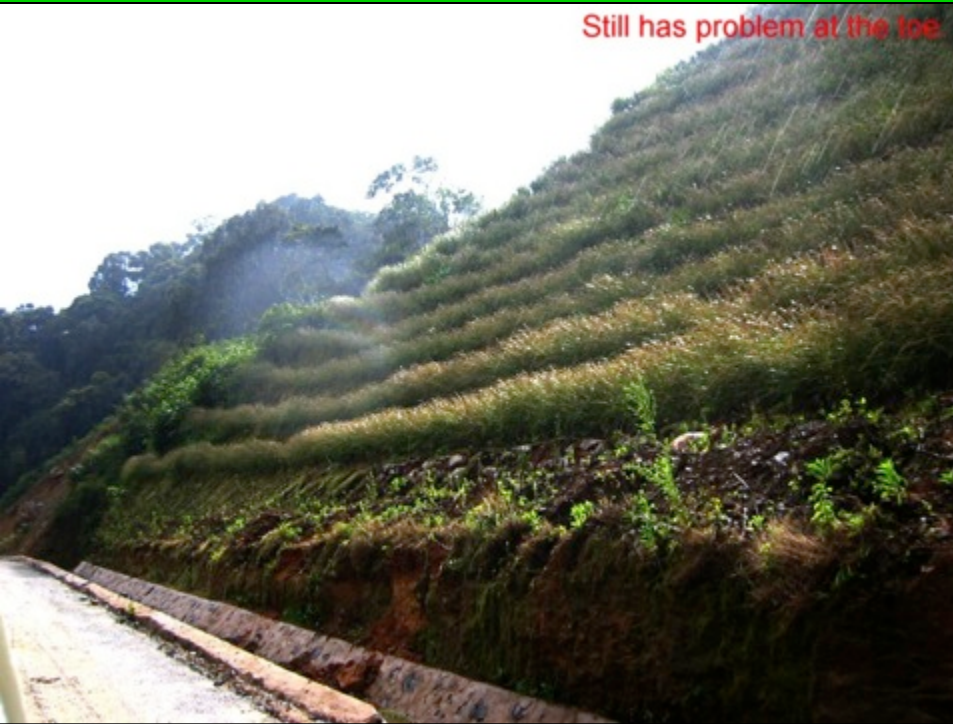
Still has problem at the toe

The slope toe was very steep when it was shattered
The pre-Cambrian metamorphic bedrock was very
strongly weathered into sandy mass, very
susceptible to sliding

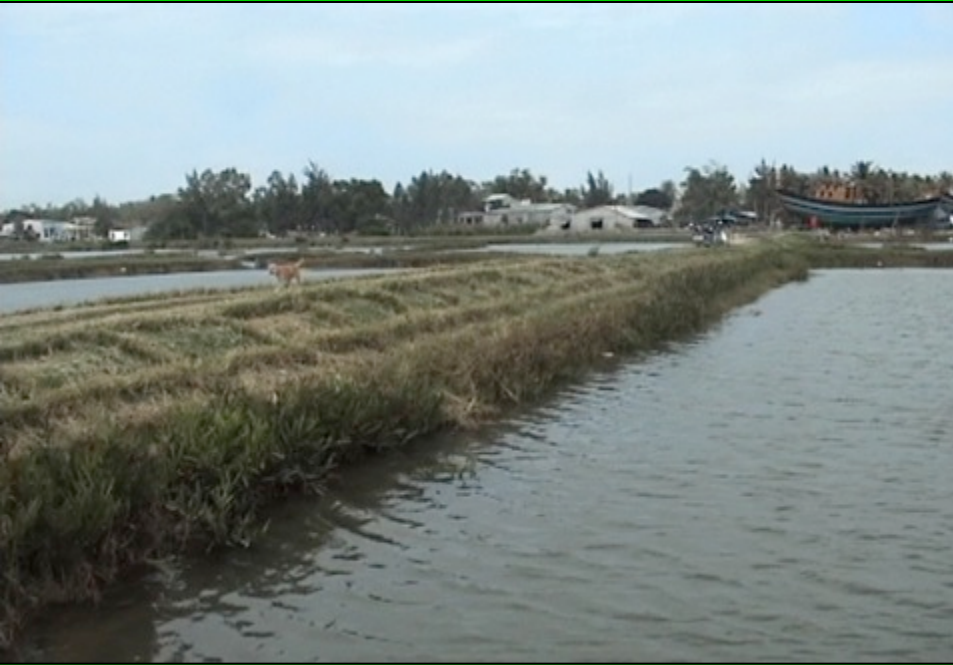
Regular trimming is important to ensure further growth of the grass to achieve good, dense hedgerows

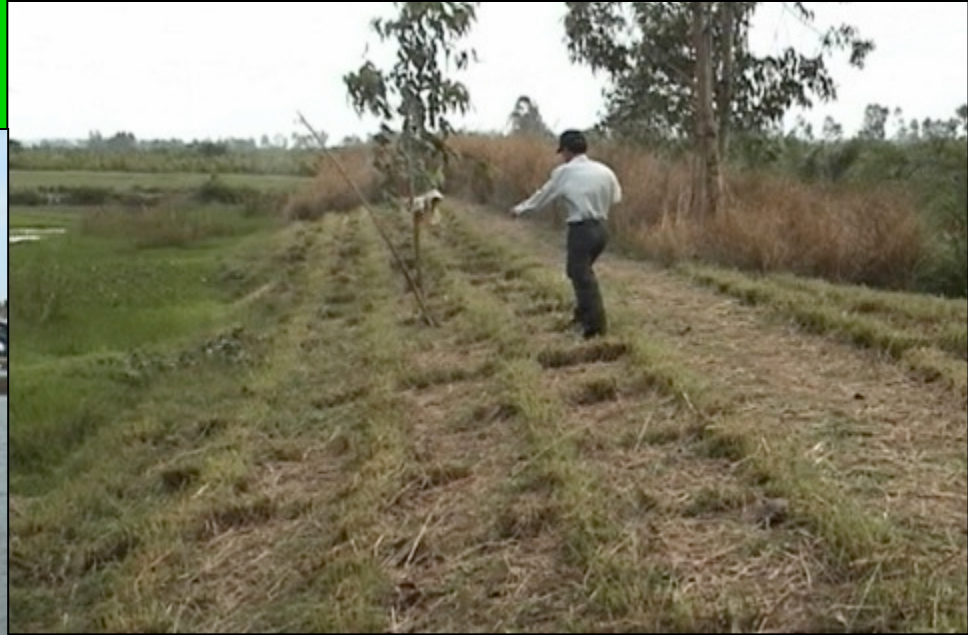
This, unfortunately was done not on the HCMHW but downstream, on anti-salinity dyke

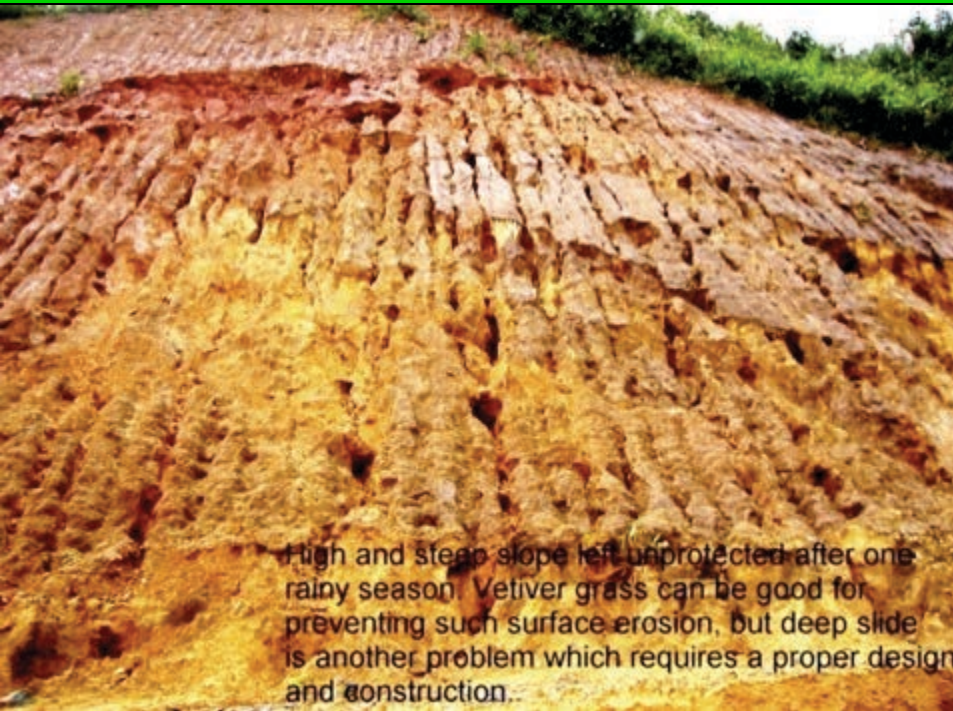
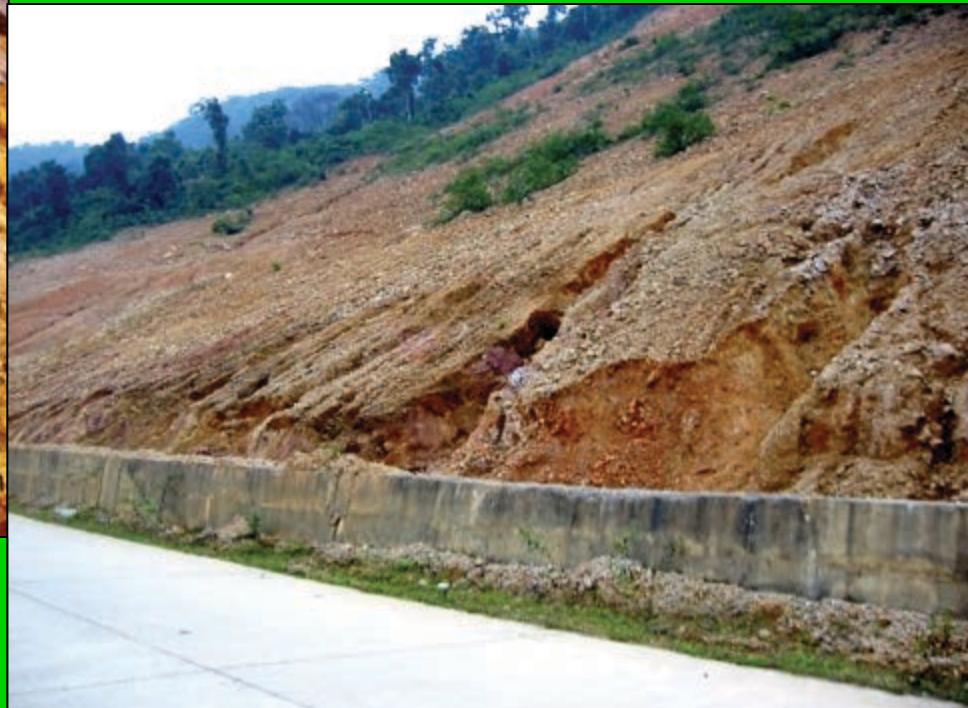
Slope surface erosion, developing into gullies...

... and small, shallow landslides

1. Slow, gradual, either continuous or seasonal slope surface erosion;
 2. Shallow, small slide, having failure surface within 1-2 m below the slope surface; and
 3. Large, deep-seated slide, having failure surface sometimes exceeding a few m or even tens of m below the slope surface.
- Slope instability is usually progressive, starting from (1) via (2) to (3)
 - (3) can also happen suddenly but rarely, during extremely heavy meteorological events
 - VS can help prevent (1) and (2) but it can hardly, even if well designed, established and maintained, prevent (3)

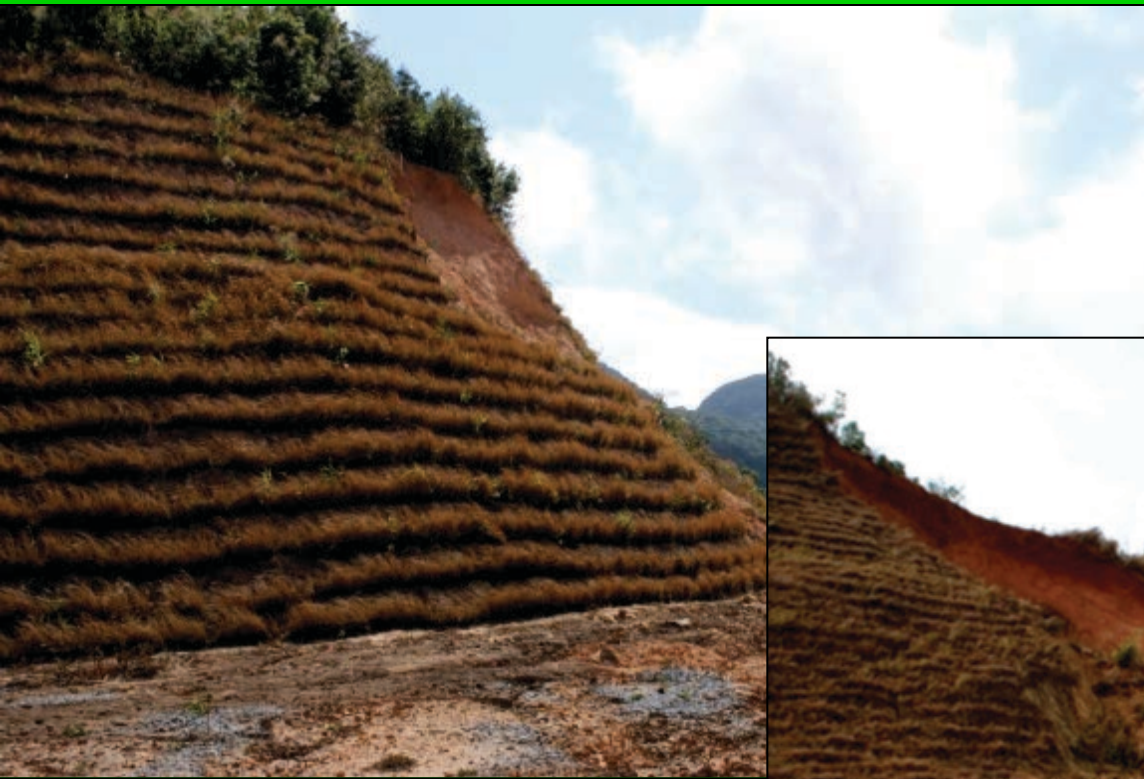
... before large, deep-seated ones take place and Vetiver grass can't help

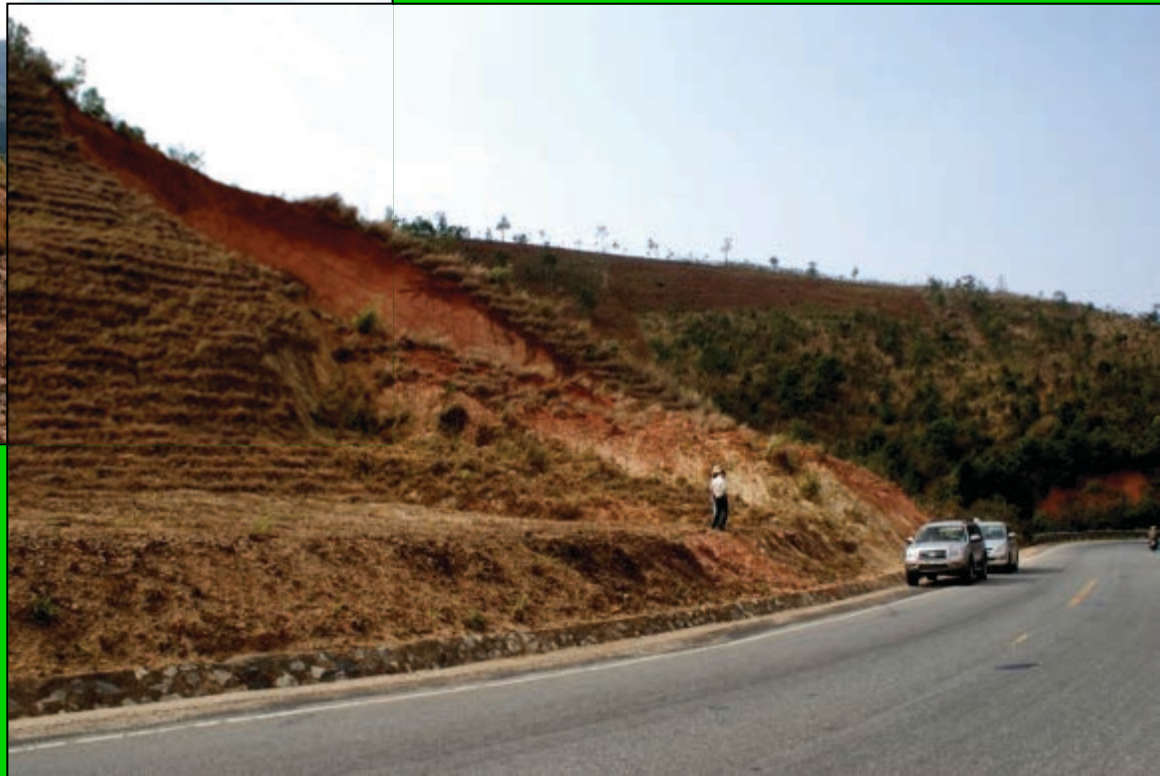
So try to stay within the capacity of the grass if it is not to be blamed in case of deep-seated failures
