The Fifth International Conference on Vetiver (ICV-5) “Vetiver and Climate Change”, Lucknow, India, 28-30 October 2011

Vetiver System for Natural Disaster Mitigation in Vietnam: Some Lessons Learned After a Decade of Application

Tran Tan Van* and Paul Truong**

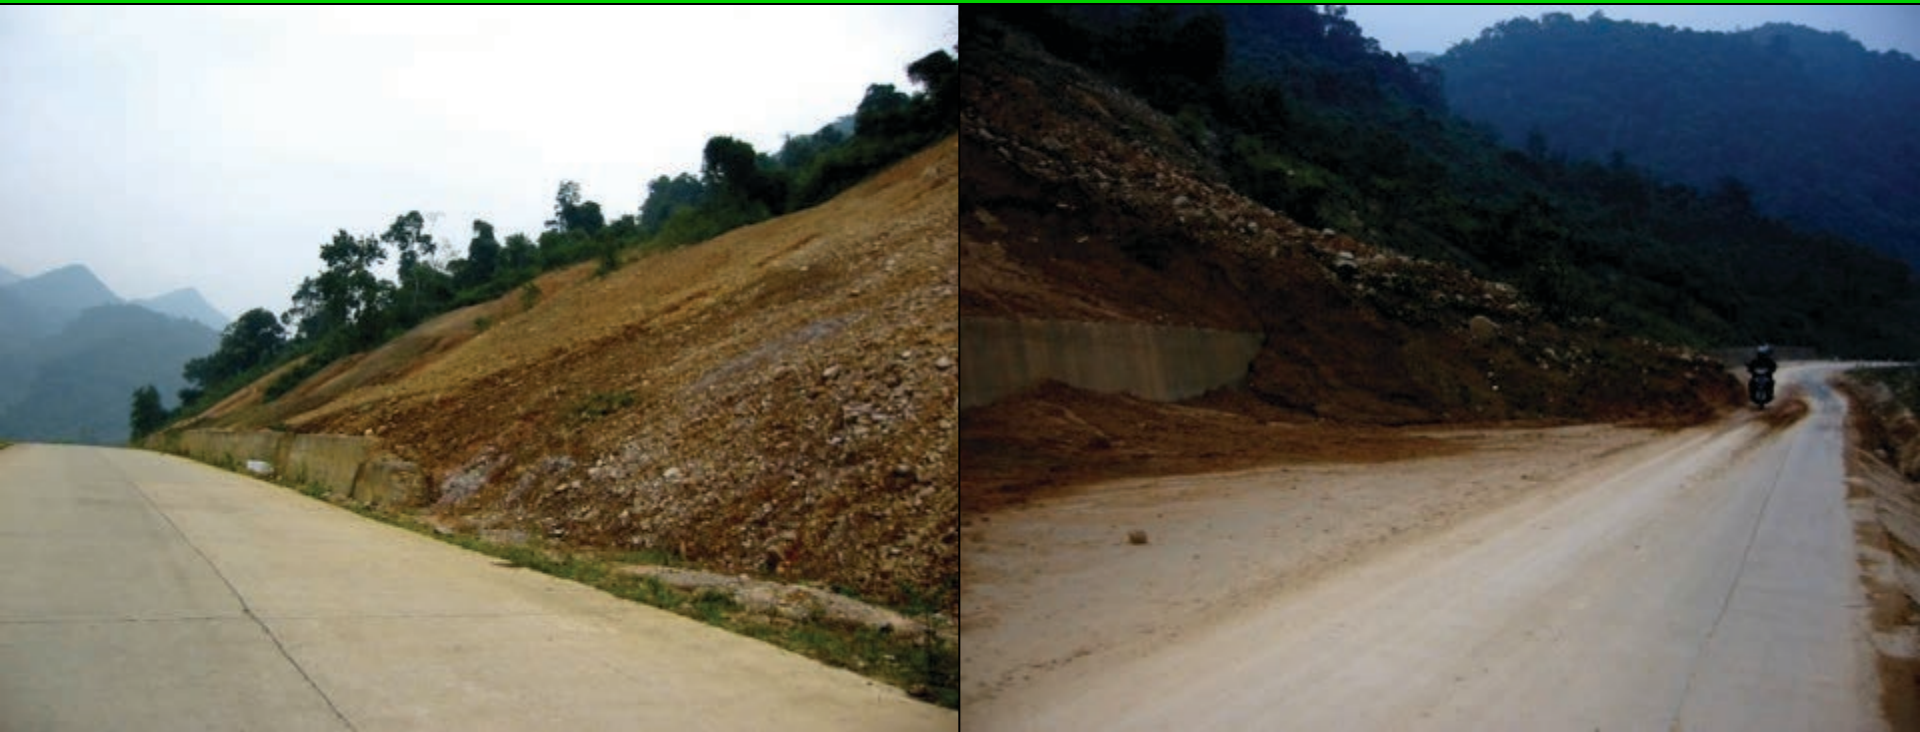
Slopes constructed on strongly crushed rock/soil along a fault zone continuously fails even though it has been very gently flattened down

Nevertheless, even in cases of large, deep-seated failures, VS, when established, can play a very useful role in retarding failure

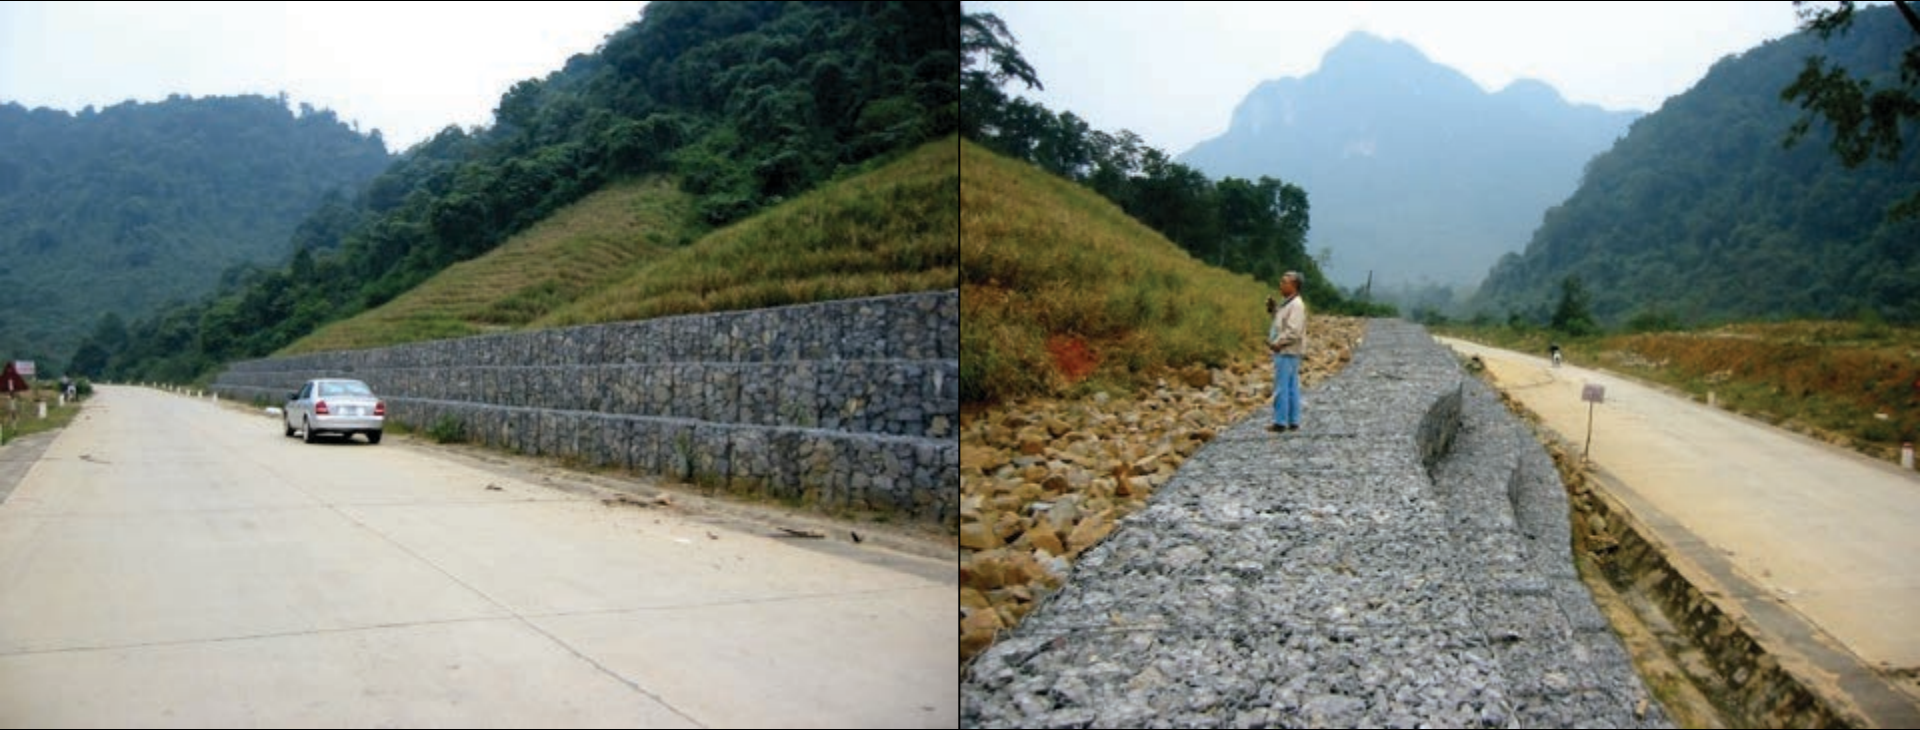
A combination of VS and rock groins did a better job even though at the other end still couldn't prevent a massive failure to occur

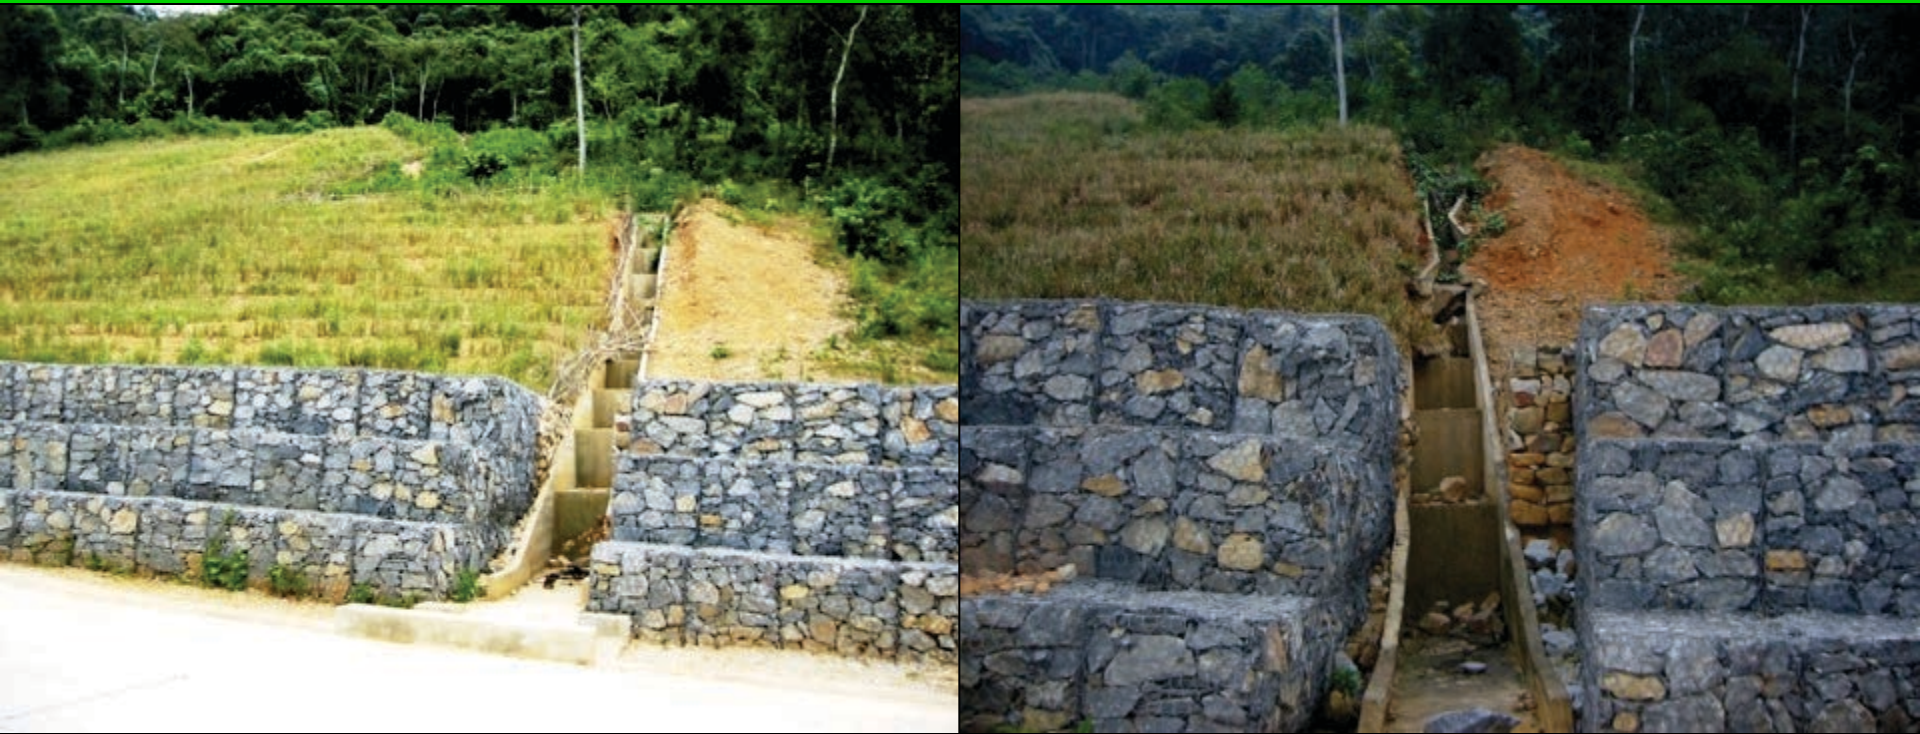
Planted in June 2004, visited in August 2004 ... and ... January 2005

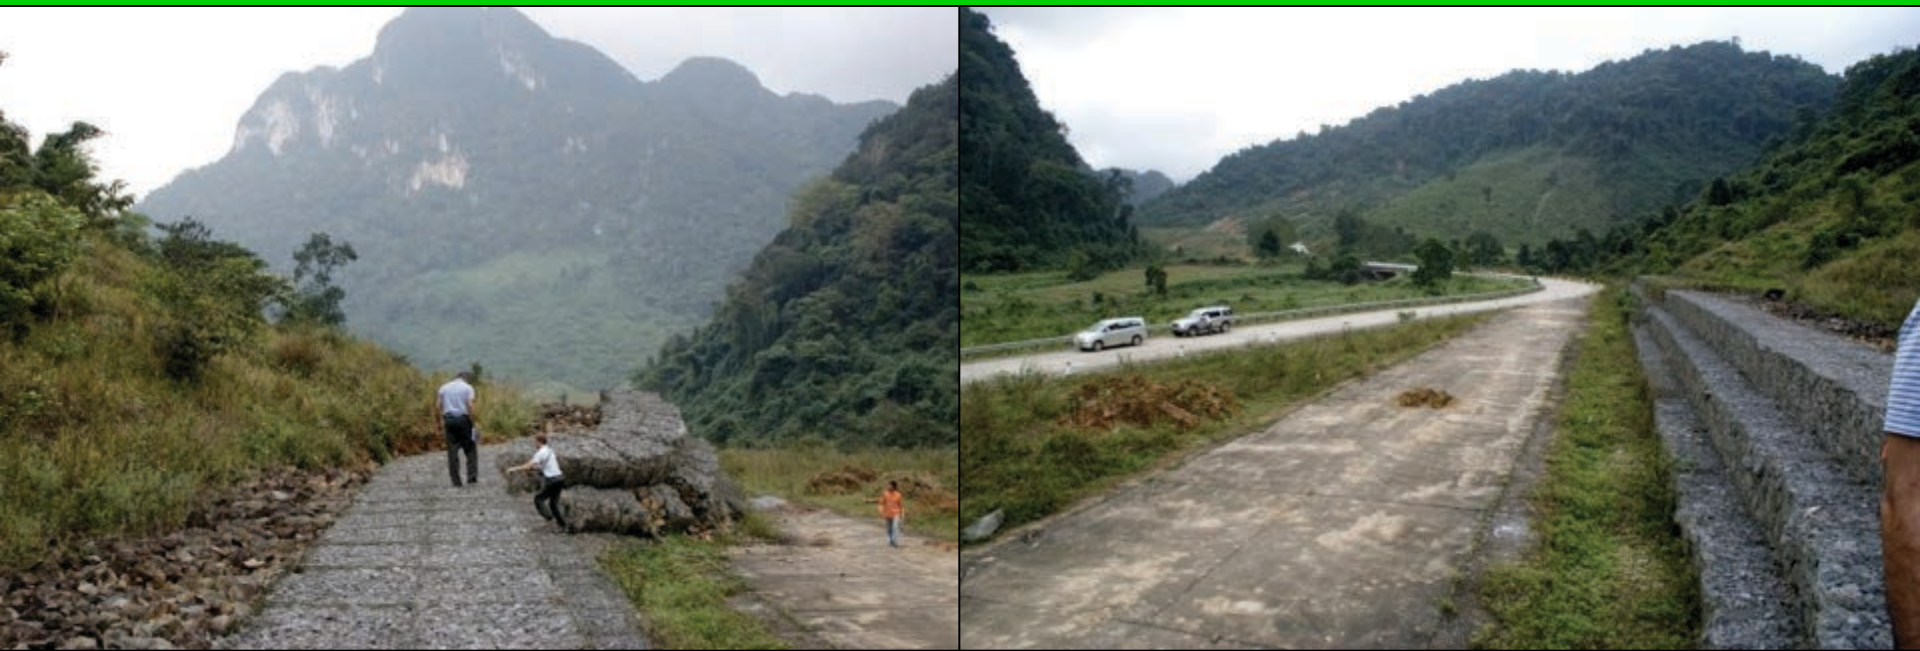
But when established it helped restore the local vegetative cover and strongly retard the failure even though eventually a by-pass had to be made a few meters down (photos taken 4/2011)

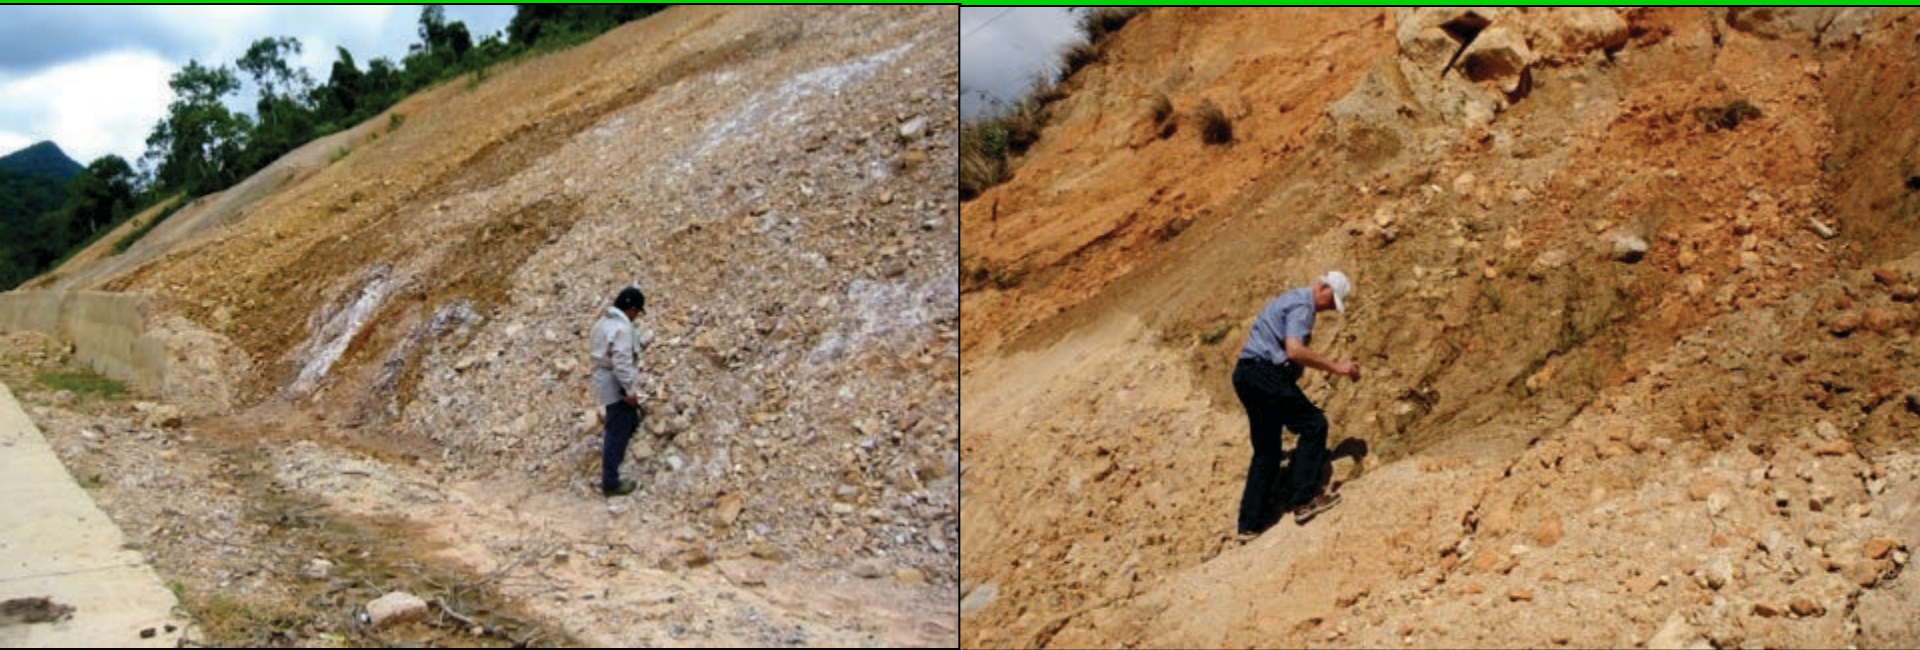
Improper drainage is an important cause of slope failure. Left photo taken Aug. 2004; Right photo taken Apr. 2011

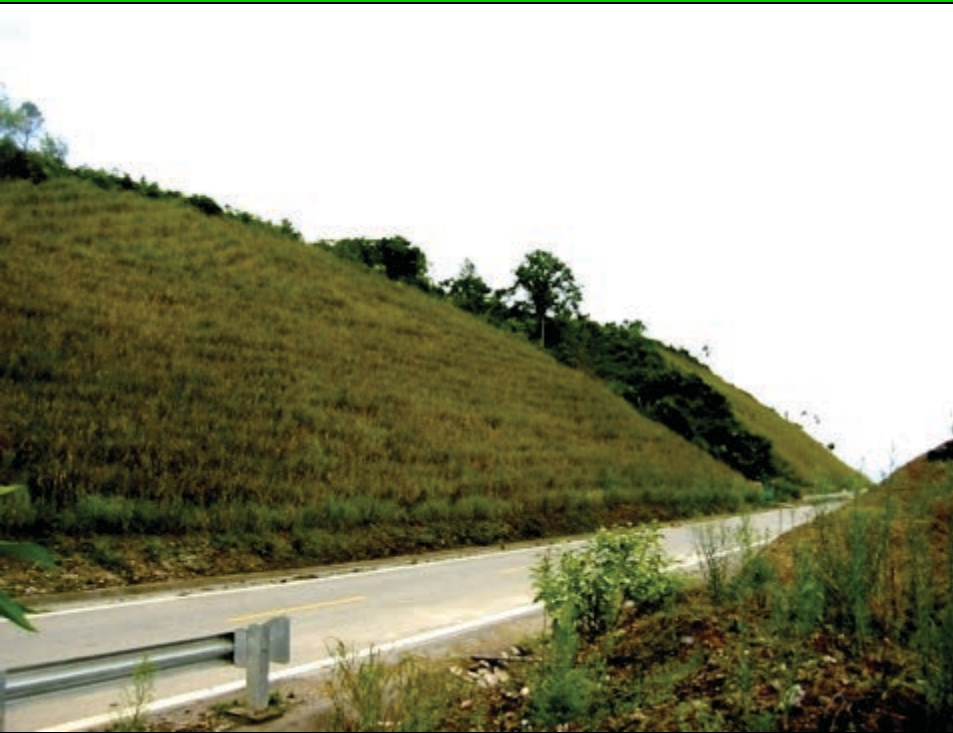
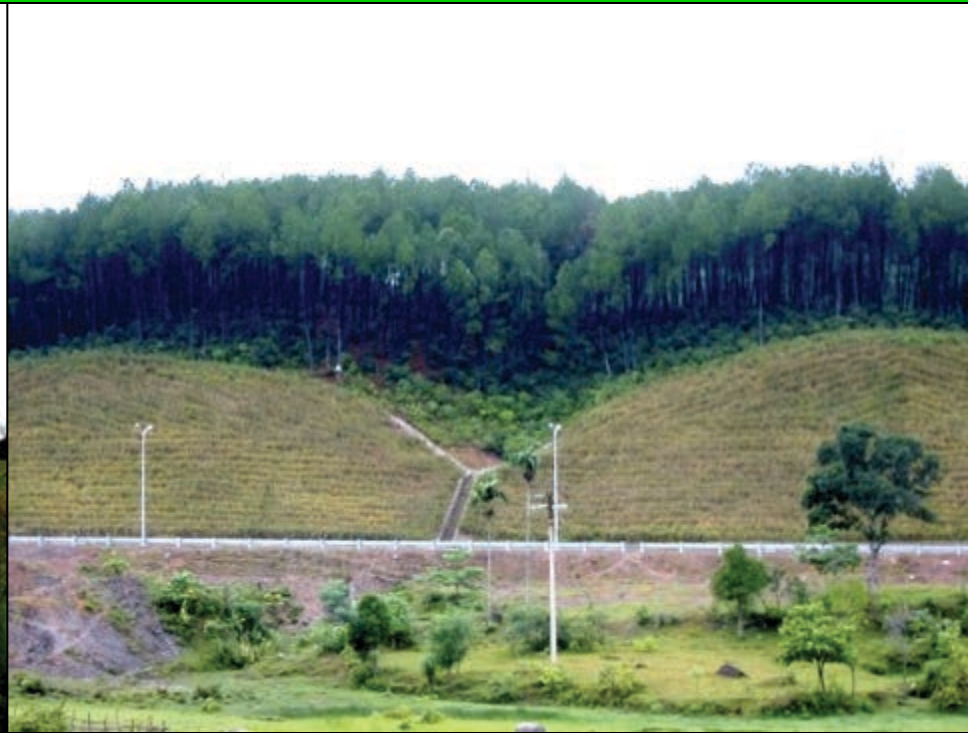
With its unique characteristics and coupled with proper design, VS does a very good job in draining away surface run-off, dissipating excessive pore pressure and reducing infiltration

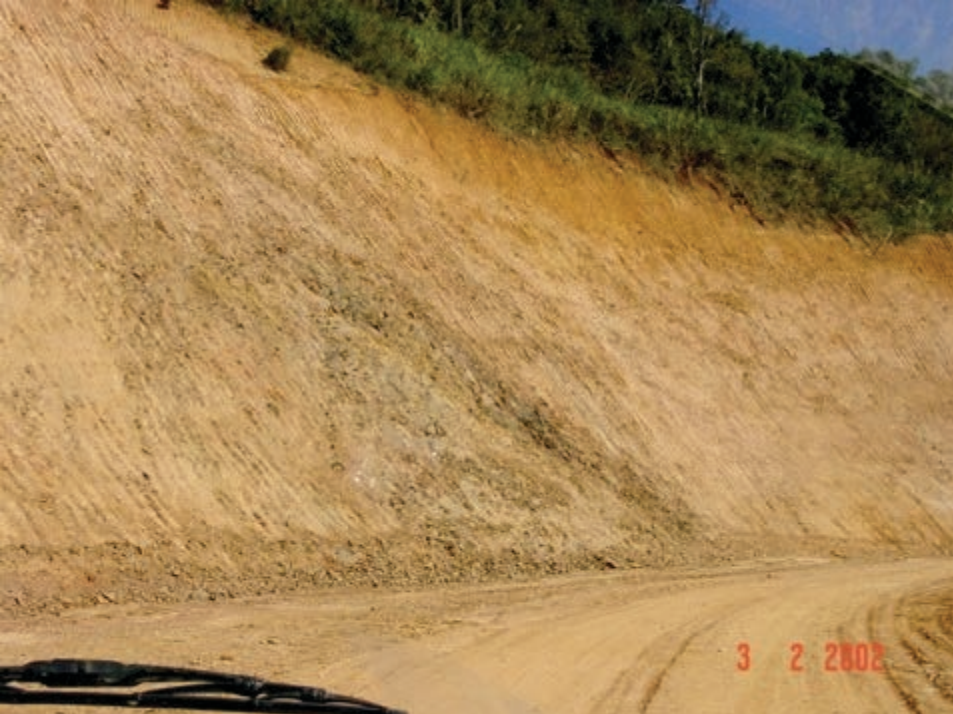
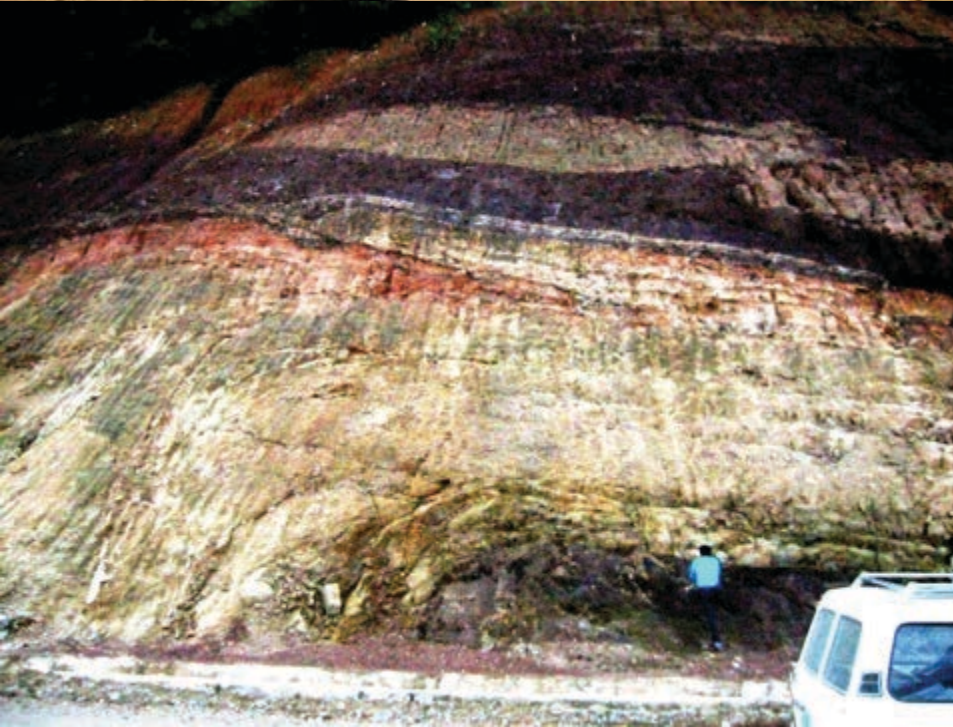
- Different parts of a cut slope may differ greatly in composition, due either to the weathering process or to the original bedrock lithology and structure.
- Understanding the regional and the slope geology and particularly its weathering profile is, therefore, a must if proper design and construction is desired
- For a completely weathered cut slope, or at least it's completely weathered part, it is advisable not to exceed 45° (H:V = 1:1).
- Moreover, although VS appears versatile enough to grow on different soil types, this difference may also influence its growth and may need to be taken into account

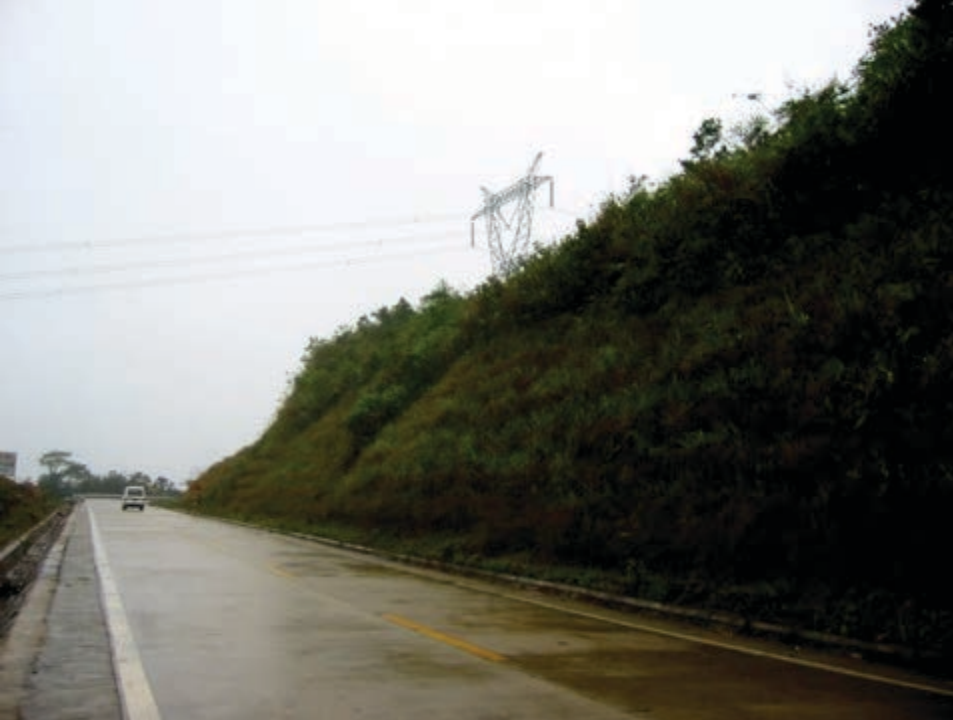
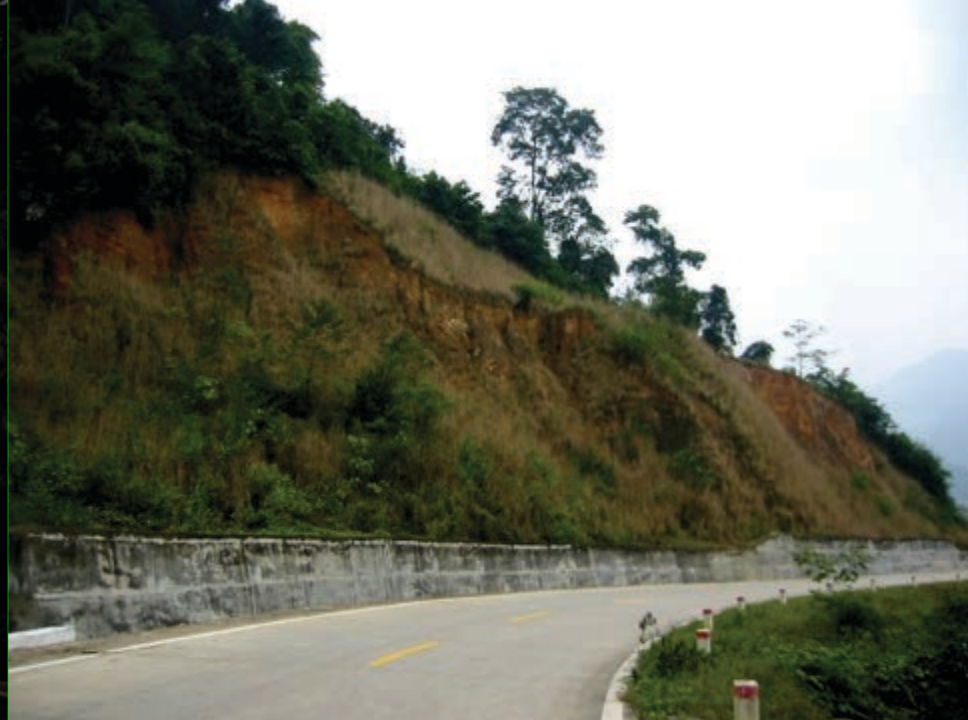
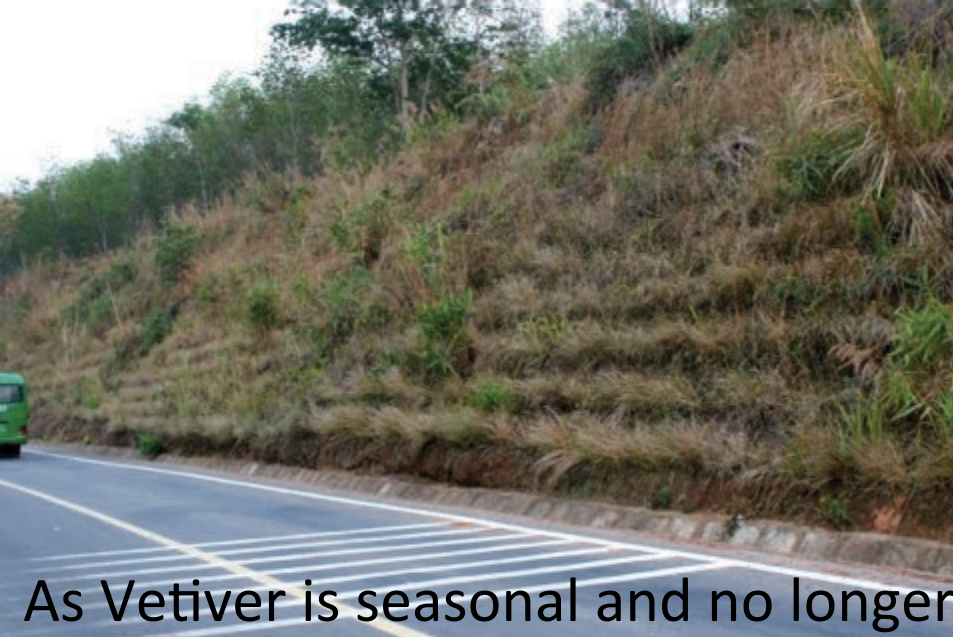
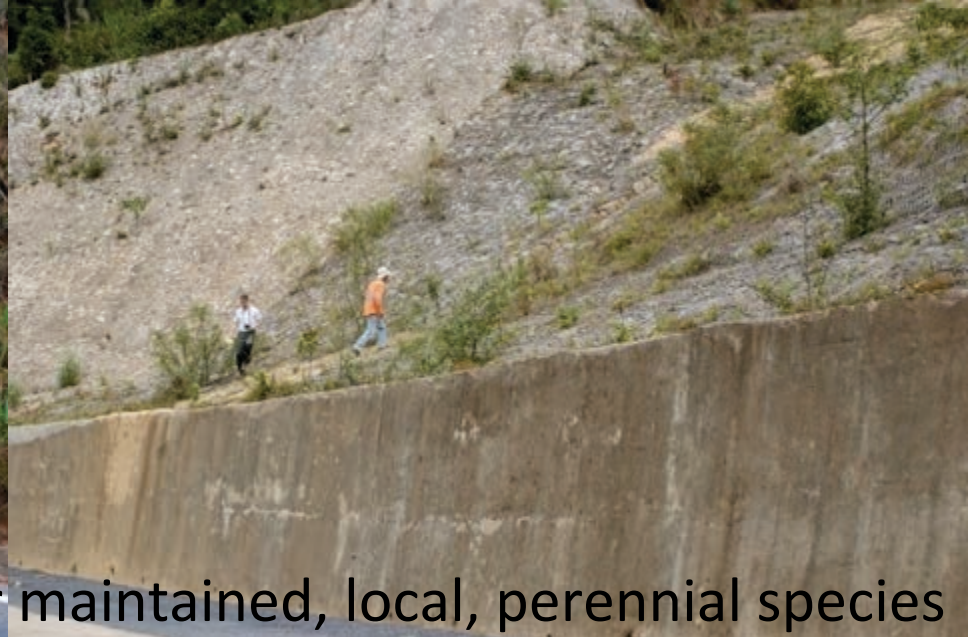
As Vetiver is seasonal and no longer maintained, local, perennial species strongly compete, penetrating even the rock rip-rap and wire mesh

- As the VS is seasonal and no longer maintained, it cannot compete with the local, perennial (shallow-rooted) species
- it is better to provide long term and regular maintenance to ensure as deep root penetration, and together with that, slope stability, as possible.
- Another reason for doing so is to maintain the environmental friendliness of the measure.

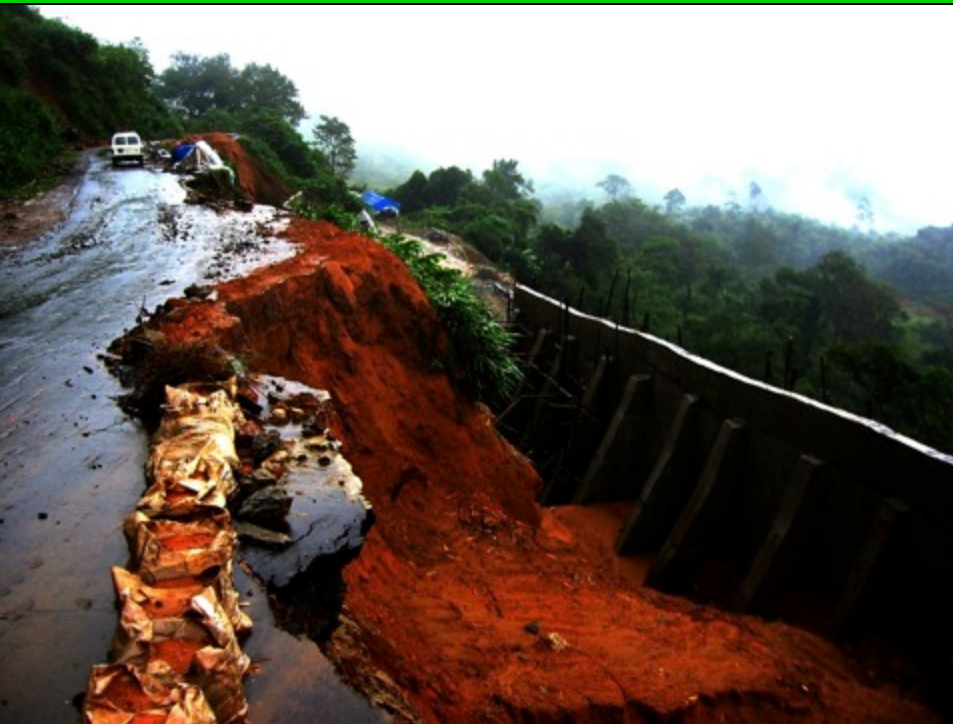
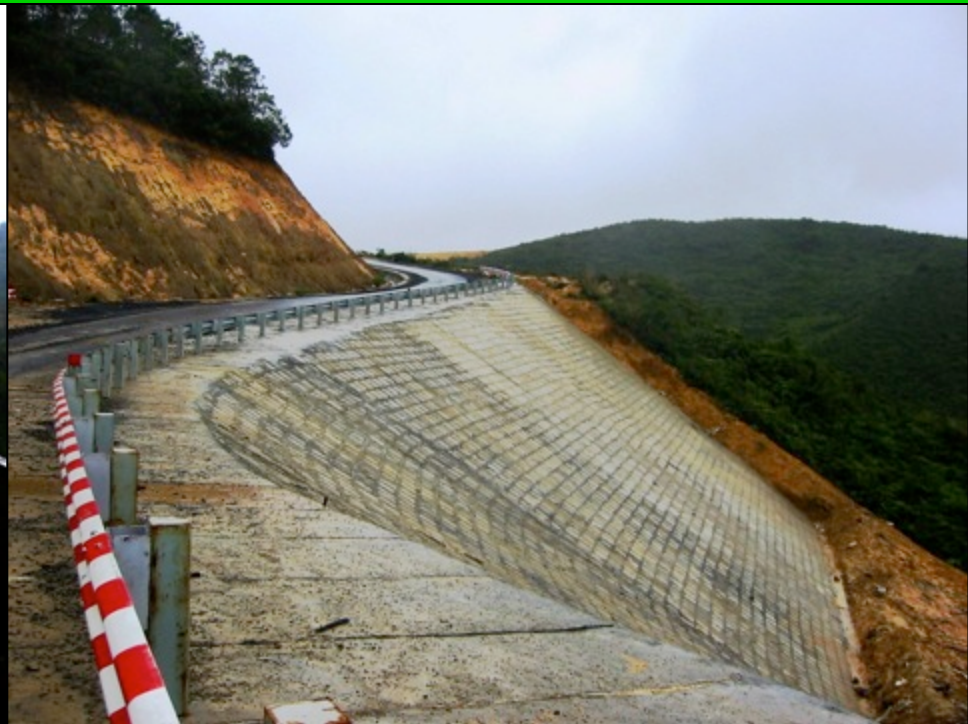
Negative side failure and rigorous remedial measures

- No VS is applied on the negative side of slopes along the HCMHW although it is very useful
