“Converting Badlands to Good-lands”

A watershed Management Technique for reducing sedimentation at the Talakhaya Watershed in Rota, CNMI

Mohammad H. Golabi, Soil Scientist

ICV6: Danang, Vietnam - May 2015

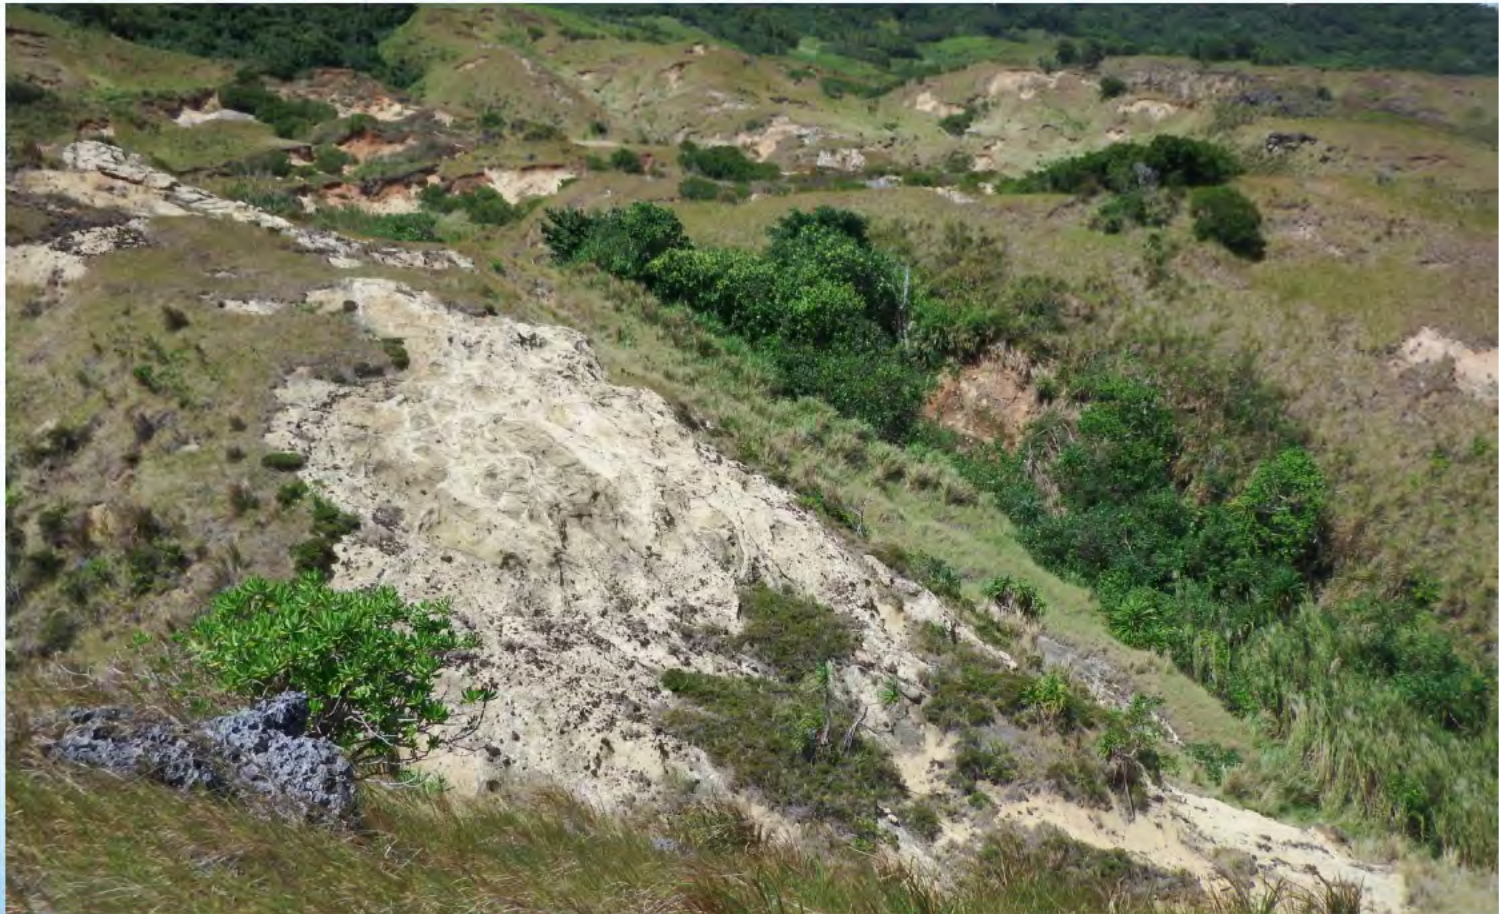
Typical exposed/badland areas at the Talakhaya watershed in Rota, CMNI

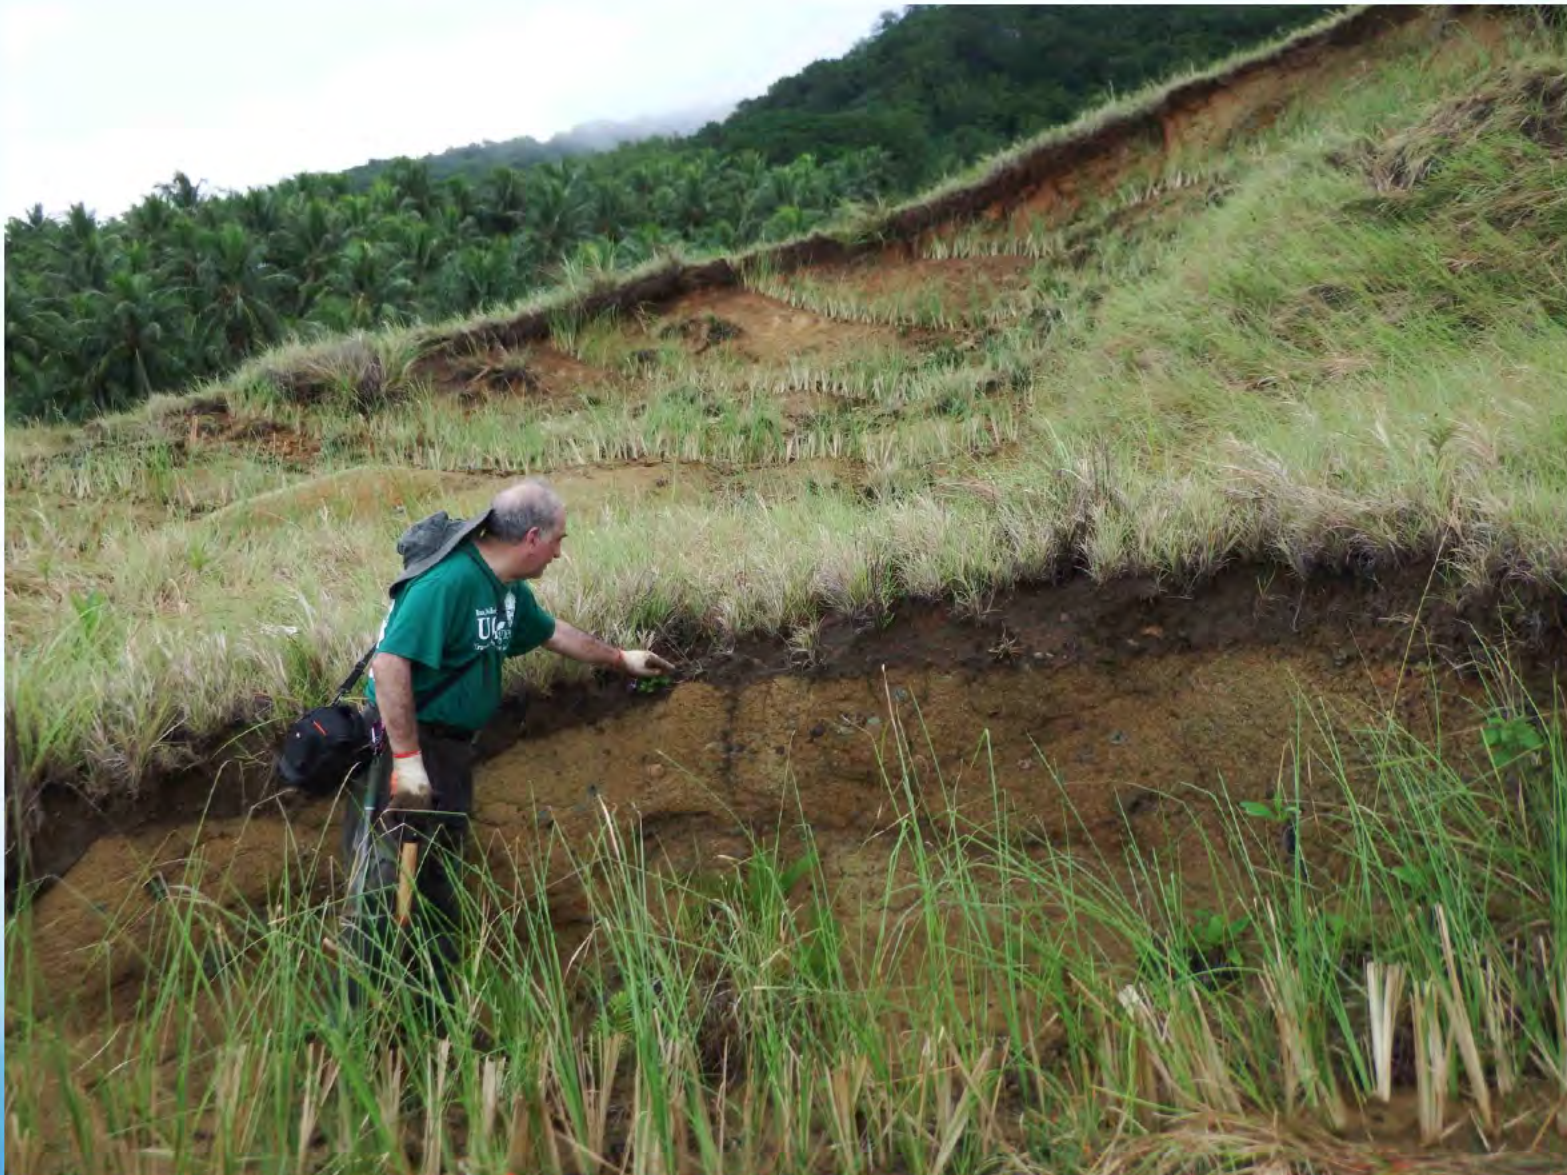
Dr. Golabi showing the local grass with little root with little or no protective ability

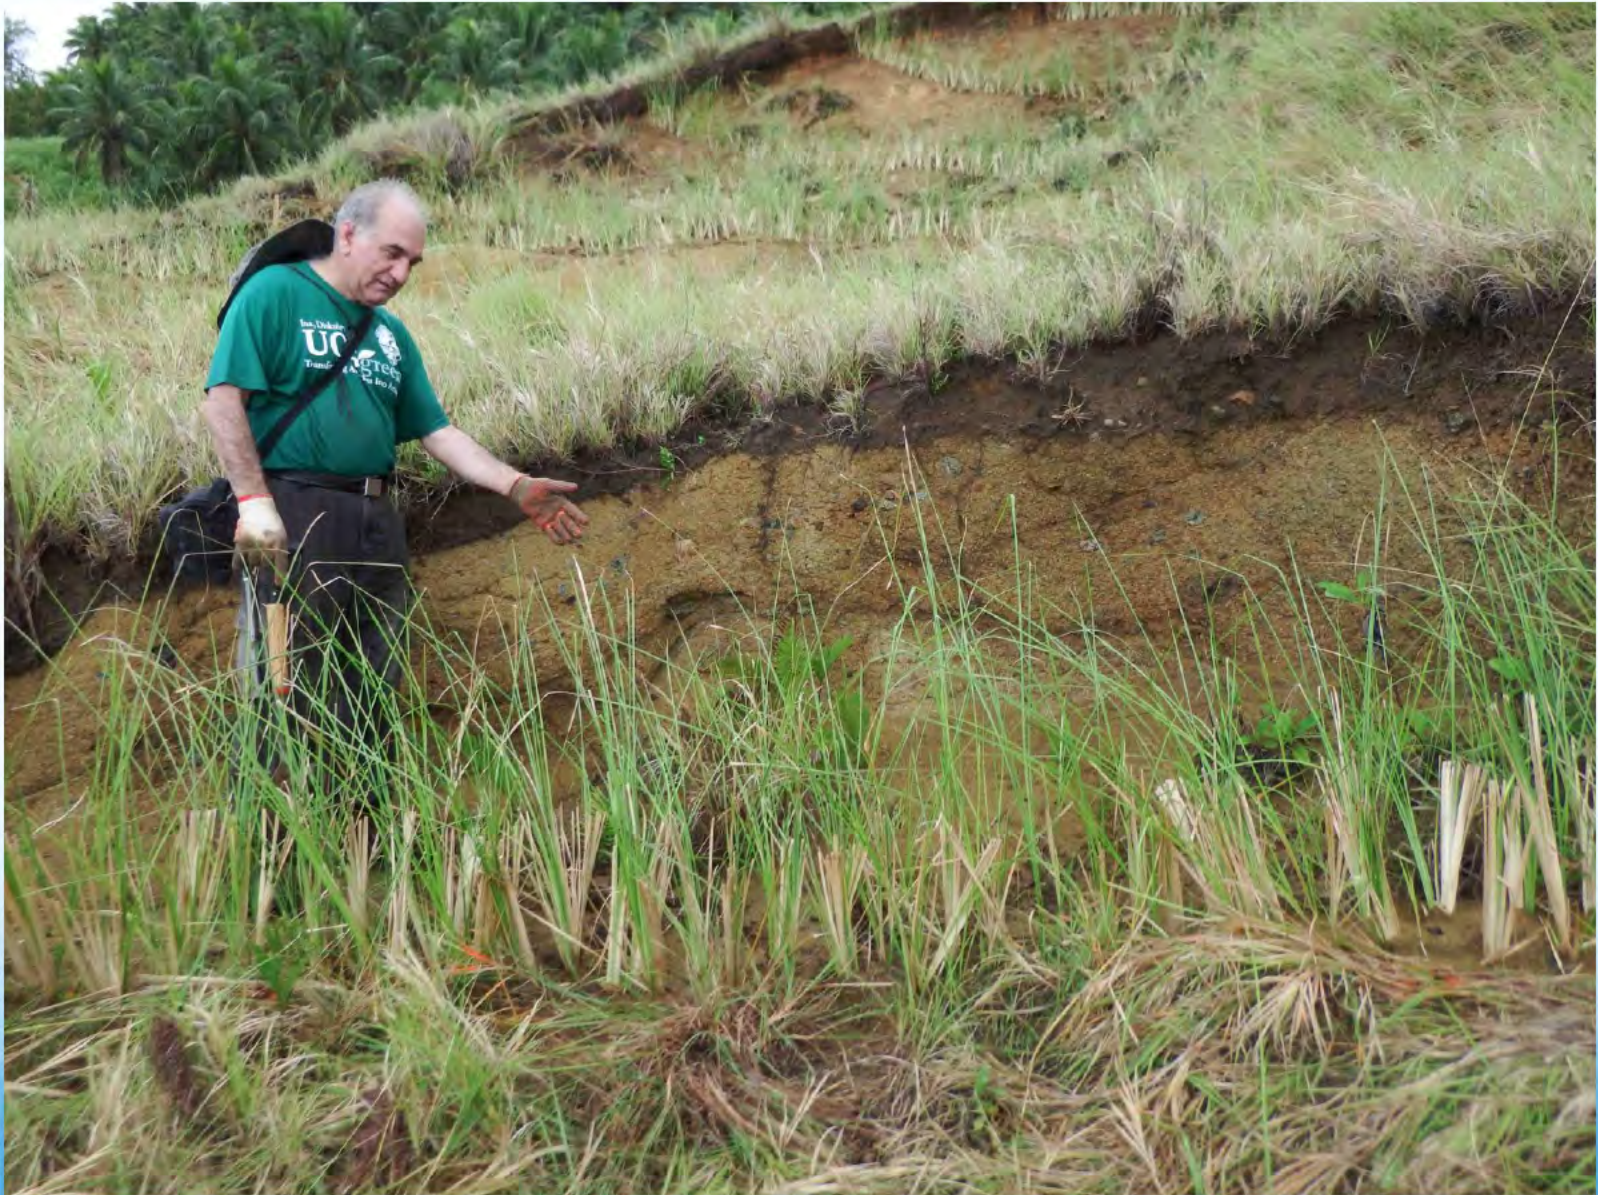
Comparing with Vetiver grass with ability to hold on sediment

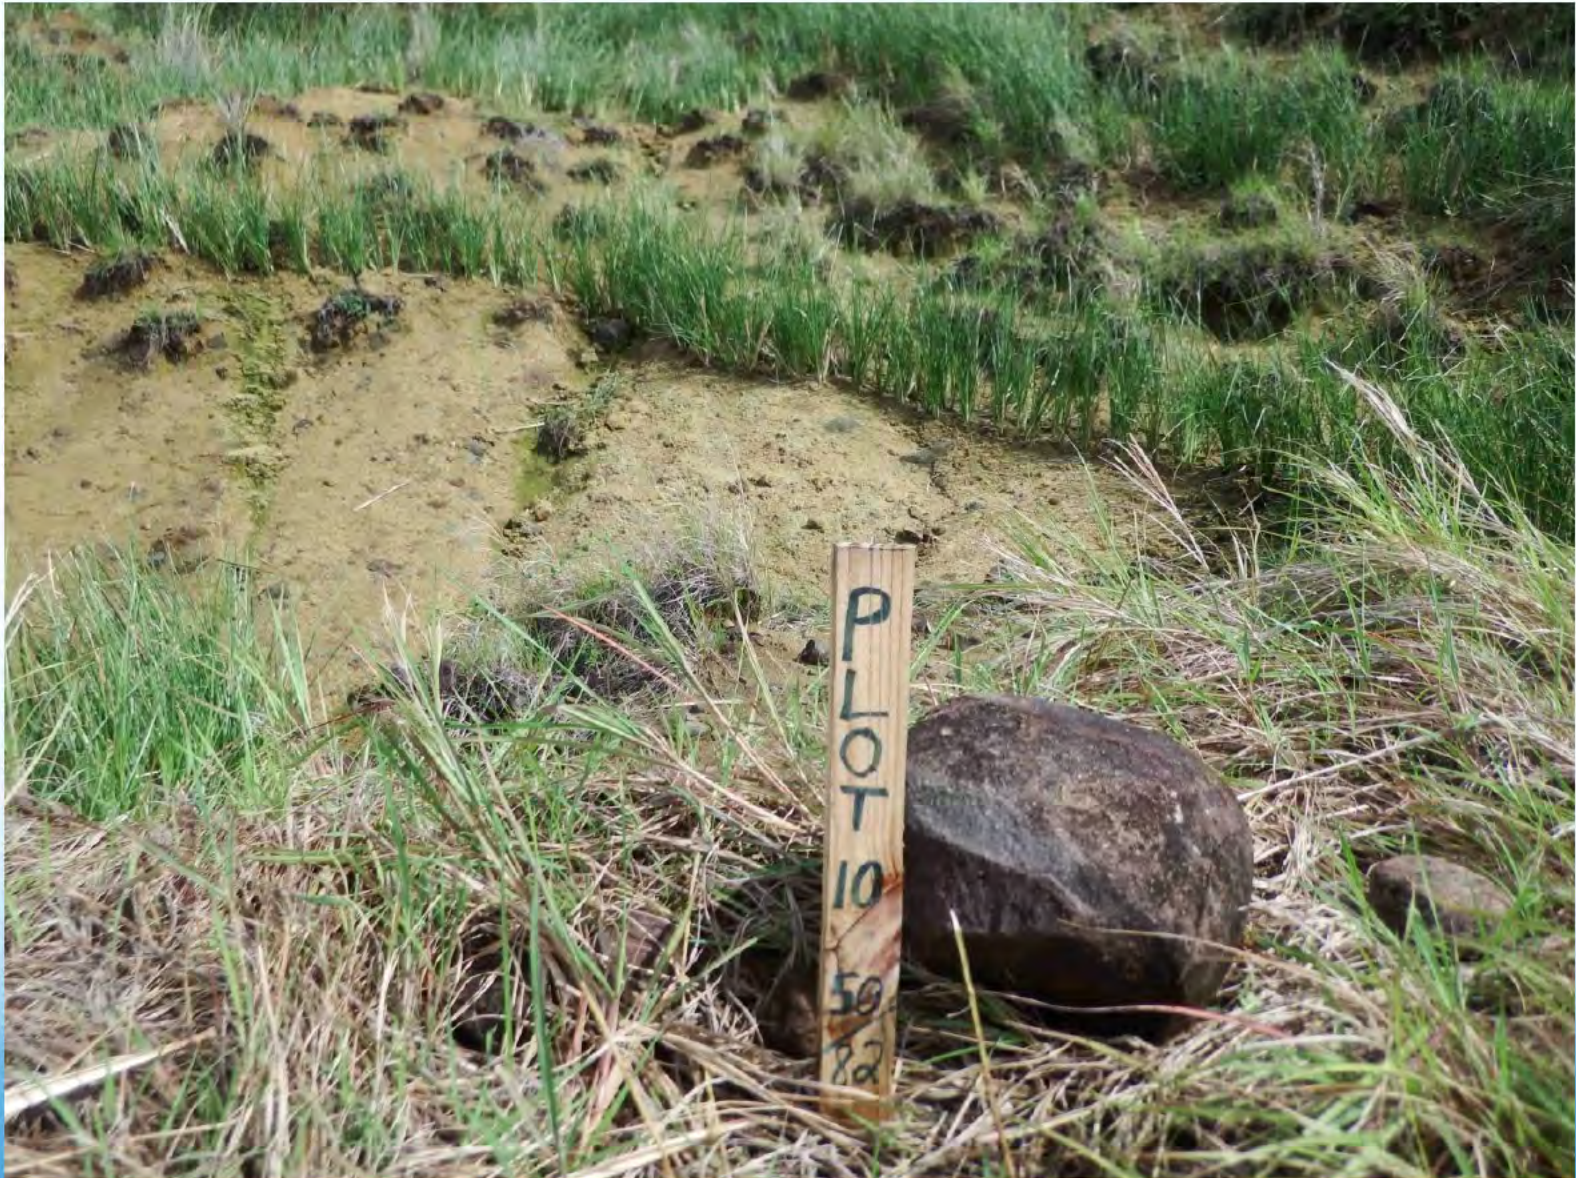
Look how the Vetiver hedges are planted in each plot at the watershed

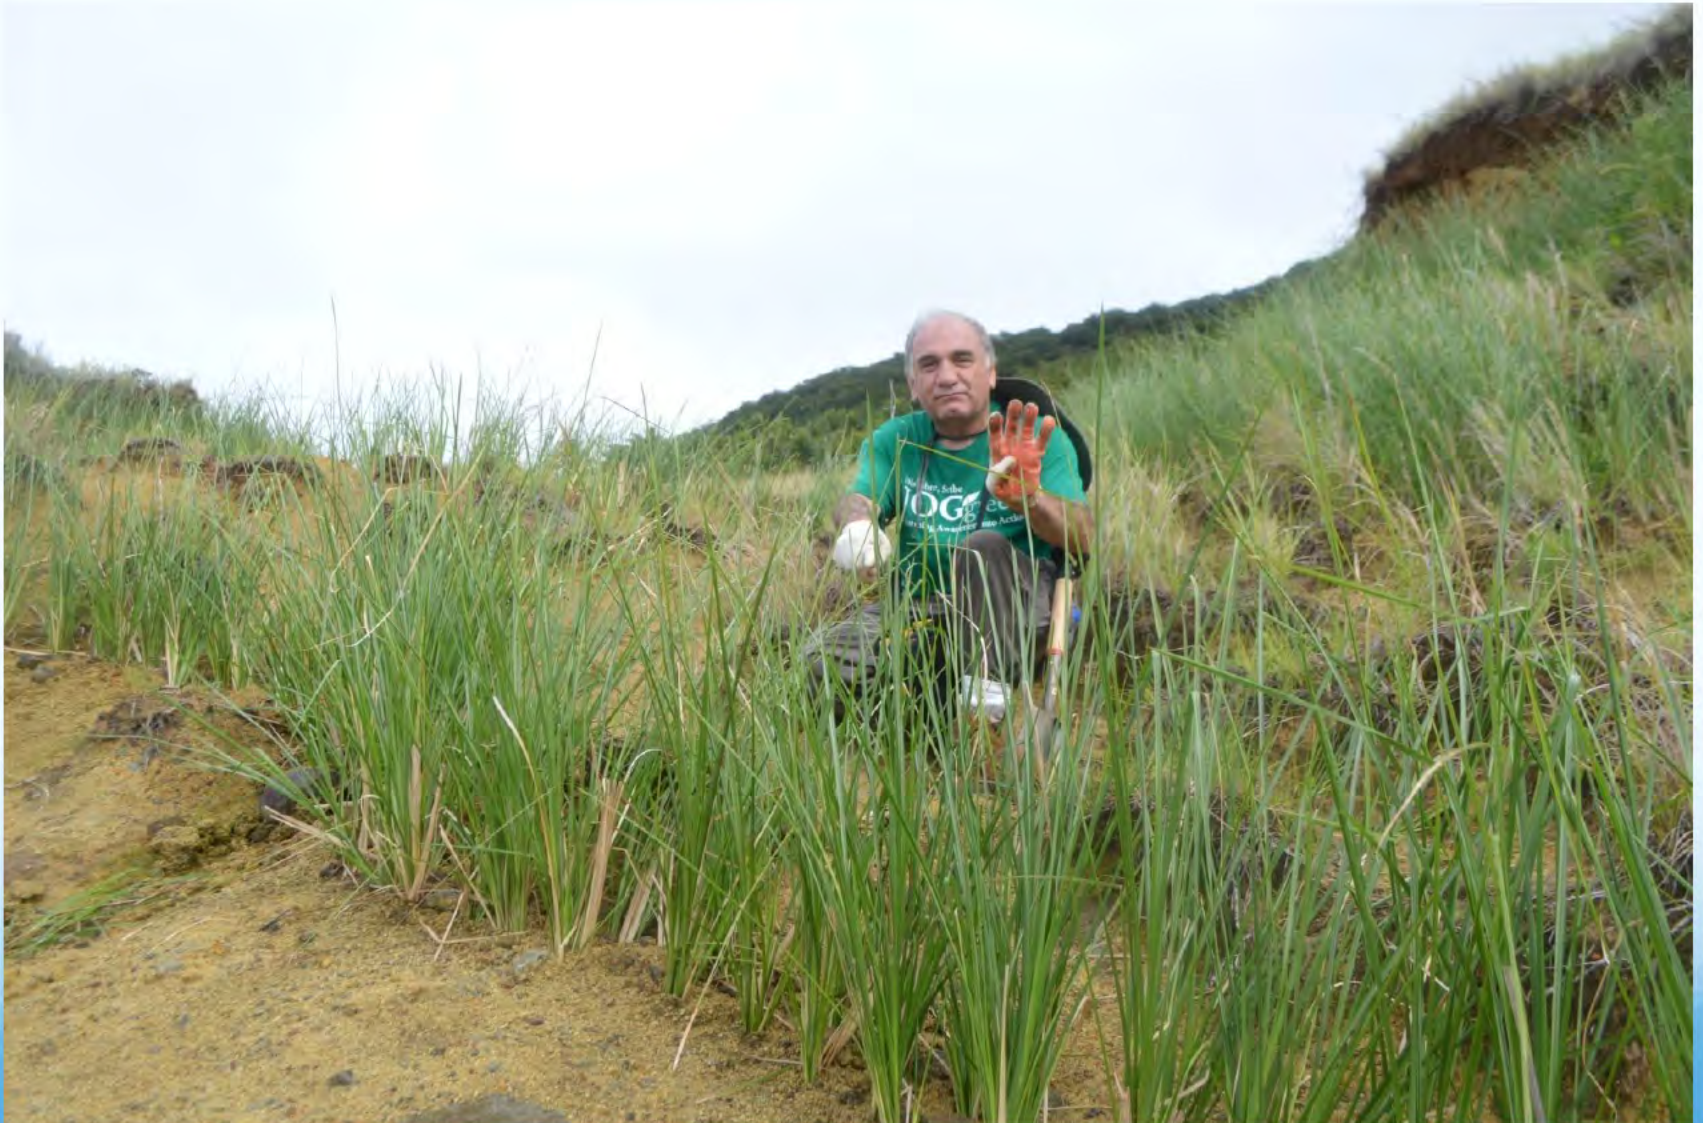
Now this hedge is only 4 months old

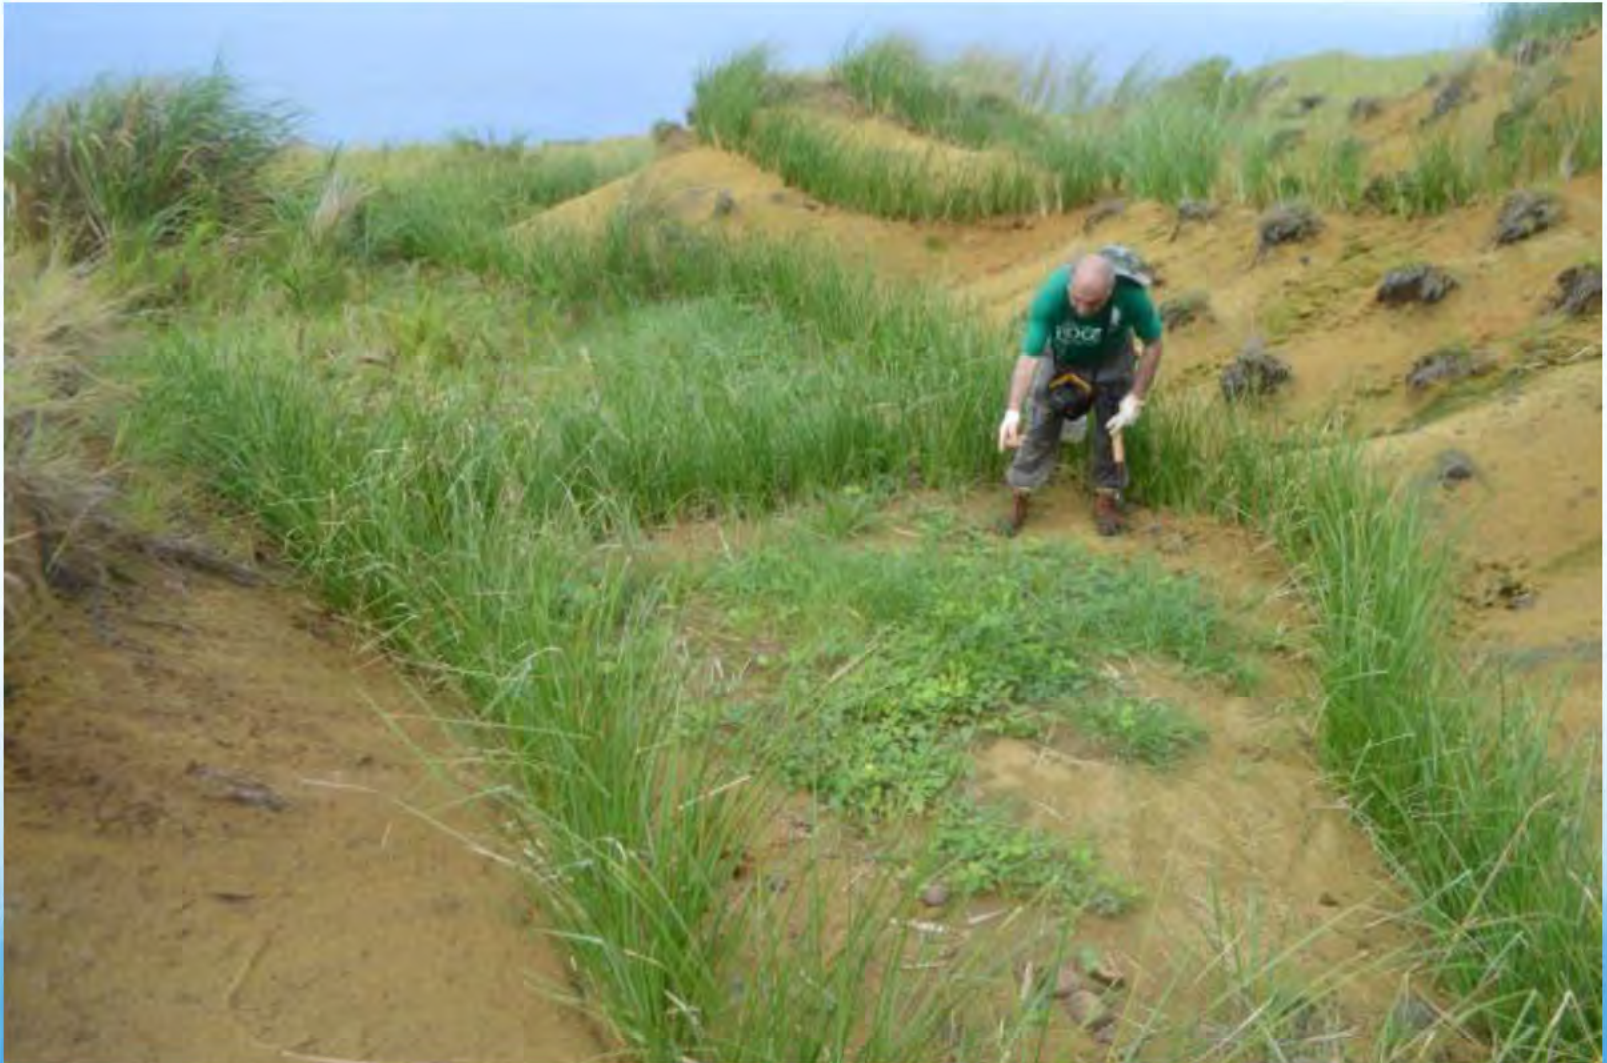
Areas where Vetiver grass is planted which in turn has induced improvement with local vegetation growth

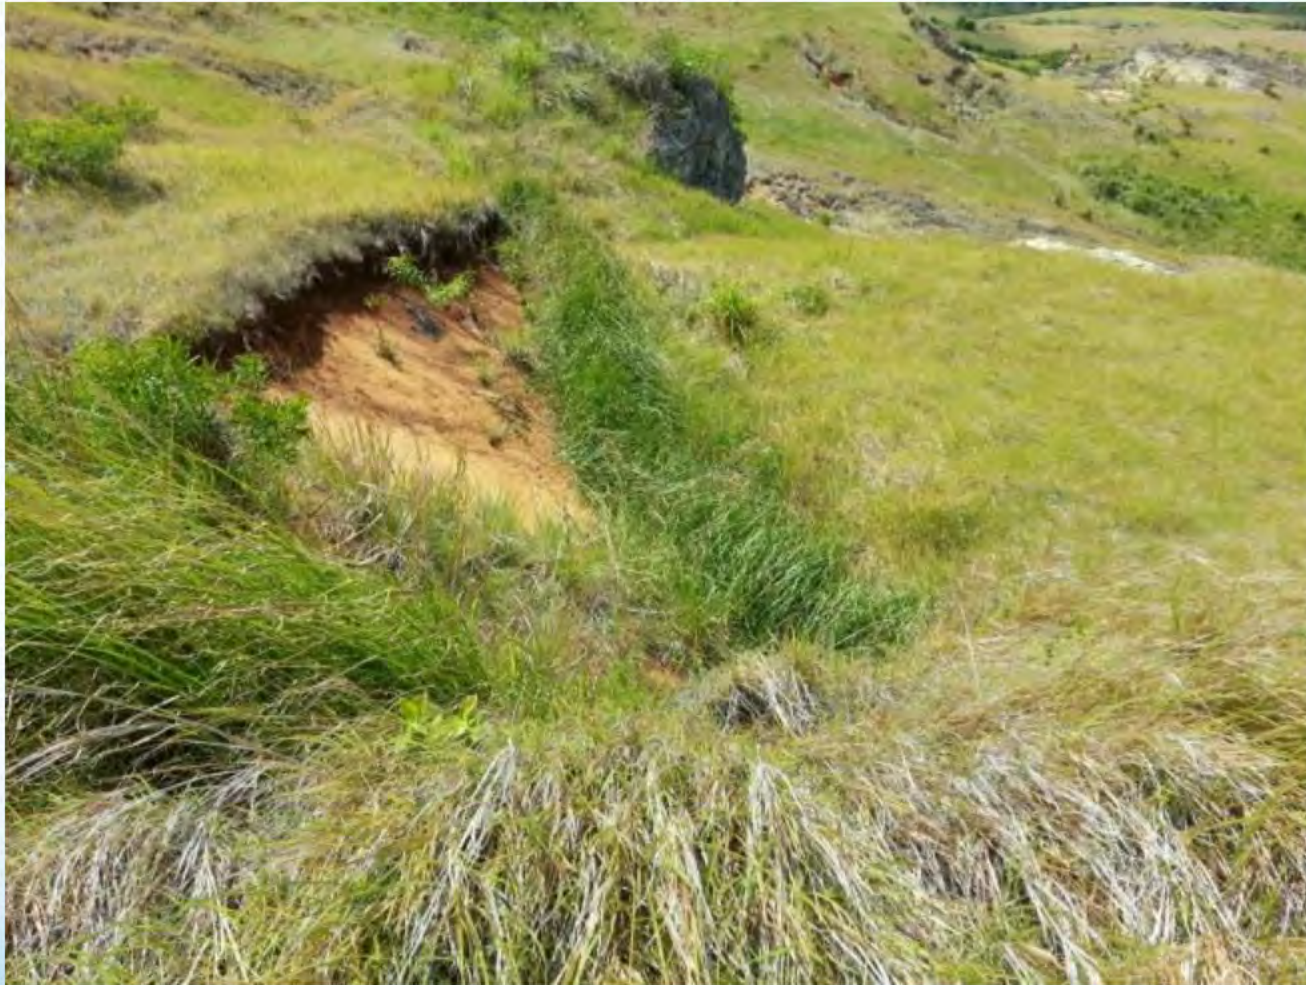
About six months old Vetiver grass at the Talakhaya Re-vegetation site

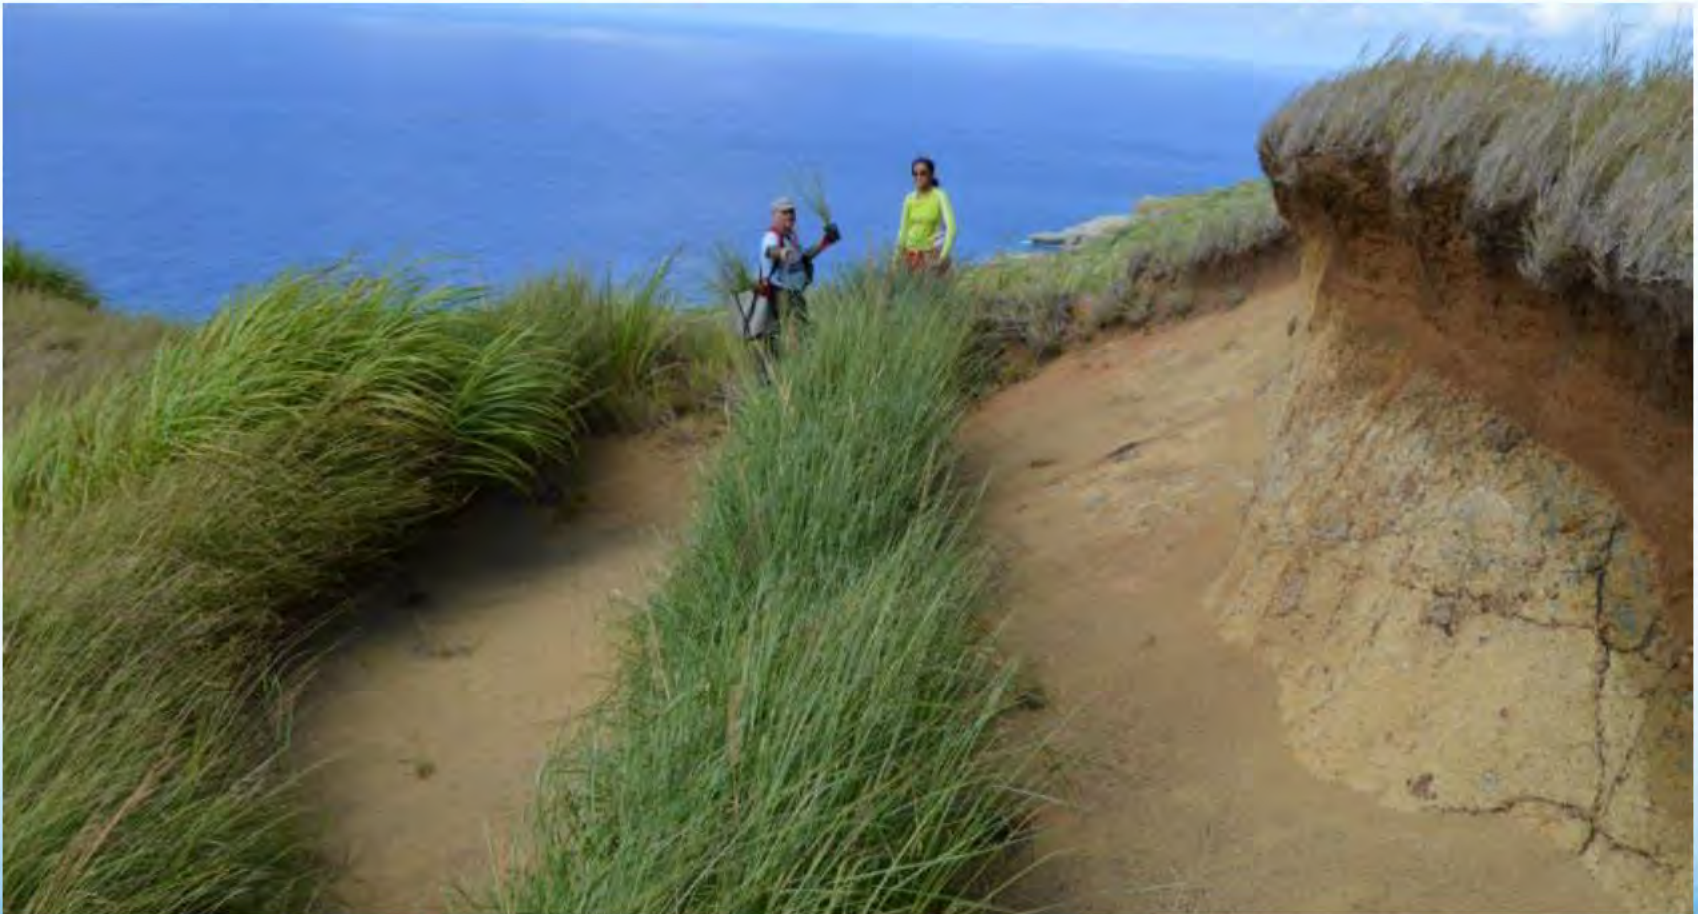
A year old Vetiver grass at the Talakhaya Re-vegetation project site:

Note: As shown Vetiver works as barrier to sediment loading down to the streams and shorelines, hence protecting the precious coral from siltation.

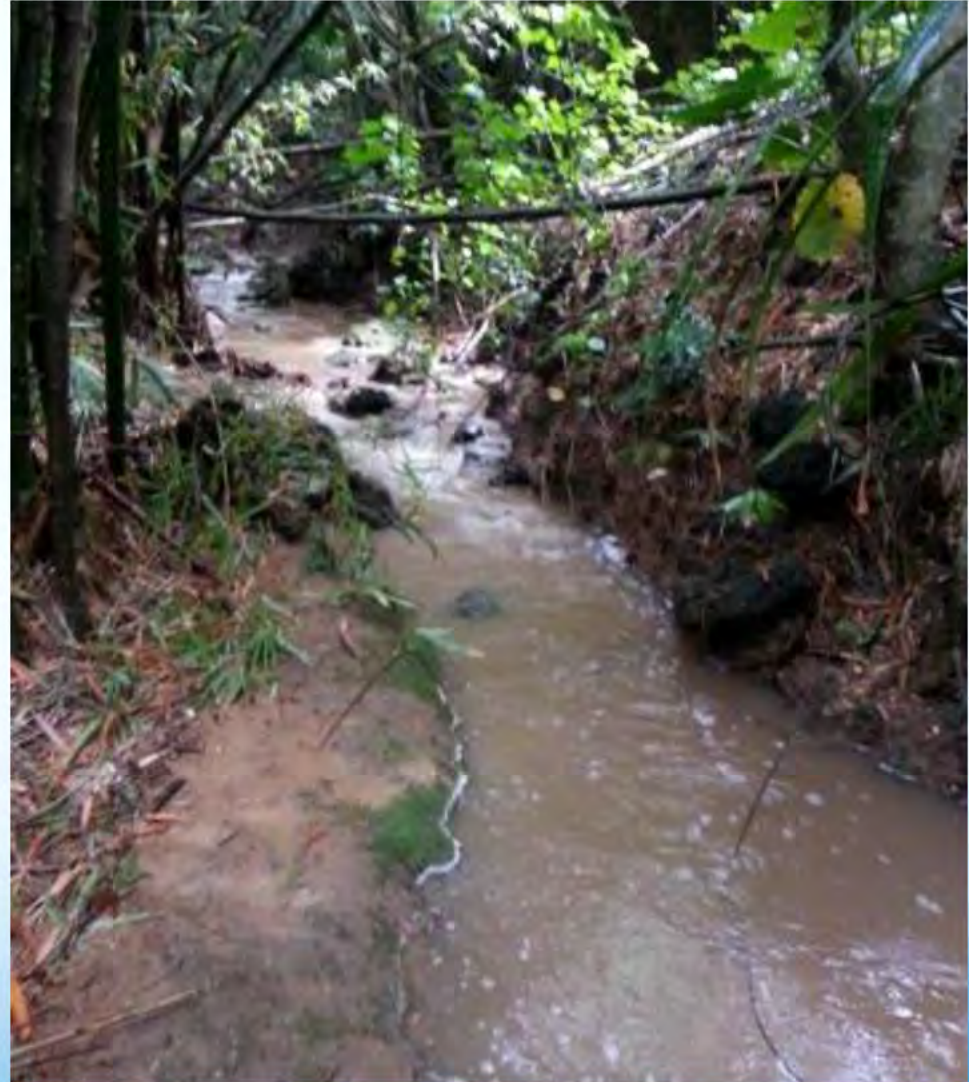
Stream Study Sites

Treatment categorization at the Talakhaya Watershed Site

- Unvegetated Project Stream (TK1)
- Re-vegetated Project Stream (TK2 and TK3)
- Natural Vegetation Control Stream (TK4)
