SUCCESS STORY OF THE VETIVER SYSTEM IN ASSAM

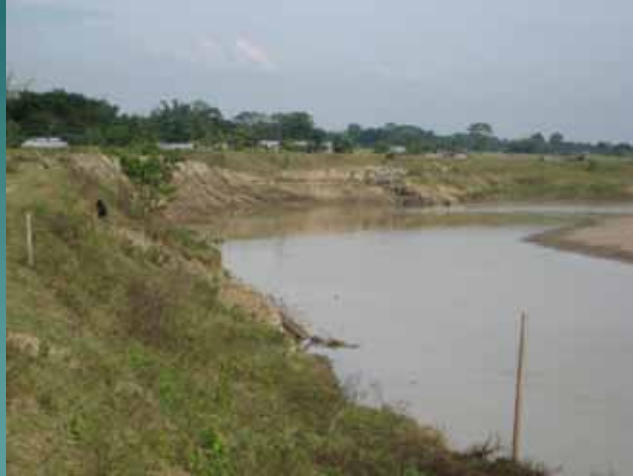
Highly eroded Kolong river bank

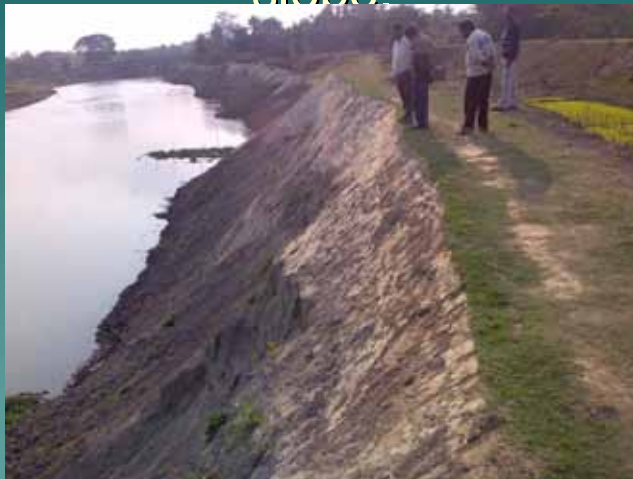
Same stretch prepared for
plantation- note the very steep
slope

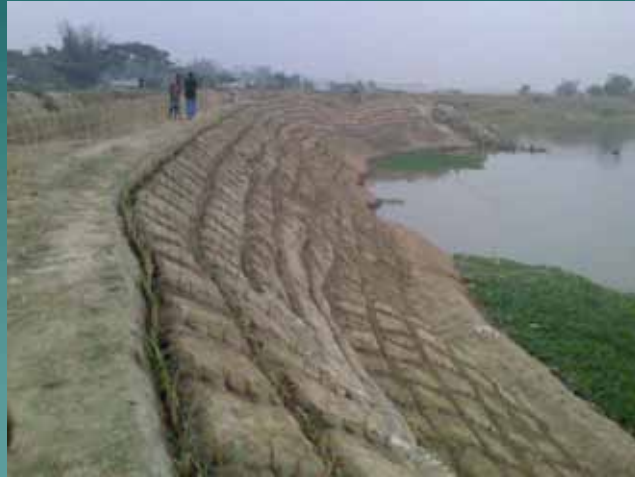
Vetiver planted in 1m x 1m grid

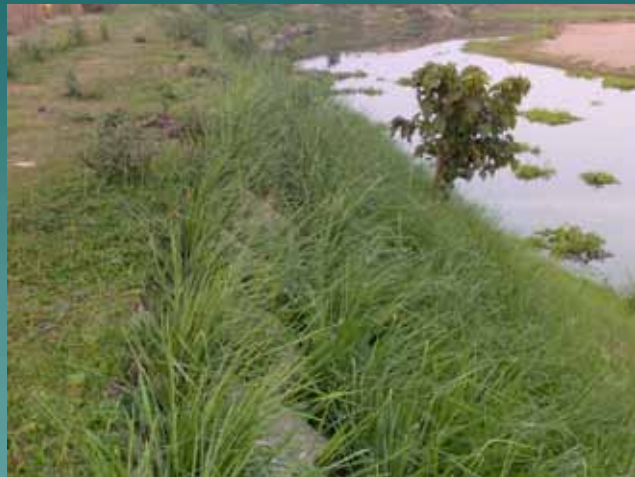
Vetiver plants in the 3rd month

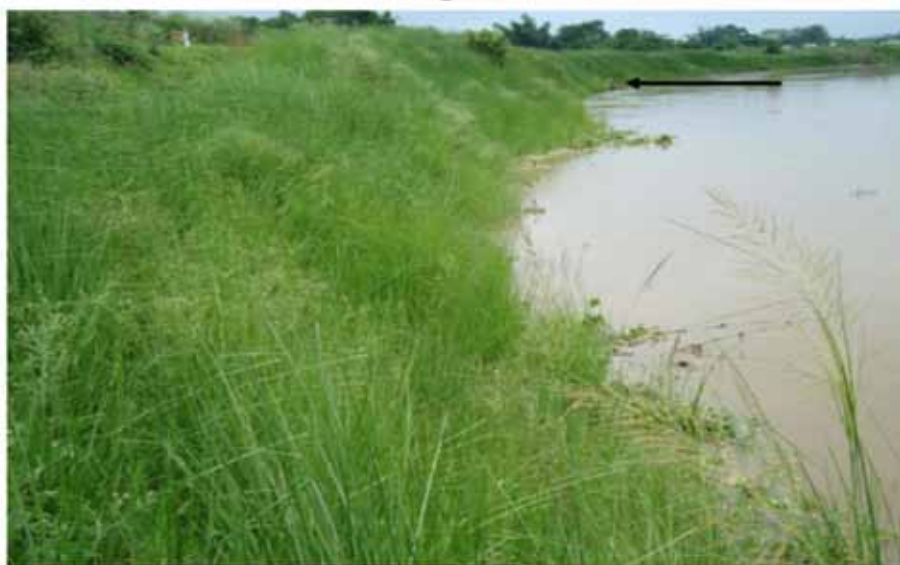
Flood water reached the arrow mark(Top of the porcupine)
as seen in the following photographs

Telahi during the first flood

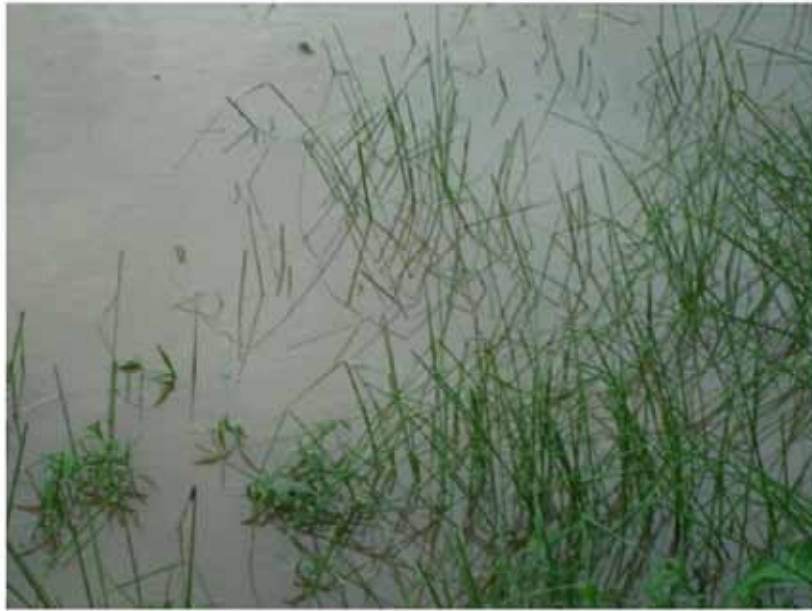
- Top of porcupine nearly submerged
-

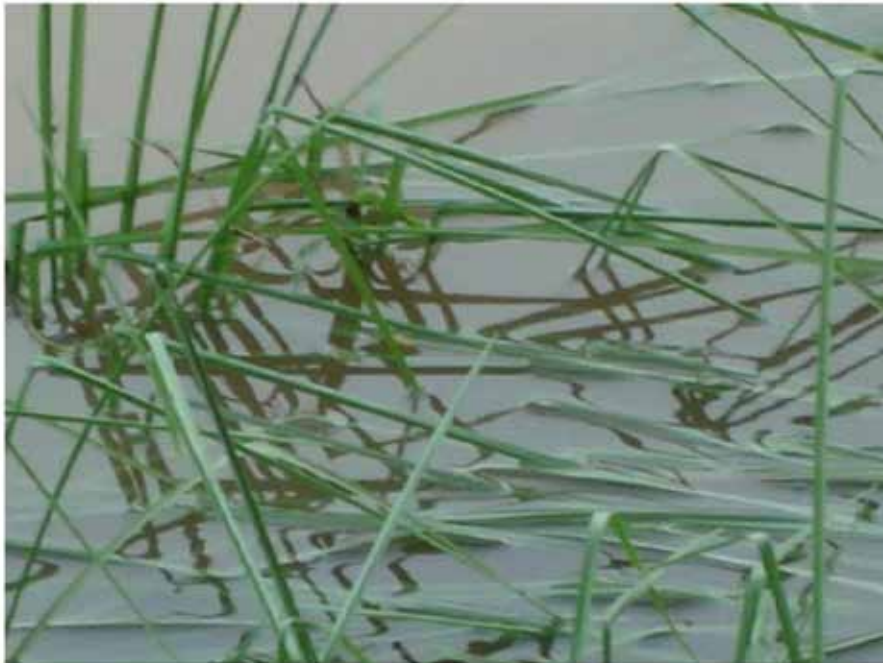
Vetiver plants submerged

- **Close-up of submerged plants**

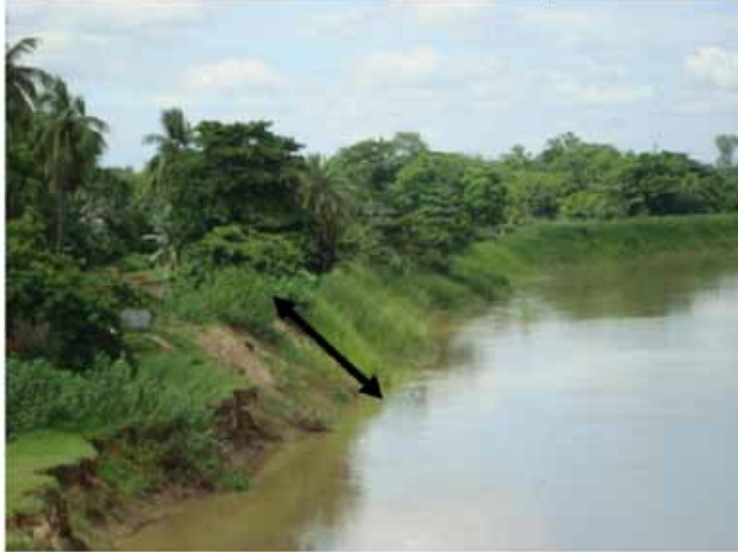
Telahi after the first flood. See the erosion downstream. No erosion on the planted stretch

- Our plantation limit marked above.

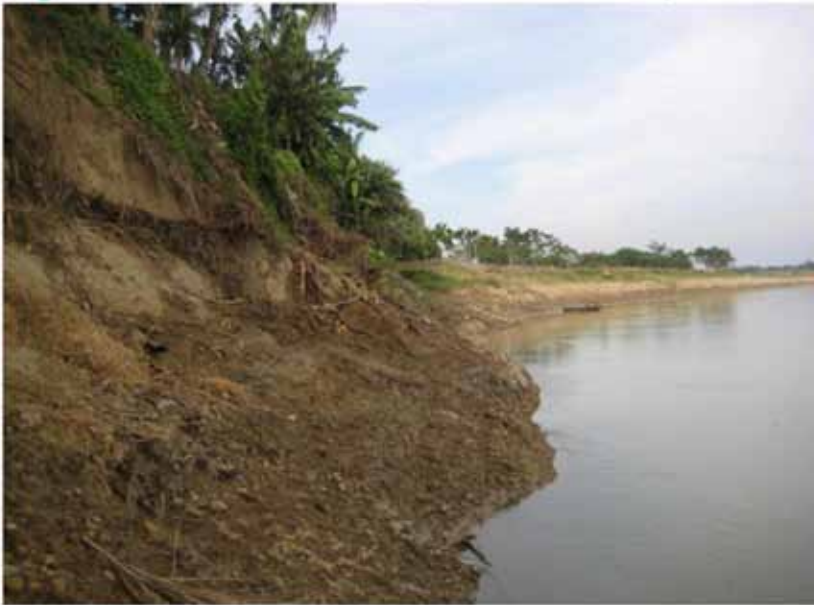
Kapili riverbank, Kachua, before

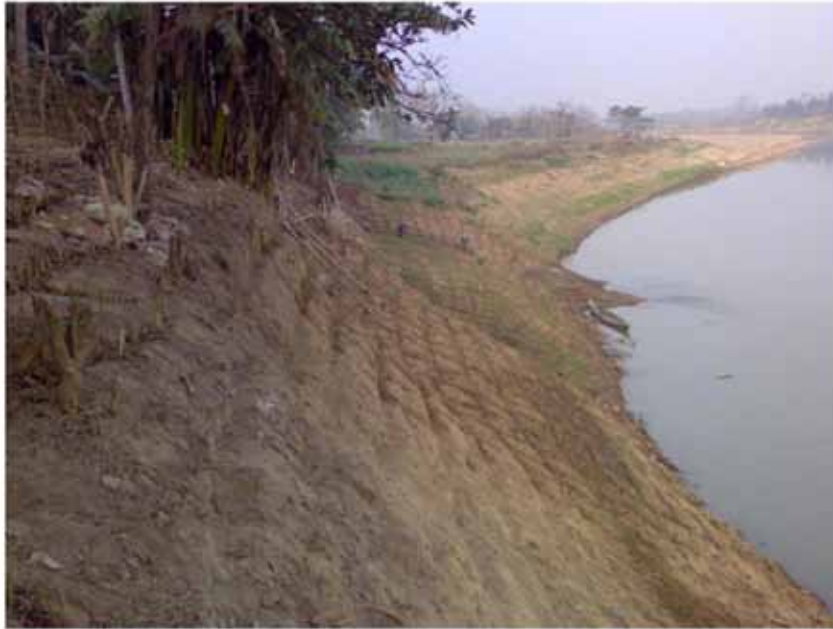
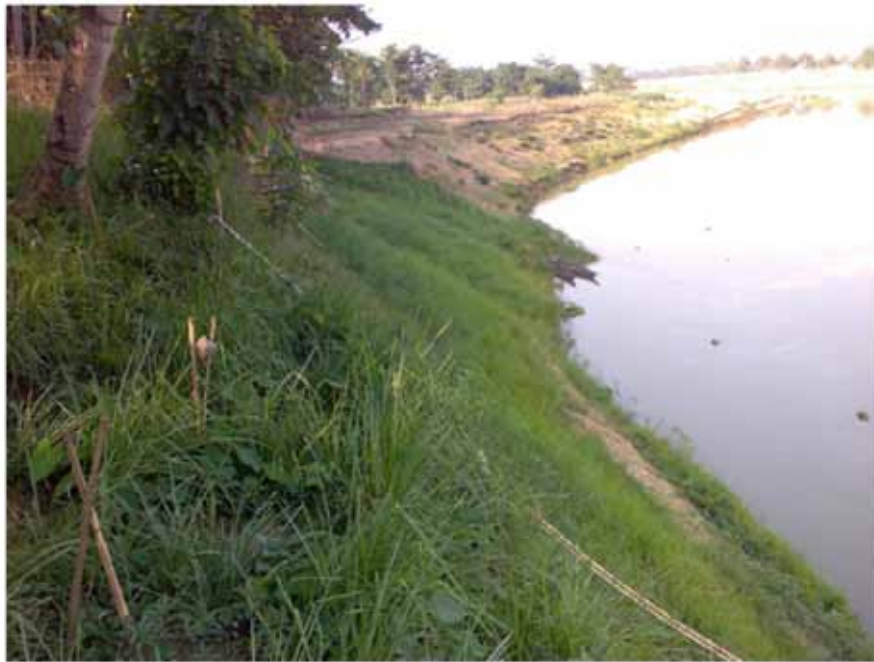
Kapili riverbank, Kachua, during plantation

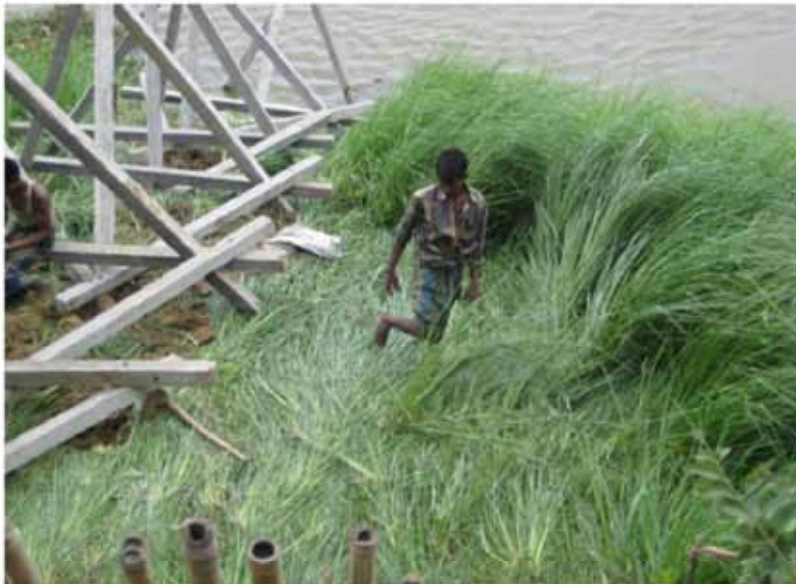
Kachua- Luxurious growth on gentler slope after 3 months, Callous departments work damaged this portion

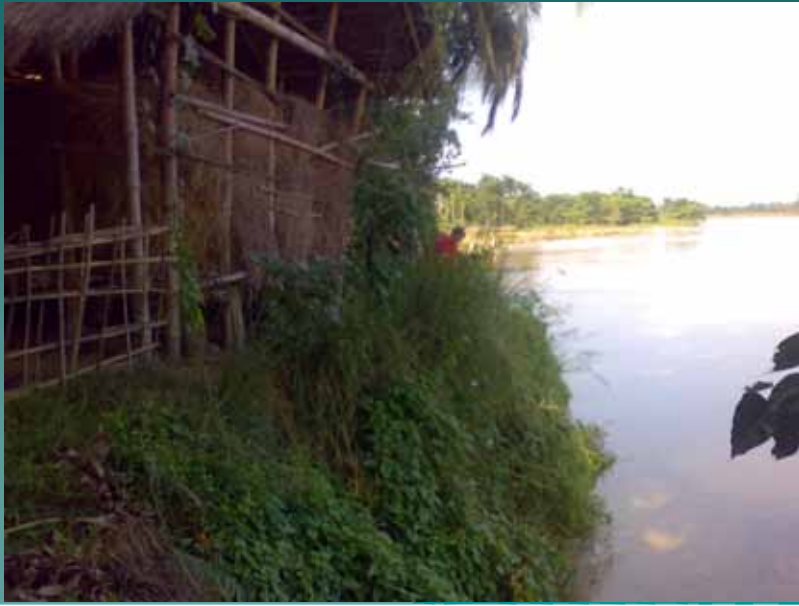
Very steep slope- but no erosion
after flood

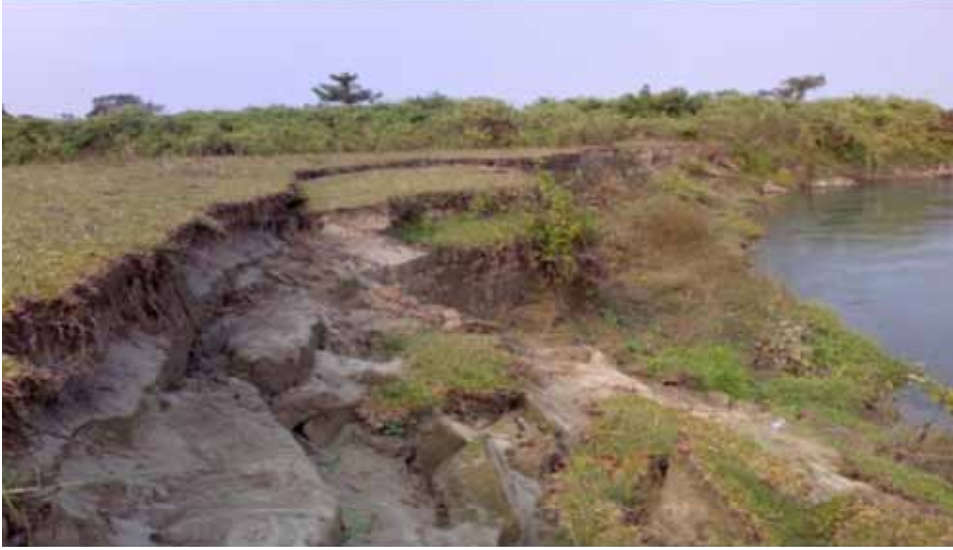
Eroded bank of Na- Dihing

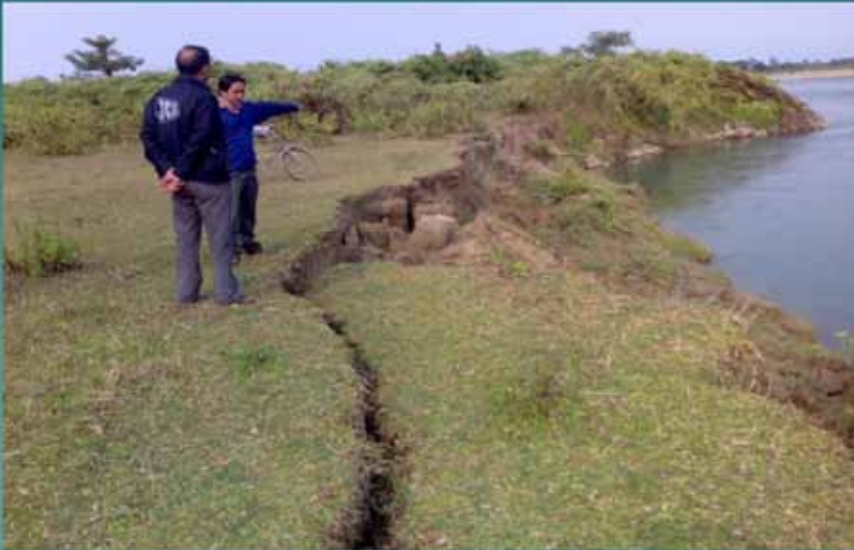
The tension crack – imminent sloughing

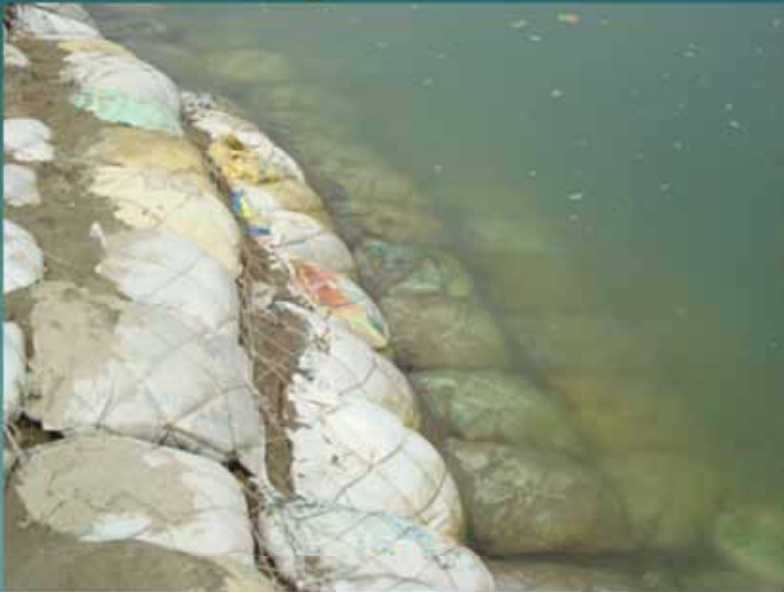
The flexible mattress with sand bags and net

This innovative mattress was designed to prevent underwater erosion

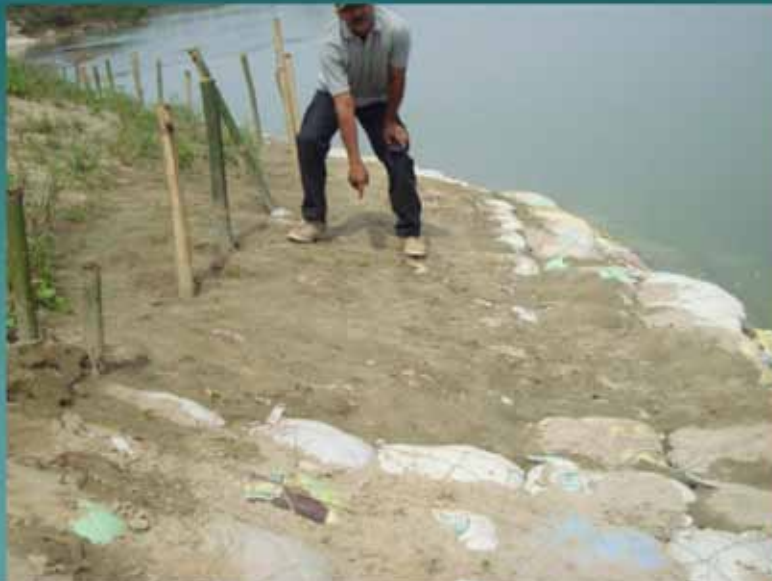
Initiation of silt deposit- seen after the water level receded.

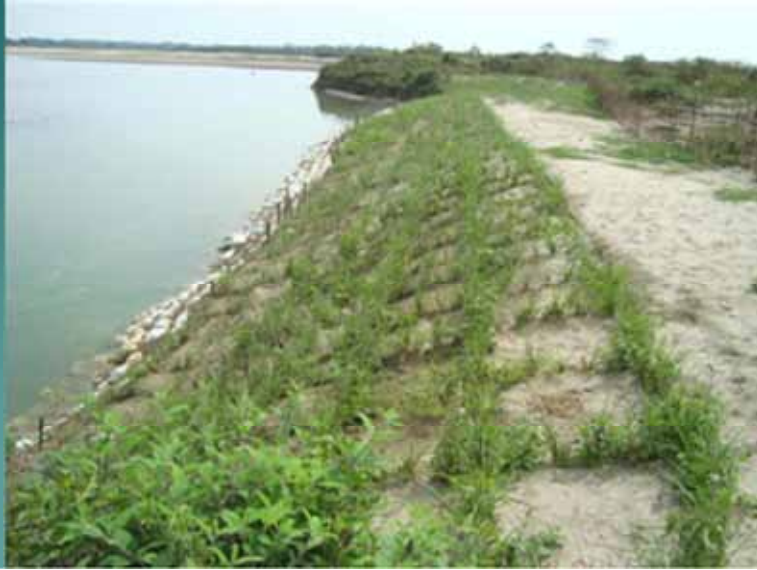
Another picture of plantation in the
3rd month- after 2 floods

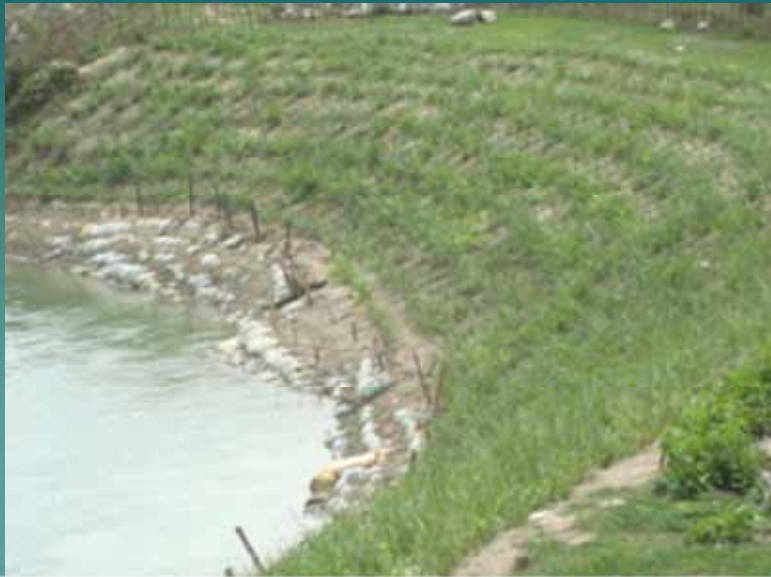
3rd month. Already withstood 2
floods

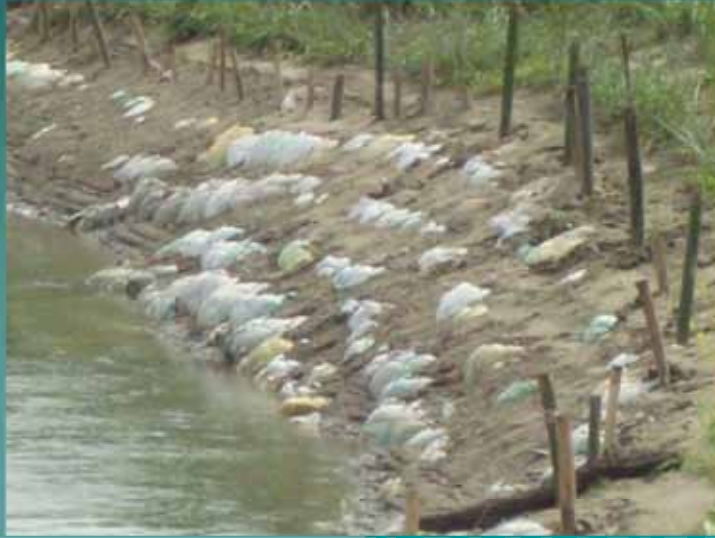
The flexible mattress is pinned by bamboo

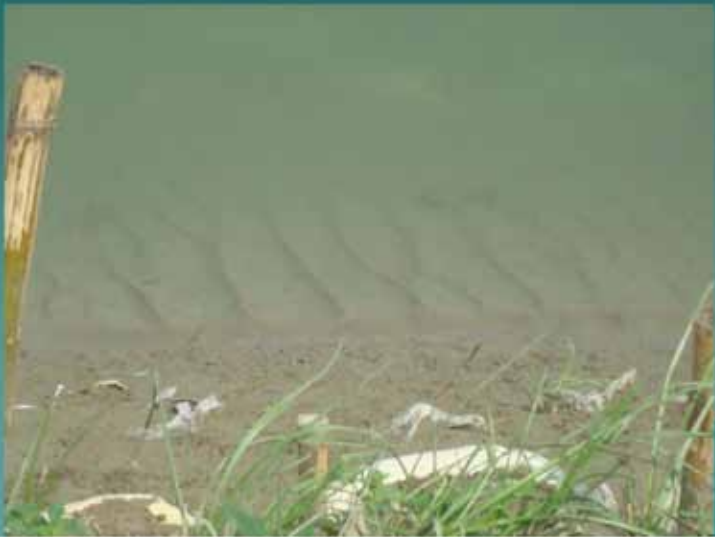
Fresh deposit of silt has almost completely buried the mattress

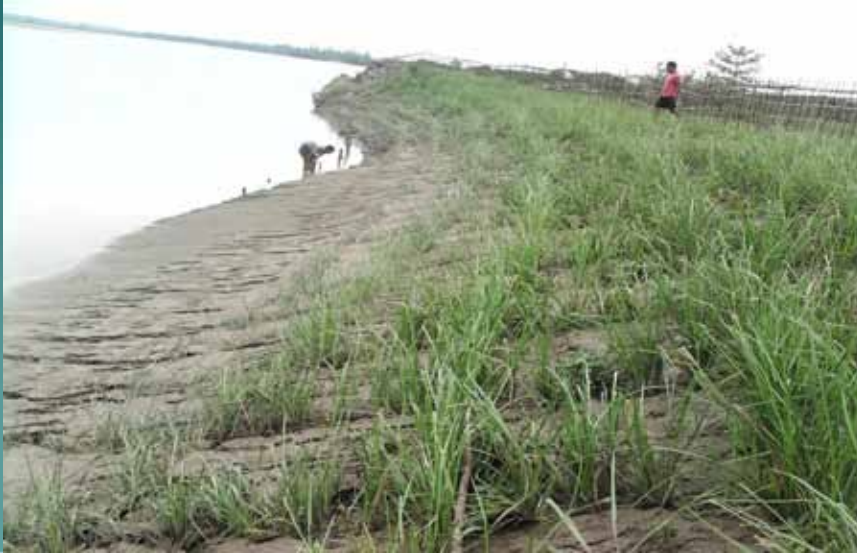
After several floods. Note the mattress completely buried in silt.

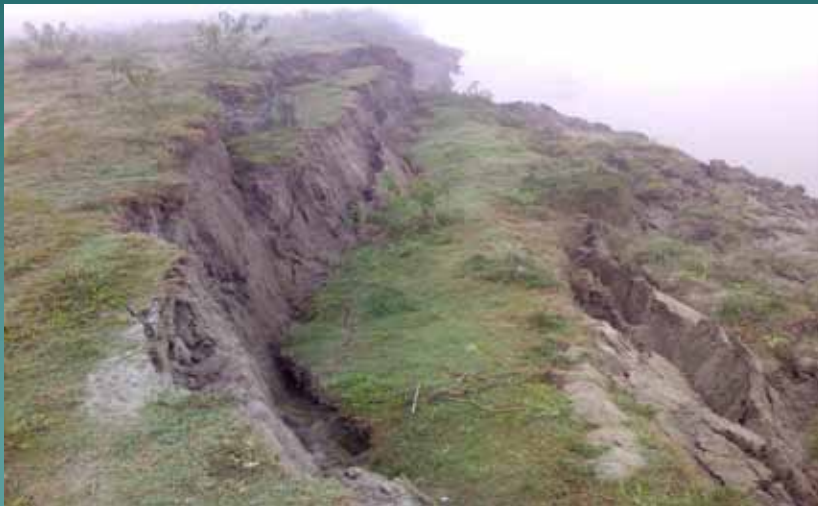
Erosion of the Brahmaputra downstream of disangmukh

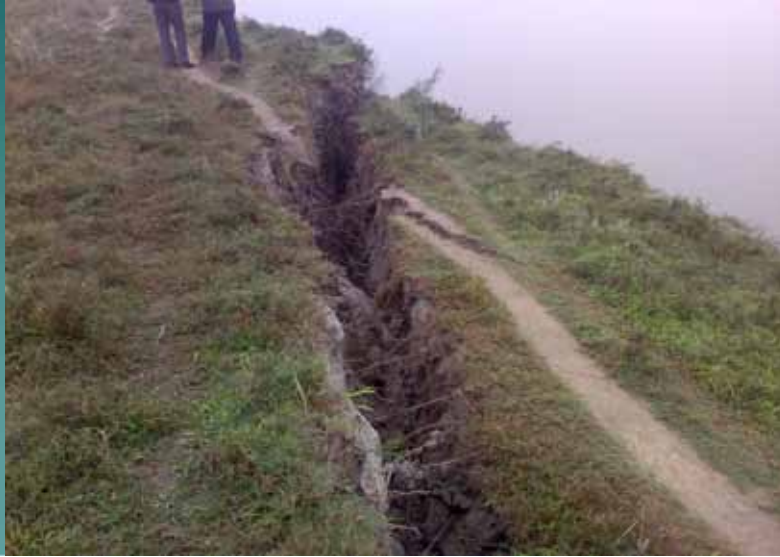
The crack before slumping

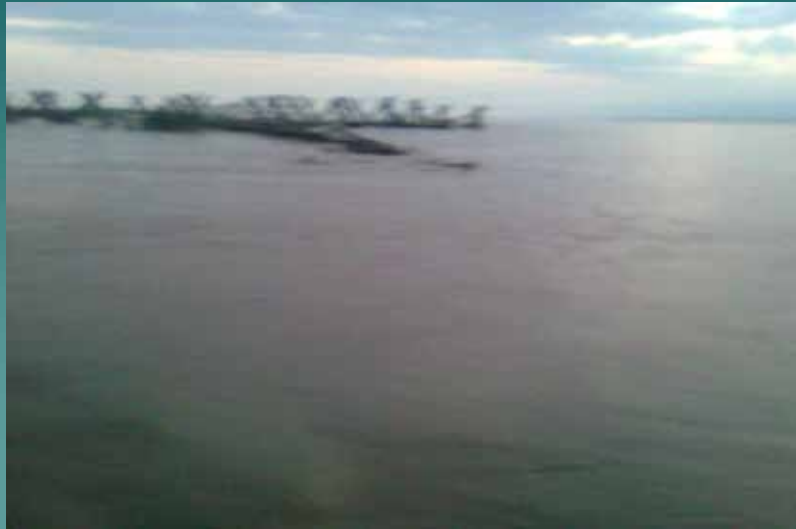
Complete inundation on 17/4/2010

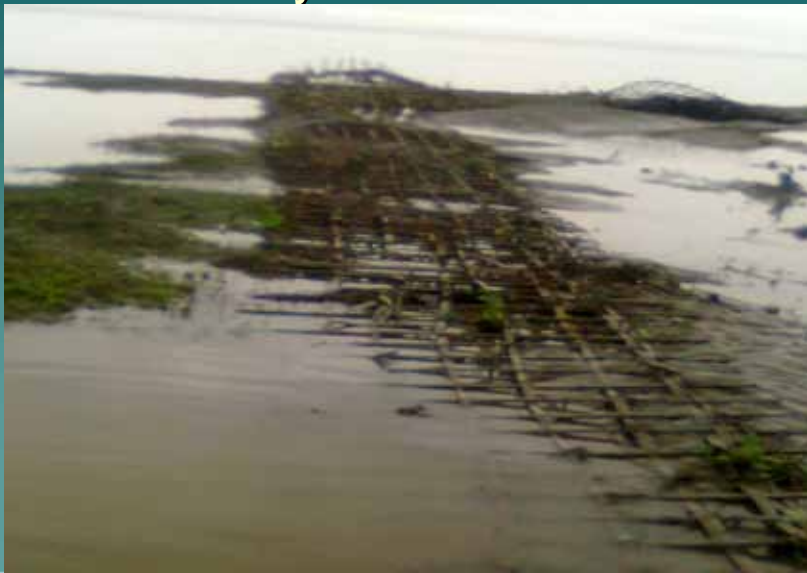
Devastation by flood. Flood water rose by about 6 metre

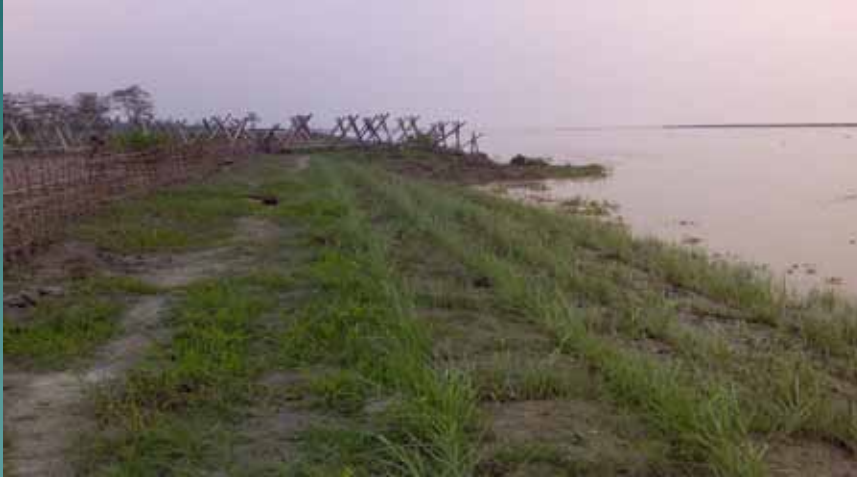
Plants on 2/5/2010. Survived 3 floods. NO EROSION SO FAR

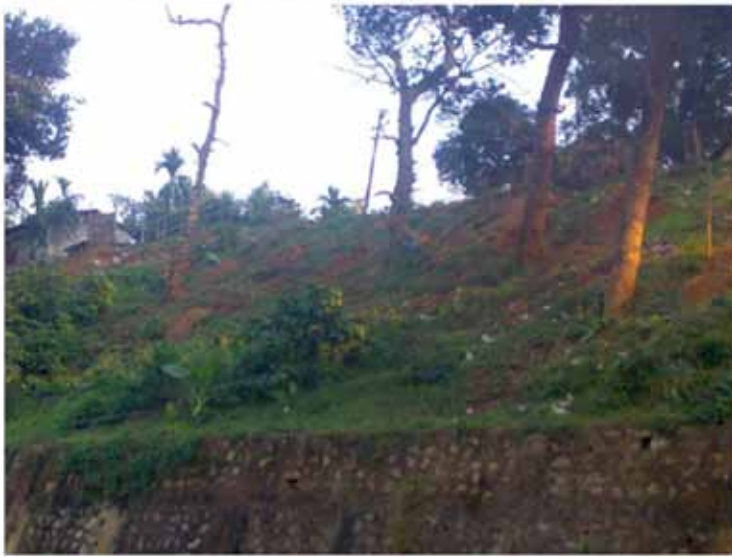
Navagraha temple - before

Note the eroded surface

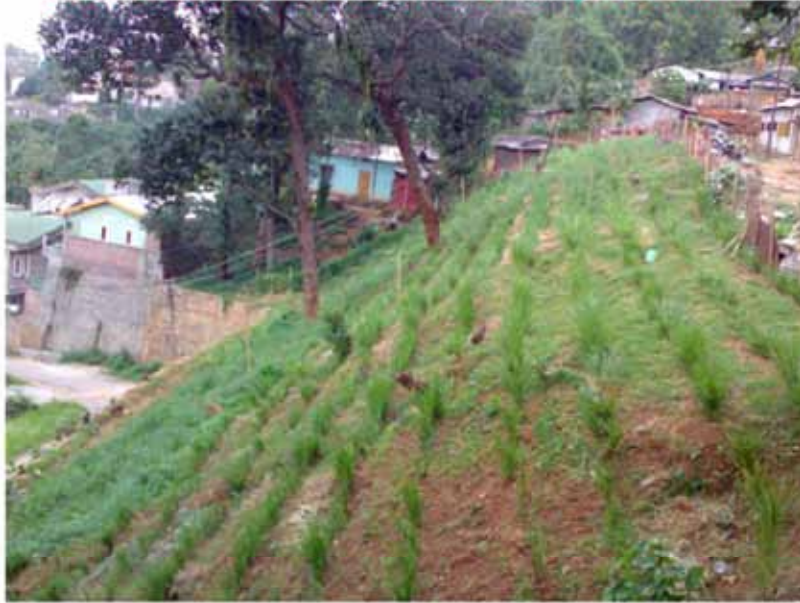
3 months after plantation. A few heavy showers could not cause any erosion.

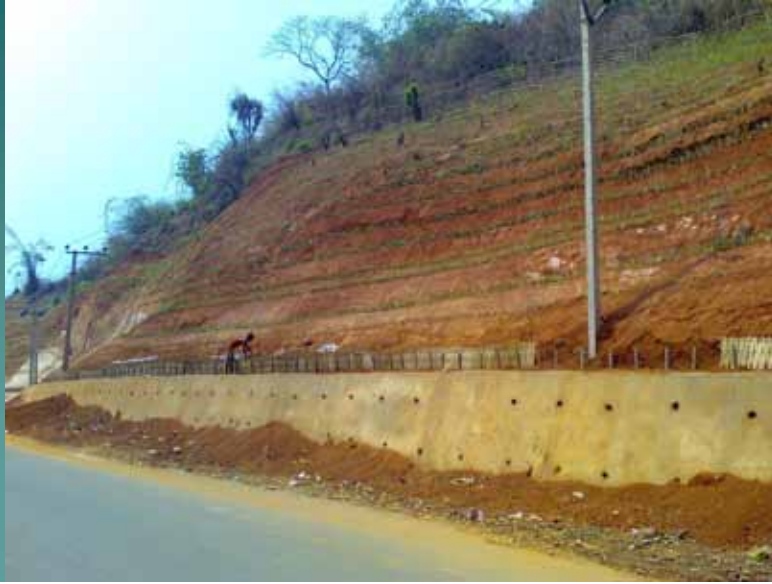
Steep slope stabilization in Guwahati. This slope was notorious for mud slide. Immediately after plantation

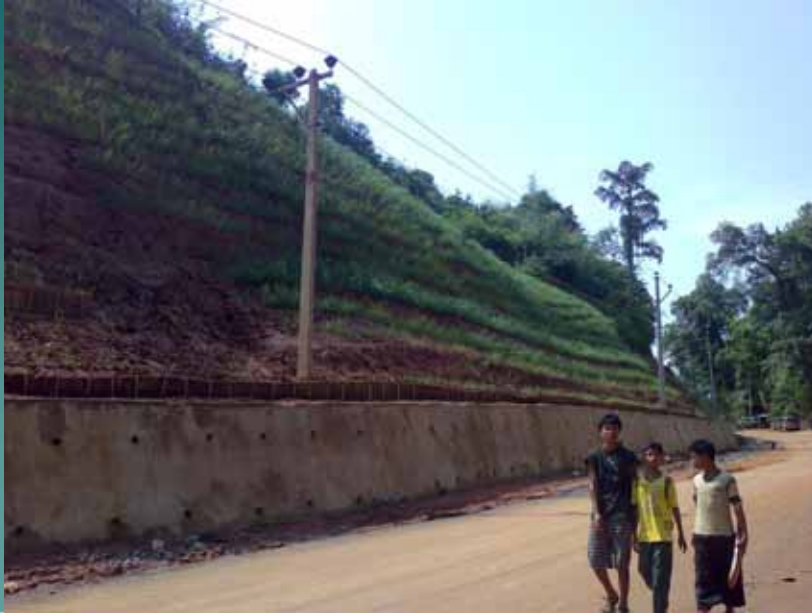
Mud slide arrested

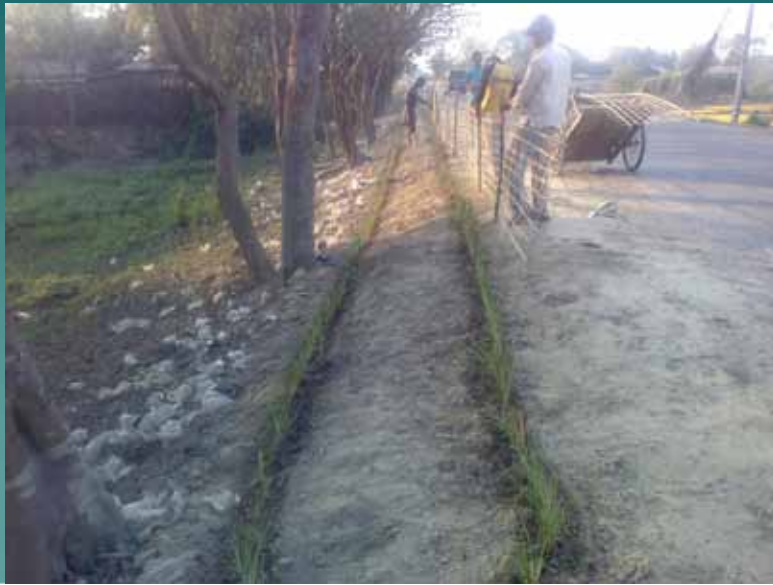
Hajo- Nalbari road
Rows 1m apart, plants @ 15 cm

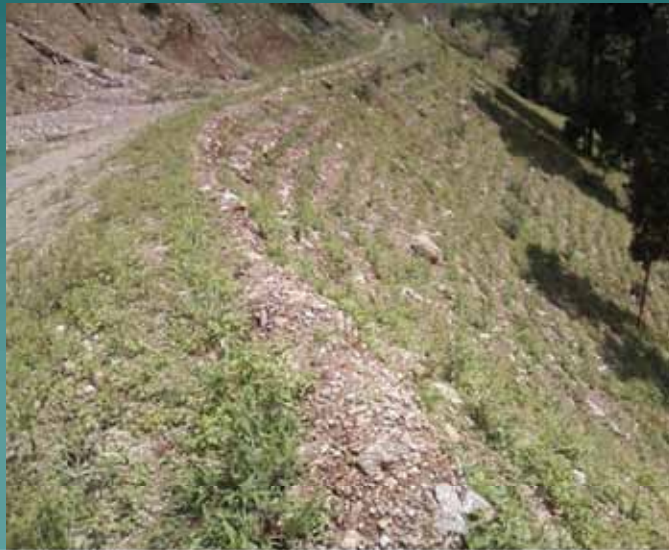
Same slope protected by Vetiver

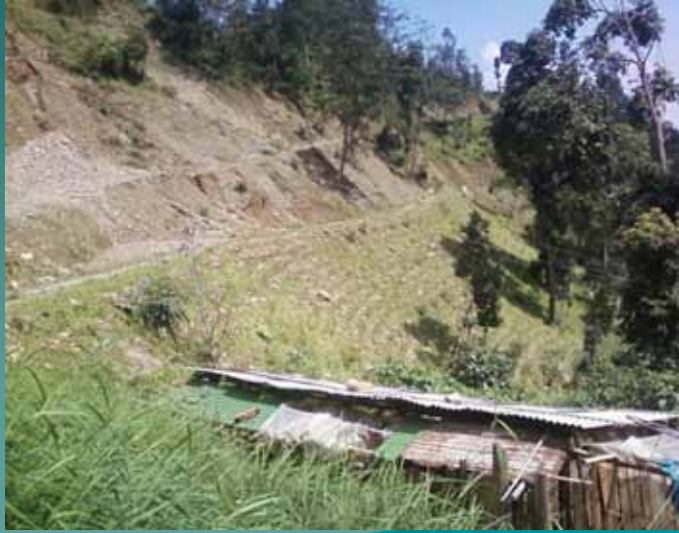
Same slope today. It has withstood heavy rainfall for more than one month without any landslip
