# LAKE NAIVASHA

## A Lake in Trouble

# **A Possible Solution?**

This PowerPoint was prepared by the Vetiver Network International as an example of how Lake Naivasha problems might dealt with. The proposed solutions have a much wider impact and implication for many other parts of Kenya.

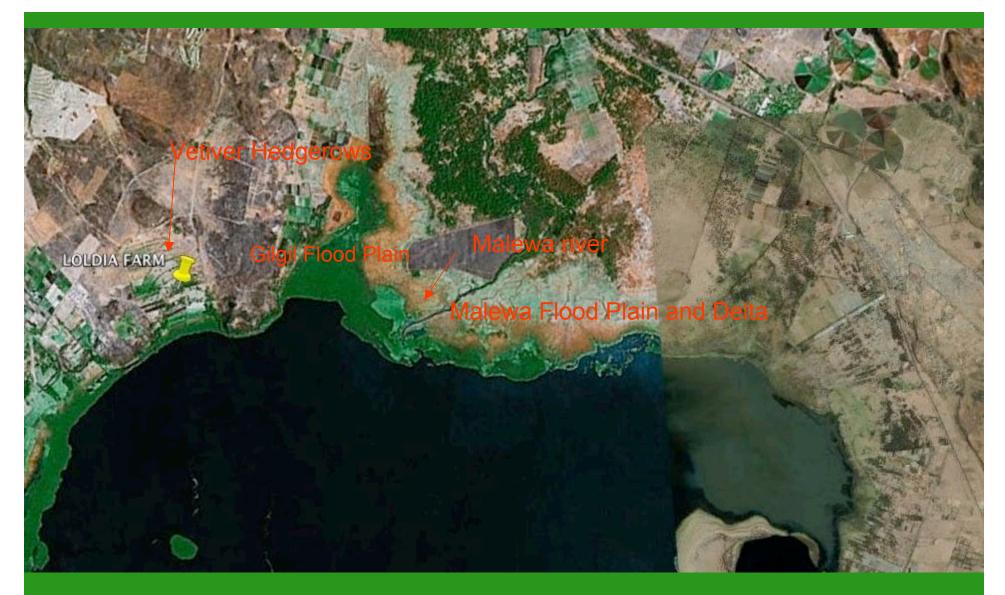
Northern shore of Lake Naivasha. From Left to right: Vetiver hedgerows on Loldia farm, Gilgil river flood plain, Malewa Flood plain and delta. Serious sediment inflows to Lake Naivasha derive from catchments of the Malewa and Gilgil Rivers

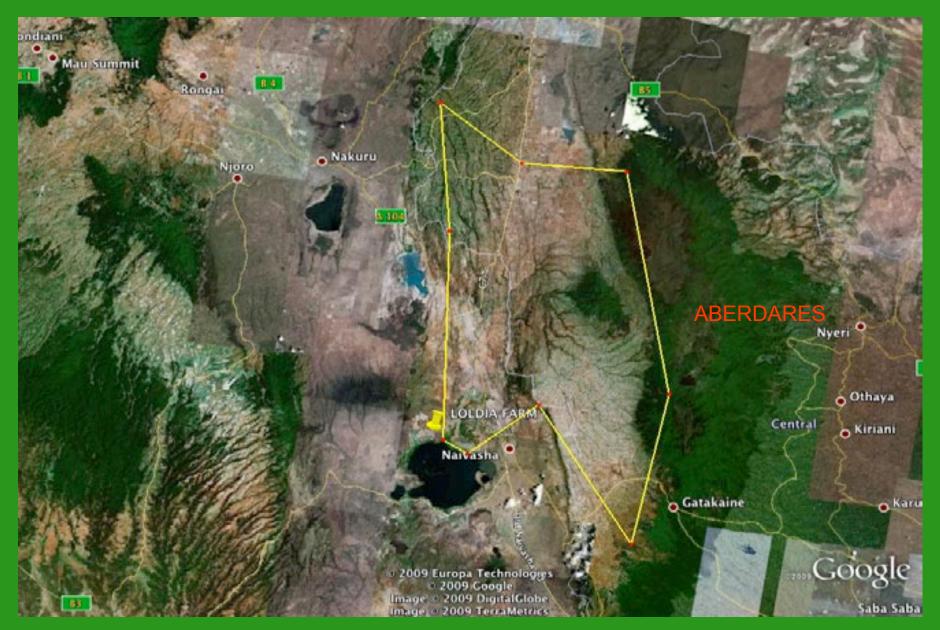
Approximate farmed catchment area of Malewa (160,000 ha) and Gilgil (60,000 ha) rivers that drain the western Aberdare mountains. The upper catchments comprise some of the most intensive and high density small farms in Kenya.

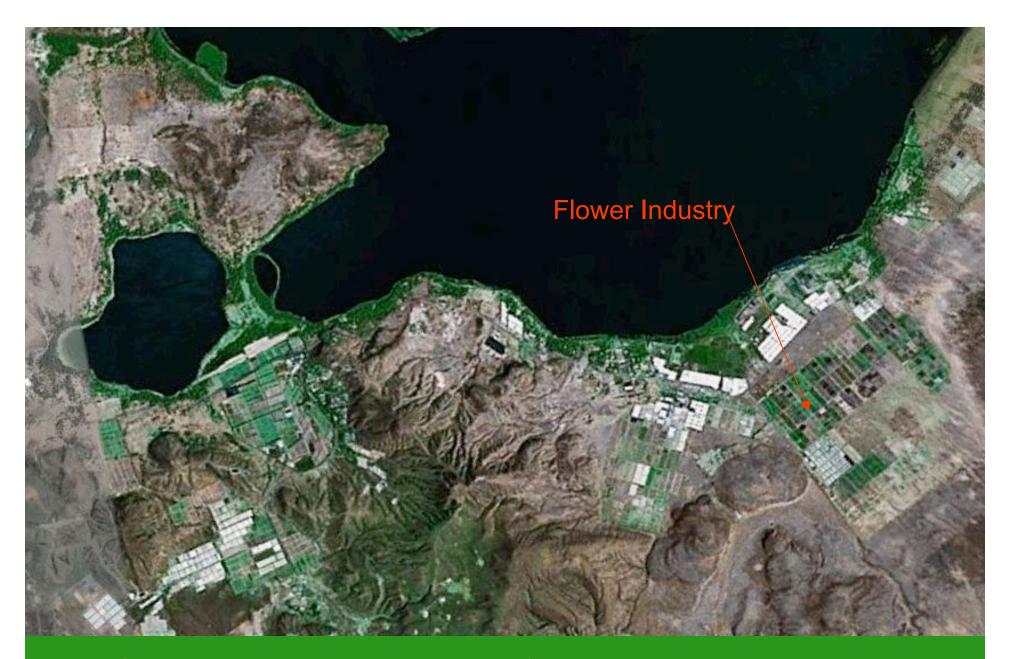
South west Lake Naivasha - intensive flower industry. These businesses discharge agrochemical effluent into the Lake either through drainage water or through storm water discharge.

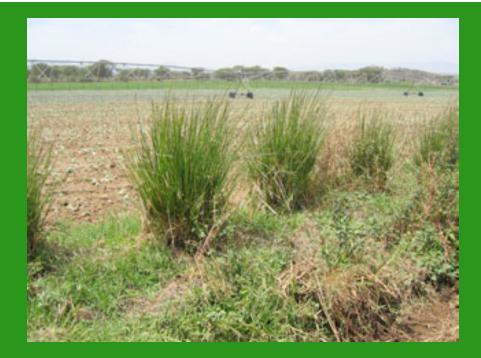
Right: 6 year old Vetiver grass on Loldia farm, north shore, Lake Naivasha. This Vetiver was not planted correctly (too far apart) - no hedge formation and on existing contour bunds, and is consequently far less effective, as it does not create a filtration barrier

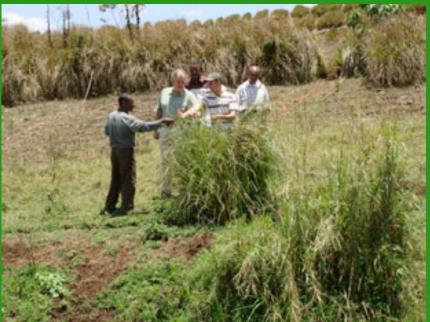
Left: Vetiver grass in Ethiopia same genotype as Kenya Vetiver grown at 1700m asl

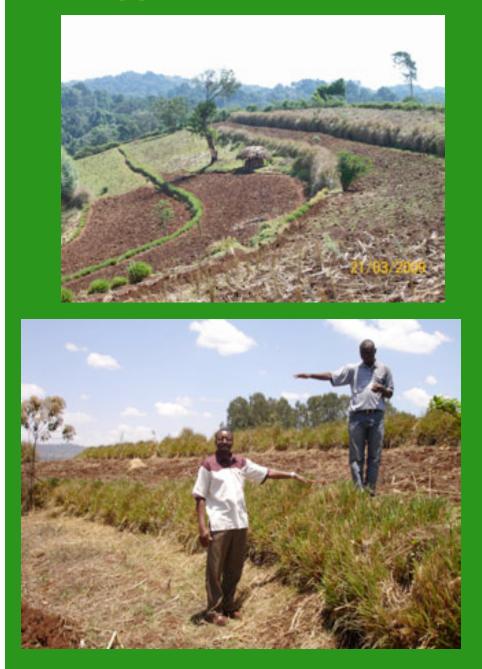
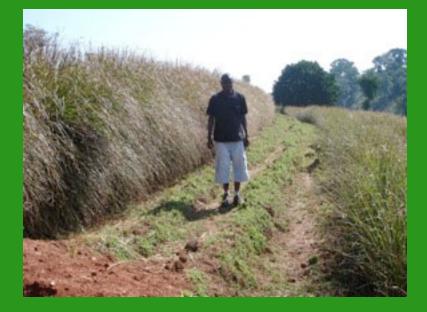
5 to 6 year old Vetiver hedgerows in Ethiopia. Some were planted on old terraces; the cut hedge on the left was planted on unterraced land and over the period has created, through trapping erosion sediment, a natural terrace that is 30 cm high (James Owino from Edgerton bottom left). The leaf of the grass is cut for forage, thatch, mulch, fuel, and for handicraft material. Vetiver reduces stem borer in maize. In Mettu district (western Ethiopia, 1700 m asl) more than 20,000 farmers are using the technology.

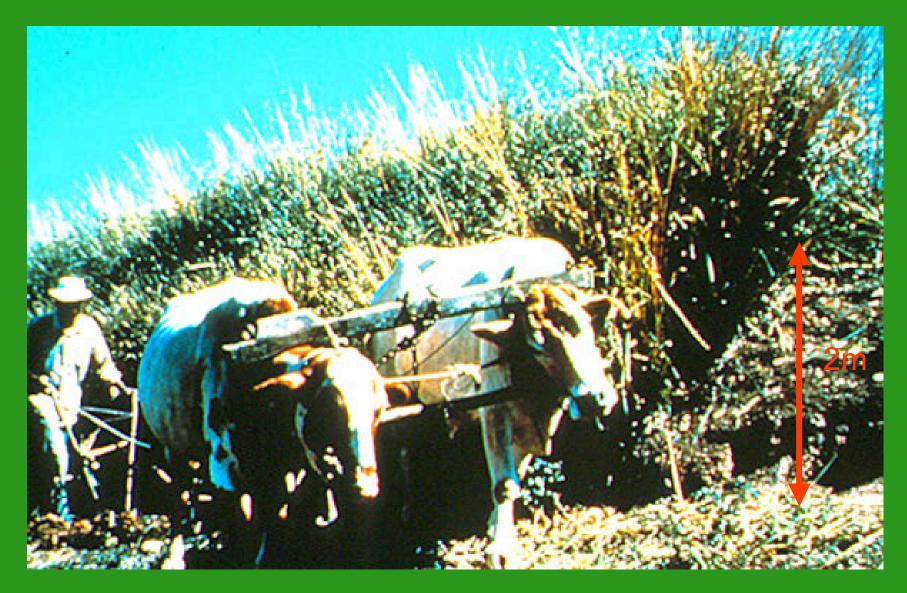
This 30 year old Vetiver hedgerow in Fiji has trapped enough sediment to create a natural terrace riser that is 2 meter high. The balance of the rainwater runoff that passed through the hedgerow was sediment free.

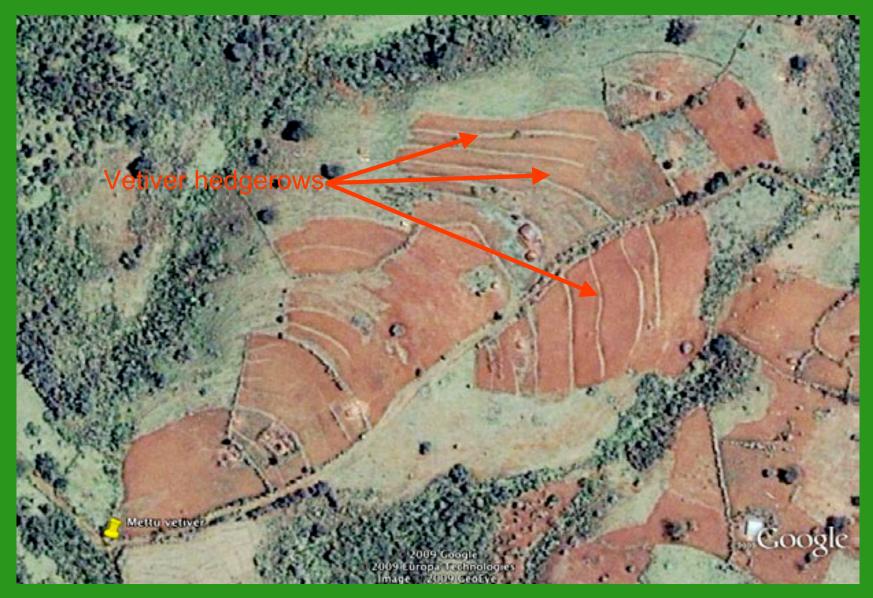
Vetiver hedgerows from space - western Ethiopia - 8° 7.930'N 35° 32.380'E. Altitude 1,700 m asl. Some of these have been in place for more than 20 years.

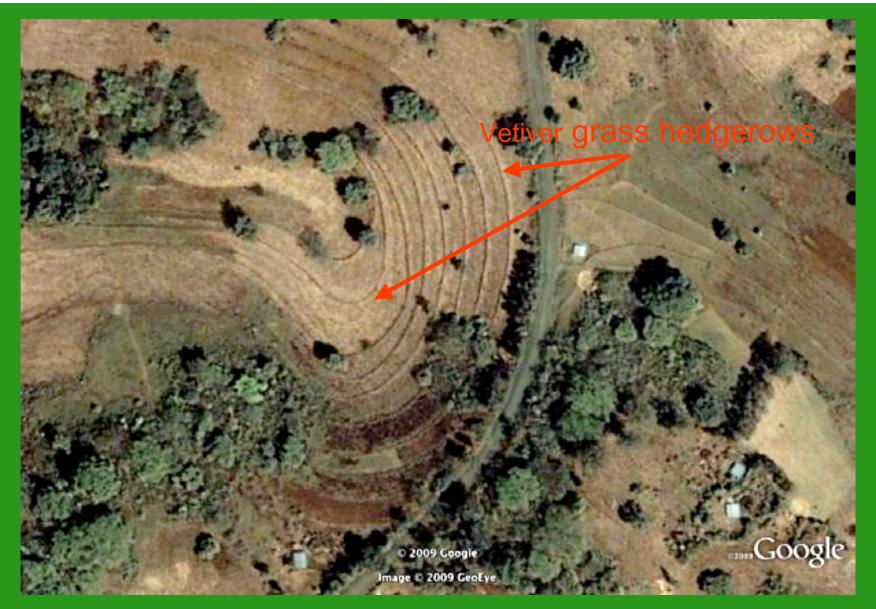
Vetiver hedgerows protecting farm land in western Ethiopia. The dissemination of the technology started with an NGO, and then driven by farmer to farmer advice and plant material supply. Note: very little evidence of erosion.. 8° 19.869'N 35° 38.424'E

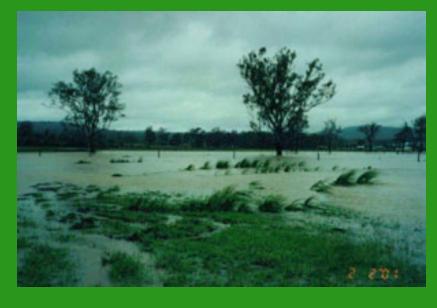
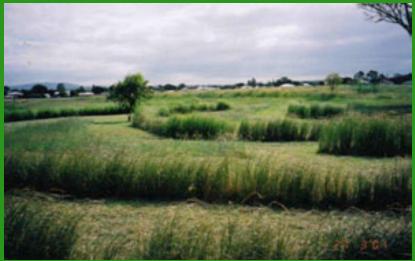
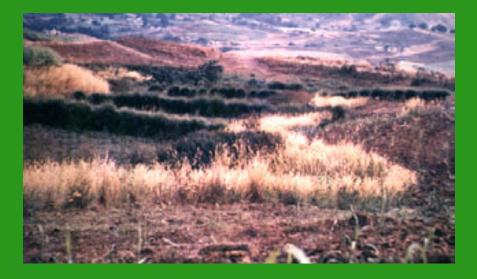
Intensive rainfall runoff can result in serious erosion and gullying. The images to the left show how Vetiver will prevent erosion in upper catchments in Australia, and can repair gullies (above) in Fiji (dark green grass + Vetiver hedgerow.

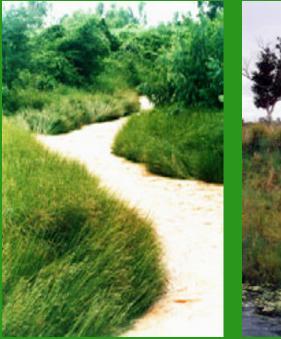
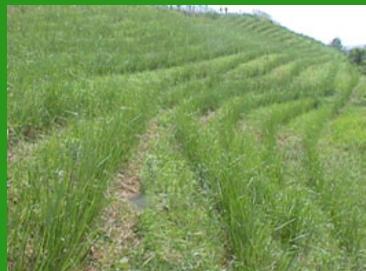
River bank stabilization using Vetiver grass at highly erodible locations - left: Zimbabwe; center: Australia. Road cut and fill are major sources of erosion; right top: Vetiver stabilizing a road cut at Jimma, Ethiopia; right bottom stabilizing fill in China.

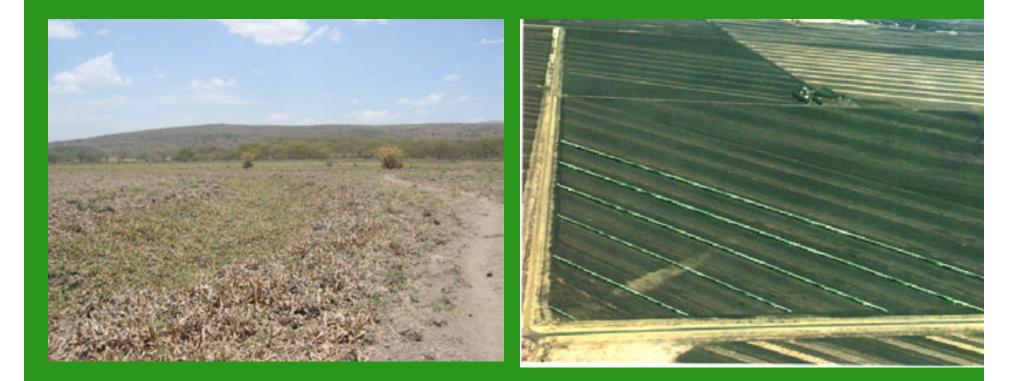
Left: Gilgil River Flood plain adjoining "Loldia Farm". Right: a part of the Darling Downs laid out with Vetiver hedgerows

- In the wet season water from the Malewa and Gilgil rivers flood the "delta" area in the north eastern part Lake Naivasha. This is flat land. The Malewa has a defined river course, but the Gilgil is less well defined.
- One solution would be to establish Vetiver hedgerows across the delta area at about 100 m intervals. If the the hedgerow lines were first established with a bulldozer to flatten the line and then planted (possible by machine) with Vetiver, very effective barriers could be established. Wildlife could move through the hedge rows but would not destroy them. Considerable silt deposits could be expected behind the hedgerows.
- This is demonstrated through the following slides of Vetiver hedges on the black soils of the Queensland's Darling Downs that can be subjected to major flooding

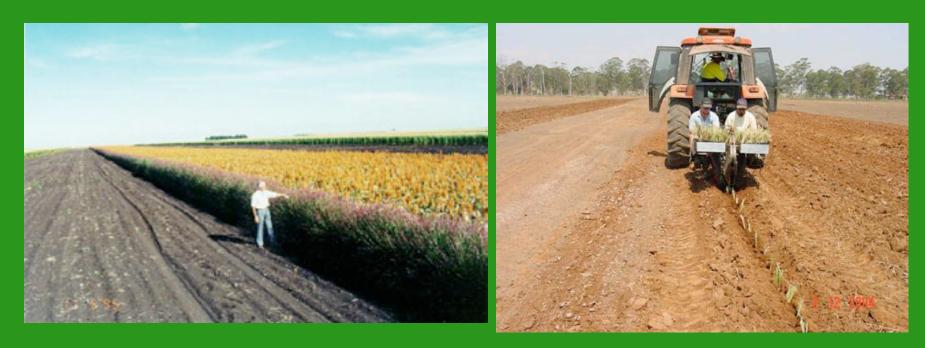
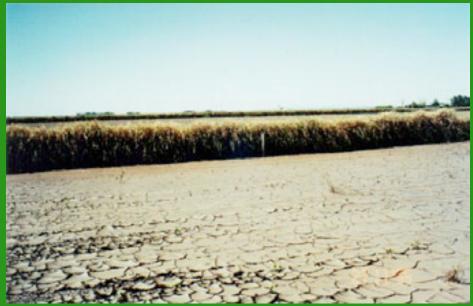
Top left: Vetiver Hedgerow on black cracking soils of the Darling Downs. Bottom left: 50 cm water flooded this area, depositing large amounts of sediment behind hedgerows. The Vetiver did not collapse from the pressure of water, and will continue to grow under flooded conditions. Top right: planting Vetiver with vegetable planter. It also recovers very quickly after fire.

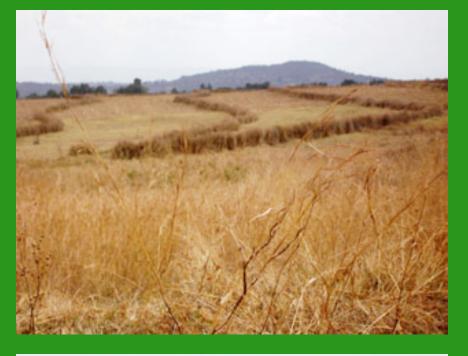
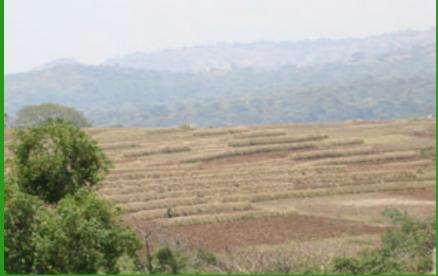
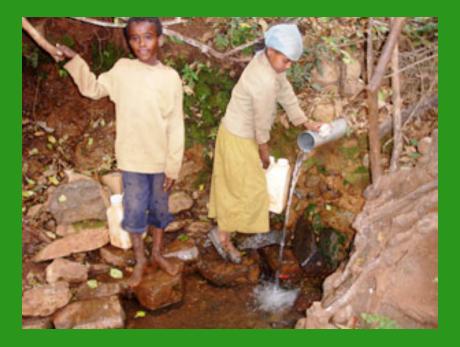
This 500 ha farm in Ethiopia was fully protected with Vetiver hedgerows (left), resulting in much higher crop yields and (above right) an annual permanent flow of potable spring water where there was none before the Vetiver application

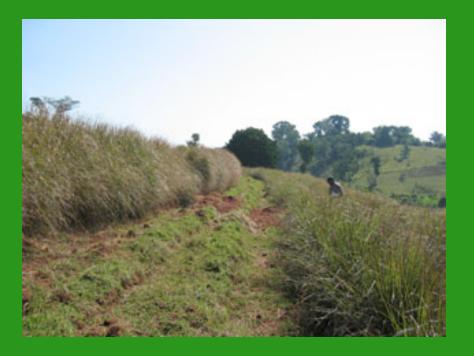
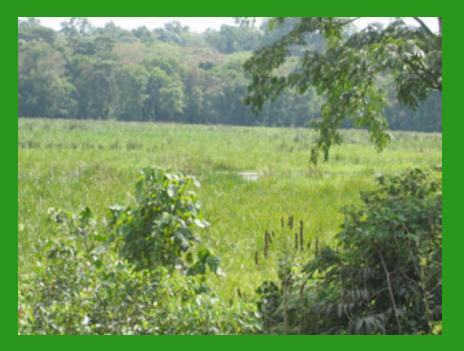
In Ethiopia, under a similar climate as the Mau forest area, extensive areas of farm land have been protected with Vetiver hedgerows (top left). These hedgerows, in some cases halted erosion and runoff entirely, resulting in substantial crop yields due to improved soil moisture, better soil fertility (the latter - reduced loss of fertilizer, and improved soil structure, organic matter, and nutrients though mulching with Vetiver. An unintended benefit was the restoration of adjacent wetlands (top right). Before VS was used this area was dry and used for football games. Now it has been restored by groundwater. You can see bodies of water. Wild life (migrating birds) have returned, and substantial forage sources are now available. Today the Ethiopian Wetland Society is a major promoter of the Vetiver System

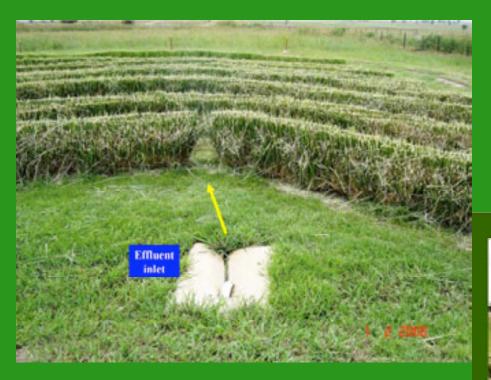
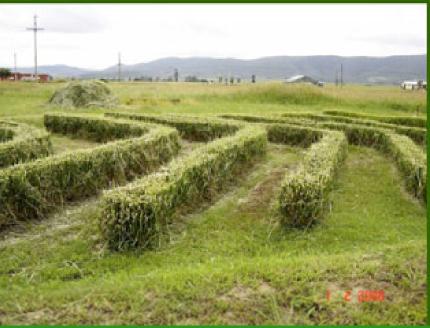
## Actual establishment of wetland using VS

Properly maintained, note no weed in or between hedges

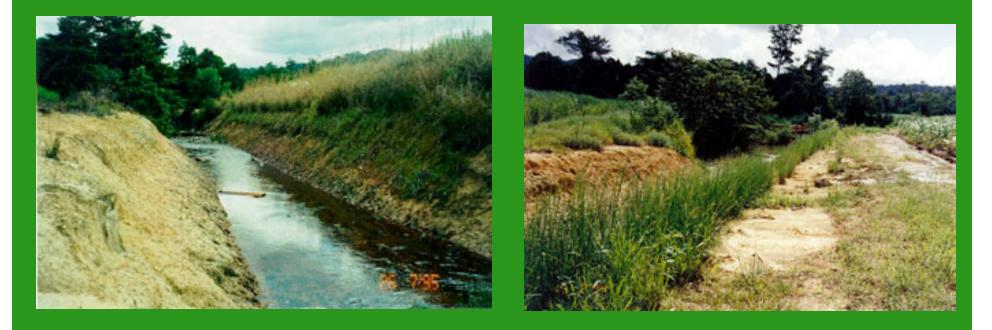
This Vetiver hedgerow established on the bank of a drain (Queensland, Australia) on acid sulphate soils (1) protected the bank from erosion (compare with unprotected left side of drain) and (2) reduced significantly the movement of agrochemicals from the adjacent sugar cane field. Note the sediment (that carries the agrochemicals) trapped behind the hedgerow. This is a young hedgerow less than 1 year old. This system could be applied to Naivasha flower farms (and also sugar cane farms in Nyanza). All farms bordering or in the vicinity of the lake should plant Vetiver hedgerows across their farms, particularly along the lower boundary.
