LANDSLIP CONTROL MECHANISM BY VETIVER

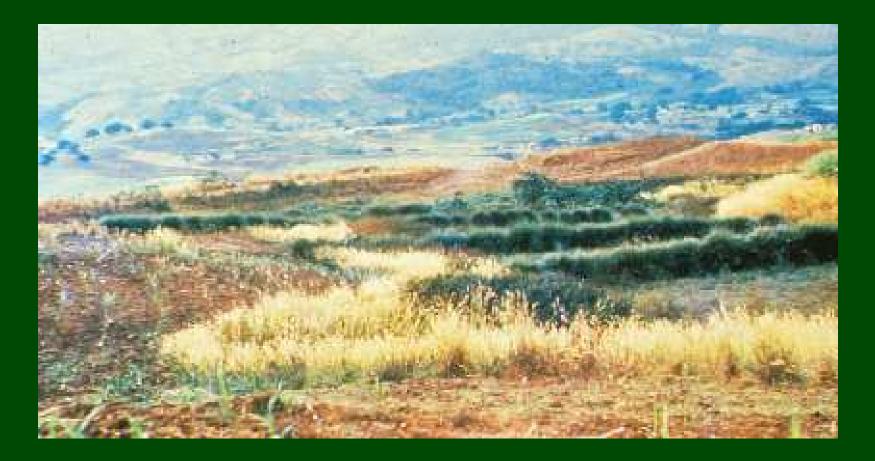
Vetiver hedgerows

Vetiver roots

slipping zone on slopes usually 0~2 m depths

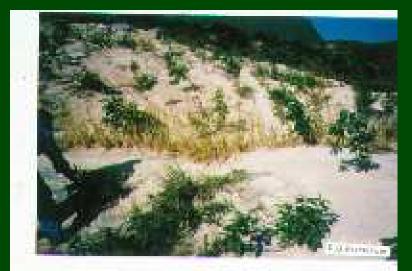
This drainage line in Fiji has been stabilized with vetiver for more than 30 years. It used to be barren and gullied

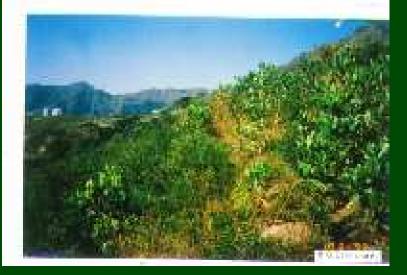
Degraded hill park in Hong Kong was planted to vetiver and Gmelina trees. The result was startling. Vetiver hedgerows acted as a pioneer system that improved soil moisture by reducing runoff on these steep hillsides. Native species colonized the slope between the hedgerow and the trees grew very well. This is typical of what Vetiver Systems will do.

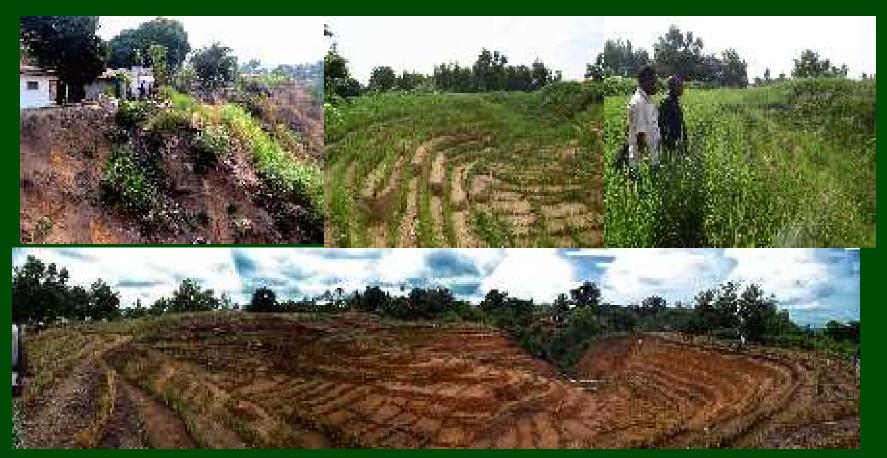
A common feature in many West African countries is the occurrence of enormous gullies (ravines) that are cutting back into urban areas. IN the Congo (DRC) this huge gully was cutting back into the city of Kikwit. With the support of USAID and The Vetiver network a community project was undertaken with the local people reshaping the gully and planting it to vetiver. Top left - a huge gully near Kinshasa, the home owner had planted a little vetiver which gave some protection. Bottom - a panorama view of the reshaped gully. Top center - planted with vetiver. Top right the gully well covered 4 months after planting.

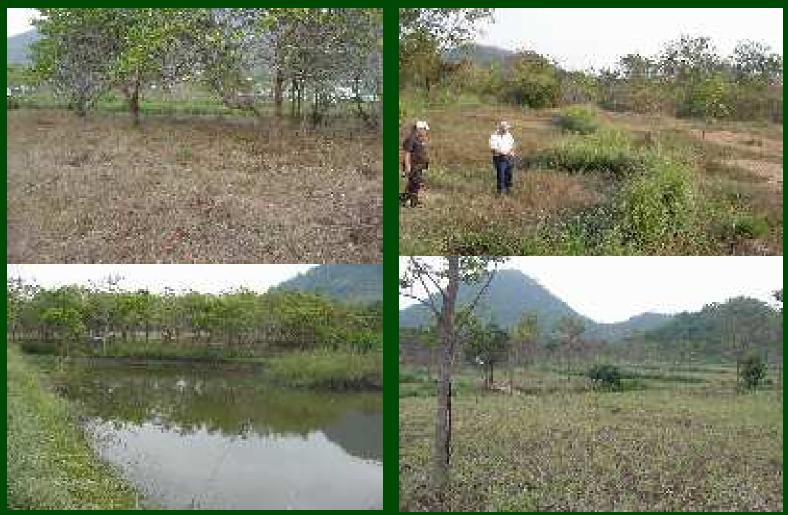
Five years previously this land was heavily eroded pineapple plantation in Thailand. With the help of vetiver it has been rehabilitated into open parkland. Note in top right how native grasses are growing vigorously in the silt deposit behind the hedgerow where the man in the white shirt is standing

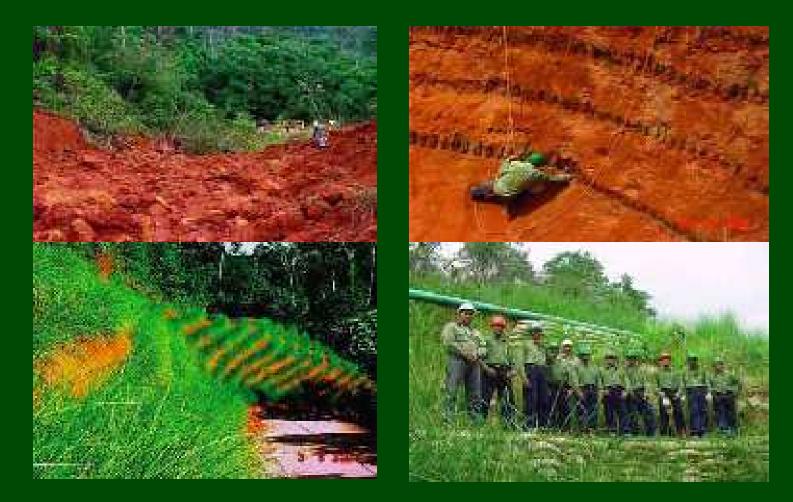
This bauxite mine tailings in Venezuela were rehabilitated using Vetiver System by a local environmental cooperative. Native species will colonize between the vetiver rows. This is a typical point source site for sediment and toxic leachates that if not for vetiver would end up in down stream drainage

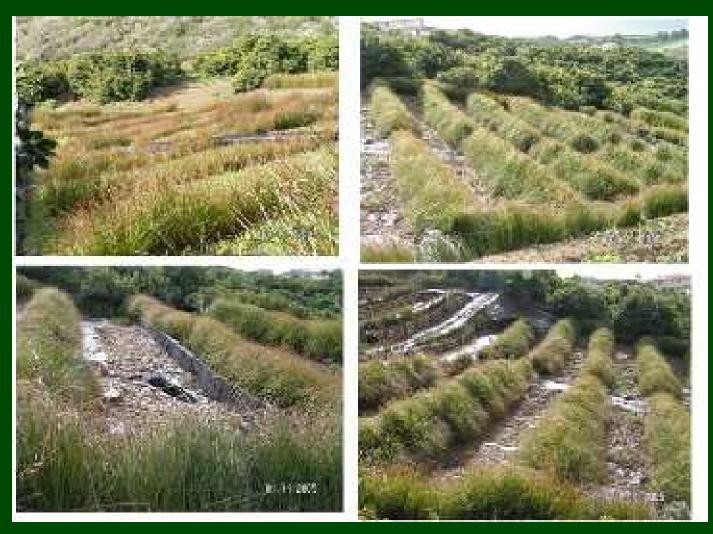
This orchard land near Santa Barbara, California was sliding down the hill. The engineered system was not working, . Vetiver was and the slide was halted. The owner rates vetiver at A+++

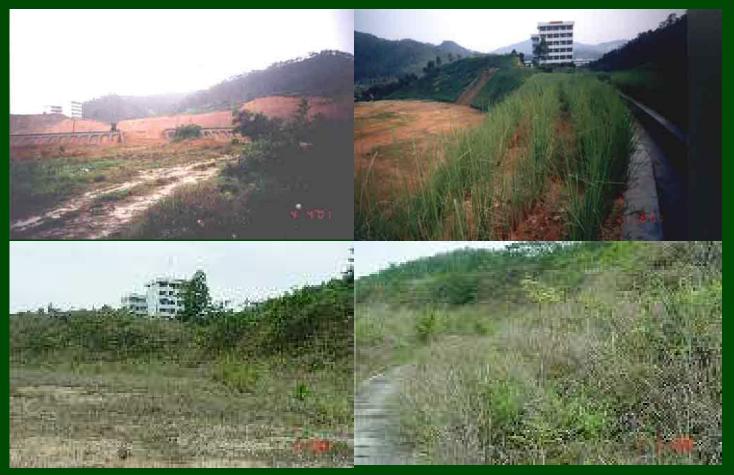
This College campus in south China was in need of land rehabilitation. Vetiver System was applied (top right). The two bottom photos show how the landscape has been protected and stabilized and how native plants have colonized the vetiver

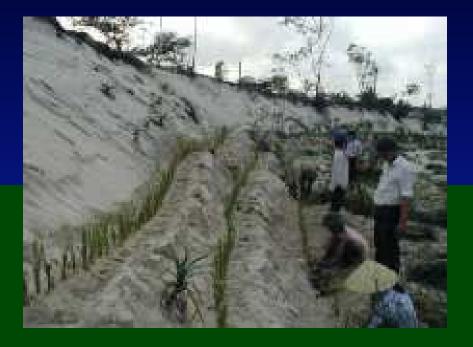
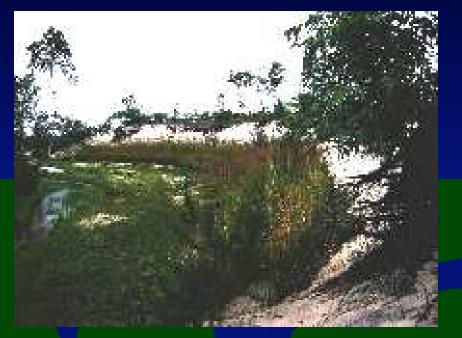
Trial of Vetiver grass for protecting sand dunes in Quang Binh. Establishment of the demo site.

The sand dune is fully stabilized after one year, favoring the growth of other trees.

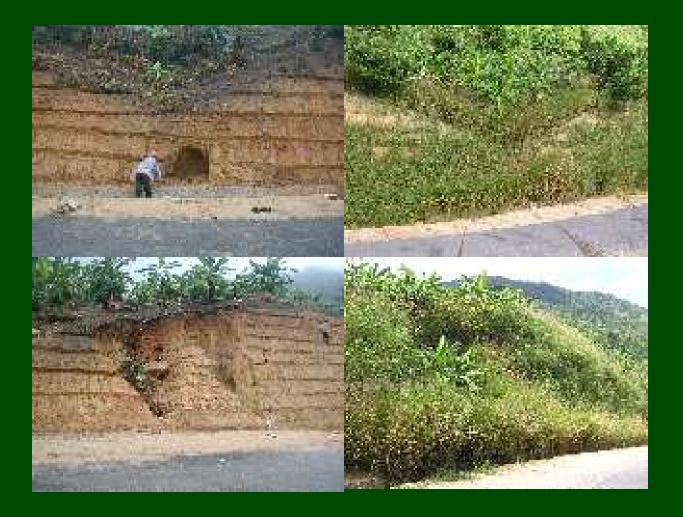
A degraded slope in Vietnam. Before treatment (left), two years later (right) THE VETIVER NETWORK INTERNATIONAL

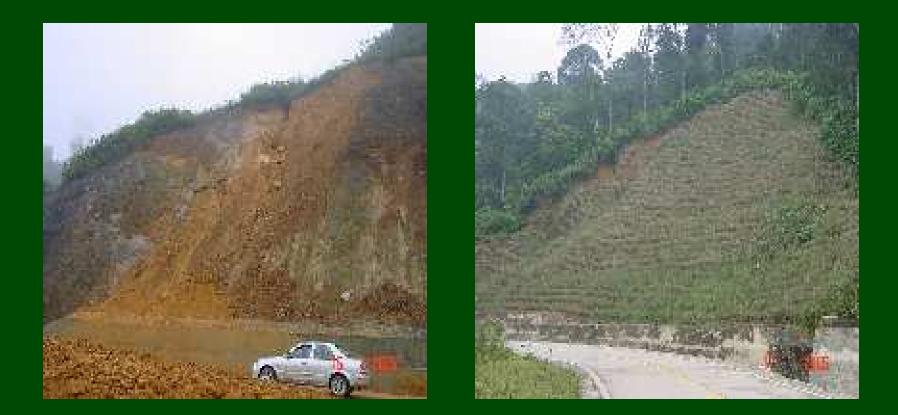
Slopes like this (left) on the Ho Chi Minh highway can be stabilized successfully with Vetiver (right). If the slope on the left is not stabilized it will slide. This is typical of land slides that occur after steep slopes have been cultivated. Vetiver can be used to protect and stop future slides
