VETIVER SYSTEM FOR RIVER AND CANAL BANK STABILISATION

Paul Truong

TVNI Technical Director, Brisbane, Australia

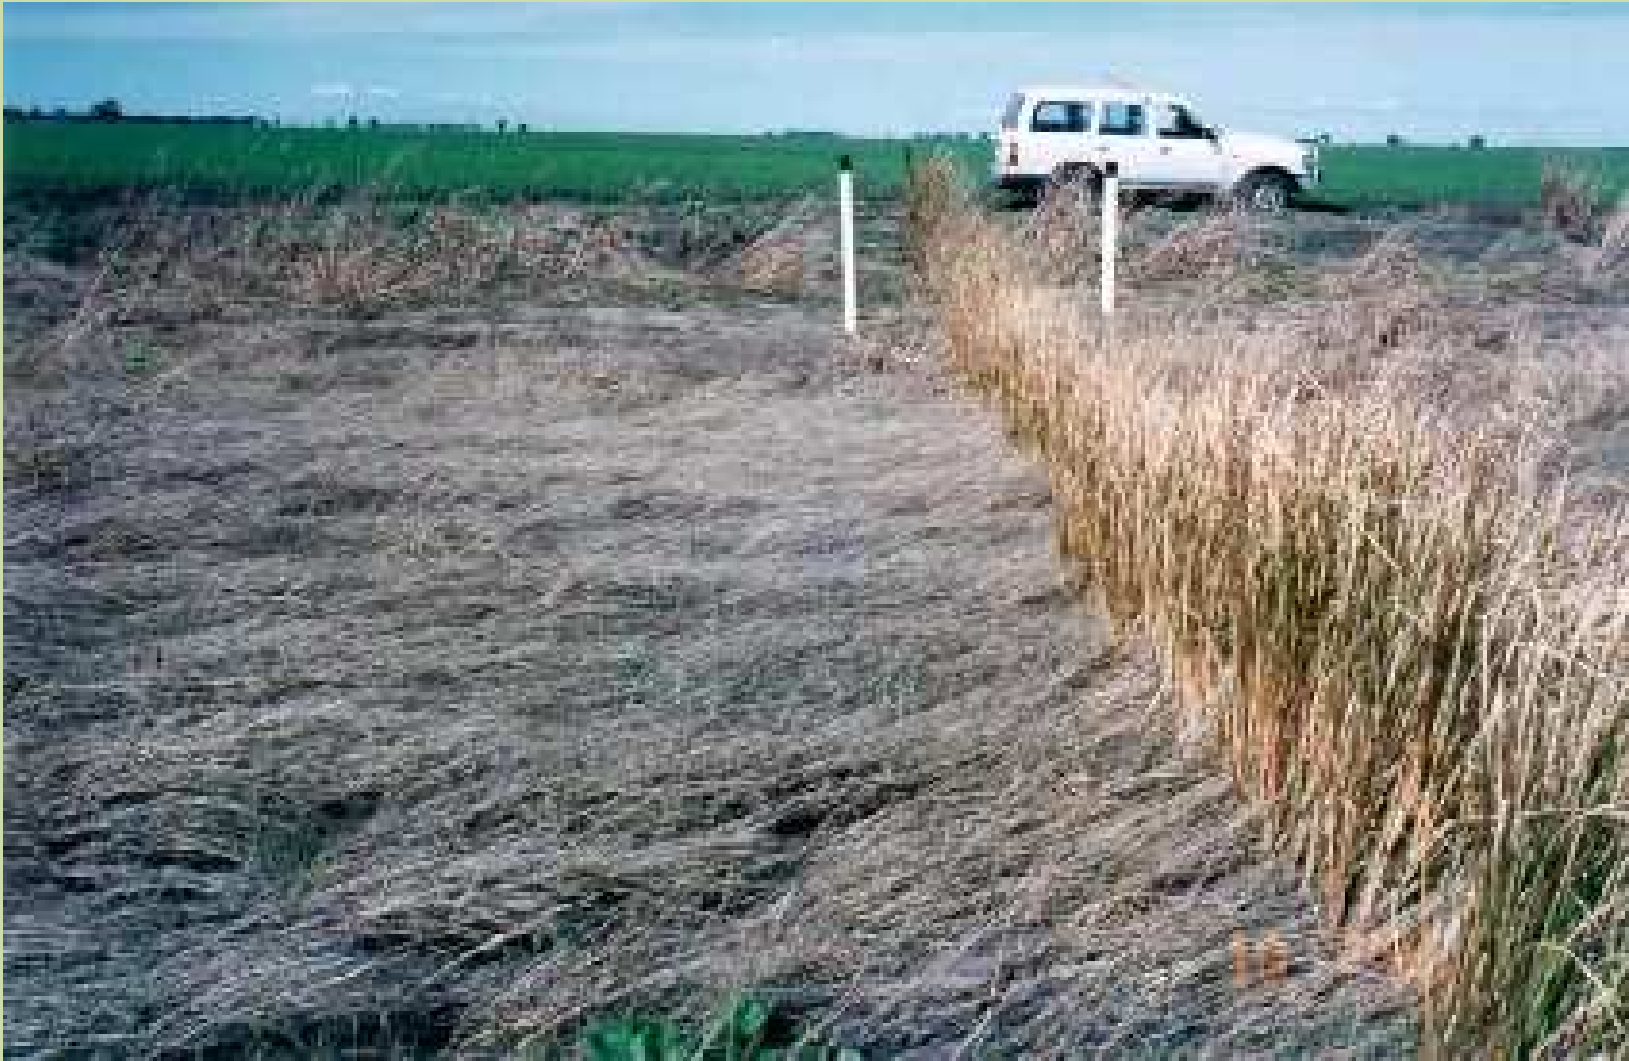
Strong current flattened the native grass but not vetiver on this waterway

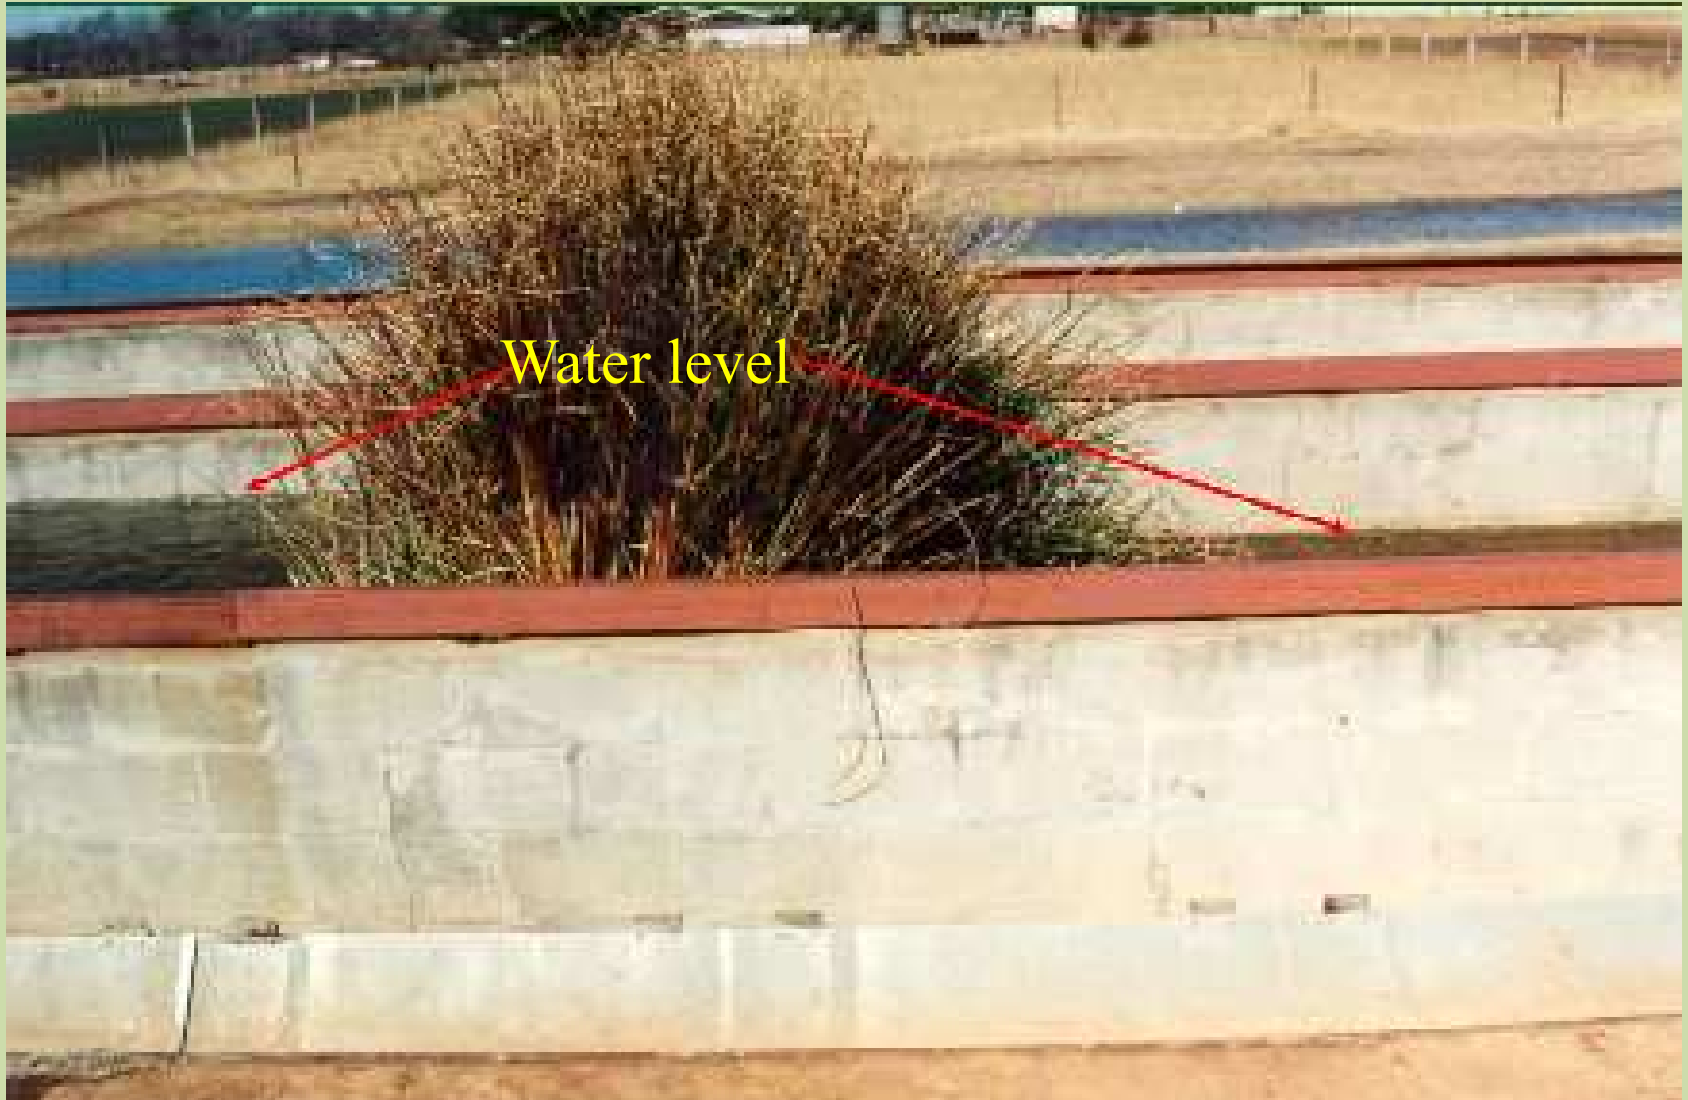
In flume test a mature hedge can bank up water to 600 mm depth

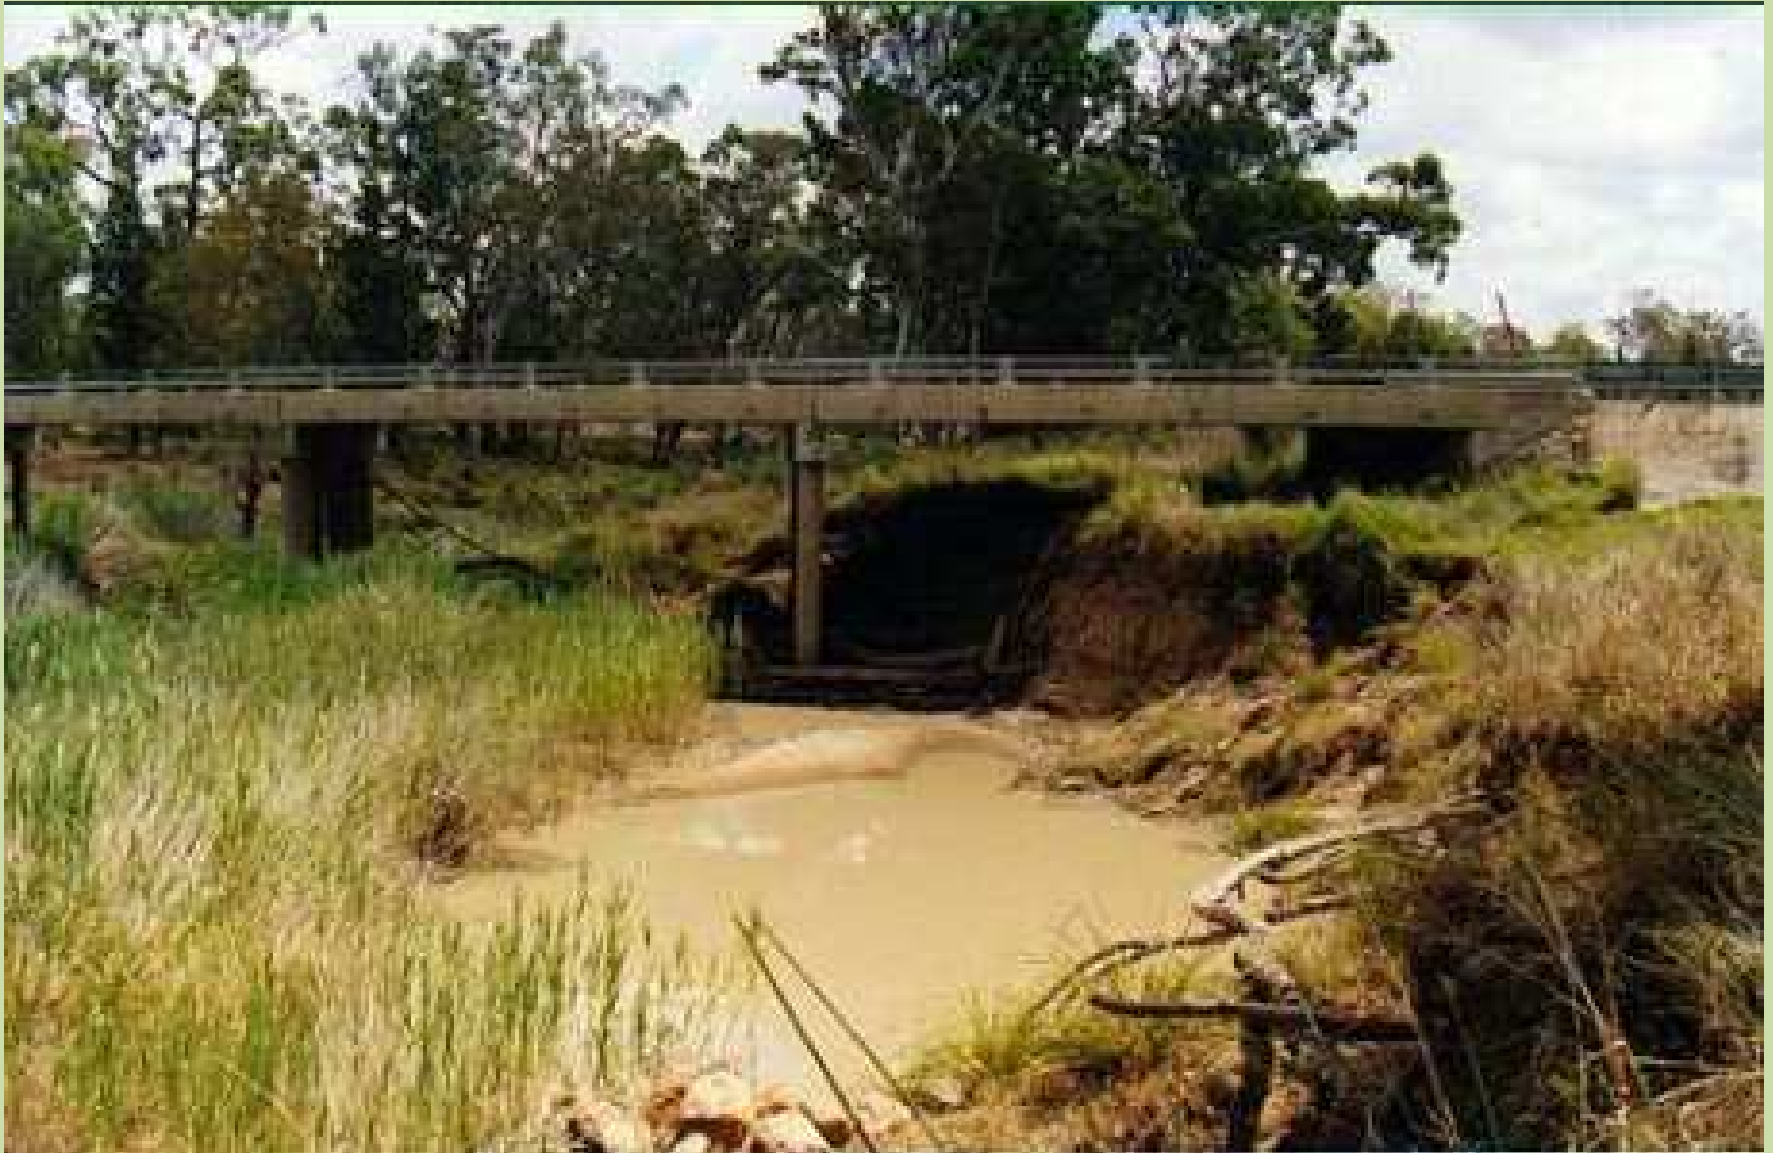
Severe erosion on the abutment of the Coolumboola Creek bridge near Miles

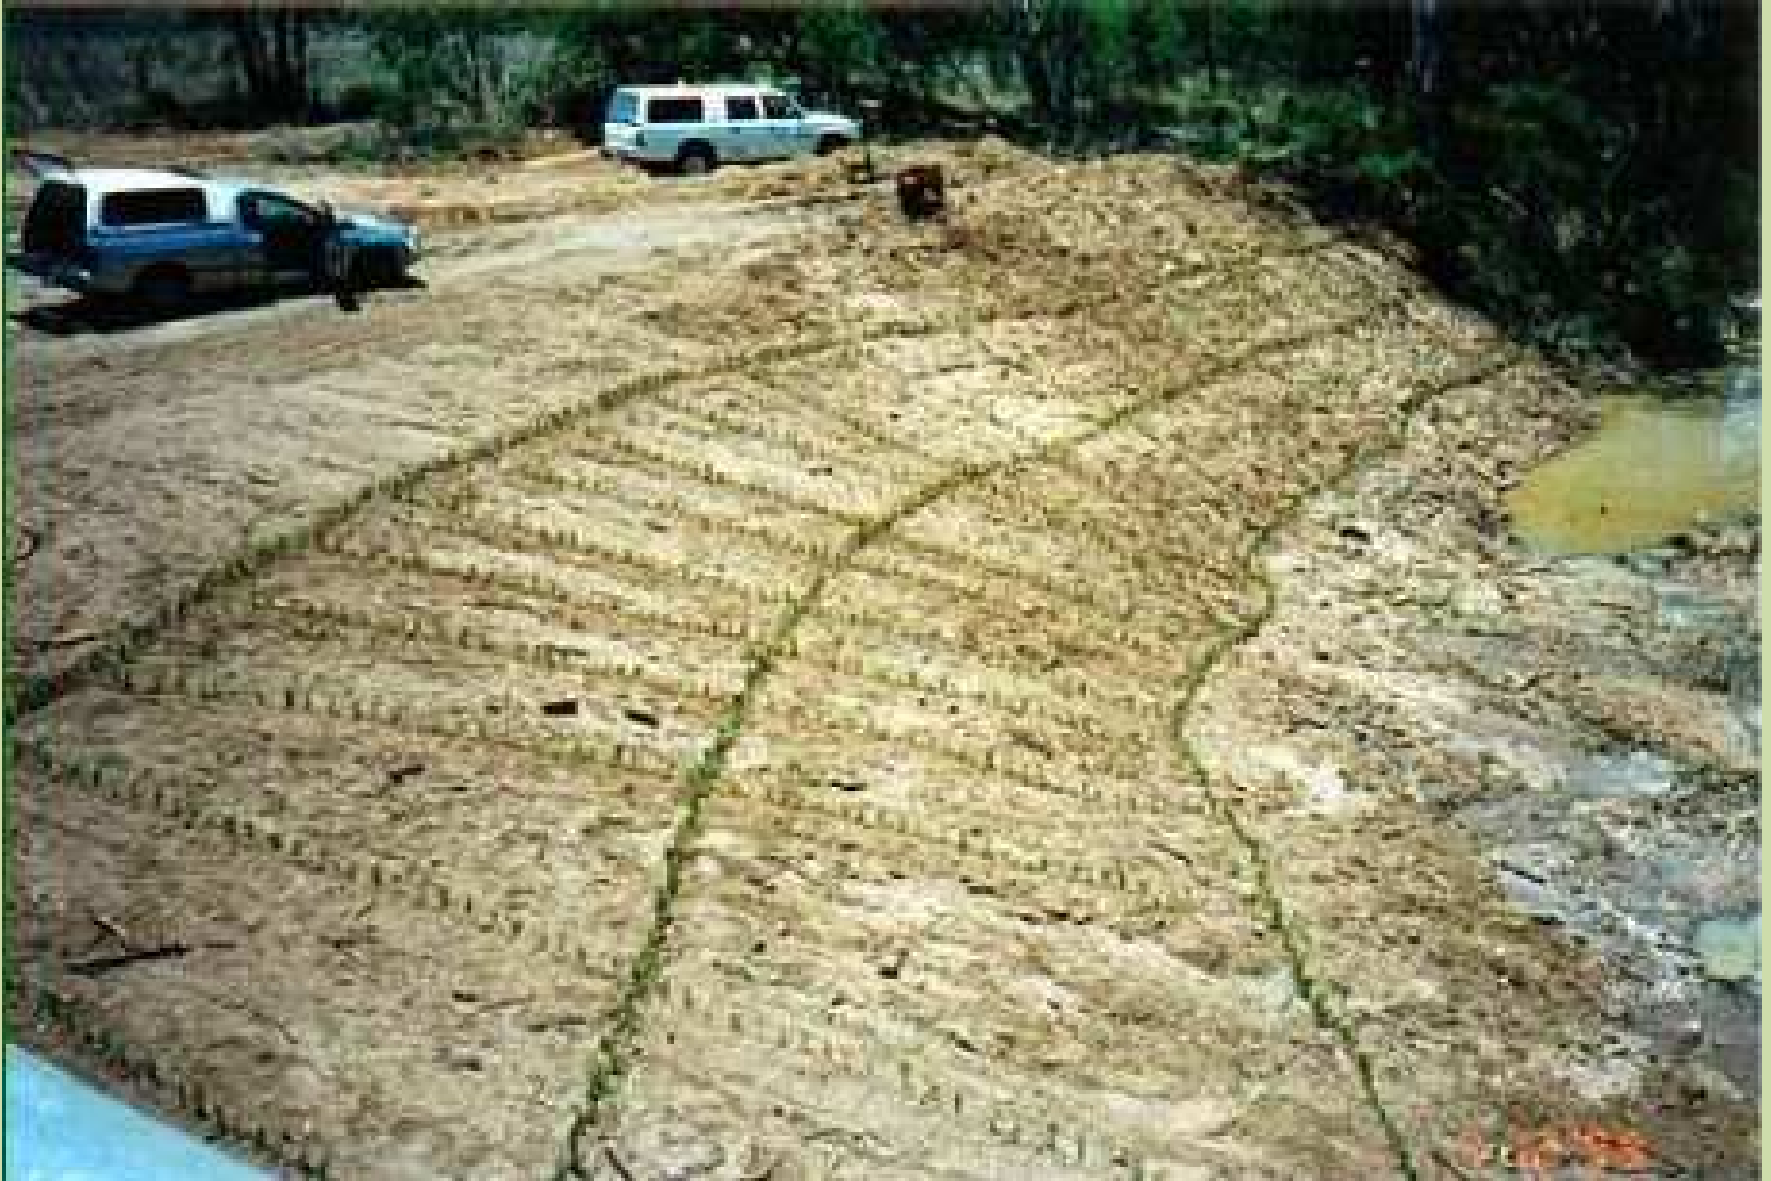
Vetiver planting following repair of bank.

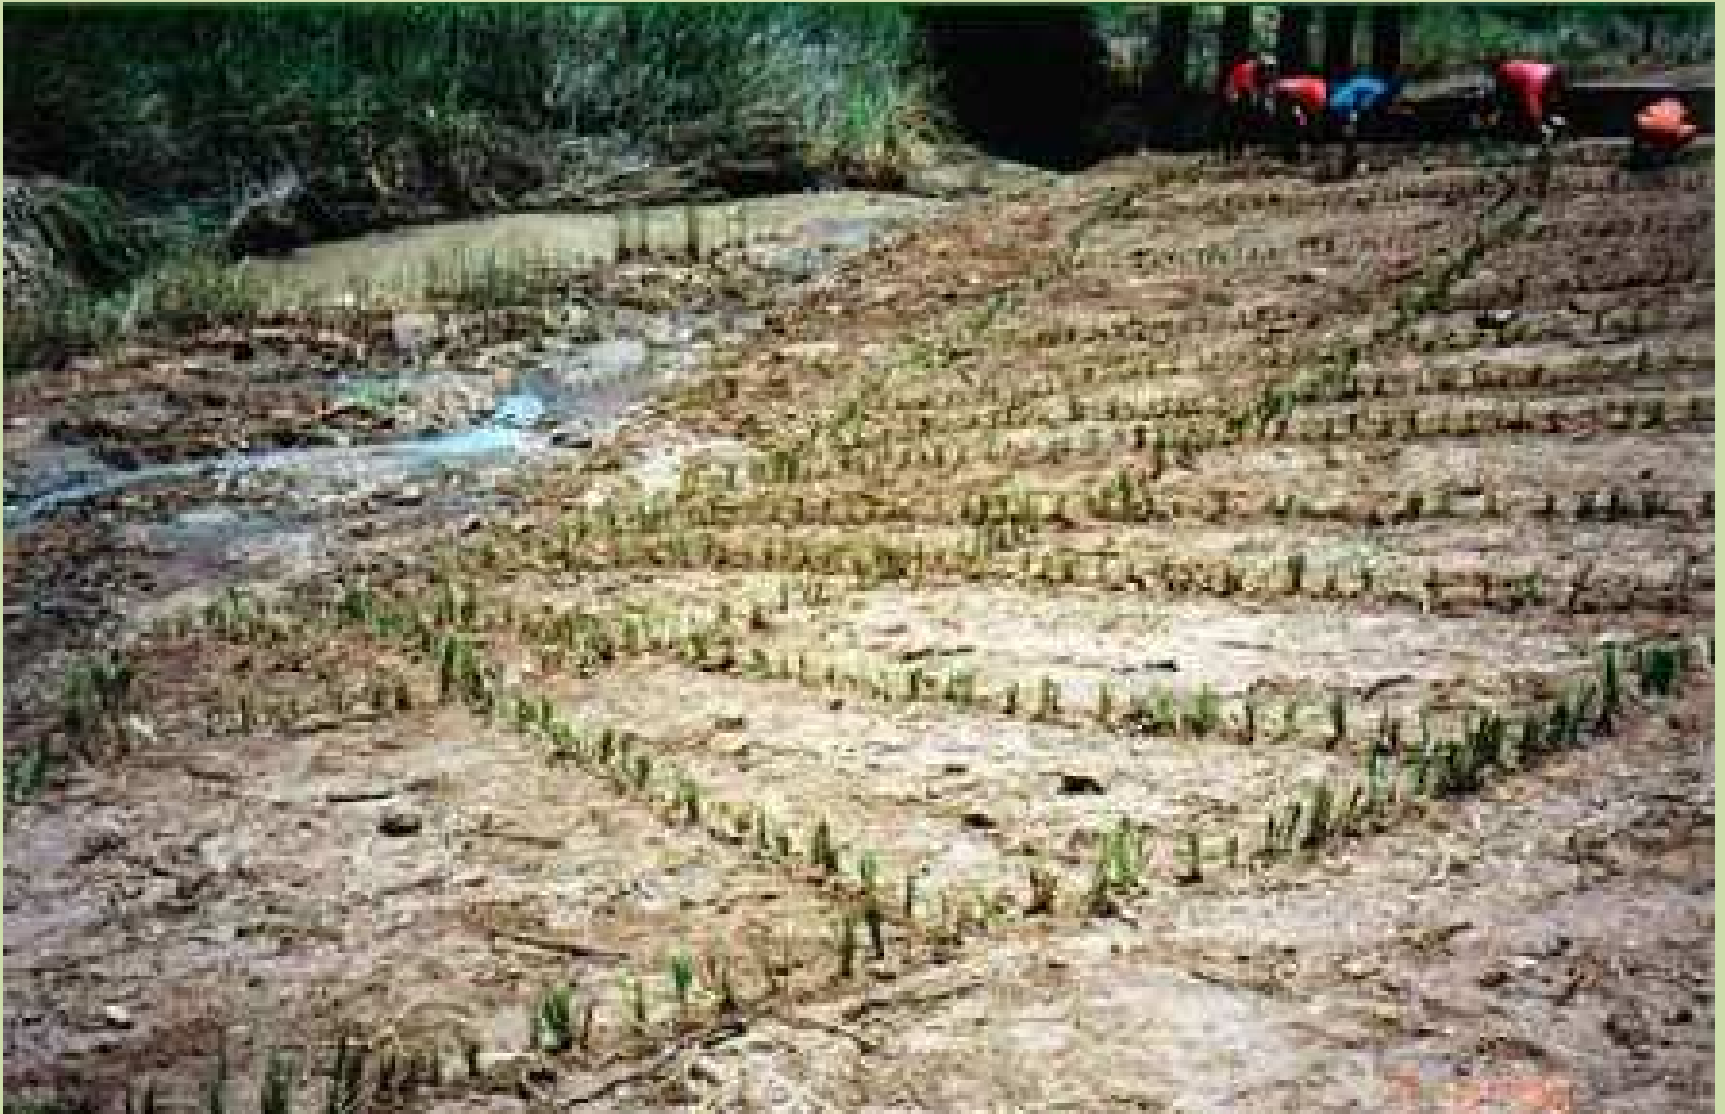
Cross rows are most effective when planted right angle to flow direction

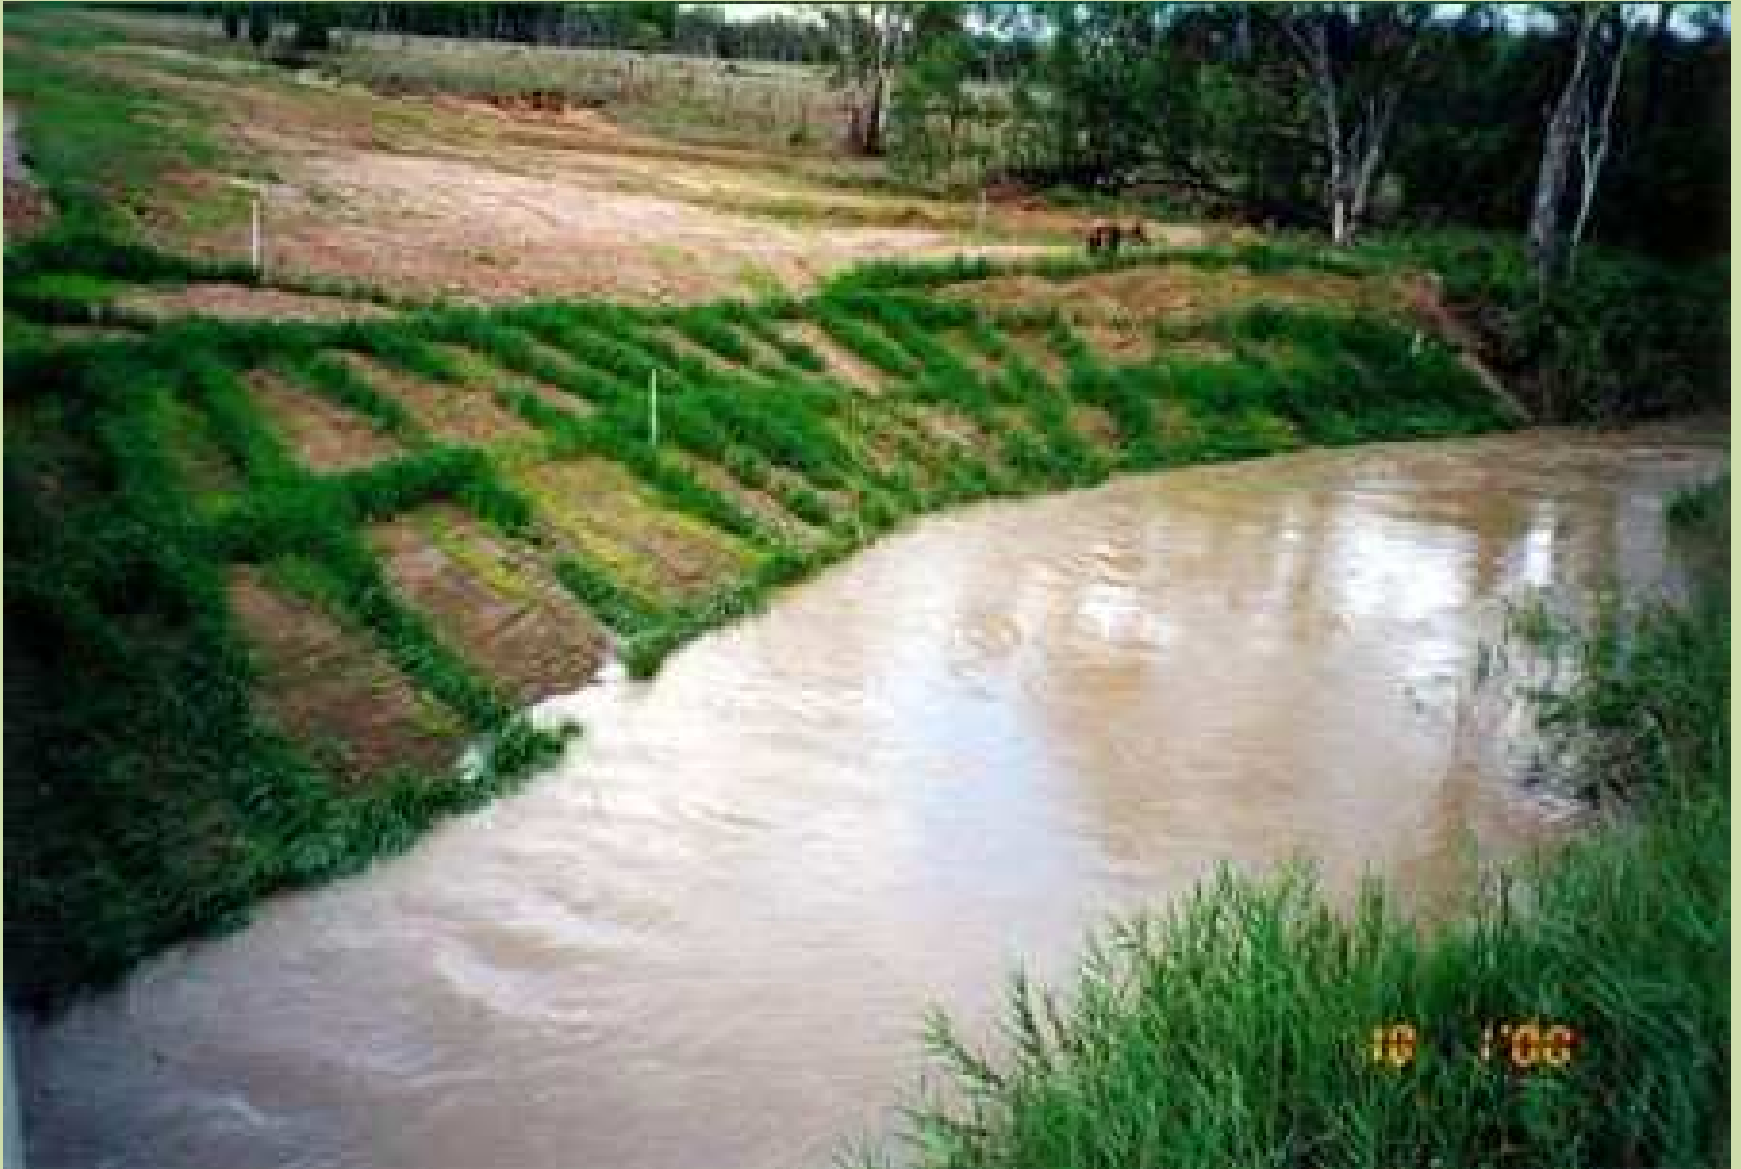
One month after planting

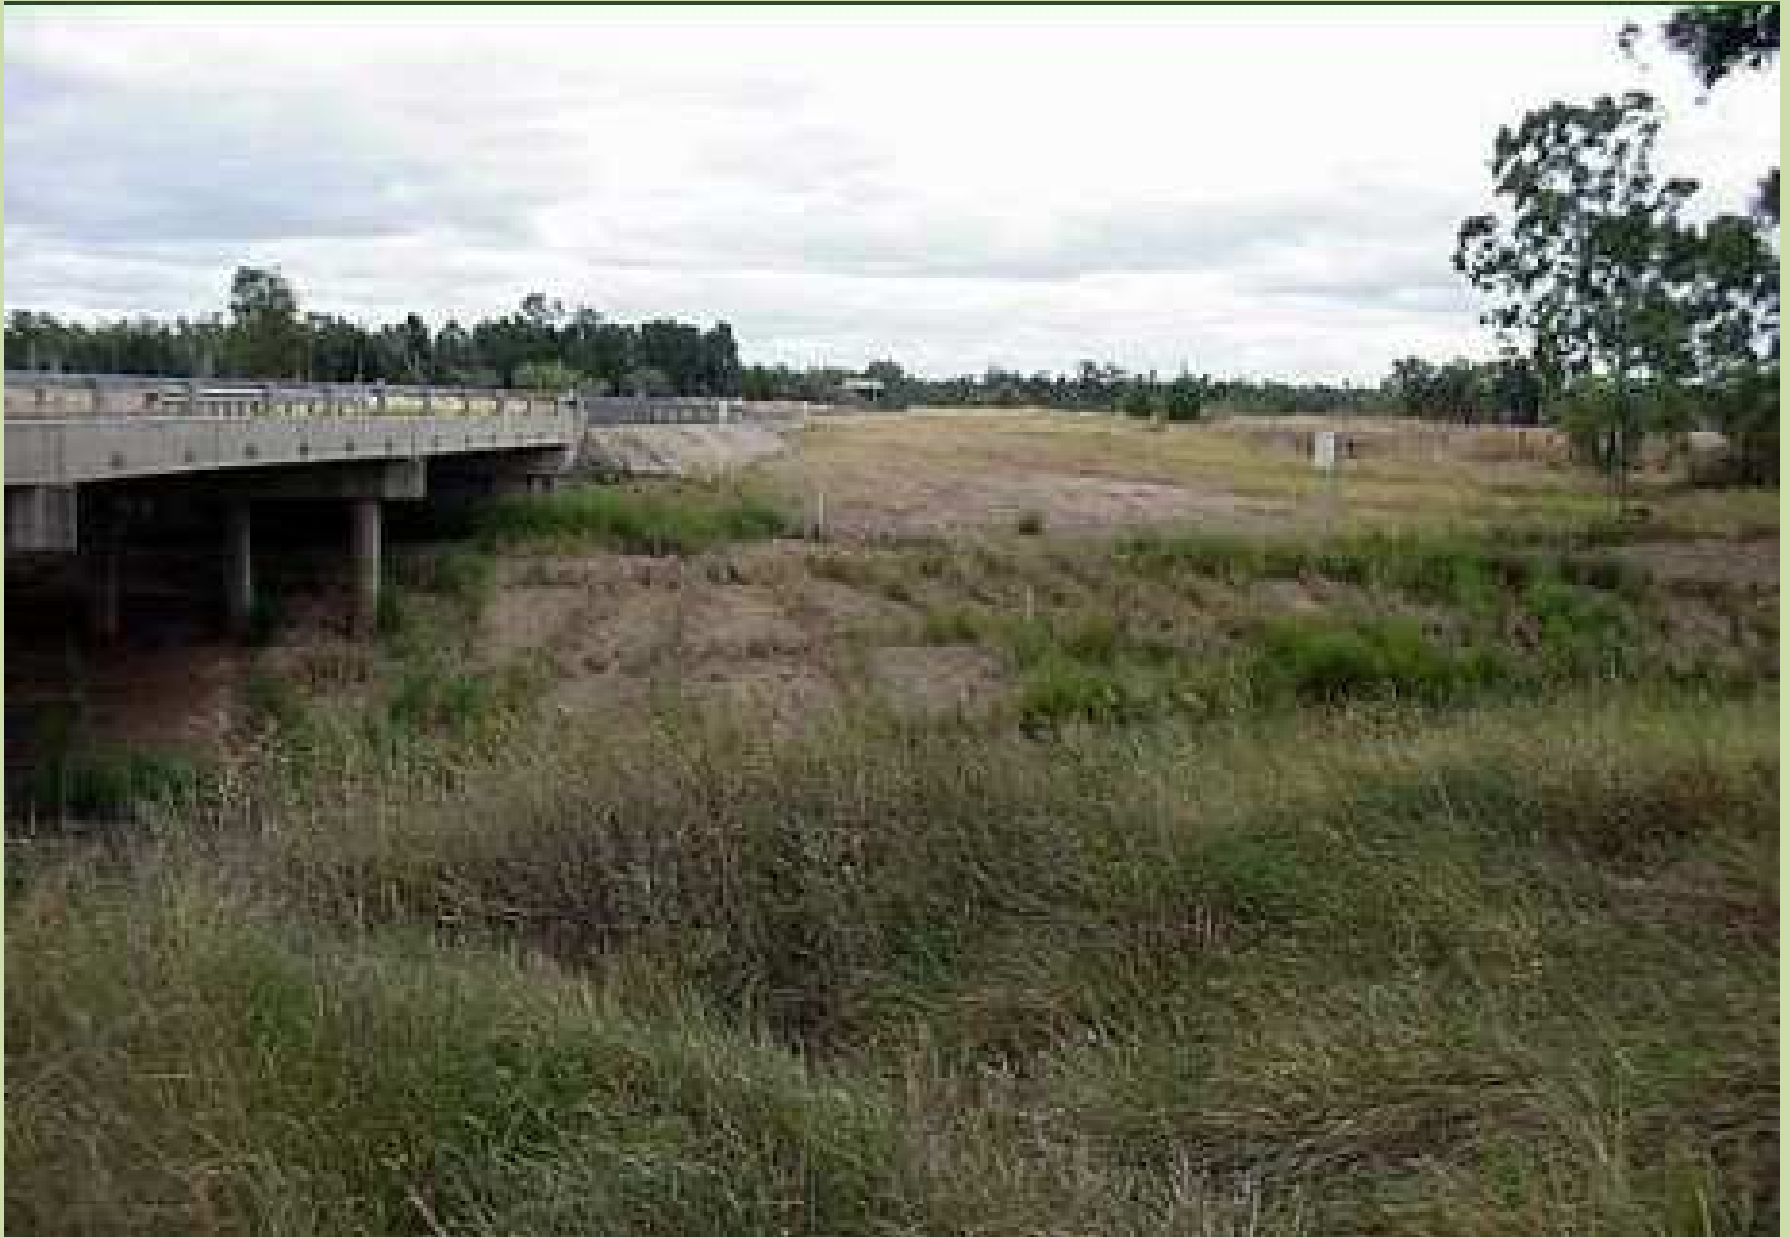
Six month after planting

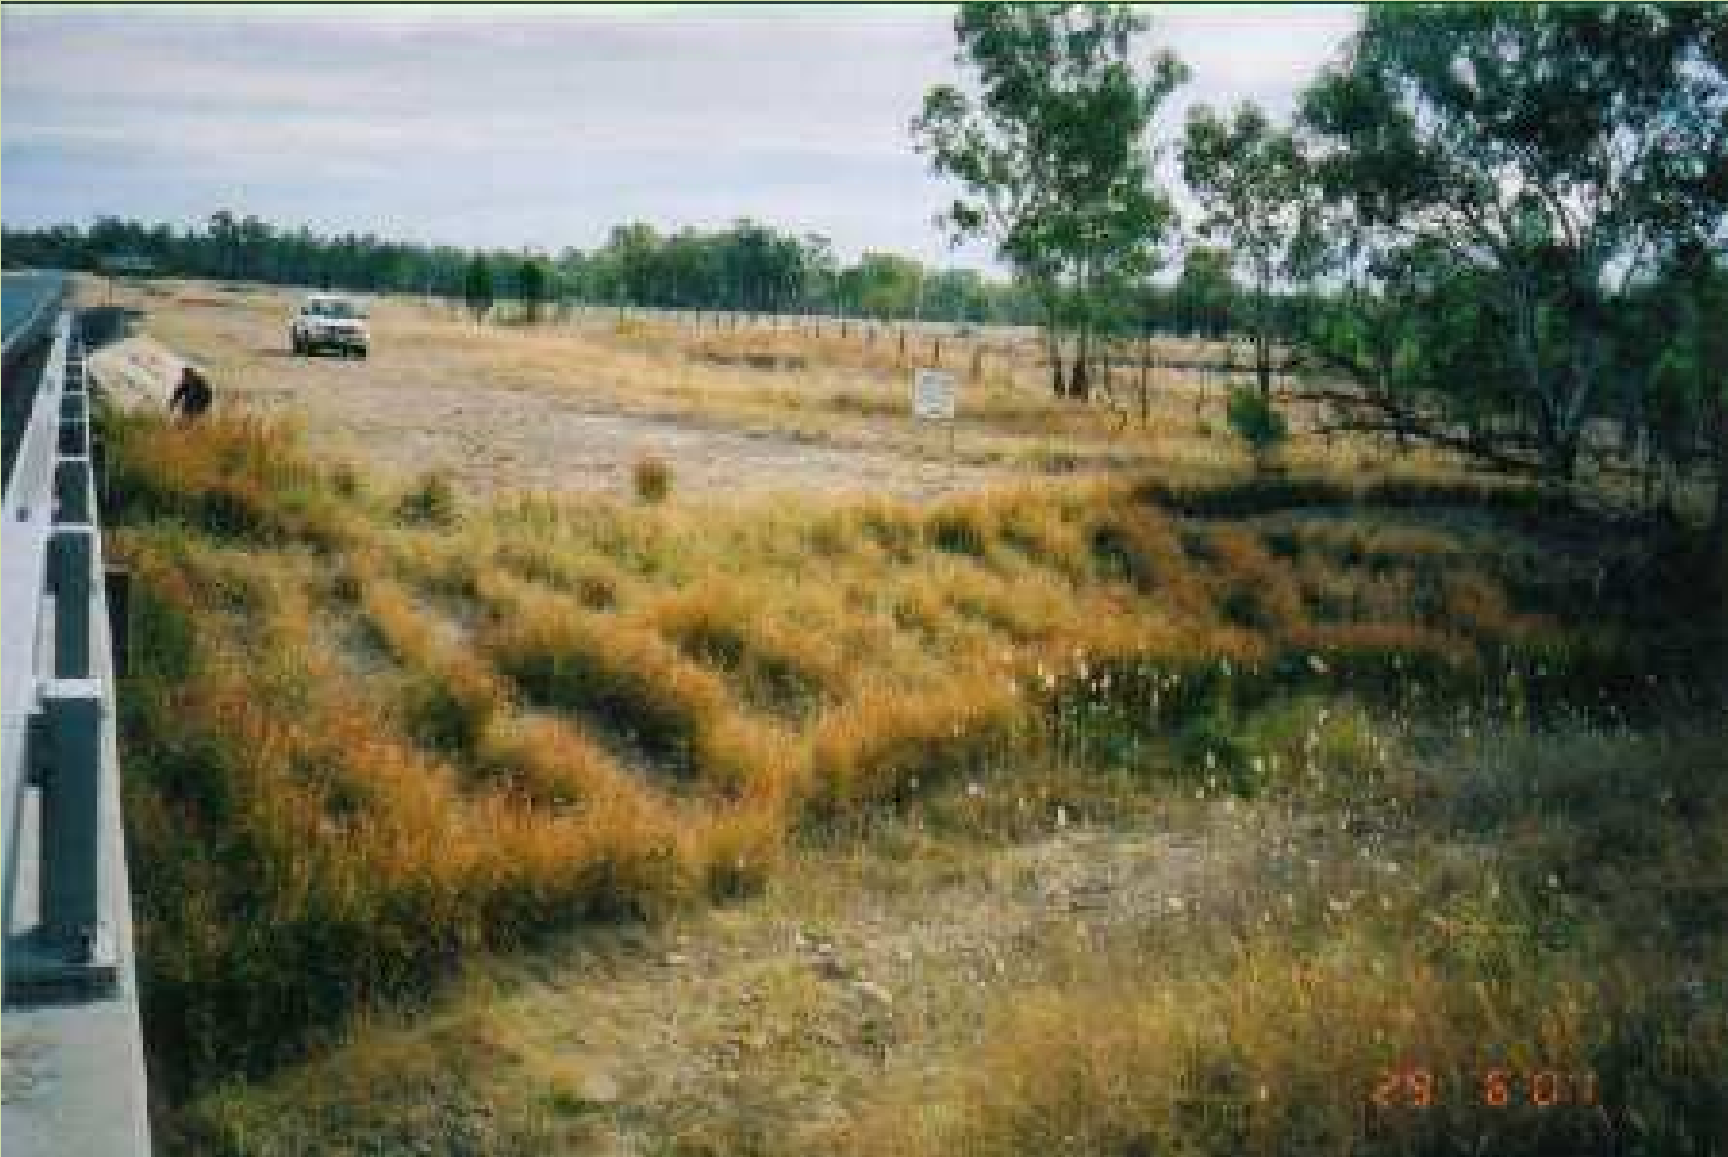
There were several big flows during the first summer and no damages were noted. This abutment is now well protected by these mature vetiver.

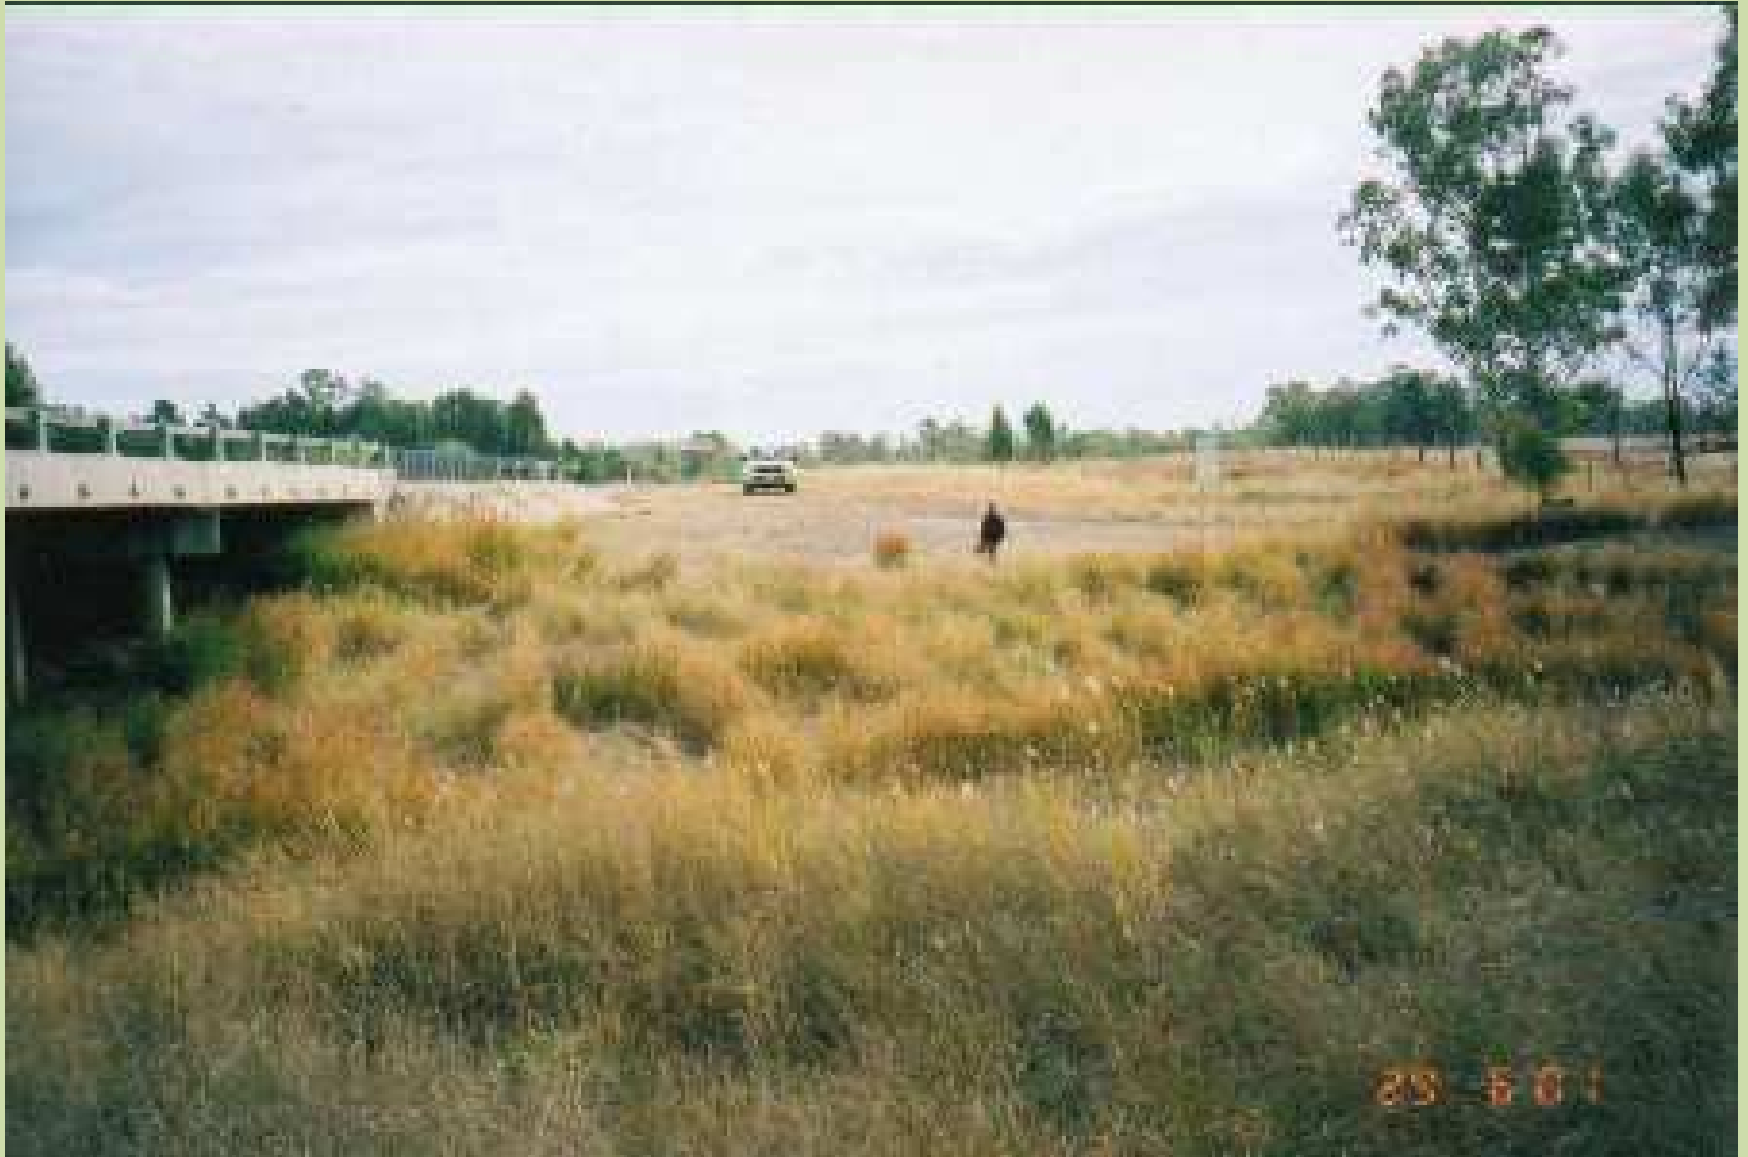
18 months after planting

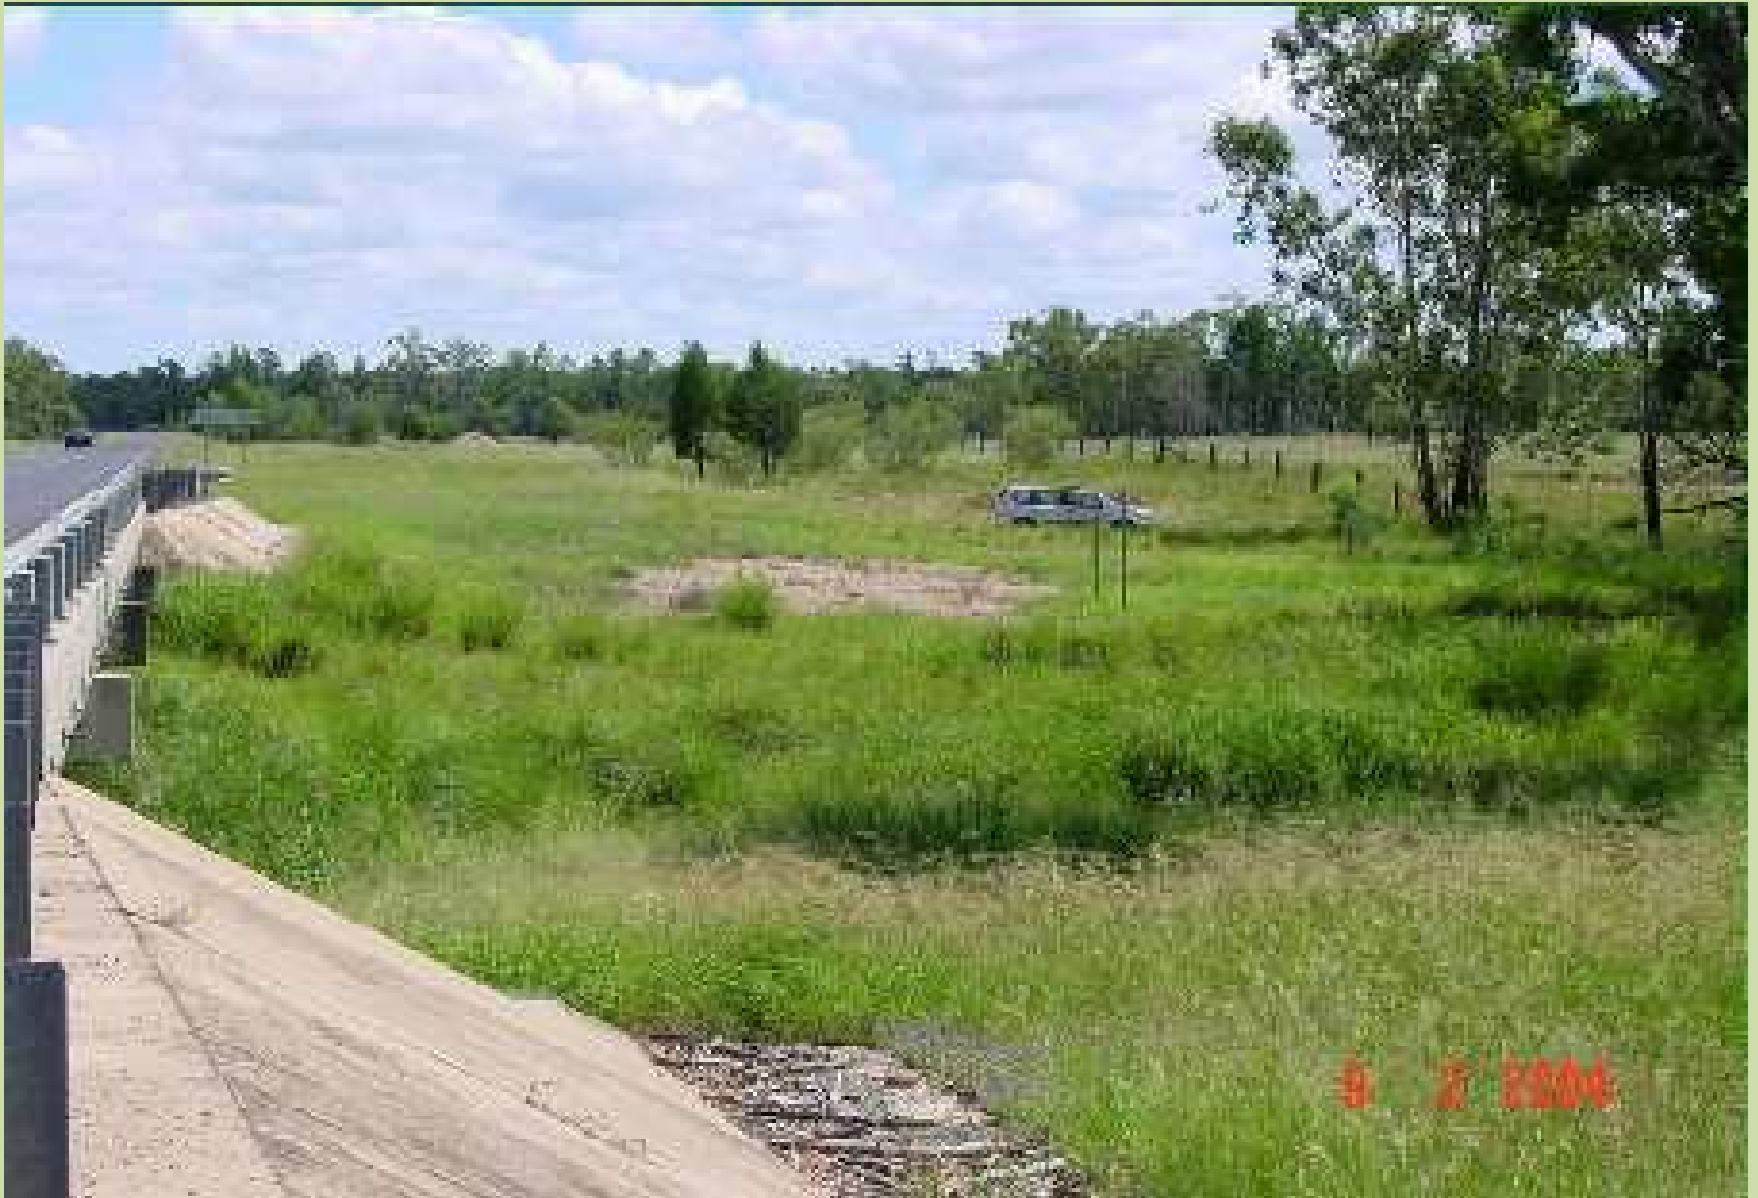
Five years after planting

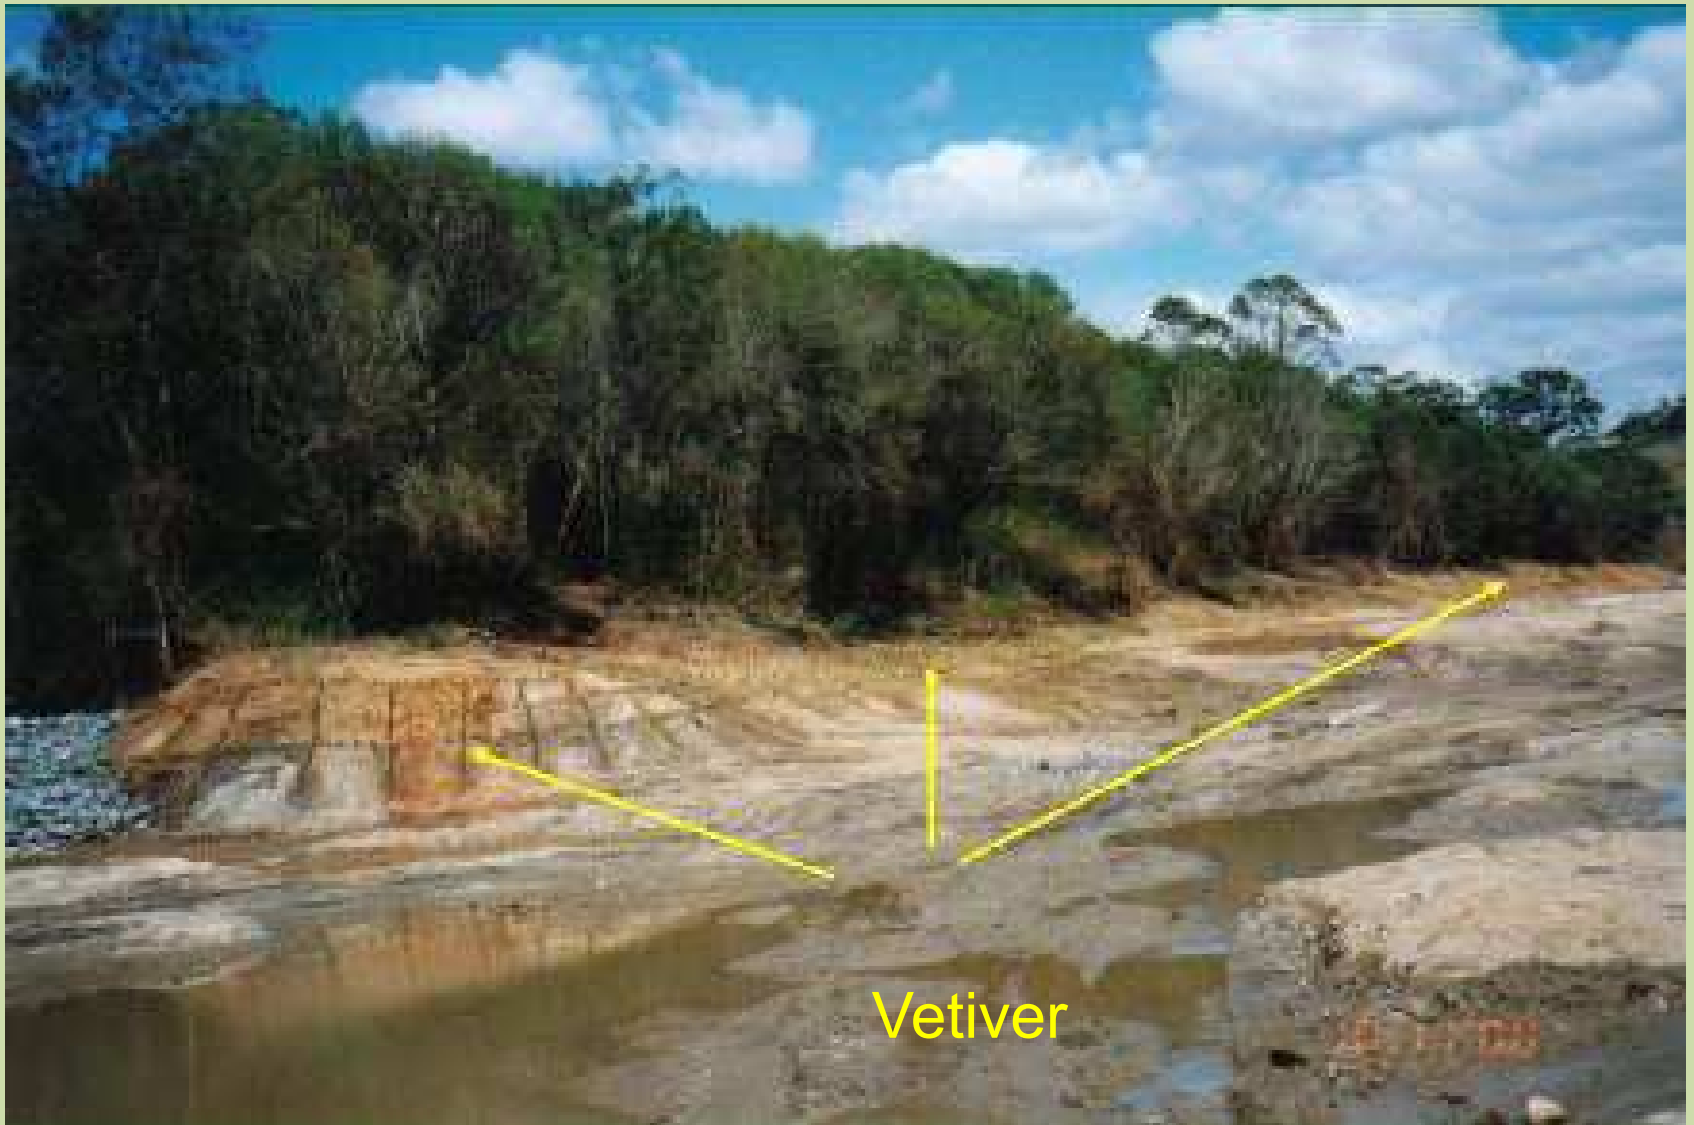
Dam spillway protection
