VETIVER SYSTEM FOR RIVER AND CANAL BANK STABILISATION

Paul Truong

TVNI Technical Director, Brisbane, Australia

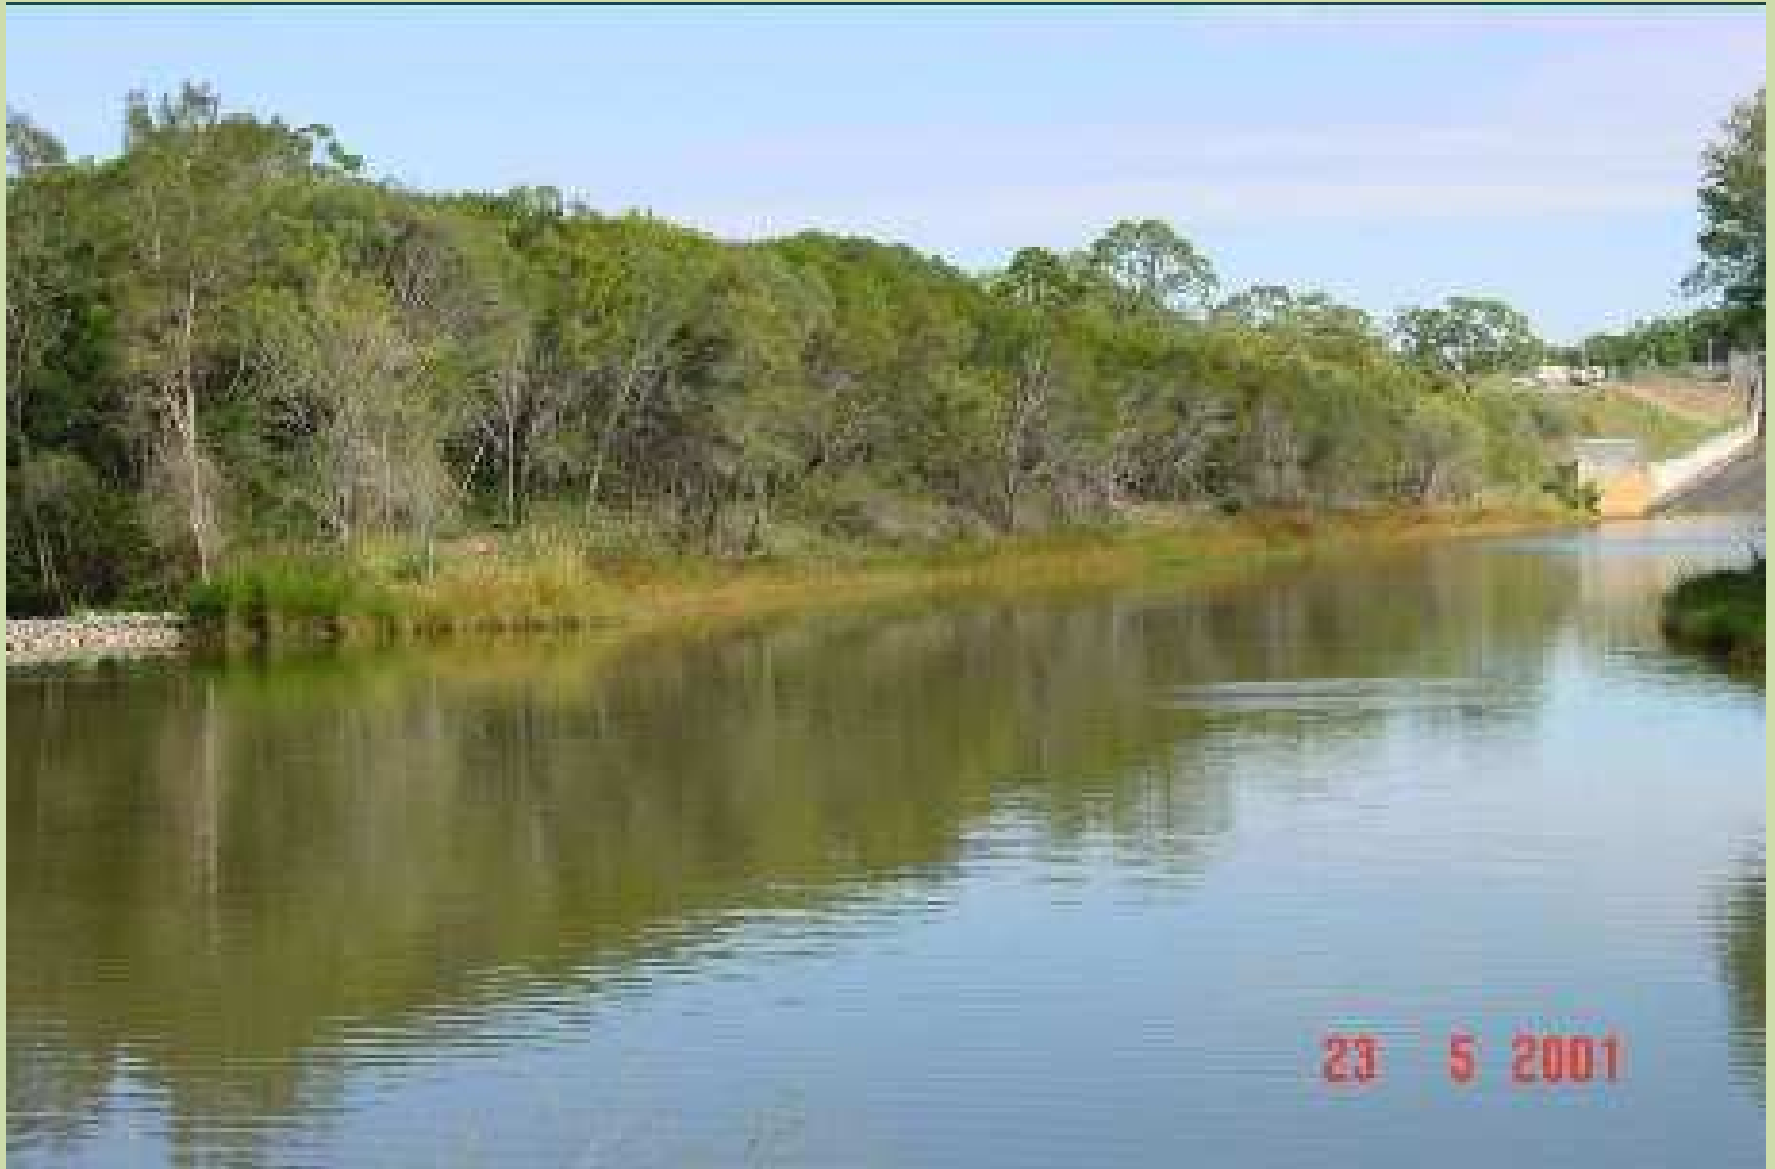
Six months after planting

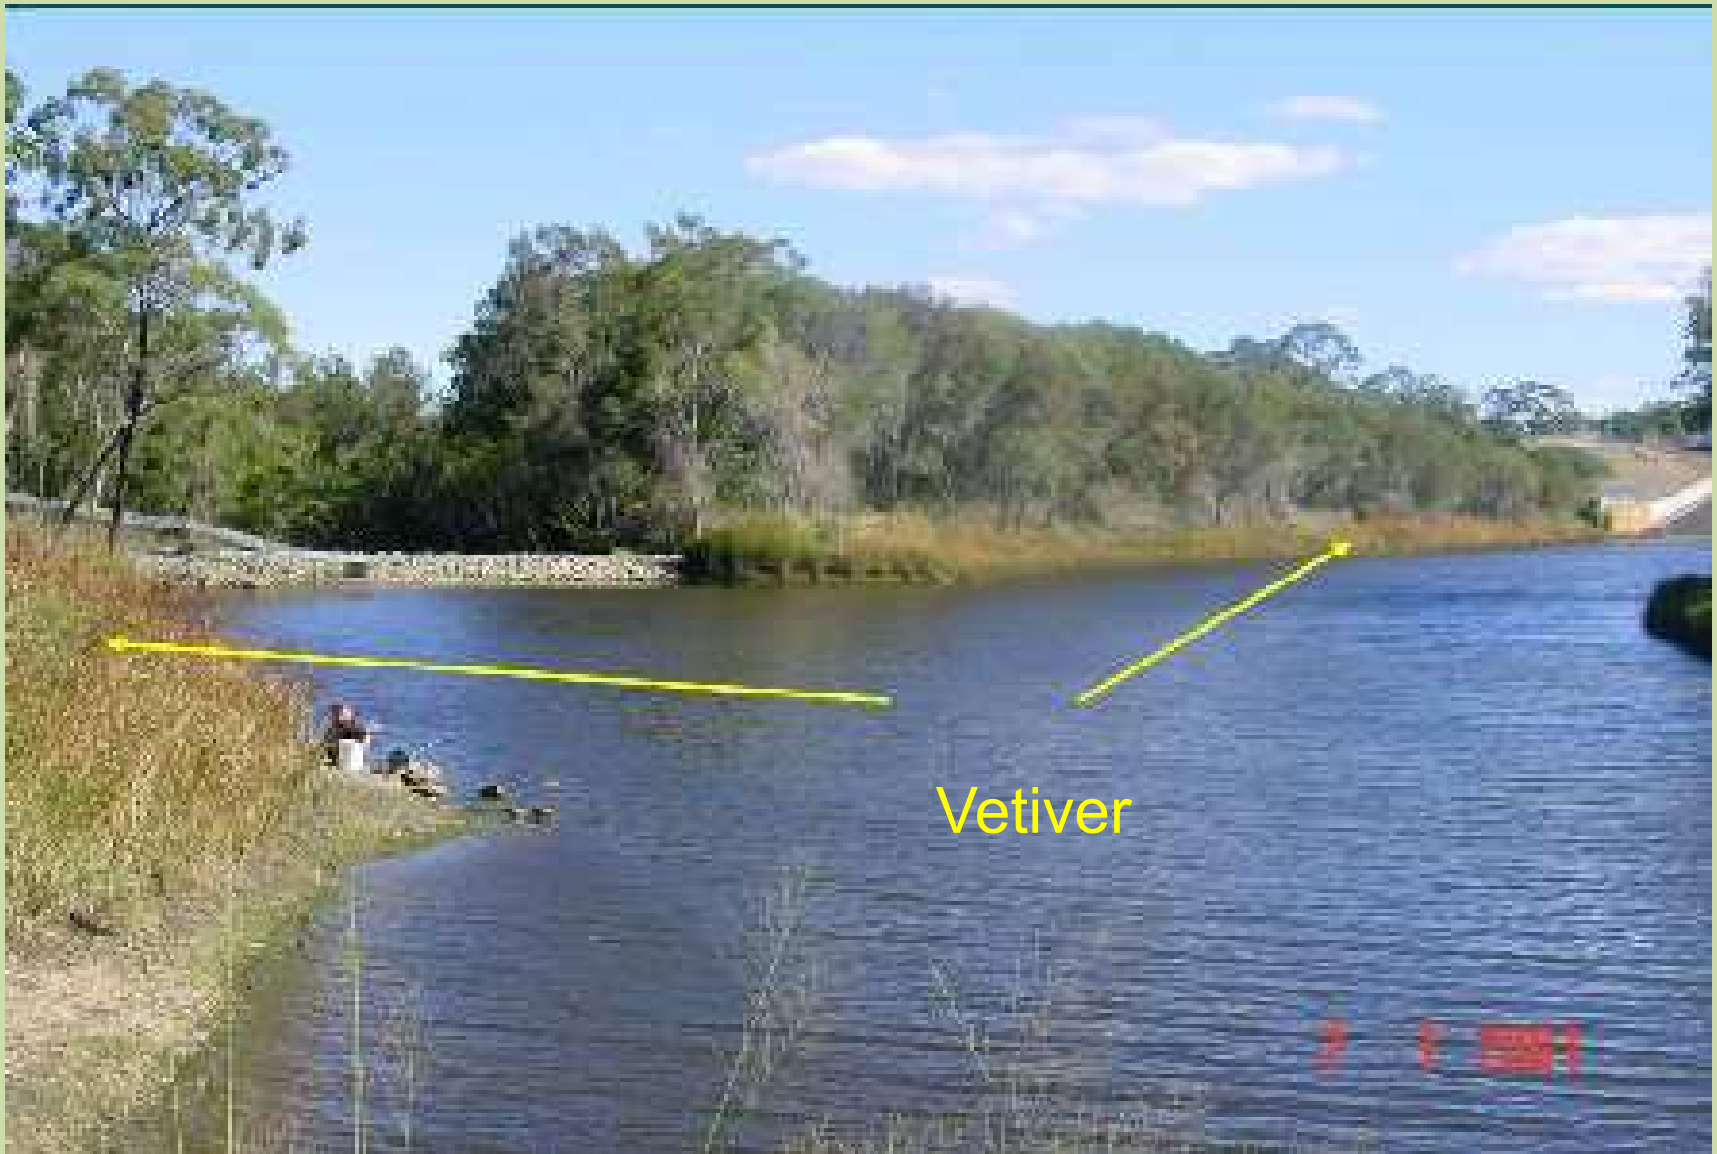
Eight months after planting

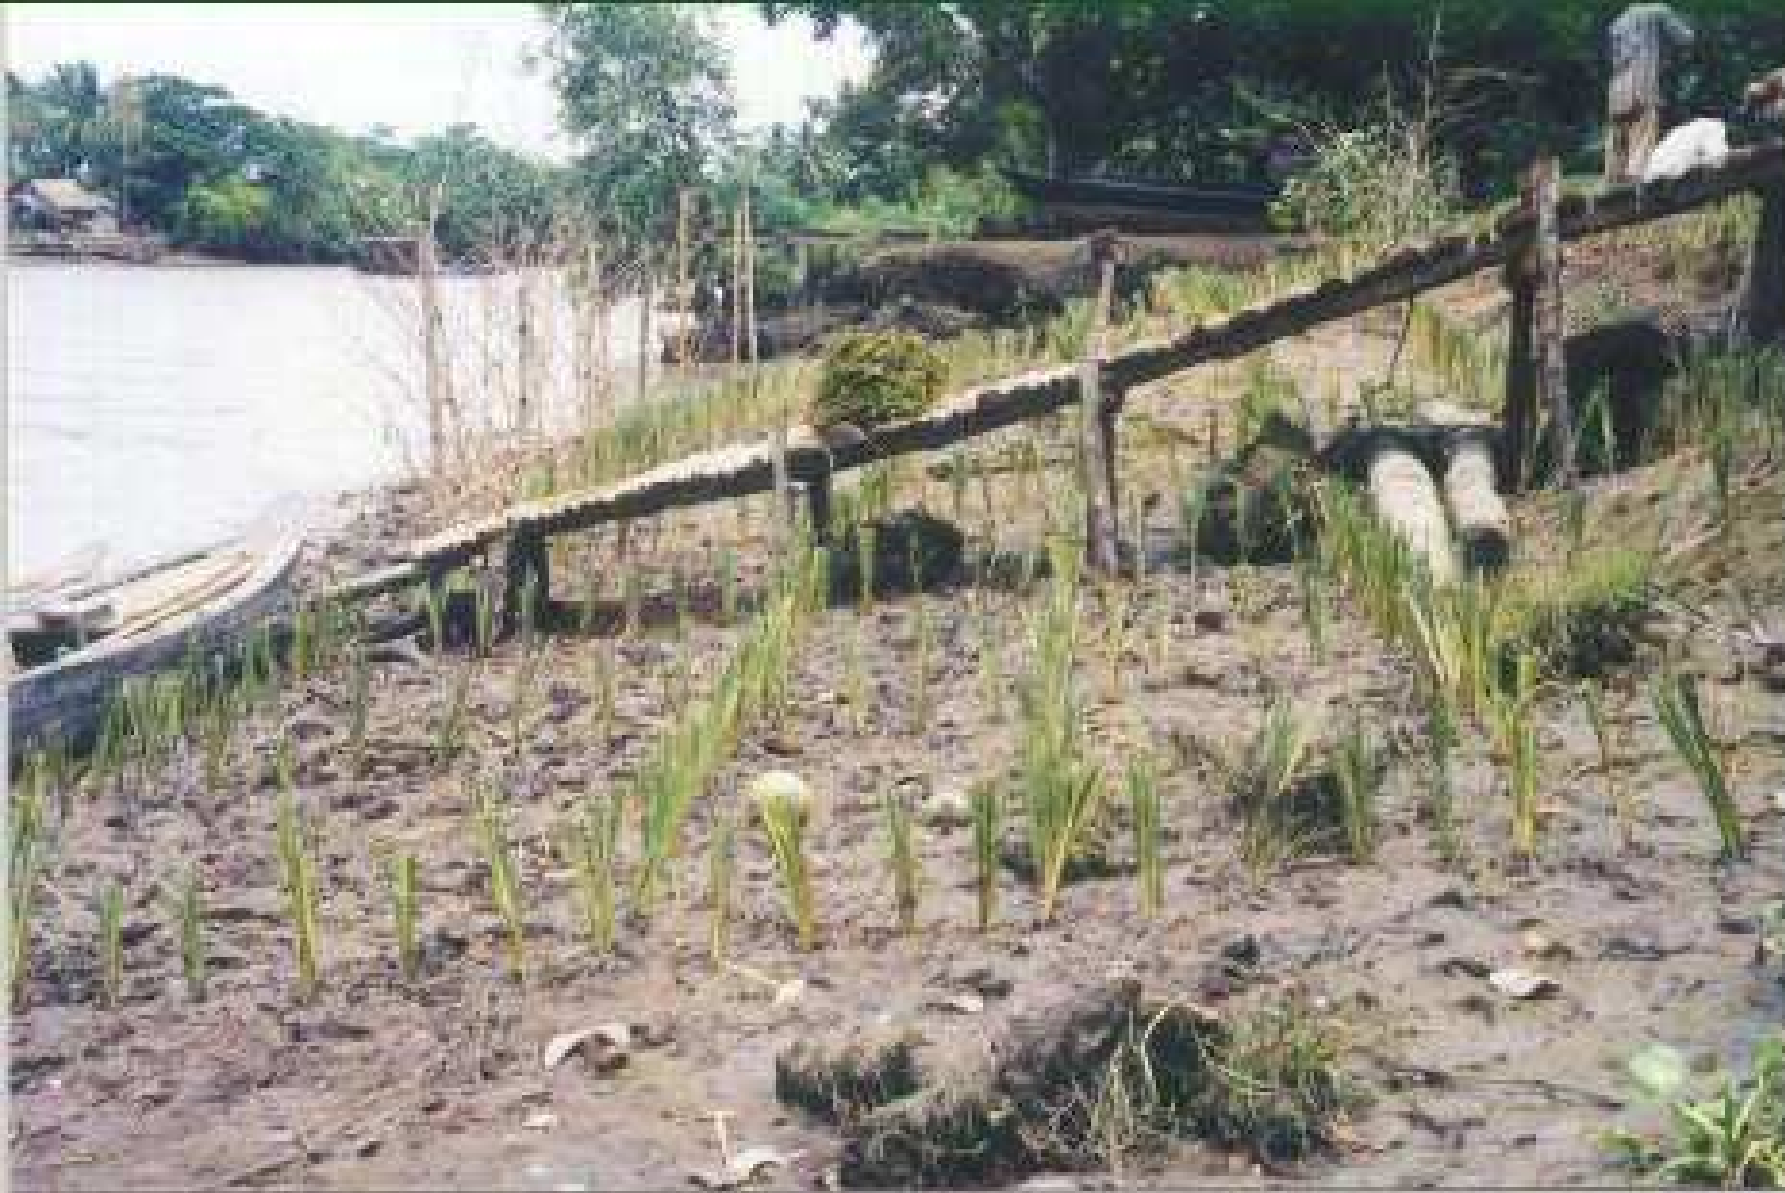
Mekong Delta Vietnam: Protecting bank against wave erosion

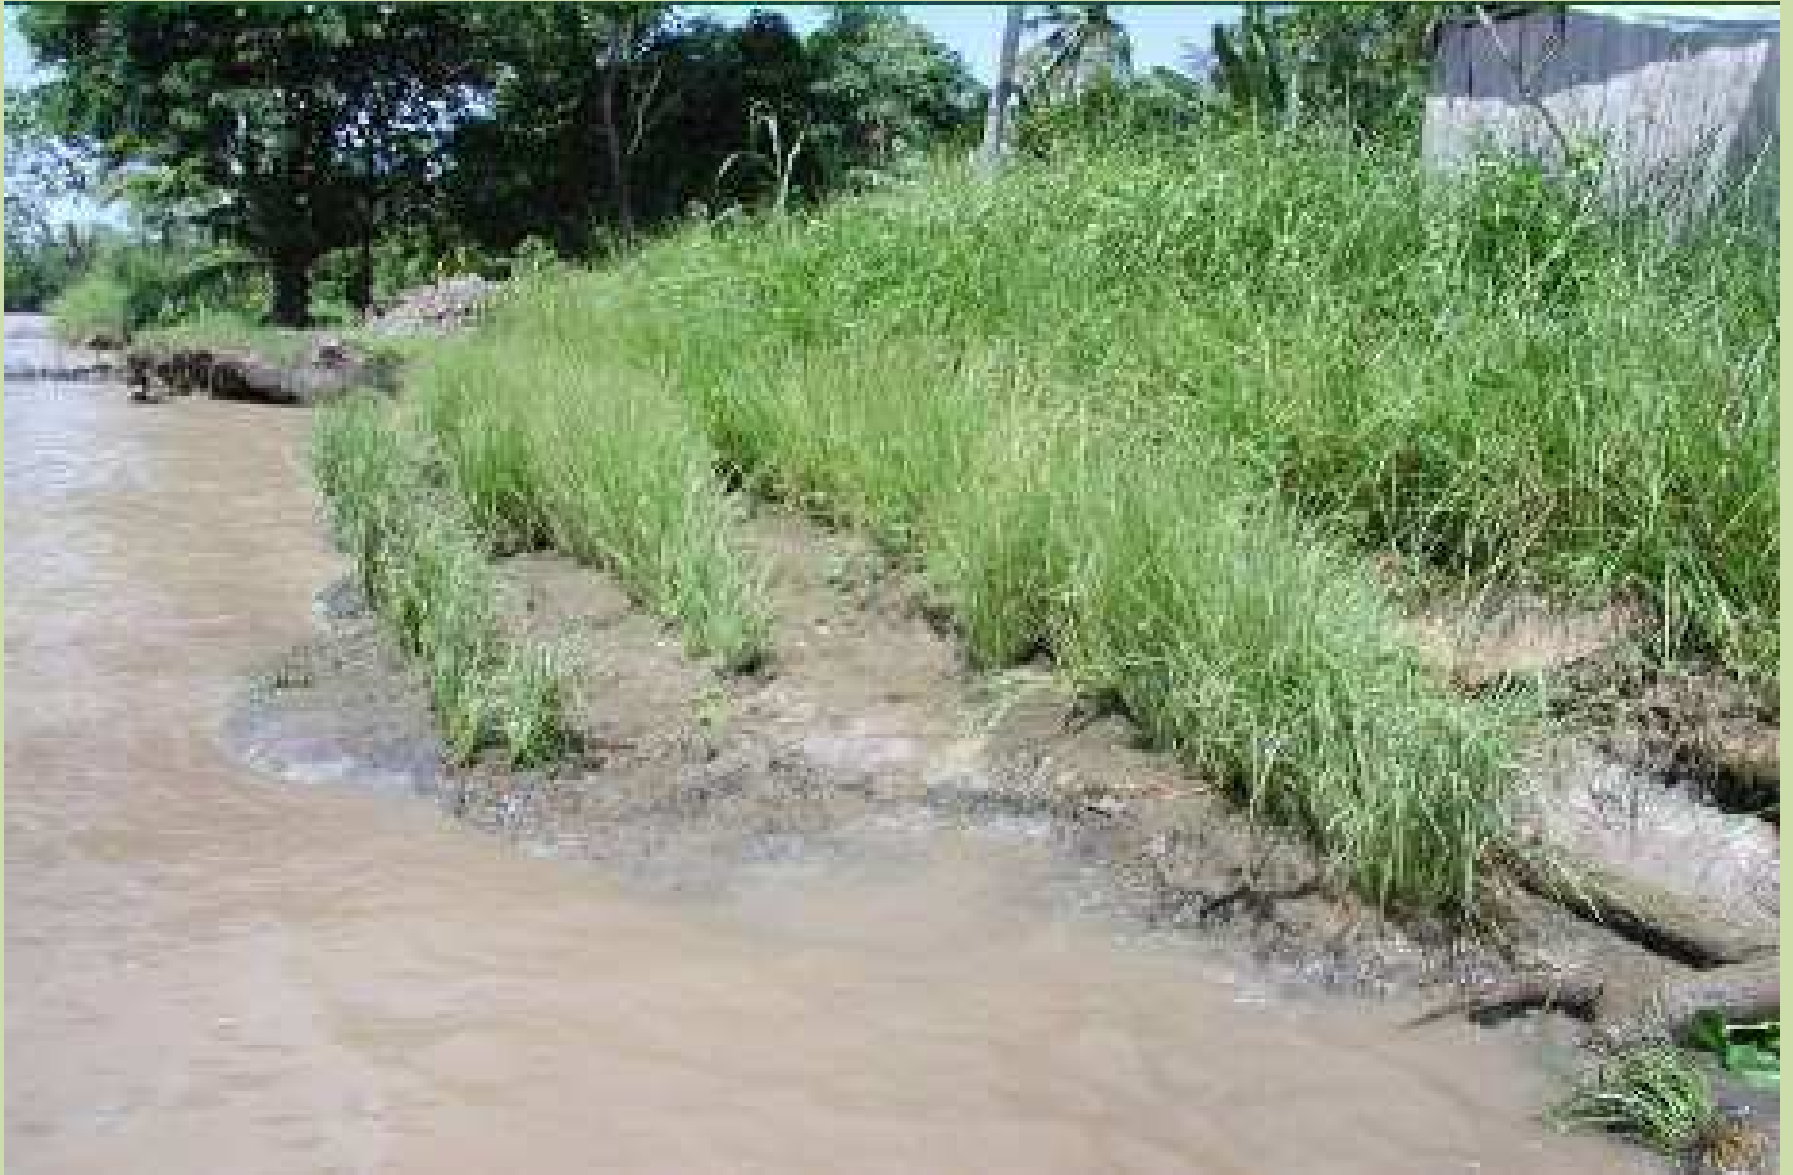
Six months after planting

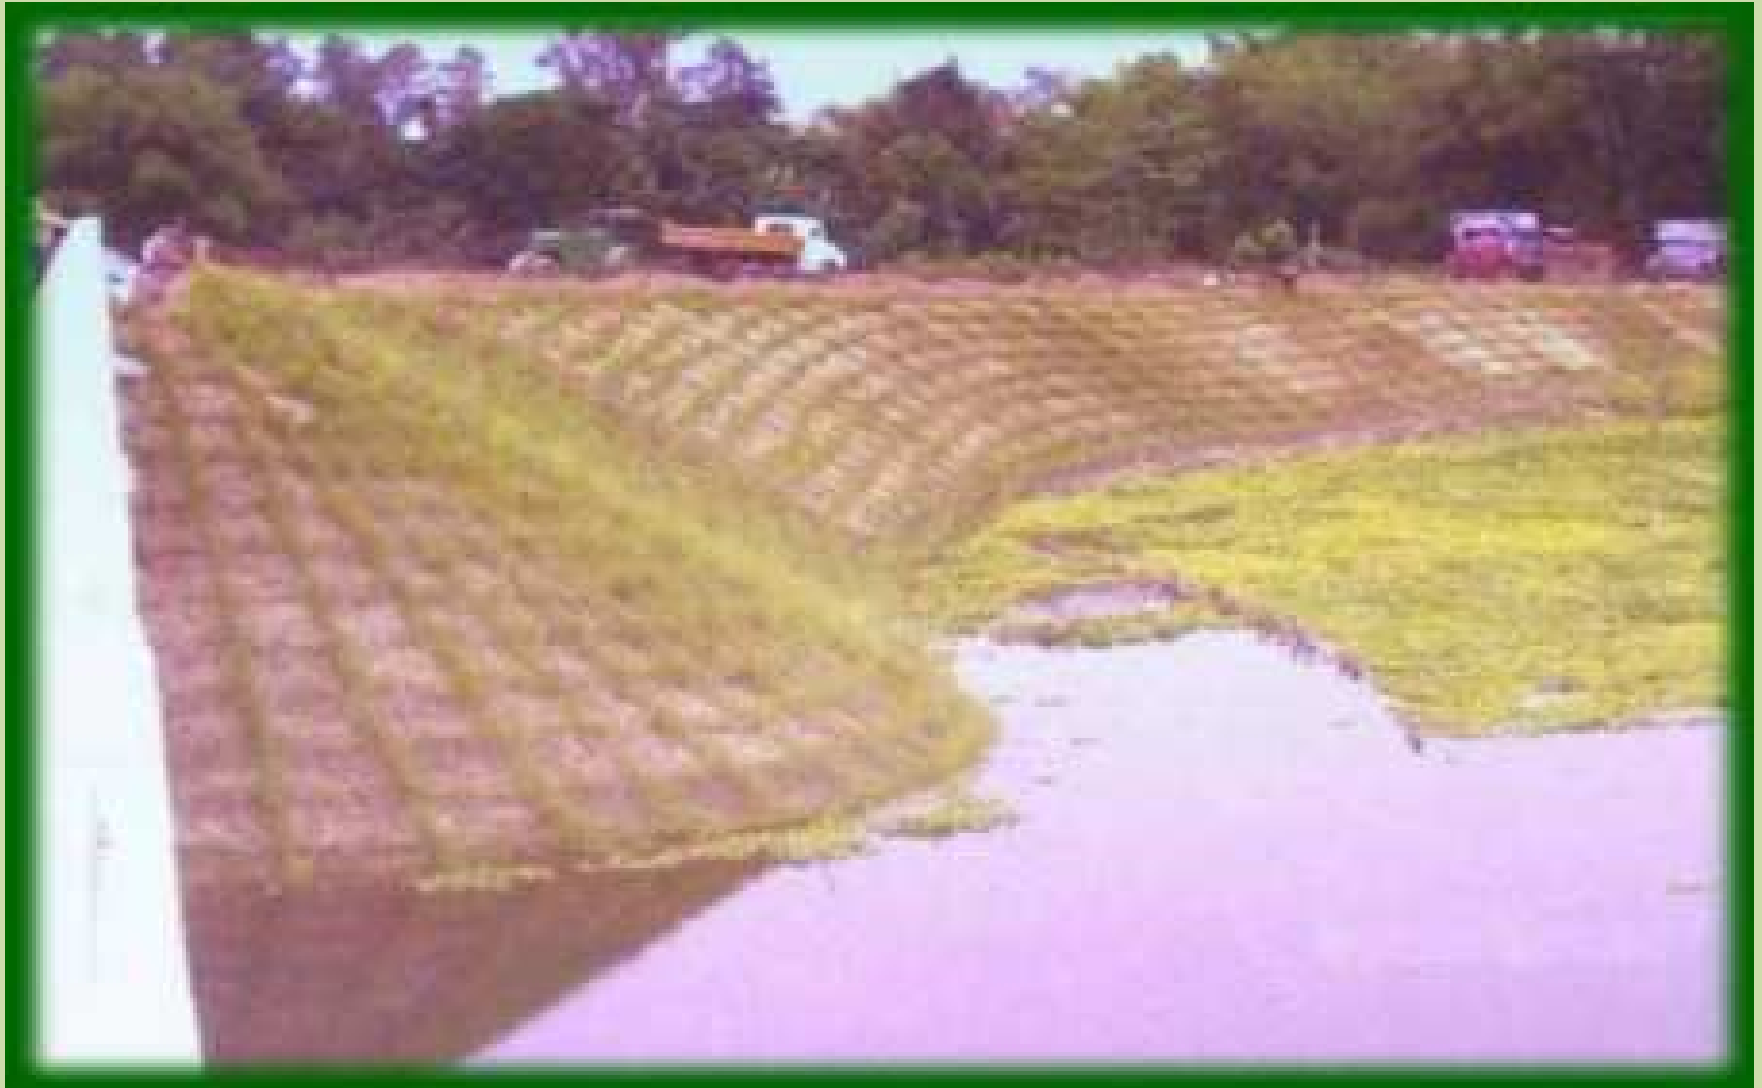
Assam, India : Doria Bridge approach, Note: grid pattern

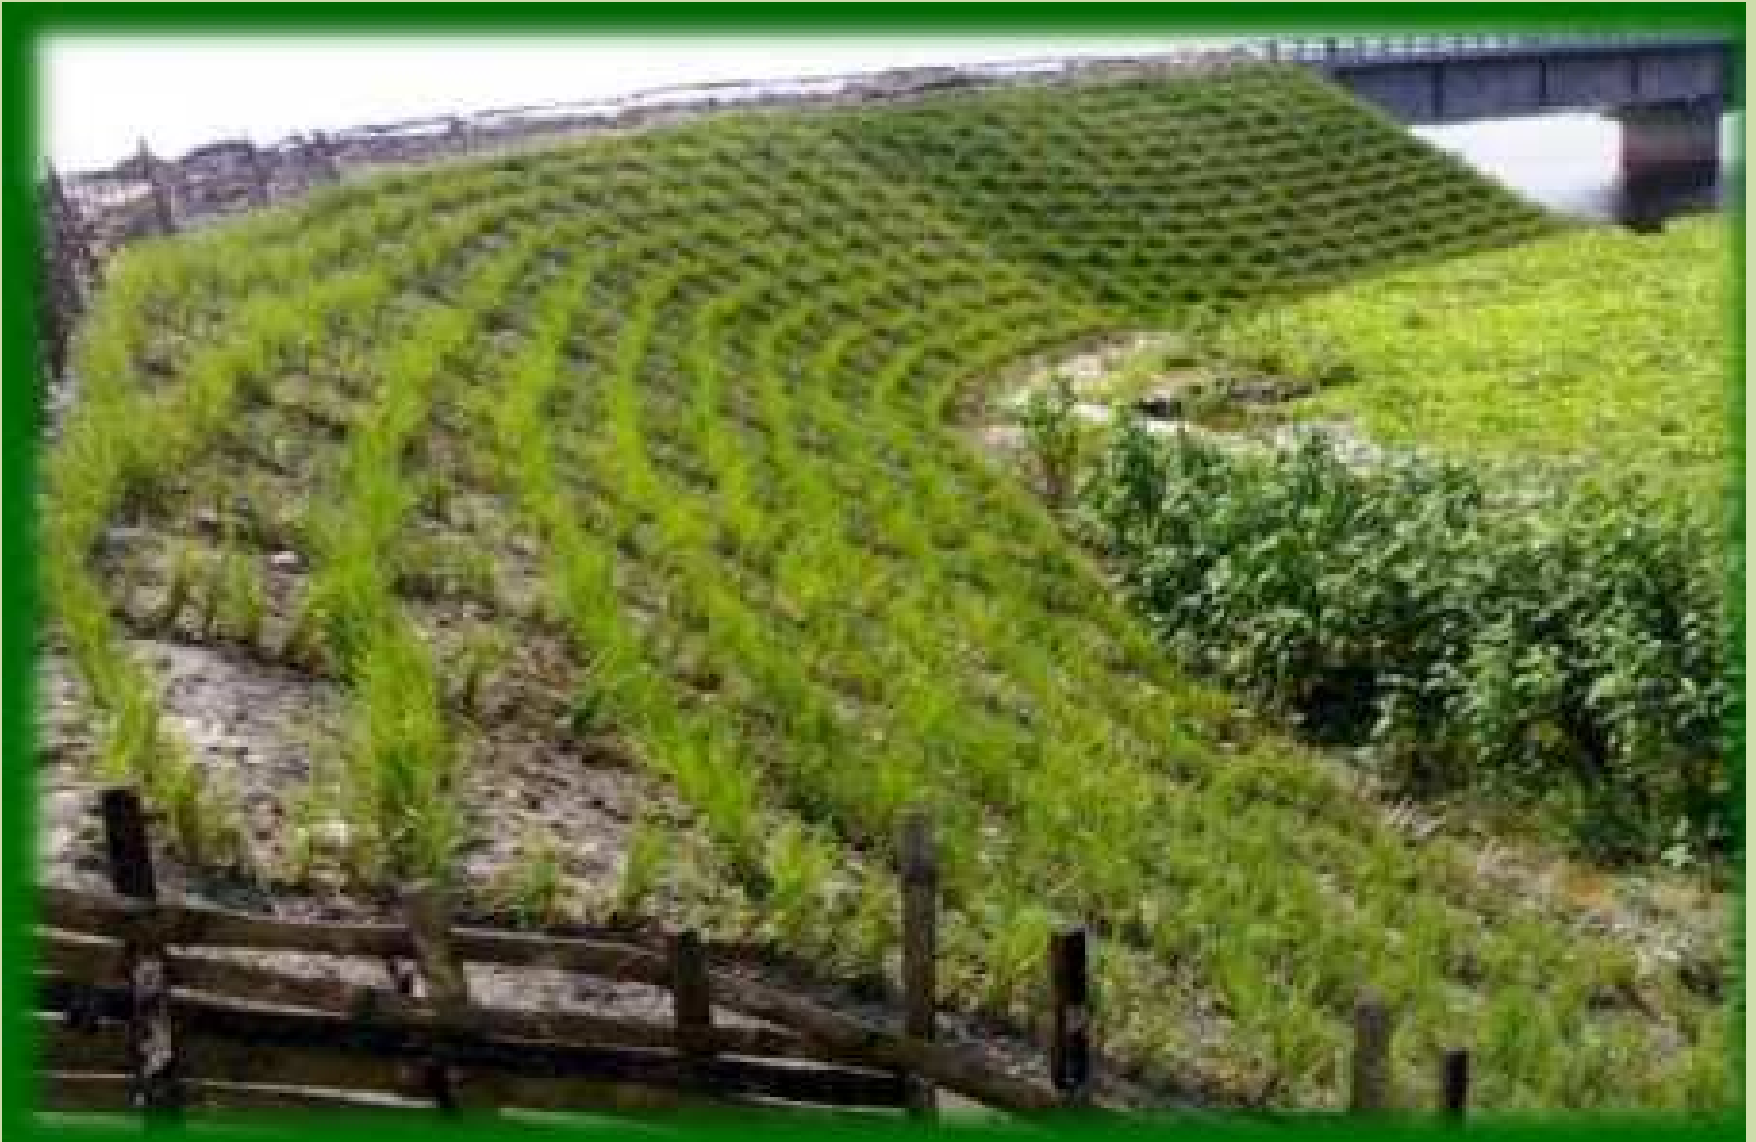
Two months after planting

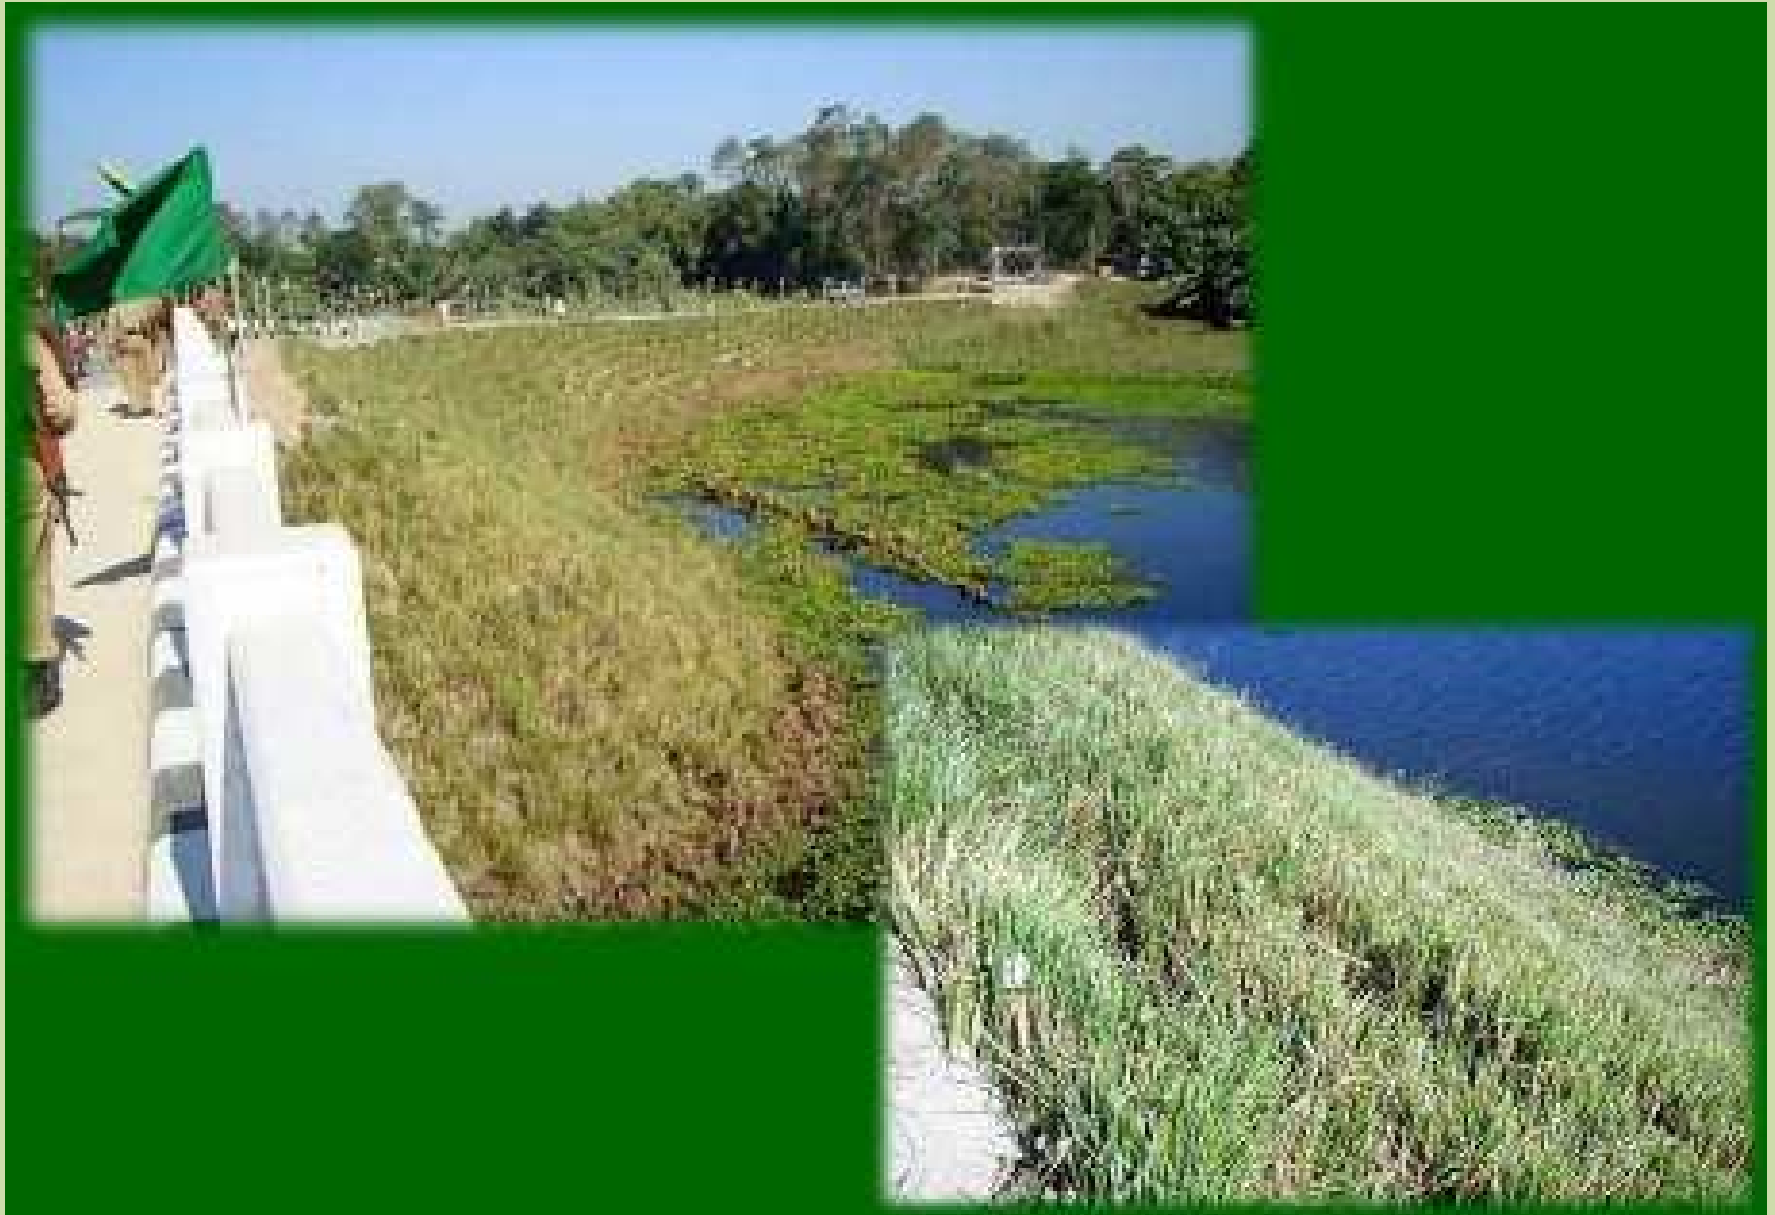
Two years after planting

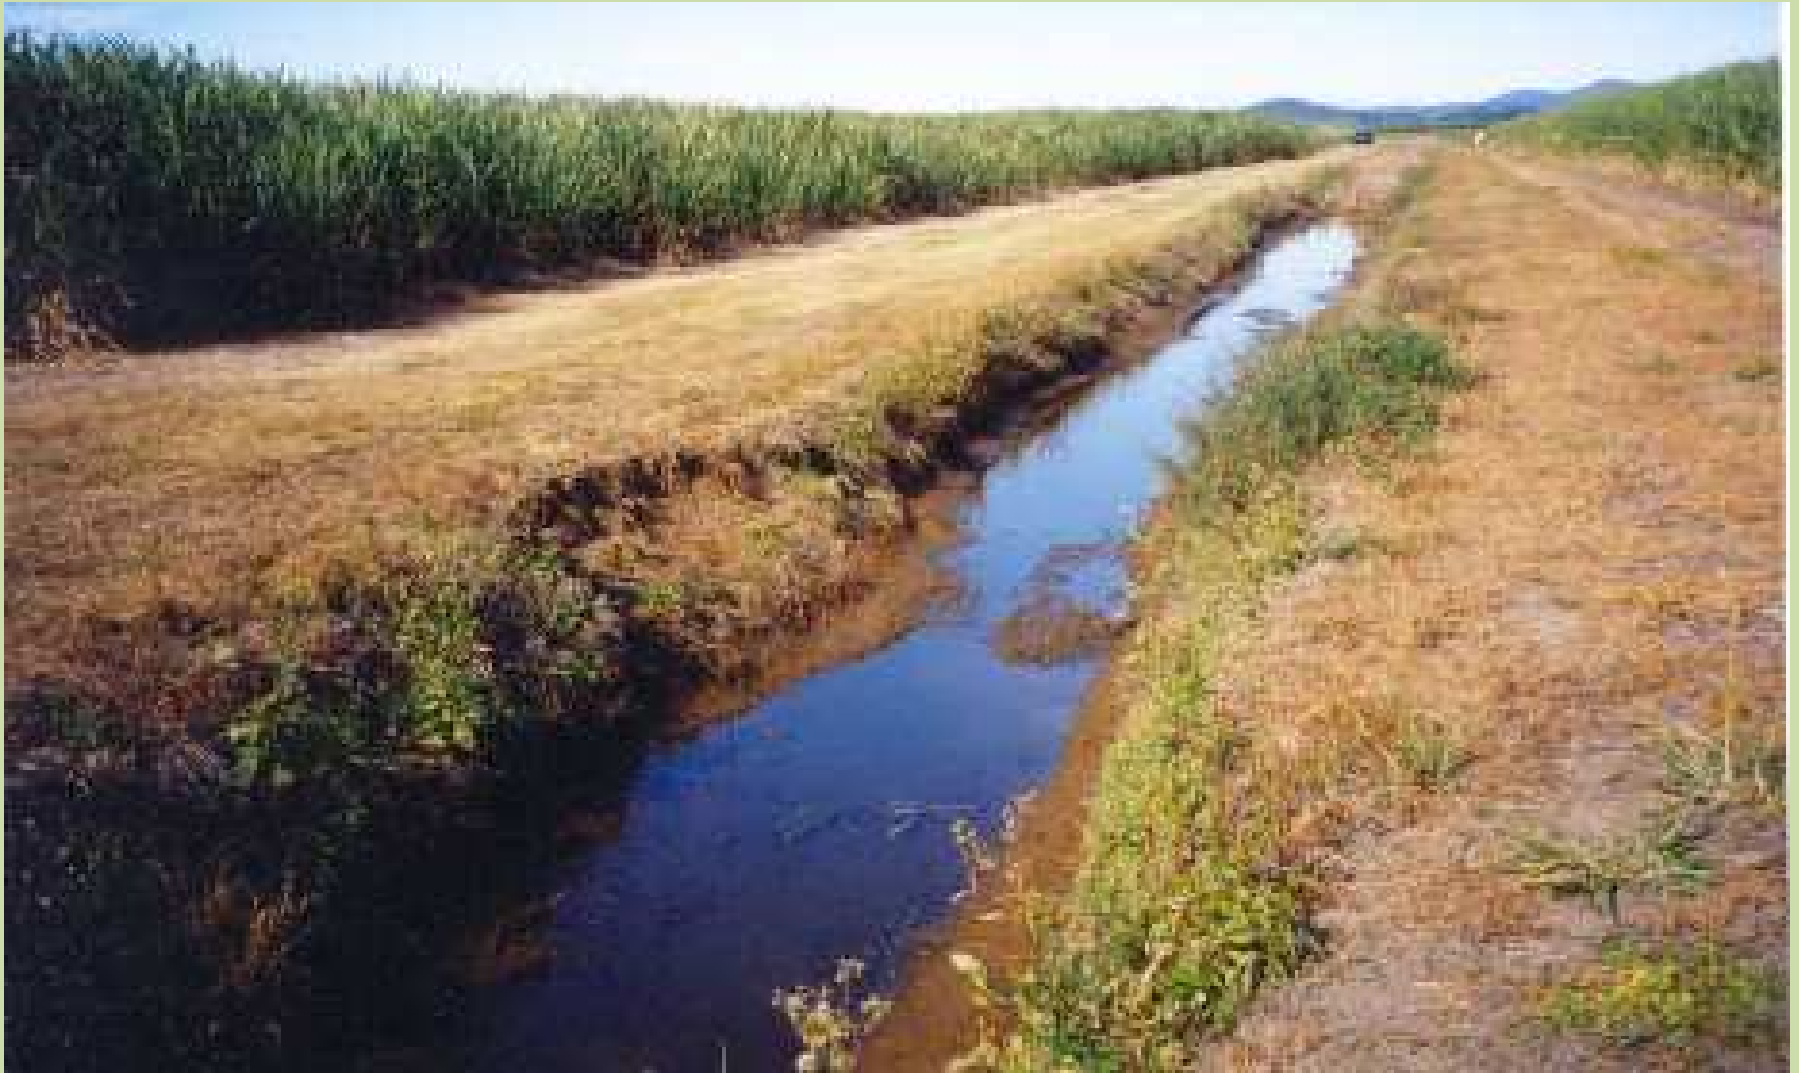
Australia - Badly eroded drainage channel on acidic sulfate

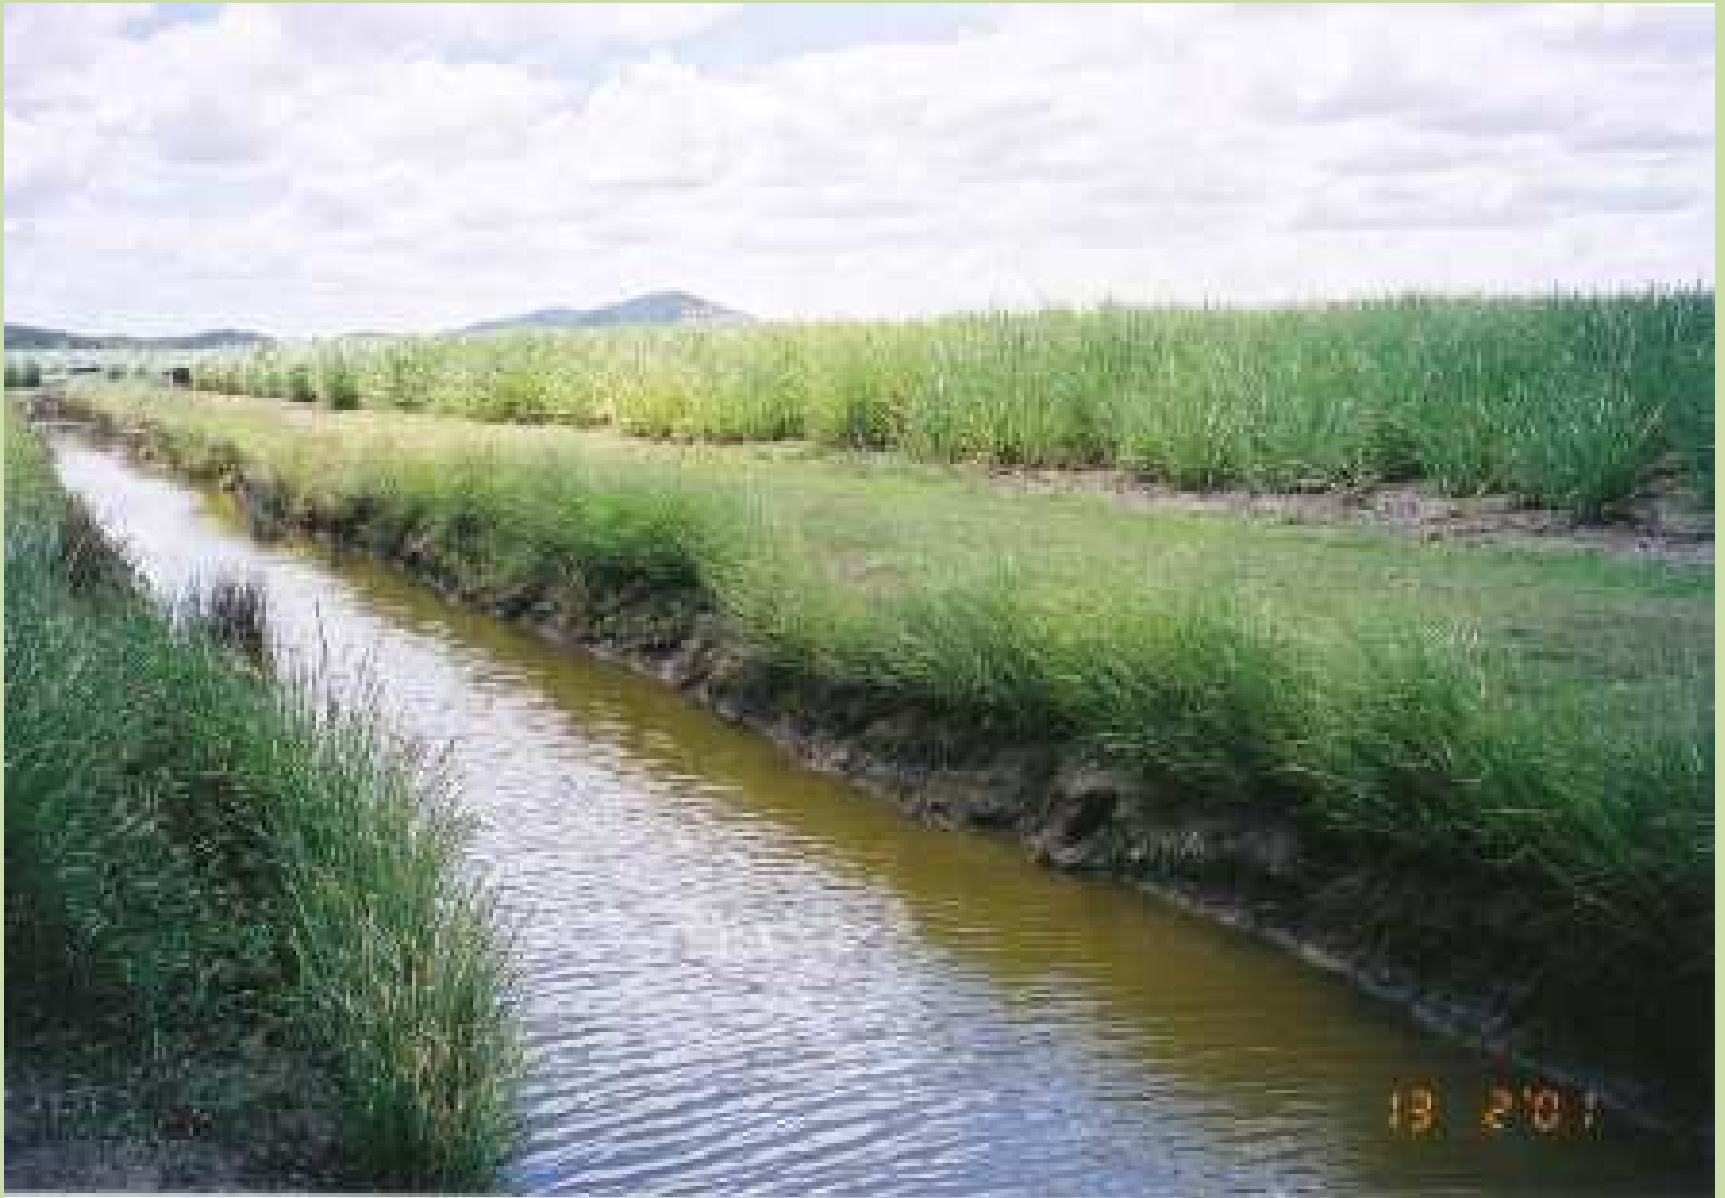
Australia - Four months after planting

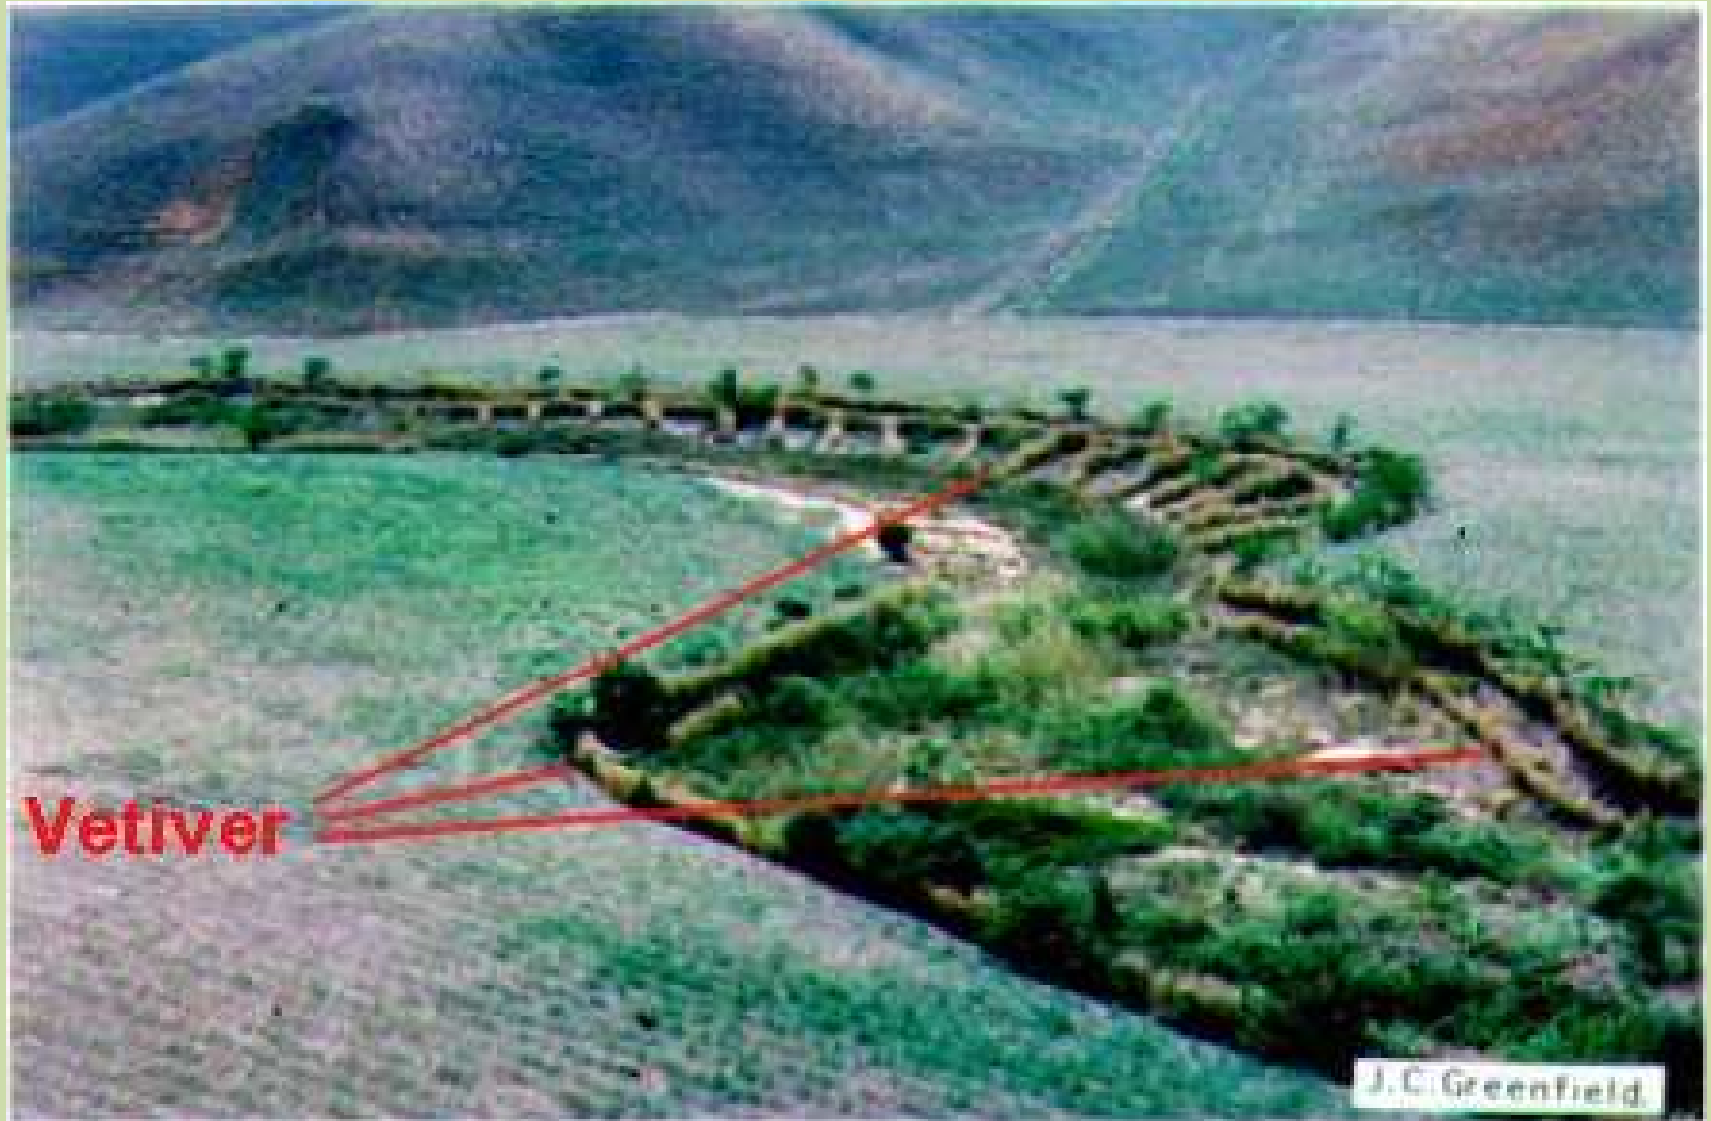
South Africa: A very well layout provided complete protection against erosion
