Ground Truthing Satellite Imagery

With the introduction of the International Vetiver Grass Tracking System it is important that the input of vetiver site locations are accurately entered and that where satellite imagery is of good resolution that sites actually point to vetiver on the ground. If done properly it should then be possible to extrapolate and identify vetiver in the vicinity – particularly important where many small growers are involved in these adjacent areas.

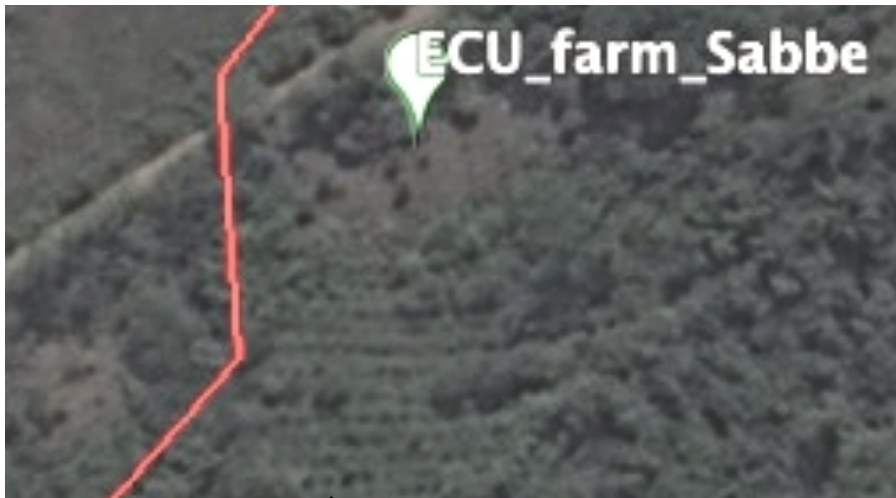
Ecuador – hill side vetiver planted for erosion control

Satellite imagery a few years after planting hedgerows visible.

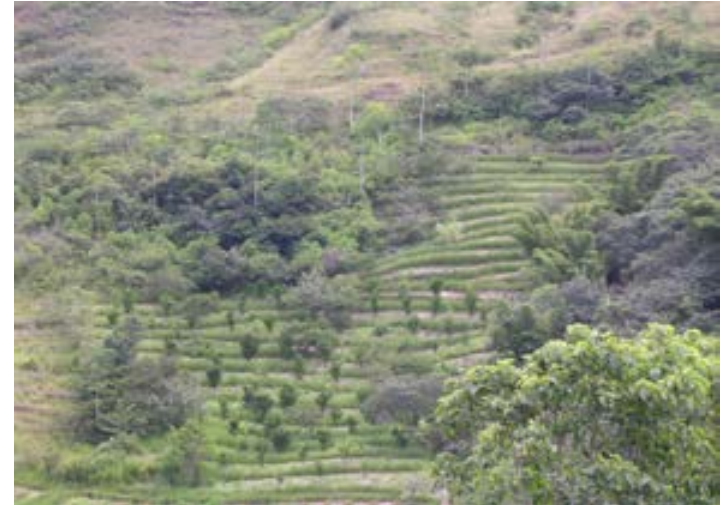
Low level aerial photography of same site with vetiver hedgerows clearly shown

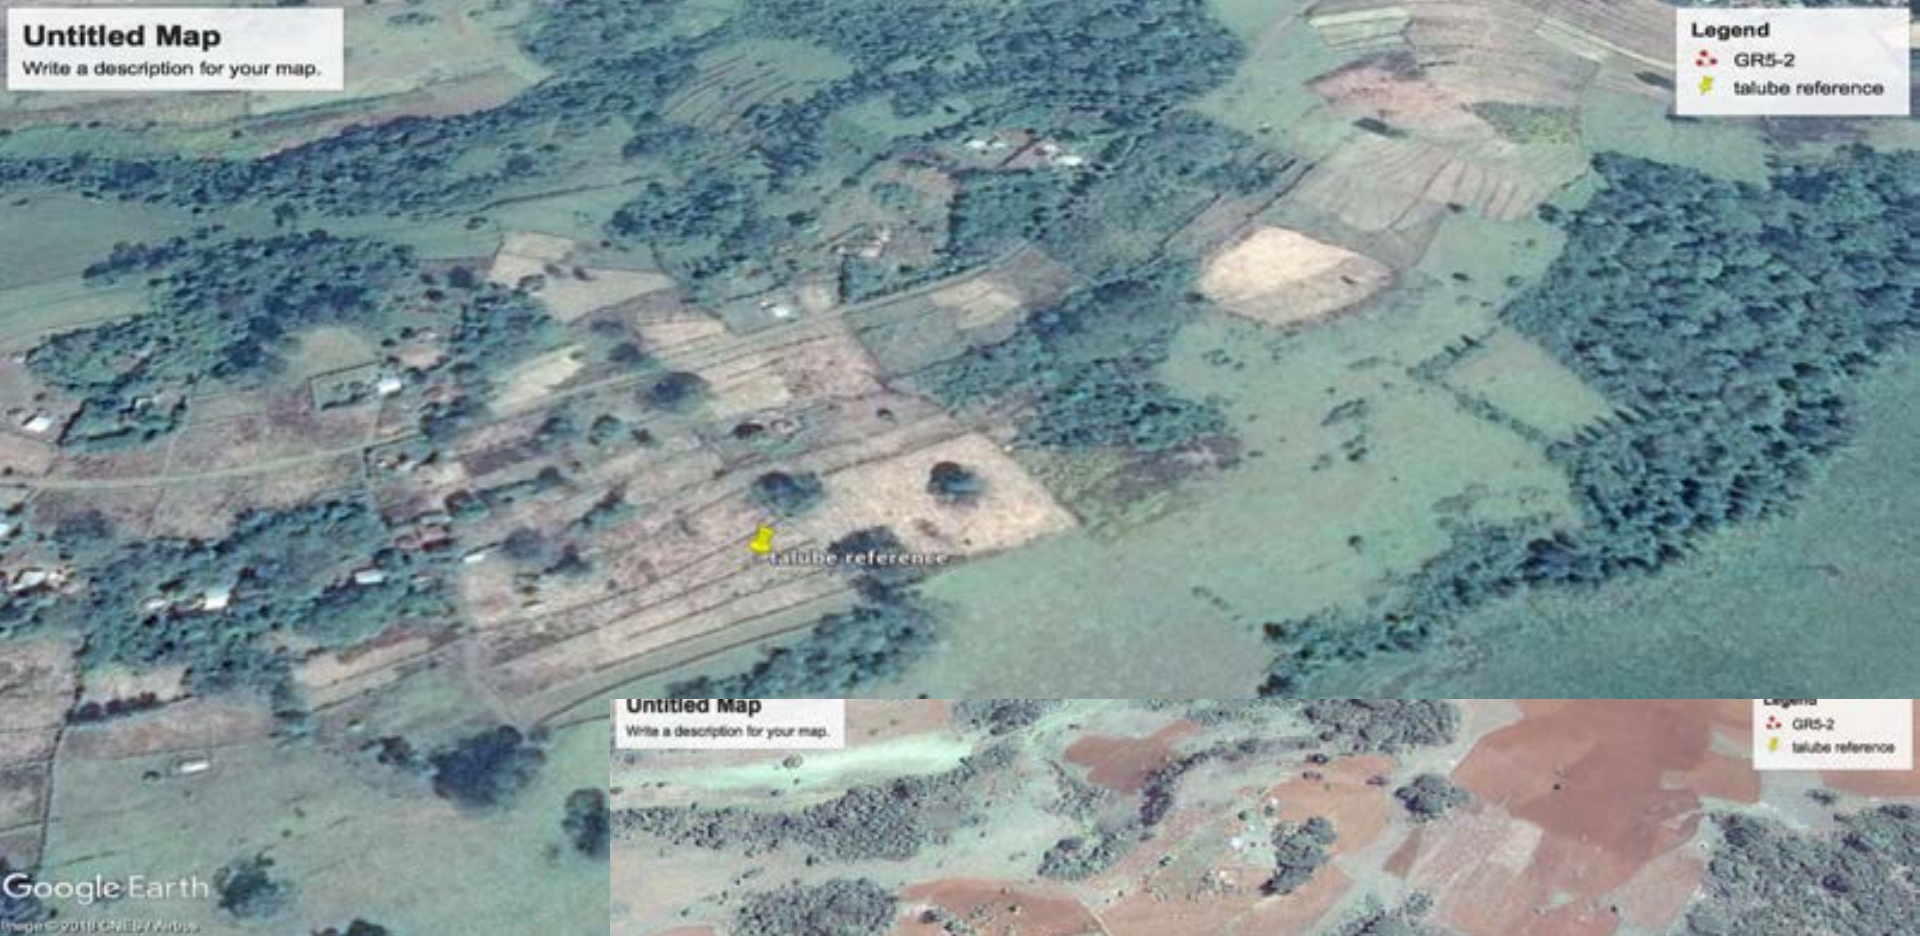
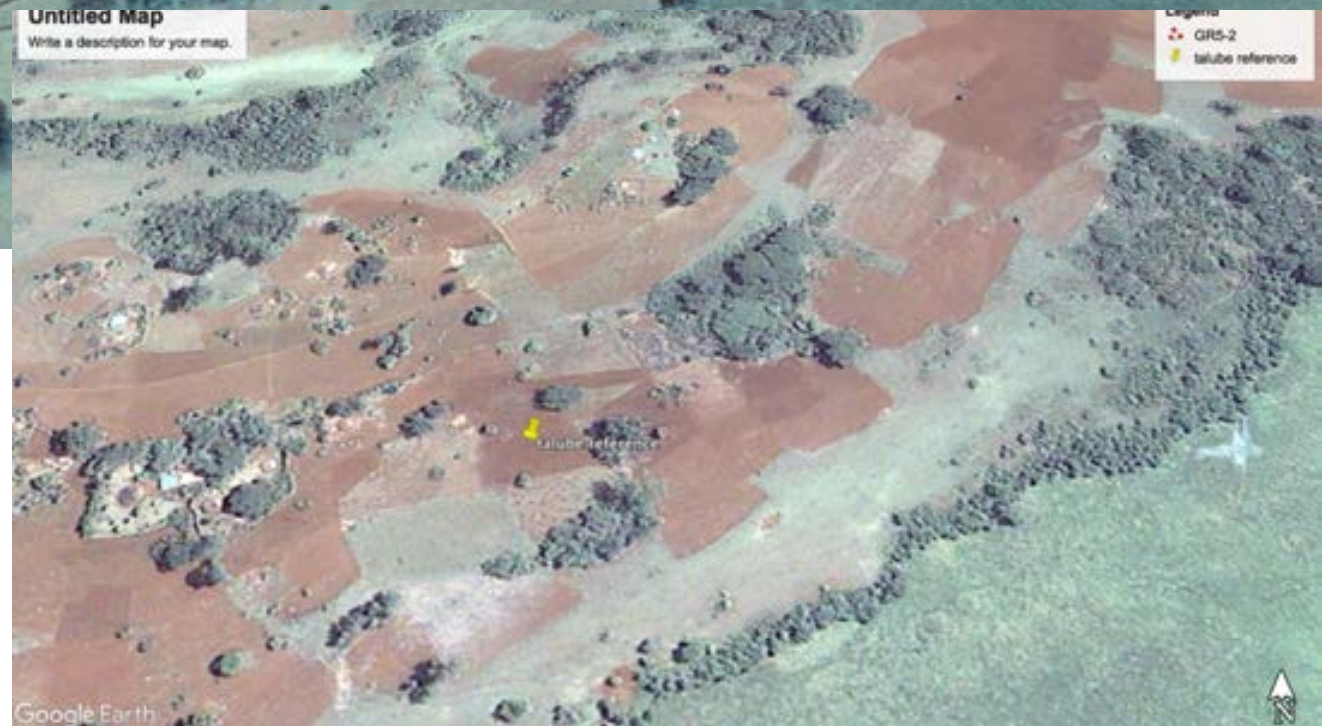
Ethiopia: Talube area
Smallholder farms
Right: 2002: no vetiver
hedgerows.
Above: 2015: with vetiver
hedgerows - ground
truthed and clearly visible

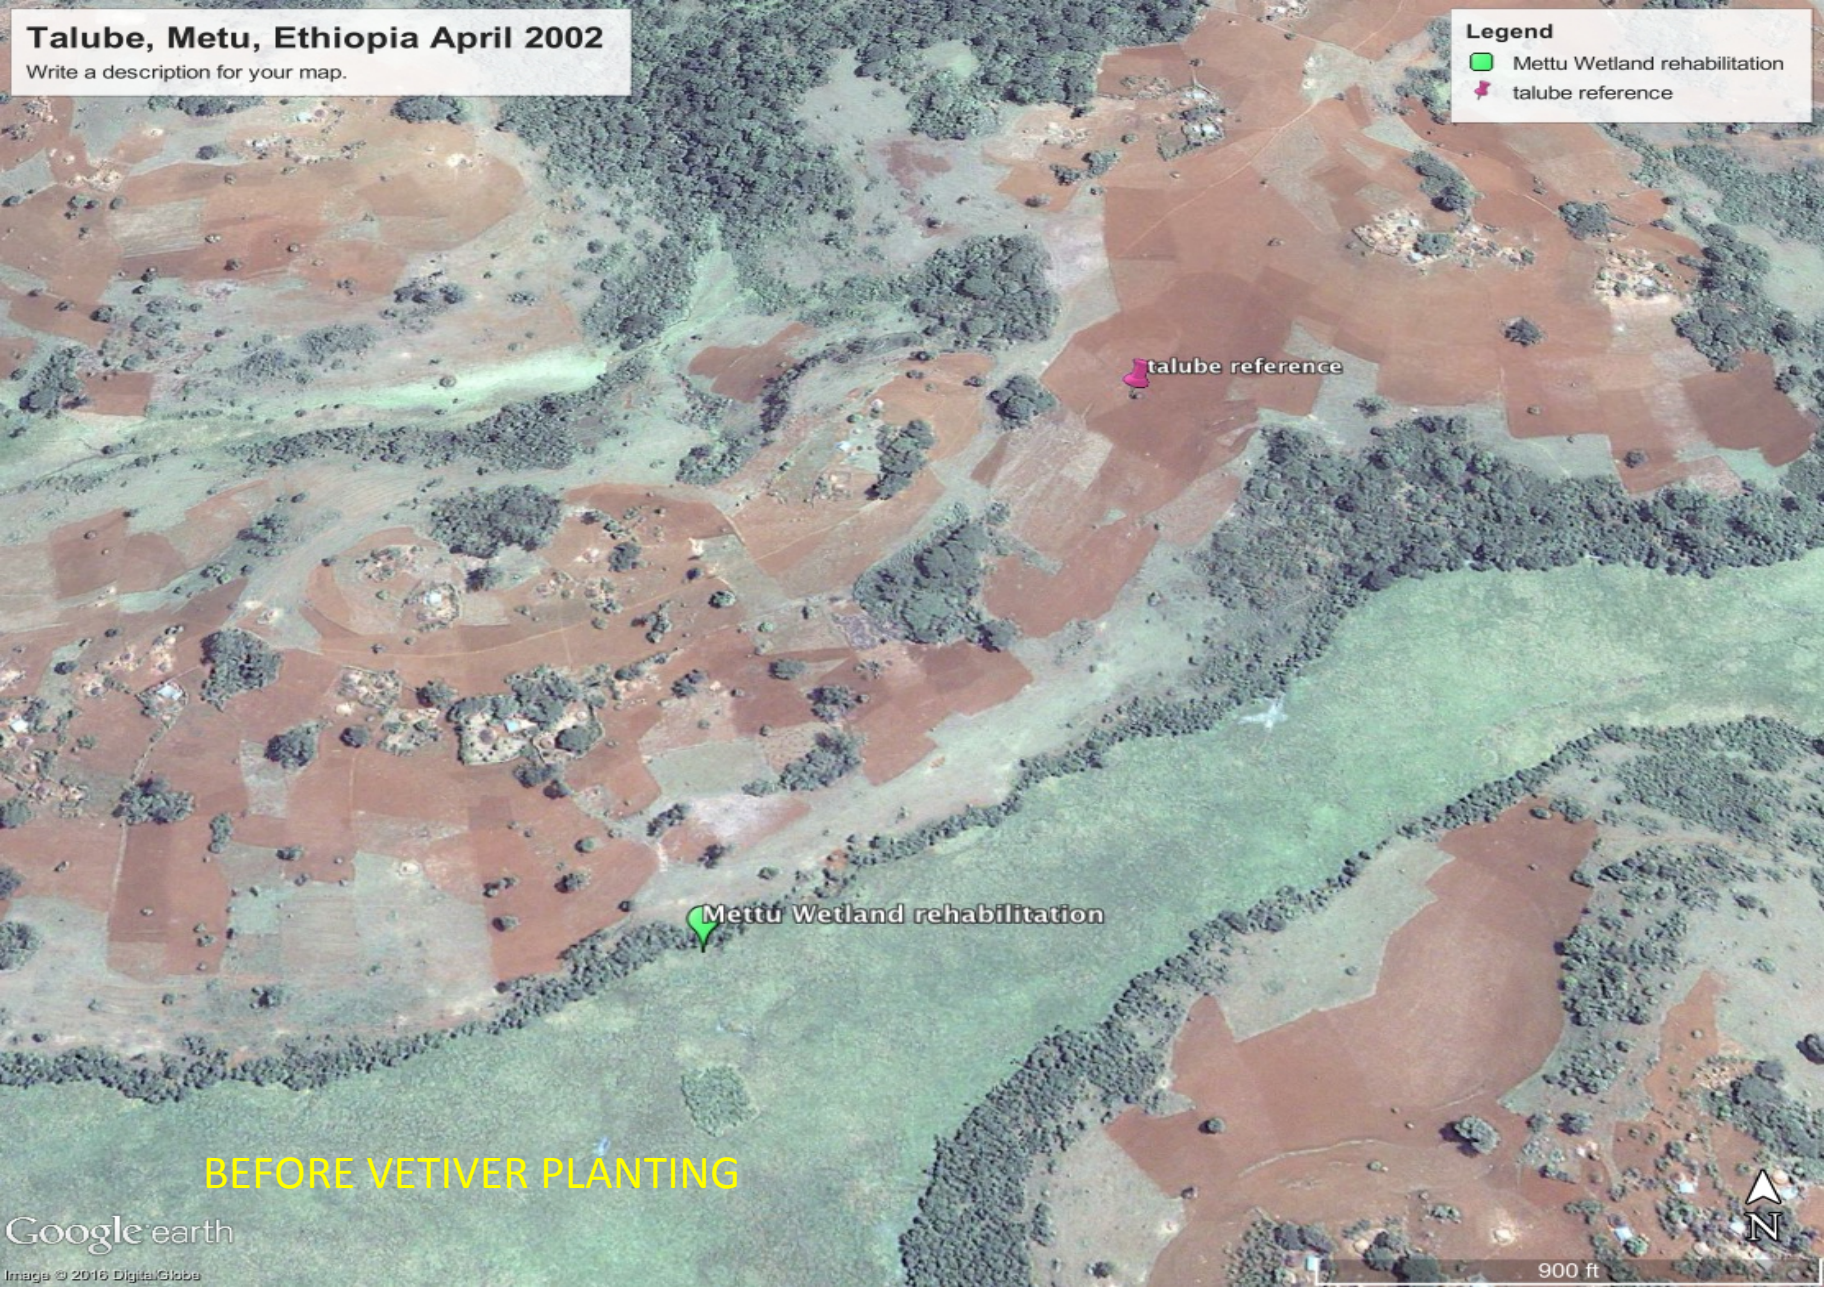
BEFORE VETIVER PLANTING

- Mettu Wetland rehabilitation
- talube reference

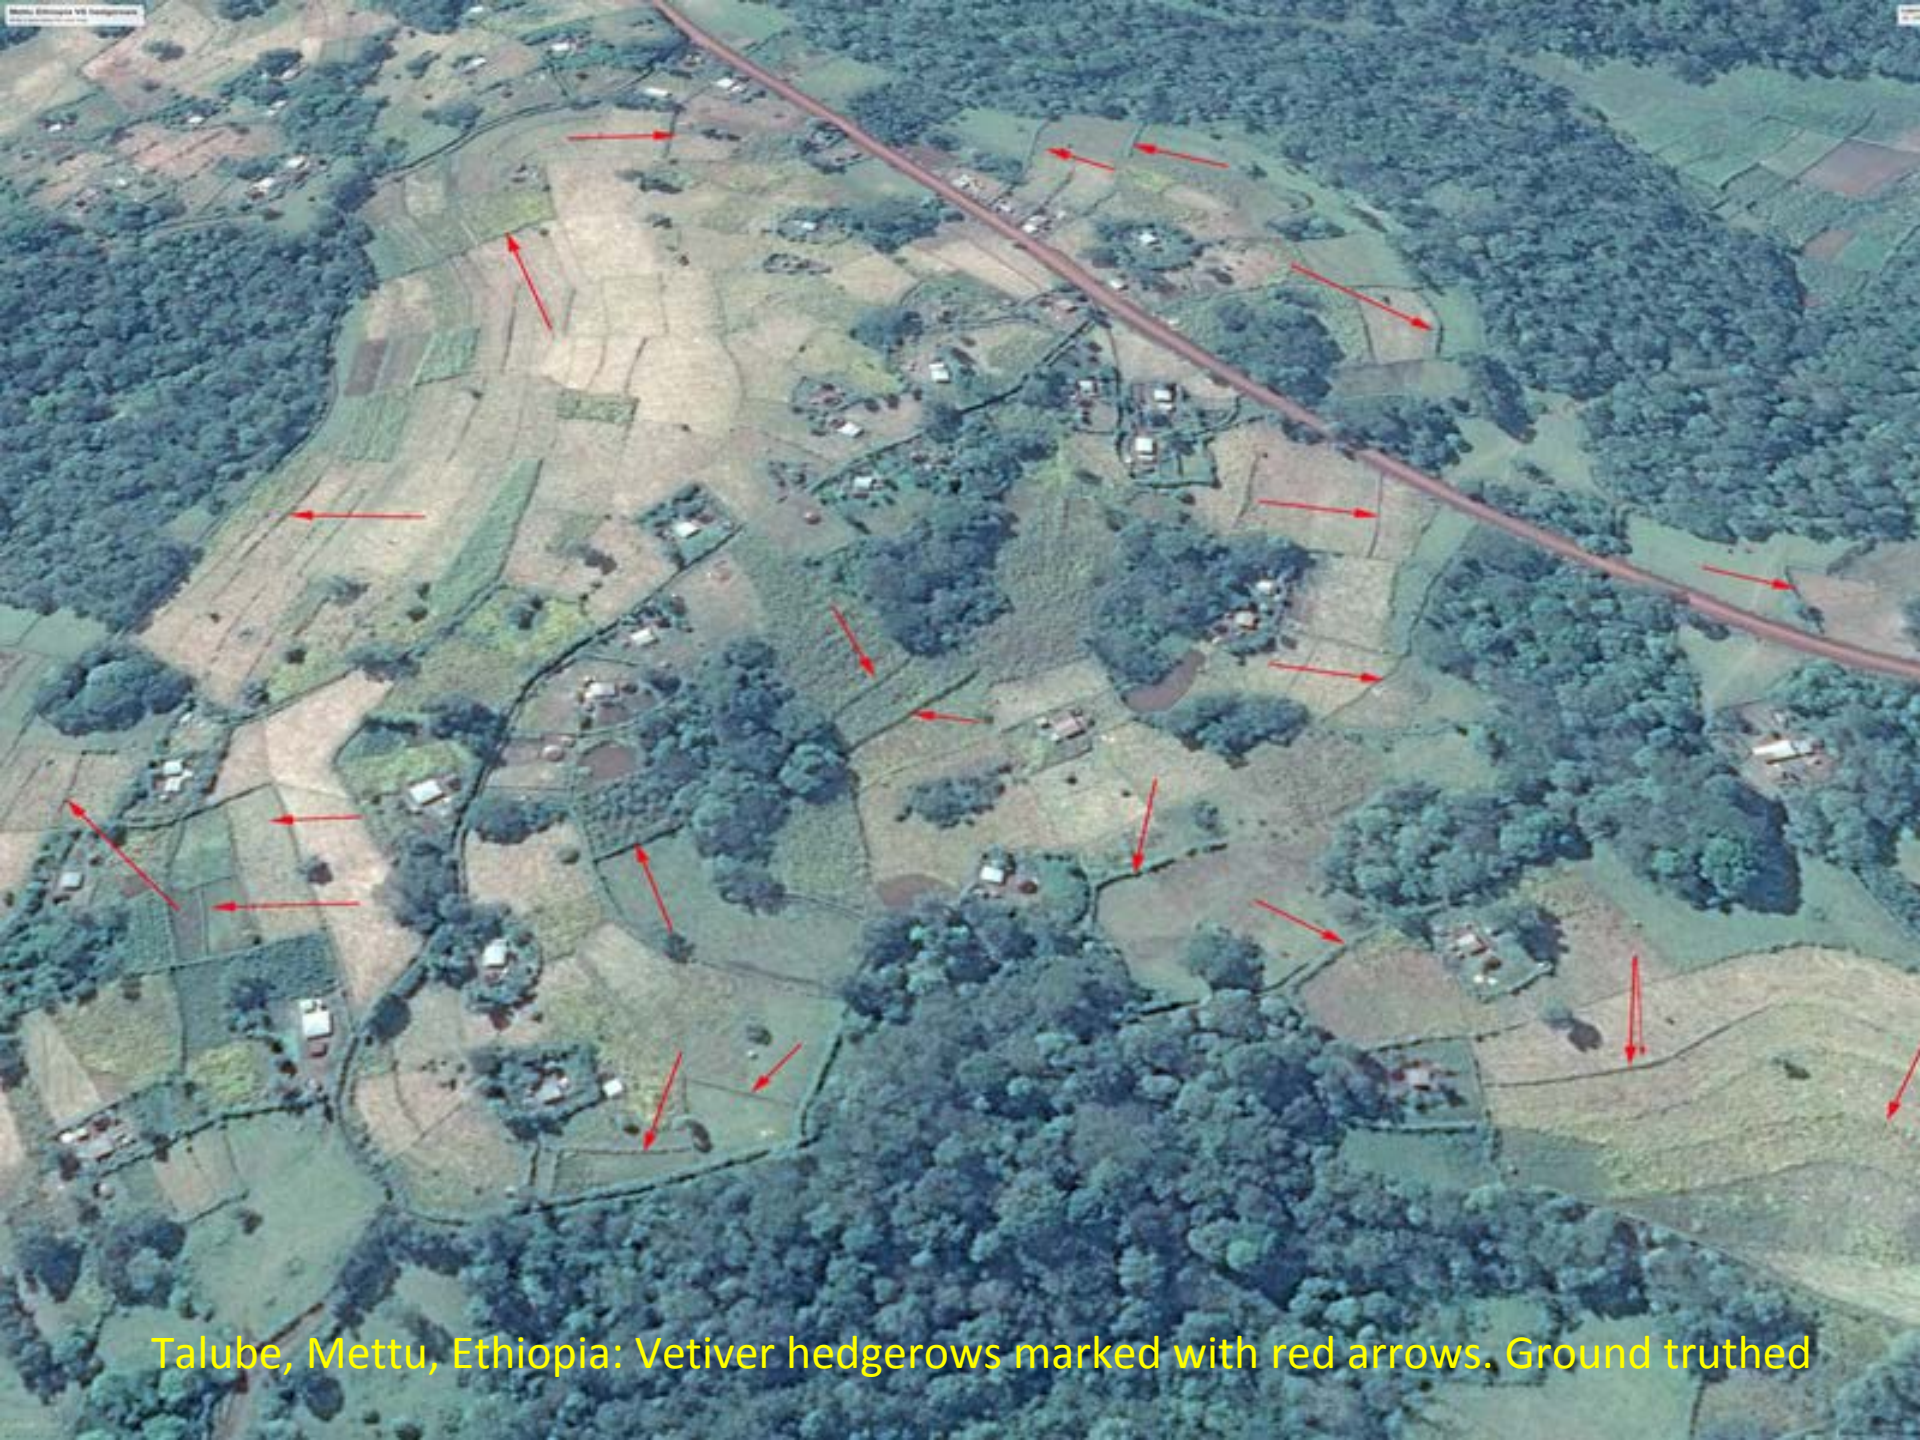
Talube, Mettu, Ethiopia: Vetiver hedgerows marked with red arrows. Ground truthed

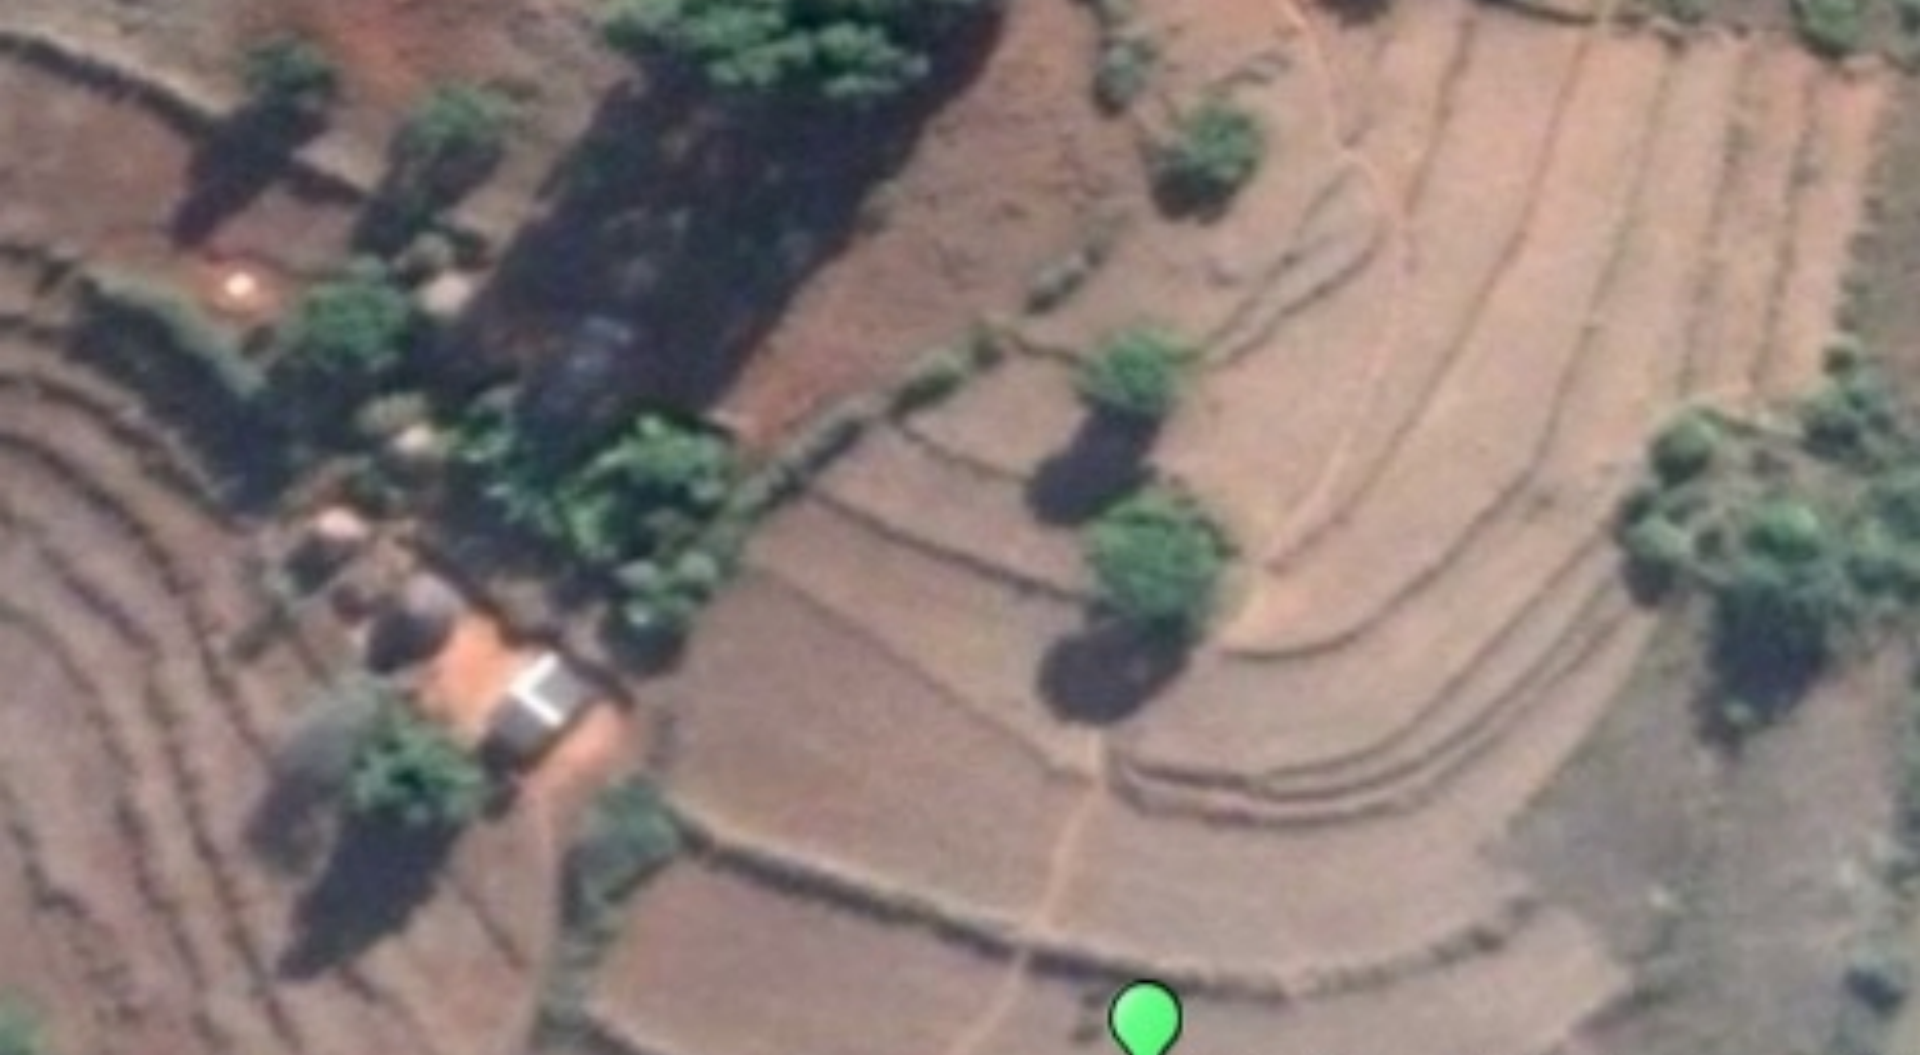
Chikukwa, Zimbabwe; Vetiver hedgerows on small farms in dry season

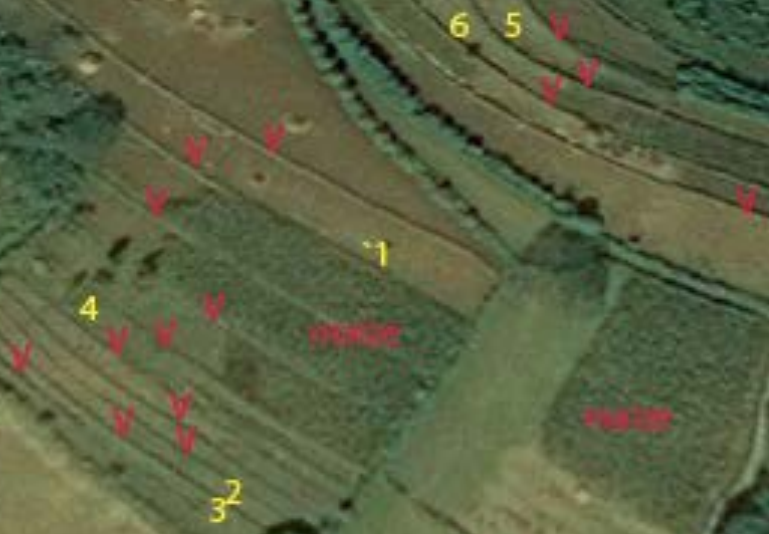
Gore Ethiopia: Ground truthed vetiver hedgerows on small farm. Vetiver Hedgerows clearly visible marked 'V'.

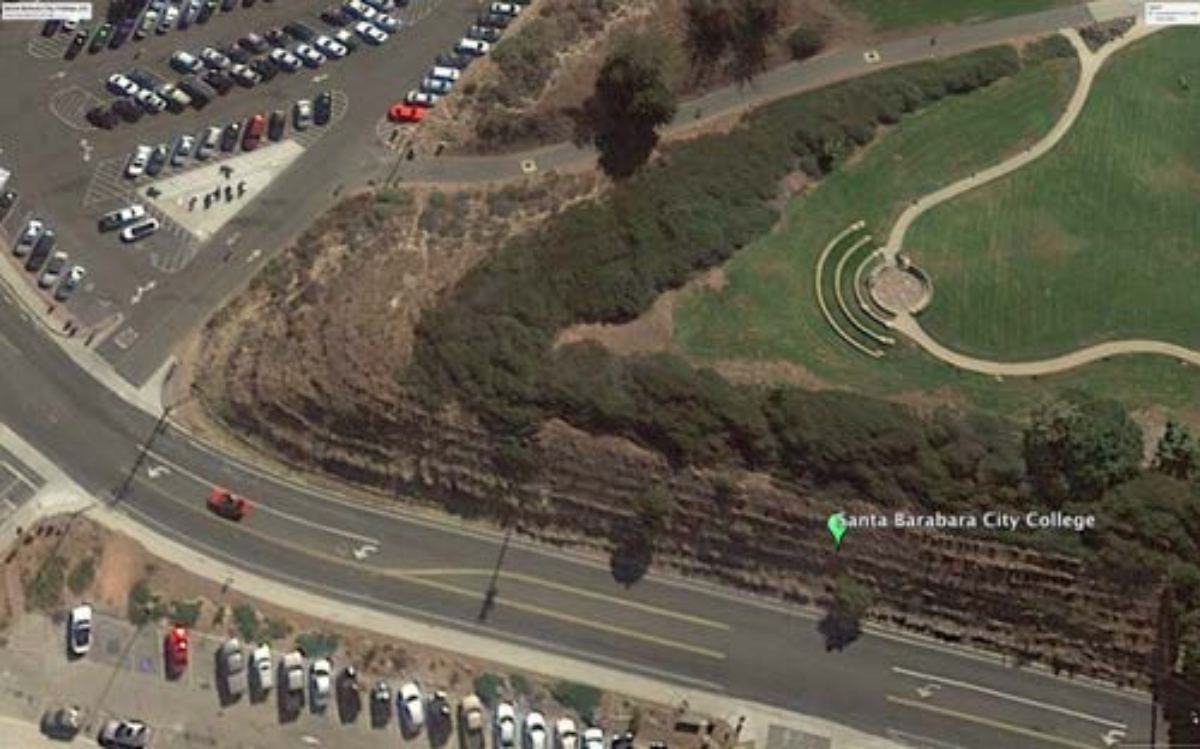
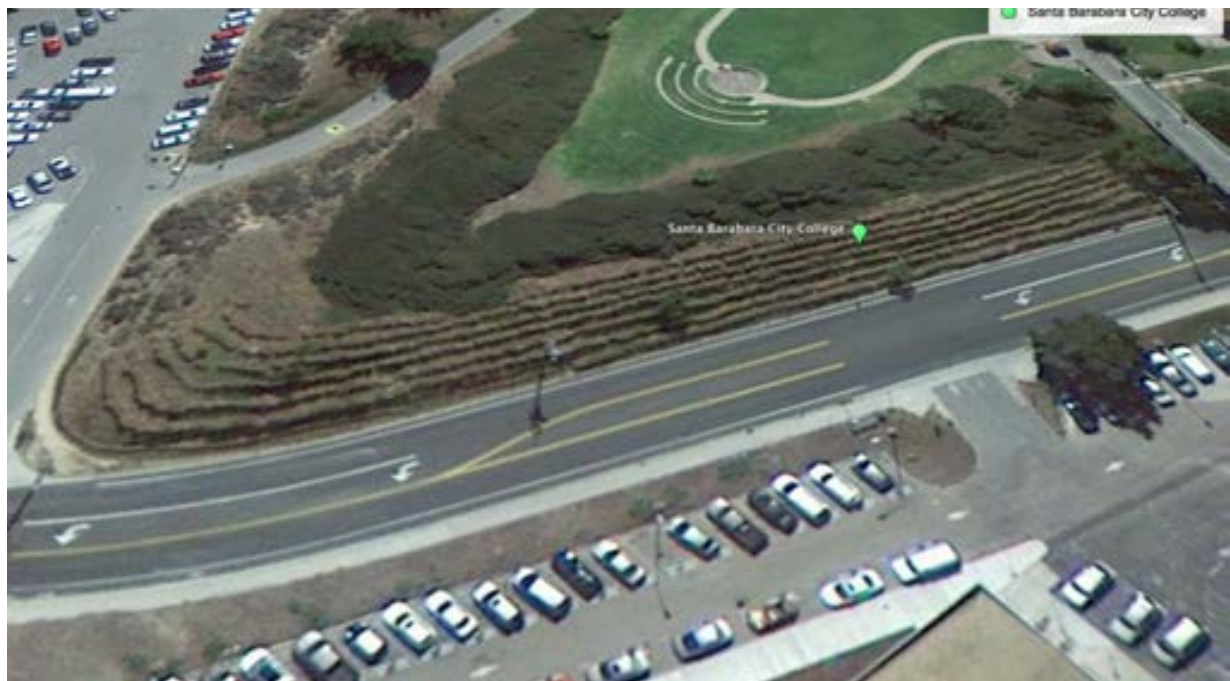
Santa Barbara, CA – USA
Highway cut - vetiver planted
in 2004 shown in 2006
imagery (above) and 2016
imagery at right

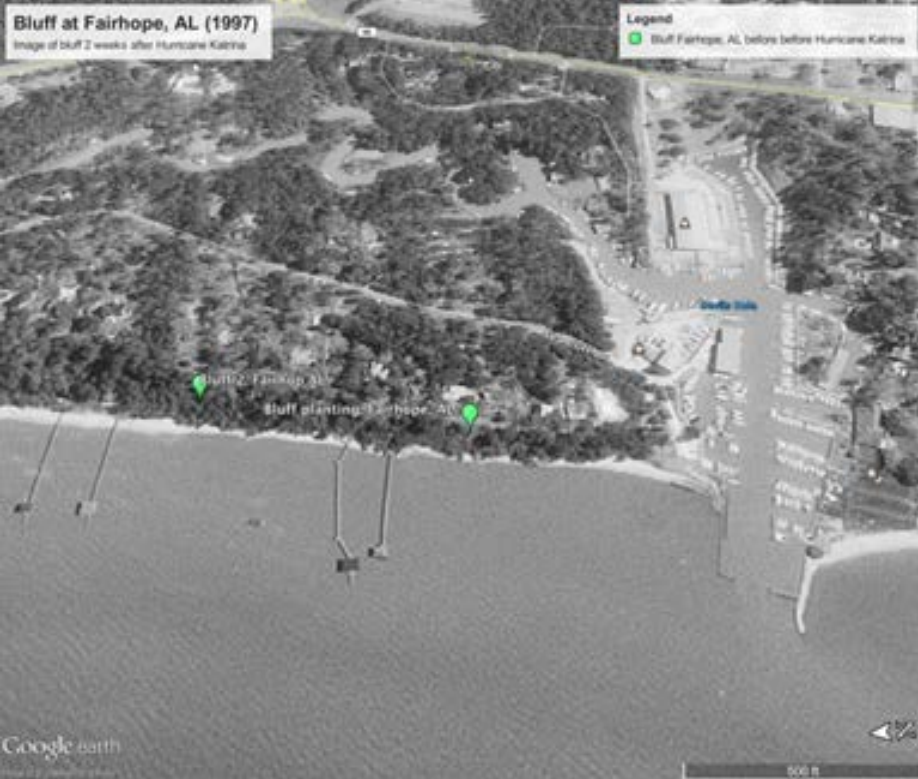
Fairhope Alabama, USA

Top left: shows a steep vegetated cliff (1997) before Hurricane Katrina.

Bottom right: the same cliff destroyed in 2004 by Hurricane Katrina. Note the green pin positions in both images

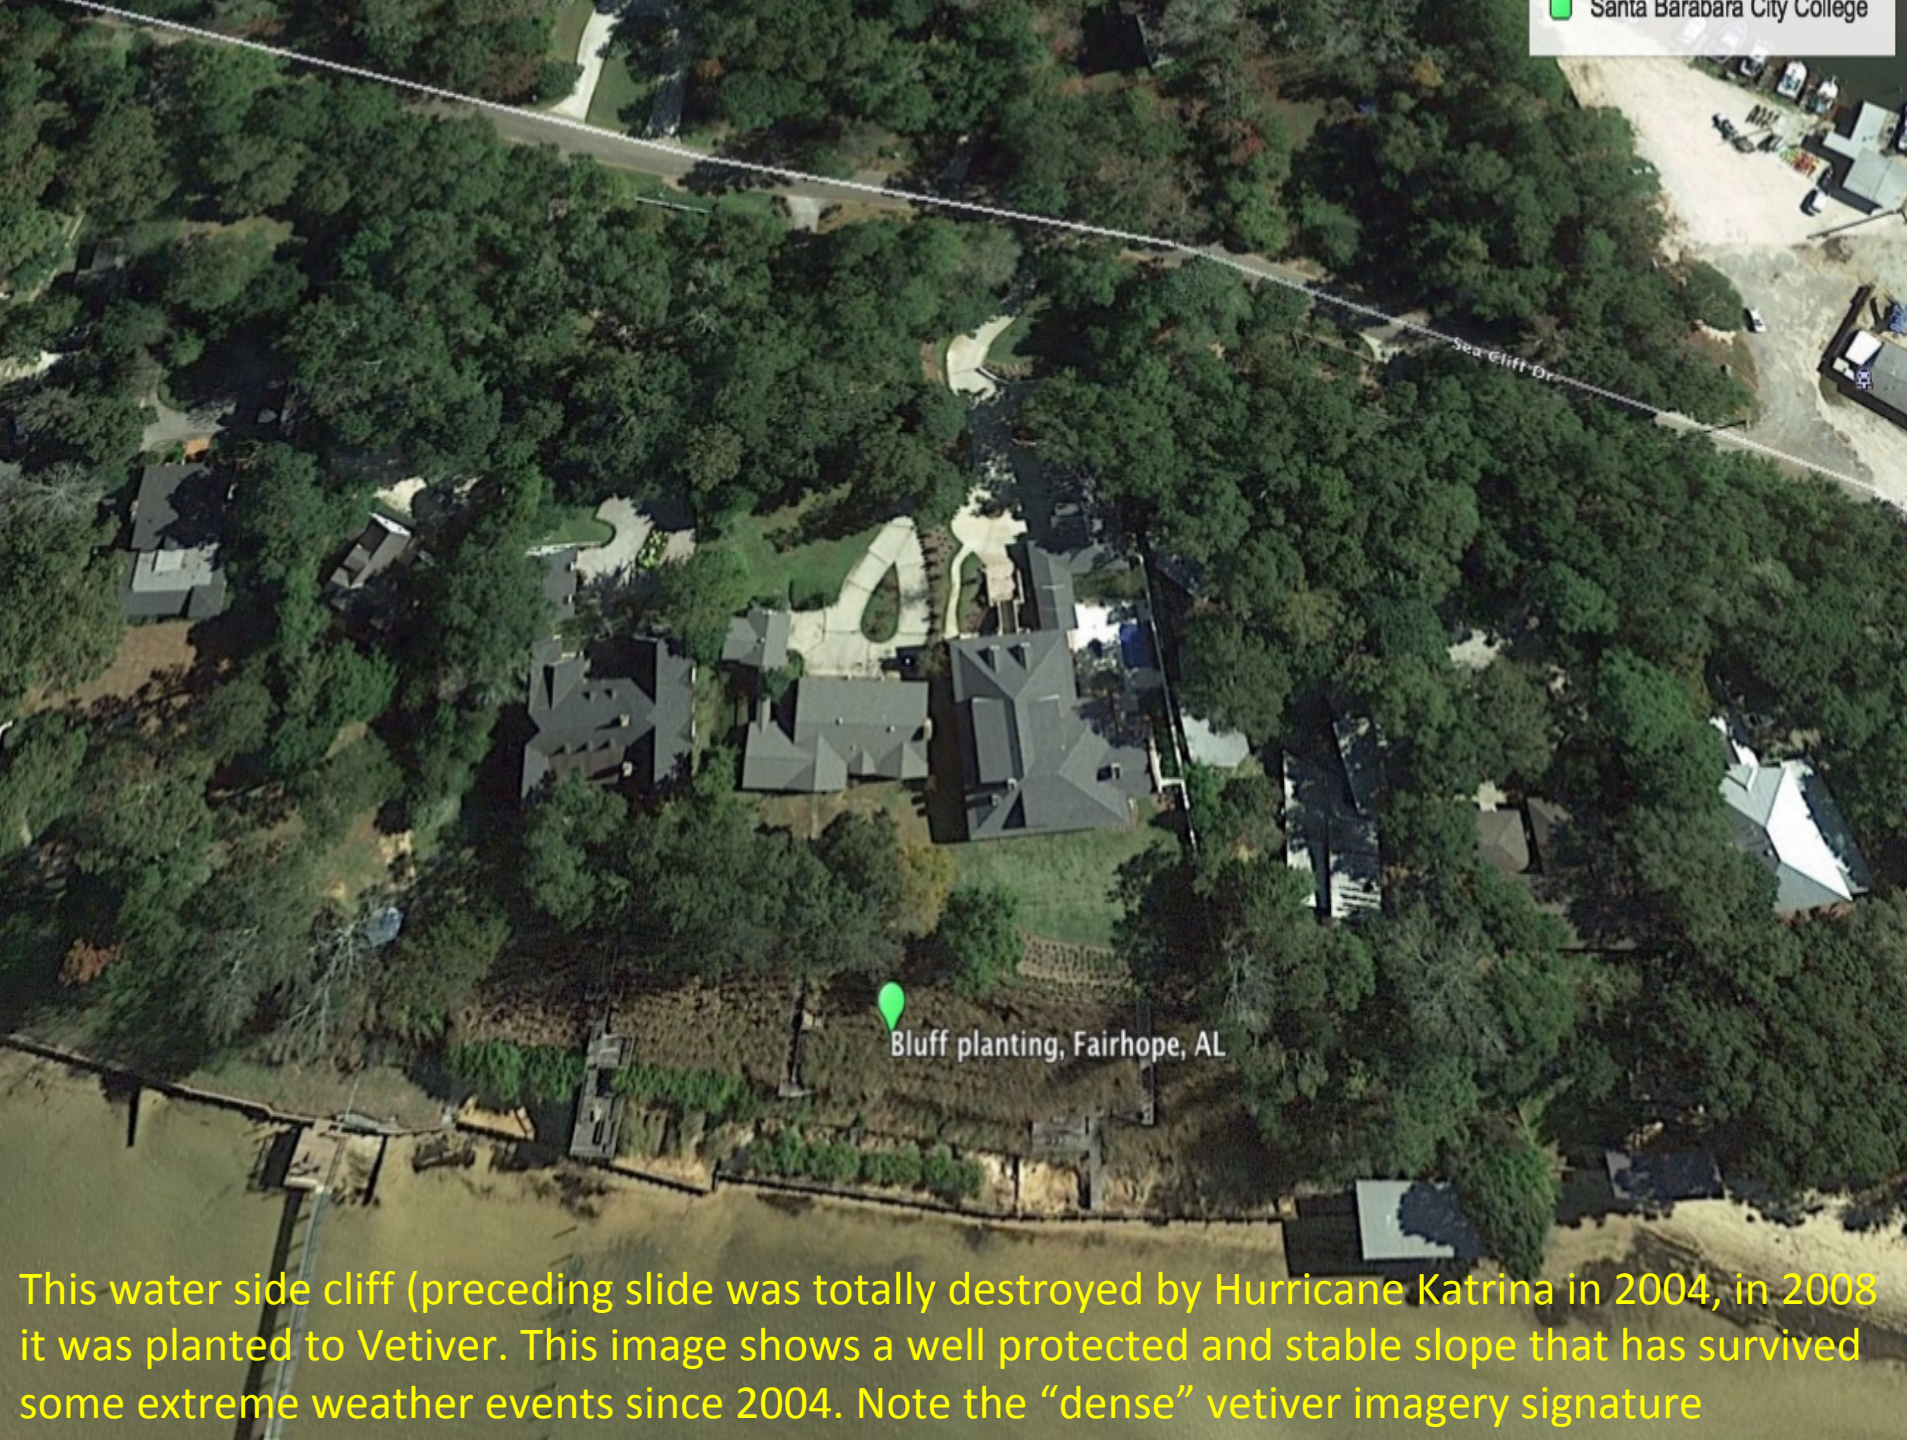
Bluff planting, Fairhope, AL

This water side cliff (preceding slide was totally destroyed by Hurricane Katrina in 2004, in 2008 it was planted to Vetiver. This image shows a well protected and stable slope that has survived some extreme weather events since 2004. Note the “dense” vetiver imagery signature

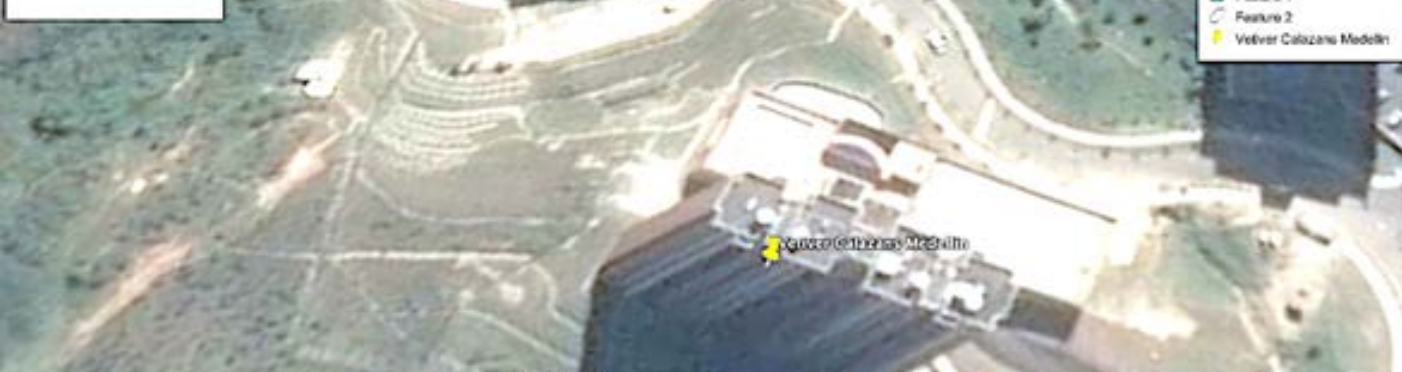
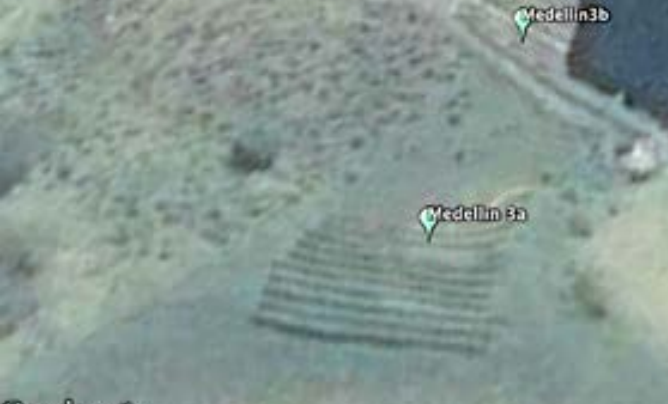
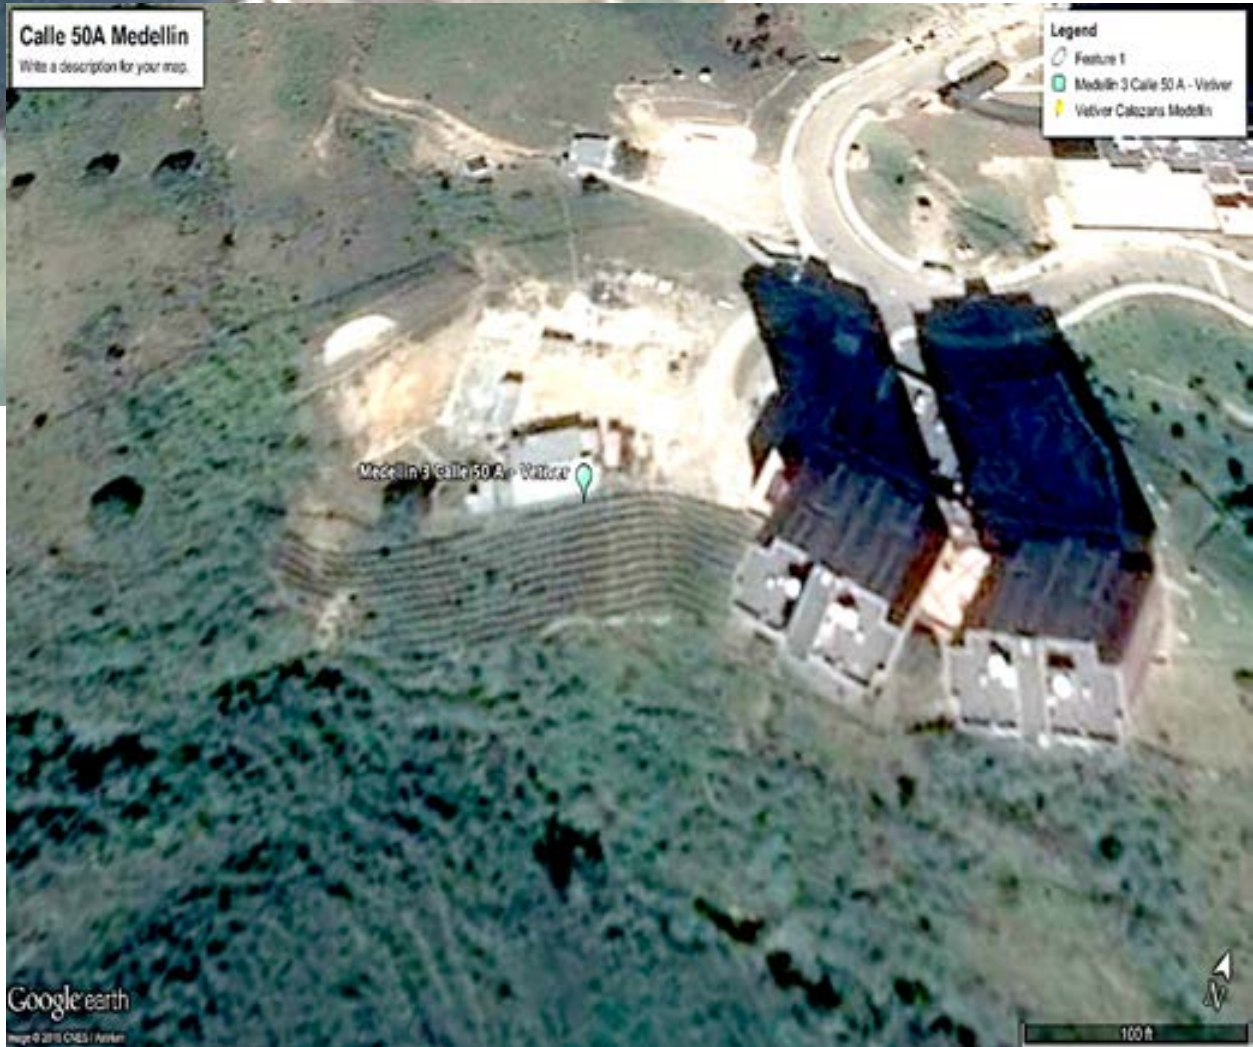
Medellin, Colombia.
Steep slope -
stabilization using
vetiver hedgerows.
Marked with green
pins. Hedges about 2
years old.

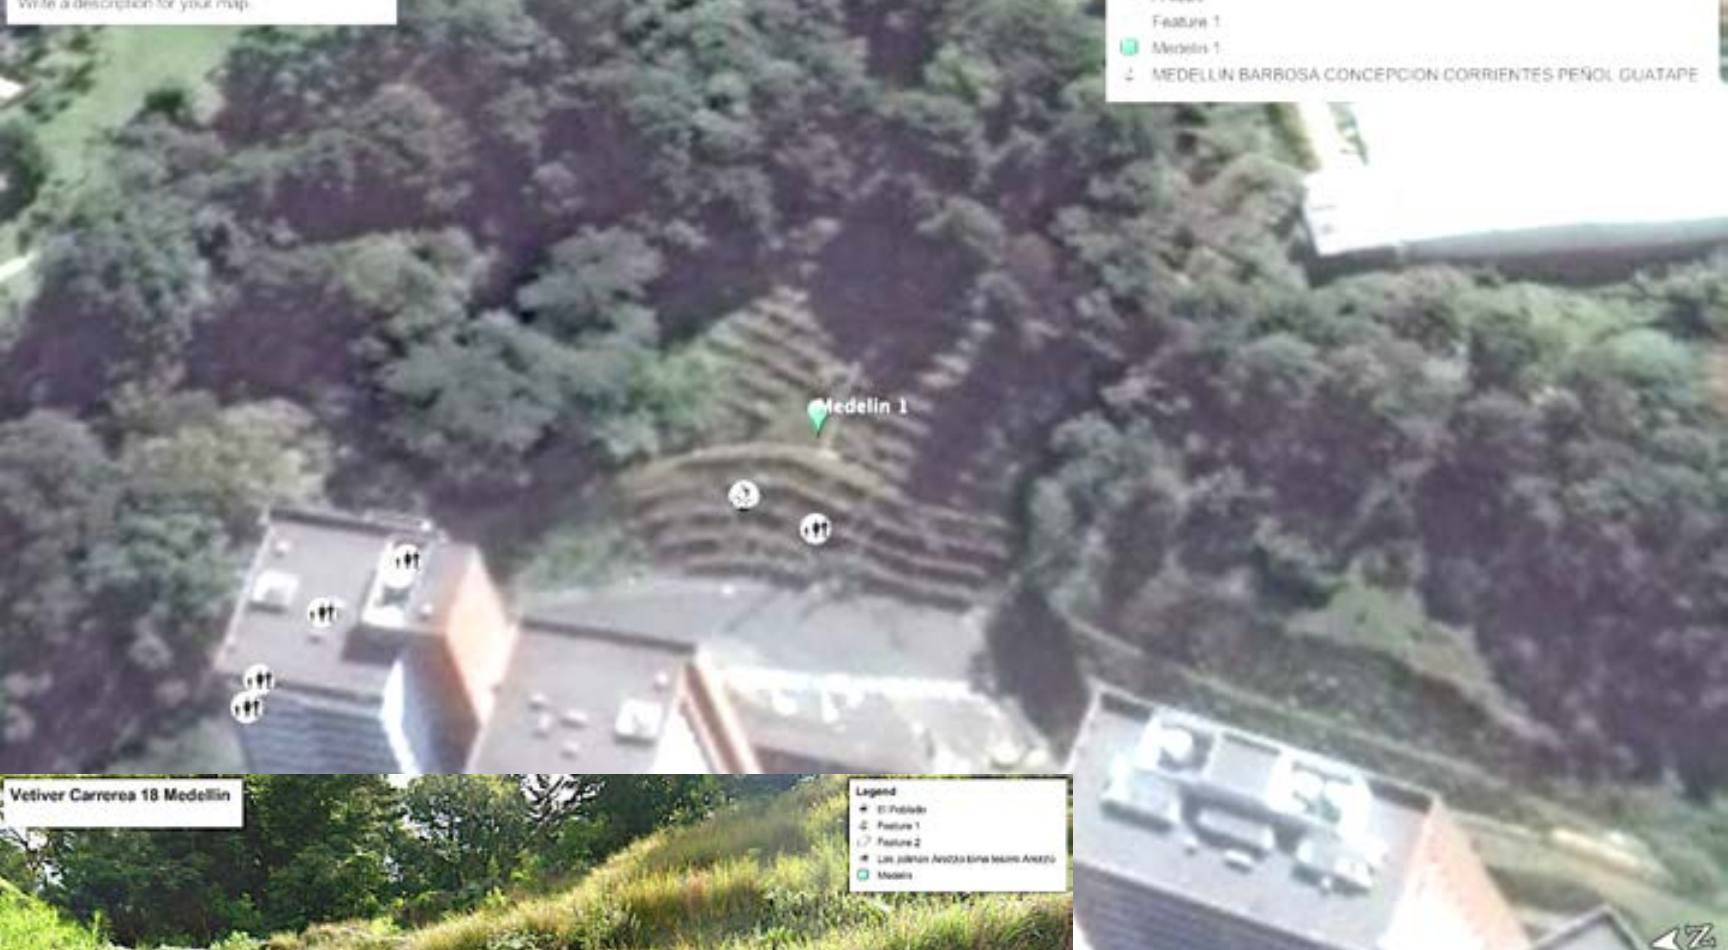
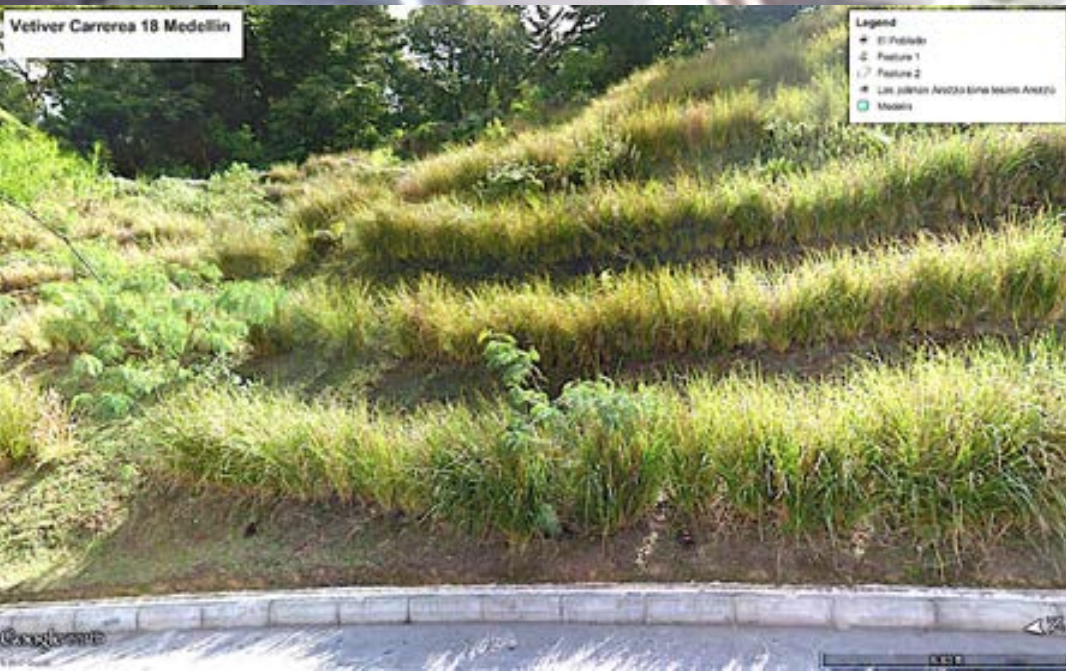
Medellin, Colombia – steep slope stabilization. Top satellite imagery (vetiver hedges at green pin). Bottom image” Google street view” of the same hedgerows

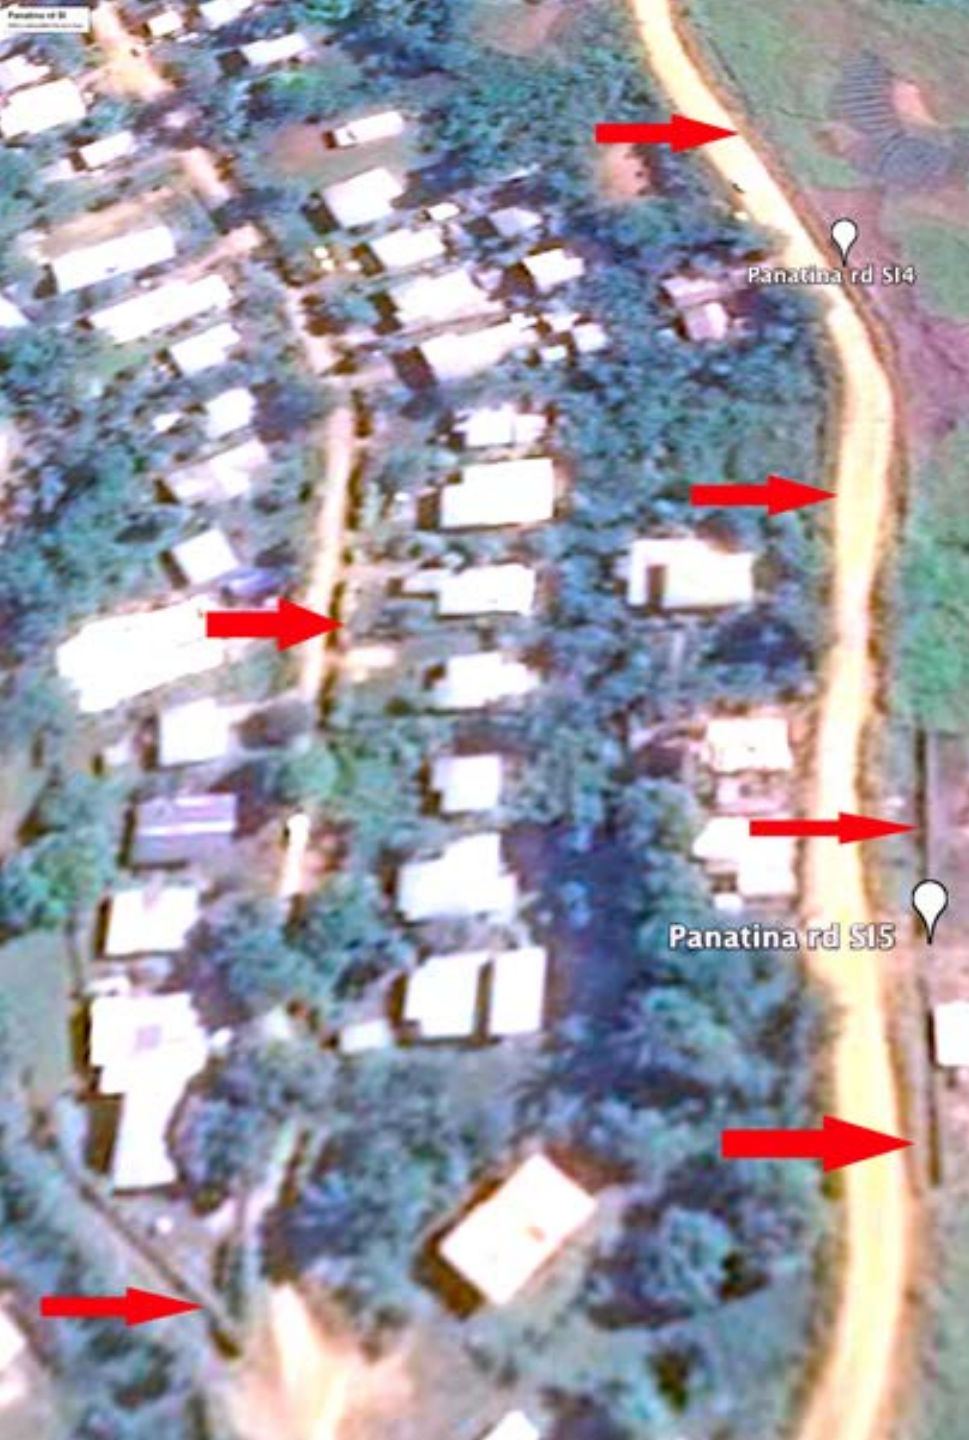
Honiara, Solomon Islands: Left image: arrows point to road side vetiver hedgerows. Right image is photo of typical road side vetiver hedge
