Ground Truthing Satellite Imagery

With the introduction of the International Vetiver Grass Tracking System it is important that the input of vetiver site locations are accurately entered and that where satellite imagery is of good resolution that sites actually point to vetiver on the ground. If done properly it should then be possible to extrapolate and identify vetiver in the vicinity – particularly important where many small growers are involved in these adjacent areas.

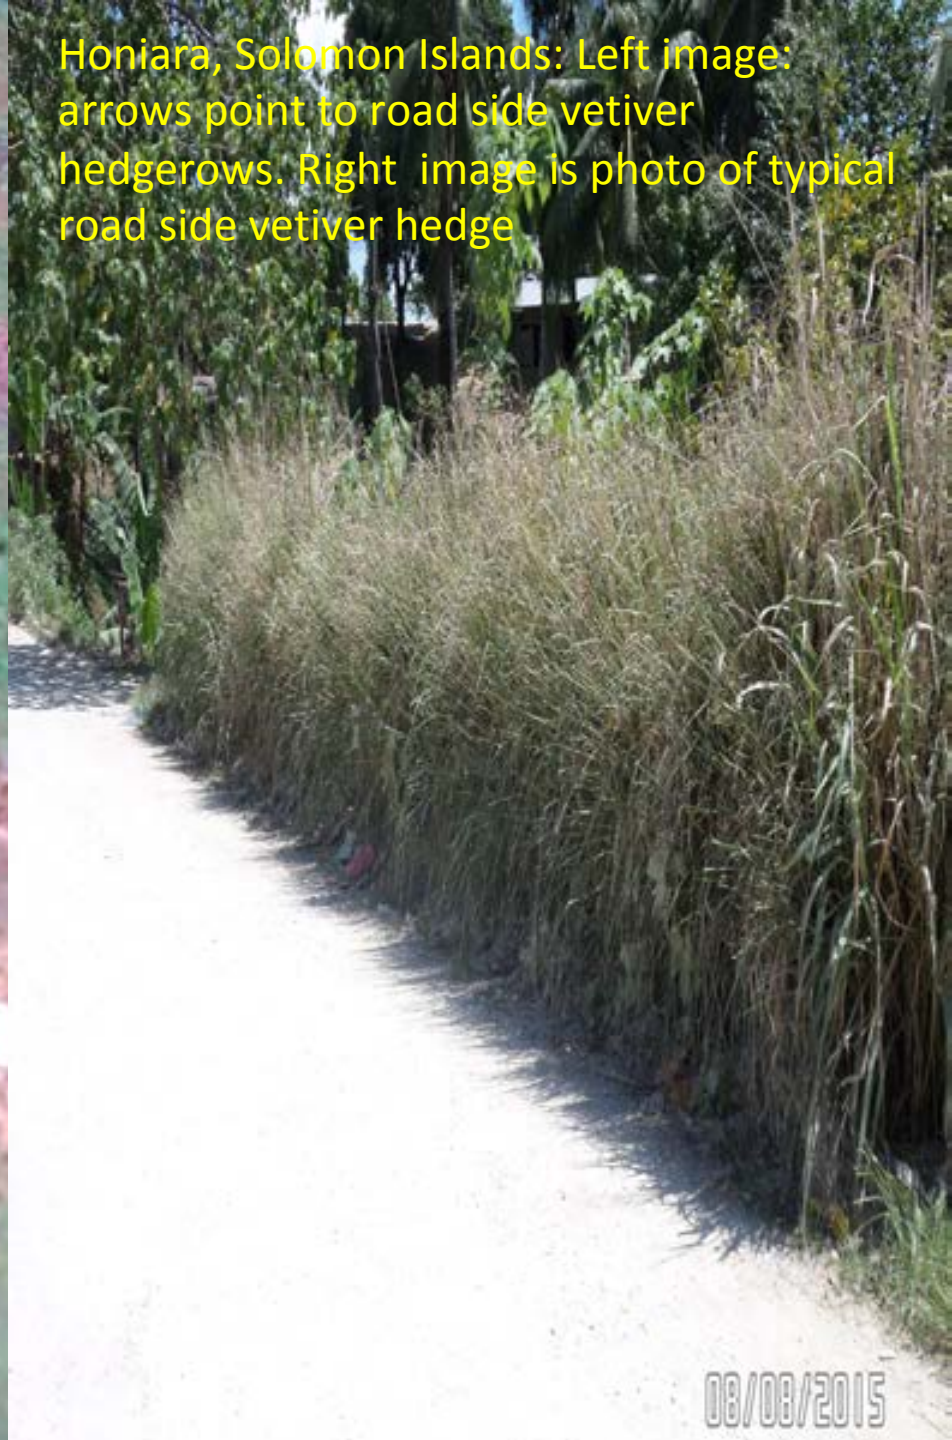
Honiara, Solomon Islands: Left image: arrows point to road side vetiver hedgerows. Right image is photo of typical road side vetiver hedge

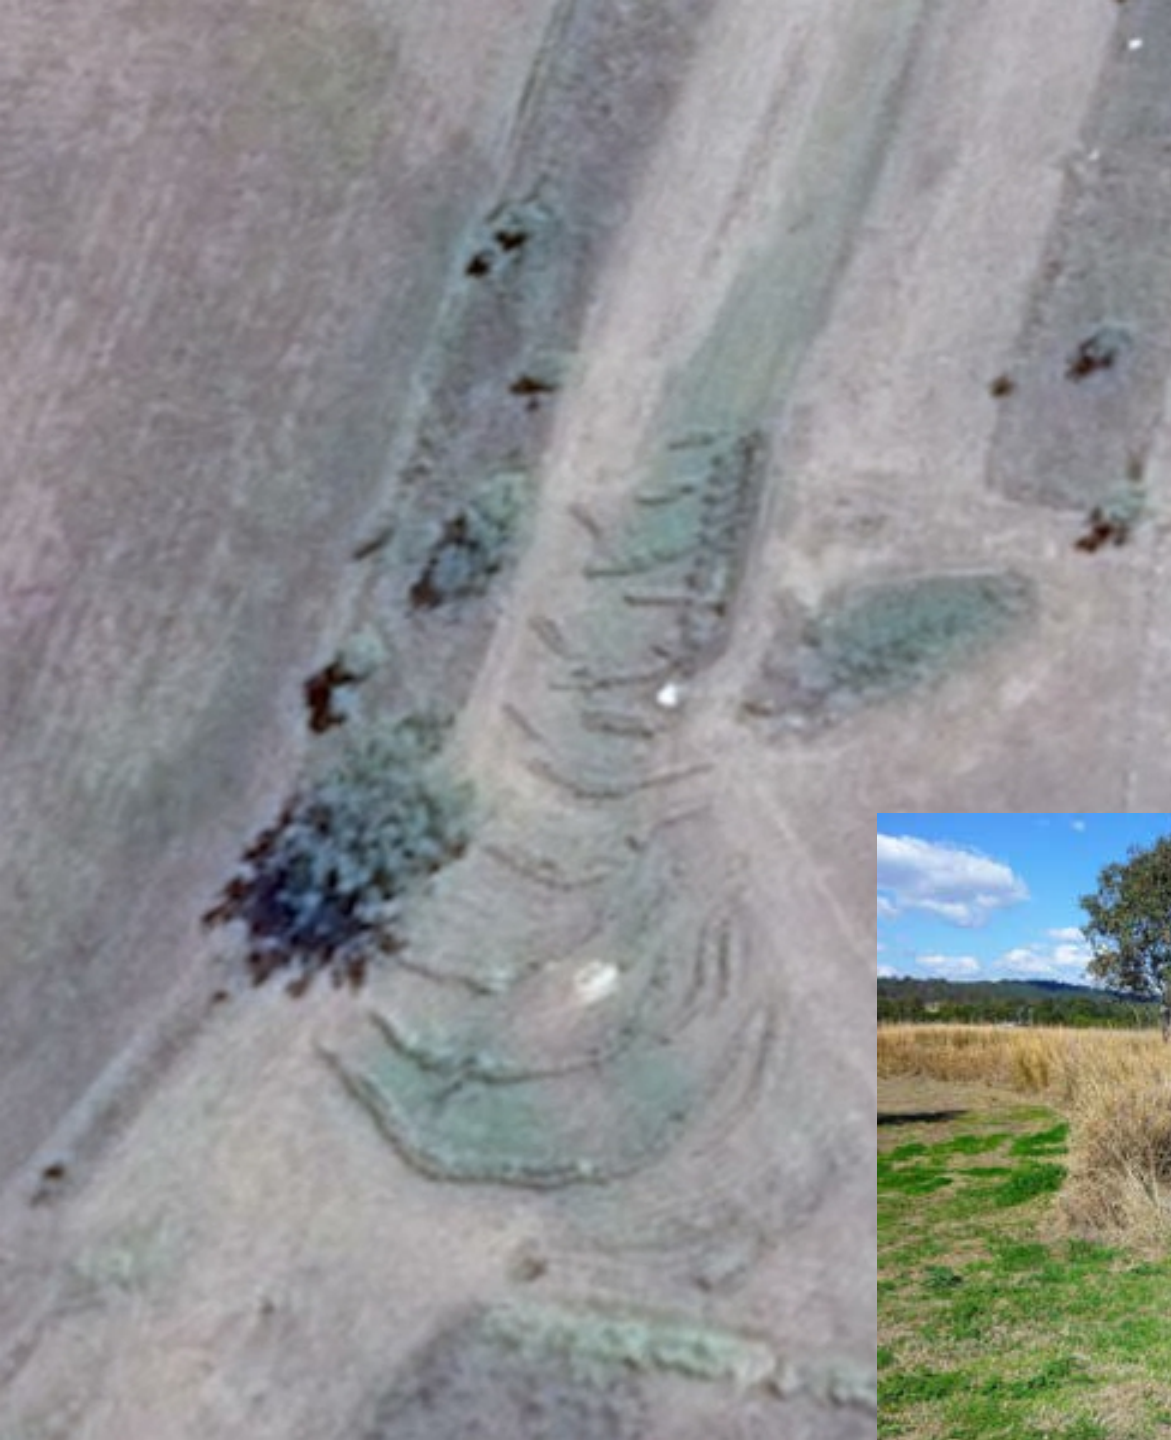
Vetiver hedgerows across major drainage channel (Storr's Creek) Laidley, Queensland, Australia. These hedges were subjected to major flooding and survived. Inset:Ground view

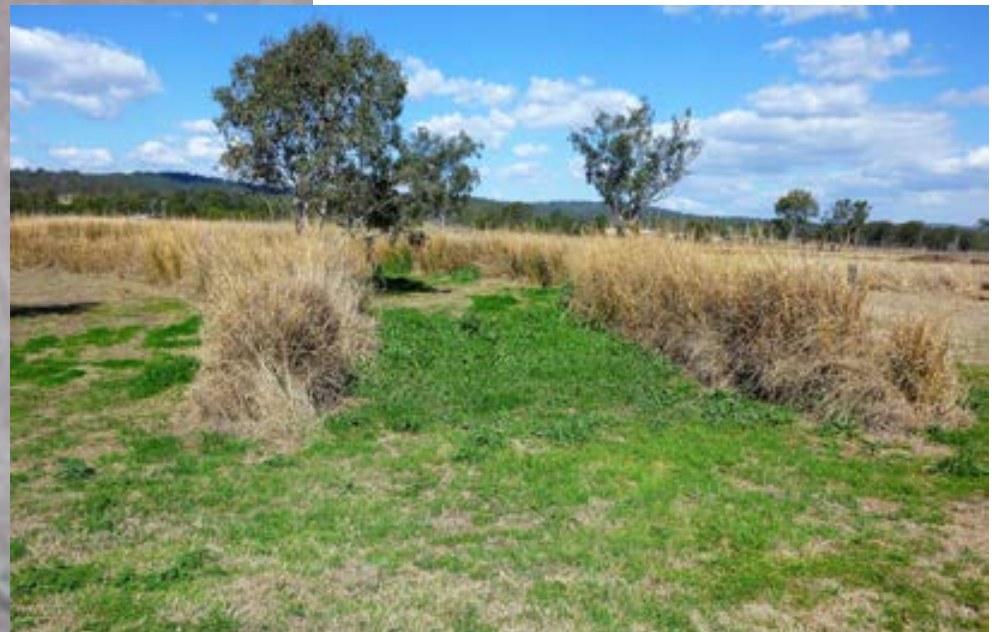
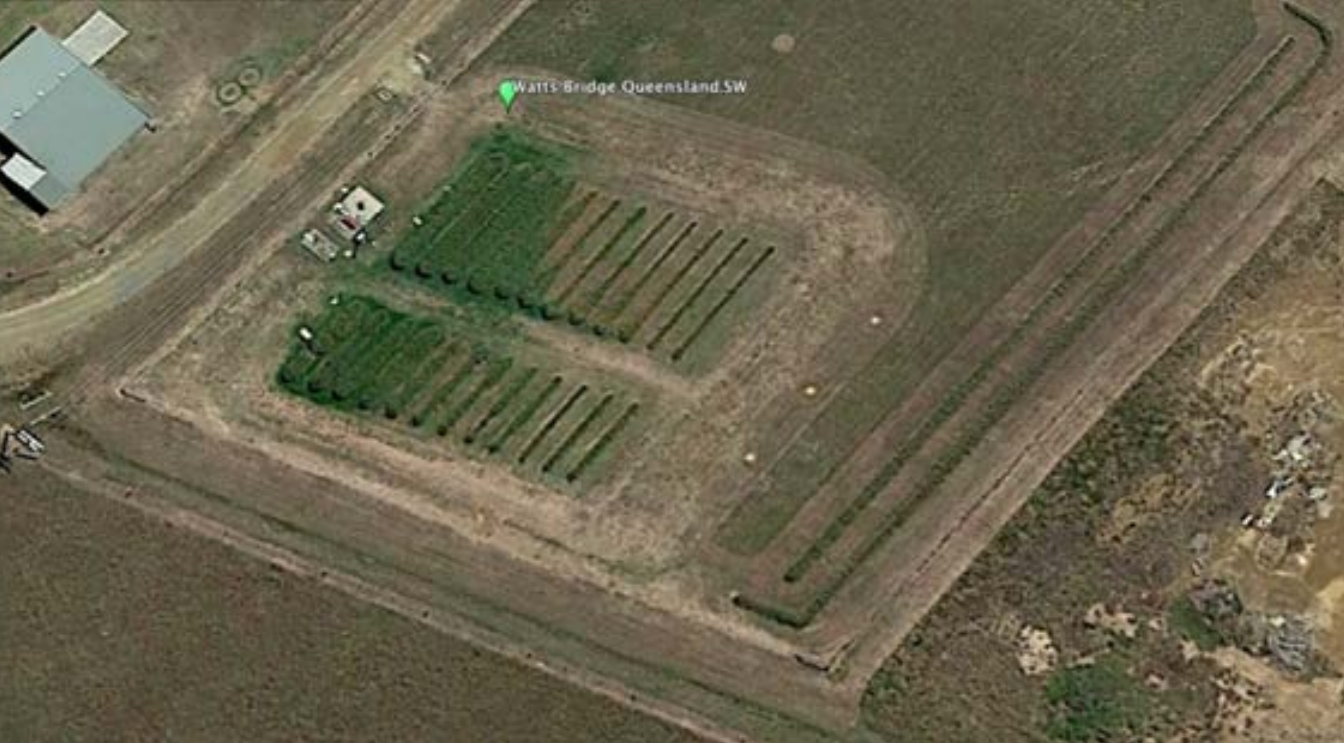
Watts Bridge – phytoremediation of effluent from airfield septic system using vetiver hedgerows. Top - satellite view. Right – ground view

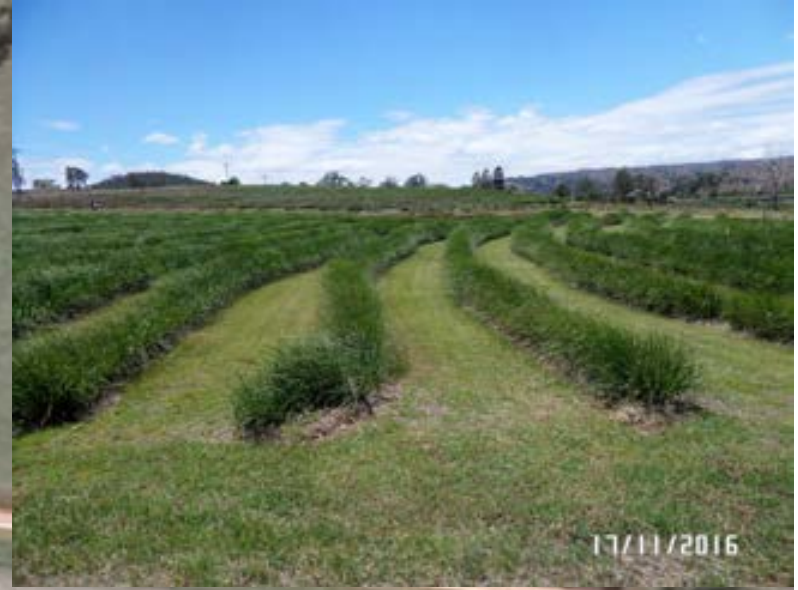
Boonah sewage treatment plant - using vetiver April 2015

Vetiver hedgerows at Boonah Sewage Plant, Queensland Australia. Inset ground view

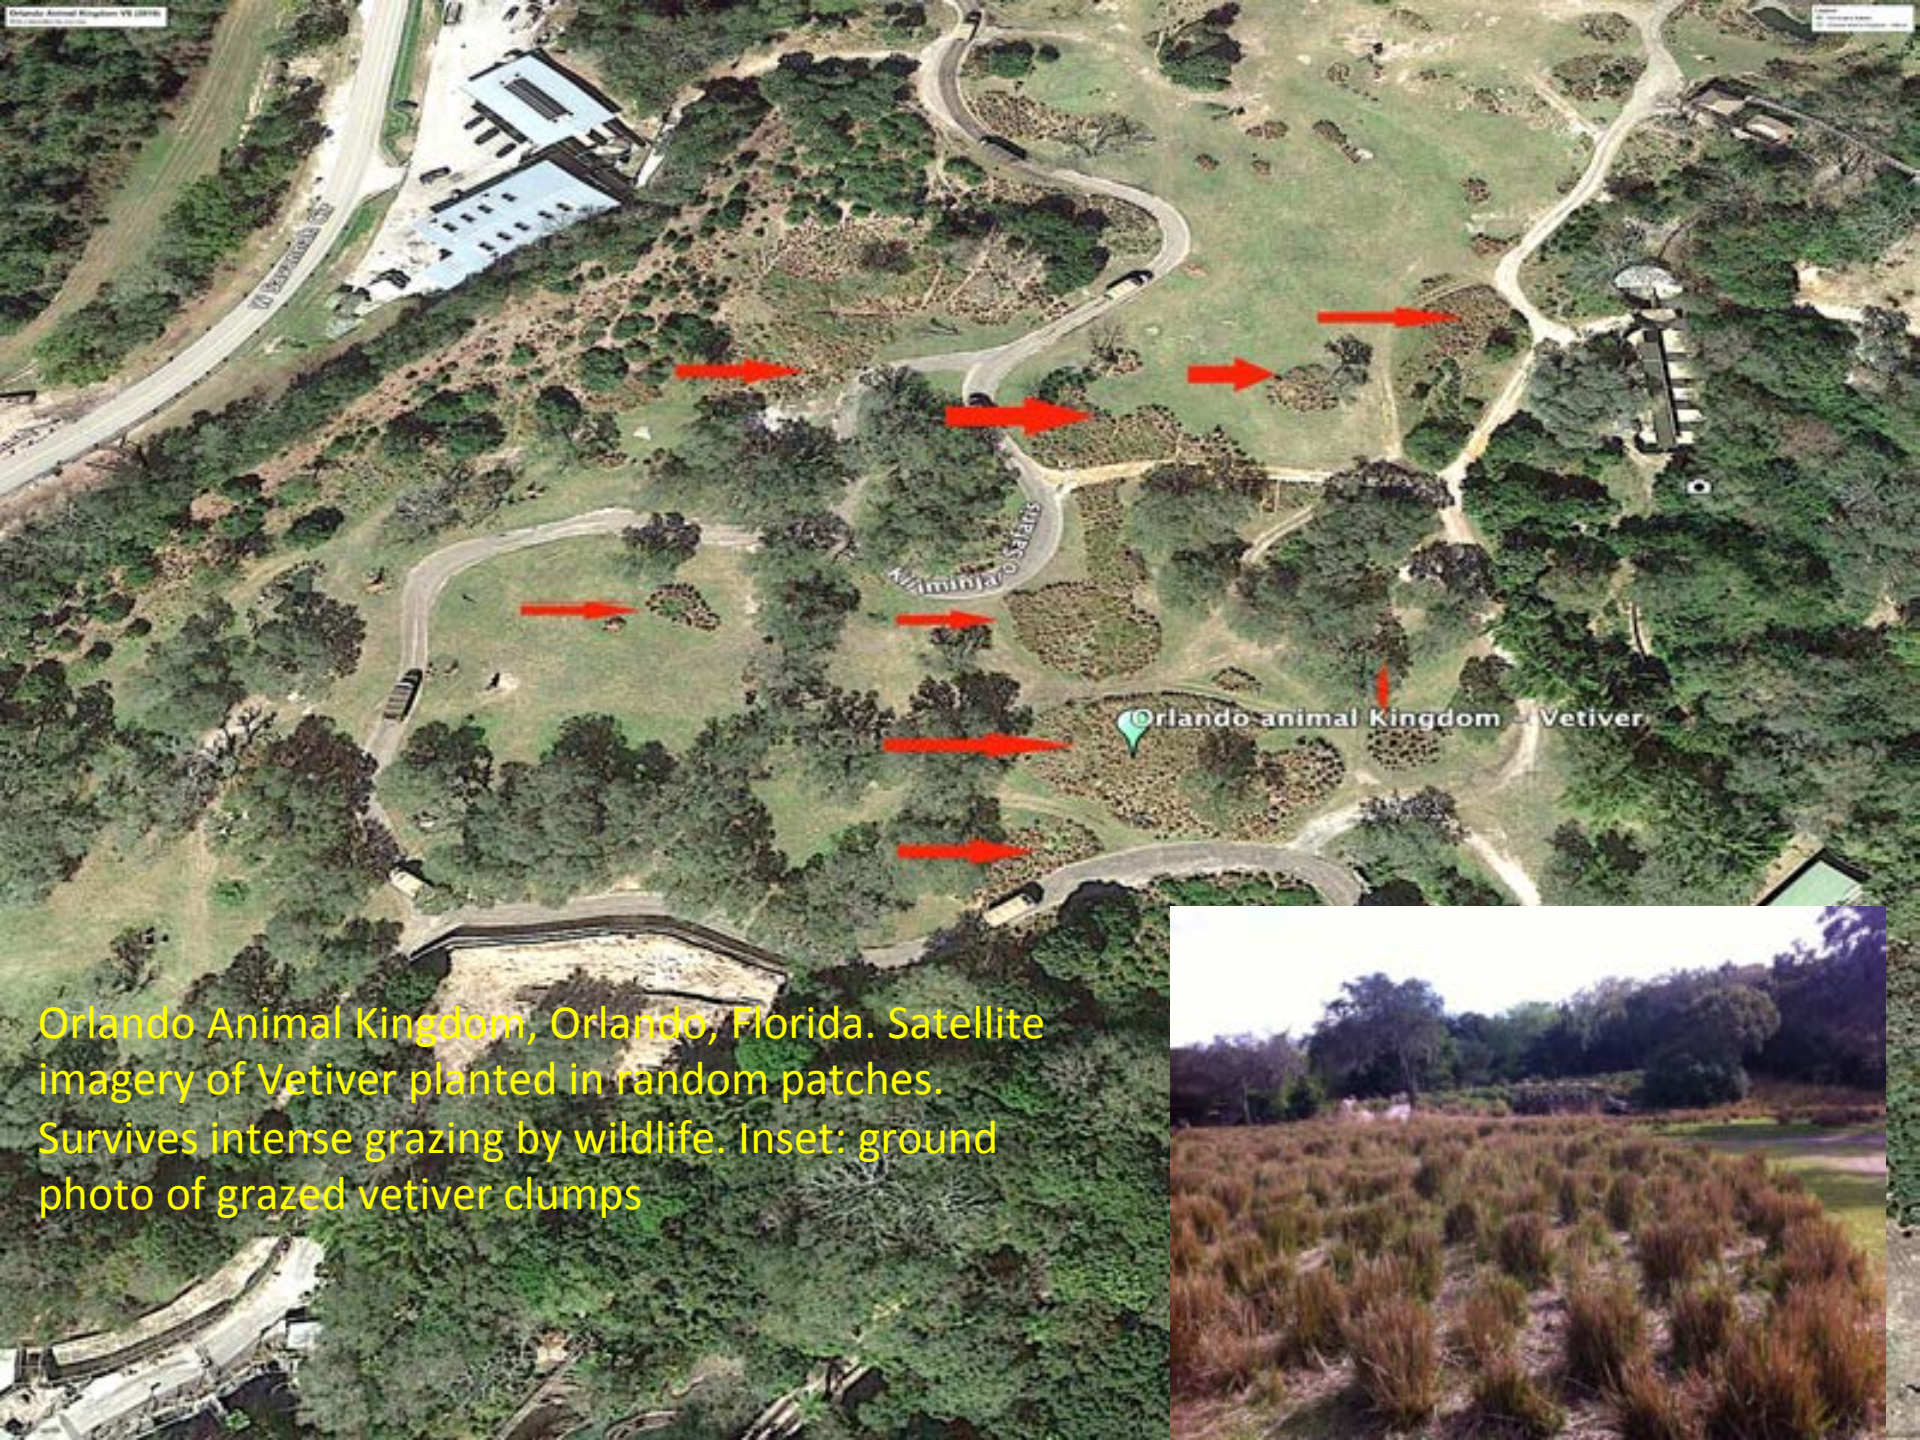
Orlando Animal Kingdom, Orlando, Florida. Satellite imagery of Vetiver planted in random patches. Survives intense grazing by wildlife. Inset: ground photo of grazed vetiver clumps

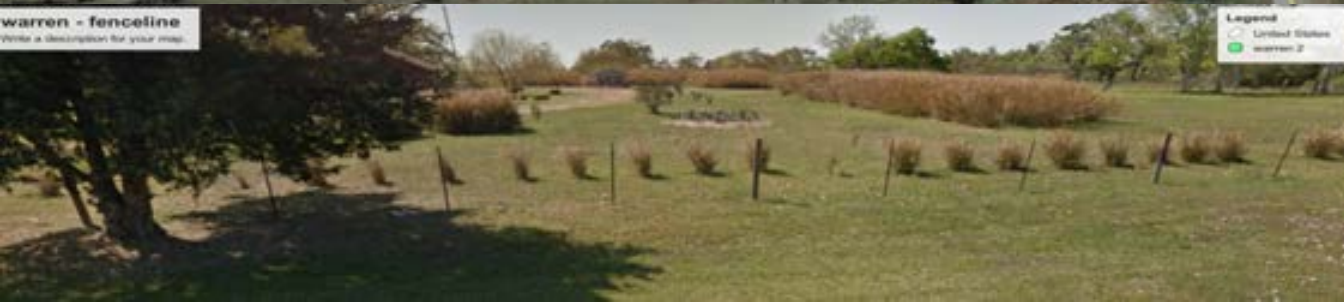
2018 - Vetiver boundary hedgerows and field planting of vetiver. Grown on brackish water water table. This vetiver has survived 7 ft of flood water as a result of a hurricane. Insets of vetiver on Mosquito farm. Insets show very good vetiver growth. (photo credit - Warren Sullivan)

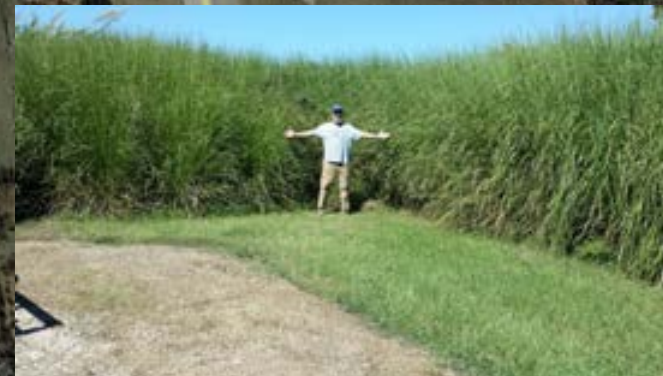
Creek at intersection of RT 10 and Bluebonne Boulevard, Louisiana

Two year old vetiver planted on creek bank 2018

Creek bank erosion prevention with vetiver planted in area of green pin markers. Insets show before and after planting at the site. (photo credit Jack Bertel)

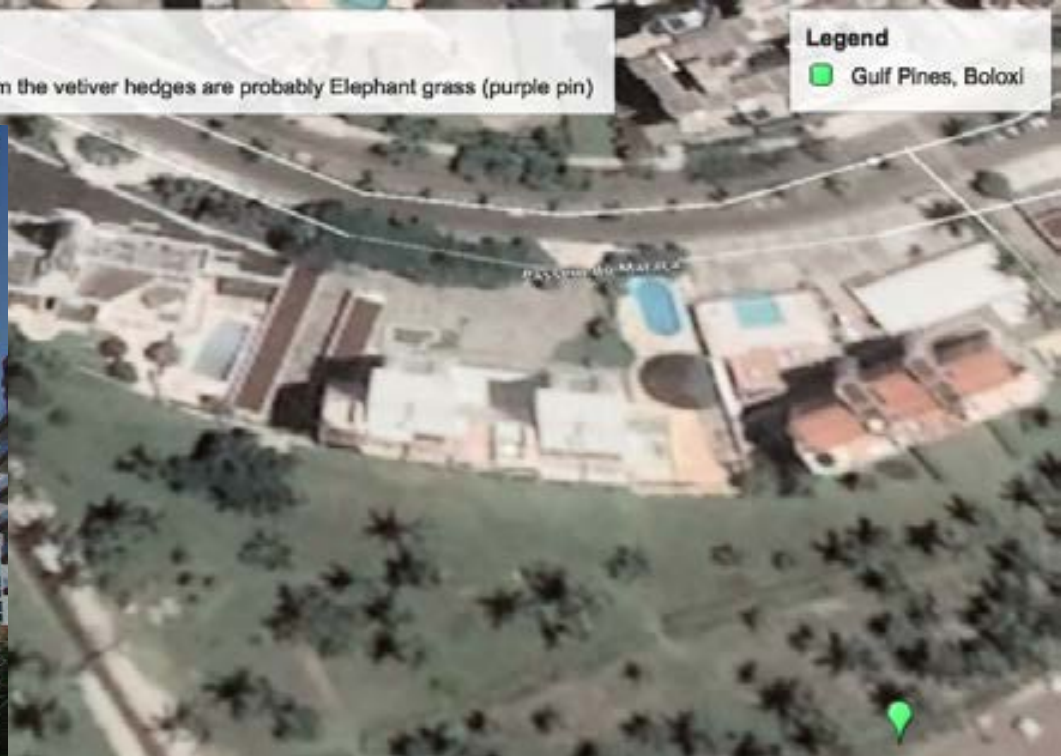
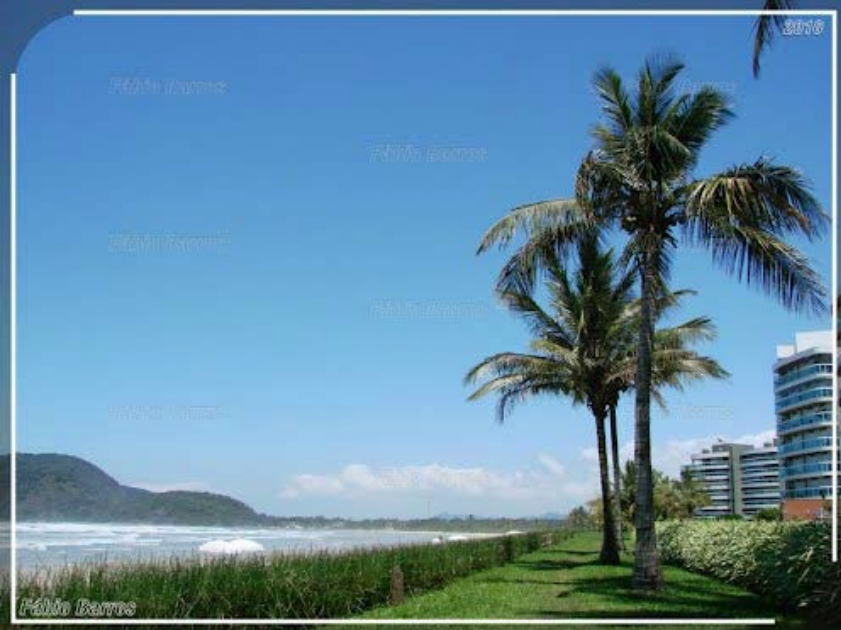
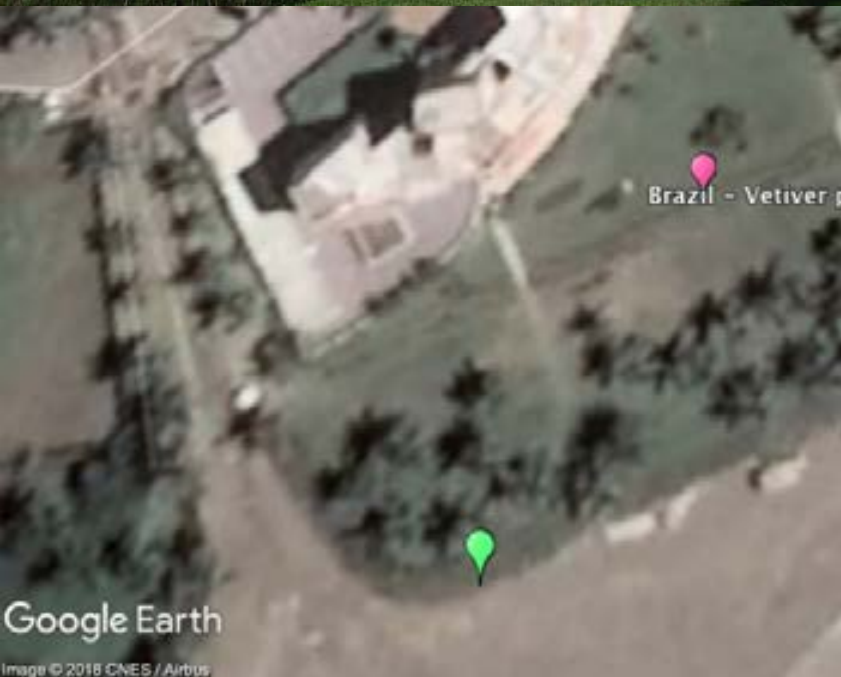
Brazil - Coastal beach protection

Vetiver (green pins) is planted along beach. The straight hedgrows 100 feet back from the vetiver hedges are probably Elephant grass (purple pin). Inset vetiver hedge along beach front.

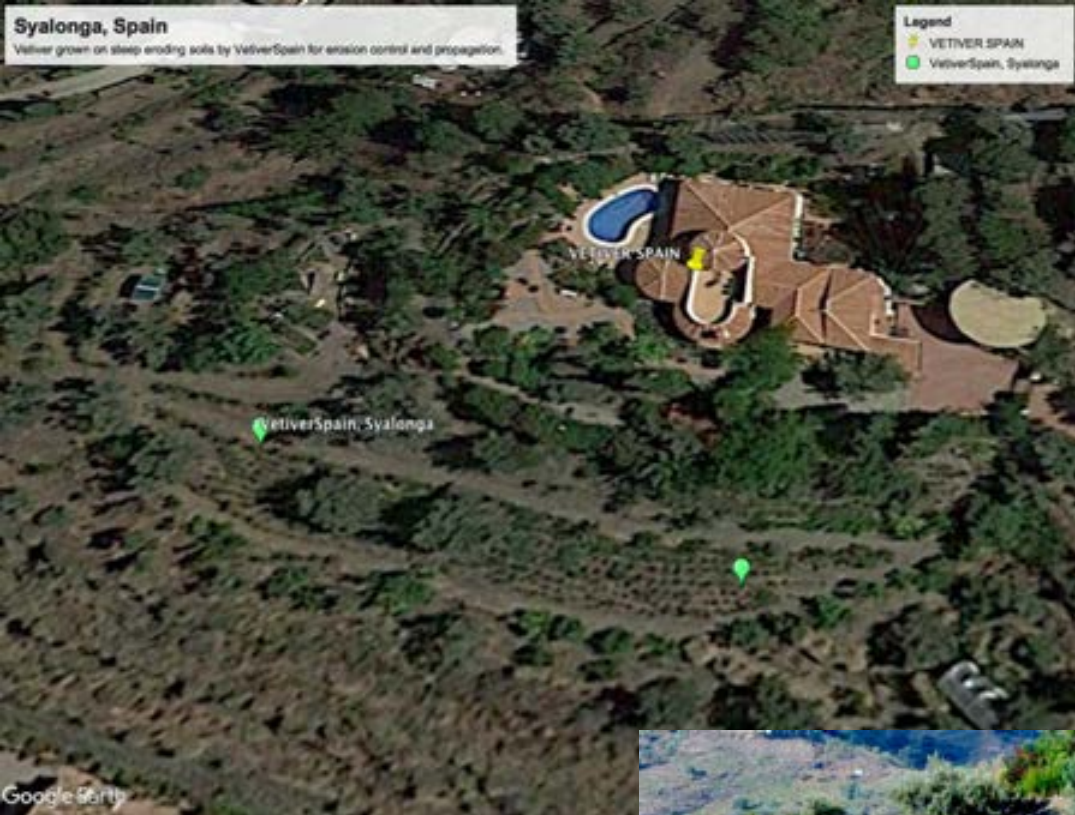
These images compare (left satellite view) vetiver planted on hill (block between two green pins) with right image a drone view – showing vetiver as bright green hedgerows

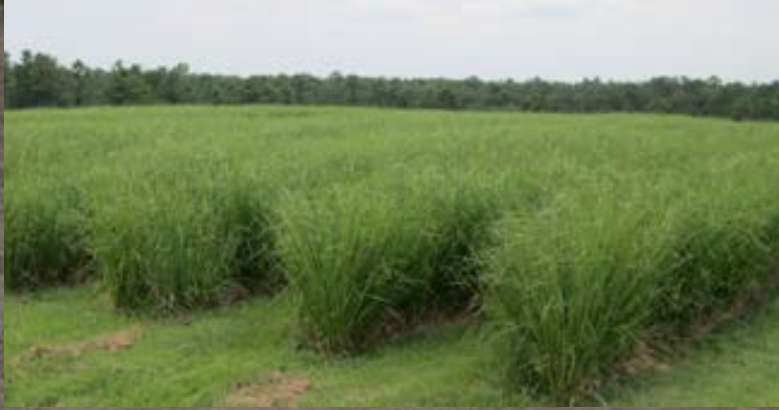
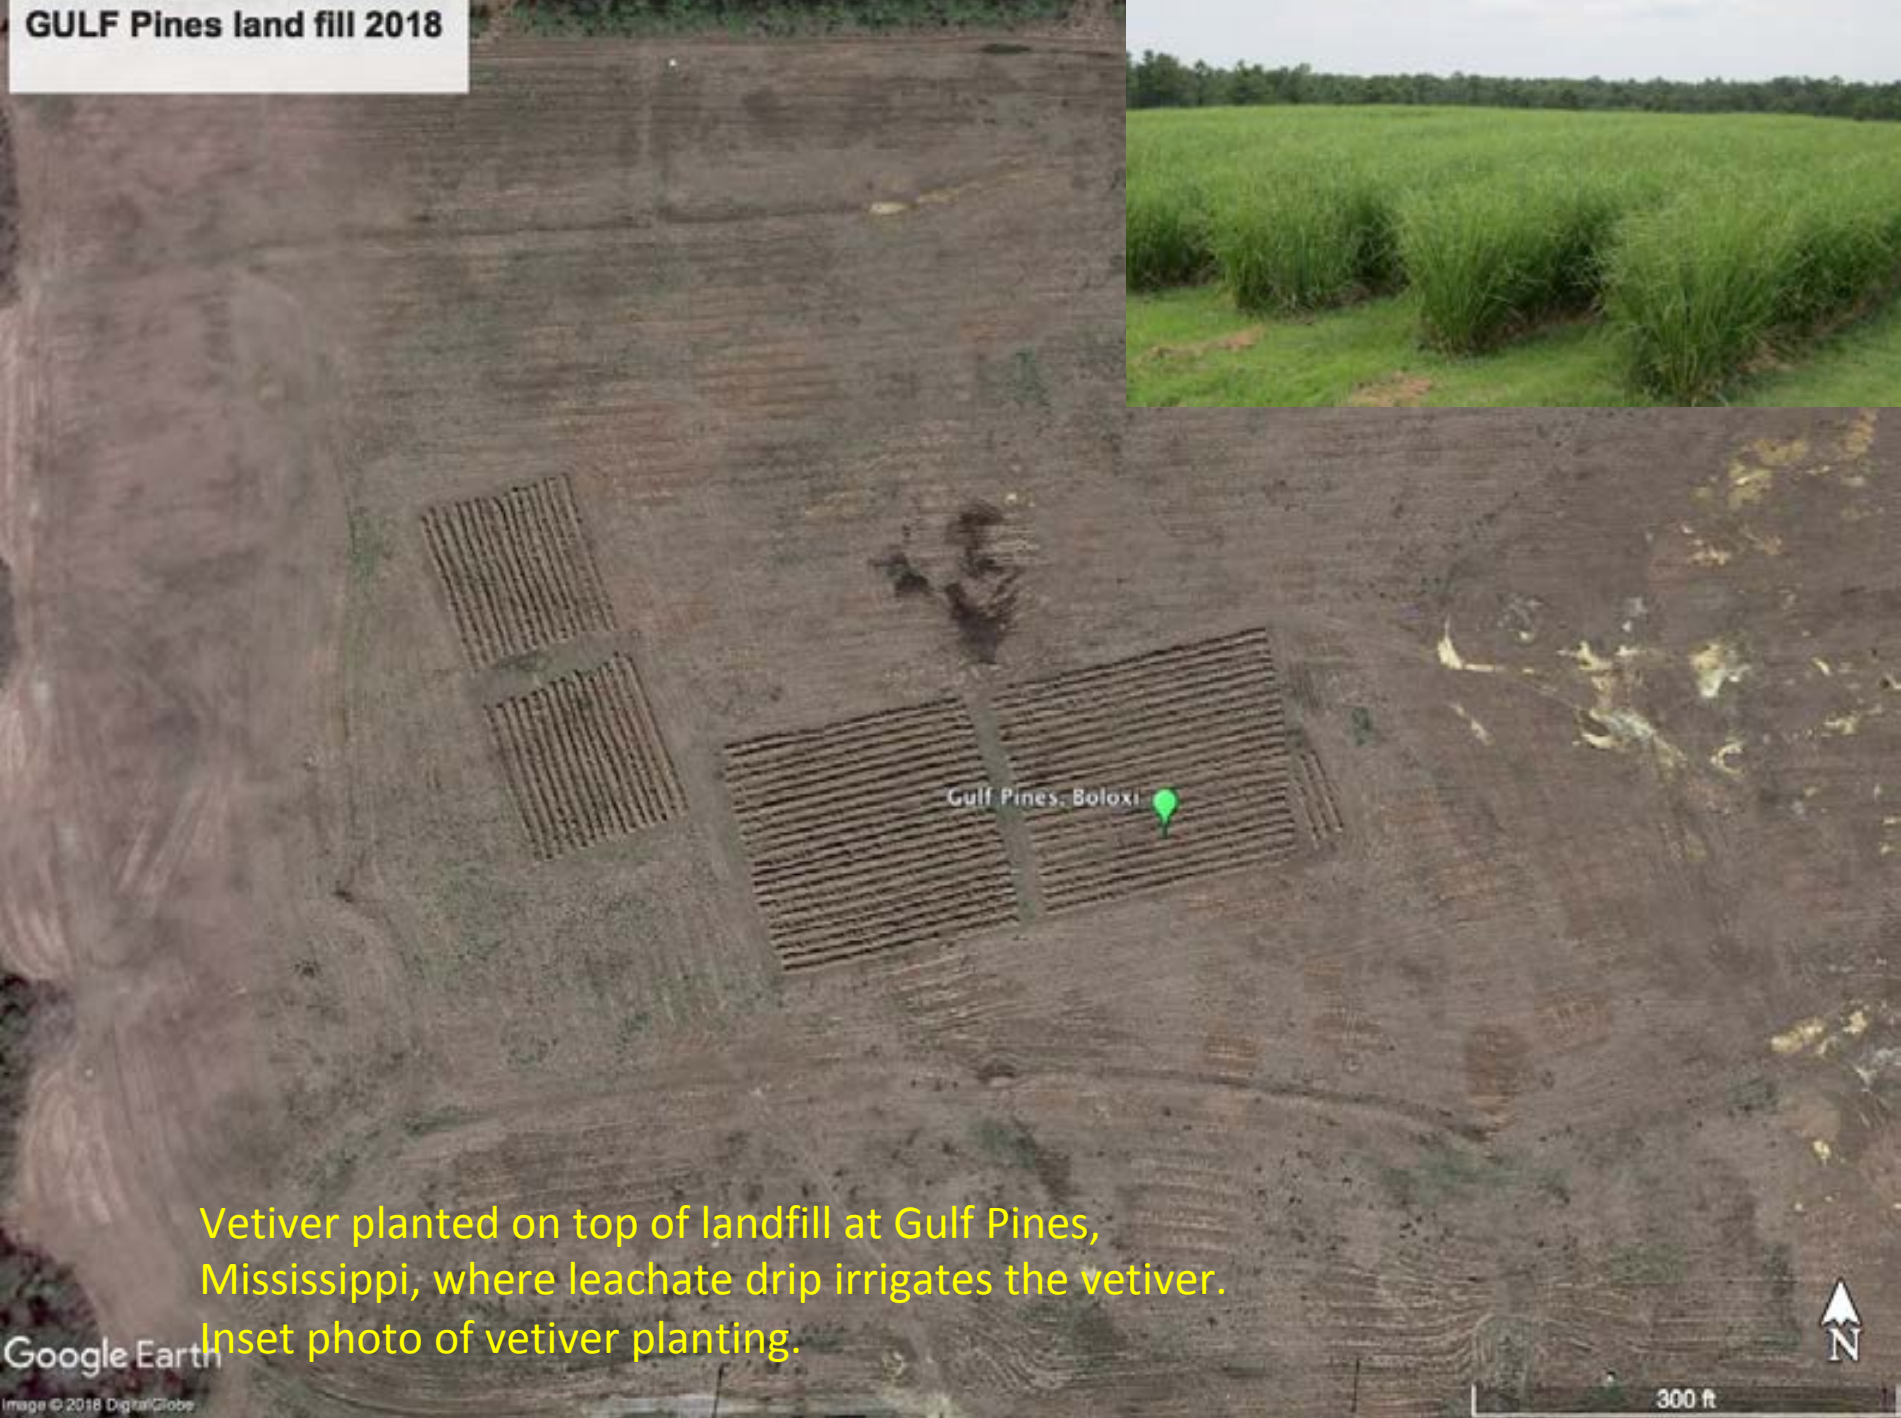
GULF Pines land fill 2018

Vetiver planted on top of landfill at Gulf Pines, Mississippi, where leachate drip irrigates the vetiver. Inset photo of vetiver planting.
