AFTERMATH OF TYPHOONS NUMBER 6 AND 7 (OCTOBER 2005) ON THE COASTAL ZONE FACING HA LONG BAY HAI HAU DISTRICT, NAM DINH PROVINCE VIETNAM

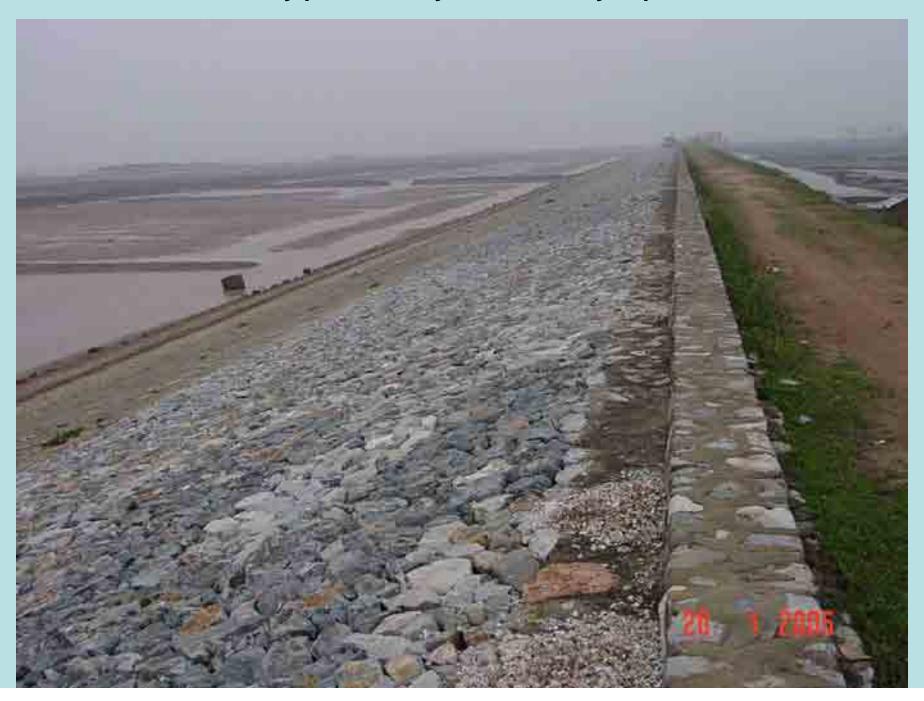
This new dike, heavily protected by the extremely expensive rock armour

But this new dike, although its outside batter protected by the extremely expensive rock armour;, its inside batter was not protected, cover only by local vegetation, mostly weeds

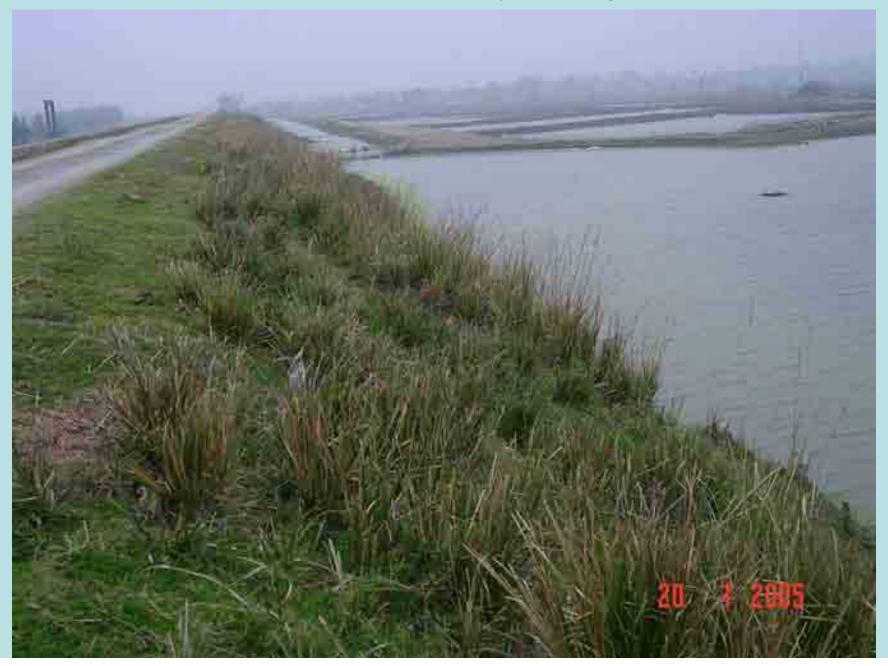
On a section of about 2km long, vetiver was planted to protect the inside batter, but not in a correct layout design

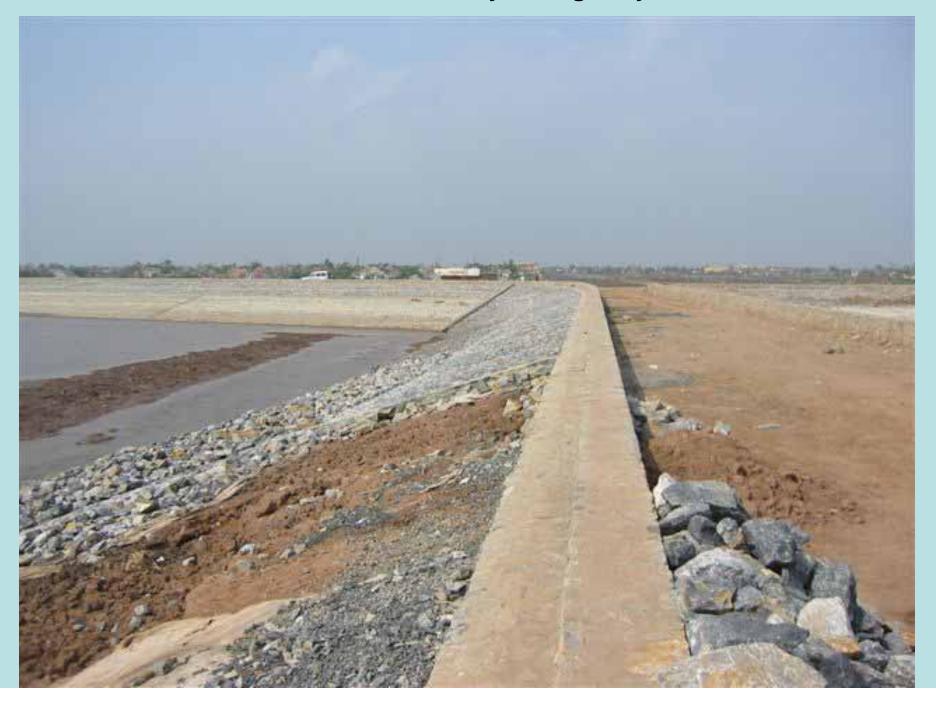
The same dike shown before was badly damaged by enormous sea waves

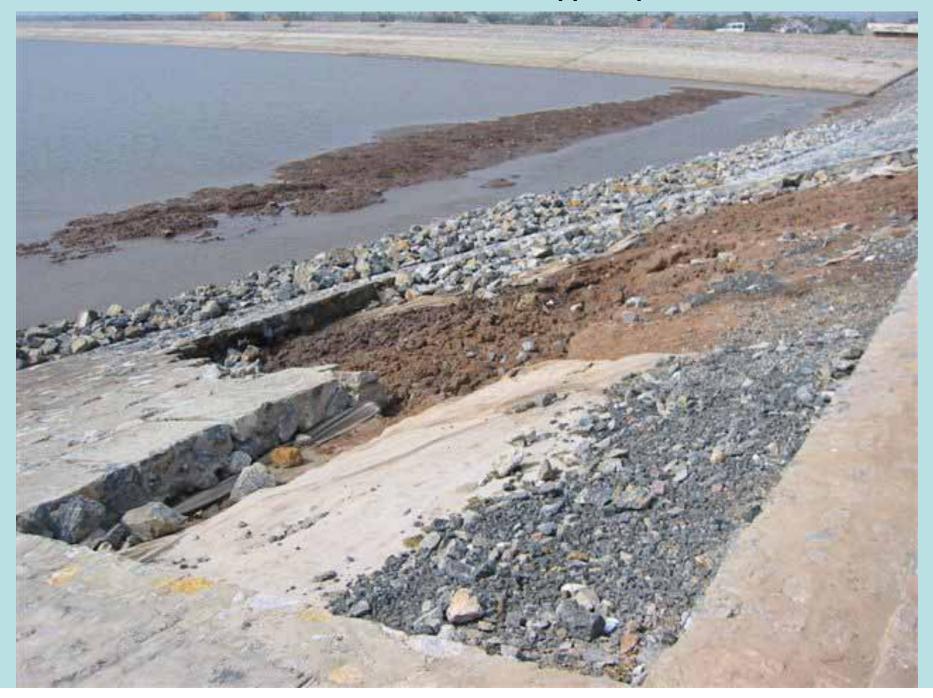
The rock armour was ripped up

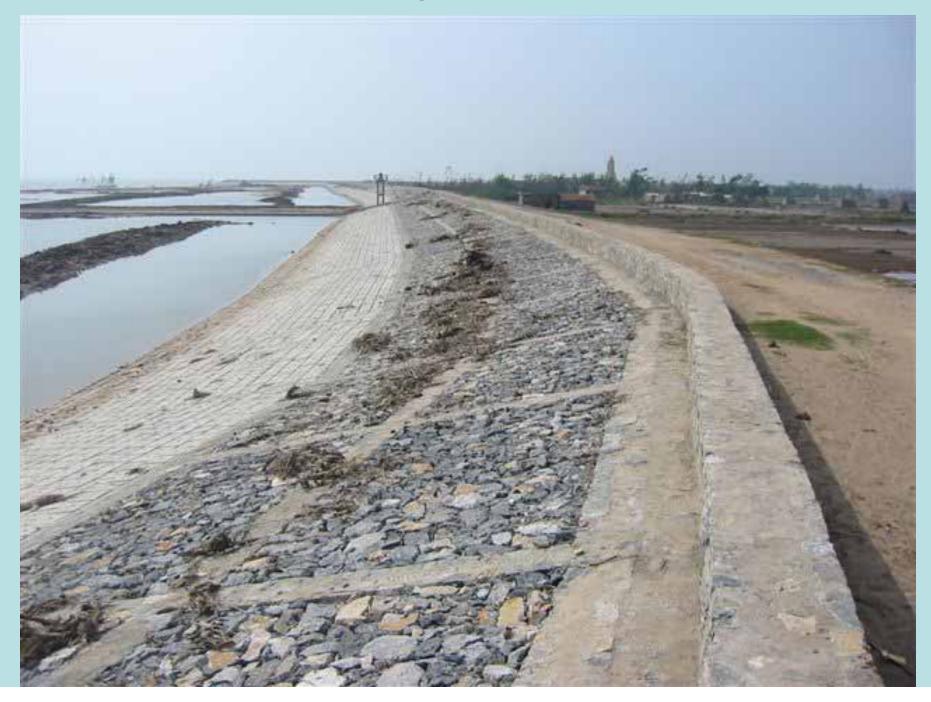
Sea facing batter

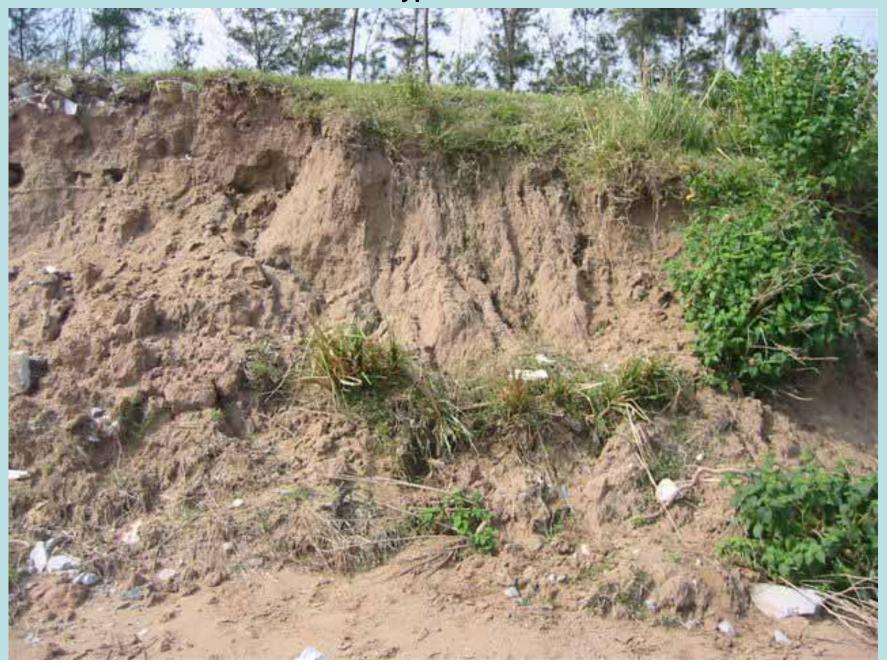
The opposite inside batter without vetiver planting, badly damaged by the typhoons

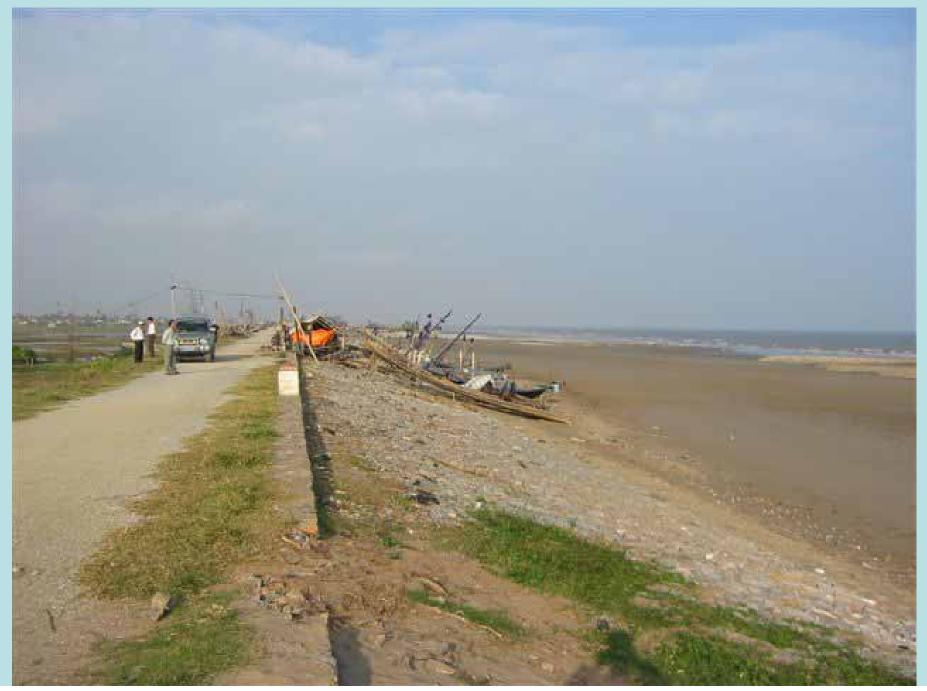
Sea facing batter

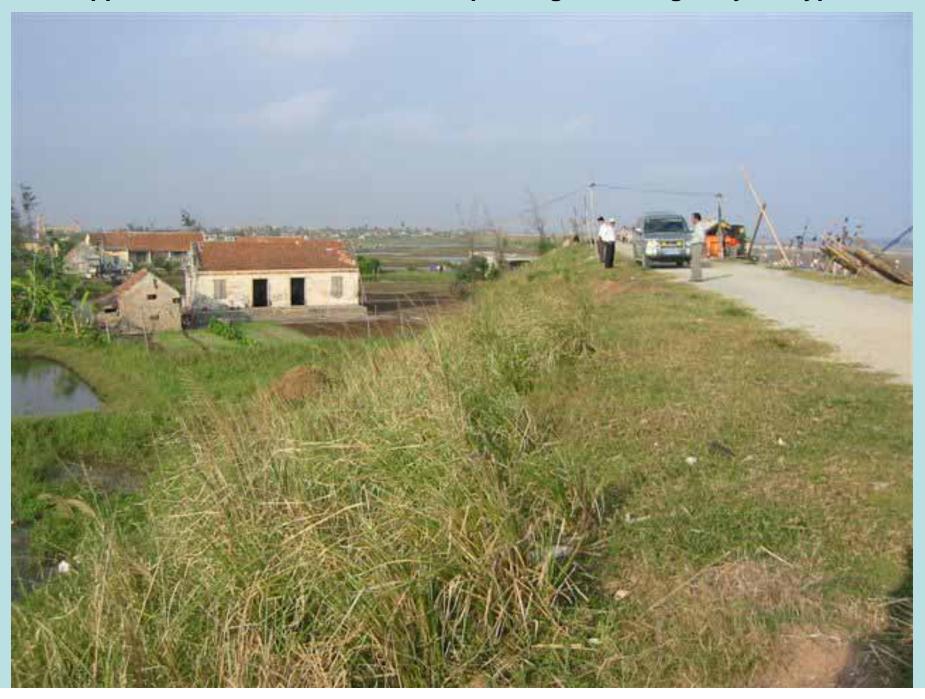
The opposite inside batter with vetiver planting, undamaged by the typhoons

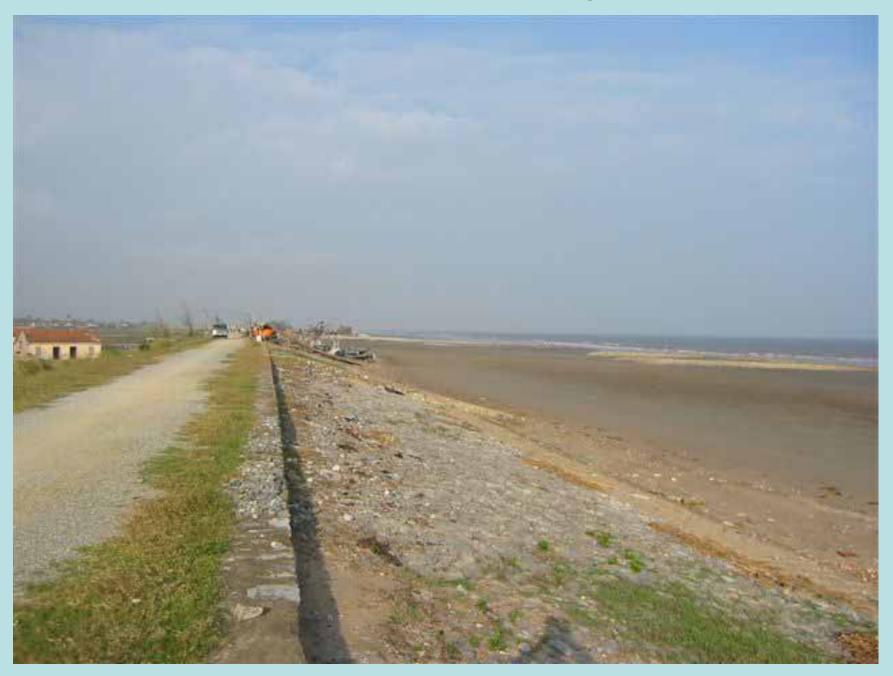
Another section of the sea facing batter

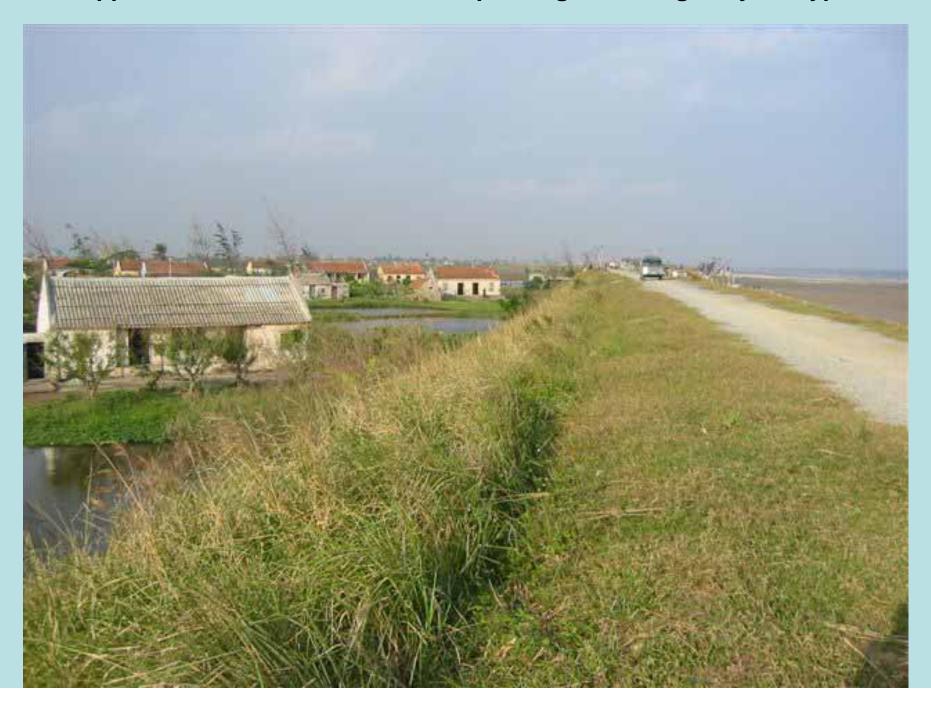
The opposite inside batter with vetiver planting, undamaged by the typhoons

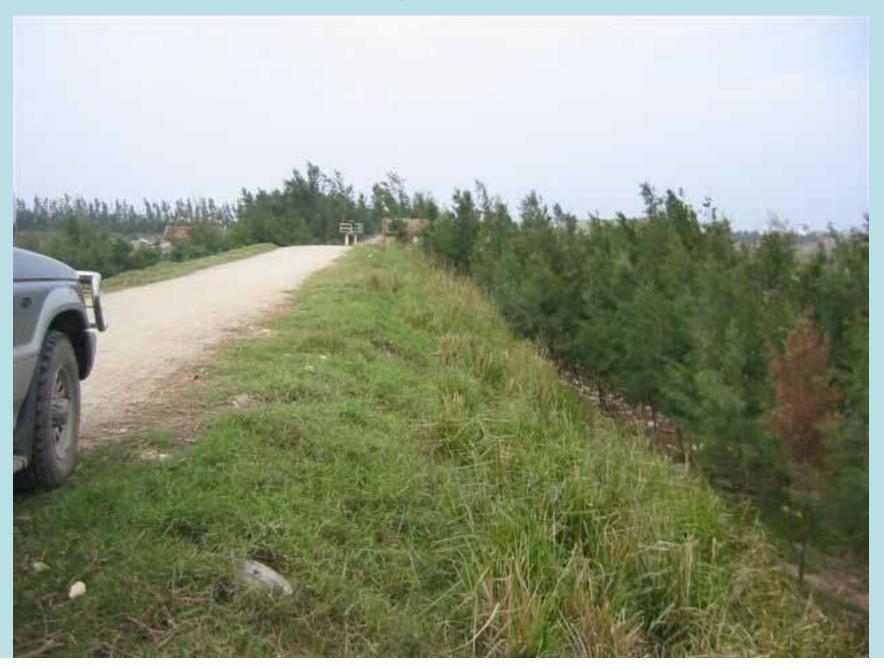
The inside batter of another sea dike with vetiver planting, undamaged by the typhoons

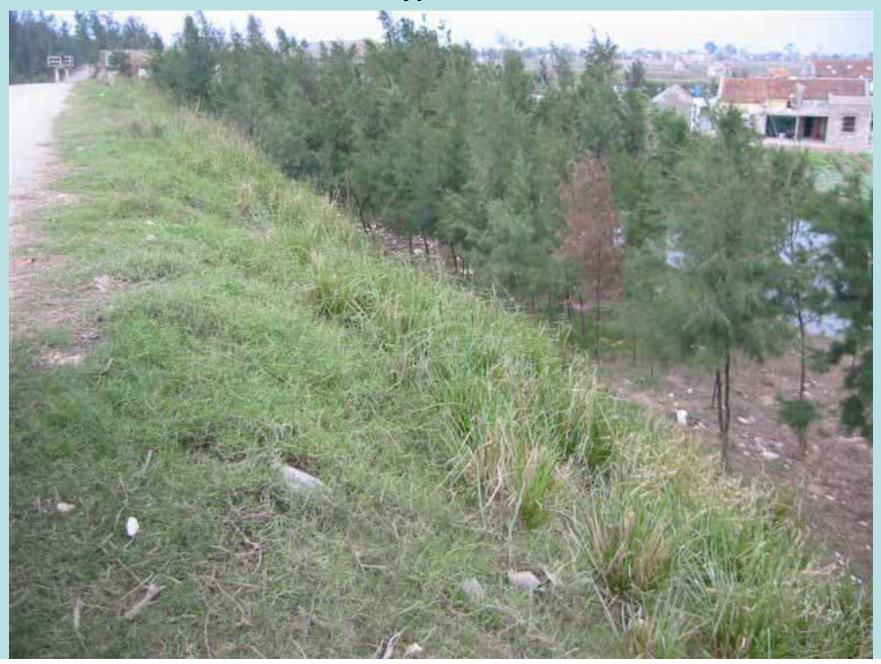
The inside batter of another sea dike with vetiver planting, undamaged by the typhoons

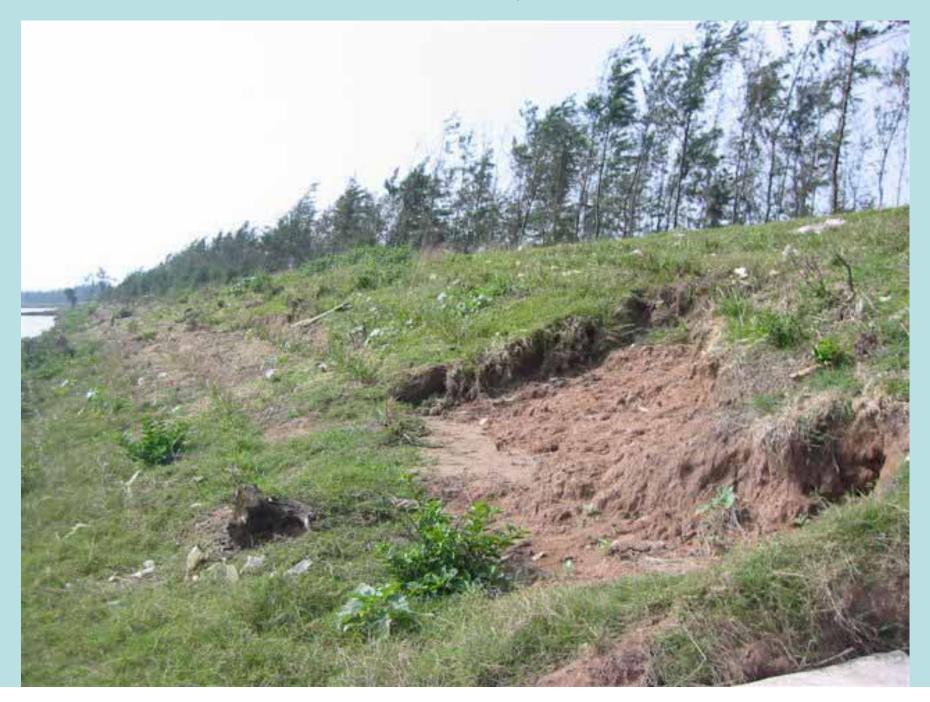
Erosion on a new and incorrectly planted inside batter

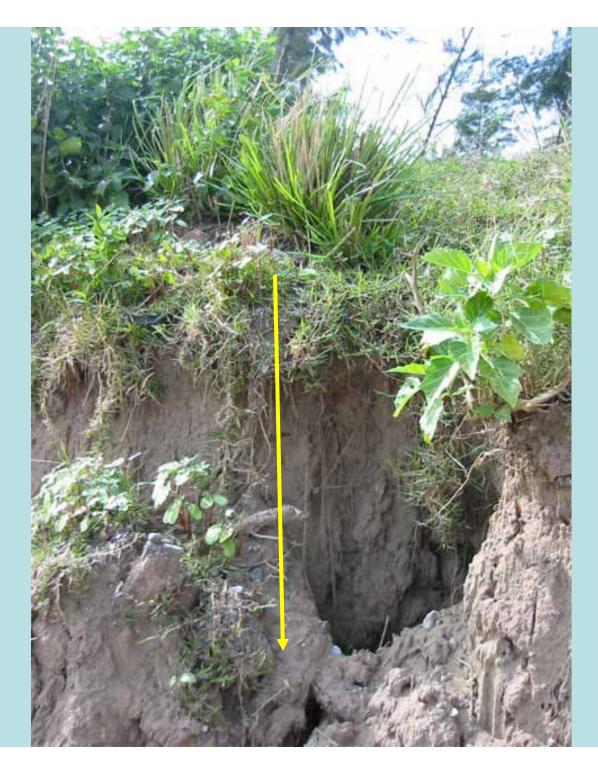
Less than 1 year old and almost 2m root.

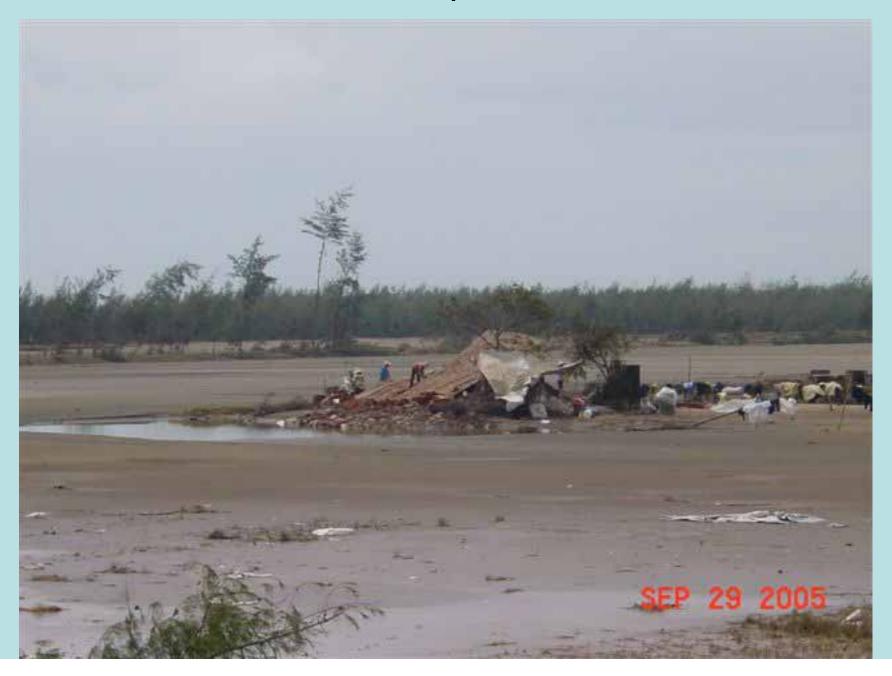
This is once a house and home of a poor farmer in the section where the dike collapsed

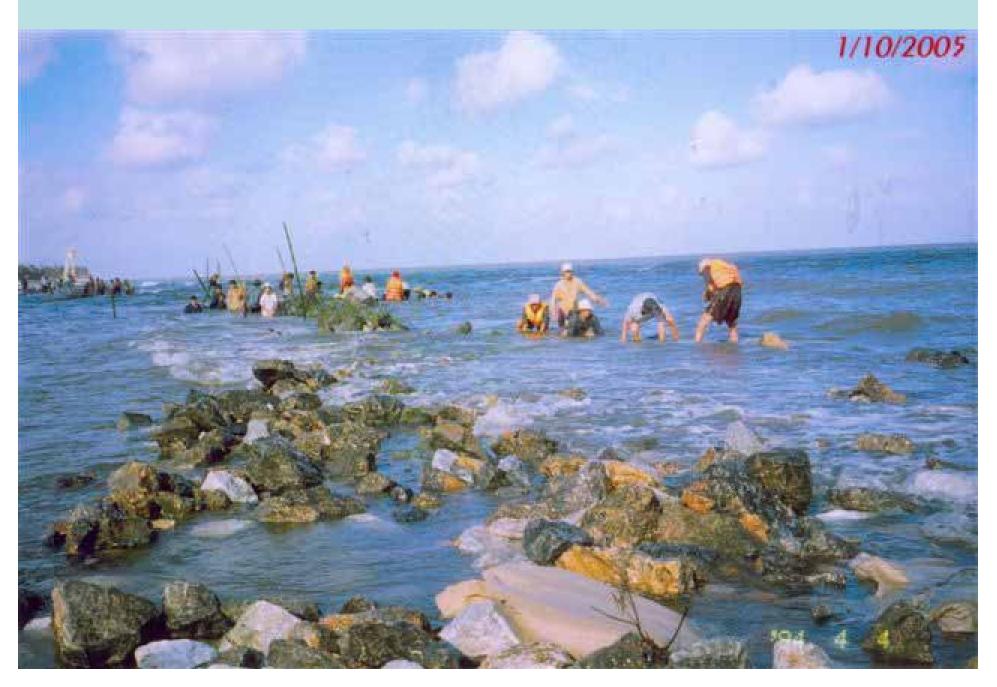
This was once a solid sea dike
