THE VANISHING DELTA

A Pictorial Essay on the Riverbank Erosion in the Mekong Delta, Viet Nam and a Proposed Remediation Plan

Dr. Paul Truong

**The Vetiver Network East Asia and South
Pacific Representative, Brisbane, Australia**

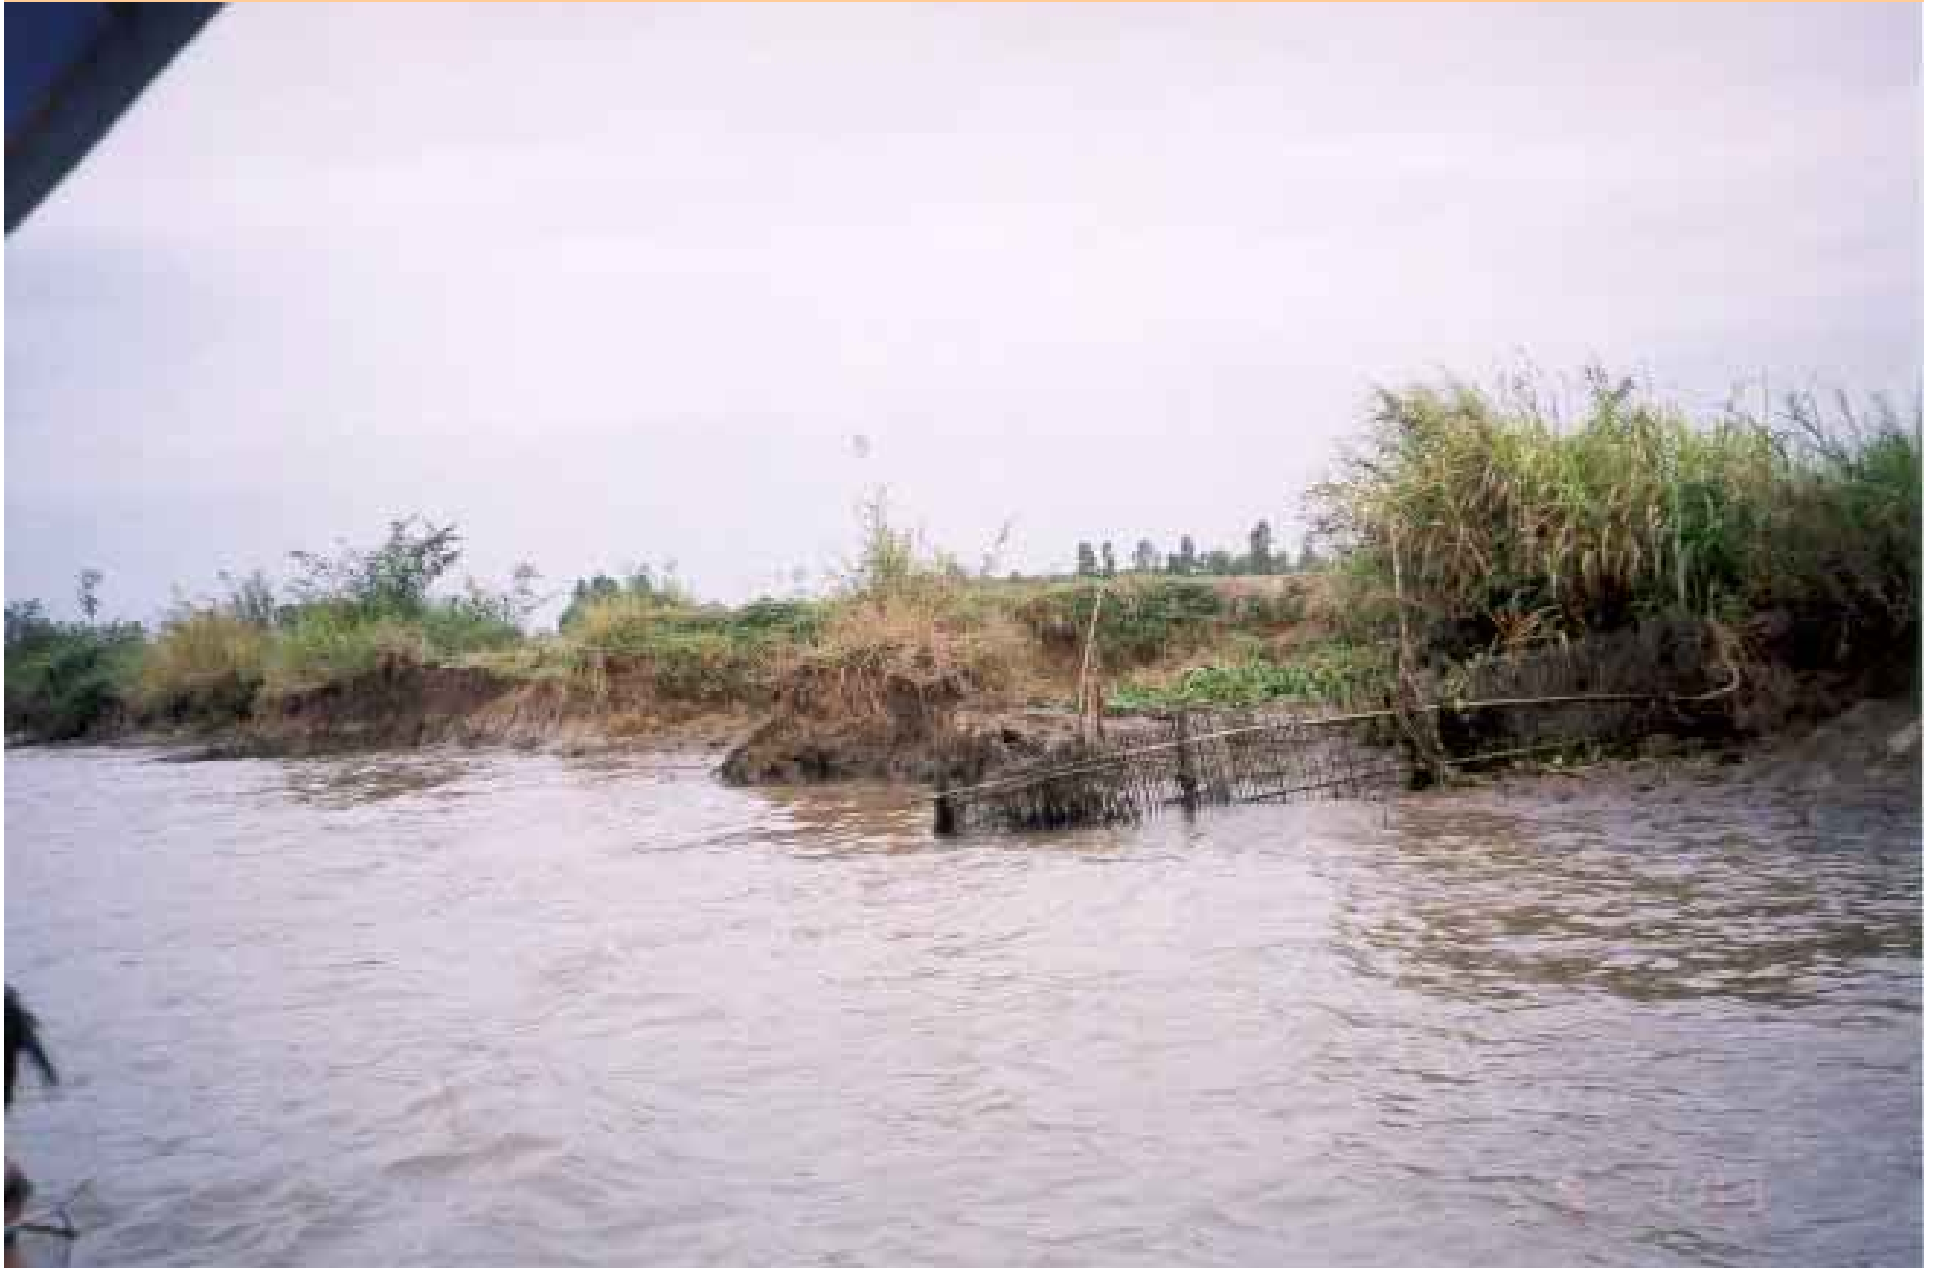
Recent erosion washed away a large chunk of land, what is left will be gone soon.

At least 20m of land was lost in the last 2 years according to the local farmer

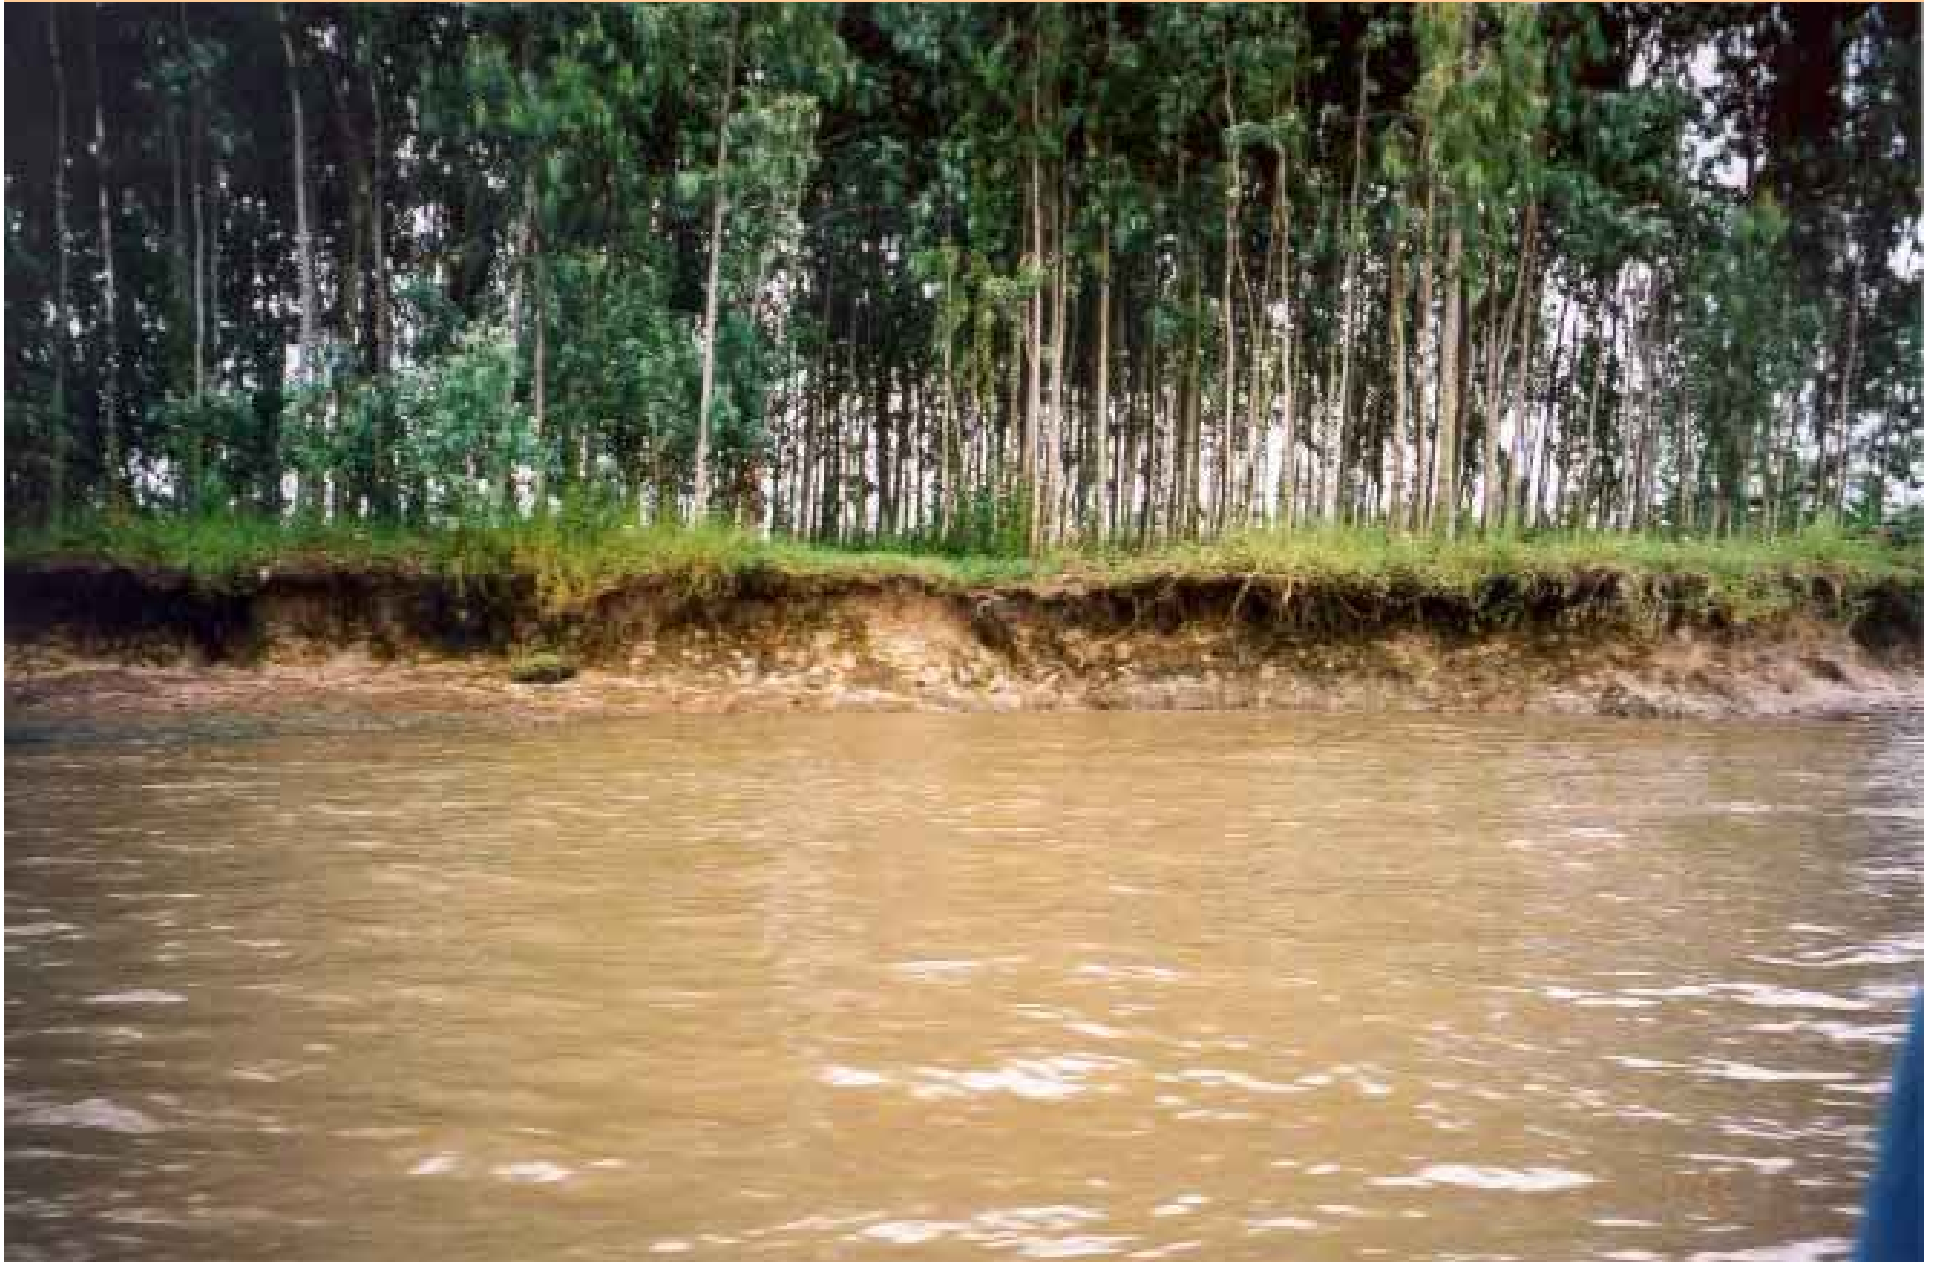
This raw surface is a common sight along the river

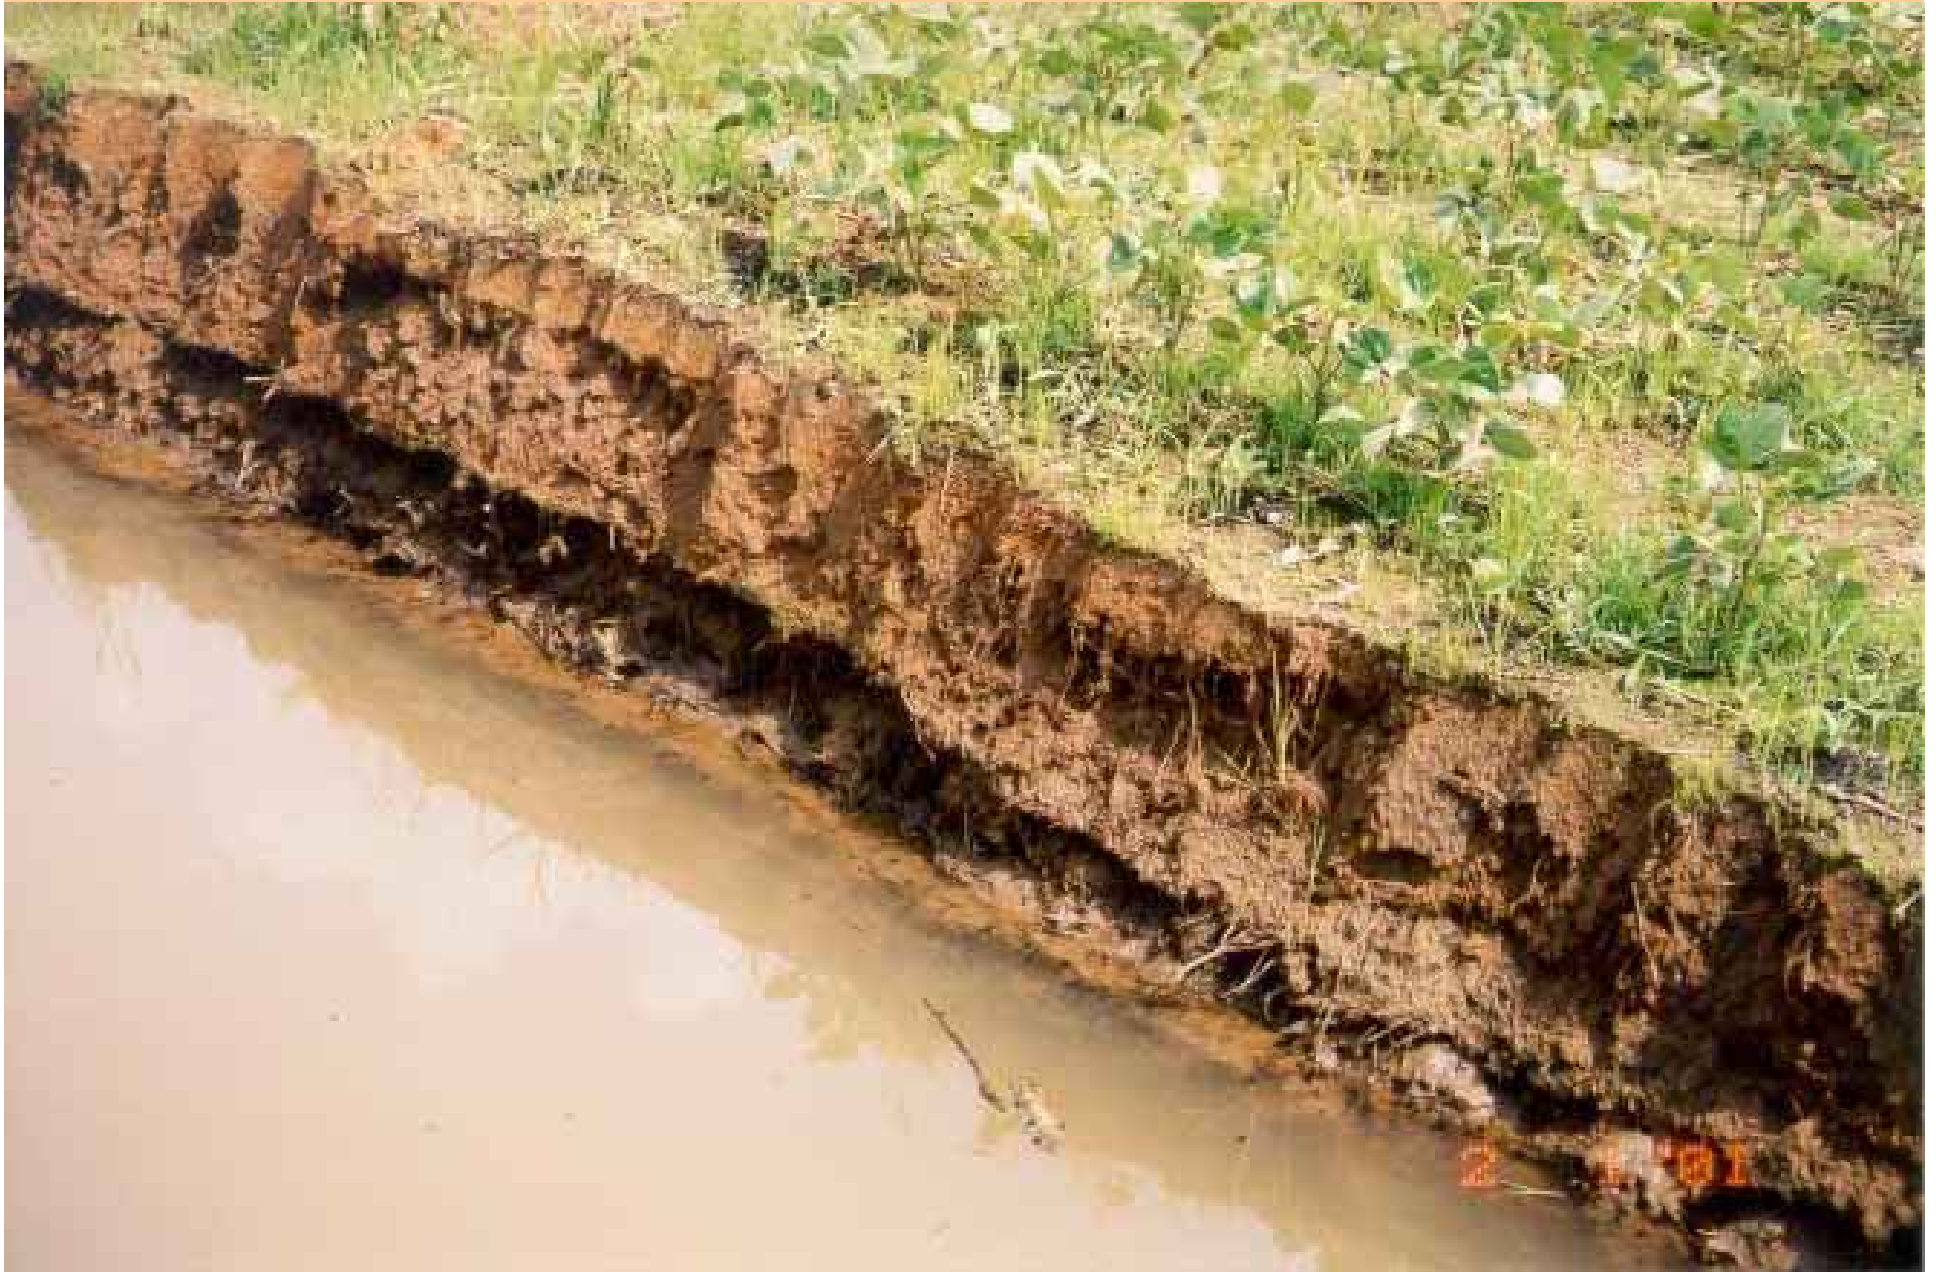
This freshly eroded surface at high tide was not caused by a recent erosive event, indicating that erosion occurred continuously

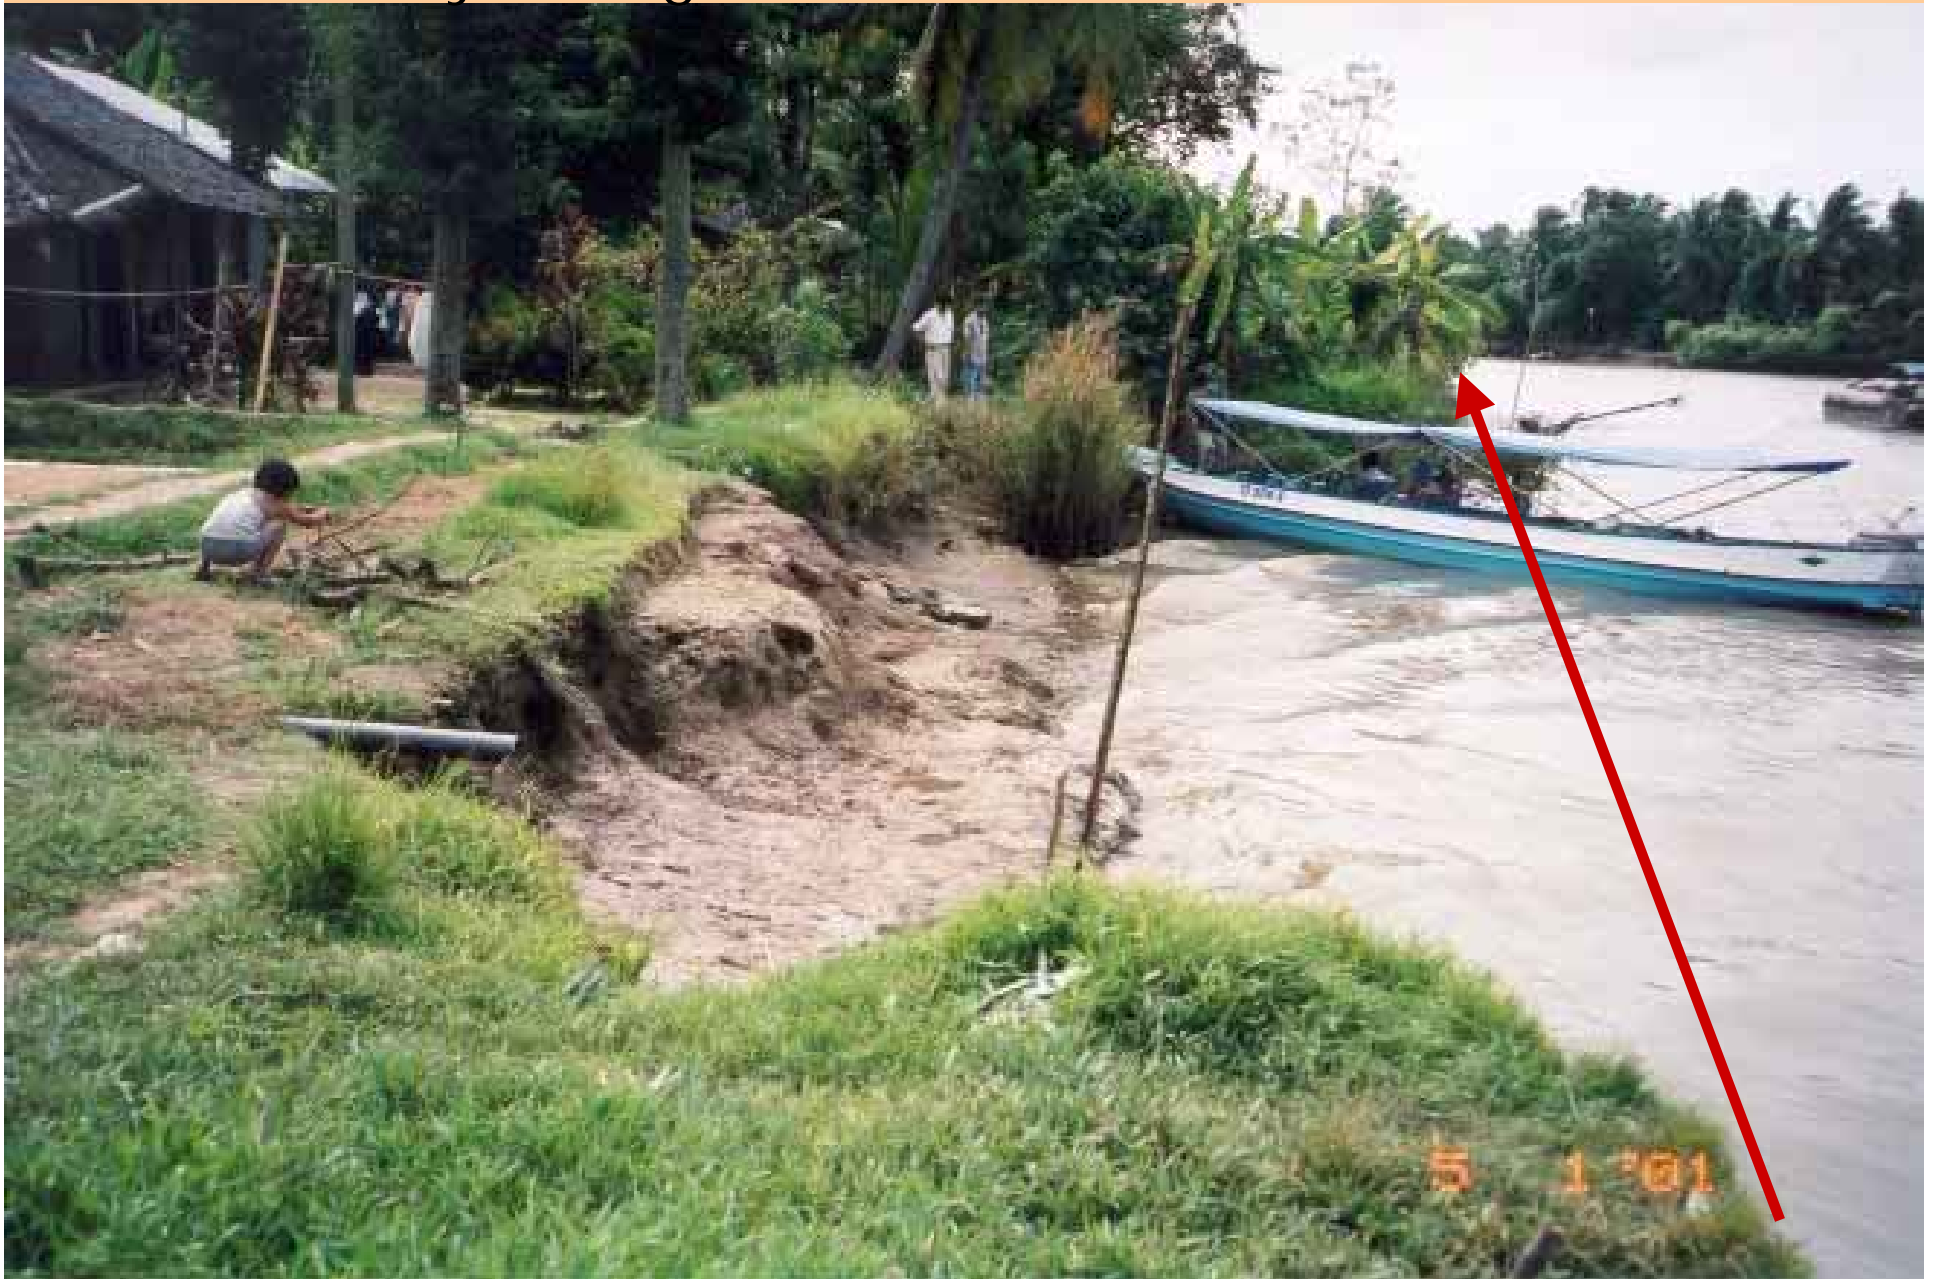
According to local residents, the red line indicates the position of the bank 3 years ago, at least 6m of land was lost.

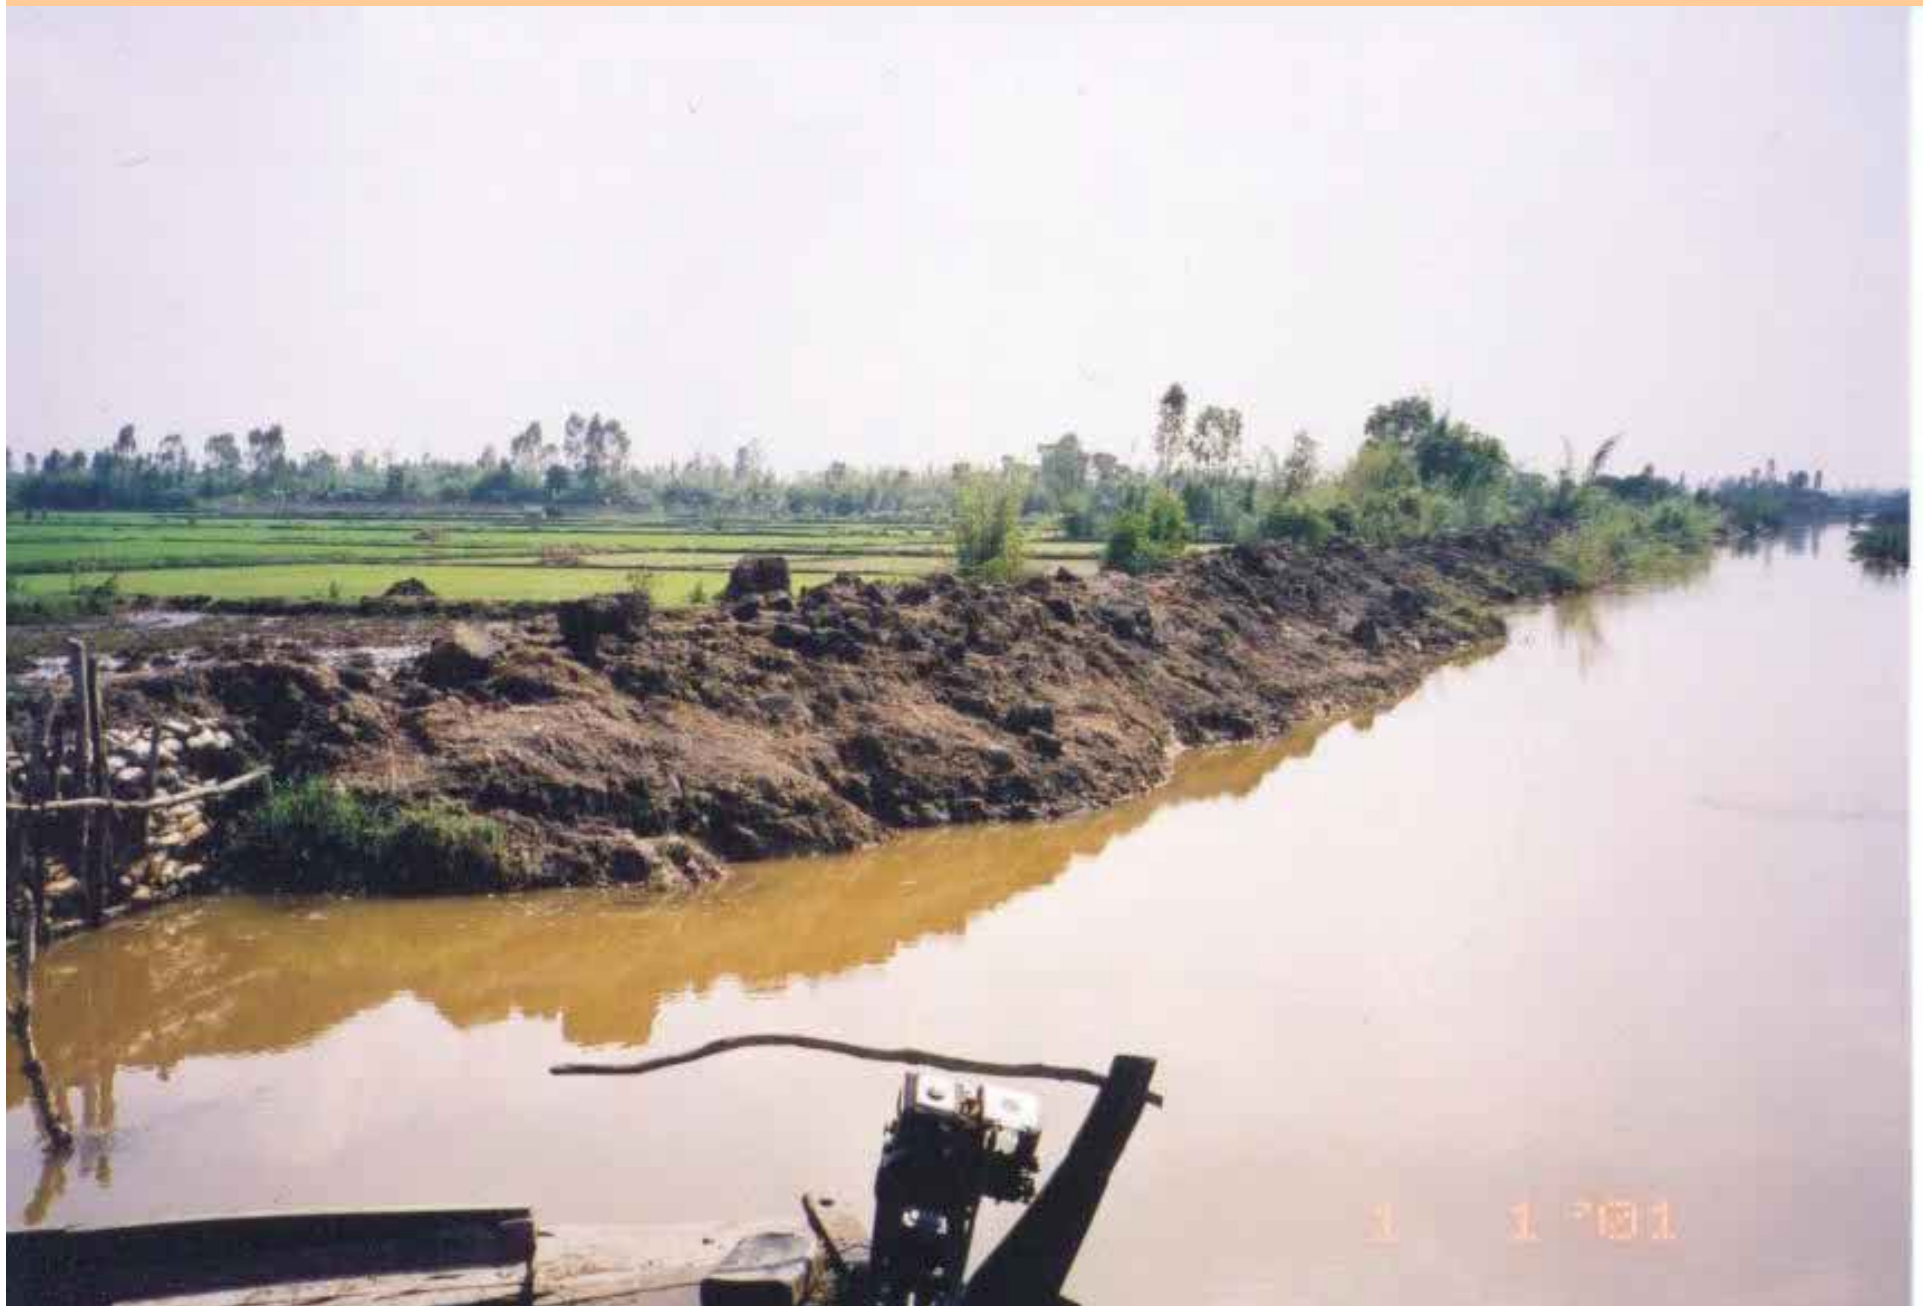
This canal bank was rebuilt with freshly dredged soil

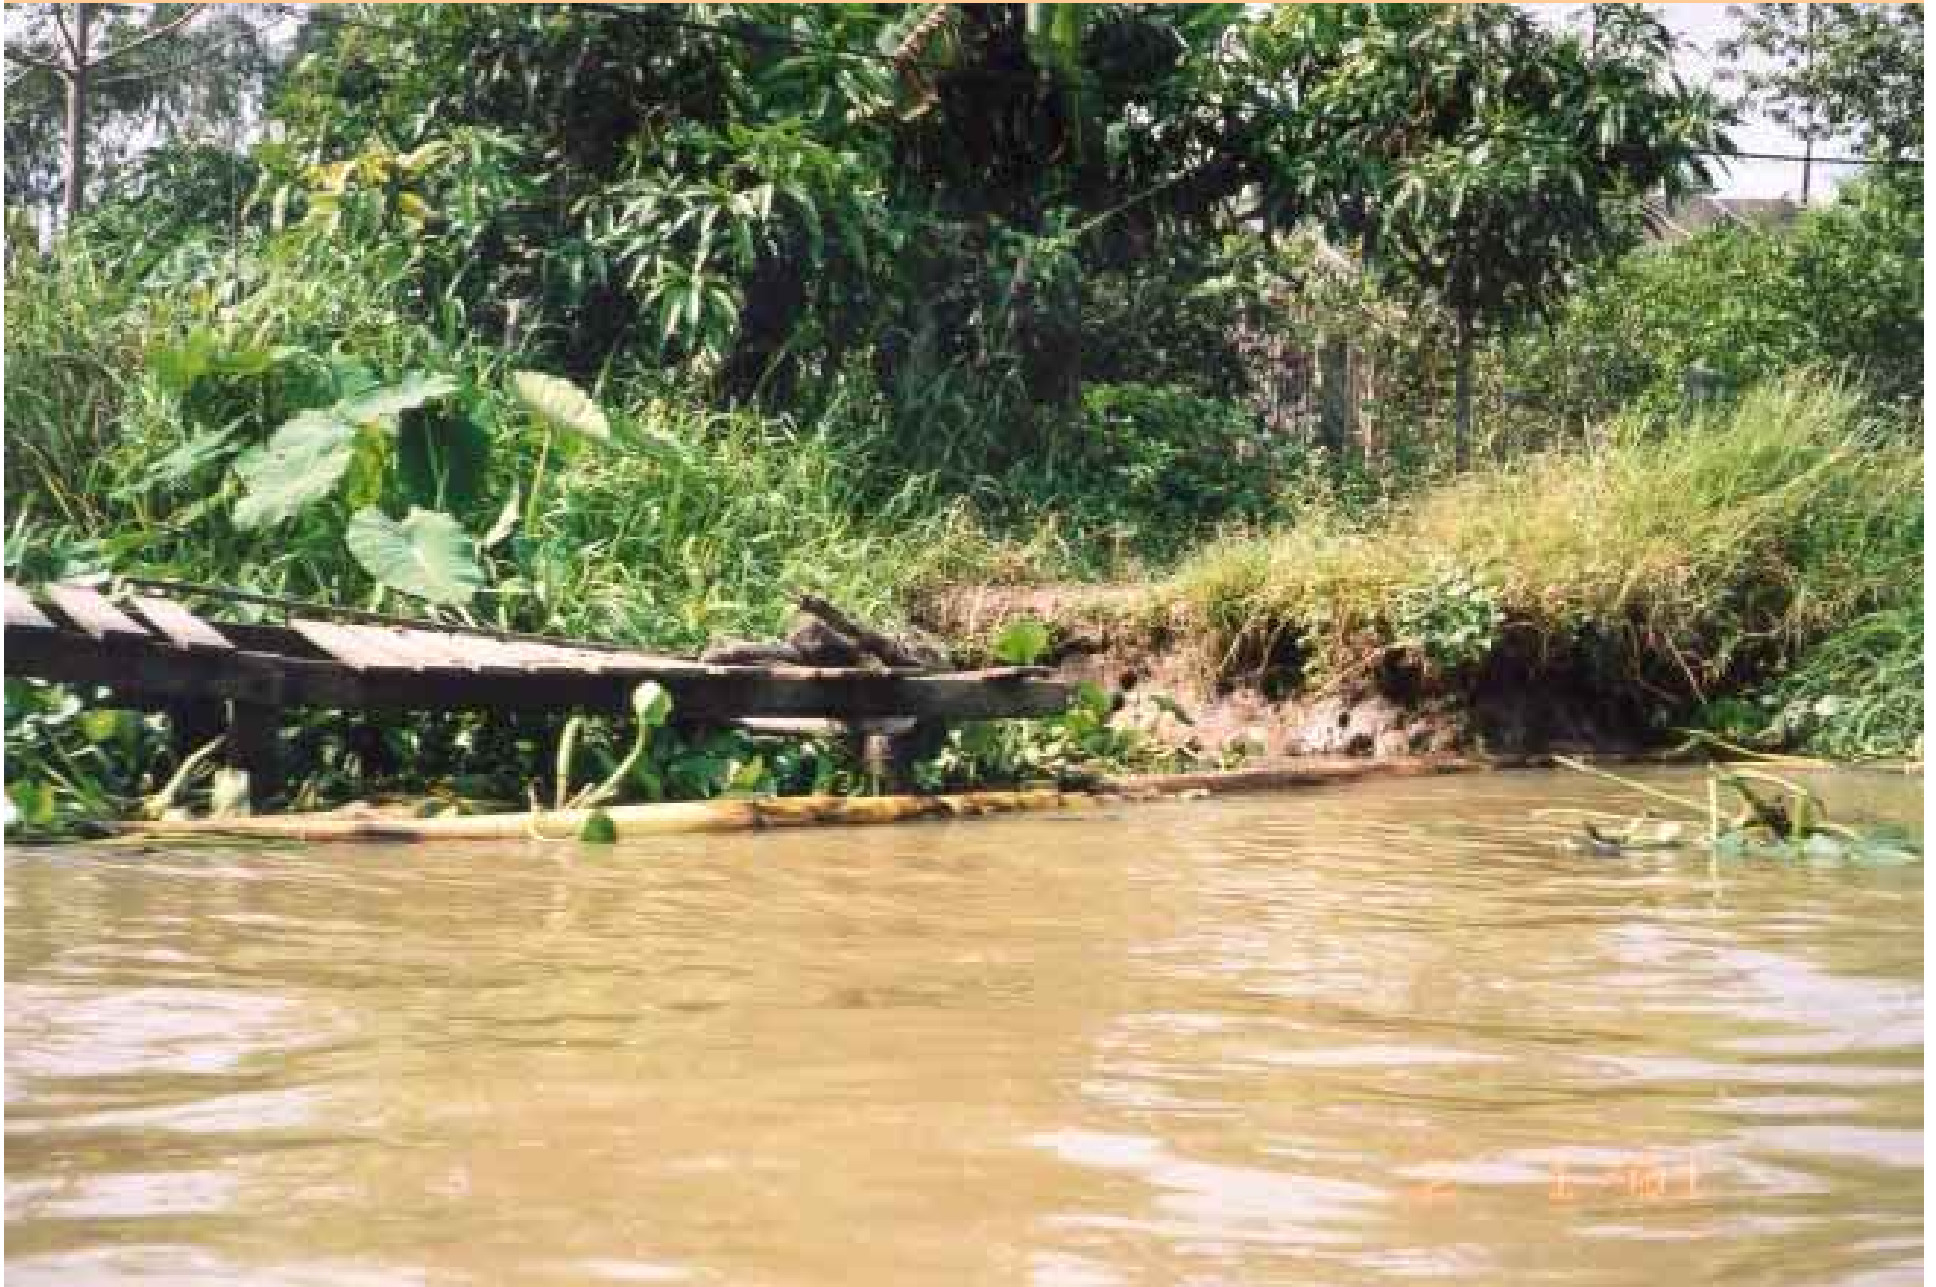
A wooden bridge abutment was washed away

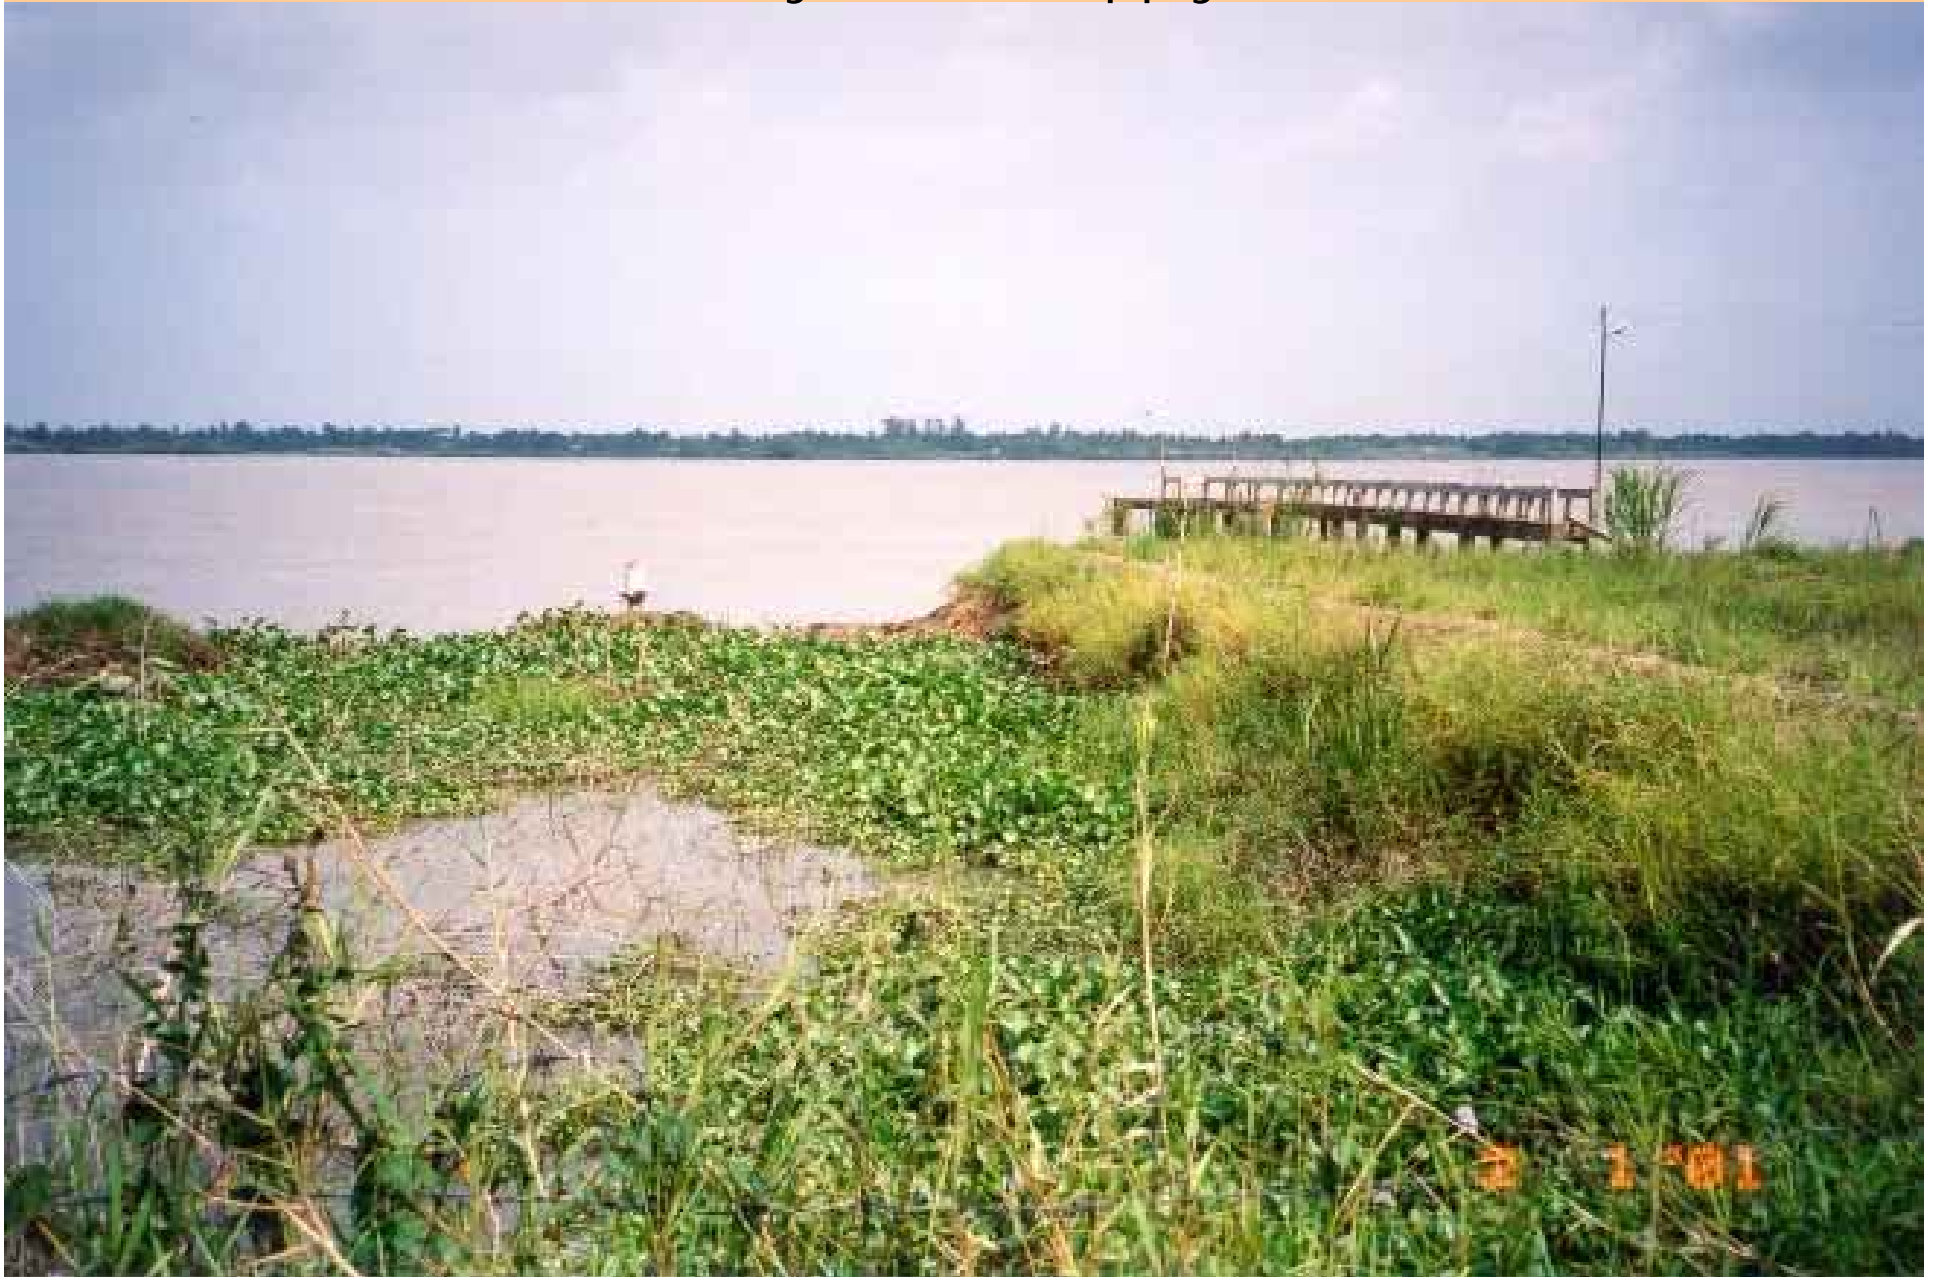
Active erosion occurs on the upstream side of the intake structure of Cantho City water supply on the Bassac bank

The water supply of Cantho City is in jeopardy as active erosion threatens the stability of the intake structure built on the bank of the Bassac river. Despite continuous effort and several major attempts to stabilise the site, erosion continues. In the past 3 years more than 10m of bank have been eroded.

It is predicted that at the current rate of erosion, the intake pipe will collapse in less than two years unless very costly measures are taken by the authority.

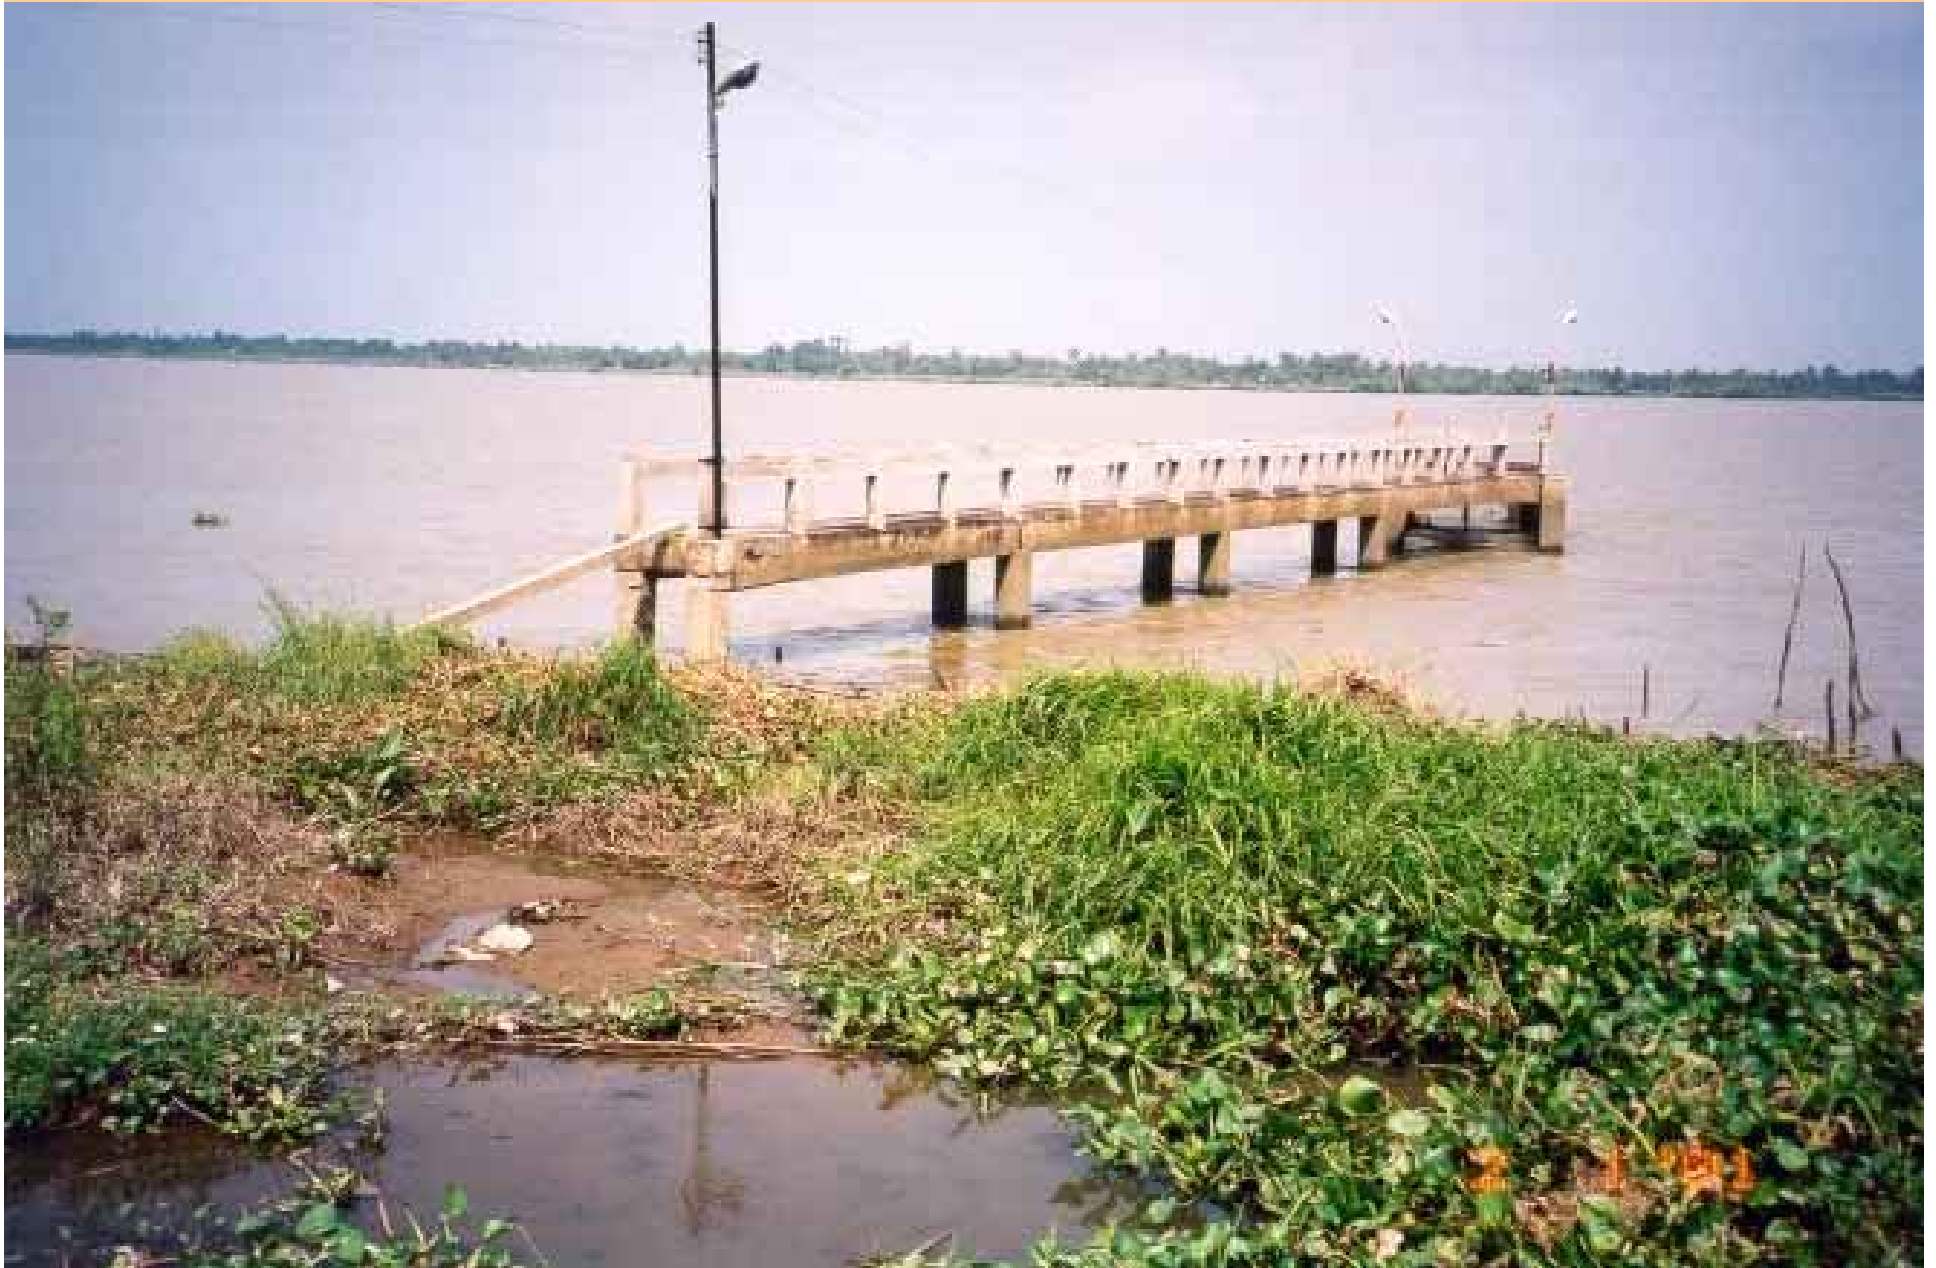
As well as on the downstream side of the structure

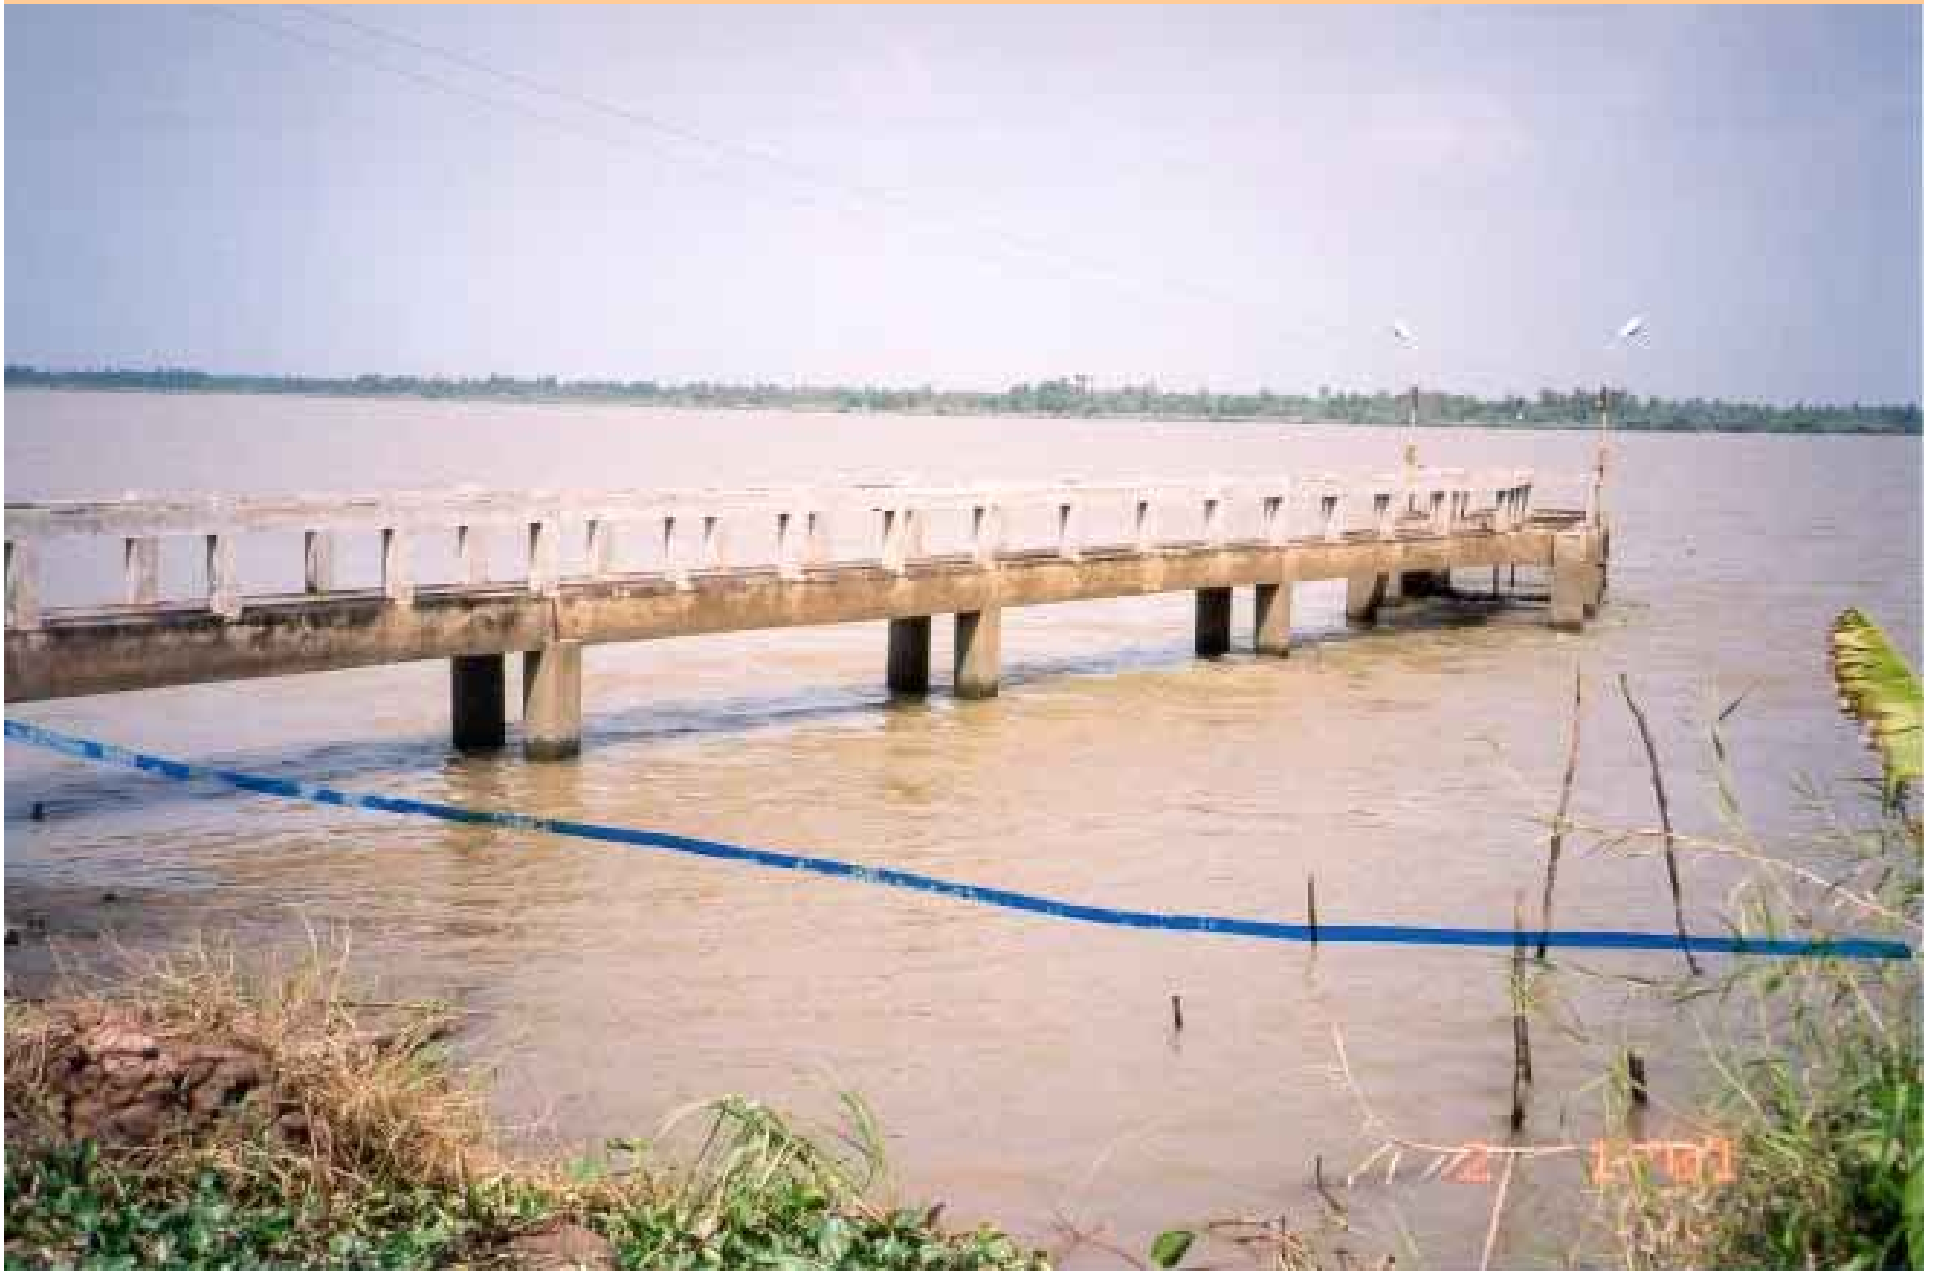
Blue line indicates the shore line 3 years ago on the downstream side
