THE VANISHING DELTA

A Pictorial Essay on the Riverbank Erosion in the Mekong Delta, Viet Nam and a Proposed Remediation Plan

Dr. Paul Truong

**The Vetiver Network East Asia and South
Pacific Representative, Brisbane, Australia**

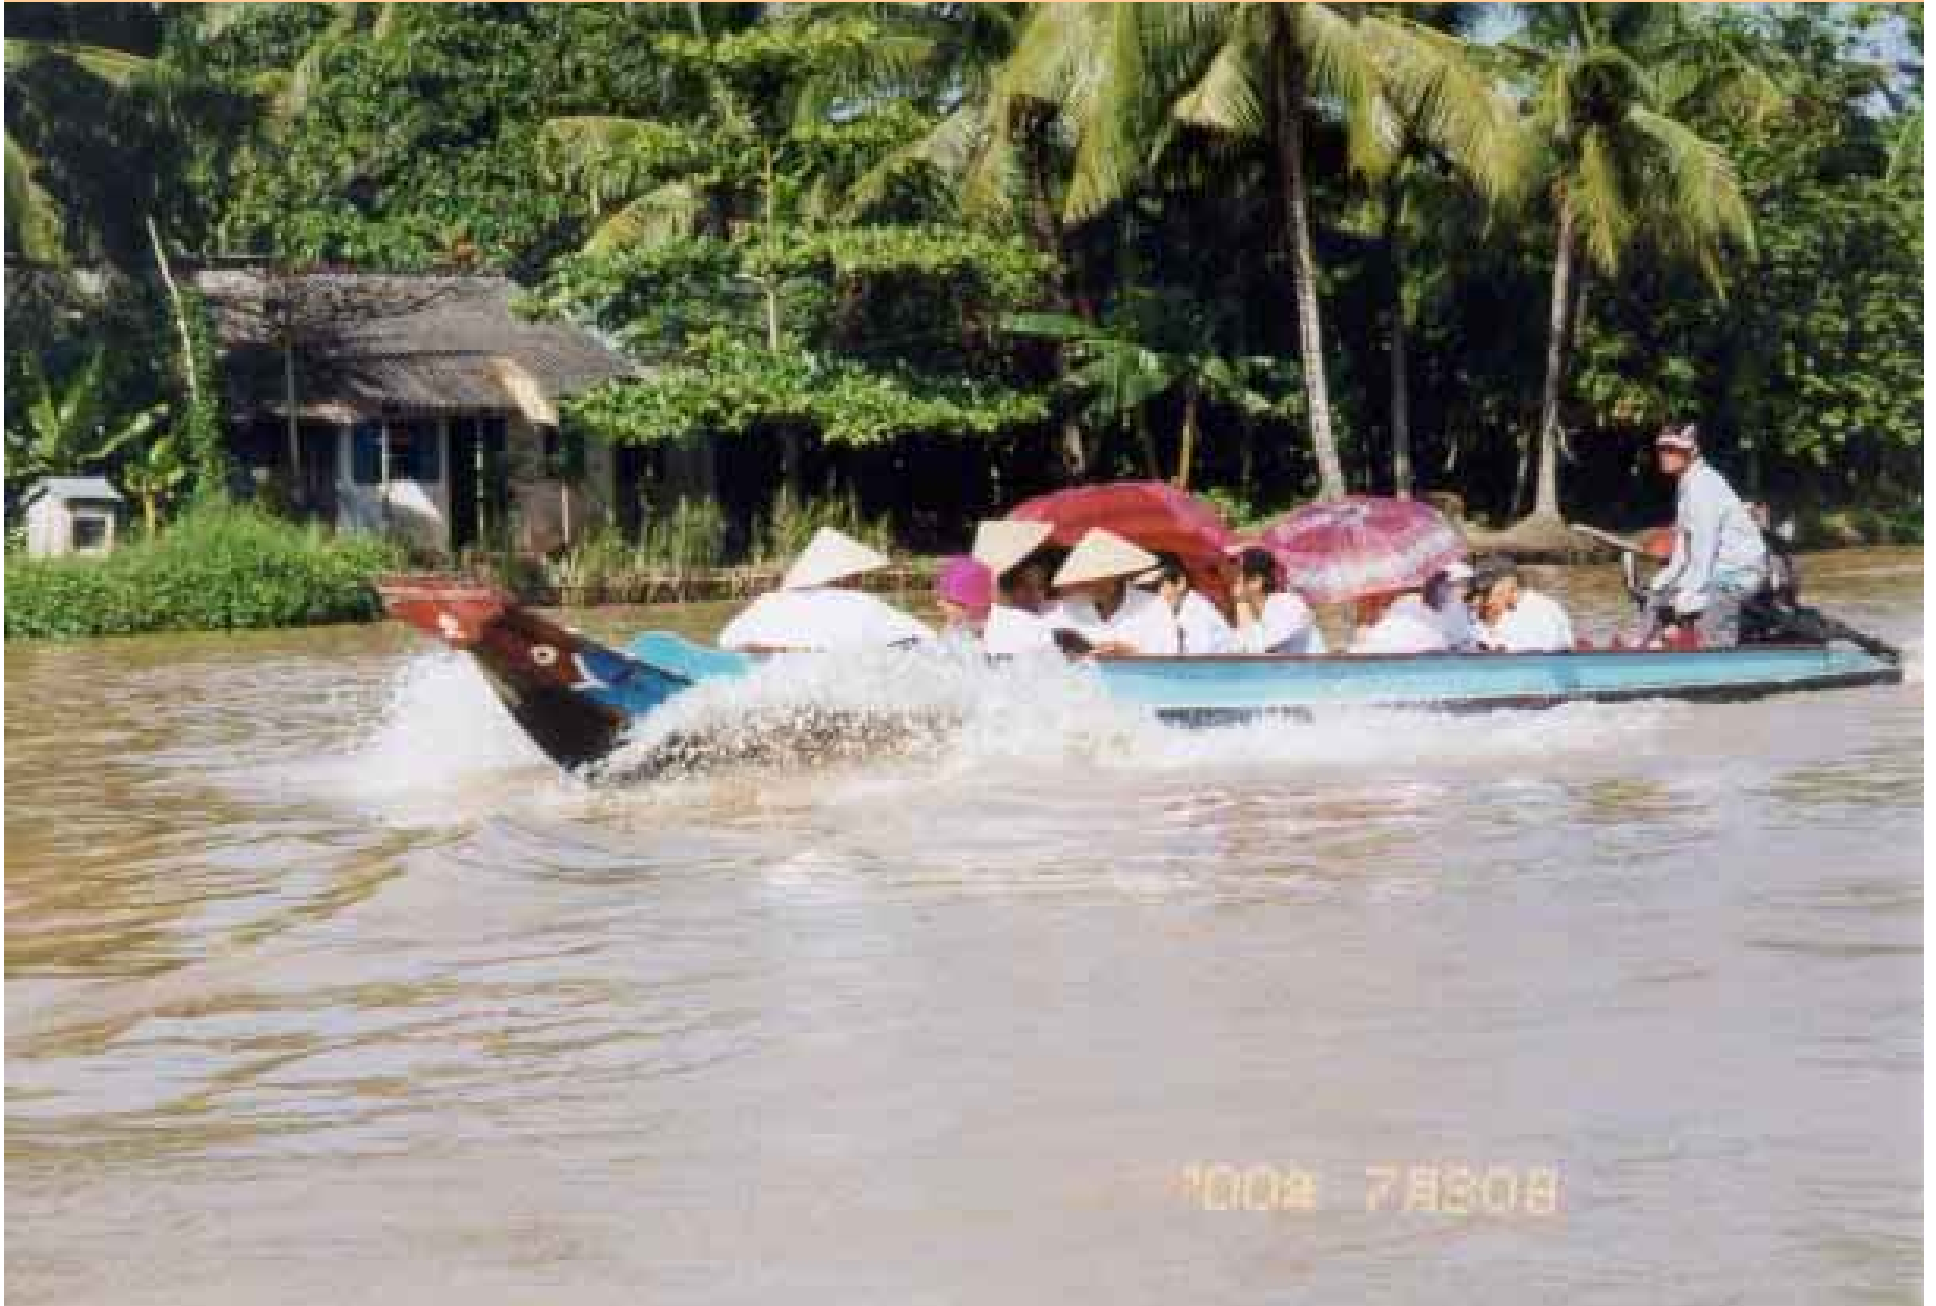
At high speed they create very destructive waves

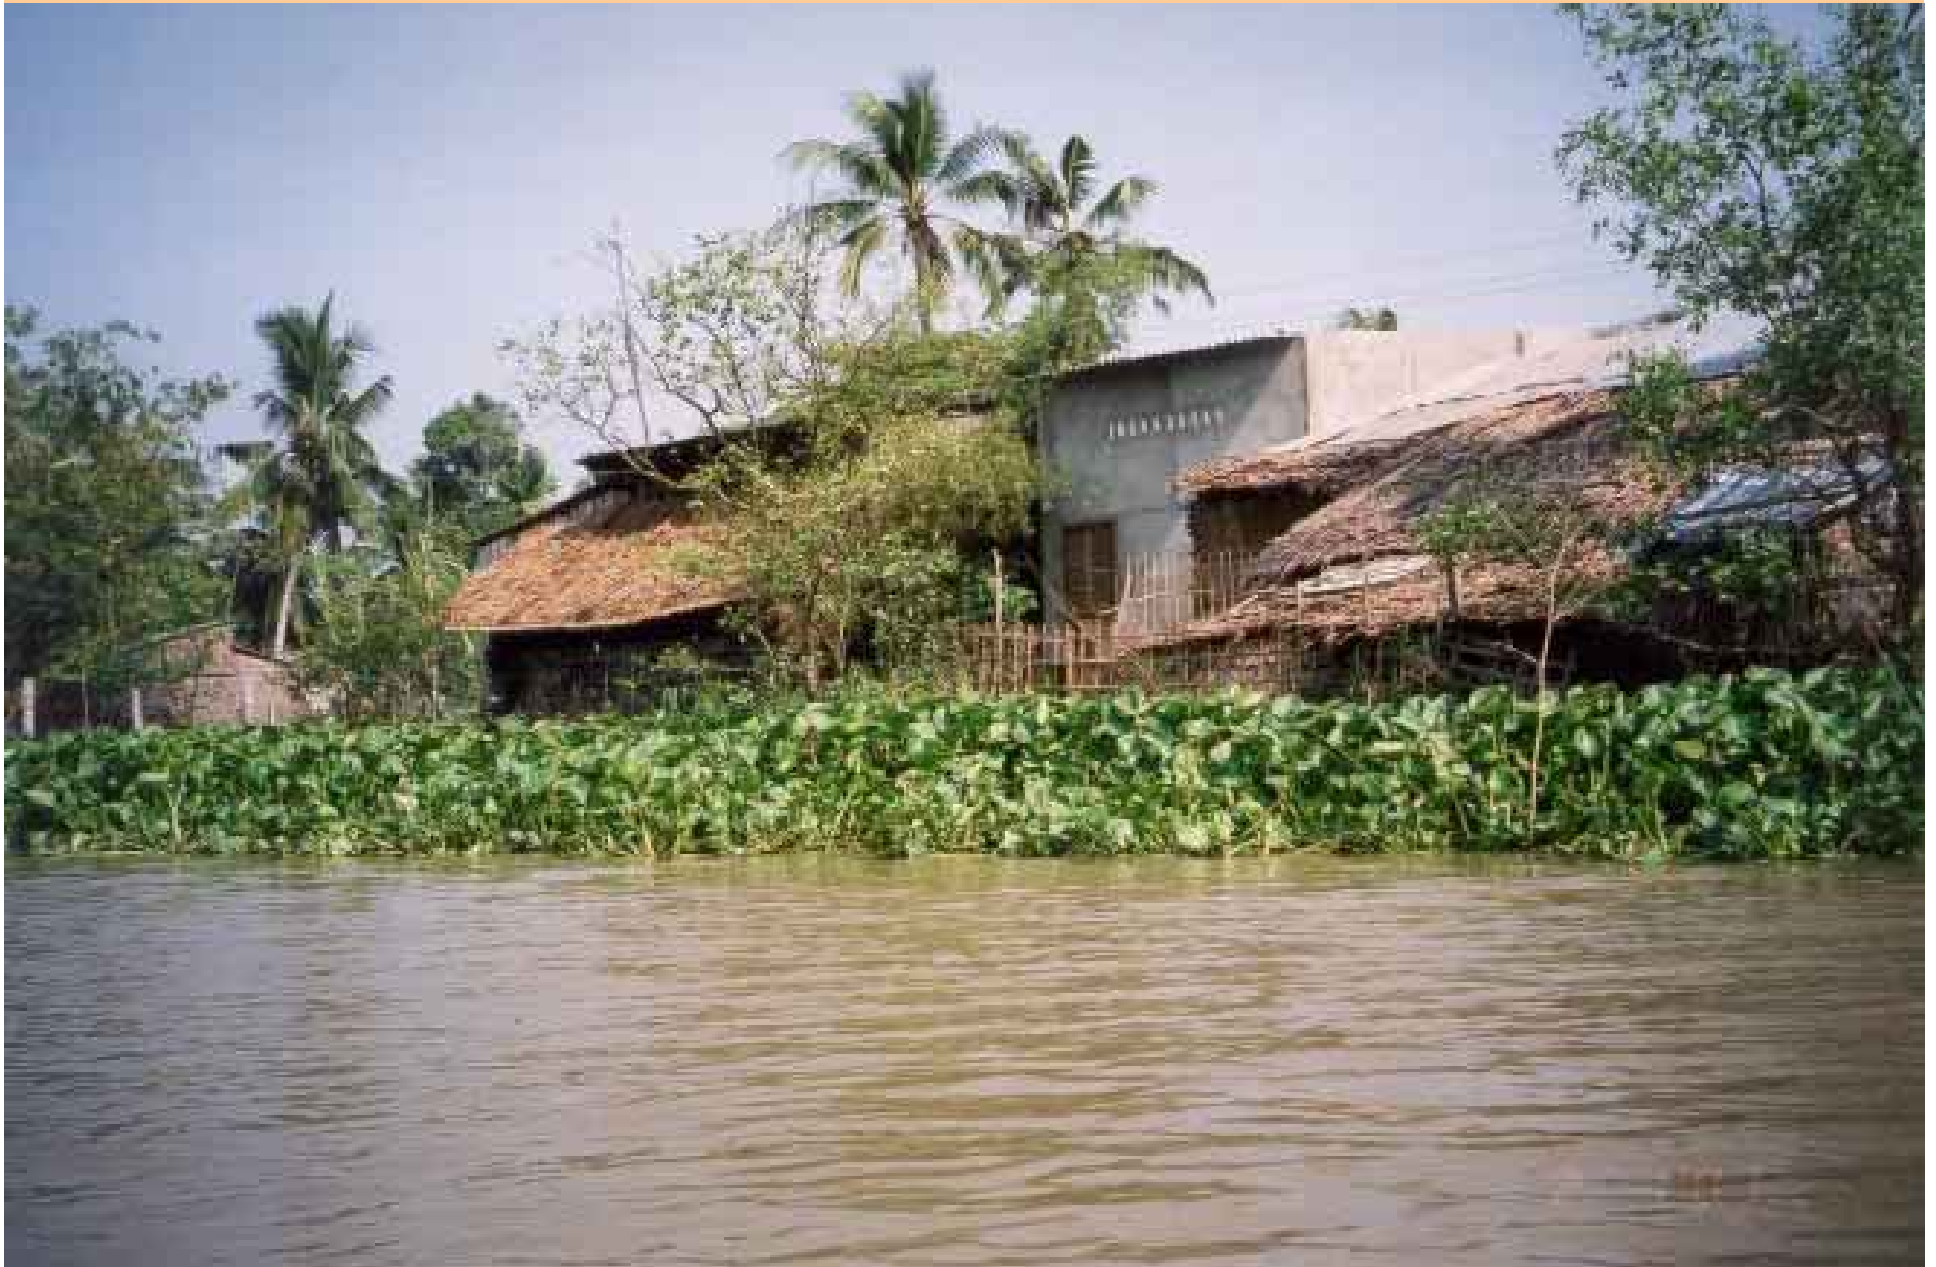
Water hyacinth is kept in place by a bamboo barrier to stop waves from reaching the shore

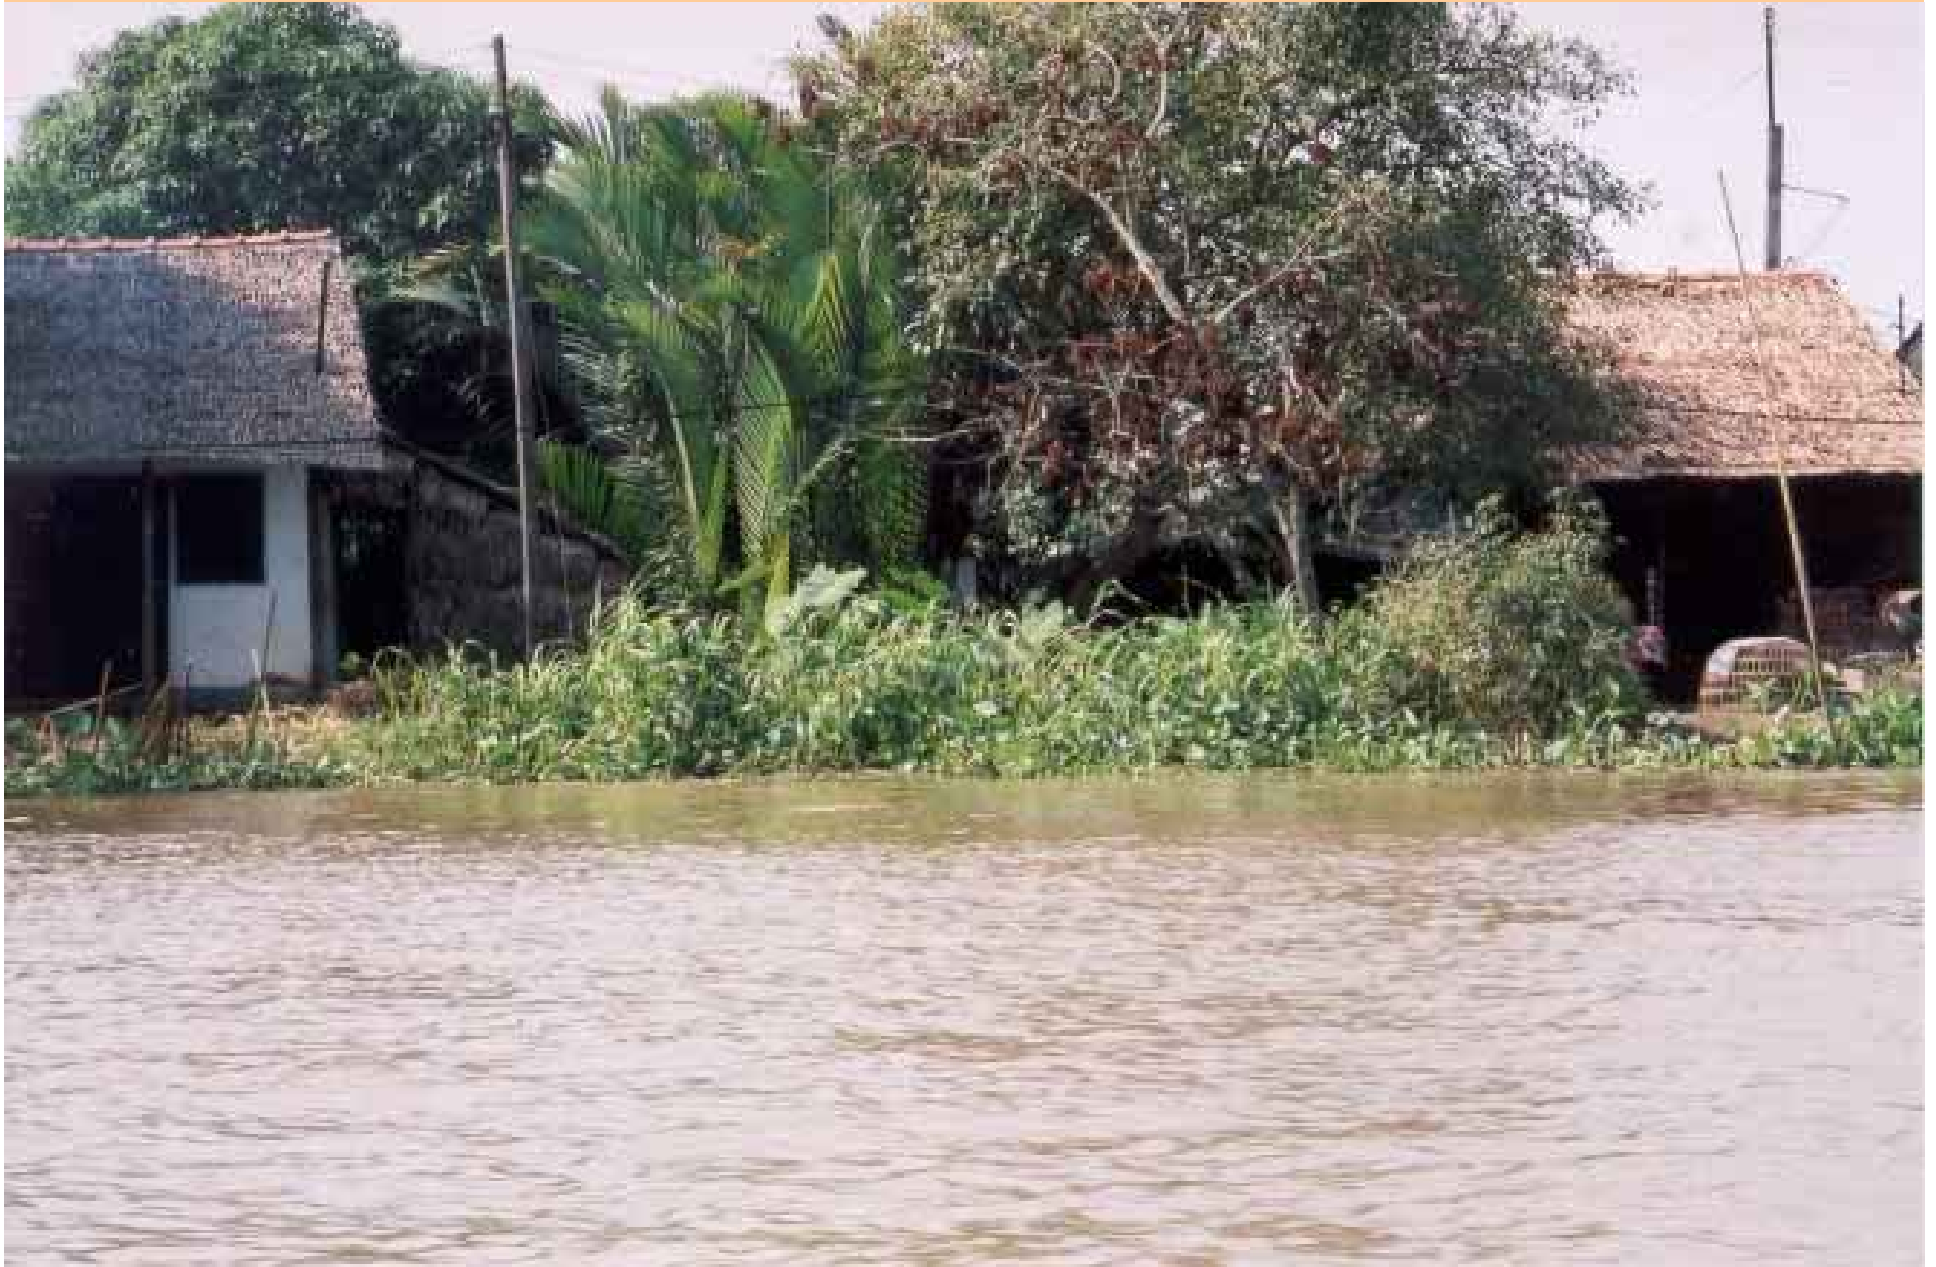
Water hyacinth is retained by Phragmites

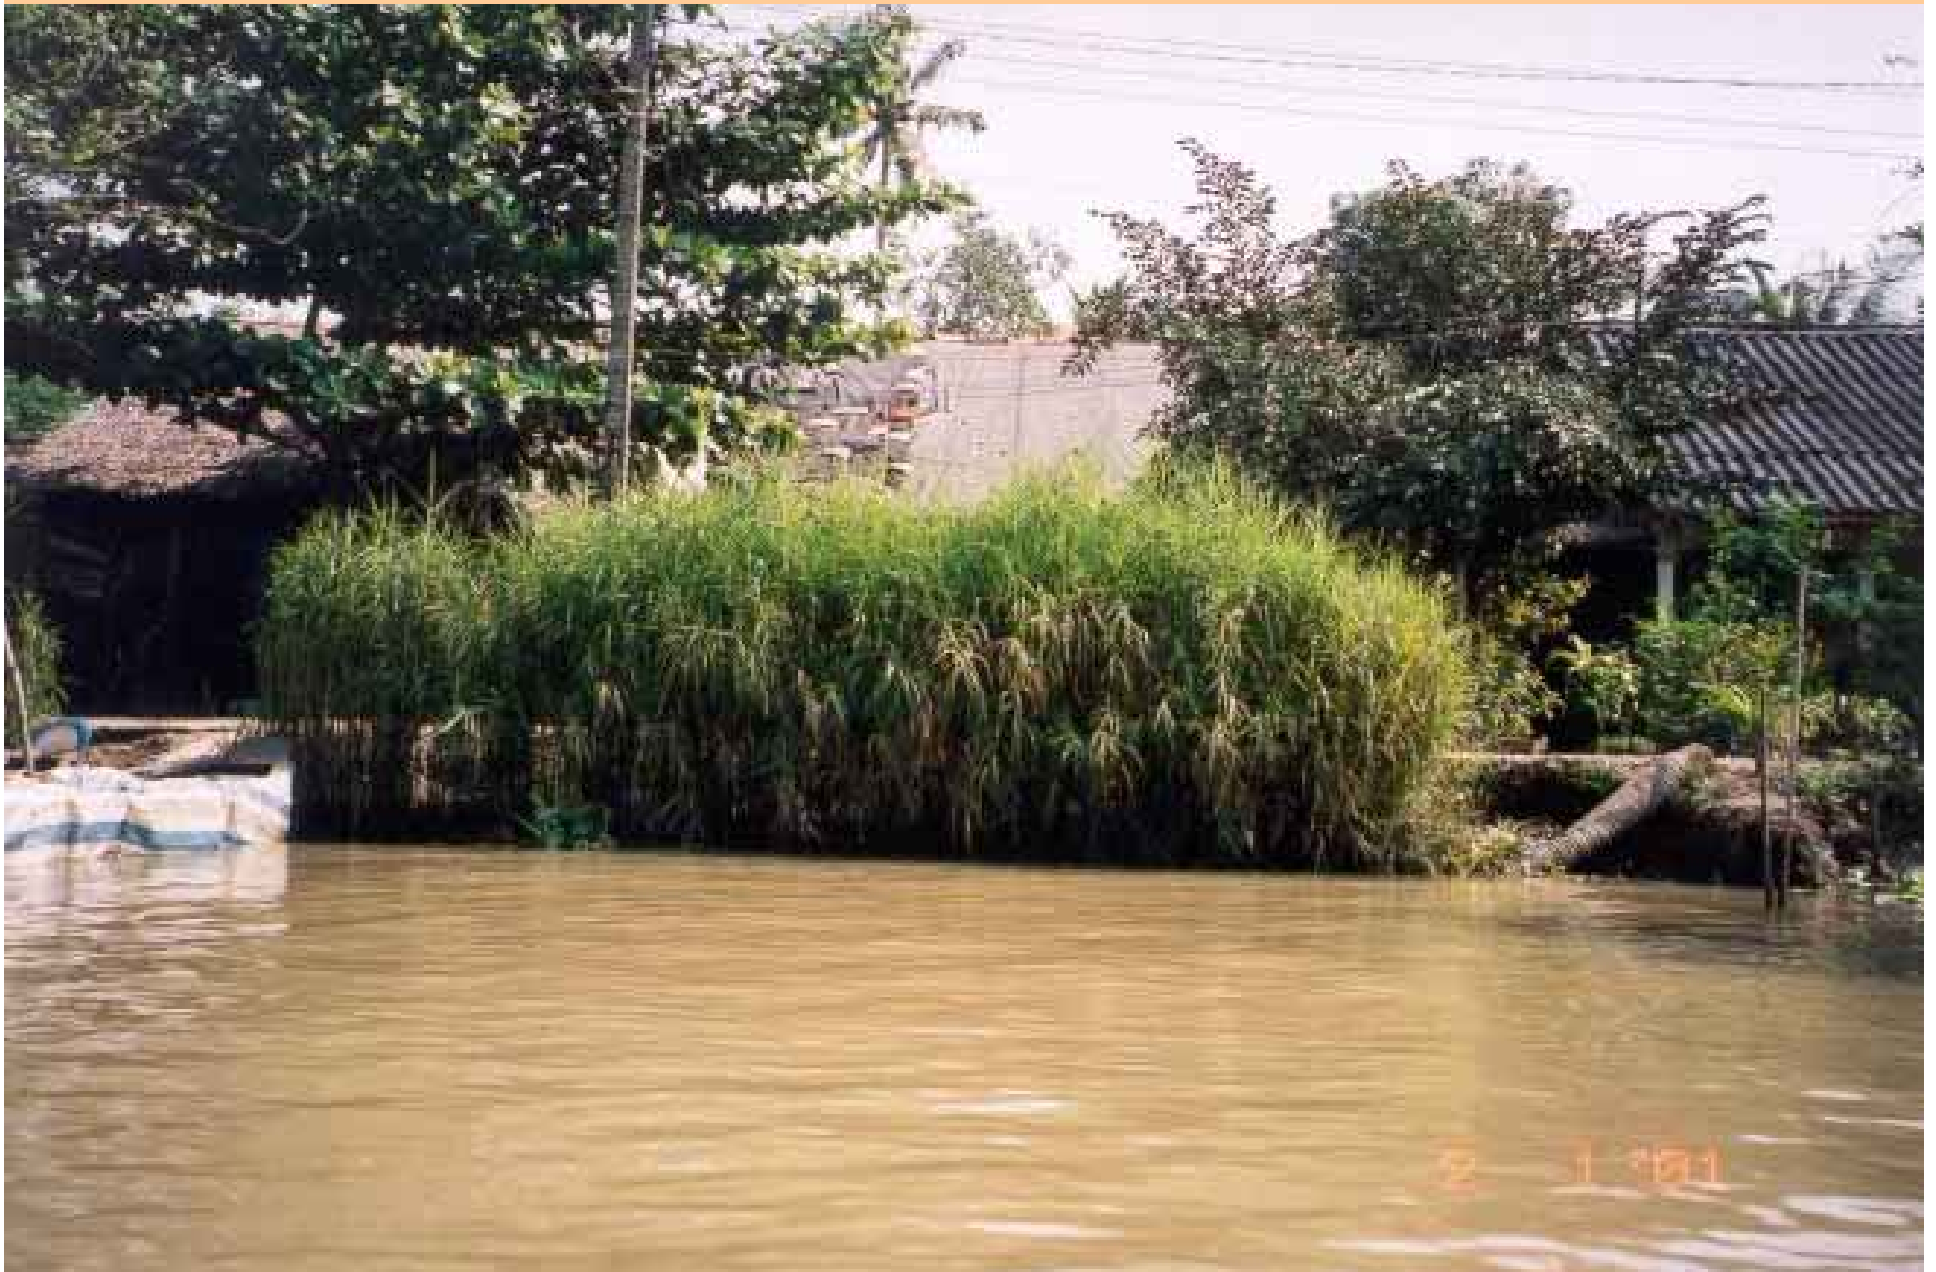
This Phragmites barrier look very impressive from the front

But erosion continues to happen behind its “back” as waves from unprotected section upstream got behind it

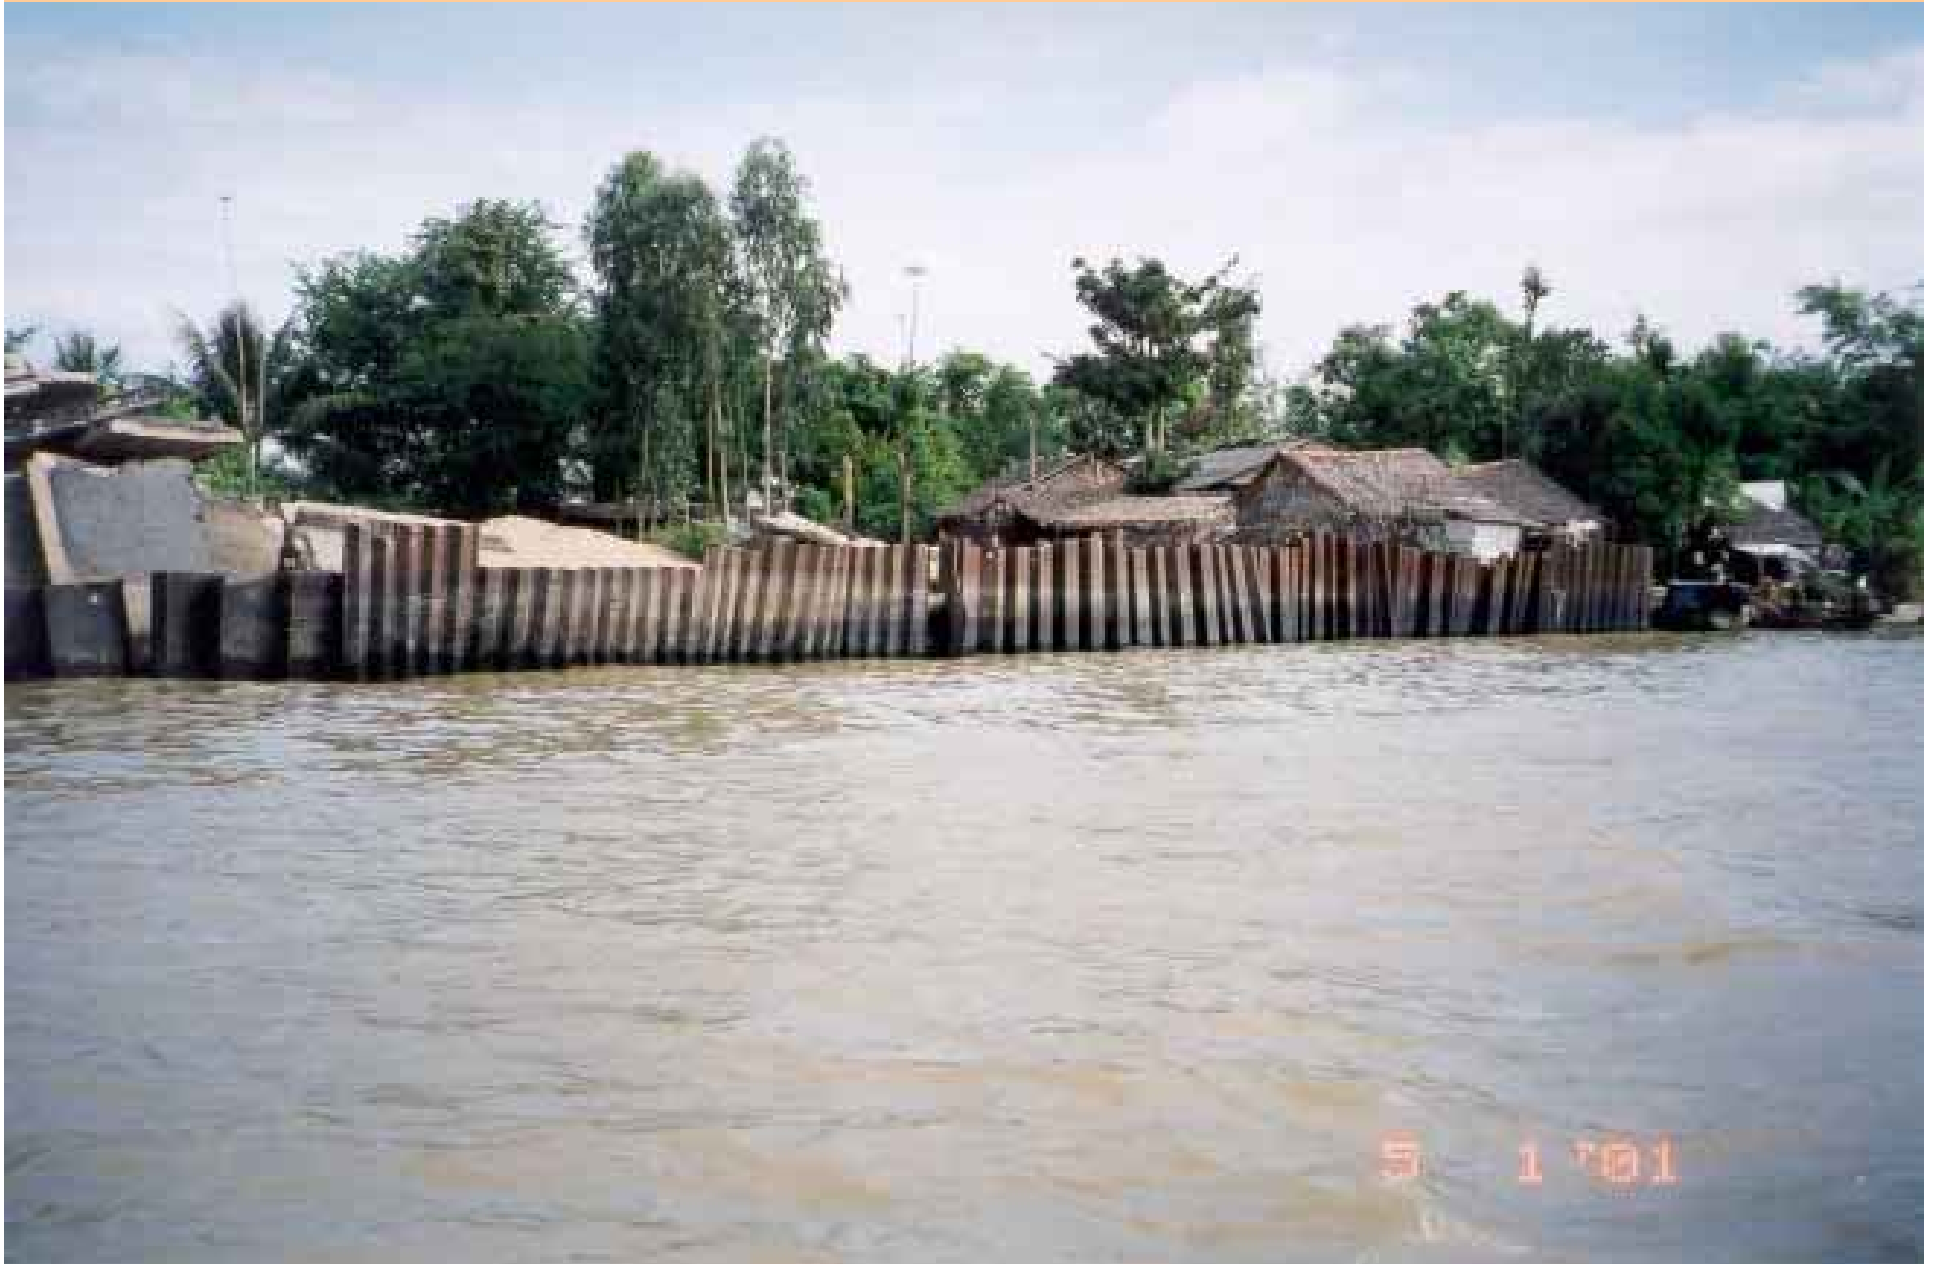
And ultimately, a steel wall, normally used for wharf construction is needed to protect this factory

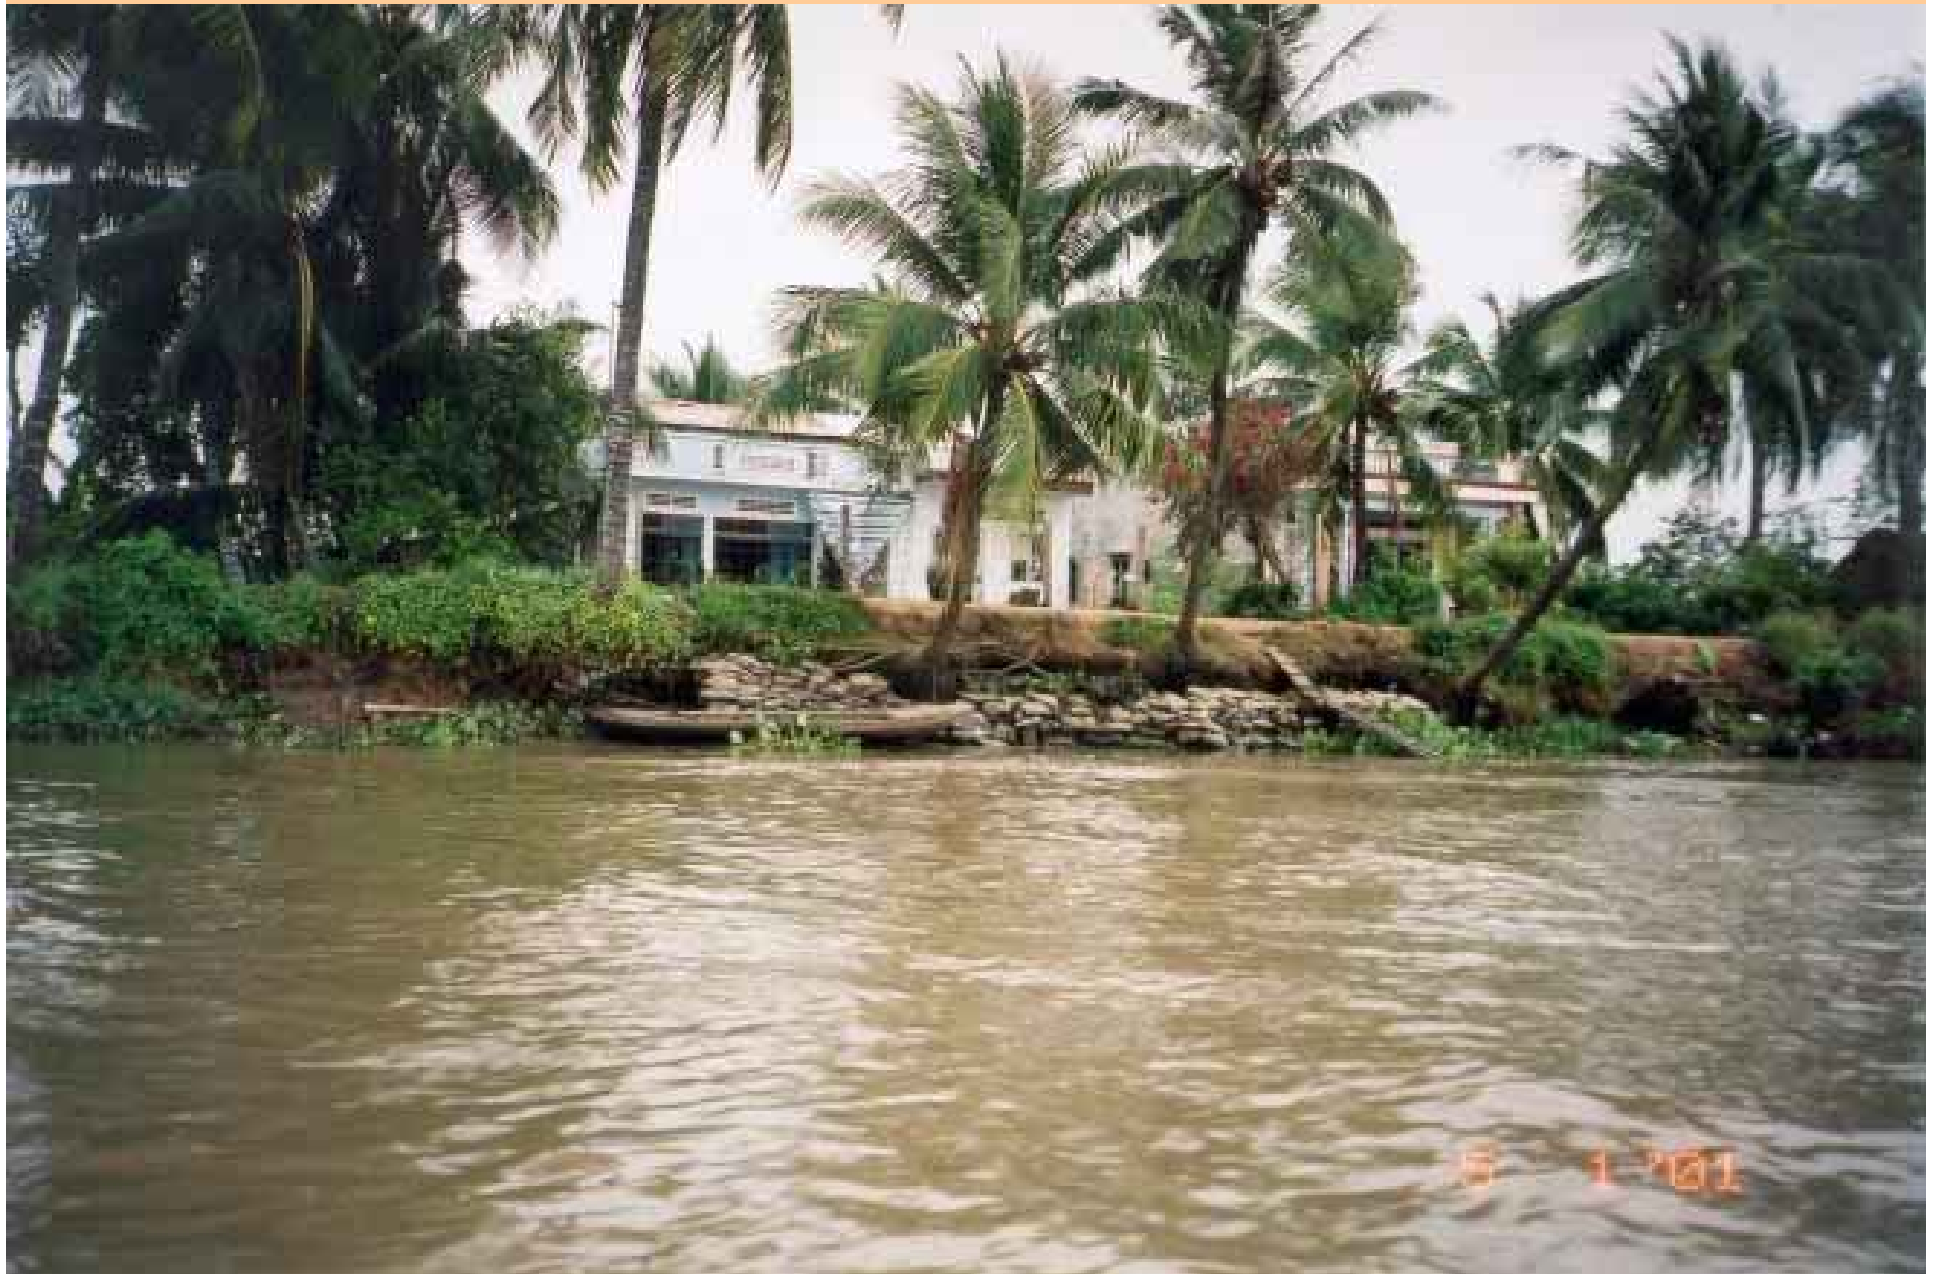
Erosion behind sand bags

Inherently, most of these structures are not stable as they are built on the *soft and highly erodible alluvial foundation*

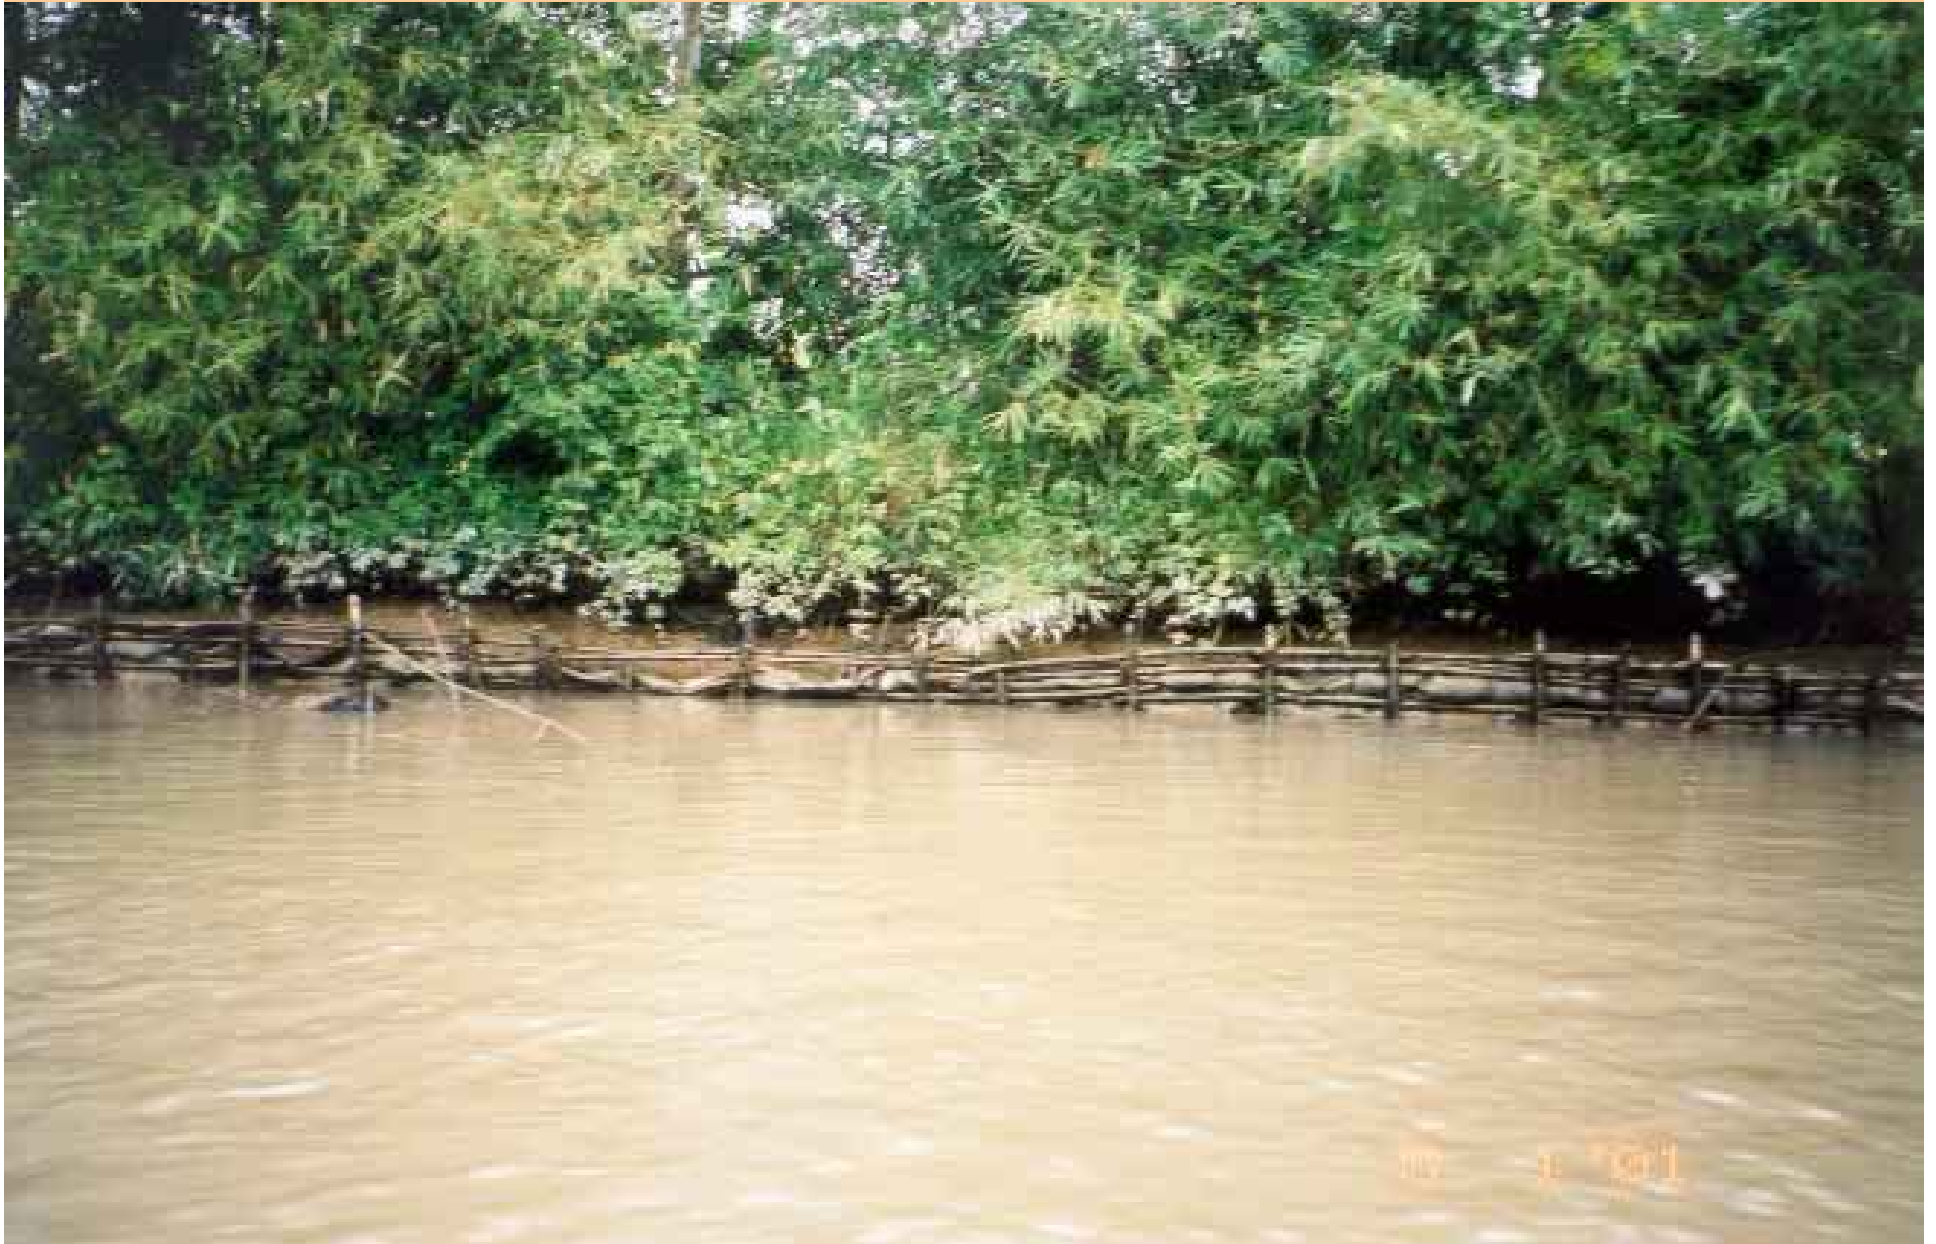
Collapse of wooden barrier due to lack of maintenance and eroded foundation

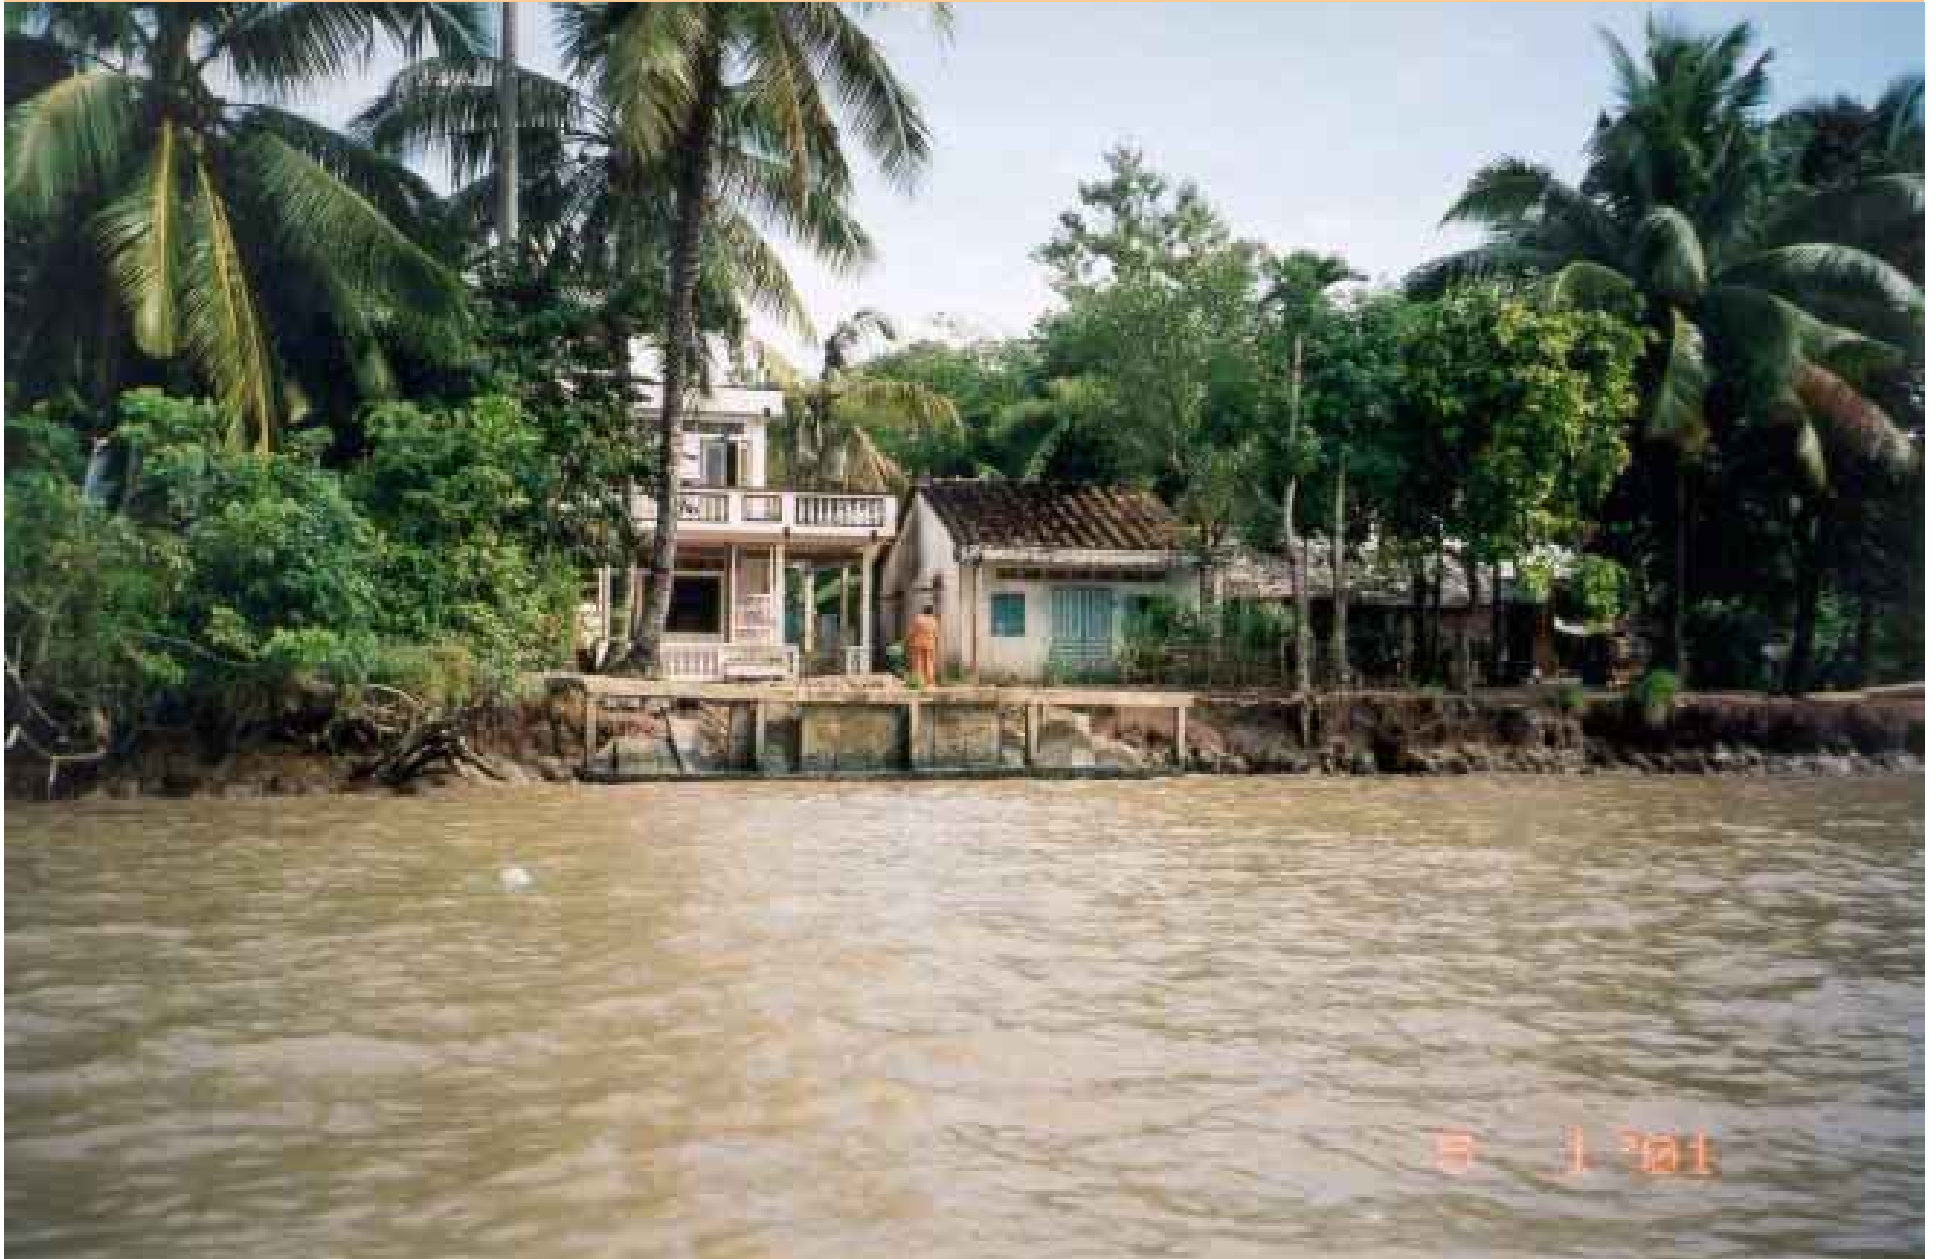
Collapse of concrete wall due to lack of maintenance and eroded foundation

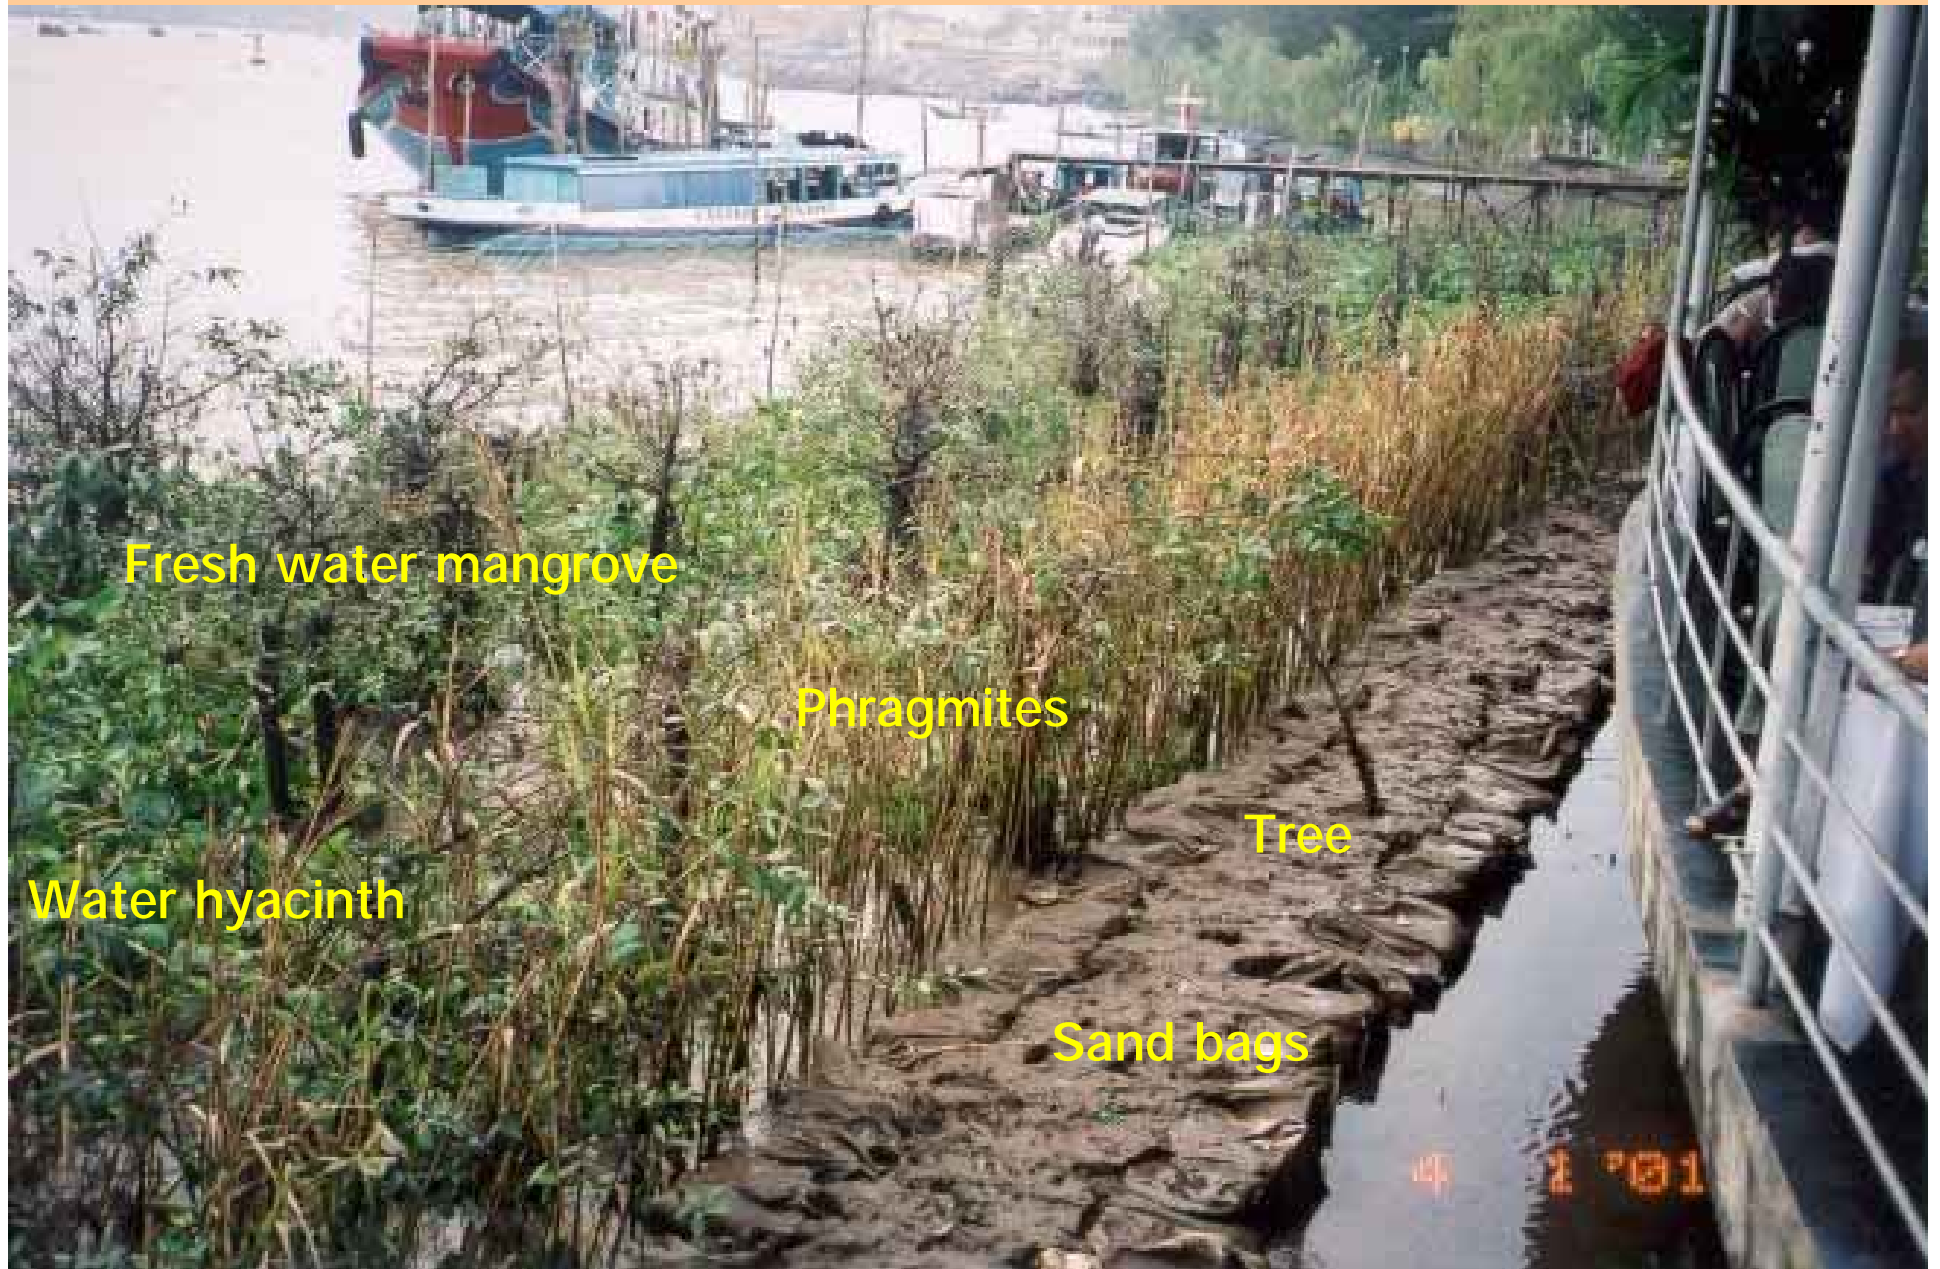
A highly elaborate defense set up

Fresh water mangrove

Phragmites

Tree

Water hyacinth

Sand bags

Transplanted mature mangrove
