THE VANISHING DELTA

A Pictorial Essay on the Riverbank Erosion in the Mekong Delta, Viet Nam and a Proposed Remediation Plan

Dr. Paul Truong

**The Vetiver Network East Asia and South
Pacific Representative, Brisbane, Australia**

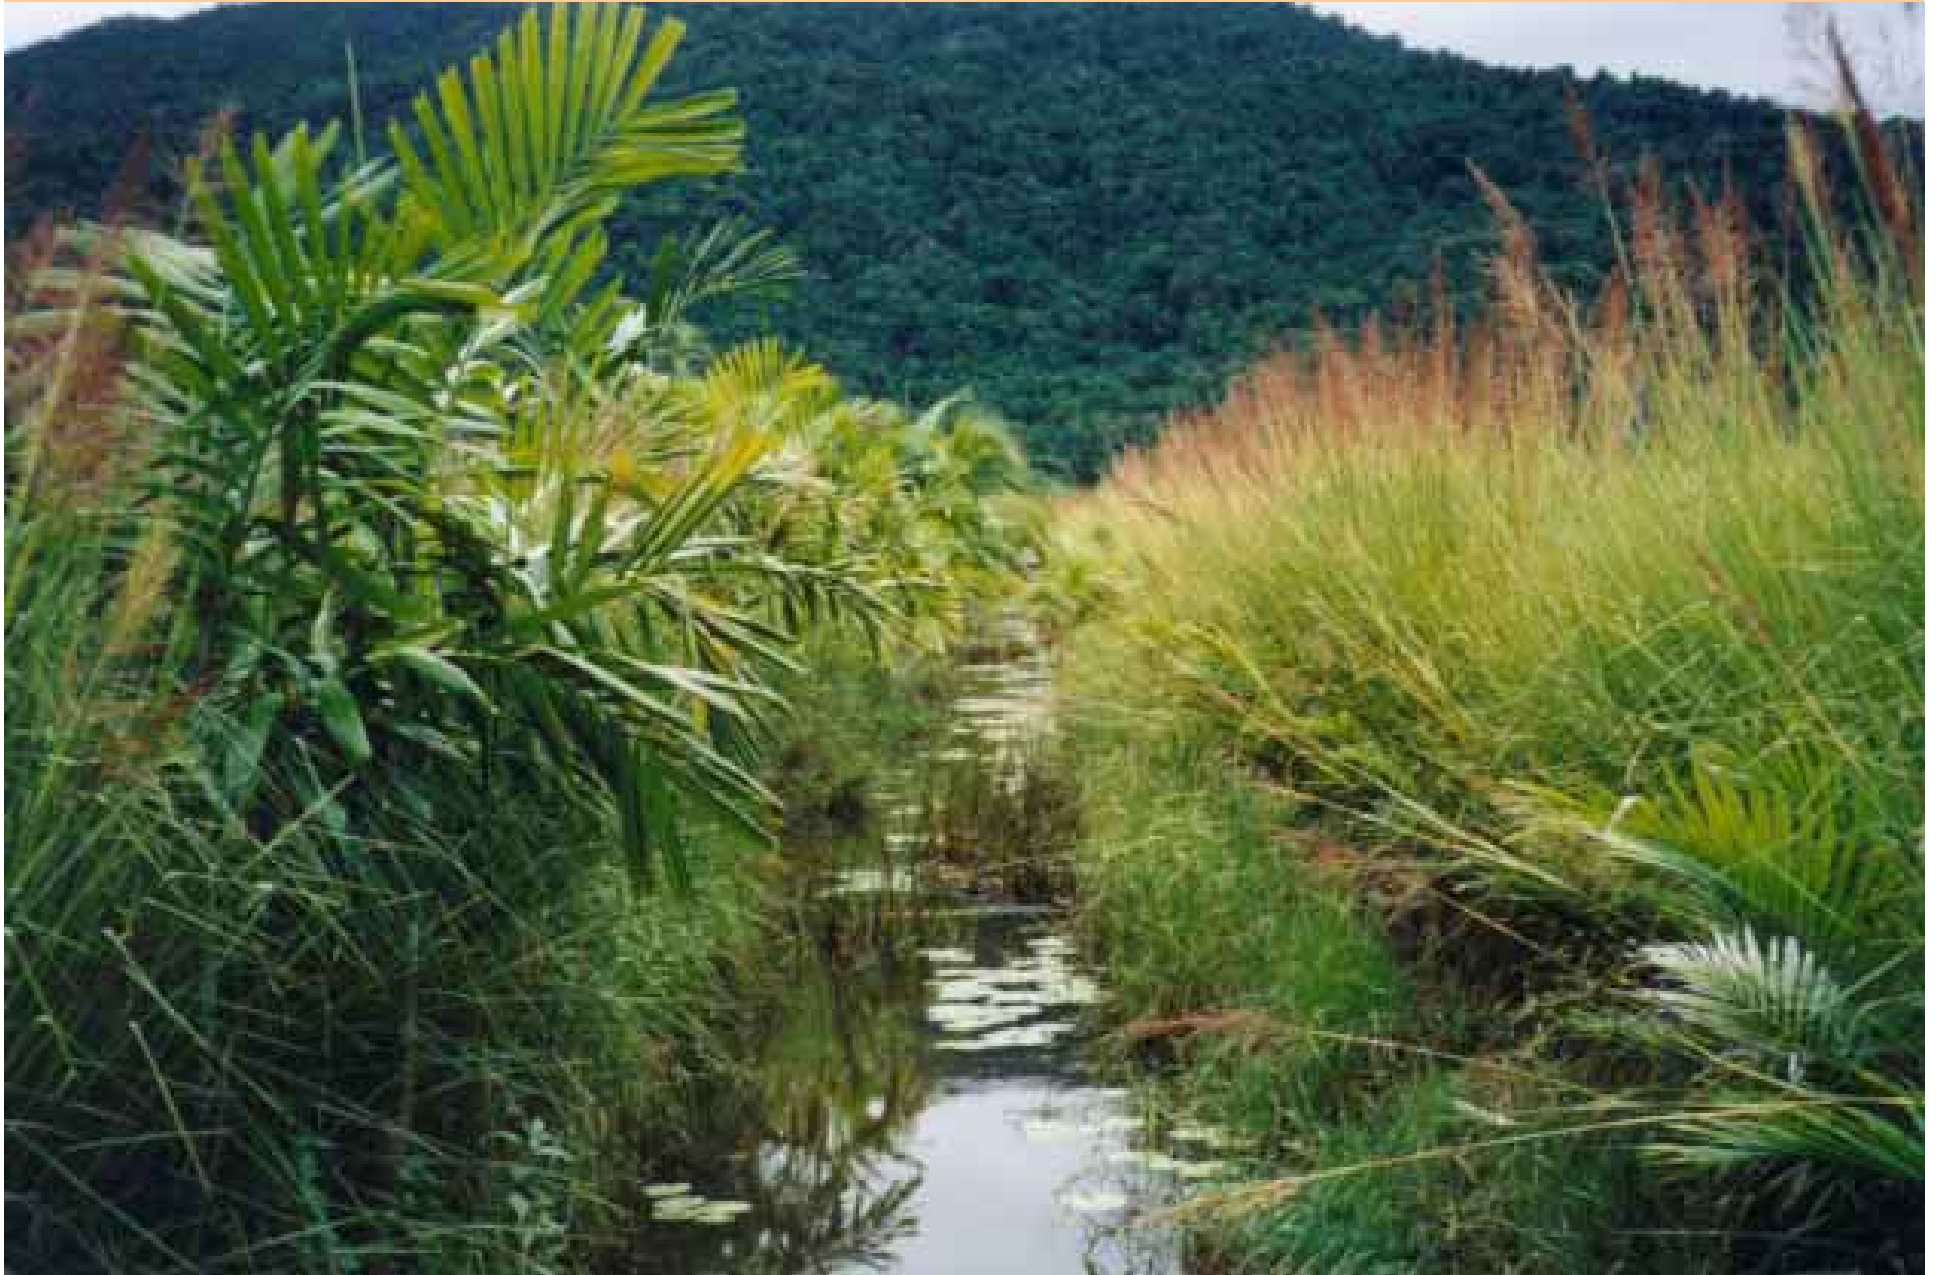
Tolerance to Acid Sulfate Soils: Vetiver planted to stabilise the banks on this highly erodible acid sulfate soil in coastal Queensland

One year after planting

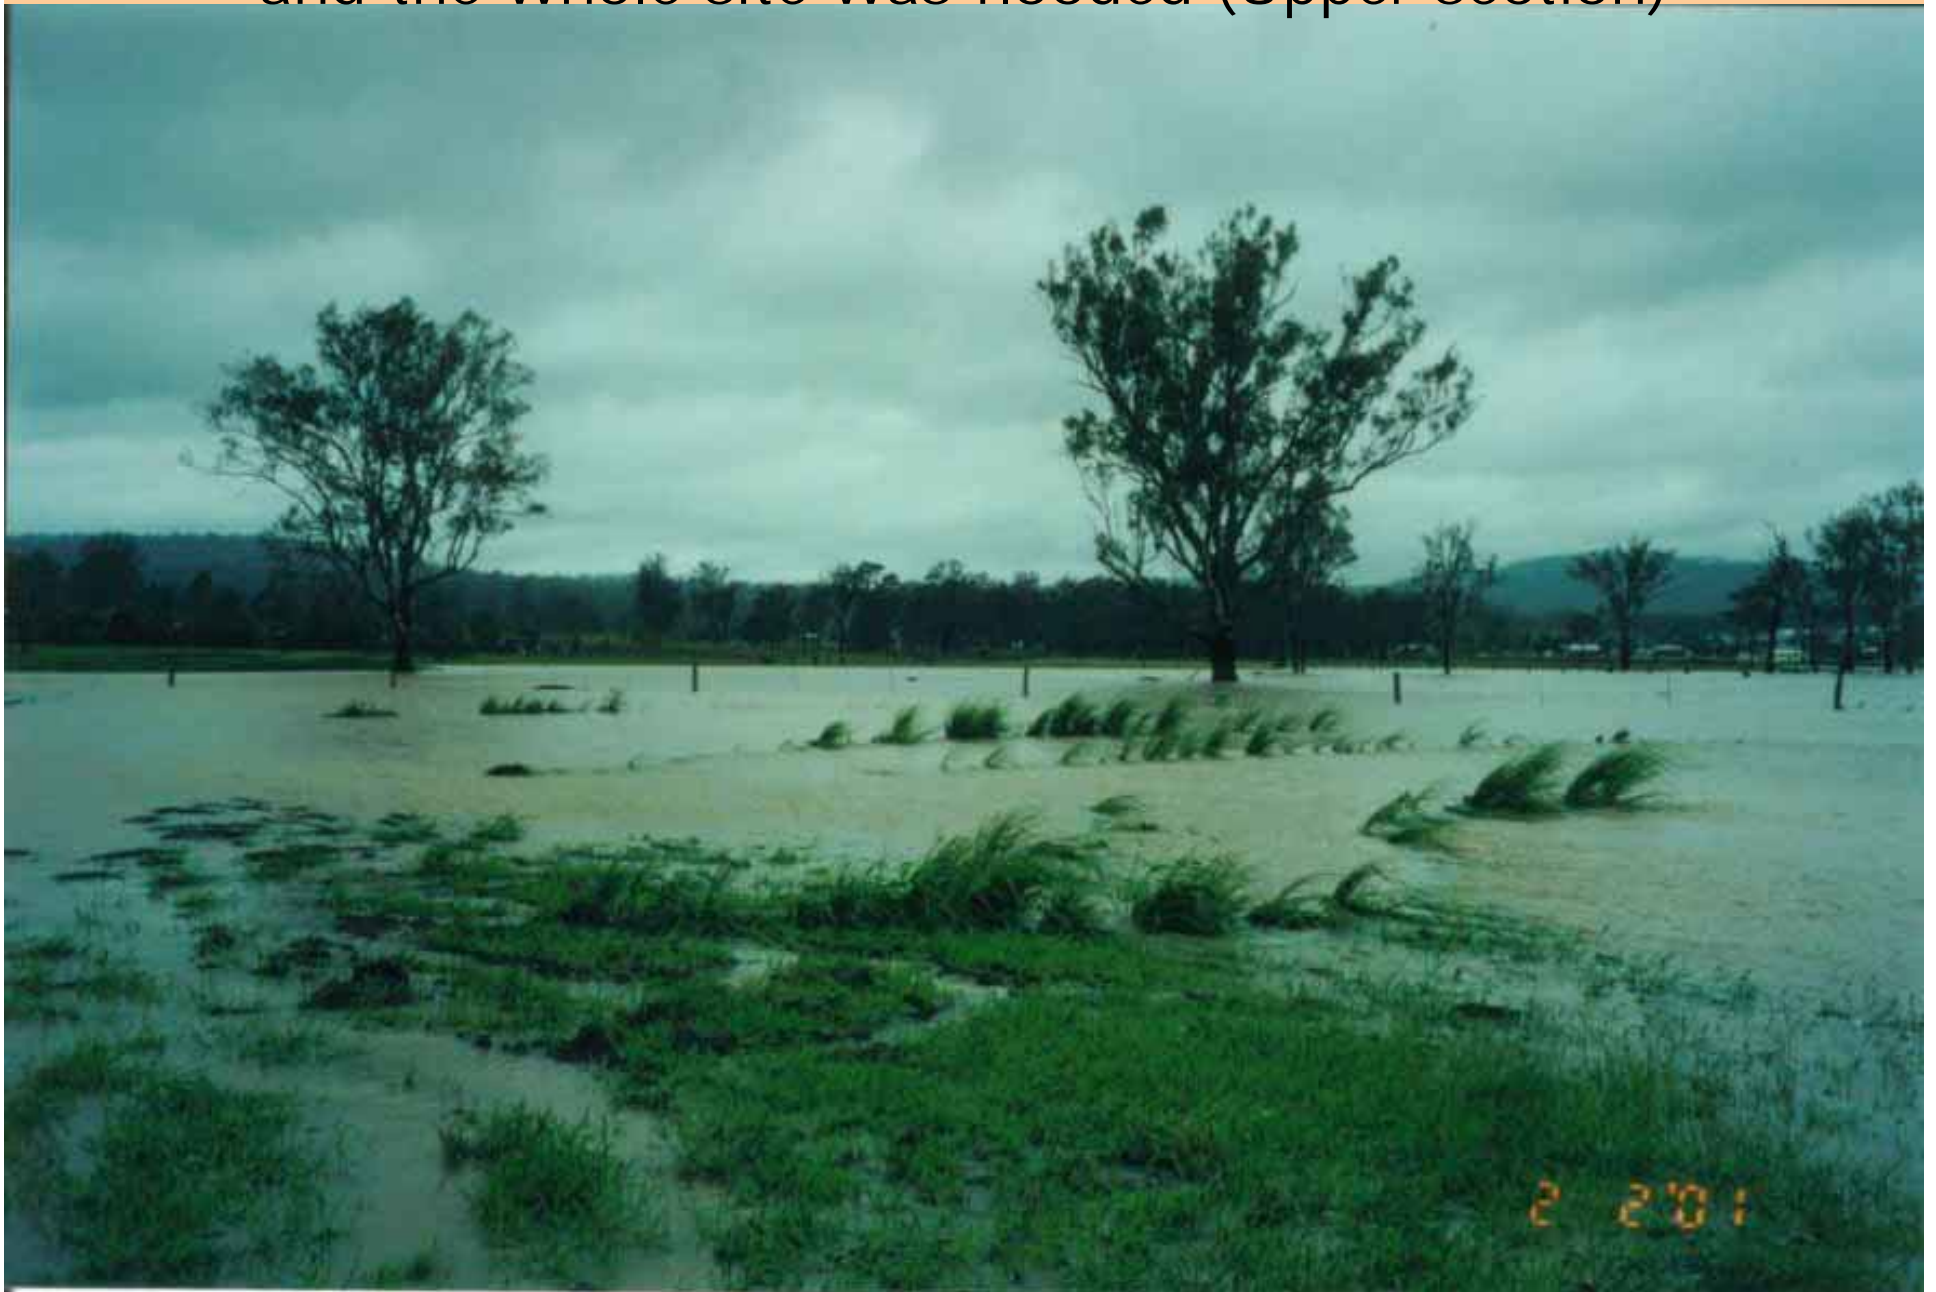
A big storm hit this drainage channel 3 months after planting and the whole site was flooded (Upper section)

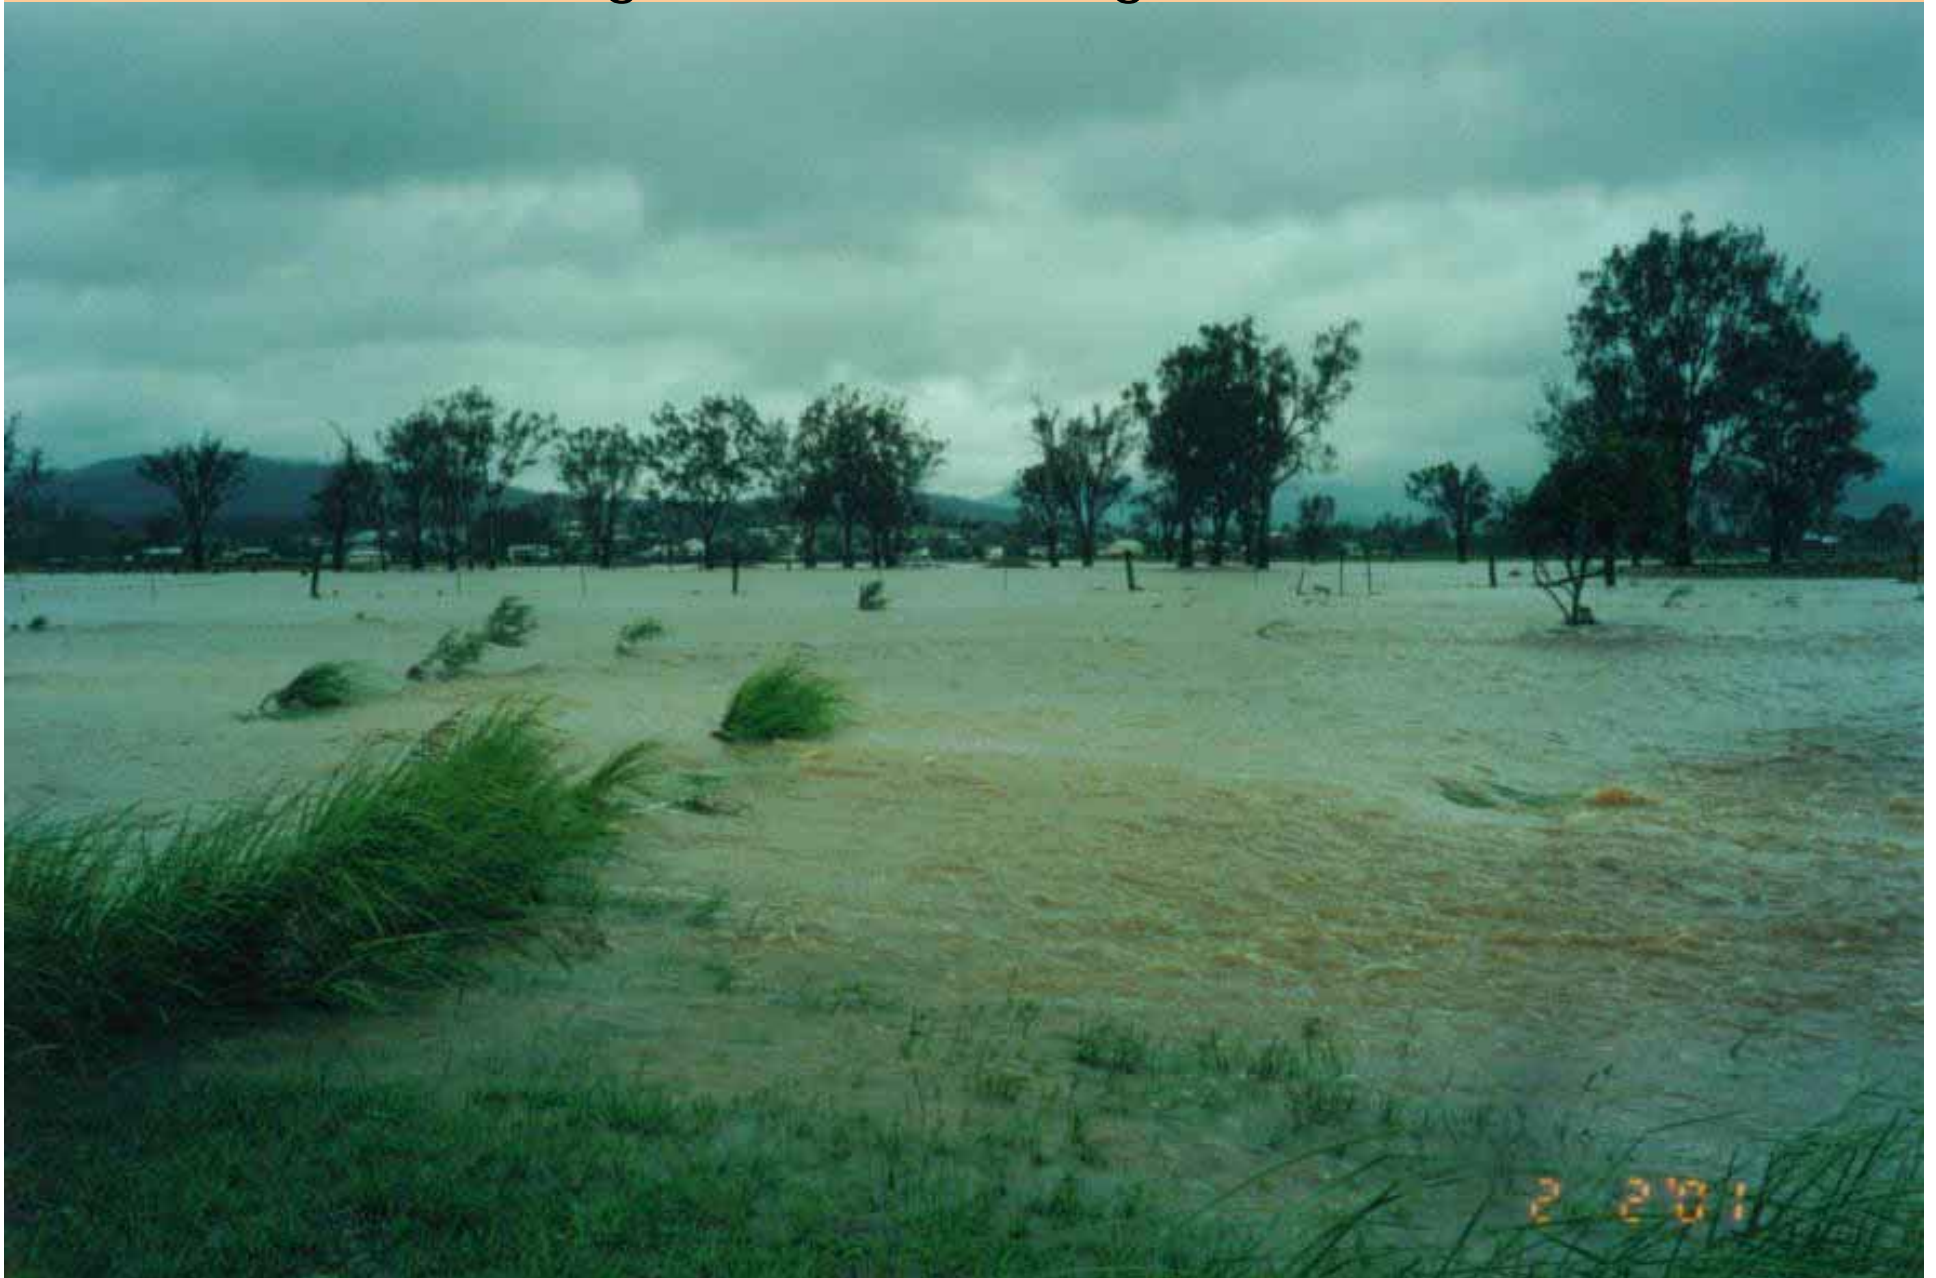
Very fast flow flattened and inundated most of the vetiver hedges in this drainage channel

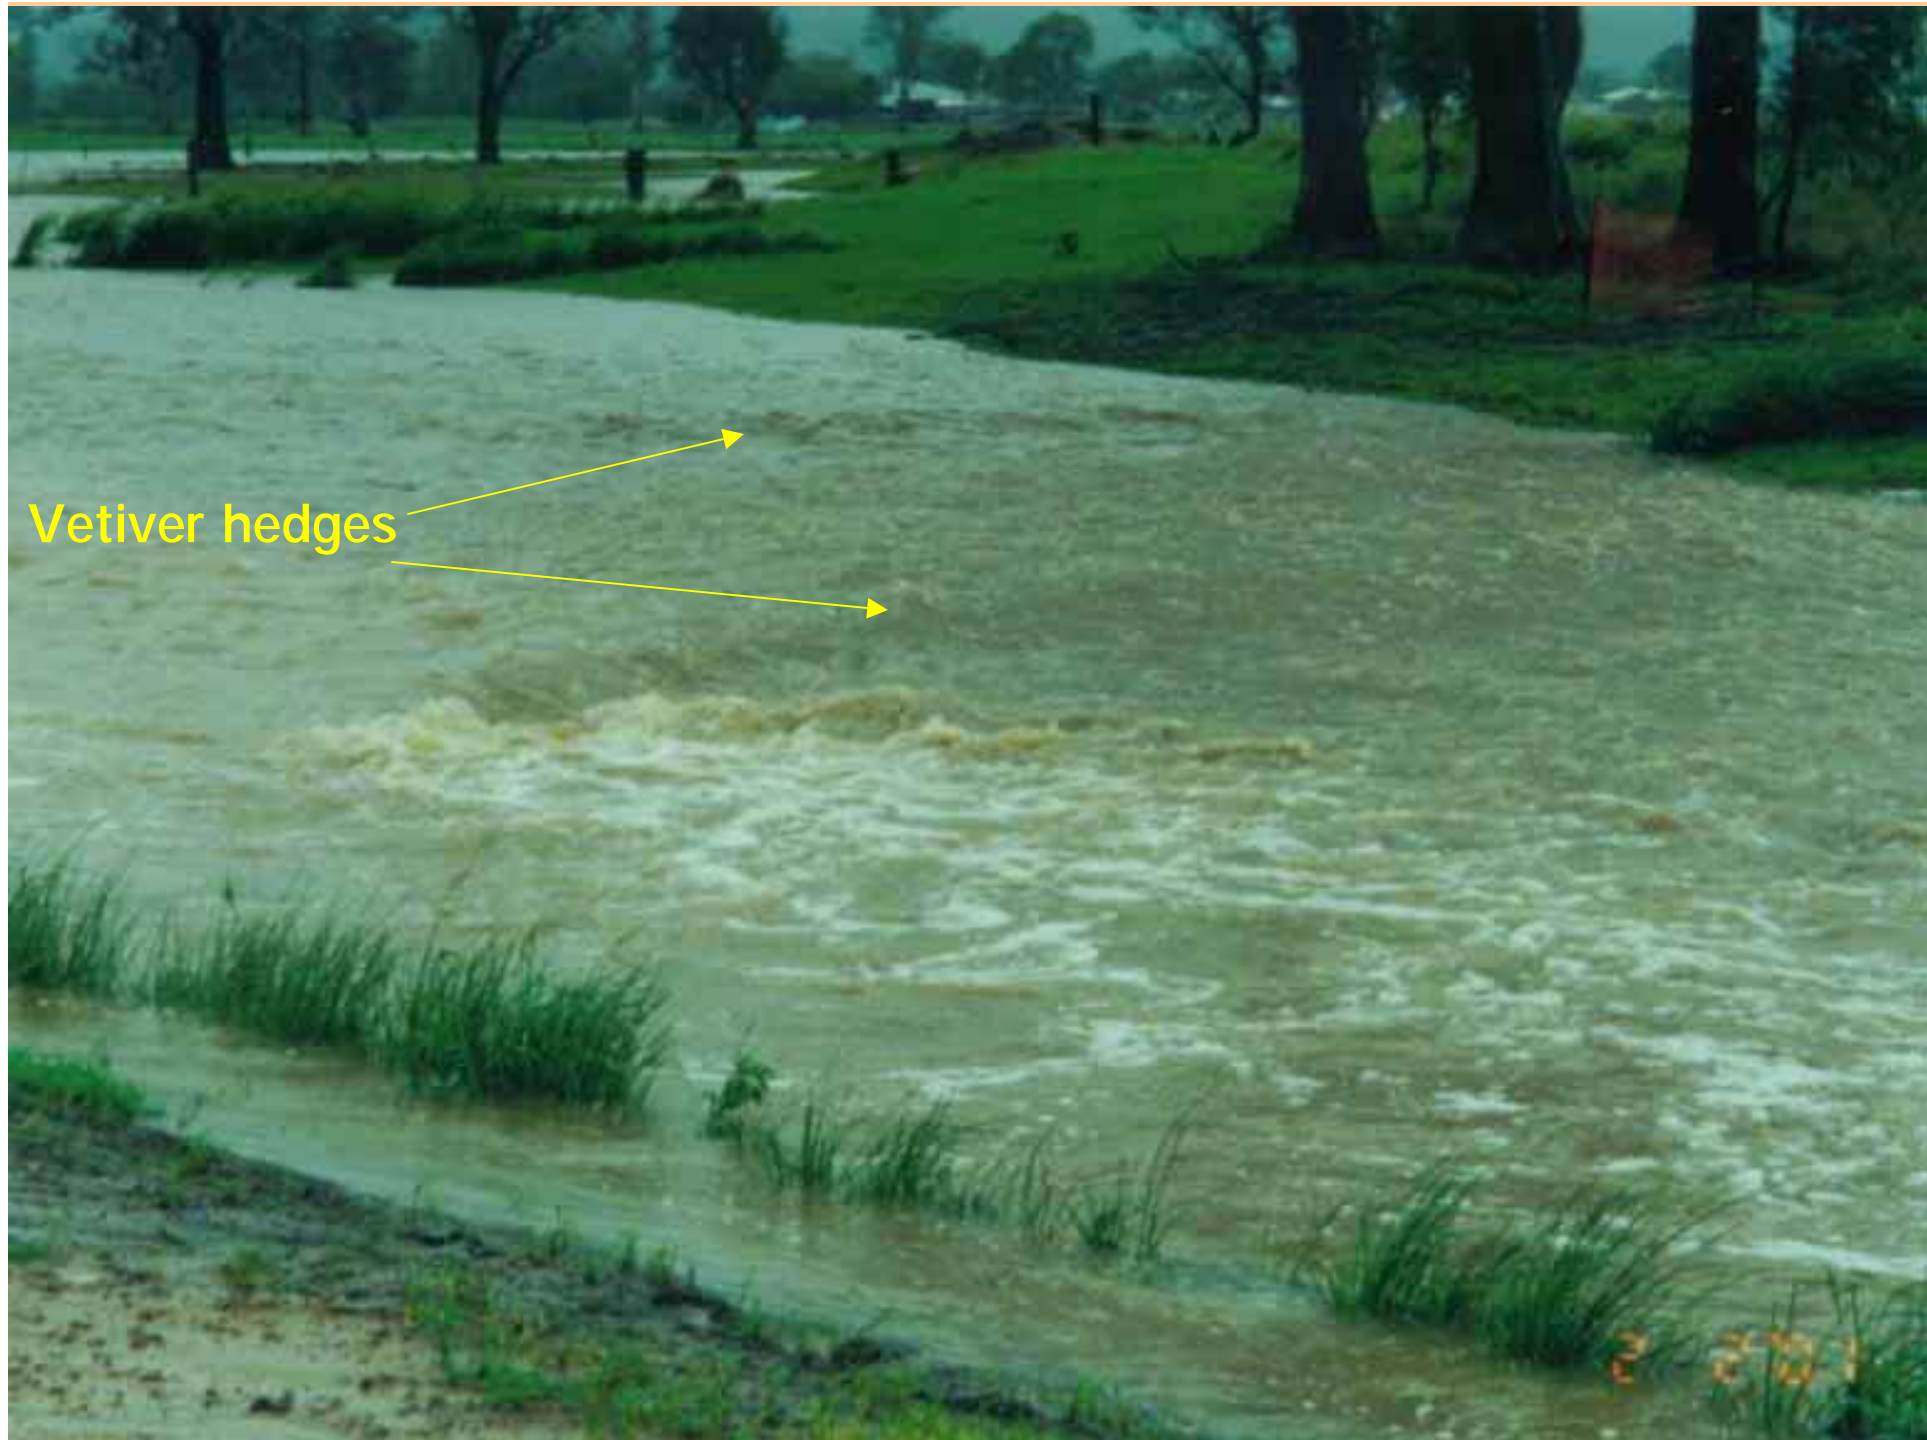
Very fast flow up to 5m/sec in some sections of the channel completely submerged and flattened the hedges

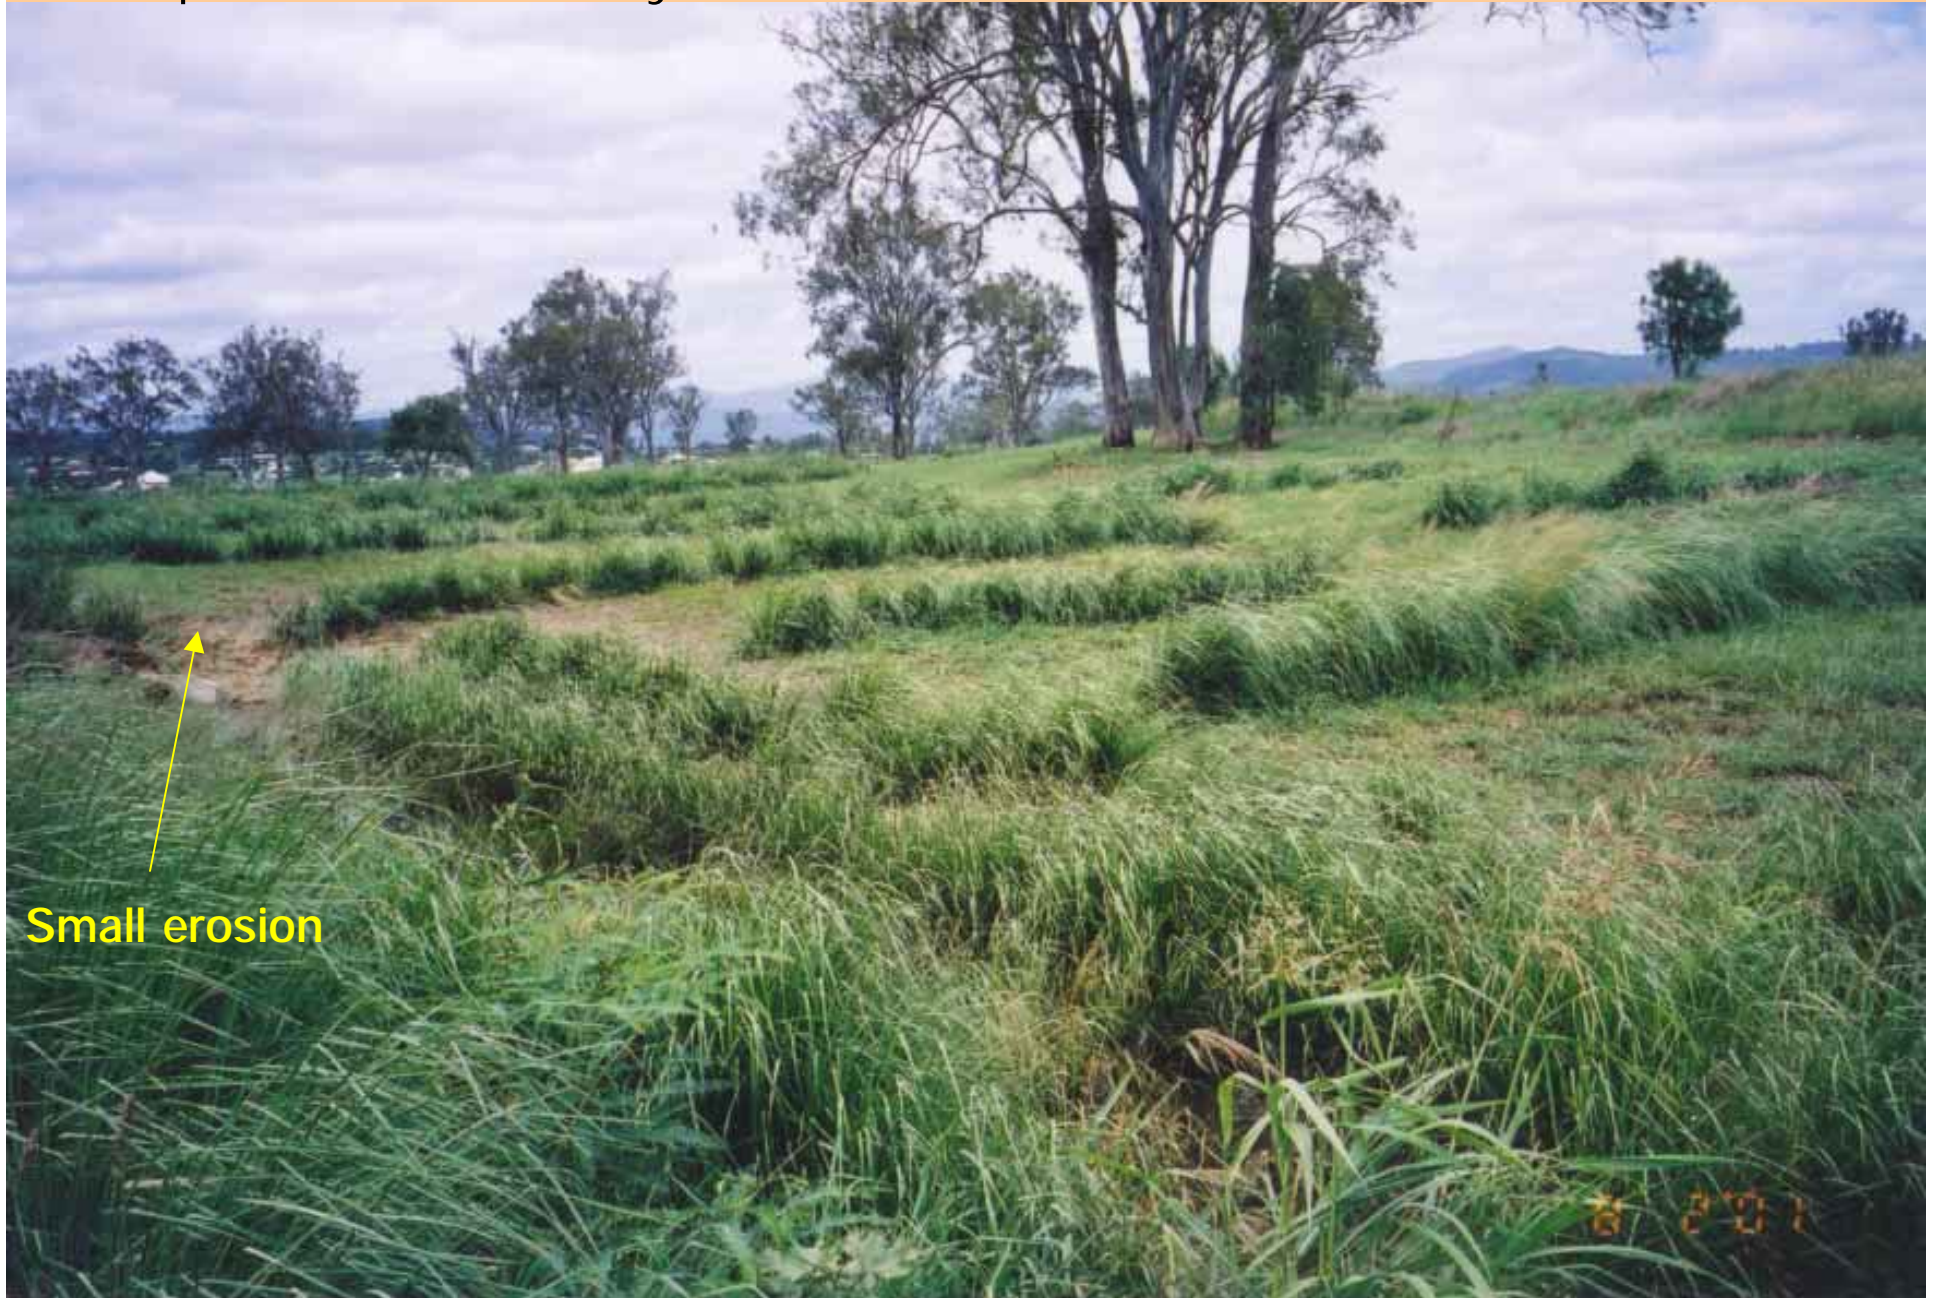
Although only 3 month old, the young hedges provide a very effective protection with only minimal erosion at the head of the channel

Small erosion

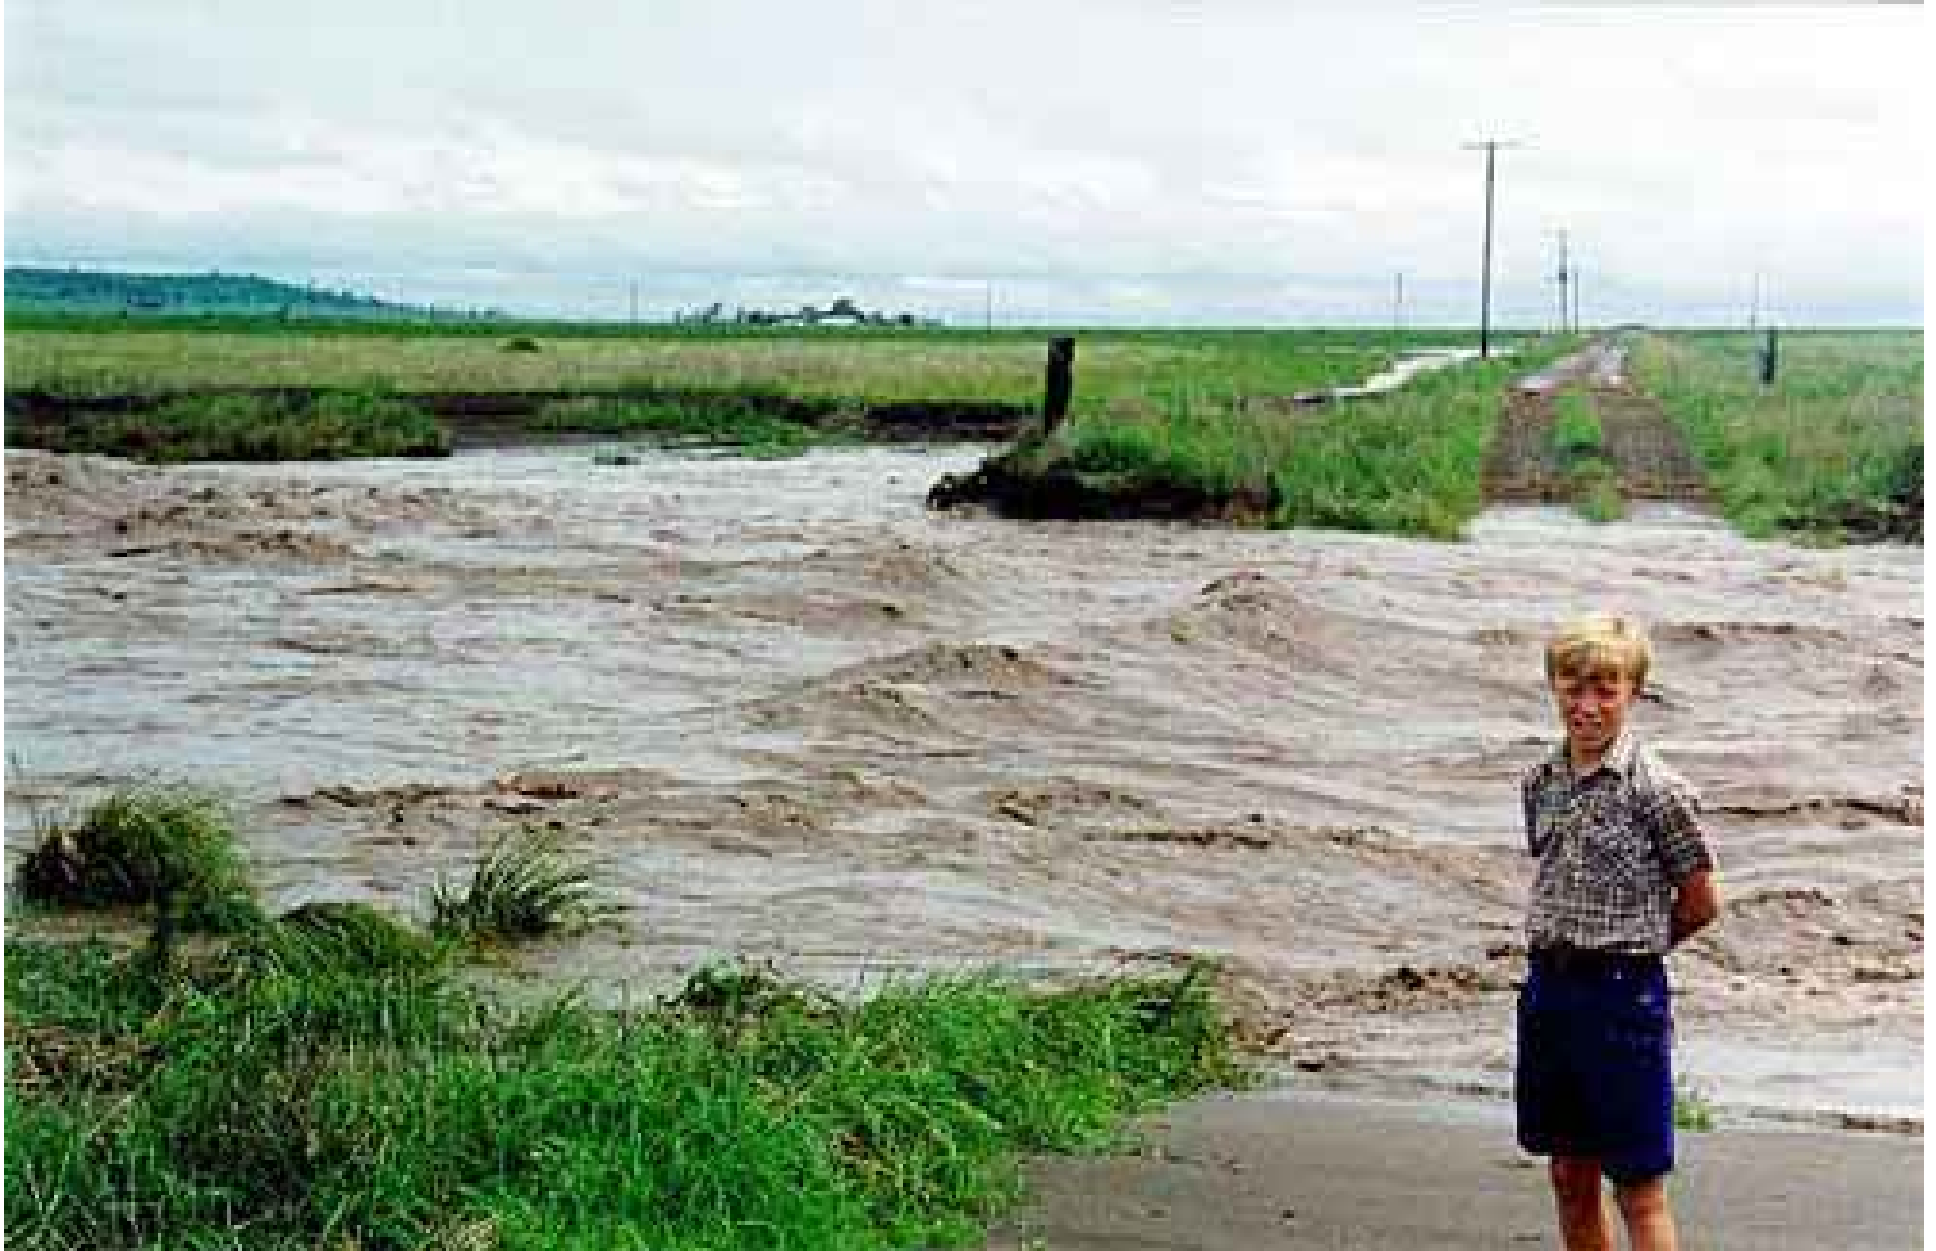
A 3m deep flood swept through this causeway, completely submerged the vetiver rows

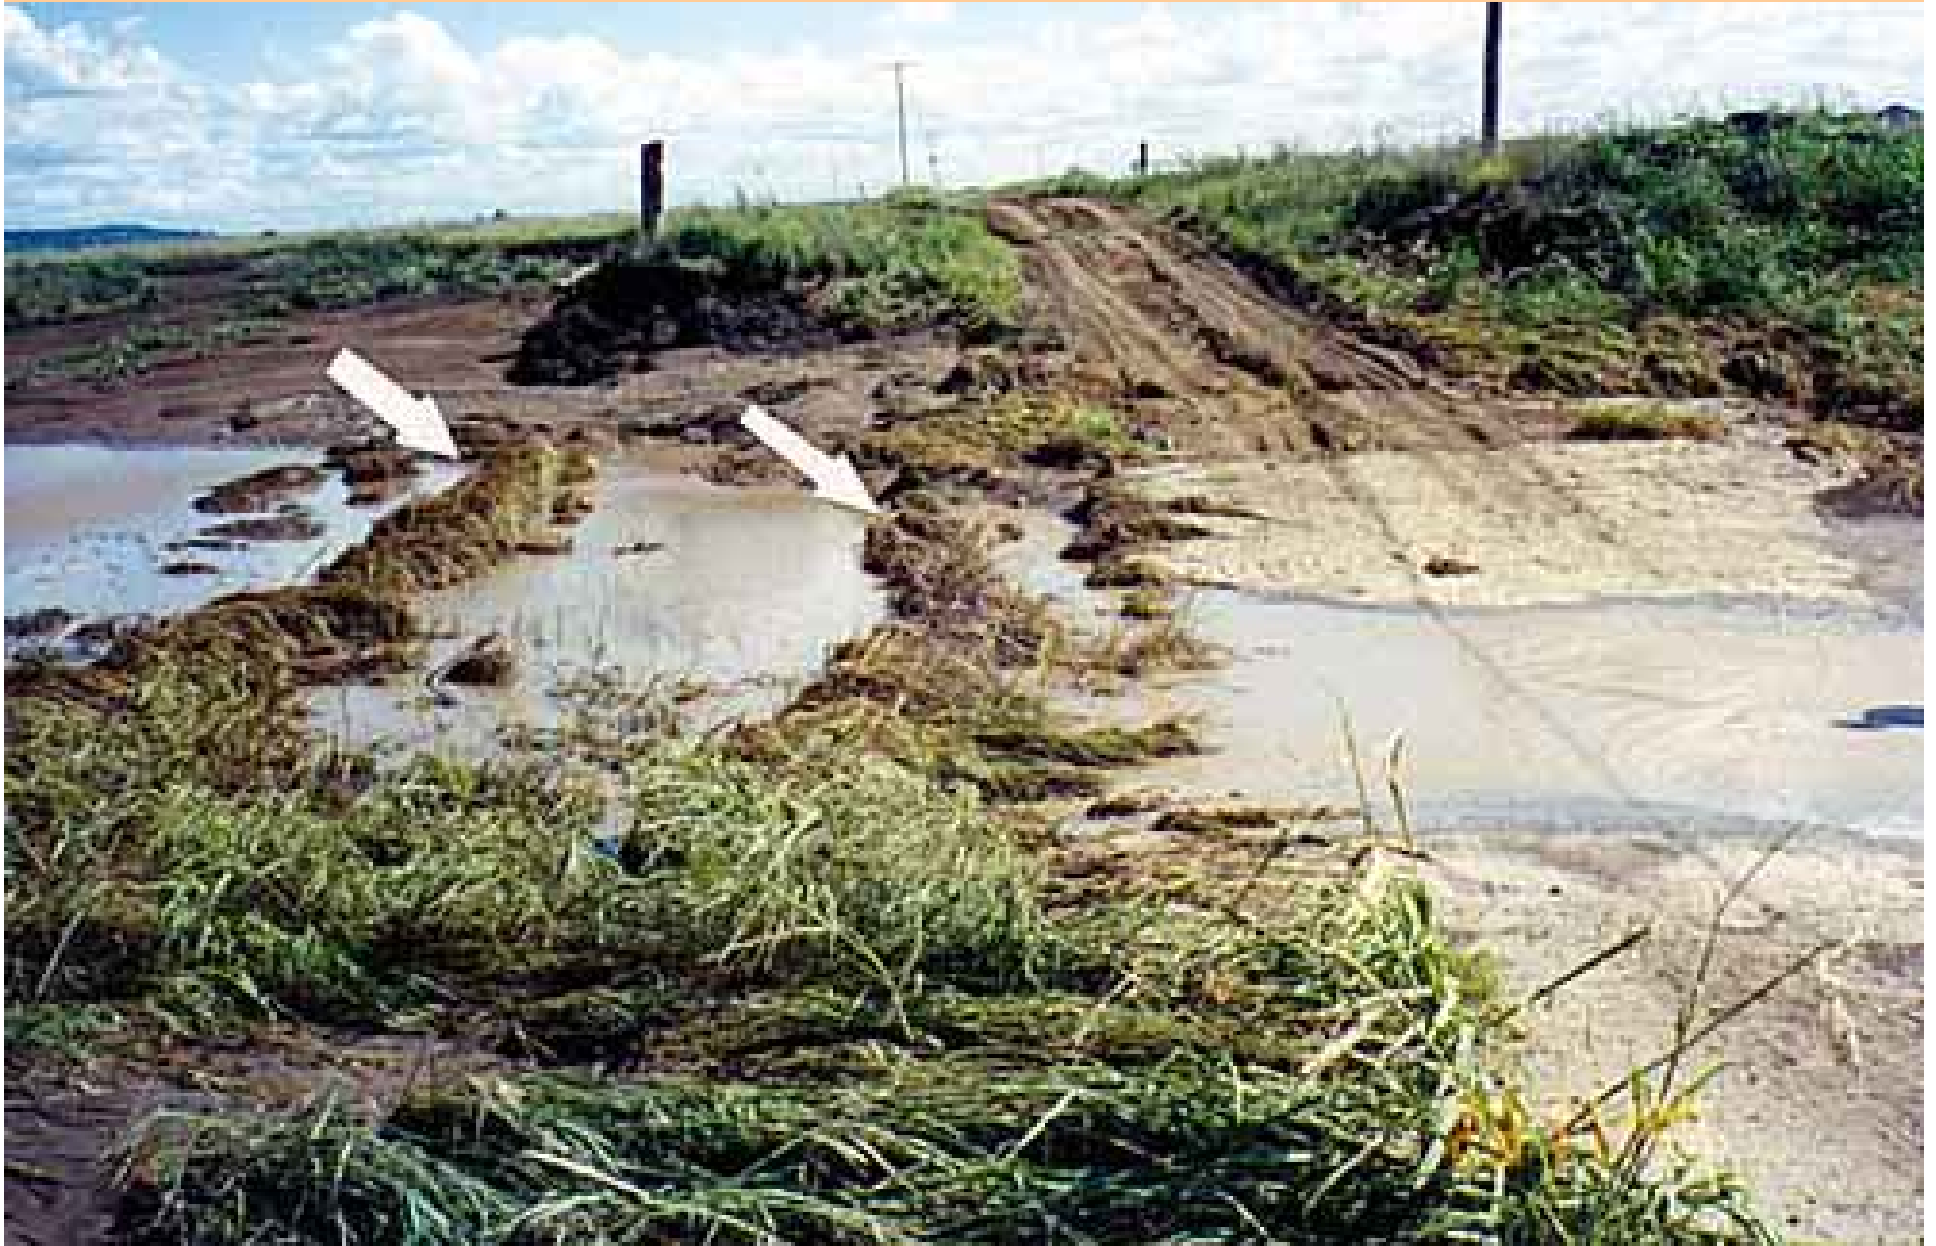
Although badly battered, the vetiver hedges held firm during the flood, preventing the undermining of the concrete causeway

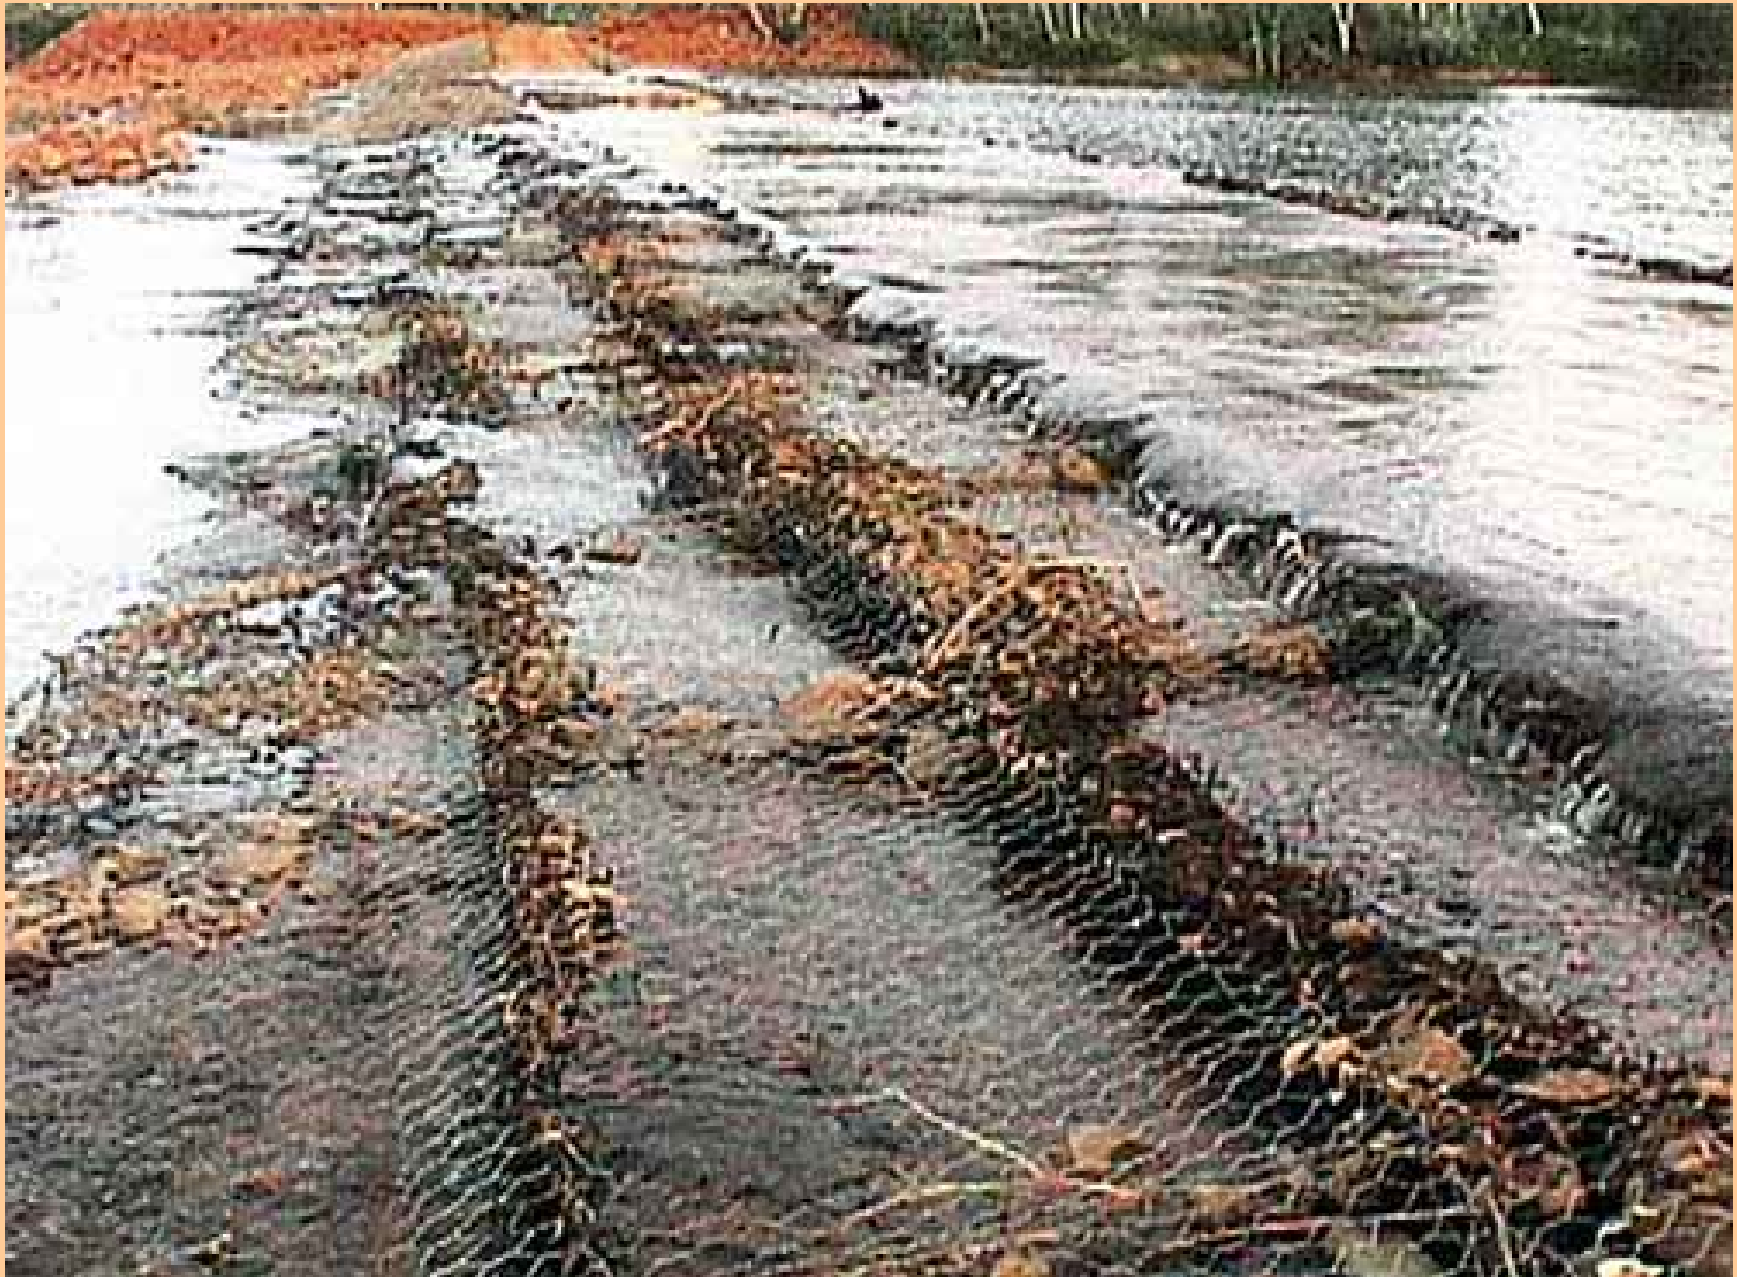
After several floods the gabion was extensively damaged, indicating the weakness of rock structure under flood

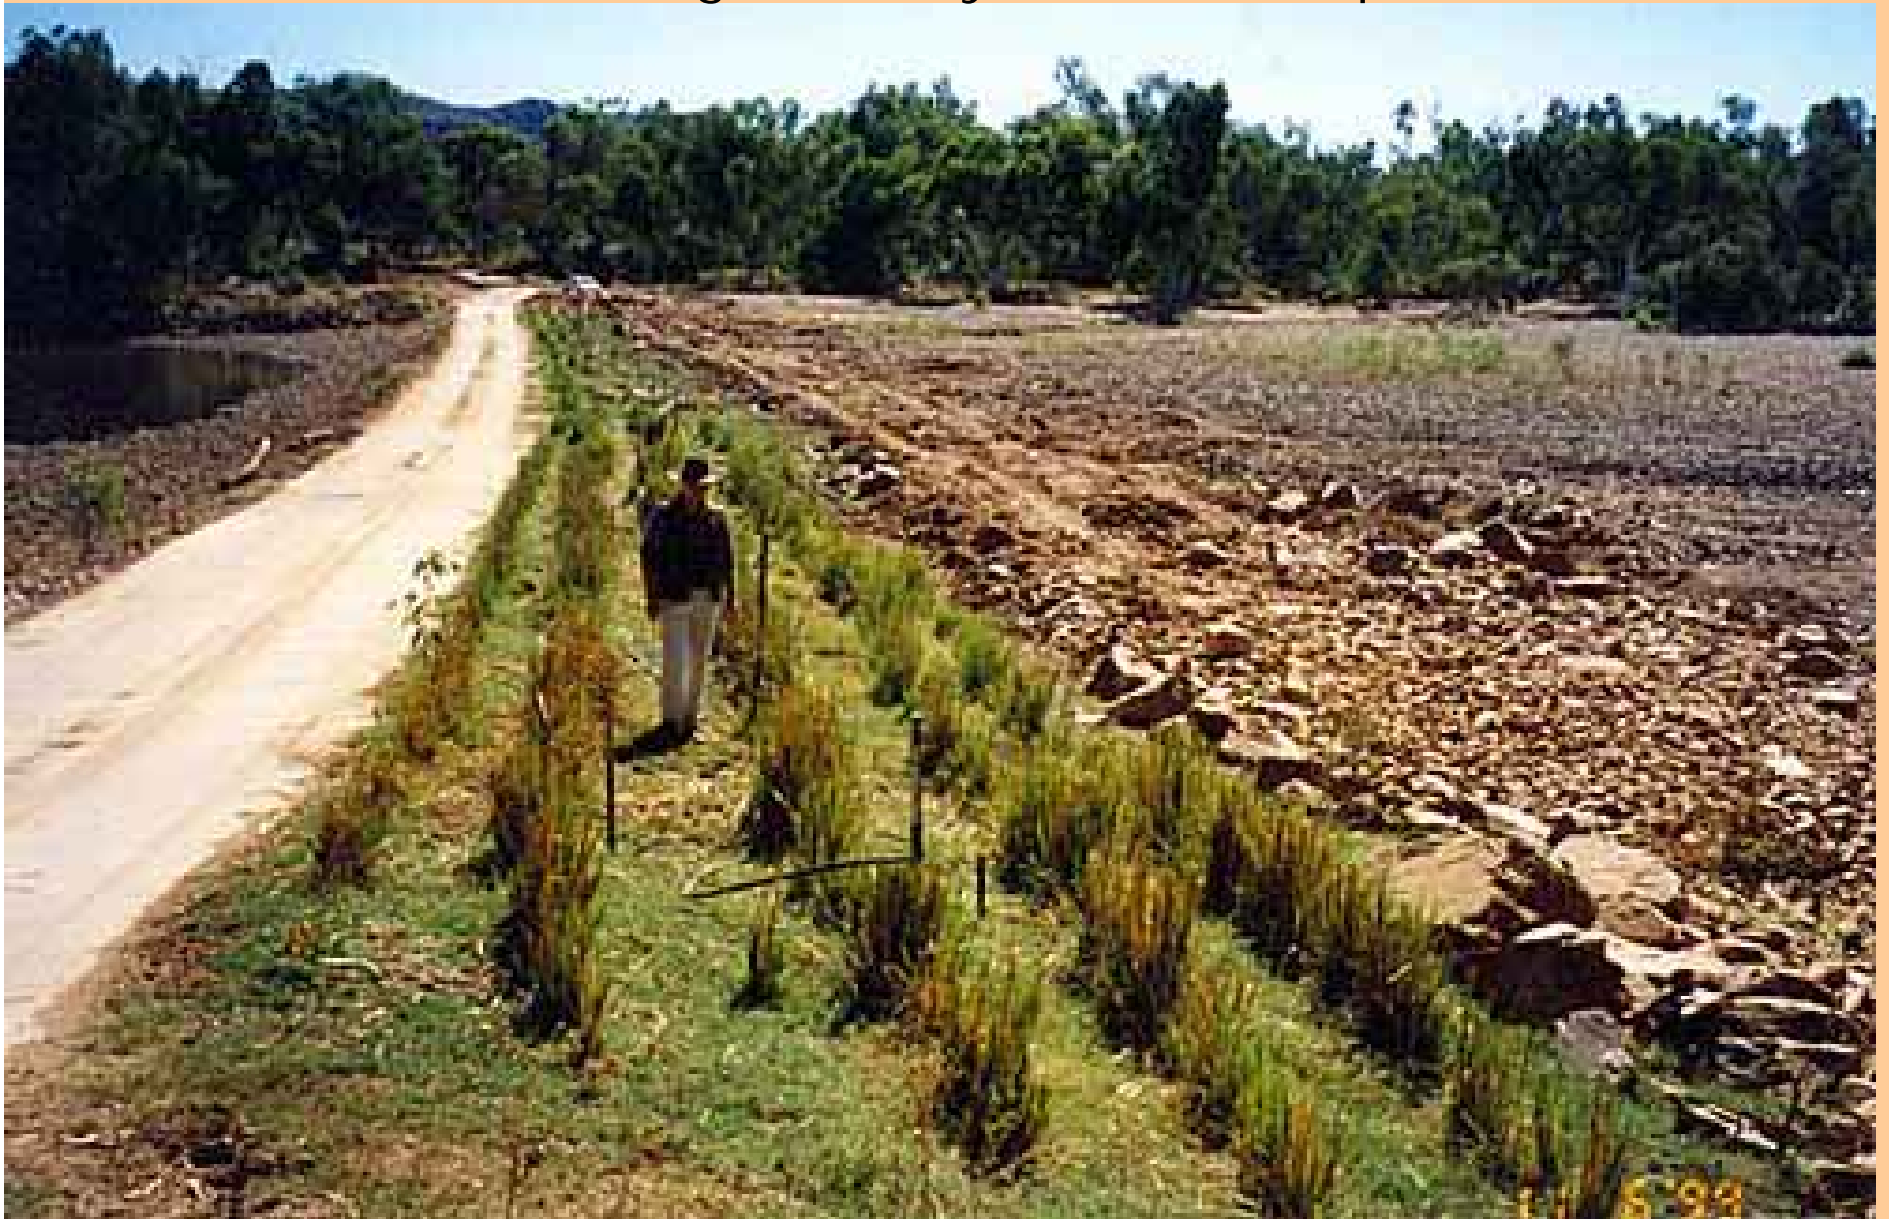
This causeway was again flooded 8 months after planting with flow up to 3m deep. Despite the young age vetiver plants were sufficient to withstand the high velocity flow and stop the erosion .
