THE VANISHING DELTA

A Pictorial Essay on the Riverbank Erosion in the Mekong Delta, Viet Nam and a Proposed Remediation Plan

Dr. Paul Truong

**The Vetiver Network East Asia and South
Pacific Representative, Brisbane, Australia**

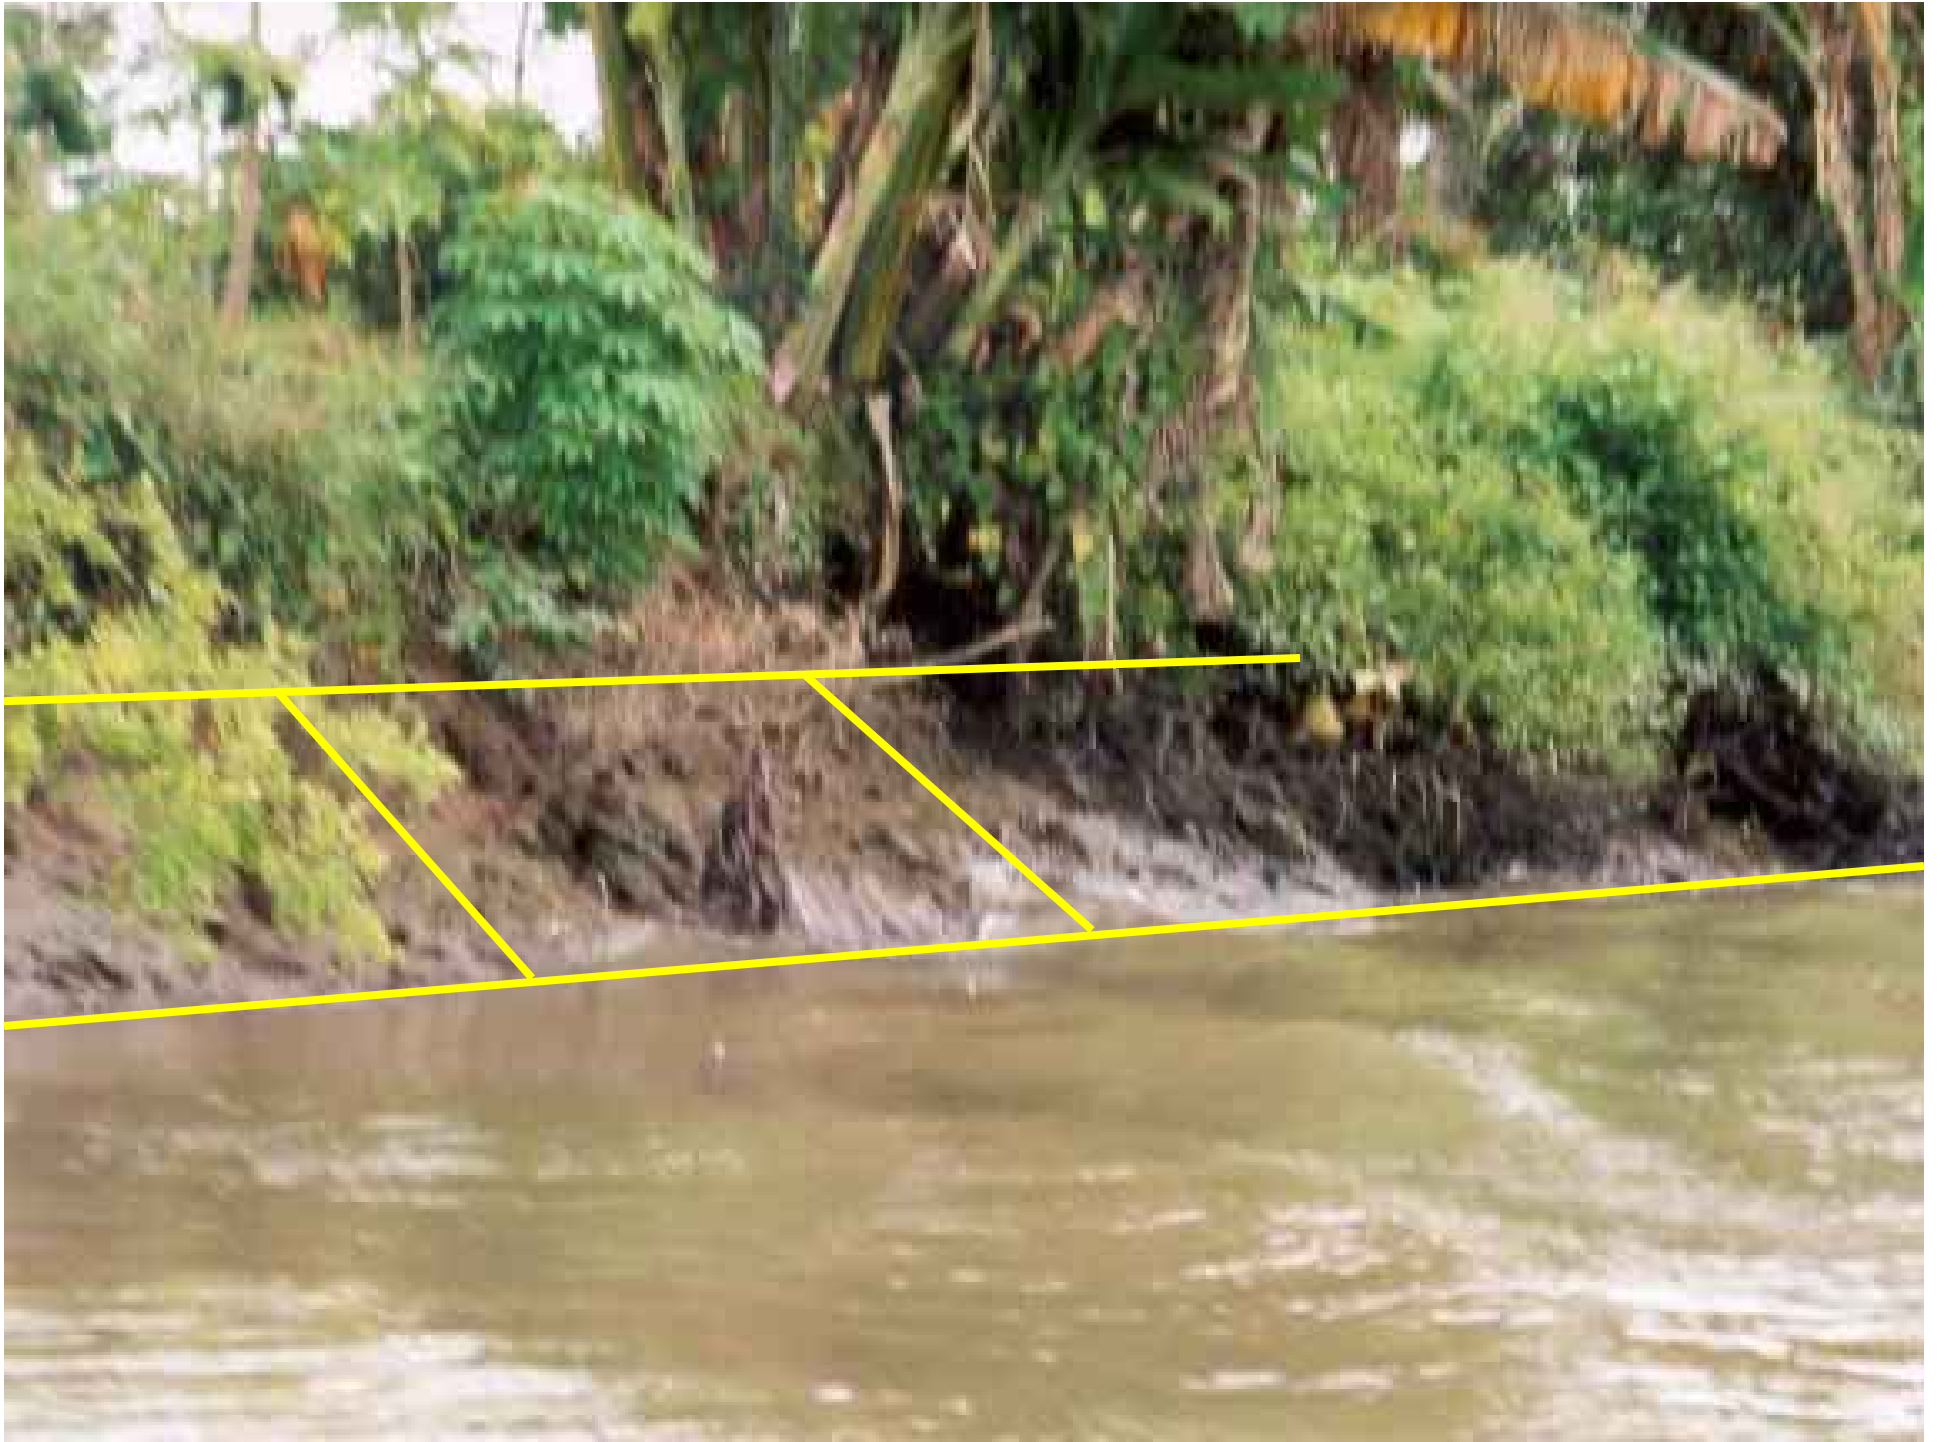
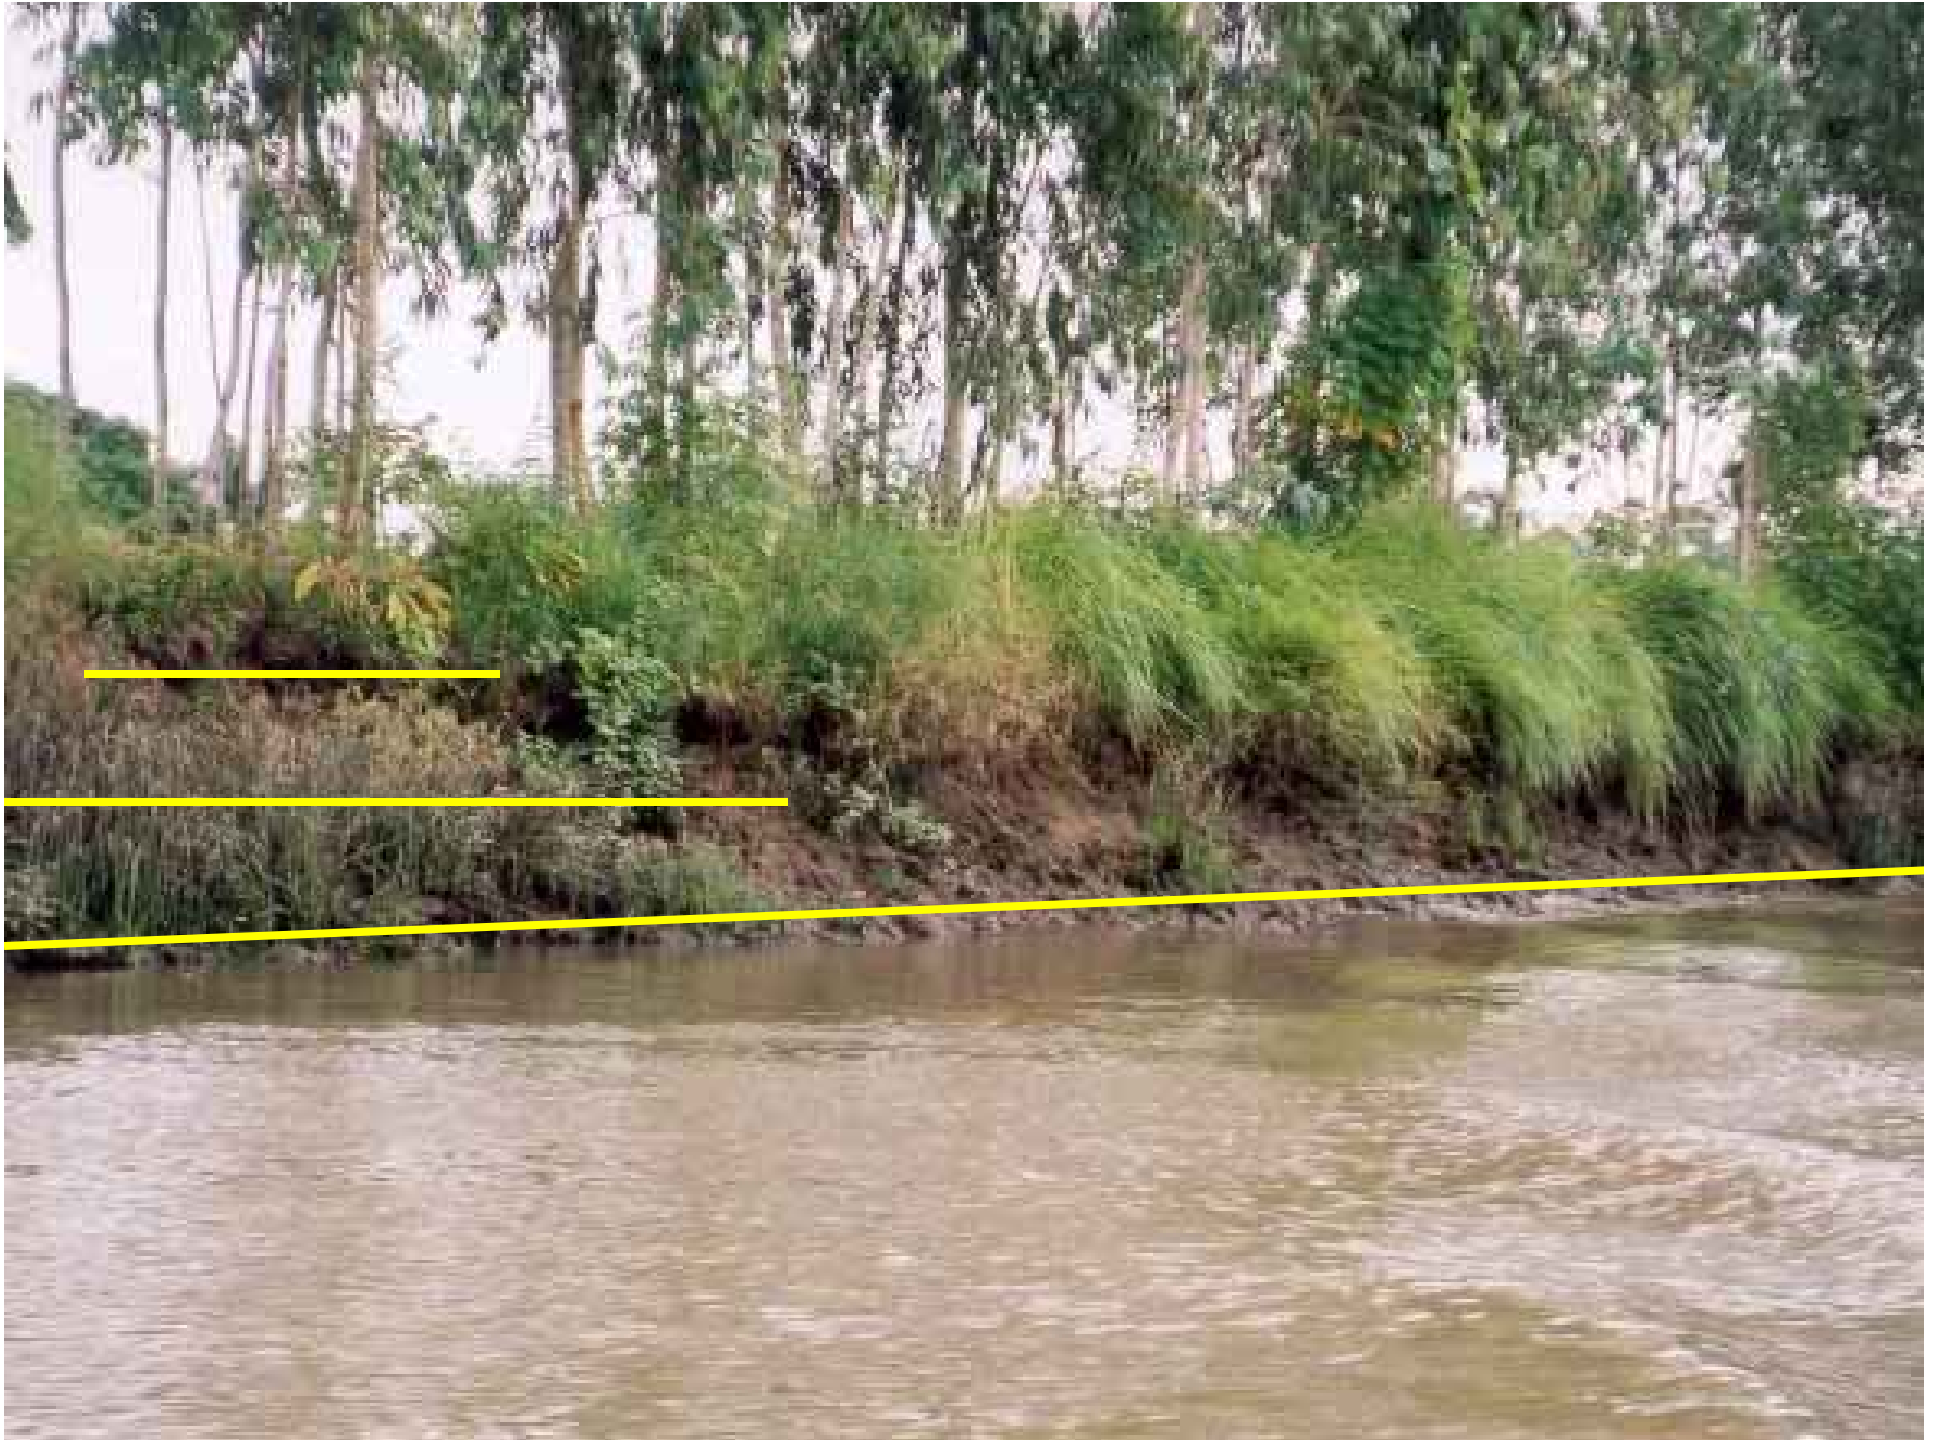
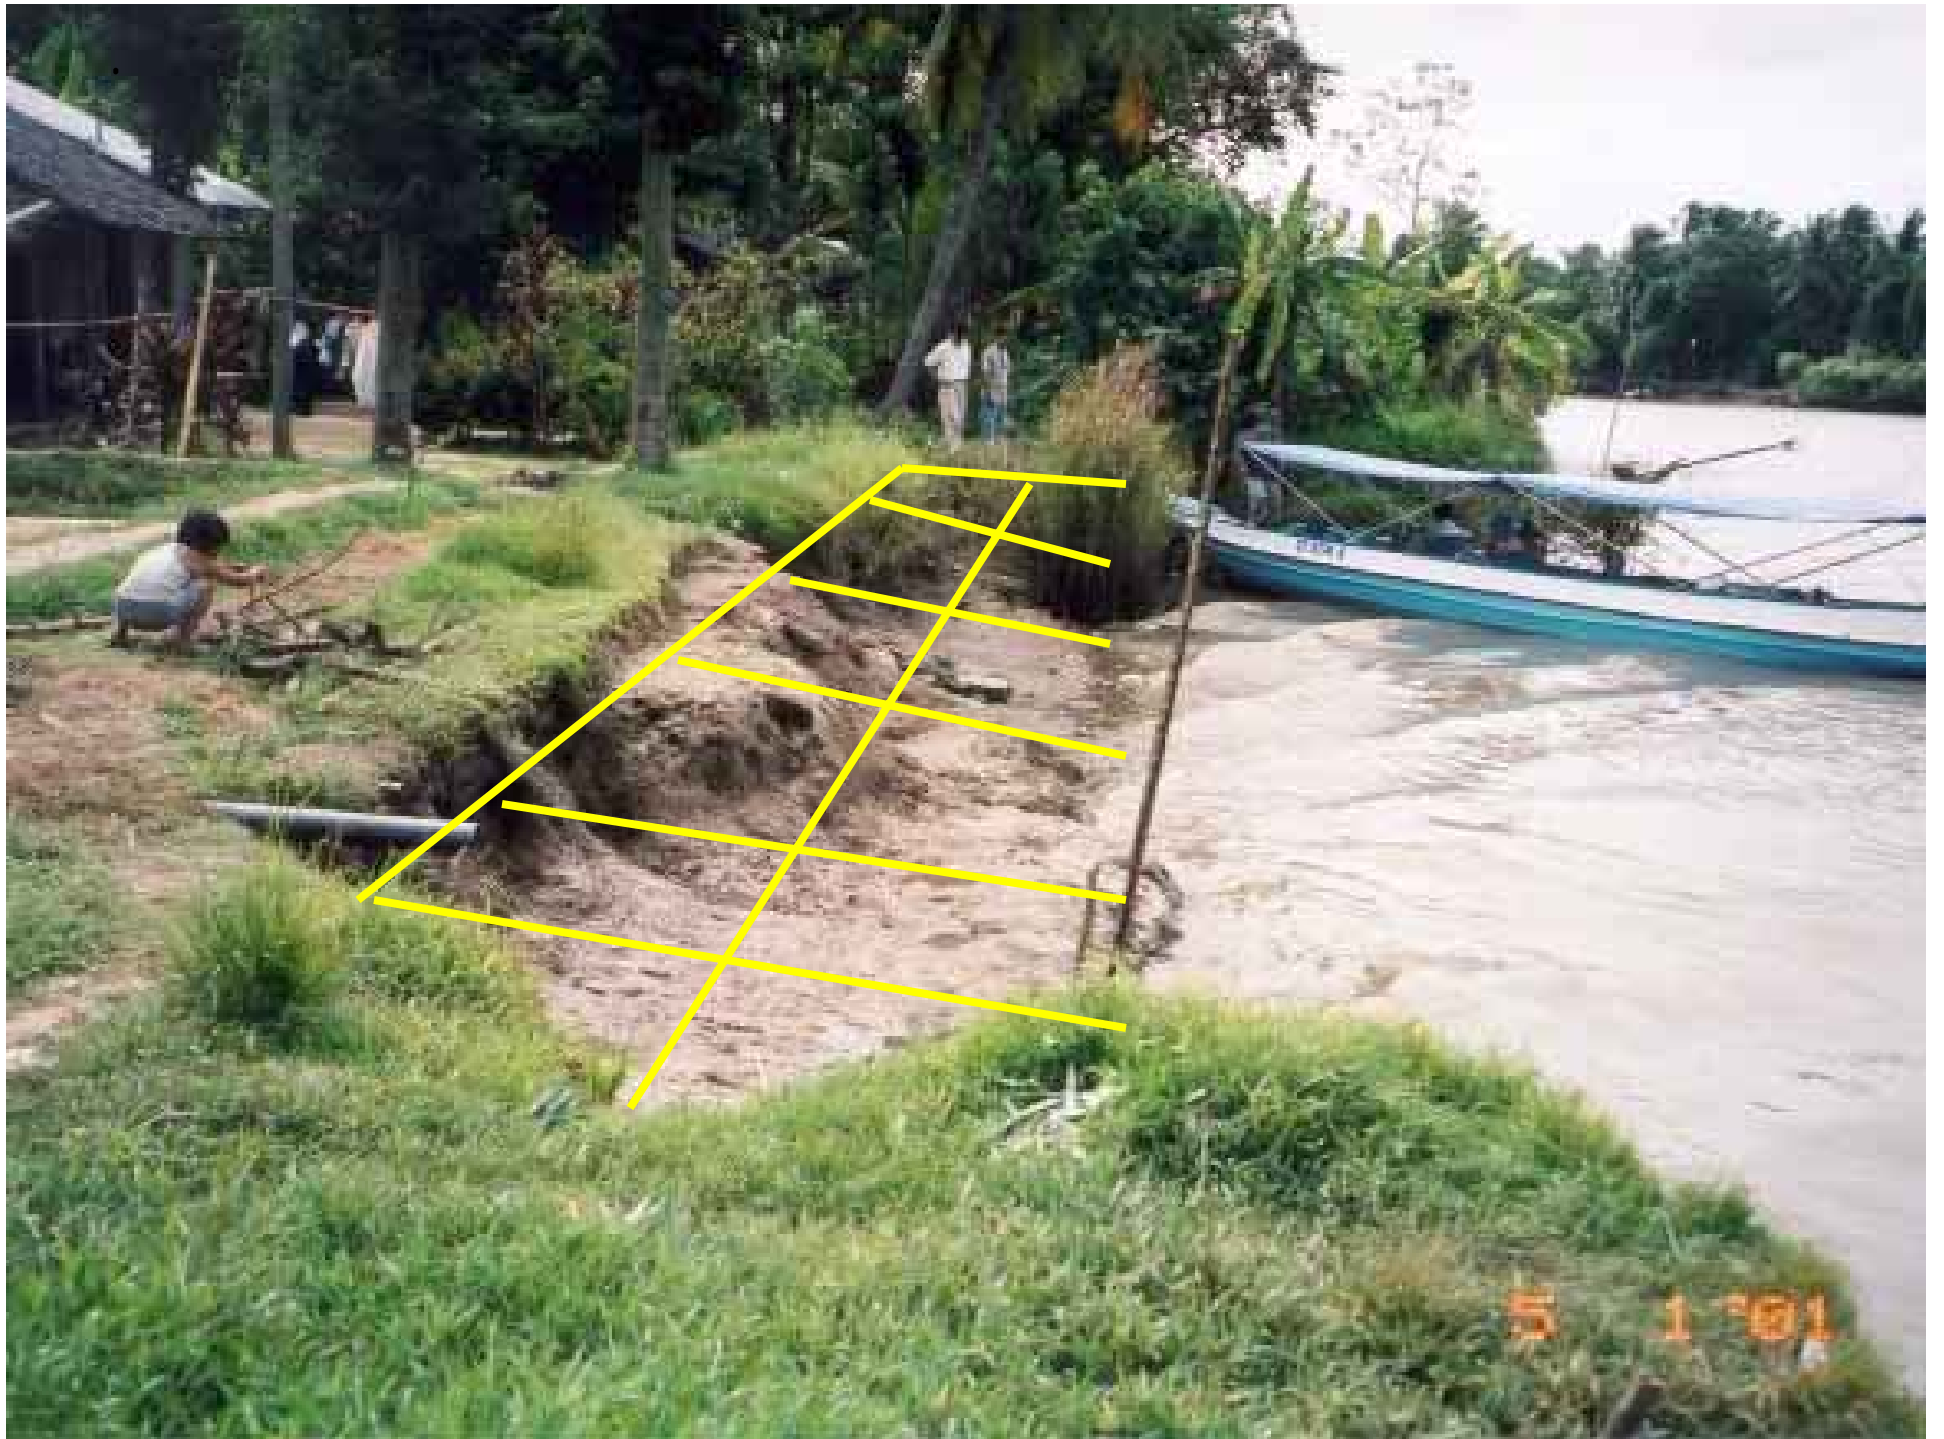
The yellow lines indicate the position of vetiver rows, row position and spacing are indicative only

The followings are diagrammatic illustrations of how the Vetiver System will be applied under various situations to control erosion on the banks of waterways in the Mekong delta.

The exact design at each location depends on the site specific characteristics such as tidal variation, salinity, soil structure, slope gradient, slope length, traffic volume etc.

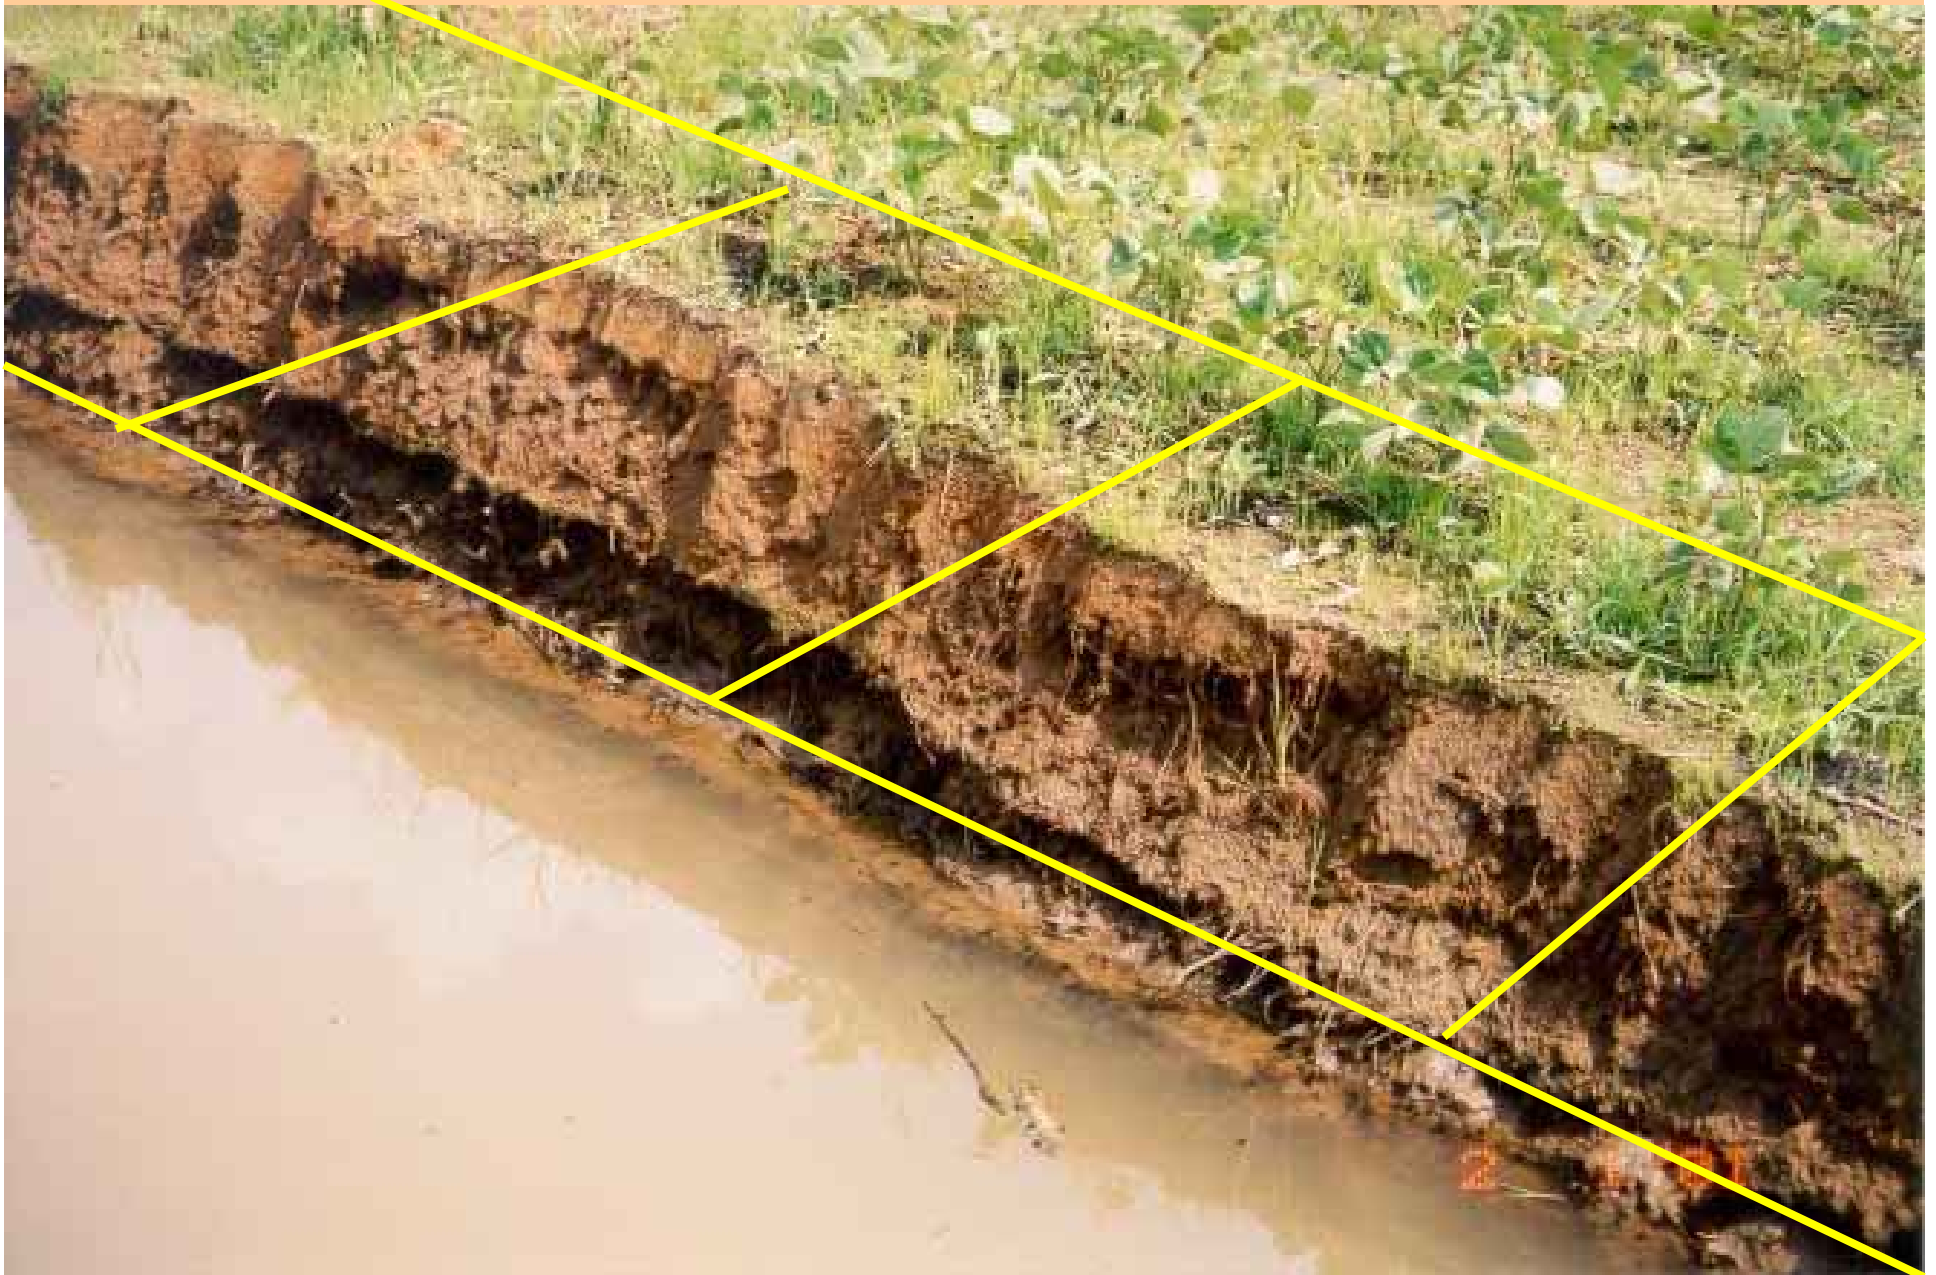
Some earth shaping is needed to reduce slope gradient for vetiver establishment

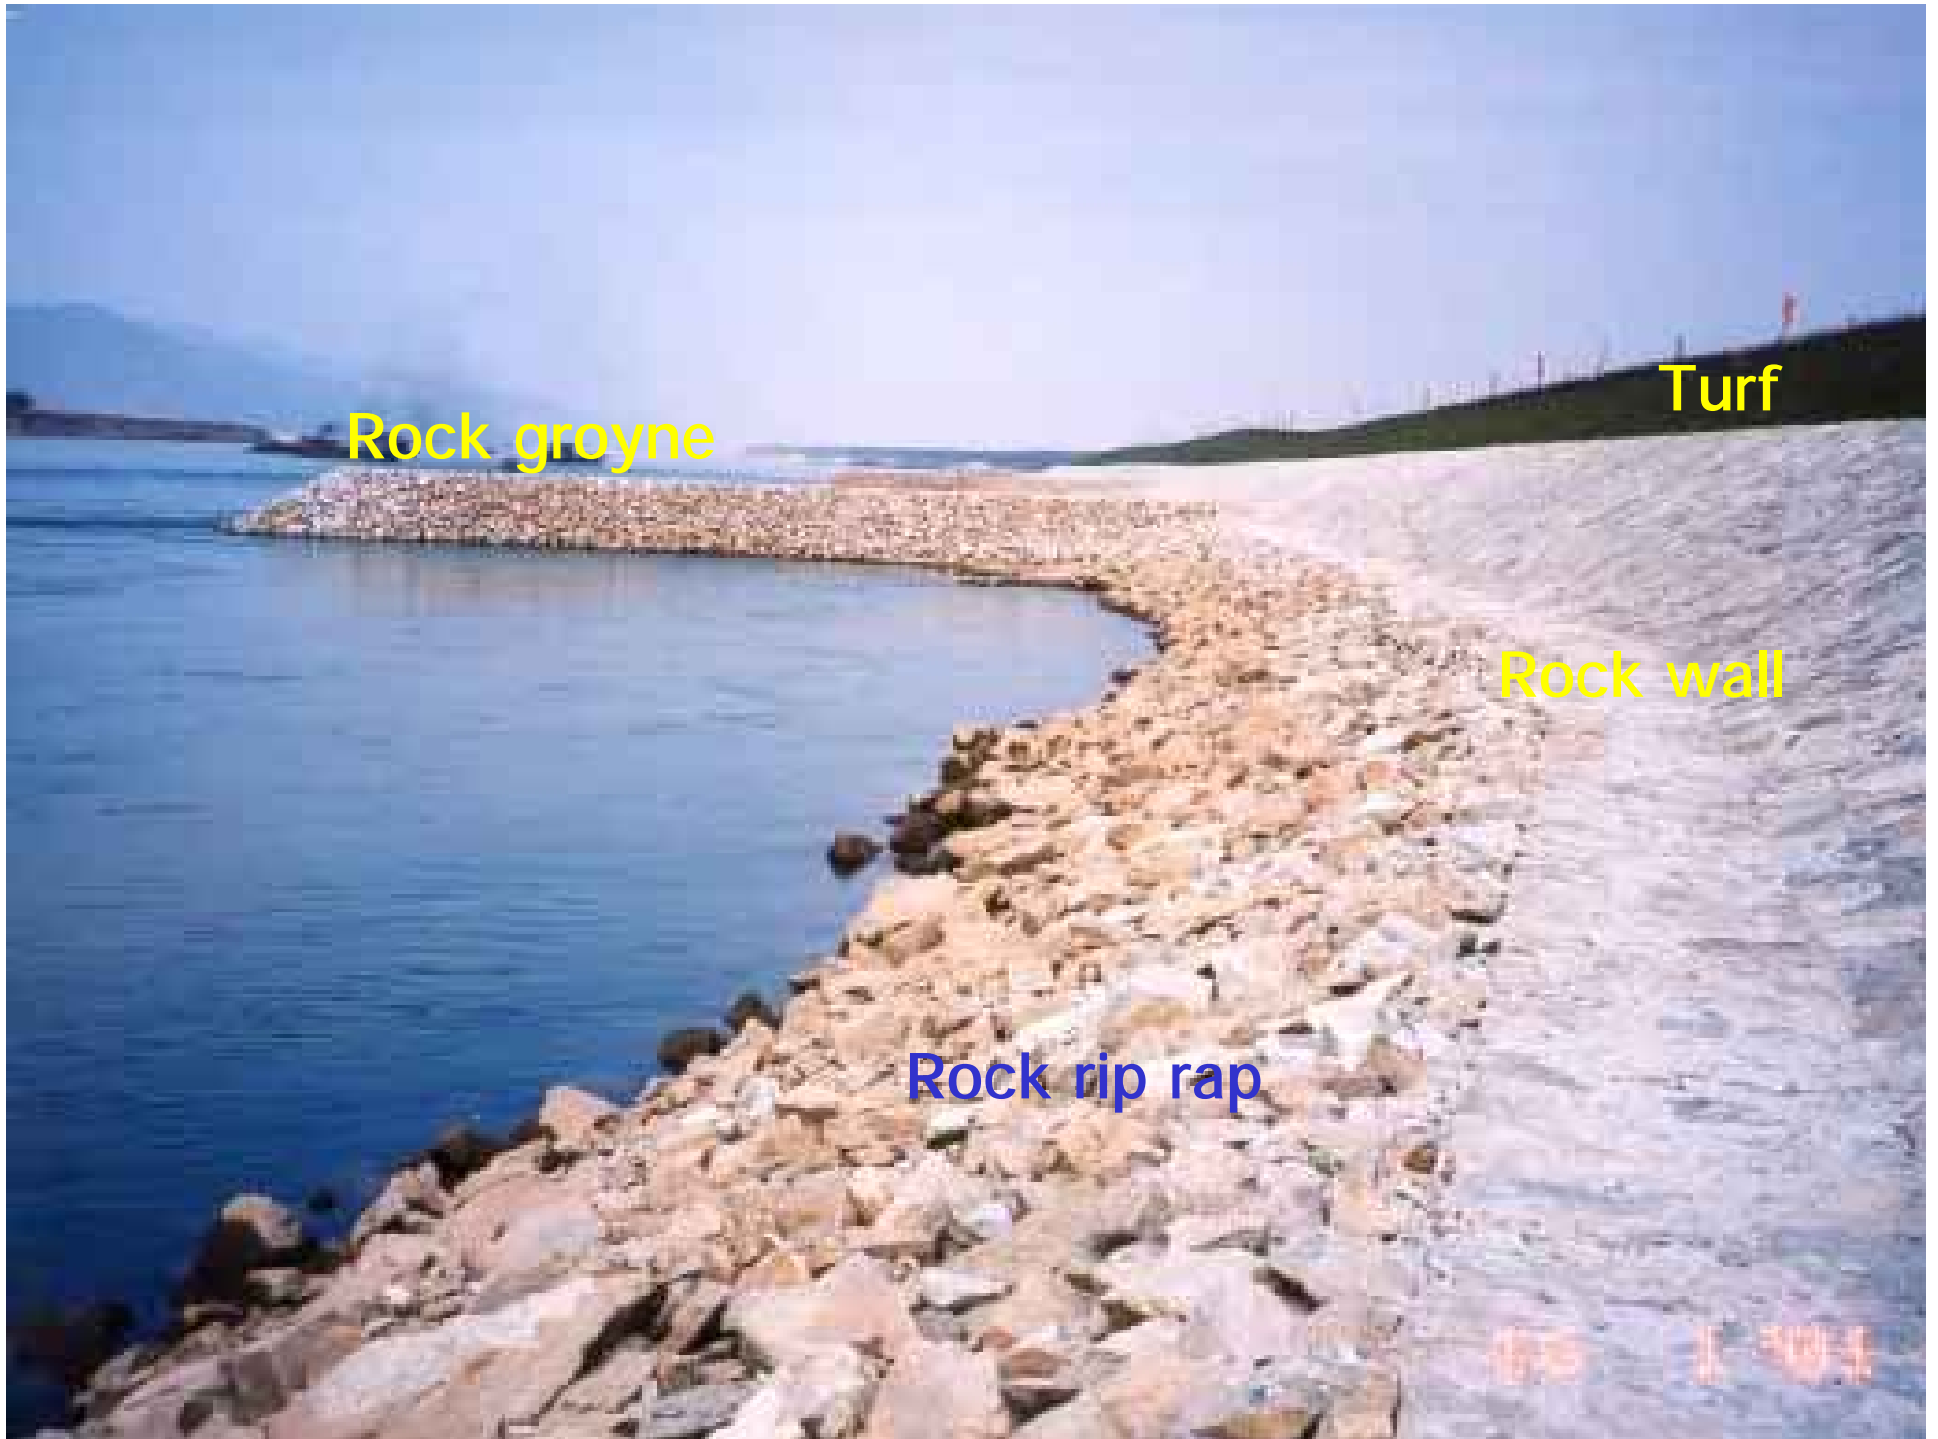
China: Similarly the Chinese also uses this very costly method to protect the bank of the Pearl river in Guangdong

Rock groyne

Turf

Rock wall

Rock rip rap
