# **Vetiver System for Stream Bank Stabilisation**

**(With special references to the river and canal bank stabilisation  
in Australia and Vietnam)**

**Paul Truong**

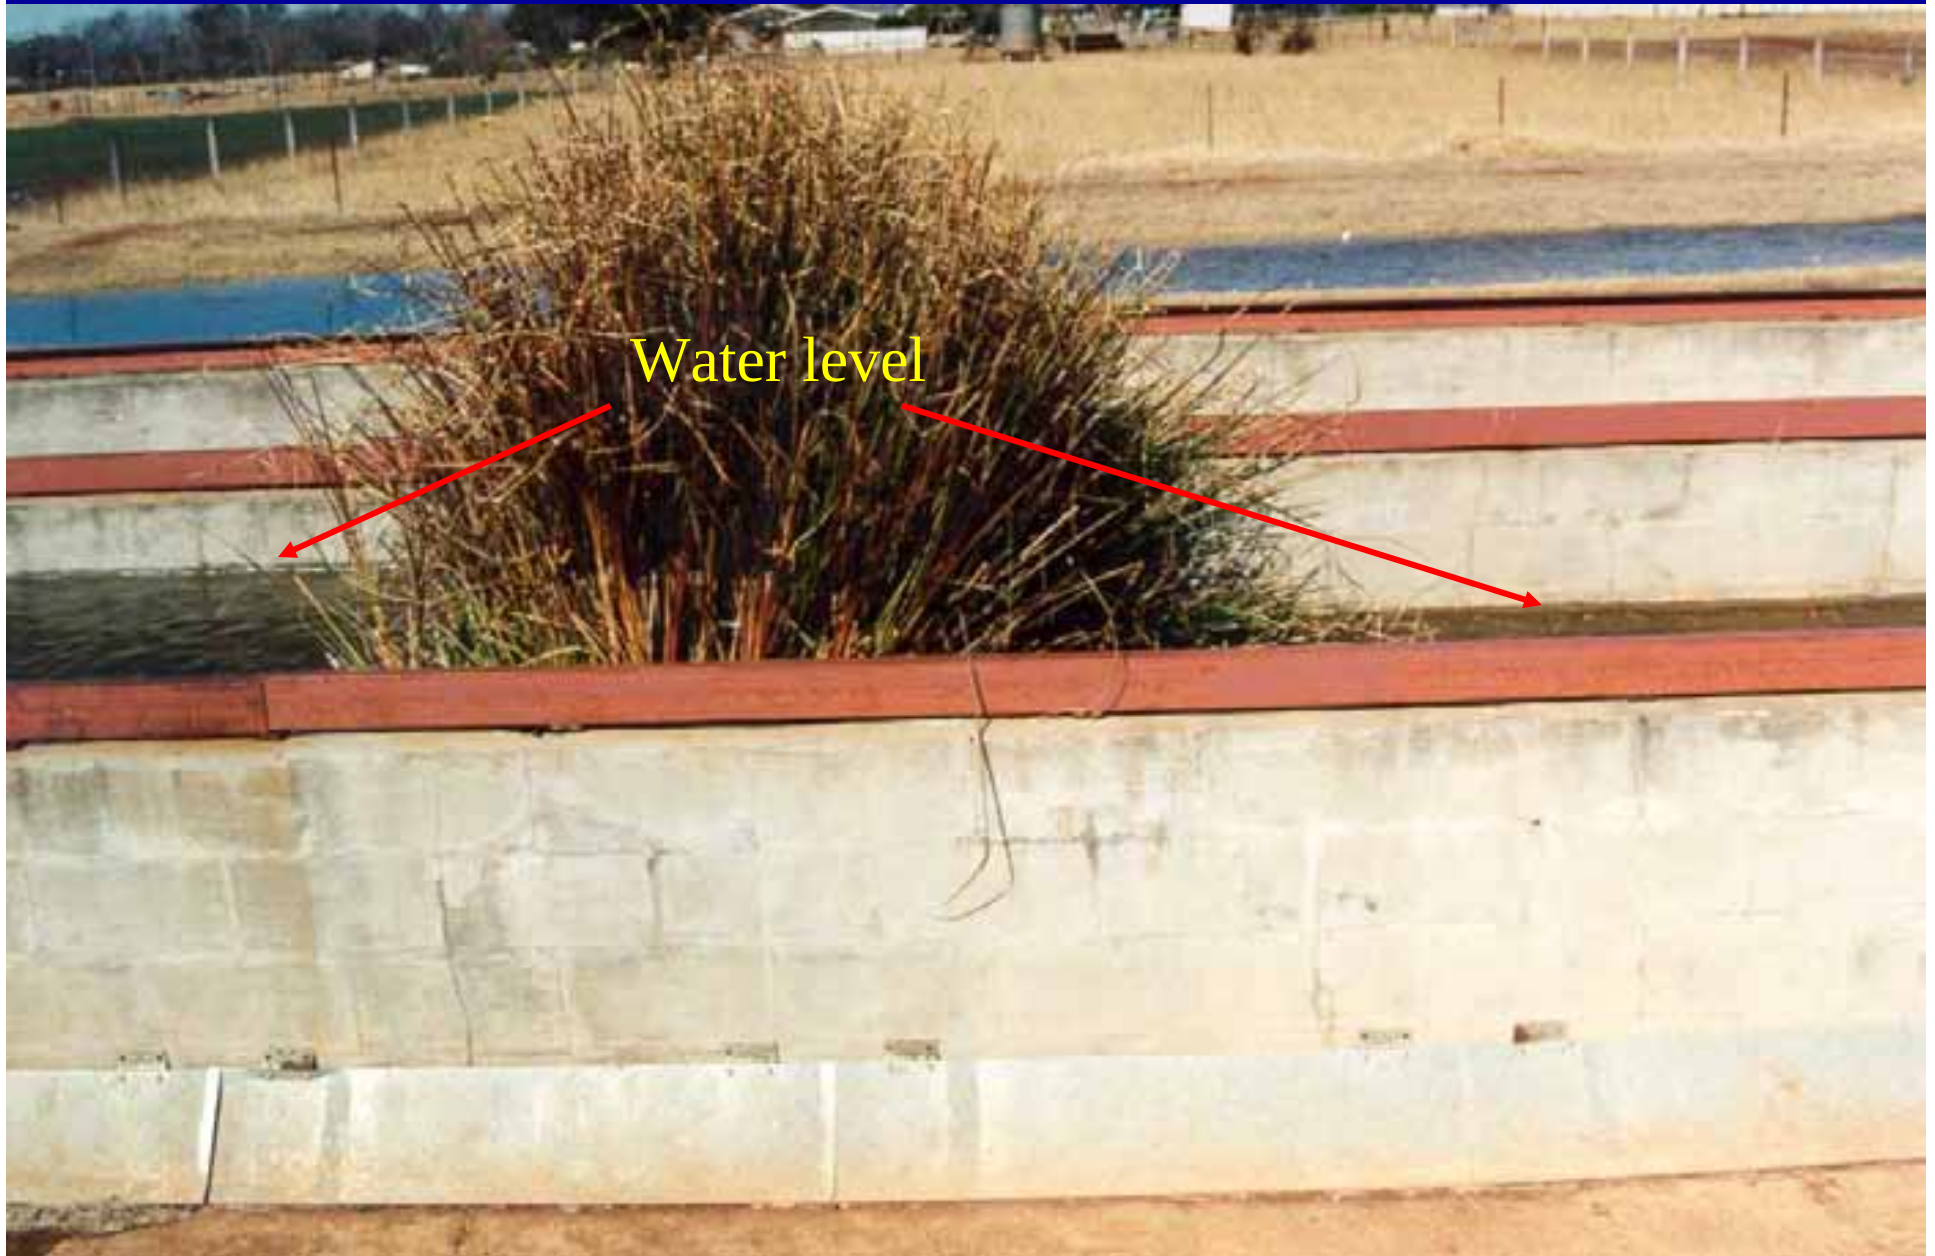
In flume test a mature hedge can bank up water to 600mm depth

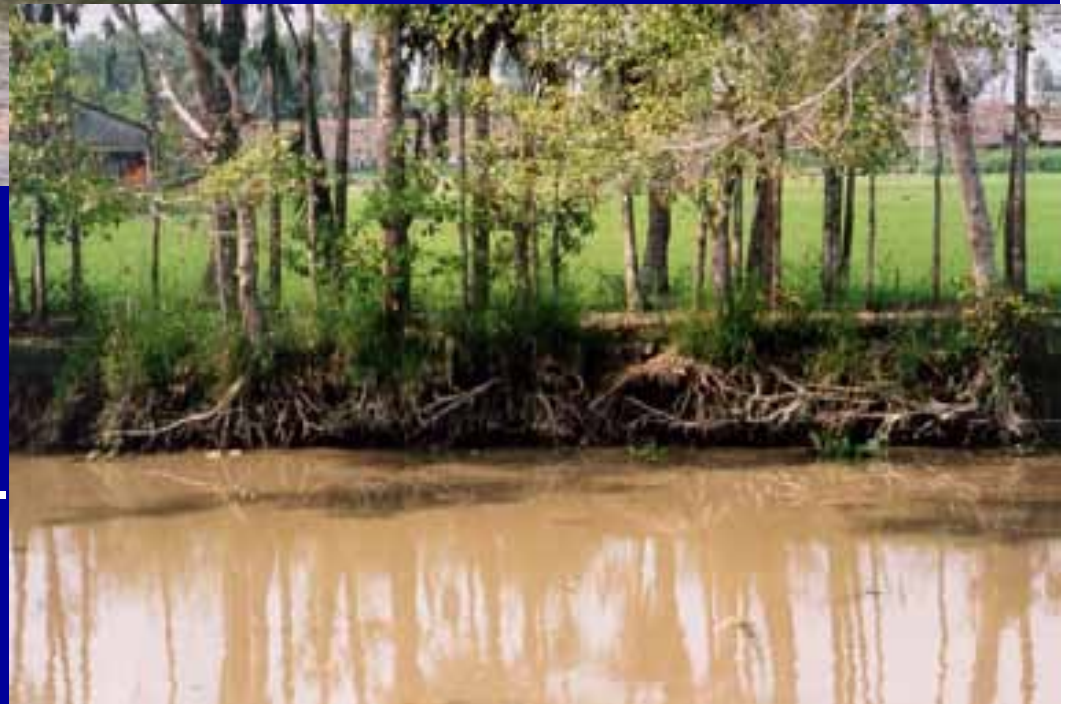
Using the water hyacinth barrier.  
But Erosion continues behind it

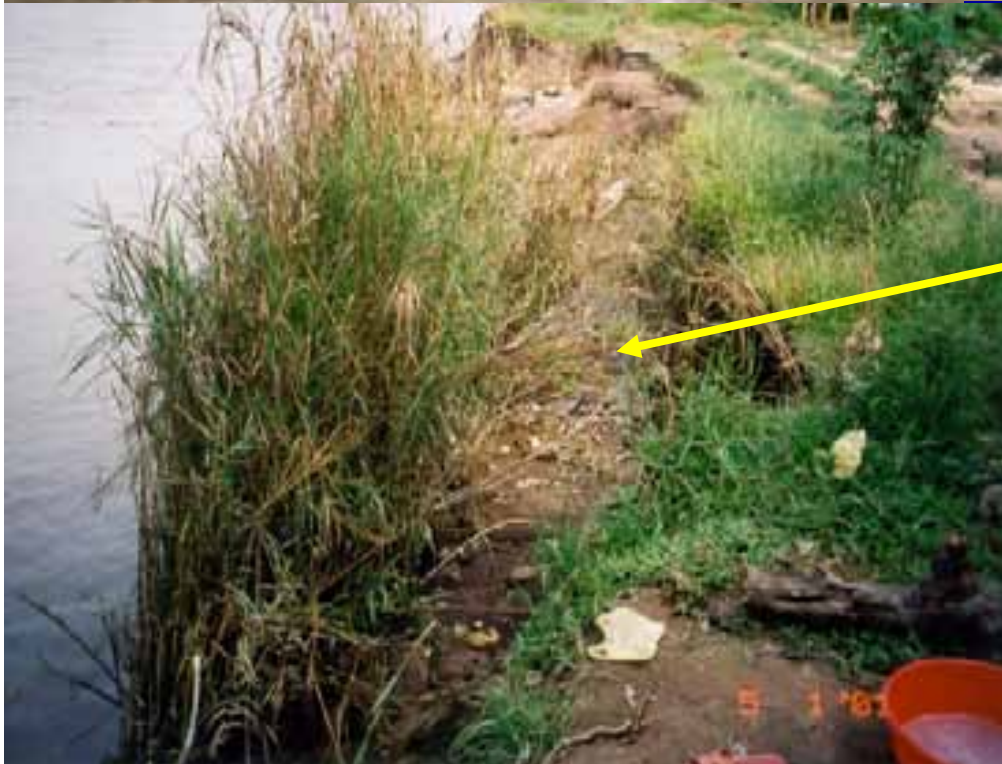
**From the front it looks like this bank is well protected. But erosion continues as waves from unprotected section upstream got behind it.**

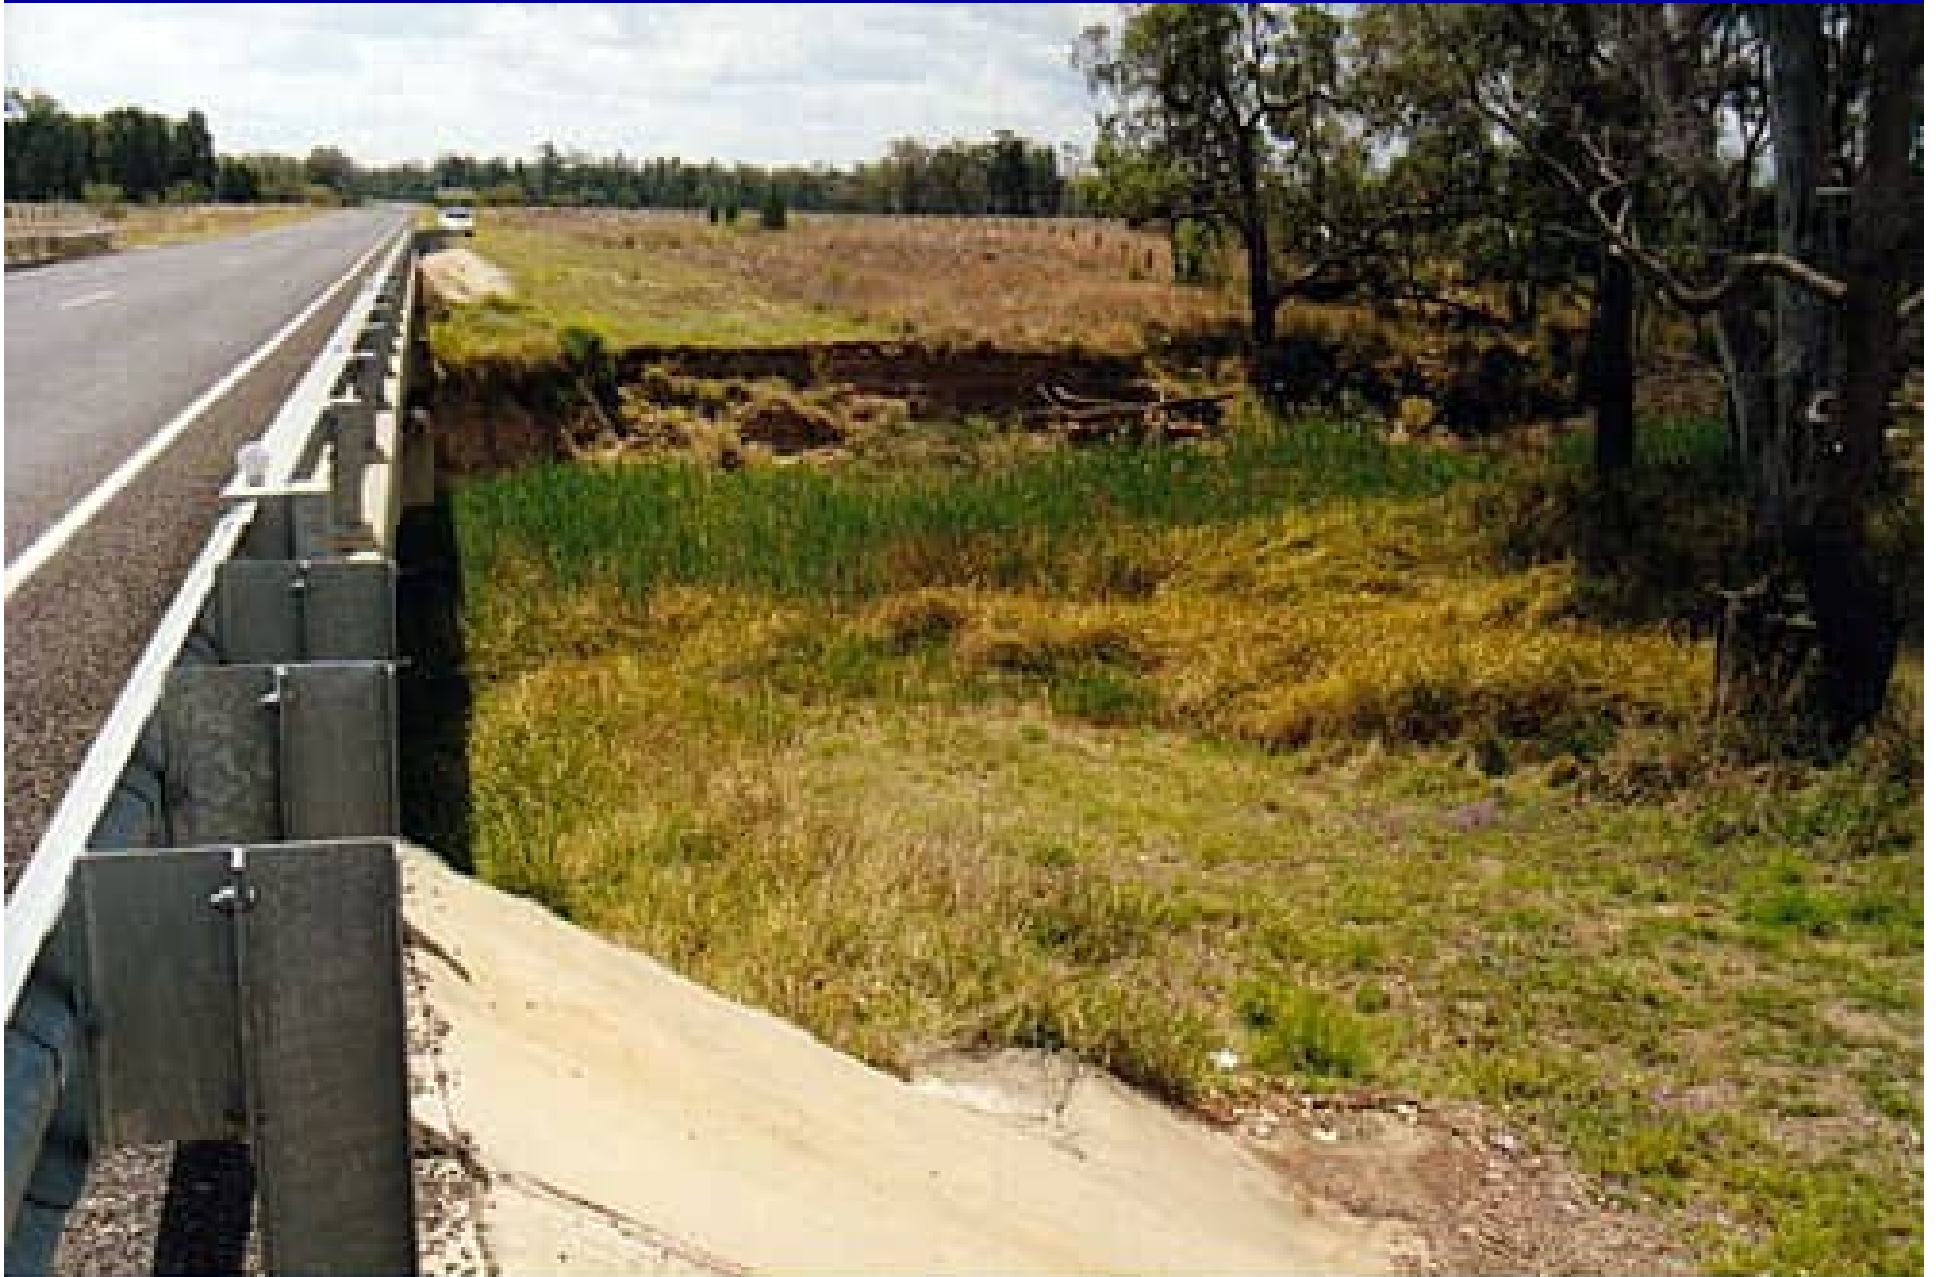
## Severe erosion on the abutment of the Coolumboola Creek

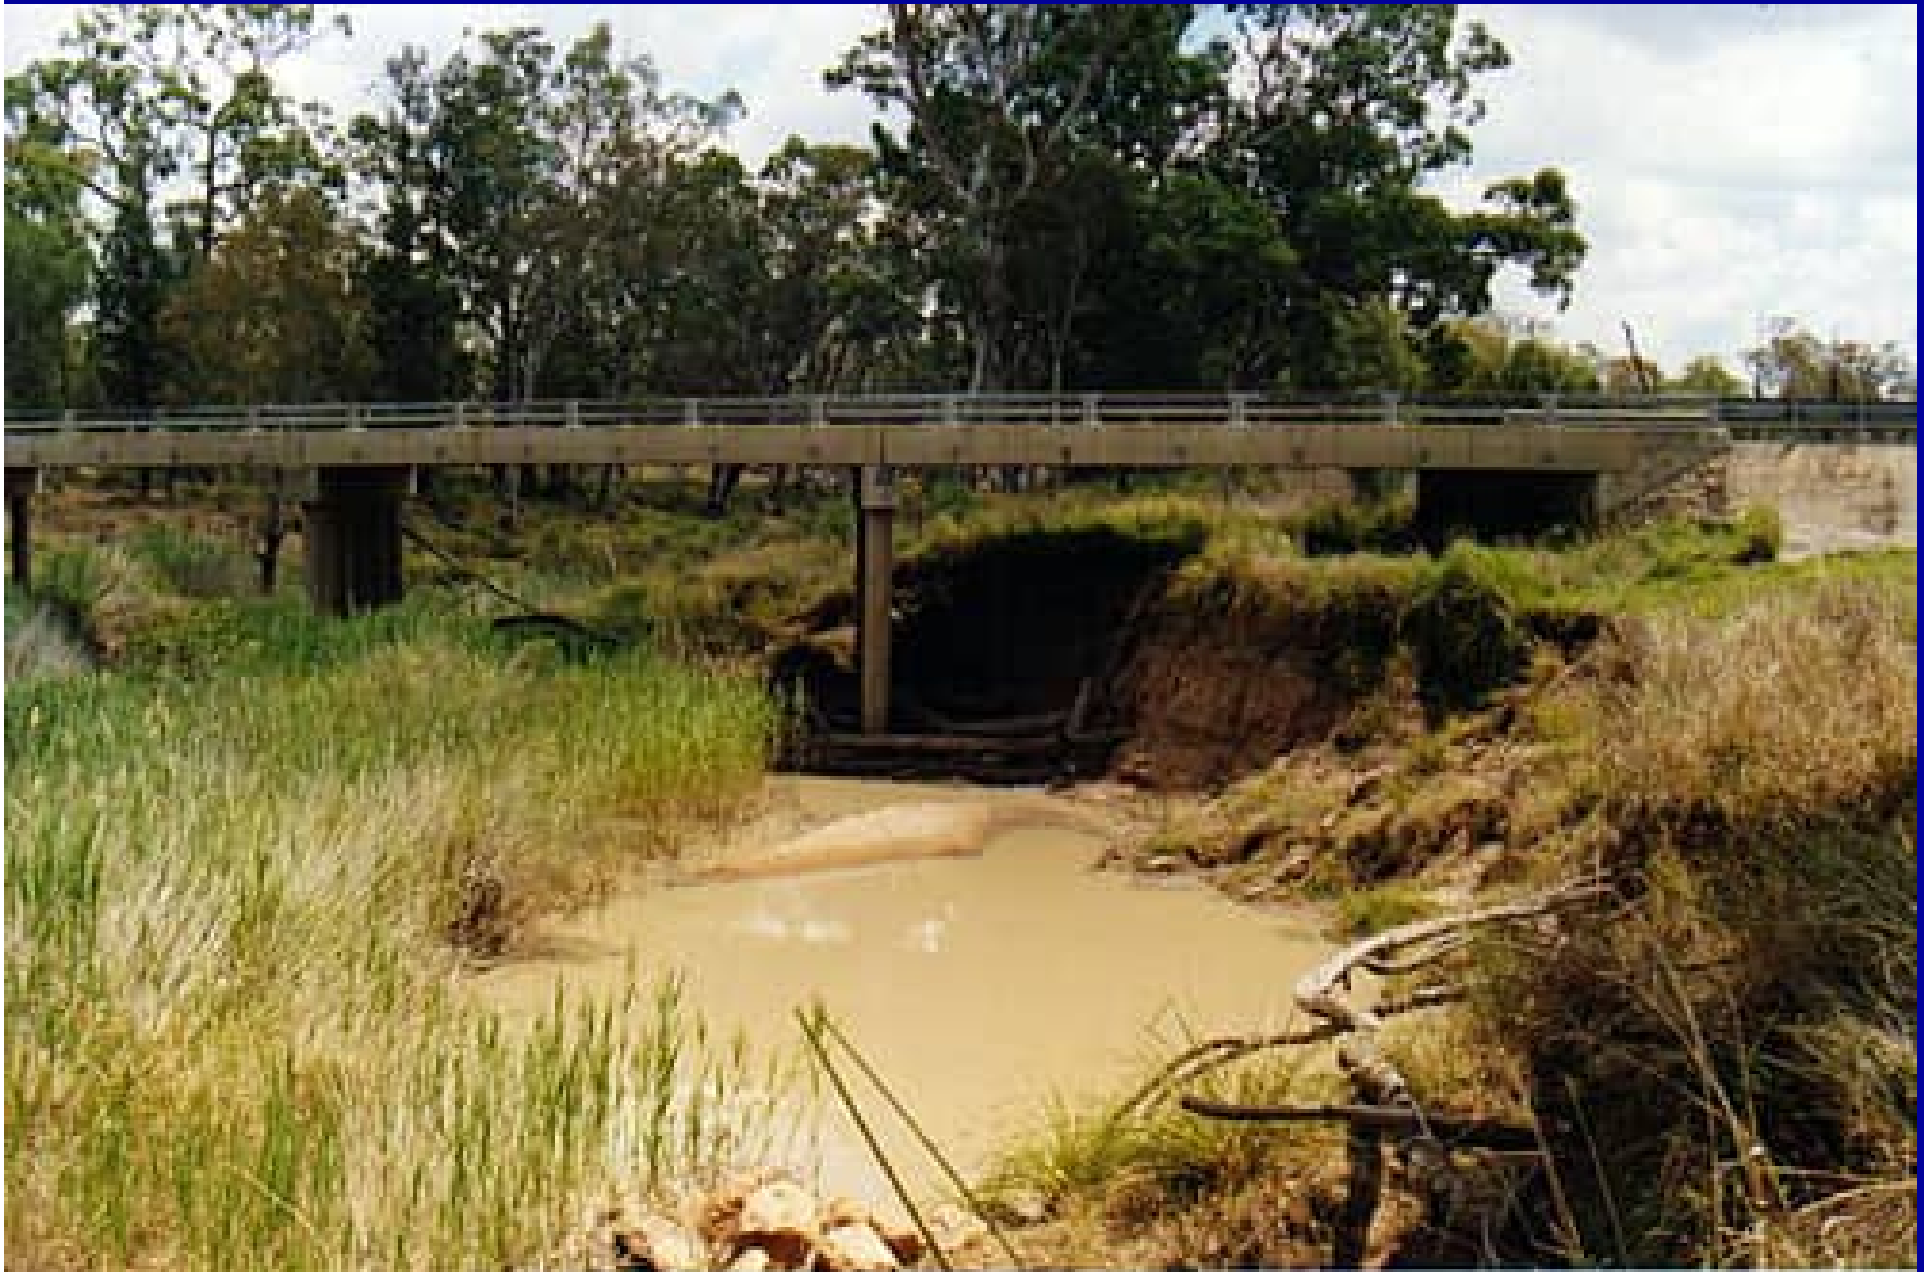
## Severe erosion on the abutment of the Coolumboola Creek

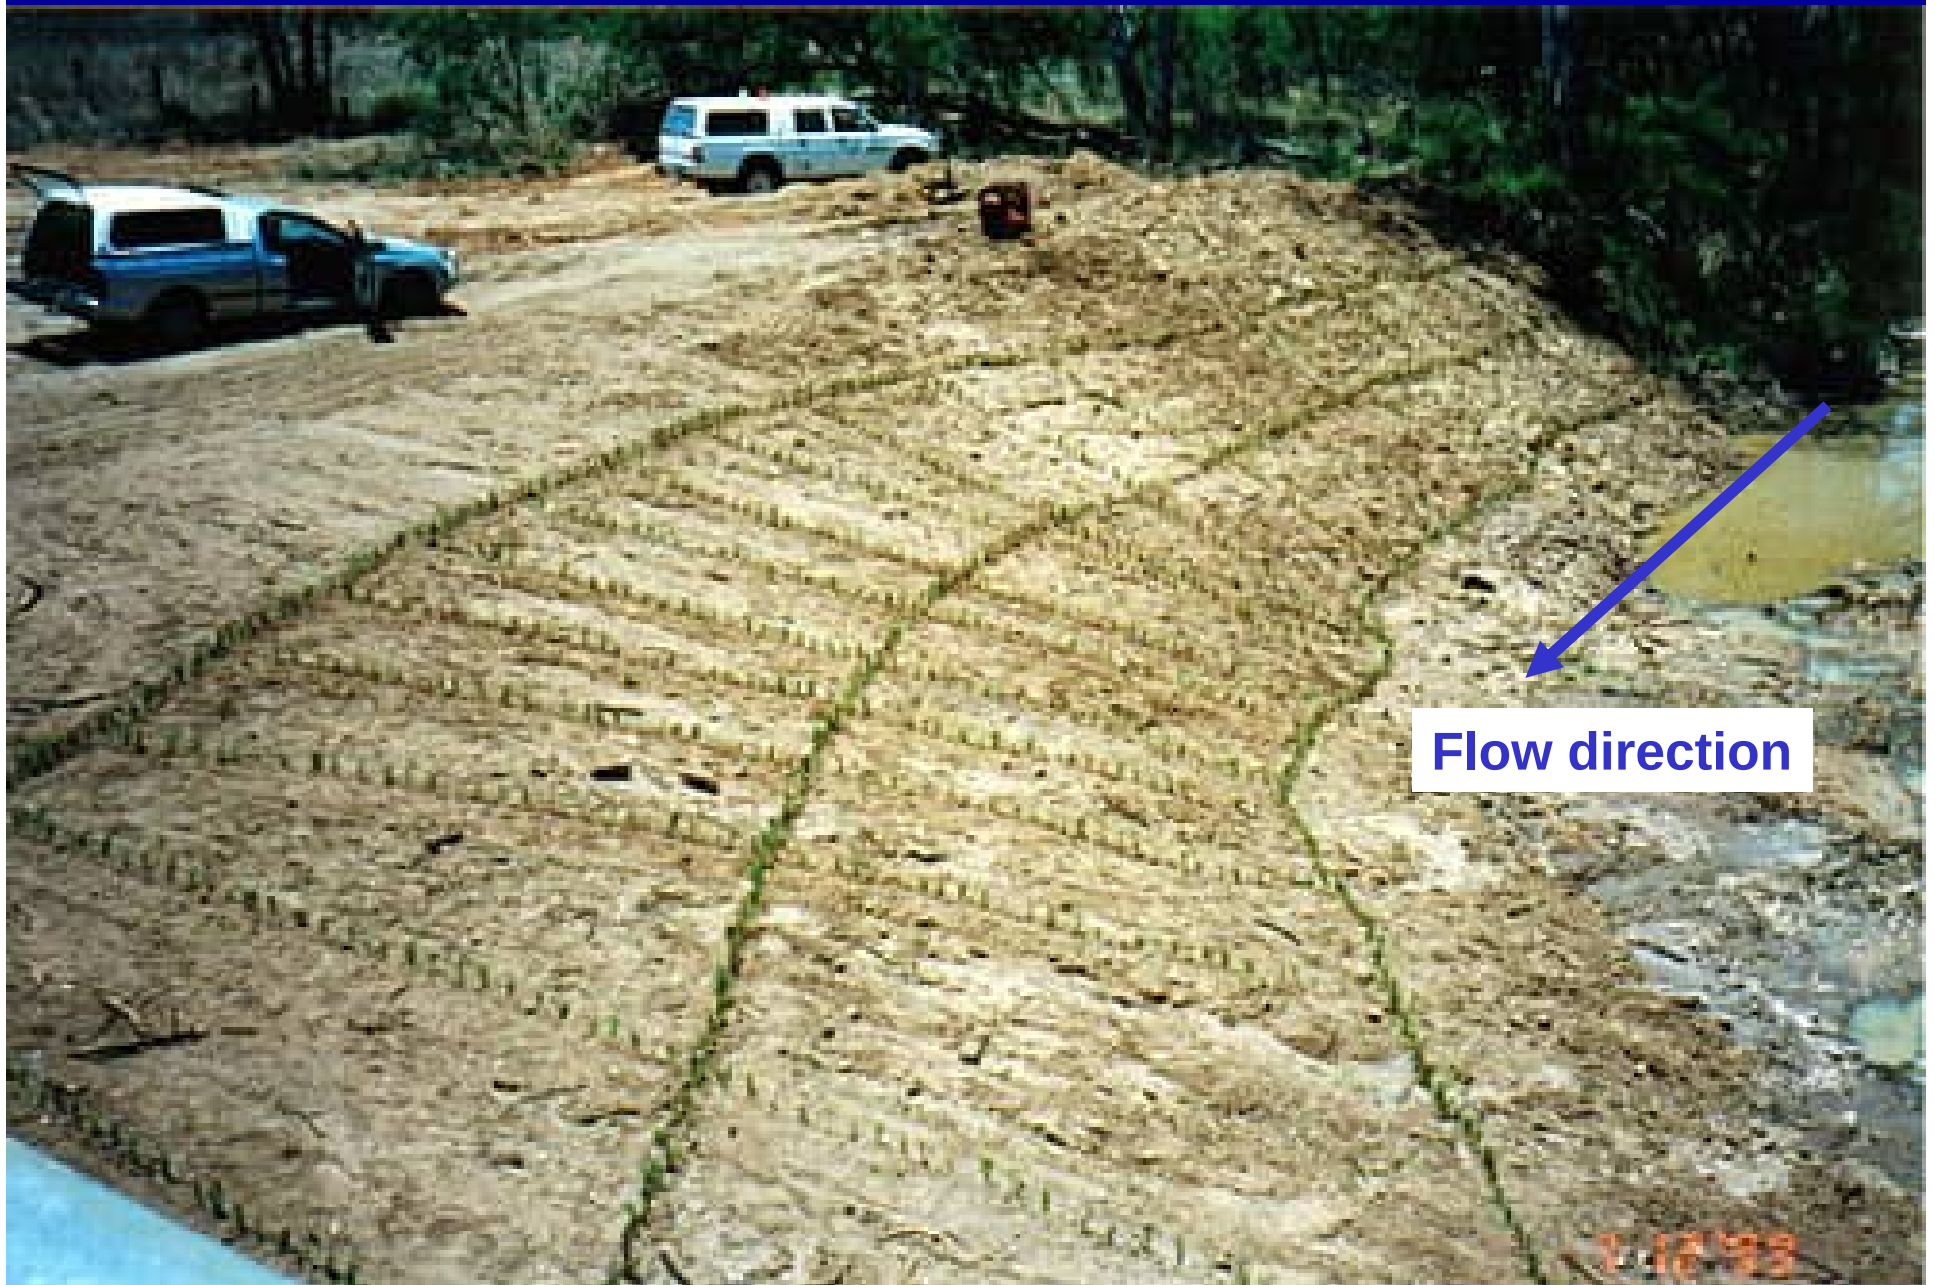
## Vetiver planted after reparation

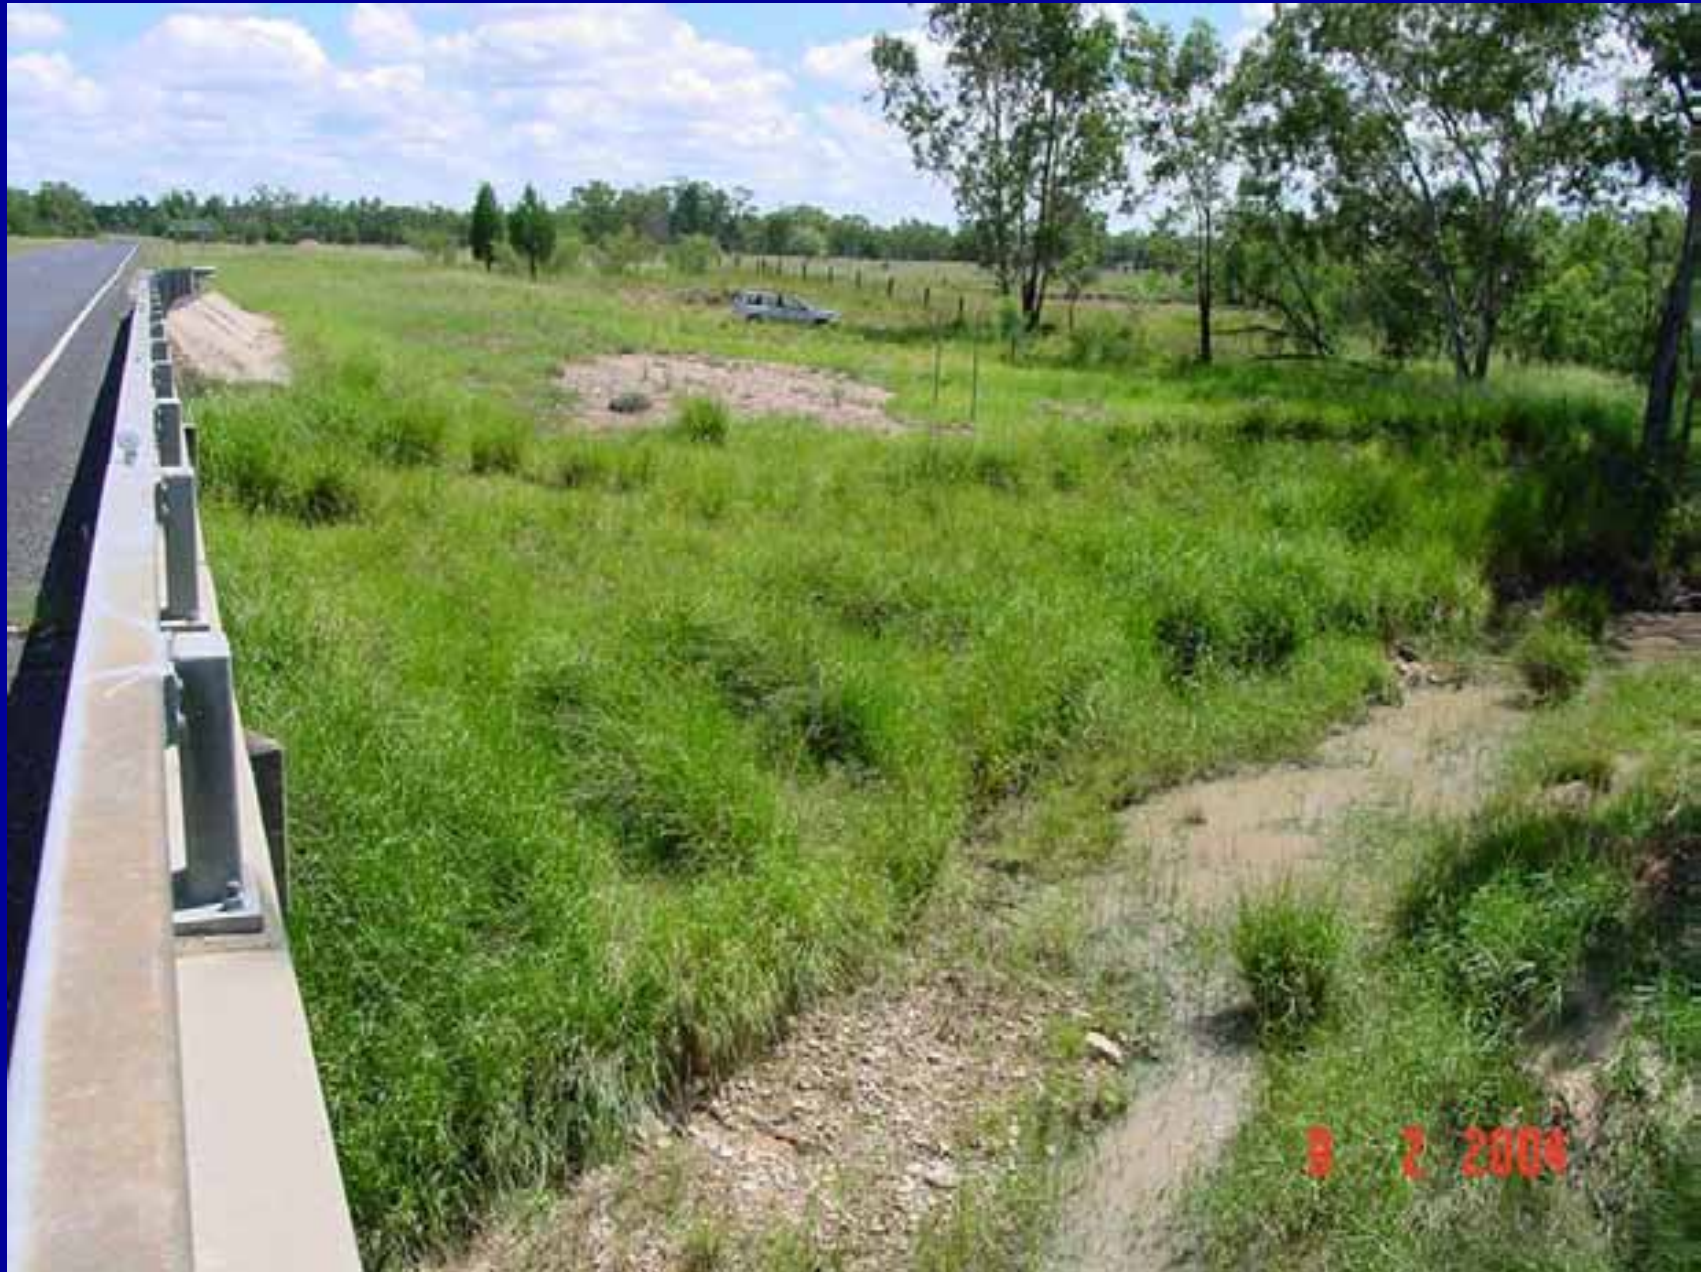
**18 months after planting, no more erosion on the whole site**

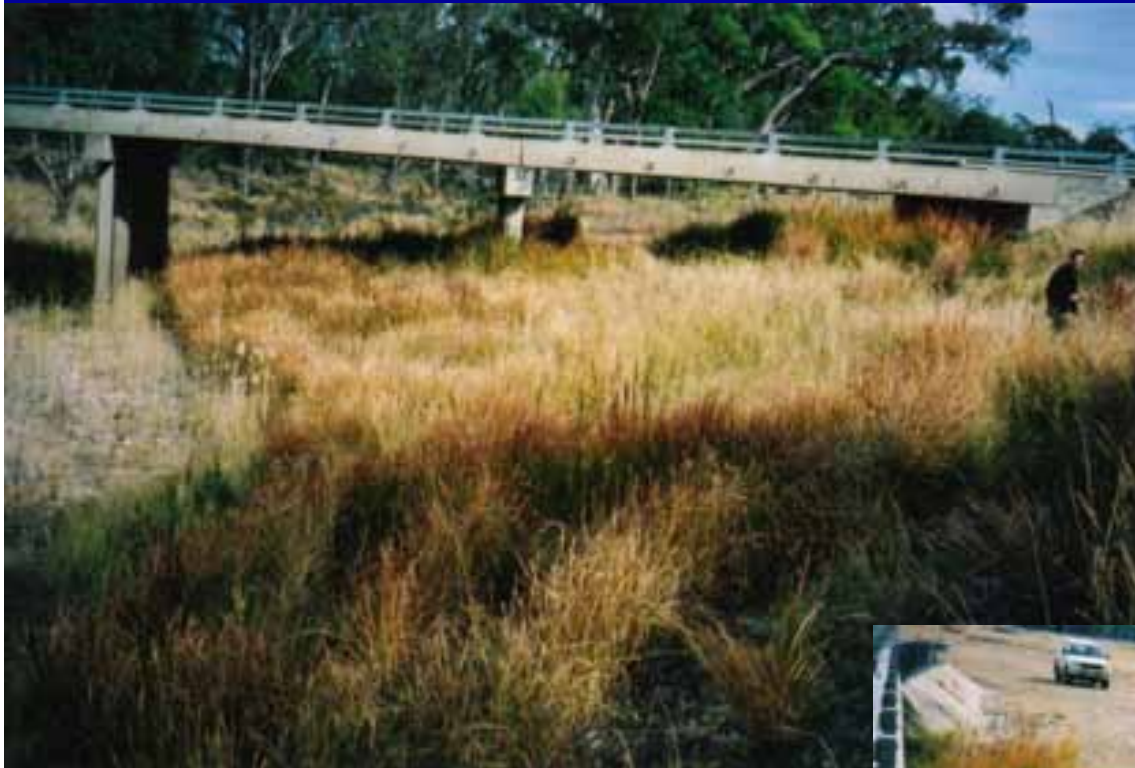
## Five years after planting and after several flash floods

**Yellow leaves due to  
winter frost**

**Note the bare area  
between rows. No other  
plants have survived**

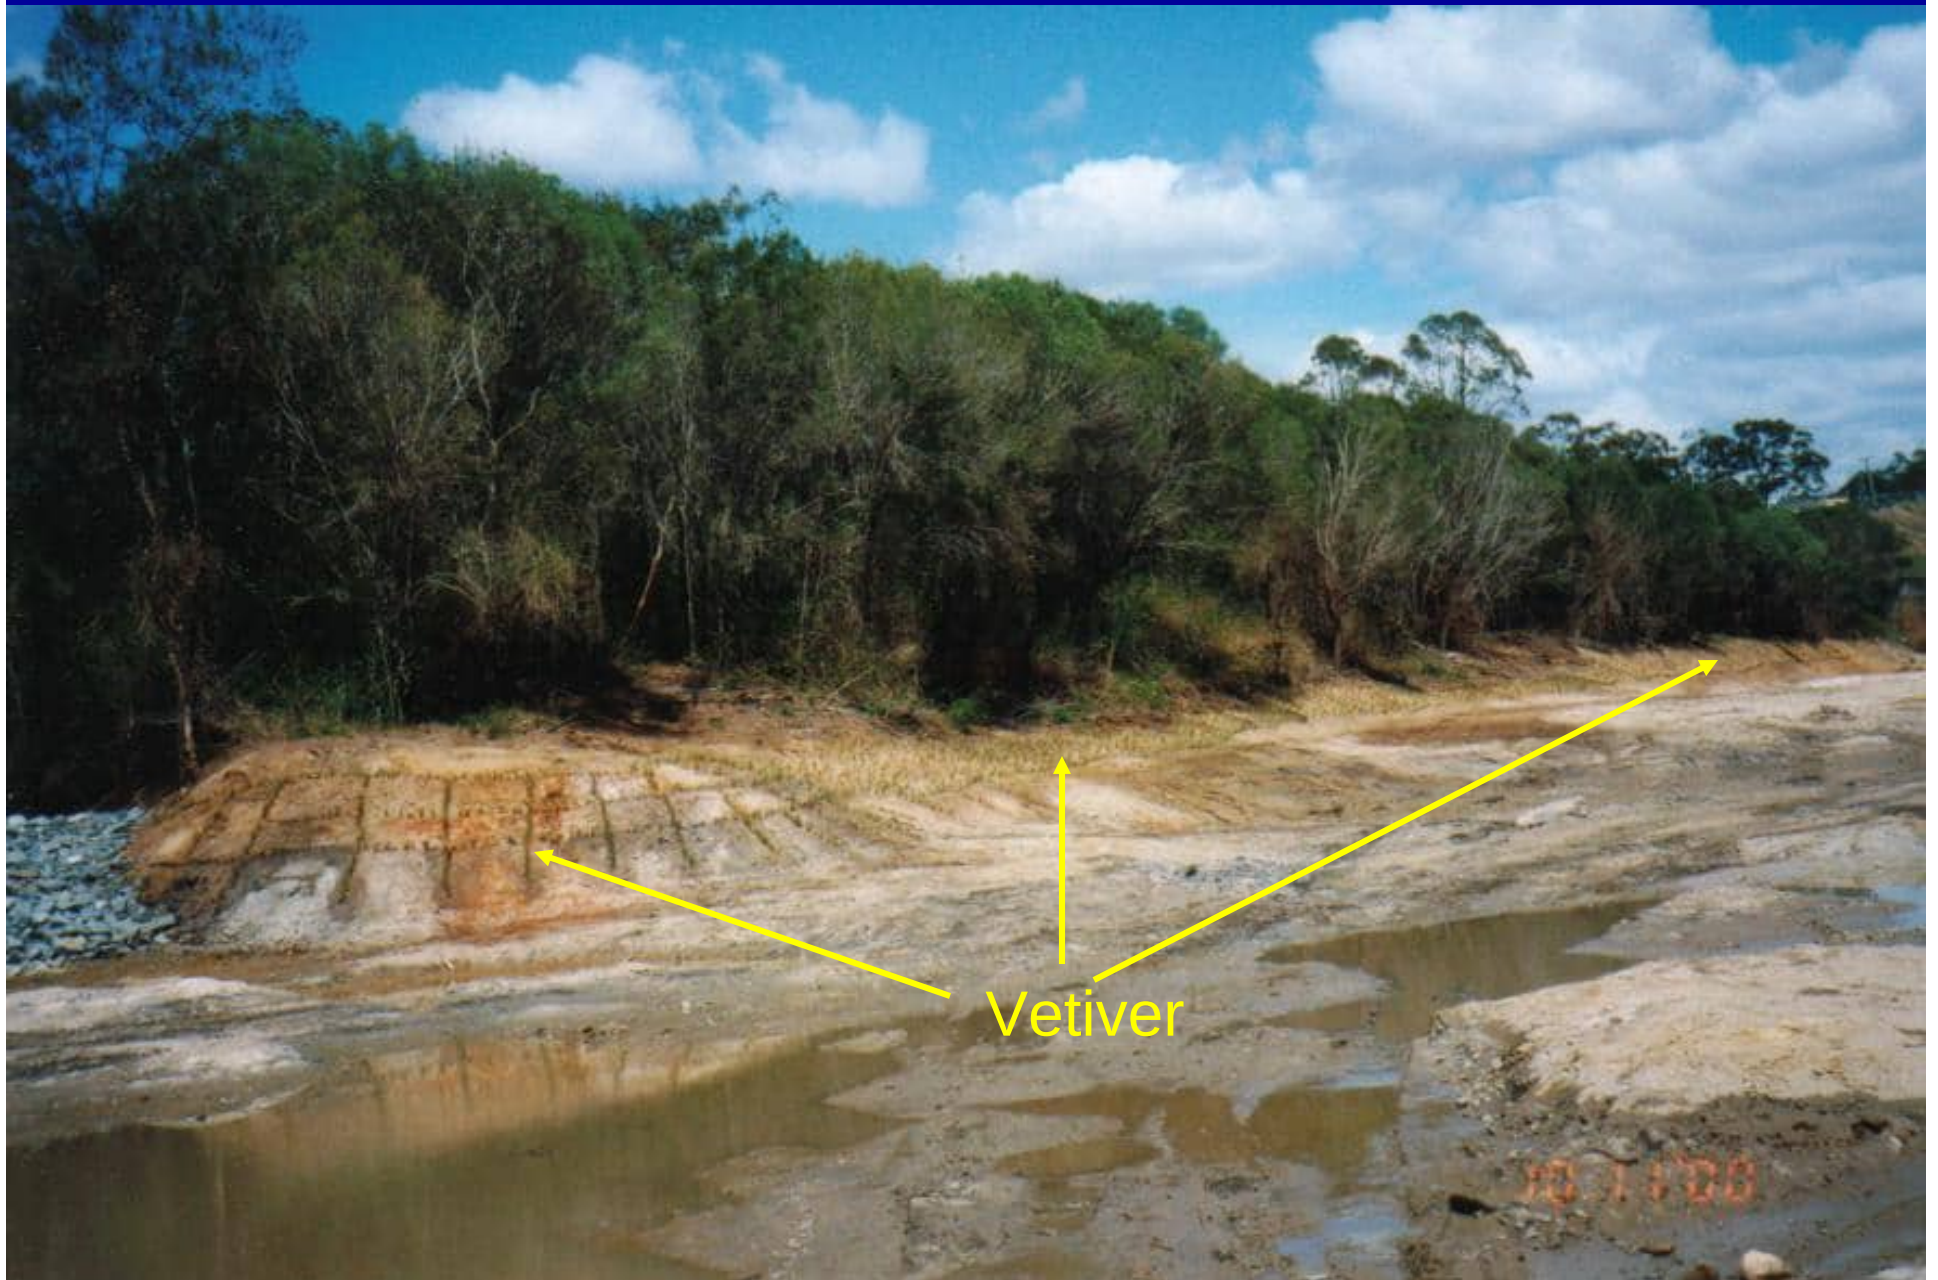
## Stabilisation of creek bank of a Dam spillway

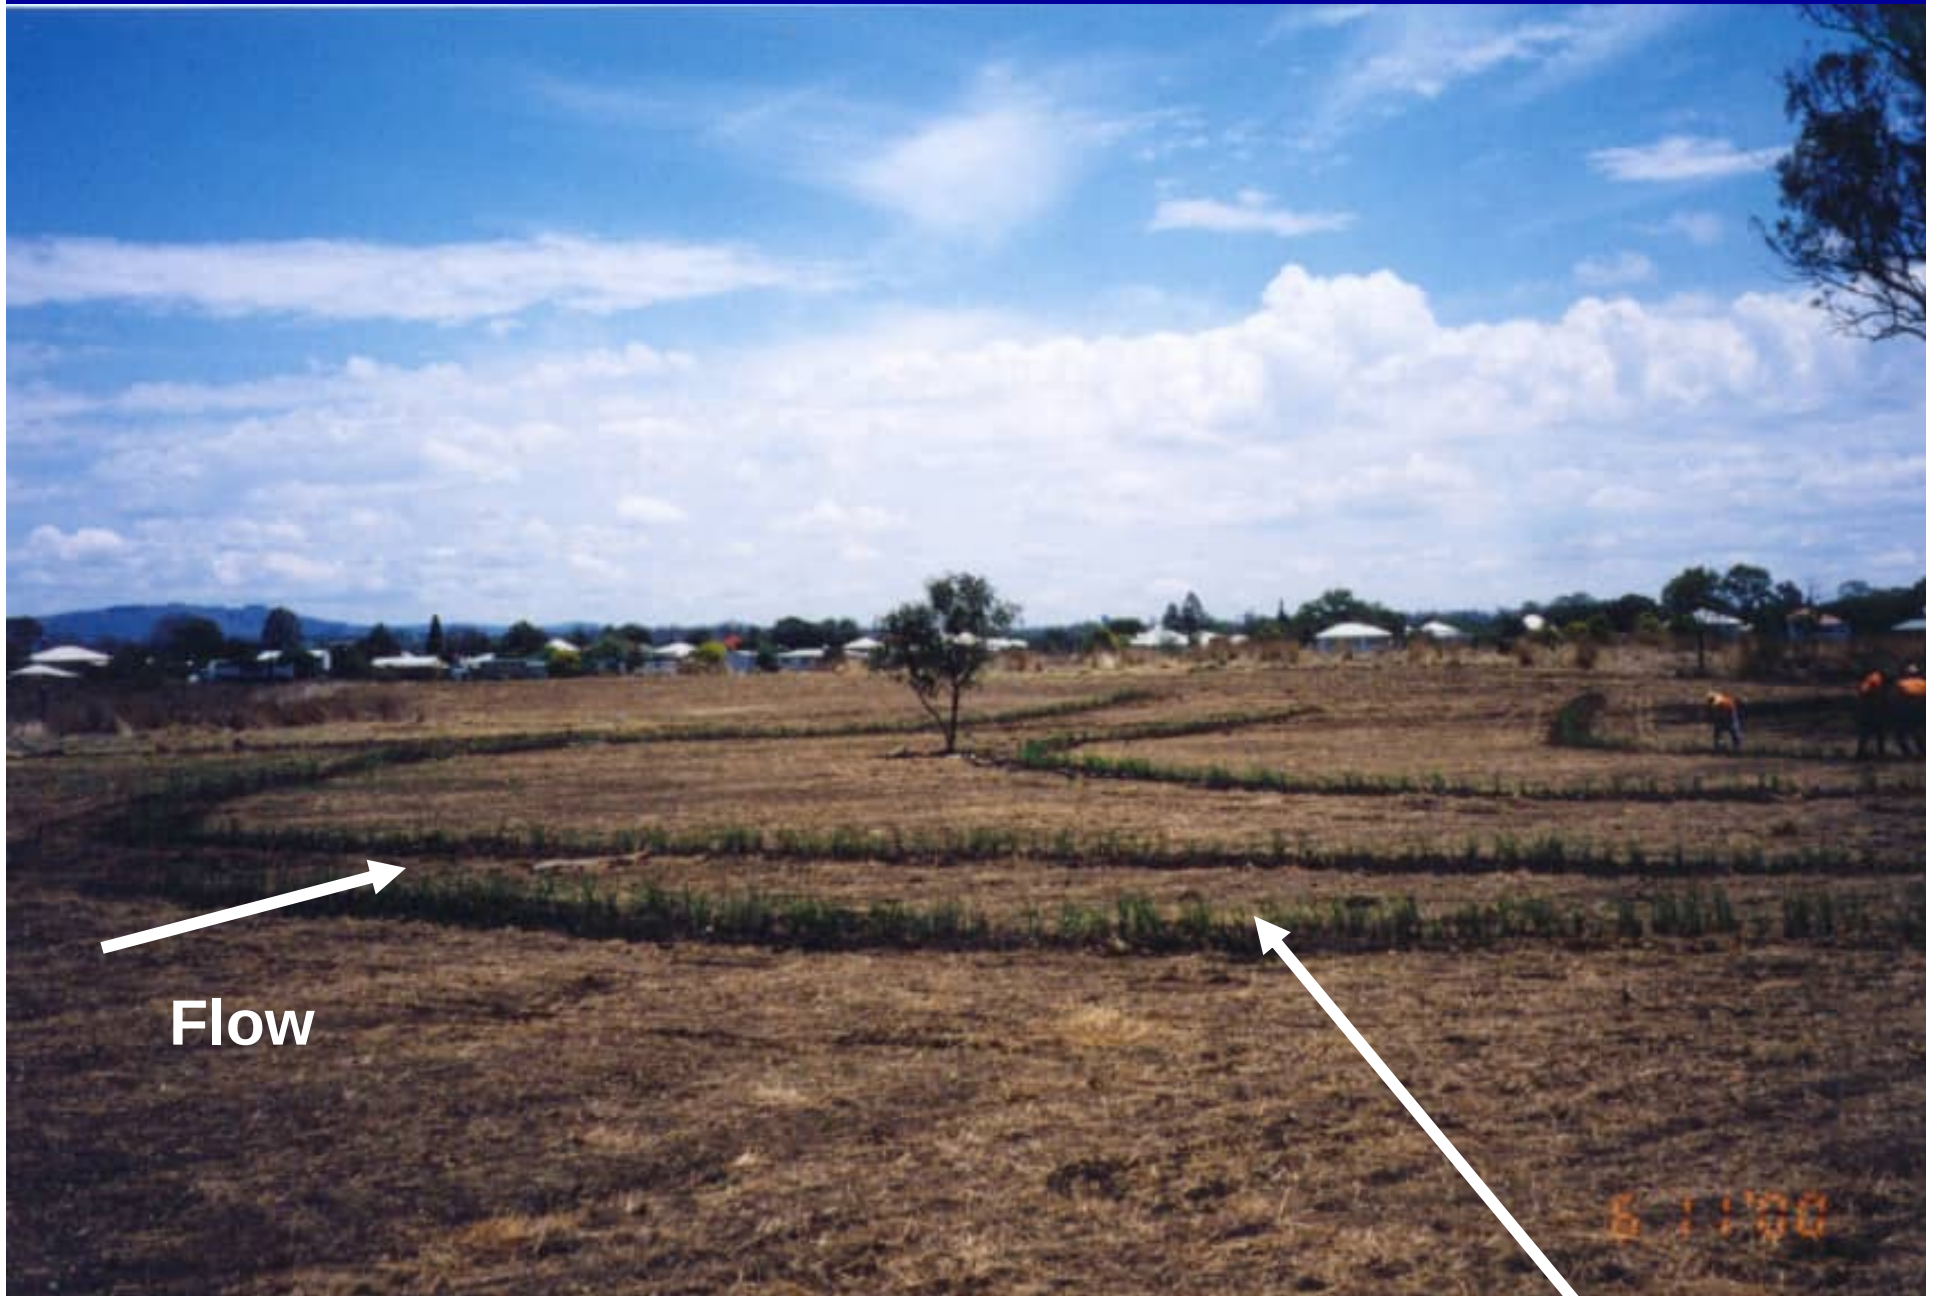
## Flood erosion control in drainage channel

Vetiver hedges were established to spread water out and also to divert water to the drain

Looking sideways towards the channel opening

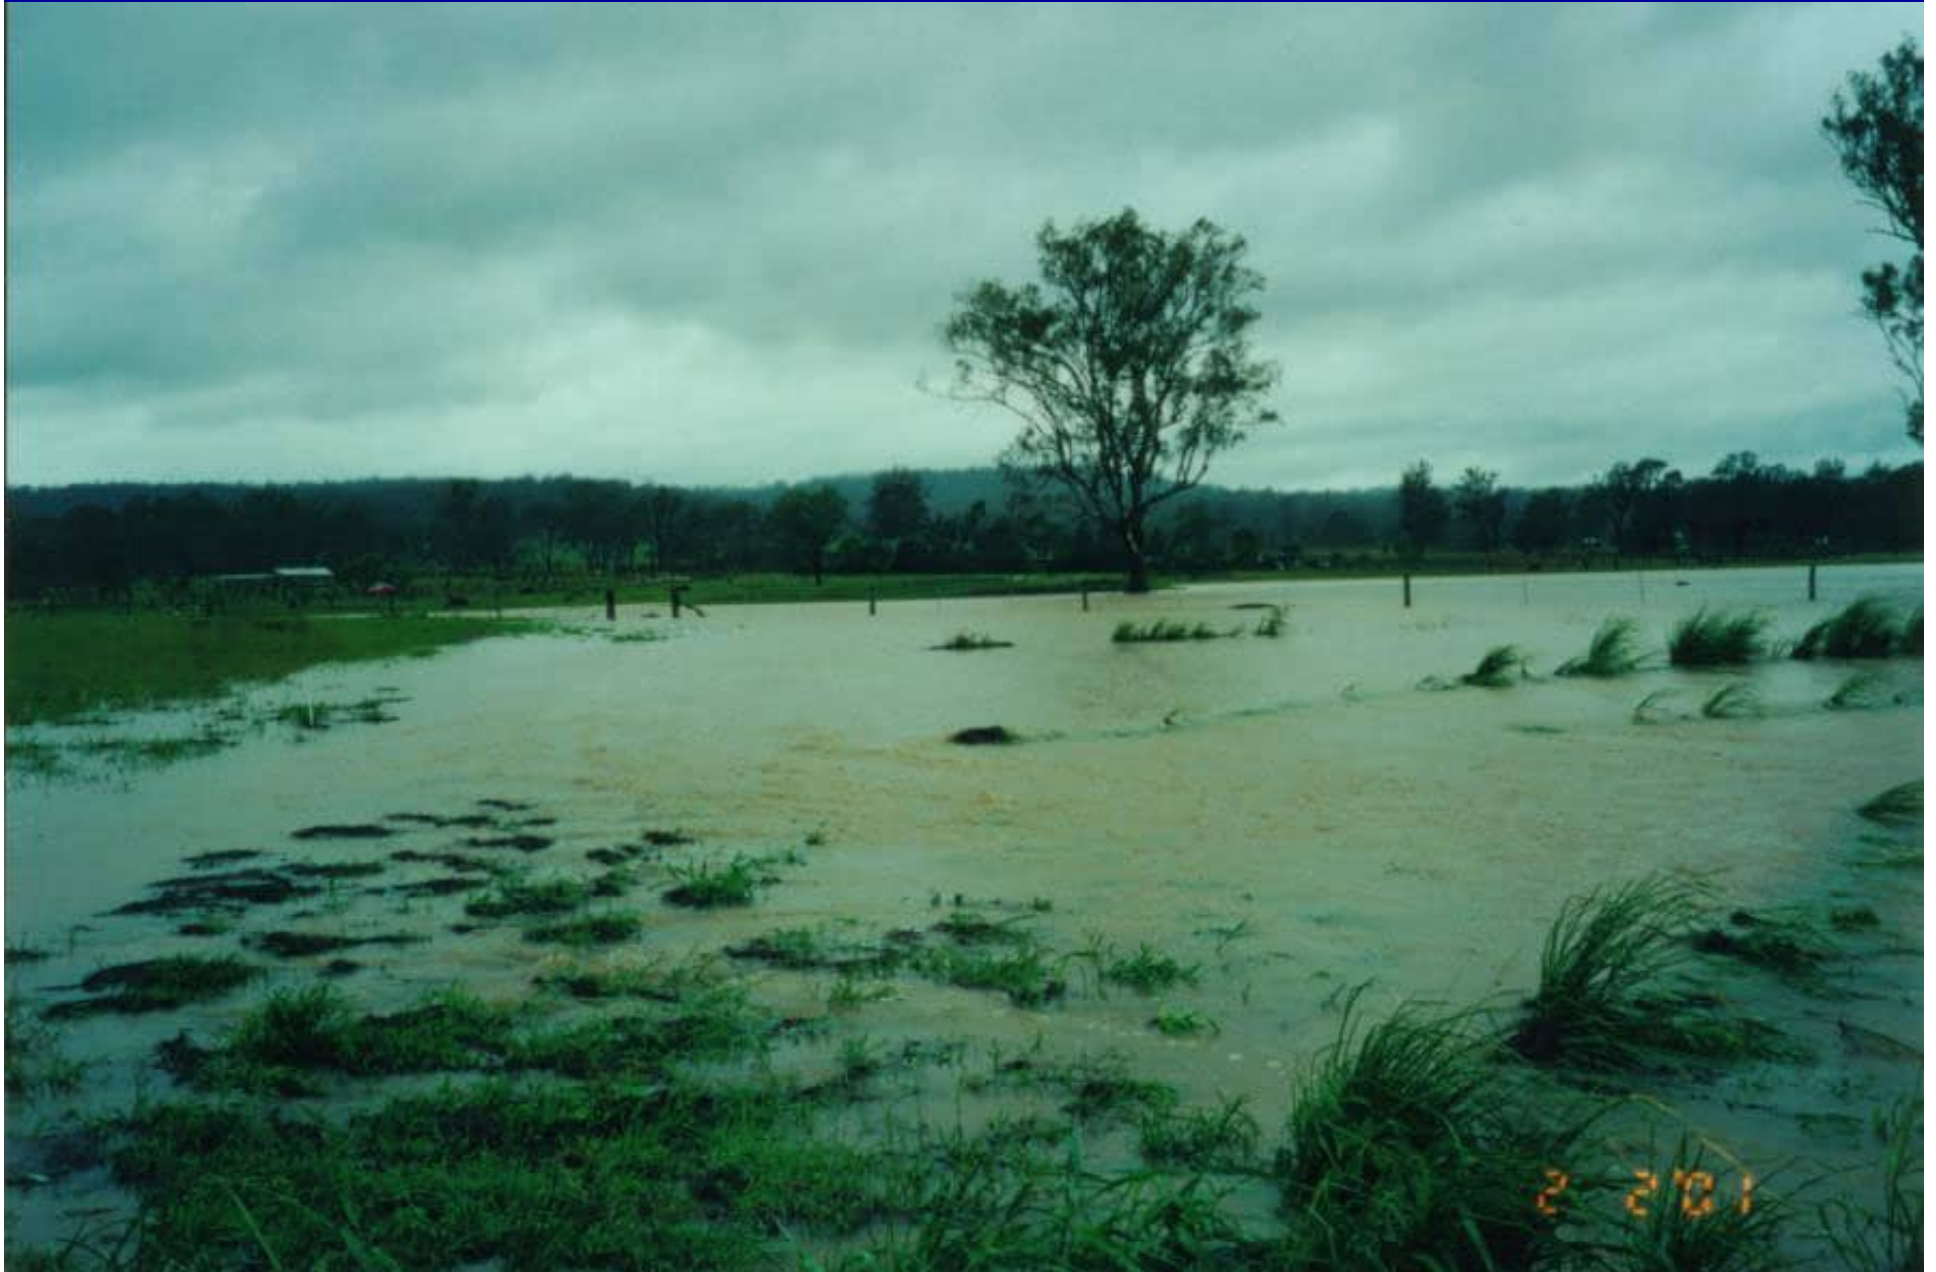
**A big storm hit the area 3 months after planting and the whole site was flooded (Upper section)**
