# **Vetiver System for Stream Bank Stabilisation**

**(With special references to the river and canal bank stabilisation  
in Australia and Vietnam)**

**Paul Truong**

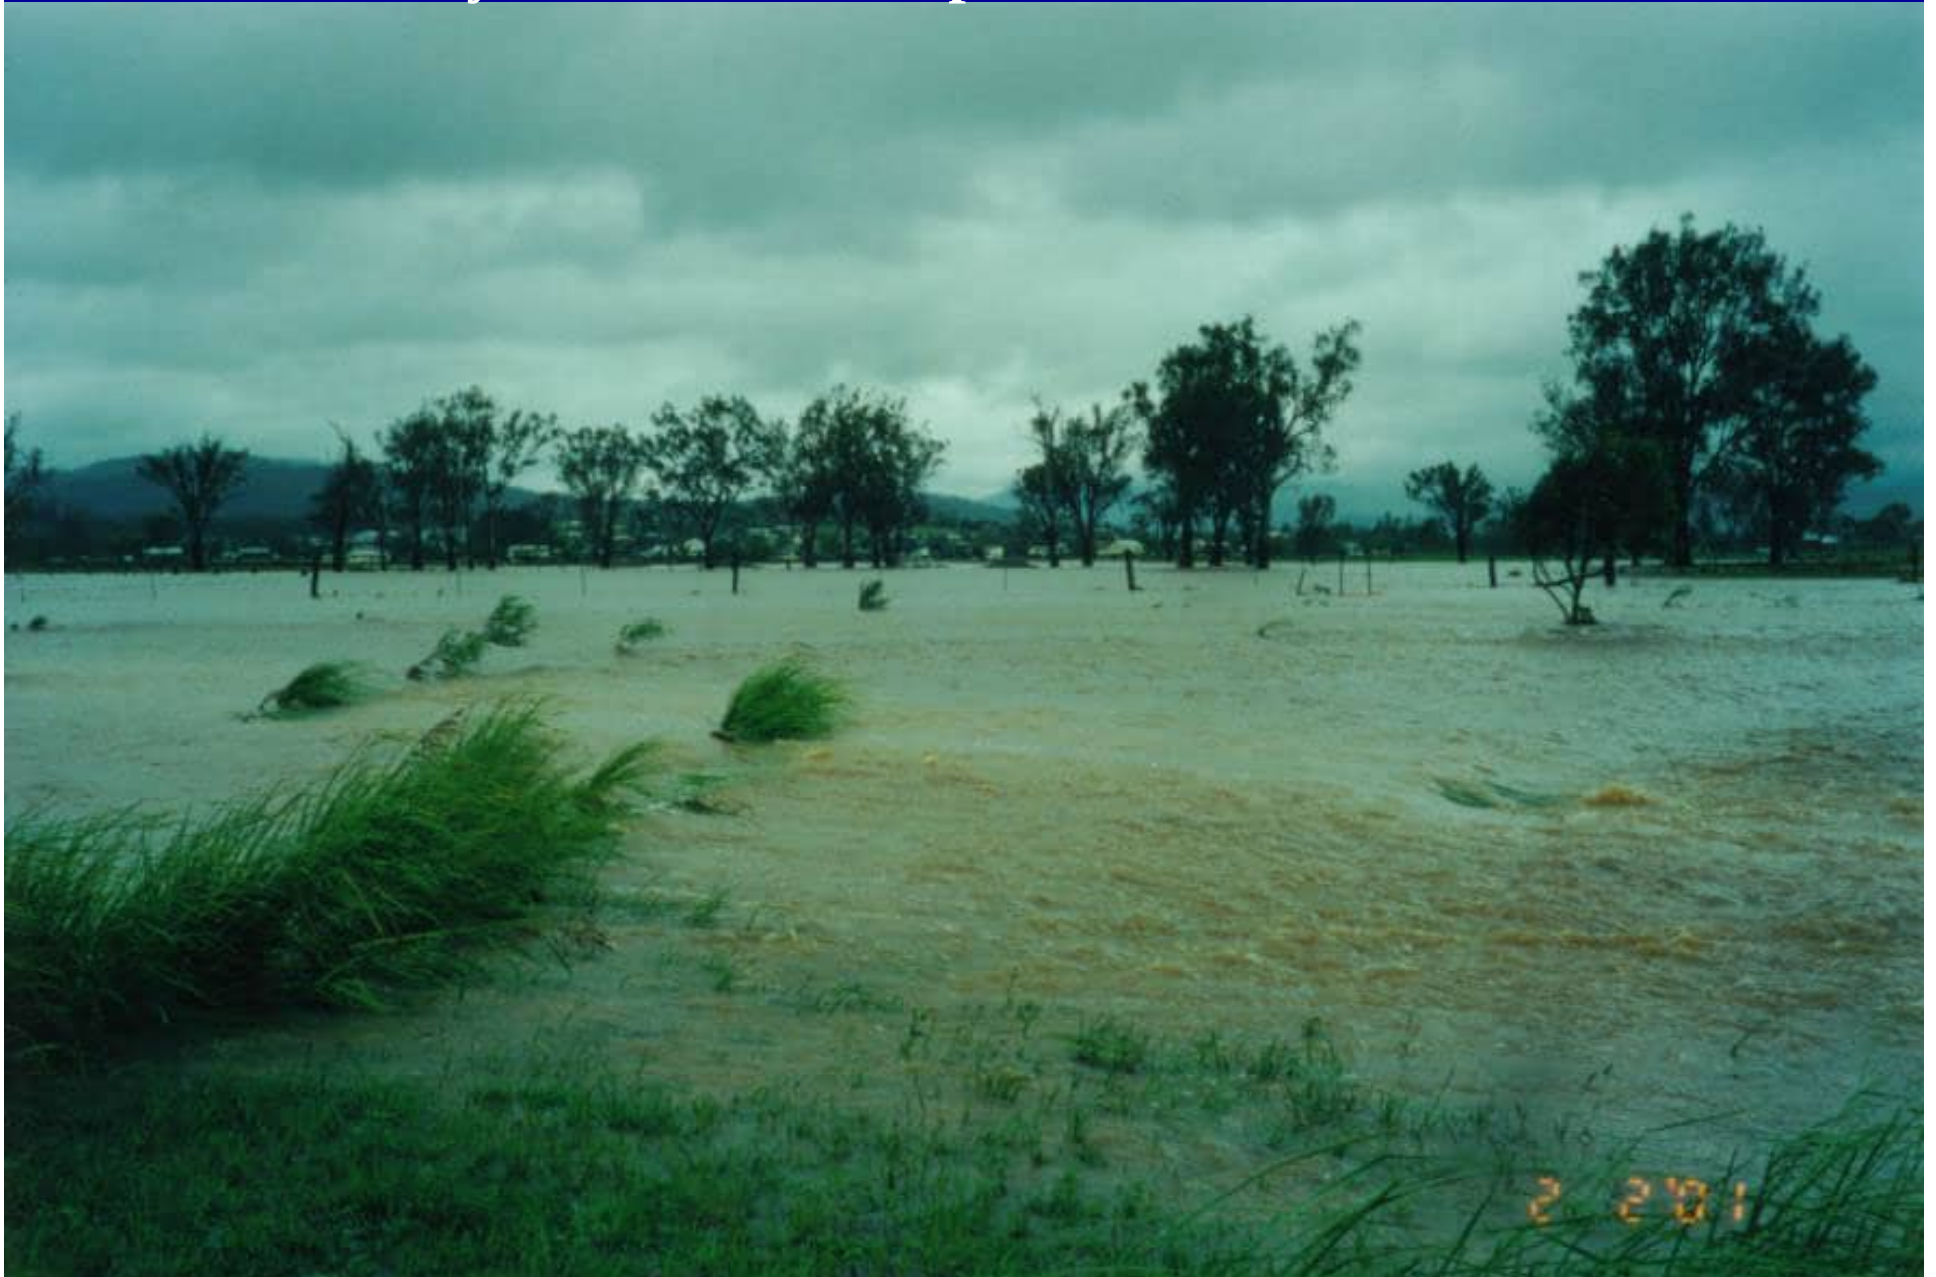
**Very fast flow flattened and inundated most of the hedges. The velocity was estimated up to 5m/sec in some areas**

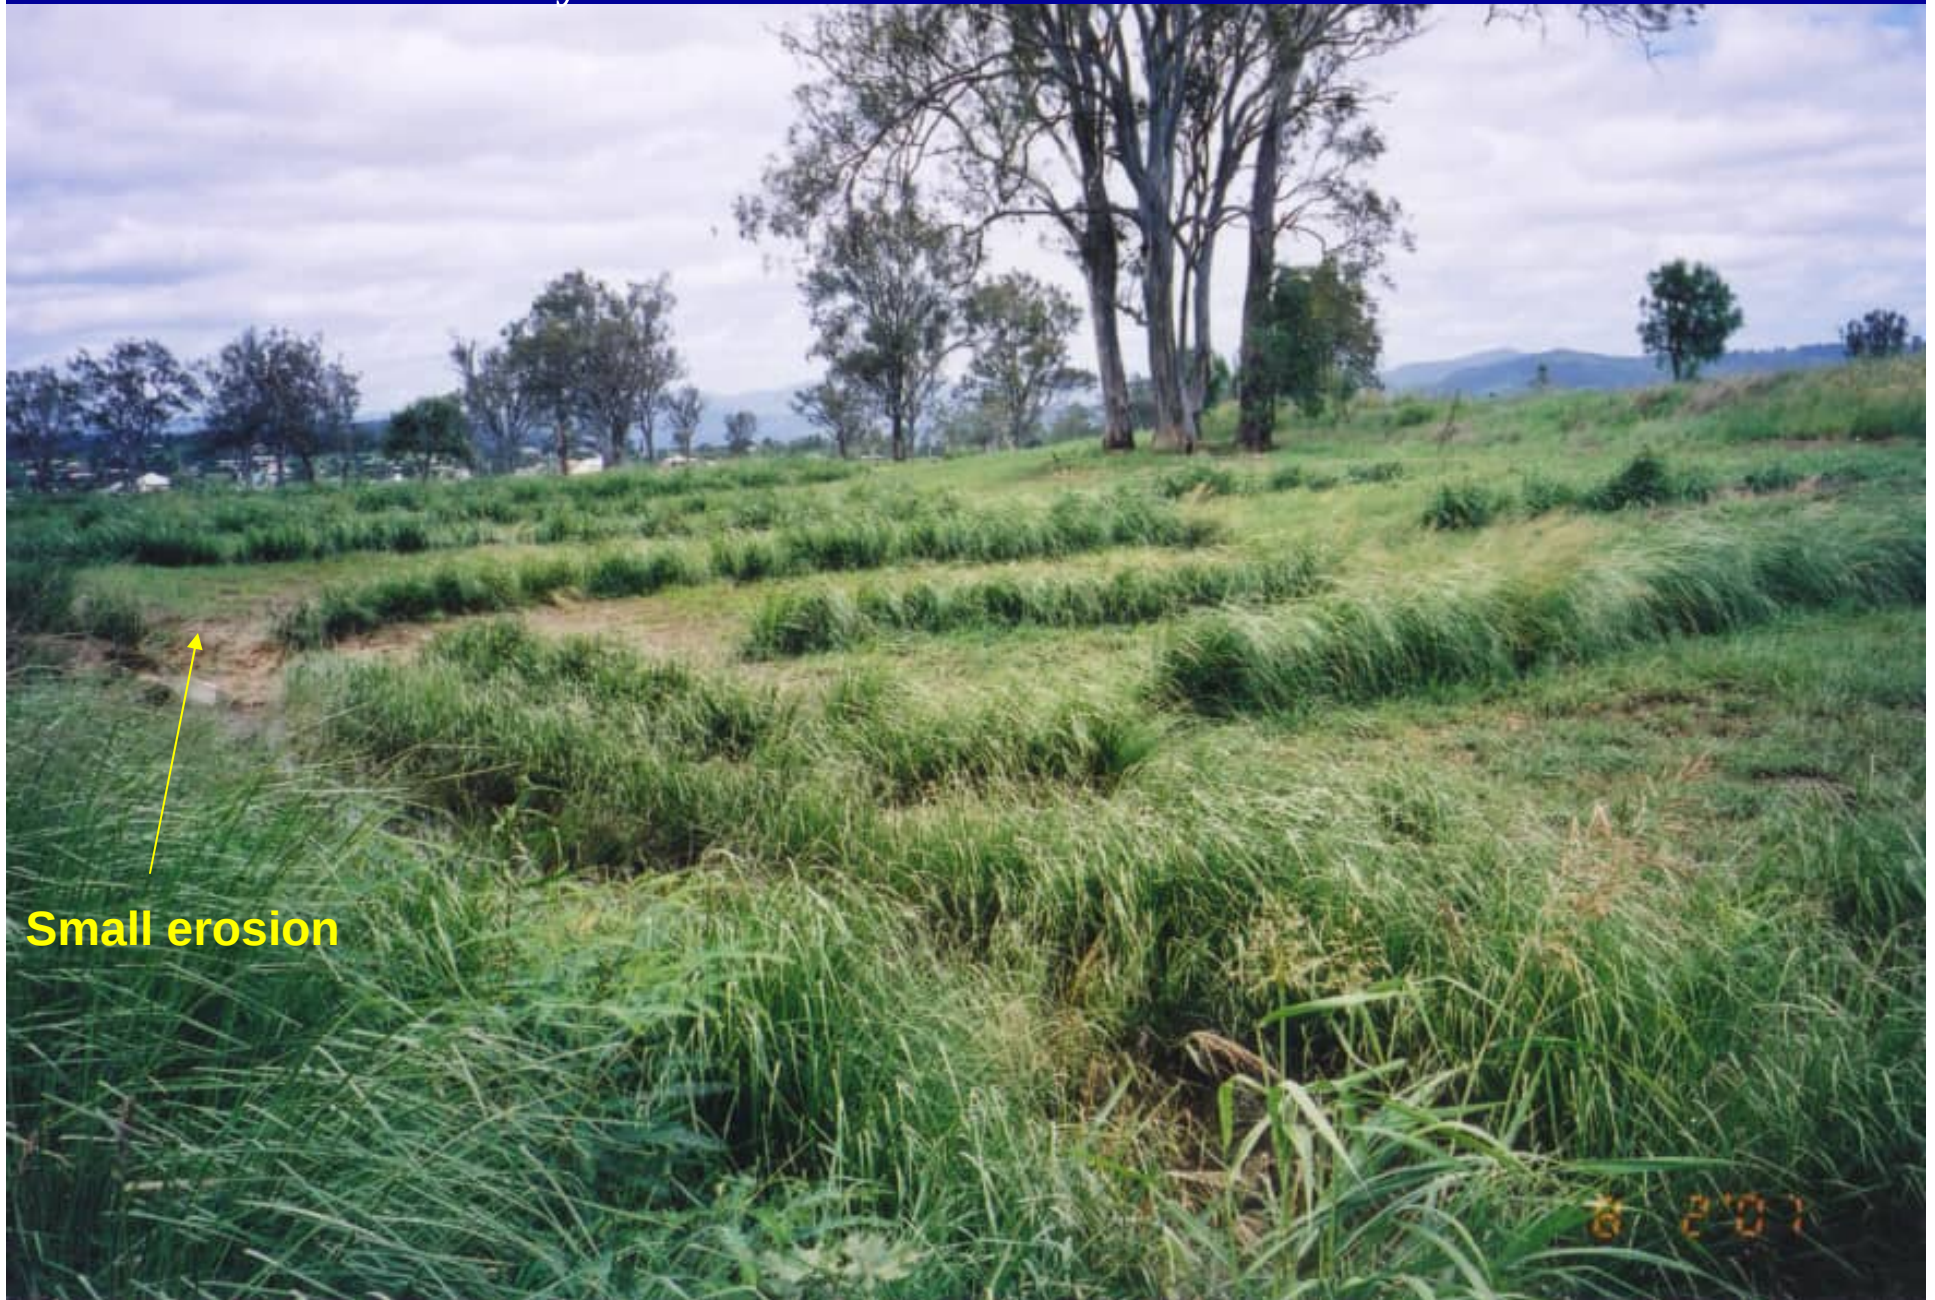
**Although only 3 month old, the young hedges provide a very effective protection with only minimal erosion at the head of the channel**

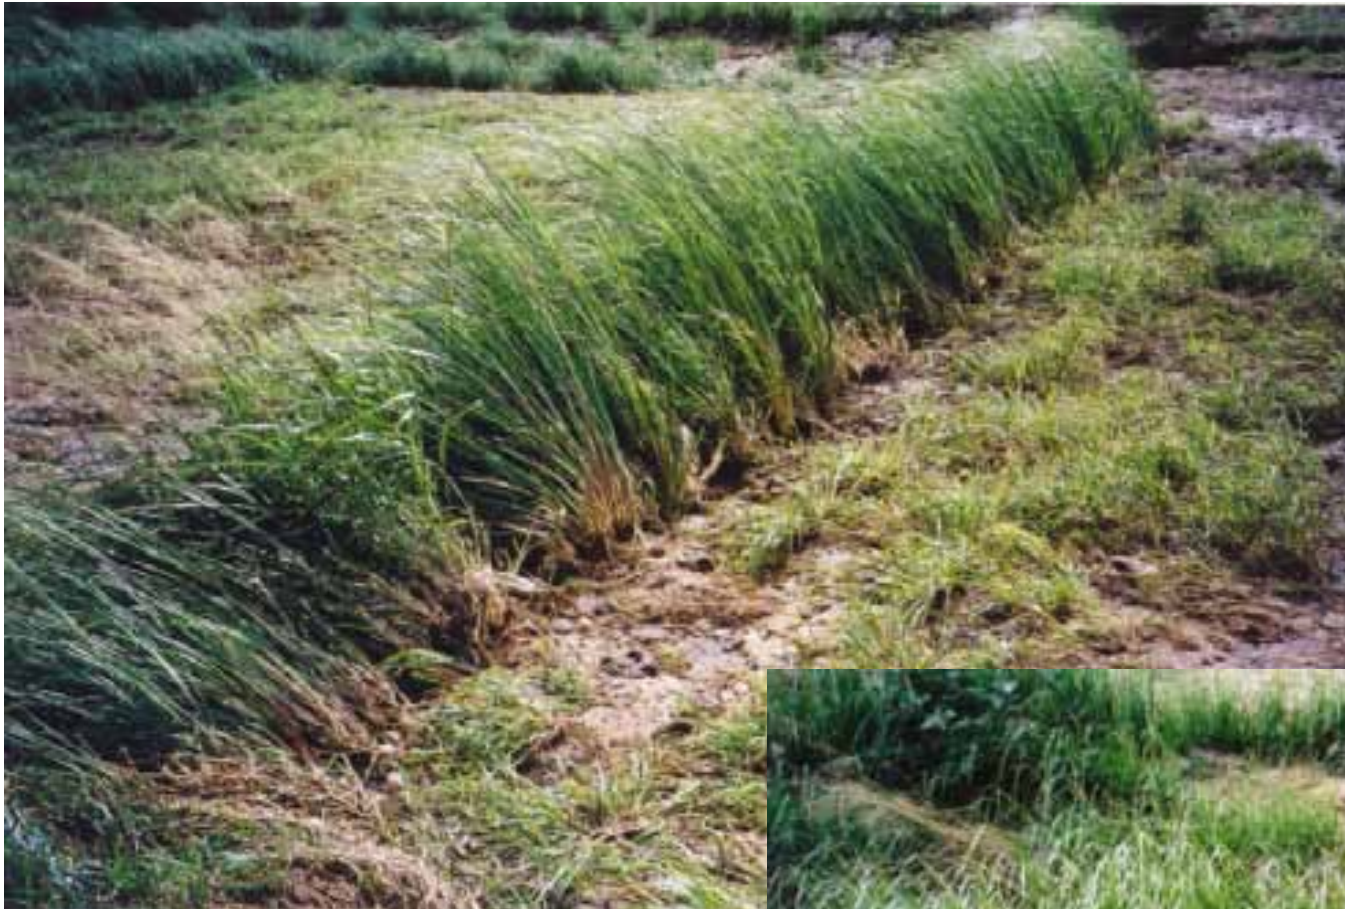
**Strong flow  
exposed part of the  
crowns but failed  
to dislodge the  
plants**

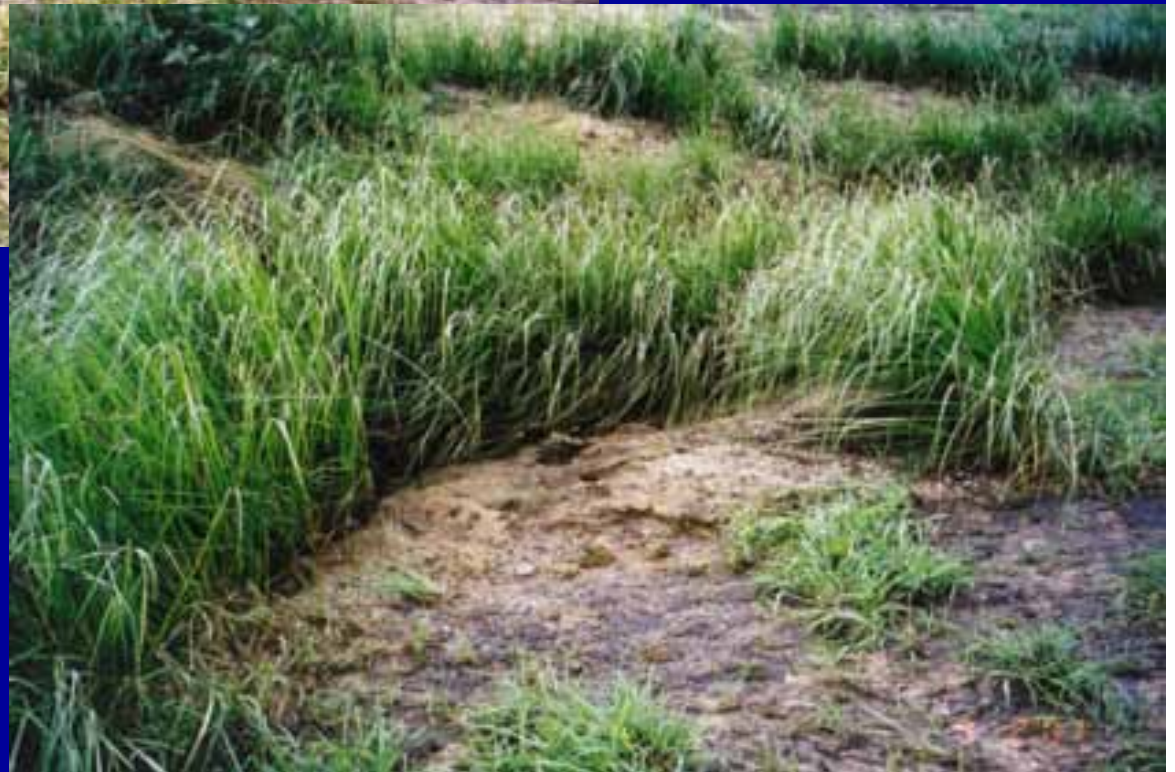
**Trapping sediment**

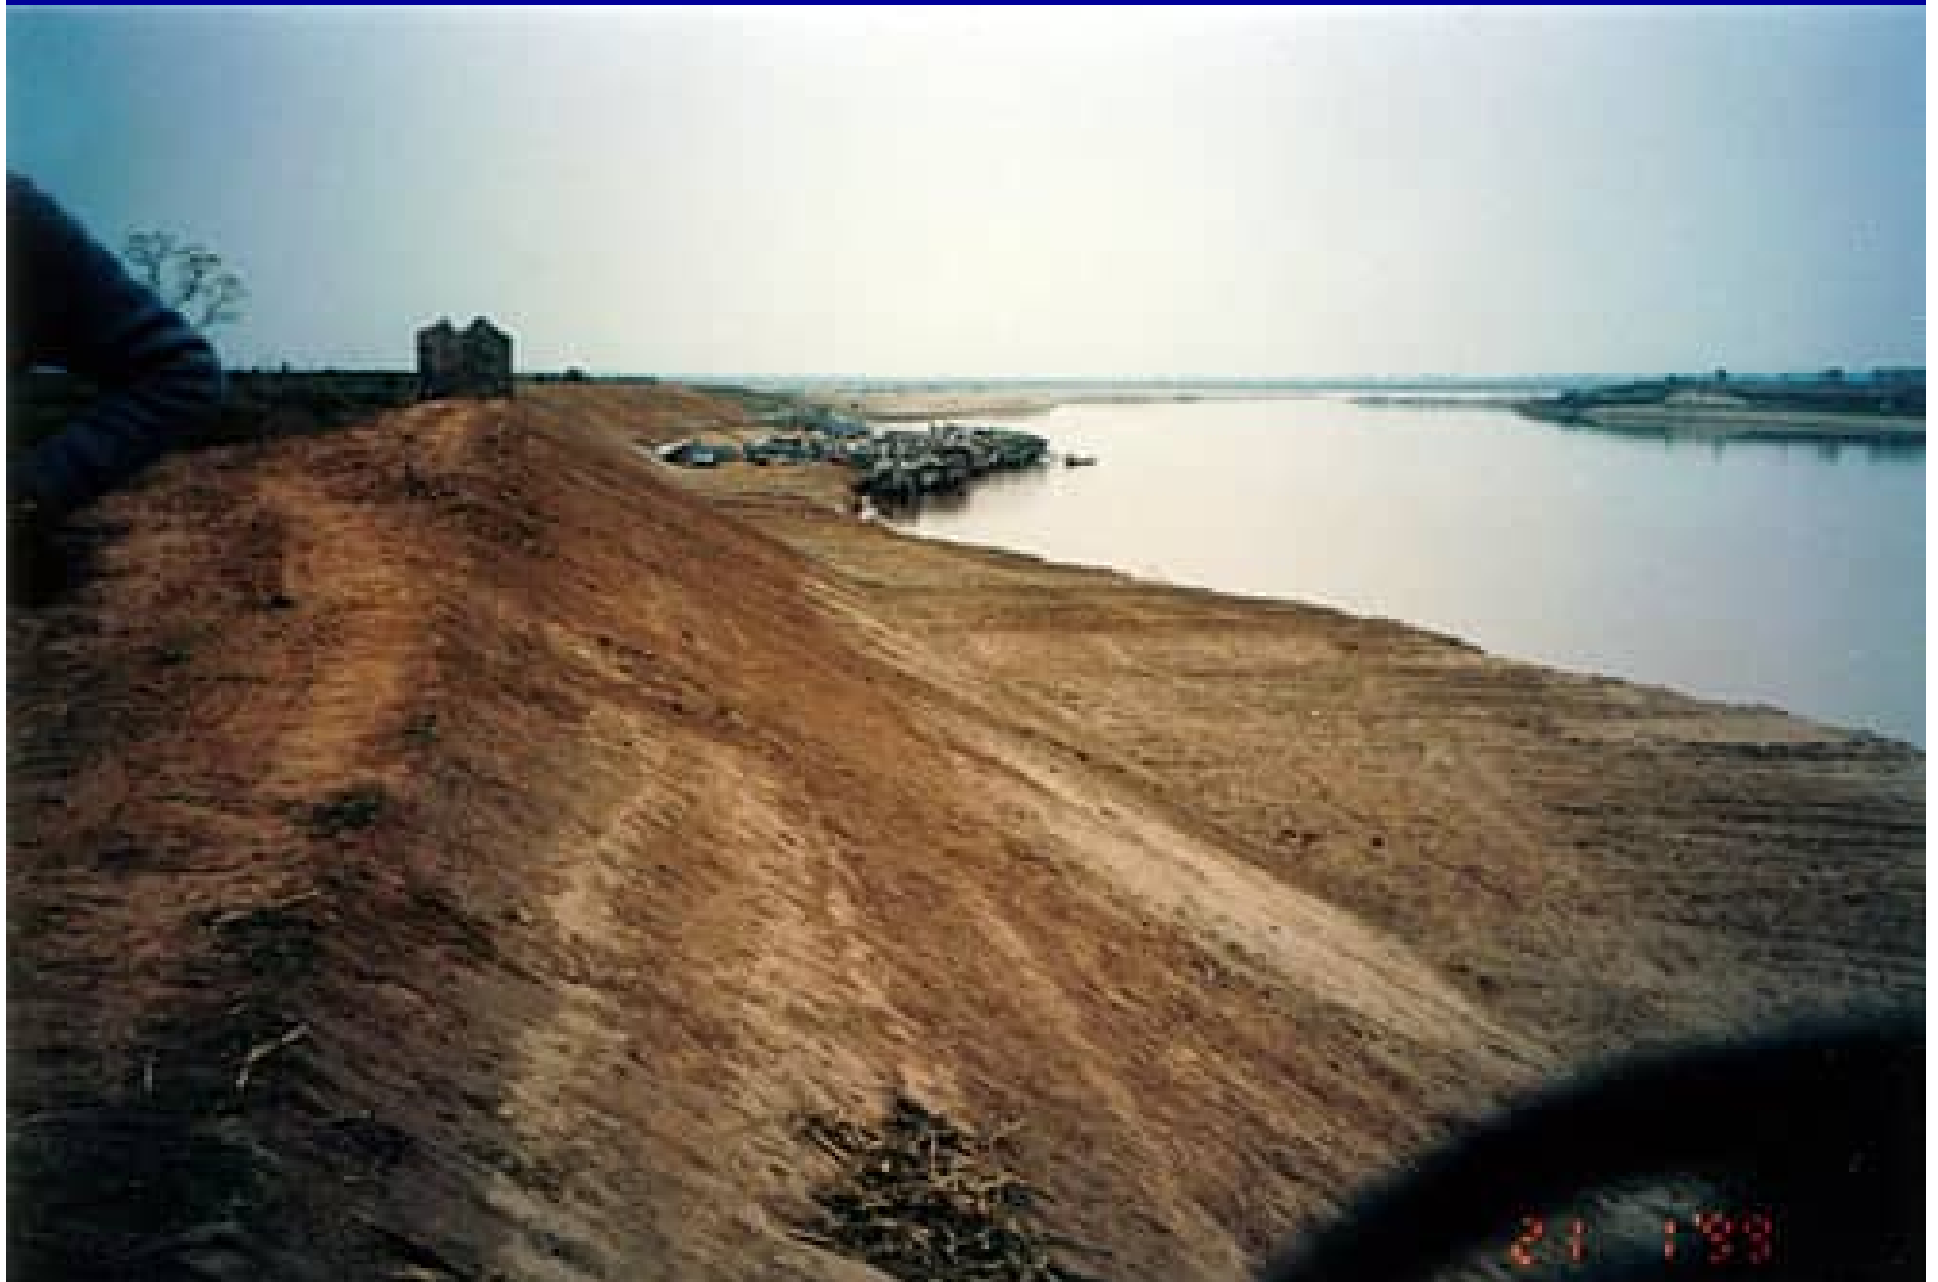
## **Viet Nam:** The levee bank of the Red river in Hanoi

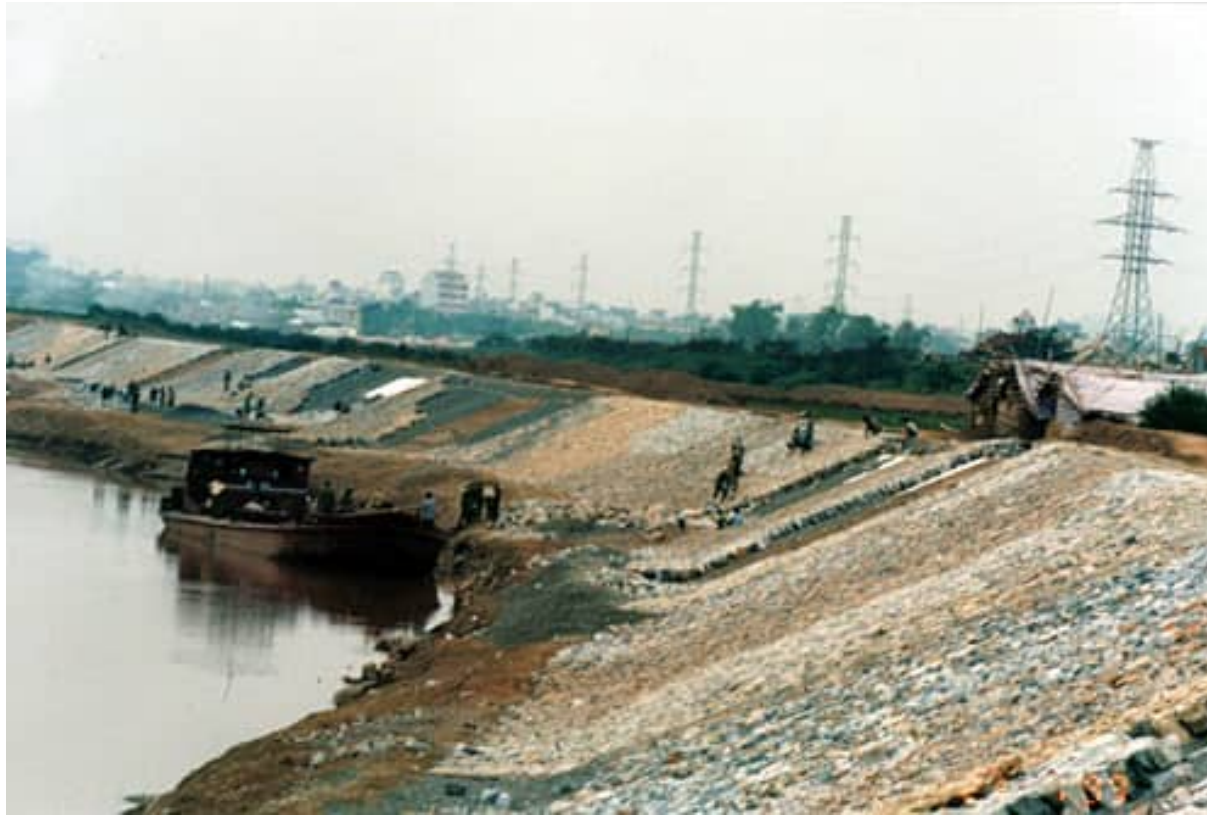
**Gabions and rock baskets are being used to repair recent flood damages which threatened the levee bank of the Red River**

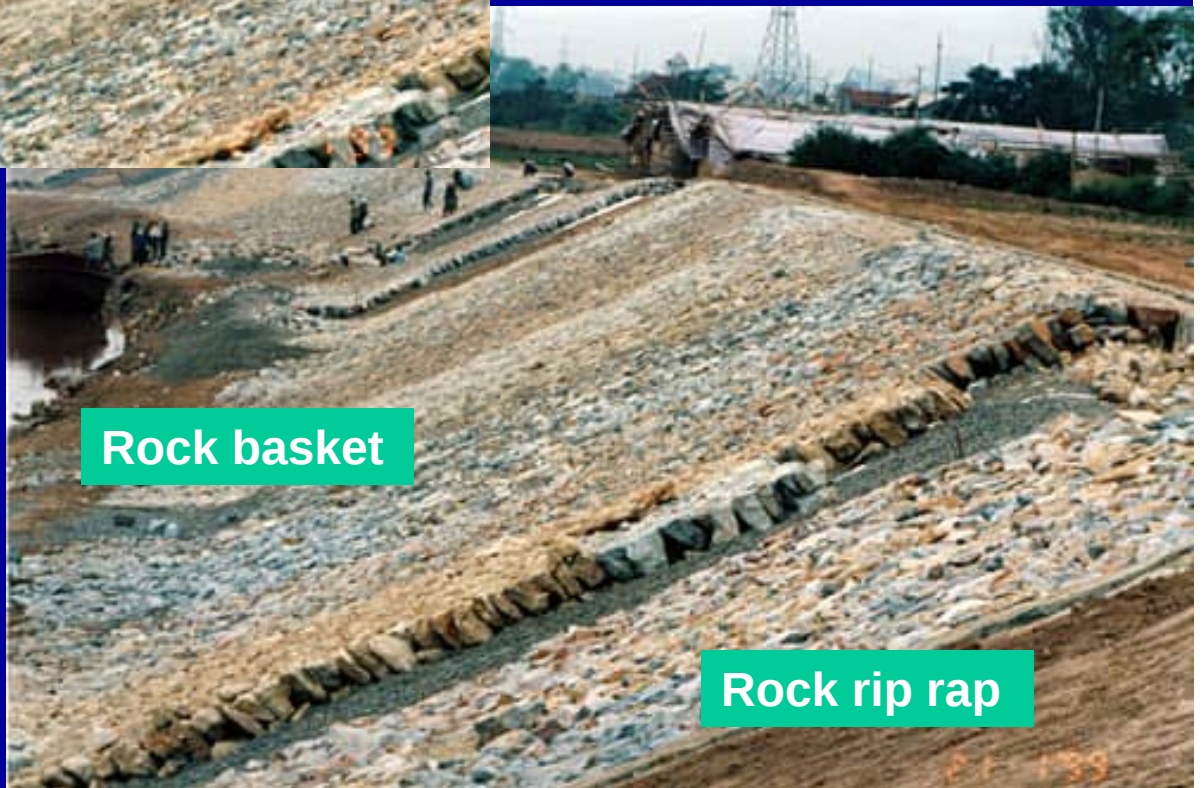
**A very elaborate and costly engineering structure, these rocks came from far away quarries**

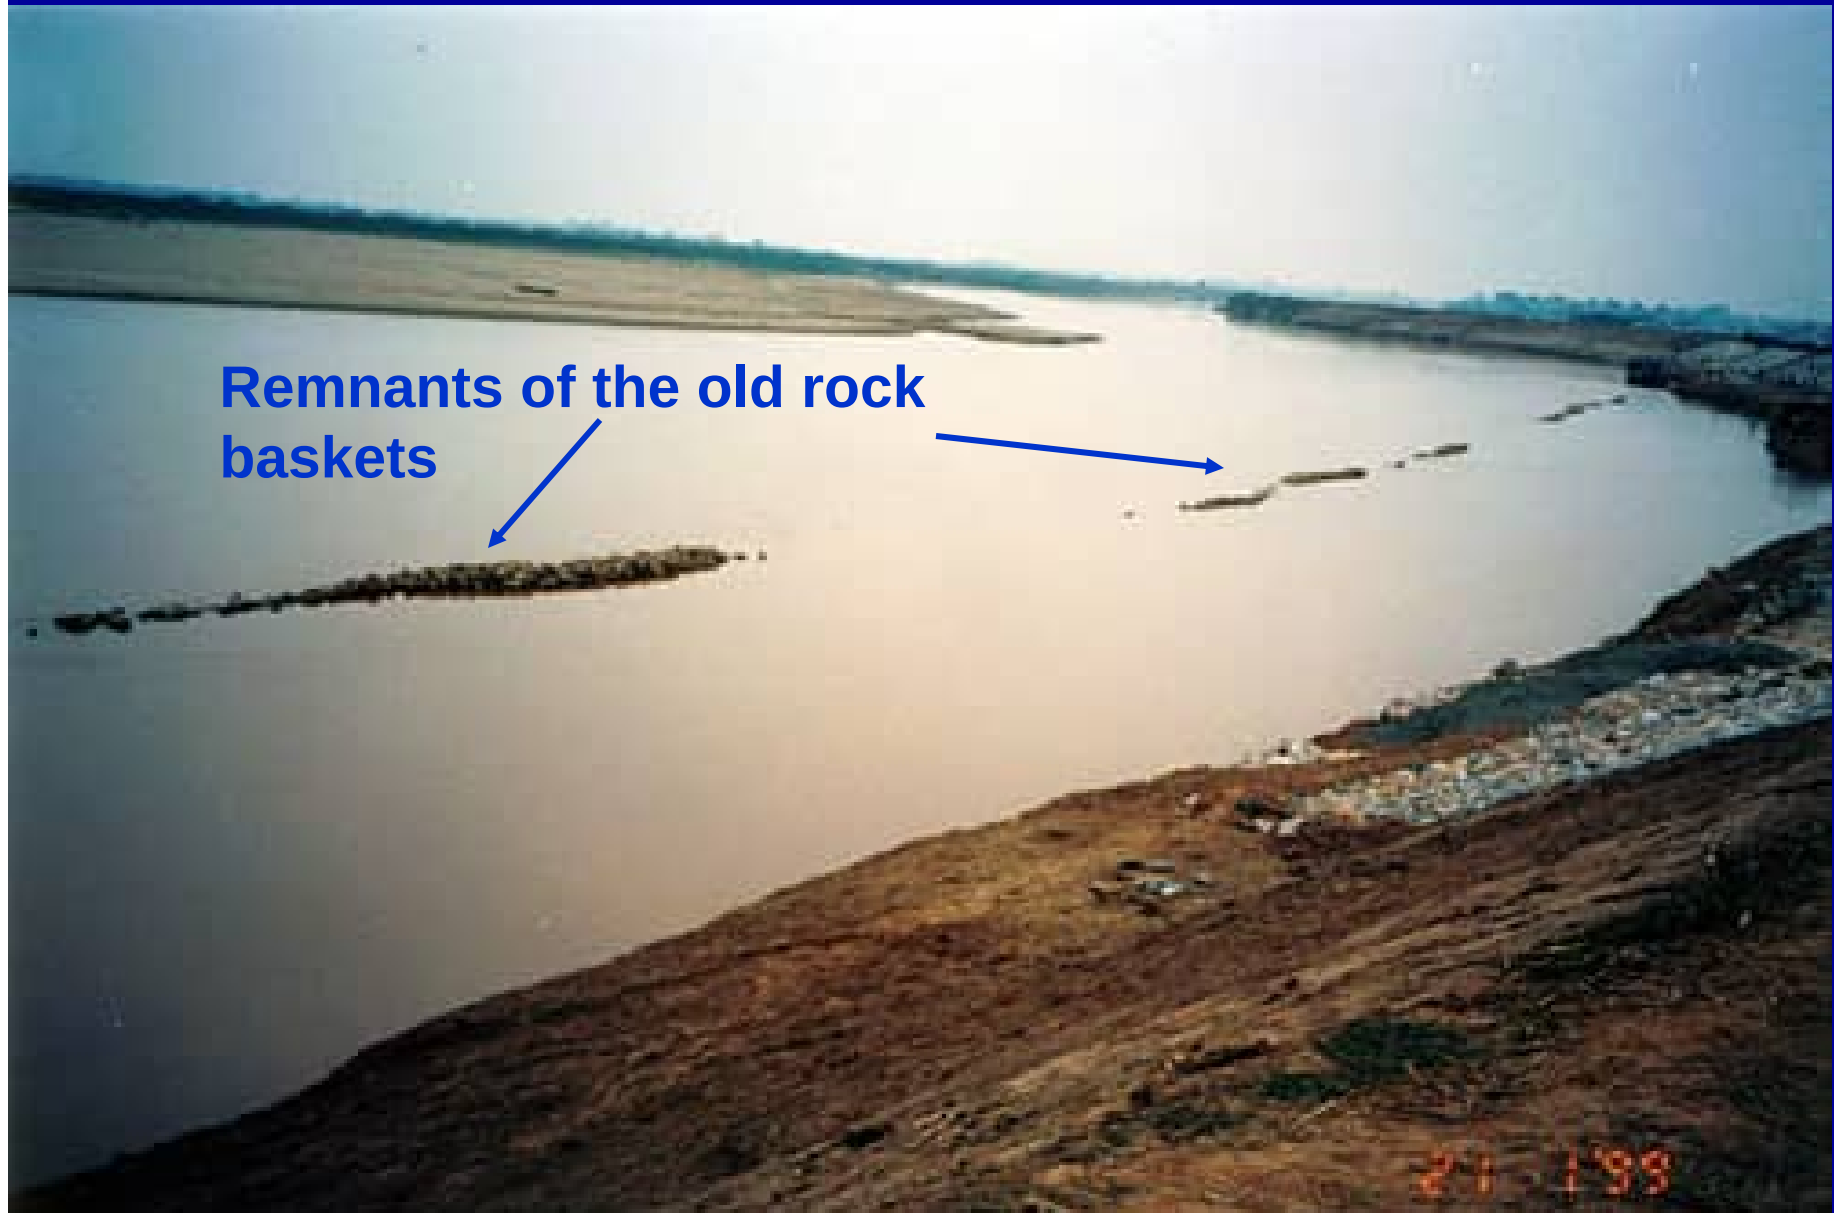
**But this method provided no protection as this bank had been previously covered by similar rock baskets. Remnants of the old rocks which collapsed in the last flood, were still visible in the river.**

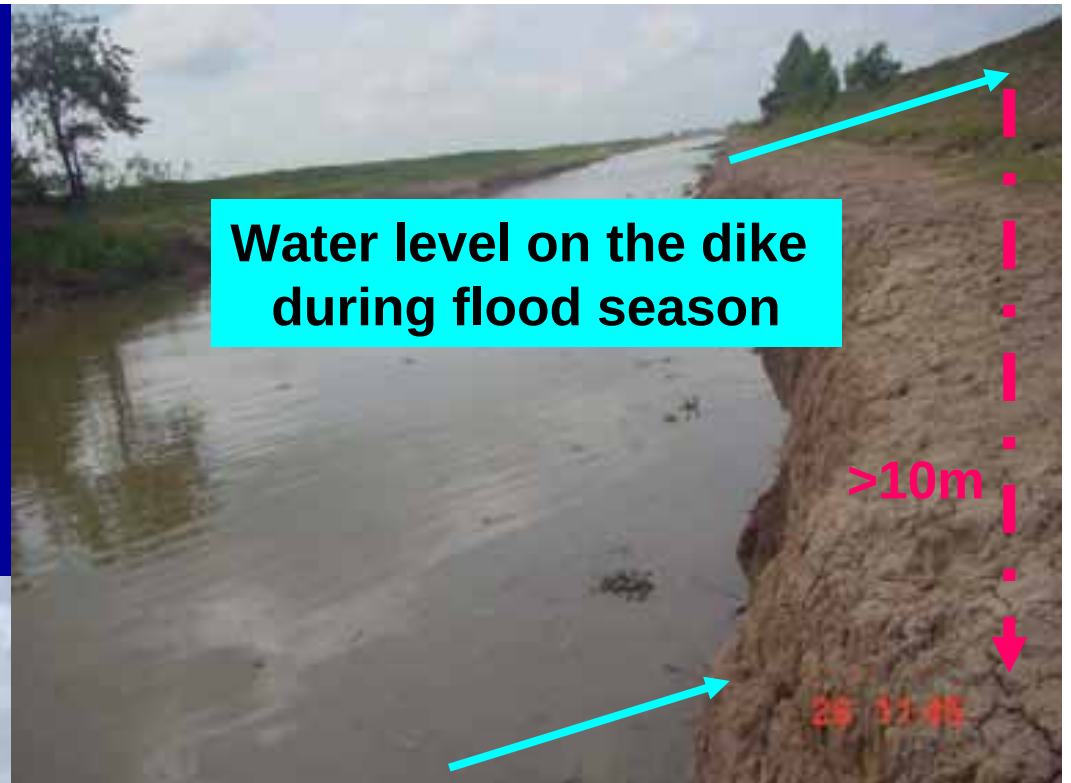
Flood control dike protection  
in the Mekong Delta Vietnam

Dike during flood

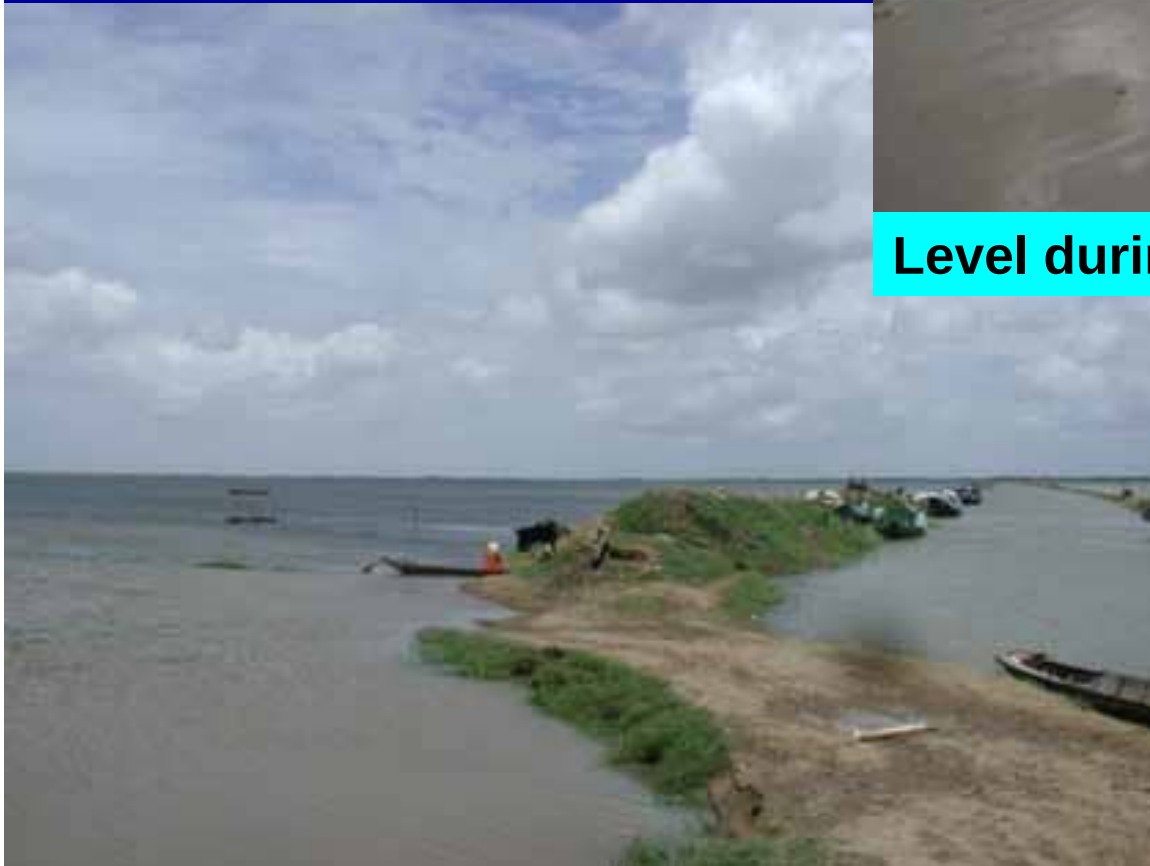
Water level on the dike  
during flood season

>10m

Level during dry season

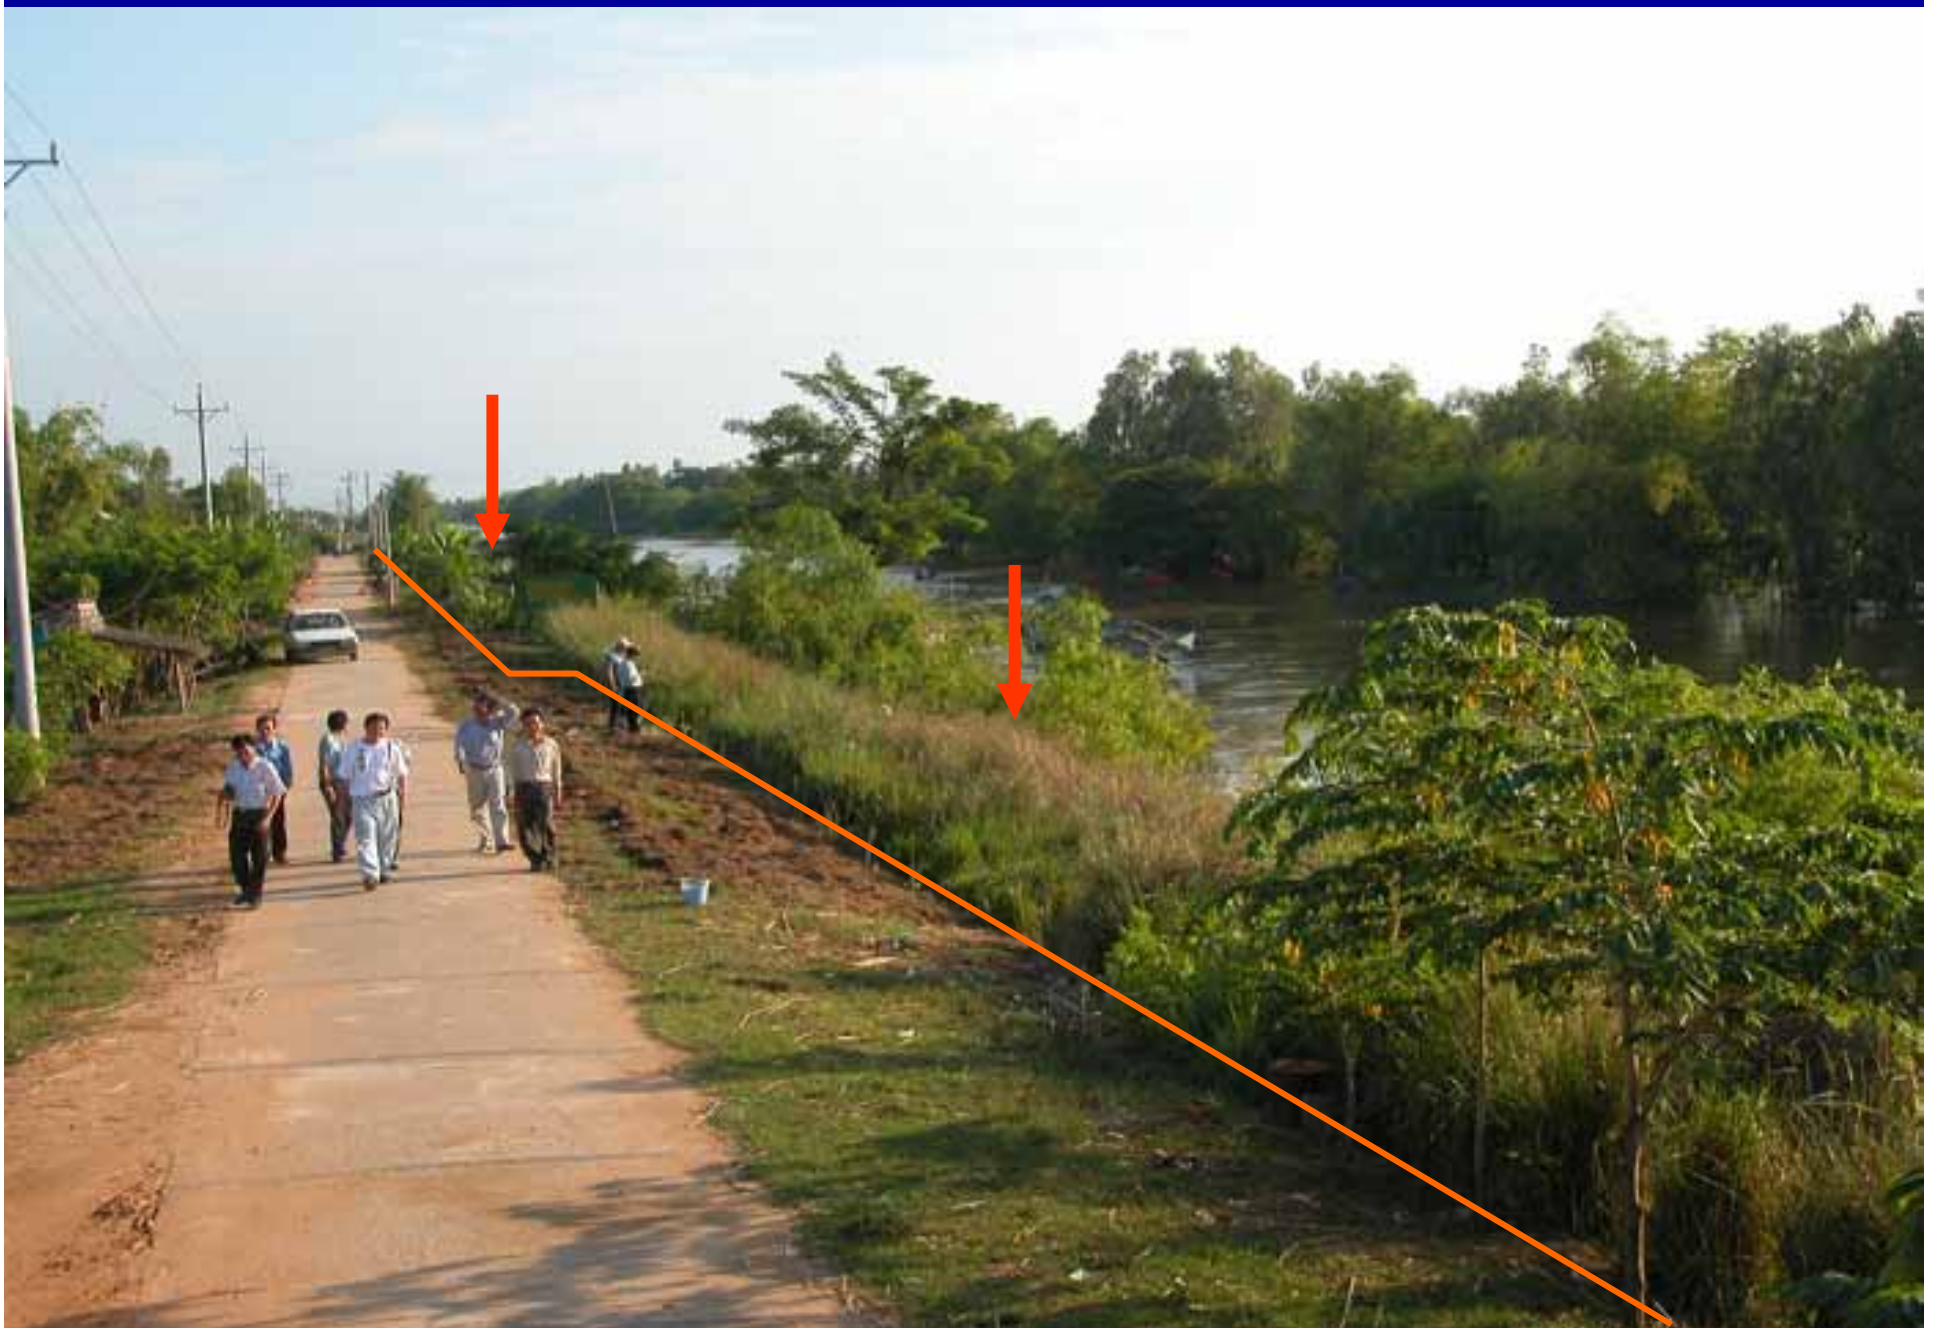
**A precious piece of land 5m wide is kept intact due to Vetiver**

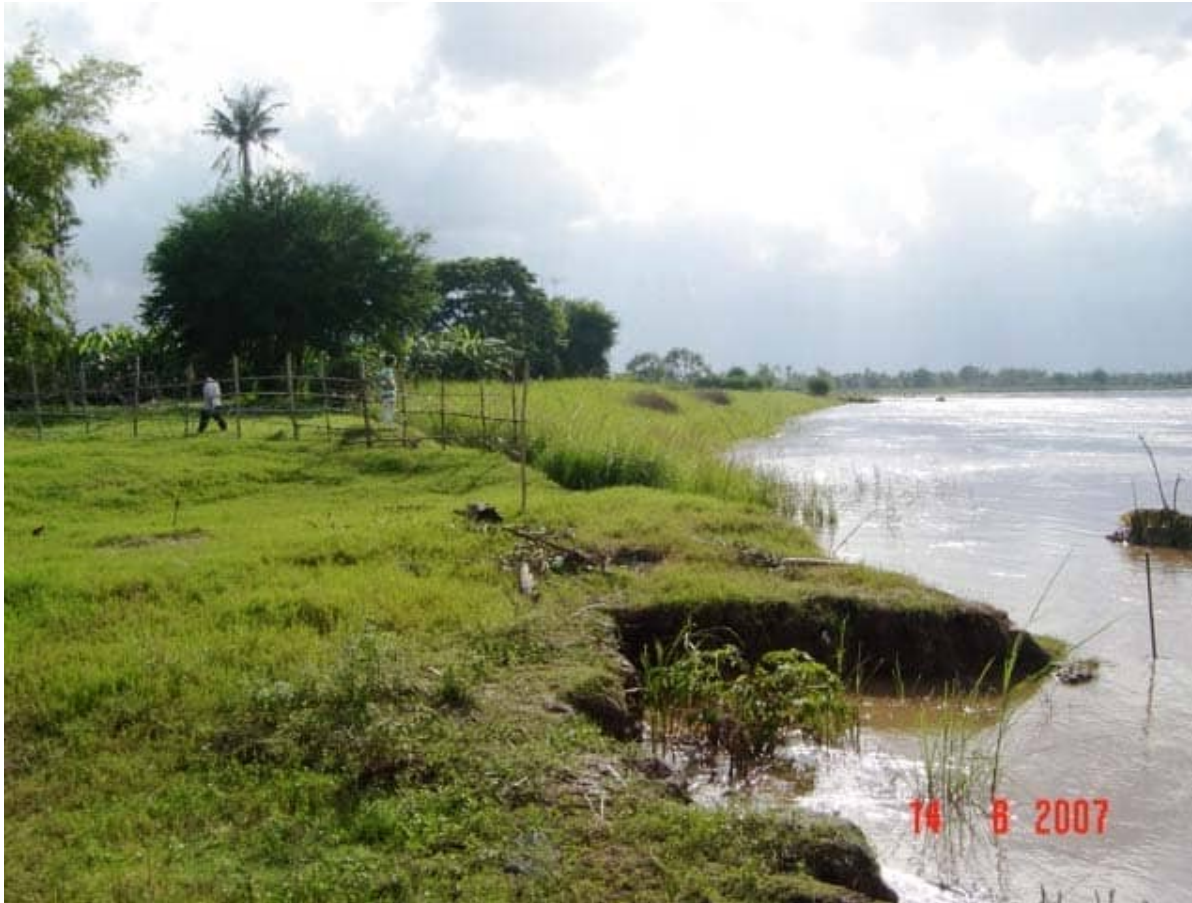
**Annual flooding with  
depth level between  
15-20m**

Flood level

under 15m

Water receded 5 months after flooding:

- the lowest rows (15m) was dead but its roots remain intact and stop erosion

- the mid section (8m) survived and resume growth after water receded

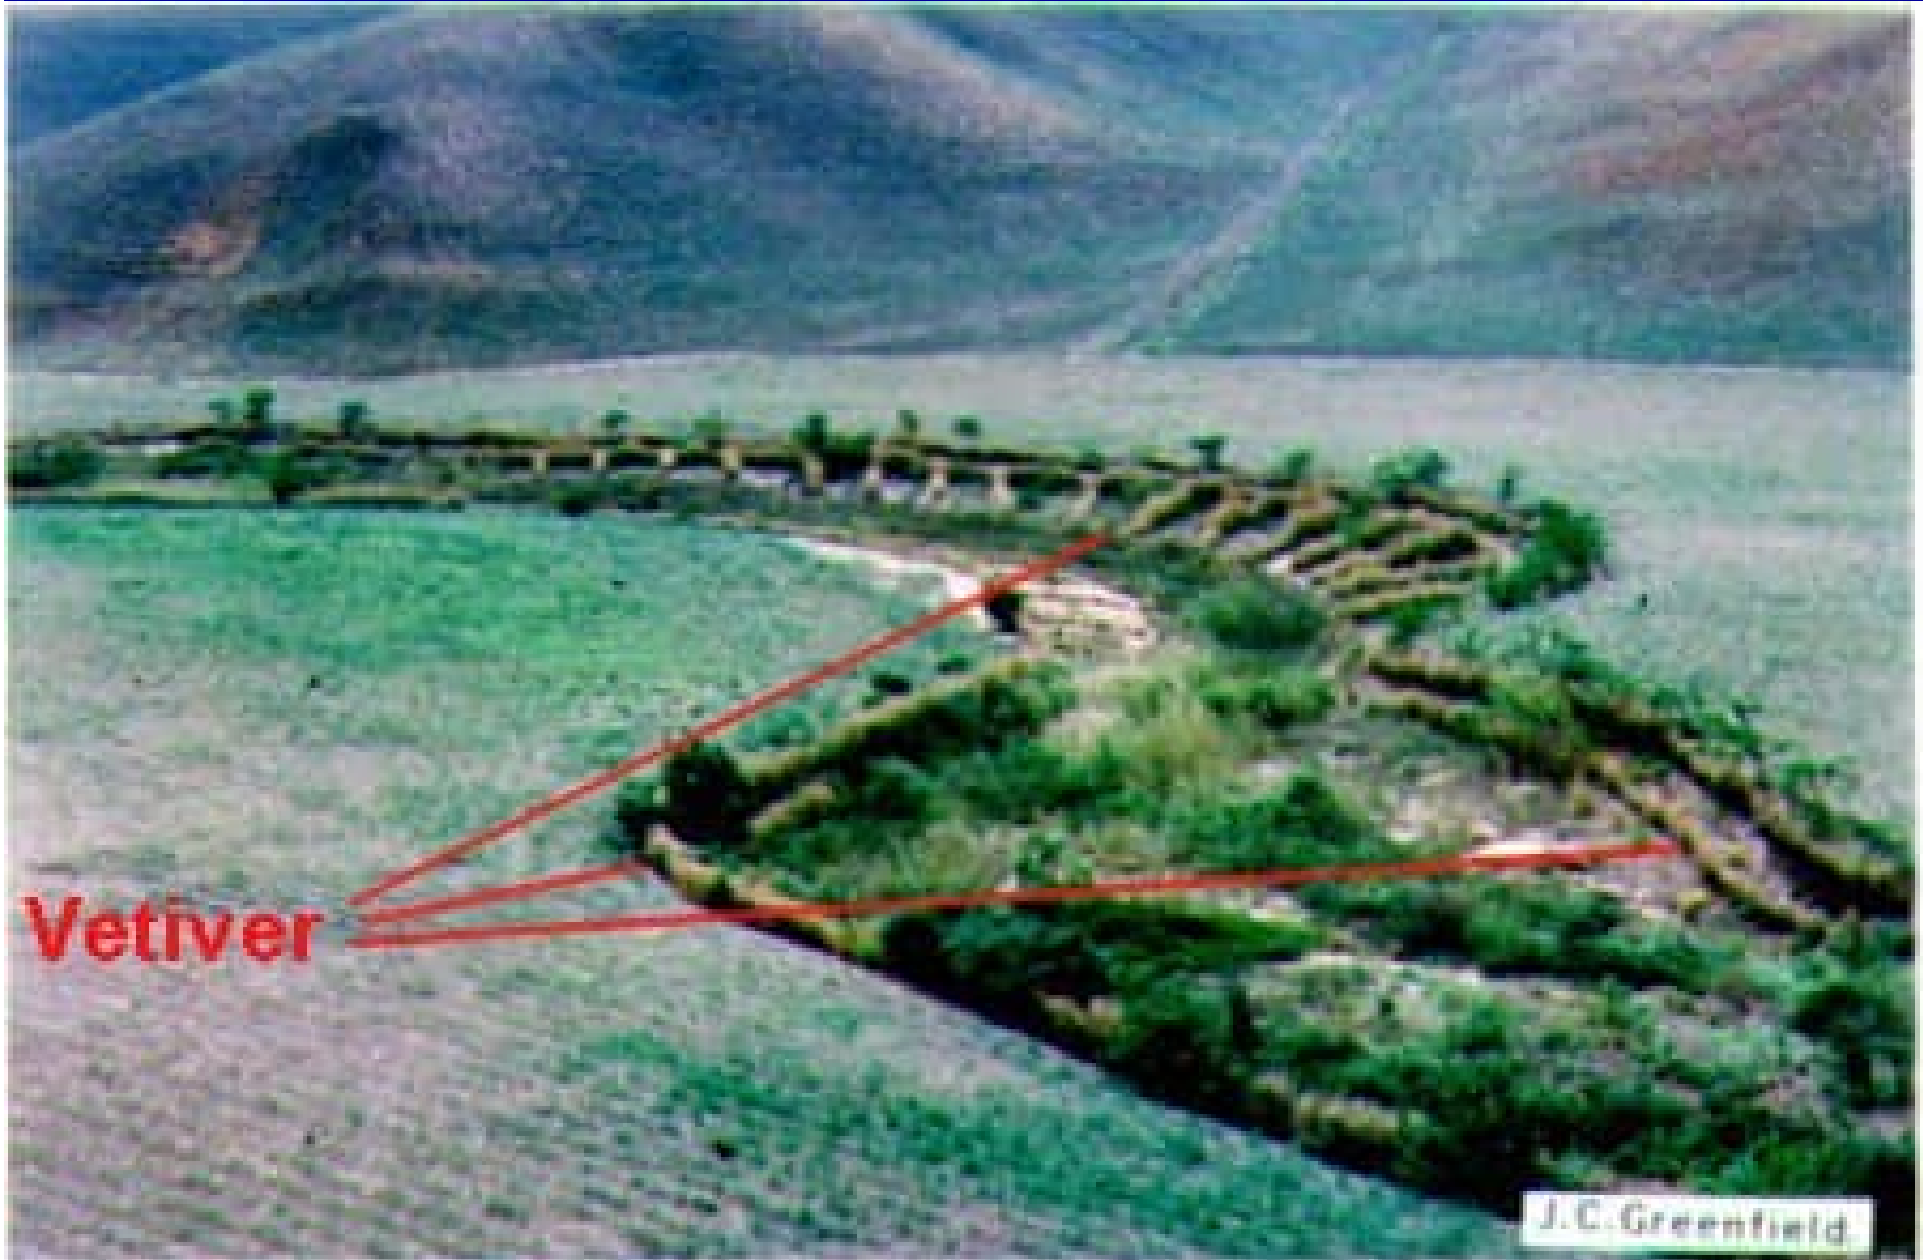
***South Africa:*** A very well layout provided complete protection against erosion
