# **Vetiver System for Stream Bank Stabilisation**

**(With special references to the river and canal bank stabilisation  
in Australia and Vietnam)**

**Paul Truong**

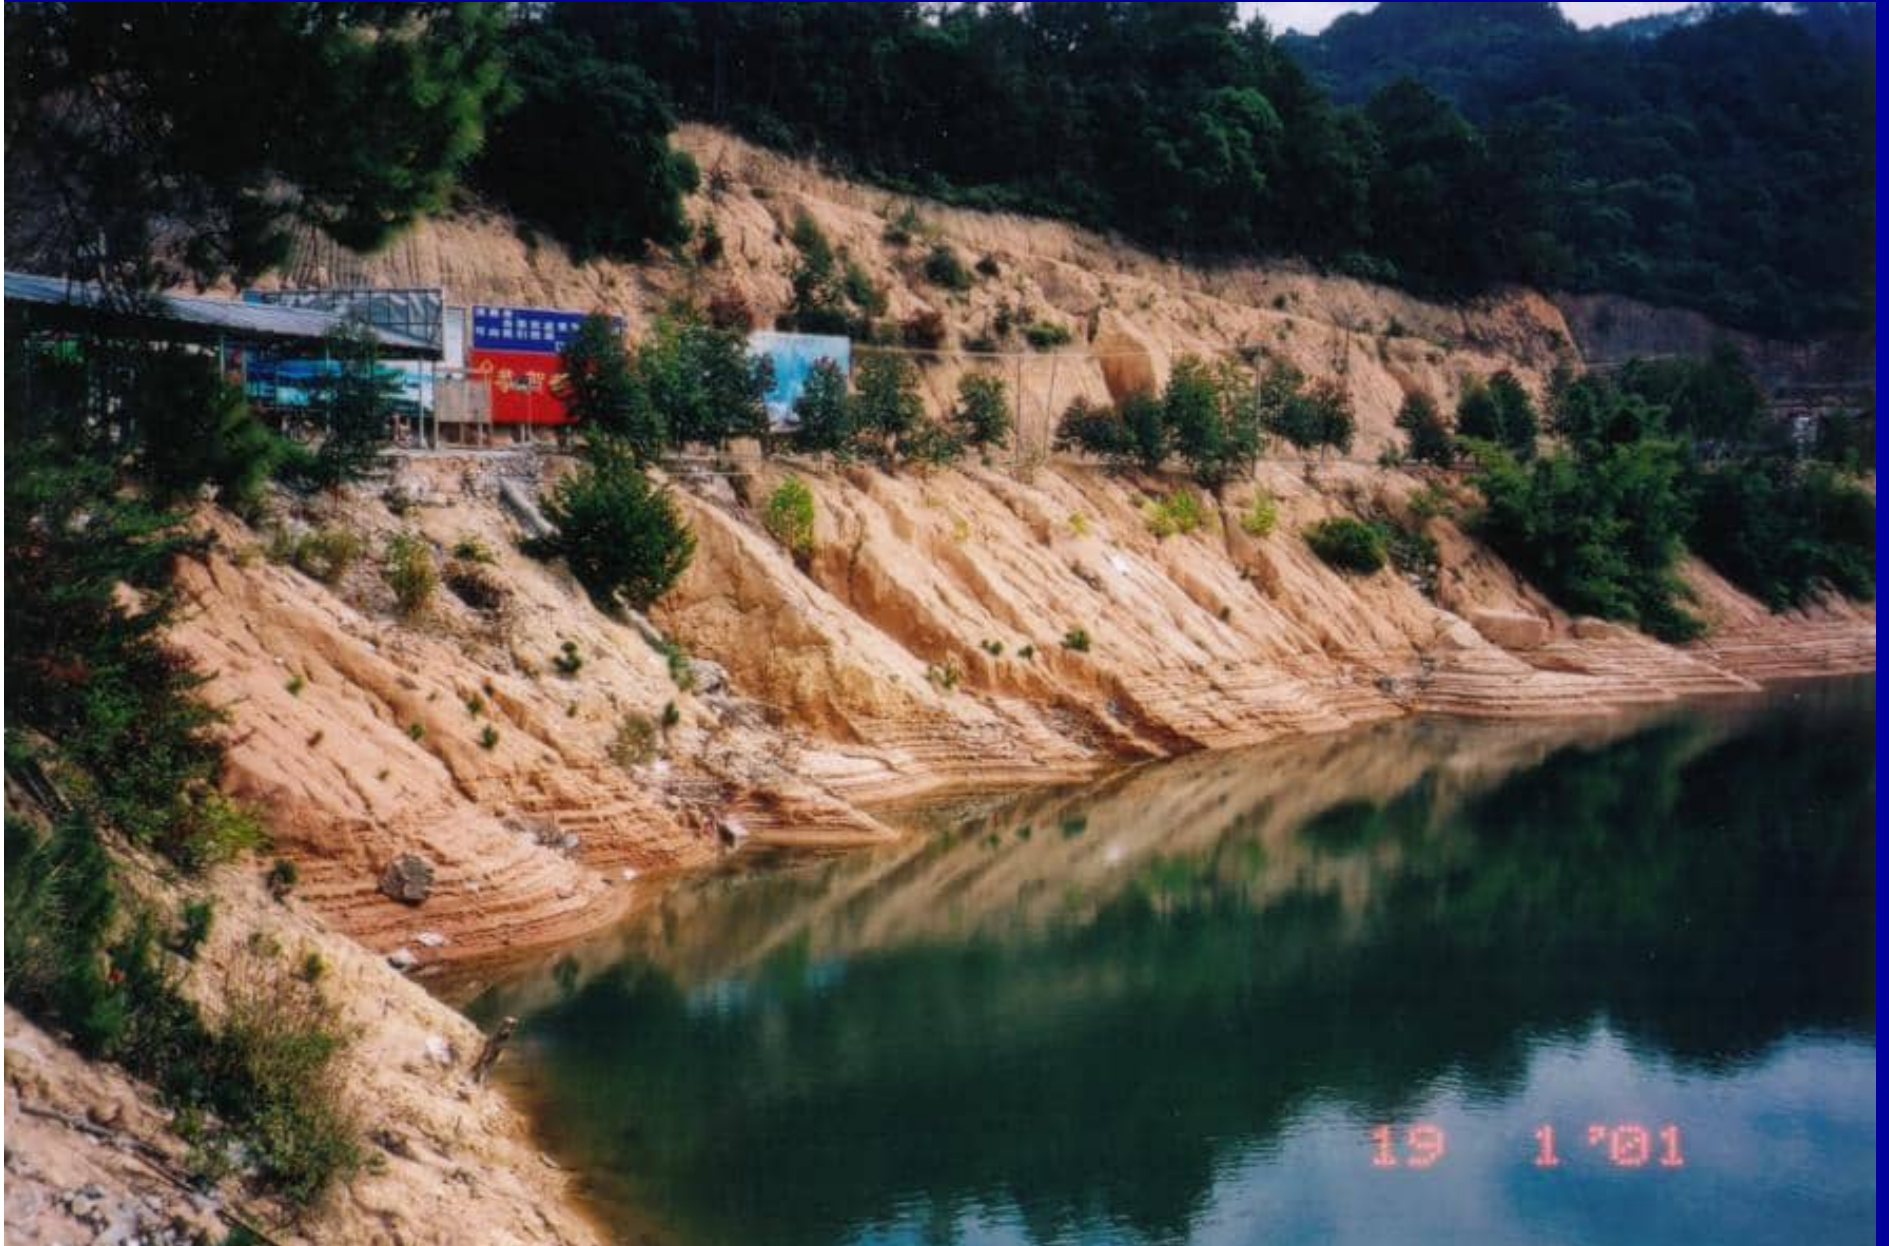
**China:** Highly erodible and badly eroded of the often flooded shore line of Lake Evergreen in Guangdong

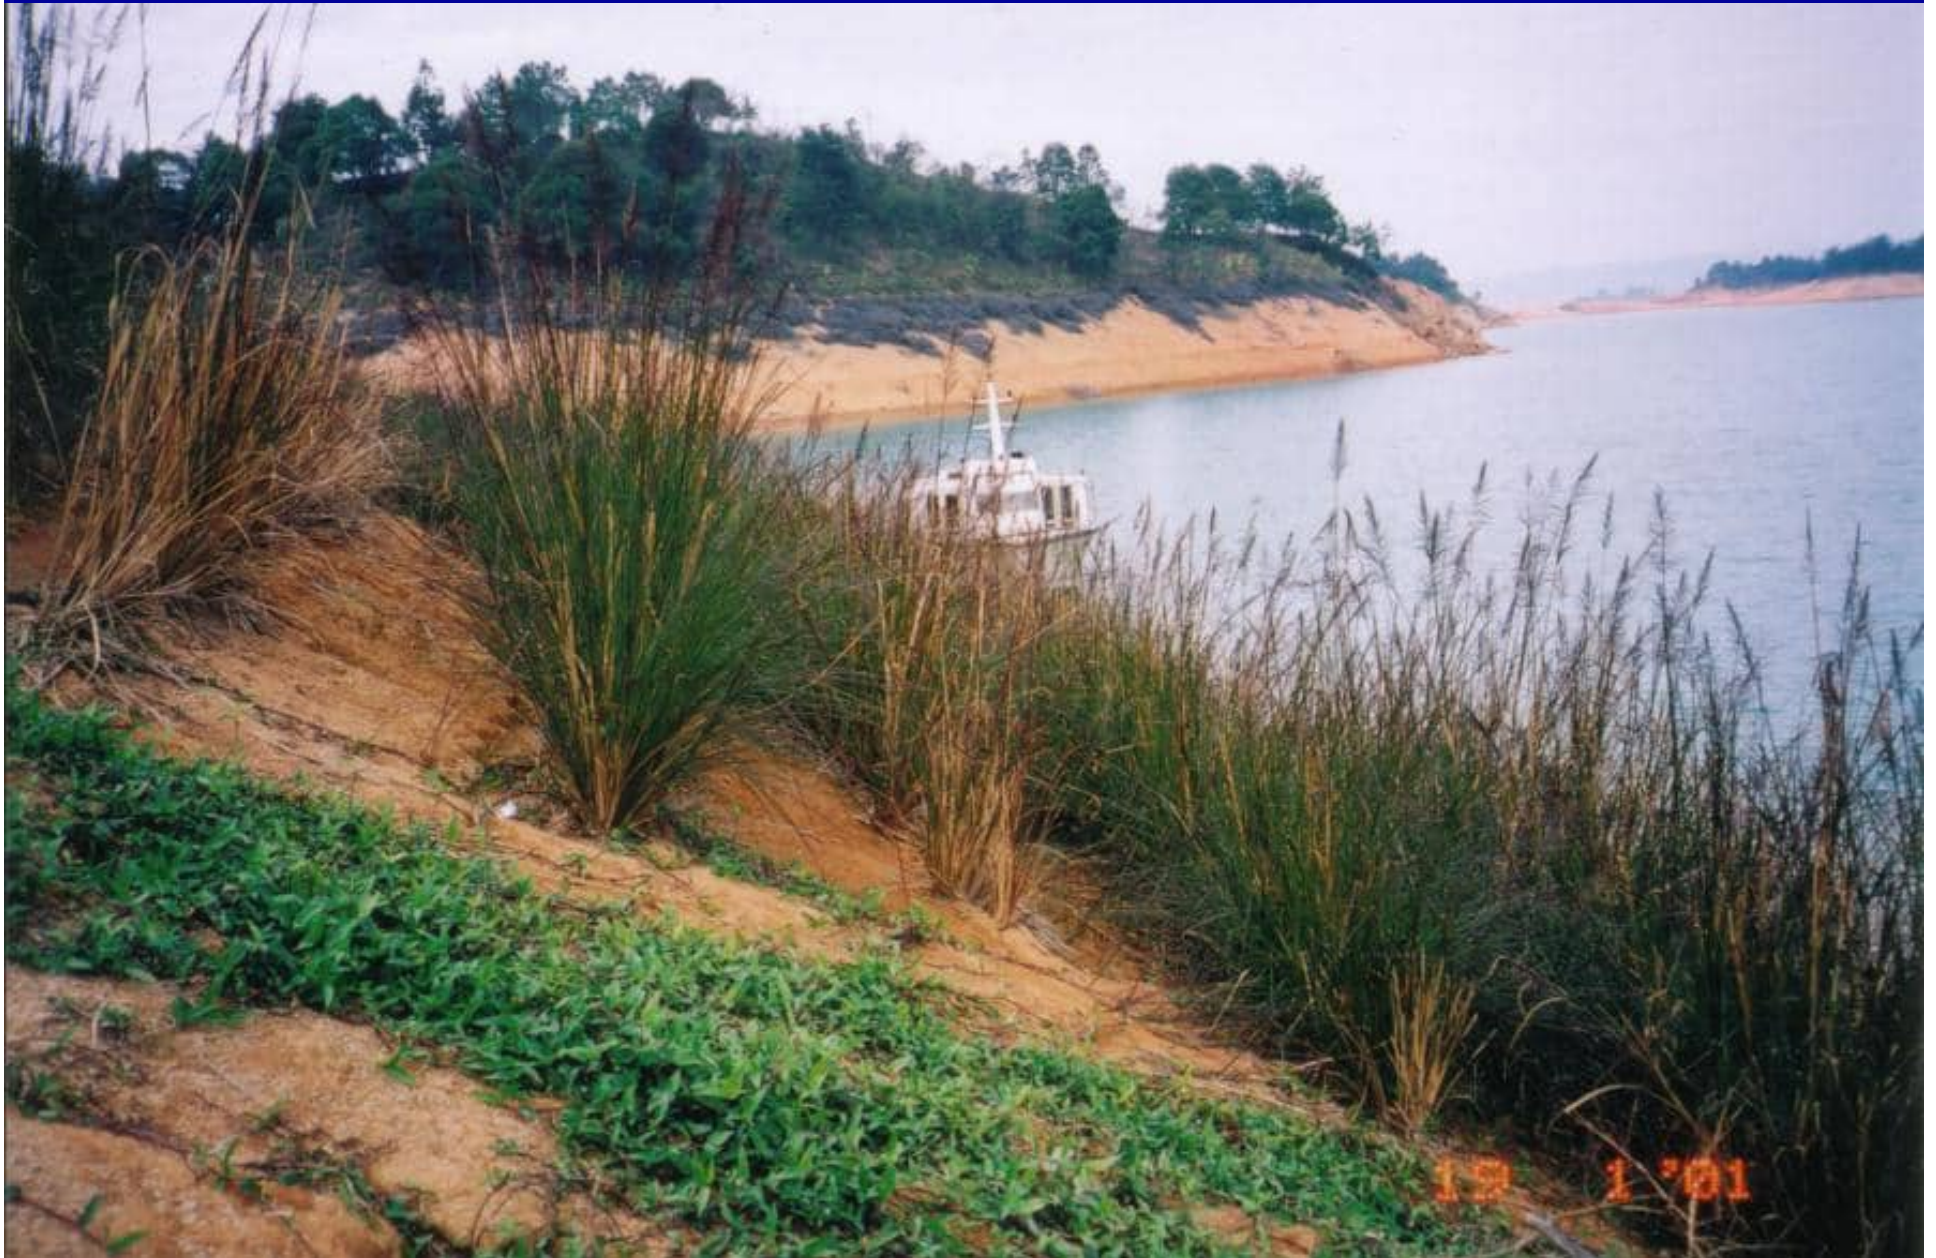
**This section of the bank has been successfully stabilised by vetiver grass in a trial**

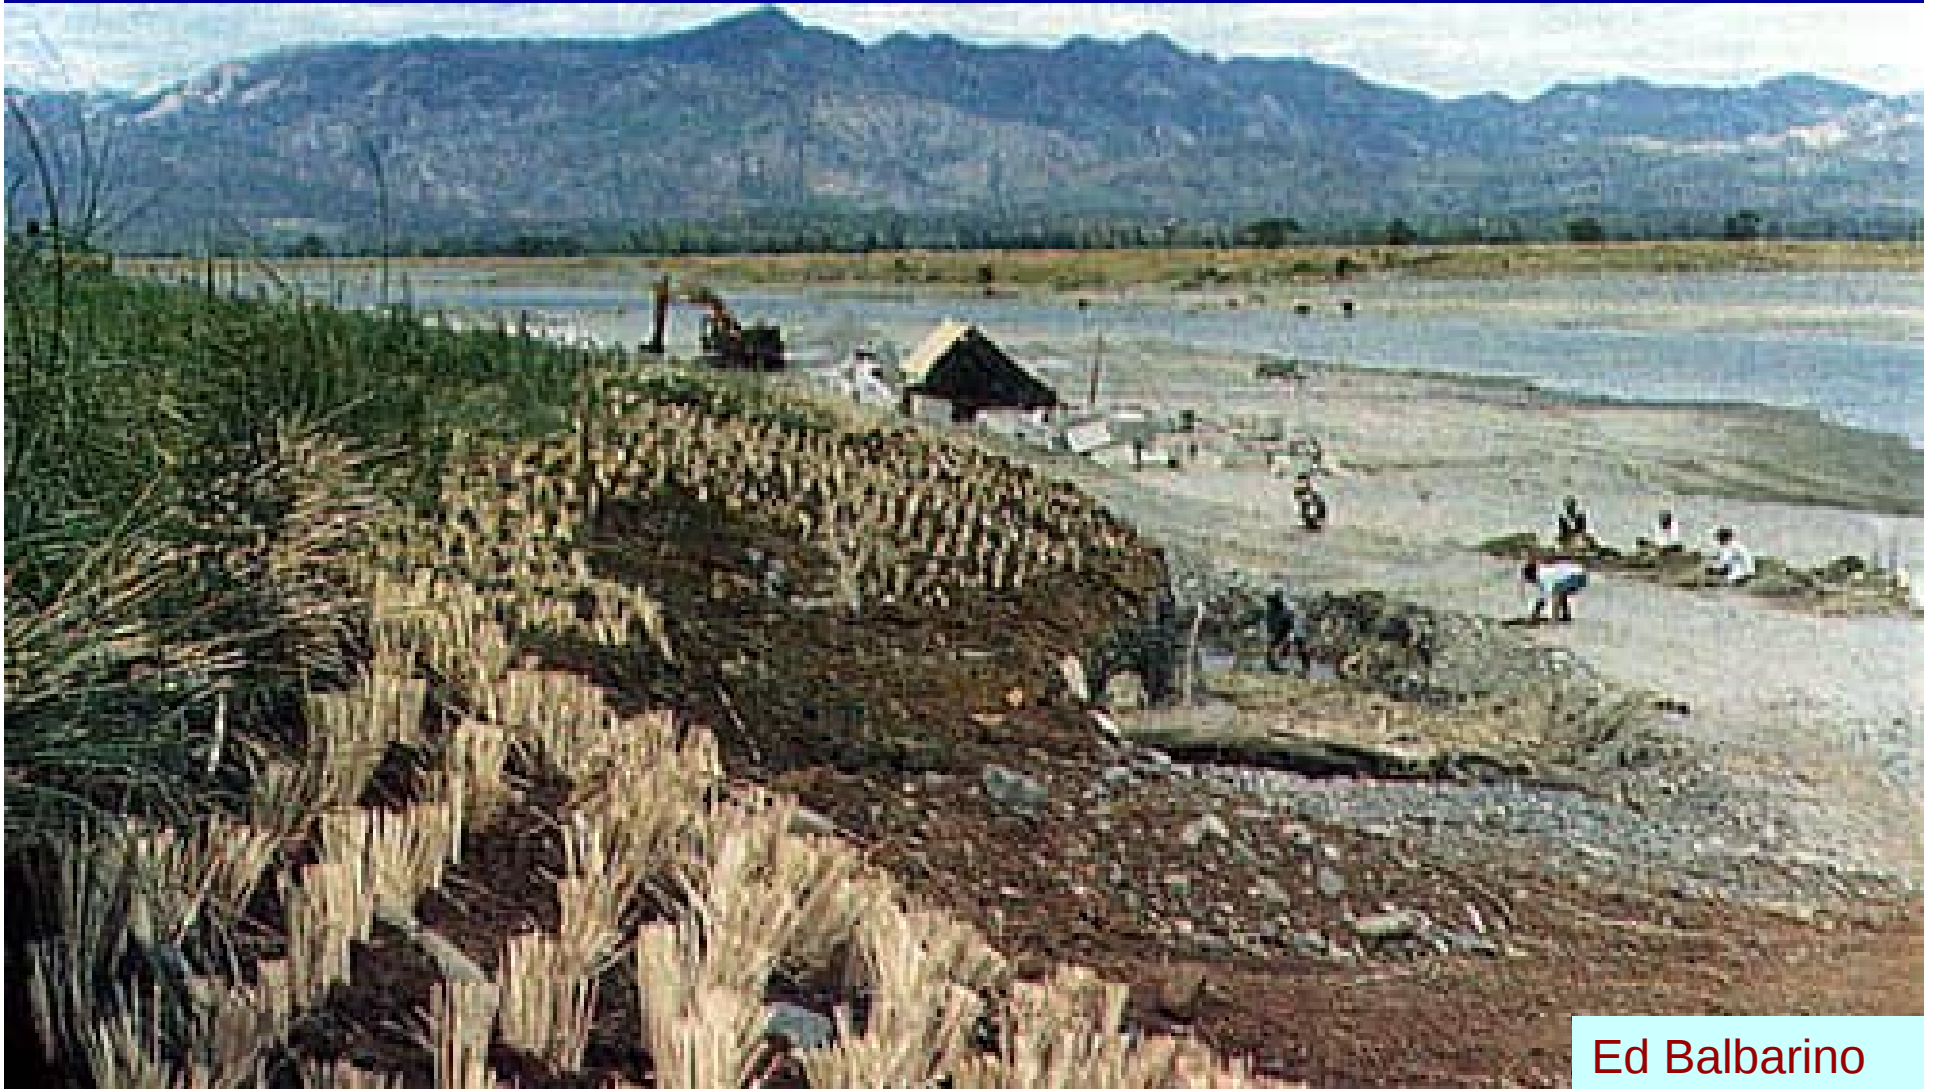
**Philippines:** Vetiver was planted to protect the bank of Abra River against flood erosion

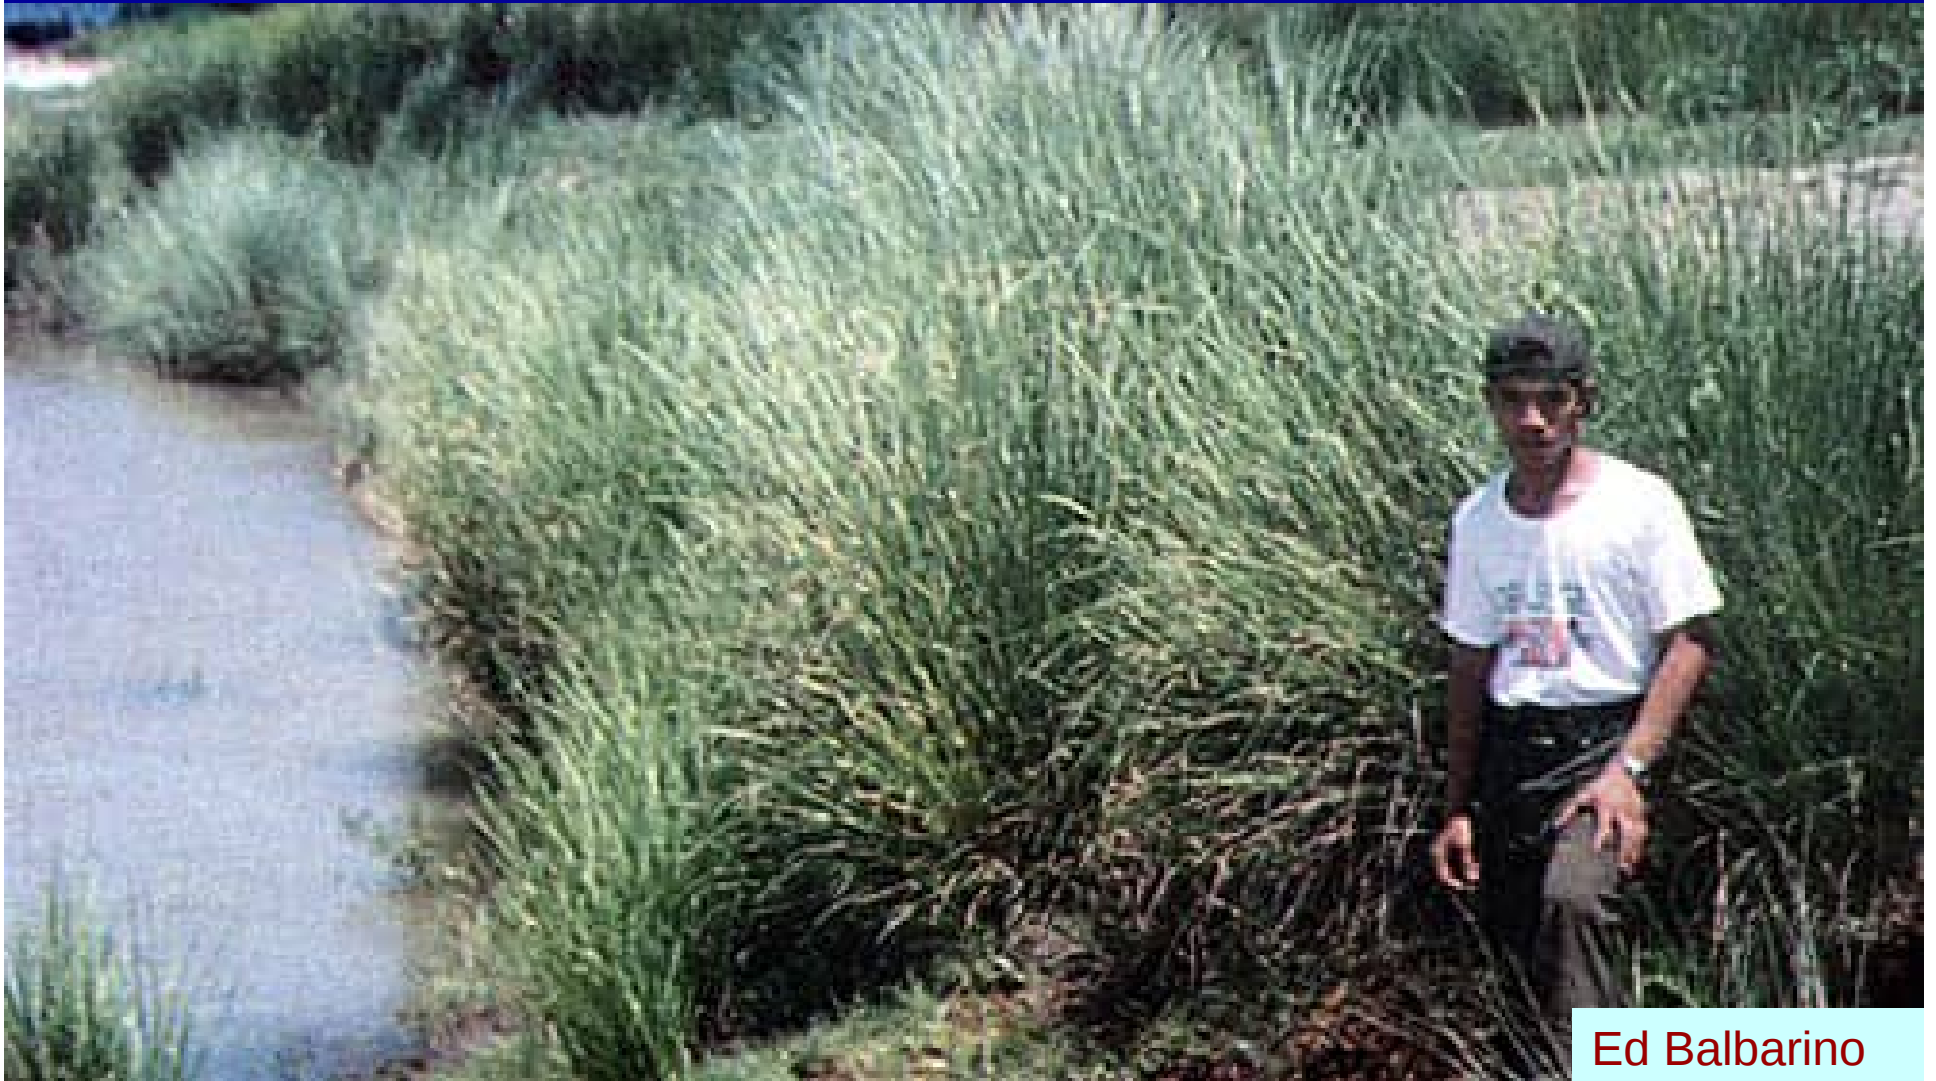
One year after planting, the bank was successfully stabilised
