Report on Visit to North Eastern October 2009

By Oliver Hawes (Geotechnical Engineer)

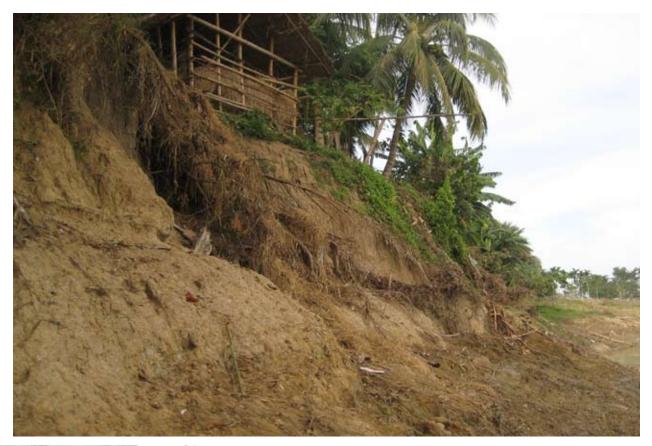
Tipling, Assam, October 2009 - A high priority area for the District Commisioner because homes are having to be abandoned. In the picture a representative of the Water Resources Department"

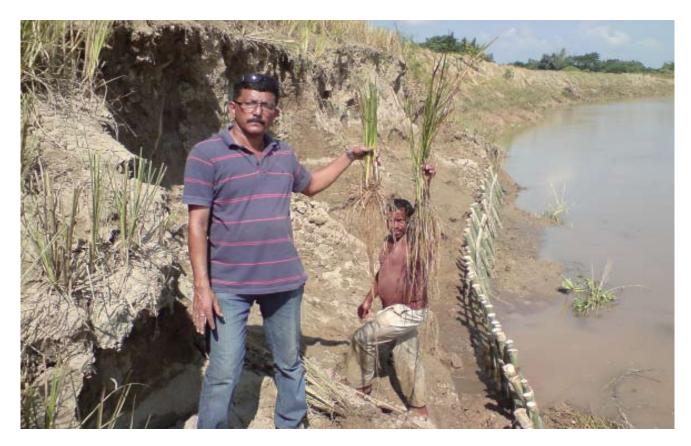
100 to 150mm of clay sediment was deposited within the river bank planted with vetiver during the monsson season 2009, Telehi, Assam, October 2009

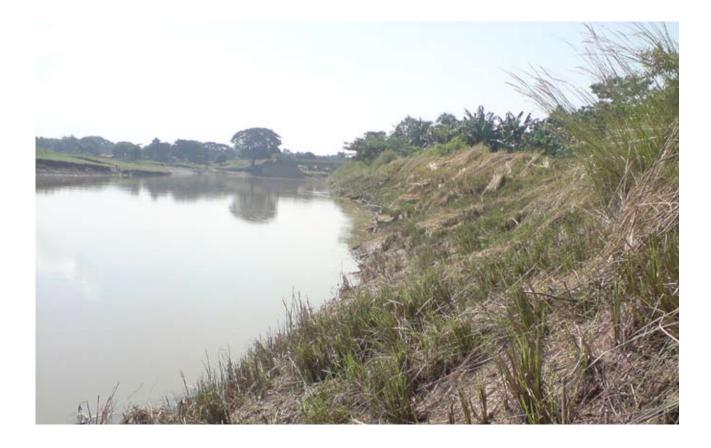
Tension cracking develops as the the river goes down - Dirak, Assam, October 2009
