VETIVER SYSTEM FOR MINE AND QUARRY REHABILITATION

Dr. Paul Truong

Veticon Consulting

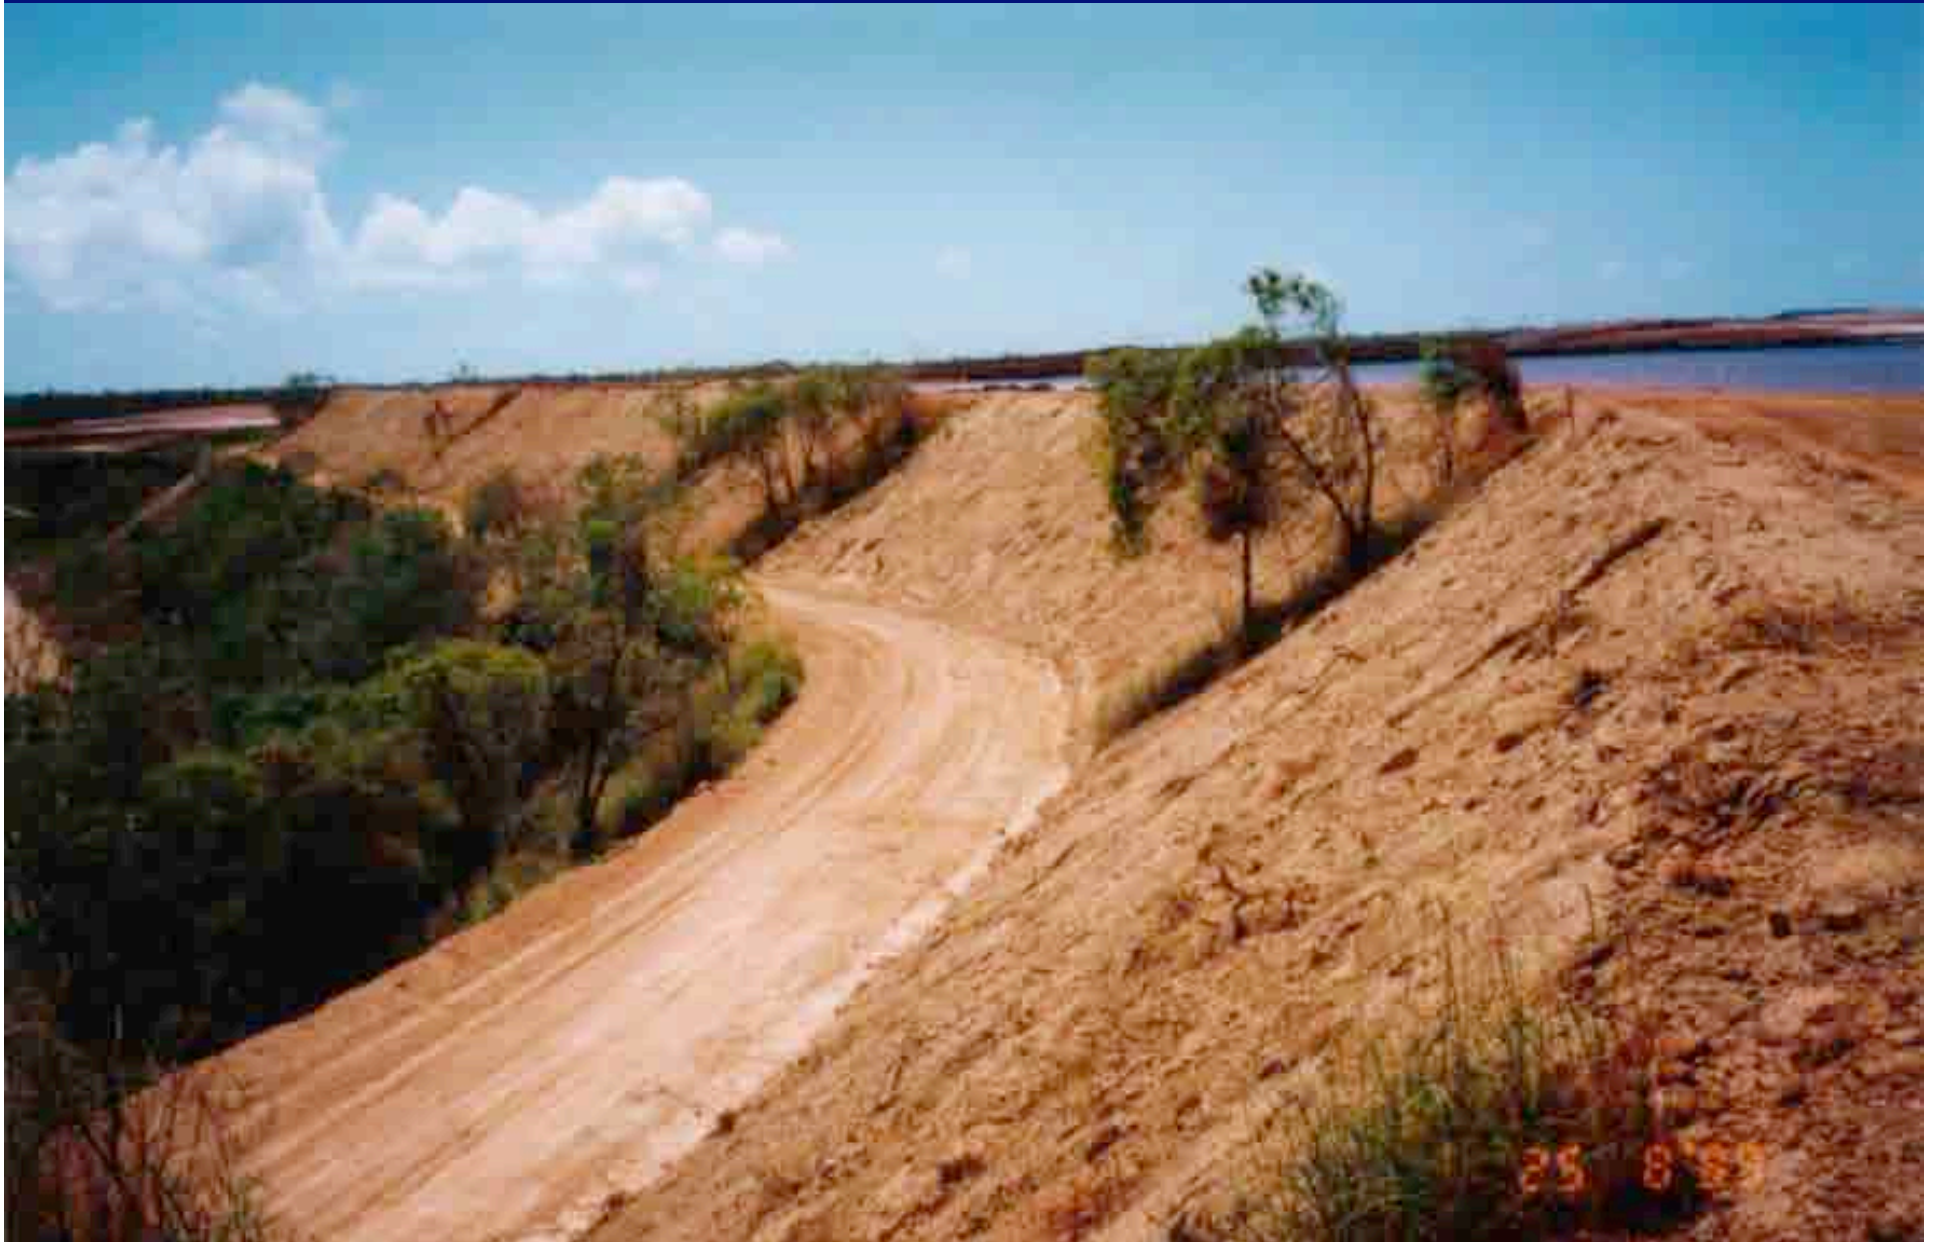
Wall repaired, ready for vetiver planting

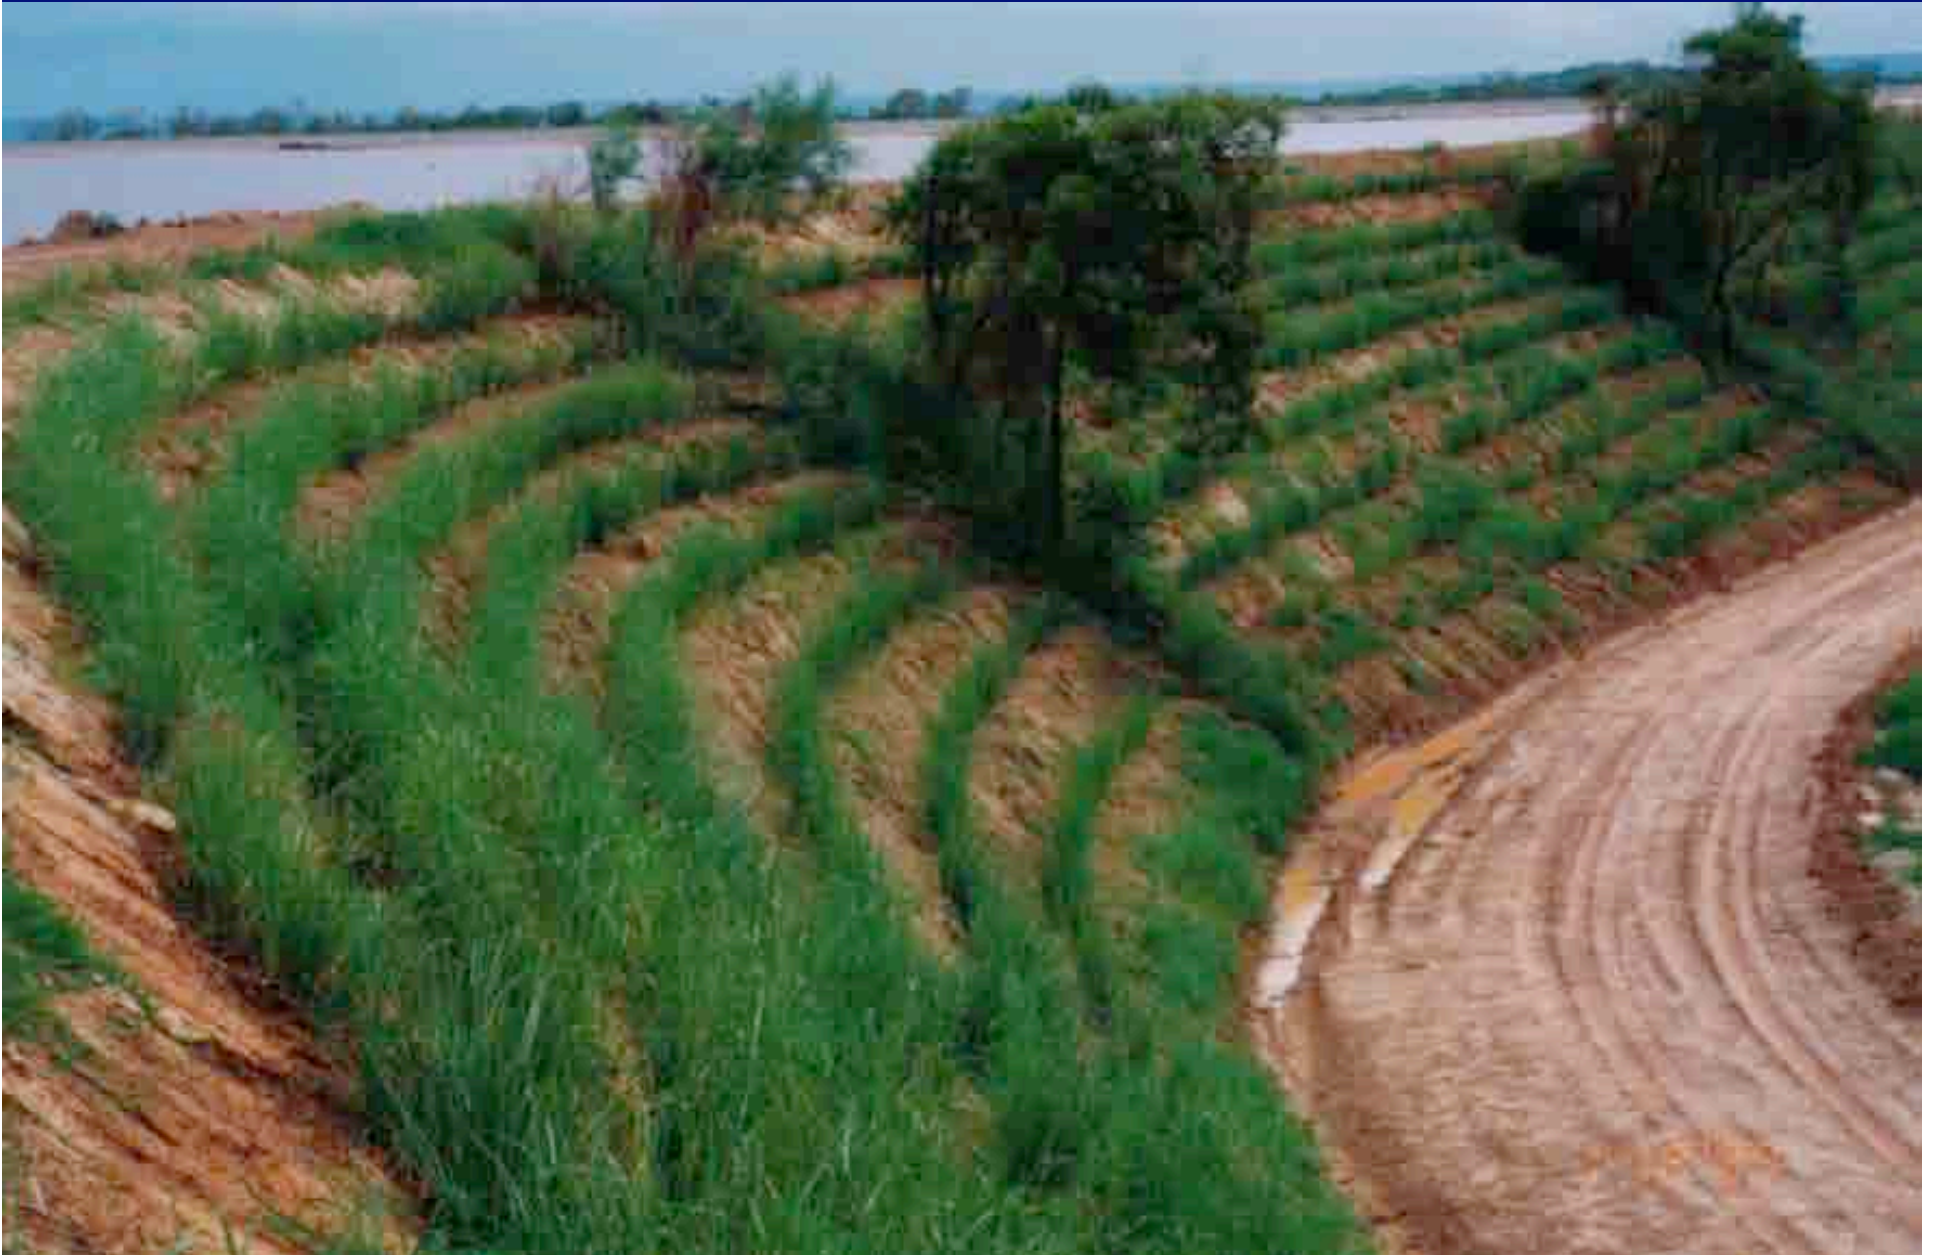
Three months after planting

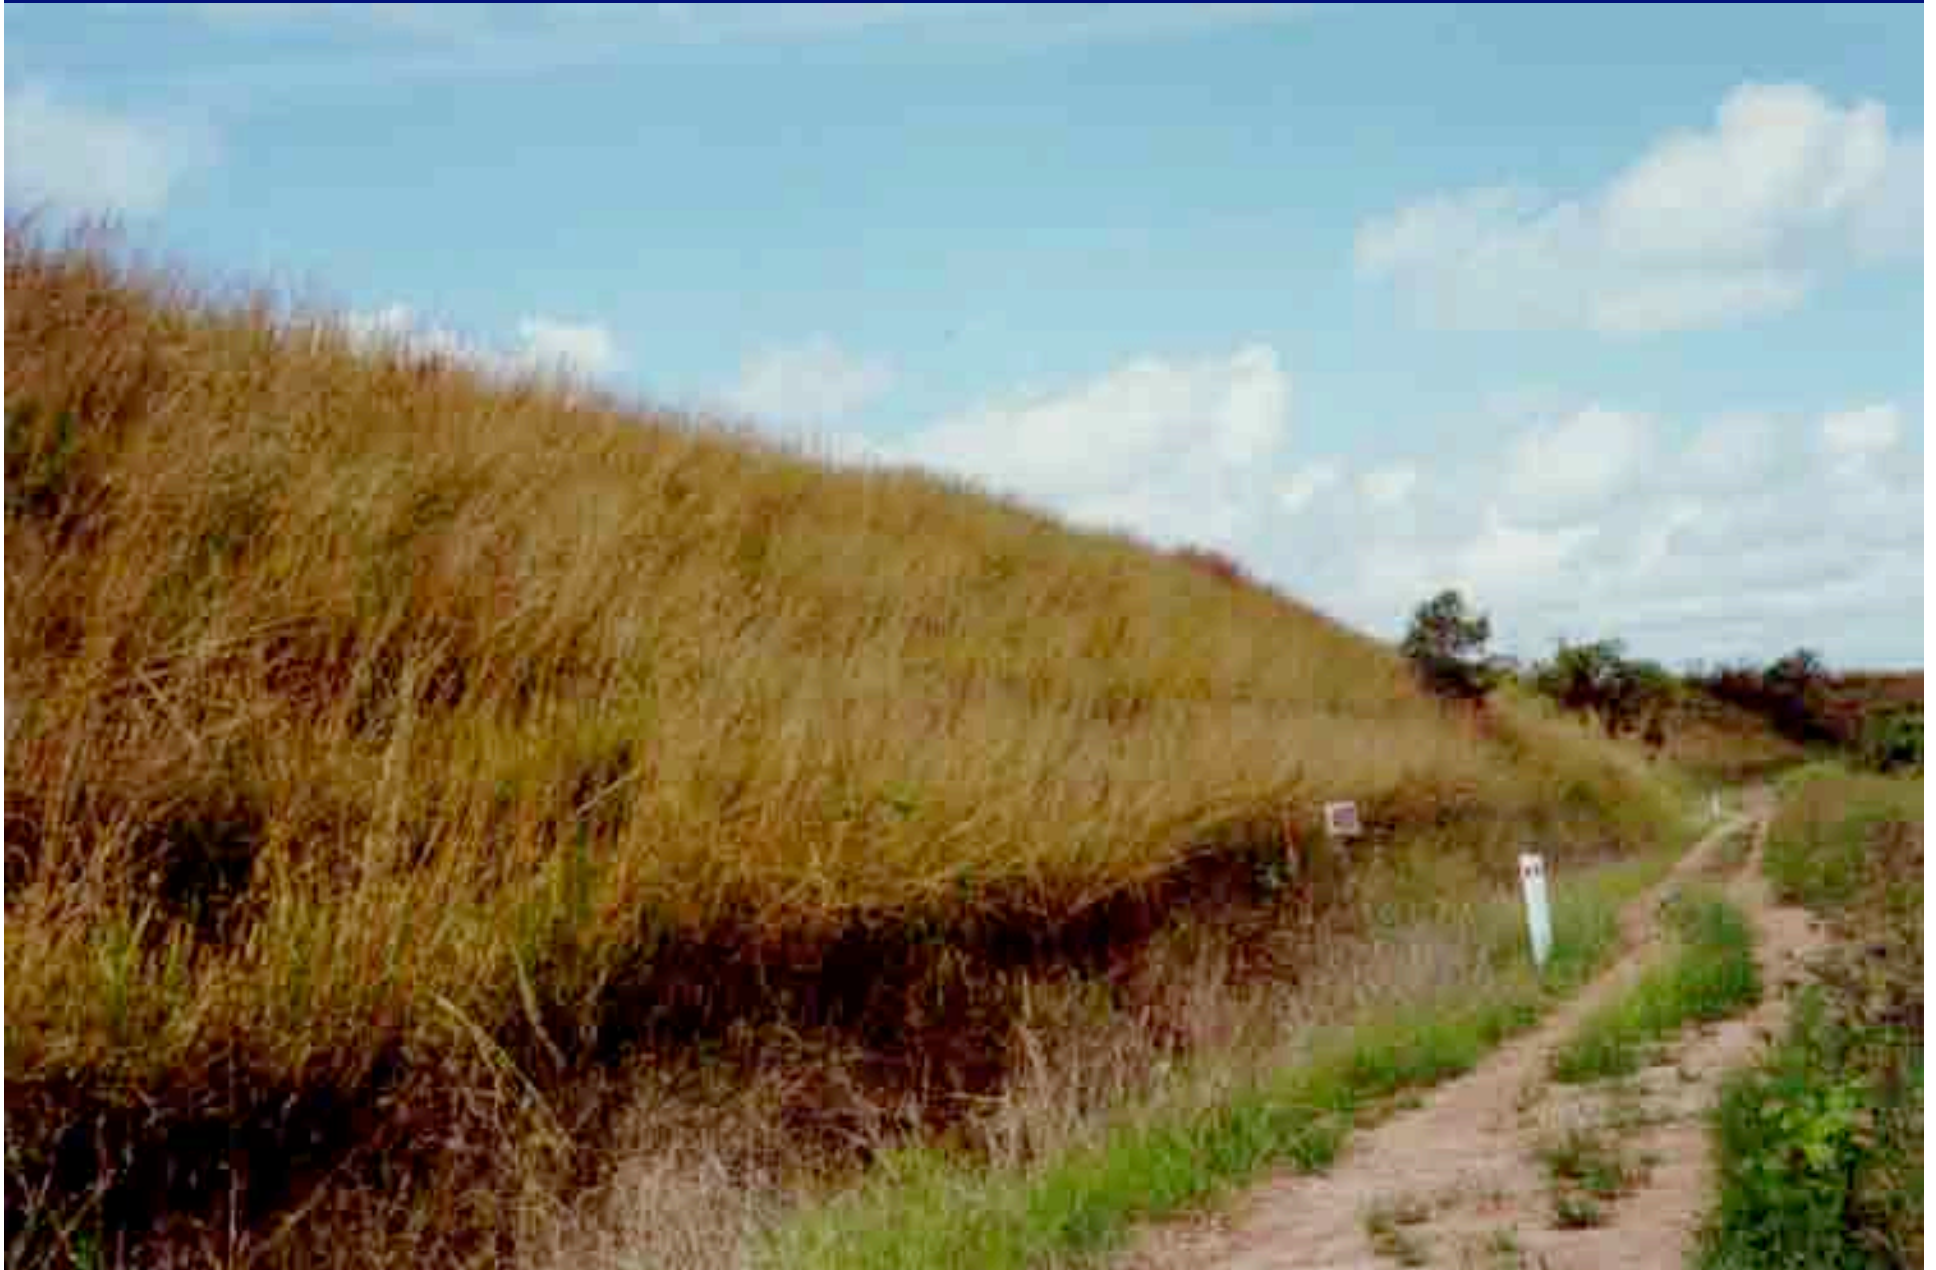
A well protected batter 9 months after planting

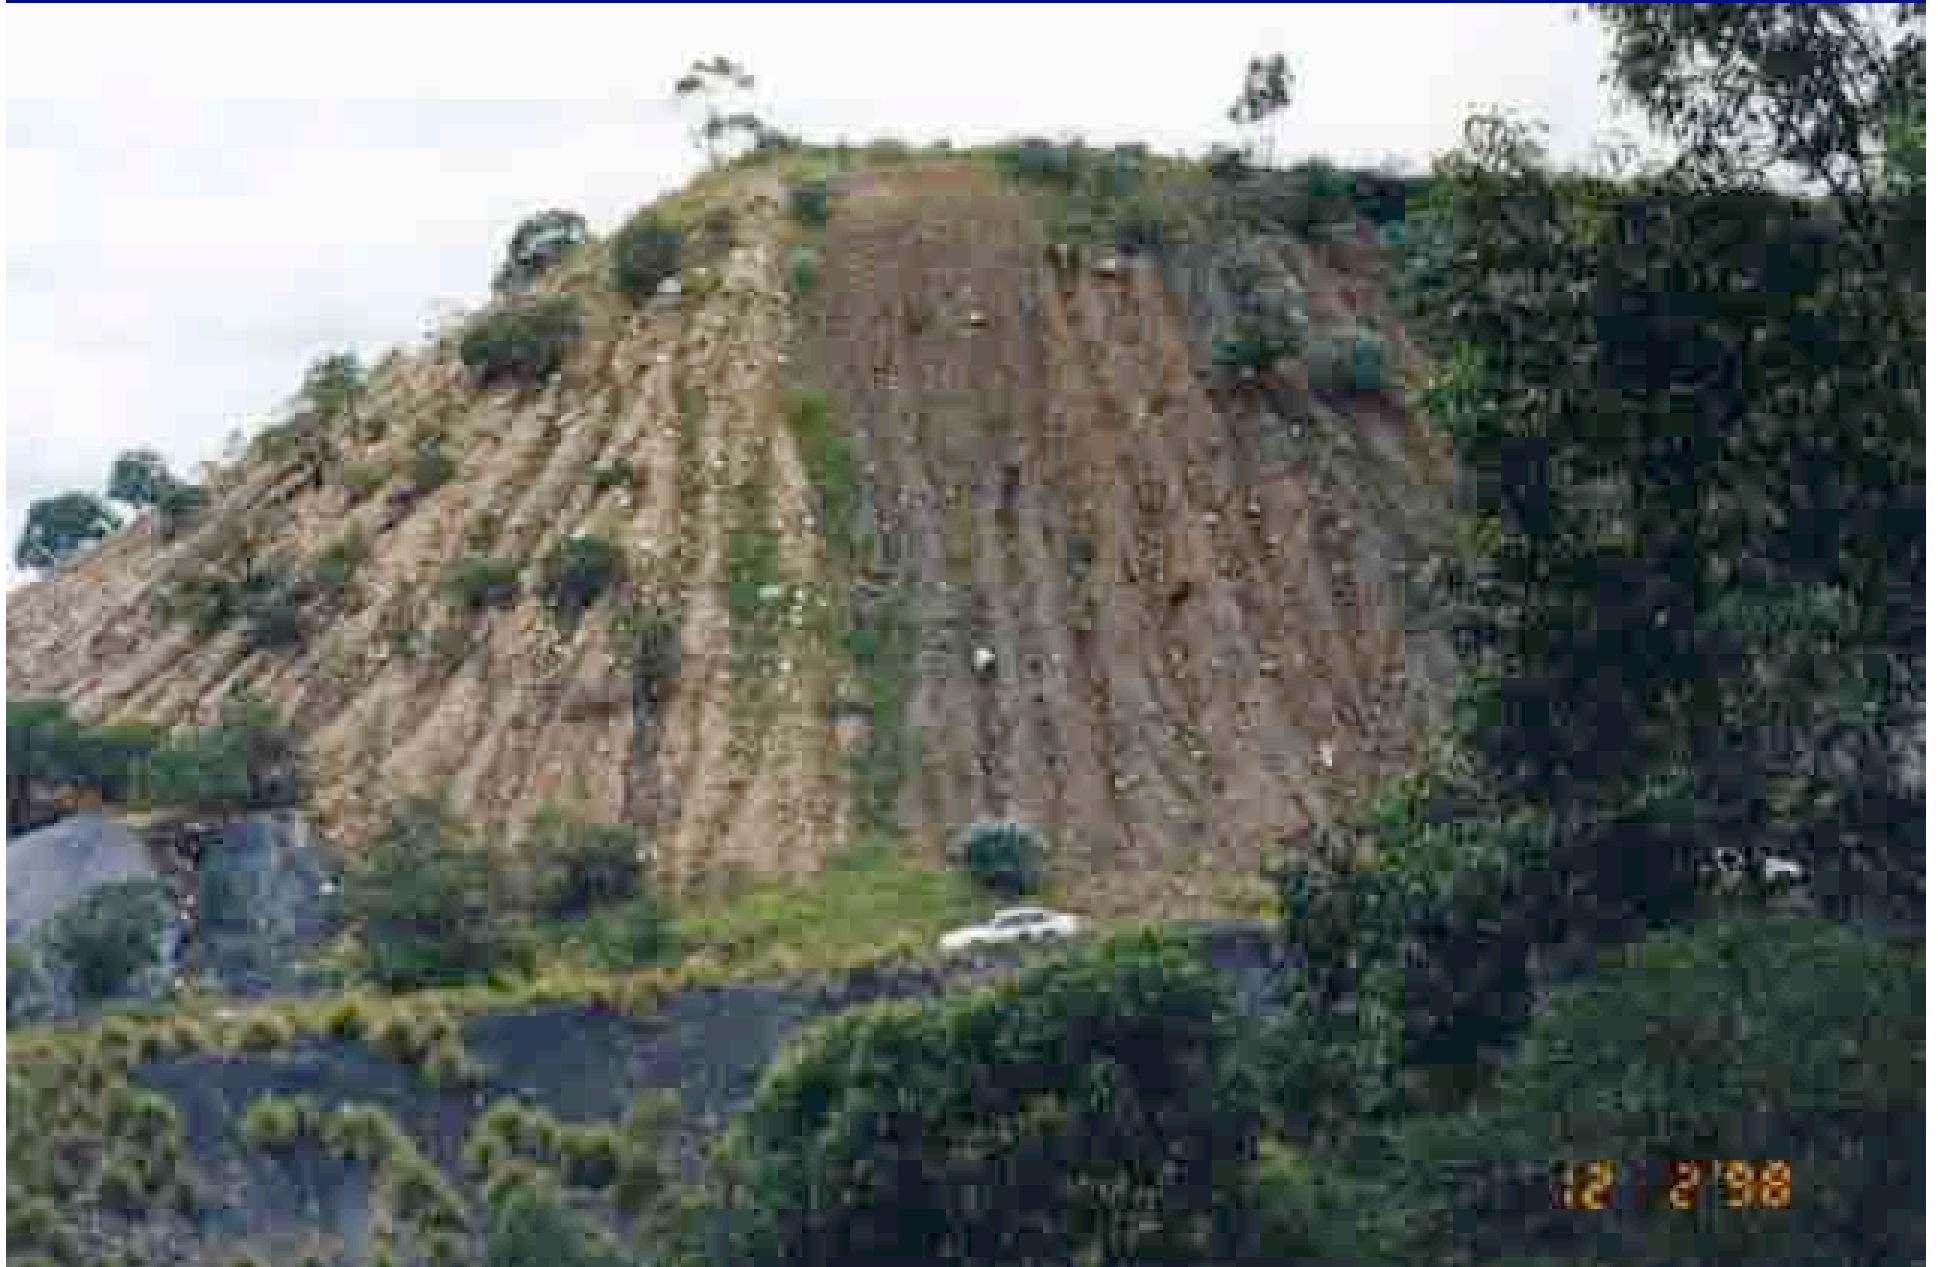
This coal mine waste rock dump remains bare after 40 years

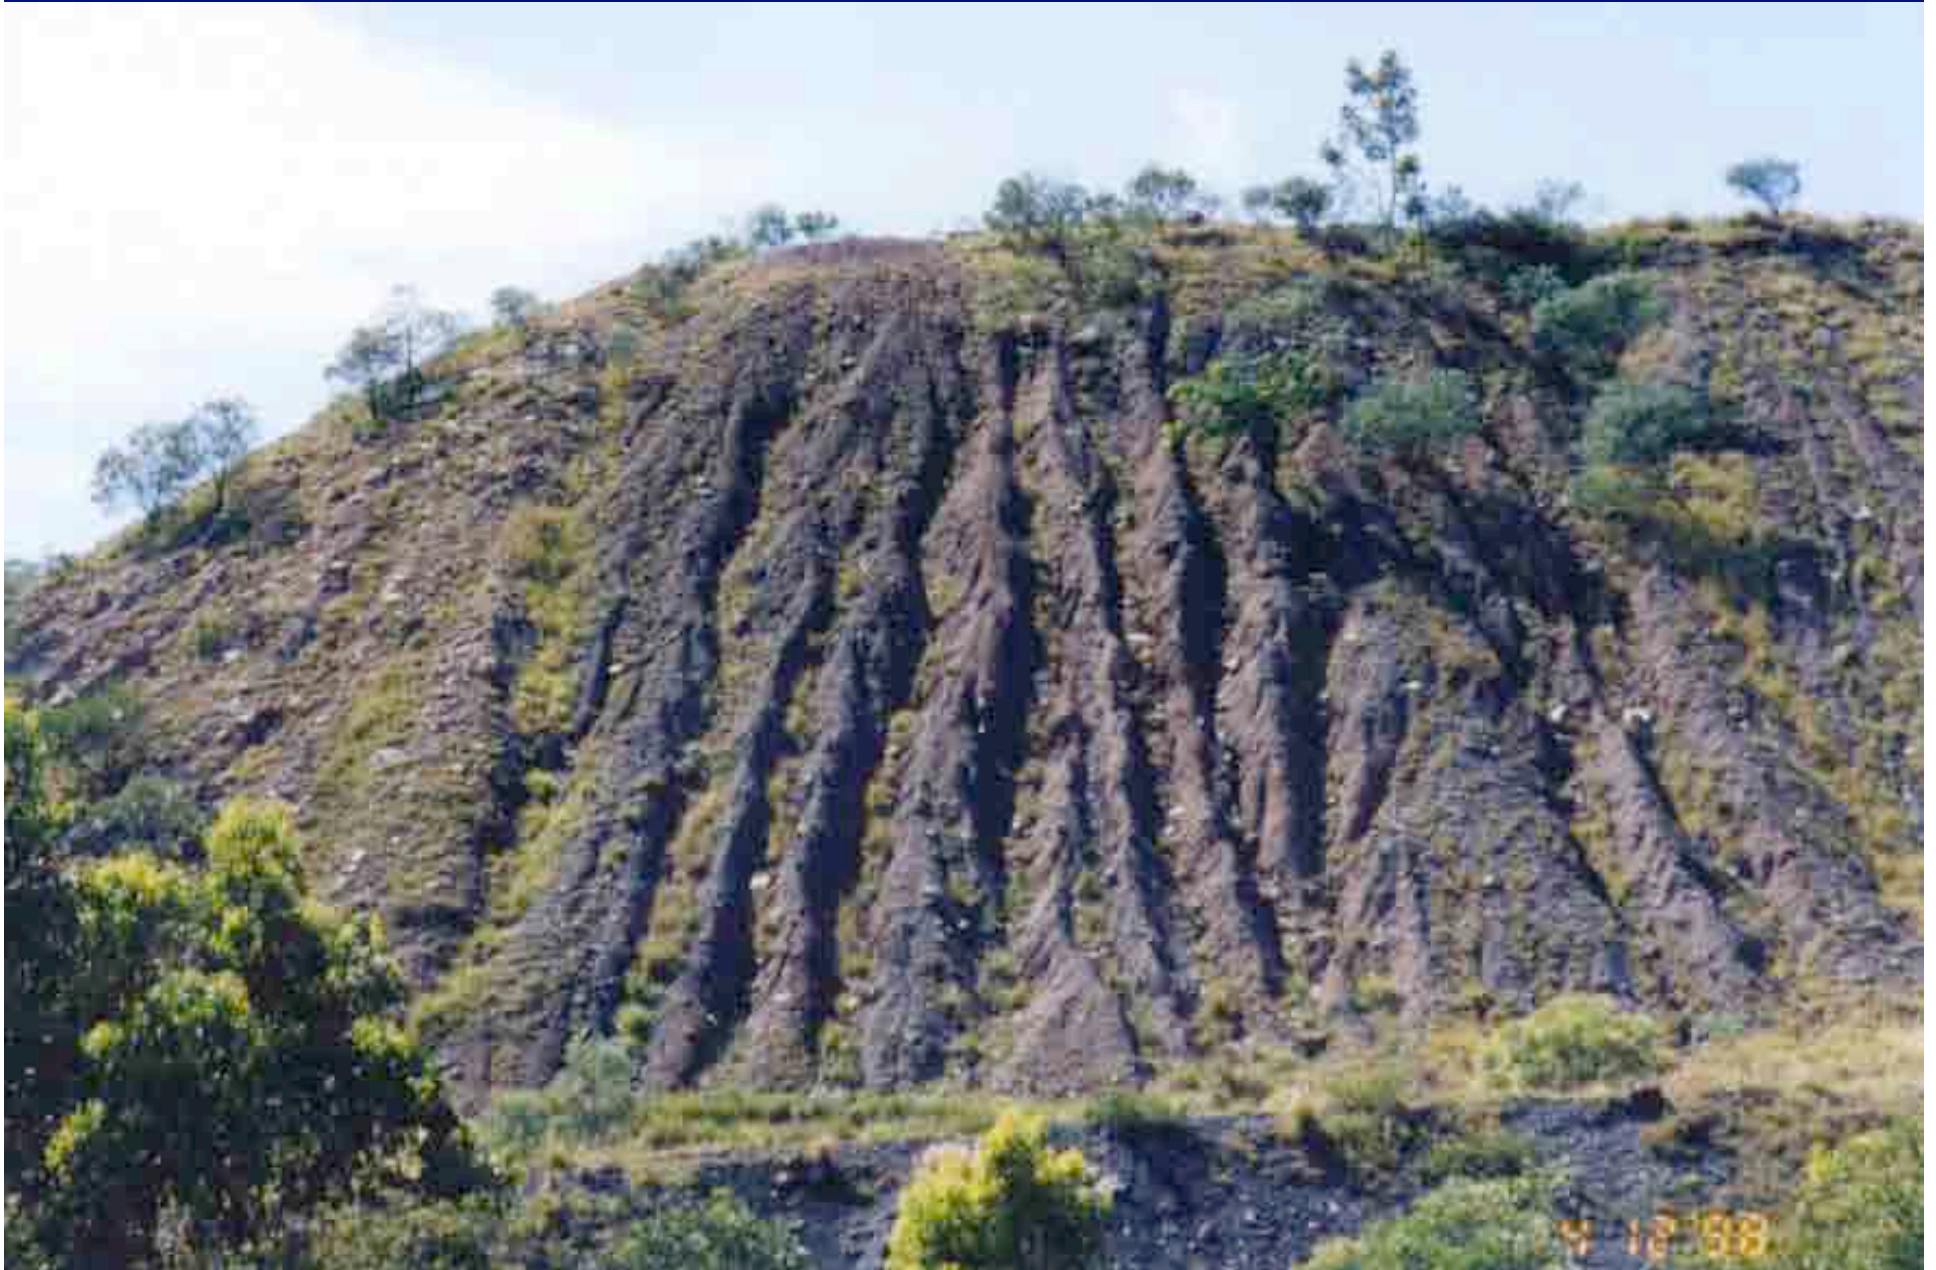
Ten months after planting

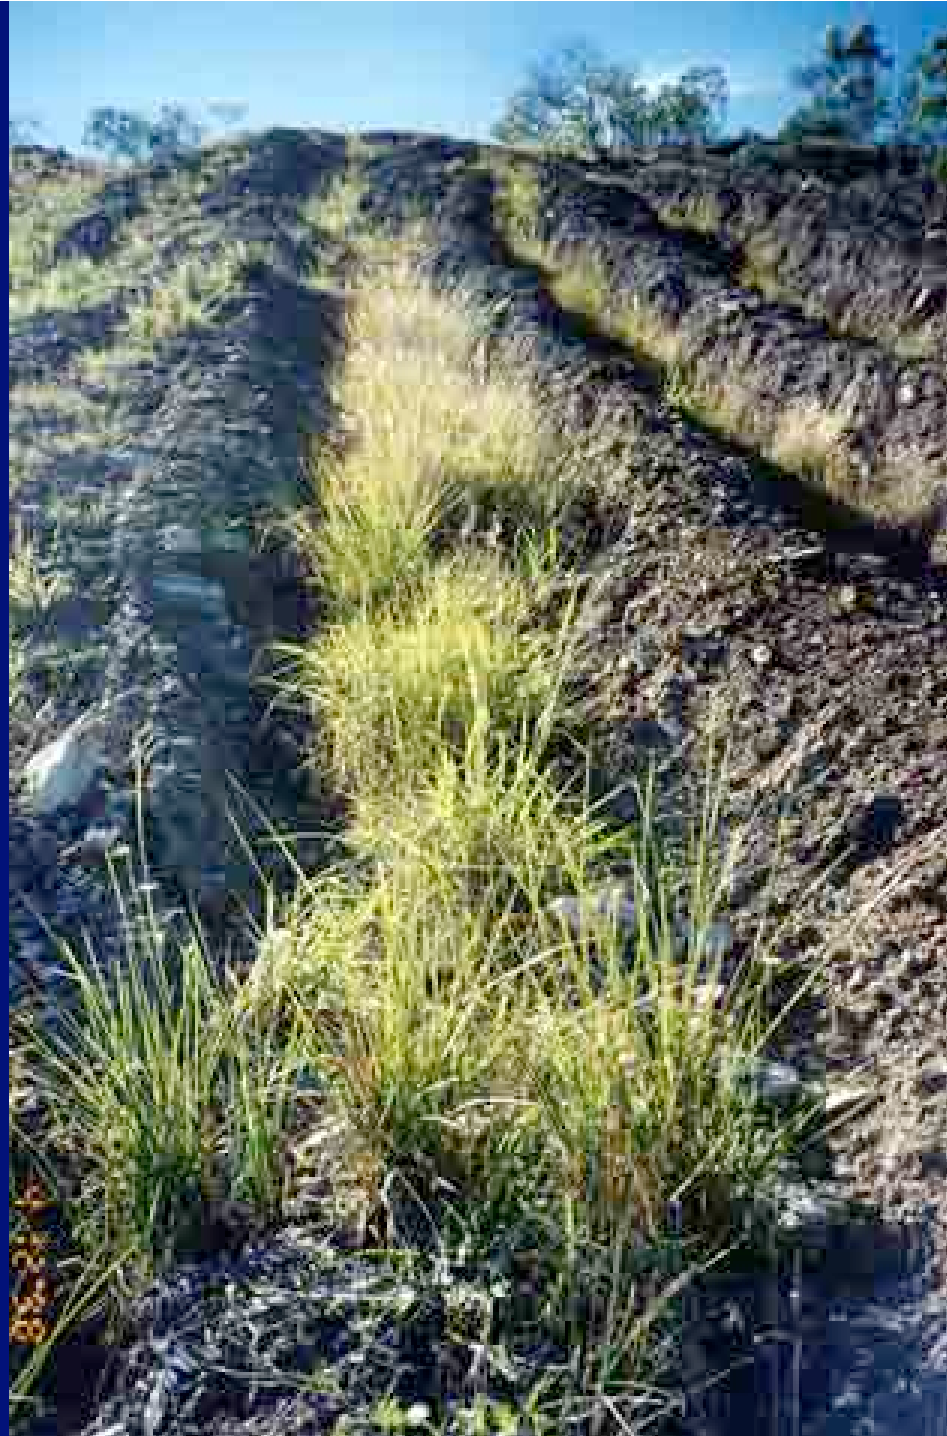
Ten
months
after
planting

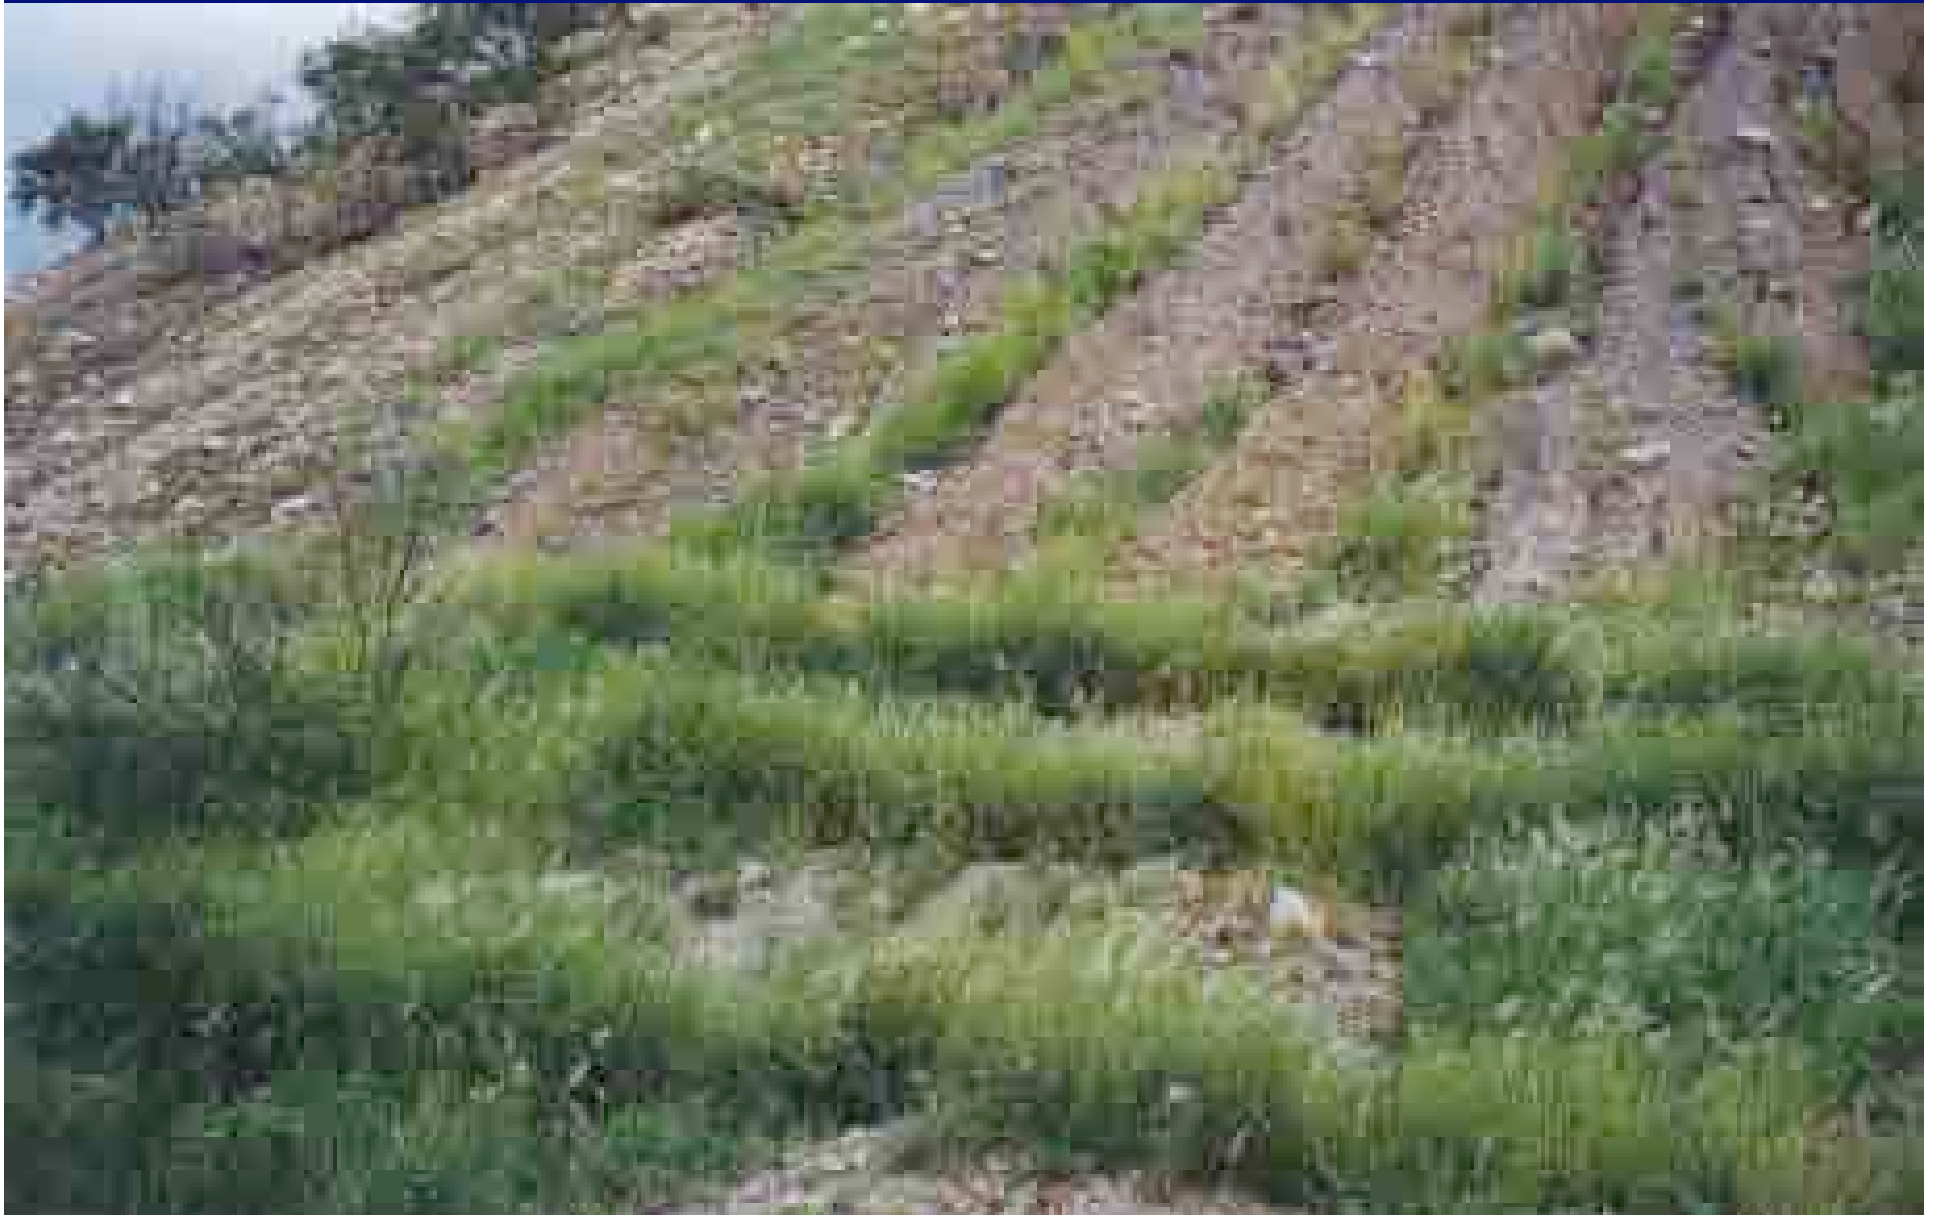
One year after planting, the horizontal rows planted to reduce runoff velocity and to catch eroded sediment

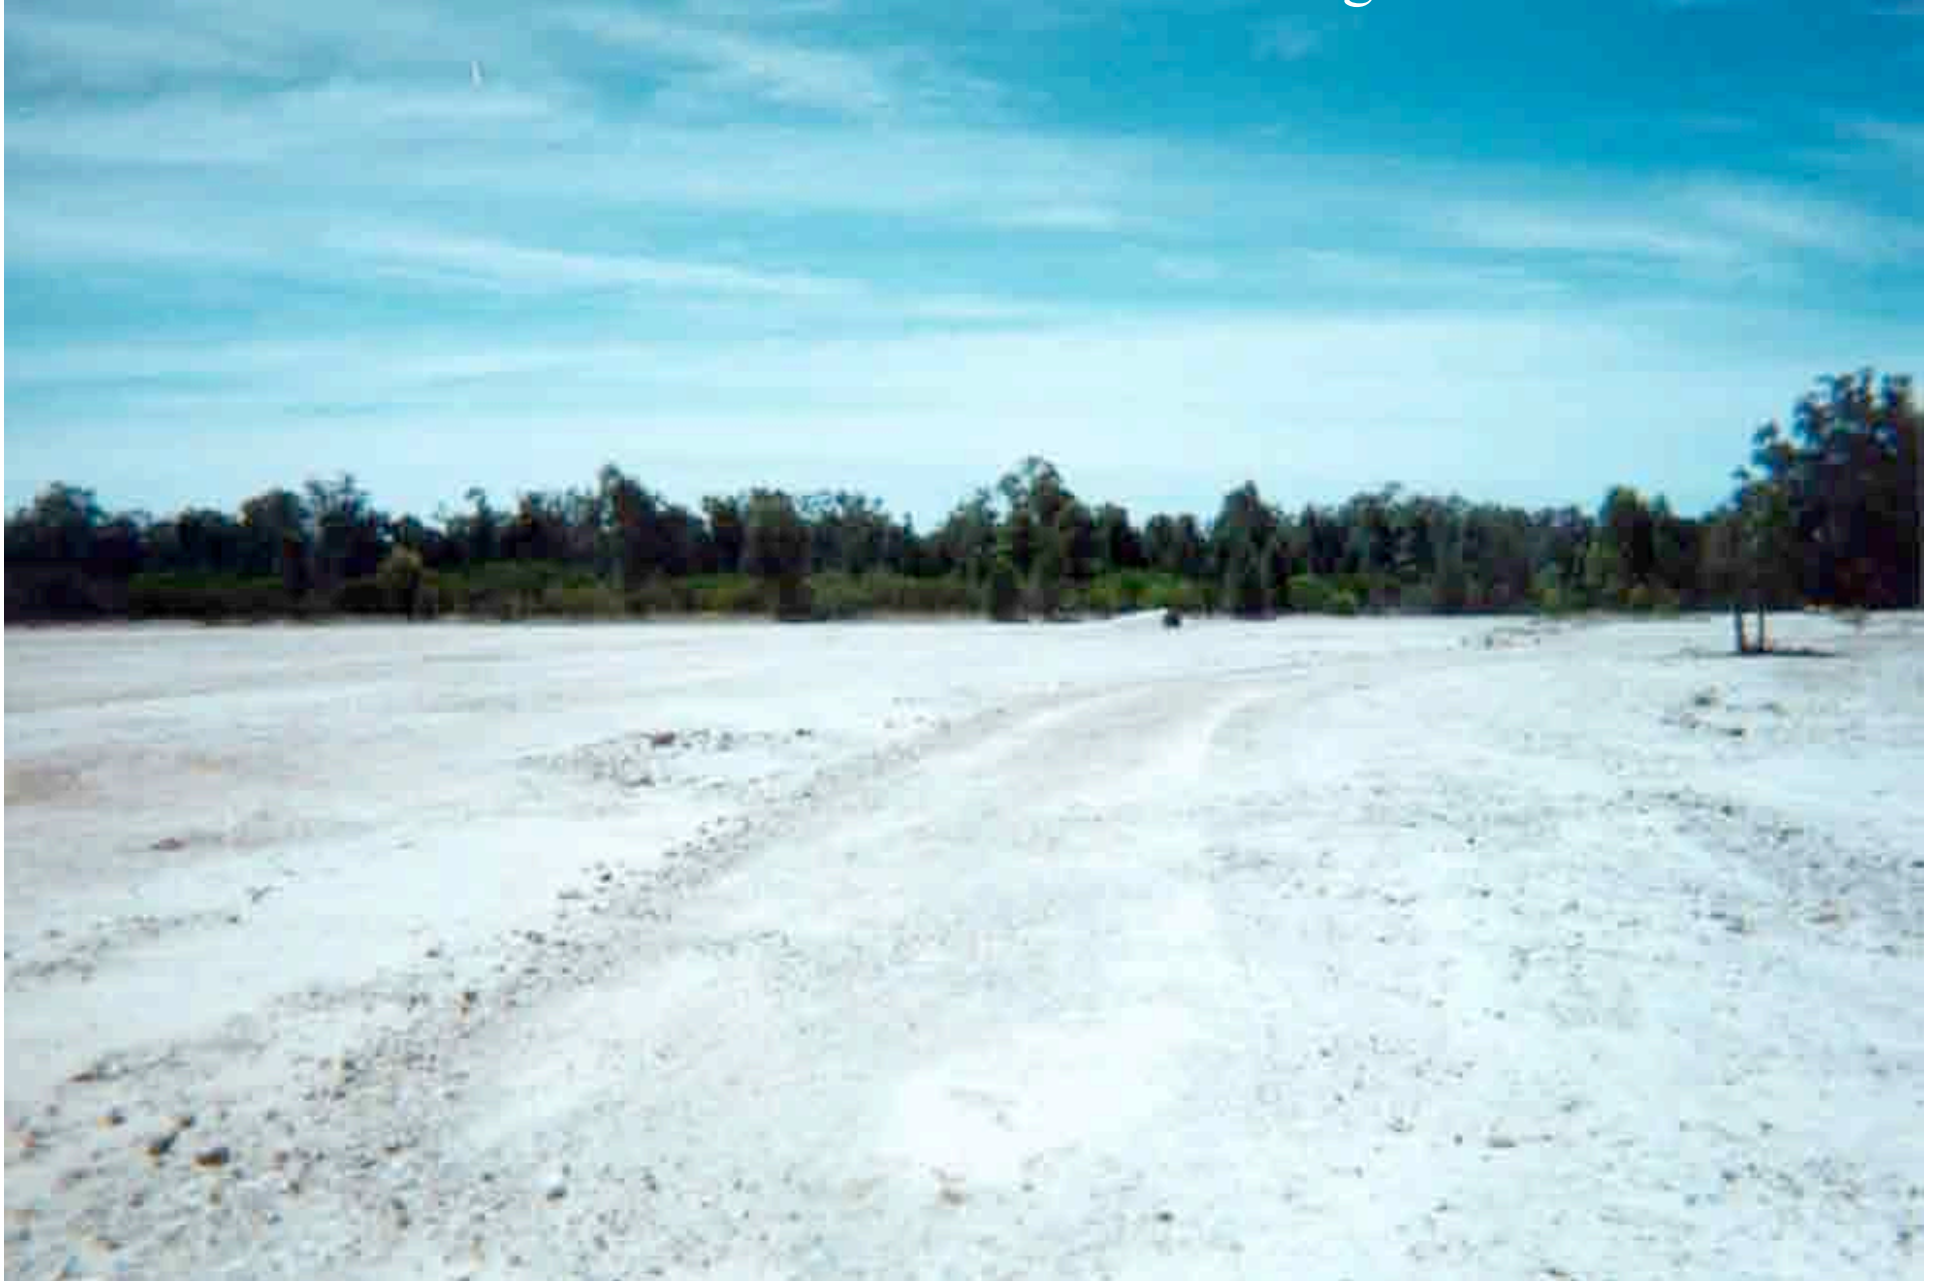
This Bentonite waste site is barren with an extremely erodible surface which has low water infiltration and high runoff rates.

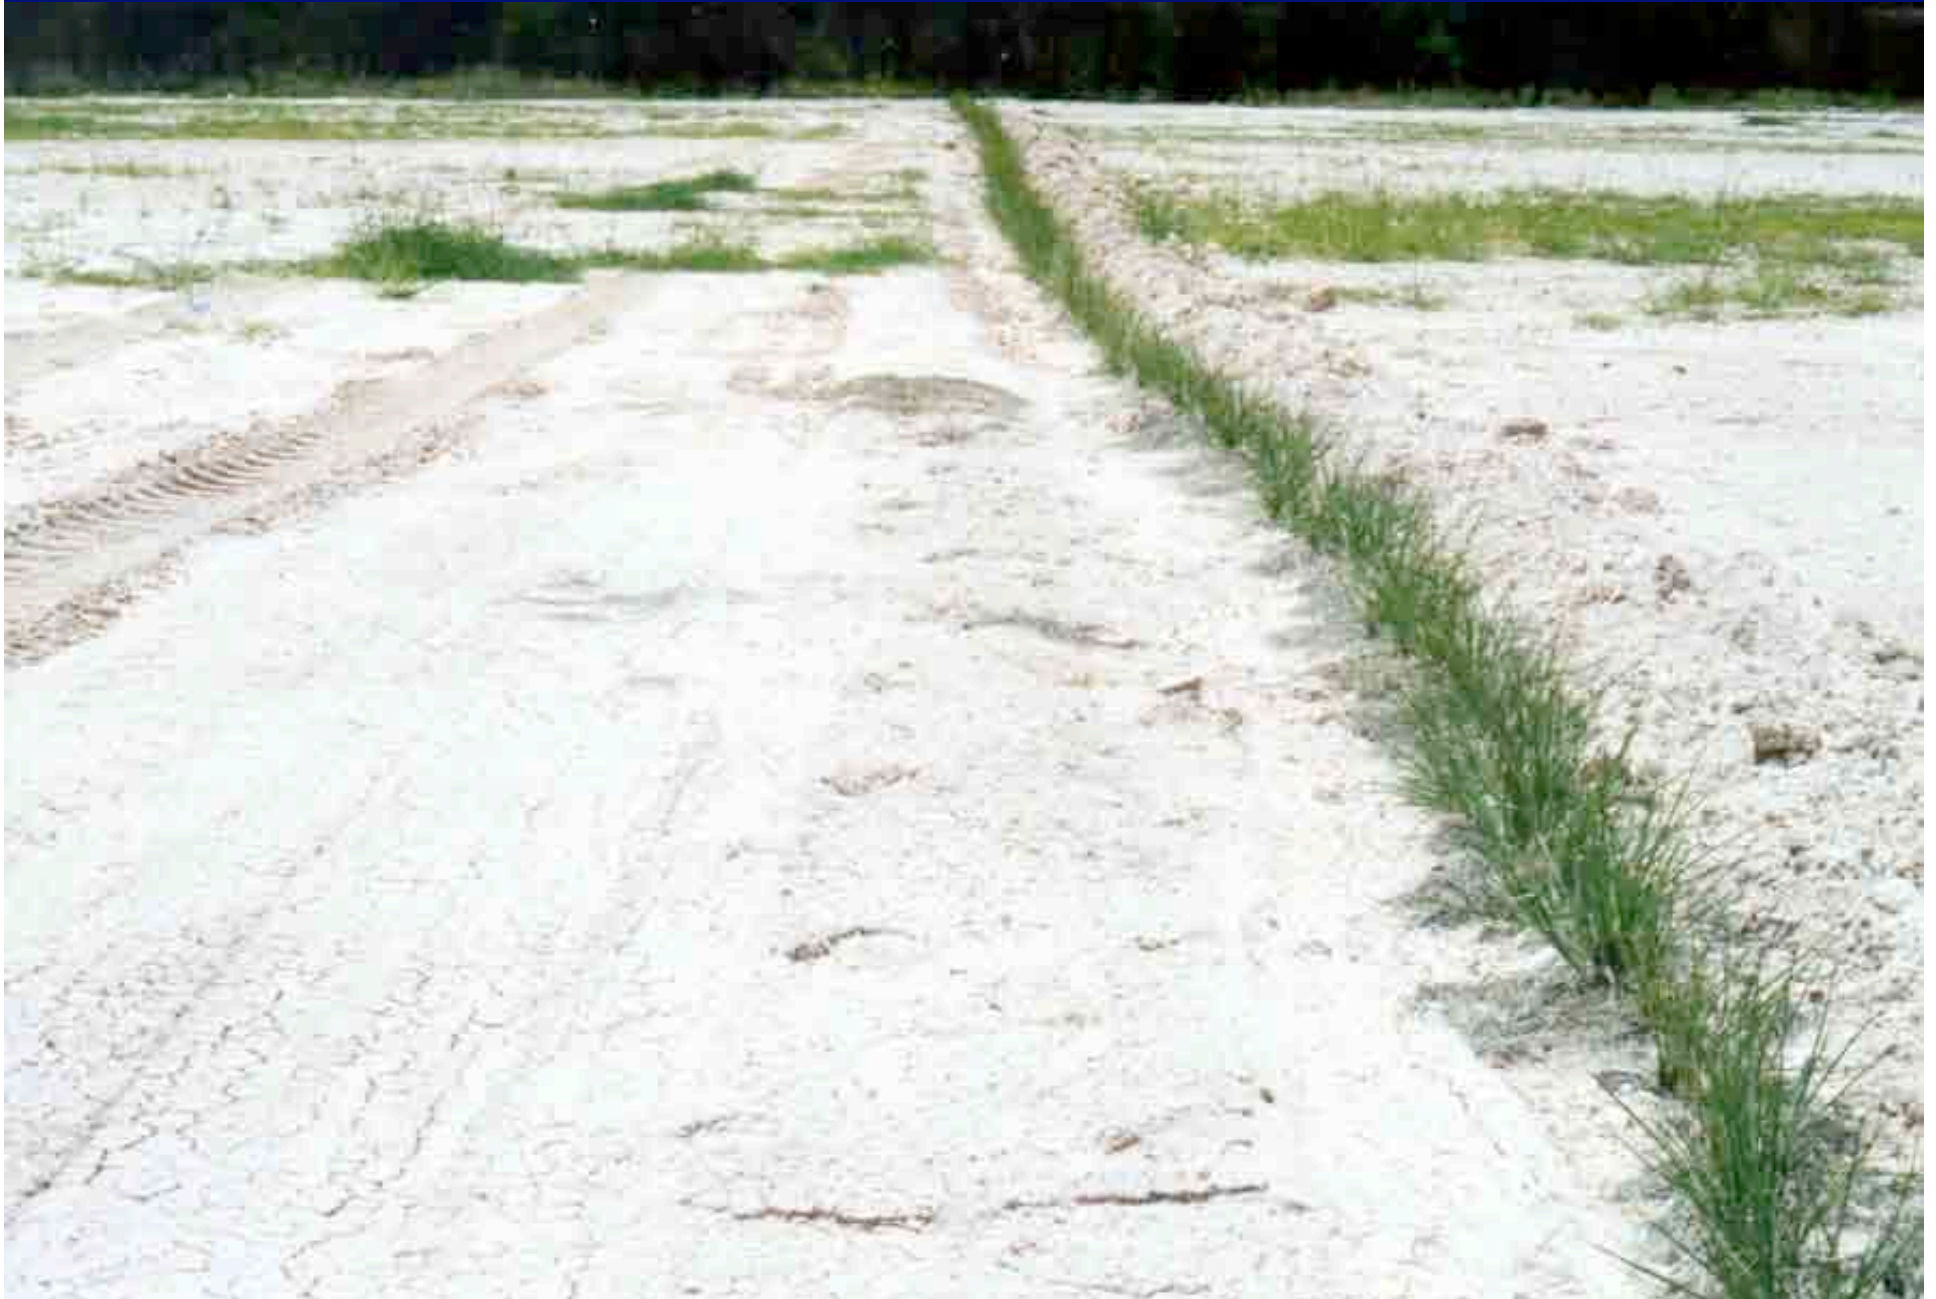
Two months after planting, good establishment and growth
