VETIVER SYSTEM FOR MINE AND QUARRY REHABILITATION

Dr. Paul Truong

Veticon Consulting

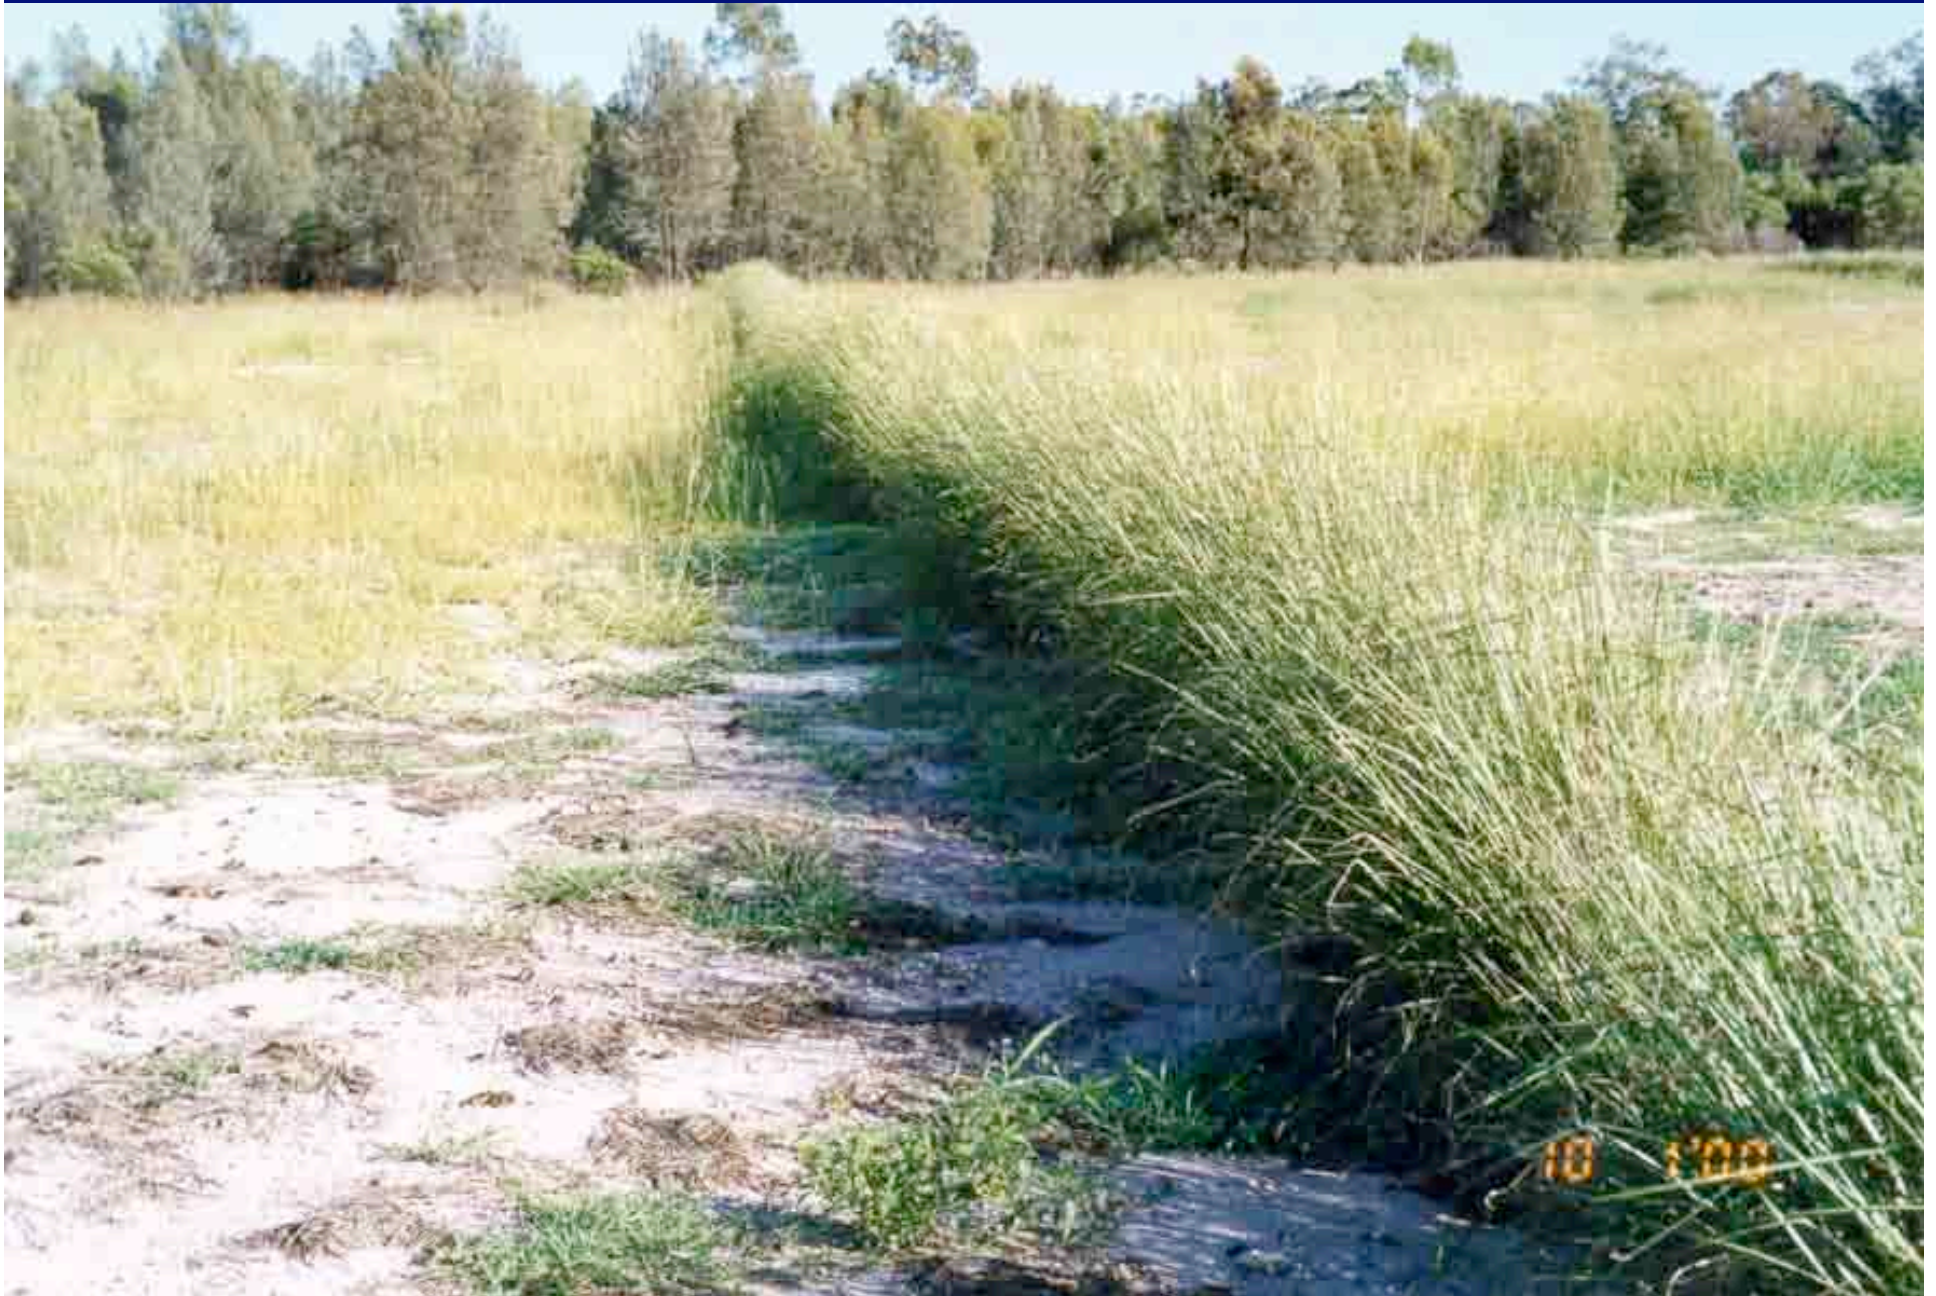
Fourteen months after planting, note the growth of other species

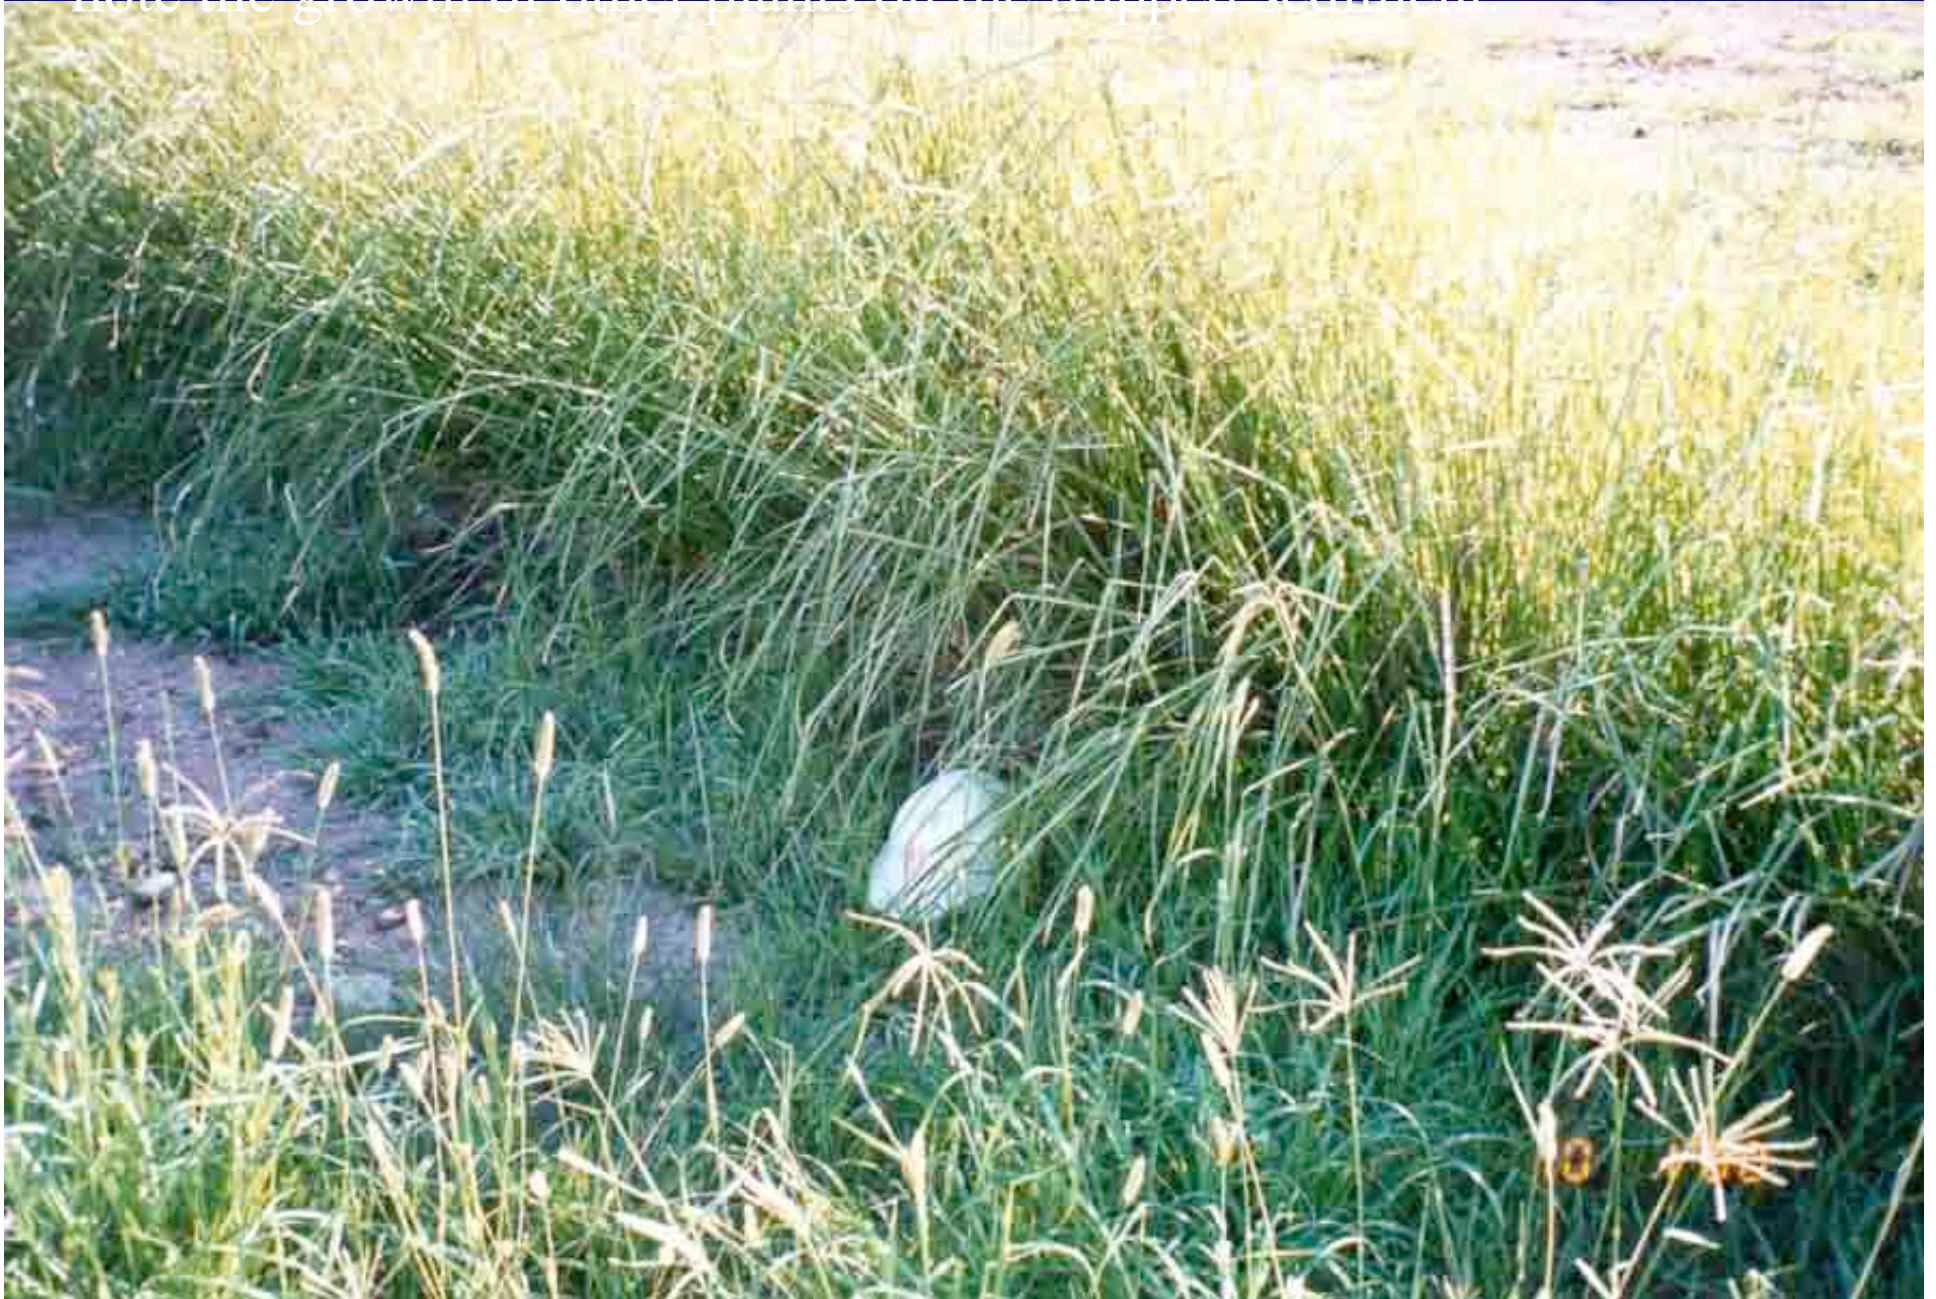
Fourteen months after planting, the hedge is now a very effective filter, note the growth of other plants on the trapped sediment.

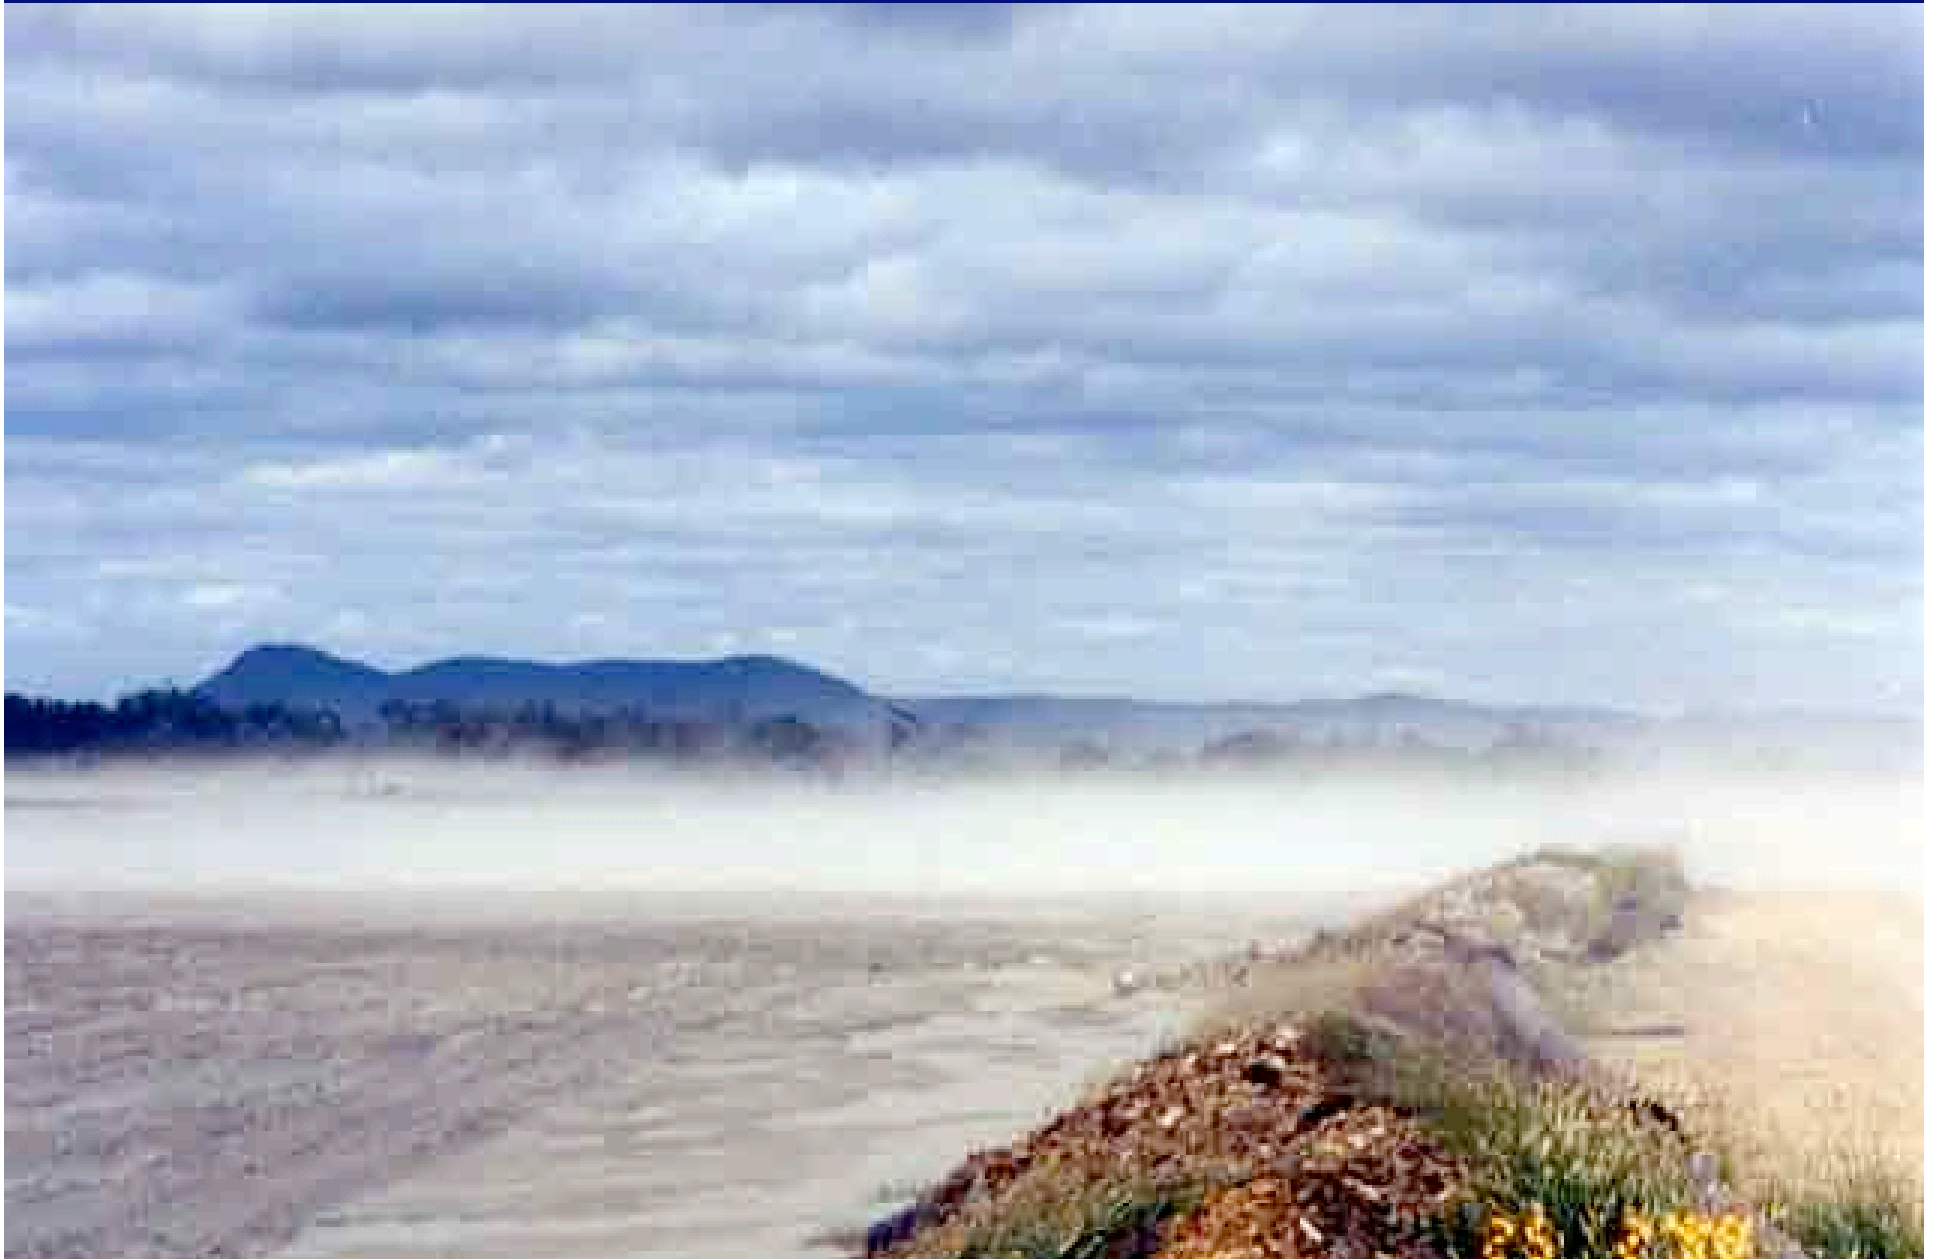
The finely ground tailings produce dust storm in the dry season

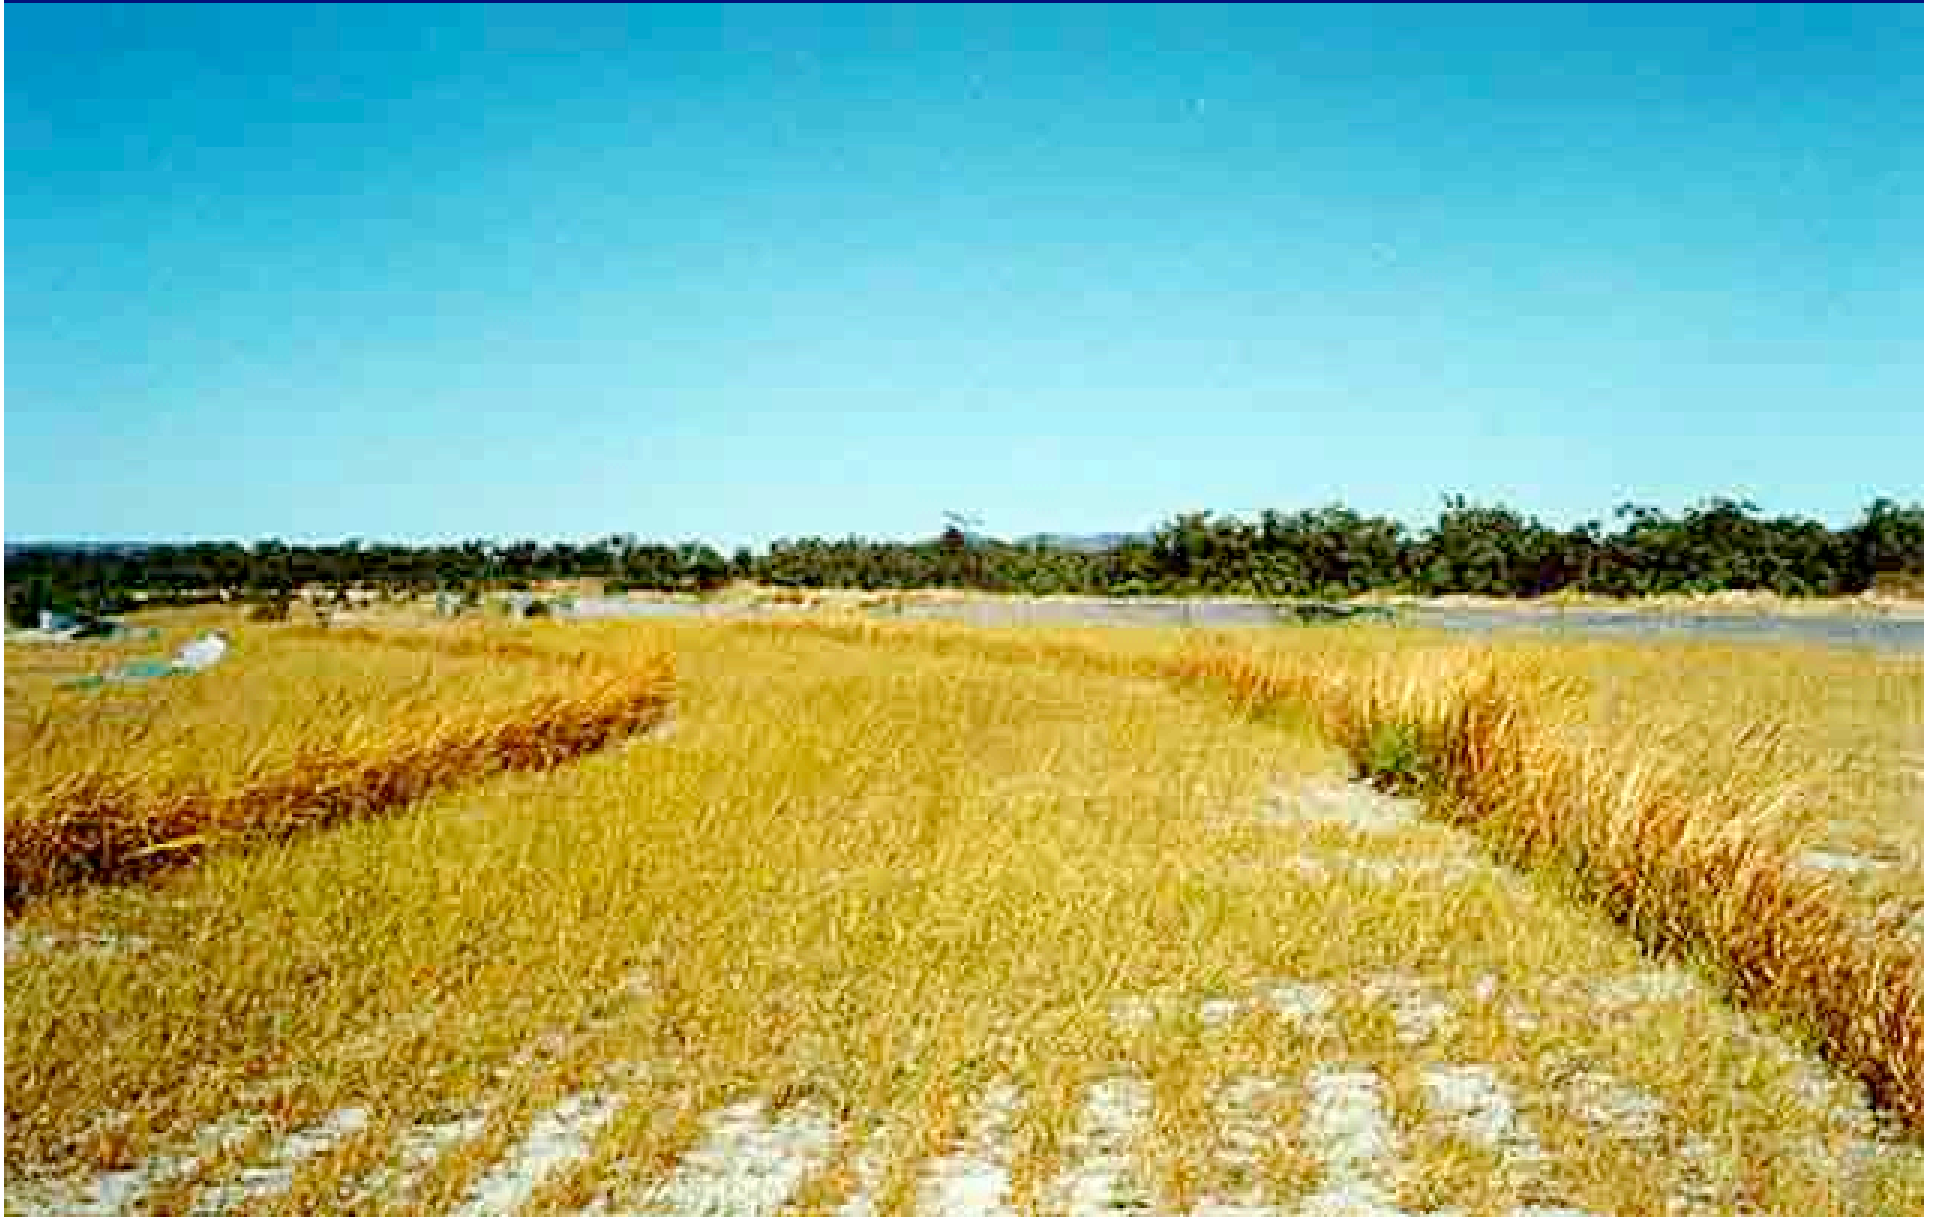
Vetiver hedges provided a low cost and permanent wind barrier unaffected by strong winds

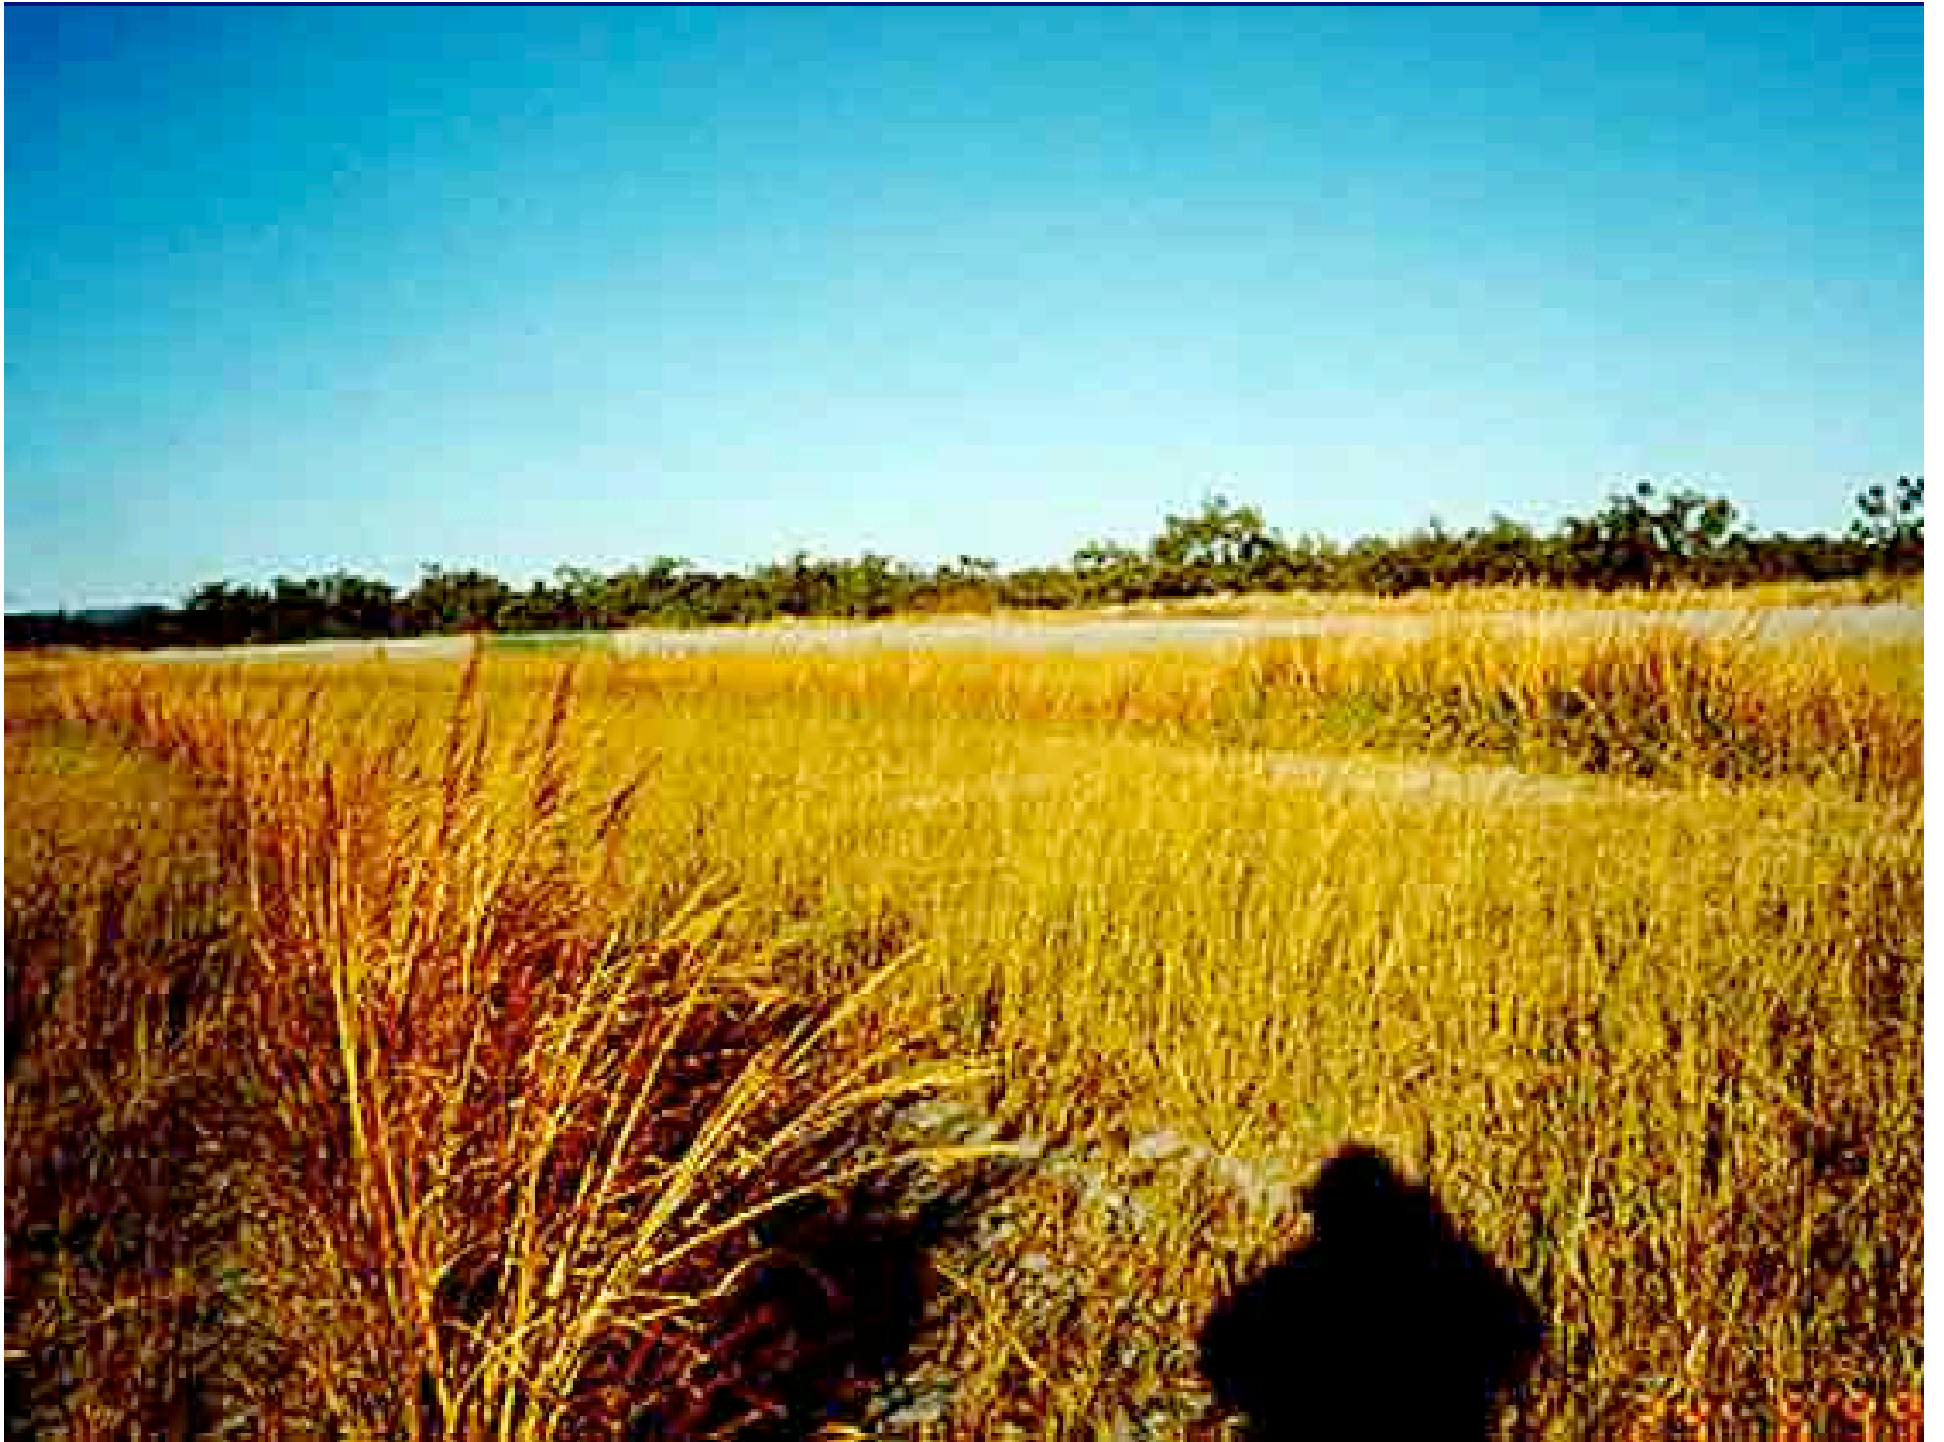
Vetiver hedges provided excellent protection for crop establishment
