Vetiver Victorious: The Systematic Use of Vetiver to Save Madagascar's FCE Railway

Diti Hengchaovanich¹, and Karen Schoonmaker Freudenberger²

²*Fianarantsoa Côte Est Rehabilitation (FCER) Project, Fianarantsoa, Madagascar*

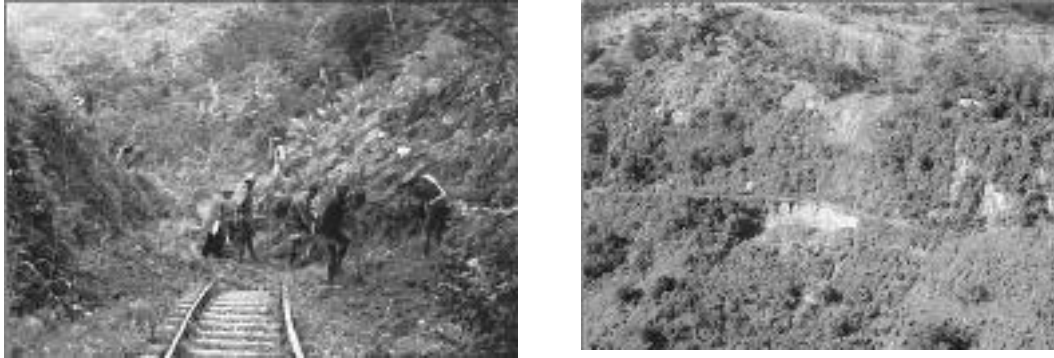
Fig. 2 Examples of devastating damage, *Left*, 280 landslides and *Right*, 28 embankment slides.

Cyclones Eline and Gloria smashed Fianarantsoa province in early 2000 and left behind devastating damage. When the second cyclone hit, the earth was already saturated by rains from the first. Streams and rivers rose to new heights as they tried to accommodate the runoff from the largely deforested mountainsides. The result was no fewer than 280 landslides and 28 embankment slides (Fig.2) ...all in a distance of 163 km.

Concerning the “technical interventions,” the landslides, embankment slides, washouts and rail subsidence were caused primarily by erosion leading to slope instability because the slopes were generally devoid of slope protection measures. In addition, drainage on the slopes and at track levels was either non-existent or non-performing due to lack of maintenance. The project team in Madagascar, in conjunction with the Thai specialists, decided to use vetiver wherever it would be effective. Where vetiver alone was not sufficient, it was used along with ‘hard’ conventional techniques such as gabions. Furthermore, any new infrastructure (or rehabilitation of an old infrastructure) was immediately protected by vetiver so as to reduce erosion and subsequent silting. For details of technical interventions, the reader is referred to PRVN’s Technical Bulletin No. 2003/2 (Hengchaovanich and Freudenberger 2003).
