# NOTES ON THE VISIT TO NEW ZEALAND DECEMBER 2009

**Paul Truong**

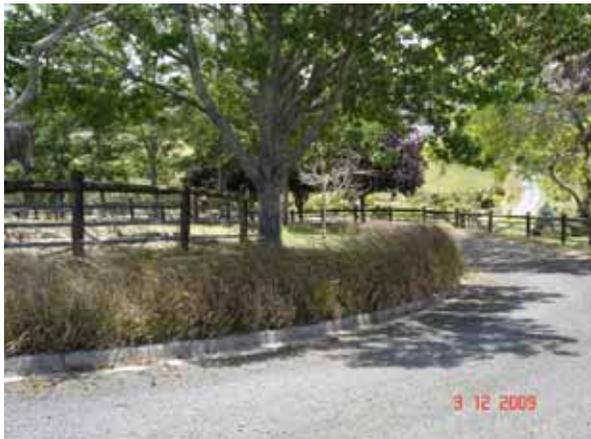
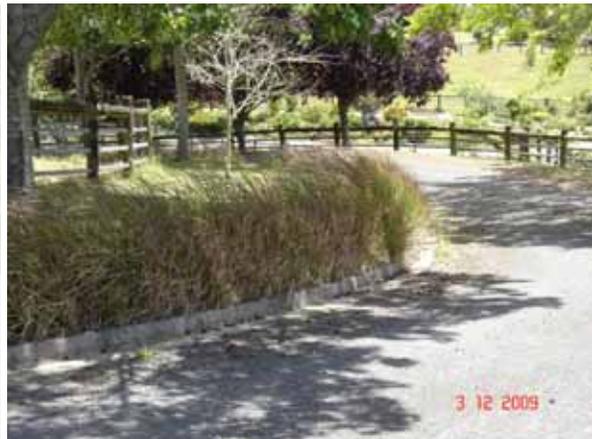
This stand of Vetiver was planted by John Greenfield at Kerikeri about 10 years ago for erosion control. It is still growing very vigorously without any maintenance since planting.

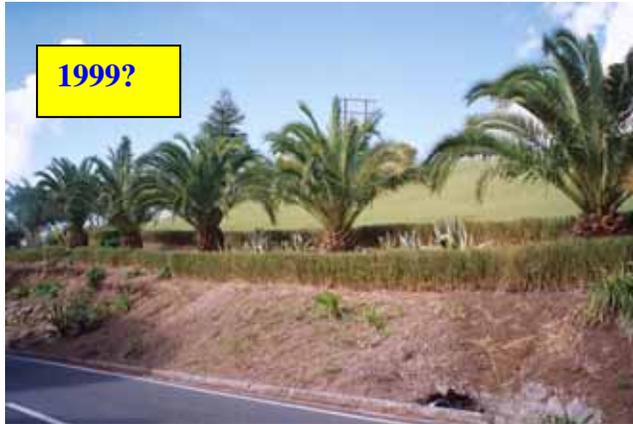
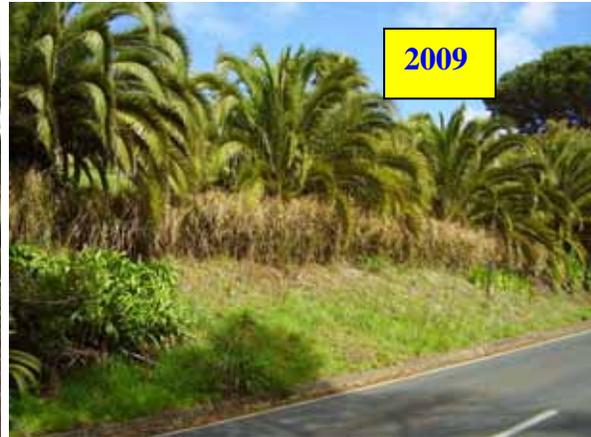
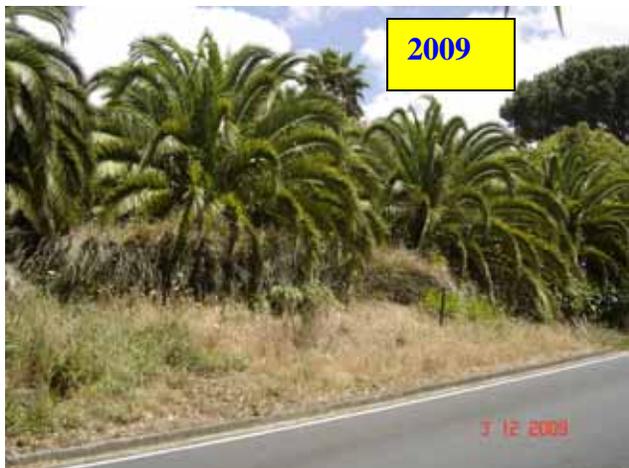
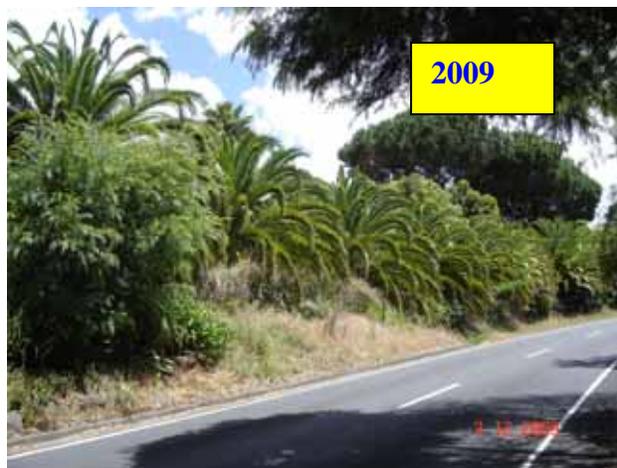
More or less at the same time, the below planting was carried out to protect this batter. Note that not only the batter is now completely stabilised, endemic plants also returned to the once barren and highly erodible batter. John also pointed out that the palms in the vetiver planted section of the batter are much bigger than on unprotected section, due to moisture conservation.

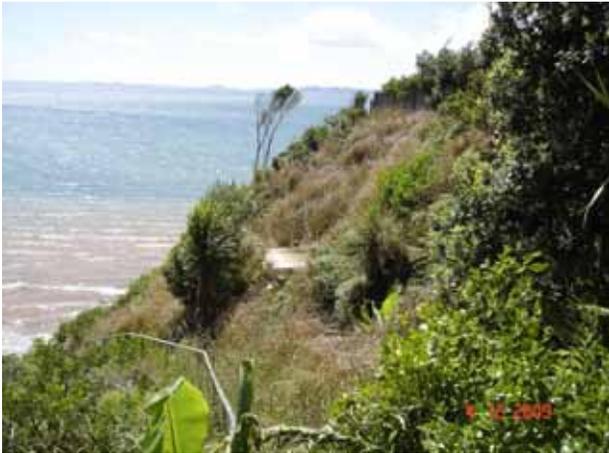
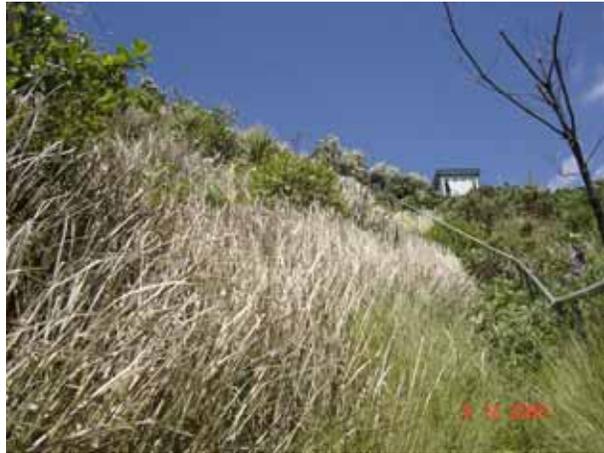
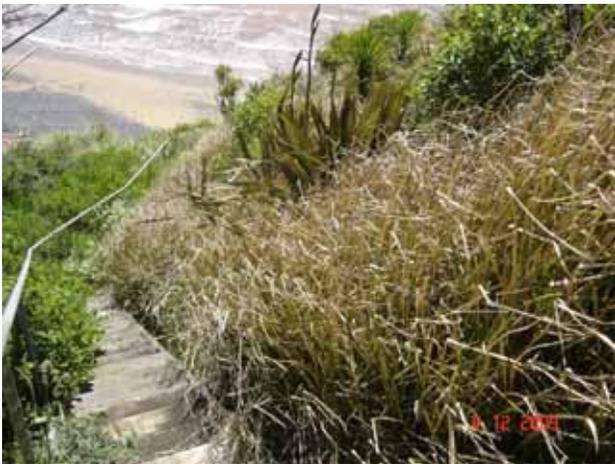
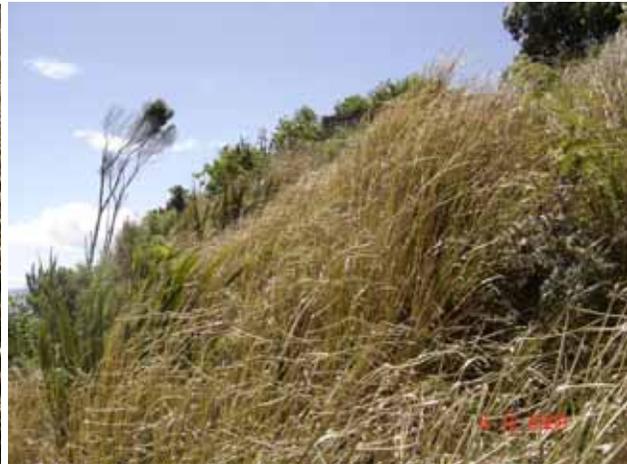
- **Land Stabilisation**
  - *Without Hard Structure:* This project was implemented by Rick Fisher, on a house block on a very steep slope on the beach.

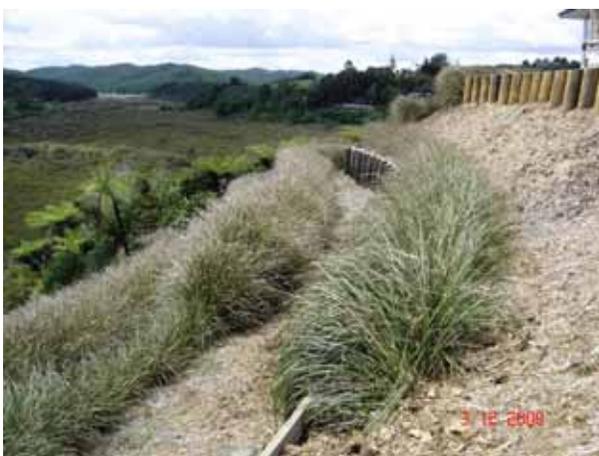
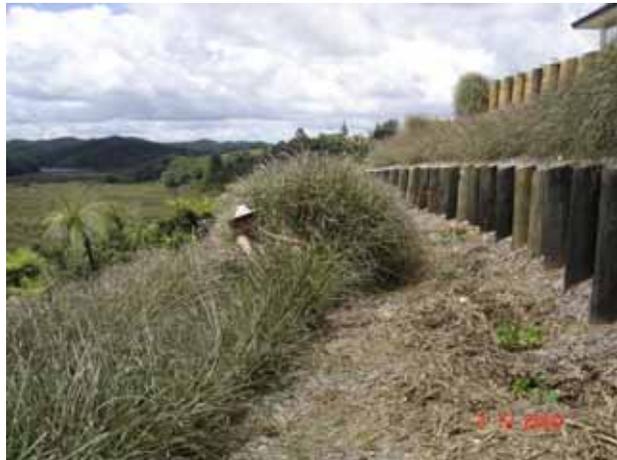
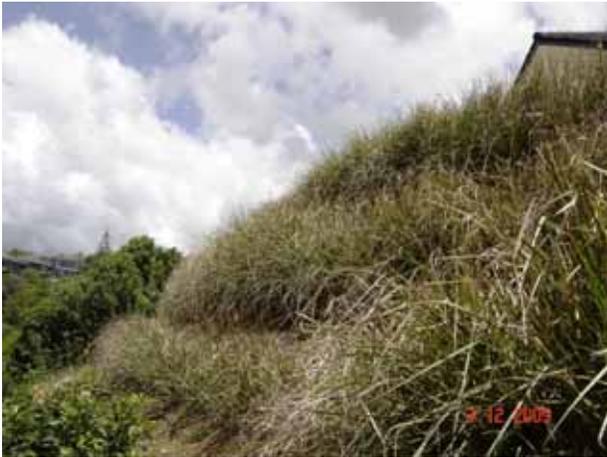
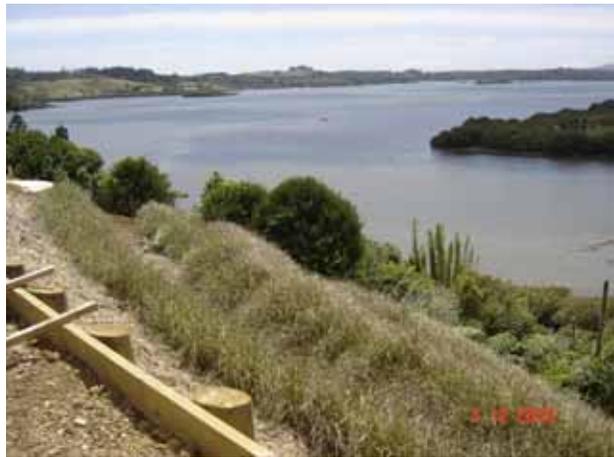
○ ***In Combination with Hard Structure:*** This project was implemented by Wendy Hamilton-Gates on a house block on a very steep slope on the bay. It has been completely stabilised and the owner is extending the planting area to protect a new house being built next door.

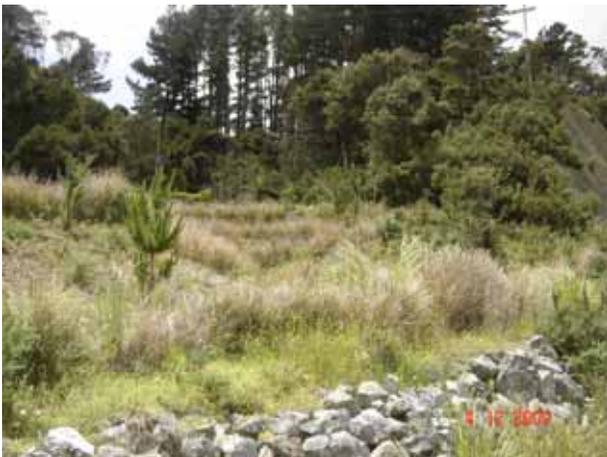
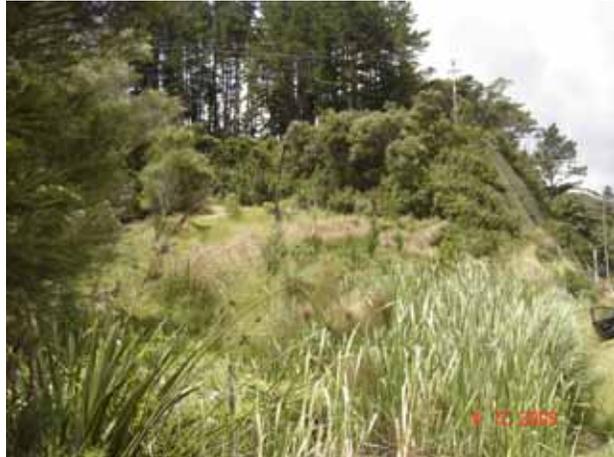
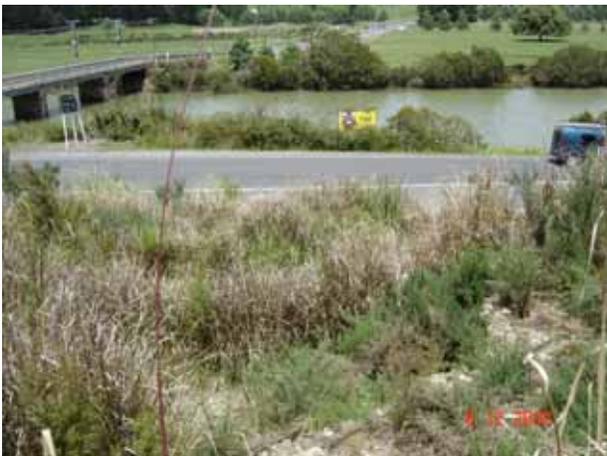
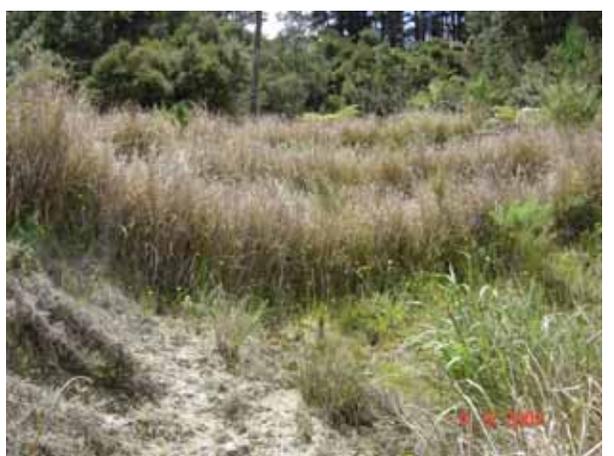
- **Landslide rehabilitation**
  - *Steep Slope* Vetiver was planted by Rick Fisher to rehabilitate this landslide on a very steep and highly erodible hill side.

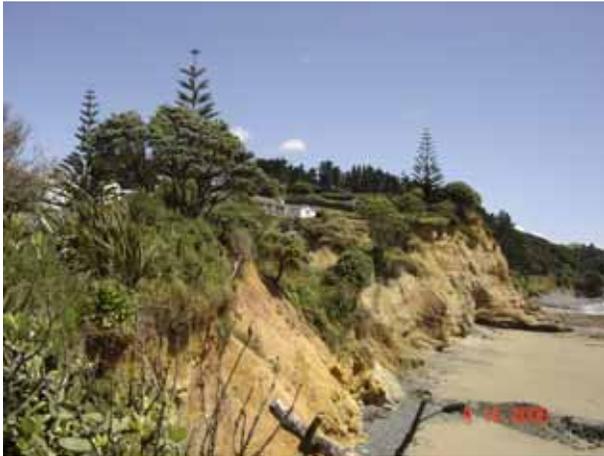
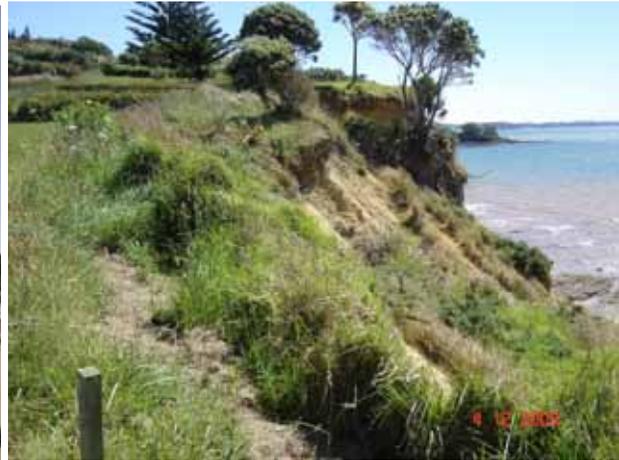
- **Beach Dune:** Under the guidance from John Greenfield, this project was implemented by Rick Fisher on a beach cliff to protect a large residential area. The soil/sand is very erodible under high rainfall and windy conditions. In addition, the strong wind also makes plant establishment very difficult.

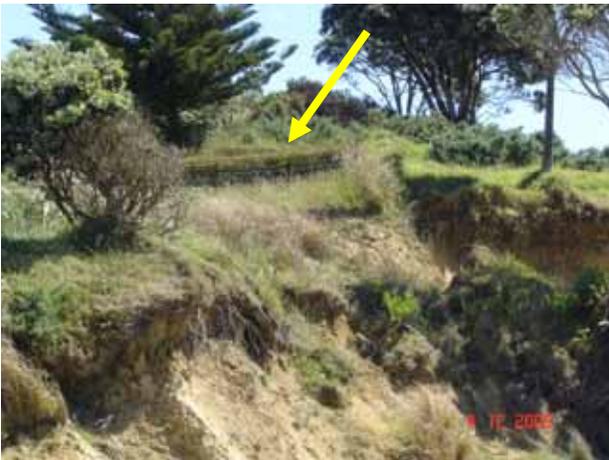
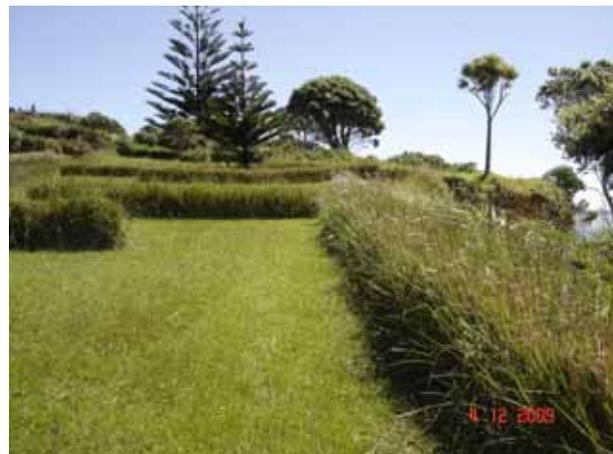
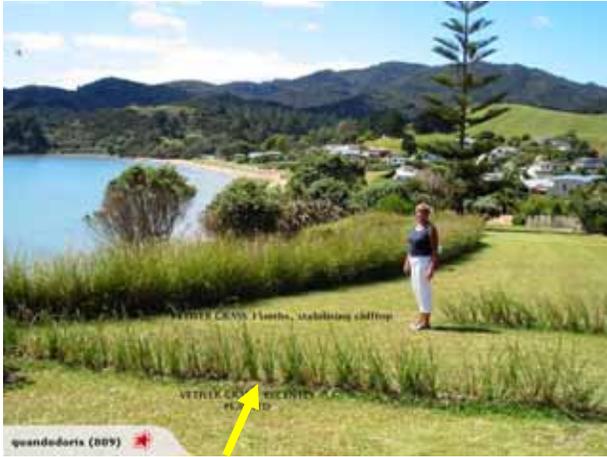
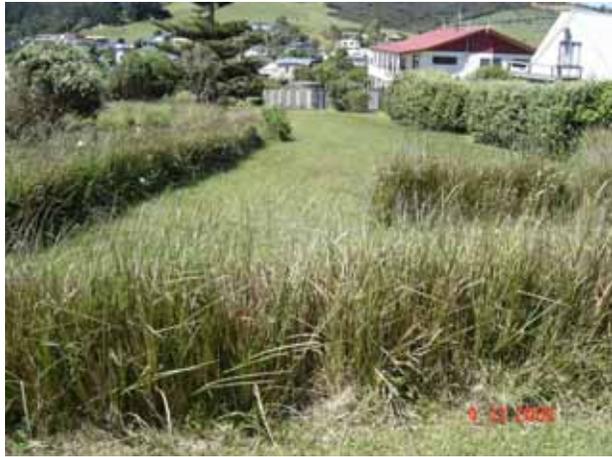
The erosion was caused mainly by urban development and tree clearing resulting in uncontrolled runoff to the cliff face. The strategy here is to protect the eroding cliff face from runoff water from the land above by diverting the runoff away from the cliff.

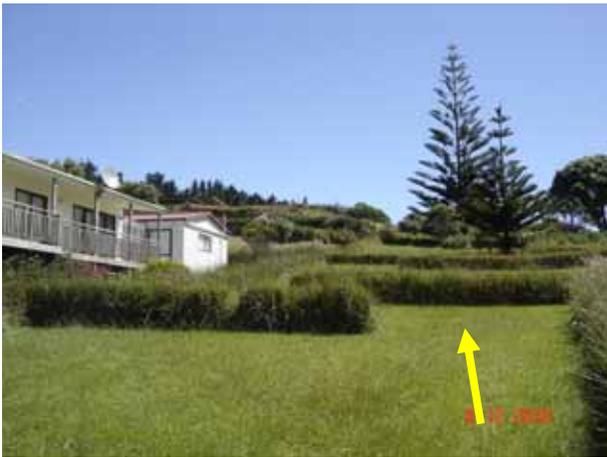
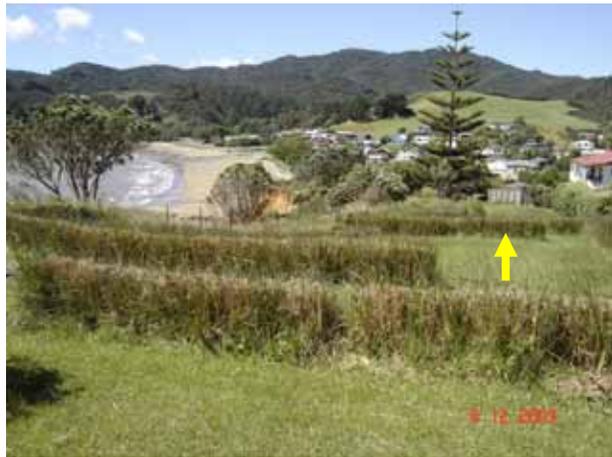
Planting short rows in zigzag pattern to reduce flow velocity on the long slope on the side of the cliff.

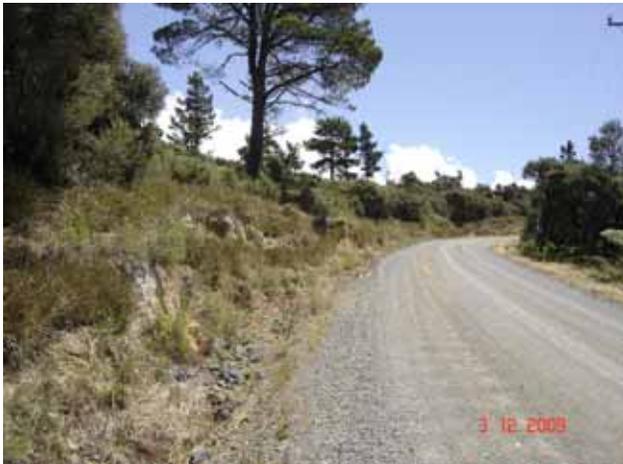
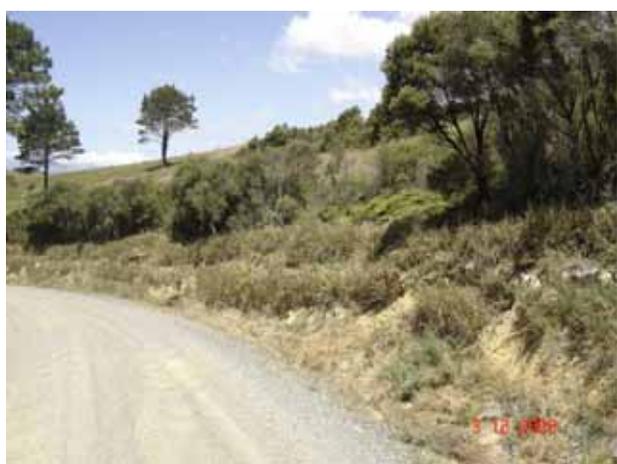
- **Road batter stabilisation**

This project was implemented by Rick Fisher on a highly erodible cut batter in Kerikeri. Four years after planting, if not protected by vetiver planting these batters would have collapsed a long time ago. Note only vetiver grew on this extremely poor soil, the land remained raw and bare of vegetation even after 3-4 years

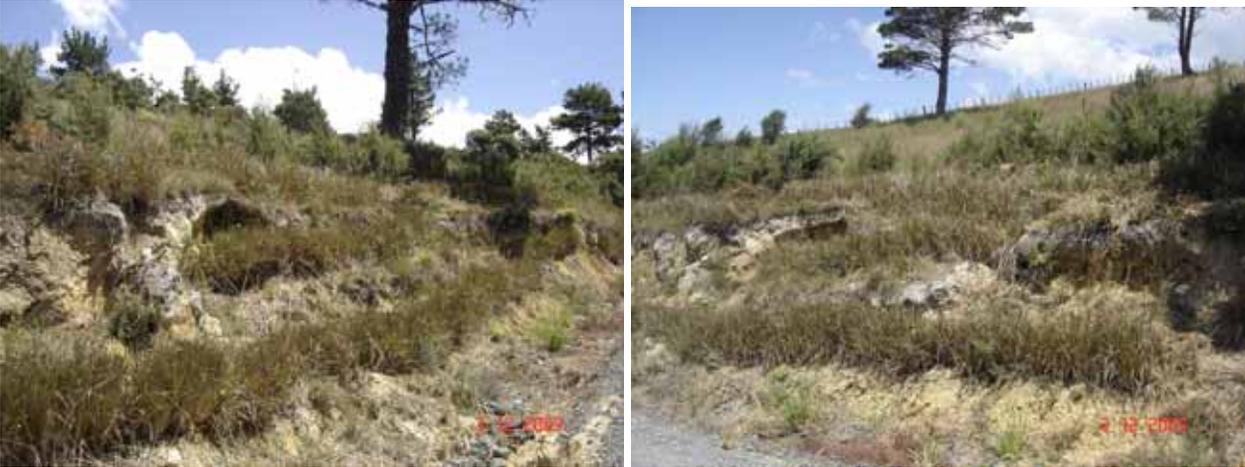
This drain is successfully stabilised by planting vetiver on the sides and in the drain. Note the vetiver was flattened but remained intact on the drain floor.

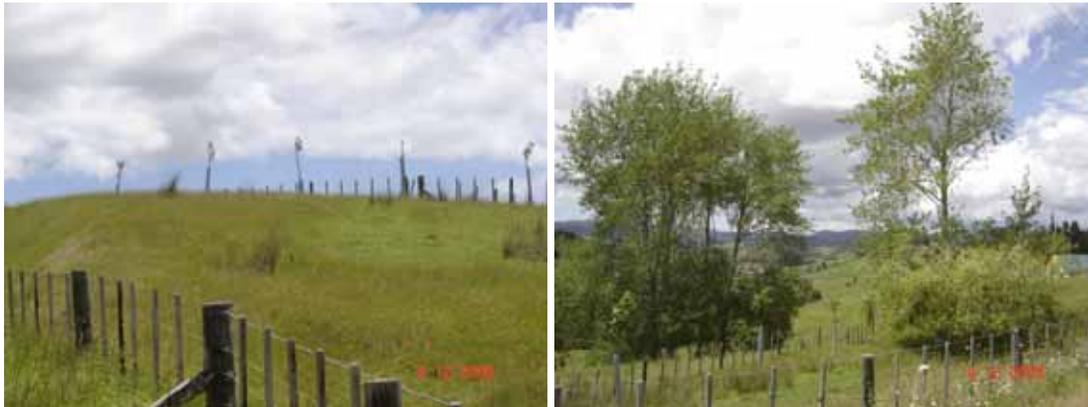
- **Current erosion control practice**

Current erosion control practice is planting Poplar trees on erodible site. In sharp contrast with VS, this practice is not only ineffective but often is the cause of erosion itself on steep slopes when the trees are toppled under the wet and windy conditions.
