Landfill Leachate Disposal with Irrigated Vetiver Grass

Abstract: Stotts Creek Landfill is a major waste depot of the Tweed Shire receiving wastes from both Tweed Heads and Murwillumbah townships and neighboring local government areas. Disposal of leachate is a major concern of the Shire as the landfill site is close to agricultural areas. An effective and low cost leachate disposal system is needed, particularly during summer high rainfall season.

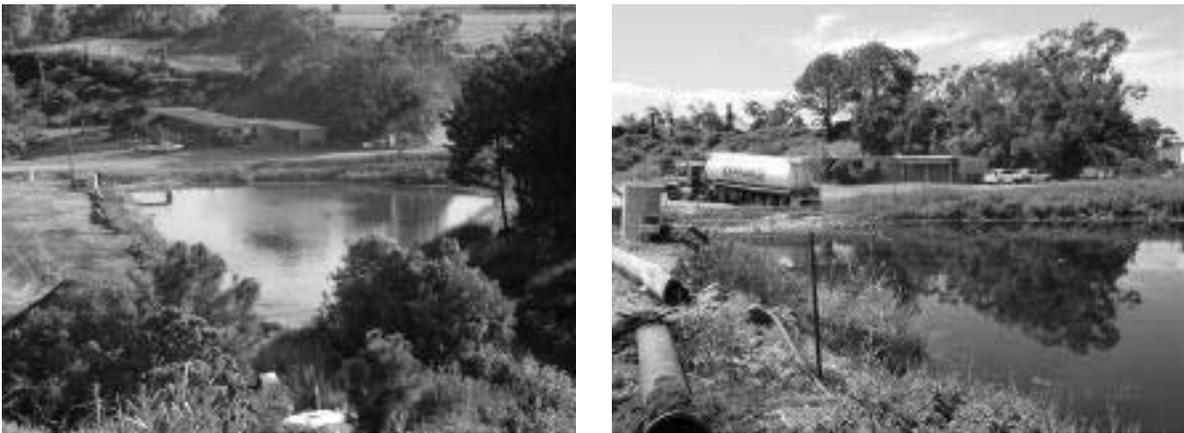
Photo 1 Leachate pond and excess leachate is taken away during high rainfall period

Currently both leachate and surface water are separated where possible to reduce the volume of leachate. The surface water is discharged to local streams via an artificial wetland, which was constructed to help improve the water quality leaving the site. The leachate is stored in a dam in the lower portion of the site and is irrigated onto completed and partially completed sections of the landfill to provide for evaporation and transpiration into the atmosphere. The amount of leachate able to be disposed of by this method is limited, particularly during high rainfall periods. During periods of heavy rainfall, excess leachate has to be transported off site to Council's effluent treatment plan. Although this practice is very inefficient and costly, it has to be done for Council to comply with Environment Protection Authority License Conditions. Therefore effective disposal of leachate is a major concern to Council (Photo 1).

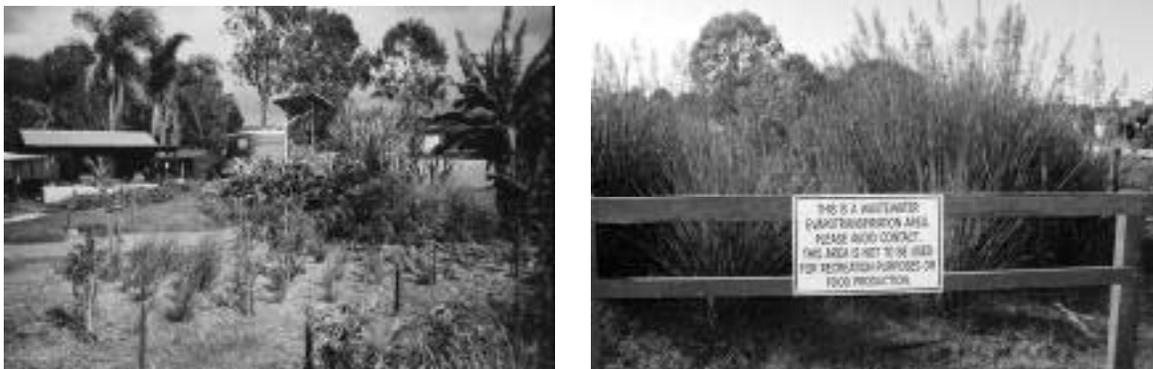
Photo 2 *Left*, new vetiver planting to treat sewage effluent from a septic tank, *Right*, 8 months later, vetiver completely absorbed all the effluent discharge

A demonstration site was set up in Brisbane to treat effluent discharged from a septic system. Vetiver grass was selected after the failure of other plants including a variety of fast growing tropical grasses and trees, and crops such as sugar cane and banana to absorb the effluent discharge from the septic tank on a public park. After five-month growth, vetiver was more than 2 m tall and a stand of about 100 vetiver plants in an area less than 50 m² have completely dried up the effluent discharge (Photo 2).

Groundwater monitoring (collected at 2m depth) showed that after passing through 5 rows of vetiver the levels of total N reduced by 99% (from 93 to 0.7 mg/L), total P by 85% (from 1.3 to 0.2 mg/L), and faecal coliforms by 95% (from 500 to 23 organisms/100 ml). These levels are well below the following thresholds set out in ARMCANZ and ANZECC (1997).

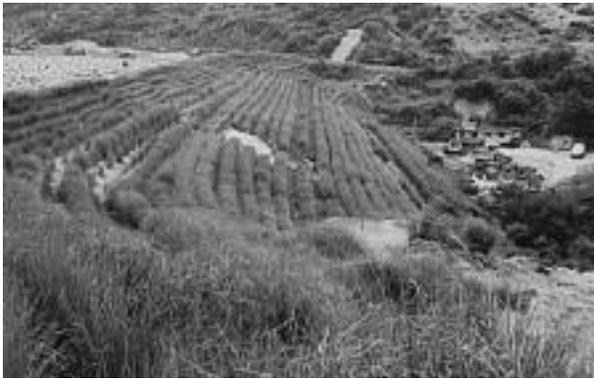
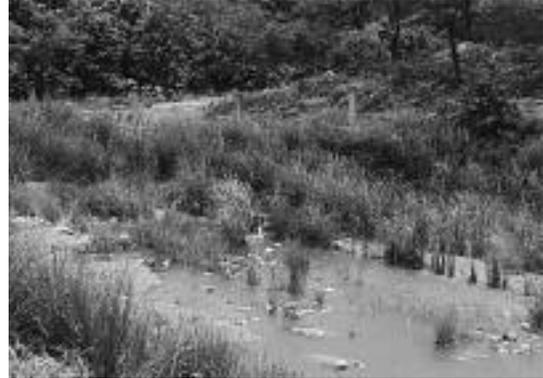
Photo 3 *Left, Vetiver planted for leachate seepage control and dam wall stabilisation*
Right, Vetiver grew well in toxic leachate pool while other plants died

Vetiver was planted in November 2000 to stabilise the dam wall and to reduce seeping leachate. Despite the extremely poor soil (crushed weathered rock, highly compacted and extremely poor in nutrients) vetiver established and not only succeeded in stabilizing the dam wall, it has also dried up leachate seepage. Vetiver also grew well on the edge of highly toxic leachate pools; both native and introduced plants were killed (Photo 3) (Xia *pers. com.*). In Thailand vetiver was also used successfully to treat landfill leachate seepage.

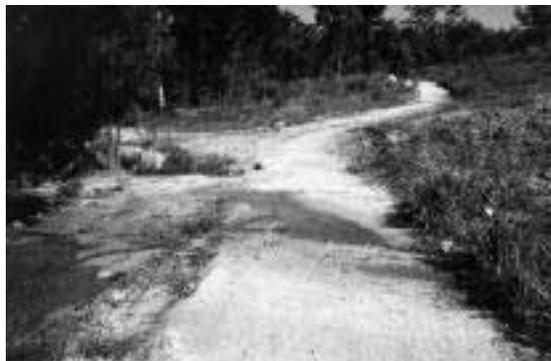
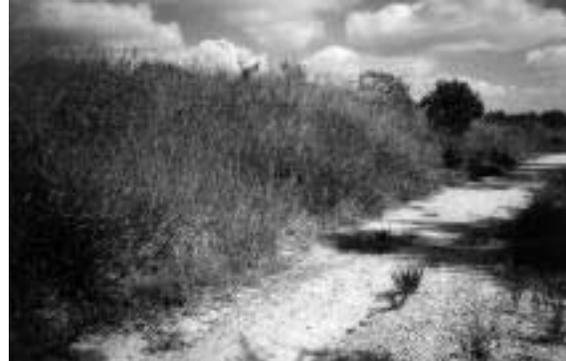
Photo 4 *Left, Toxic leachate seepage at the foot of an old landfill at Cleveland*
Right, One year after planting, Vetiver grew well and dry up the seepage

VS has also been used successfully to treat leachate from landfill seepage in Cleveland (Photo 4) and Port Douglas in Queensland; Armidale City (Photo 5) and Lithgow City in New South Wales.

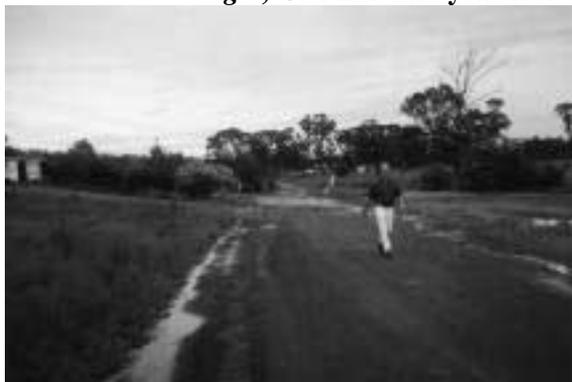
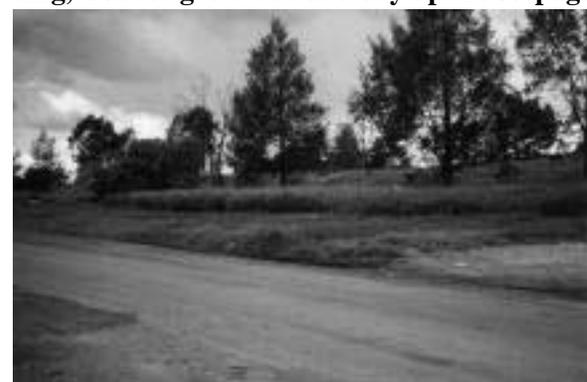
Photo 5 *Left, Toxic leachate seepage at the foot of an working landfill at Armidale*
Right, One and half year after planting, Vetiver grew well and dry up the seepage

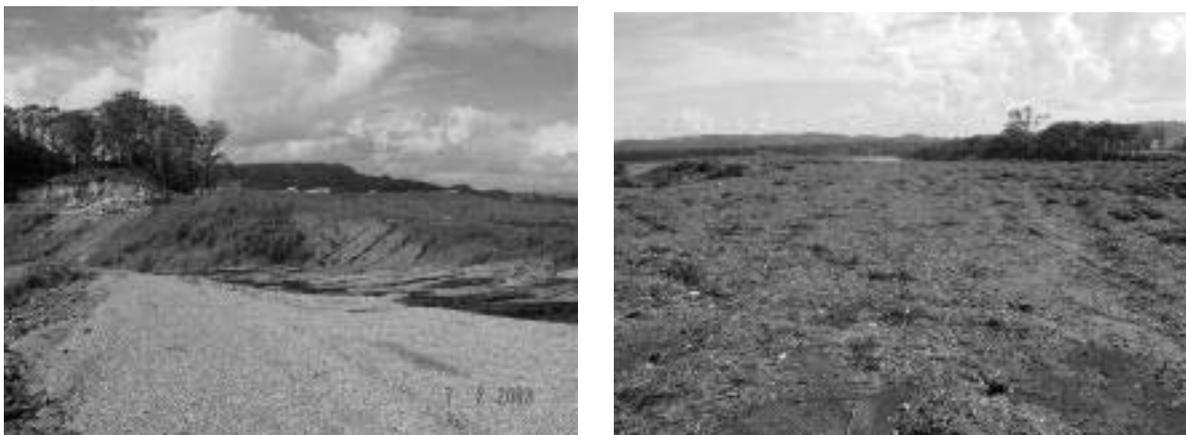
Photo 6 Side view (left) and top view (right) of the landfill mound, which has been mulched

When the designed height was reached, the mound top surface was first capped with a thick layer of impervious clay and then topped up with topsoil and organic mulch. The planting area consists of a short northern slope (100 m) of about 15% gradient and a longer (300 m) southern slope of 10% gradient, both slopes drain to a flat area near the middle where excess rain water will be collected and drain off the mound to the storage ponds (Fig.1 and Photo 6). Because of this gradient vetiver was planted on contour lines to spread irrigated and rain water evenly down slope.

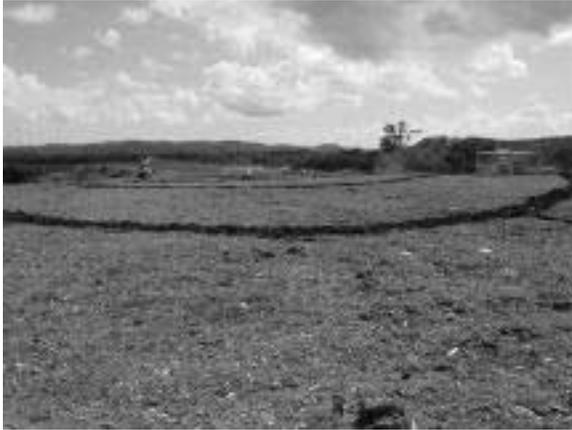
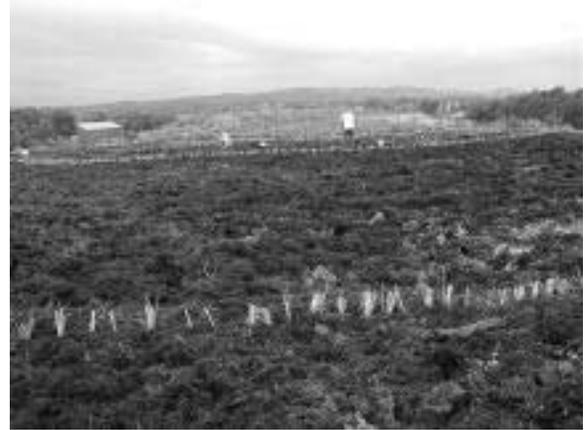
Photo 7 Contour lines marked before planting (left) and after planting (right) on the mound

The whole area was first surveyed and contour lines marked out before planting. Due to the thick layer of mulch, a small backhoe was used to mix up the mulch and topsoil for planting (Photo 7).

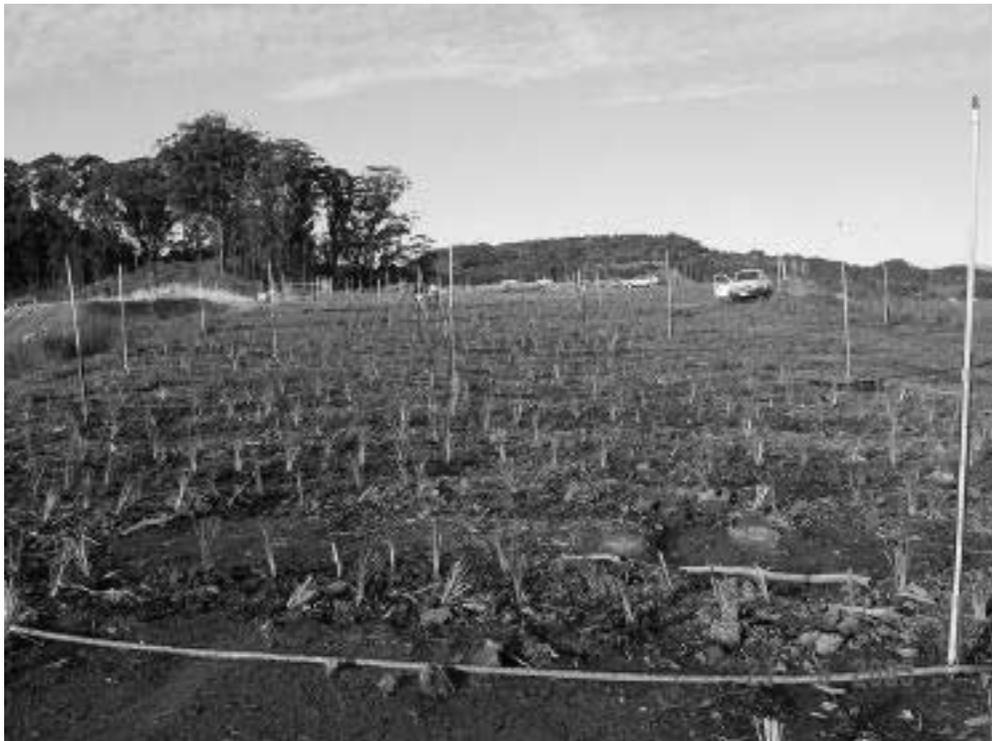
Photo 8 Random planting between contour lines

- Thick contour hedges (10 plants/m) to spread runoff and irrigation water, the contour lines were planted at 0.5 m Vertical Interval. Vetiver tube stock was used for the contour lines planting.
- Random pattern in the areas between the hedges planted with bare root slips (Photo 8).

The overall planting density is at 5 plants per square metre. Due to the variation in nutrient levels of the leachate, Di-Ammonium Phosphate was used at the rate of 500 kg/ha at planting.

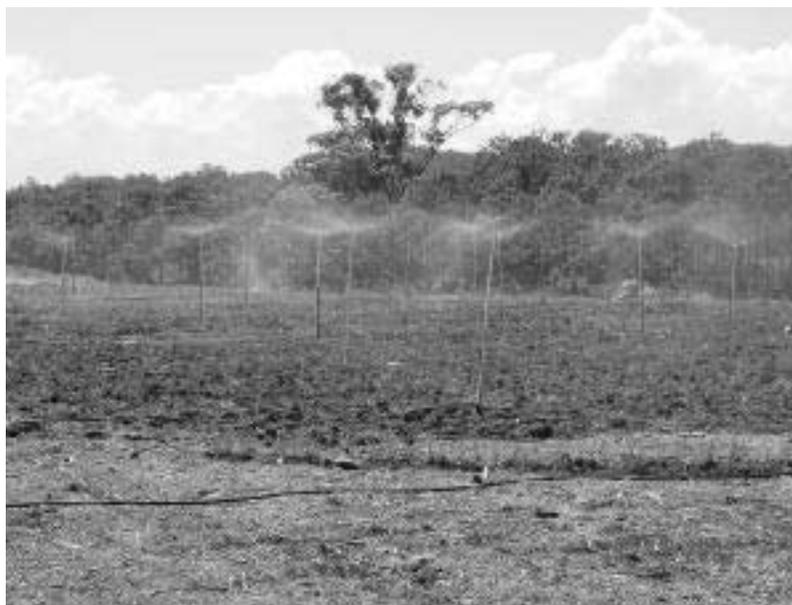
An overhead spray irrigation system was installed and used immediately after planting each day. This system has a capacity of delivering 1300 L/min (Photo 9).

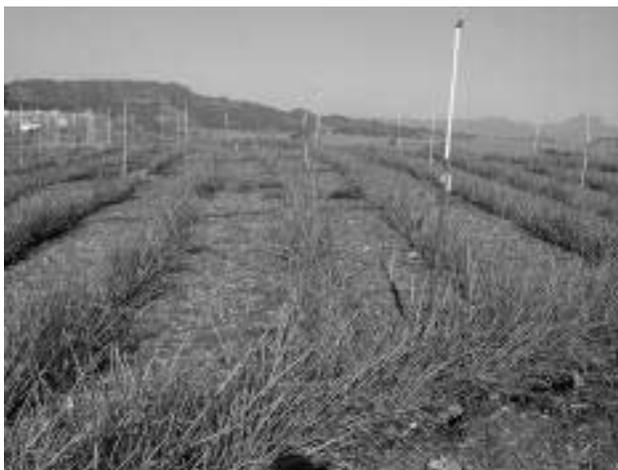
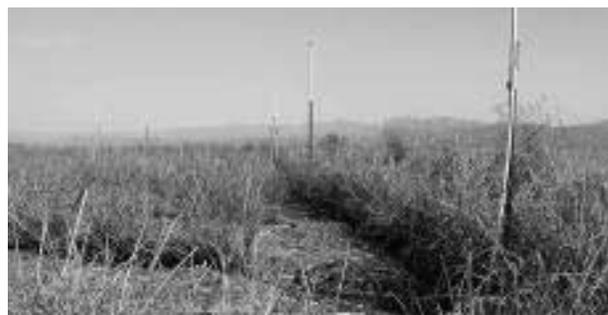
Photo10 Excellent establishment and growth three months after planting

Excellent establishment was obtained on the contour lines with potted vetiver (100%) and very good rate (90%) were also achieved with bare root slips (Photo 10).
