Coastal Dune Stabilisation in Central Vietnam

Tran tan Van¹, Elise Pinners², and Paul Truong³

This paper reports only the coastal dune stabilisation work in Quang Binh province, Le Thuy district. The site is a few hundreds meters from a group of sand dunes bordering a small river. The local authority has built a number of sand dikes to protect farmland from floodwater but these dikes are very unstable and mostly barren, only some *Casuarina spp* and wild pineapples are found on these dikes.

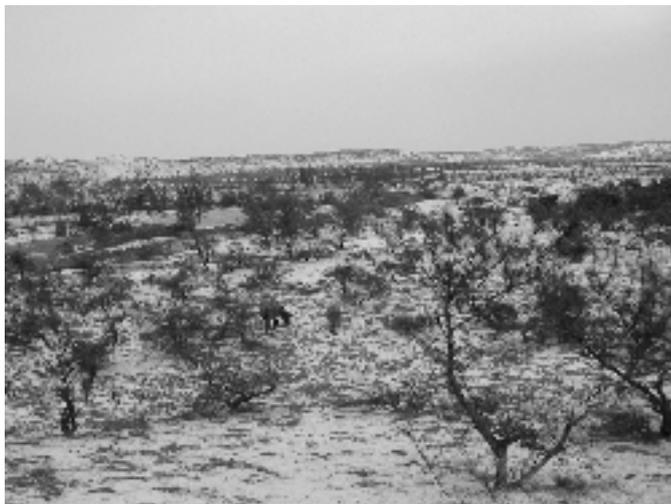
Photo 1 Typical coastal dunes with planted *Casuarina* in Central Vietnam

Farmers in Central Coastal Vietnam are regularly confronted with flood or storm related damage to their farmland, and have to spend much of their time and money to restore badly damaged structures. The measures they used are not effective enough (e.g. stabilisation of dykes by local grass, which are easily uprooted by flood, or small waves) or of short-term measures such as blocking sand dune flow by sand dikes, which themselves are poorly stabilised due to lack of vegetation cover (Photo1).

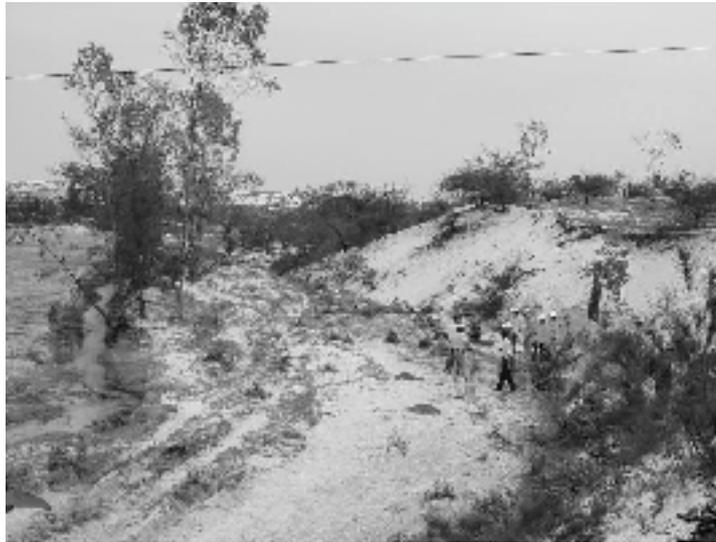
Photo 2 Overview of the riverbank on the left and the sand dike on the right before planting

Farmers have to protect their farmland against sand intrusion from the dunes and the dikes. The erosion was so bad that when it rains they even had to get up at night to guard the dikes (Photo 2).

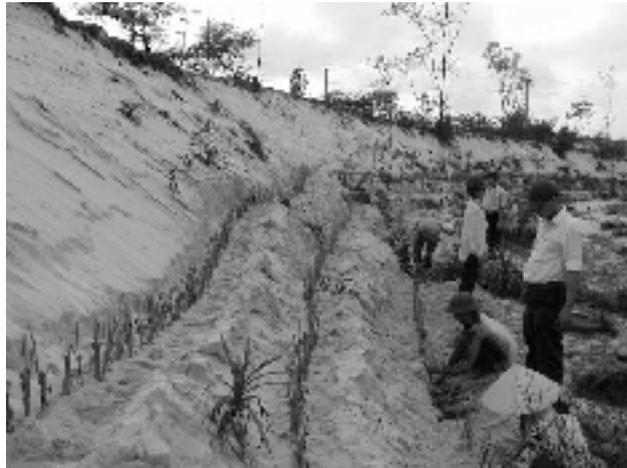
Photo 3 Planting during the dry season and watering is needed until rain

The initial planting started early in March 2002, during the driest and hottest part of the year so it had to be watered until rain. Three rows 60 m each were divided in two trials, on one side (30 m) only bare root slips were used ; on the other side (30 m) potted plants were used in the upper line, and 5m on the 2nd line. Planting density was at 10 plants/m and cross rows at 1m above the wet sand (Photo 3).

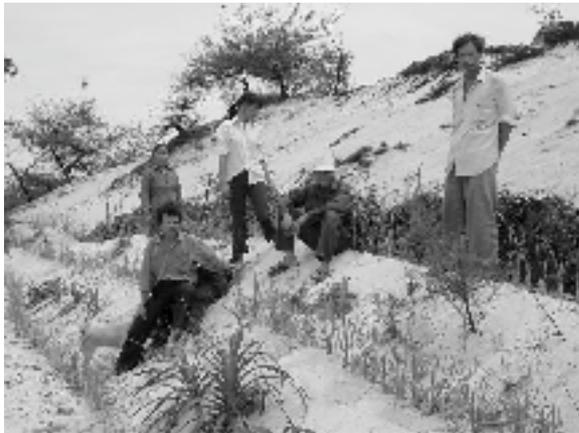
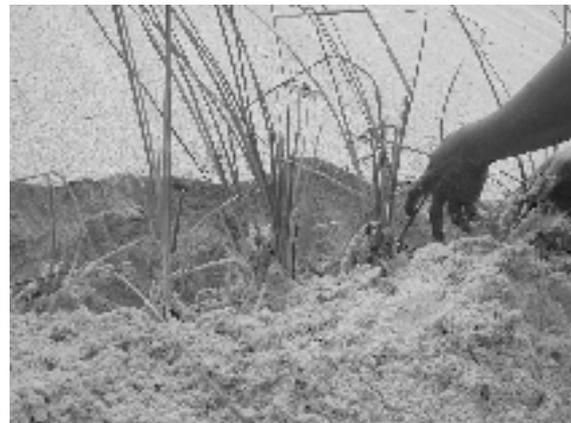
Photo 4 Shifting sand buried vetiver 200 mm deep in 4 weeks

Vetiver grass established and survived in sand dunes, but whether it can survive the hot and dry summer that is unbearable even for people (Photo 4). Plants in the nursery also grew well (Photo 5).

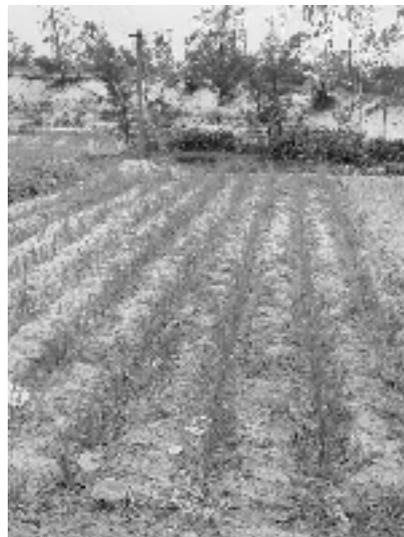
Photo 5 Very healthy nursery next to the dune

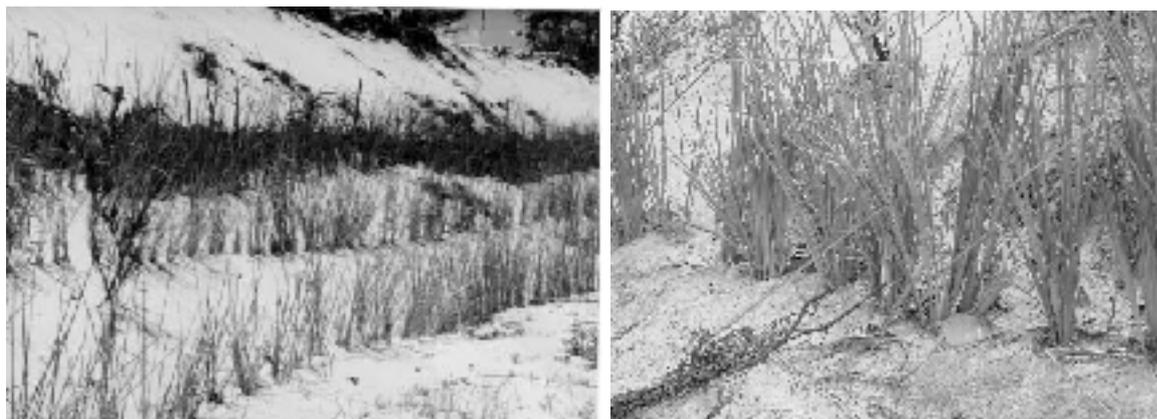
Photo 6 Left, Unfertilised plant and Right, fertilised plants

The unfertilised grasses survived but did not grow or multiply vigorously. On contrary, vetiver grew well producing strong and healthy growth. A fence from dry Casuarinas branches was installed to prevent the sand from sliding, this promoted better growth. Evidence of small sand slips are very clear, with the grass row becoming pushed out of line. Some whole individual clumps even slid down a little

bit, showing their root system is not yet deep enough. It might have also taken time for them to re-establish which explains why they look smaller and lower than other unaffected plants (Photo 6).

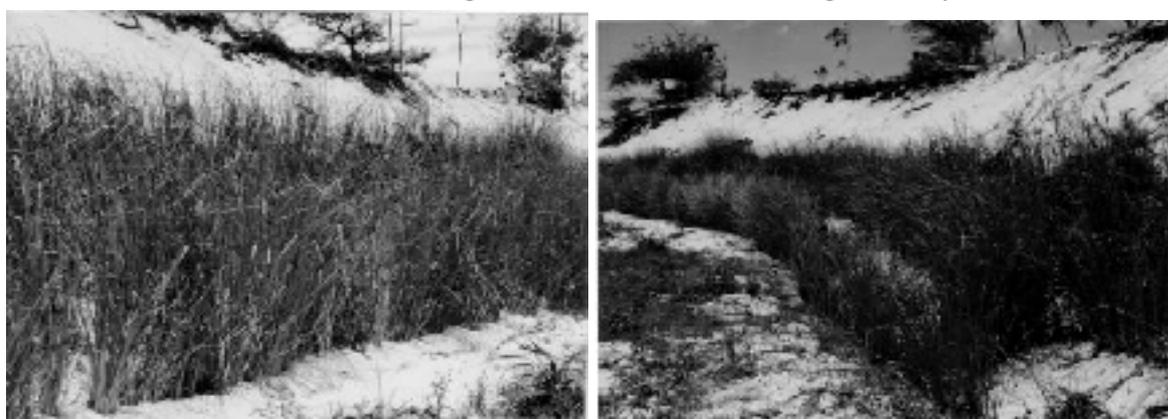
Photo 7 Excellent growth after 4 months, during the rainy season

The nursery plants are very good, green, strong and straight, no dry leaf. Fertilizer was applied once (NPK + manure mix). Clumps have maximum up to 30 tillers, usually 10-20 tillers (Photo 7).

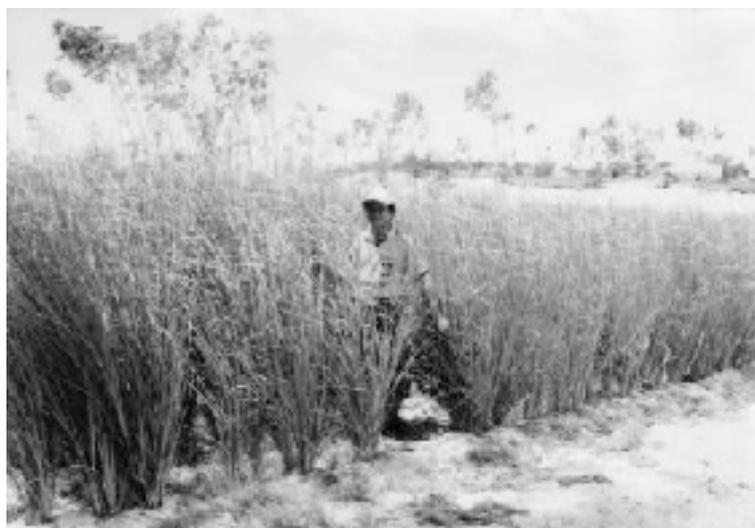
Photo 8 Excellent growth in nursery after 4 months

The nursery looks very good, green, strong and straight, no dry leaf. All are up to 1.5-1.7 m high. Many tillers have become mature with a lot of noded culms (Photo 8).

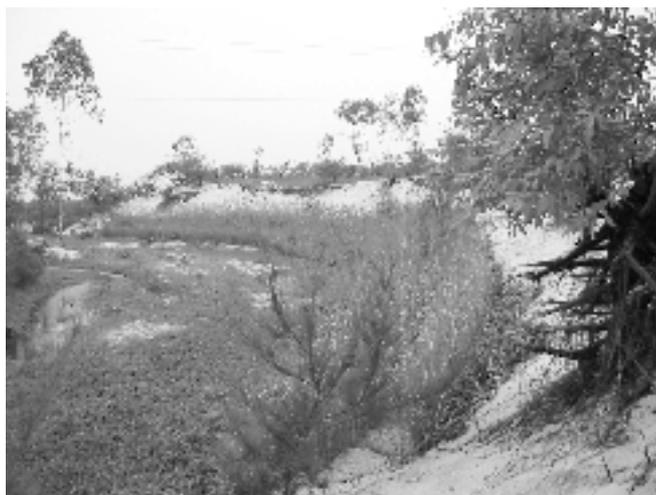
Photo 9 Seven months after planting, note other plants grew between and below vetiver hedges

- The Vetiver hedgerows become so dense. All gaps in between (especially in the two upper rows) are closed. All farmers, including directors and technicians of the Forestry Enterprise, are now convinced that the hedgerows could stop the sand dune from moving (Photo 9).
- Even the young Casuarinas and wild pineapple planted before, in between the grass, looks fresh and green, probably due to moisture that the grass helps to retain in the sand.
- A hole was dug to see how deep the root system could reach. The hole was almost 1 m deep but the roots still continued; the wall started collapsing so it was not sure how deep the roots grow (Photo 10).

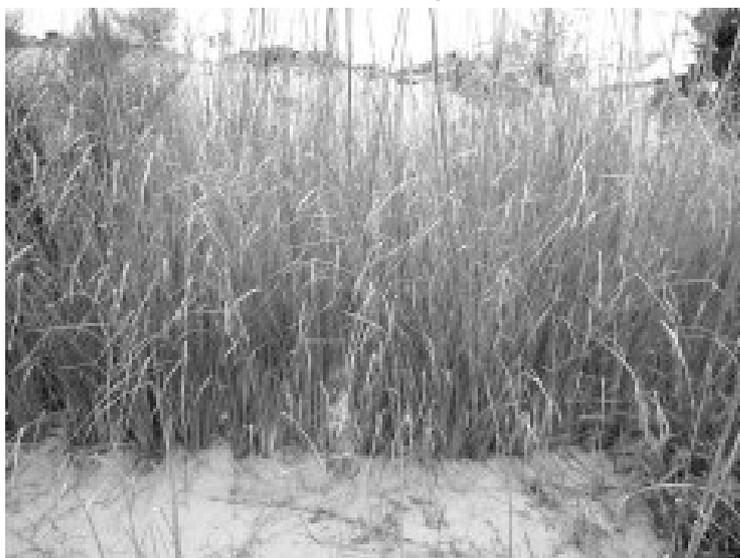
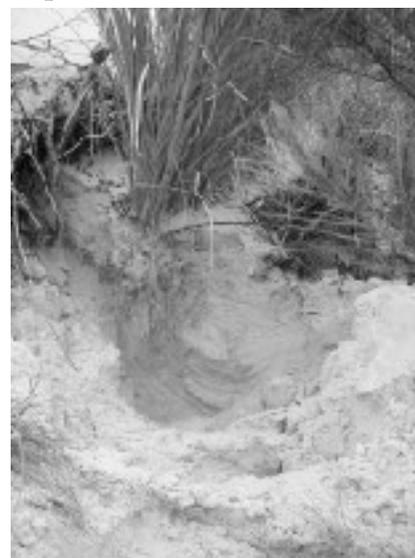
Photo 10 Thick growth and roots was much deeper than 1 m

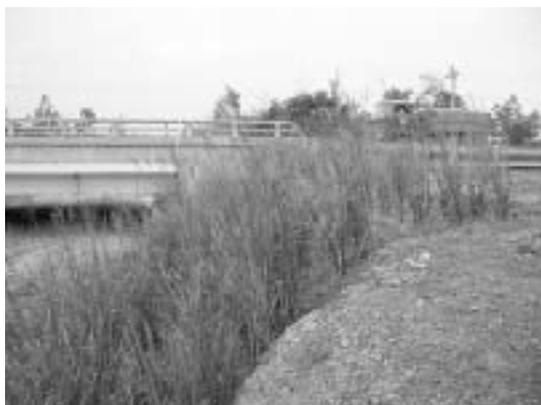
Photo 11 A well-stabilised bridge abutment on Highway 1 in Quang Binh province

- The first incident involved the local authority, the provincial Enterprise director, who was very impressed and completely convinced about the effectiveness of the VS. When a new bridge on Highway 1, which passes by his headquarter office, was completed there was no protection for the bridge abutment against the coming flood season. Concerned about the weather and the threat of floods, he made an executive decision of ‘commandeering’ some vetiver grass (2 rows) from the nursery and planted on the bridge abutment. Although he did not follow the manual he planted correctly the grass, all survived this transplantation and successfully stabilised the bridge abutment (Photo 11).

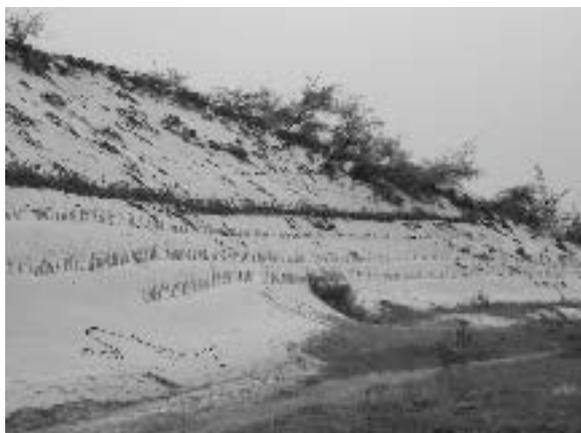
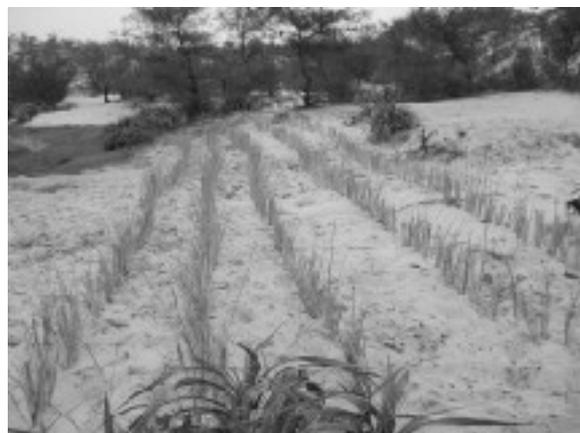
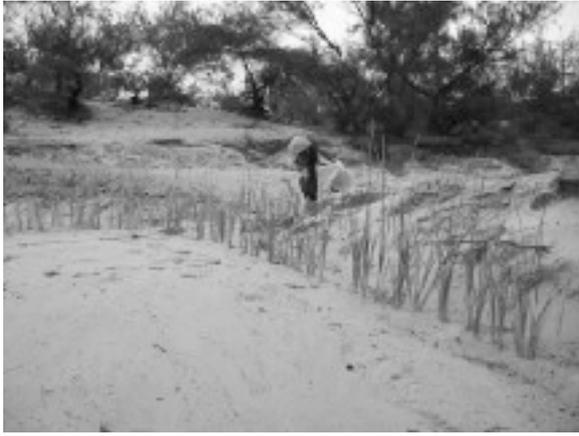
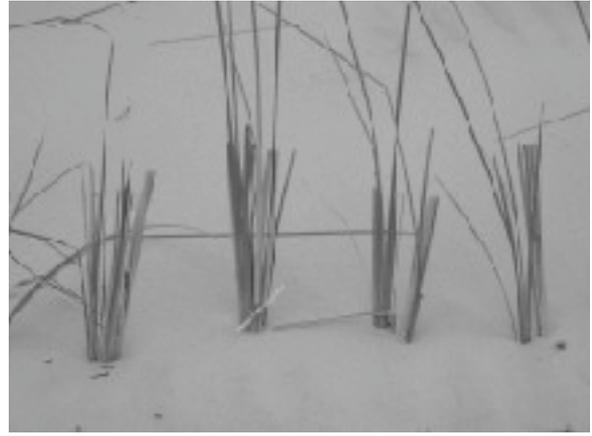
Photo 12 One month after planting

Initially the nursery had 14 rows, giving in total about 30,000 slips, sufficient for about 1.5-2 km planting. But due to the two incidents mentioned above 1000m were planted in October 2002 at three sites. This was at the beginning of the rainy season, one month later all the grasses established well (Photo 12).
